# Building and Timber Pest Inspection Report

Inspection Date: Wed, 4 Mar 2026

Property Address: 20 Ravenswood Rise, Bella Vista NSW 2153, Australia

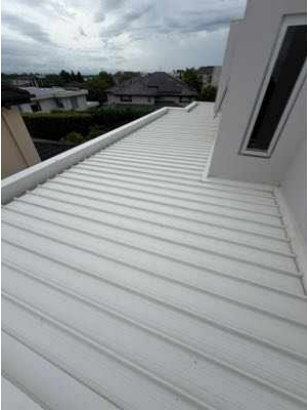
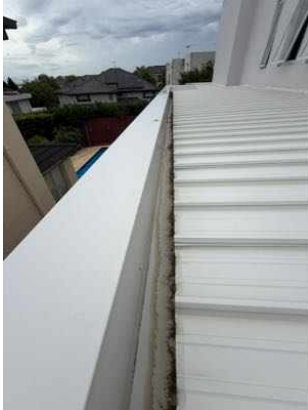
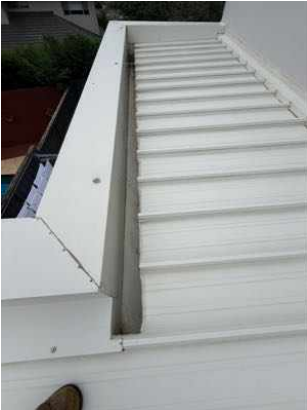
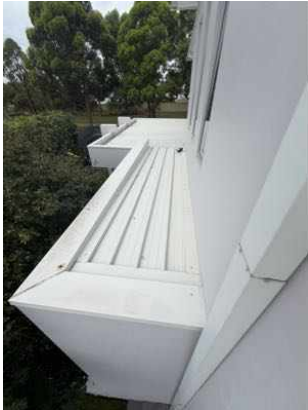
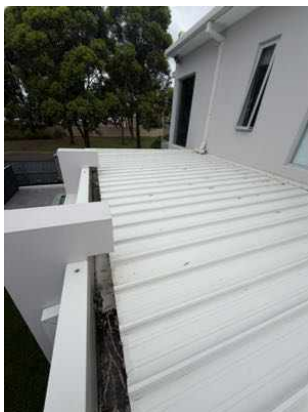
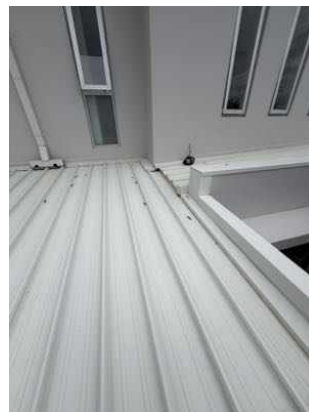
Building: Main Building  
Location: Roof Exterior  
Finding: FYI-Roofing Condition  
Information:

It should be noted that a building inspection is limited to a visual assessment only, and not all areas of the roof may be safely accessible or visible at the time of inspection. As such, the long-term performance of the roof covering cannot be guaranteed.

Based on the observations made during the inspection, the roofing appeared to be serviceable and performing as intended at the time of assessment. Regular maintenance and periodic roof inspections are recommended to help ensure the roof covering continues to perform effectively over time.

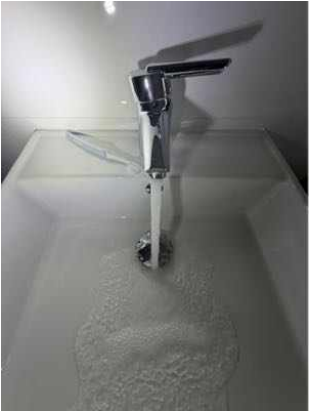
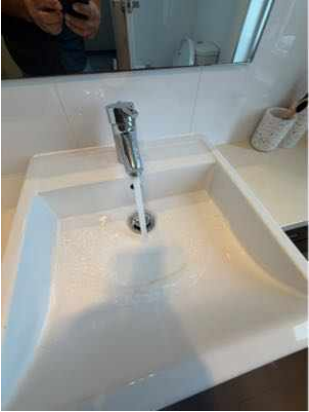
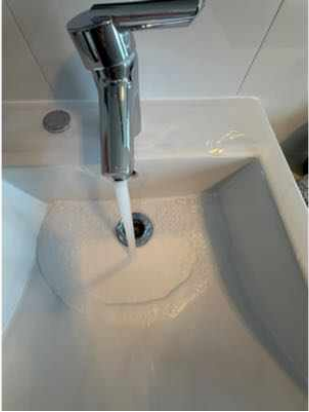
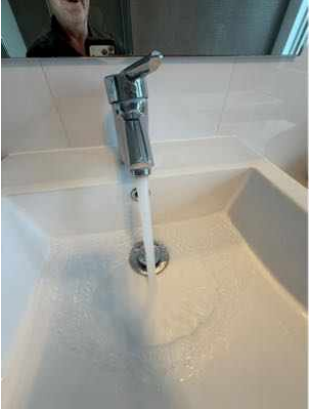
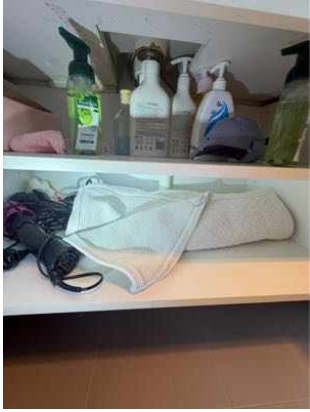
Building: Main Building  
 Location: Cabinetry Plumbing  
 Finding: FYI-Cabinetry Plumbing  
 Information: All cupboards where sinks and basins with drainage plumbing were inspected no evidence of leaks were present at the time of inspection.

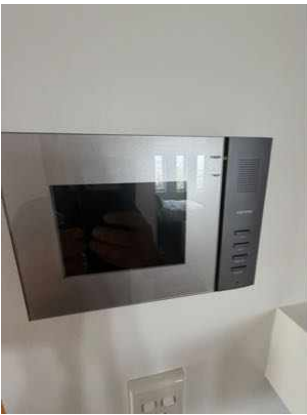
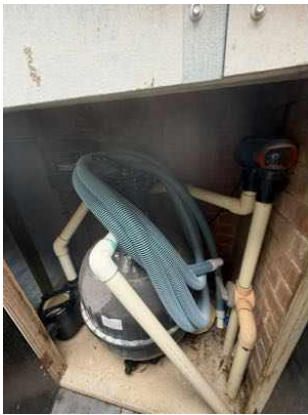
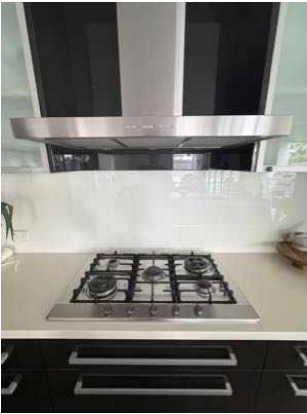
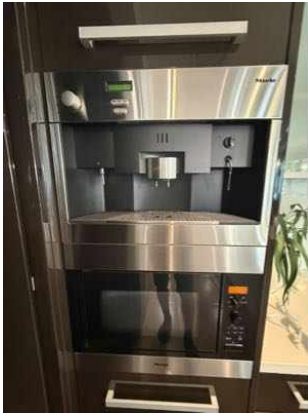
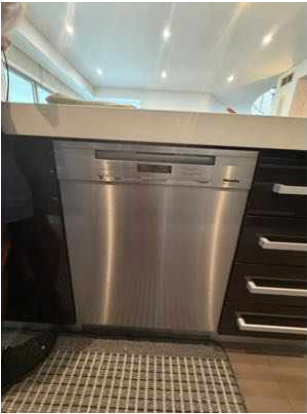
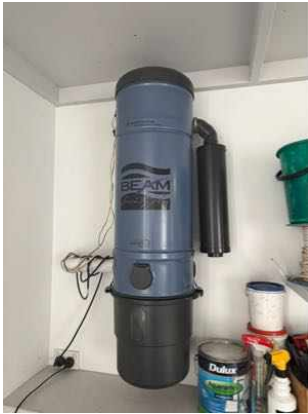
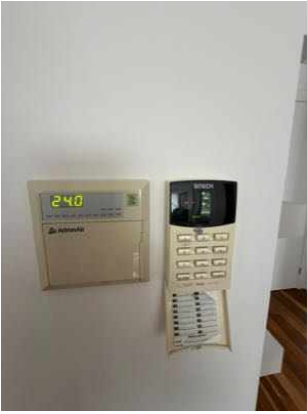
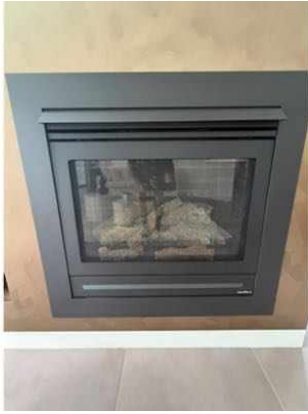
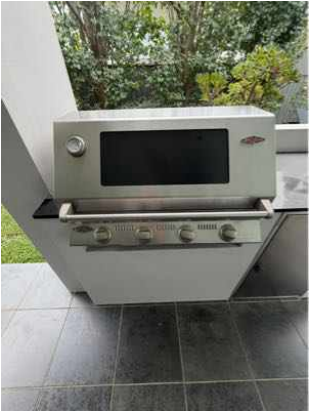
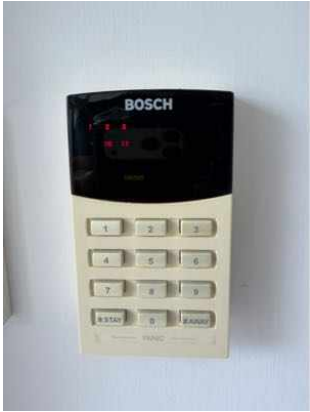
Building: Main Building  
Location: Plumbing/electrical/gas/aircon/pool equipment etc  
Finding: FYI-Plumbing and Electrical  
Information: Plumbing and Electrical inspections are outside the scope of the building inspection and must be conducted by a licensed and registered trades person.

It is highly recommended that the client makes immediate arrangements to have the gas appliances checked by a licensed gas plumber to ensure that the appliances are working safely and efficiently.

We recommend all other installations be checked also.

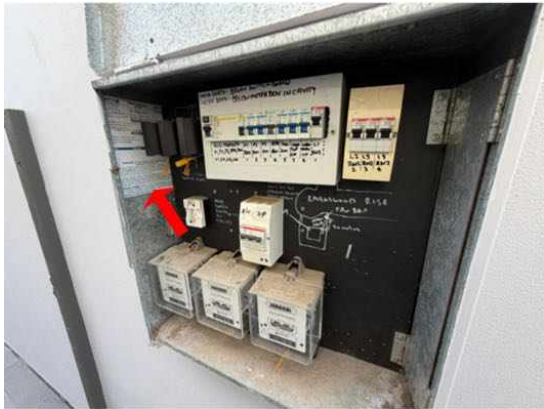
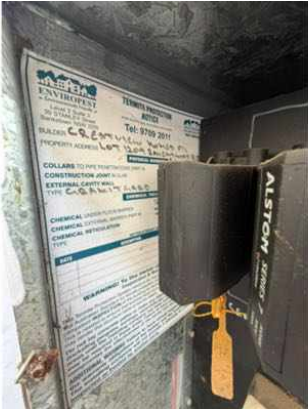
Where a Termite Management System has been identified you should refer to the type of barrier date of installation warranty conditions and any documentation provided by a builder or past owner. Consult the company who installed the barrier to confirm whether the system is still under warranty.

Most chemical termite management systems expire and require replenishment and all physical systems are primarily designed to prevent concealed entry.
