Building Inspection Report

Inspection Date: Thu, 26 Feb 2026

Property Address: 9 Franklin Court, Sheidow Park SA 5158,
Australia

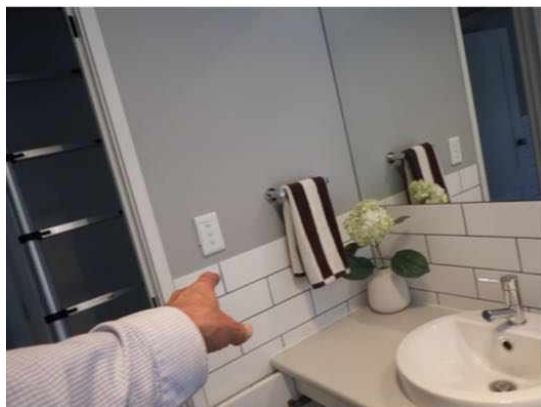
Defects 1.01

Building: Building 1
Location: Bathroom 2
Finding: Electrical fitting - Broken
Information: The electrical fitting in this bathroom-2 area was found to be broken at the time of inspection. Breakage occurs generally when the building materials have aged and decayed, but may also be indicative of impact damage to the building element (accidental or deliberate).

Left unmanaged, the fitting is unlikely to cause further damage to surrounding building elements. However, the broken fitting does expose electrical works, and may create a safety hazard if there is potential contact with persons in the area.

Repair and/or replacement of the broken fitting is advised. A Licensed electrician should be appointed to repair/replace the fitting immediately.

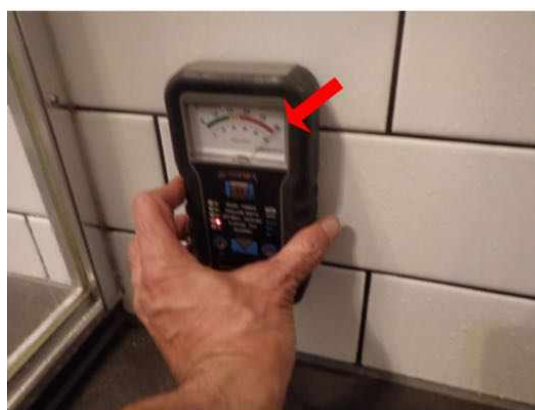
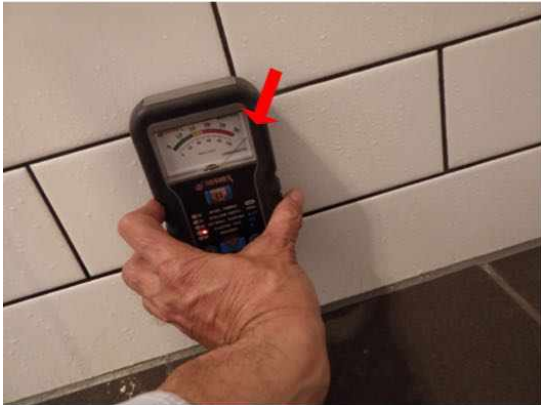
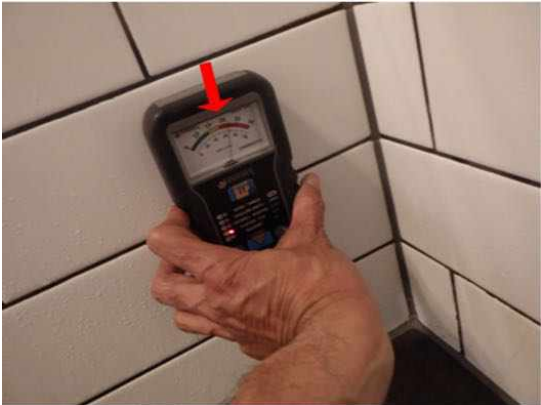
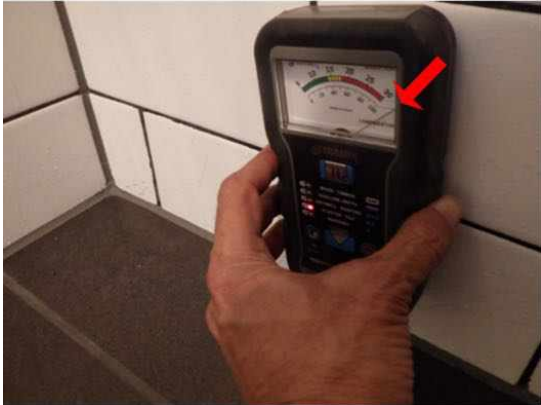
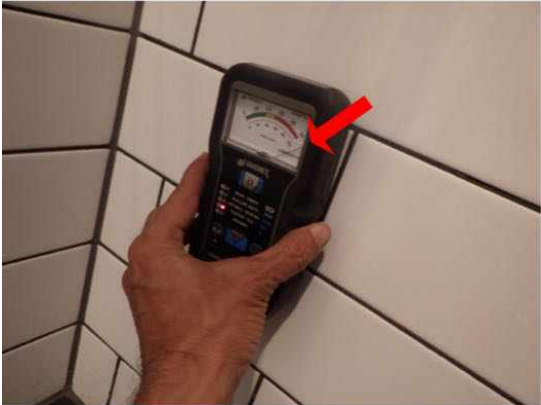
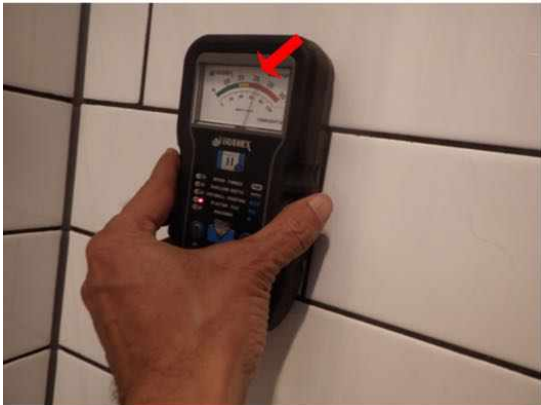
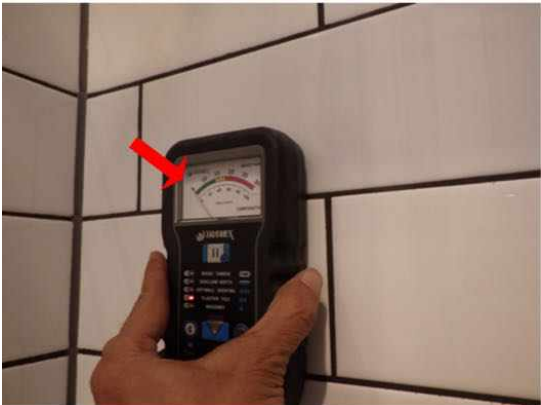
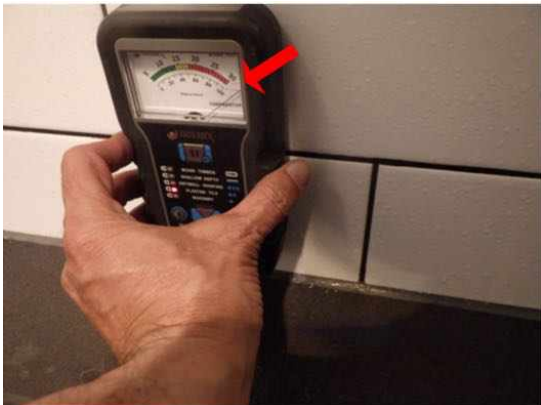
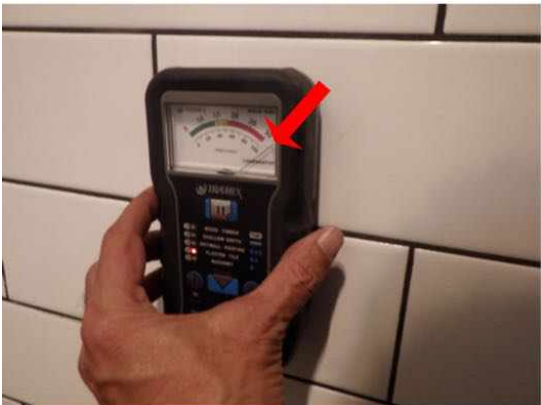
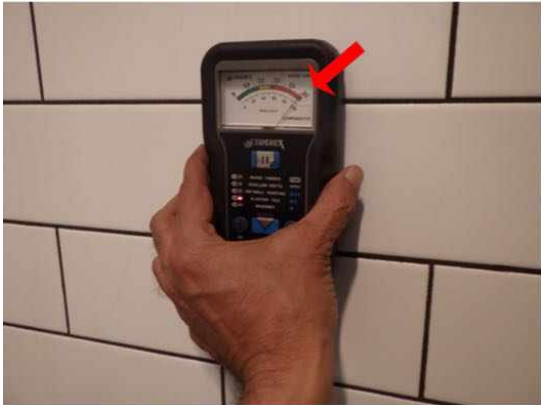
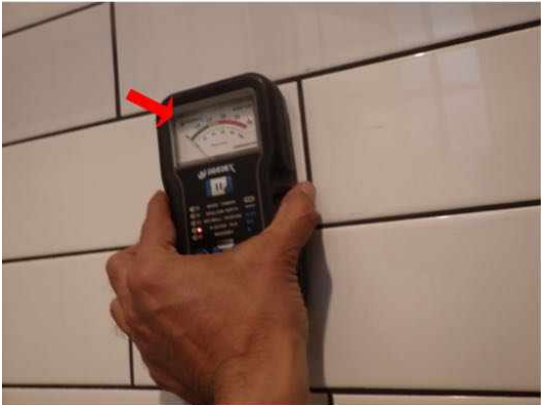
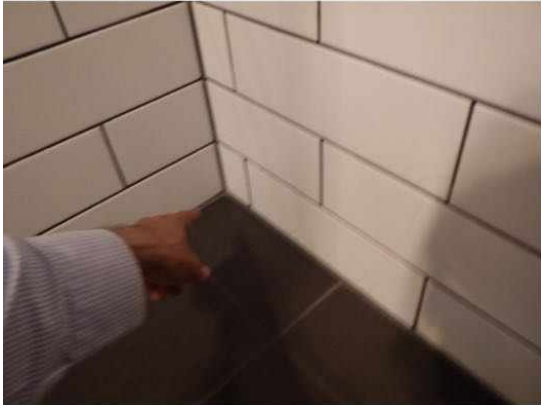
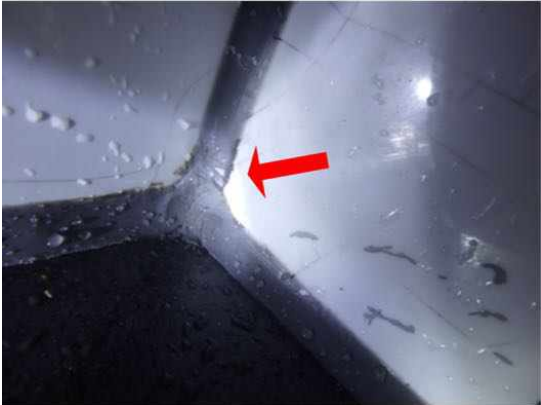
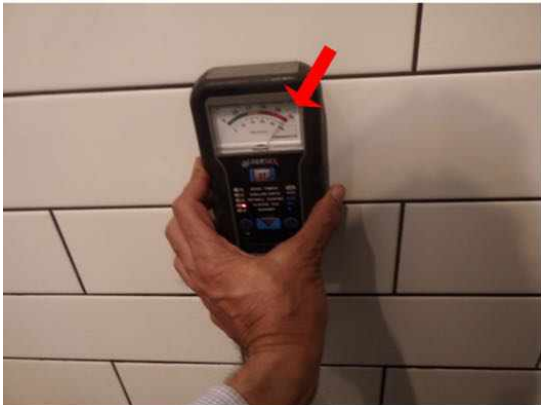
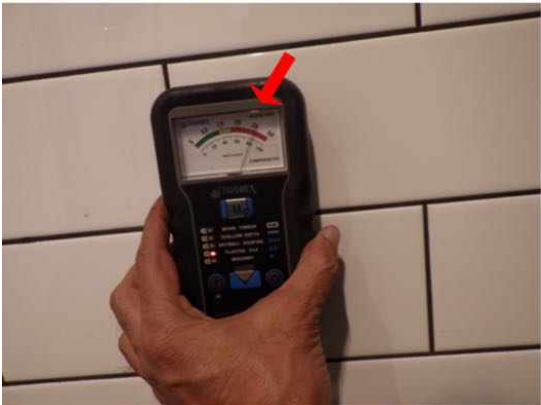
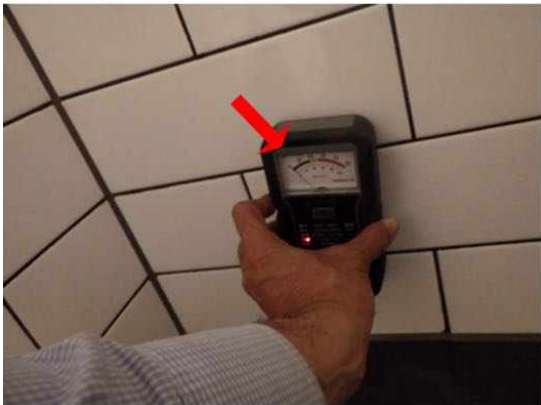
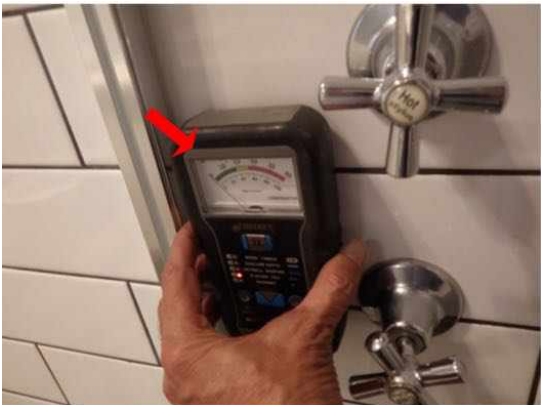
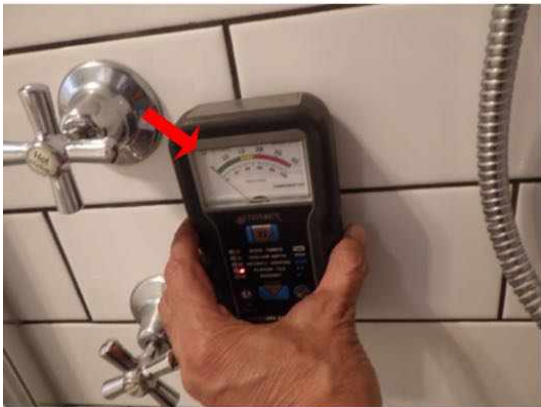
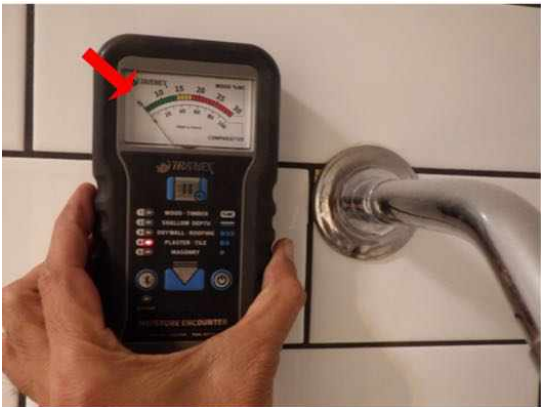
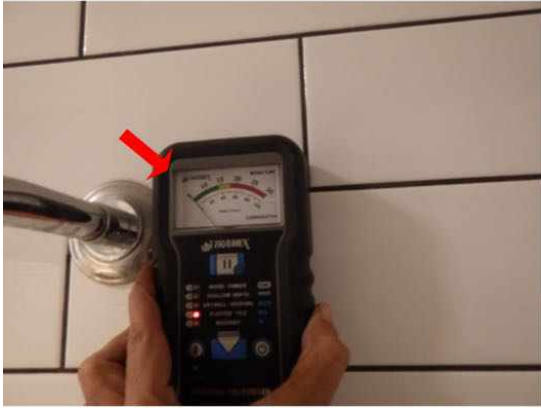
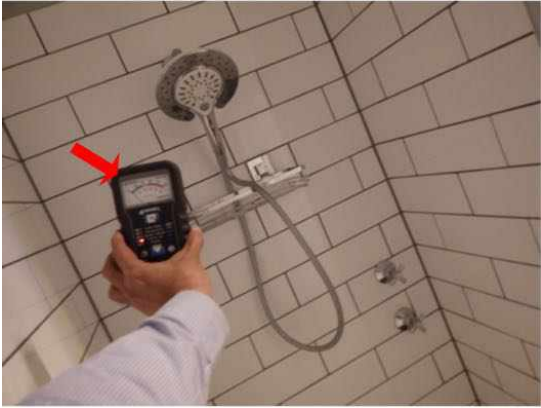
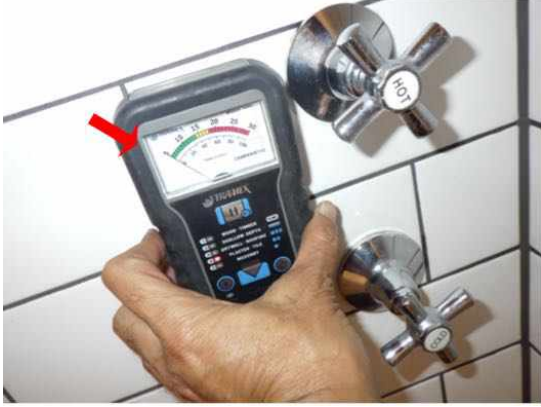
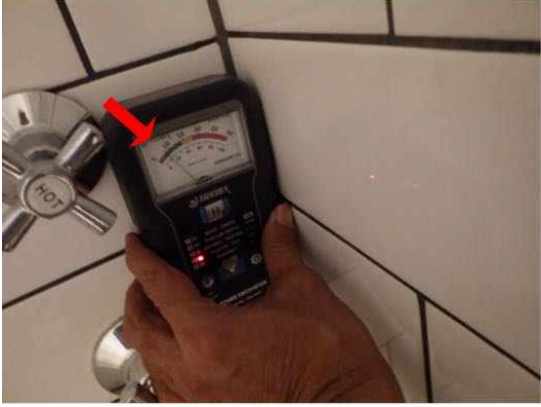
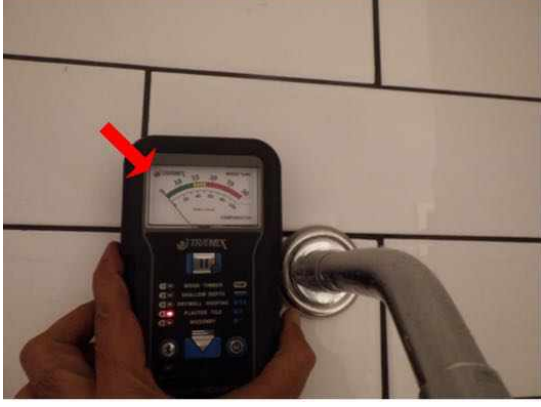
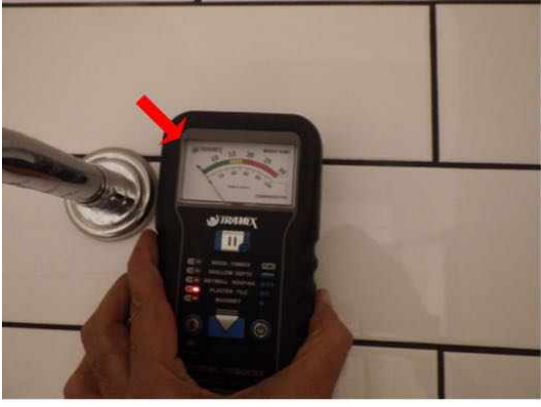
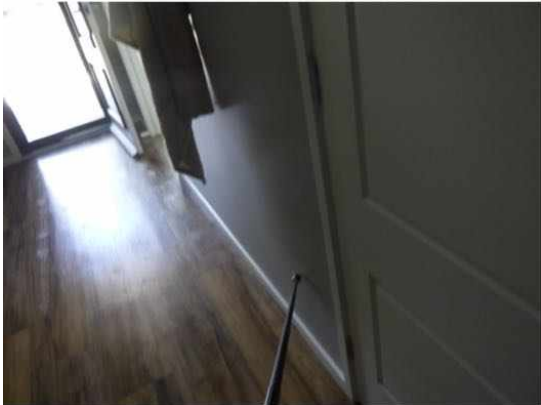
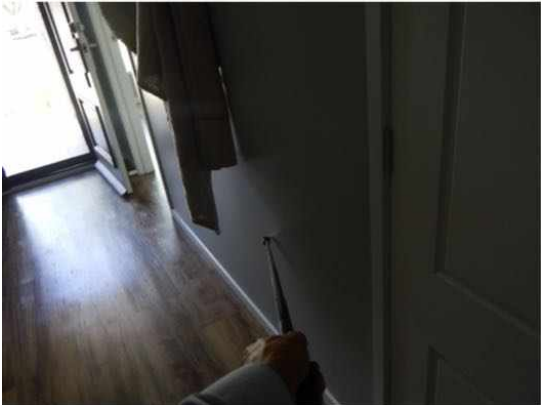
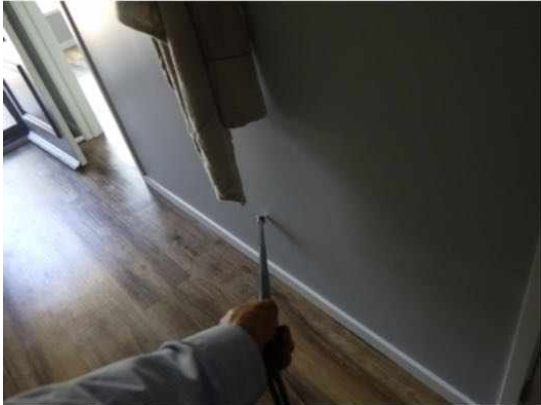
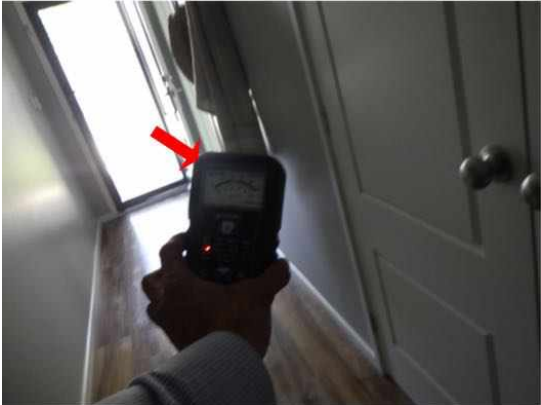
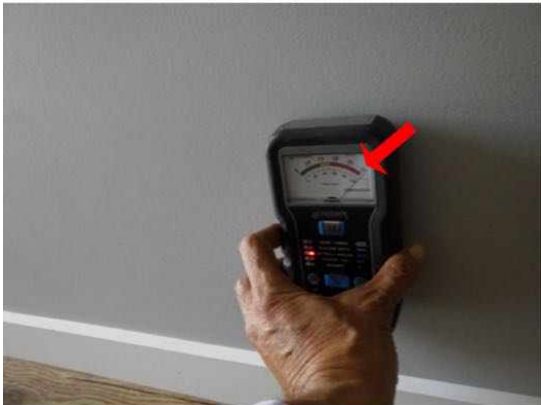
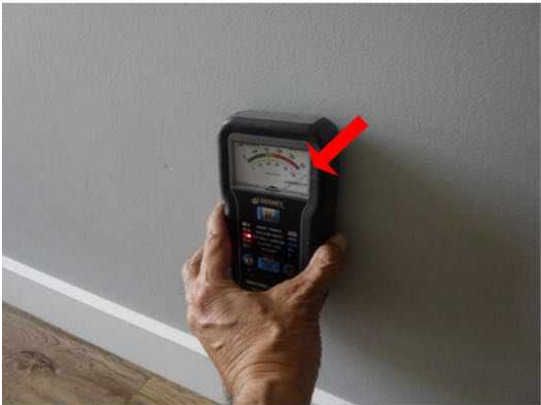
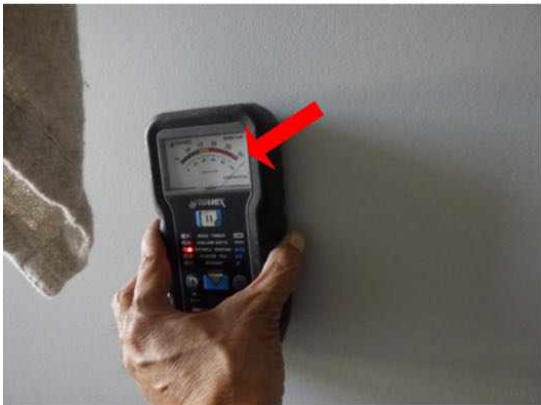
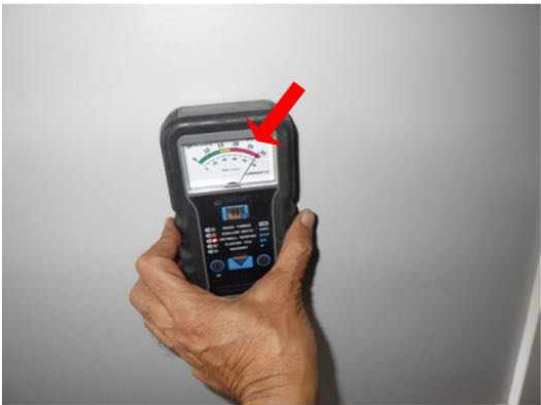
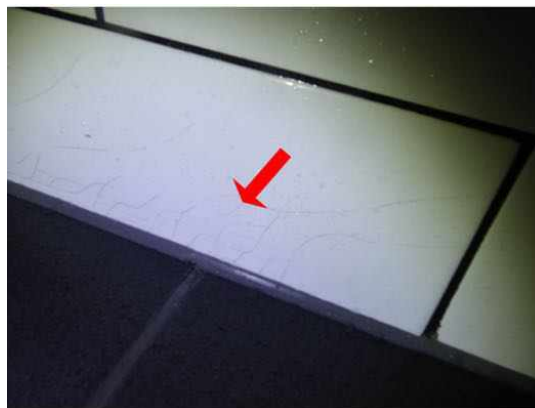
Defects 2.01

| Finding: | Shower Alcove - Damp & Moisture transferring to other side of the walls |
| Information: | Damp is evident to the lower 400mm approximately of wall to the shower alcove. This defect is quite common, and is suspected to have been caused by moisture permeating through the grouting in this area, which shows evidence of deterioration. Leaking pipes within the adjoining wall is also a possible cause. |

Apart from that at the time of inspection it was also noticed that moisture is transferring to other side of the walls.

Unmanaged damp in the shower recess is likely to facilitate the formation and development of mould and fungi growth, decaying associated building materials and compromising their structural integrity. Exposure to these contaminants is associated with a wide range of respiratory and other health-related problems.

Consultation with a qualified plumber or bathroom specialist is advised immediately to identify the cause of damp and to perform remedial works as required. Where excessive mould growth is present, further inspection by a specialist environmental health inspector should also be considered.

Always ensure that sealant and grout is in good condition to prevent any moisture issues occurring in the future.

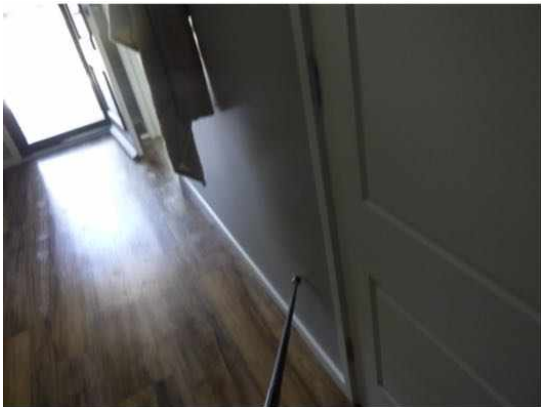
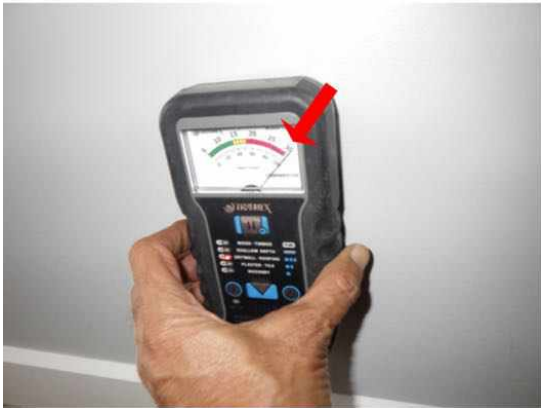
Defects 2.02

| Information: | At the time of inspection it was noticed that high moisture readings were noticed in this internal walls adjacent to bathroom - ensuite . |

Consultation with a qualified plumber is advised immediately to identify the cause of damp and perform remedial works as required. Where excessive mould growth is present, further inspection by a specialist environmental health inspector should also be considered.

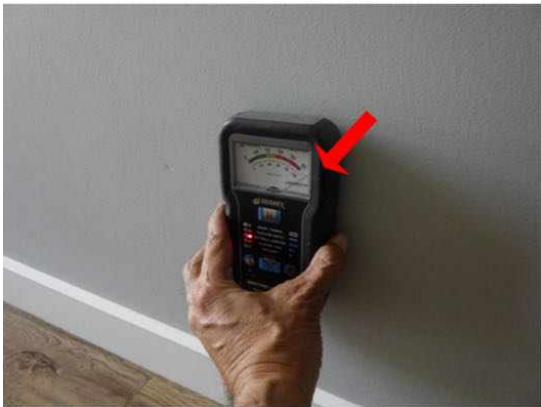
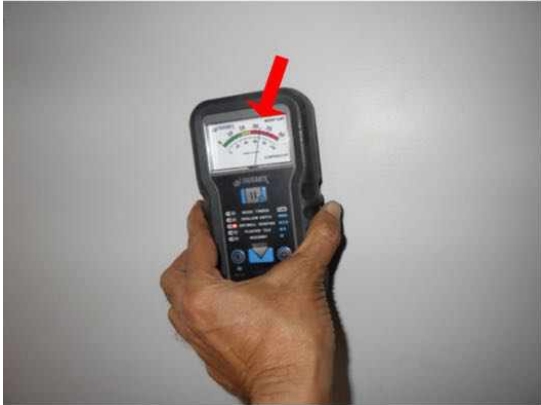
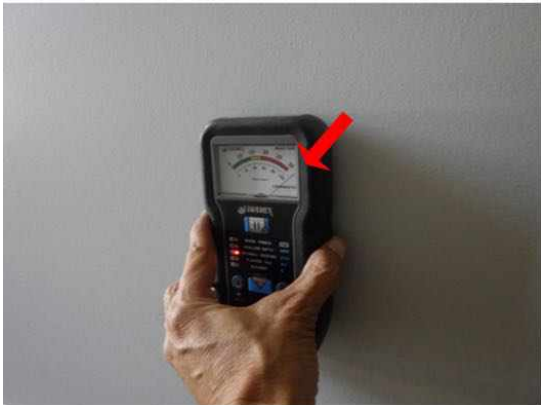
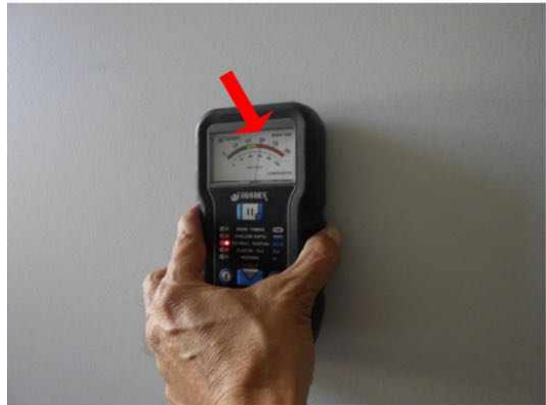
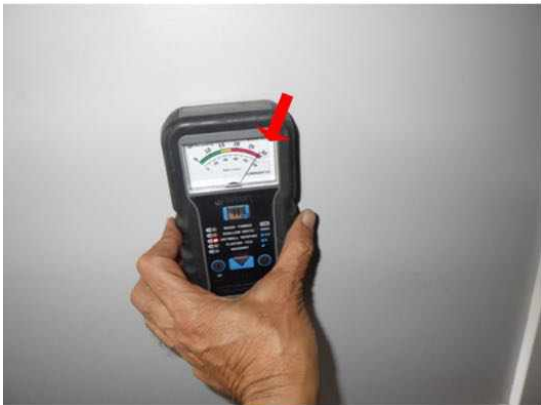
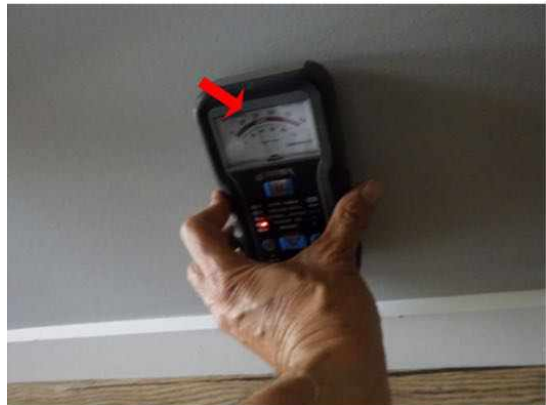
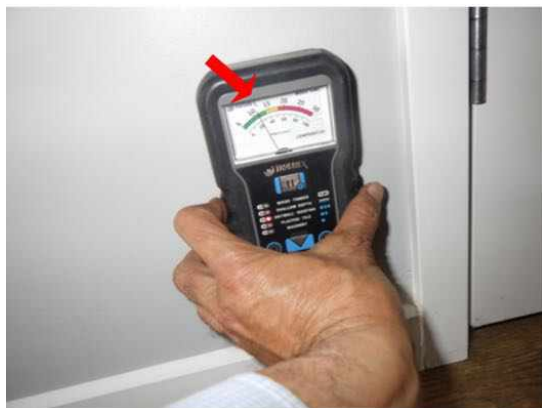
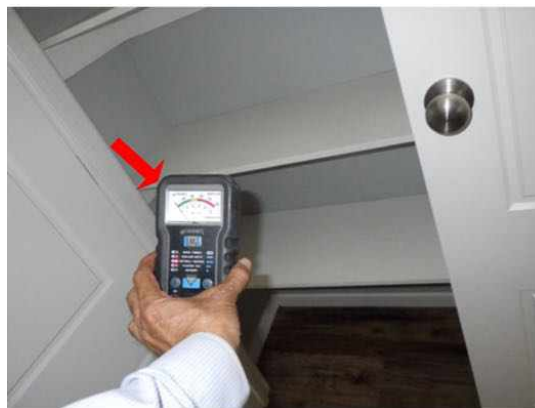
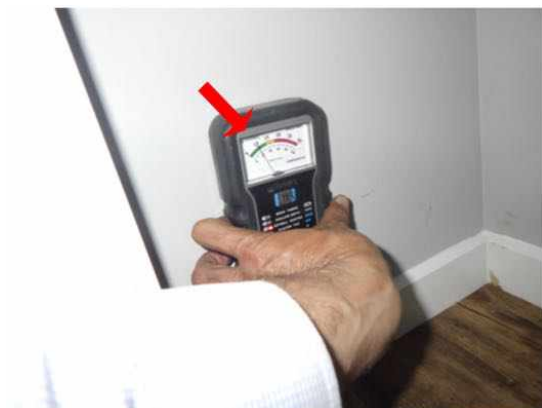
Damp (or structural damp) refers to the presence of unwanted moisture in the structure of a building, either as the result of intrusion from outside, or condensation from within the structure. Generally, structural damp is caused by rain penetration, rising damp, and leaks from plumbing pipes.

Unmanaged damp facilitates the formation and development of mould, fungi growth and wood rot, decaying associated building materials and compromising their structural integrity. Damage to finishes is also likely to occur, including lifting, bubbling, peeling and staining of paint, plaster and wallpaper.

The first step in addressing damp is to diagnose the cause. The identified cause

should be addressed first prior to repairing the appearance and other defects which have resulted from the rising damp. If the original cause is not resolved, further cases of damp are likely to ensue, resulting in secondary defects.

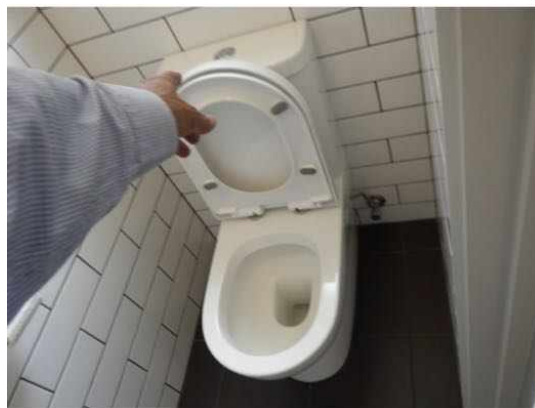
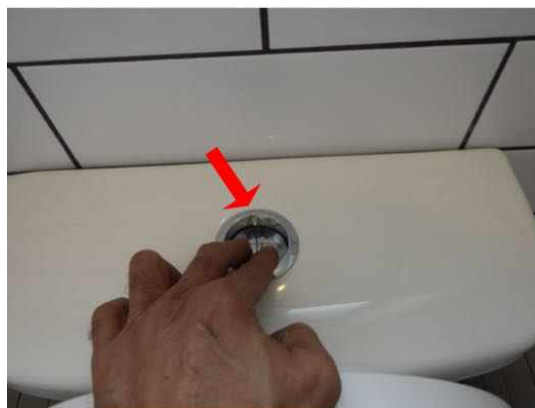
Defects 2.03

| Information: | At the time of inspection, it was observed that the water supply was not connected to the toilet assembly, rendering the fixture non-operational. |

Non-operational fixtures and services should be addressed to ensure the building is capable of full and intended use. Where building elements are not functioning as designed, there is potential for secondary defects or damage to occur due to prolonged non-operation.

It is recommended that the water supply be connected and the toilet assembly inspected, repaired, or replaced as required. Repair and/or replacement of the faulty building element is recommended. It is highly recommended that the relevant tradesperson be engaged to as soon as perform any necessary works.

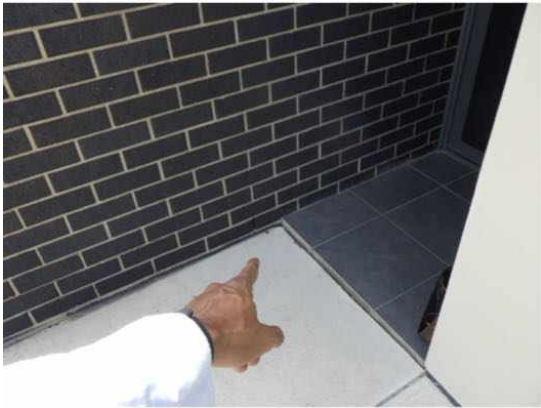
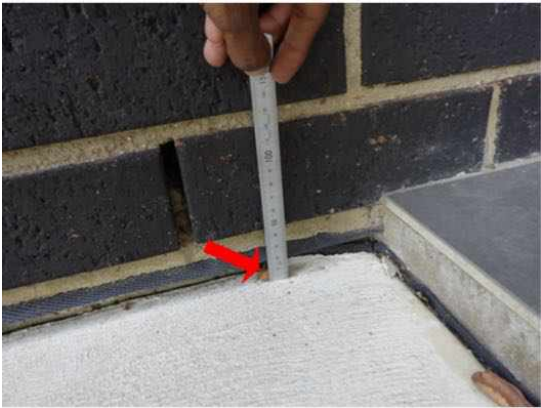
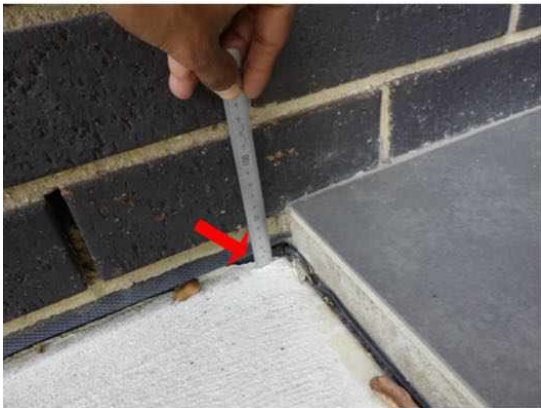
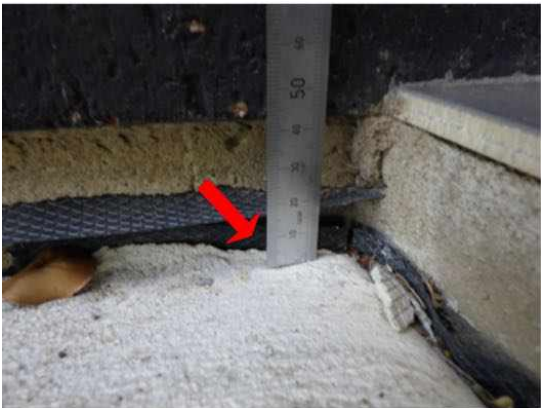
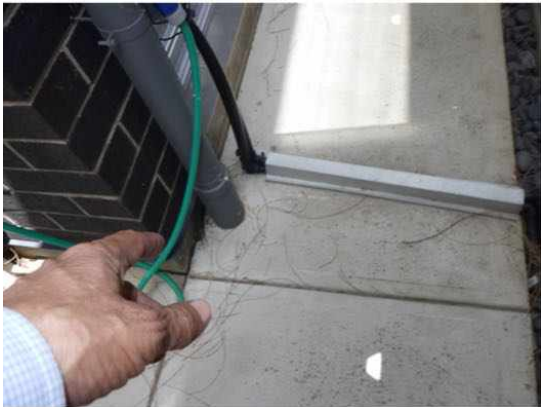
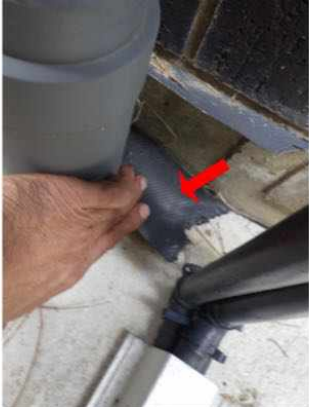
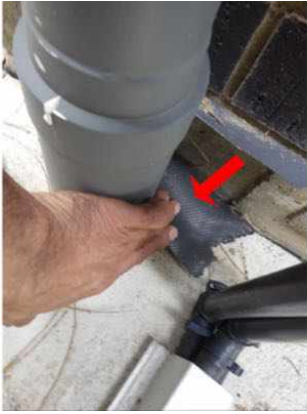
Defects 3.01

Sometimes, in order to determine the type of slab, a suitably qualified person such as an architect or builder may be required to consult the construction plans.

Where the slab edge cannot be properly inspected, it is highly recommended that termite or timber pest inspections be carried out every 6-12 months to aid protection of the property against infestation.

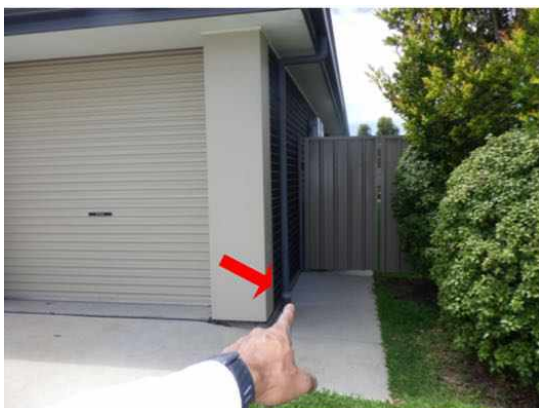
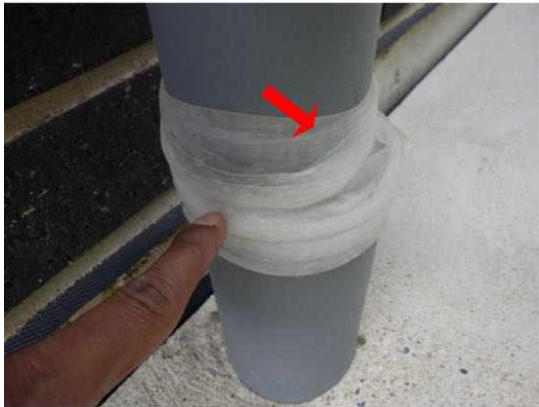
Defects 3.02

| Finding: | Downpipes - Damaged & Evidences of repairs |
| Information: | At the time of inspection it was noticed that downpipe is damaged and evidence of repairs to the downpipe at lower base in this external wall front area. |

Breakage occurs generally when the building materials have either aged and decayed, or as a result of damage (accidental or deliberate).

Repair and/or replacement of broken elements is advised to ensure that additional secondary defects do not arise as a consequence. Such works are necessary, as all building elements play a key role in the operation and function of the overall structure and its performance.

A relevant tradesperson should be appointed to repair or replace the affected building element prior to any subsequent damage being caused.

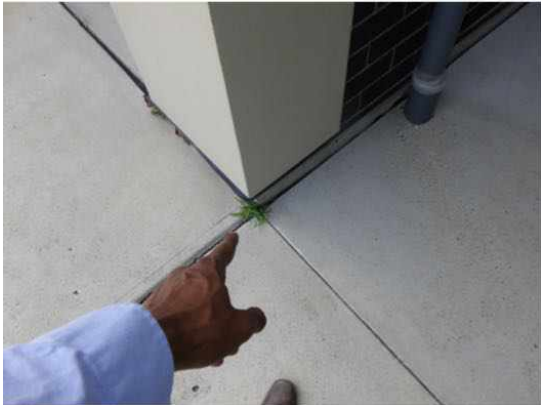
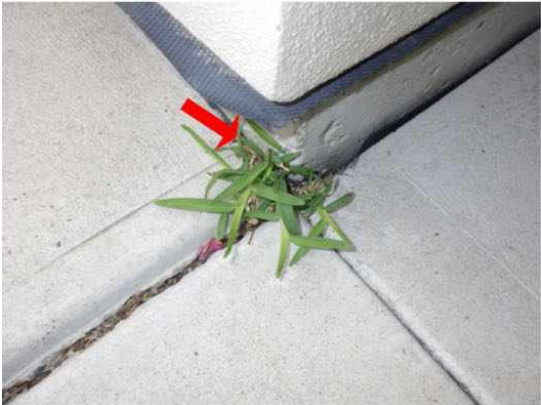
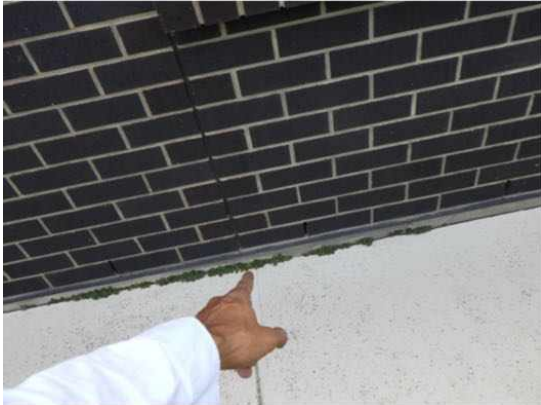
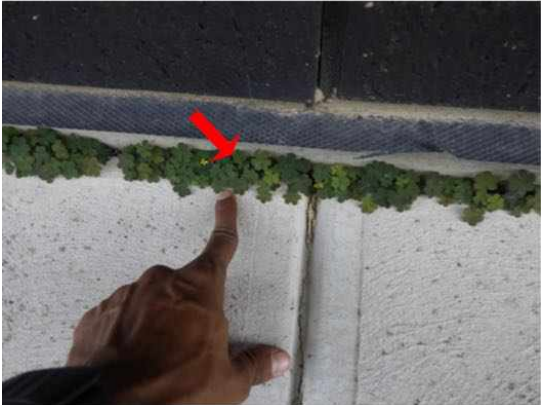
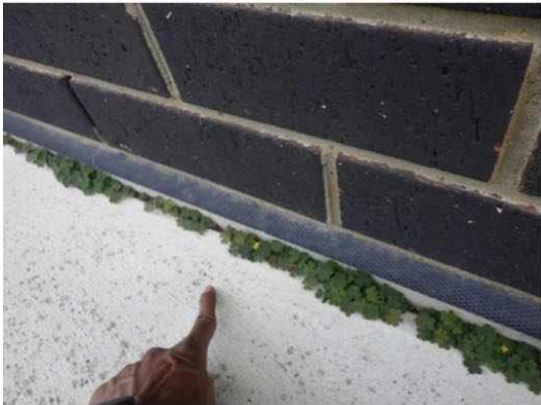
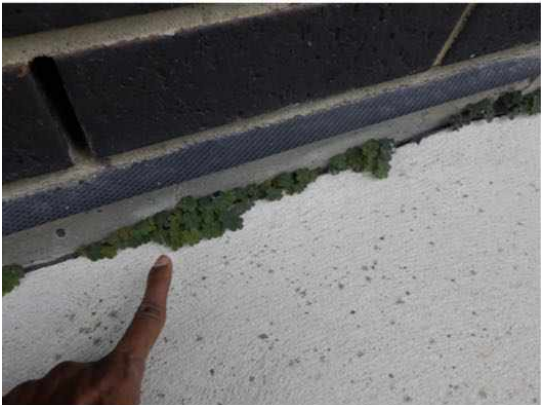
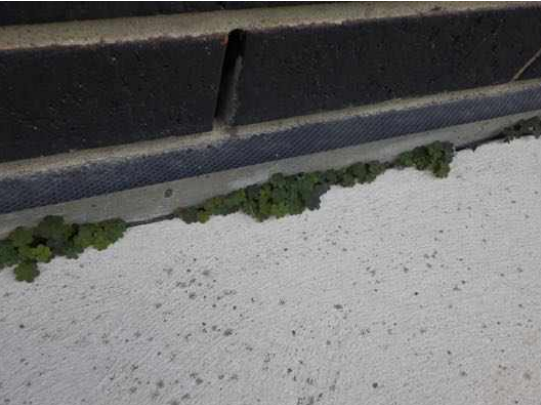
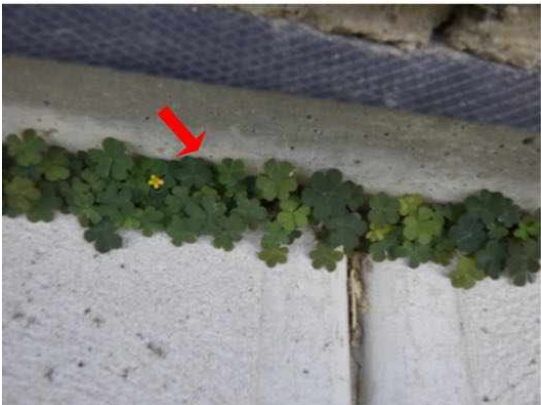
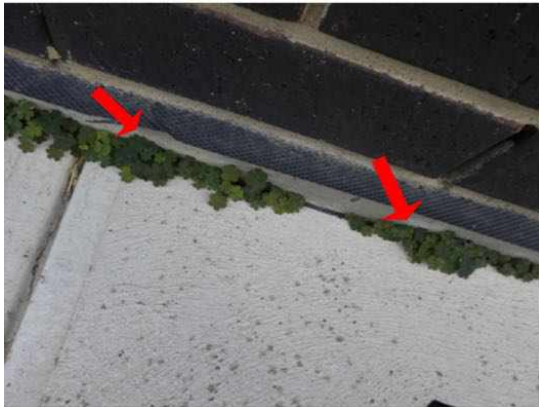
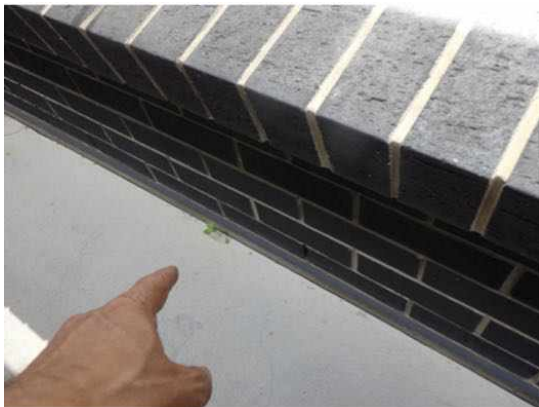
Defects 3.03

| Information: | Where vegetation obstructs inspection of building elements, also known as bridging as it provides a bridging point for the access of termites, full inspection can not be achieved. Consequently moisture or dampness may be present and the areas becomes conducive to termite activity. Plants against or very close to buildings provide cover, shade and can provide an environment that is attractive to termite infestation. |

The removal and replanting of species that do not provide "cover" or cutting back of existing vegetation will assist greatly in preventing Bridging from occurring.

The removal of any such materials that may be conducive to termite activity should be carried out as soon as possible and arrange re inspection to minimize the risk of termite attack.

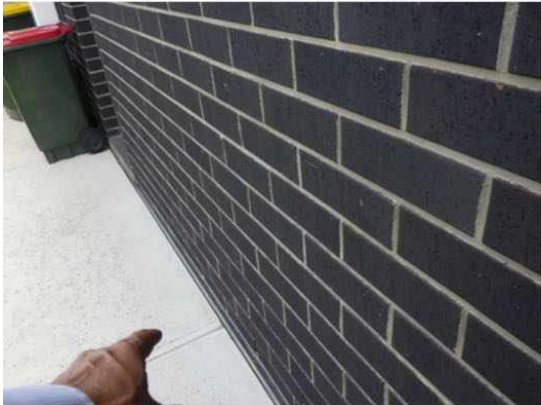
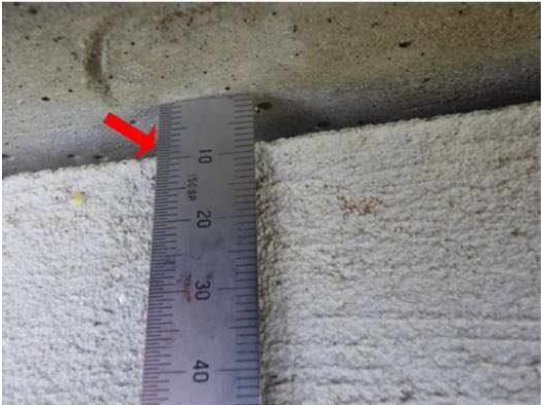
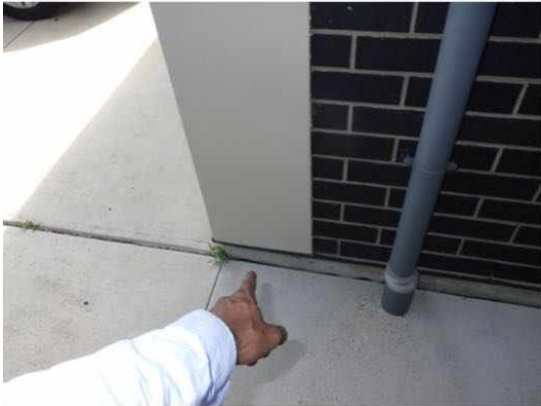
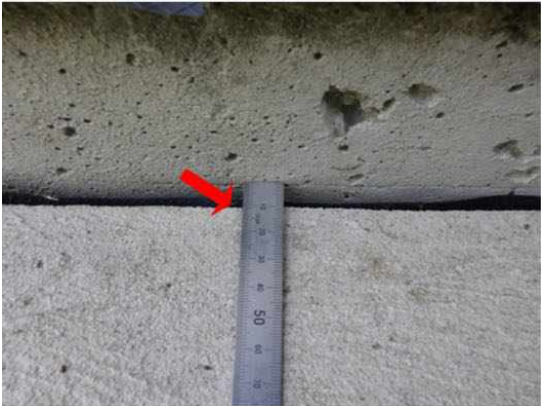
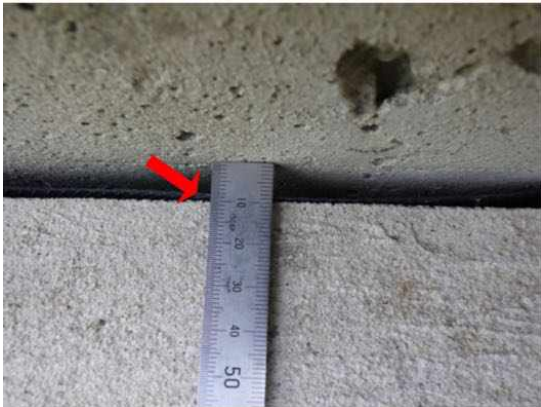
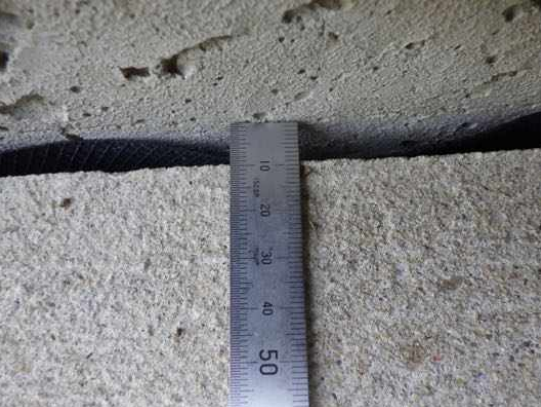
Defects 3.04

| Information: | Gap in external concrete paving were identified at the time of inspection. Gaps in slab are significant and are likely to lead to the development of secondary defects if left unmanaged, such as the creation of a trip hazards and water entry point. |

including roof and ground flows, contained and continually maintained. High moisture also creates an environment that is conducive to termite attack.

A licensed Plumber should be appointed immediately to ensure that the storm water pipework is in tact and adequate, and all gaps to concrete, driveways and paths should be sealed by a licensed builder or a general handy person to keep moisture from entering.

A licensed concreter may be required to place pavements that area beyond repairs.

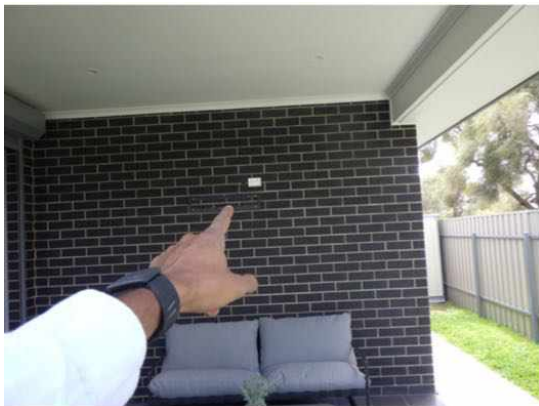
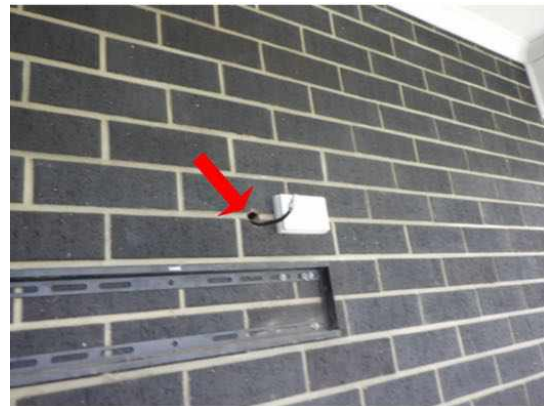
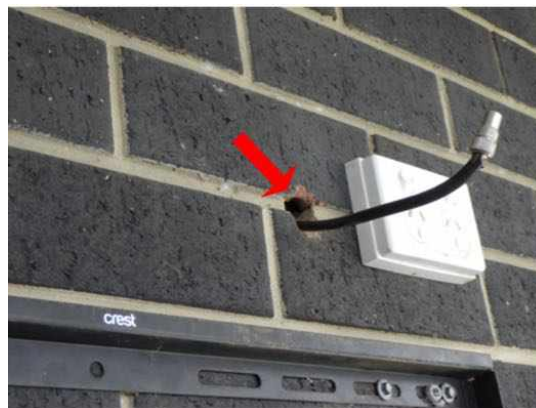
Defects 3.05

Gaps and holes around pipework makes the area susceptible to insect and vermin ingress, as well as allowing water penetration to the cavity wall. As such, associated building elements are likely to deteriorate at an accelerated rate, and major implications are expected if holes around the pipework are left unmanaged.

All excessive holes, gaps or cracks should be adequately filled by a suitable sealant or trimmings as soon as possible to prevent any further damage. Such works may be conducted by a general handyperson or licensed plumber.

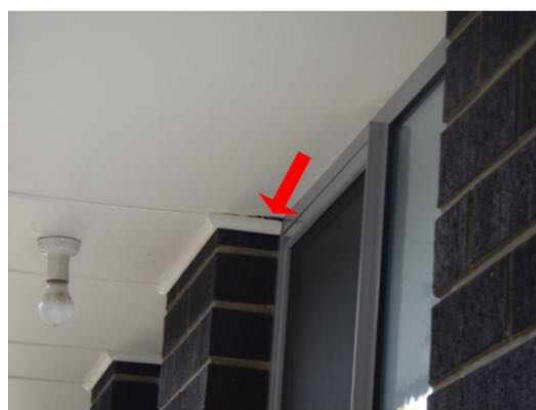
Defects 3.06

| Finding: | Building element - Damaged/ Loose from its original fixing |
| Information: | At the time of inspection it was noticed that few sections of building element were damaged around the property . |

Breakage occurs generally when the building materials have either aged and decayed, or as a result of damage (accidental or deliberate).

Repair and/or replacement of broken elements is advised to ensure that additional secondary defects do not arise as a consequence. Such works are necessary, as all building elements play a key role in the operation and function of the overall structure and its performance.

A relevant tradesperson should be appointed to repair or replace the affected building element prior to any subsequent damage being caused.

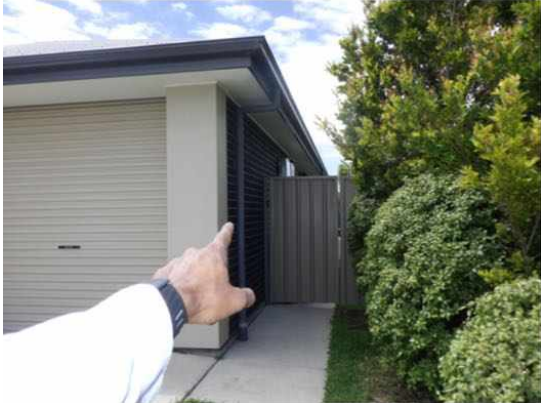
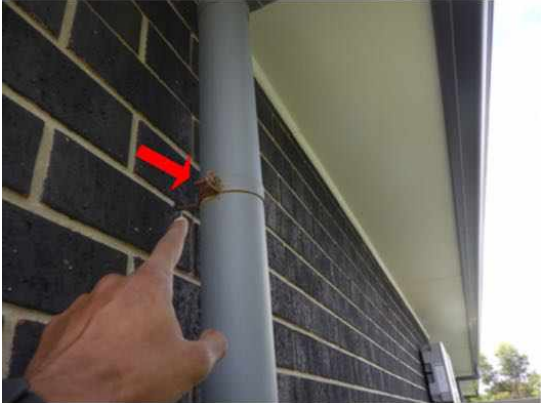
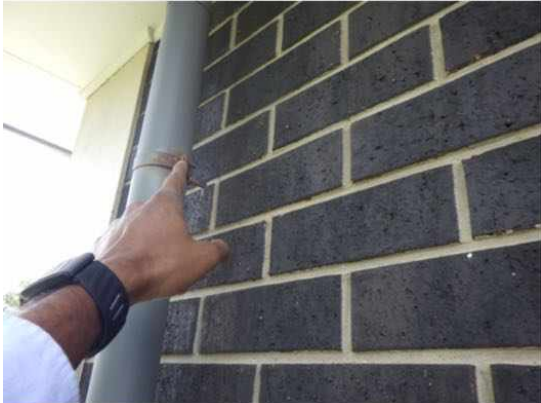
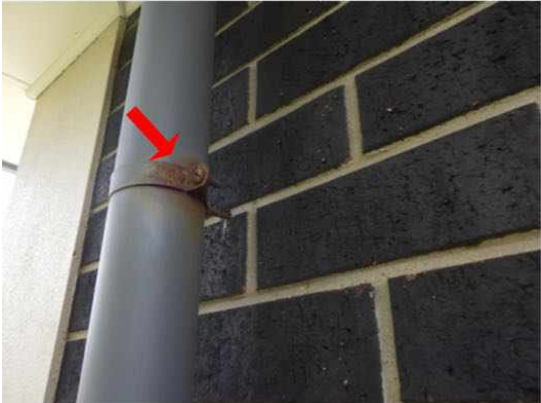
Defects 3.07

| Finding: | Building element - Rusted or corroded |
| Information: | This building element shows evidence of rusting and corrosion, which is likely to have developed as a result of excessive exposure to moisture and or inadequate coatings. |

As surface rust provides no protection to the underlying iron, the deteriorating condition is likely to worsen if not addressed in the short-term future.

Where possible, the use of galvanized (treated) metals or aluminium coated metals aid in rust prevention, as does regular general maintenance. Rust formation can be

controlled with coatings, such as paint, that isolate the iron from the environment.

Rusting and corrosion should be managed by ideally removing or limiting the affected surface from exposure to moisture. A registered builder may be appointed to replace any building elements that have been severely affected by rust or water damage.

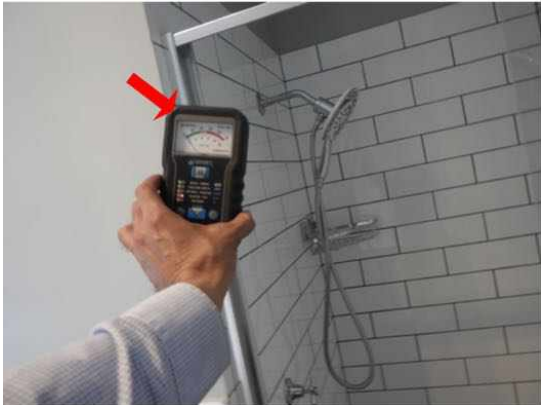
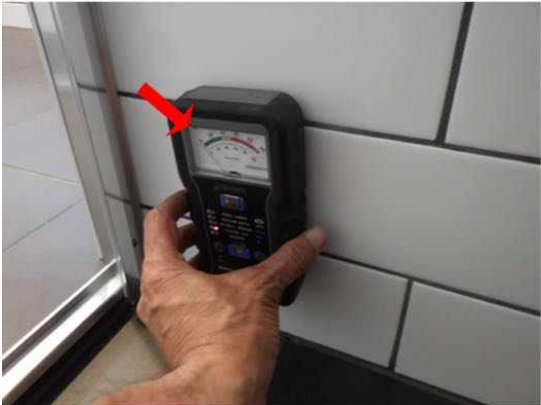
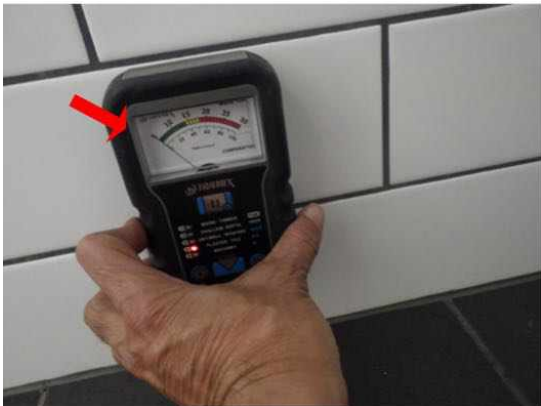
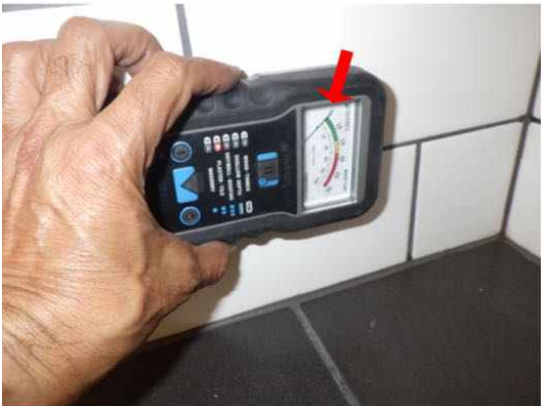
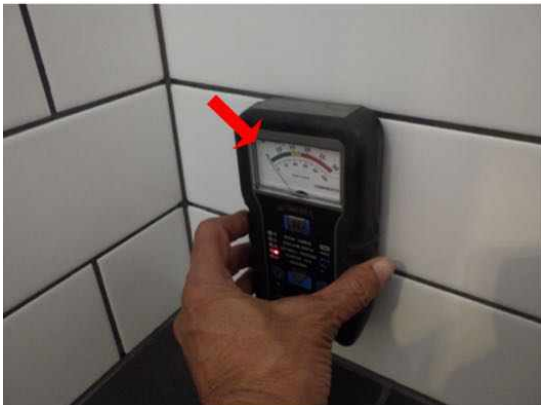
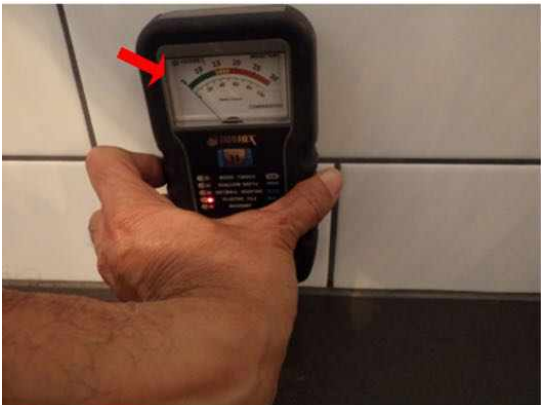
Damp (or structural damp) refers to the presence of unwanted moisture in the structure of a building, either as the result of intrusion from outside, or condensation

from within the structure. In the shower area, internal water leaks or other sources of excessive moisture are generally the cause of damp.

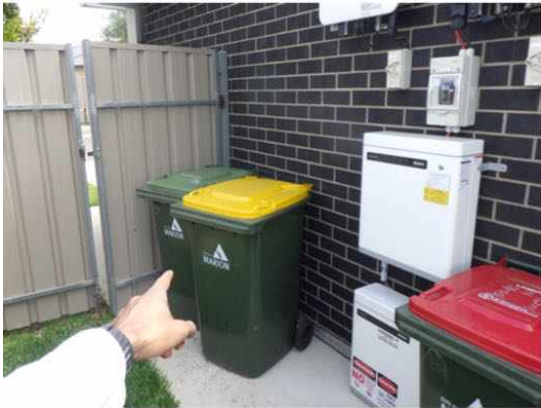
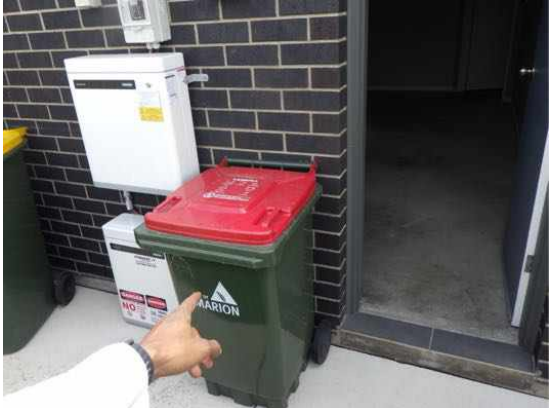
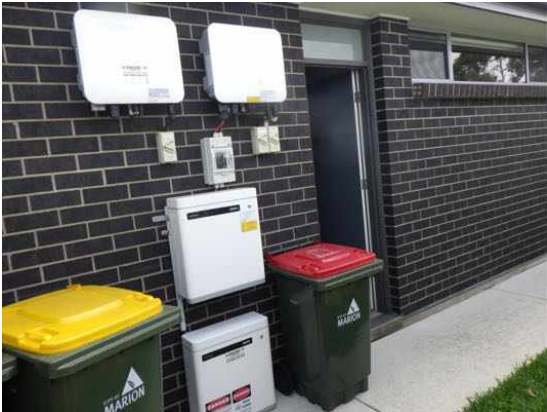
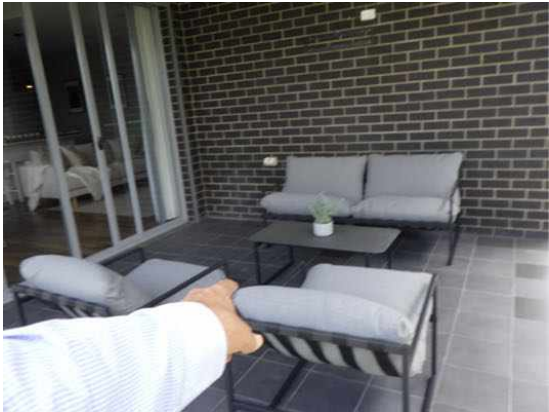
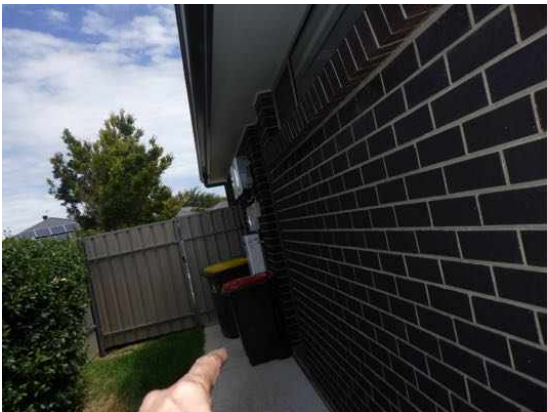
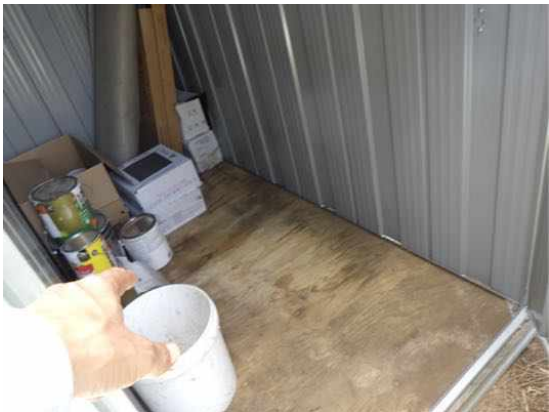
Building: Building 1
Location: All Areas
Finding: Additional Photos - Obstructions and Limitations
Information: These photographs are an indication of the obstructions and limitations which impeded full inspection of the property at the time of inspection. These obstructions can hide an array of defects and should be removed to allow full inspection to be carried out. A re-inspection is recommended once the areas are made accessible.
