Building Inspection Report

Inspection Date: Thu, 26 Feb 2026

Property Address: 9 Franklin Court, Sheidow Park SA 5158,
Australia

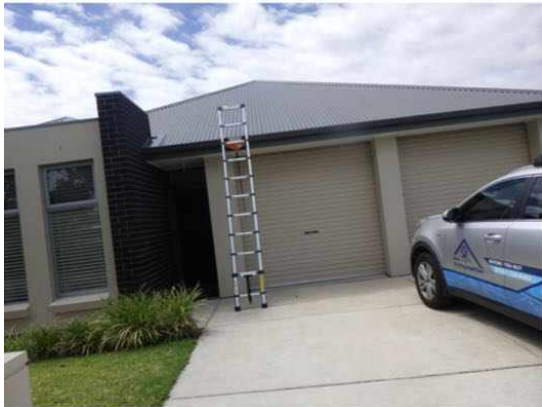
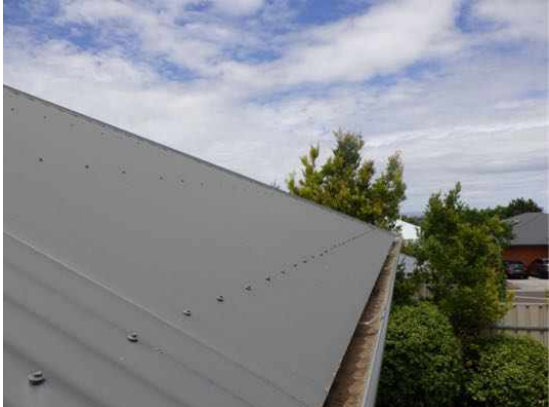
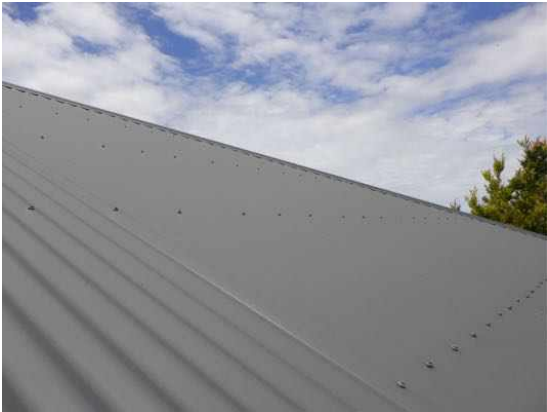
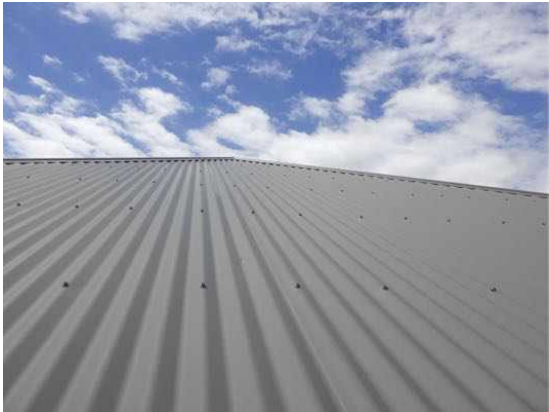
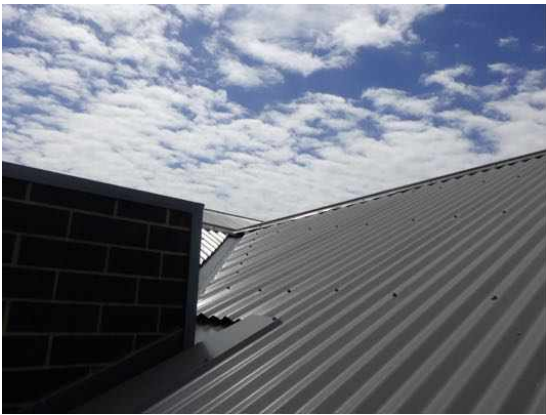
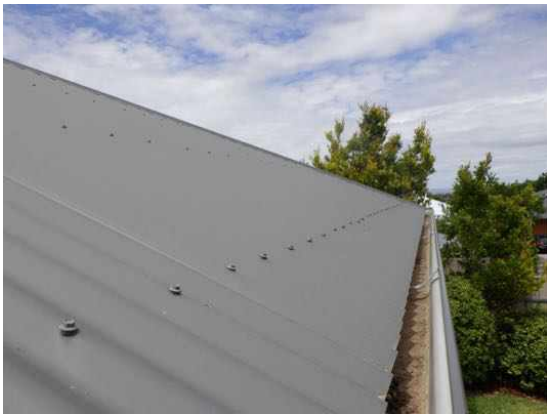
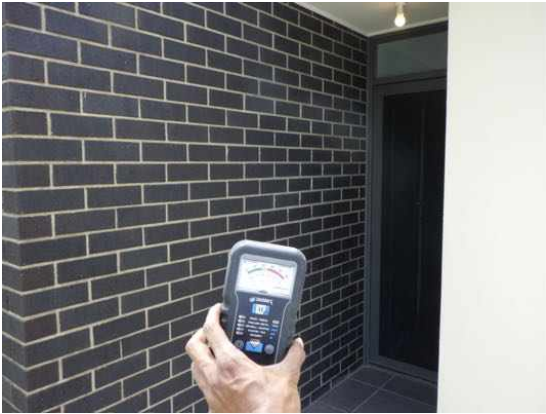
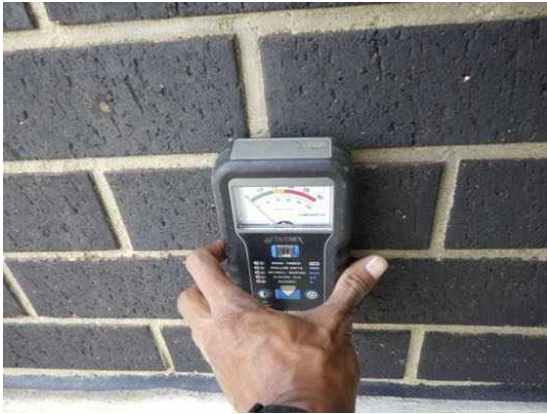
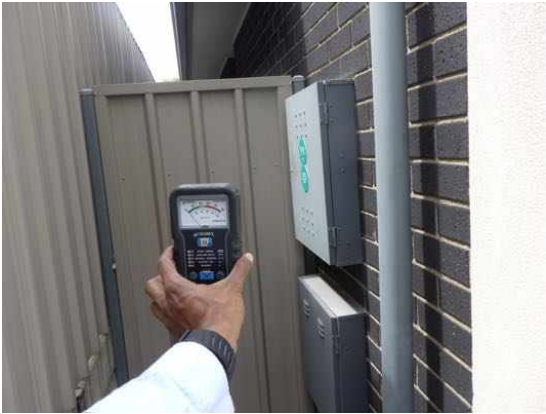
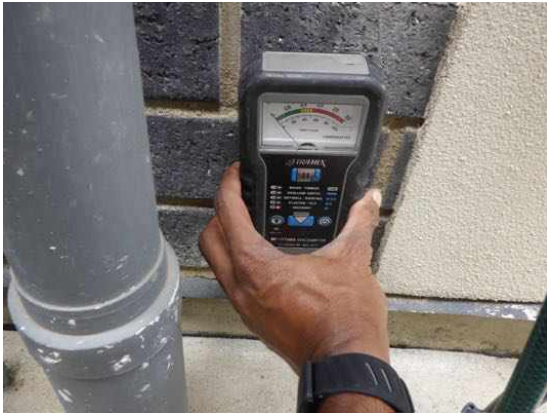
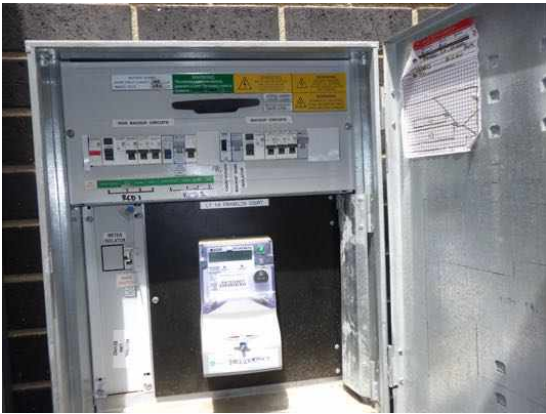
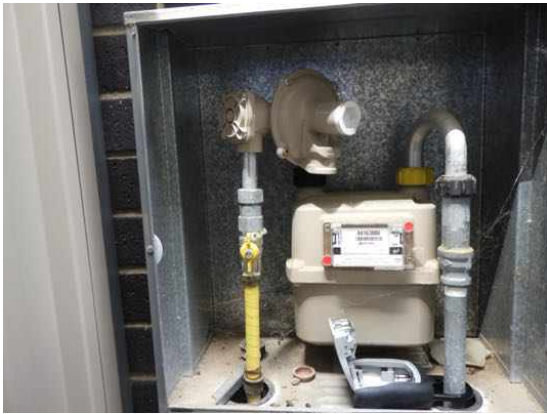
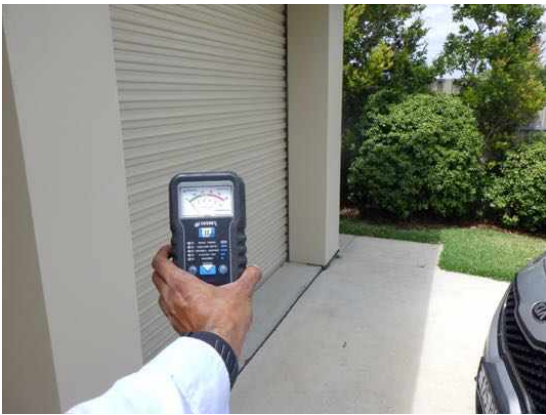
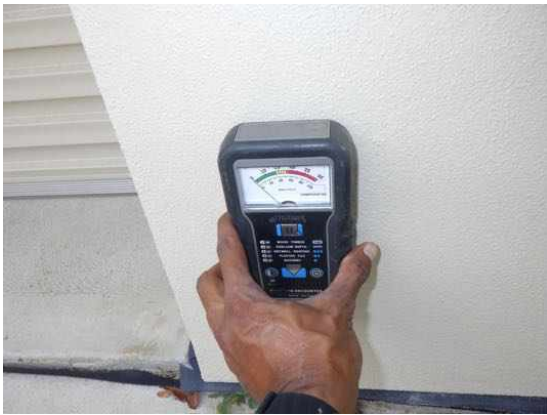
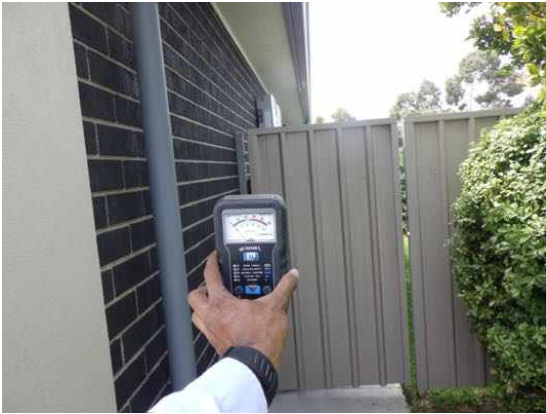
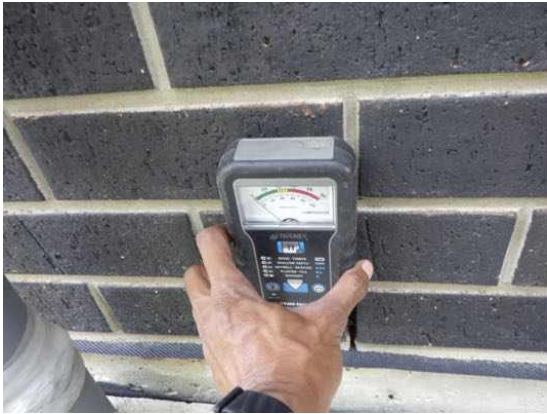
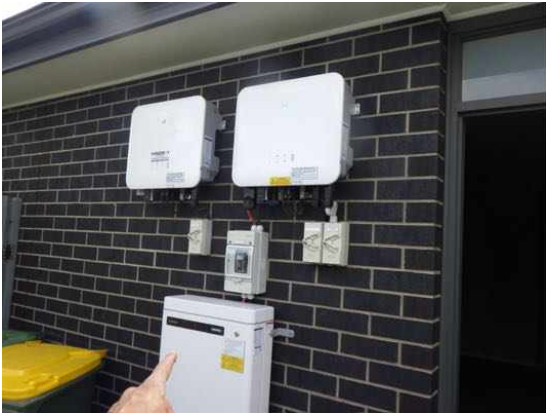
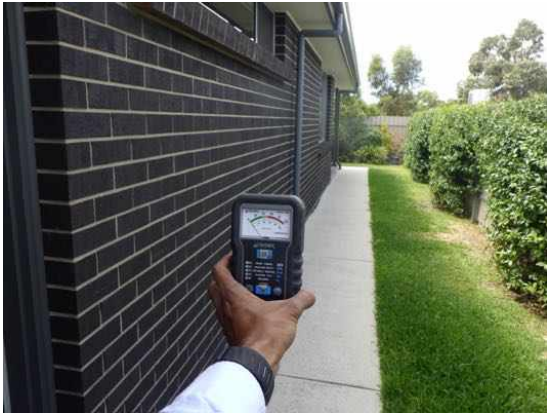
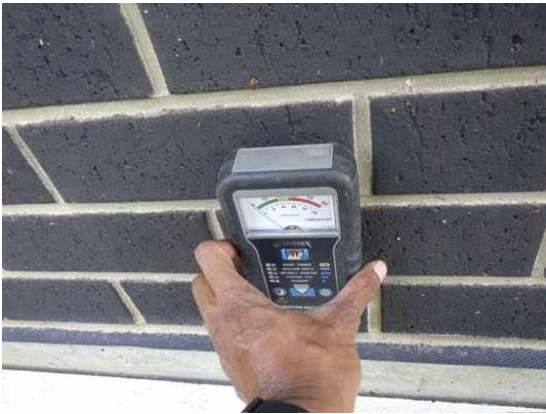
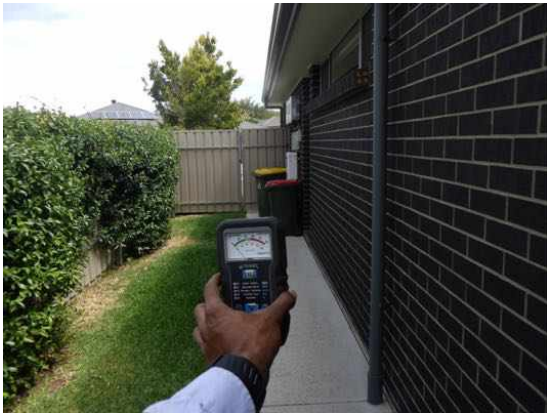
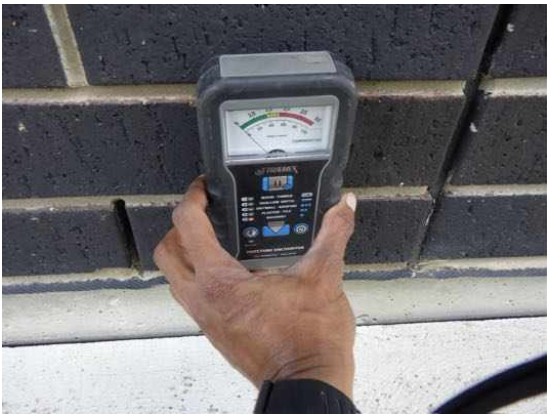
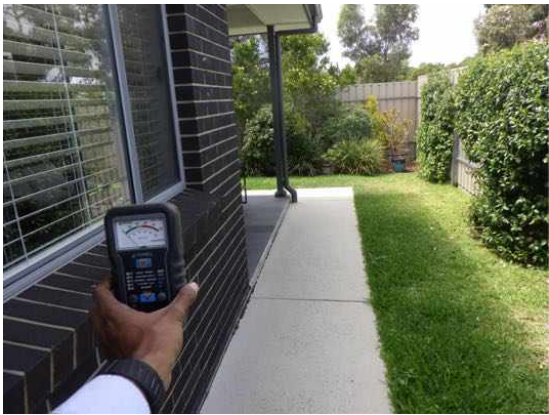
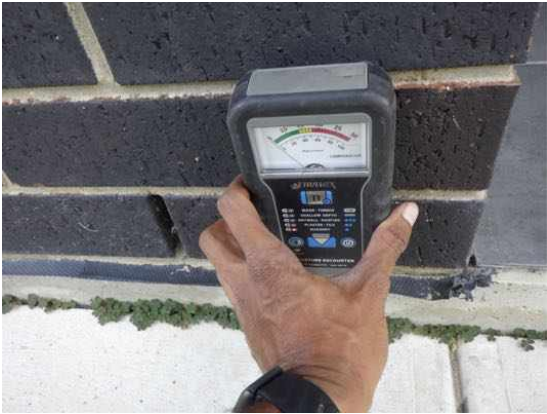
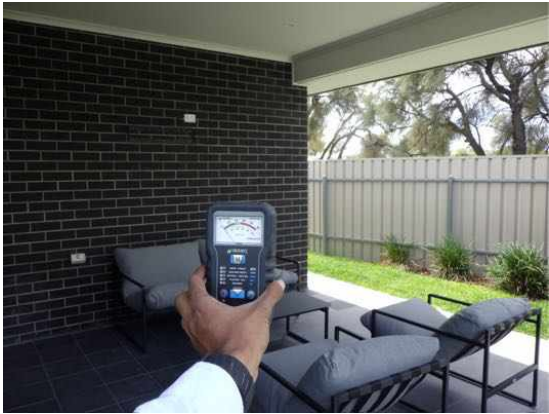
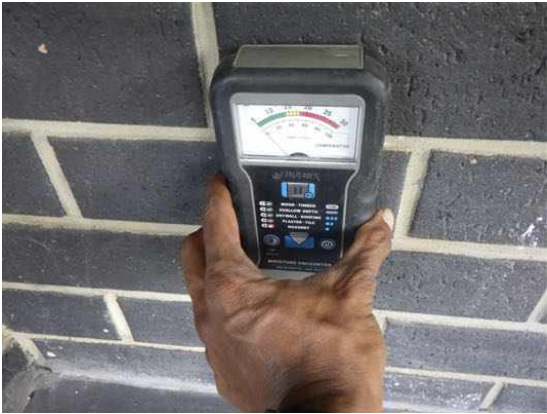
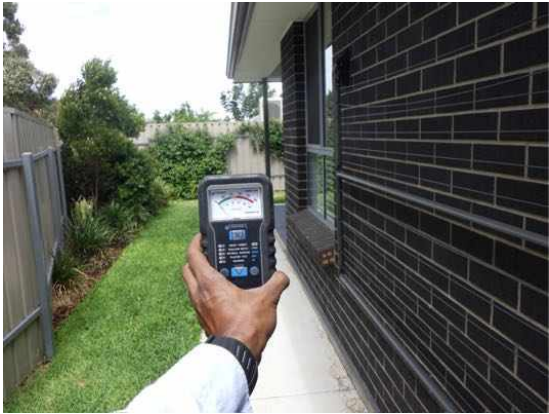
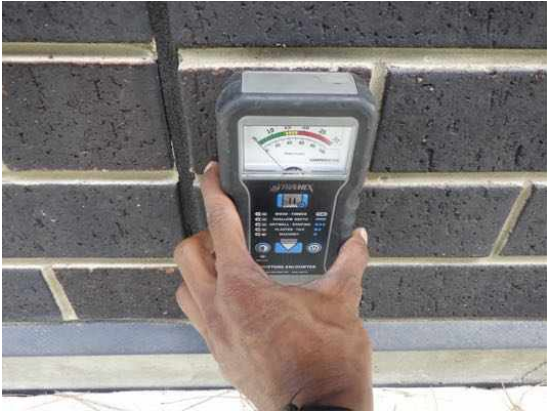
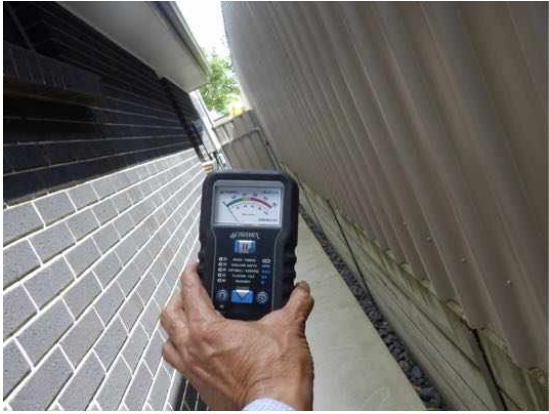
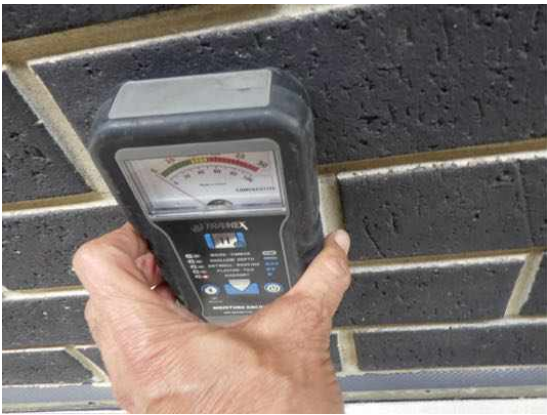
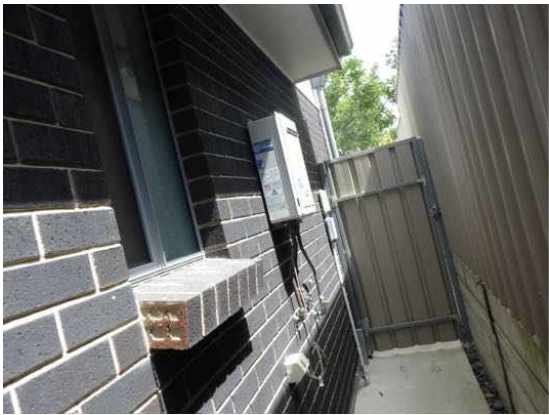
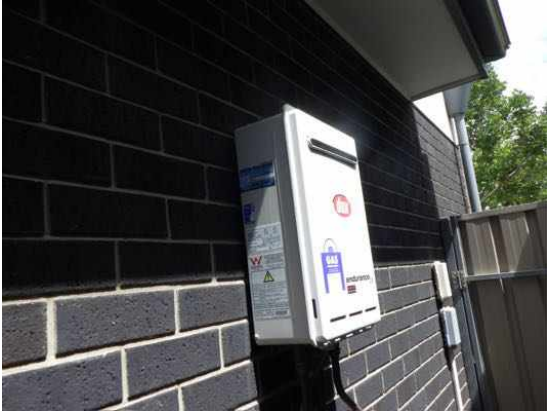
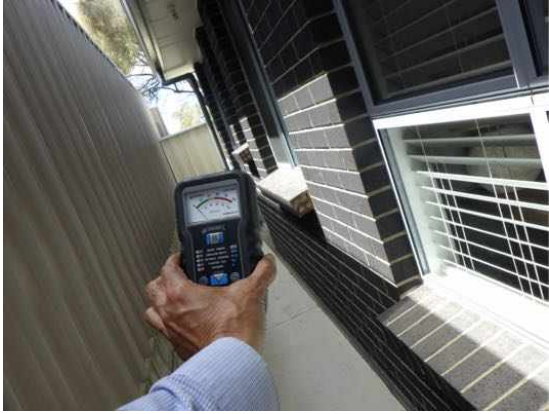
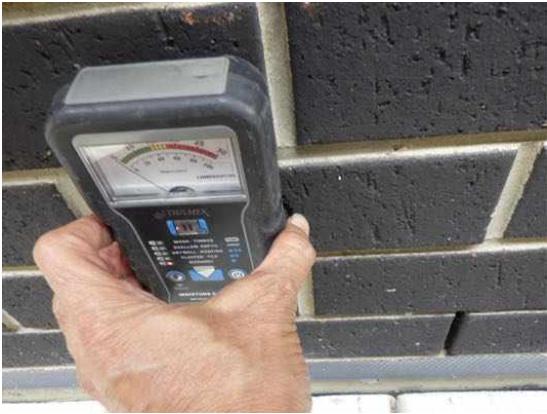
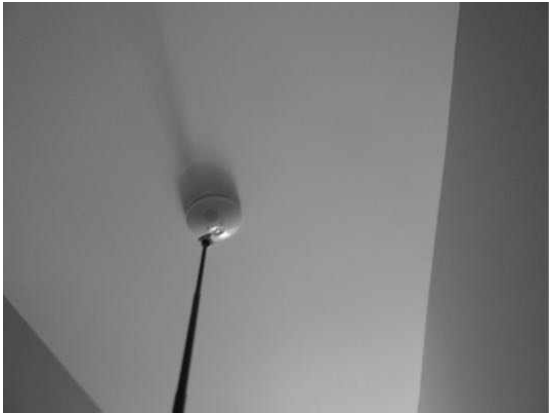
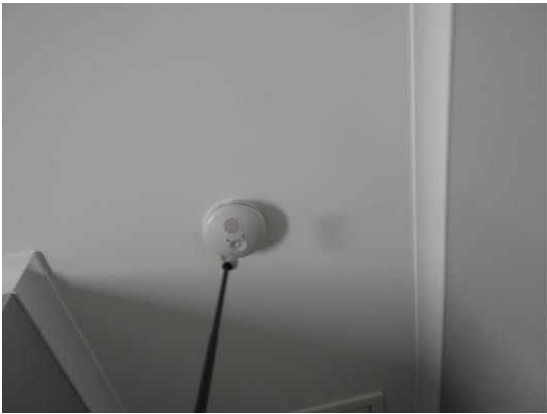
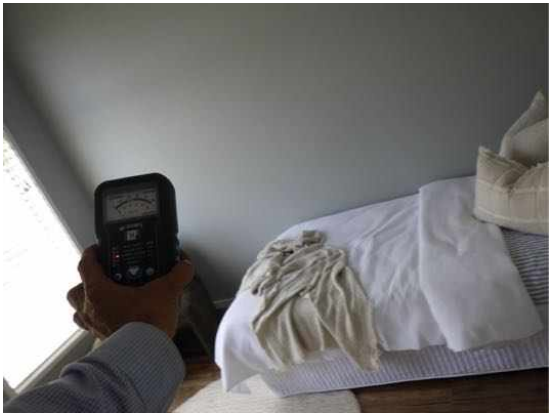
Building: Building 1
Location: All Areas
Finding: Additional Photos
Information: Additional photos are provided for your general reference
