# Building and Timber Pest Inspection Report VR

Inspection Date: Wed, 25 Feb 2026

Property Address: 138 Salisbury Rd, Camperdown NSW 2050,  
Australia

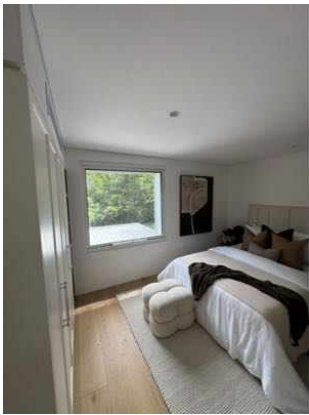
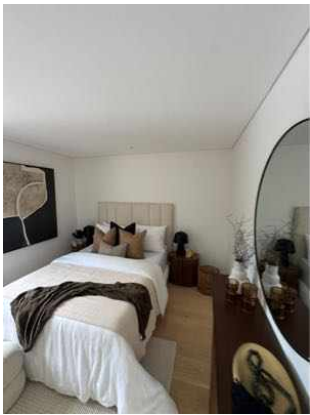
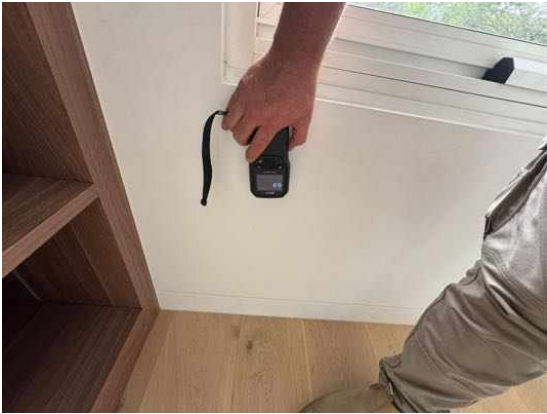
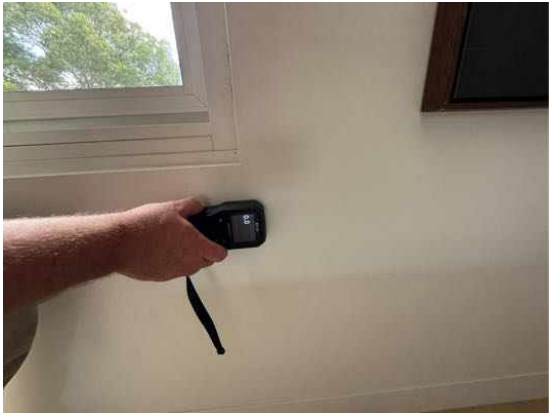
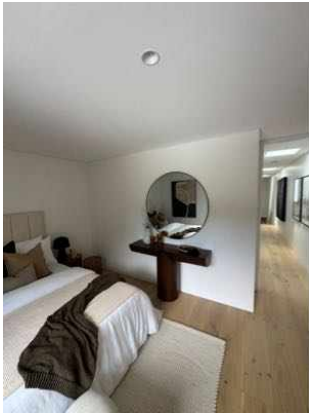
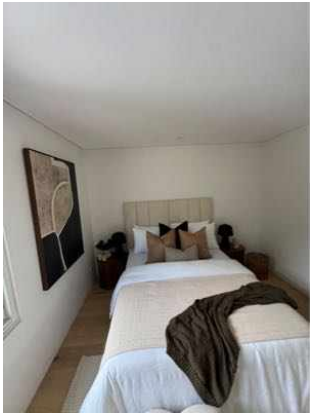
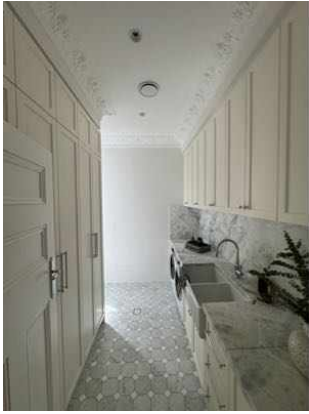
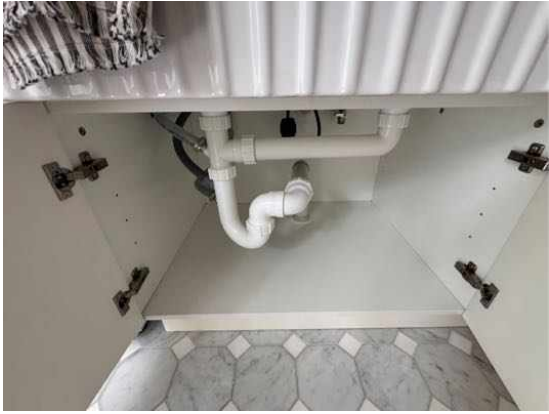
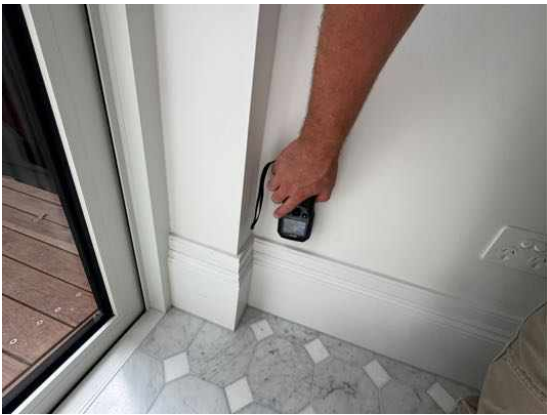
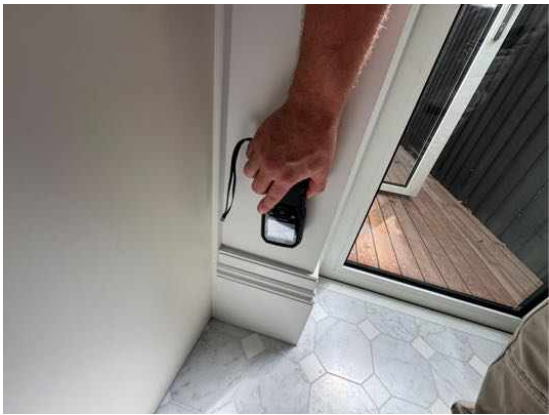
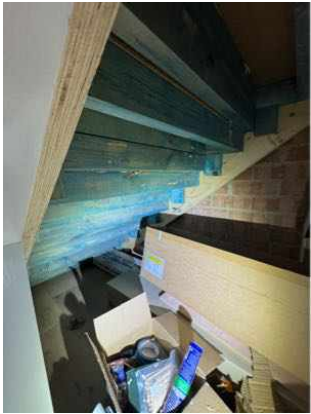
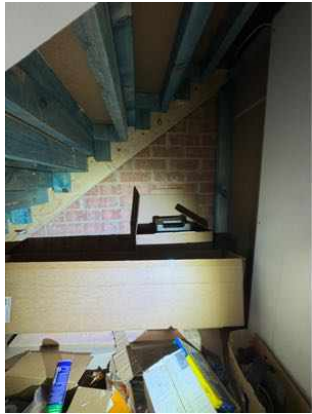
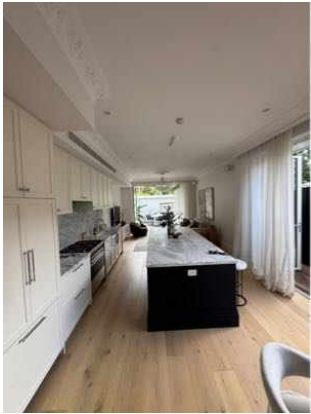
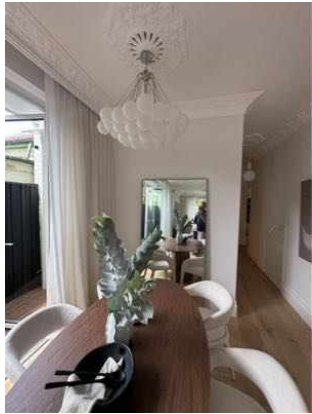
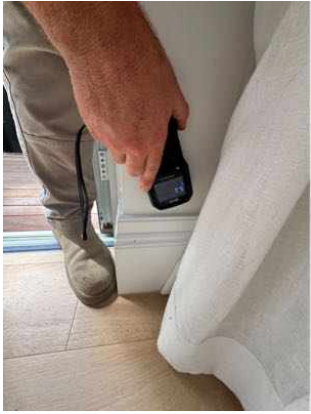
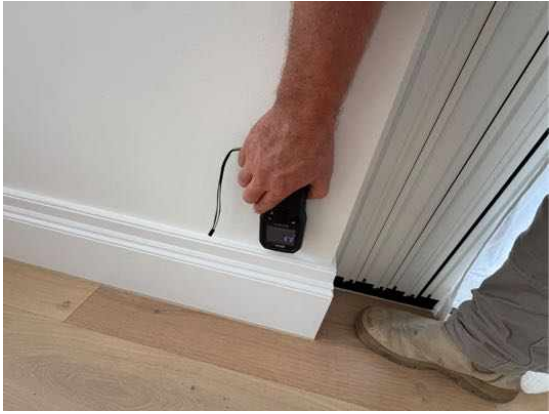
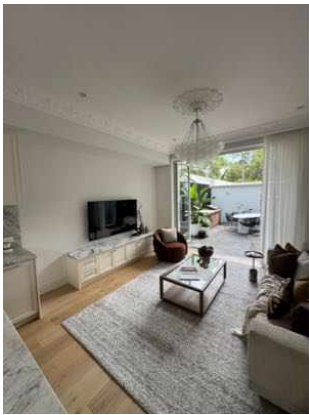
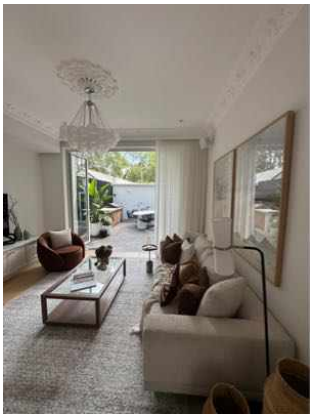
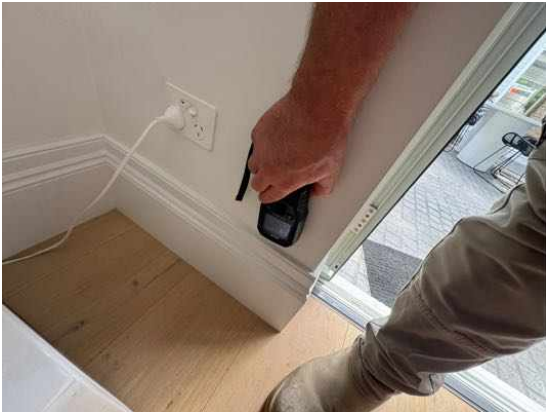
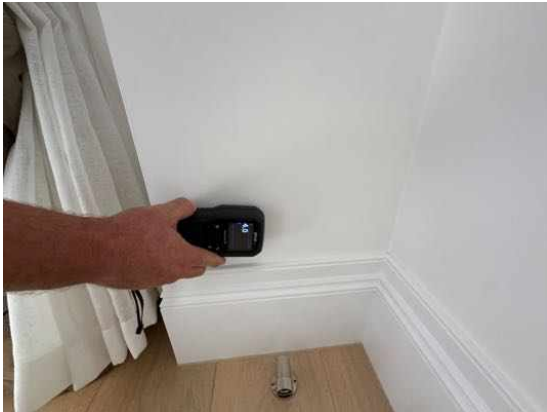
Building: Main Building  
Location: All Areas  
Finding: Photos Added  
Information: Additional photos are provided for your general reference.
