Building and Timber Pest Inspection Report

Inspection Date: Wed, 4 Mar 2026

Property Address: 15 Kurmond St, Jamisontown NSW 2750,
Australia

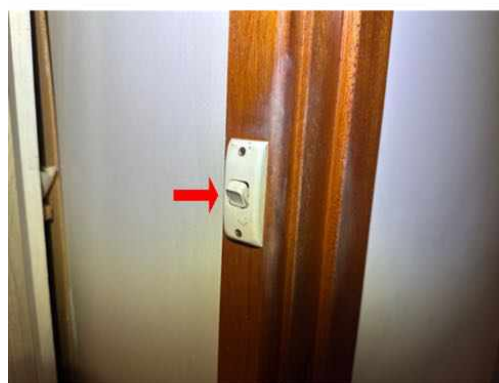
Building:	Main Building
Location:	All Areas > All Areas
Finding:	Electrical fittings: Deteriorated damage.
Information:	The electrical fitting in this area was found to be showing signs of deterioration at the time of inspection.

Left unmanaged, the fitting is unlikely to cause further damage to surrounding building elements. However, the broken fitting may create a safety hazard if there is potential contact with persons in the area.

Repair and/or replacement of the broken fitting is advised. A Licensed electrician should be appointed to repair/replace the fitting immediately.

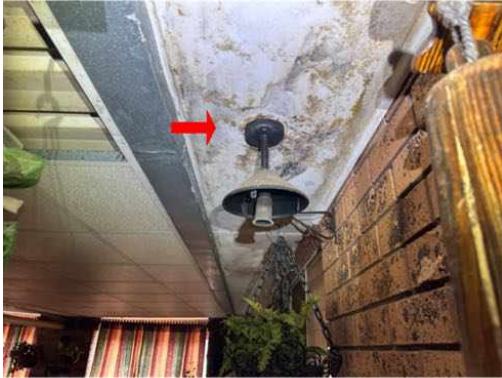
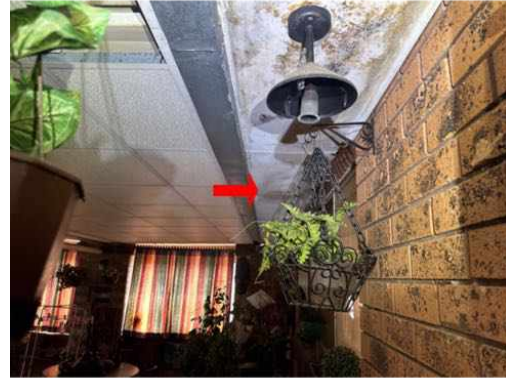
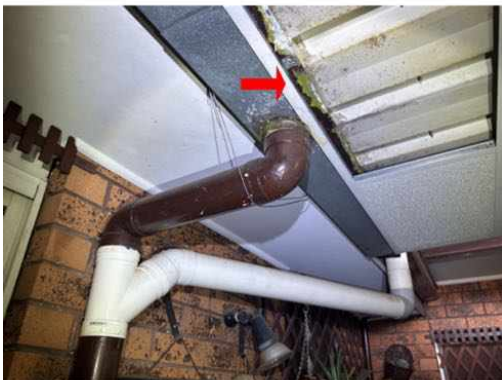
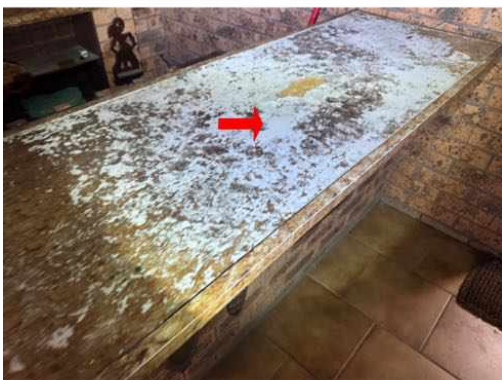
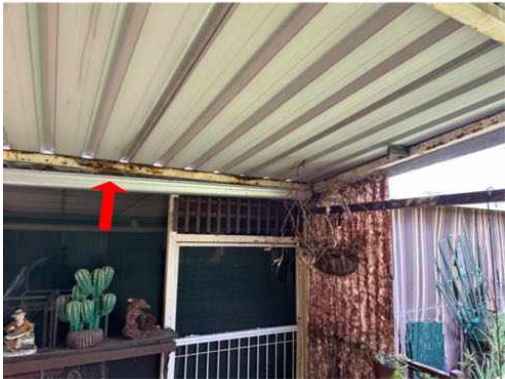
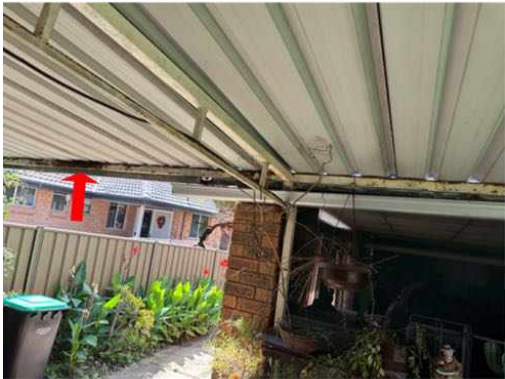
Finding 2.01

Building:	Main Building
Location:	Alfresco > Rear
Finding:	Water staining
Information:	Water staining was evident in this area at the time of inspection. Water staining indicates that surfaces have been exposed to excessive moisture over time. The minerals and other elements in the water lead to staining, which may graduate to corrosion and deterioration if left unmanaged.

While mostly an appearance defect, water staining can be indicative of more serious defects, which may be currently concealed by other building elements.

Where water staining is active, a licensed plumber must be consulted to identify the cause of the staining and to provide advice on any reparation works that may be required. Replacement of any broken or damaged structures is advised.

Conversely, where water staining is old and inactive, affected building materials may be repaired or replaced at client discretion. A qualified carpenter or registered builder may be appointed to perform these works.

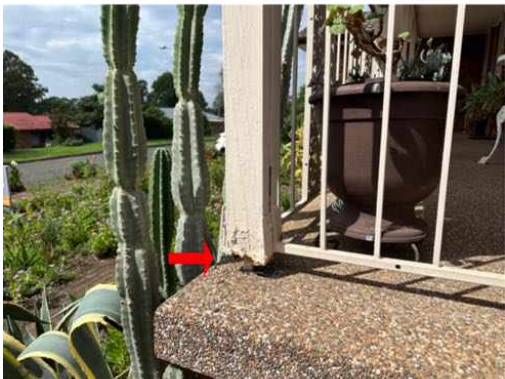
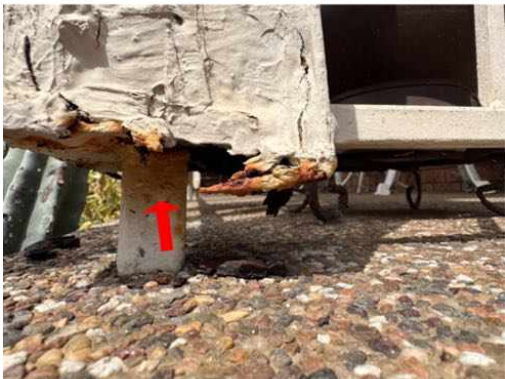
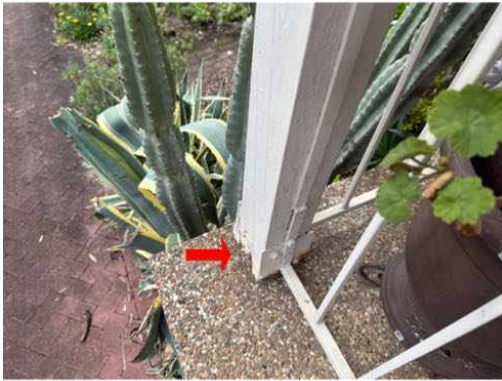
Finding 2.02

Building: Main Building
Location: Front Elevation > Front Right
Finding: Building element - Rusted or corroded
Information: This building element shows evidence of rusting and corrosion, which is likely to have developed as a result of excessive exposure to moisture and or inadequate coatings.

As surface rust provides no protection to the underlying iron, the deteriorating condition is likely to worsen if not addressed in the short-term future.

Where possible, the use of galvanized (treated) metals or aluminium coated metals aid in rust prevention, as does regular general maintenance. Rust formation can be controlled with coatings, such as paint, that isolate the iron from the environment.

Rusting and corrosion should be managed by ideally removing or limiting the affected surface from exposure to moisture. A registered builder may be appointed to replace any building elements that have been severely affected by rust or water damage.

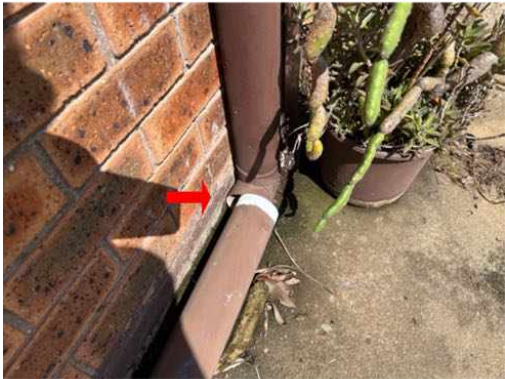
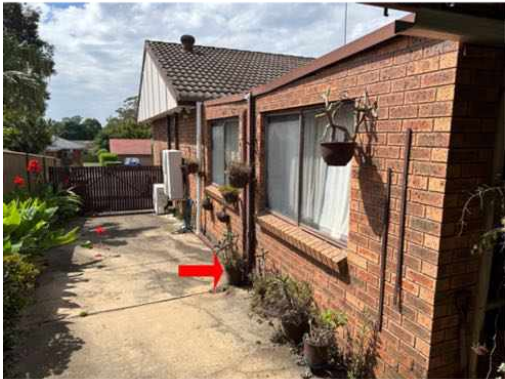
Finding 3.01

Building:	Main Building
Location:	Exterior walls - right side > Centre Right
Finding:	Roof plumbing - Missing
Information:	Some sections of the roof are not adequately drained via gutters and downpipes. Gutters and downpipes that are not installed adequately are likely to result in excessively damp conditions against the exterior surfaces and around the base perimeter of the building.

Excessive moisture creates an environment which accelerates the deterioration of building elements in the area, as well as being conducive to termite and pest infestation. Such an environment is likely to necessitate repair and/or replacement of building elements, which are prone to sustaining wood rot, rust or corrosion.

A roofing plumber should be appointed as soon as possible to install relevant roof plumbing materials. Depending on the extent of the damage, repair and/or replacement of damaged building elements may be required.

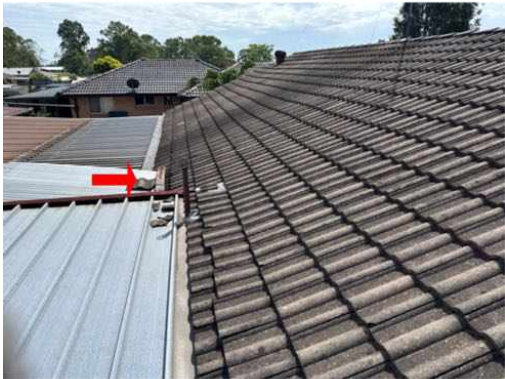
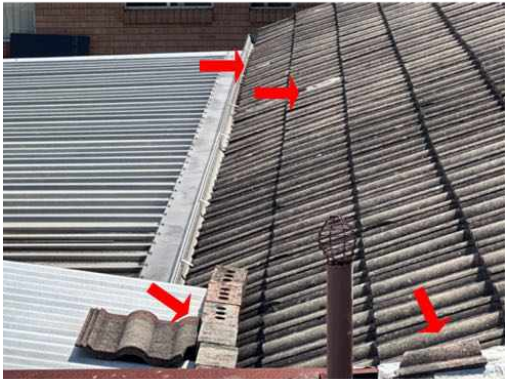
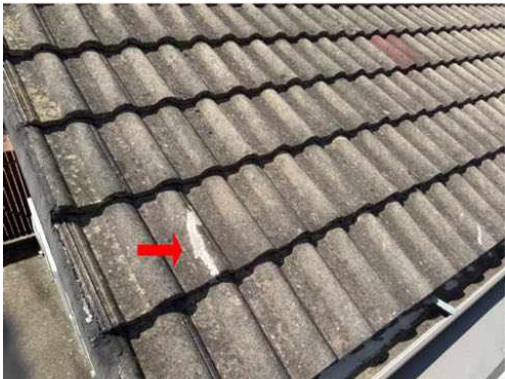
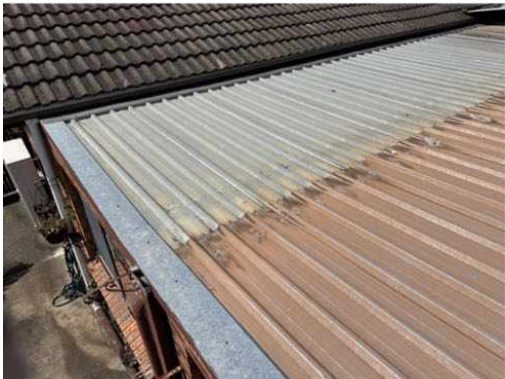
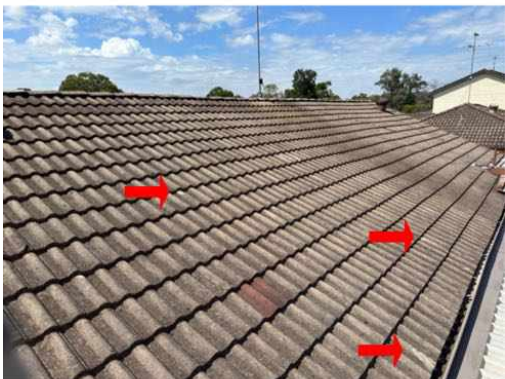
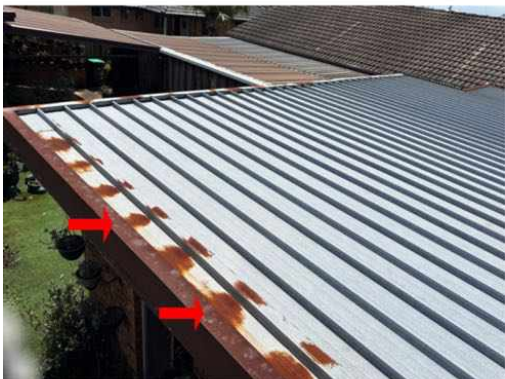
Finding 3.02

Building: Main Building
Location: Roof Exterior > All Areas
Finding: Roof tiles - Weathered
Information: Upon inspection of the exterior roofing, the majority of roof tiles were considered to be in a fair condition. While weathering of the tiles is consistent with the age of the property, maintenance works are required.

Isolated areas of mortar have come loose in the valleys and minor cracking is also present. Re-pointing and re-sealing the may be considered as an interim solution by the client to help preserve and extend the life span of the tiles.

Where left unmanaged, deteriorating roof tiles are likely to lead to a number of secondary defects, including minor water leaks and weather exposure to internal roofing structures.

Consultation with a roofing contractor is highly advised to gain advice on cost of remedial works that may be required in the short to medium term. Remedial works are likely to increase the longevity of the exterior roofing structure.

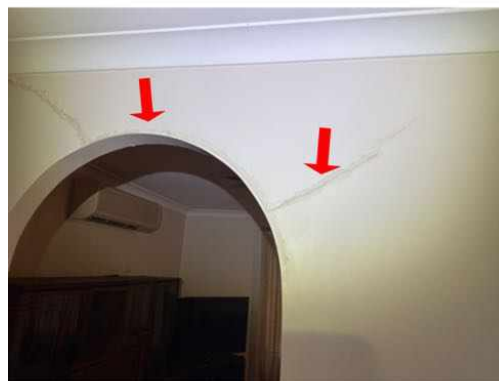
Finding 3.03

Building: Main Building
 Location: Dining Room > Rear Right
 Finding: Cracking - Damage Category 2 - Noticeable (up to 5mm)
 Information: Noticeable cracks are a common occurrence as a result of many primary defects. Such causes may include age, general wear and tear, expected building movement, general expansion/contraction of building materials in different weather conditions, and/or minor failings in the installation or application of building materials.

Noticeable cracks may result in minor sticking or jamming of associated doors and windows, which require easement. However, noticeable cracks are easily filled and repaired. A plasterer can be consulted to install an expansion joint at this point to allow

for this movement during different weather conditions.

Monitoring of all cracking should be conducted frequently. Always contact a building inspector should cracks widen, lengthen, or become more numerous. Additionally, your building inspector should also be contacted if associated building elements such as doors and windows become more difficult to operate over time.

Relevant tradespeople, such as carpenters, painters and plasterers, should be appointed to perform remedial works, as deemed necessary.

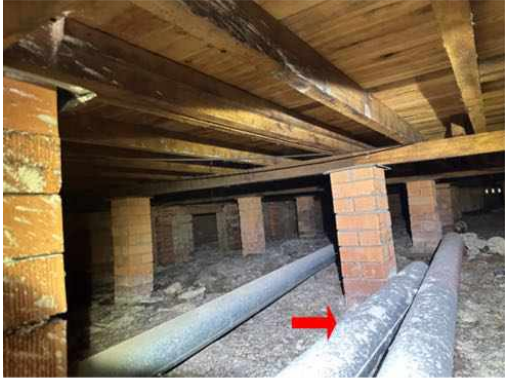
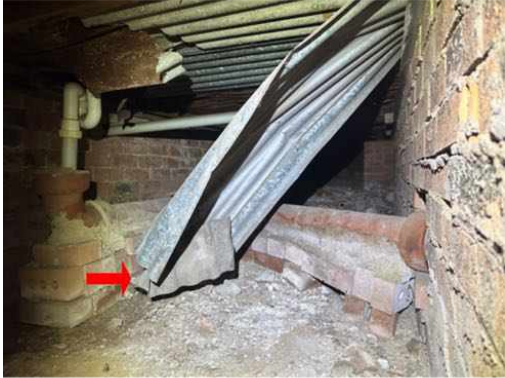
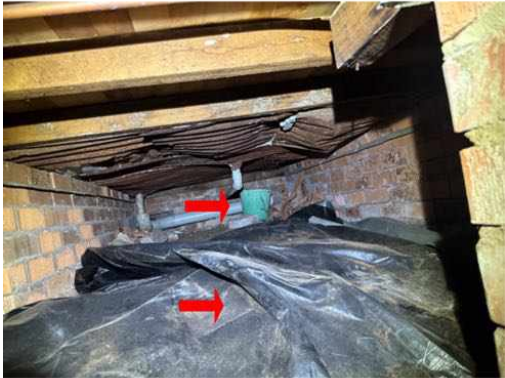
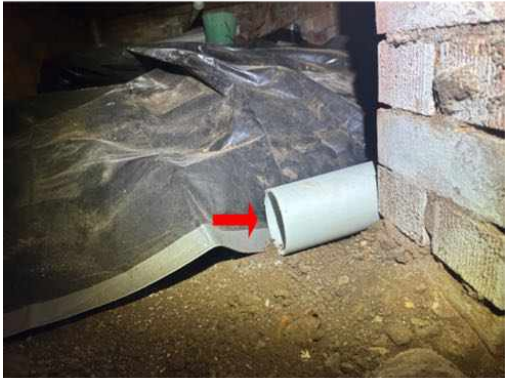
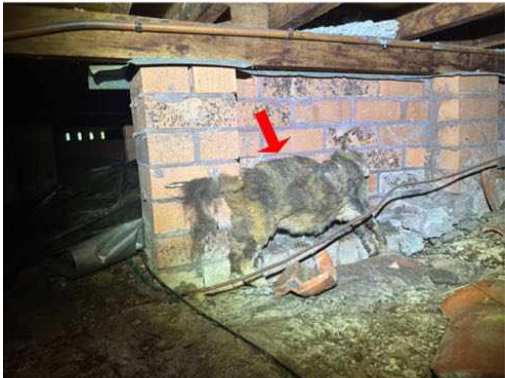
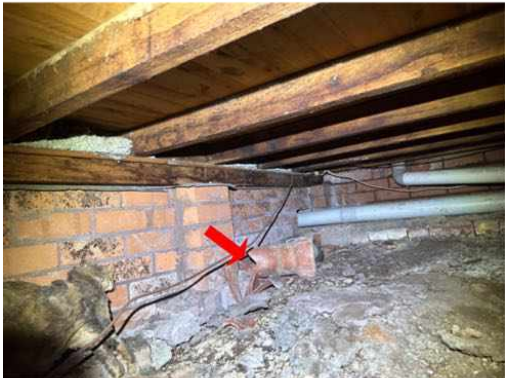
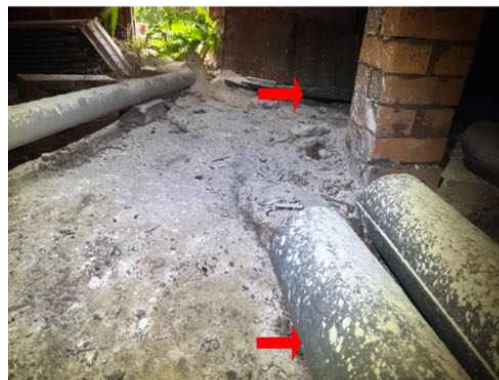
Finding 3.04

Building:	Main Building
Location:	Subfloor > All Areas
Finding:	Subfloor - Debris
Information:	An array of debris was found in the subfloor area at the time of inspection. Debris in this area restricts subfloor ventilation and creates potential for concealed pest entry. Stored timbers and other materials may also make the area susceptible to termite activity and wood rot.

A clear and empty subfloor will be better ventilated and easier to maintain in a dry condition. The removal of any timber debris is vital in minimising the risk of termite or wood borer activity.

Debris in the subfloor should be removed as soon as possible. Depending on the location and amount of debris and stored items, the homeowner may elect to undertake this task. Alternatively there are a large number of rubbish removal subcontractors that could undertake these works.

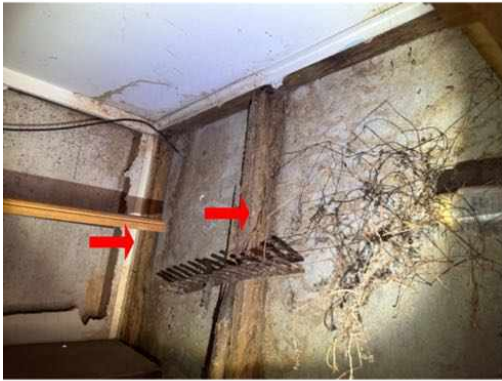
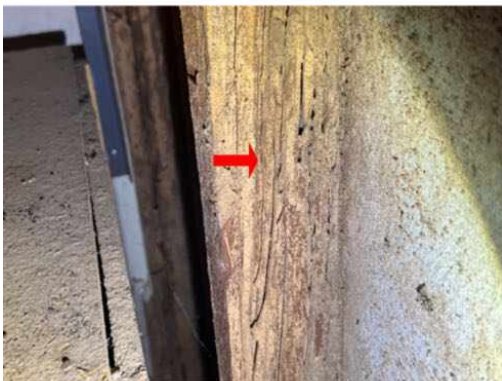
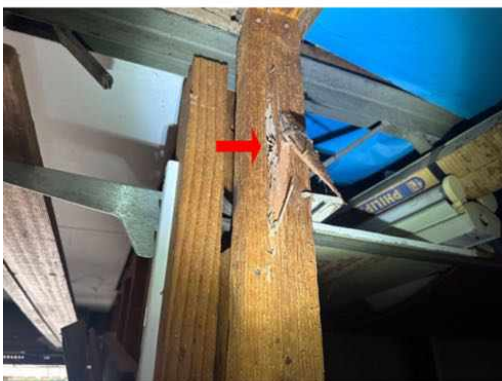
Building:	Garage
Location:	Garage > Rear Right
Finding:	Evidence of termite damage - structural
Information:	Despite no live termite or timber pest activity being identified, previous termite damage was found in this area. This damage is considered to be major and structural in nature. Such damage creates a potential safety hazard, and is likely to worsen and cause further damage to adjoining building materials.

If left unattended, this damage creates an unsafe environment and is likely to lead to the need for major structural works.

A building contractor should be appointed immediately to advise on options to prevent further damage and repair all affected building materials. Until such time, caution should be taken by all people coming into contact with these building elements and this area.

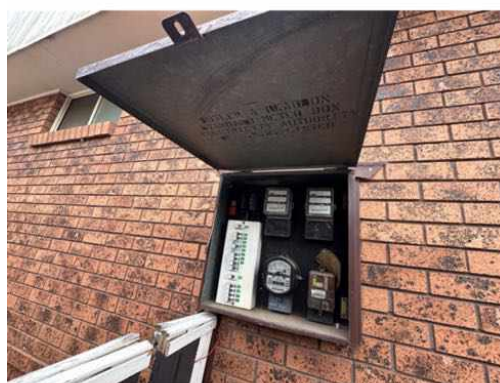
Finding 6.01

Building:	Main Building
Location:	Electrical circuit box > Front Left
Finding:	Termite Management System - no evidence of a chemical installation
Information:	The application of a post-construction chemical termite barrier is highly recommended for all properties, particularly if live termite activity has been found on the site previously. Such barriers are highly effective in preventing termite attack on any timber building elements throughout the property.

A durable notice should be placed in the switchboard unit to indicate current termite barriers. At the time of inspection, it appeared as though no termite management system has been installed, with no evidence to suggest preventative works taking place.

The client may consider gaining further advice from a pest controller as to the costs and procedures involved with this application. It is recommended that obtaining such advice be a short-term priority.

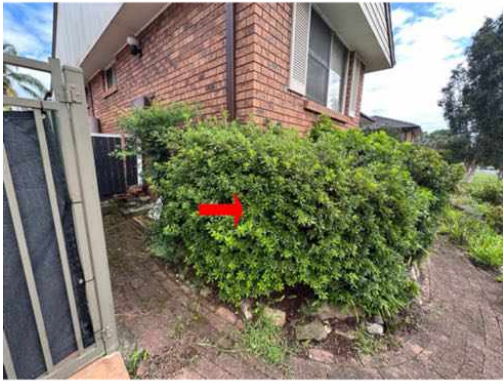
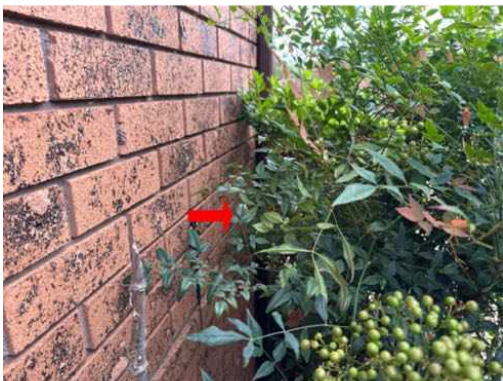
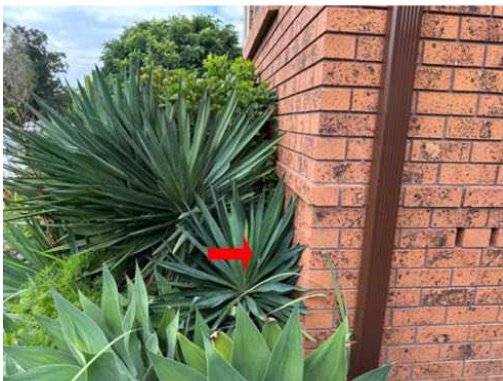
Finding 6.02

Building:	Main Building
Location:	All Areas > All Areas
Finding:	Bridging - Vegetation
Information:	Where vegetation obstructs inspection of building elements, also known as bridging as it provides a bridging point for the access of termites, full inspection can not be achieved. Consequently moisture or dampness may be present and the areas becomes conducive to termite activity. Plants against or very close to buildings provide cover, shade and can provide an environment that is attractive to termite infestation.

The removal and replanting of species that do not provide "cover" or cutting back of existing vegetation will assist greatly in preventing Bridging from occurring.

The removal of any such materials that may be conducive to termite activity should be carried out as soon as possible and arrange re inspection to minimize the risk of termite attack.

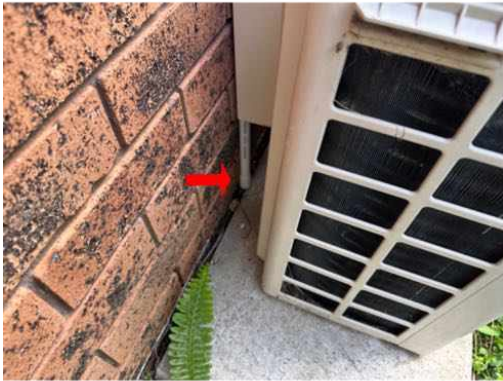
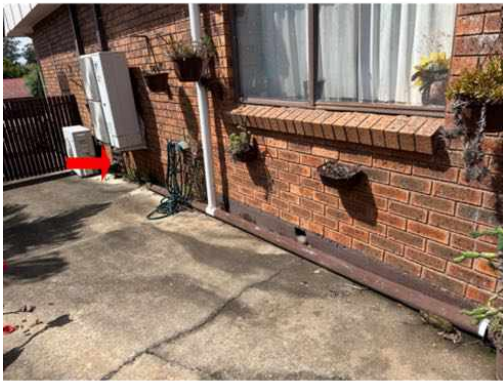
Finding 6.03

Building:	Main Building
Location:	All Areas > All Areas
Finding:	Air conditioner - Disconnected overflow
Information:	The Air Conditioner (A/C) overflow was found to be disconnected from storm water drainage and is creating excessive moisture in the surrounding area.

Such leaking creates an environment which is conducive to an array of defects, including water damage to associated building elements and the attraction of termite or timber pest infestation.

It is highly recommended that a licensed plumber be appointed to connect the A/C

overflow in order to prevent such an environment from being created. These minor works should be carried out as soon as possible.

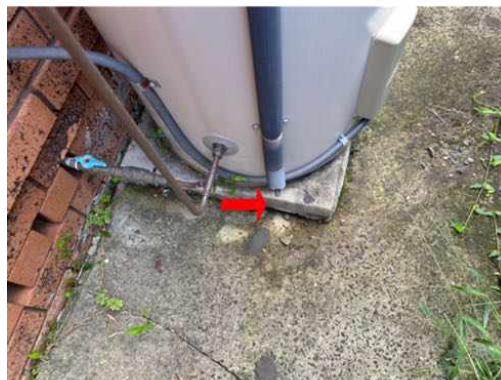
Finding 6.04

Building:	Main Building
Location:	Exterior walls - left side > Centre Left
Finding:	HWS Overflow - Not Connected
Information:	The Hot Water System (HWS) overflow was found to be disconnected from storm water drainage and is creating excessive moisture in the surrounding area.

These damp conditions can lead to secondary defects such as rot, rust or corrosion of associated building elements, the formation of fungal decay, or even the creation of potential slip hazards. When coupled with poor site drainage, pooling of water may also attract termite activity to this area.

It is highly recommended that a licensed plumber be appointed to connect the HWS overflow in order to prevent such an environment from being created. These minor works should be carried out as soon as possible.

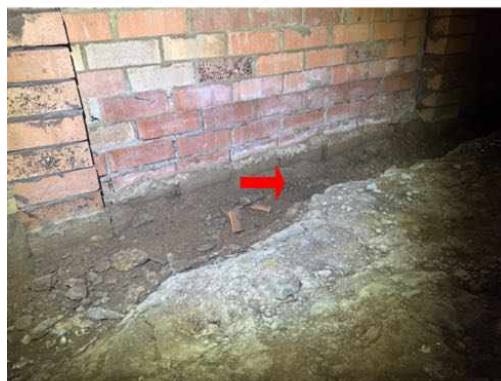
Finding 6.05

Building: Main Building
 Location: Subfloor > All Areas
 Finding: Subfloor: Damp.
 Information:

At the time of inspection there appeared to be sections of the subfloor area with excessive moisture which can lead to secondary defect of other building materials. A well drained sub floor can aid in preventing secondary damage such as wood rot and pest activity, as well as preventing the development of mould and mildew (which can lead to respiratory safety hazards for occupants). This should be investigated as soon as possible by a plumber for leaking pipes or to improve site drainage.

Ventilation can be restricted by a variety of minor defects, including obstructions in the subfloor space, a lack of vents or a low clearance.

The initial step in improving ventilation is to ensure that the subfloor area is free of any debris or stored items. Where ventilation is still inadequate, it is advised to ensure that all vents are clear of blockages, and additional vents may be installed.

The client may also consider mechanical ventilation (powered fans) to improve subfloor airflow. Remedial works should be conducted as a matter of urgency to protect against the development of potentially harmful subfloor conditions.

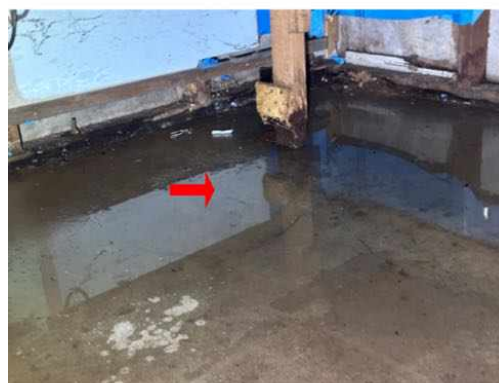
Finding 6.06

Building:	Garage
Location:	Garage > Rear Right
Finding:	Damp
Information:	Damp (or structural damp) refers to the presence of unwanted moisture in the structure of a building, either as the result of intrusion from outside, or condensation from within the structure. Generally, structural damp is caused by rain penetration, rising damp, and leaks from plumbing pipes.

Unmanaged damp facilitates the formation and development of mould, fungi growth and wood rot, decaying associated building materials and compromising their

structural integrity. Damage to finishes is also likely to occur, including lifting, bubbling, peeling and staining of paint, plaster and wallpaper.

It is important to address damp conditions, as the World Health Organisation notes that excess moisture leads - on almost all indoor materials - to growth of microbes such as moulds, fungi and bacteria, which subsequently emit spores and other matter into the indoor air. Exposure to these contaminants is associated with a wide range of respiratory and other health-related problems. Additionally, the development of damp in timber building elements also provides an environment that is conducive to termite / timber pest attack.

The first step in addressing damp is to diagnose the cause. The identified cause should be addressed first prior to repairing the appearance and other defects which have resulted from the rising damp. If the original cause is not resolved, further cases of damp are likely to ensue, resulting in secondary defects.

Consultation with a qualified plumber is advised immediately to identify the cause of damp and perform remedial works as required. Where excessive mould growth is present, further inspection by a specialist environmental health inspector should also be considered.

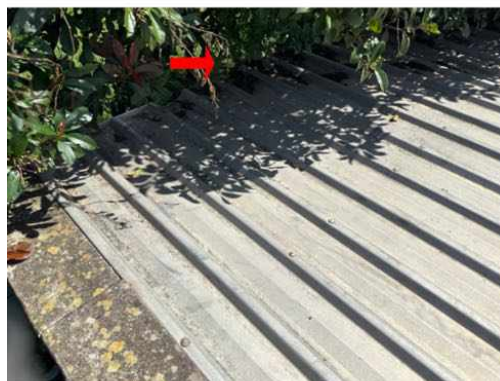
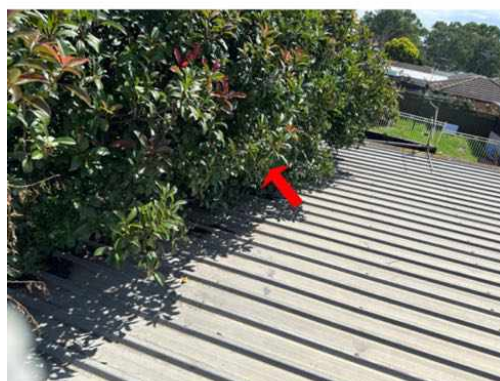
Finding 6.07

Building:	Garage
Location:	Garage > Rear Right
Finding:	Bridging - Vegetation
Information:	Where vegetation obstructs inspection of building elements, also known as bridging as it provides a bridging point for the access of termites, full inspection can not be achieved. Consequently moisture or dampness may be present and the areas becomes conducive to termite activity. Plants against or very close to buildings provide cover, shade and can provide an environment that is attractive to termite infestation.

The removal and replanting of species that do not provide "cover" or cutting back of existing vegetation will assist greatly in preventing Bridging from occurring.

The removal of any such materials that may be conducive to termite activity should be carried out as soon as possible and arrange re inspection to minimize the risk of termite attack.

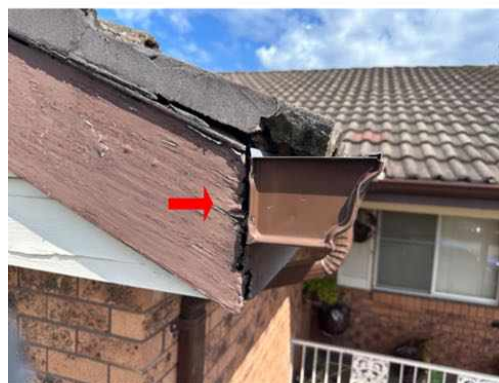
Finding 7.01

Building:	Main Building
Location:	Roof Exterior > Front
Finding:	Fascias - Wood rot
Information:	Wood rot was found to be affecting fascias and barges in this area, evidenced by the presence of mould on the surface in some areas. Wood rot, also known as Fungal Decay, occurs when timbers and other cellulose building materials are exposed to damp conditions on an ongoing basis.

It is likely that this wood rot has developed as a result of faults in the roof plumbing, creating excessive moisture in this areas. Frequent exposure to rain and other weather conditions also make fascias and barges susceptible to accelerated deterioration.

Wood rot or fungal decay was found in the barge boards at the time of inspection. Wood rot is conducive to termite activity, all susceptible timbers (where applicable) should be removed and where applicable replaced with non-susceptible timber as soon as possible.

elements. Prior to any works being performed, the cause of the moisture that has created the visible wood rot should be identified and addressed in a suitable manner.

It is advised that a roof plumber be appointed to inspect all roof plumbing and subsequently identify the cause of the wood rot. Replacement of affected fascias and barges may then be a necessary step in protecting surrounding building elements from such deterioration.

A qualified plumber may be appointed to assess the cause of excessive moisture and to provide advice on any remedial works as required. A qualified carpenter or registered builder may also be required to replace affected building materials.

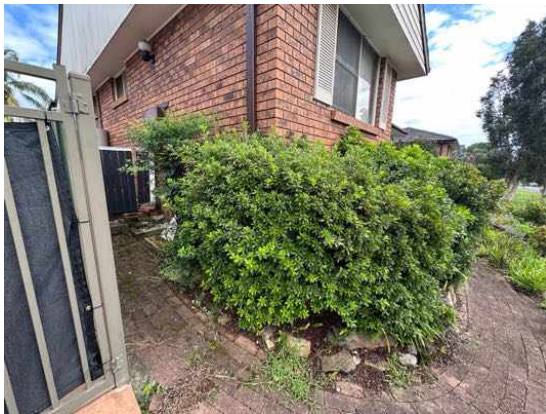
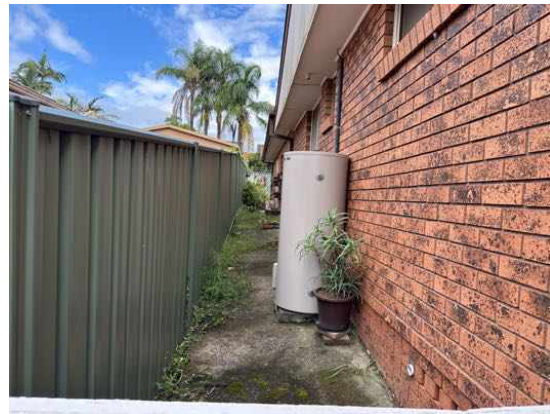
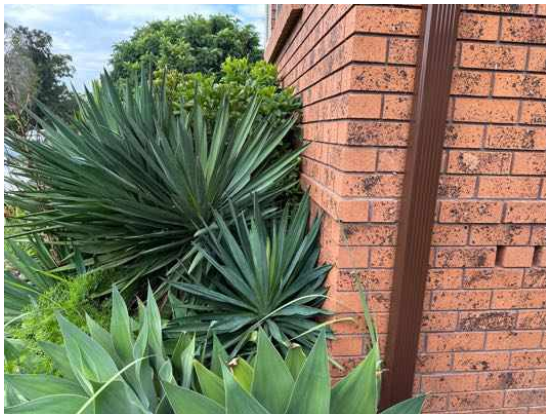
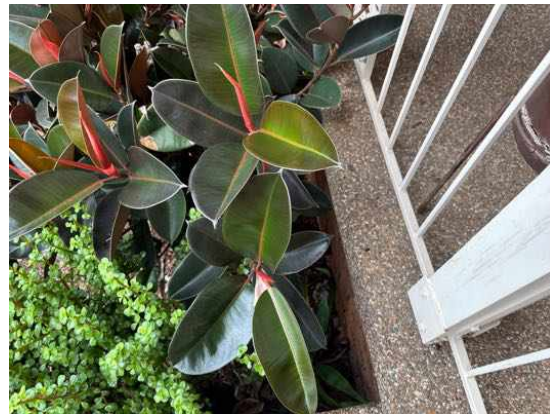
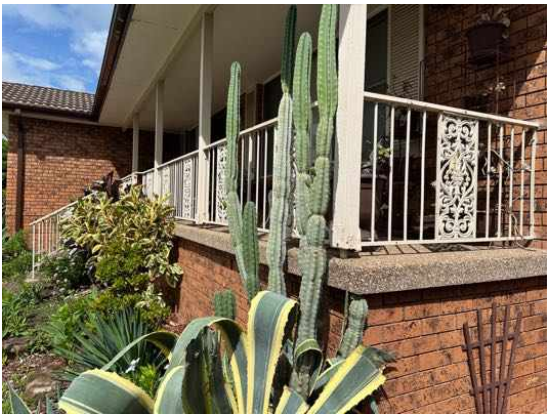
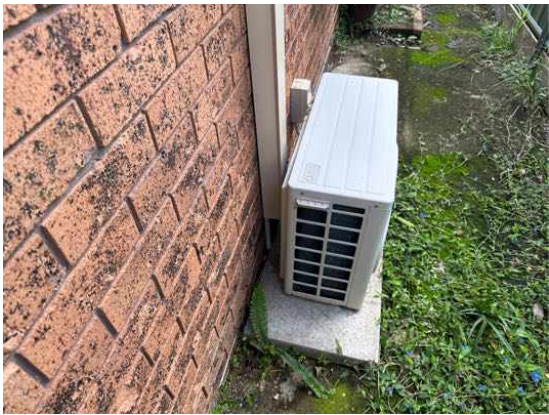
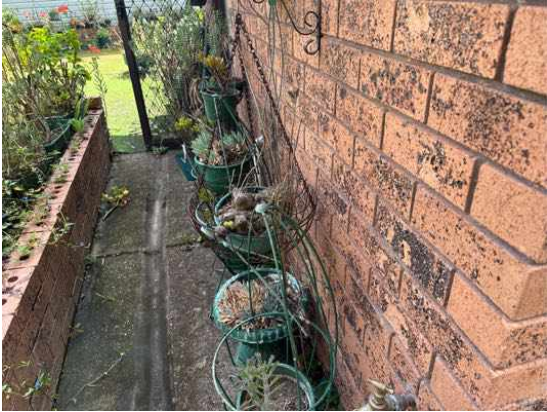
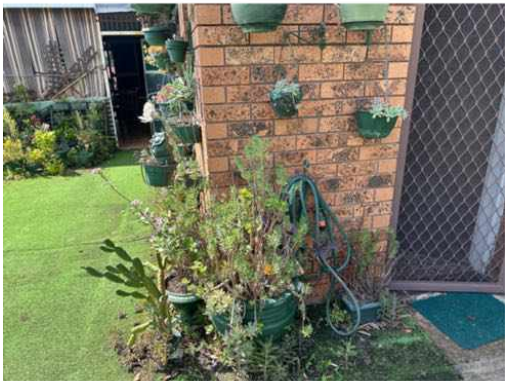
Building: Main Building
Location: All Areas > All Areas
Finding: Additional Photos - Obstructions and Limitations
Information: These photographs are an indication of the obstructions and limitations which impeded full inspection of the property at the time of inspection. These obstructions can hide an array of defects and should be removed to allow full inspection to be carried out. A re-inspection is recommended once the areas are made accessible.

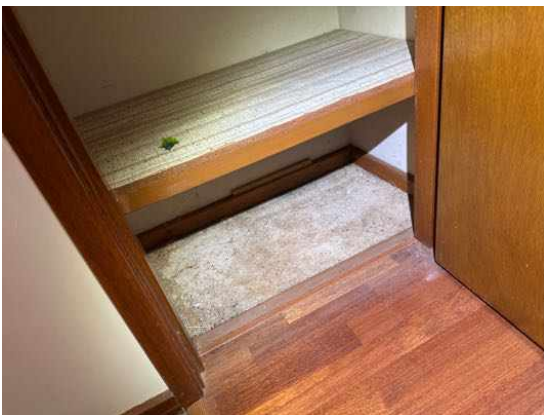
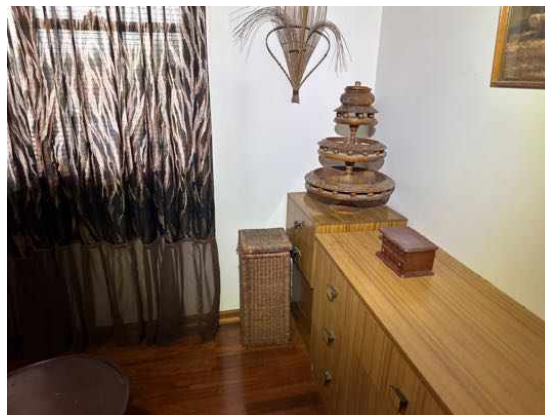
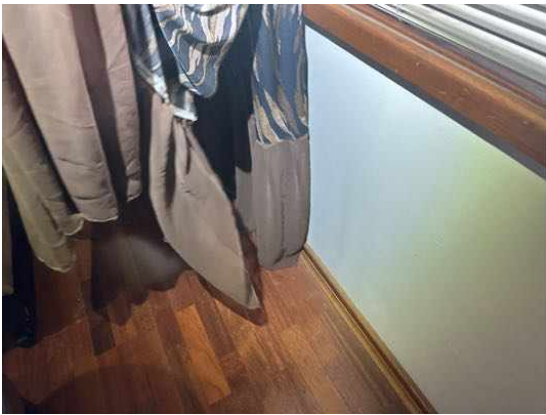
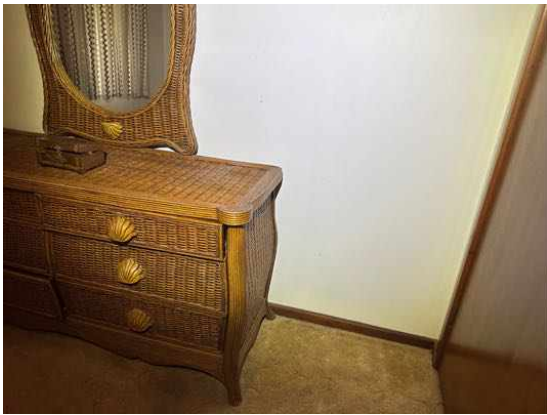
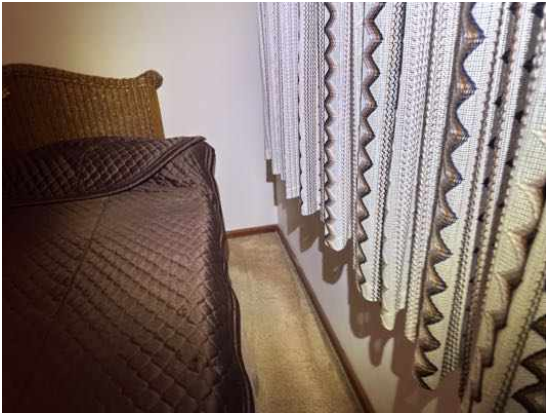
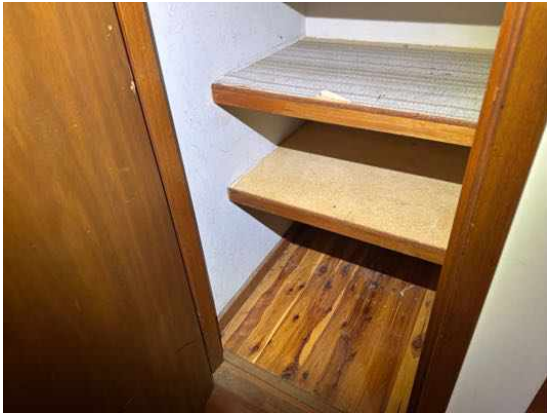
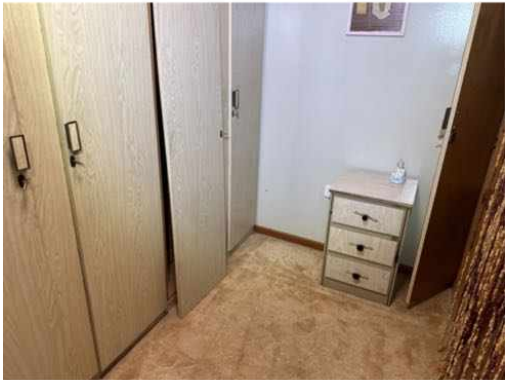
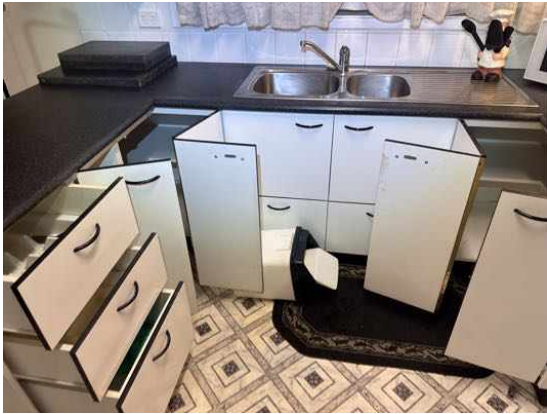
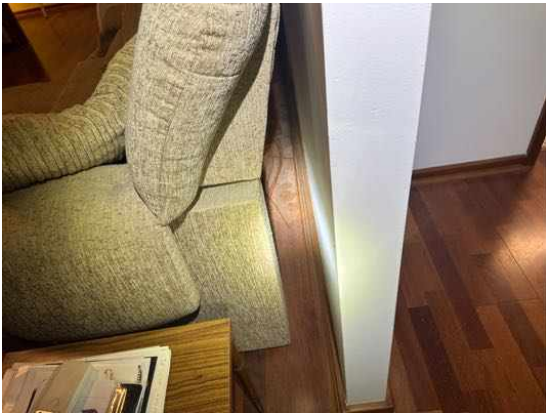
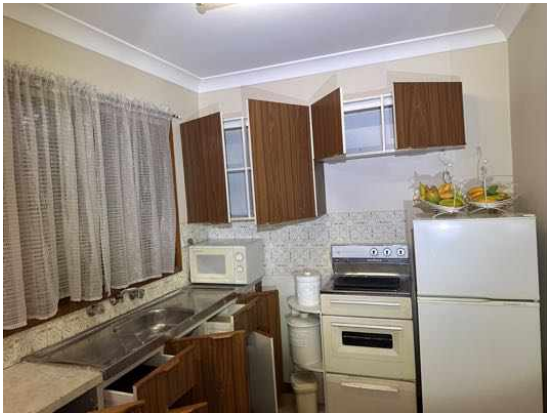
Building:	Main Building
Location:	All Areas > All Areas
Finding:	Additional Photos - Obstructions and Limitations
Information:	These photographs are an indication of the obstructions and limitations which impeded full inspection of the property at the time of inspection. These obstructions can hide an array of defects and should be removed to allow full inspection to be carried out. A re-inspection is recommended once the areas are made accessible.

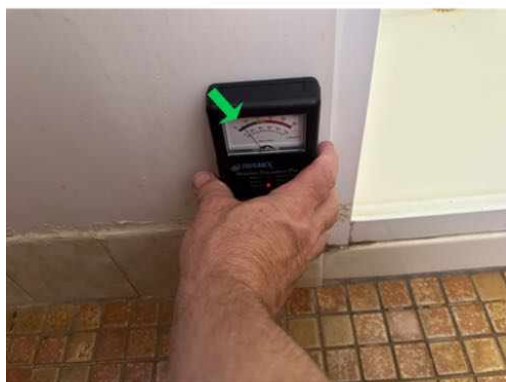
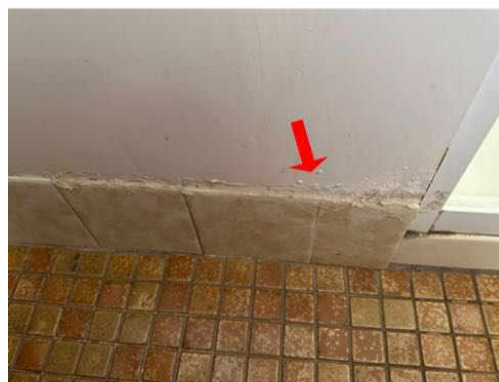
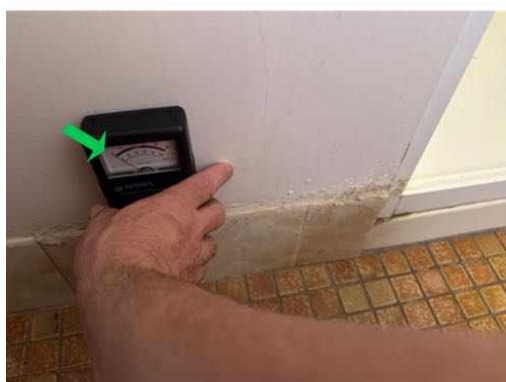
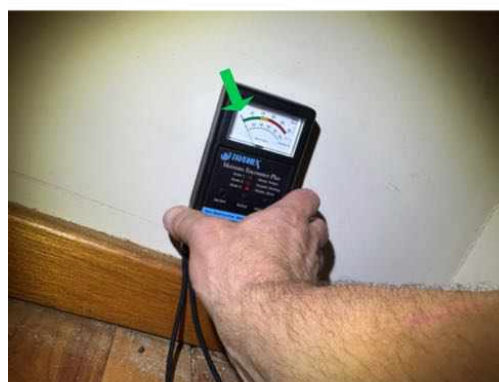
Building: Main Building
Location: Bathroom > Centre Left
Finding: Moisture Meter used: No Moisture Detected.
Information: Moisture meter was used during the inspection and no excessive moisture was detected to accessible walls inside the shower recess at the time of inspection.

The grout and tiles in this area appear to be in poor condition at the time of inspection

Monitoring the area is advised and if any visual signs of excessive moisture appear (peeling paint, mould) then consultation with a qualified plumber or bathroom specialist would be advised to identify the cause of damp and to perform remedial works as required.

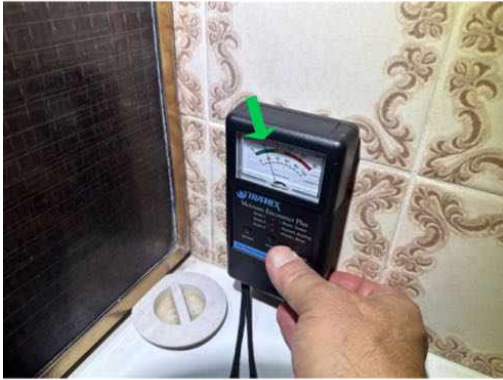
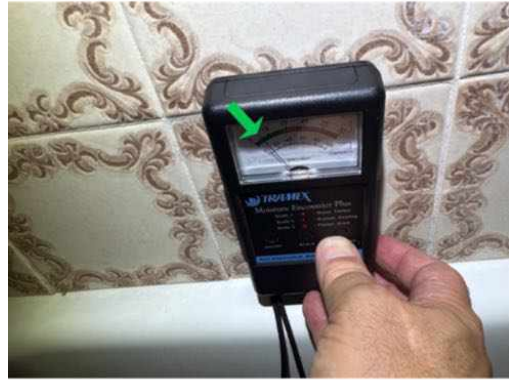
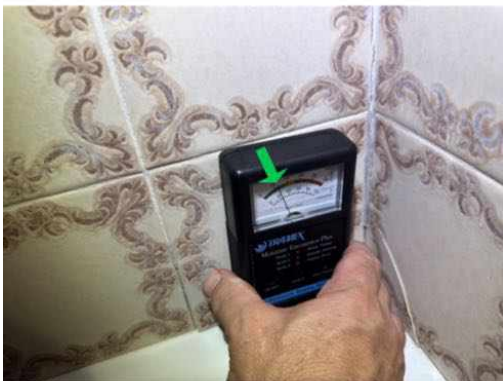
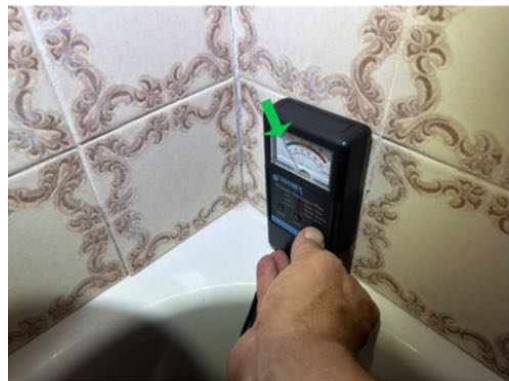
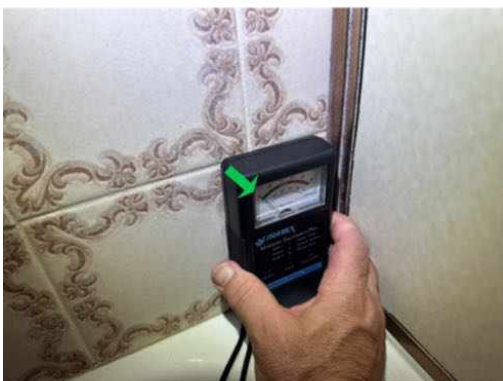
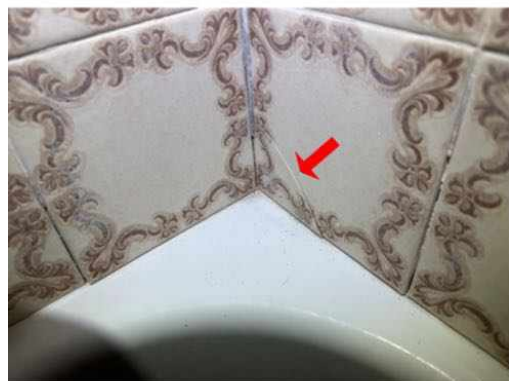
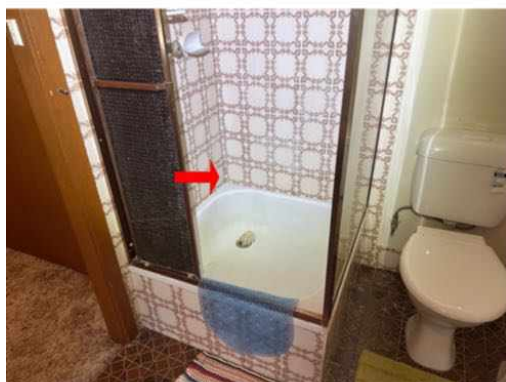
Building: Main Building
Location: Bathroom 2 > Rear Left
Finding: Moisture Meter used: No Moisture Detected
Information: Moisture meter was used during the inspection and no excessive moisture was detected to accessible walls inside the shower recess at the time of inspection.

The grout and tiles in this area appear to be in fair condition to most of the shower recess, with some areas requiring maintenance at the time of inspection.

Monitoring the area is advised and if any visual signs of excessive moisture appear (peeling paint, mould) then consultation with a qualified plumber or bathroom specialist would be advised to identify the cause of damp and to perform remedial works as required.

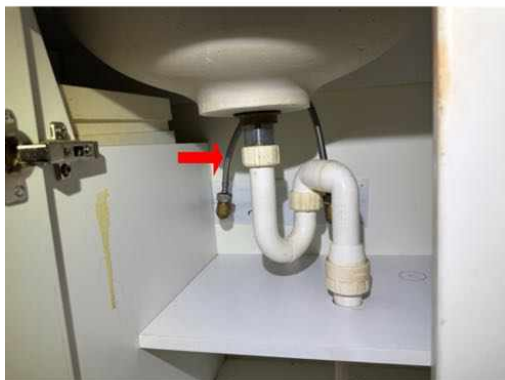
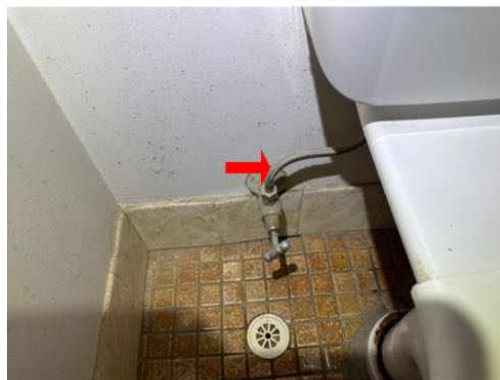
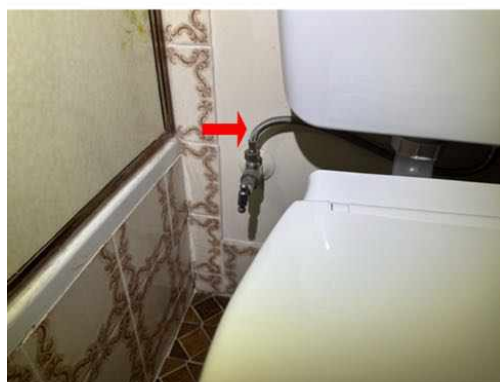
Building:	Main Building
Location:	All Areas > All Areas
Finding:	Pipe: Flexible Braided pipes.
Information:	Braided Stainless Steel Flexi connector hose are popular in modern home fit outs because they can be bent into shape. They started to be installed in the early two thousands and their use is now extremely widespread in contemporary construction and renovations.

Flexible braided hoses accounted for more than one in five water damage claims lodged by Australian households according to research released by general insurer IAG.

It is recommended that the Flexi pipes to be replaced at the owners discretion to avoid an “escape water incident” which may lead to water damage to other building elements in the home.

This work can be undertaken by a licensed plumber, general handy person at the owners discretion.

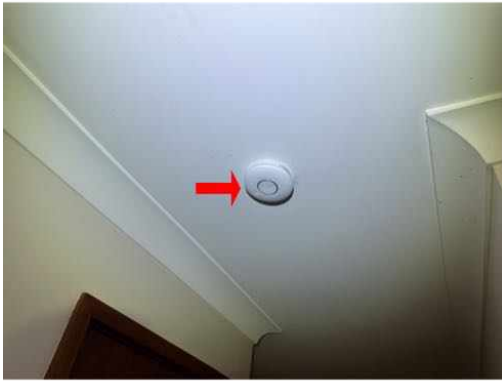
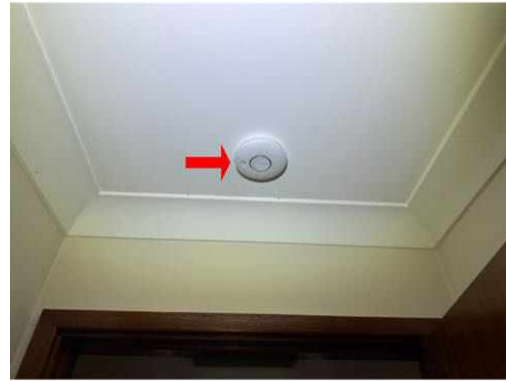
Building:	Main Building
Location:	Hallway > Centre
Finding:	Smoke Detectors and Alarms
Information:	Reporting on Smoke Detectors or Alarms, including hard wired smoke detection systems and their legislative requirements, is outside the Scope of this Report.

Please note that this defect is highlighted as a caution only. We suspect, based on our experience in the building industry, that the absence of smoke detectors, or their poor condition, should be addressed as a matter of urgency to improve occupant safety.

Always ensure sufficient working and suitable smoke detectors are installed prior to occupying any building. Additionally, it is advised that all smoke detectors be tested by the homeowner on a monthly basis.

Please refer to AS3786 and state based legislation, which may also apply.
