Building and Timber Pest Inspection Report

Inspection Date: Wed, 4 Mar 2026

Property Address: 15 Kurmond St, Jamisontown NSW 2750,
Australia

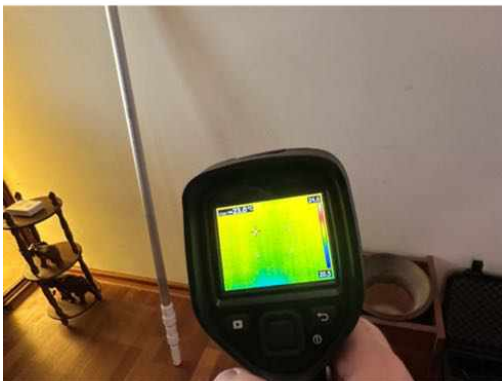
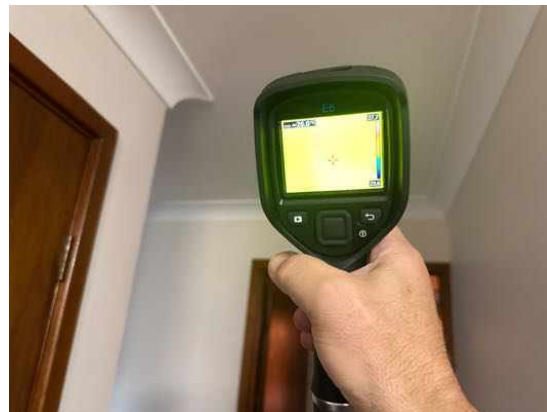
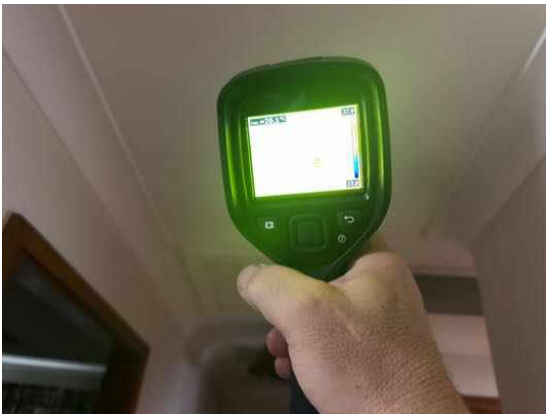
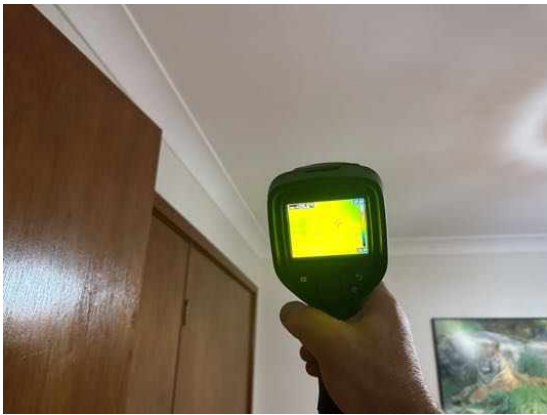
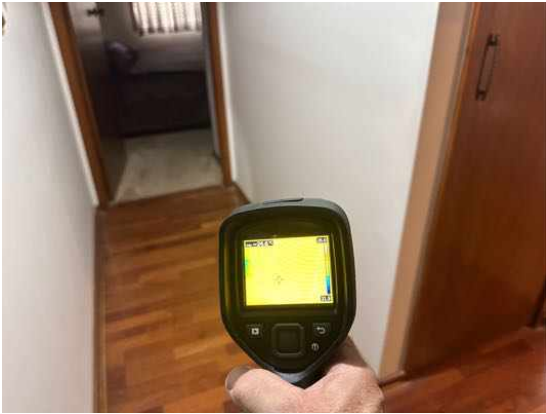
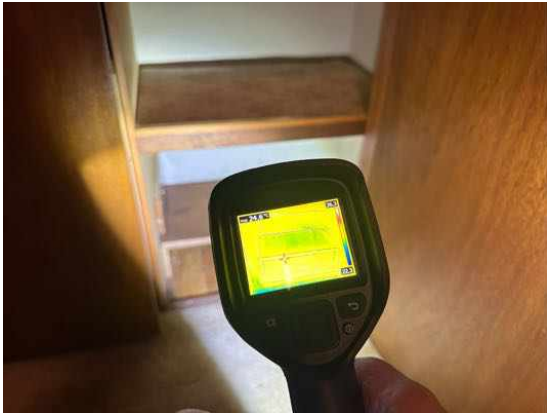
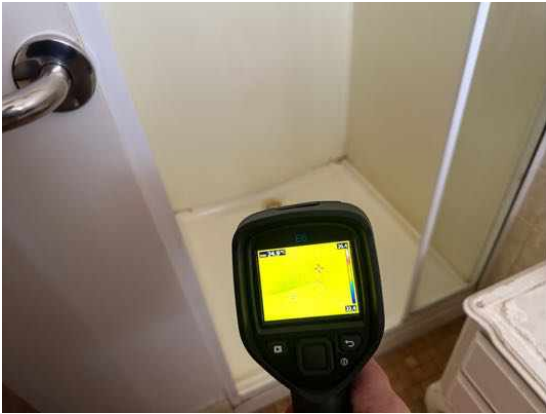
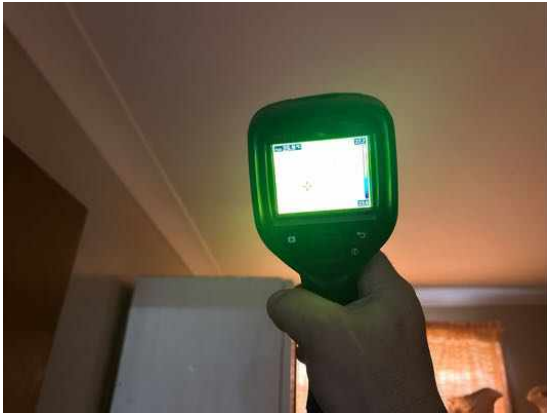
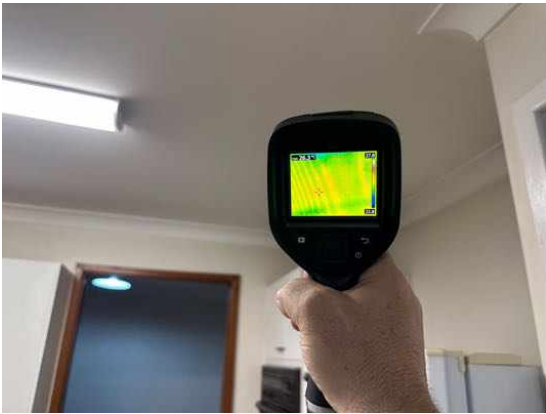
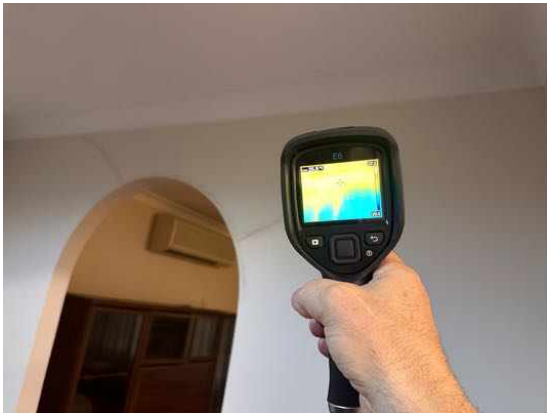
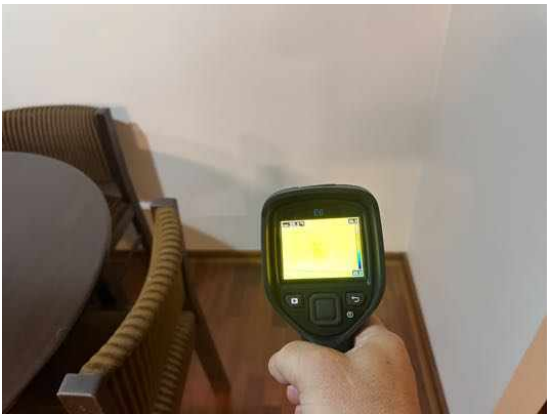
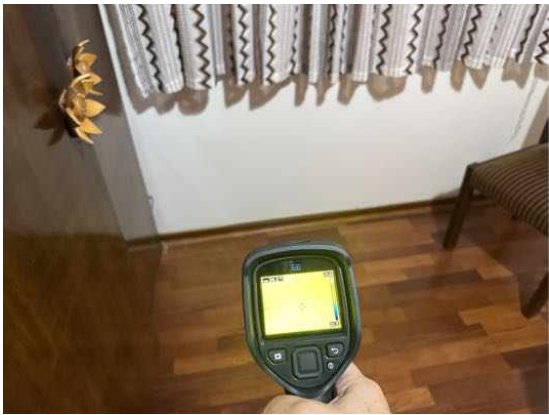
Building: Main Building
 Location: All Areas > All Areas
 Finding: Thermal imaging: No excessive moisture presentation.
 Information: At the time of inspection there appeared to be no excessive moisture presentation in this area.

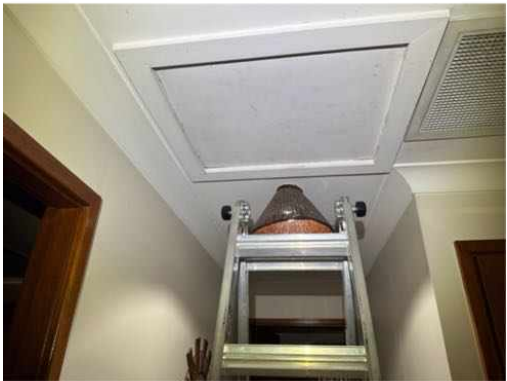
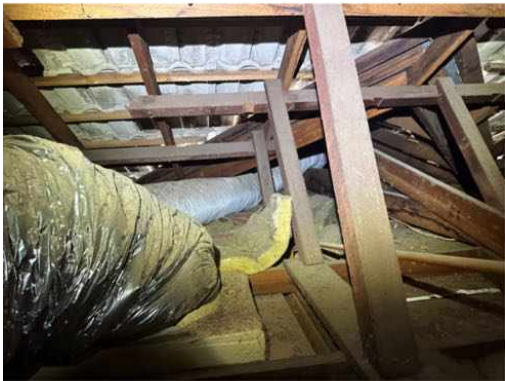
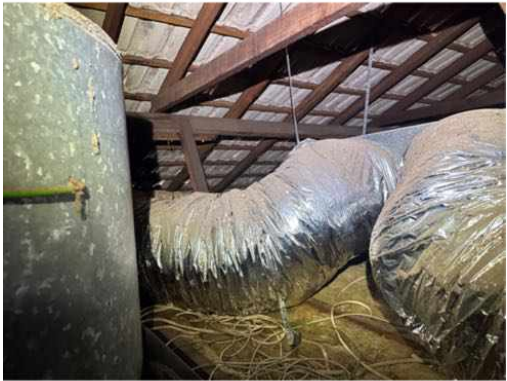
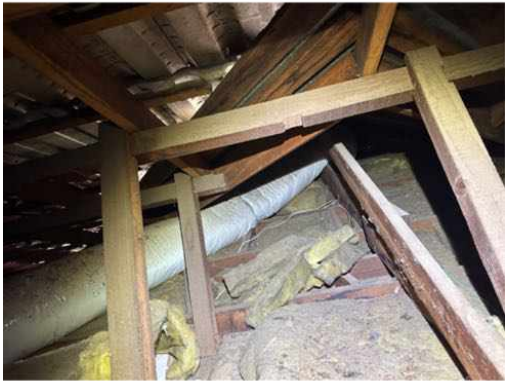
Building: Main Building
Location: All Areas > All Areas
Finding: Roof void: limited access.
Information: Limited access to the roof void was present due to facts including but not limited to access hatch size or placement, insulation, boards, air conditioning ductwork, disconnect gravity hot water service, for this reason inspection to the roof void was minimal and a range of defect's from minor to major may not be visible at the time of inspection.
