Building and Timber Pest Inspection Report

Inspection Date: Wed, 18 Feb 2026

Property Address: 74 Osborne St, Williamstown VIC 3016,
Australia

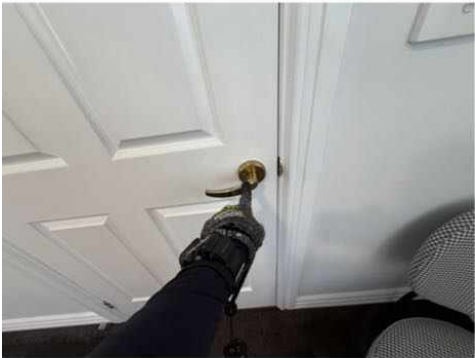
Finding 3.06

Building: Main Building
Location: Bedroom 1
Finding: Door not latching
Information: The door knob/ latch was found to be non operational at the time of inspection.

Consultation with a locksmith or general handyman is required to gain further advice.

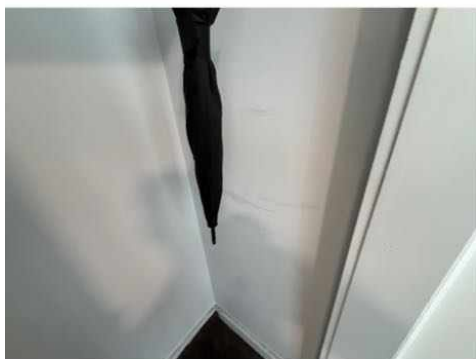
Finding 3.07

Location: Some Internal Areas
 Finding: Surface - Marked
 Information: Although detracting from the overall appearance, marked or stained surfaces do not indicate any operational or structural damage. This degree of surface damage is consistent with general wear and tear and is expected of a property of this age and condition.

Marked surfaces may be left as is at client discretion, as no repairs or replacement are necessarily required for this appearance defect. However, the client may wish to seek quotations for the cost to refurbish or replace the identified building element.

A painting or cleaning contractor may be appointed to rectify marked surfaces at the discretion of the client.

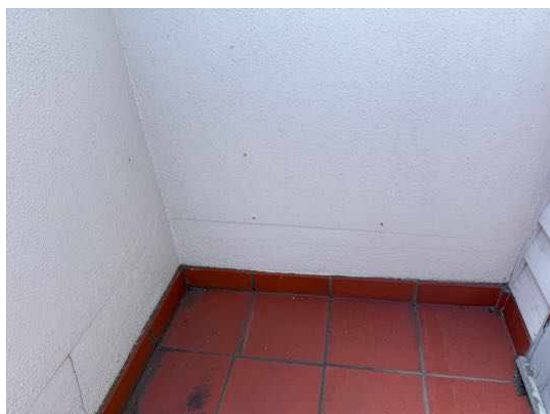
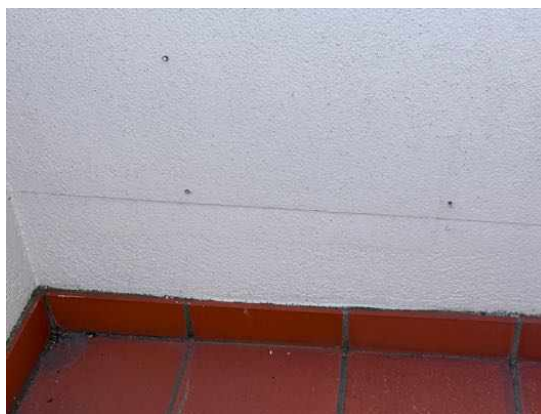
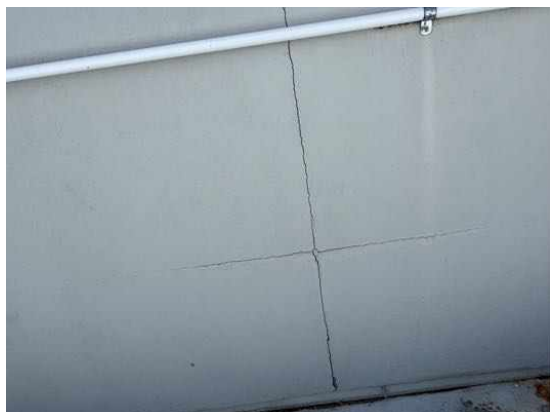
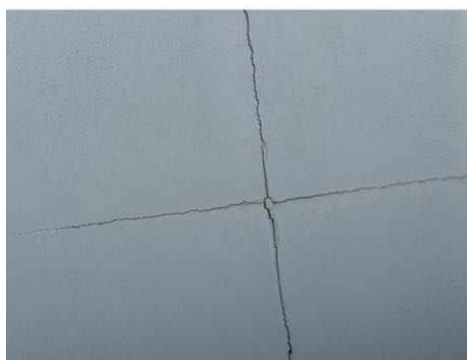
Finding 3.08

Building: Main Building
 Location: Some Internal Areas
 Finding: Cracking - Damage Category 1 - Fine (up to 1mm)
 Information: Although fine cracks are quite noticeable, they are often only considered to be an appearance defect, and usually do not indicate any structural damage. Generally, the cause of a fine crack is indicative of a separation between building materials and finishes (e.g. paint, plaster, etc.) along joins.

Cracking of this nature can generally be repaired with minor sanding, filling and/or repainting. Such works should be performed by a qualified painter or a general handyman.

Monitoring of all cracking should be conducted frequently. Always contact a building inspector should cracks widen, lengthen, or become more numerous.

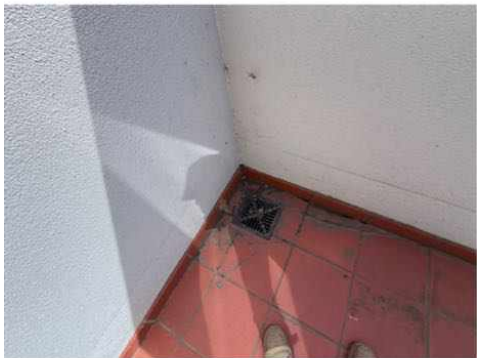
Finding 3.09

Building:	Main Building
Location:	Balcony
Finding:	Balcony Drain Requires Cleaning
Information:	The balcony floor waste drain was observed to contain accumulated debris, dirt, and organic matter at the time of inspection. The build-up is partially obstructing the drain grate and may restrict the effective discharge of stormwater during rainfall events. If not maintained, this condition can lead to ponding of water against the balcony surface and adjoining walls, increasing the risk of moisture ingress and premature deterioration of finishes.

It is recommended that the drain grate be removed and the waste cleared to ensure free-flowing drainage. Ongoing periodic maintenance is advised to prevent recurrence.

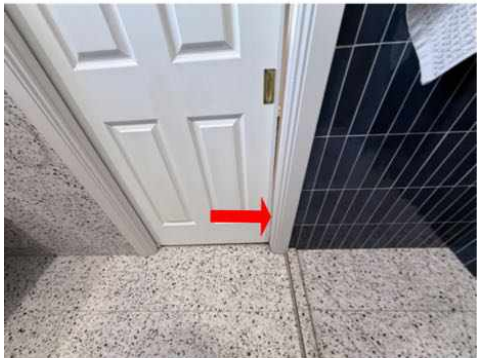
Finding 3.10

Building: Main Building
Location: Ensuite
Finding: Door Misaligned on closing.
Information: The bathroom sliding door was observed to be misaligned when in the closed position. The door does not sit flush within the frame and exhibits uneven clearances along the jamb, indicating possible misalignment of the track, rollers, or door stops. This condition may result in improper latching, reduced privacy, and premature wear to the sliding mechanism over time.

Adjustment of the door alignment, including inspection of the track, rollers, and guides, is recommended to ensure smooth operation and proper closure. This is considered a minor maintenance issue at the time of inspection.

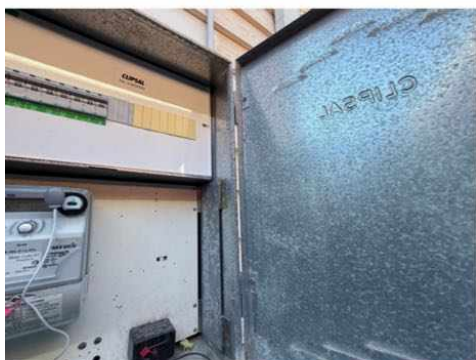
Building:	Main Building
Location:	Meter Box
Finding:	Termite Management System - no evidence of a chemical installation
Information:	The application of a post-construction chemical termite barrier is highly recommended for all properties, particularly if live termite activity has been found on the site previously. Such barriers are highly effective in preventing termite attack on any timber building elements throughout the property.

A durable notice should be placed in the switchboard unit to indicate current termite barriers. At the time of inspection, it appeared as though no termite management system has been installed, with no evidence to suggest preventative works taking place.

The client may consider gaining further advice from a pest controller as to the costs and procedures involved with this application. It is recommended that obtaining such advice be a short-term priority.

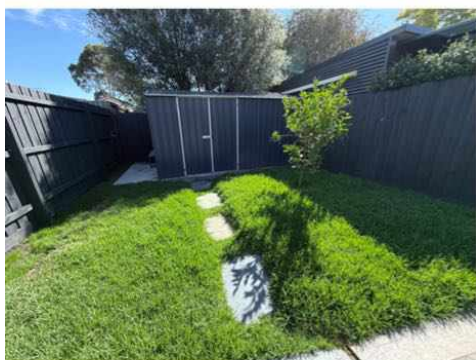
Finding 6.02

Building:	Main Building
Location:	All External Areas
Finding:	Garden Bed/ Mulch - Conditions Conducive to Termites
Information:	Mulch were found around the property. These areas can include untreated timber, and with a combination of moisture from watering hosing can make conditions conducive to termite activity and termite ingress.

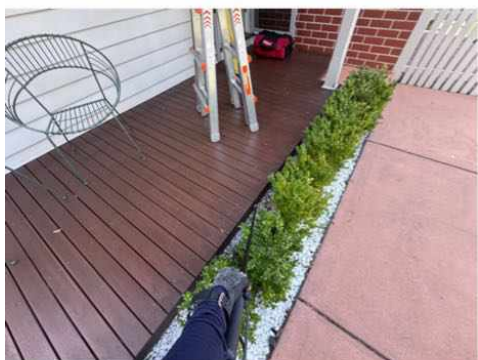
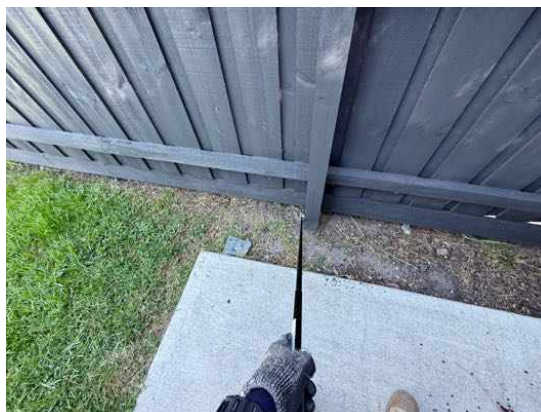
Finding 6.03

Building:	Main Building
Location:	All External Areas
Finding:	In ground contact
Information:	Any timbers in direct ground contact provide opportunity for concealed termite entry and are likely to be subject to premature rot and decay as the soil retains moisture or damp conditions against the timbers.

Remove untreated timber that is in direct contact with external grounds. Consider replacement with more durable materials i.e. treated timber or non timber elements. Frequent pest inspections are advised to readily identify any termite activity in these areas.

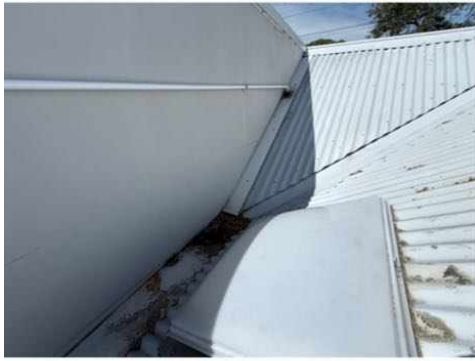
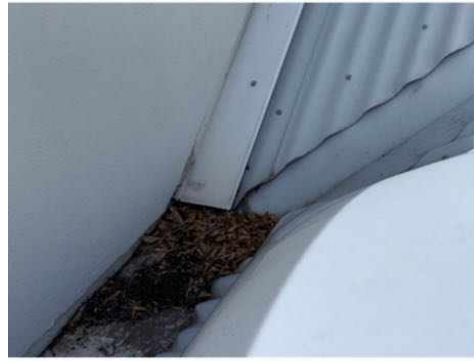
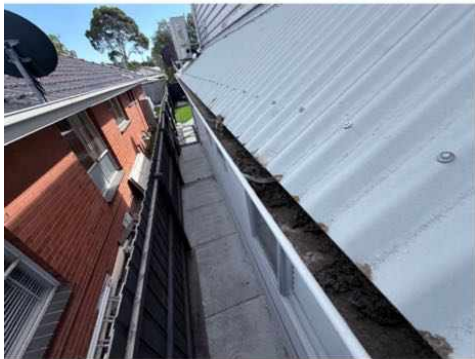
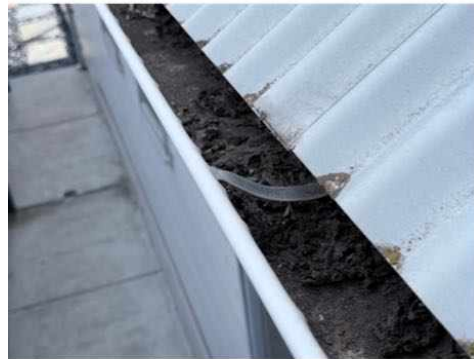
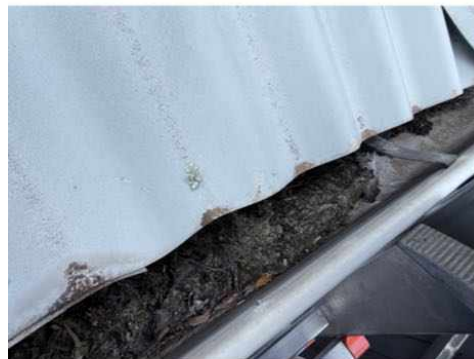
Finding 6.04

Building:	Main Building
Location:	Roof Exterior
Finding:	Gutters - Needs maintenance
Information:	Roof plumbing structures, such as guttering and downpipes, should be free of all debris to prevent blockages. Accumulation of debris in gutters and downpipes will lead to pooling and accumulated water overflows, which is likely to subsequently flood eaves and exterior walls.

Blocked or partially blocked gutters can lead to high levels of moisture in the affected areas (eg: entry porch). Such moisture will not only cause rust and decay of the associated building materials, but can also provide conditions that are conducive to termite and timber pest activity. Blocked part of the gutters should therefore be cleaned immediately to ensure dry conditions are maintained.

It is advised that gutters should be maintained regularly by the homeowner & a general handyperson should be appointed as a matter of urgency to clean the gutters.

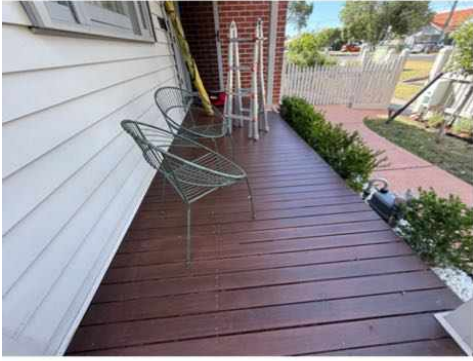
Building:	Main Building
Location:	All External Areas
Finding:	Timber deck- High conducive condition.
Information:	We are unable to inspect under the timber deck if its in close proximity to the ground.

Where we are unable to inspect timber structures, decks and subfloor areas the risk of undetected termite activity is rated as extremely High.

We strongly recommend the purchaser prioritise a termite treatment by a Licensed Pest Controller to protect and maintain the asset as it is a timber structure.

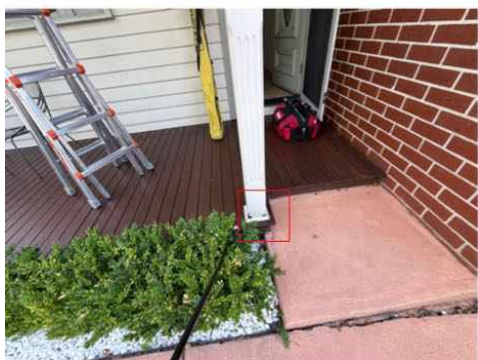
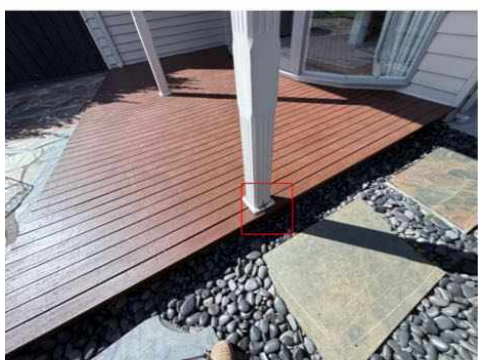
Finding 7.01

Building:	Main Building
Location:	All External Areas
Finding:	Timber Post Base Deterioration (Entry & Alfresco Areas)
Information:	Timber posts at the front entry and alfresco areas were observed to have localised wood rot and paint deterioration at their base sections. The decay appears concentrated around the lower plinth/trim where the posts interface with the decking, likely due to prolonged moisture exposure and inadequate sealing at ground/deck

level. Timber fibres in these sections show softness and minor material loss; however, no significant structural displacement or instability was noted at the time of inspection yet.

While the current condition does not indicate imminent structural failure, continued moisture ingress may accelerate decay and compromise the load-bearing capacity of the posts over time.

A qualified carpenter should assess the affected sections. Localised repair or replacement of the deteriorated base trim/post sections is recommended, including removal of decayed timber, installation of treated material, and proper sealing/painting to prevent further moisture penetration. Ongoing monitoring is advised to ensure deterioration does not progress.

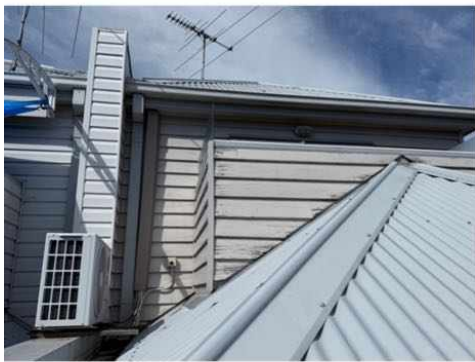
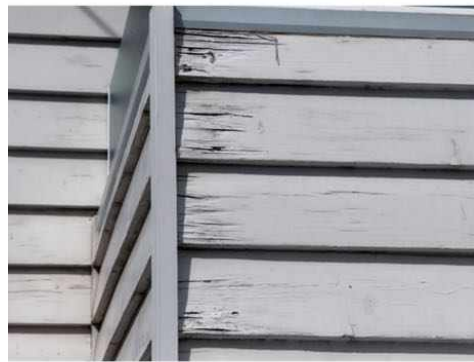
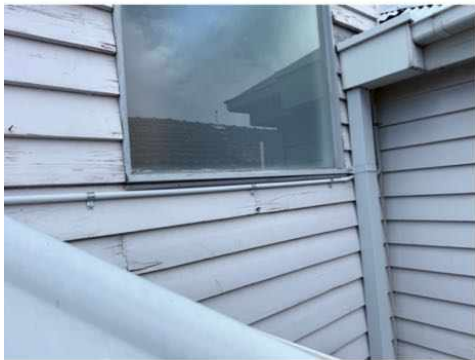
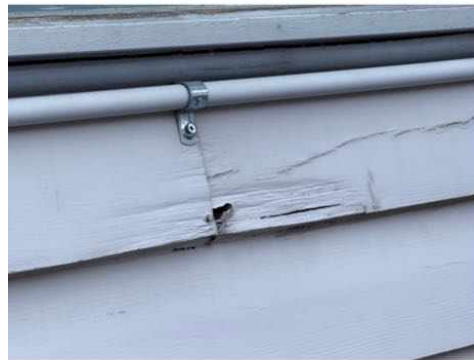
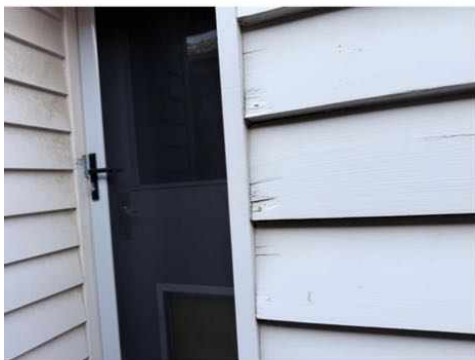
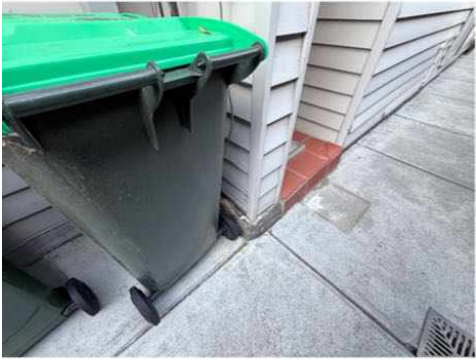
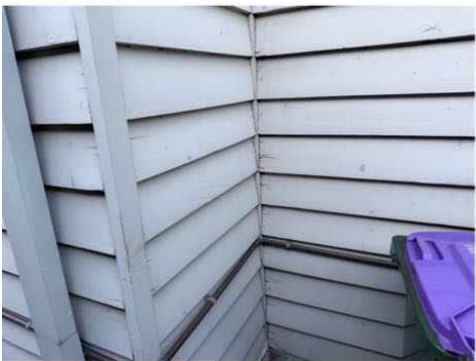
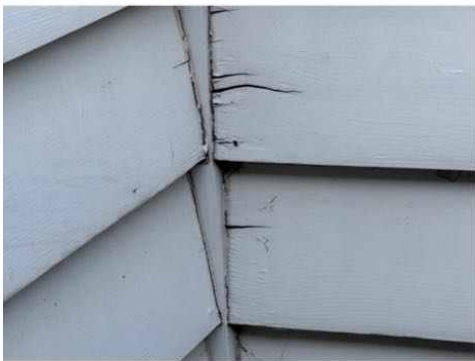
Finding 7.02

Building:	Main Building
Location:	All External Areas
Finding:	Weatherboards - Rotting
Information:	The external weatherboards show signs of fungal decay (wood rot) in several sections. This wood rot is suspected to have developed over a prolonged period of time due to frequent weather exposure, which is expected in a property of this age and condition

Weatherboards are sealed and protected by paint and other sealants. When these sealants deteriorate over time, they allow water penetration to the weatherboards, causing wood rot. If left unmanaged, the wood rot is likely to develop further, possibly necessitating major repair or replacement works in the long-term future.

To maintain the condition of the external wall cladding, any severely affected weatherboards should be substituted as soon as possible with pre-treated replacements. Where weatherboards have rotted due to excessive moisture other than rain penetration, the cause of the moisture should be identified immediately by a licensed plumber. A qualified carpenter should be appointed to repair and replace rotting weatherboards.

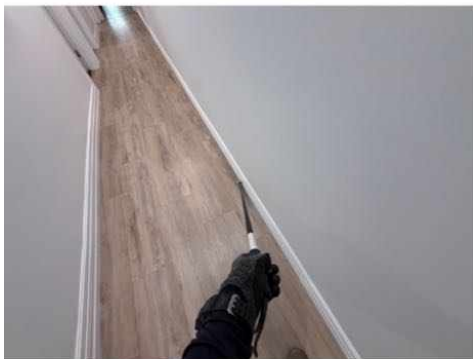
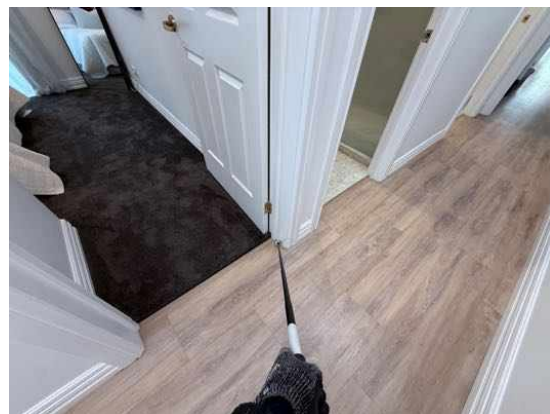
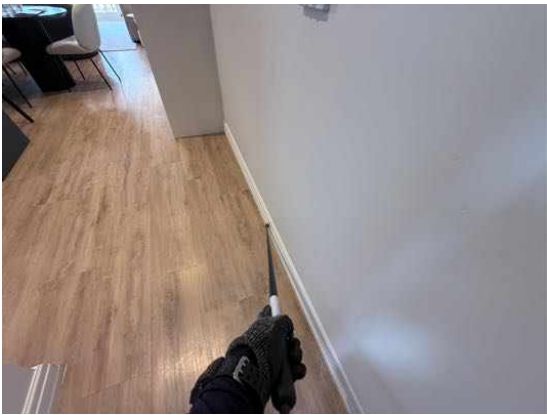
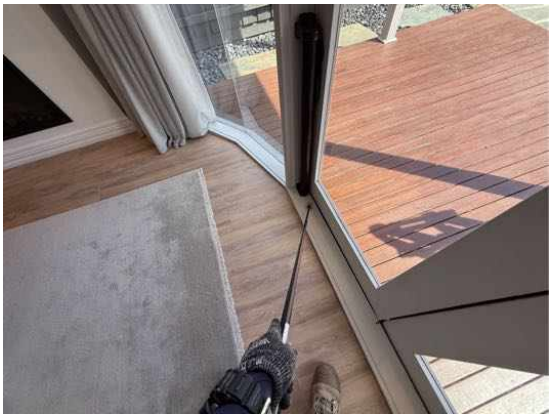
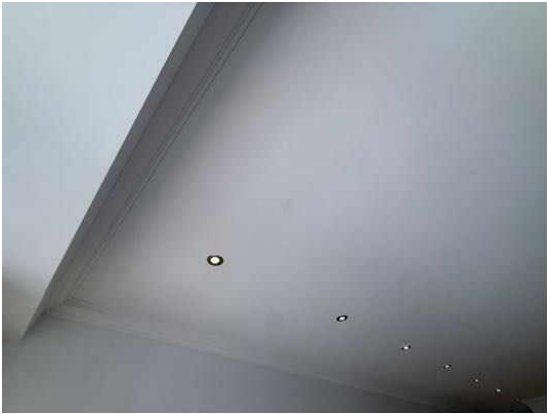
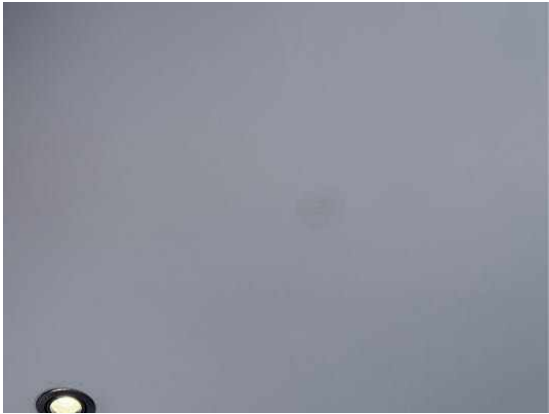
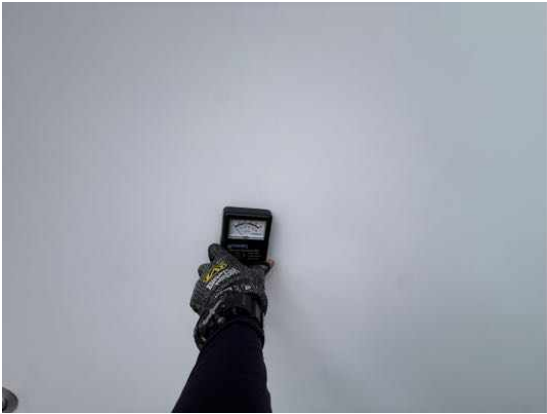
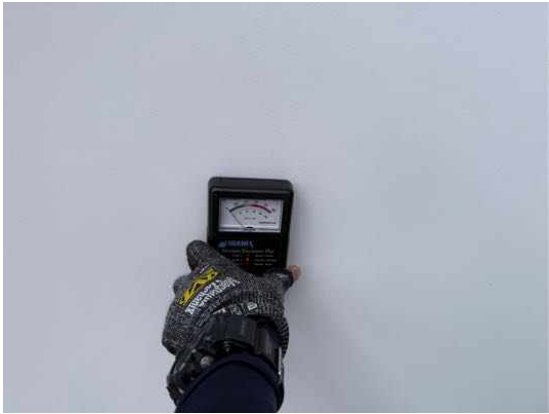
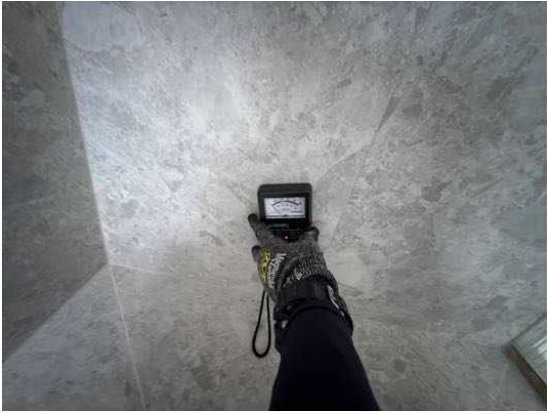
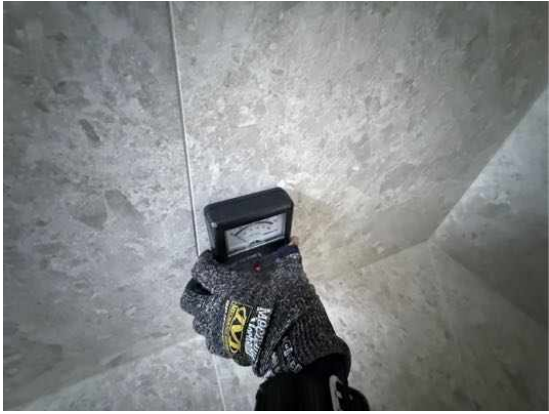
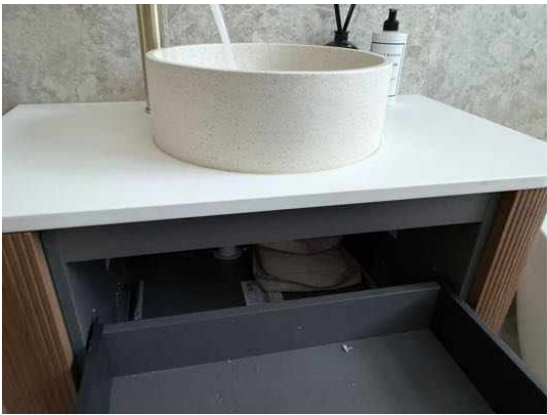
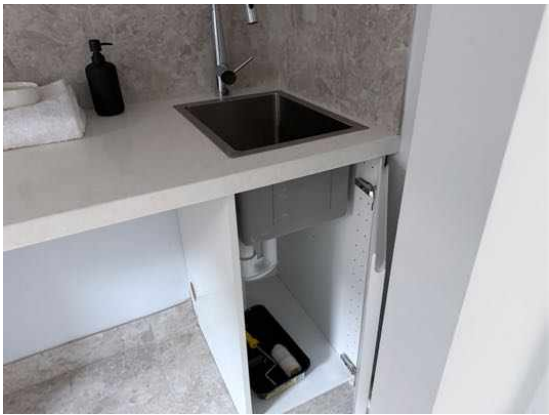
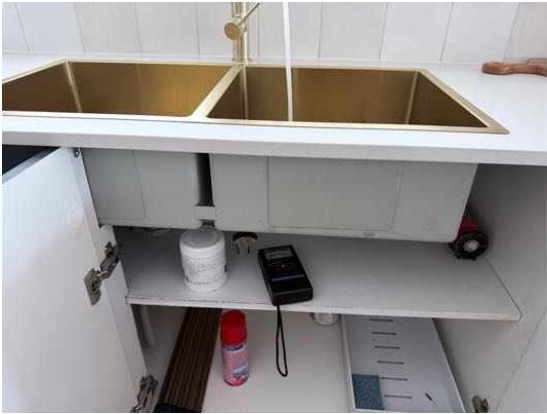
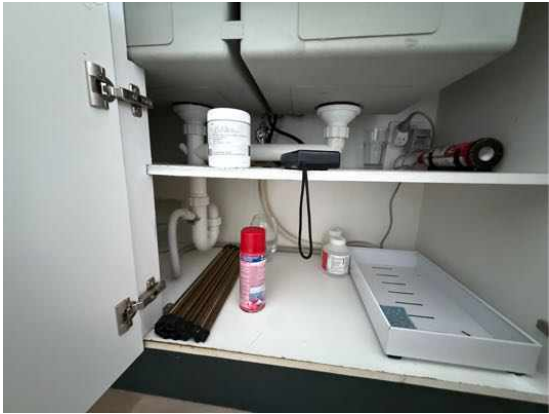
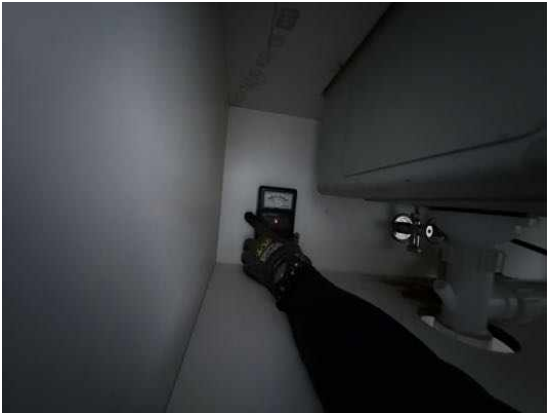
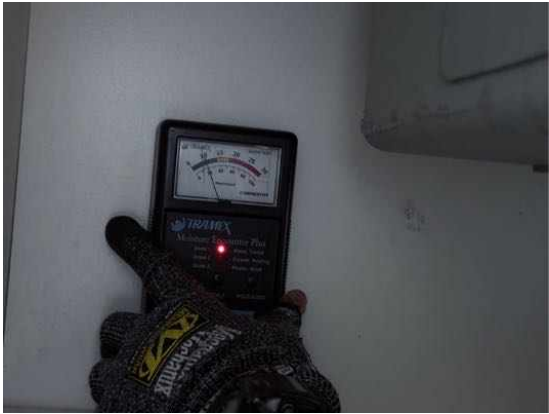
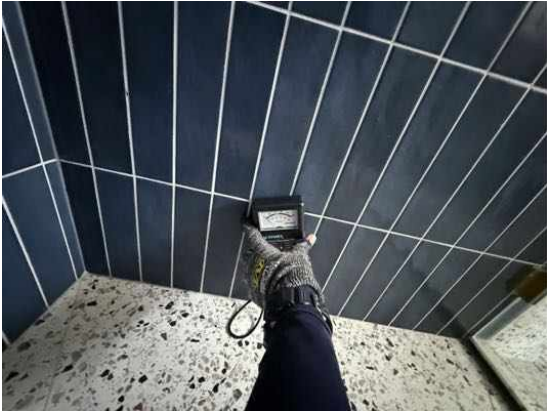
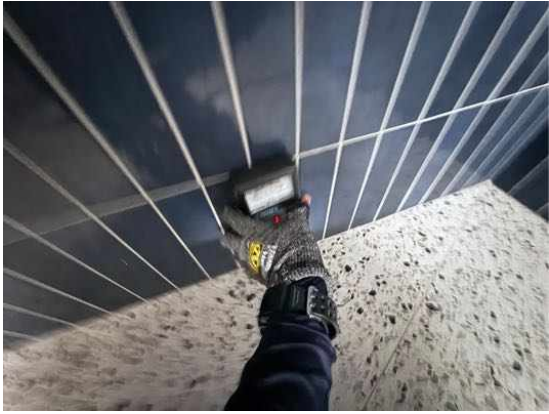
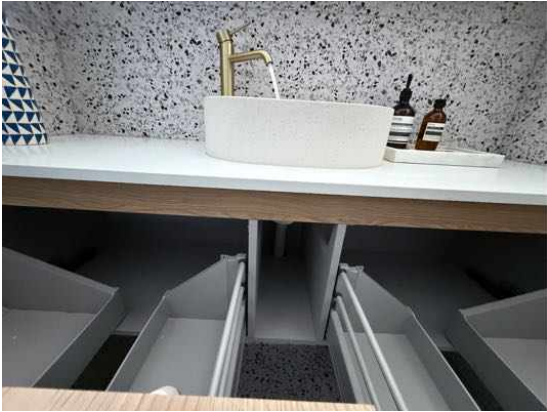
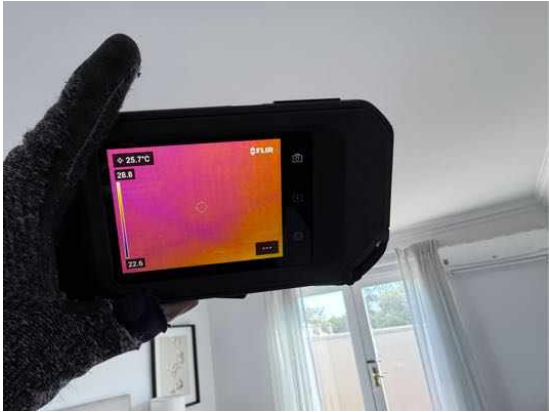
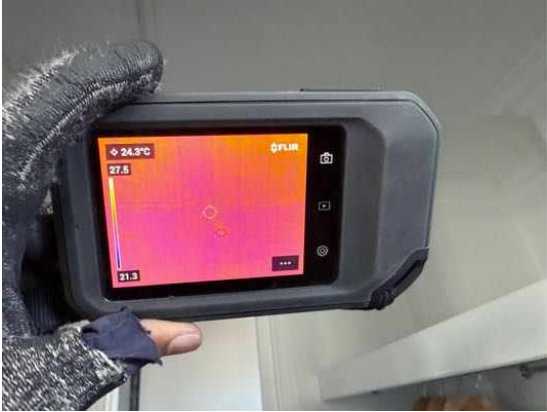
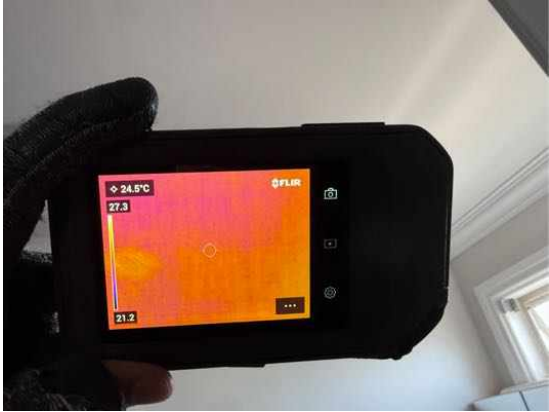
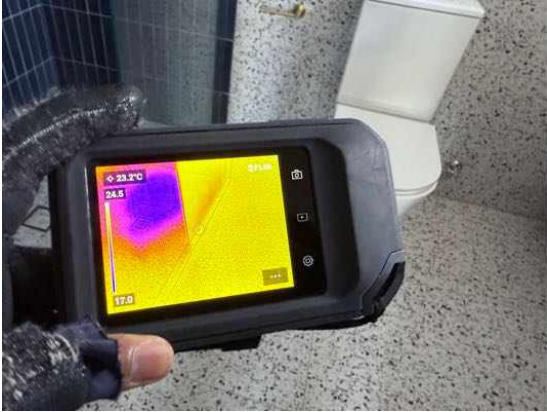
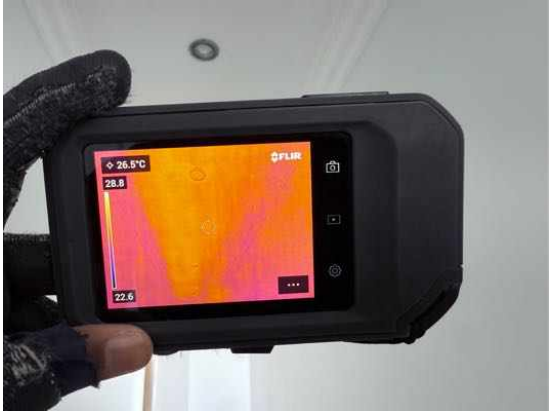
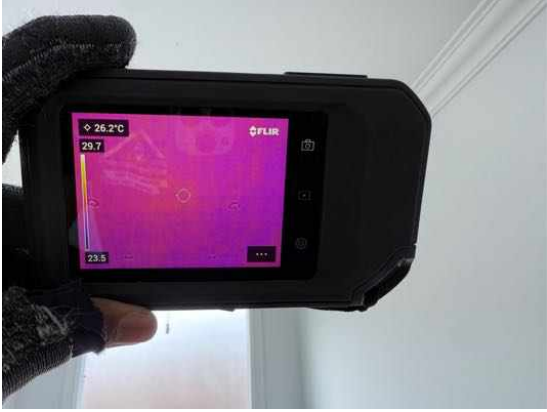
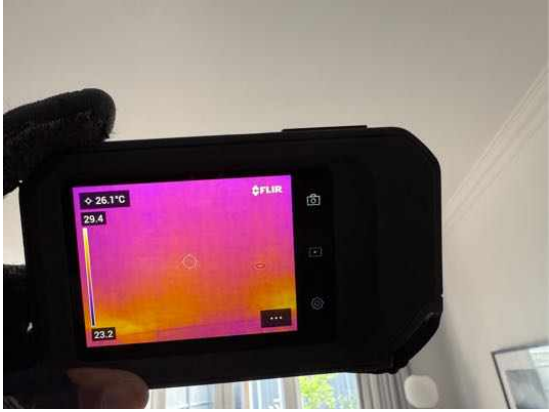
Building: Main Building
Location: All Areas
Finding: Termite Techniques
Information: All areas of the dwelling are checked with particular attention paid to wet areas which were closely assessed to check for excessive levels of moisture and temperature anomalies.

No evidence of termite activity was found inside the house at the time of the inspection.

In an attempt to identify the presence of hidden timber pest activity, a variety of techniques are adopted to identify irregularities including, a moisture meter reading of susceptible areas, sounding of timber elements using a device called a "donga" visual assessment of materials affected by moisture or signs of deformity, trails and bridging constructed by termites, irregular and regular shaped holes in timber elements indicating pest destruction.

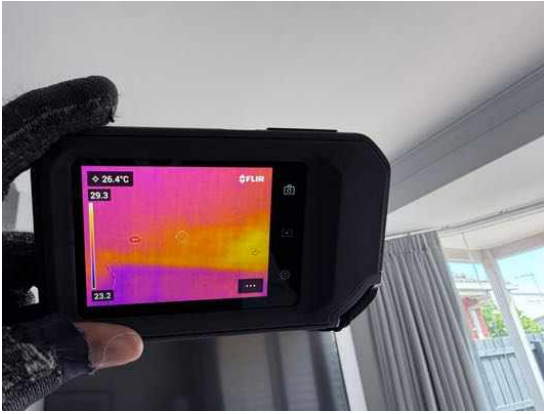
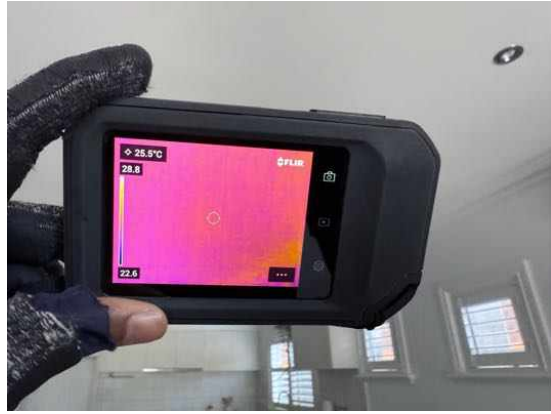
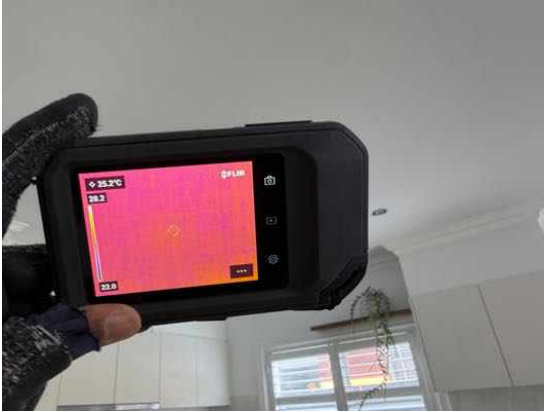
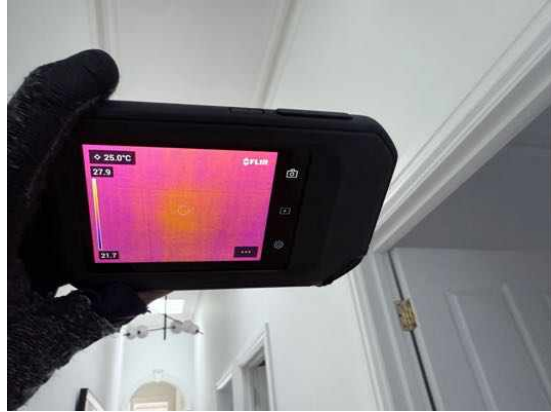
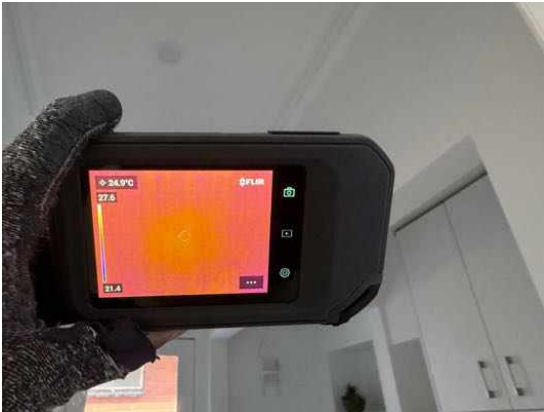
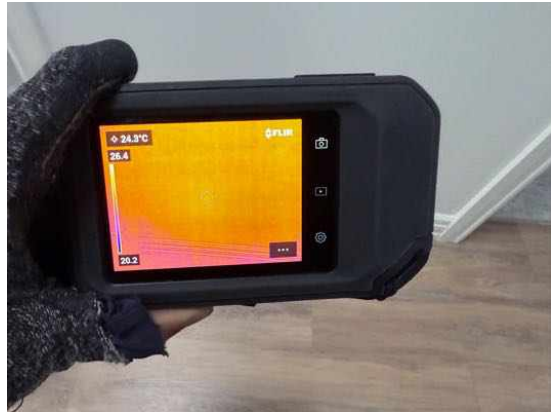
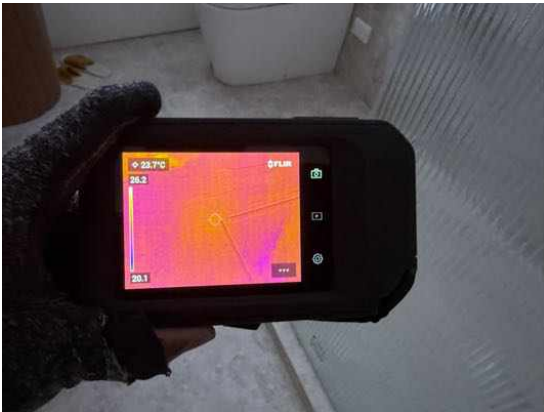
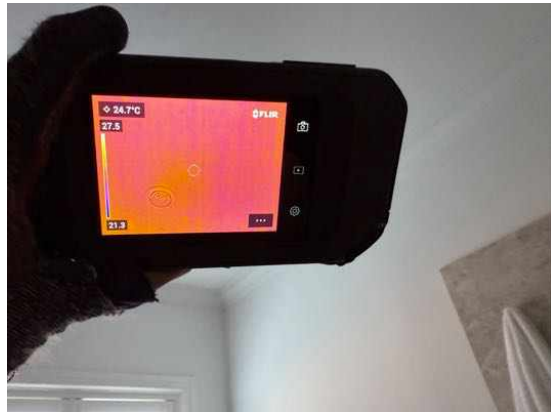
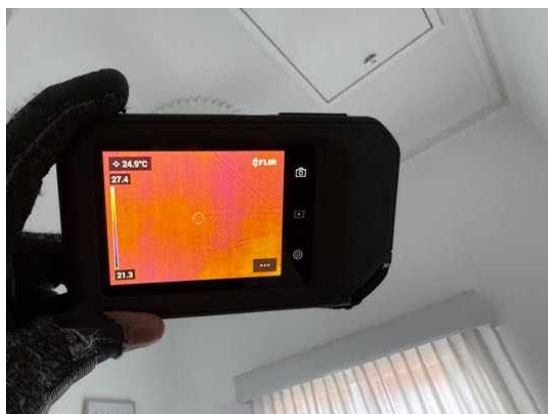
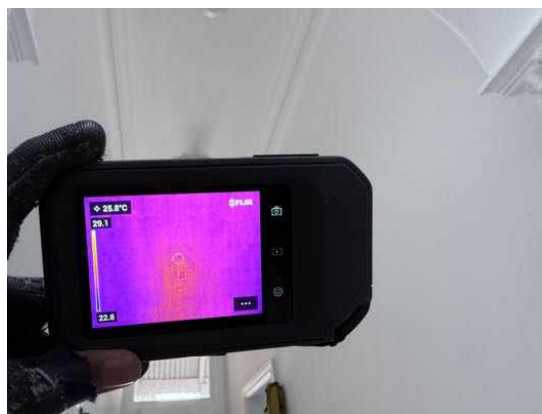
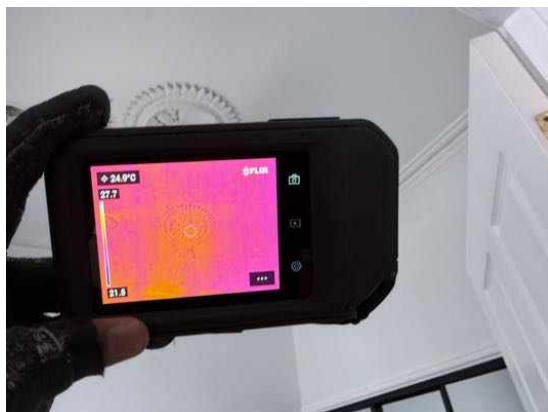
Noted Item

Building: Main Building
 Location: All Areas
 Finding: Evidence of recent renovations.
 Information: Whenever a property is refurbished, majority of the defects if present could get obscured beneath the revamped work. The same can be said for this property as well. Some fine cracks are filled over, walls have been painted etc. It is difficult to pinpoint on any particular defects present below such layers.

Once the property is occupied, all areas should be monitored for a period of 12-24 months to lookout for any arising defects. If staining or cracking is noticed extensively in that period, always consult your building inspector.

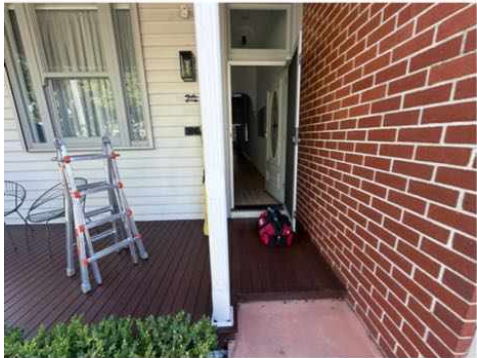
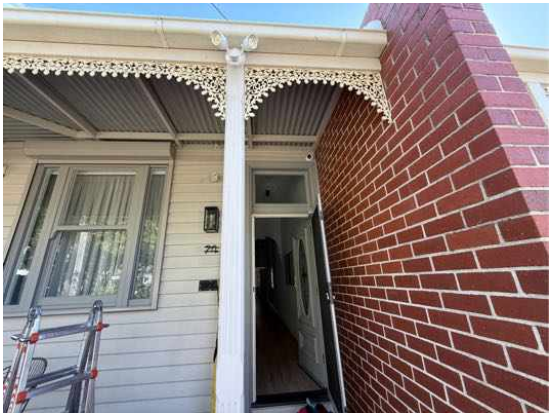
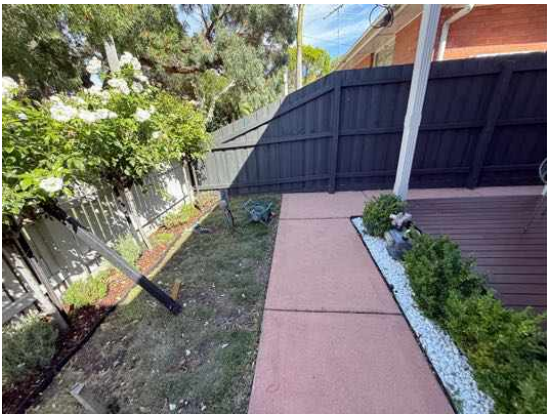
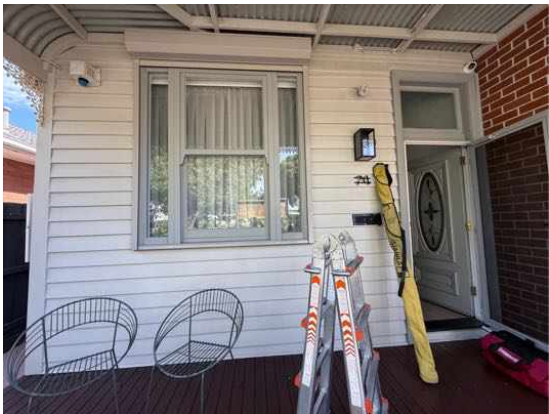
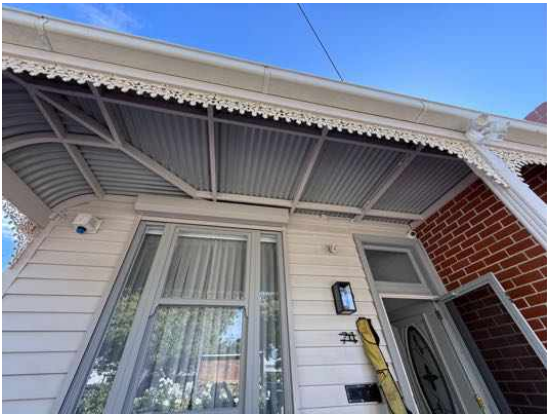
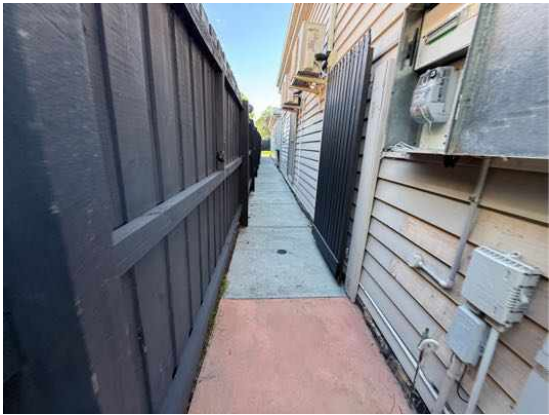
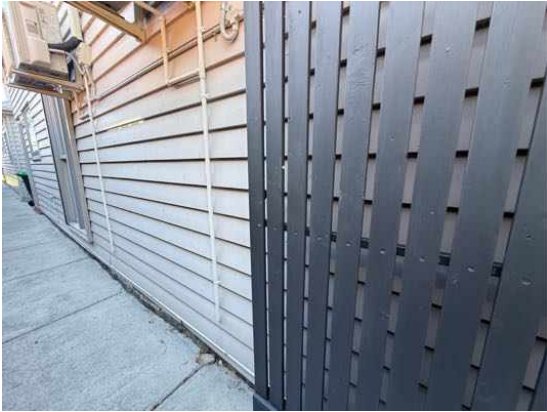
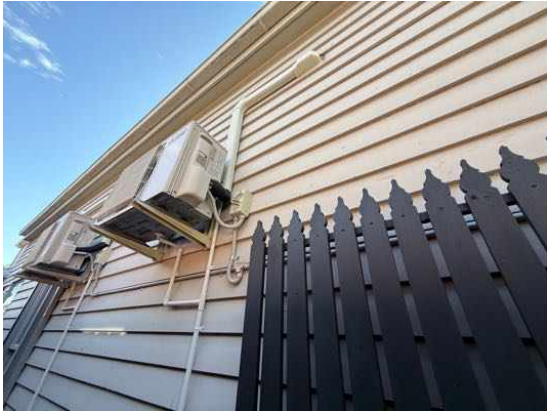
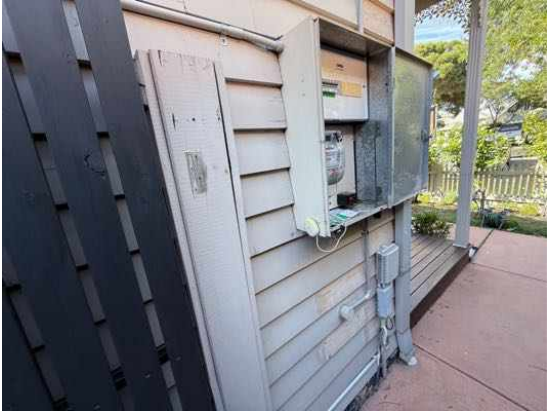
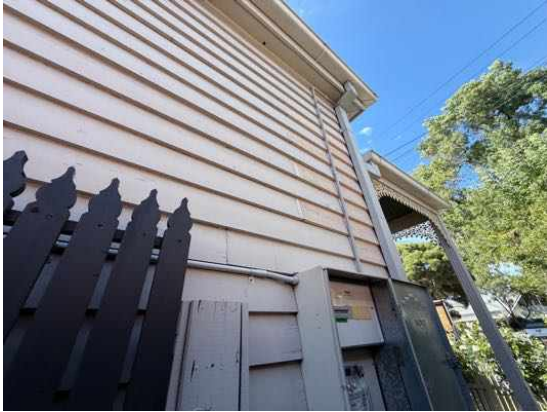
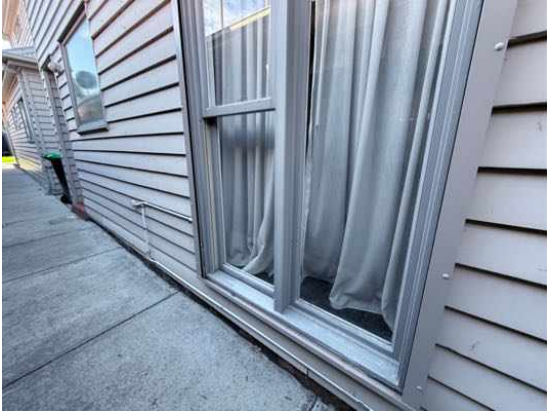
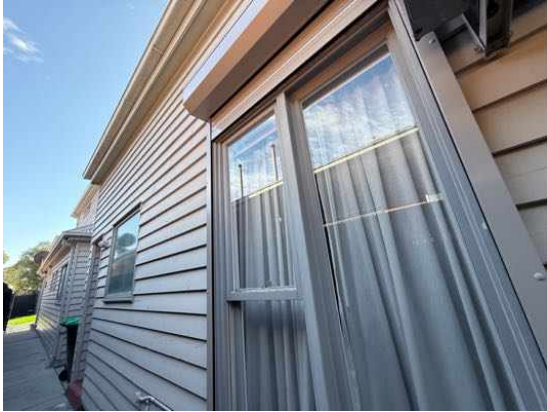
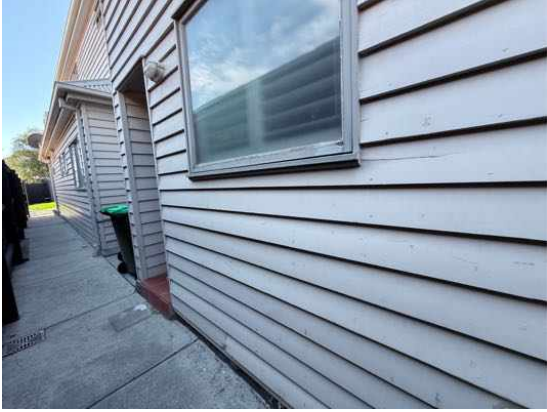
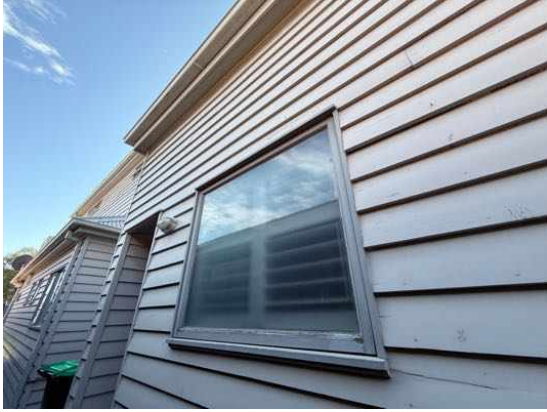
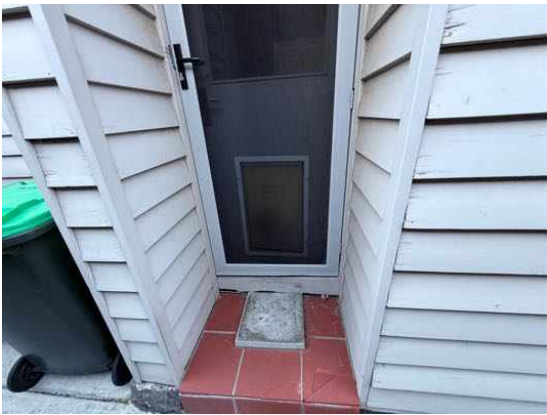
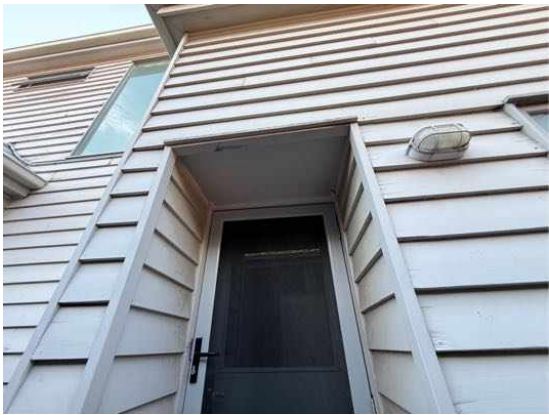
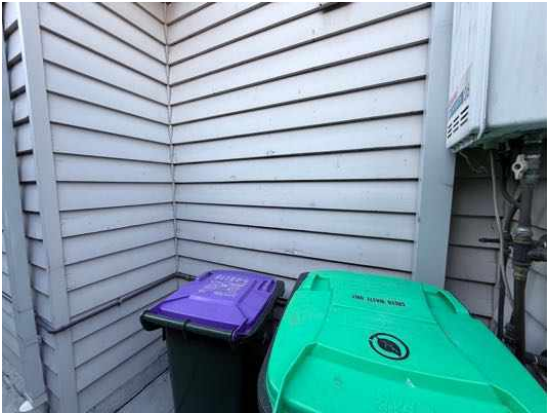
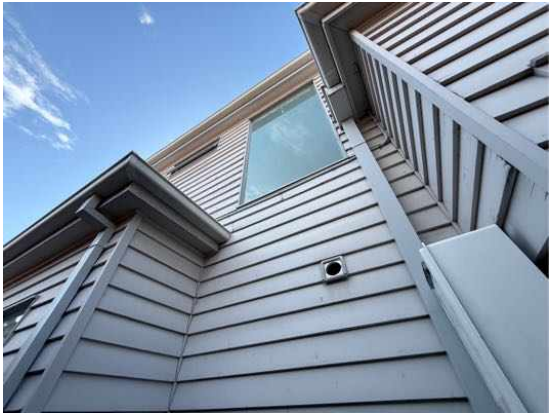
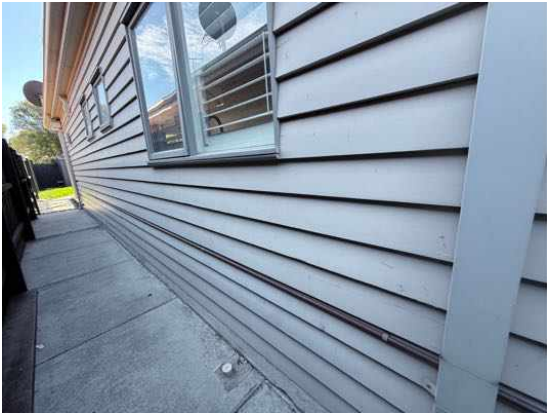
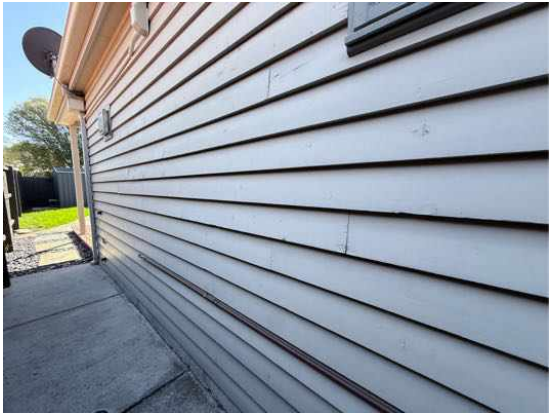
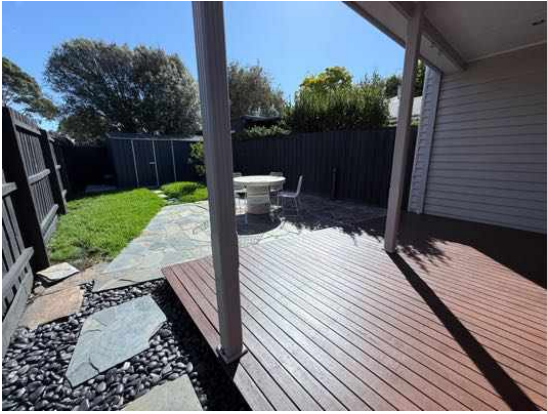
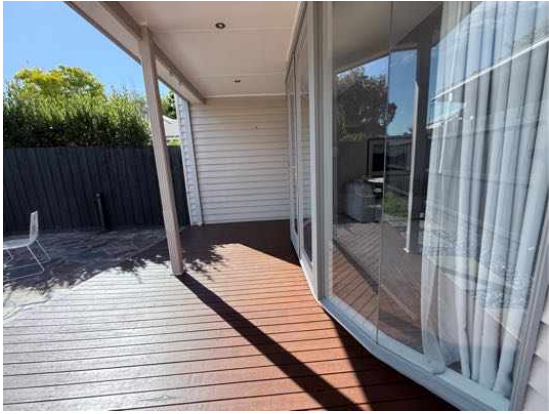
Noted Item

Building: Main Building
 Location: All Areas
 Finding: Additional photos & Obstruction/Limitations.
 Information: Additional photos for general documentation. May have some minor maintenance items not listed in the defects section.

Furthermore, some photographs are an indication of the obstructions and limitations

which impeded full inspection of the property at the time of inspection. These obstructions can hide an array of defects and should be removed to allow full inspection to be carried out. A re-inspection is recommended once the areas are made accessible.
