Building and Timber Pest Inspection Report

Inspection Date: Wed, 18 Feb 2026

Property Address: 74 Osborne St, Williamstown VIC 3016,
Australia

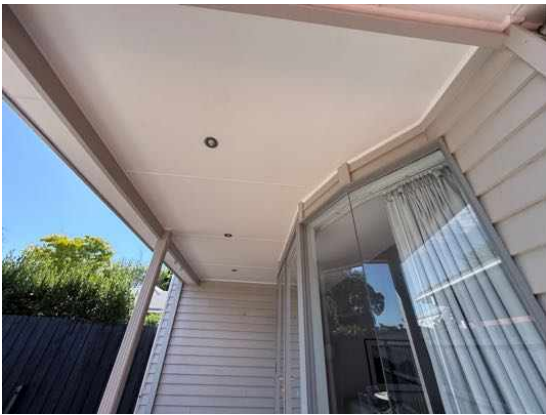
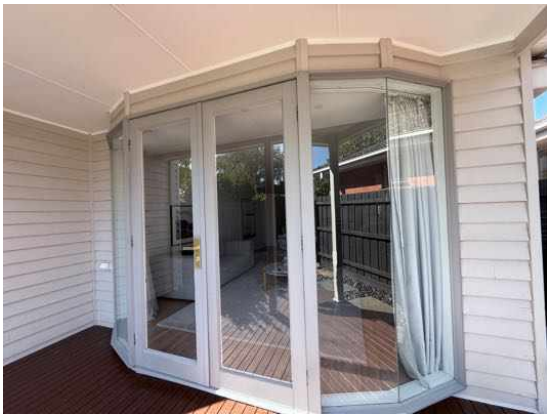
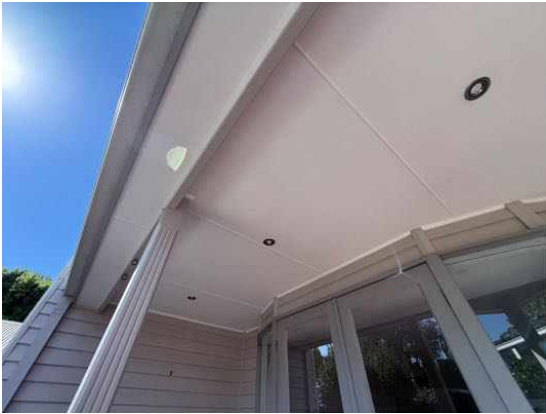
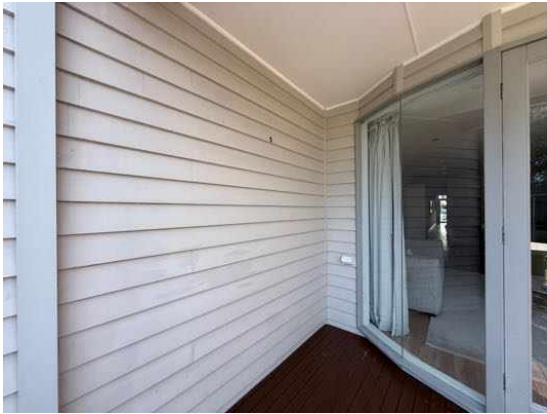
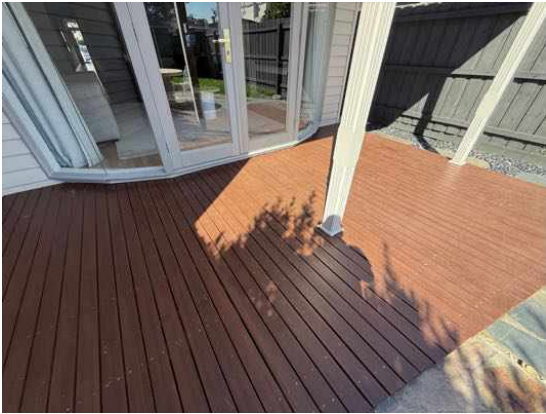
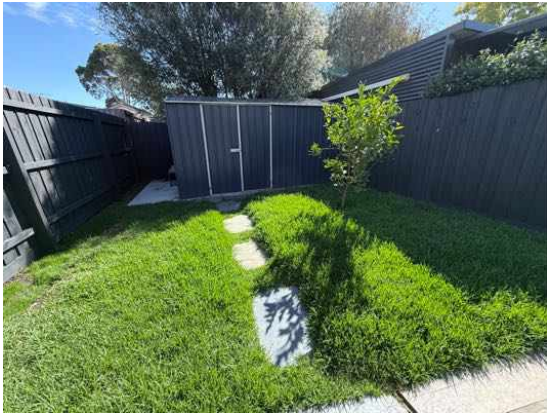
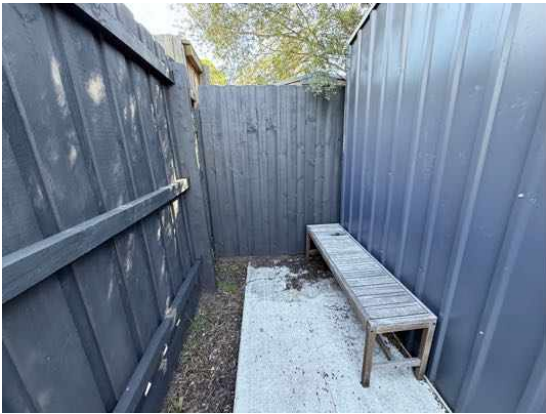
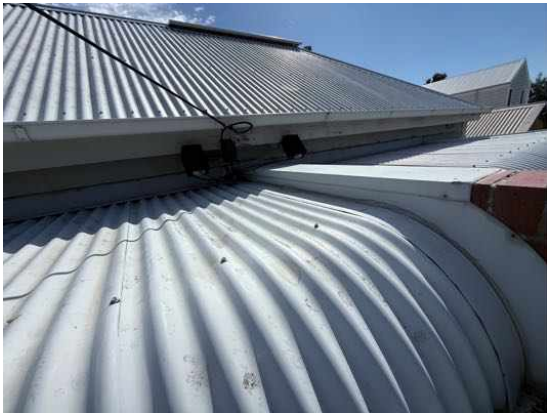
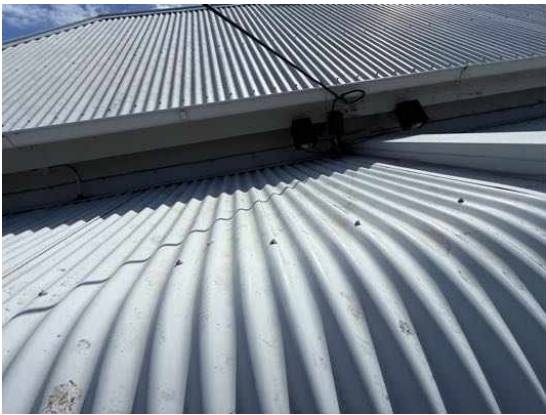
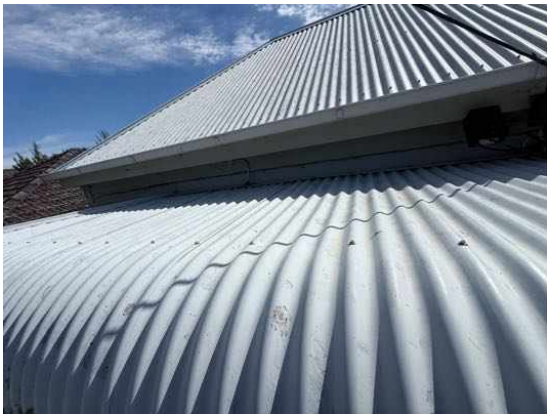
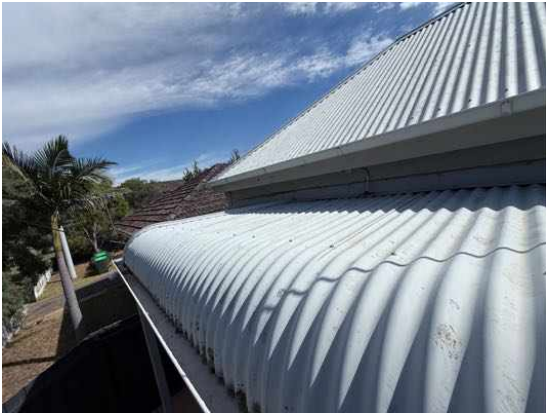
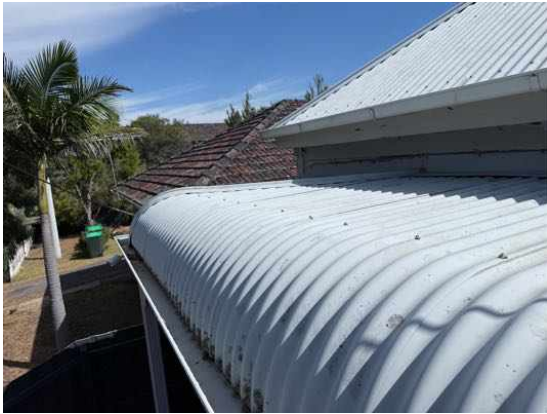
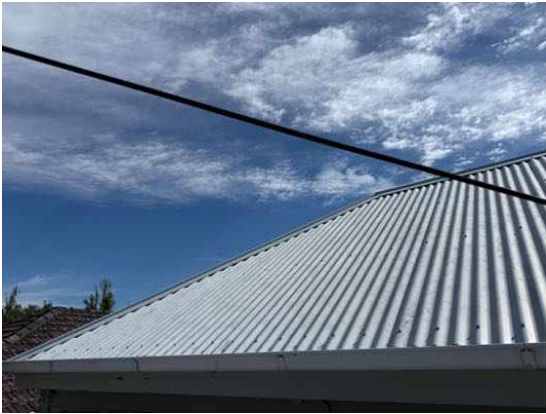
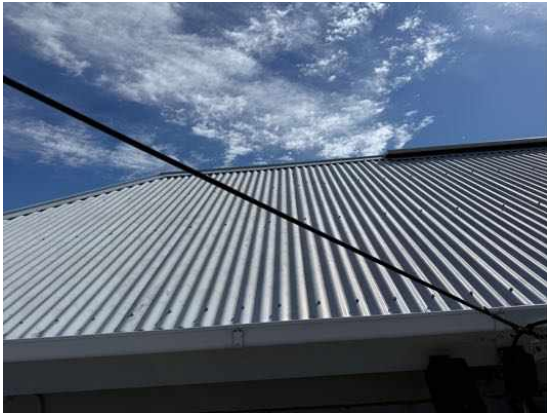
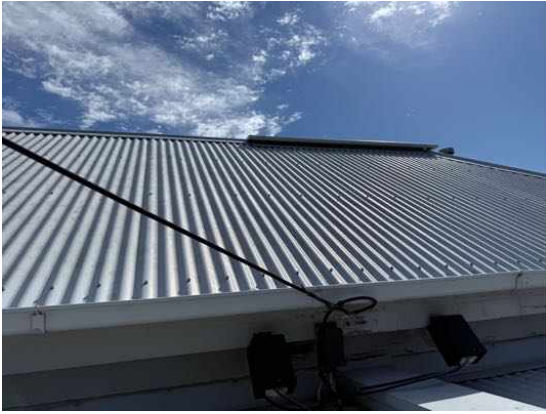
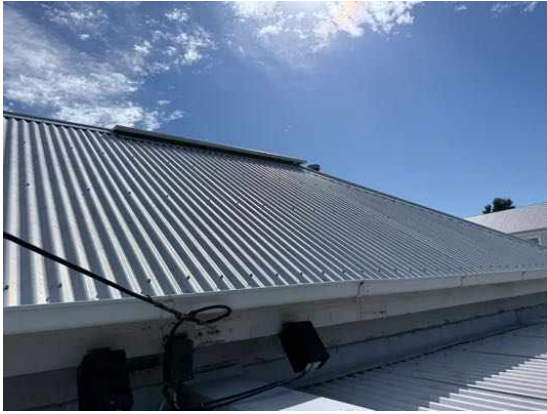
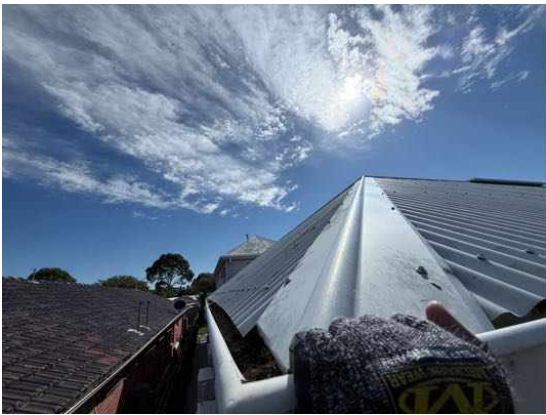
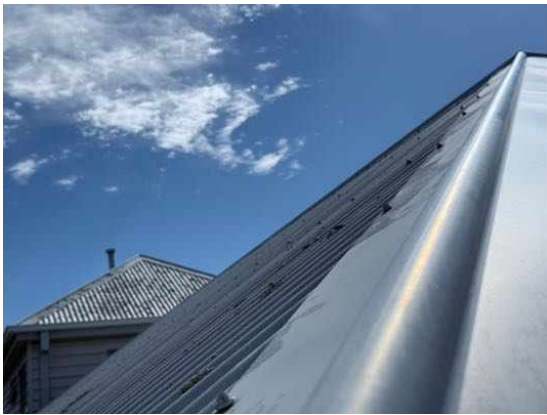
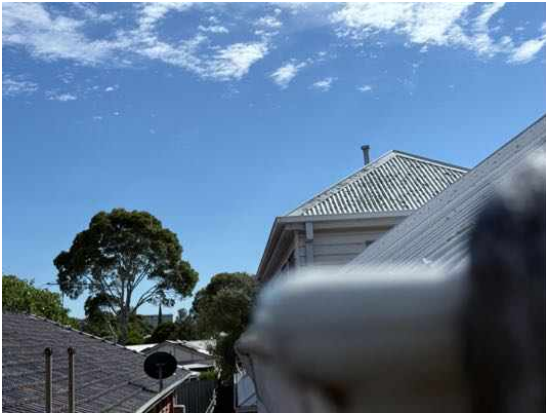
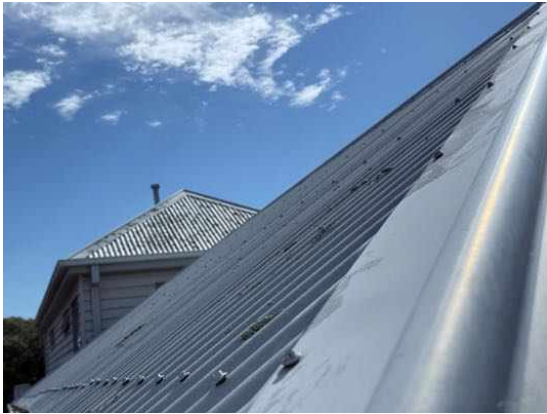
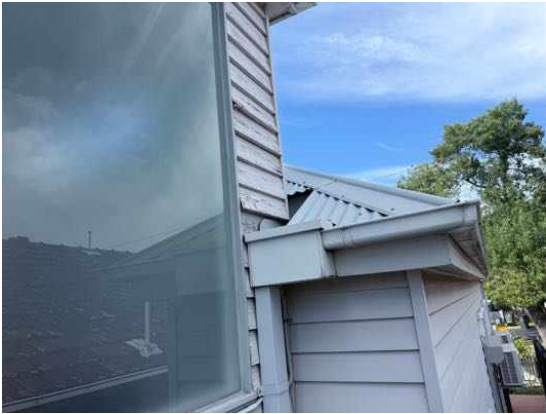
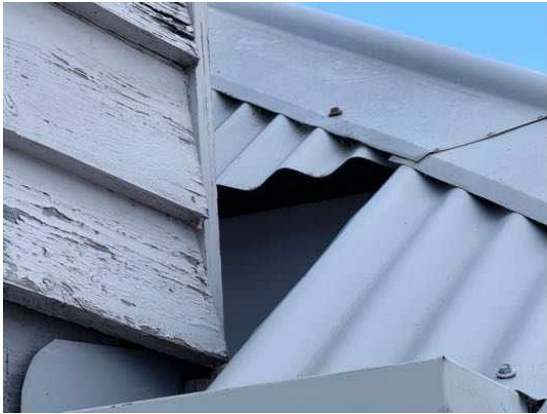
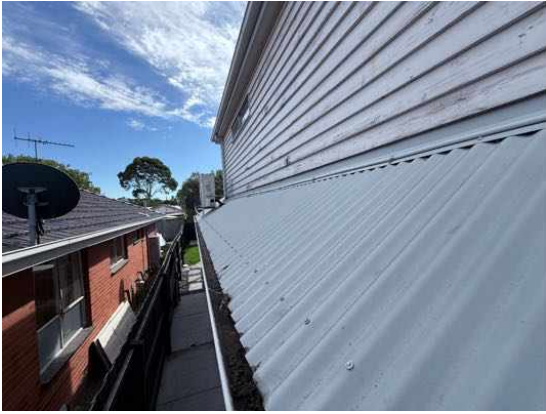
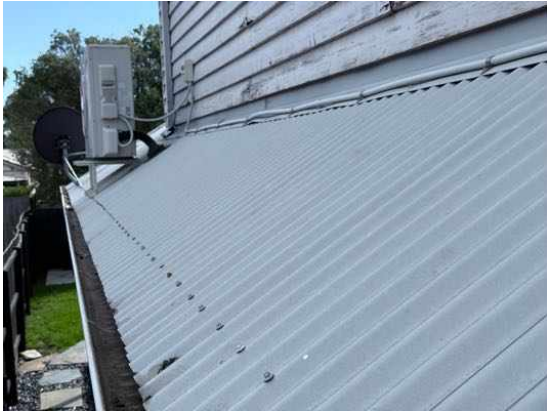
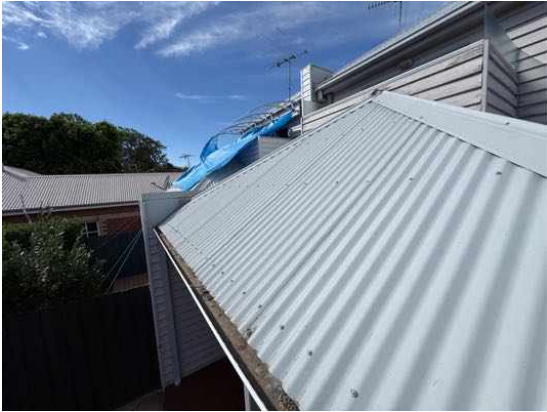
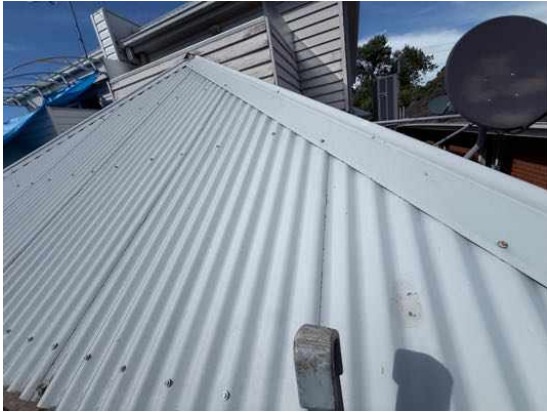
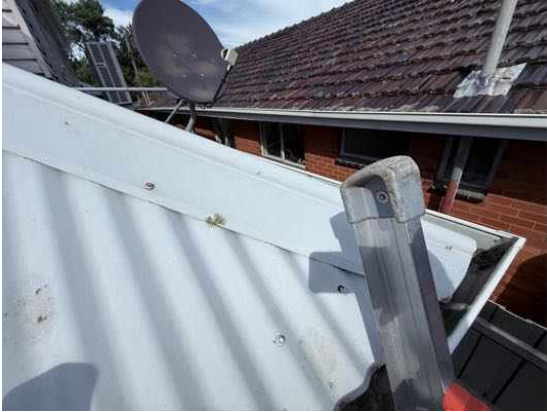
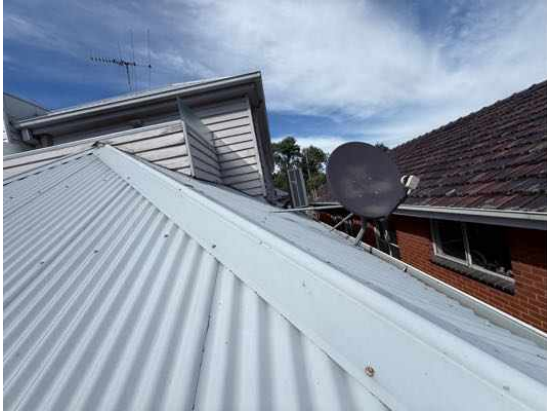
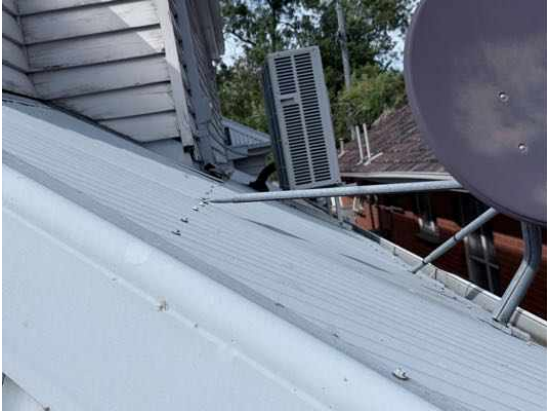
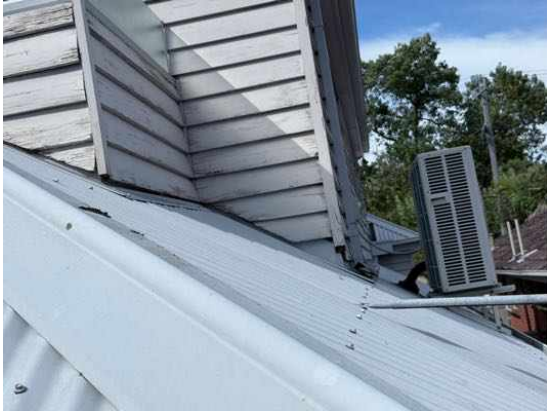
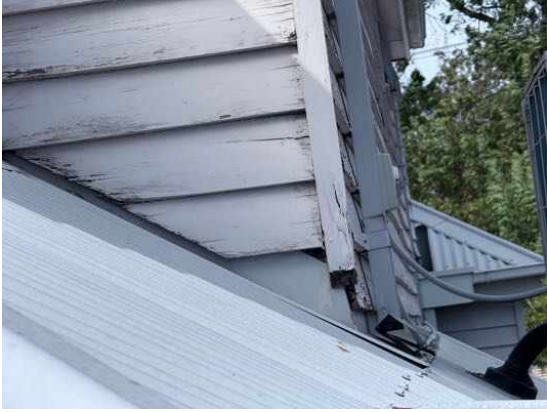
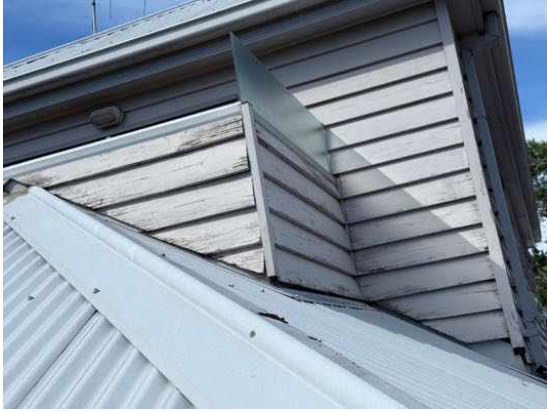
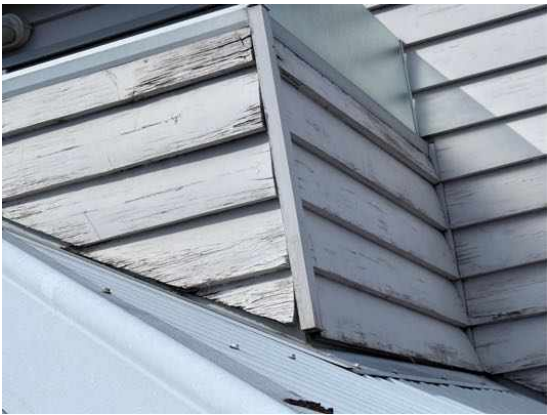
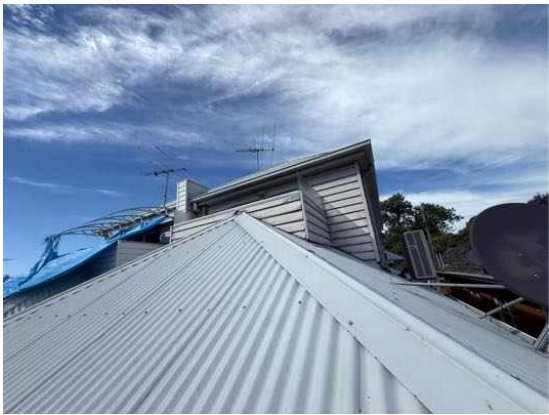
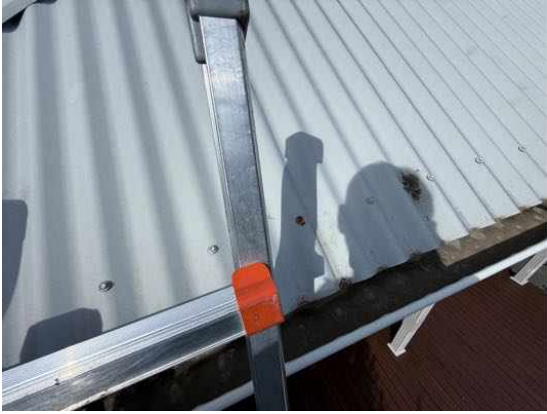
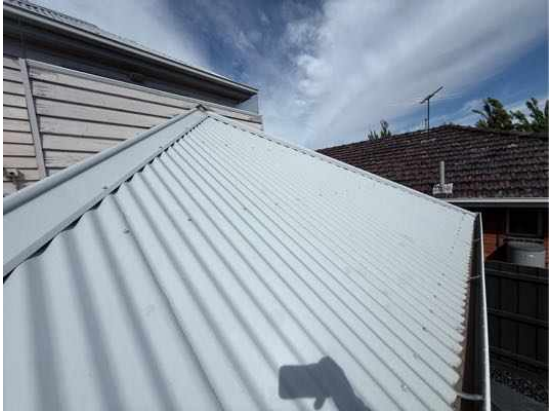
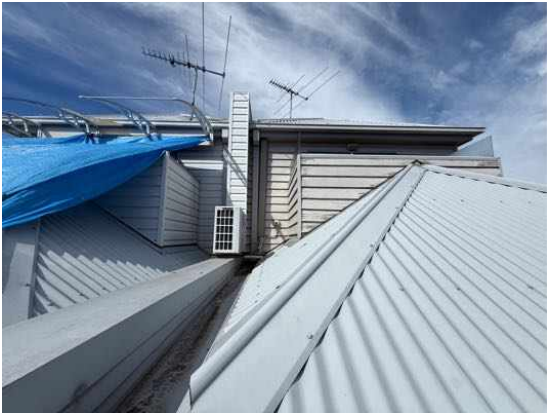
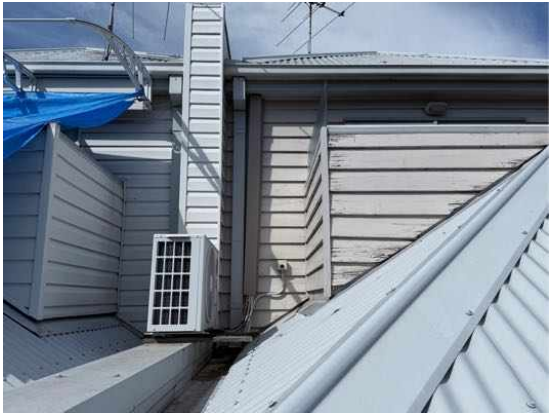
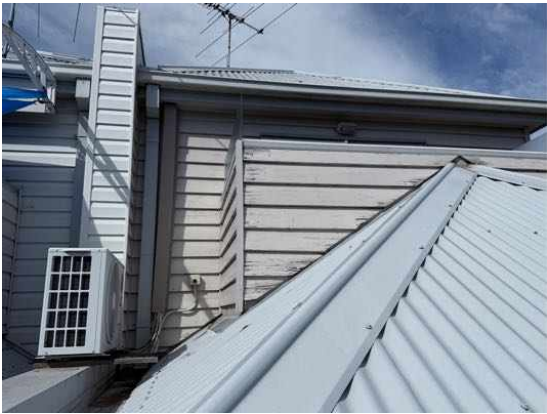
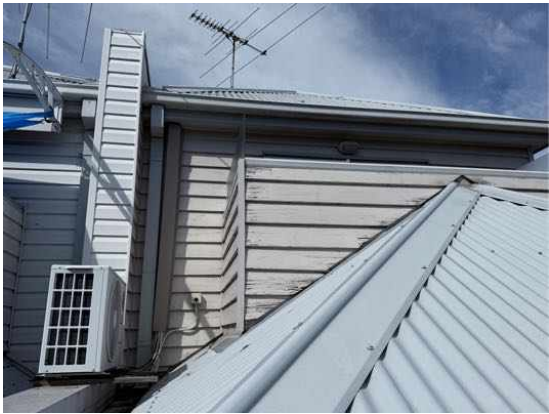
Building: Main Building
 Location: All Areas
 Finding: Additional photos & Obstruction/Limitations.
 Information: Additional photos for general documentation. May have some minor maintenance items not listed in the defects section.

which impeded full inspection of the property at the time of inspection. These obstructions can hide an array of defects and should be removed to allow full inspection to be carried out. A re-inspection is recommended once the areas are made accessible.
