# Building Inspection Report

Inspection Date: Fri, 30 Jan 2026

Property Address: 16 Dodson Rd, Officer VIC 3809, Australia

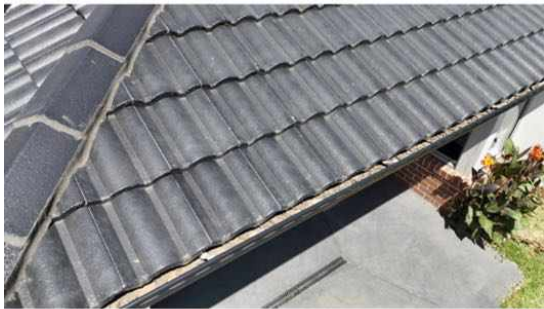
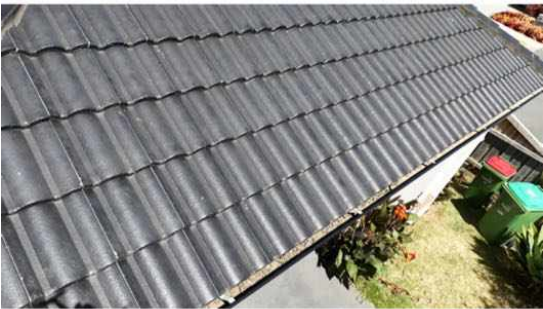
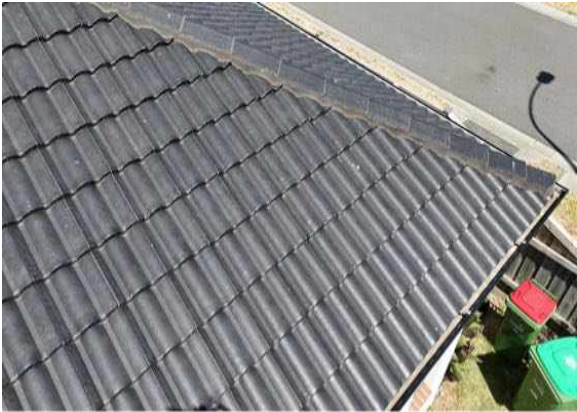
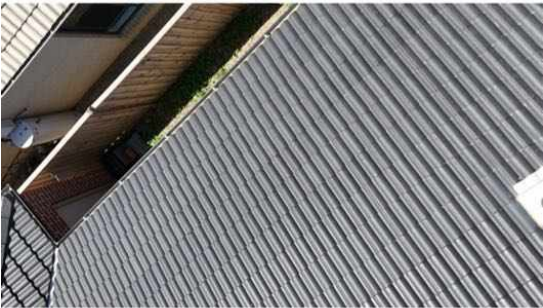
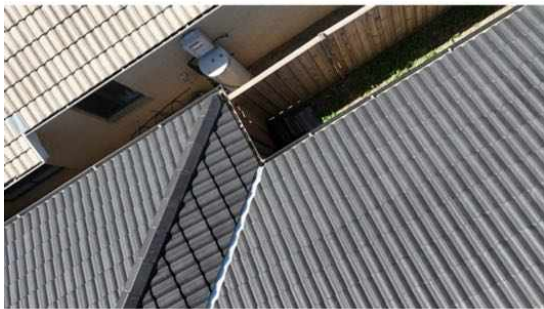
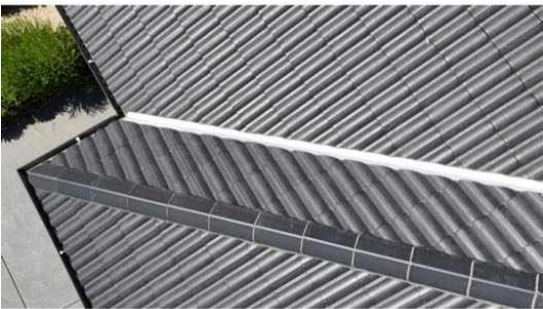
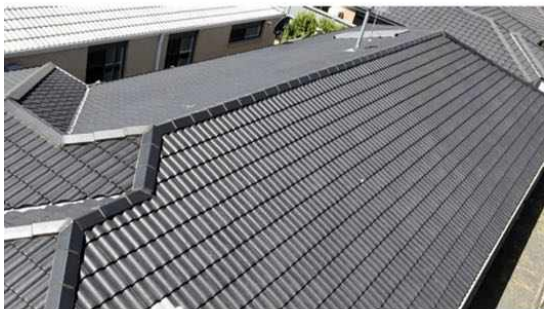
Building: Main Building  
Location: Roof Exterior  
Finding: Additional Photos  
Information: Additional photos are provided for your general reference
