## Building Inspection Report

Inspection Date: Tue, 7 Apr 2026

Property Address: 2/99 Reddall Parade, Lake Illawarra NSW  
2528, Australia

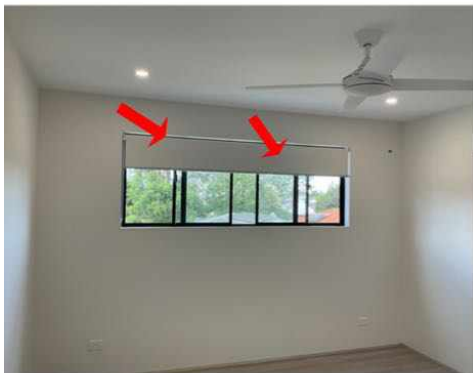
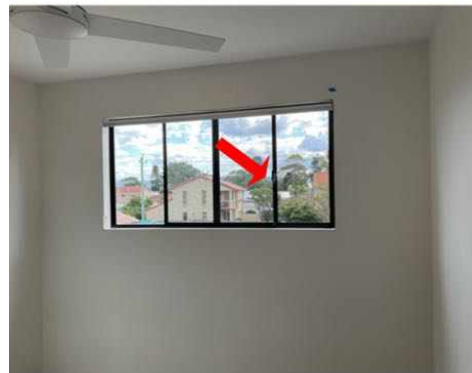
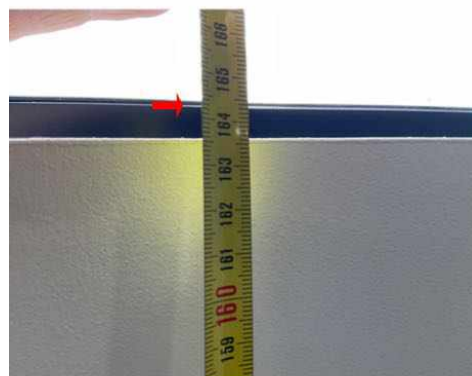
#### Defects 1.01

Building:	Building 1
Location:	Most upper windows
Finding:	Window opening restrictors missing.
Information:	The Building Code of Australia rules require all openable windows (where the internal floor is more than 2m above the ground outside) in residential rooms to be fitted with a suitable screen or restrictor. Windows located 1.7m above the floor level do not require protection.

Window restrictors are required to these pictured windows where people who are vulnerable to the risk of falling have access to windows. This means all windows above ground level which do not have another fall prevention safety measure in place, such as a balcony or balustrade should have a restrictor.

These need to be added urgently for the safety of all persons.

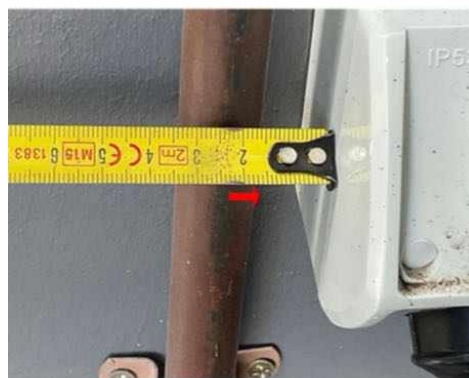
## Defects 1.02

Information: There was insufficient separation found between the rear wall electrical wiring and the plumbing at the time of the inspection. The tap pipe is under 18mm from the electrical outlet. Locating a tap over the electrical outlet also presents an increased safety risk to nearby persons.

As 3000-2018 Electrical Installations - Wiring rules states "Wiring systems shall maintain a separation of not less than 25 mm from any above-ground gas or water piping."

Where a building elements installation fails to achieve the required minimum standard at the time of the inspection, the builder needs to complete the works to the required standard prior to purchase.

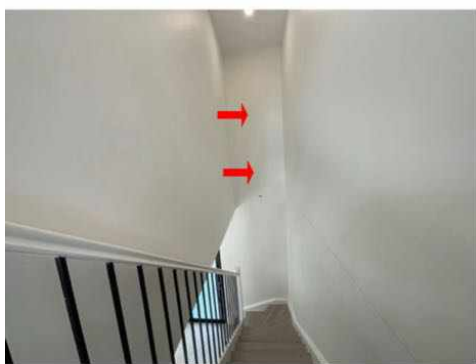
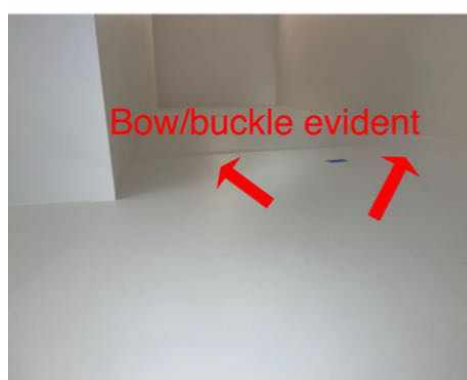
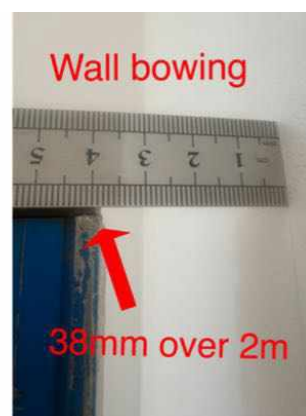
### Defects 2.01

Location: Stairs - Internal east wall >  
 Finding: Bow in upper wall  
 Information: Bulging was noted to the stairs upper wall surface. The upper wall is out of plumb . The wall plaster has cracked horizontally in the middle. Vertically, this wall is bowing 38mm over 2m in the middle.

Building works required to fix this bulging wall should be completed immediately and before purchase as the cause may be significant and may indicate a structural defect which would require extensive works in the long-term future.

Further invasive inspection is required to determine the actual cause. It is advised to consult a Structural Engineer to determine the cause and advise on rectification works required.

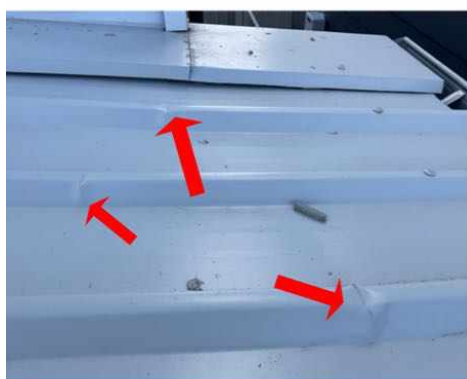
## Defects 2.02

Building: Building 1  
 Location: Roof Exterior  
 Finding: Roof sheet damaged  
 Information: Upon inspection of the exterior roof covering, it was noted that one roof sheet in the front right has impact damage. It is suspected that something very heavy has been dropped on these sheets and has caused holes in two roof sheet ridges.

Damaged roof sheeting detracts from the weather tightness of the roof covering and will be subject to premature rust and water ingress.

This applies here where these holes will allow rainwater to damage internal building areas.

These need to be brought to the attention of the builder for urgent rectification.

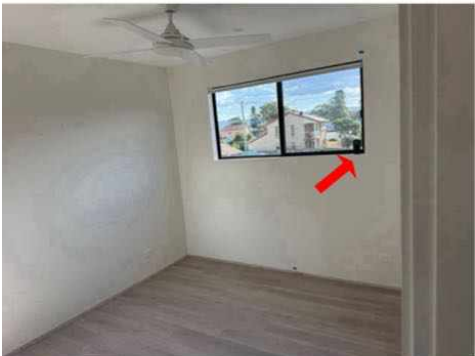
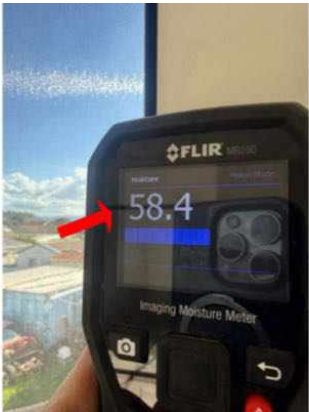
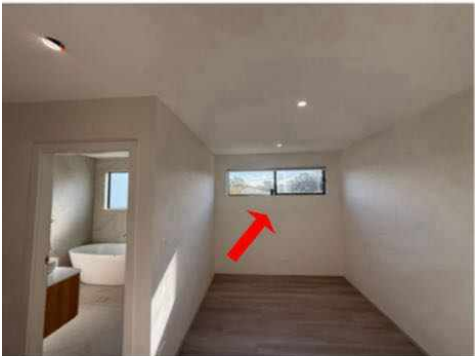
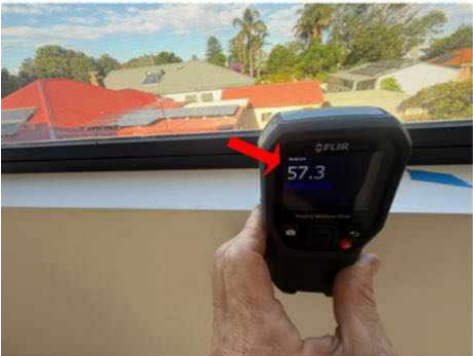
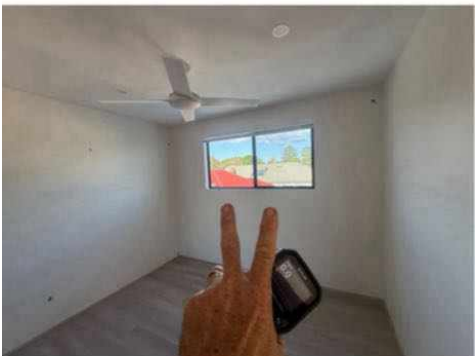
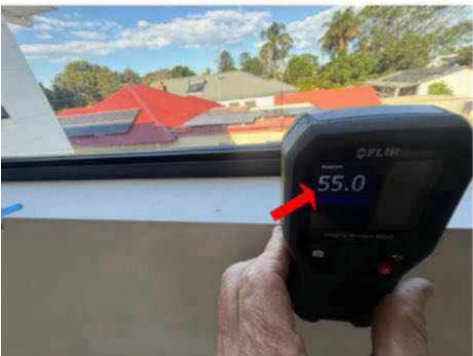
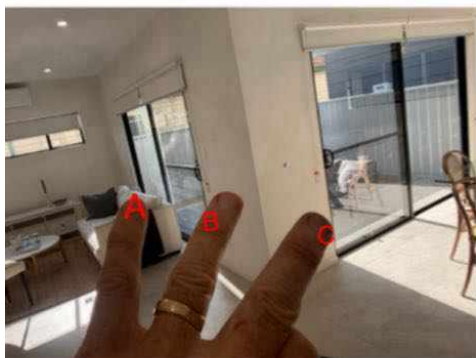
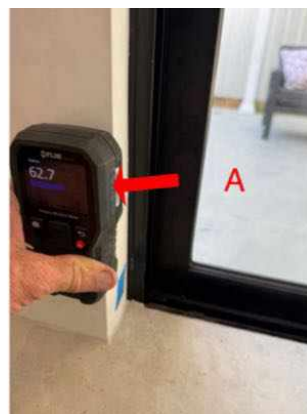
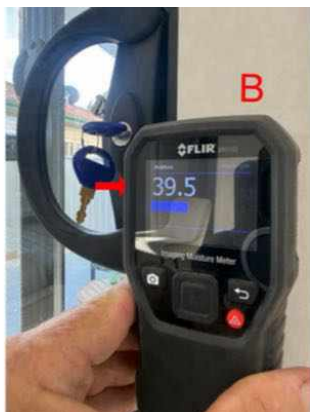
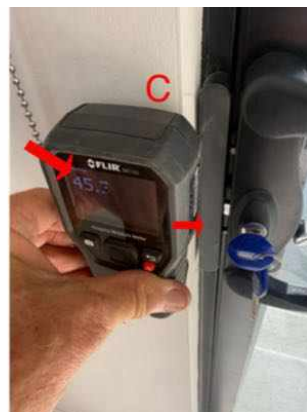
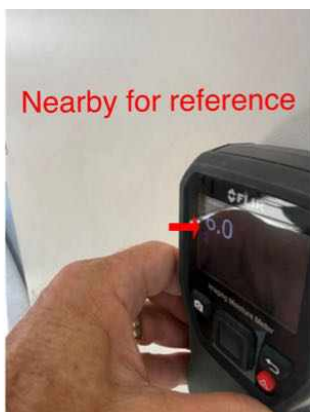
### Defects 3.01

Building:	Building 1
Location:	Upper windows & lower doors
Finding:	Evidence of excessive moisture was present at the time of inspection
Information:	Excessive moisture was found adjacent to many upper windows and lower doors at the time of the inspection. Medium moisture readings of 58.4 and 62.7 were recorded in the upper windows and lower door areas respectively. All areas adjacent to these areas were checked for reference and showed readings of under 6.

This moisture can attract termites and produce conditions that promote termite attack, fungal growth and wood decay.

Excessive moisture is generally caused by deteriorated, inadequate or missing roof drainage, missing sealant of flashing, leaking plumbing pipes or fixtures, poorly plumbed HWS overflows or condenser units and poor site drainage. It is highly recommended that all plumbing and drainage fixtures and fittings be maintained regularly in order to prevent excessive moisture being present in the internal property.

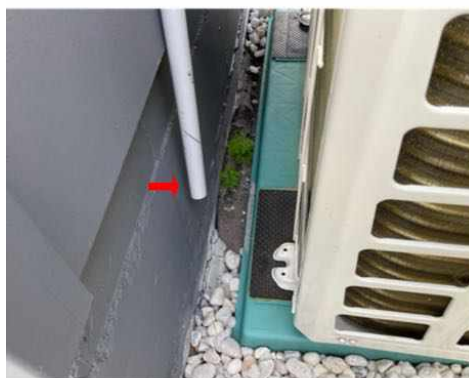
### Defects 3.02

Building: Building 1  
 Location: South wall  
 Finding: Water pooling - Surface Water Drainage - NCC 2022 Housing Provisions Part 3.3.3  
 Information: Water has been observed pooling on external concrete/paved surfaces adjacent to the dwelling, with falls directing water towards the building instead of away from it.

Where water is pooling against the house, water damage to the external wall cladding is imminent. The rear wall air conditioner runoff also runs onto the rear house wall.

Such water pooling and Ac runoff also increases the risk of termite activity and the development of fungal decay in these areas.

These need to be brought to the attention of the builder.

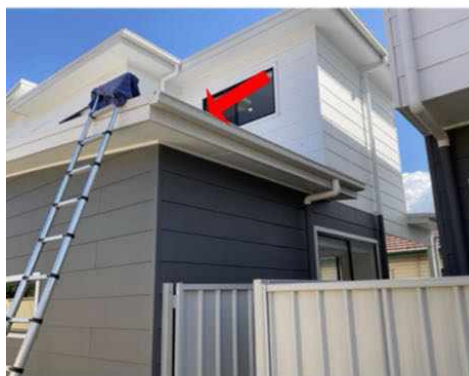
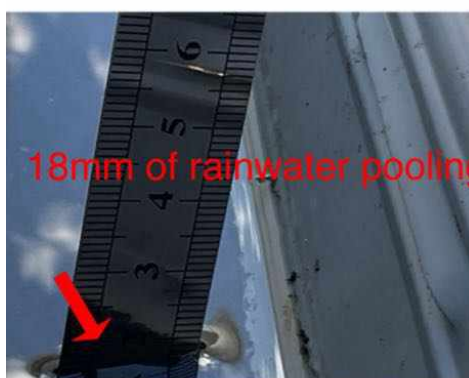
### Defects 3.03

Building:	Building 1
Location:	North gutters
Finding:	Gutters - Insufficient fall and water pooling
Information:	It was identified that there is insufficient fall or angle in the two north gutters which is leading to pooling of water in these gutters and will result in secondary related building defects such as rust and fascia damage. Such defects are likely to include material deterioration, leaks and/or corrosion of associated building materials.

Over time, if this defect is not addressed, further building defects will develop.

These need to be brought to the attention of the builder.

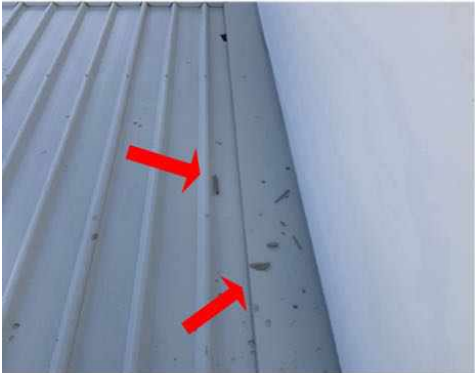
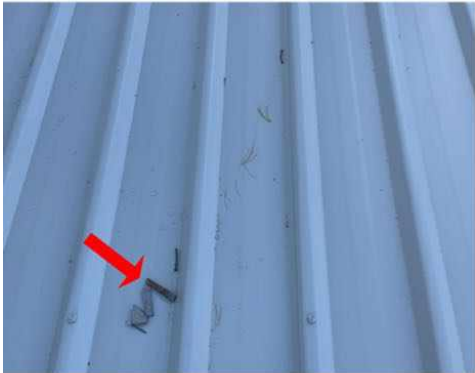
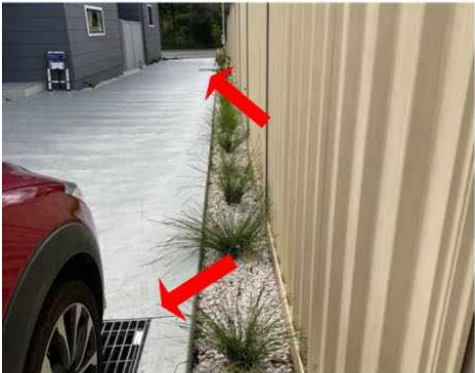
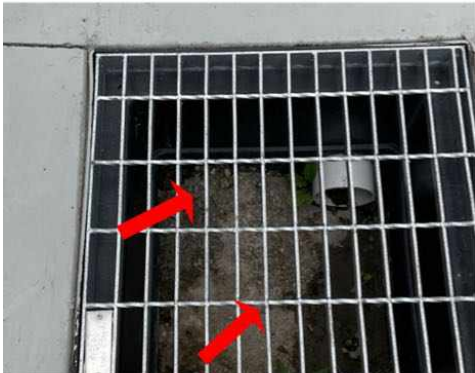
### Defects 3.04

Building:	Building 1
Location:	Roof areas, driveway, bathroom & laundry drains
Finding:	Building waste in drains and on roofs
Information:	Builders waste was found on rooves and in driveway and bathroom floor wastes at the time of the inspection. Builders waste left in any drains or roof areas has the potential to interrupt the normal function of these drains or gutters and may lead to blockages and flooding of surrounding areas. Some waste left on the front right roof is rusting the roof sheets.

These areas need to be brought to the attention of the builder.

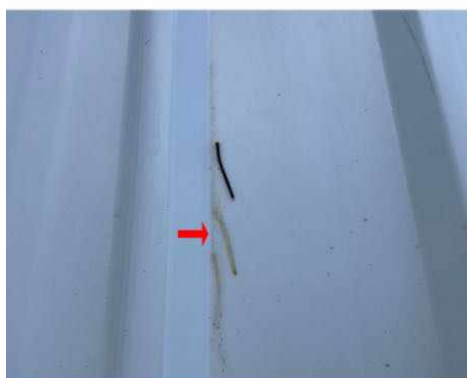
Defects 3.05

Building:	Building 1
Location:	Roof Exterior
Finding:	Swarfing stains
Information:	This pictured areas shows evidence of rusting and corrosion, which is a result of swarfing.

Fresh swarf stains are characterised by small red-brown coloured areas with a central dark spot (the remains of the steel particles). The surface will feel like sandpaper, and the particle may be lifted with a fingernail. An old swarf stain will appear as a localised red- brown stain, the steel particle having corroded away, and the surface will be smoother. Prevention of swarf staining is the responsibility of the installer.

This needs to be brought to the attention of the builder and cleaned immediately.

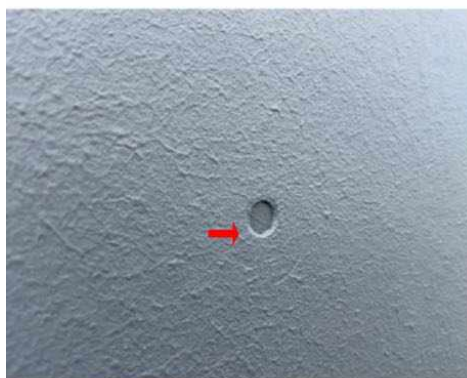
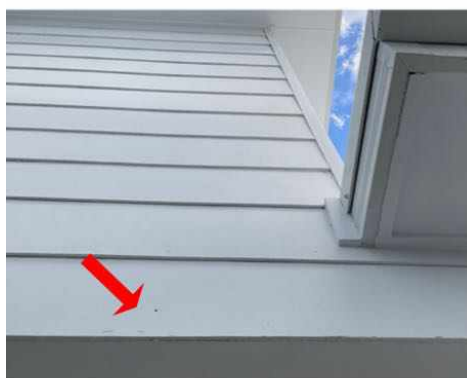
### Defects 3.07

Building: Building 1  
 Location: Pictured areas  
 Finding: Nails protruding from cladding and nail holes not sealed.  
 Information: The external wall cladding fixings have been installed without sealing to nail/screw penetrations. This is non-compliant with NCC requirements for weatherproof external walls and manufacturer installation instructions. Unsealed fixings pose a risk of water ingress and deterioration of wall elements. Rectification is required to seal all exposed fasteners with a suitable external-grade sealant or as per the cladding manufacturer's specifications.

Nails that are not driven flush break the cladding's weather-resistant surface. Water can track down the nail shank and enter the wall cavity. This increases risk of moisture ingress, rot, mould, and corrosion. All protruding nails need to be driven in and sealed.

These areas need to be brought to the attention of the builder.

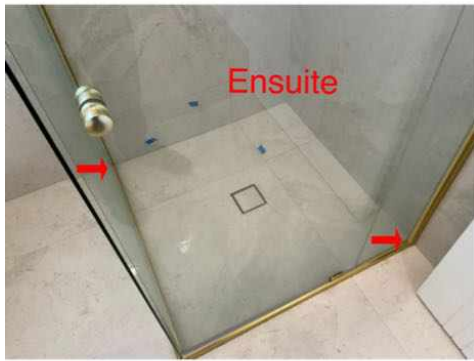
### Defects 3.08

Building:	Building 1
Location:	Bathrooms
Finding:	Shower screens - Leaking
Information:	Three leaks were evident to the two shower screens at the time of inspection. It is suspected that the leaking has occurred as a result missing sealant. Leaking from the showers , where left unattended, is likely to lead to water damage to adjoining flooring and walls. Such damage can lead to water damage and necessitate extensive remedial works being required. Active water leaks may also create an environment that is susceptible to the formation and development of mould.

This should be brought to the attention of the builder.

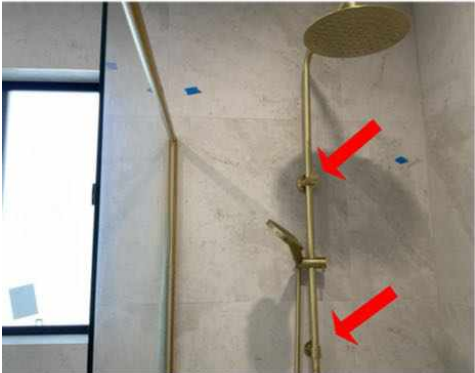
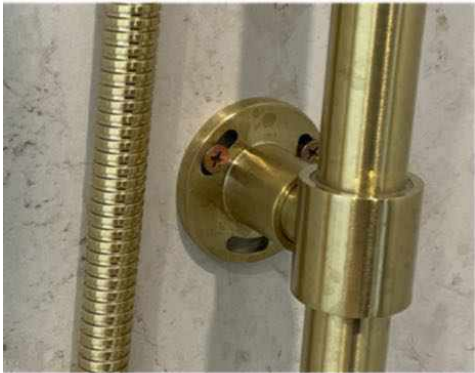
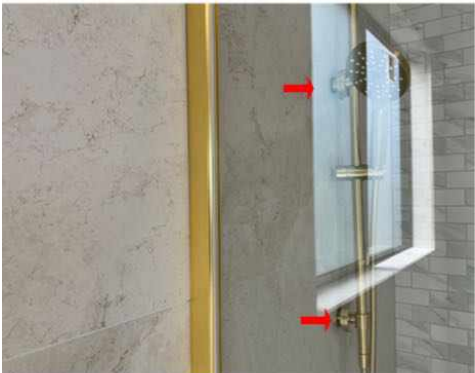
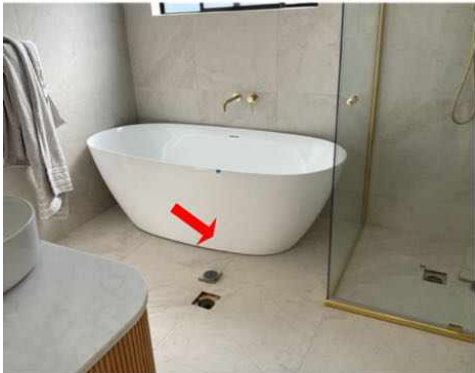
### Defects 3.09

Building: Building 1  
 Location: Bathrooms  
 Finding: Shower rail cover plates loose and missing and bath very loose  
 Information: All shower rail covers were loose and one was missing. The bath was also loose, damage to the bath to floor connecting pipe is likely.

This should be brought to the attention of the builder.

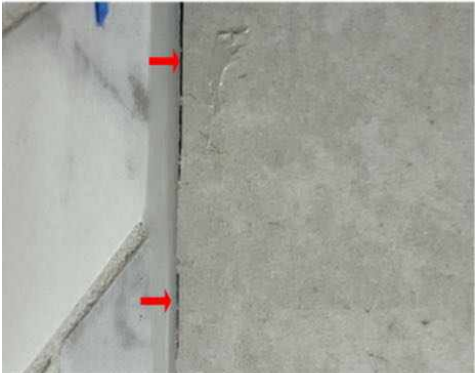
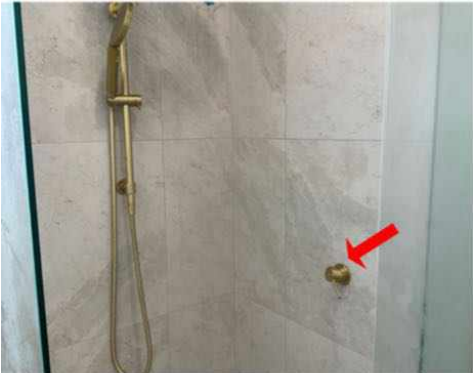
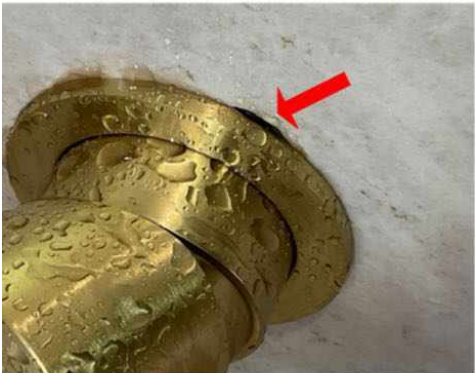
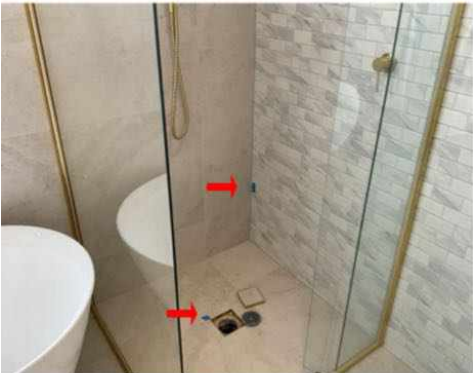
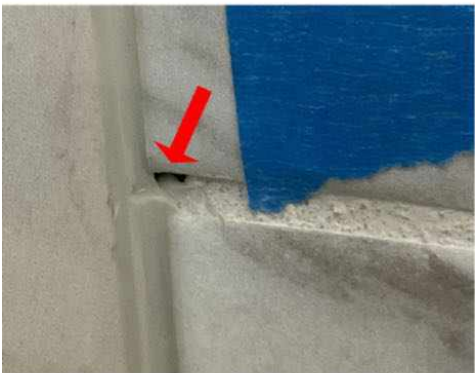
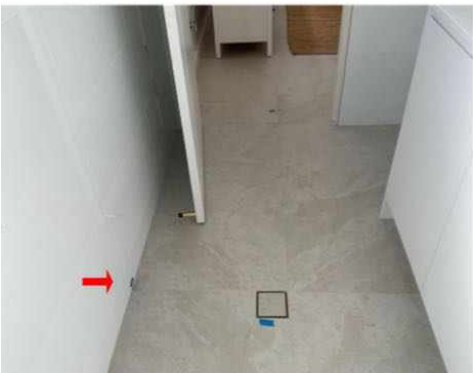
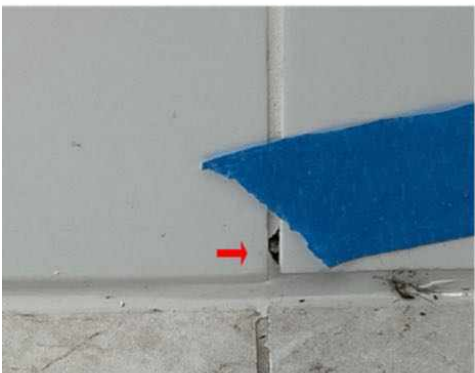
**Defects 3.10**

Building: Building 1  
Location: Bathrooms  
Finding: Sealant and grouting - Missing  
Information: It was noted on inspection that sealant or grout is missing to the pictured bathroom areas. A flexible sealant is required to allow for expected expansion and contraction, while keeping the joint water tight and protective of all associated building materials.

These areas need to be brought to the attention of the builder.

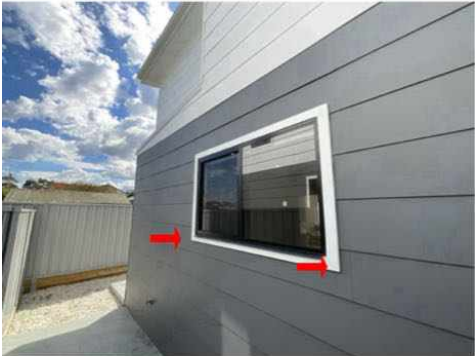
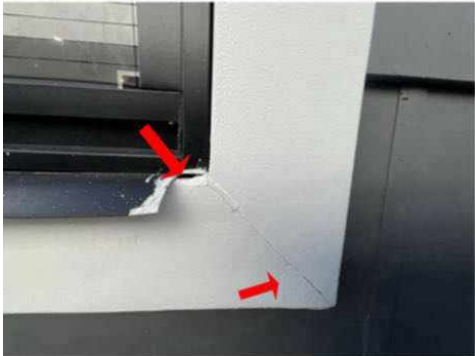
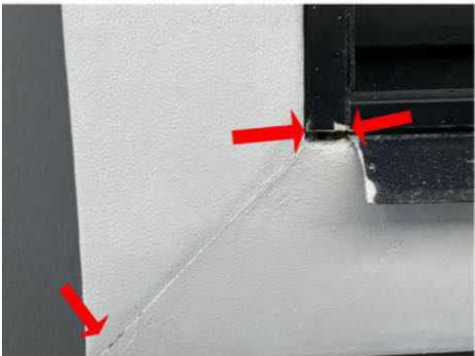
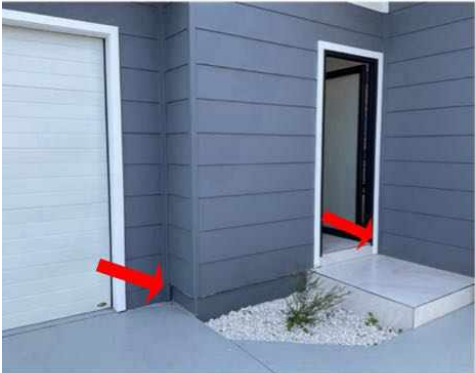
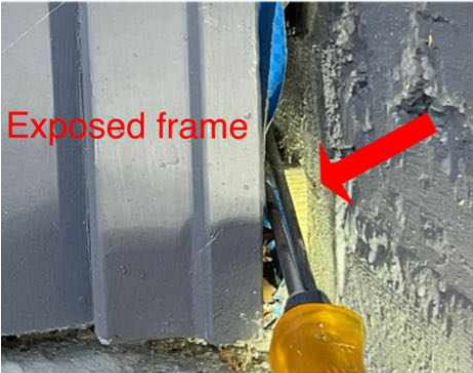
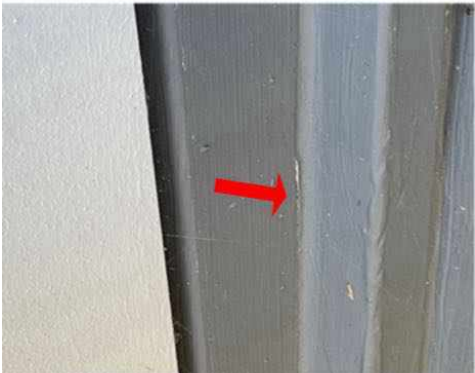
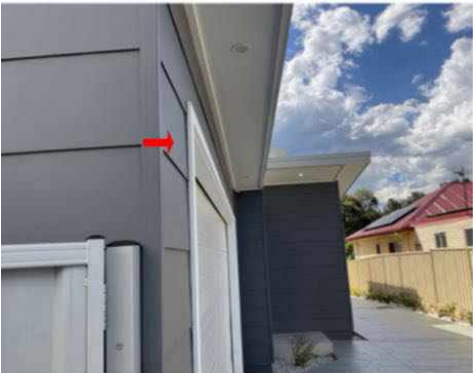
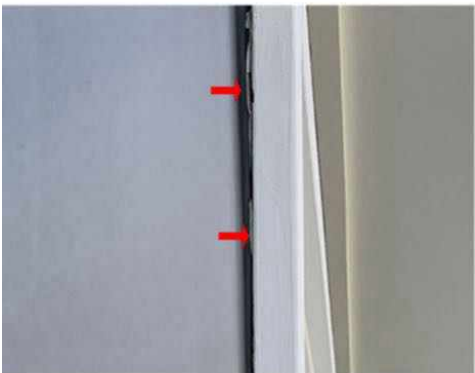
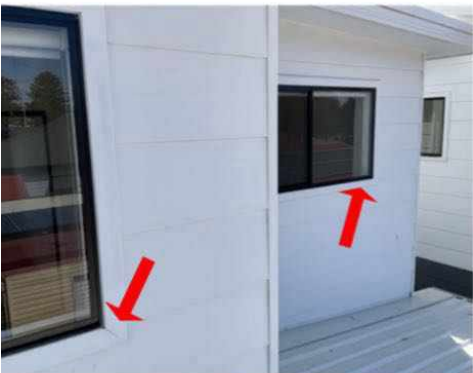
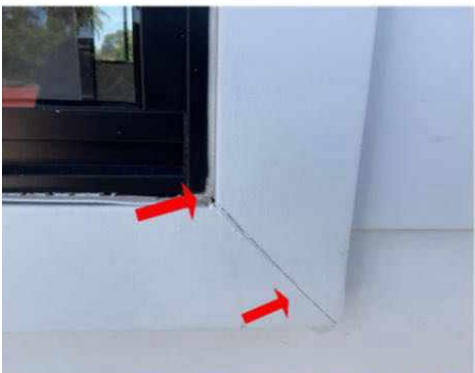
Defects 3.11

Building: Building 1  
Location: Many areas  
Finding: Sealant in External areas - The NSW Standards and Tolerances 2017 - 12.7  
Information: It was noted on inspection that sealant or flashing is missing to some external wall areas. Pictures 4 to 6 show missing flashing/ cladding which is required to stop water ingress to internal areas.

Flexible or waterproof sealants to junctions are defective if they are not installed when required by the BCA and AS 3958.1.

All holes, gaps or cracks should be adequately filled by a suitable sealant or flashings as soon as possible to prevent any water damage that may occur.

These areas need to be brought to the attention of the builder.

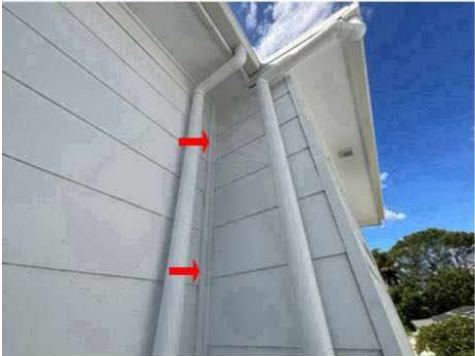
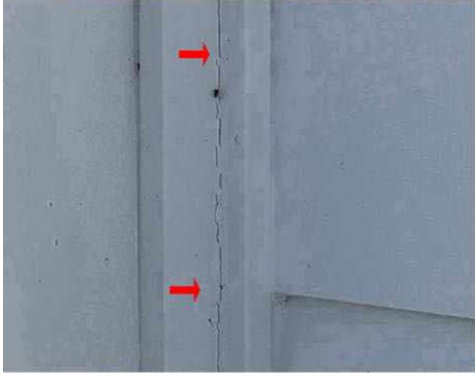
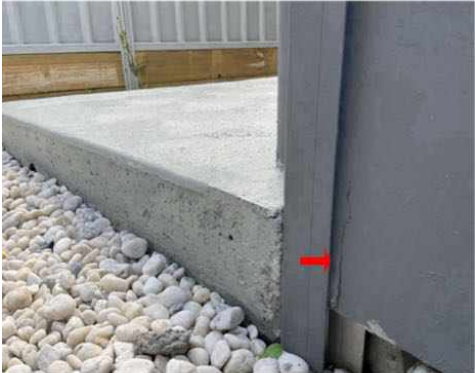
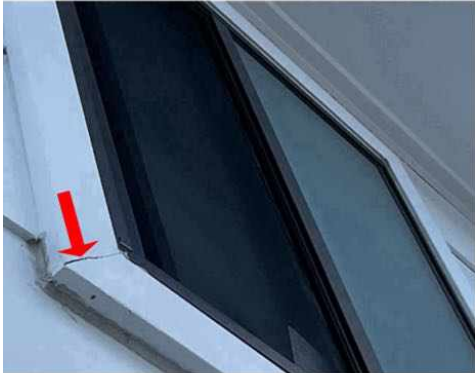
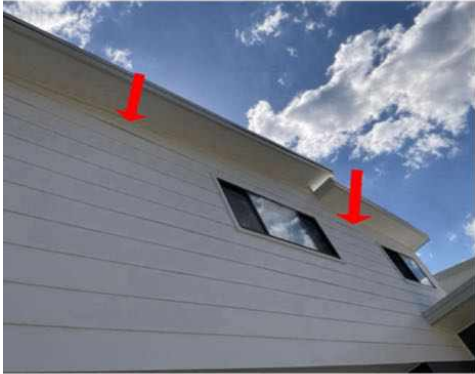
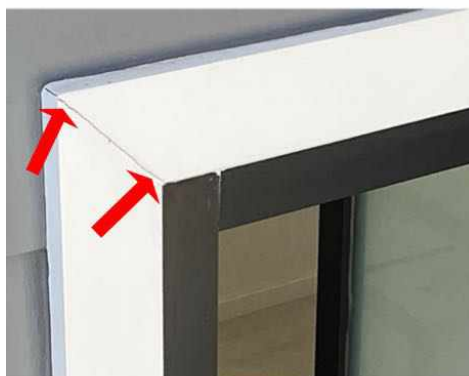
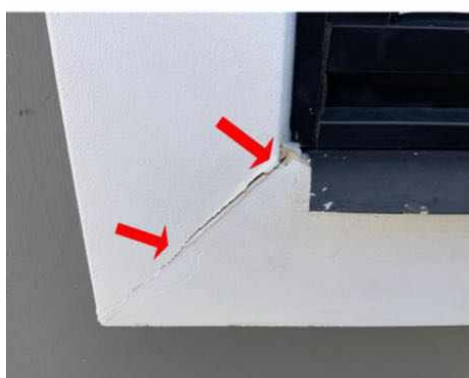
Defects 3.12

Building: Building 1  
Location: Pictured external areas  
Finding: Sealant in External areas - The NSW Standards and Tolerances 2017 - 12.7 (continued)  
Information:

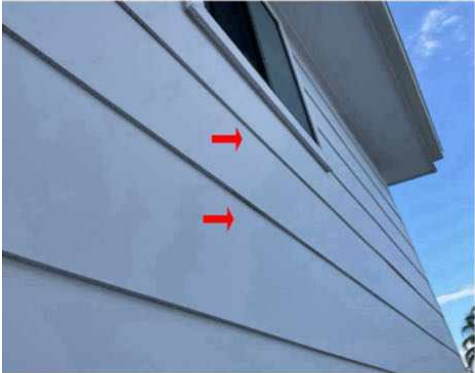
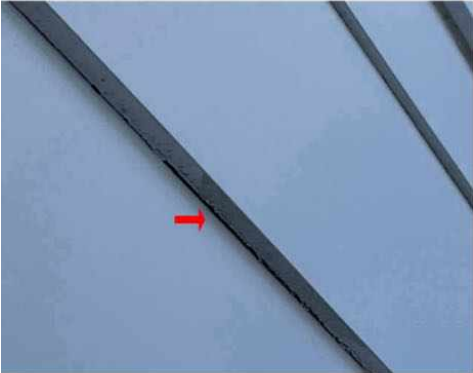
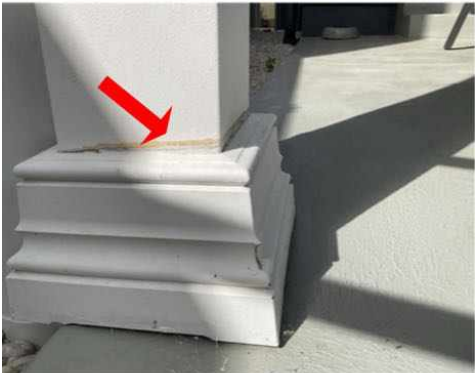
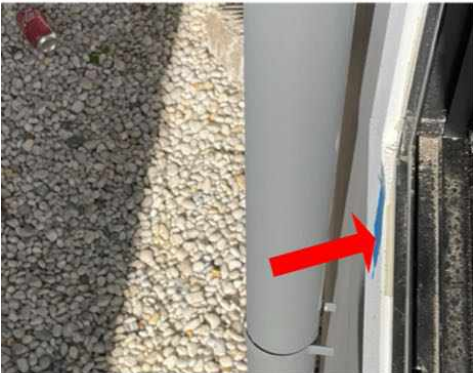
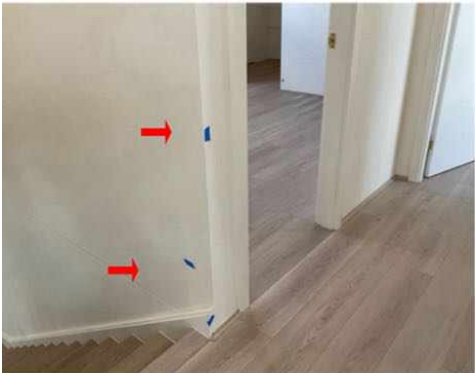
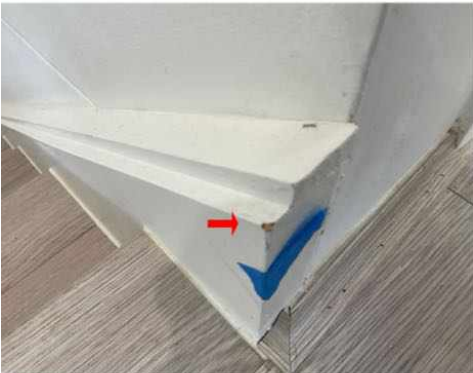
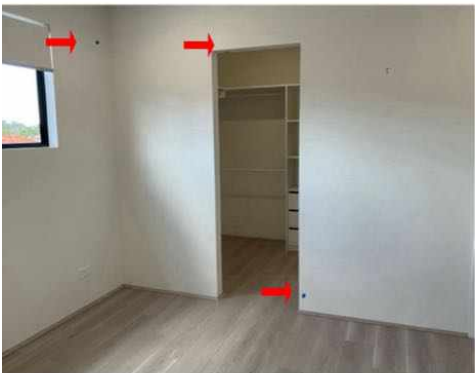
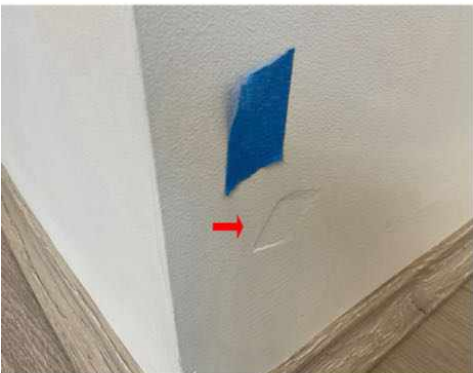
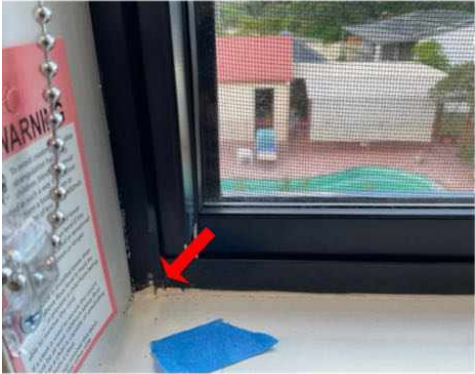
### Defects 3.13

Building:	Building 1
Location:	External and Internal areas
Finding:	Paintwork defective - NSW Guide to standards and tolerances part 13.2
Information:	Several areas of substandard paint finishes were identified on the building at the time of the inspection. Paintwork is defective if the application has blemishes such as paint runs, paint sags, wrinkling, dust, bare or starved painted areas, colour variations, surface cracks, irregular and coarse brush marks, sanding marks, blistering, non-uniformity of gloss level and other irregularities in the surface that are visible from a normal viewing position. Paintwork is defective if the application results in excessive over-painting of fittings, trims, skirtings, architraves, glazing and other finished edges.

These areas need to be brought to the attention of the builder.

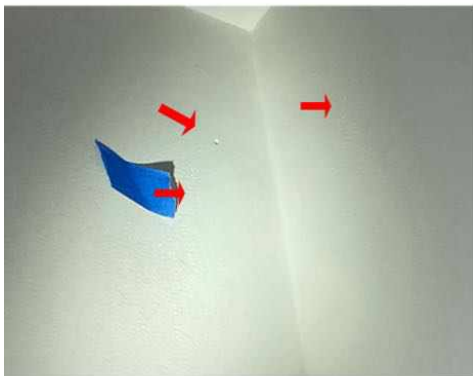
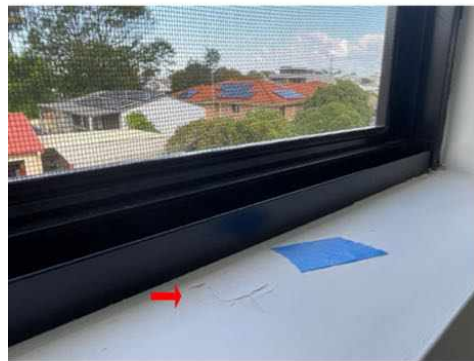
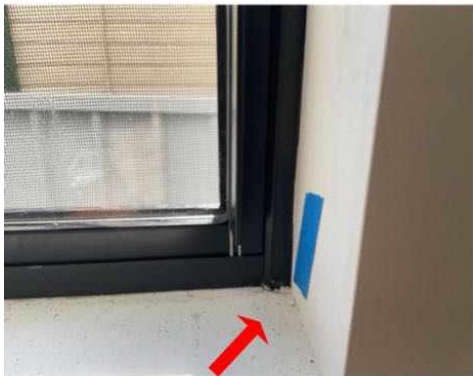
**Defects 3.14**

Building: Building 1  
Location: Many upstairs areas  
Finding: Paintwork defective - NSW Guide to standards and tolerances part 13.2 (continued)  
Information: These areas need to be brought to the attention of the builder.

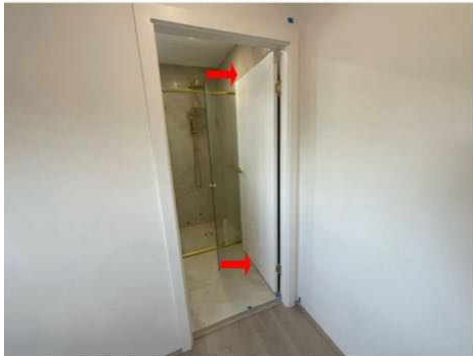
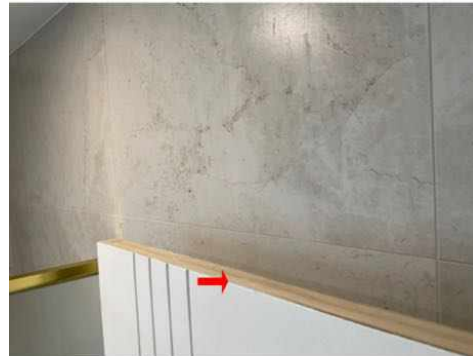
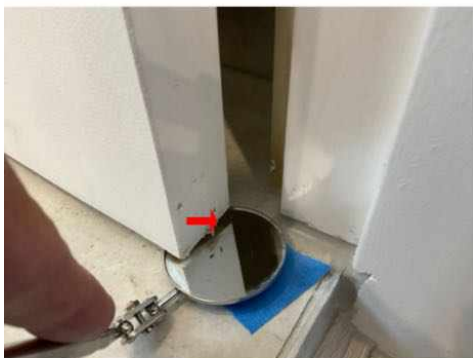
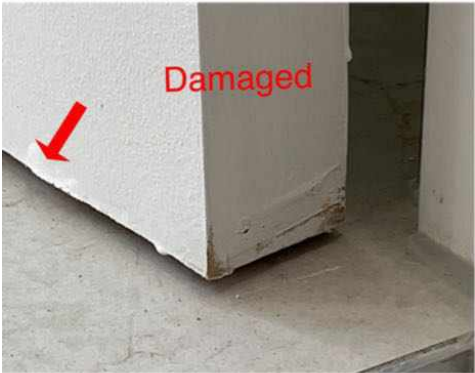
### Defects 3.15

Building:	Building 1
Location:	Many doors
Finding:	Paint finish on doors - Incomplete and minor damage evident
Information:	The paint finish to many doors was identified as being incomplete at the time of inspection.

NSW Guide to Standards and Tolerances 9.6 states that "door leaves are defective if they do not have all sides, top and bottom edges sealed/painted

Whilst incomplete or missing paint finish is generally an appearance defect, it can also lead to the development of secondary building defects over time. Incomplete areas of paint finish expose the area to moisture, potentially accelerating the deterioration of underlying building materials.

Incomplete paint finishes should be sanded back, filled, leveled and painted, as applicable. Where inadequate or missing paint protection has led to the deterioration of any doors, replacement of the damaged doors will be required.

These areas need to be brought to the attention of the builder.

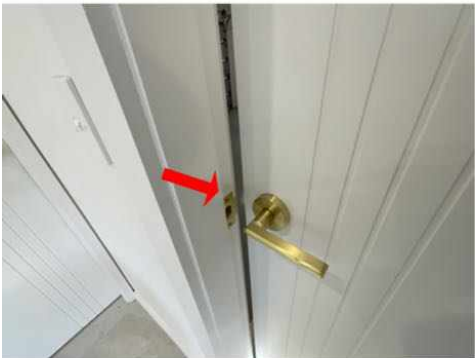
**Defects 3.16**

Building: Building 1  
Location: Entry, rear garage, loungeroom screen door  
Finding: Doors - Binding/jamming  
Information: Binding and/or jamming of these three doors was evident during standard operation. This defect inhibits the functionality of the affected doors as well as creating potential for secondary defects to associated building elements, such as damage to the floor covering.

These areas need to be brought to the attention of the builder.

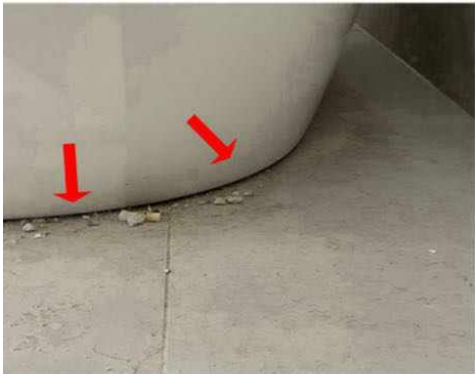
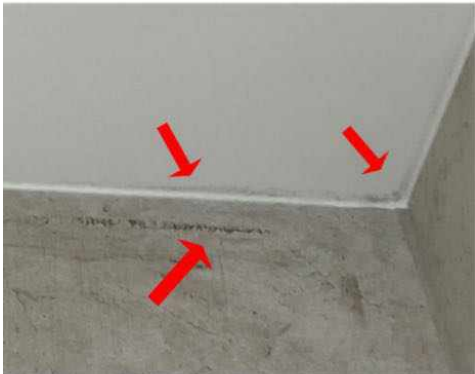
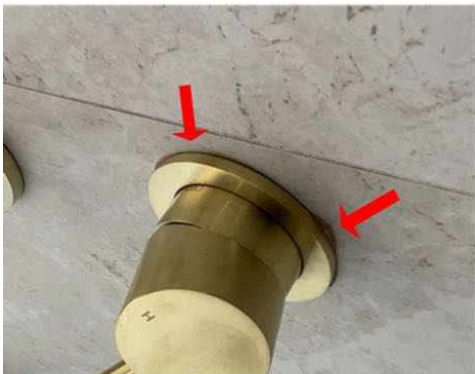
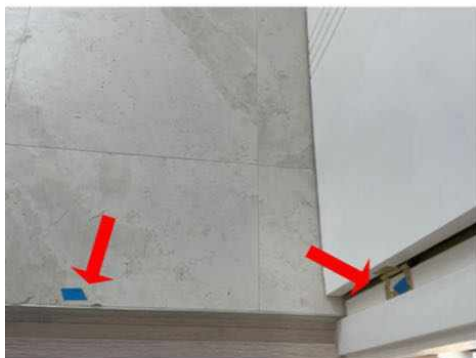
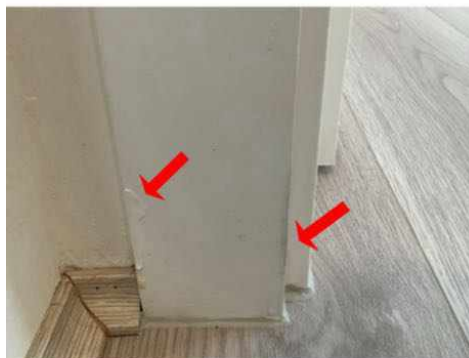
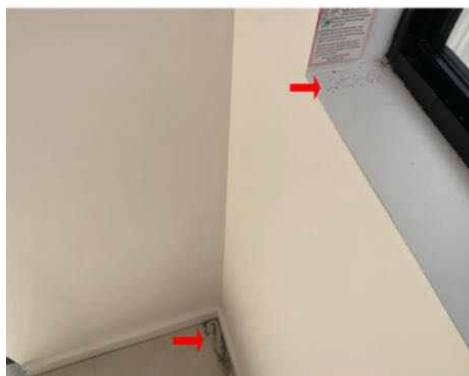
### Defects 3.18

Building:	Building 1
Location:	Many Internal Areas
Finding:	Cleaning of building elements - NSW Standards and Tolerance 2017 - 3.11
Information:	It was observed that the pictured building elements are not cleaned and ready for use.

The NSW Standards and Tolerances 2017 - 3.11 state - Cleaning, mortar smears and stains

“Stains, mortar smears and damage caused by cleaning are defective if they are visible from a normal viewing position.”

These areas need to be cleaned and ready for use.

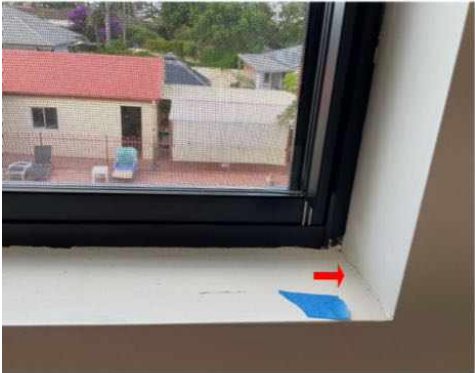
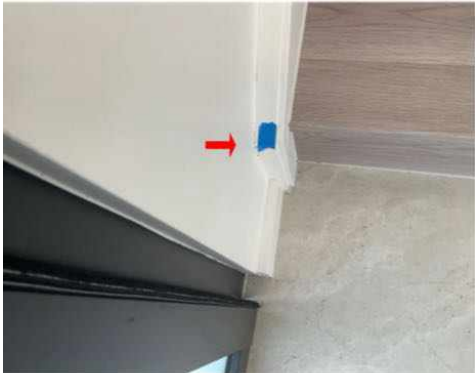
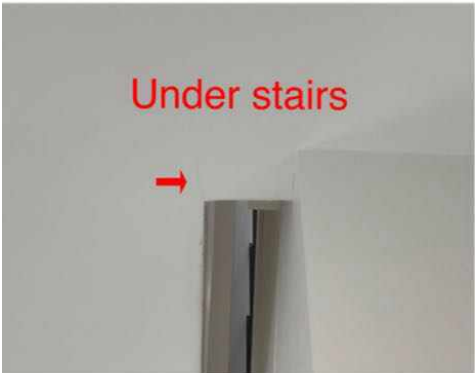
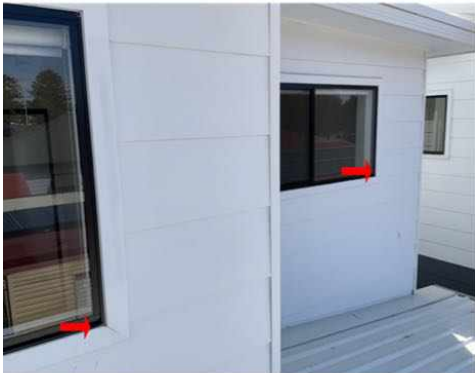
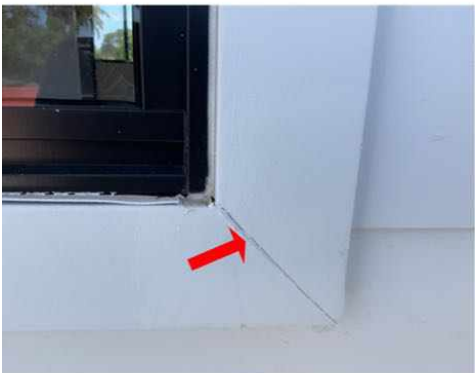
### Defects 3.19

Building:	Building 1
Location:	Pictured external and internal areas
Finding:	Gaps or cracks in mouldings including many external windows
Information:	Gaps were found in these mouldings.

Unless documented otherwise, gaps between mouldings or between mouldings and other fixtures, at mitre or butt joints, or at junctions with a wall or other surfaces, are defective if they exist at handover, or exceed 1 mm in width within the first 12 months of completion and are visible from a normal viewing position.

This should be brought to the attention of the builder.

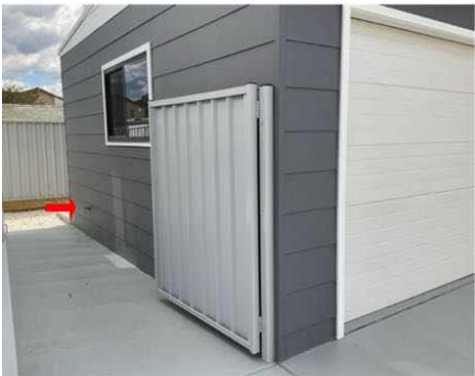
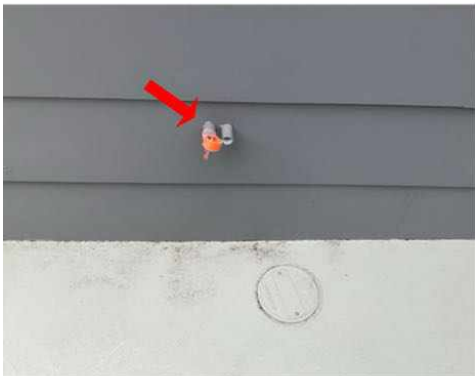
**Defects 3.20**

Building: Building 1  
Location: Left wall  
Finding: Unfinished construction  
Information: The construction of this structure appears to be incomplete. There are pipes protruding in the garage left wall.

The Builder should complete this construction process.

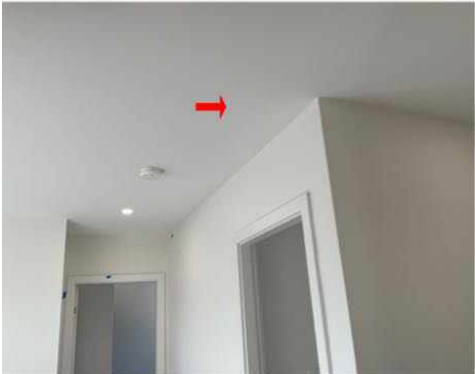
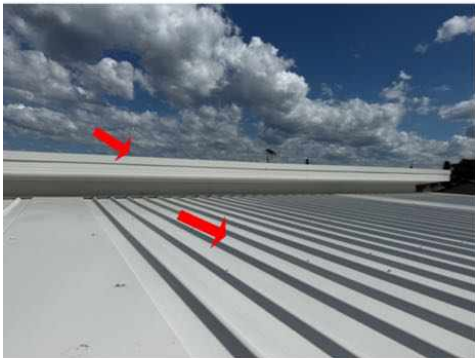
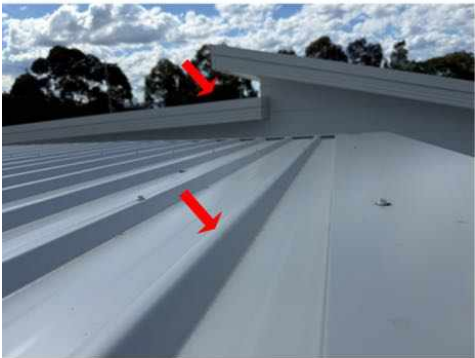
Building: Building 1  
Location: Roof Void  
Finding: Additional Photos - Obstructions and Limitations of the ROOF CAVITY  
Information: These photographs are an indication of the obstructions and limitations which impeded full inspection of roof cavity areas at the time of inspection. These obstructions can hide an array of defects and should be removed to allow full inspection to be carried out if applicable. A re-inspection is recommended once the areas are made accessible.
