## Building and Timber Pest Inspection Report

Inspection Date: Fri, 20 Feb 2026

Property Address: 2/123 Cooper St, Waterloo NSW 2017,  
Australia

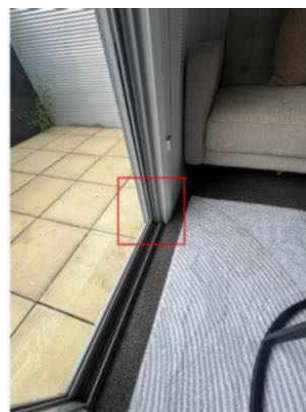
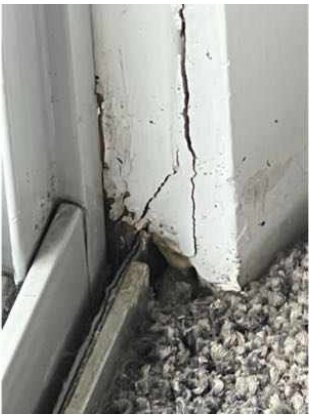
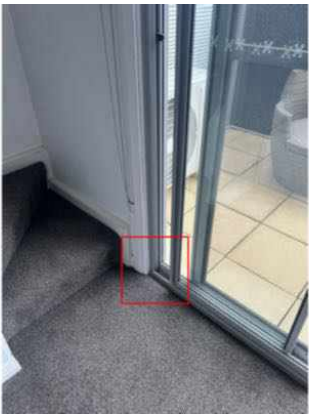
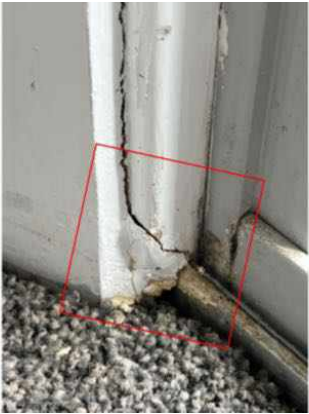
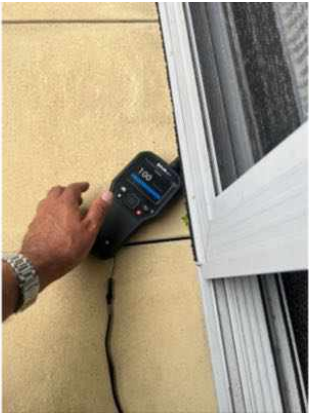
Building: Main Building  
Location: Lounge Room  
Finding: Elevated Moisture at Balcony and skirting  
Information: Minor deterioration and elevated moisture levels were detected to the balcony tiling and adjoining sliding door skirting, indicating a possible moisture pathway from the external balcony or cladding into the internal wall structure. The pattern of readings suggests potential water ingress through the balcony membrane, tiling system, or door threshold detailing. This condition may contribute to concealed deterioration of building materials, timber decay or mould growth if left unresolved. Further investigation and appropriate rectification by a licensed waterproofing contractor and builder are recommended.

Failure to investigate and rectify this defect could cause further damage to the area and associated costs.

Depending on the strata plan, this area may form part of the common property, in which case remedial responsibility may rest with the owners corporation (strata). Purchasers should seek clarification from the strata manager and legal adviser prior to purchase.

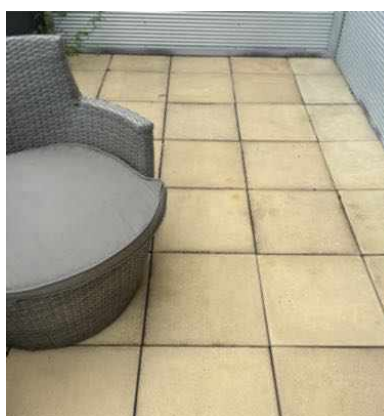
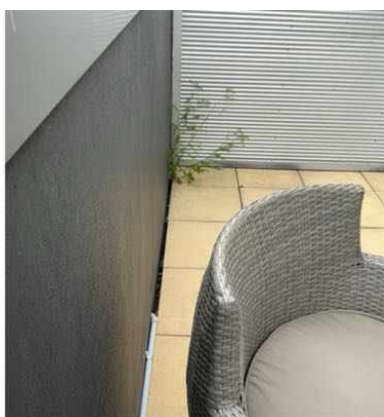
Finding 3.02

Building: Main Building  
 Location: Lounge Room  
 Finding: Pedestal Paver System - Balcony  
 Information: Vegetation growth was observed within the perimeter drainage cavity of the balcony pedestal paver system, indicating accumulation of debris and ongoing moisture retention in an area intended to remain clear for drainage and ventilation. Organic build-up in this zone can obstruct water flow, promote prolonged damp conditions against adjacent wall surfaces, and increase the risk of waterproof membrane deterioration or moisture ingress over time. Cleaning of debris and removal of vegetation is recommended to reinstate proper drainage performance, and the condition of the underlying waterproofing should be monitored in accordance with AS 4654.2 where applicable

Minor movement of individual pavers can be characteristic of this system, however, any excessive rocking or instability should be assessed and adjusted to ensure even support and minimise trip hazards. Ongoing maintenance of pedestal alignment and drainage beneath the pavers is recommended.

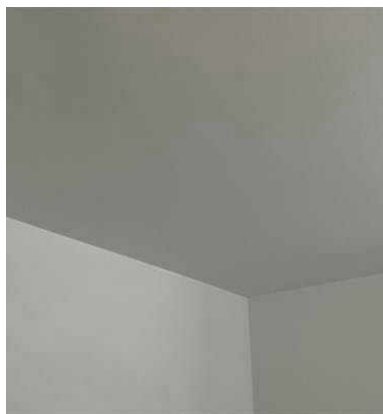
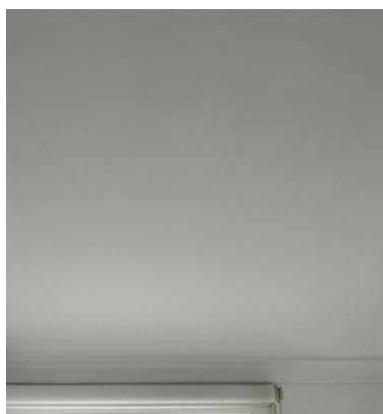
### Finding 3.03

Building: Main Building  
 Location: Laundry/Ensuite  
 Finding: Building element - Missing - No ventilation

Replacement of any missing building element should be conducted as soon as possible to ensure that no damage or functional issues occur to associated building materials.

The appropriate tradesperson should be appointed as soon as possible to replace the missing building element.

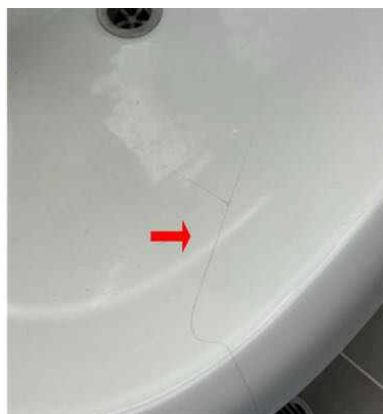
Building:	Main Building
Location:	Bathroom
Finding:	Building element - Damaged - Sink cracked
Information:	Breakage occurs generally when the building materials have either aged and decayed, or as a result of damage (accidental or deliberate).

Repair and/or replacement of broken elements is advised to ensure that additional secondary defects do not arise as a consequence. Such works are necessary, as all building elements play a key role in the operation and function of the overall structure and its performance.

A relevant tradesperson should be appointed to repair or replace the affected building element prior to any subsequent damage being caused.

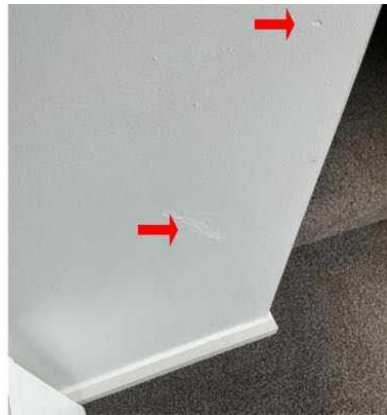
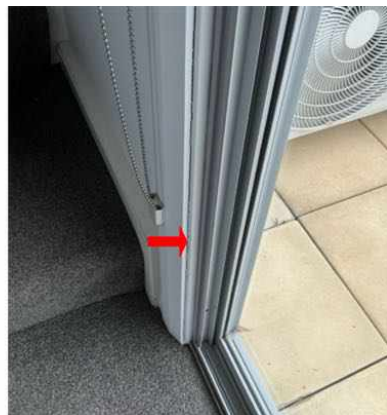
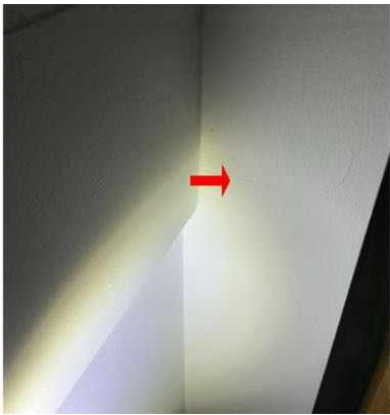
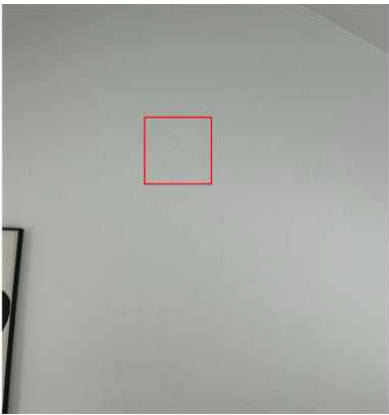
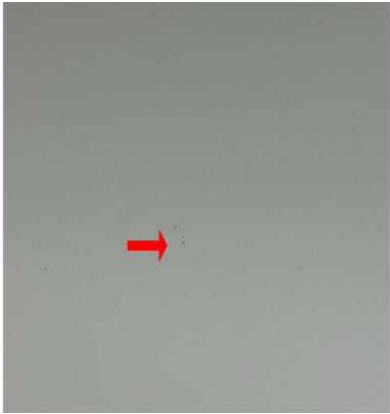
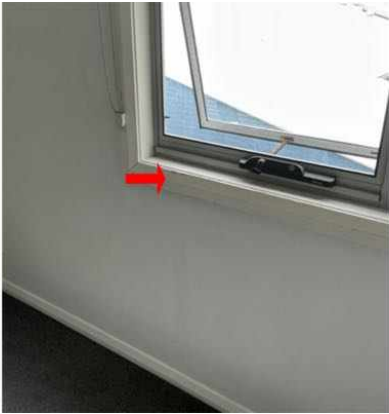
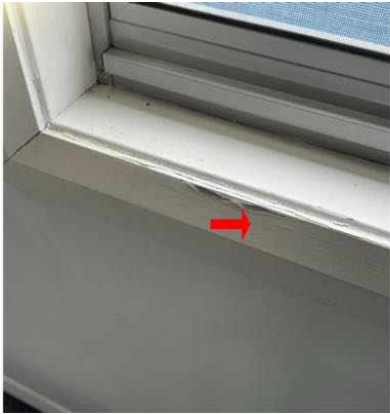
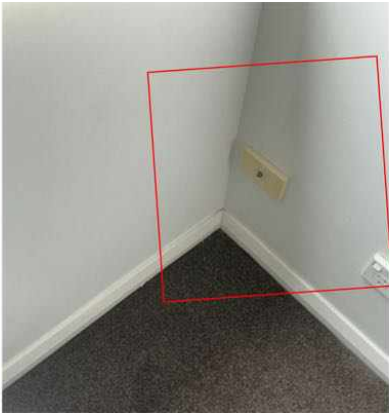
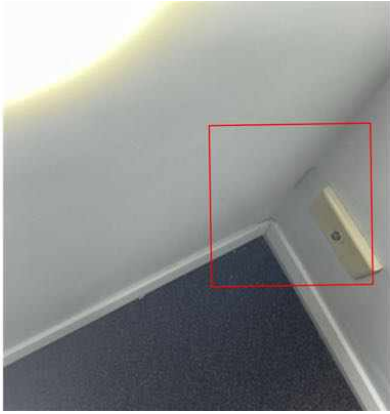
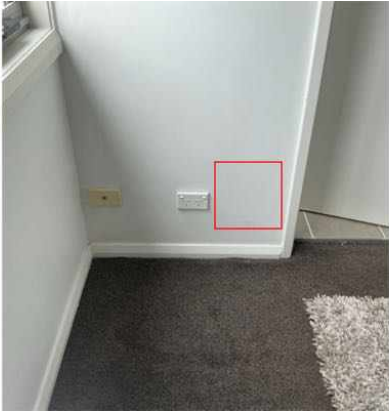
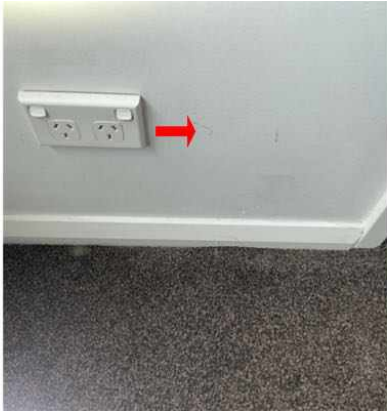
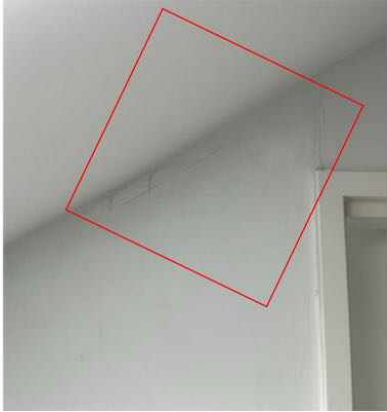
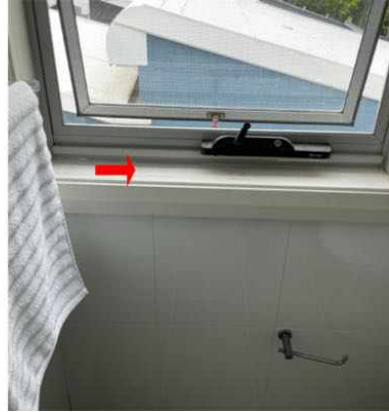
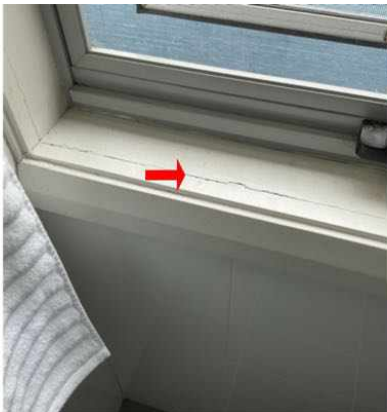
### Finding 3.08

Building:	Main Building
Location:	All Internal Areas
Finding:	Paint finish and hairline cracking
Information:	The paint finish in this area was identified as being incomplete at the time of inspection including some hairline minor cracking.

Whilst incomplete or missing paint finish is generally an appearance defect, it can also lead to the development of secondary building defects over time. Incomplete areas of paint finish expose the area to moisture, potentially accelerating the deterioration of underlying building materials.

Incomplete paint finishes should be sanded back, filled, leveled and painted, as applicable. Where inadequate or missing paint protection has led to the deterioration of the associated building element, repair and/or replacement of this building element may be required.

A painting contractor should be appointed as soon as possible to perform necessary works to aid the appearance of the affected area and to ensure the area is protected against further deterioration. Alternatively, the homeowner following manufacturer instructions may perform these works.

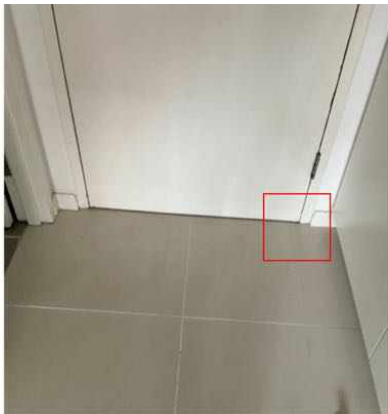
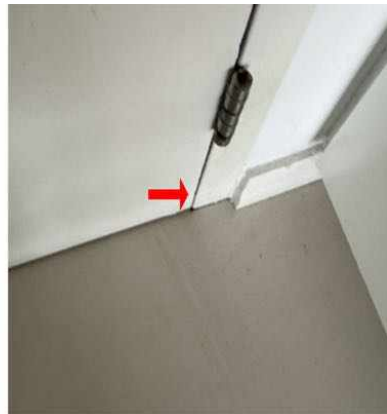
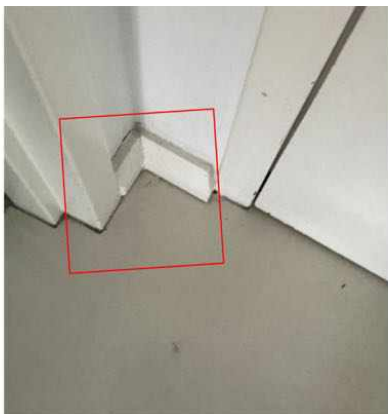
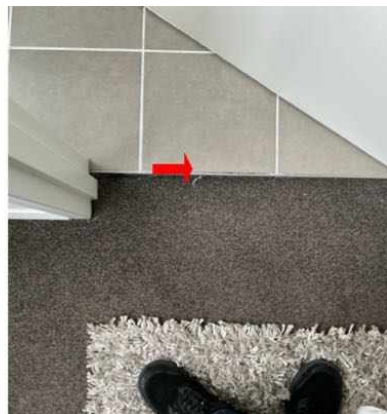
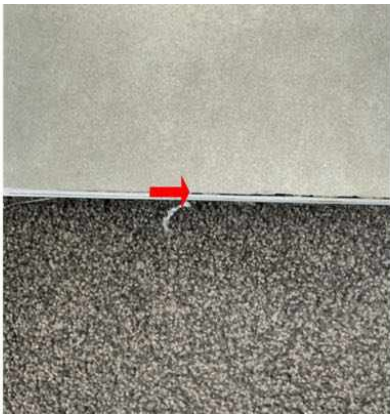
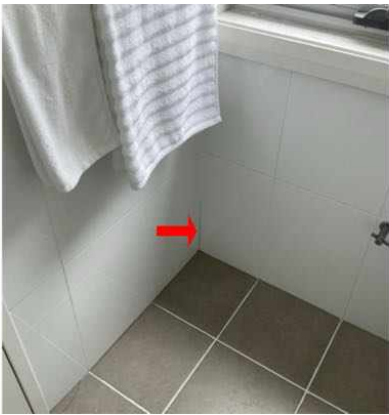
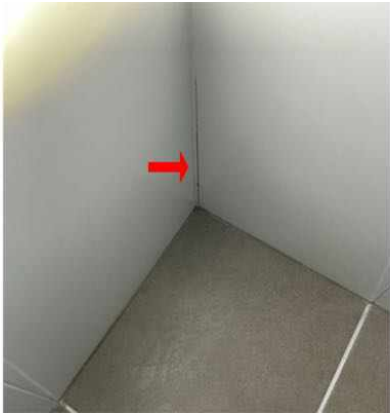
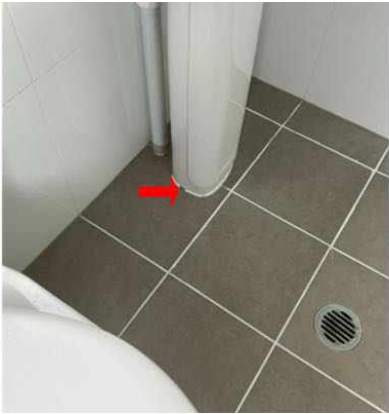
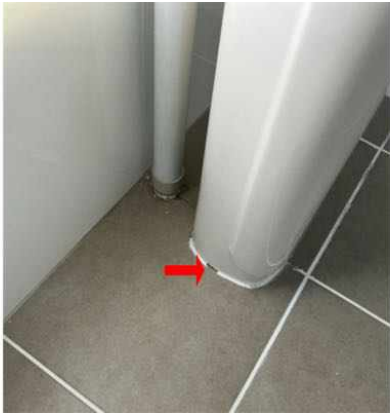
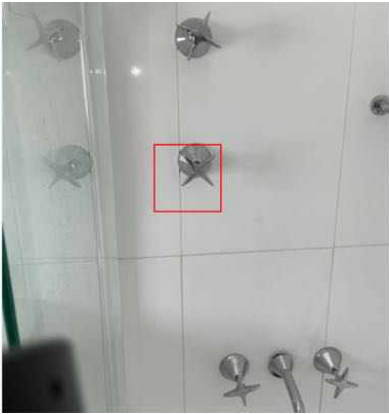
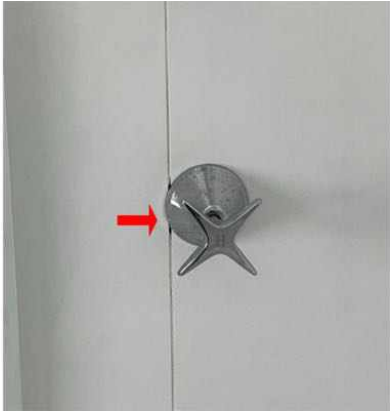
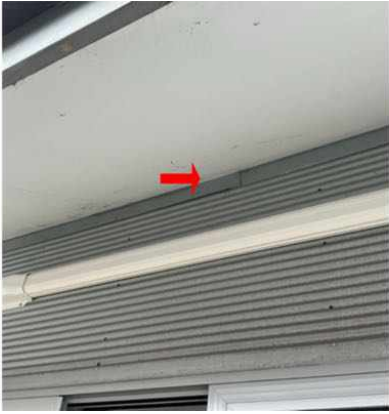
### Finding 3.09

Building:	Main Building
Location:	All Internal Areas
Finding:	Sealant and grouting - Missing or degraded to some areas
Information:	It was noted on inspection that sealant or grout is degraded. There is also evidence of poor workmanship and excessive use of sealant. Silicone should never be used as a first line of defence against waterproofing. Further inspection by a licensed waterproofing contractor is highly recommend

Different materials and floor areas move at different rates, generally causing cracking to grout or sealant at this point. A flexible sealant is required to allow for expected expansion and contraction, while keeping the joint water tight and protective of all

There appears to be excessive mould to the sealant and grout which will likely require scraping out and replacement.

Flexible and mould resistant materials should be applied to affected areas to prevent any subsequent water damage that is likely to occur. Regular maintenance and replacement of damage or missing or damaged sealant and grout is highly recommended to the wet areas, as this is a regular wear and tear defect. Sealant and grouting in areas that come into regular contact with water should be maintained for the long term care of your property.

A sealant specialist or tiling contractor should be appointed to complete these works as soon as possible

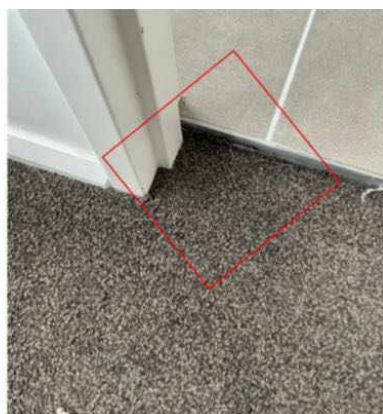
### Finding 3.10

Building:	Main Building
Location:	Bedroom
Finding:	Building element - Damaged - Carpet lifting to some areas
Information:	Breakage occurs generally when the building materials have either aged and decayed, or as a result of damage (accidental or deliberate).

Repair and/or replacement of broken elements is advised to ensure that additional secondary defects do not arise as a consequence. Such works are necessary, as all building elements play a key role in the operation and function of the overall structure and its performance.

A relevant tradesperson should be appointed to repair or replace the affected building element prior to any subsequent damage being caused.

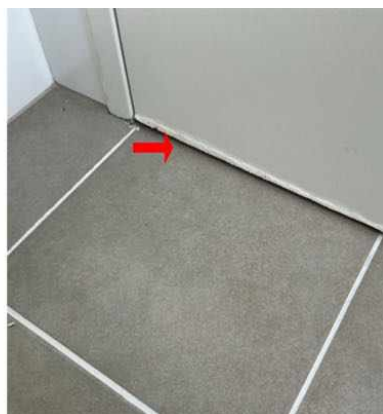
### Finding 3.11

Building:	Main Building
Location:	Bathroom
Finding:	Delamination of timbers
Information:	Delamination is one means by which composite materials (e.g. layered timber composites) may fail over time. In laminated materials, repeated cyclic stresses may

lead to the formation of mini-structures of separate layers, with significant loss of mechanical toughness. Water penetration or the presence of excessive moisture also generally contributes to delamination.

Where building materials have become delaminated, they lose their structural strength, and are likely to have a variety of appearance and serviceability defects as a result.

Delamination of timbers may be repaired where the area affected is minor and/or easily accessible, by gluing and screwing layers back together. However, this is an interim repair, and where delamination has occurred, the client should plan for the replacement of affected timbers sooner than would otherwise be expected.

All timber structures affected by delamination should be replaced as soon as possible to avoid any further damage. Repair and replacement estimates should be sought from a registered builder or qualified carpenter.

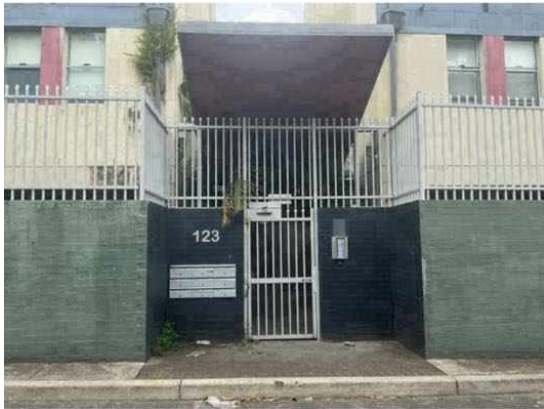
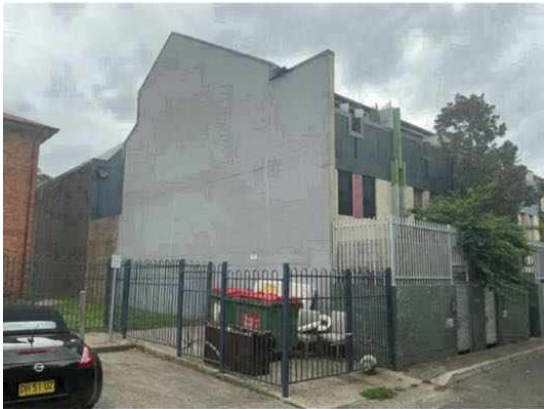
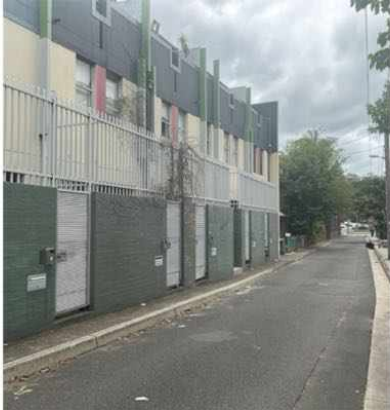
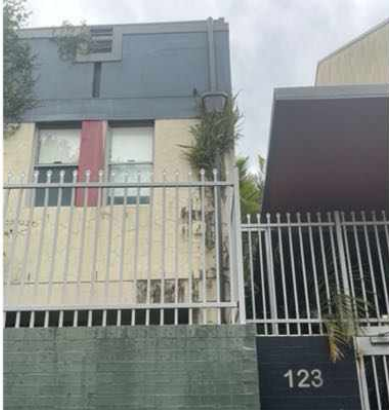
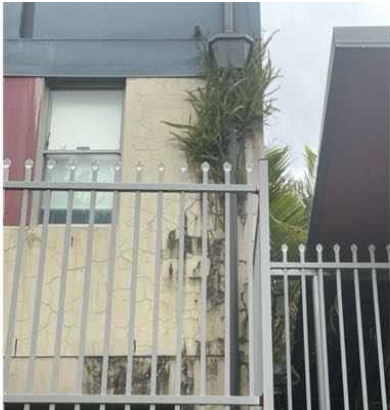
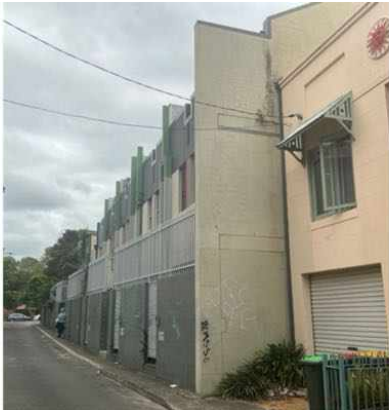
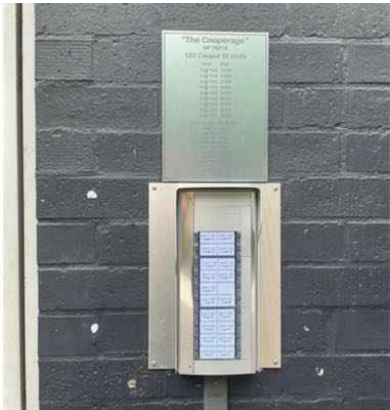
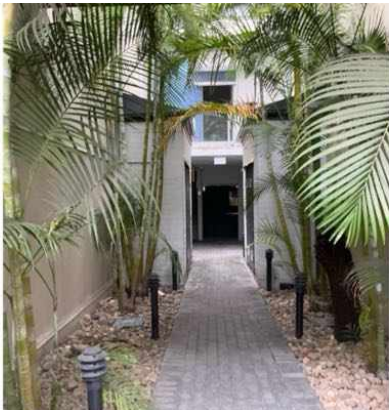
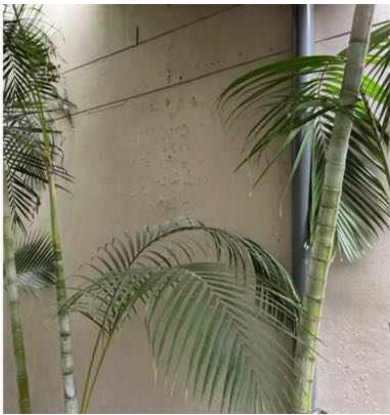
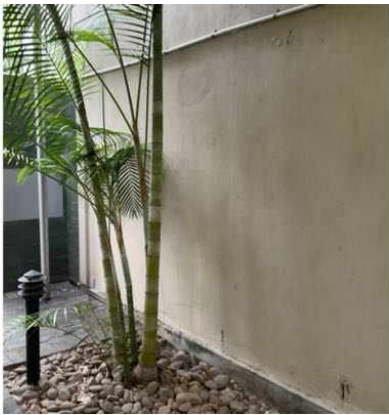
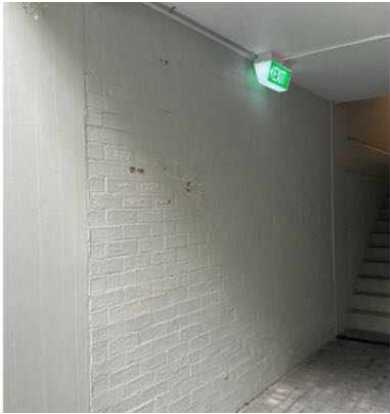
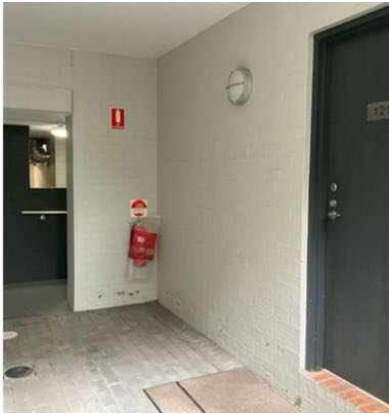
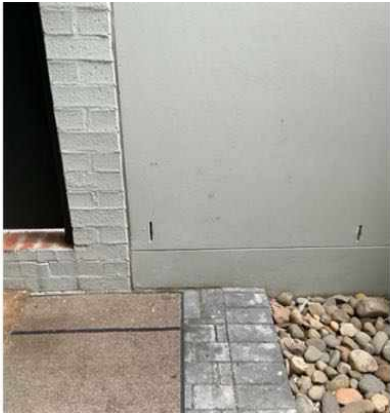
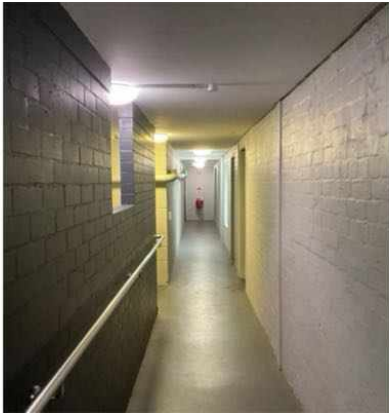
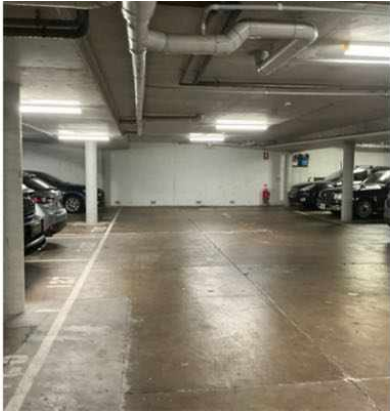
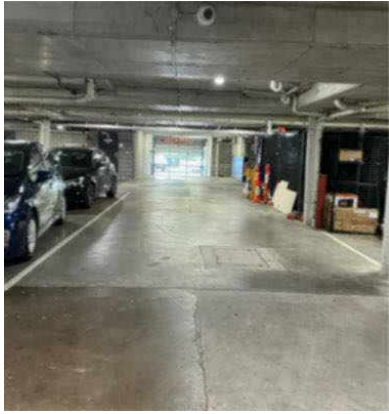
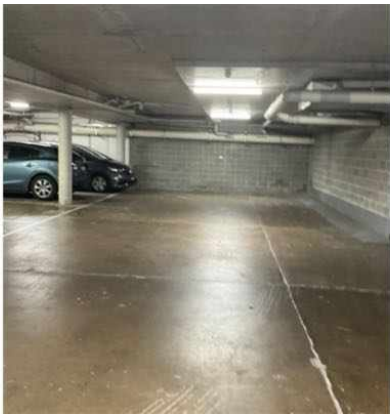
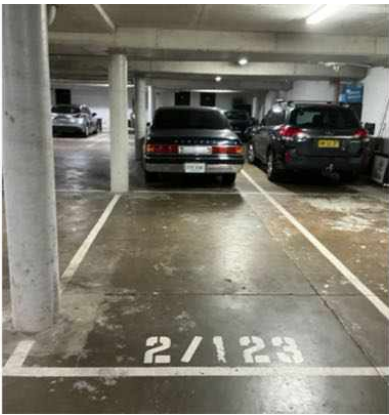
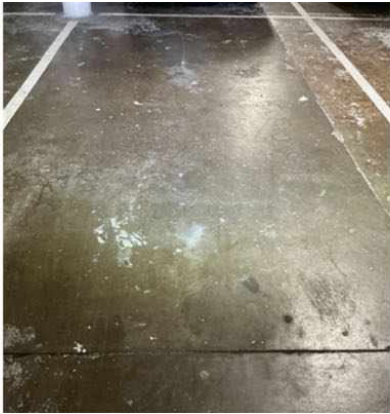
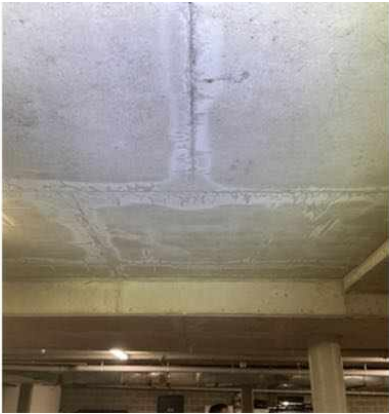
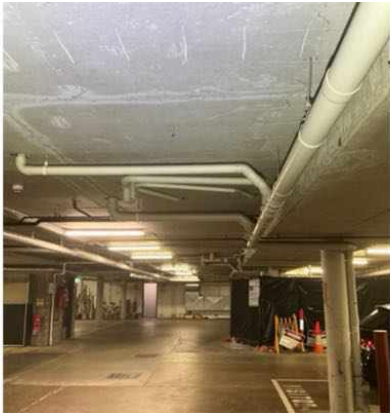
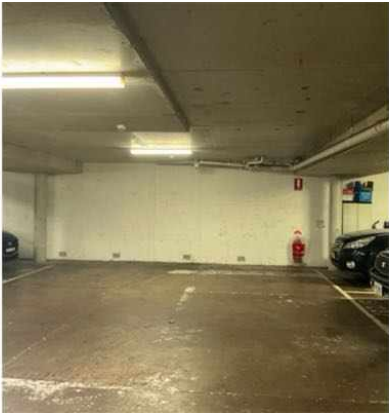
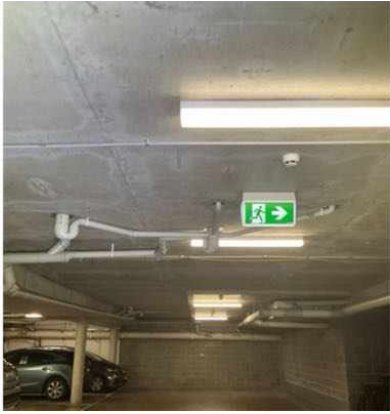
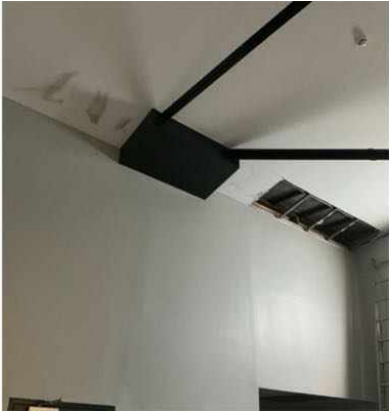
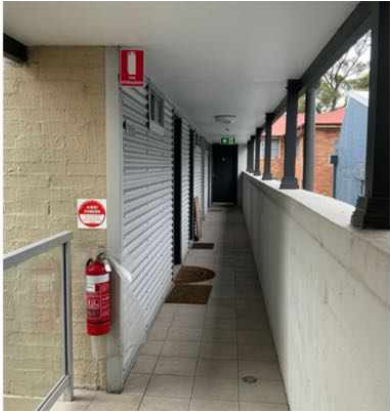
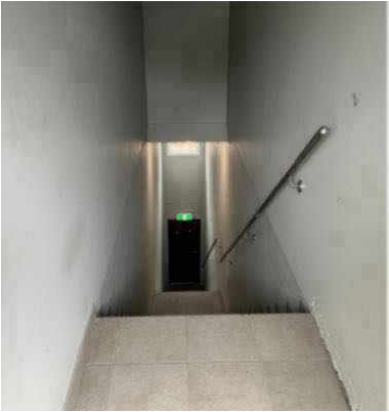
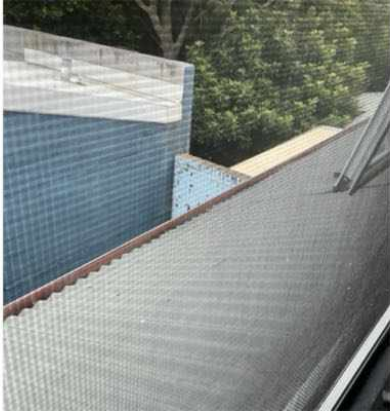
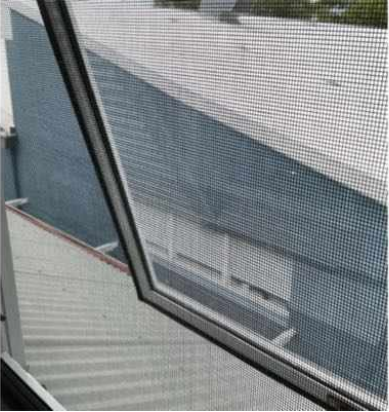
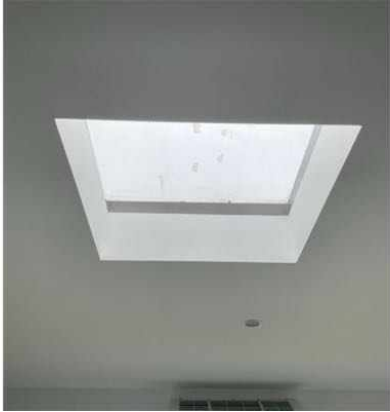
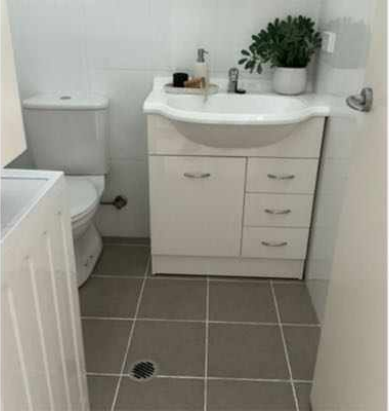
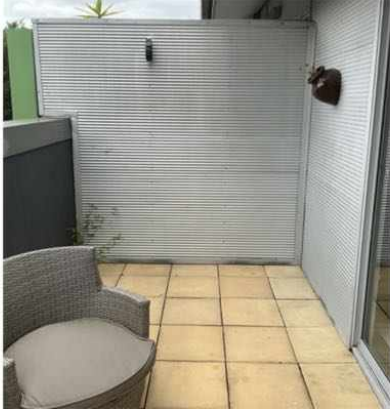
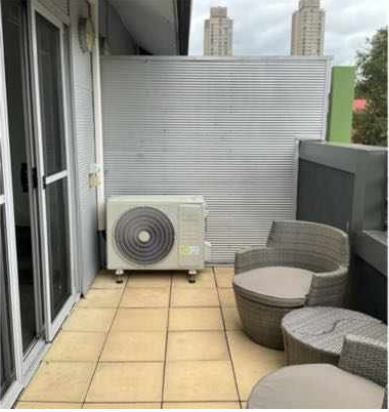
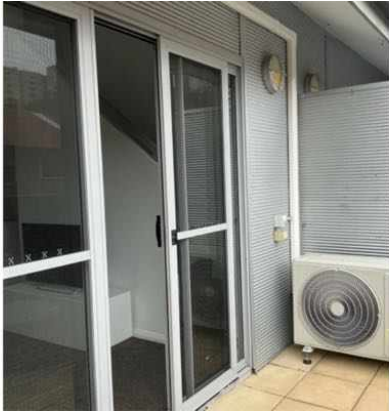
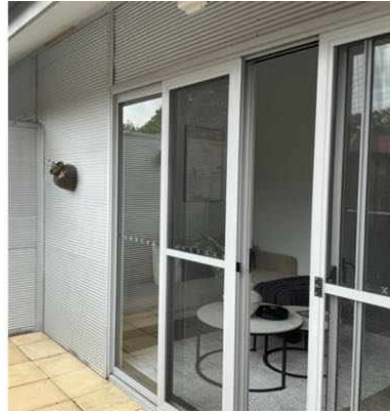
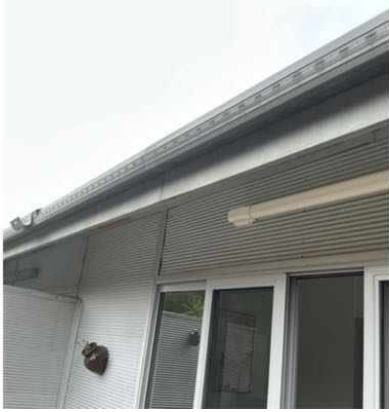
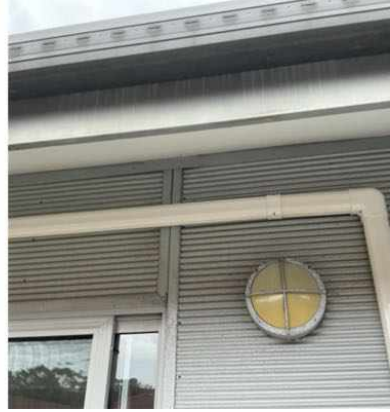
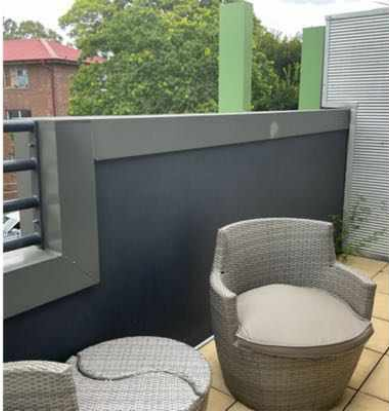
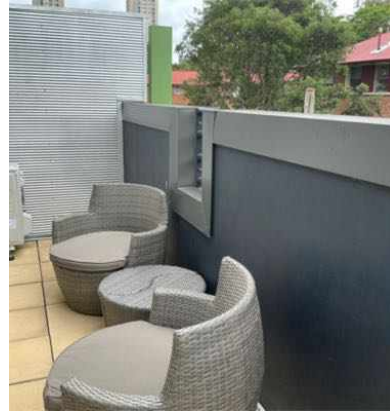
Building: Main Building  
Location: All External Areas  
Finding: Additional Photos - Obstructions and Limitations  
Information: These photographs are an indication of the obstructions and limitations which impeded full inspection of the property at the time of inspection. These obstructions can hide an array of defects and should be removed to allow full inspection to be carried out. A re-inspection is recommended once the areas are made accessible.

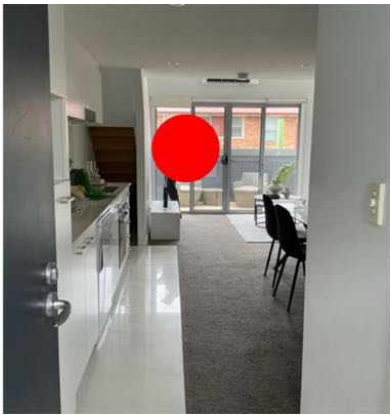
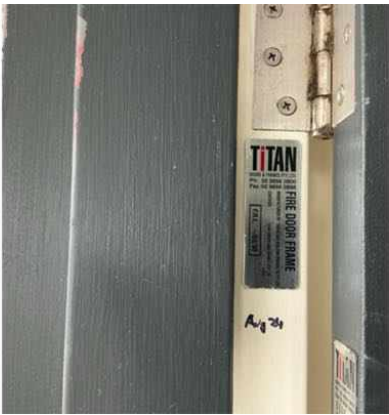
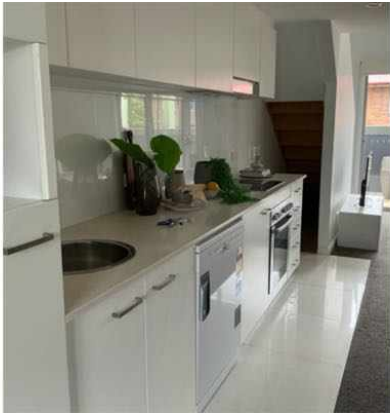
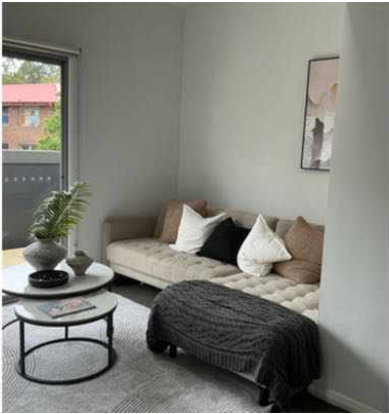
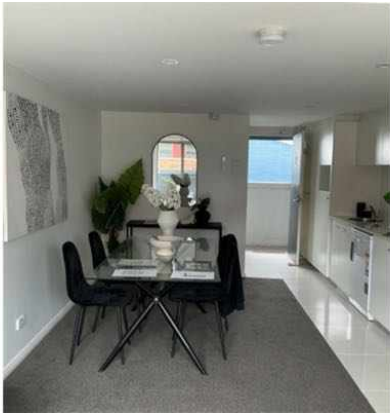
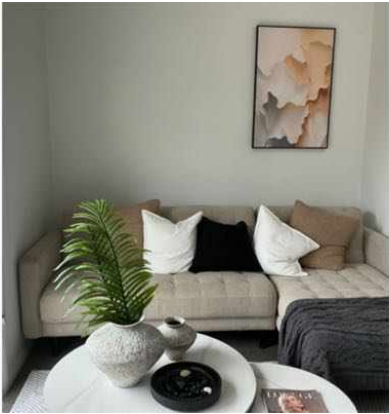
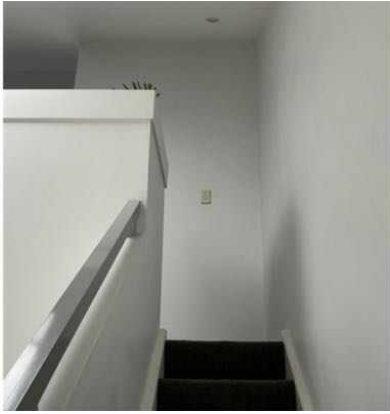
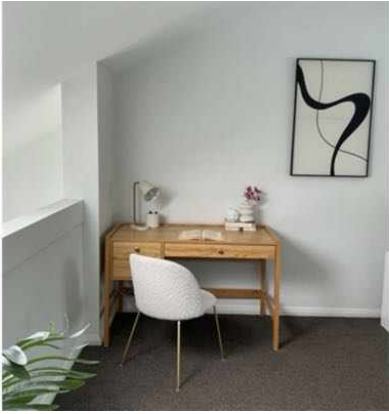
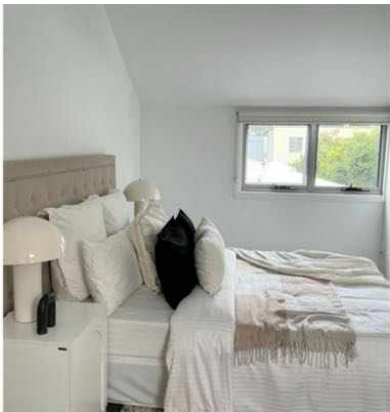
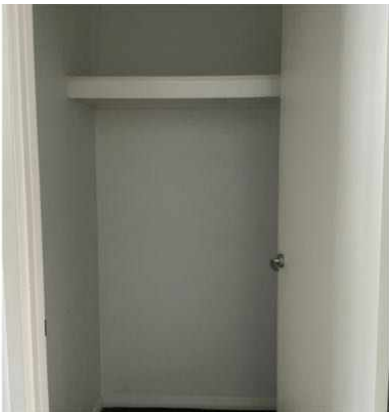
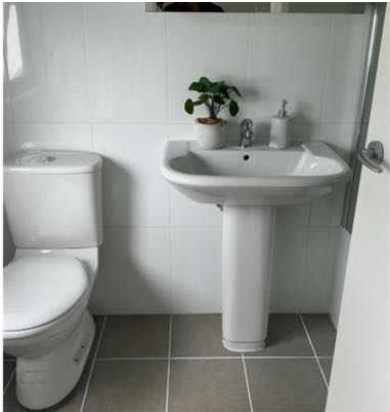
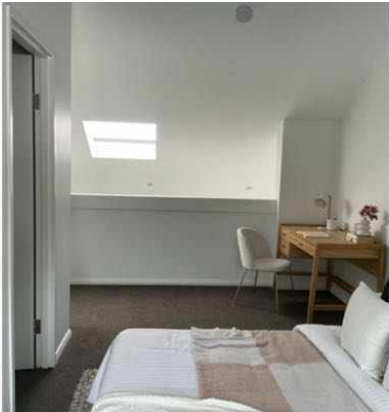
Building:	Main Building
Location:	All Internal Areas
Finding:	Additional Photos - Obstructions and Limitations
Information:	These photographs are an indication of the obstructions and limitations which impeded full inspection of the property at the time of inspection. These obstructions can hide an array of defects and should be removed to allow full inspection to be carried out. A re-inspection is recommended once the areas are made accessible.
