# Building and Timber Pest Inspection Report

Inspection Date: Mon, 16 Mar 2026

Property Address: 46 O'Farrell St, Yarraville VIC 3013,  
Australia

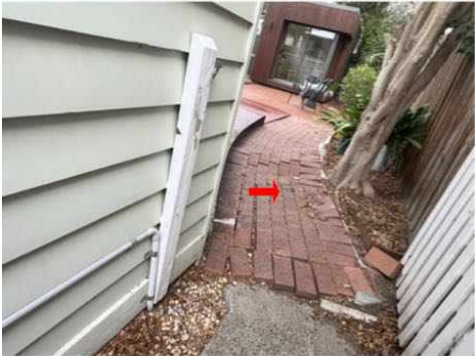
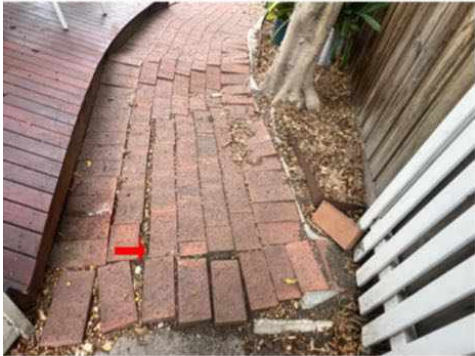
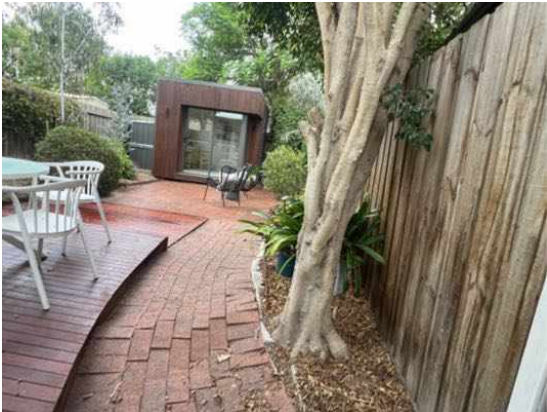
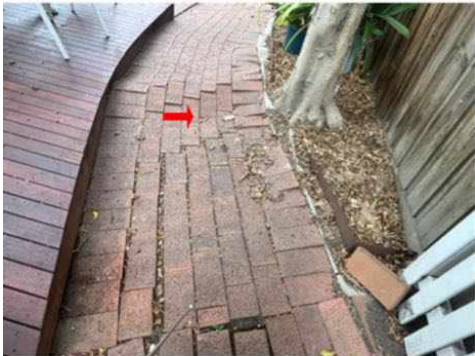
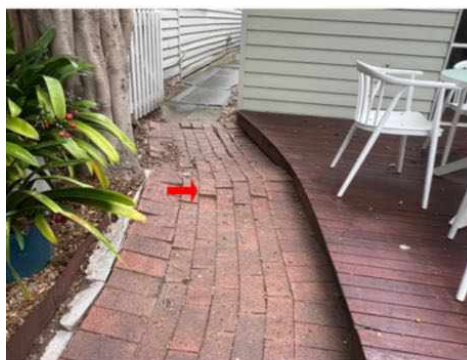
Building: Yard  
Location: Yard - Back > Rear Right  
Finding: Paving - Uneven  
Information: Sections of the external paved area are uneven, creating a potential trip hazard. It appears as though the area has been subject to rough installation, or that paving sections have lifted due to movements in the foundation of the property.

Where paving creates a trip hazard, personal injury may ensue if due caution is not taken by all persons within this area.

Re-paving of the area is required as soon as possible to remedy this situation. Further consultation with a specialist concreter is advised.

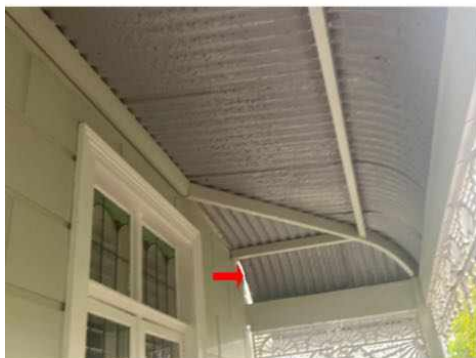
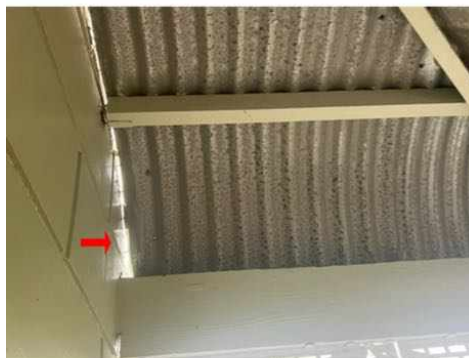
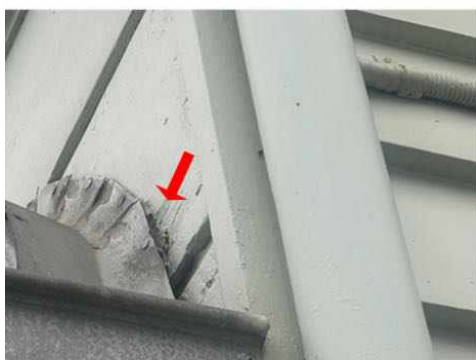
Building:	Main Building
Location:	Front Elevation > Front Right
Finding:	Roof plumbing - Flashing inadequate
Information:	Some sections of the roof are missing or have inadequate roof flashings. Flashings are metal and other materials which are applied to seals and intersections between roof coverings and building elements. They are designed to aid in weatherproofing of roof joins.

Flashings that are not installed adequately or are missing are likely to result in water penetration to the interior of the property, as well as creating excessively damp conditions against the exterior surfaces and around the base perimeter of the building.

Premature ageing and secondary building defects are imminent where roof plumbing is missing or inadequately installed. Additionally, water pooling also creates an environment that is susceptible to termite and pest infestation.

A roofing plumber should be appointed as soon as possible to install relevant roof plumbing materials, ensuring that no further damage is sustained.

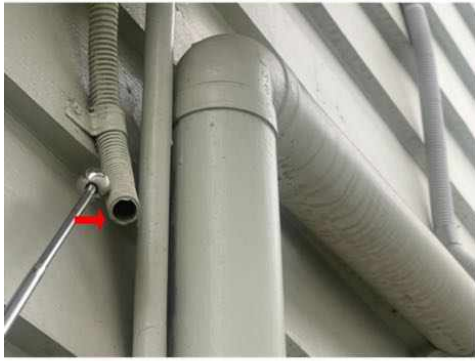
### Finding 3.02

Building:	Main Building
Location:	Exterior walls - right side > Centre
Finding:	Air conditioner - Disconnected overflow
Information:	The Air Conditioner (A/C) overflow was found to be disconnected from storm water drainage and is creating excessive moisture in the surrounding area.

Such leaking creates an environment which is conducive to an array of defects, including water damage to associated building elements and the attraction of termite or timber pest infestation.

It is highly recommended that a licensed plumber be appointed to connect the A/C overflow in order to prevent such an environment from being created. These minor works should be carried out as soon as possible.

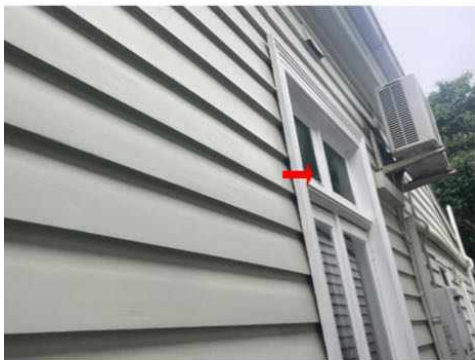
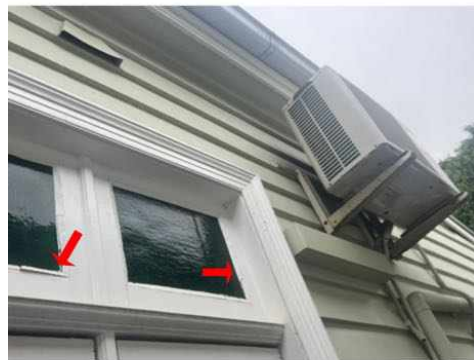
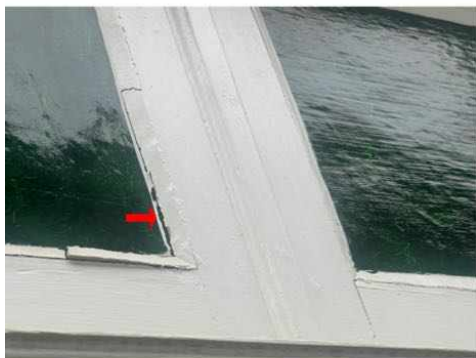
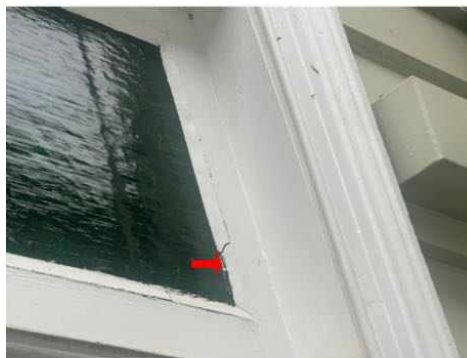
### Finding 3.03

Building:	Main Building
Location:	Exterior walls - right side > Centre
Finding:	Building element - Damaged-window -putty & frame requires attention
Information:	Breakage occurs generally when the building materials have either aged and decayed, or as a result of damage (accidental or deliberate).

Repair and/or replacement of broken elements is advised to ensure that additional secondary defects do not arise as a consequence. Such works are necessary, as all building elements play a key role in the operation and function of the overall structure and its performance.

A relevant tradesperson should be appointed to repair or replace the affected building element prior to any subsequent damage being caused.

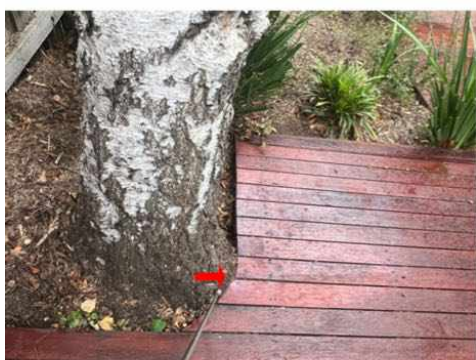
### Finding 3.04

Building:	Main Building
Location:	Deck > Rear Left
Finding:	Building element - Damaged-tree is 'lifting' decking....works required to mitigate further damage
Information:	Breakage occurs generally when the building materials have either aged and decayed, or as a result of damage (accidental or deliberate).

Repair and/or replacement of broken elements is advised to ensure that additional secondary defects do not arise as a consequence. Such works are necessary, as all building elements play a key role in the operation and function of the overall structure and its performance.

A relevant tradesperson should be appointed to repair or replace the affected building element prior to any subsequent damage being caused.

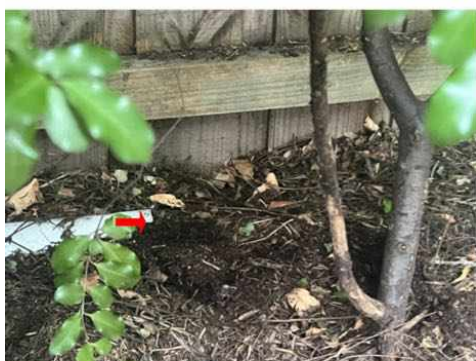
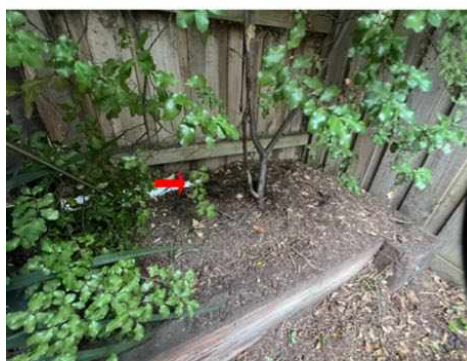
### Finding 3.05

Building:	Yard
Location:	Rear Elevation > Rear Right
Finding:	Plumbing - Point of connection non-compliant
Information:	At the time of inspection it was noted that connections between above ground pipe

Additionally, where sewer pipes are concerned, gases can escape from unsealed connections which can pose a serious health risk.

Engagement of a certified plumber is strongly recommended to ensure all connection points are sealed in accordance with the plumbing construction guidelines.

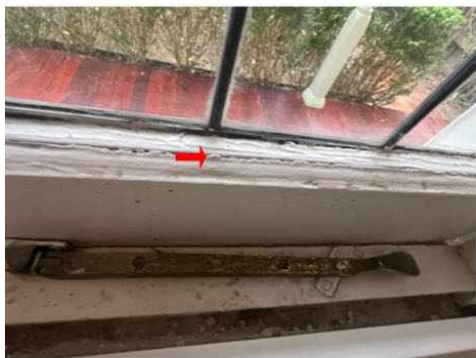
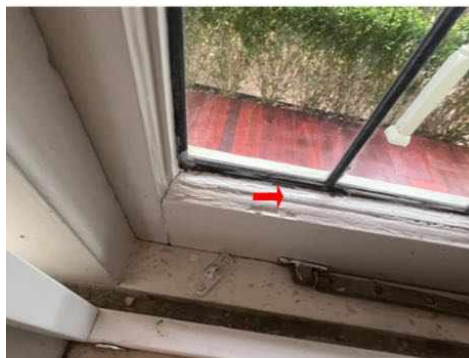
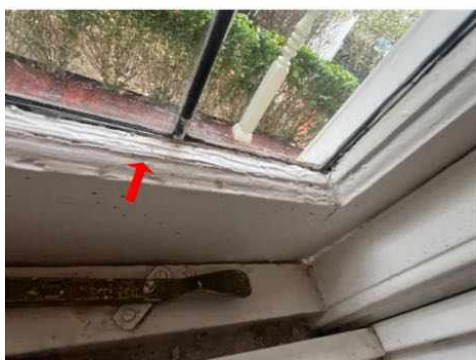
### Finding 3.06

Building:	Main Building
Location:	Bedroom > Front Right
Finding:	Building element - Damaged-window frame
Information:	Breakage occurs generally when the building materials have either aged and decayed, or as a result of damage (accidental or deliberate).

Repair and/or replacement of broken elements is advised to ensure that additional secondary defects do not arise as a consequence. Such works are necessary, as all building elements play a key role in the operation and function of the overall structure and its performance.

A relevant tradesperson should be appointed to repair or replace the affected building element prior to any subsequent damage being caused.

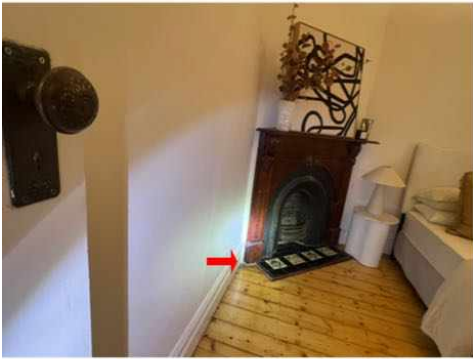
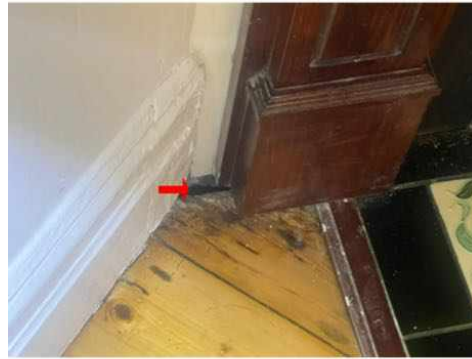
### Finding 3.07

Building:	Main Building
Location:	Bedroom > Rear Left
Finding:	Surface - Holes b/w fire place & wall & floor-gap requires sealing
Information:	Holes in surfaces are generally indicative of impact damage, whether accidental or deliberate, or a failing of the surface material.

Where holes are apparent in the surface of a building material, the surface is no longer sealed against water penetration or further impact damage, which may lead to additional damage to the surrounding surface.

Repair or replacement of the affected building element is recommended as soon as possible to ensure that any secondary defects are minimised. A qualified carpenter or general handyperson should be appointed to perform these works.

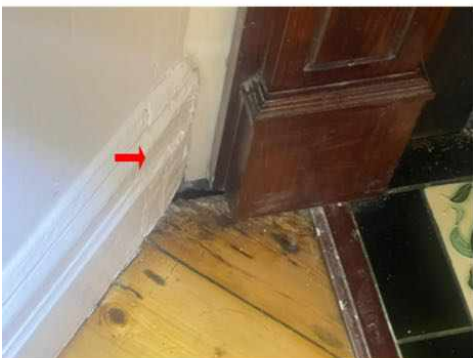
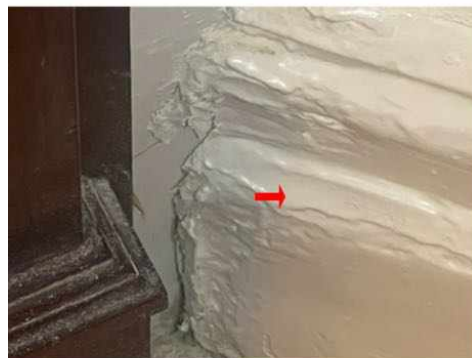
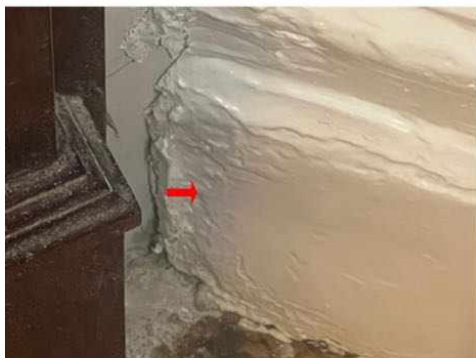
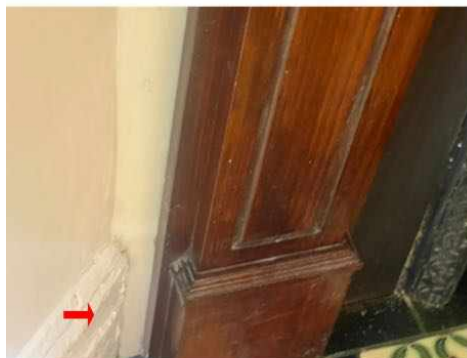
### Finding 3.08

Building:	Main Building
Location:	Bedroom > Rear Right,Rear Left
Finding:	Unconventional handyman work
Information:	This handyman work appears to have been completed to a substandard level and does not comply with regular building practices. Where handyman work is not completed satisfactorily, accelerated deterioration of the associated building elements is likely to occur and secondary defects to surrounding structures may develop.

It is highly recommended that the substandard work be rectified by professional services. Works to improve this area are likely to increase the safety and the operation of the associated building elements.

The client should exercise care when coming into the immediate vicinity of the substandard works. Rectification works are advised as soon as possible by the appropriate trades.

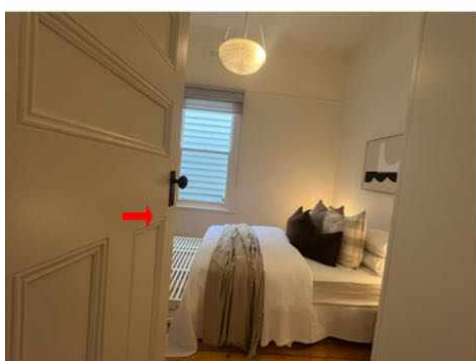
### Finding 3.09

Building:	Main Building
Location:	Bedroom 2 > Front
Finding:	Door - Binding/jamming
Information:	Binding and/or jamming of this door is evident during standard operation. This defect inhibits the functionality of the affected door as well as creating potential for secondary defects to associated building elements, such as damage to the floor covering.

A door that binds to flooring or to the associated door frame may have several causes, ranging from minor defects, such as poor installation of the door or deteriorated hinges, through to major structural issues, such as damage to subfloor structures.

Where door binding/jamming appears to indicate major structural issues, a registered builder specialising in re-stumping should be appointed to provide an estimate on the cost of rectification.

For minor causes, a qualified carpenter or general handyperson should be appointed to perform minor rectification works at client discretion.

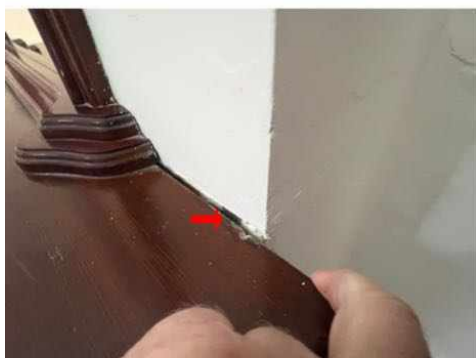
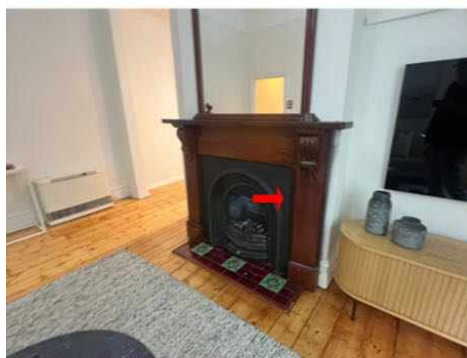
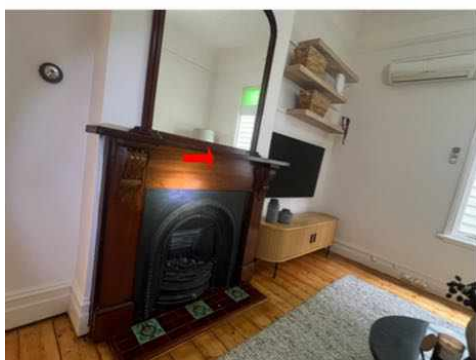
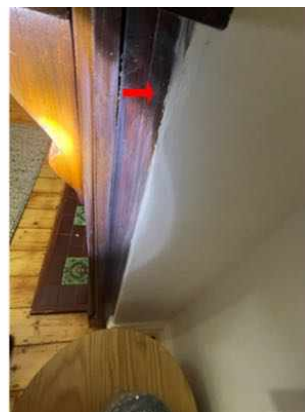
### Finding 3.10

Information: Non-operational items should be addressed to ensure that the full function of the building structure is available. Where some building elements are not operating as intended, it is possible that secondary building defects could arise due to their non-operation.

Repair and/or replacement of the faulty building element is recommended. It is highly recommended that the relevant tradesperson be engaged to perform any necessary works.

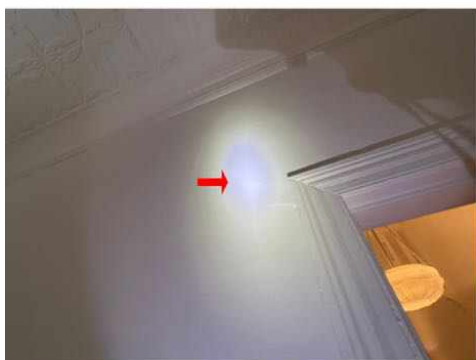
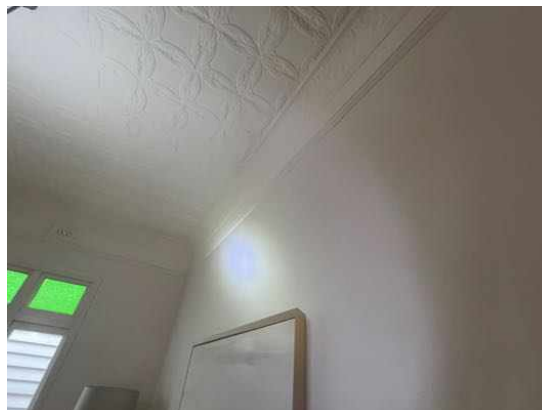
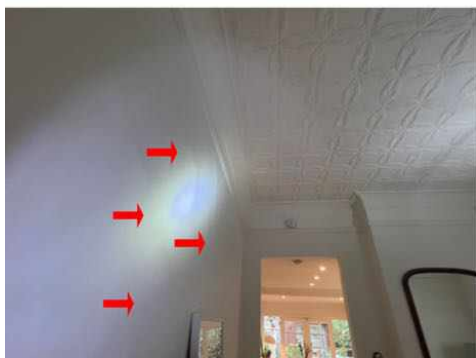
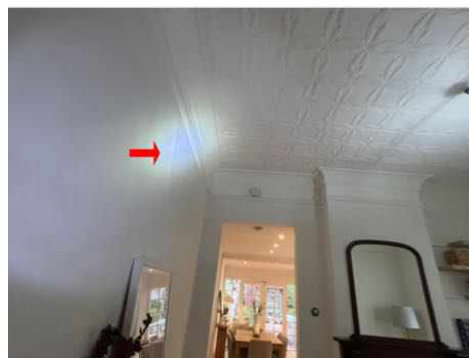
### Finding 3.11

Finding: Unconventional handyman work-poor repairs to wall noted

Information: This handyman work appears to have been completed to a substandard level and does not comply with regular building practices. Where handyman work is not completed satisfactorily, accelerated deterioration of the associated building elements is likely to occur and secondary defects to surrounding structures may develop.

It is highly recommended that the substandard work be rectified by professional services. Works to improve this area are likely to increase the safety and the operation

of the associated building elements.

The client should exercise care when coming into the immediate vicinity of the substandard works. Rectification works are advised as soon as possible by the appropriate trades.

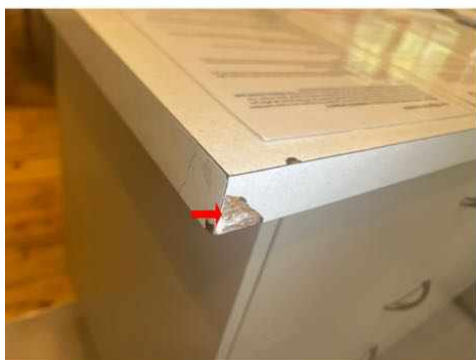
### Finding 3.12

Building:	Main Building
Location:	Kitchen > Centre
Finding:	Building element - Damaged-corner bench-laminate
Information:	Breakage occurs generally when the building materials have either aged and decayed, or as a result of damage (accidental or deliberate).

Repair and/or replacement of broken elements is advised to ensure that additional secondary defects do not arise as a consequence. Such works are necessary, as all building elements play a key role in the operation and function of the overall structure and its performance.

A relevant tradesperson should be appointed to repair or replace the affected building element prior to any subsequent damage being caused.

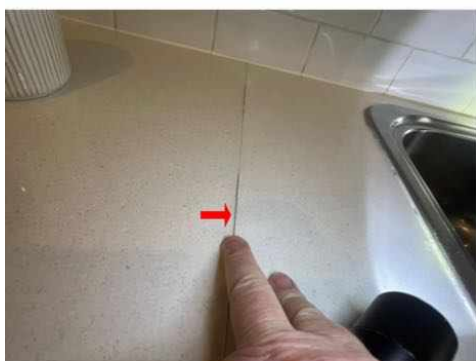
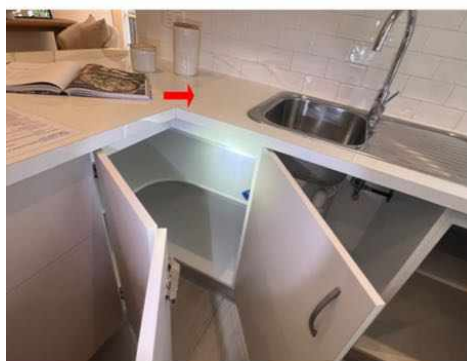
### Finding 3.13

Building:	Main Building
Location:	Kitchen > Centre, Front
Finding:	Delamination of timbers-laminate join
Information:	Delamination is one means by which composite materials (e.g. layered timber composites) may fail over time. In laminated materials, repeated cyclic stresses may lead to the formation of mini-structures of separate layers, with significant loss of mechanical toughness. Water penetration or the presence of excessive moisture also generally contributes to delamination.

Where building materials have become delaminated, they lose their structural strength, and are likely to have a variety of appearance and serviceability defects as a result.

Delamination of timbers may be repaired where the area affected is minor and/or easily accessible, by gluing and screwing layers back together. However, this is an interim repair, and where delamination has occurred, the client should plan for the replacement of affected timbers sooner than would otherwise be expected.

All timber structures affected by delamination should be replaced as soon as possible to avoid any further damage. Repair and replacement estimates should be sought from a registered builder or qualified carpenter.

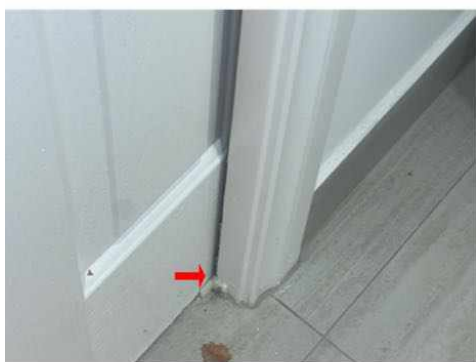
### Finding 3.14

Building:	Main Building
Location:	Bathroom > Front
Finding:	Building element - Missing-sliding door guide requires installation
Information:	Although some building elements may seem irrelevant or unnecessary, all building elements play a key role in the operation and function of the overall structure and its performance.

Replacement of any missing building element should be conducted as soon as possible to ensure that no damage or functional issues occur to associated building materials.

The appropriate tradesperson should be appointed as soon as possible to replace the missing building element.

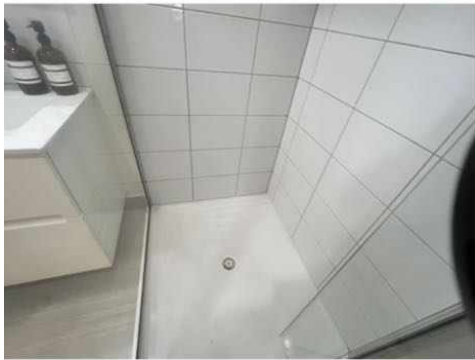
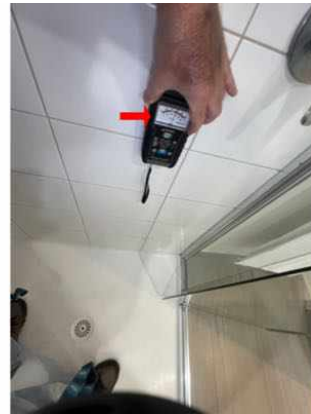
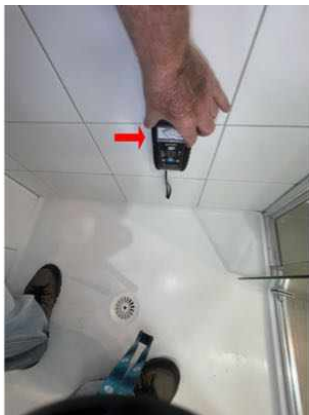
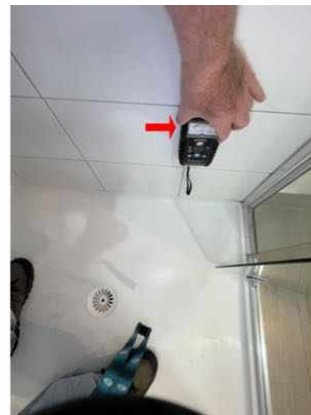
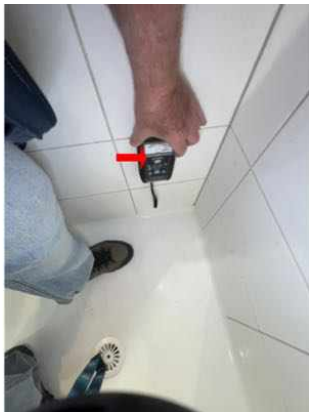
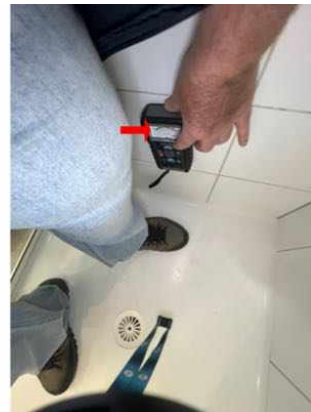
Building:	Main Building
Location:	Bathroom > Front Right
Finding:	Shower - Damp
Information:	Damp is evident to the lower 300mm + of wall to the shower alcove. This defect is quite common, and is suspected to have been caused by moisture permeating through the grouting in this area, which shows evidence of deterioration. Leaking pipes within the adjoining wall is also a possible cause.

Damp (or structural damp) refers to the presence of unwanted moisture in the structure of a building, either as the result of intrusion from outside, or condensation from within the structure. In the shower area, internal water leaks or other sources of excessive moisture are generally the cause of damp.

Unmanaged damp in the shower recess is likely to facilitate the formation and development of mould and fungi growth, decaying associated building materials and compromising their structural integrity. It is important to address damp conditions, as the World Health Organisation notes that excess moisture leads - on almost all indoor materials - to growth of microbes such as moulds, fungi and bacteria, which

Consultation with a qualified plumber or bathroom specialist is advised immediately to identify the cause of damp and to perform remedial works as required. Where excessive mould growth is present, further inspection by a specialist environmental health inspector should also be considered.

Always ensure that sealant and grout is in good condition to prevent any moisture issues occurring in the future.

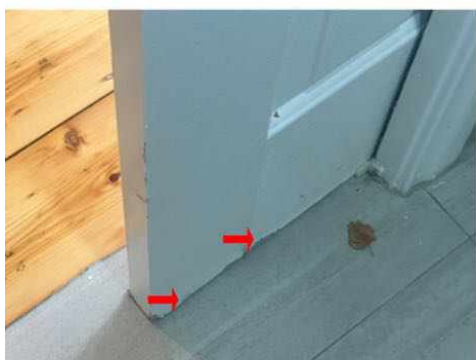
Finding 3.16

Building:	Main Building
Location:	Bathroom > Front
Finding:	Building element - Swollen
Information:	Swollen building elements generally indicate that the building materials have been affected by excessive moisture over a prolonged period of time, and have swollen as a result. The formation and development of mould/fungi or mildew is also a likely consequence of excessive moisture, which may pose major respiratory issues for occupants, particularly the elderly, the very young and those with existing illnesses and could be potential health safety hazards. In these cases an appropriately qualified inspector/tester should also be contacted for advice and/or technical assistance.

The structural integrity of swollen building elements can not be guaranteed, and further damage is likely to develop if left unmanaged. Excessive moisture is likely to lead to the development of secondary damage to any associated building elements, which may necessitate major repair works if prolonged.

Rectification of the cause of the water leak should be addressed prior to any remedial works to the swollen building elements. A licensed plumber should be appointed immediately to identify the cause of the leak and provide advice on remedial works as necessary, Repair and/or replacement of swollen building elements should be conducted as a matter of urgency by a registered builder or qualified carpenter.

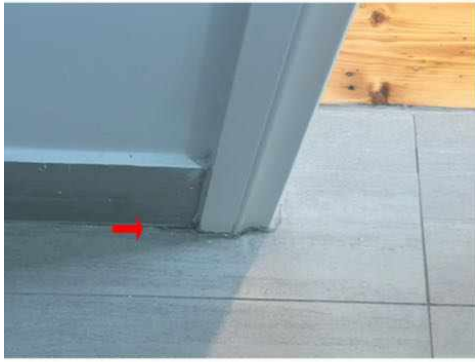
### Finding 3.17

Building:	Main Building
Location:	Bathroom > All Areas, Centre Right
Finding:	Grout - Missing
Information:	Grout is missing in this area. Grout is used to protect gaps and crevices in building materials to ensure that they are water-tight and prevent water penetration to the associated structures.

Where grout is missing, a tiling contractor should be appointed immediately to apply grout and re-apply any silicone where necessary. Failure to do so is likely to lead to water damage to the surrounding area.

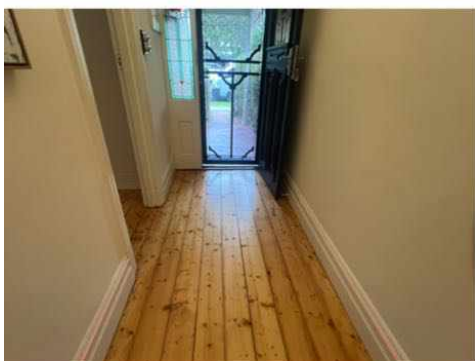
### Finding 3.18

Information: The internal flooring in this area is out of level and uneven. Uneven flooring is likely to indicate minor defects such as expected movement of the foundations of the property, but may also indicate subsidence of the associated subfloor stumps.

It is advised that the flooring be closely monitored to identify any further movement. Where flooring remains relatively unchanged for an extended period of time (i.e. several months), it is likely that this defect has been caused by expected movement of the foundations of the property.

However, where flooring is uneven further, potentially invasive inspection of the subfloor structures and stumps in this area is required. In this case, works to repair are likely to be required, and would be carried out by a registered builder specialising in re-stumping.

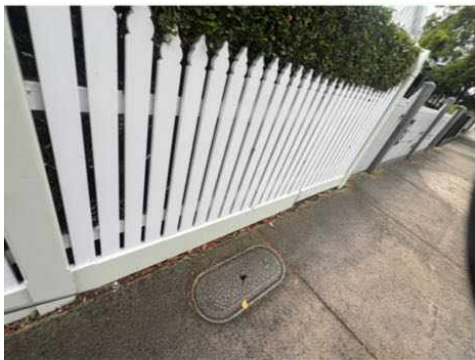
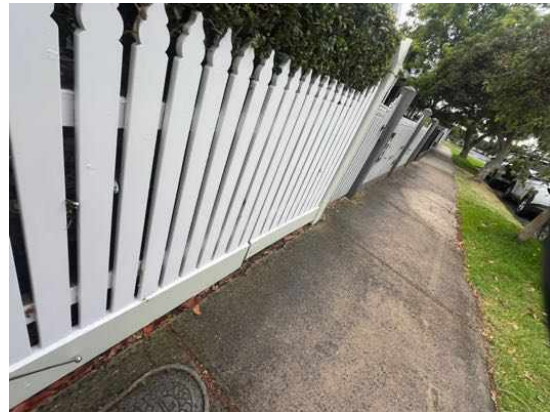
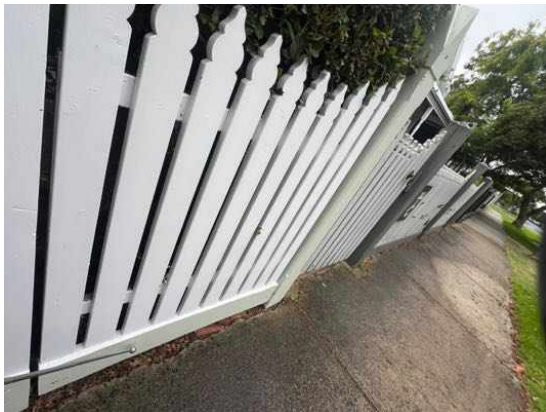
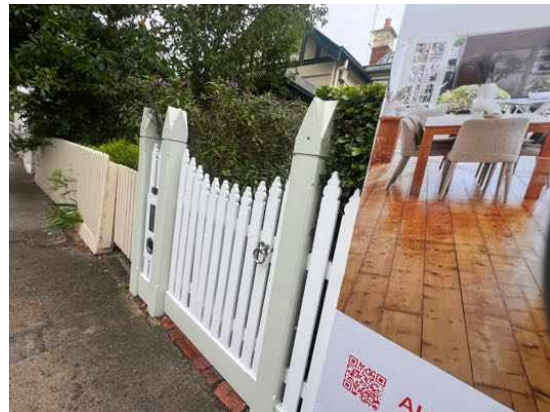
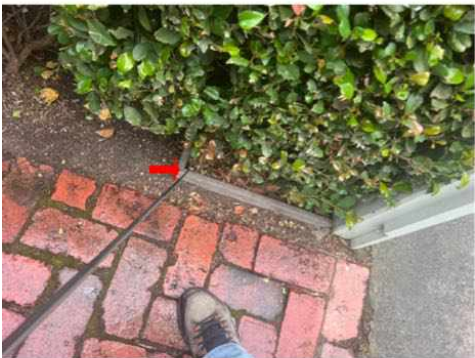
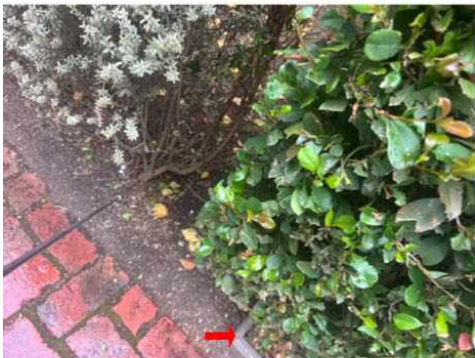
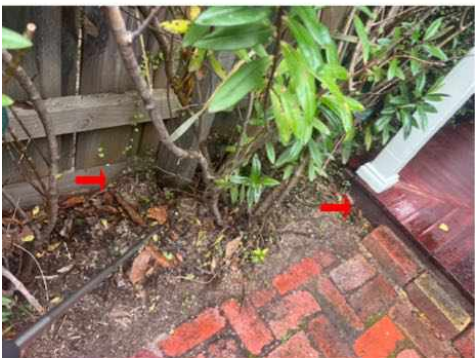
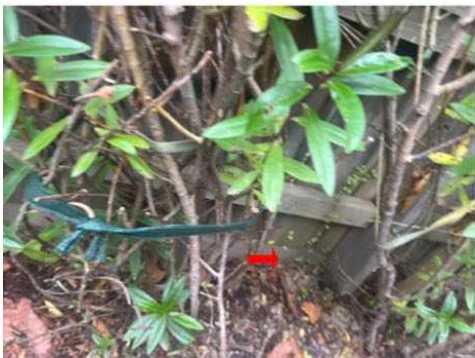
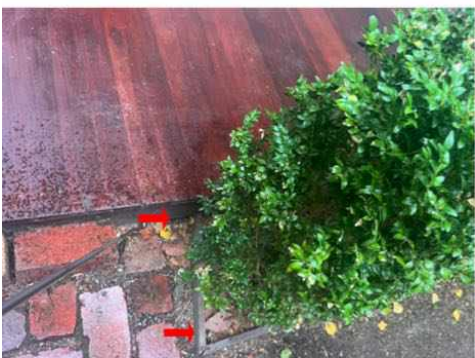
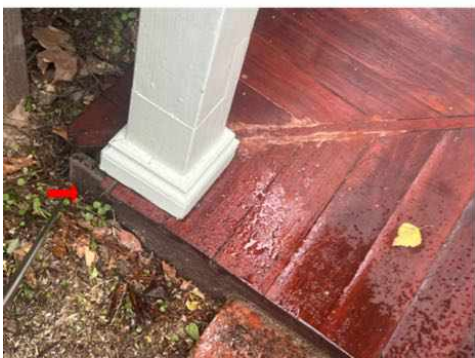
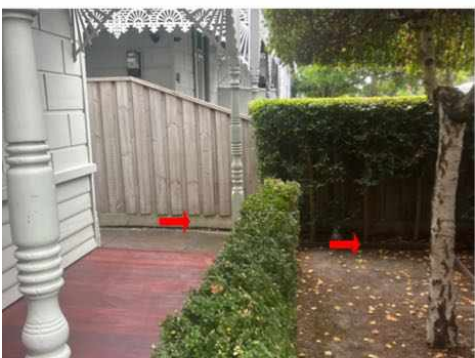
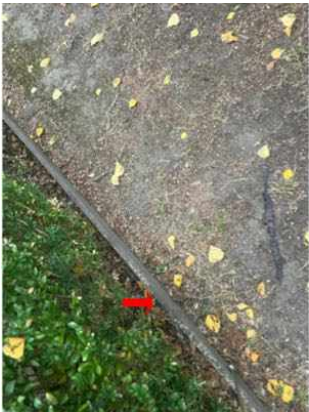
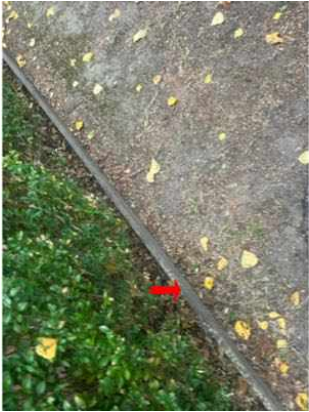
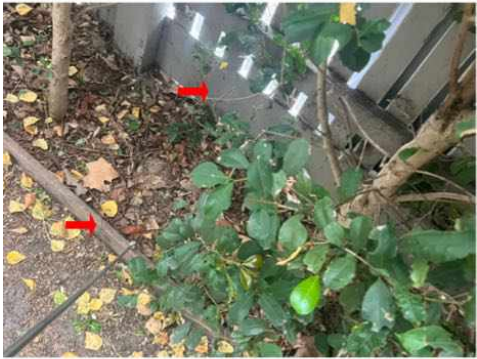
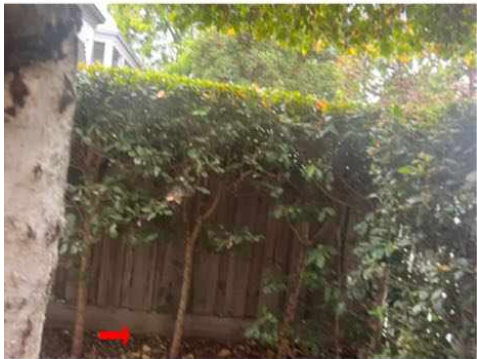
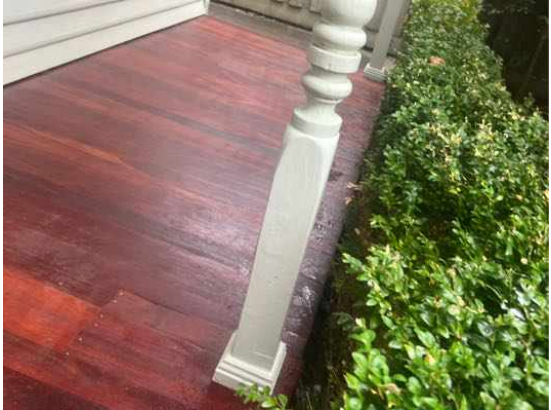
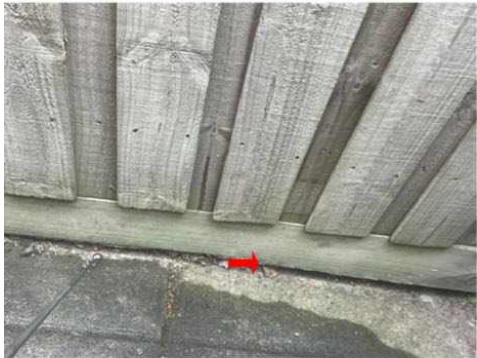
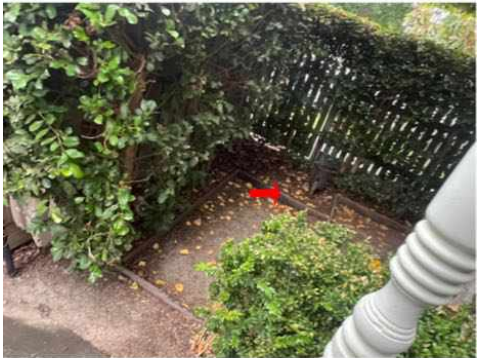
Building: Yard  
Location: Yard - Front > All Areas  
Finding: Building materials in direct ground contact - conducive to termites  
Information: Where timber elements are in direct contact with the ground and consequently moisture or dampness they become conducive to termite activity. Whether timber is used as a building element part of a fencing structure or stored as an unused item they can provide an environment that is attractive to termite infestation.

When met with excessive moisture timber begins to decay and develop wood rot. Any timbers that are in direct contact with external grounds especially if left untreated or non-durable also provide ingress for subterranean termites into that particular element.

The removal of any such materials that may be conducive to termite activity should be removed as soon as possible to minimise the risk of termite attack.

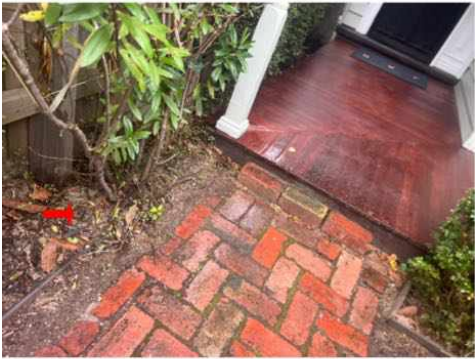
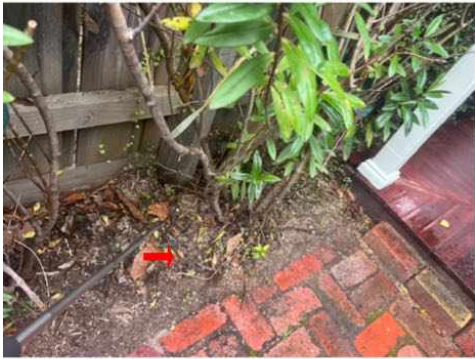
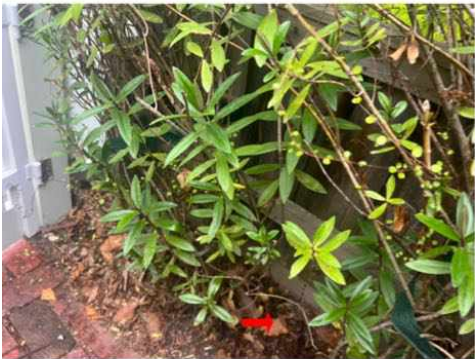
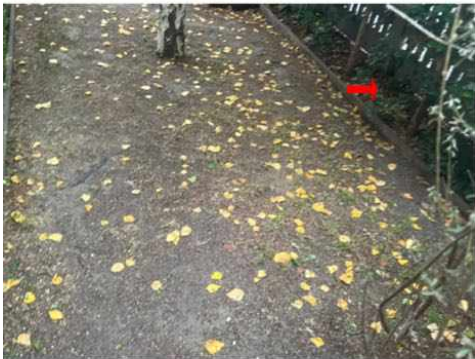
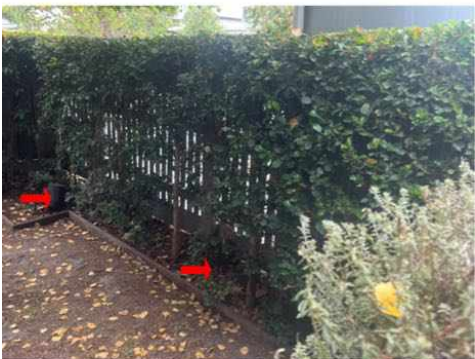
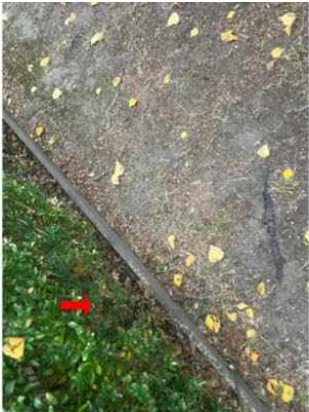
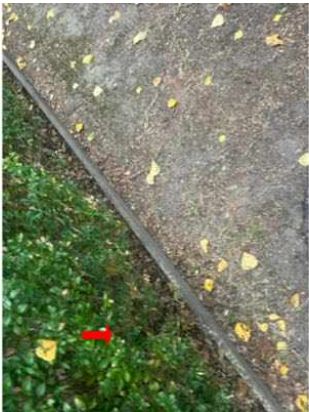
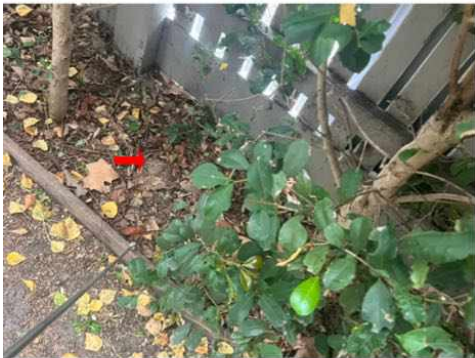
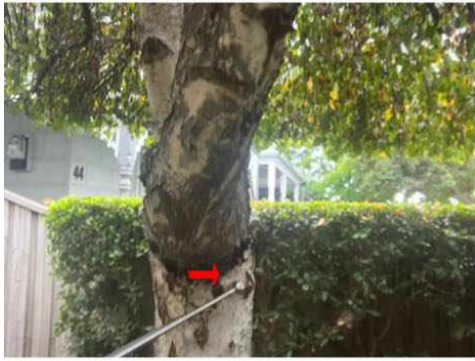
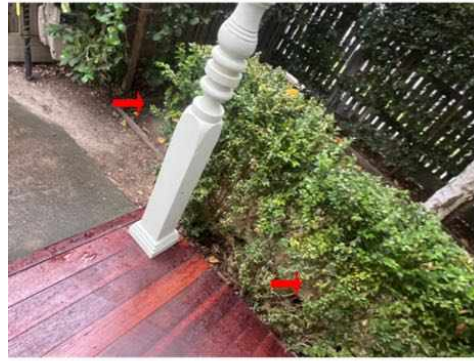
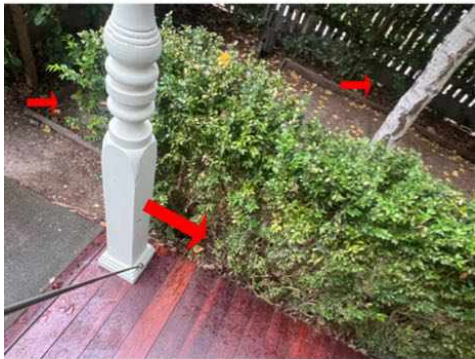
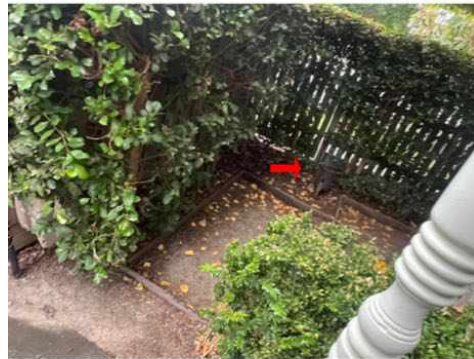
**Finding 6.02**

Building: Main Building  
 Location: Front Elevation > All Areas  
 Finding: Garden Beds - Conditions Conducive to Termites  
 Information: Garden beds were found to be evident in the garden area. These garden beds can include untreated timber, and with a combination of moisture from watering hosing can make conditions conducive to termite activity and termite ingress.

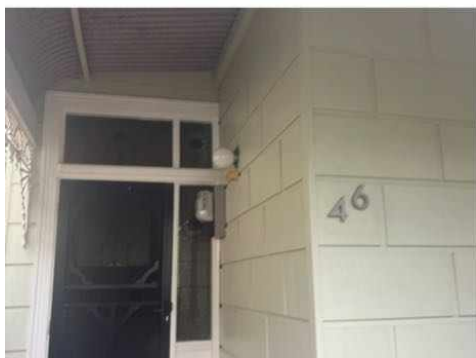
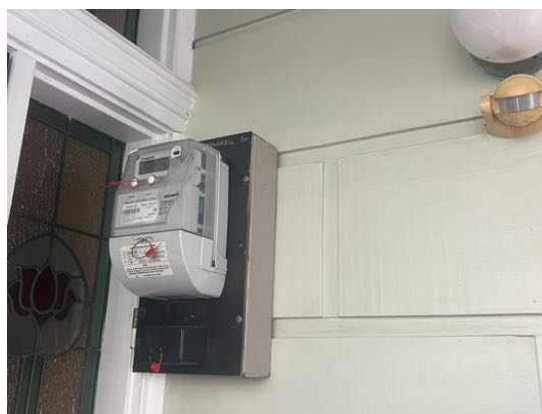
### Finding 6.03

Building: Main Building  
 Location: Front Elevation > Front Left  
 Finding: Timber Pest-meterbox no durable notice-found  
 Information: Meter Box

The application of a post-construction chemical termite barrier is highly recommended for all

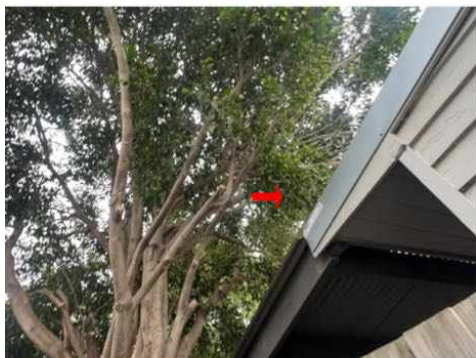
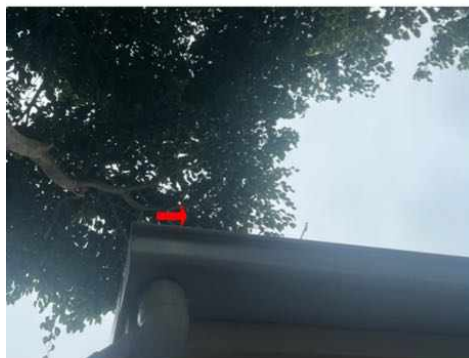
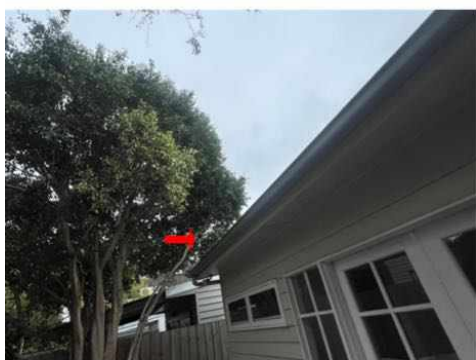
#### Finding 6.04

Building:	Yard
Location:	Yard - Side > Rear Right
Finding:	Bridging - Vegetation
Information:	Where vegetation obstructs inspection of building elements, also known as bridging as it provides a bridging point for the access of termites, full inspection can not be achieved. Consequently moisture or dampness may be present and the areas becomes conducive to termite activity. Plants against or very close to buildings provide cover, shade and can provide an environment that is attractive to termite infestation.

The removal and replanting of species that do not provide "cover" or cutting back of existing vegetation will assist greatly in preventing Bridging from occurring.

The removal of any such materials that may be conducive to termite activity should be carried out as soon as possible and arrange re inspection to minimize the risk of termite attack.

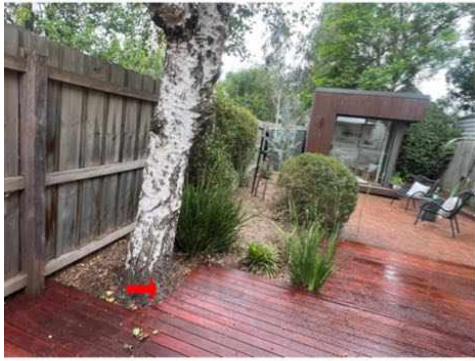
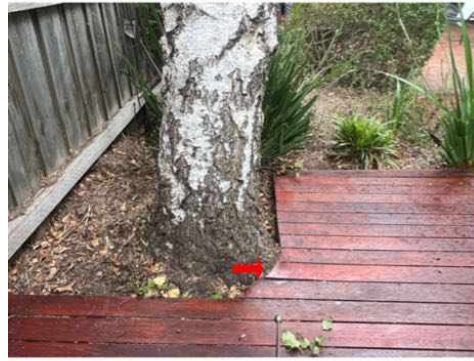
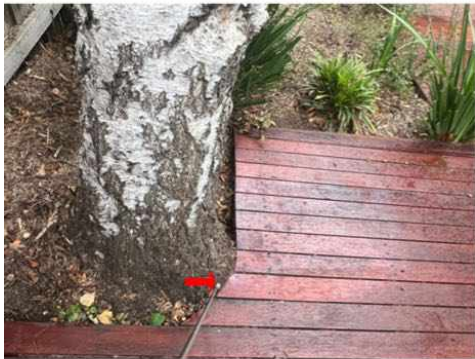
### Finding 6.05

Building:	Main Building
Location:	Deck > Rear Left
Finding:	Pest -Attachments to buildings-structures-EG steps, verandahs, porches, carports, trellises, decks-down pipes-
Information:	5.4.3 Attachments to buildings Attachments to buildings such as downpipes and service pipes mounted on external walls shall have a nominal gap, which provides clear and uninterrupted visual inspection across the inspection zone. Structures such as steps, verandahs, porches, access ramps, carports, trellises, decks, hot- water systems, air-conditioners, or similar, which are not provided with a termite management system in accordance with AS 3660.1, shall be separated from the building by gap of at least 25 mm, to allow clear and uninterrupted visual inspection across the inspection zone.

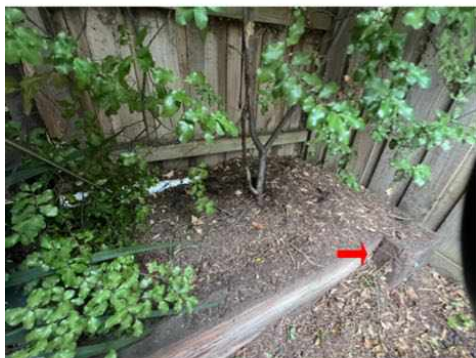
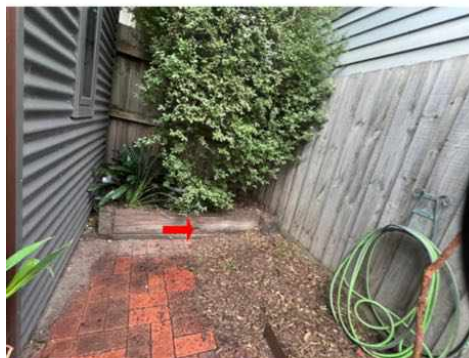
### Finding 6.06

Building:	Yard
Location:	Rear Elevation > Rear Right
Finding:	Building materials in direct ground contact - conducive to termites
Information:	Where timber elements are in direct contact with the ground and consequently moisture or dampness they become conducive to termite activity. Whether timber is used as a building element part of a fencing structure or stored as an unused item they can provide an environment that is attractive to termite infestation.

When met with excessive moisture timber begins to decay and develop wood rot. Any timbers that are in direct contact with external grounds especially if left untreated or non-durable also provide ingress for subterranean termites into that particular element.

The removal of any such materials that may be conducive to termite activity should be removed as soon as possible to minimise the risk of termite attack.

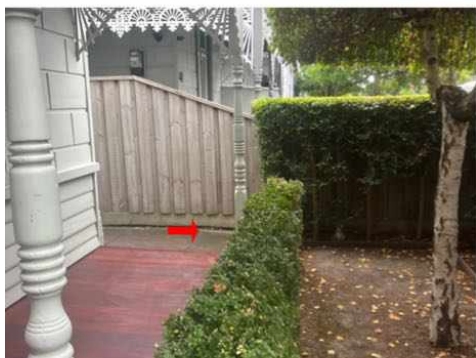
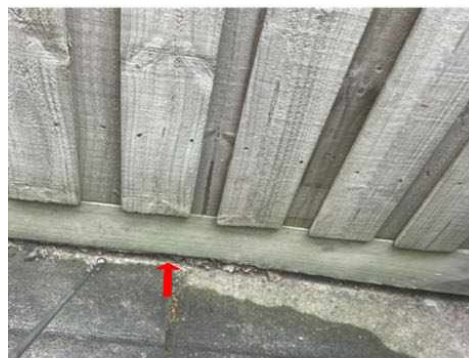
### Finding 7.01

Location: Front Elevation > Front Right  
 Finding: Fungal decay - present (localised)-boundary fence -plinth board  
 Information: Fungal decay also known as wood decay or wood rot generally refers to the deterioration of timber elements when in contact with excessive levels of moisture for a prolonged period of time.

The development of fungal decay is accelerated by temperatures in the range of 5degreeC to 40degreeC as well as the presence of oxygen. Generally fungal decay develops on timber elements that are in use in an external environment which are exposed to rain penetration.

In this case although the affected timber element is in a decaying state the extent of any visible damage appears to be localised to a specific area and is yet to spread to other parts of the building element or affect adjoining structures. The fungal decay is therefore likely to be of a relatively superficial nature with minimal impact on the structural integrity or tensile strength of the timber element.

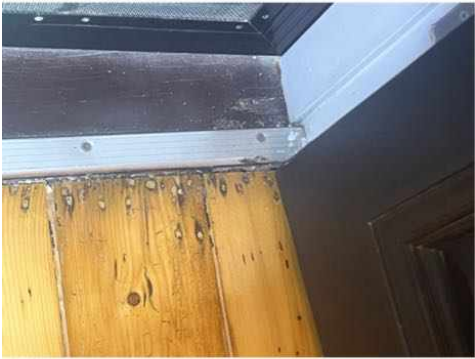
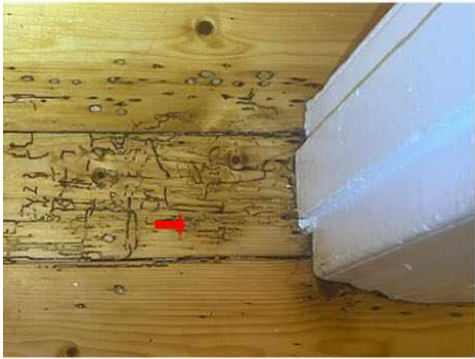
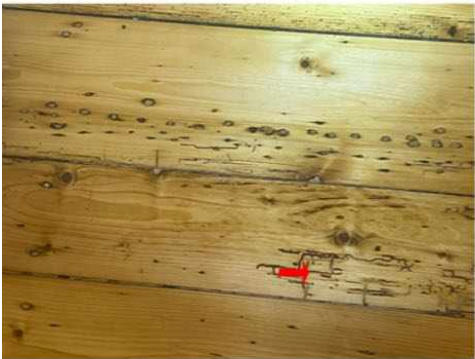
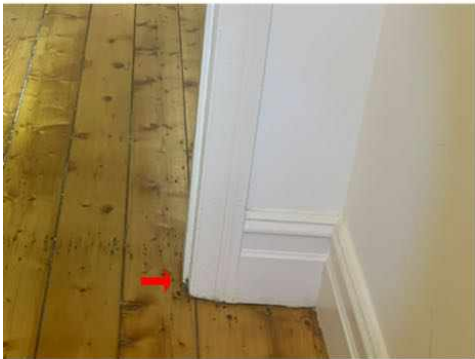
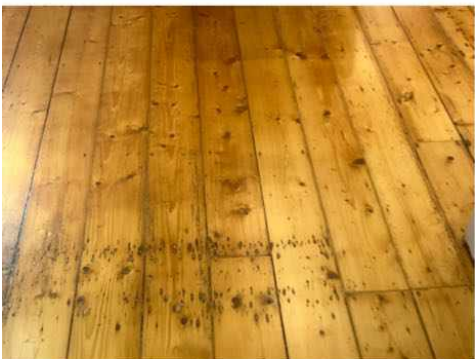
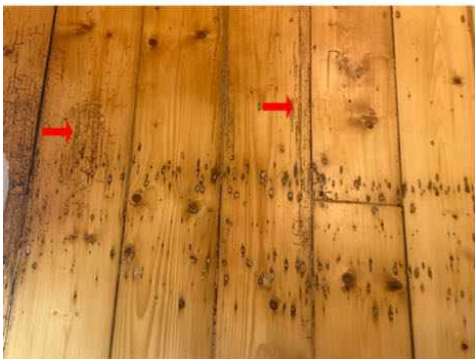
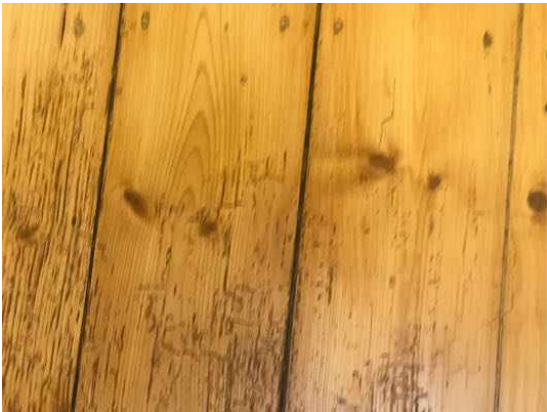
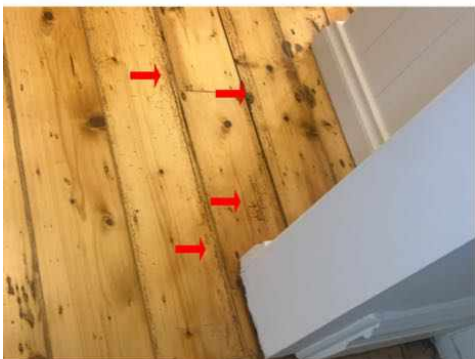
### Finding 8.01

Building: Main Building  
 Location: All Areas > All Areas  
 Finding: Lyctus Borer - damage identified-to timber flooring throughout the dwelling  
 Information: It is suspected that timber which has been affected by lyctus borer attack has been used in construction. Whilst the client should have this finding confirmed by a timber pest inspector the timber if it is affected would be considered defective unless otherwise approved by the manufacturer.
