# Building and Timber Pest Inspection Report

Inspection Date: Mon, 16 Mar 2026

Property Address: 46 O'Farrell St, Yarraville VIC 3013,  
Australia

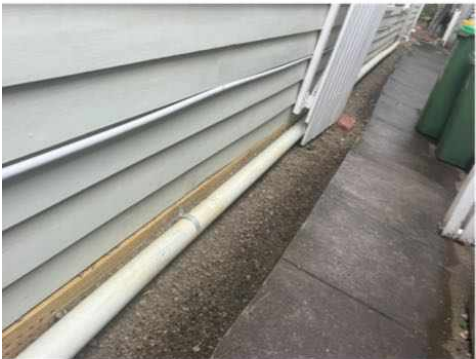
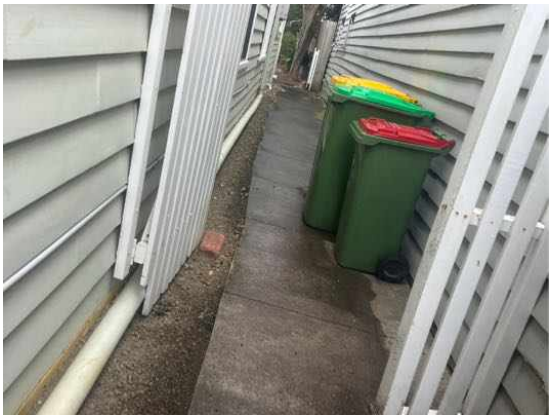
Building: Main Building  
Location: Exterior walls - right side > All Areas  
Finding: Additional Photos - Obstructions and Limitations  
Information: These photographs are an indication of the obstructions and limitations which impeded full inspection of the property at the time of inspection. These obstructions can hide an array of defects and should be removed to allow full inspection to be carried out. A re-inspection is recommended once the areas are made accessible.

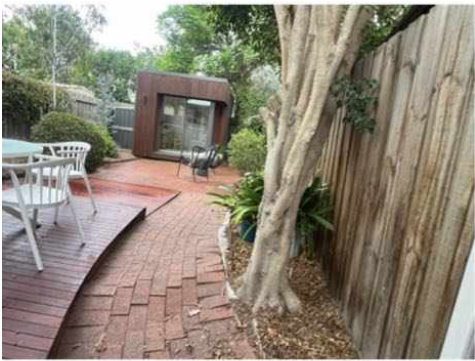
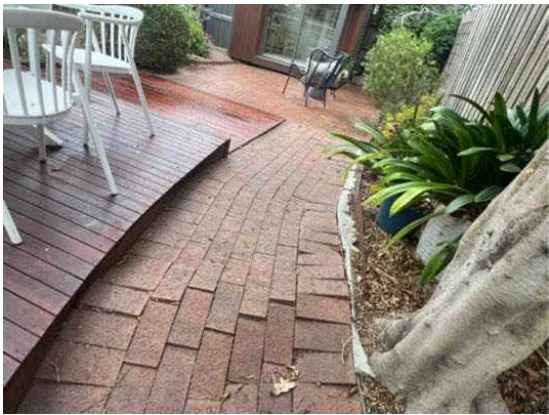
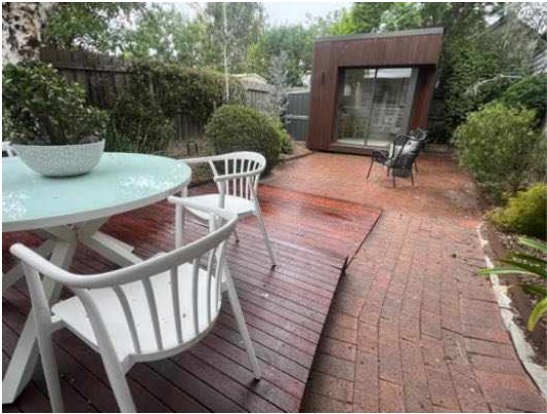
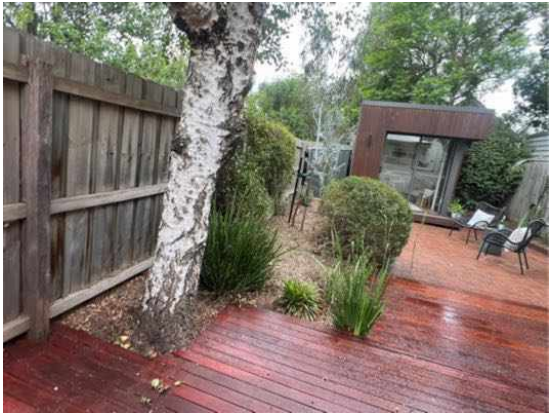
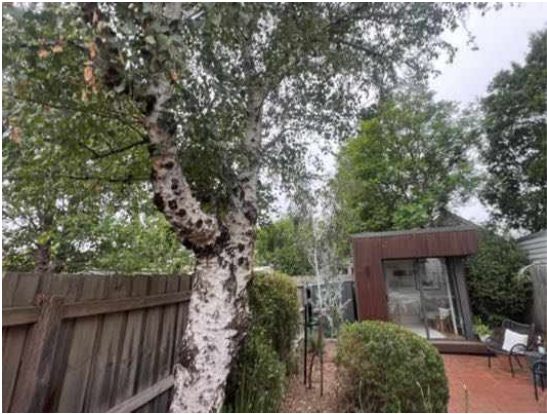
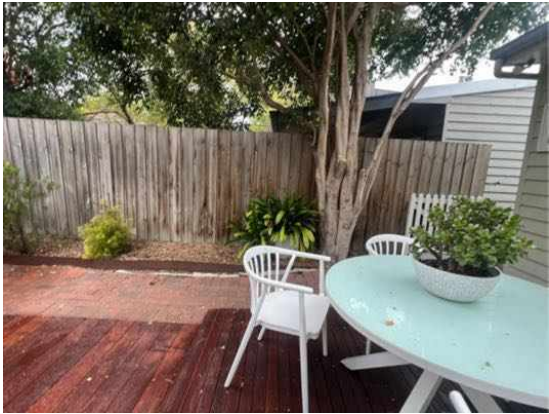
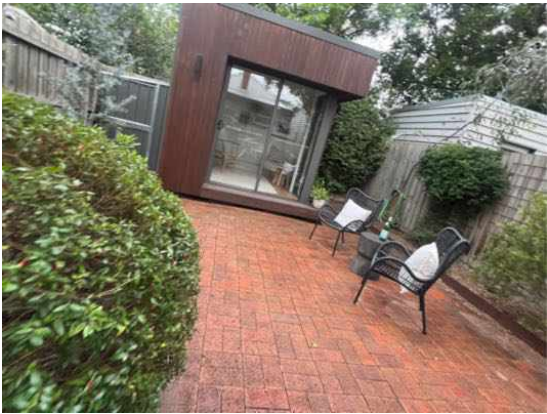
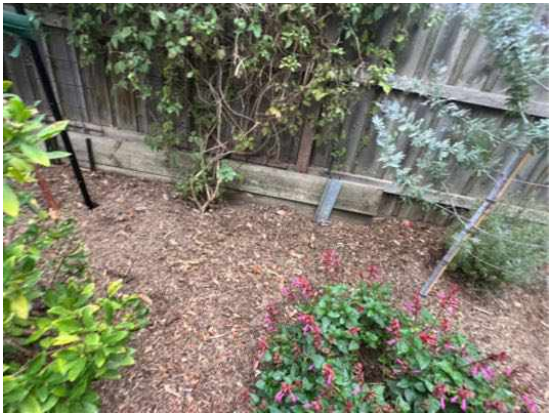
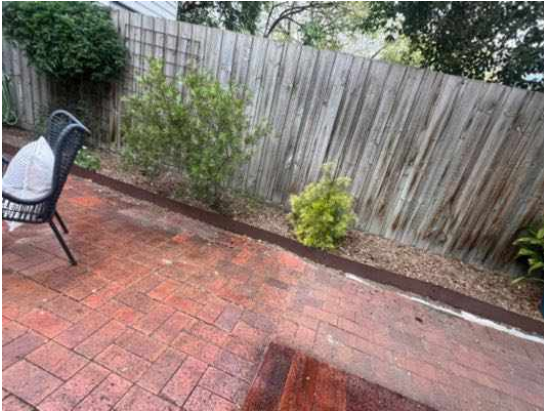
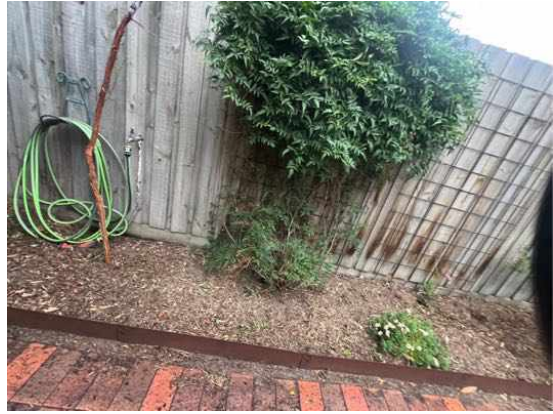
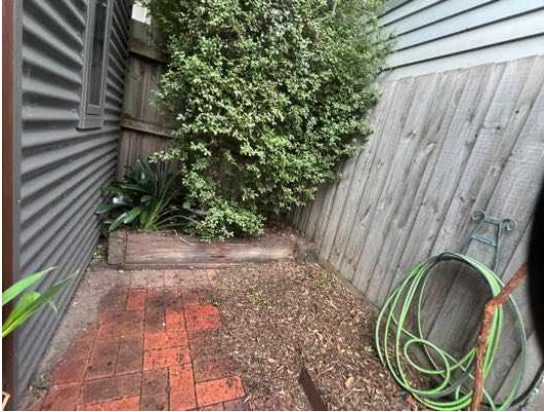
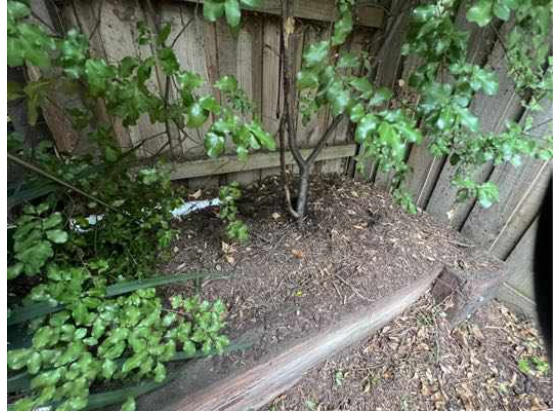
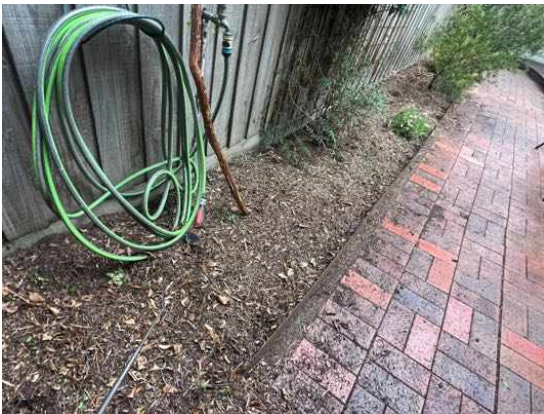
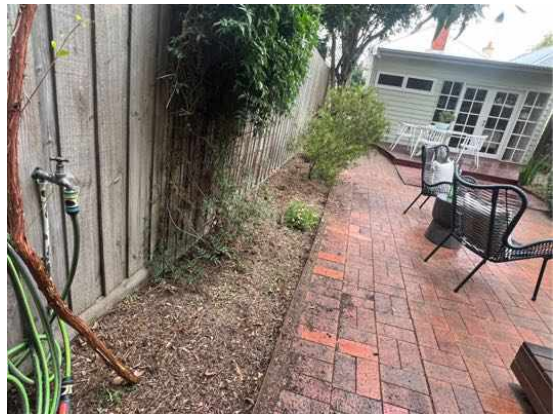
Building: Yard  
Location: Yard - Back > All Areas  
Finding: Additional Photos  
Information: Additional photos are provided for your general reference

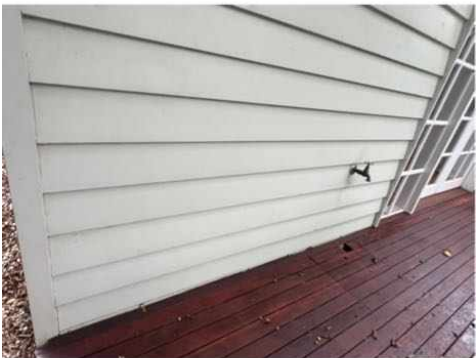
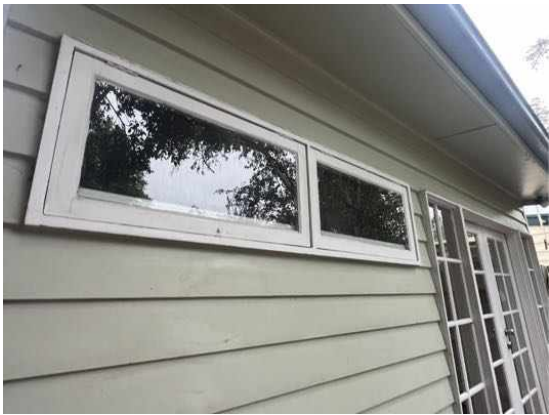
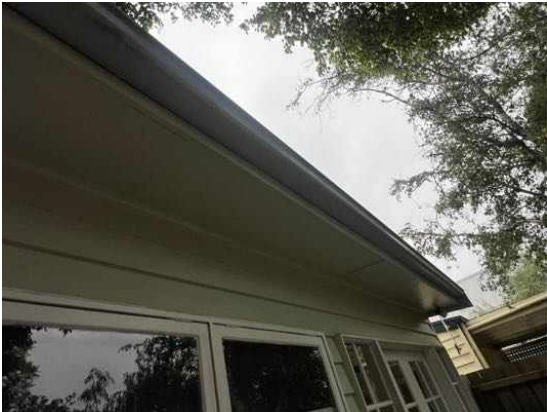
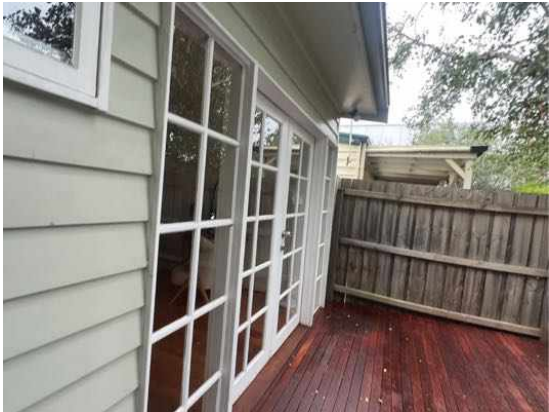
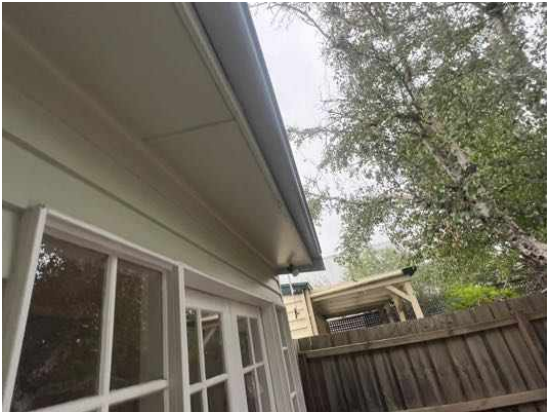
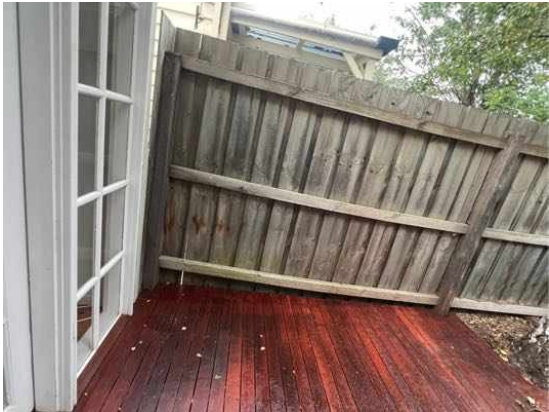
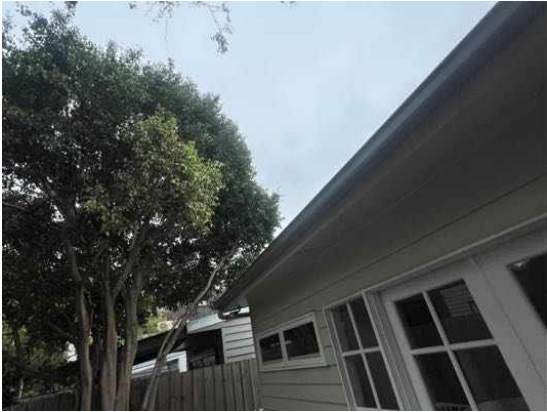
Building: Main Building  
Location: Rear Elevation > All Areas  
Finding: Additional Photos  
Information: Additional photos are provided for your general reference

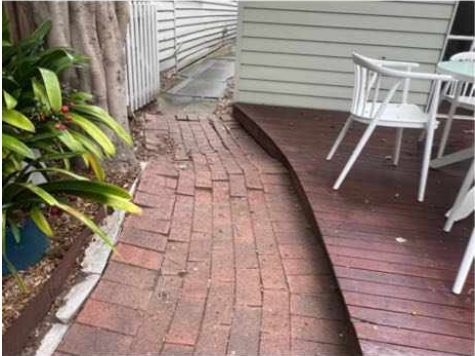
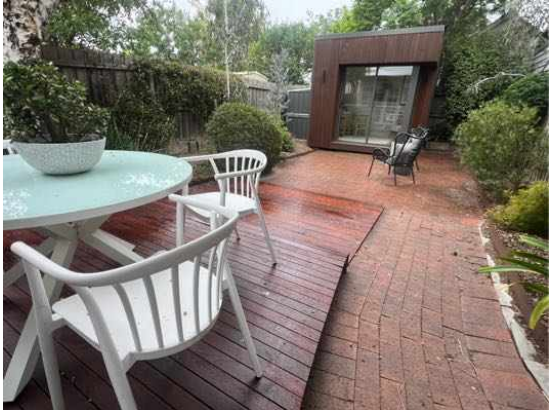
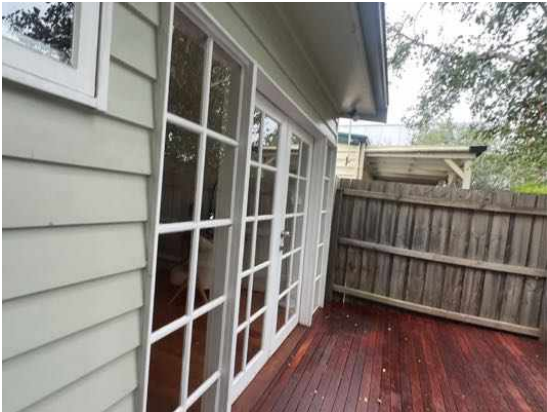
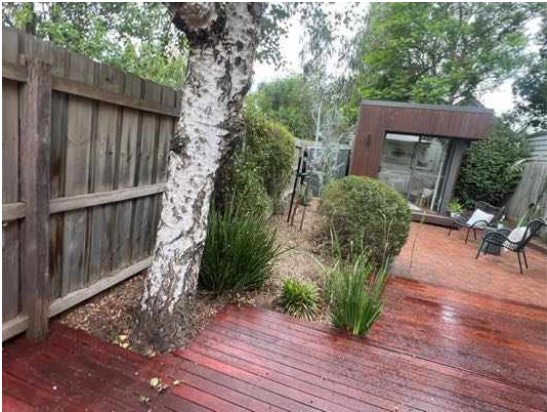
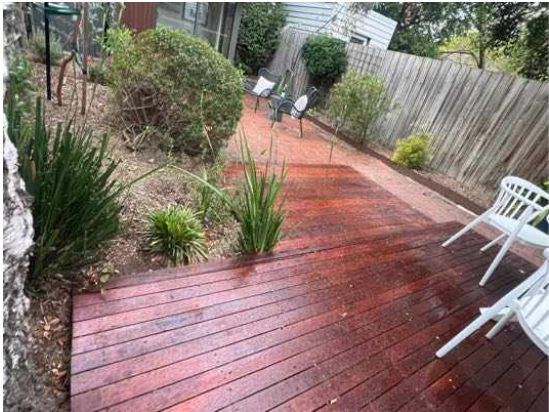
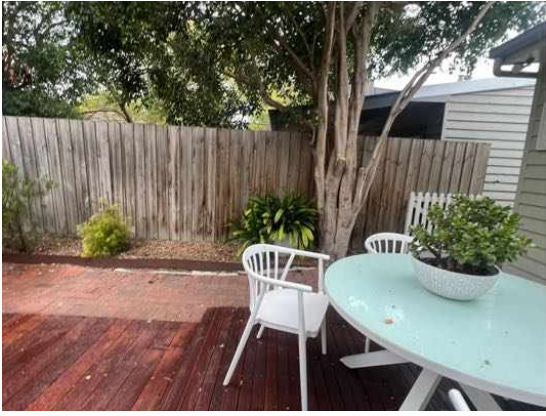
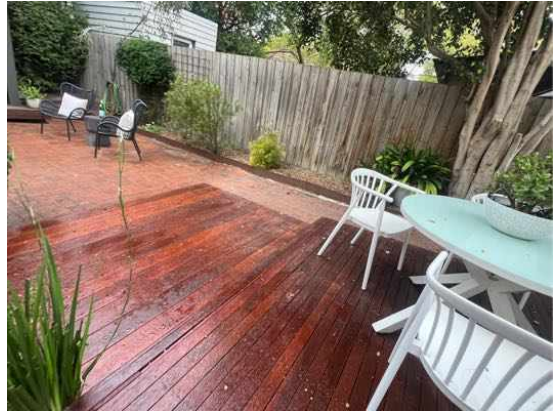
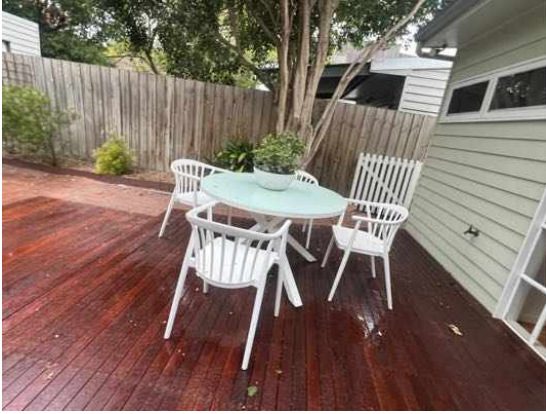
Building: Main Building  
Location: Deck > All Areas, Centre  
Finding: Additional Photos  
Information: Additional photos are provided for your general reference

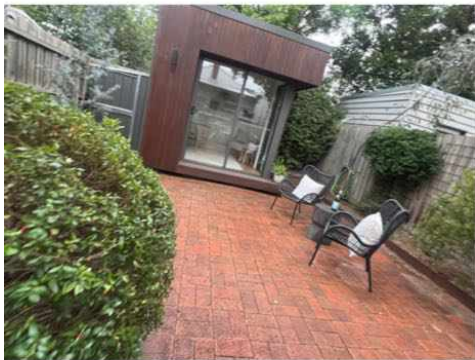
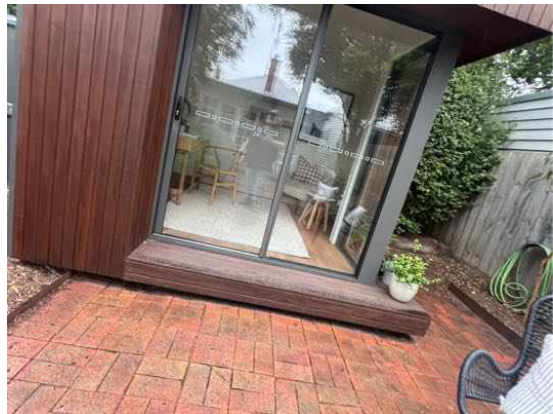
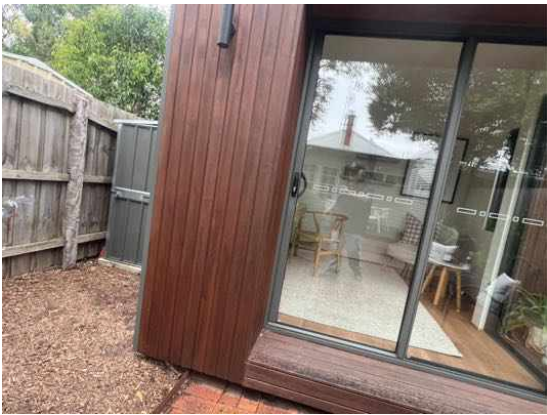
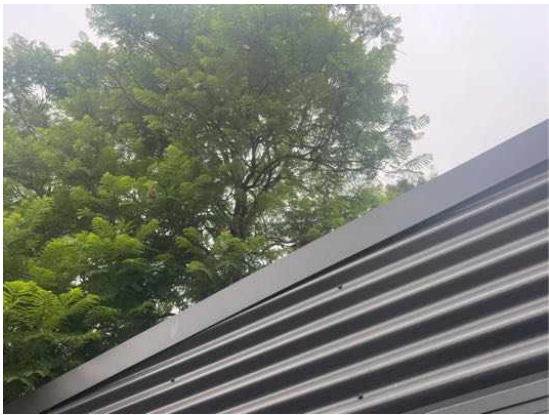
Building: Out Building  
Location: Front Elevation > All Areas  
Finding: Additional Photos  
Information: Additional photos are provided for your general reference

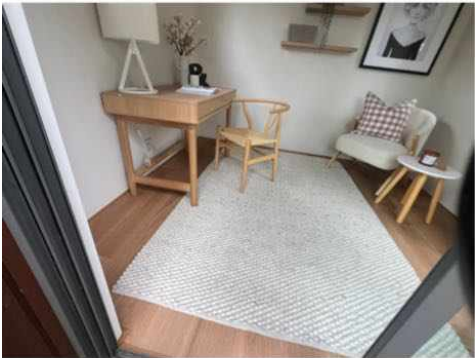
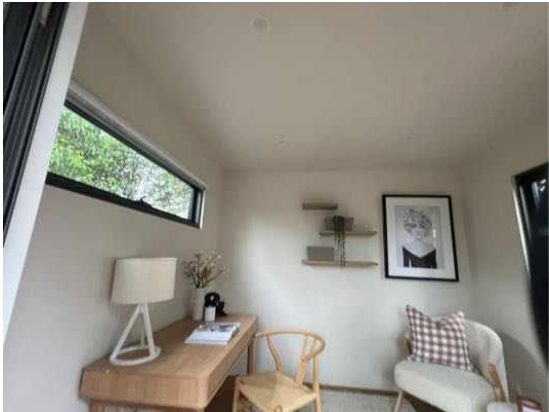
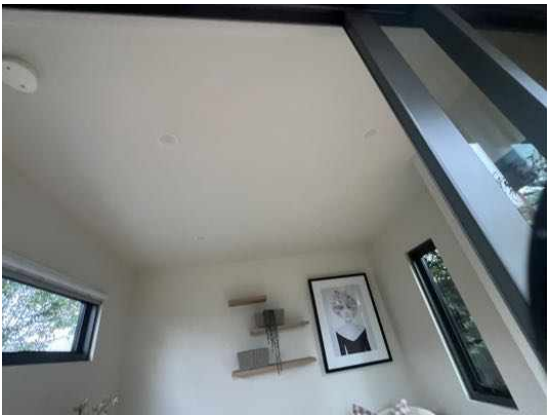
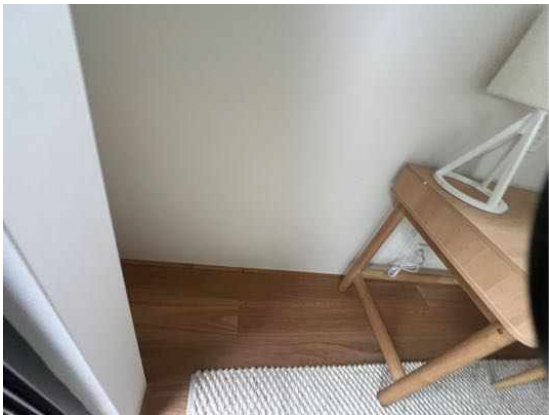
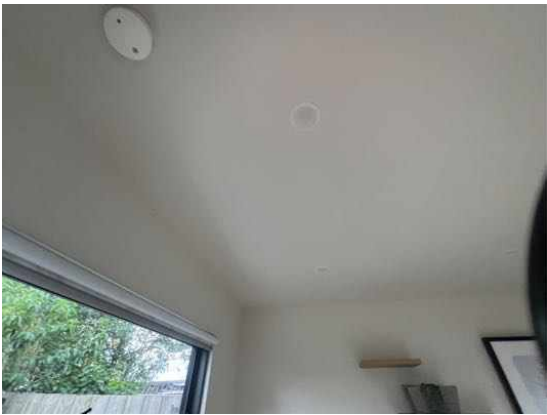
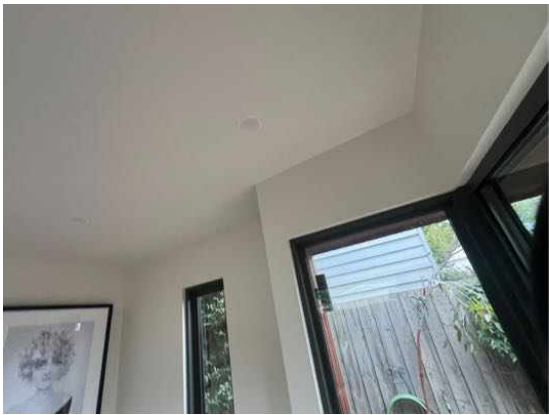
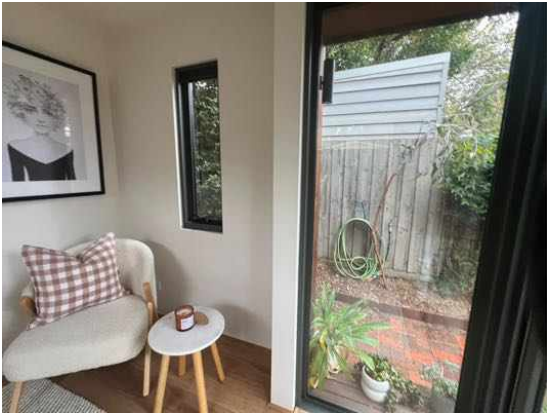
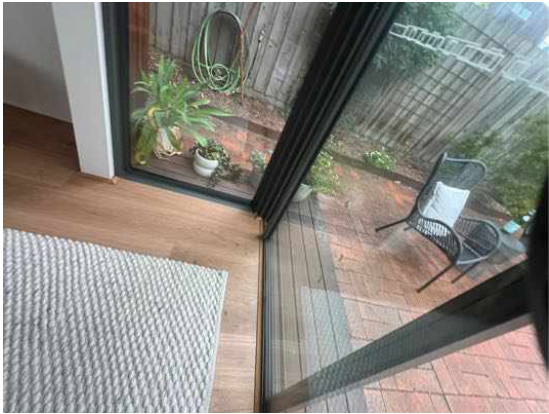
Building: Out Building  
 Location: All Areas > Centre, All Areas  
 Finding: Additional Photos - Obstructions and Limitations  
 Information: These photographs are an indication of the obstructions and limitations which impeded full inspection of the property at the time of inspection. These obstructions can hide an array of defects and should be removed to allow full inspection to be carried out. A re-inspection is recommended once the areas are made accessible.

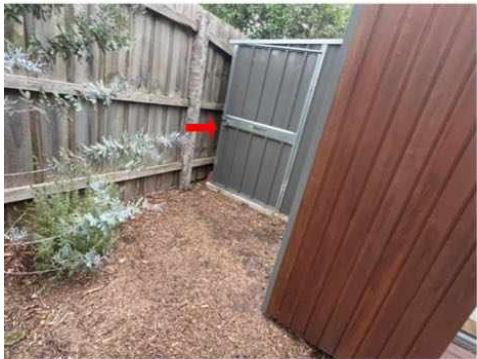
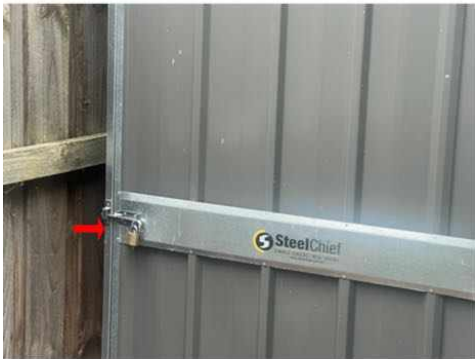
Building: Shed

Finding: Additional Photos - Obstructions and Limitations-no access

Information: These photographs are an indication of the obstructions and limitations which impeded full inspection of the property at the time of inspection. These obstructions can hide an array of defects and should be removed to allow full inspection to be carried out. A re-inspection is recommended once the areas are made accessible.

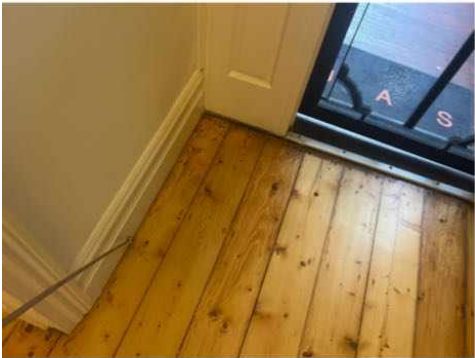
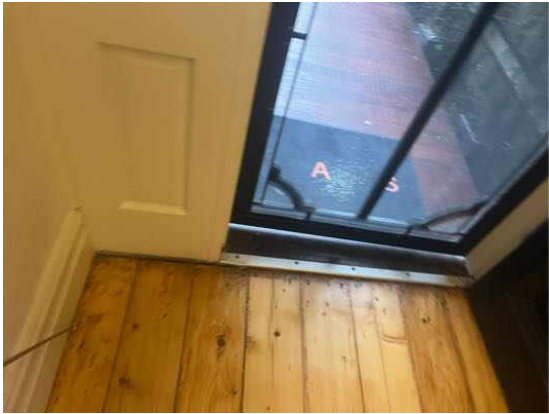
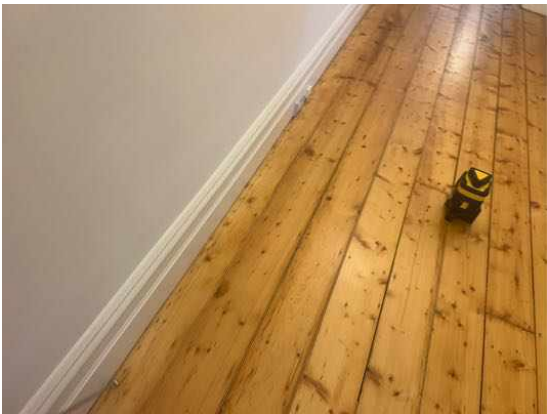
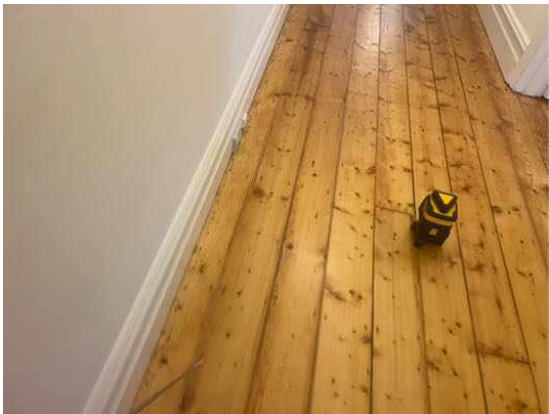
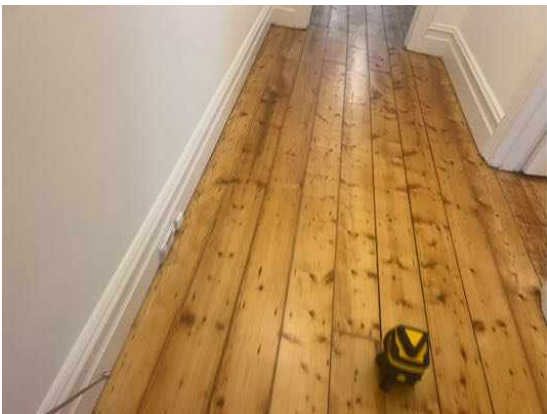
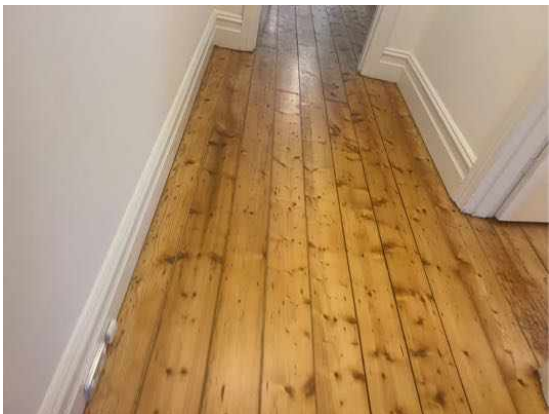
Building: Main Building  
Location: All Areas > All Areas  
Finding: Pest inspection-FYI-Methodology-and inspection of cabinetry  
Information: As part of the course of the Pest Inspection-we /knock on skirting boards and architraves to determine if Pests are present-we also visually examine in and around internal cabinetry-as note in images supplied-

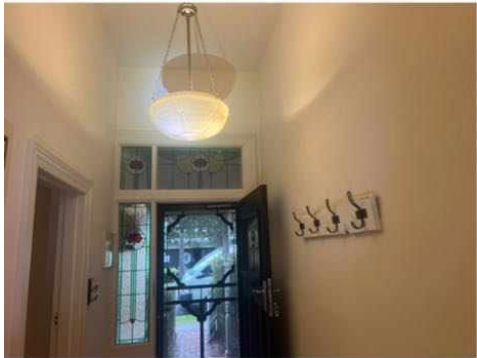
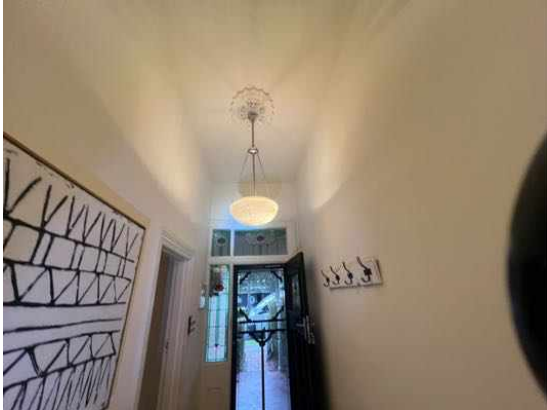
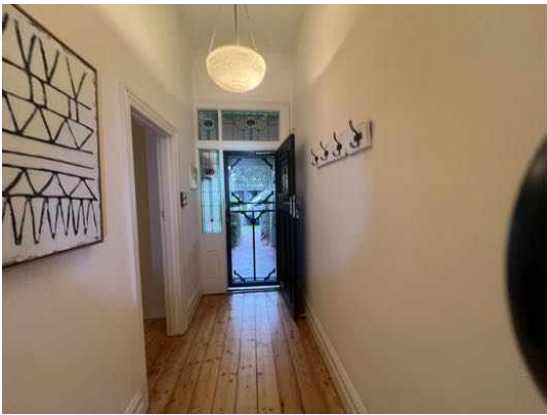
Building: Main Building  
Location: Entry > All Areas  
Finding: Additional Photos  
Information: Additional photos are provided for your general reference

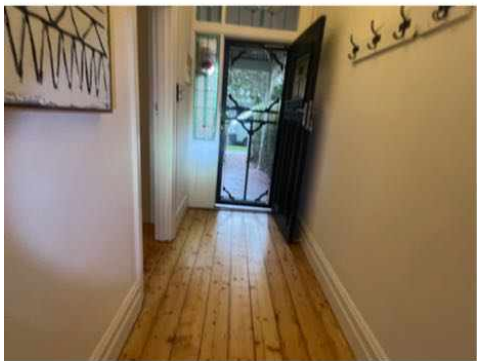
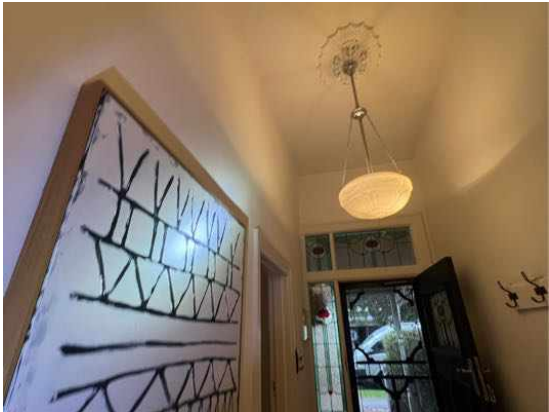
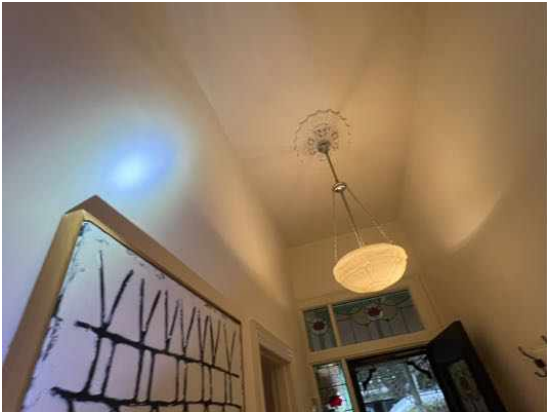
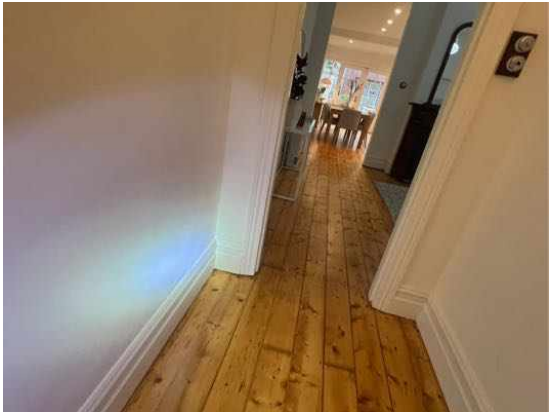
Building: Main Building  
Location: Hallway > All Areas  
Finding: Additional Photos  
Information: Additional photos are provided for your general reference

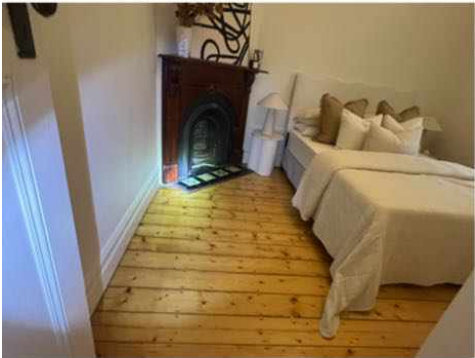
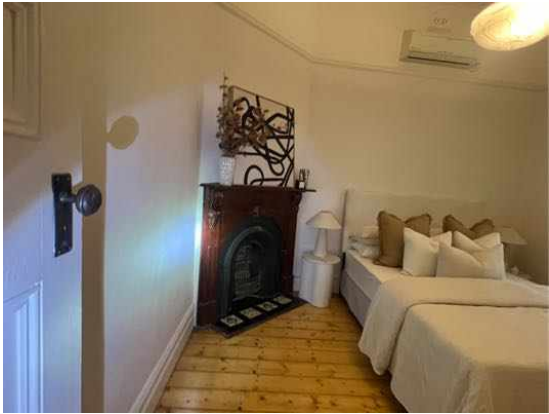
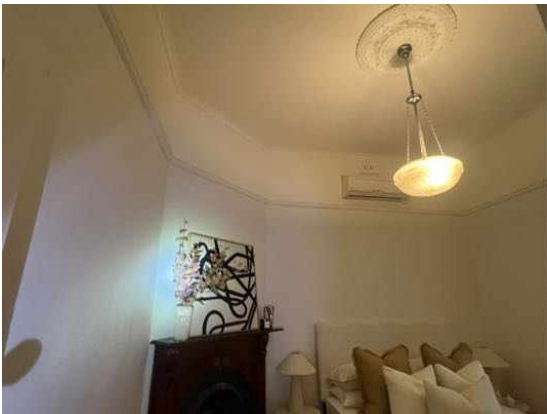
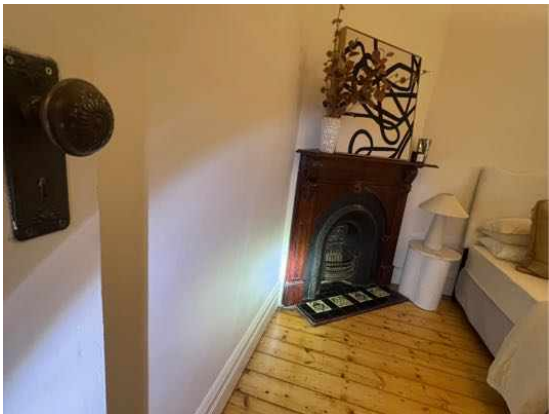
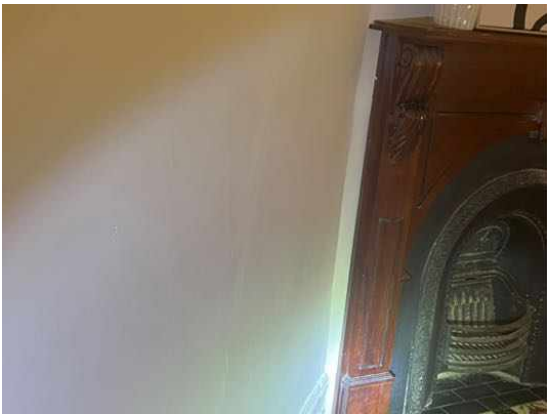
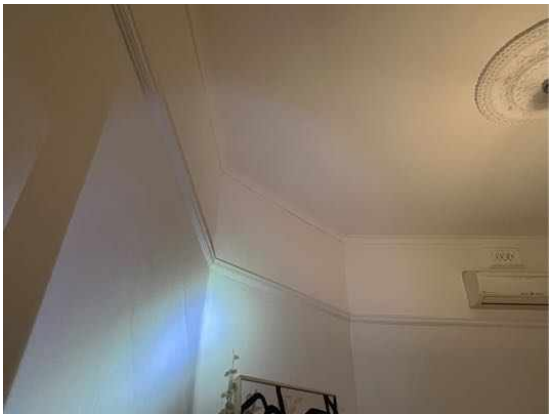
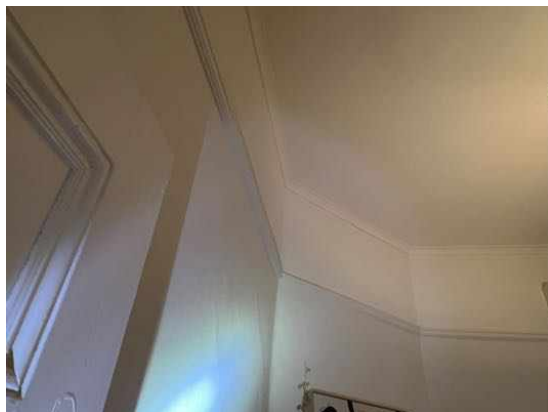
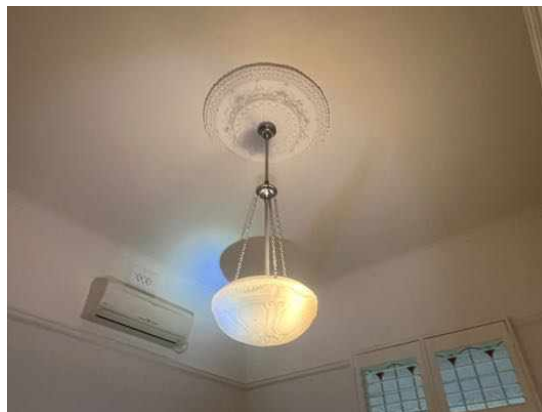
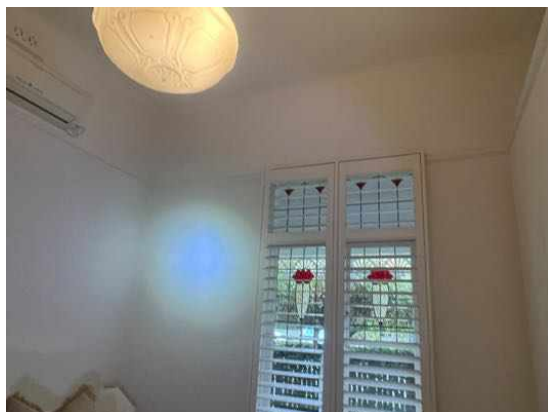
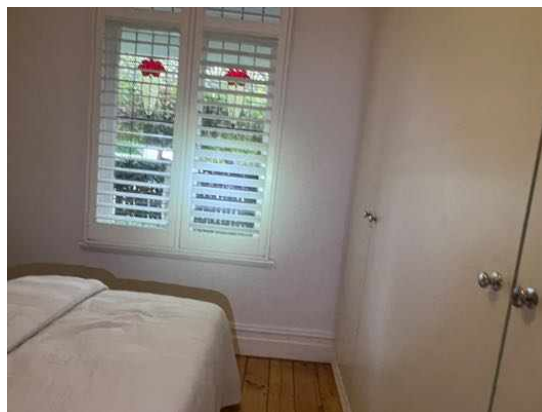
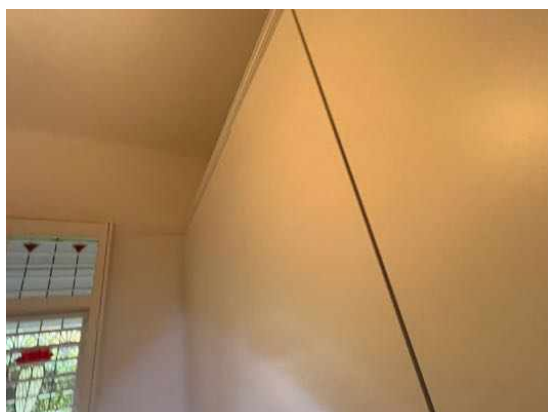
Building: Main Building  
Location: Bedroom > All Areas  
Finding: Additional Photos - Obstructions and Limitations  
Information: These photographs are an indication of the obstructions and limitations which impeded full inspection of the property at the time of inspection. These obstructions can hide an array of defects and should be removed to allow full inspection to be carried out. A re-inspection is recommended once the areas are made accessible.

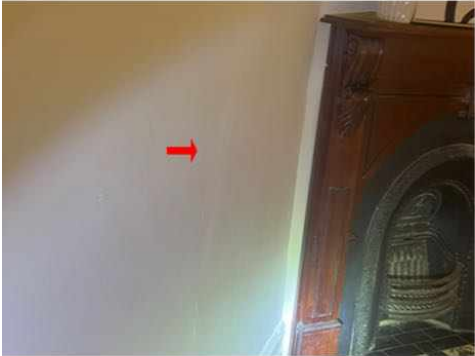
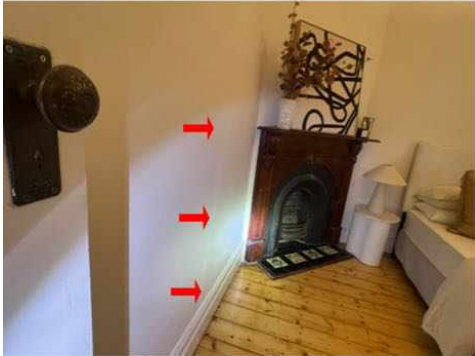
Building: Main Building  
 Location: Bedroom > Front Left  
 Finding: Unconventional handyman work-repairs noted to wall  
 Information: This handyman work appears to have been completed to a substandard level and does not comply with regular building practices. Where handyman work is not completed satisfactorily, accelerated deterioration of the associated building elements is likely to occur and secondary defects to surrounding structures may develop.

It is highly recommended that the substandard work be rectified by professional services. Works to improve this area are likely to increase the safety and the operation of the associated building elements.

The client should exercise care when coming into the immediate vicinity of the substandard works. Rectification works are advised as soon as possible by the appropriate trades.

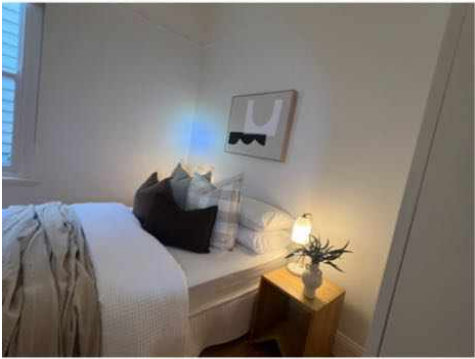
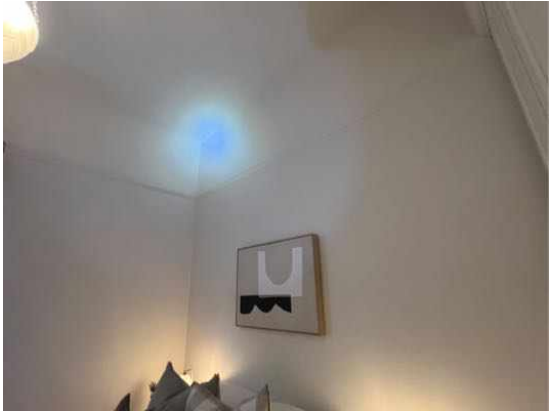
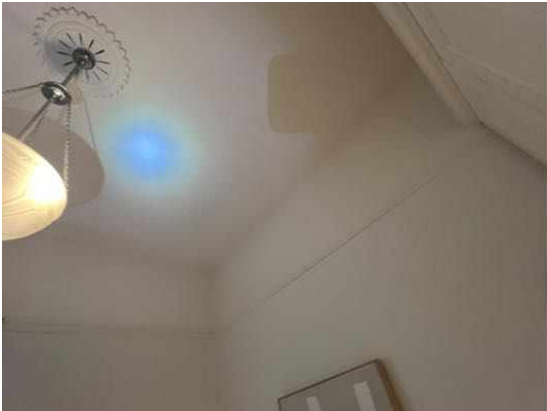
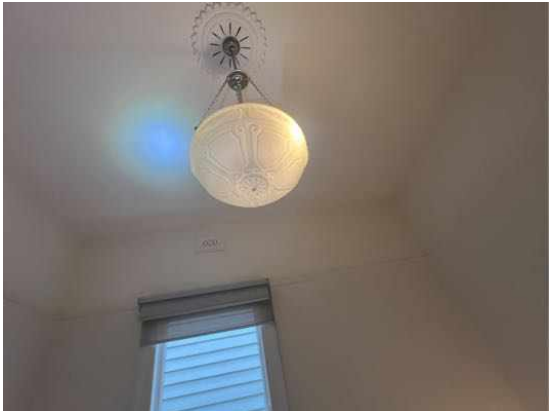
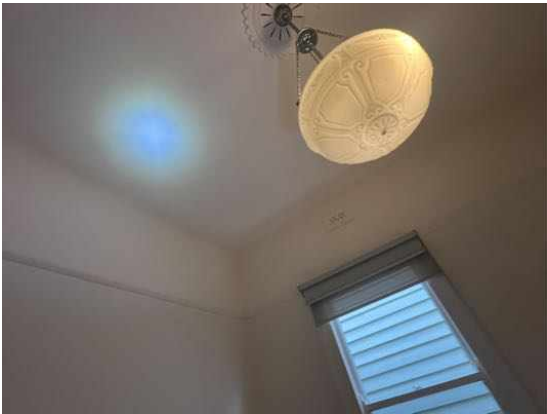
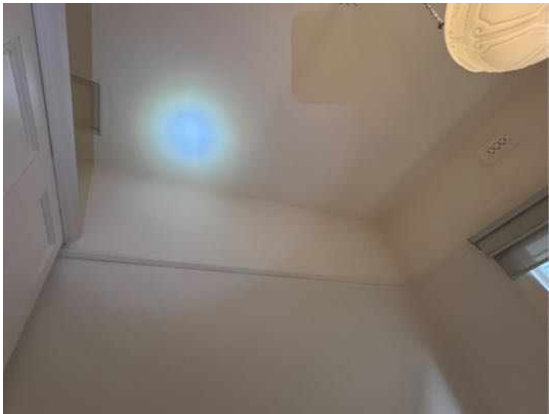
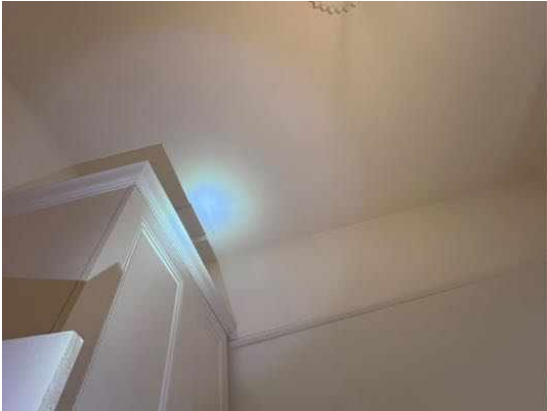
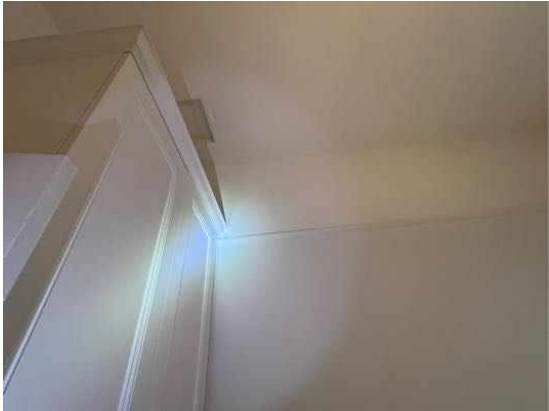
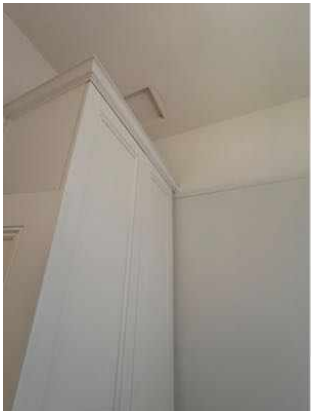
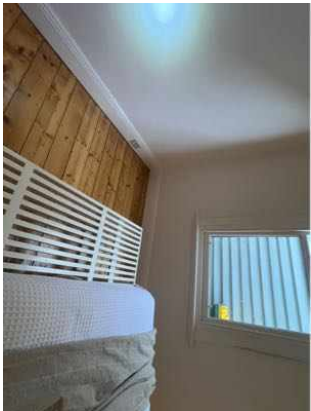
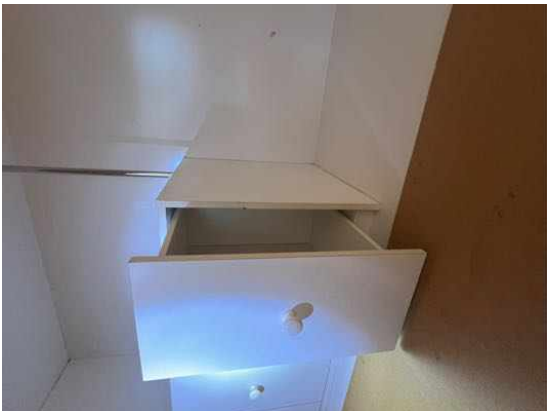
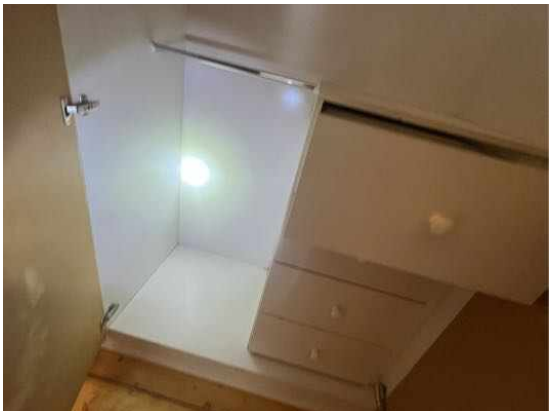
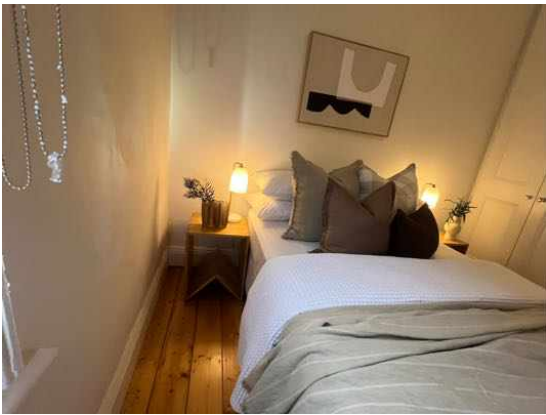
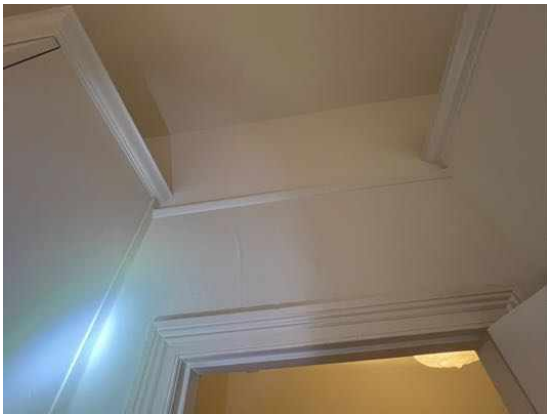
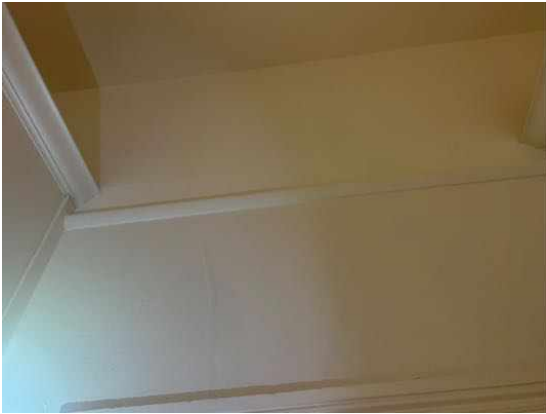
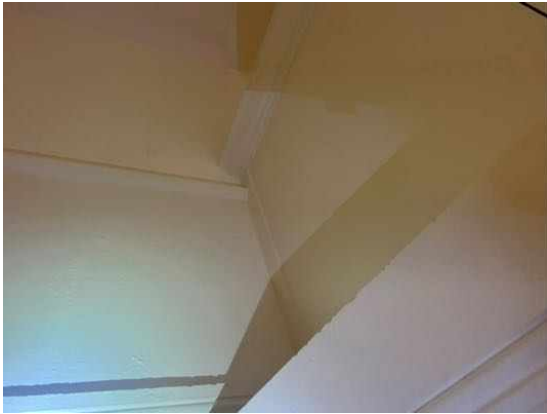
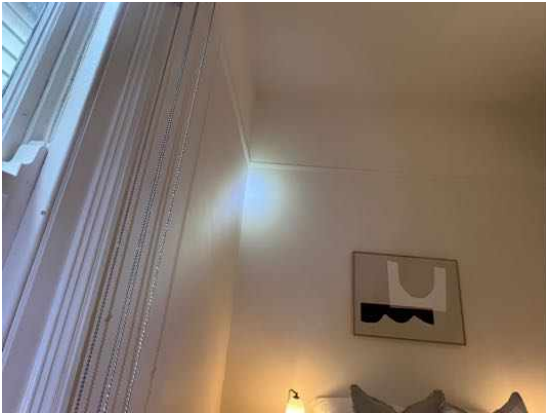
Building: Main Building  
Location: Bedroom 2 > All Areas  
Finding: Additional Photos  
Information: Additional photos are provided for your general reference

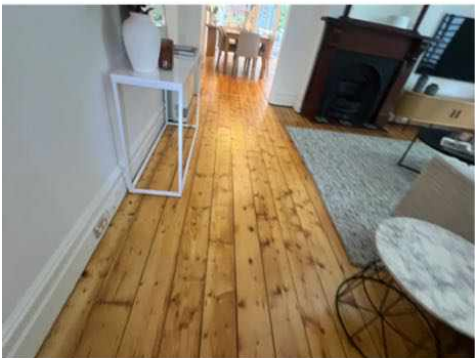
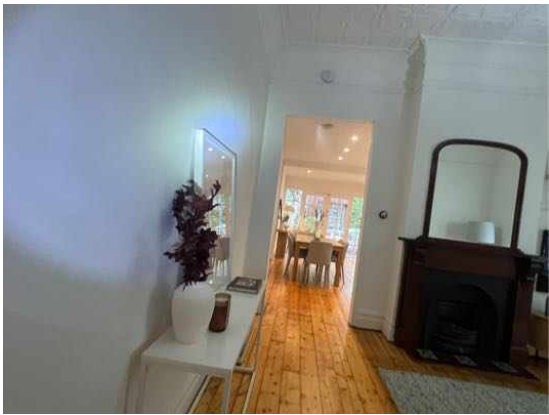
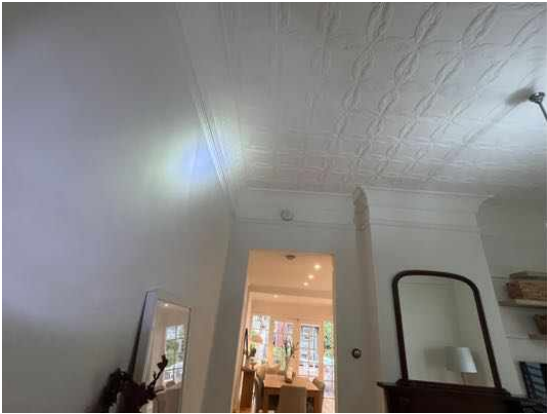
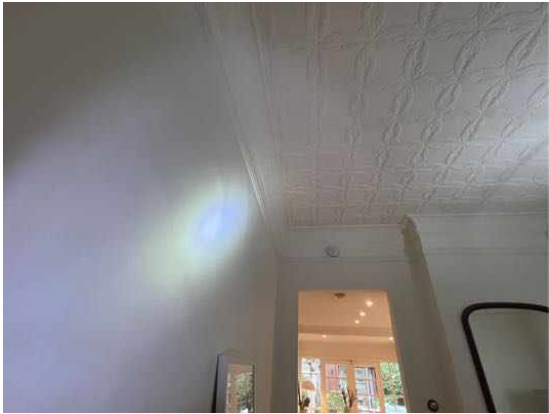
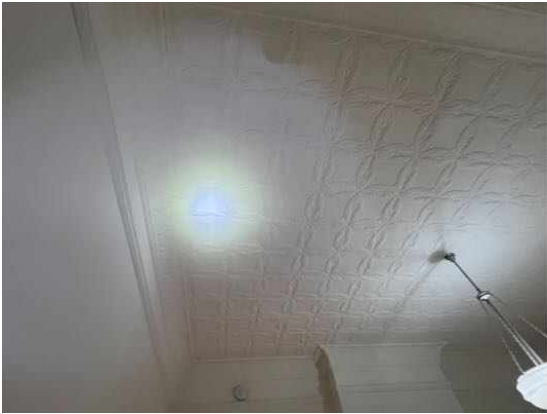
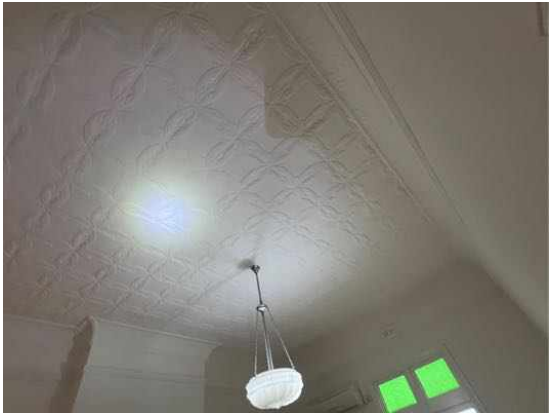
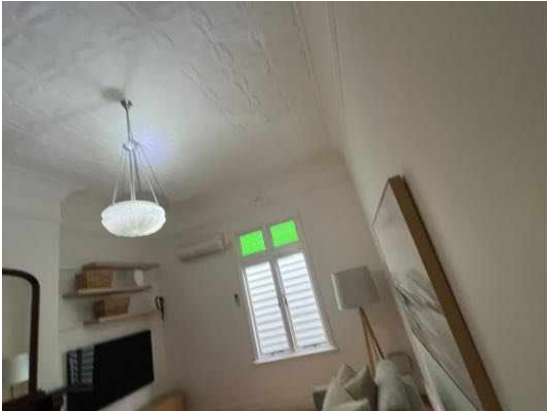
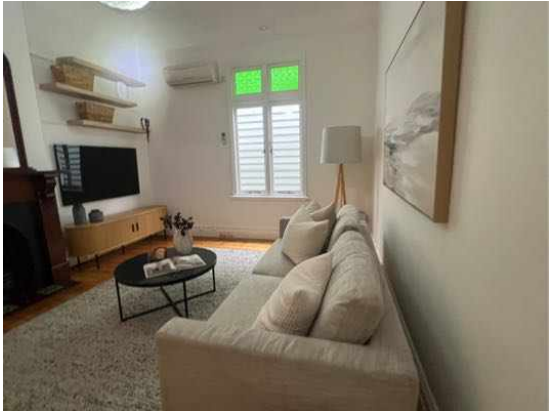
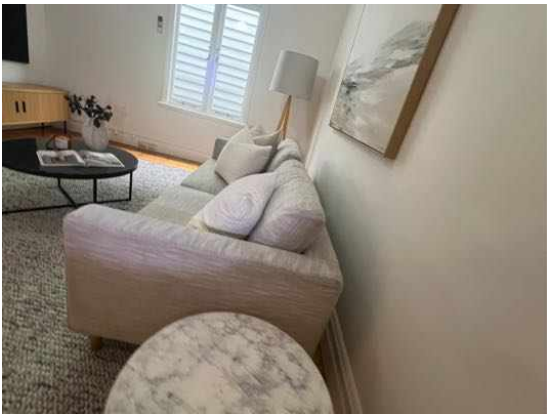
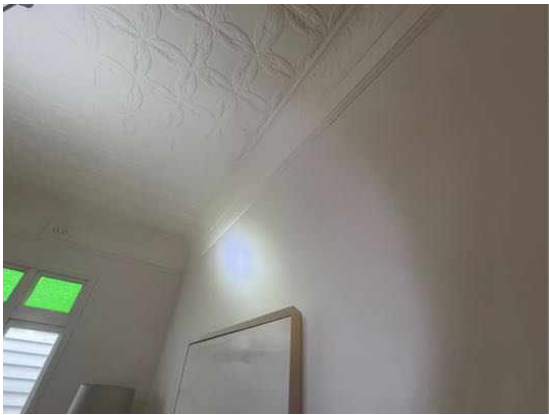
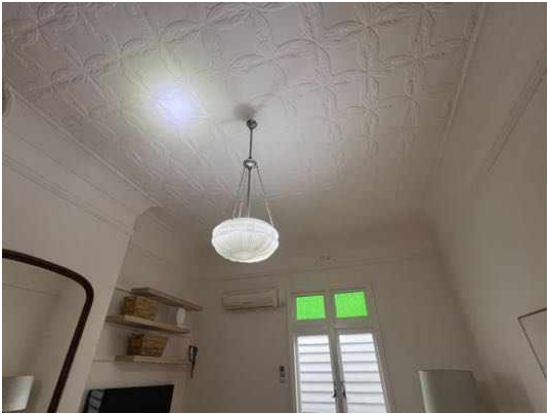
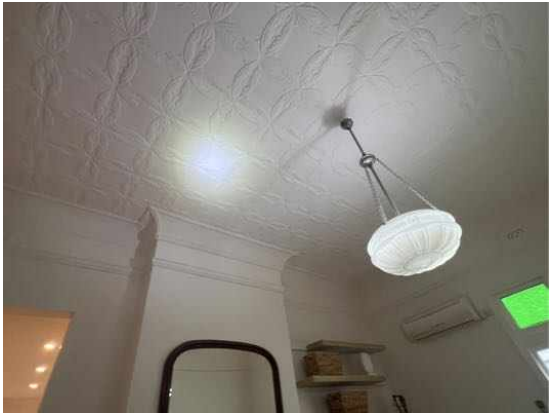
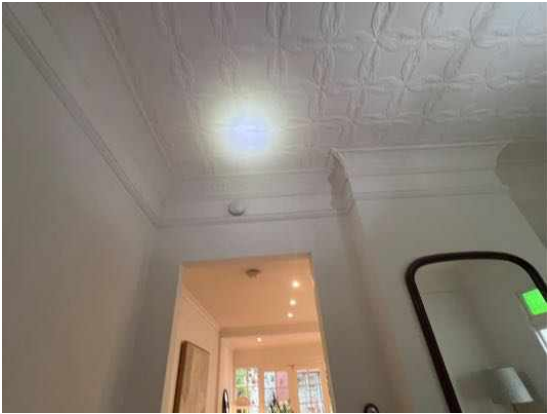
**Noted Item**

Building: Main Building  
Location: Lounge Room > All Areas  
Finding: Additional Photos  
Information: Additional photos are provided for your general reference
