# Building and Timber Pest Inspection Report

Inspection Date: Mon, 16 Mar 2026

Property Address: 46 O'Farrell St, Yarraville VIC 3013,  
Australia

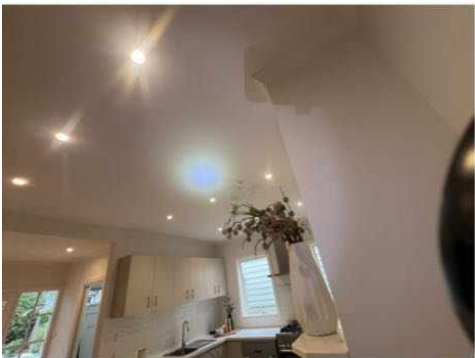
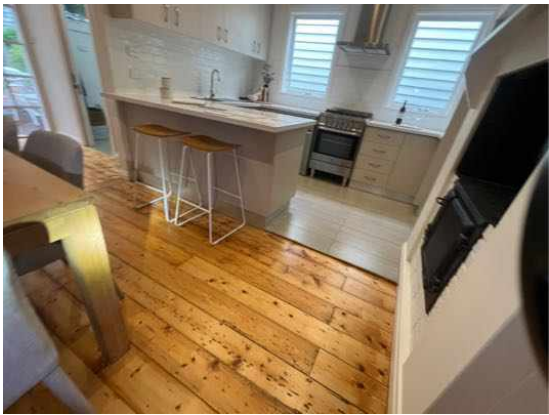
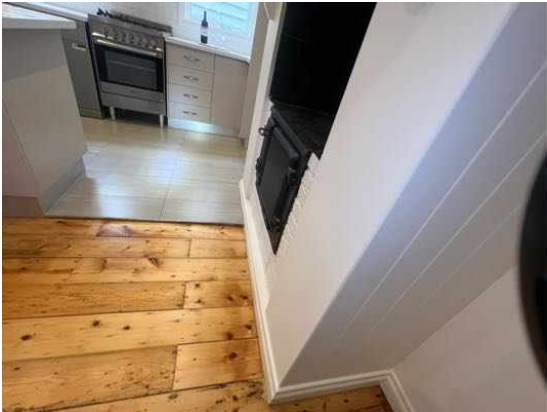
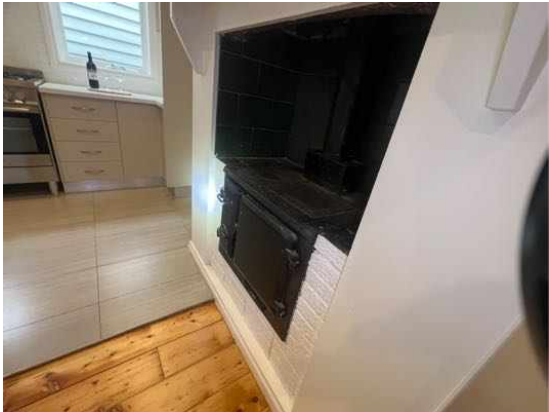
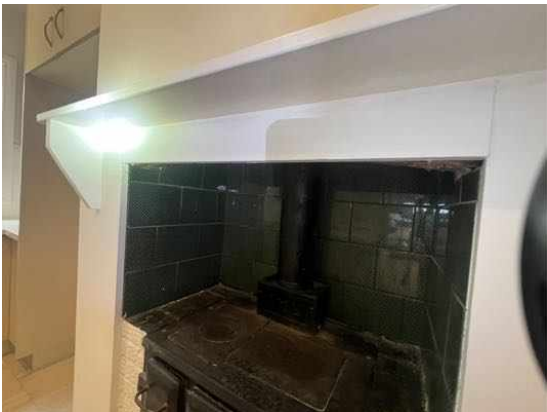
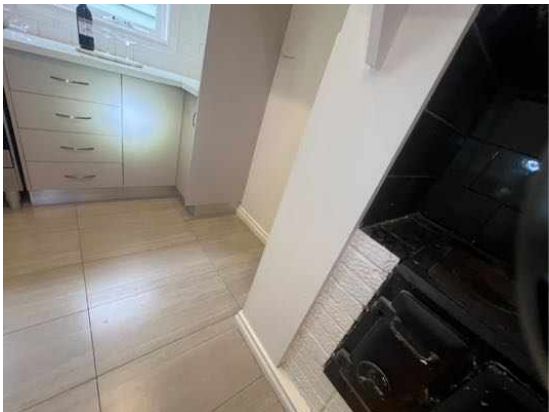
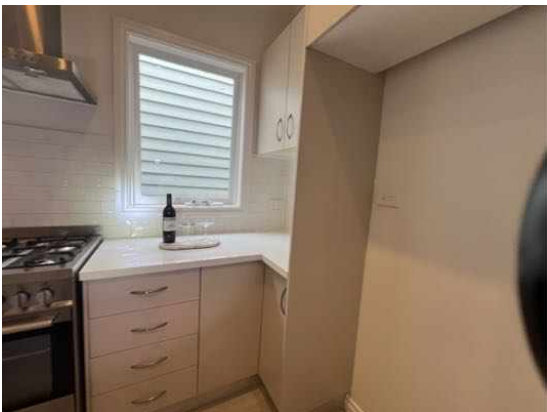
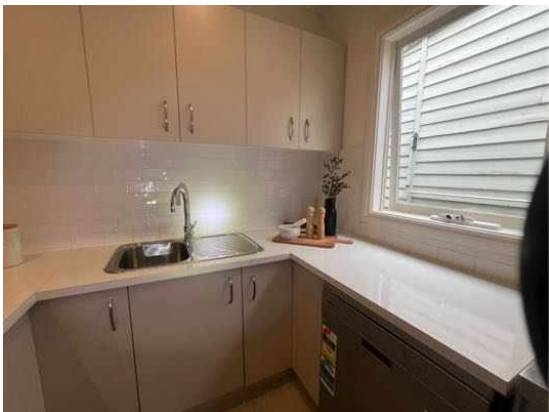
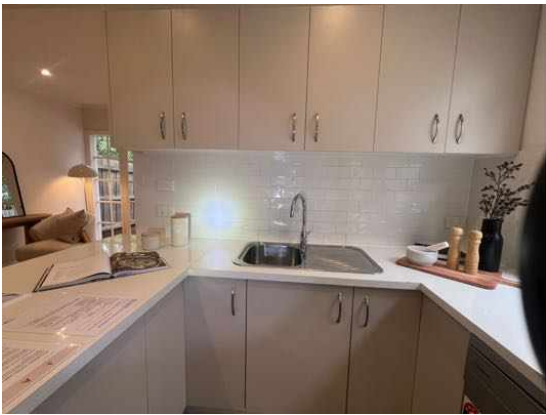
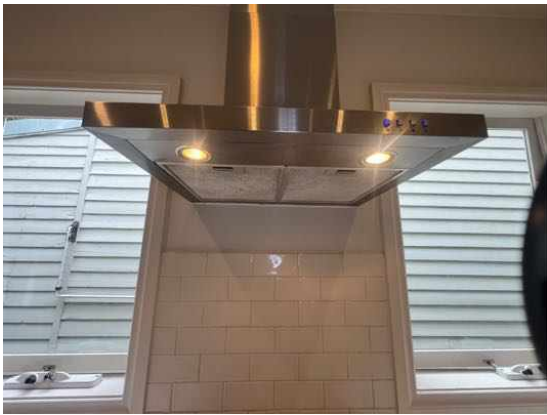
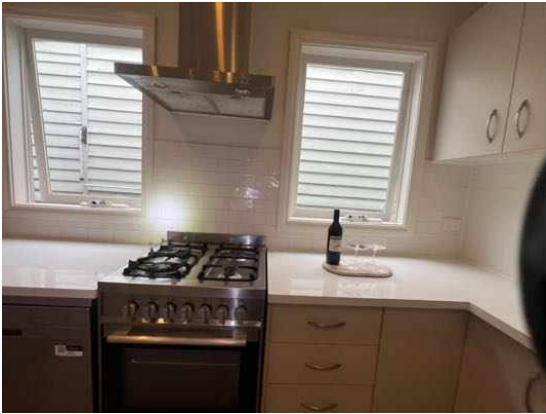
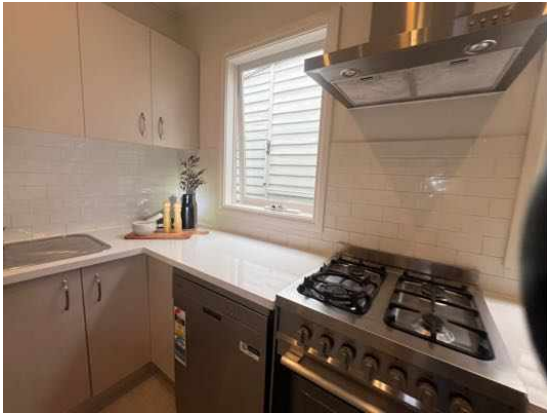
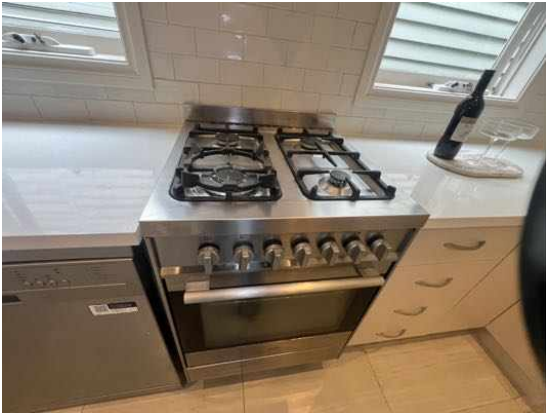
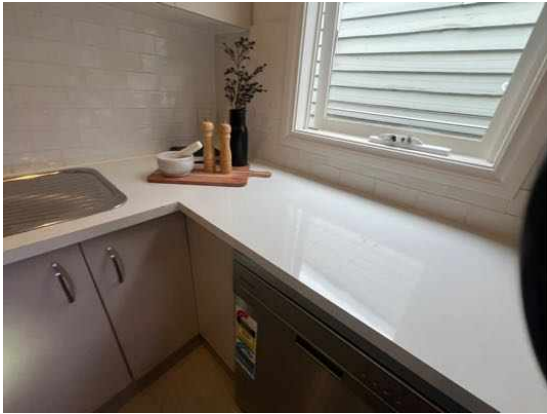
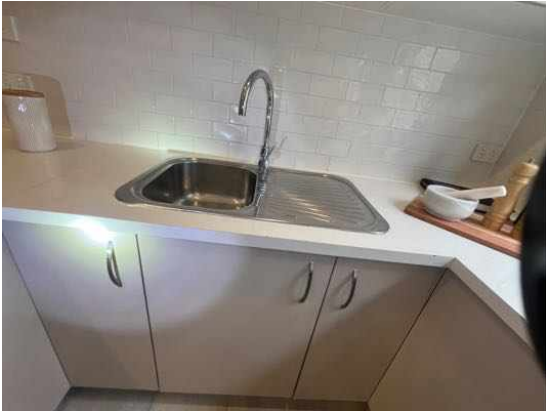
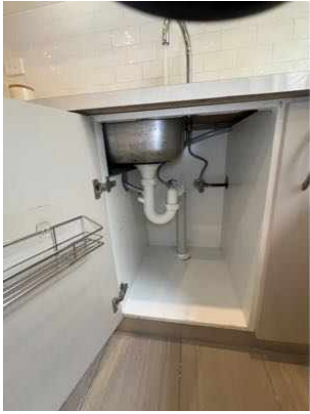
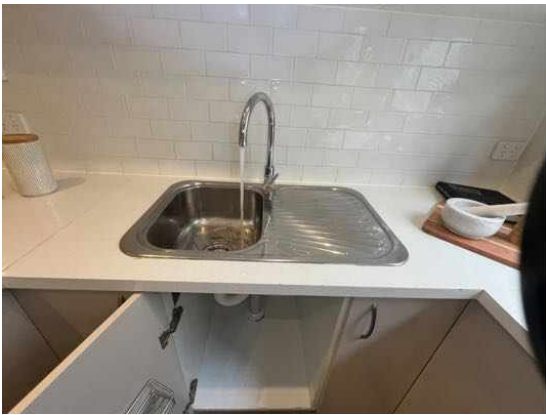
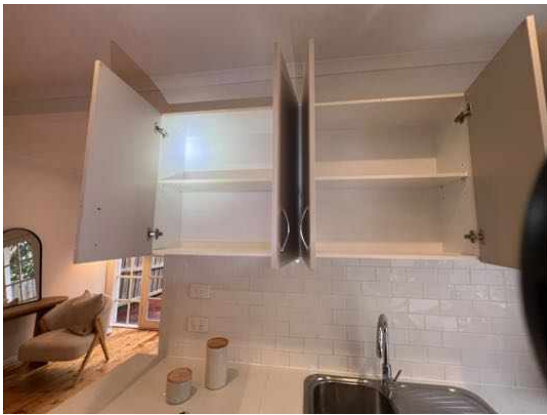
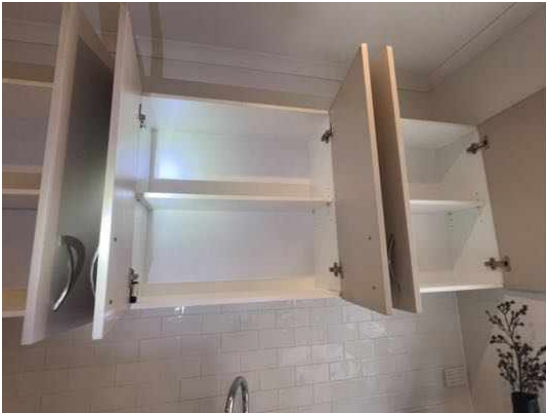
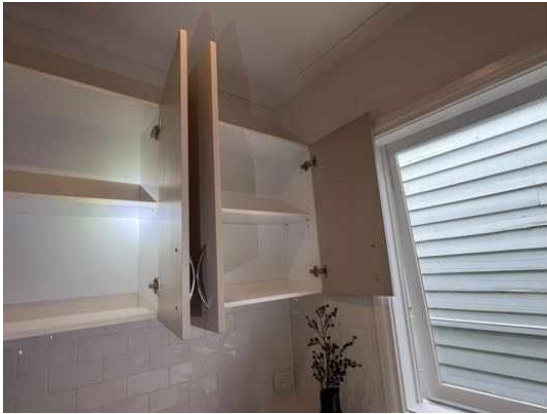
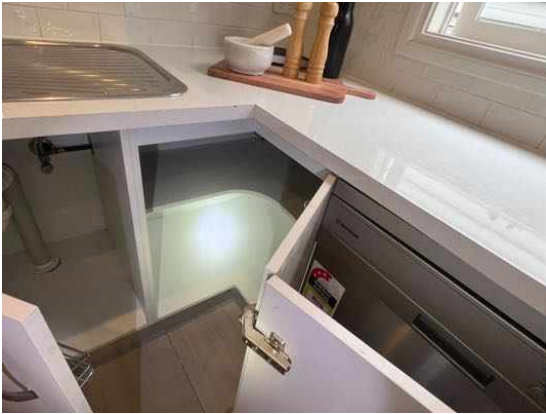
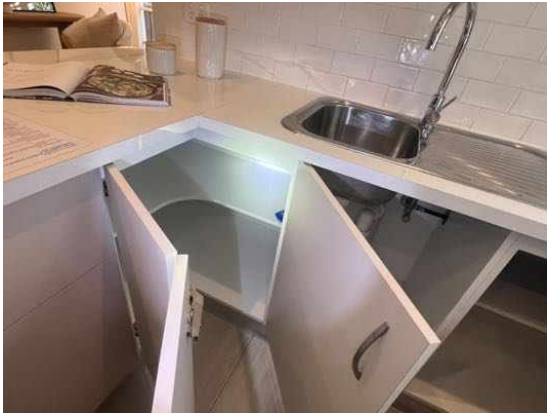
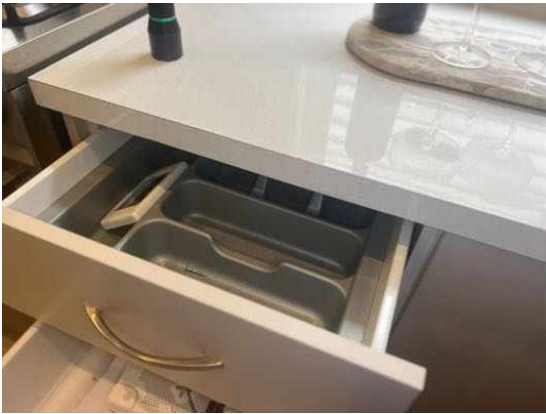
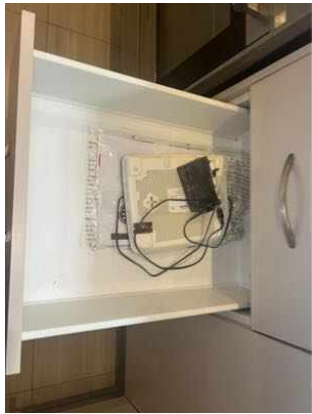
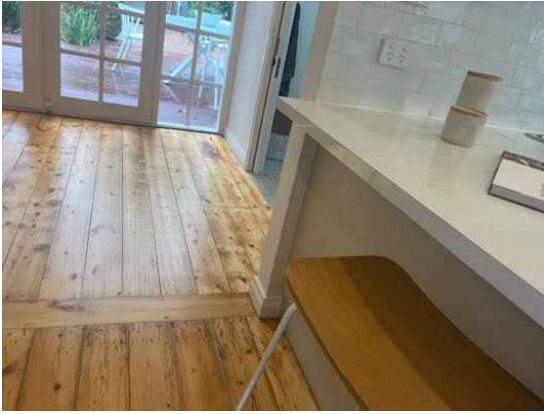
**Noted Item**

Building: Main Building  
Location: Kitchen > All Areas  
Finding: Additional Photos  
Information: Additional photos are provided for your general reference

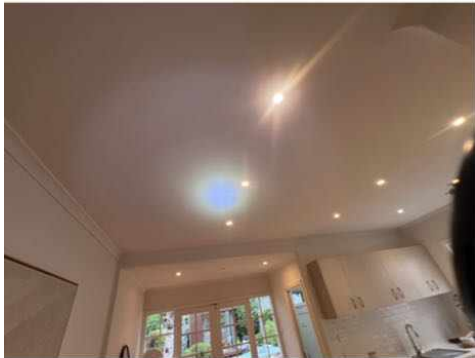
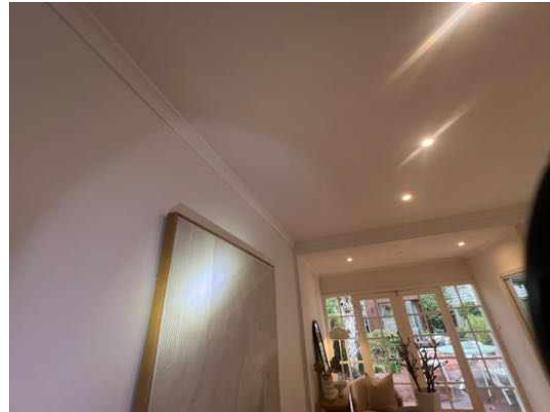
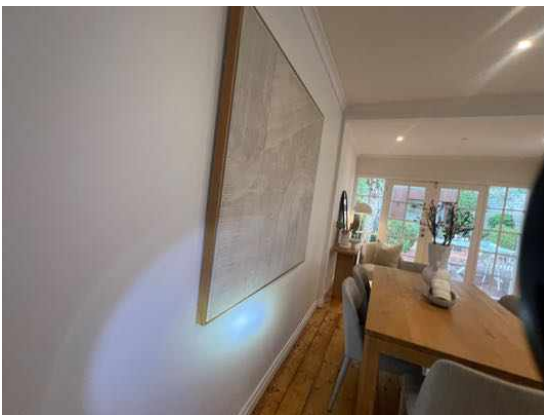
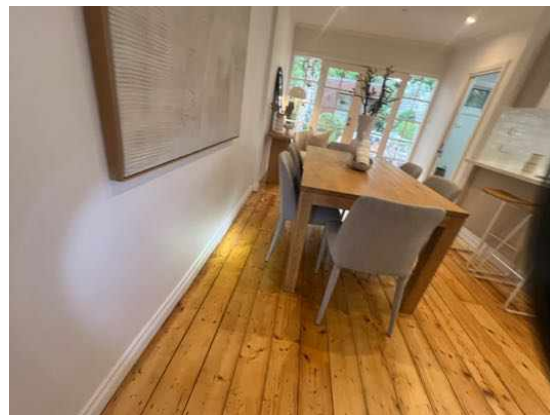
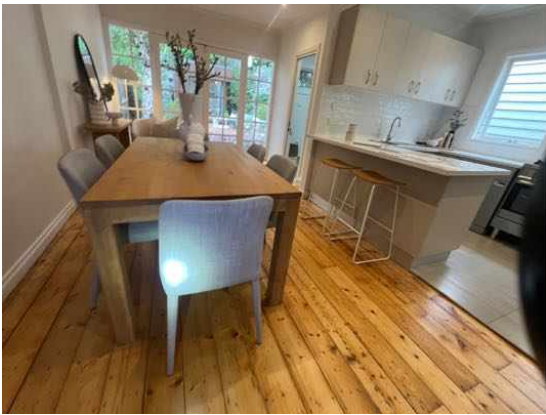
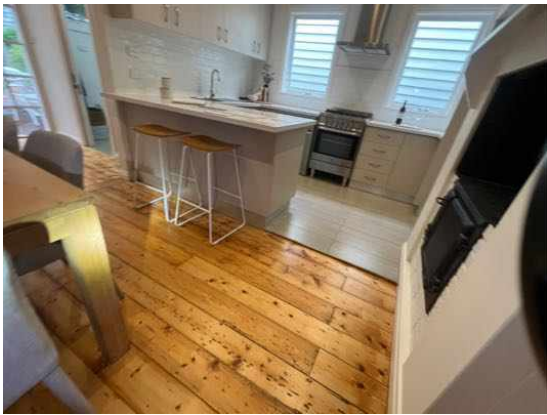
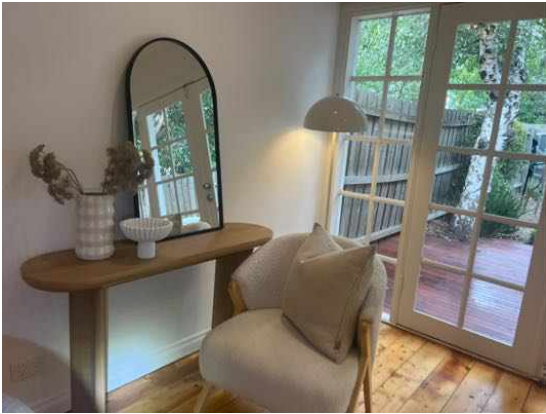
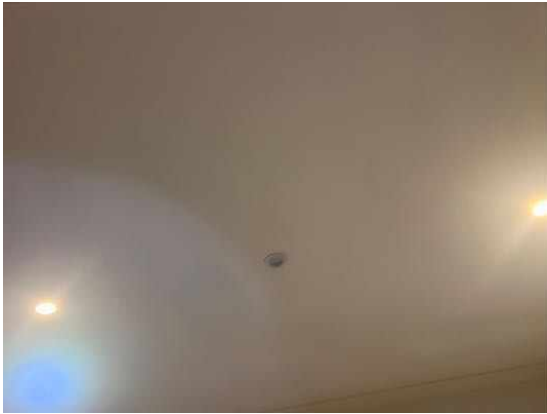
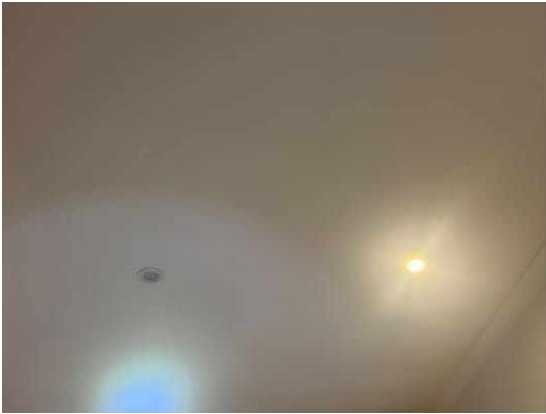
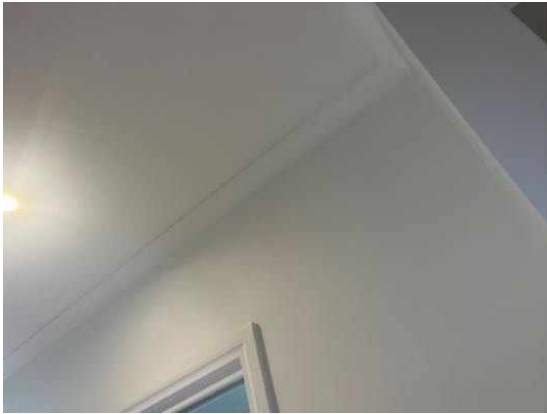
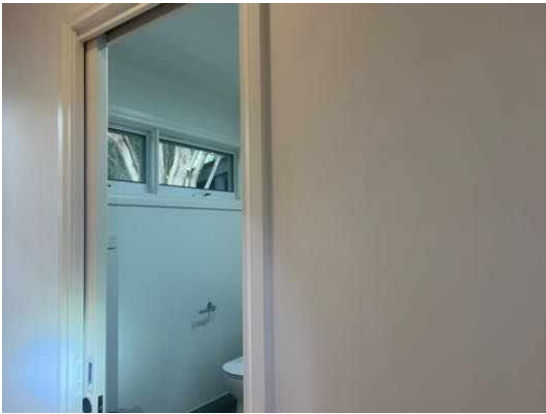
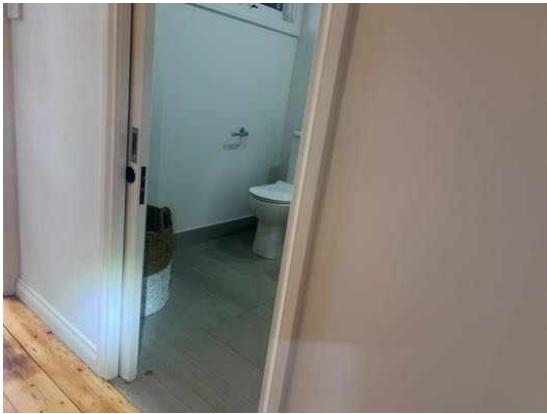
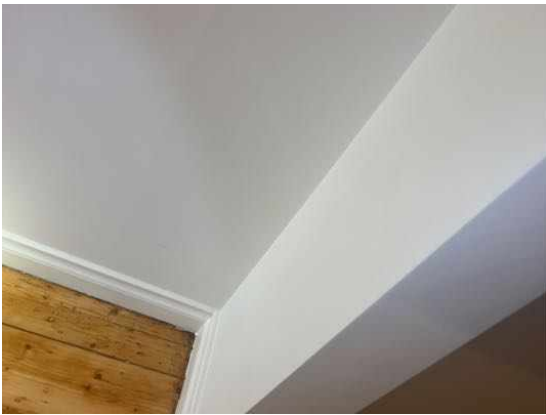
Building: Main Building  
 Location: Dining Room > All Areas  
 Finding: Additional Photos - Obstructions and Limitations  
 Information: These photographs are an indication of the obstructions and limitations which impeded full inspection of the property at the time of inspection. These obstructions can hide an array of defects and should be removed to allow full inspection to be carried out. A re-inspection is recommended once the areas are made accessible.

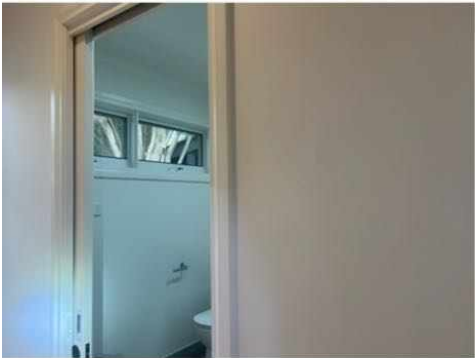
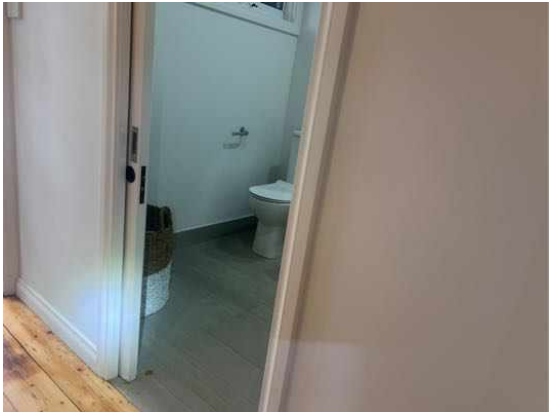
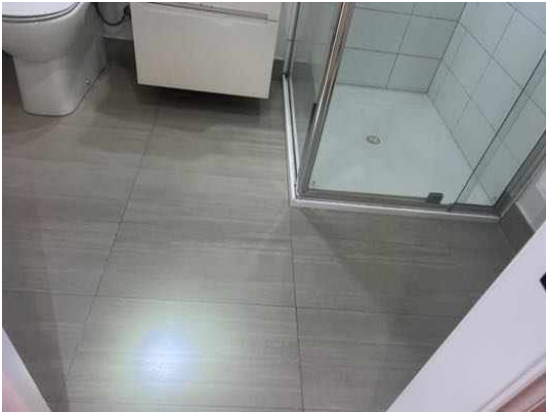
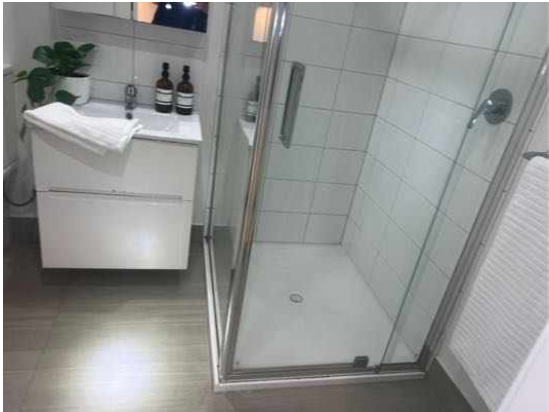
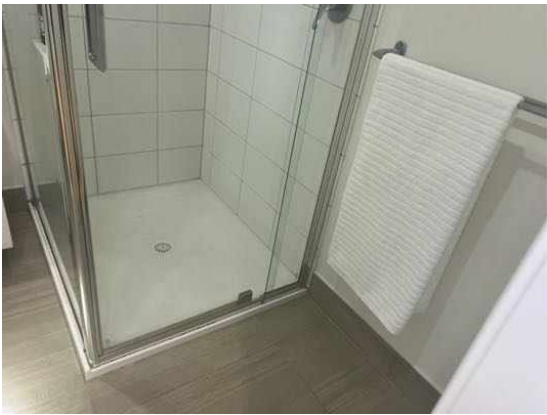
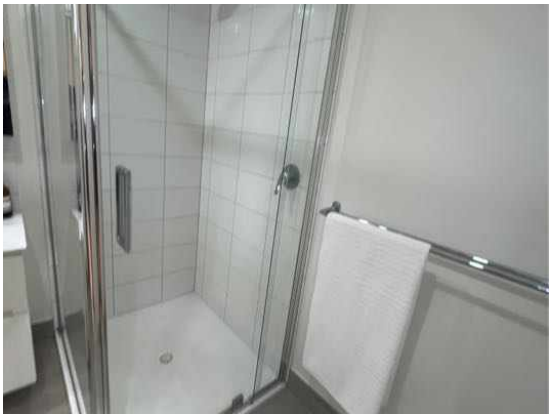
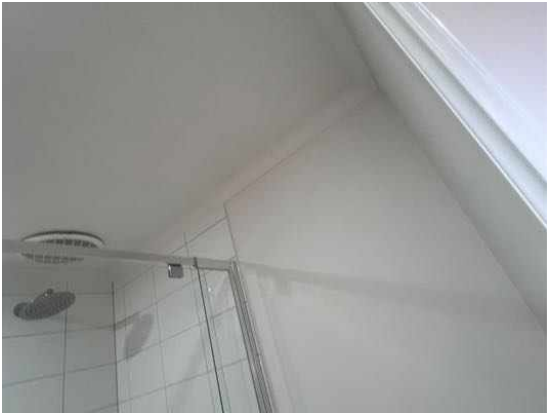
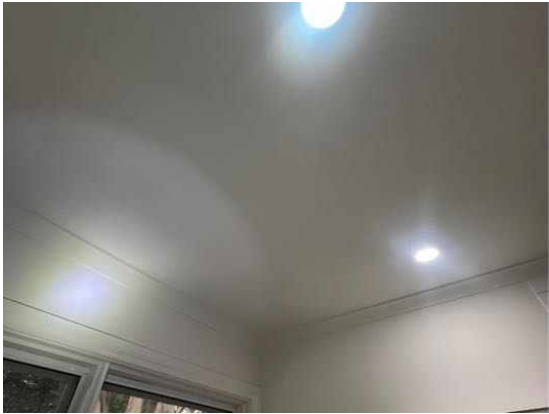
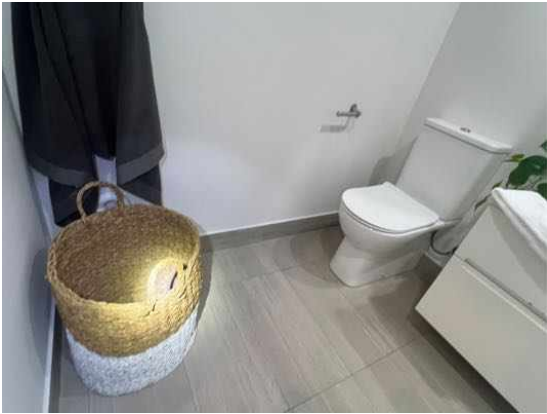
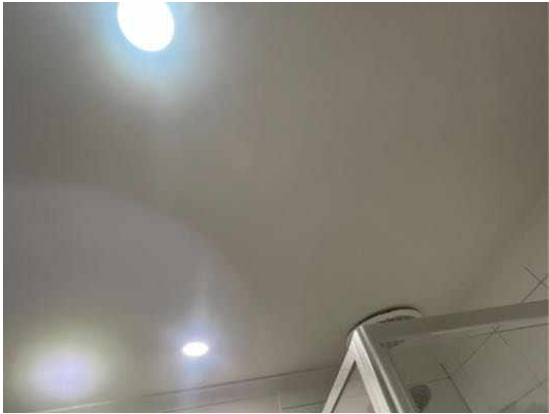
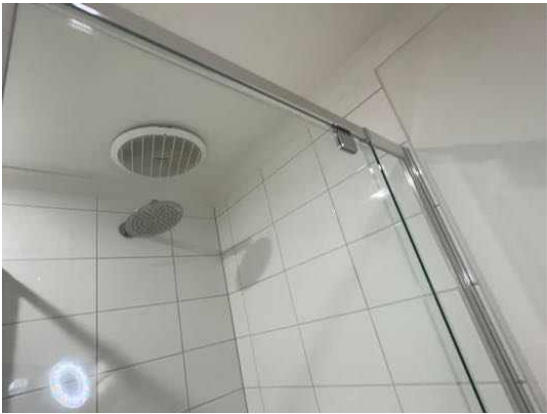
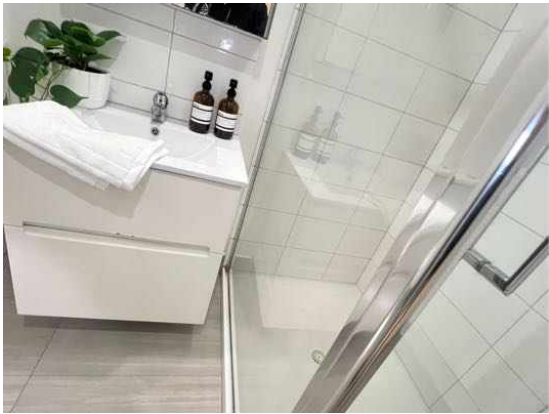
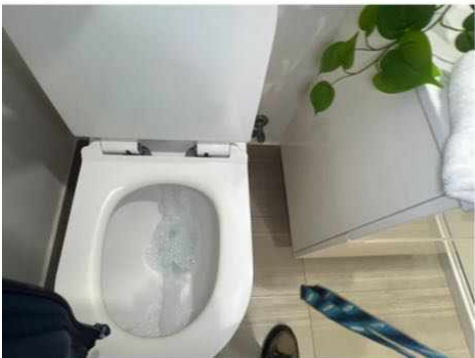
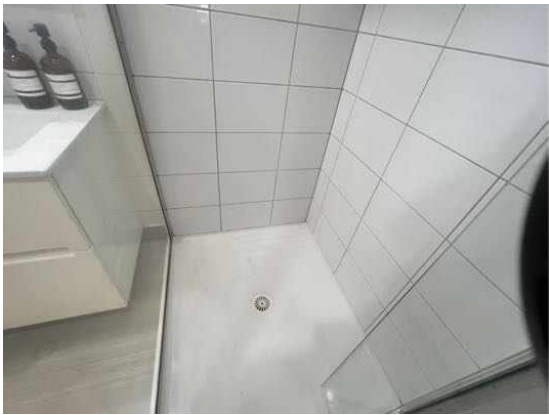
Building: Main Building  
Location: Bathroom > All Areas  
Finding: Additional Photos  
Information: Additional photos are provided for your general reference

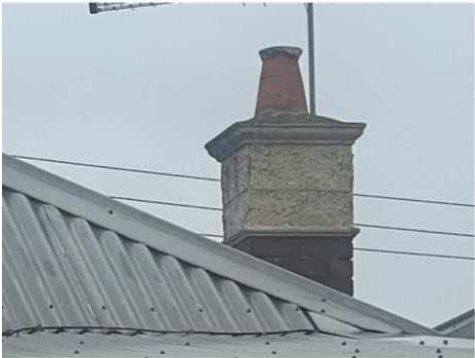
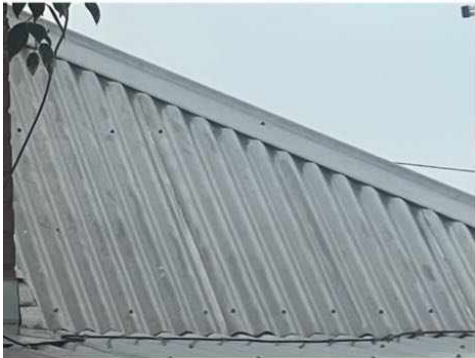
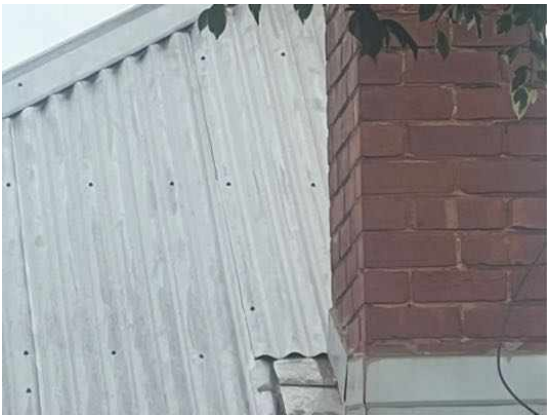
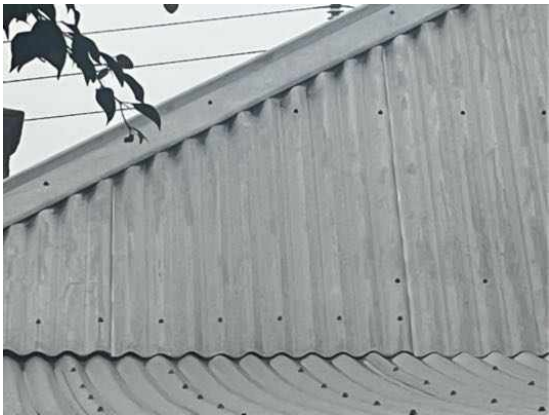
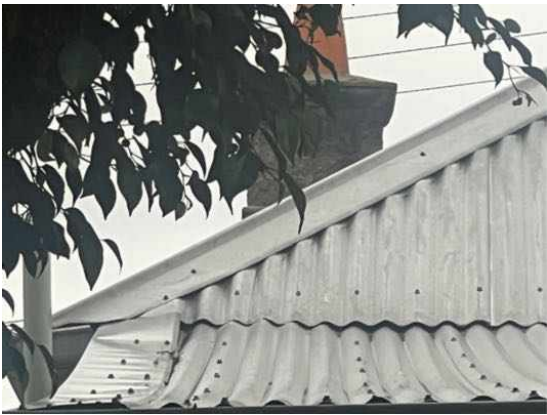
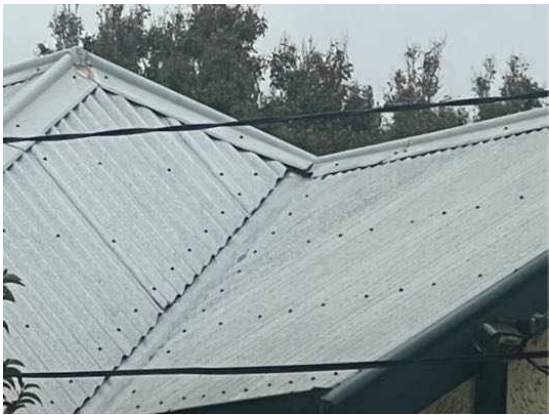
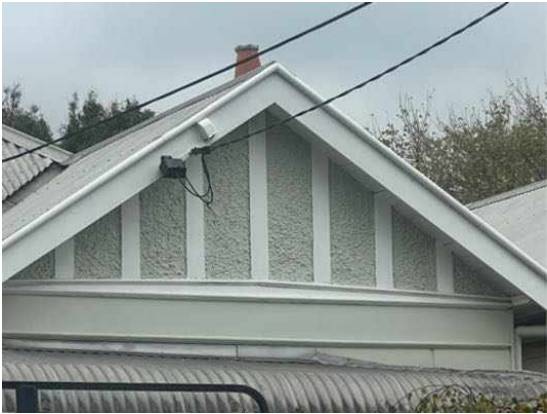
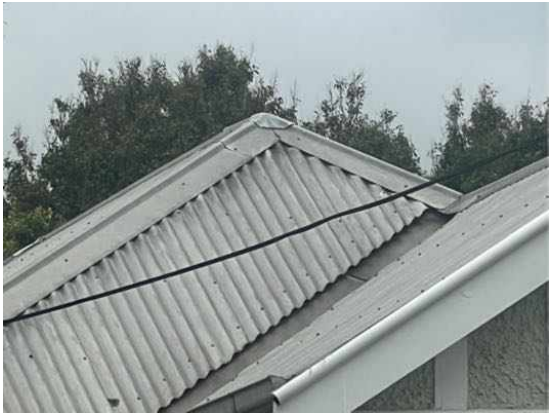
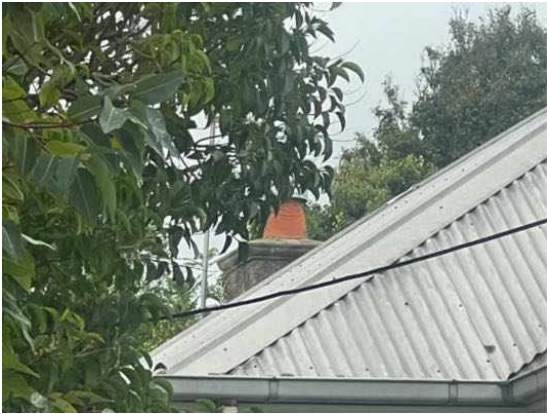
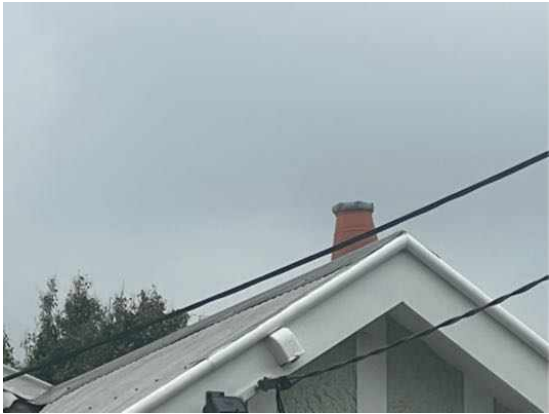
Building: Main Building  
Location: All Areas > All Areas  
Finding: Additional Photos - Obstructions and Limitations-raining-no access  
Information: These photographs are an indication of the obstructions and limitations which impeded full inspection of the property at the time of inspection. These obstructions can hide an array of defects and should be removed to allow full inspection to be carried out. A re-inspection is recommended once the areas are made accessible.

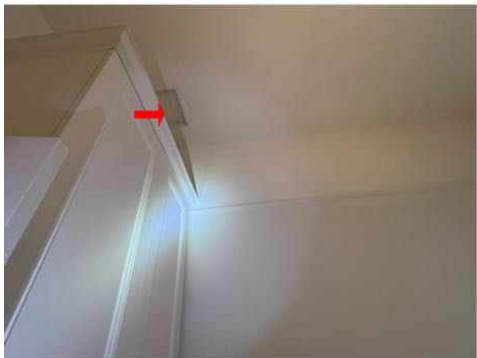
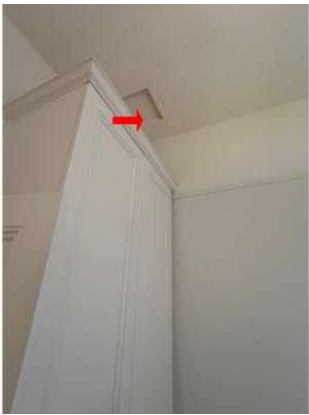
Building: Main Building  
Location: All Areas > All Areas  
Finding: Additional Photos - Obstructions and Limitations-no access as manhole above cabinetry  
Information: These photographs are an indication of the obstructions and limitations which impeded full inspection of the property at the time of inspection. These obstructions can hide an array of defects and should be removed to allow full inspection to be carried out. A re-inspection is recommended once the areas are made accessible.

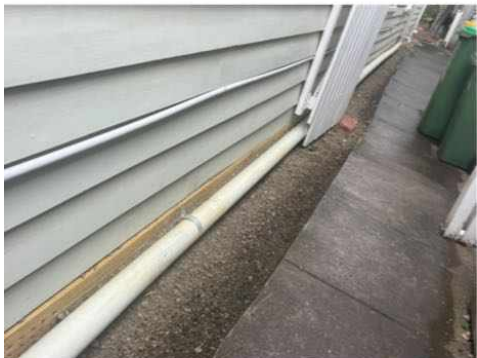
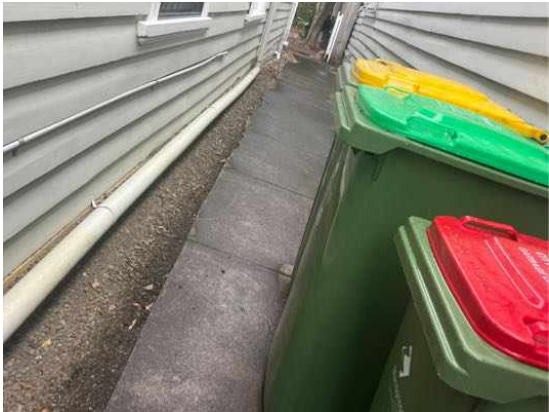
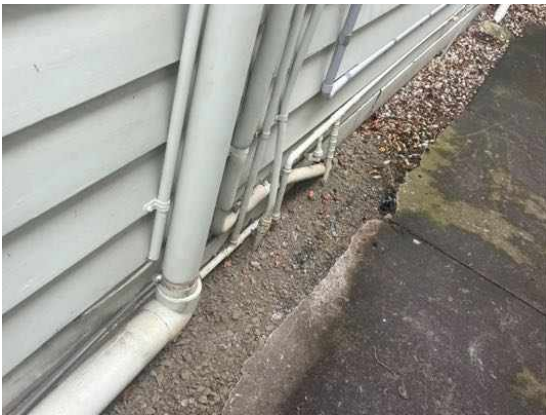
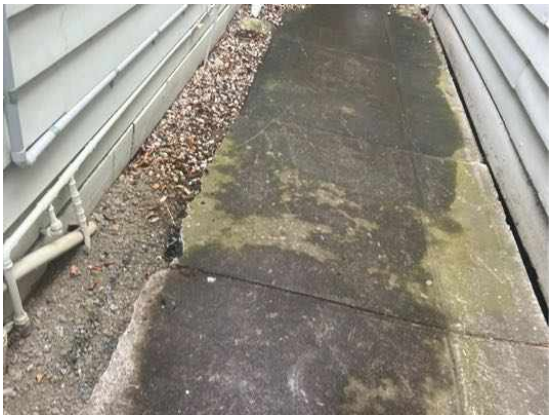
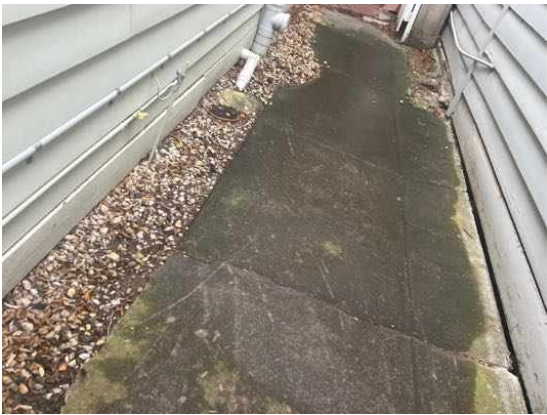
**Noted Item**

Building: Main Building  
Location: All Areas > All Areas  
Finding: Additional Photos - Obstructions and Limitations-No access to subfloor-  
Information: These photographs are an indication of the obstructions and limitations which impeded full inspection of the property at the time of inspection. These obstructions can hide an array of defects and should be removed to allow full inspection to be carried out. A re-inspection is recommended once the areas are made accessible.
