# Building and Timber Pest Inspection Report

Inspection Date: Wed, 11 Mar 2026

Property Address: 140 Kalang Rd, Bellingen NSW 2454,  
Australia

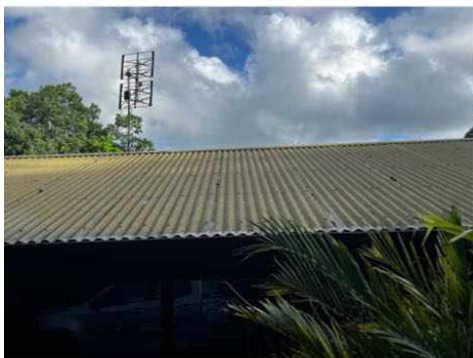
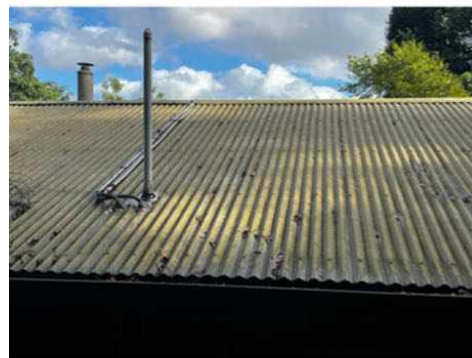
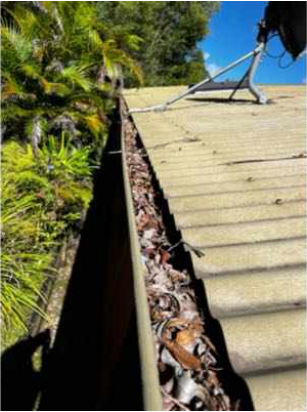
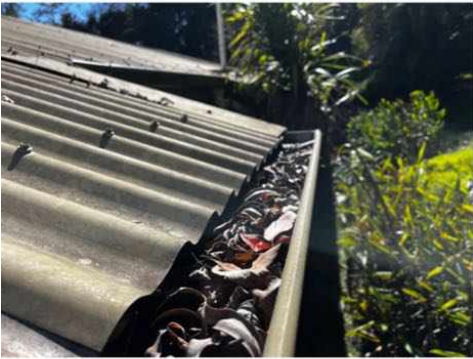
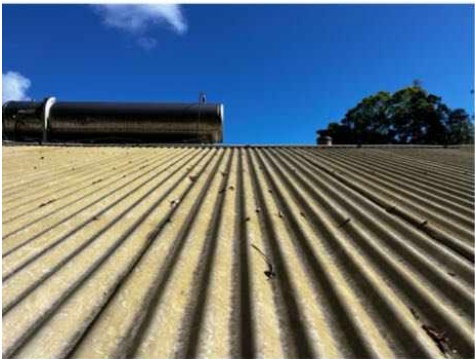
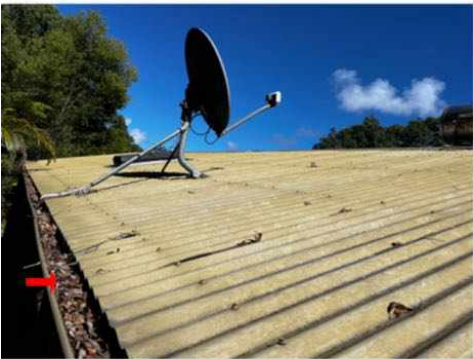
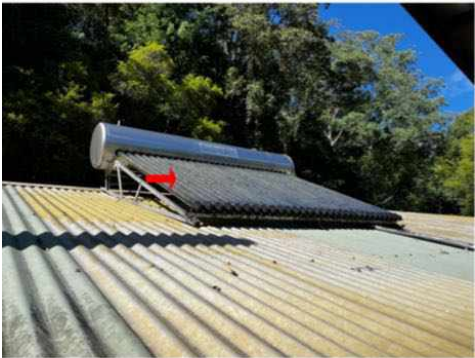
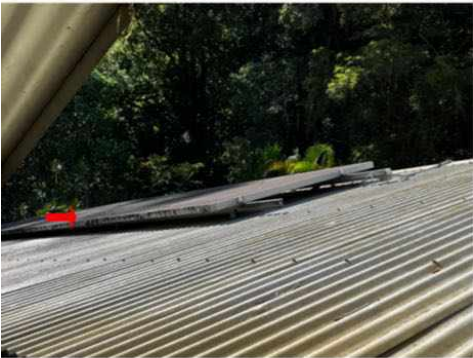
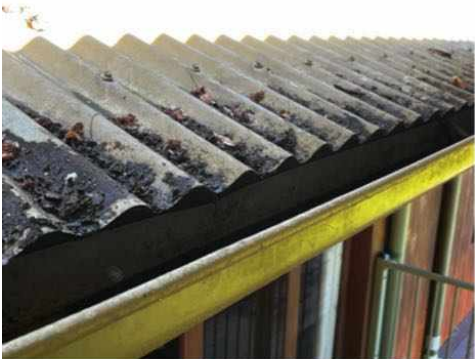
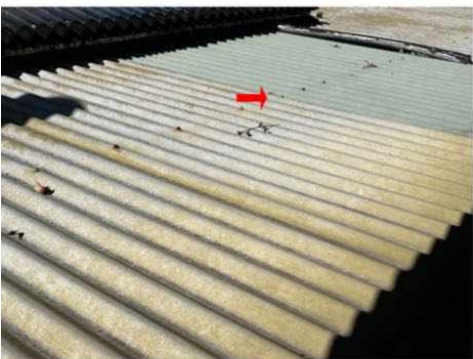
Building: Main Building  
Location: Roof Exterior  
Finding: Roof exterior and guttering  
Information: At the time of this inspection, the roof sheeting, roof flashings and roof penetration flashings appeared to be in weathered and poor condition with some deterioration evident.

The guttering was generally full of leaf litter and water and has minor rusting in the bottom of the gutters in areas. It is recommended that the guttering be cleaned out as soon as possible.

There were numerous rusted roofing screws, these should be replaced by a roofer.

It was observed that the hot water solar panels and the electrical solar panels had extensive mould and fungus evident, it is recommended that these items and the roofing be pressure cleaned.

It is recommended that a roofer thoroughly inspect the roof sheets, roof flashings and guttering as soon as possible and provide required maintenance.

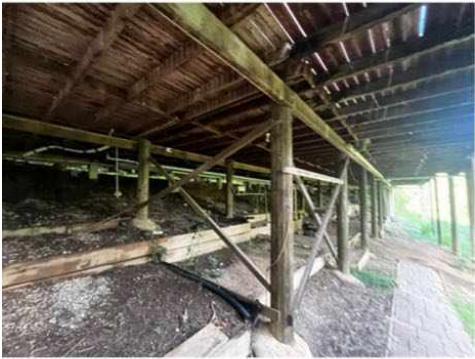
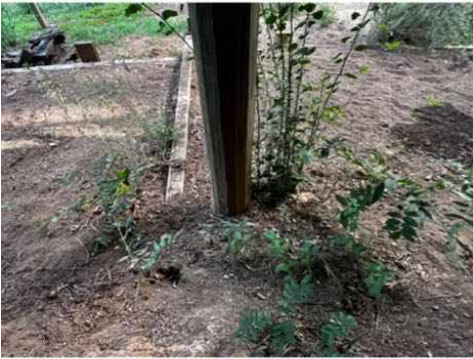
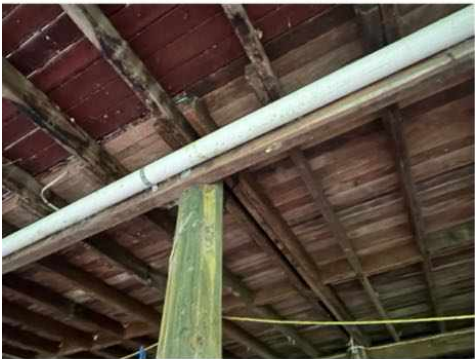
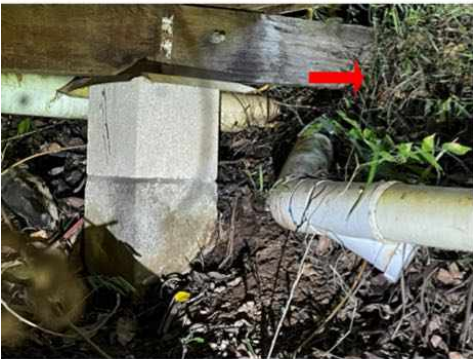
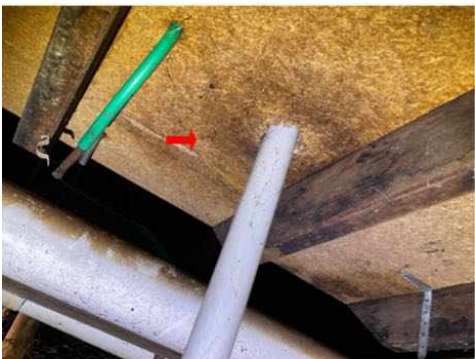
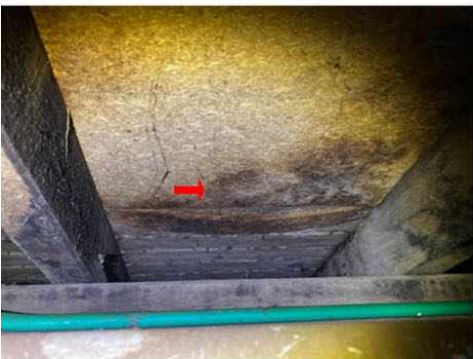
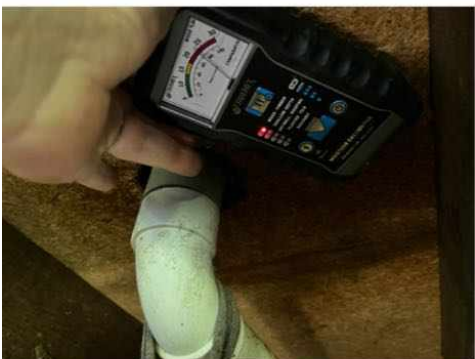
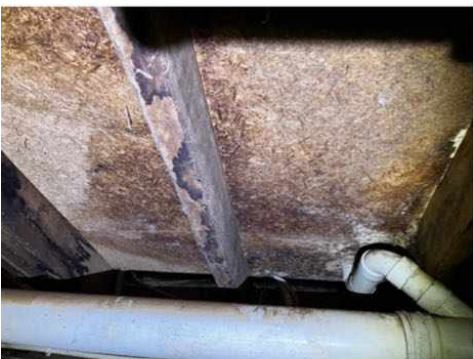
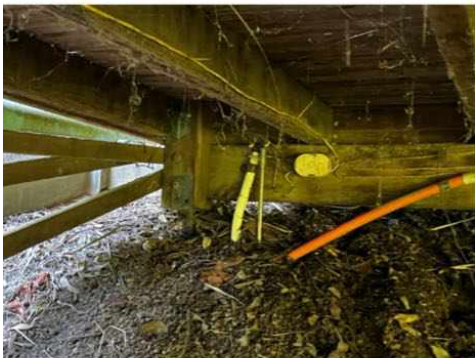
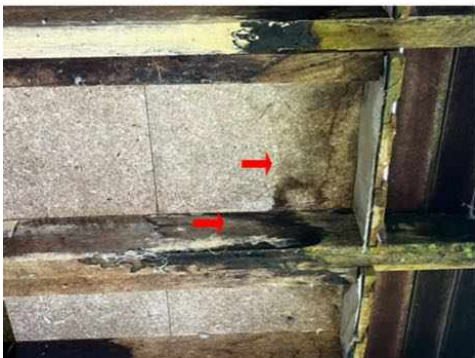
## Finding 2.02

Building:	Main Building
Location:	Subfloor
Finding:	Subfloor space - defects
Information:	At the time of this inspection it was observed that there were numerous defects in the subfloor area,

1 - The subfloor has a combination of masonry piers to the front wall and timber posts buried in the ground. It was observed that the masonry piers has metal ant caps fitted. The timber posts had no termite protection. It is recommended that a timber pest expert provide terminate protection to all timber posts as soon as possible.

2 - It was also noted that there was wet soil and areas where water runs under the floor, a plumber should be engaged to provide additional drainage to the front of the house to eliminate this issue.

3 - It was observed that some sections of the excessive vegetation was in contact with the timber floor structure elements, it is recommended that this vegetation be removed as soon as possible.

4 - It was further observed that some water was running down the rear wall timber cladding and under the floor structure creating water damage and mould. It is recommended that a carpenter repair any damage to the wall cladding and seal this junction.

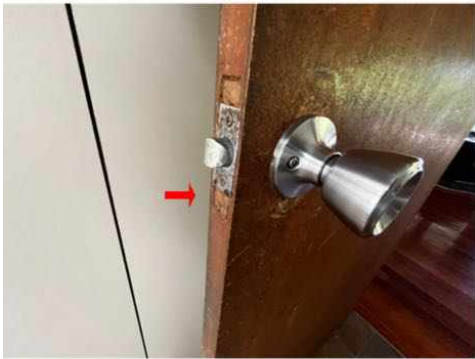
**Finding 2.03**

Building: Main Building  
Location: Powder room  
Finding: Powder room - defects  
Information: At the time of this inspection it was observed that there were a number of defects in the powder room area,

It appears that the water is leaking from the powder room and causing damage to the floor of the powder room, as detailed in this report under “excessive moisture”.

It is recommended that the powder room be renovated as soon as possible.

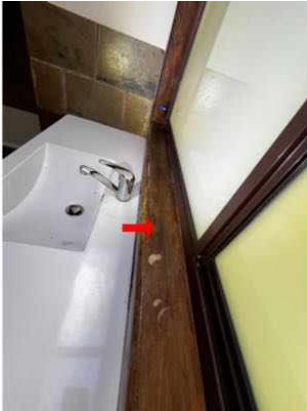
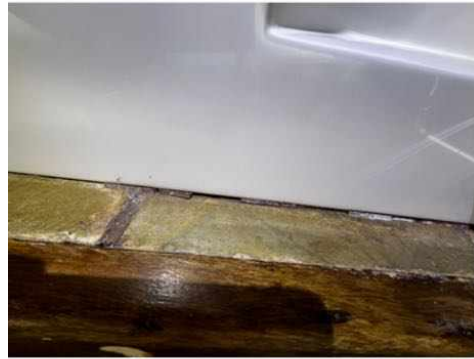
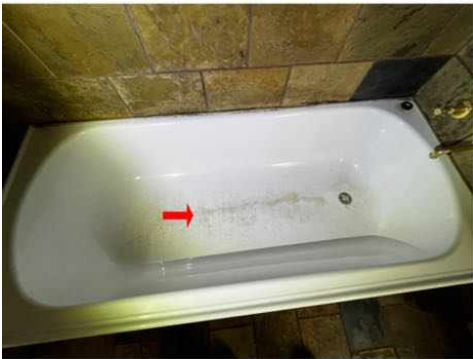
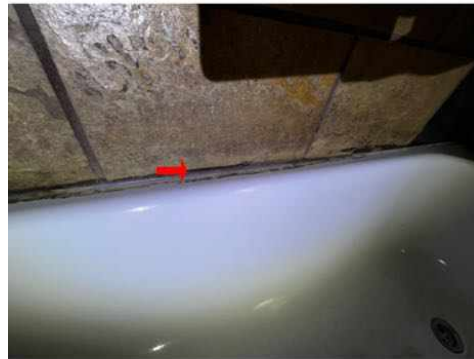
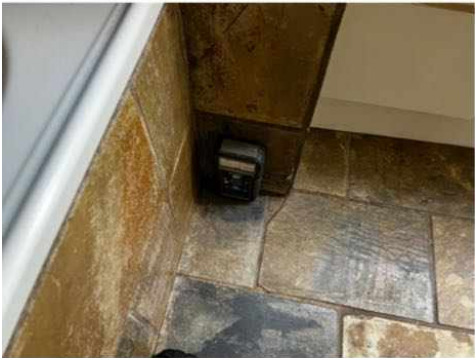
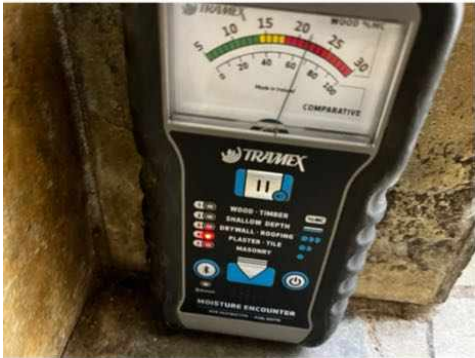
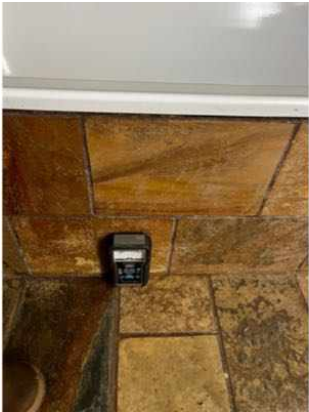
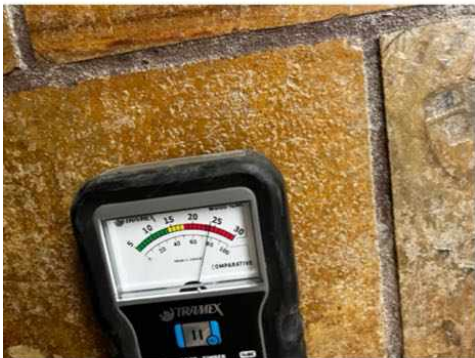
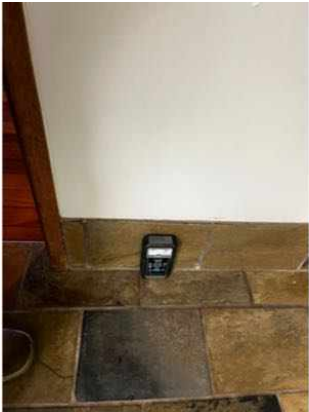
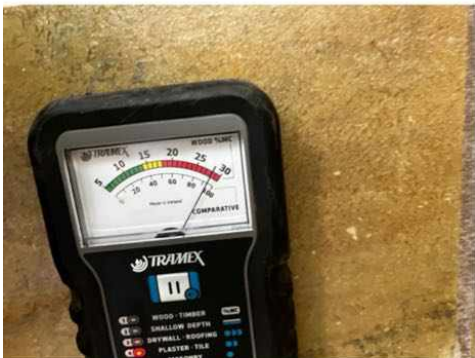
### Finding 2.04

Building: Main Building  
 Location: Powder room  
 Finding: Moisture - powder room excessive moisture evident  
 Information: At the time of this inspection a moisture meter was used to take reading of moisture outside the shower cubicle on both tiled walls.

An excessive moisture reading was evident in the wall tiles around the shower and bath.

The moisture readings in the tiles ranged from 22 to 28 on the moisture metre out of a

Water damage was evident under the bathroom floor and it appears that water is leaking from the shower area.

It is assumed that the waterproofing membrane has failed in the shower/ bathroom area.

It is recommended that a builder and plumber investigate this issue further to determine the cause of the excessive moisture content in the wall tiles and damage to the flooring and suggest remedial works to fix the underlying issue.

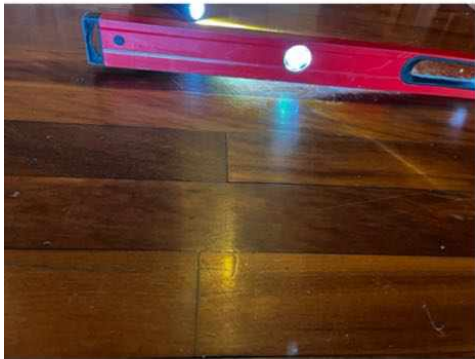
### Finding 2.05

Information: At the time of this inspection it was observed that the timber floors were generally level throughout the house.

It is recommended that a builder thoroughly inspect the subfloor area to determine any remedial works required to level the floors, at your discretion.

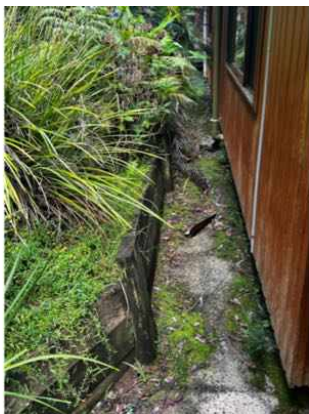
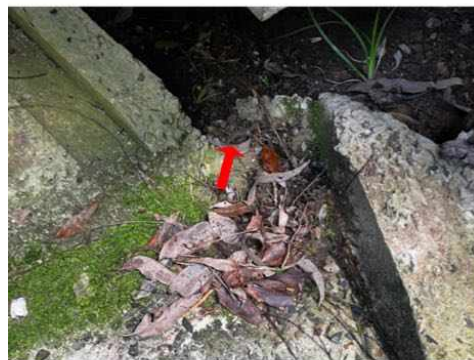
### Finding 2.06

Information: It was observed that there was no barrier to prevent water running under the house, it was also noted that there was no drainage at the front of the house to capture surface or subsoil water. It is recommended that a plumber install a sub soil agg drain to collect all water before it gets to the house and retaining walls, this work should be completed as soon as possible.

Damp soil under the house has the potential to attract termites and cause mould.

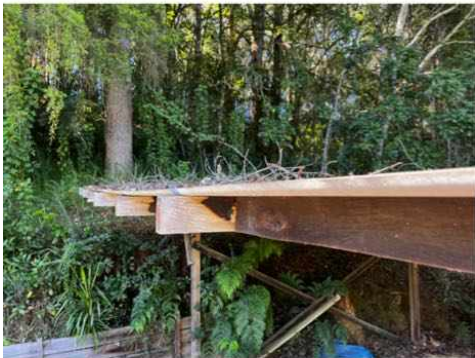
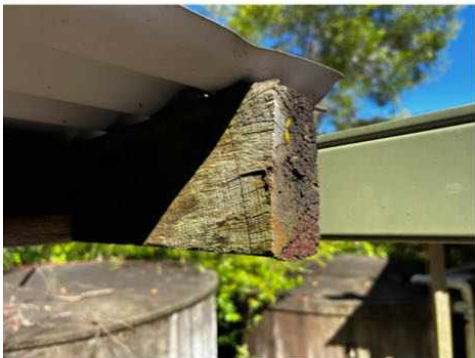
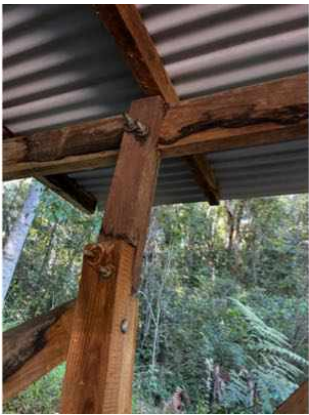
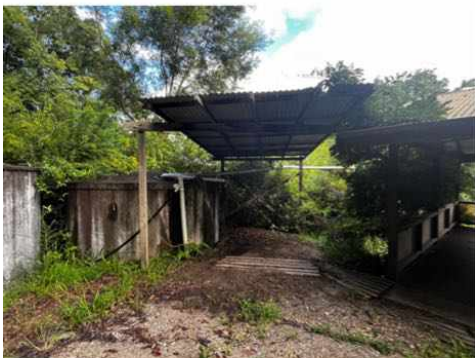
**Finding 3.01**

Building: Main Building  
Location: Carport  
Finding: Carport - defects  
Information: At the time of this inspection it was observed that the two carports at the front of the house were in poor condition and should be repaired or replaced.

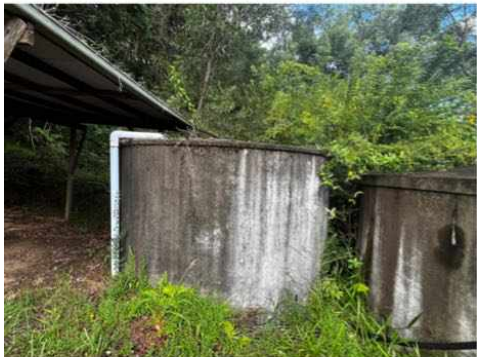
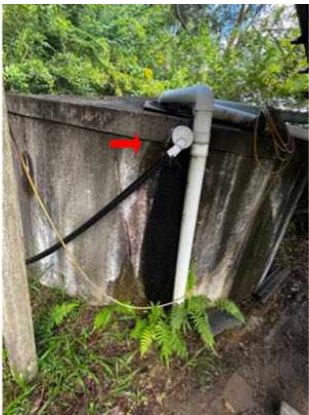
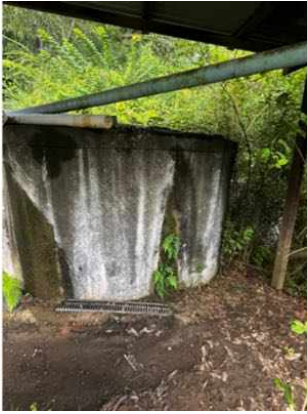
**Finding 3.02**

Building: Main Building  
Location: Water tanks  
Finding: Concrete water tanks - defects  
Information: It was observed at the time of this inspection that the concrete water tanks had excessive mould and fungus growth evident to the external areas, also noted was a water leak to the one tank where the pipe joins the tank. It is recommended that the vegetation around the tanks be cleared and tanks cleaned for inspection and repair.

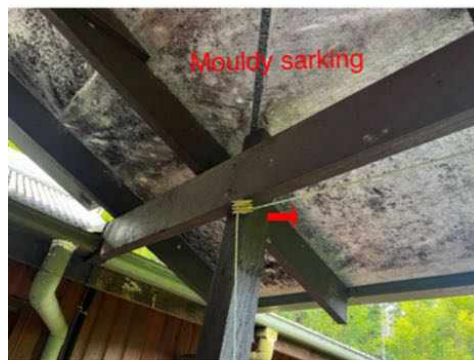
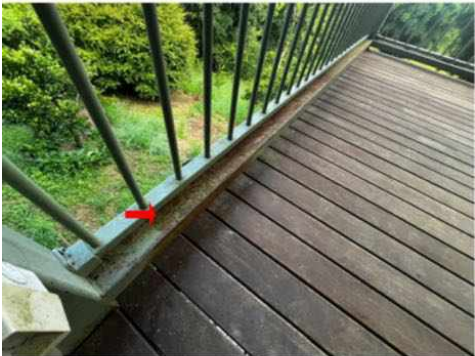
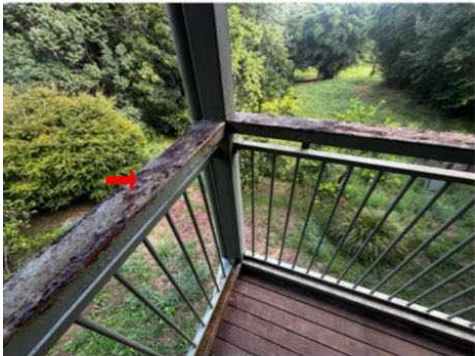
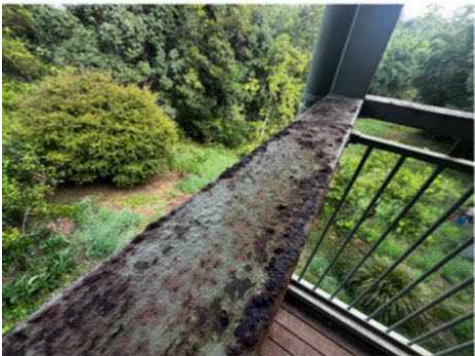
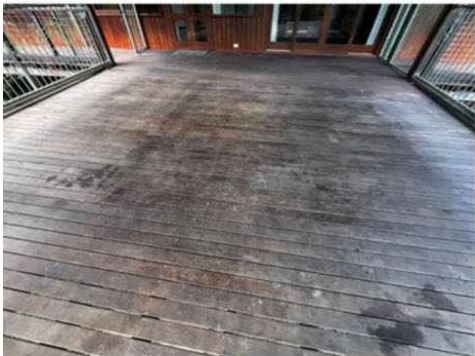
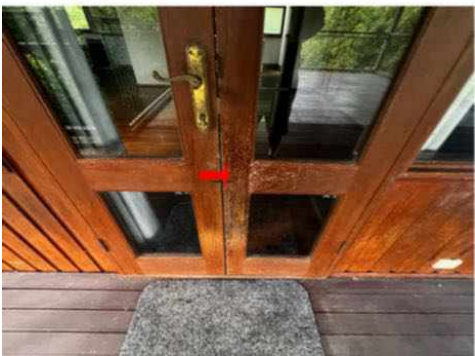
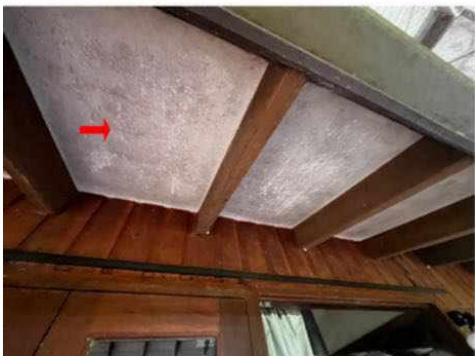
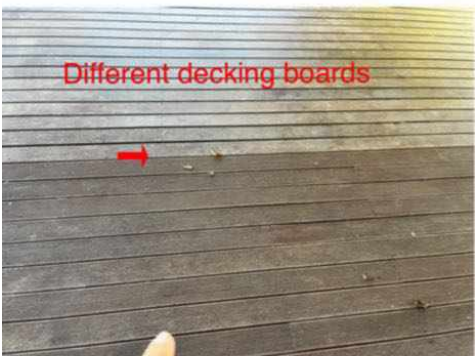
### Finding 3.03

Building:	Main Building
Location:	Rear covered deck
Finding:	Rear covered deck - defects
Information:	It was observed at the time of this inspection that the rear covered deck and rear wall area was in poor condition.

It was also observed that the steel balustrade elements were severely rusted in areas, it is recommended that a steel worker grind off the rust make any required repairs and re prime and paint the steel elements as soon as possible.

It was also observed that the rear eaves sheets and sarking to the underside of the deck roof were mouldy and should be pressure cleaned and repainted.

Maintenance is required to a number of items in this area, decking, timber balustrade, timber wall cladding, timber fascias and timber window and door frames all require repairing, sanding and re coating, it is recommended that a carpenter and painter complete these work as soon as possible.

The guttering should be cleaned of leaf litter.

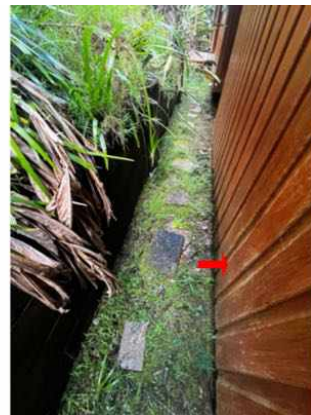
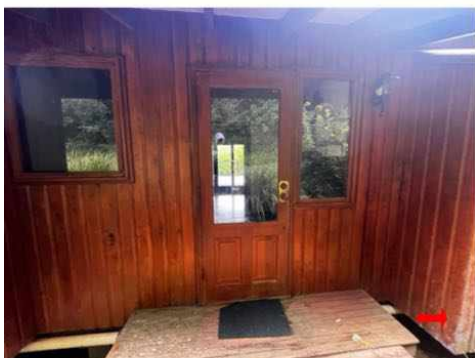
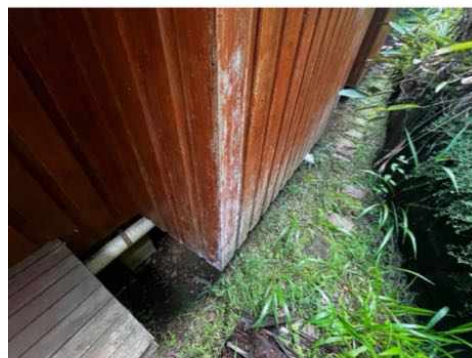
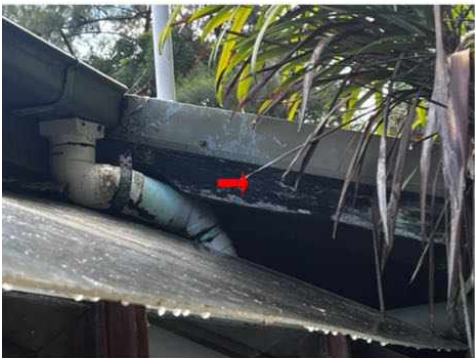
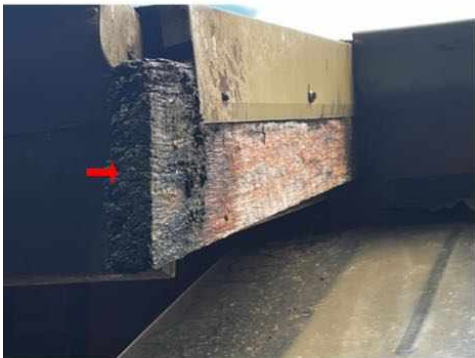
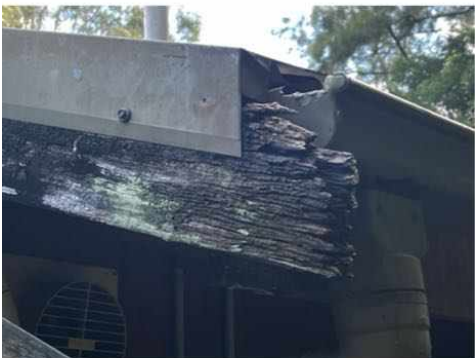
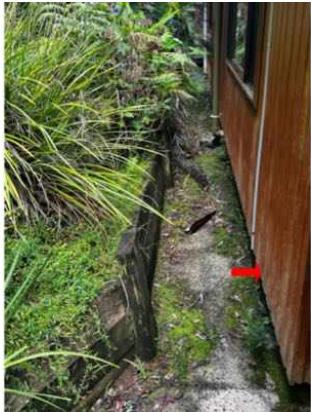
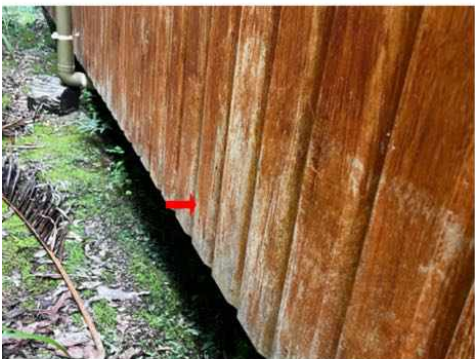
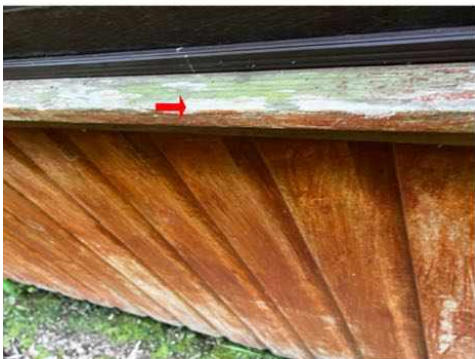
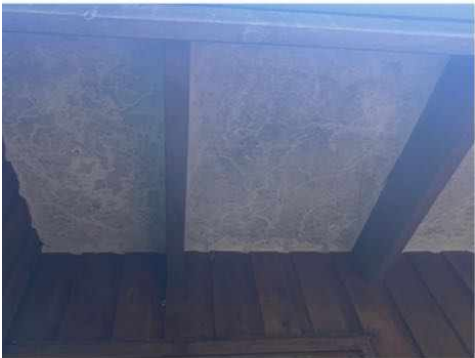
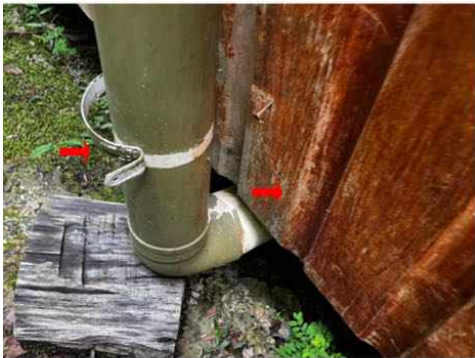
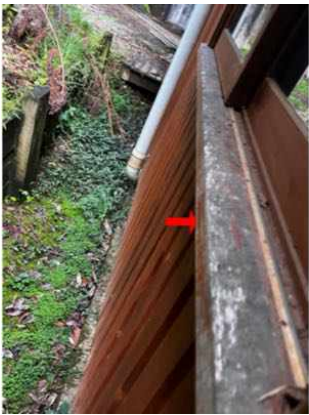
Finding 3.04

Building: Main Building  
Location: Exterior walls - front  
Finding: Exterior area front - defects  
Information: It was observed at the time of this inspection that there were a number of defects at the front of the house,

It was also observed that the front eaves sheets were mouldy and should be pressure cleaned and repainted.

It was observed that the front down pipe bracket was broken, a plumber should re fit the bracket as soon as possible.

Maintenance is required to a number of items in this area, timber wall cladding, timber fascias and timber window and door frames all require repairing, sanding and re coating, it is recommended that a carpenter and painter complete these work as soon as possible.

The guttering should be cleaned of leaf litter.

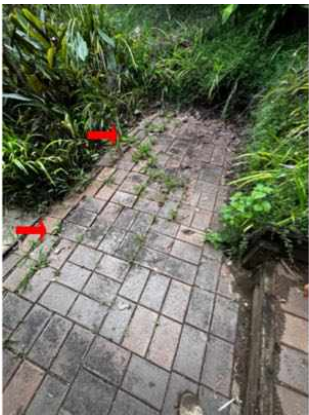
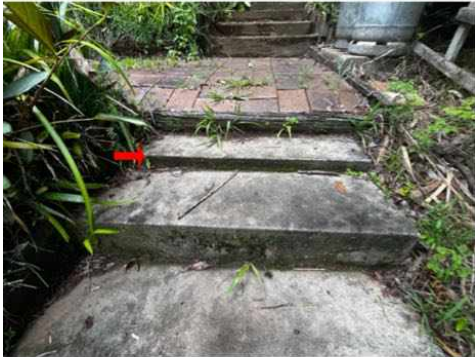
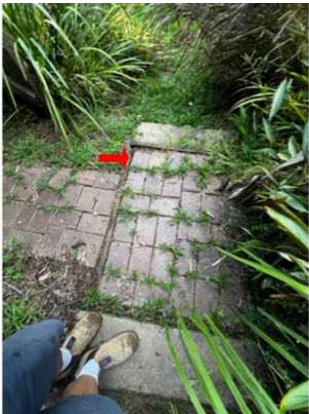
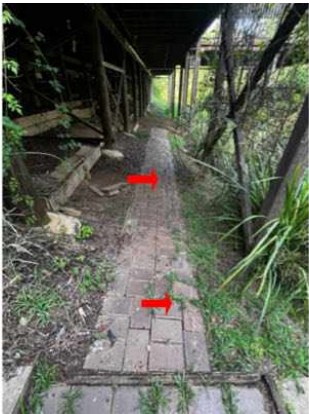
**Finding 3.05**

Building: Main Building  
Location: All External Areas  
Finding: Rear paved area - defects  
Information: At the time of this inspection it was observed that there was a paved footpath to the right side and rear of the house, it was observed that there were sunken areas in the paving.

It is recommended that a landscaper be engaged to replace any broken pavers and re level any areas of paving as soon as possible, there are possible trip hazards.

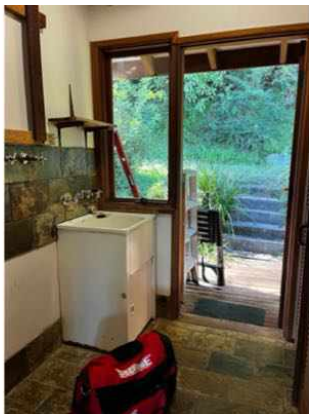
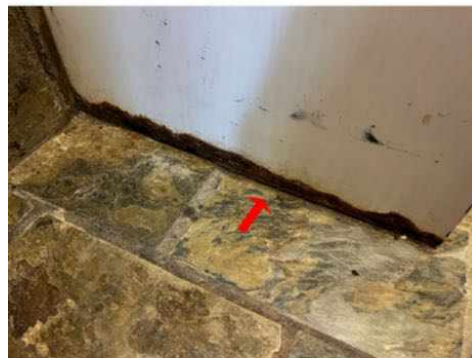
### Finding 3.06

Information: At the time of this inspection it was noted that there were a number of minor defects in the laundry.

1 - It was observed that the laundry tub and cabinet require replacement, the steel cabinet was rusted and the plastic tub stained.

2 - It was observed that there was damage to one linen cupboard door with a timber slat missing, a carpenter should repair the door.

3 - It was also observed that the timber to the window and door frames was weathered with minor damage, it is recommended that a painter prepare and repaint the entire room.

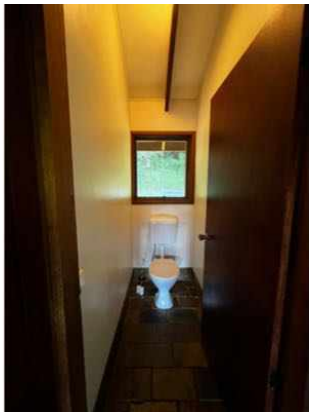
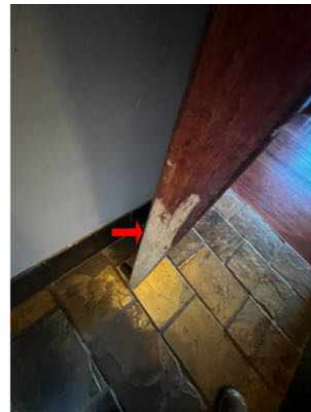
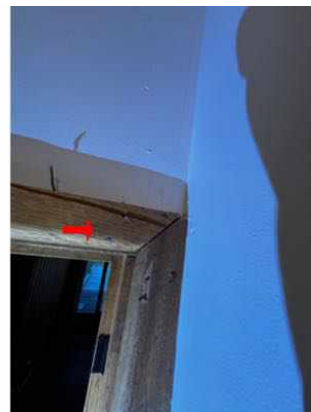
### Finding 3.07

Information: It was observed at the time of this inspection, it was observed that there was minor damage to the timber passage door, wall sheeting and timber architrave, it is recommended that a painter should prepare all surfaces and repaint the entire room.

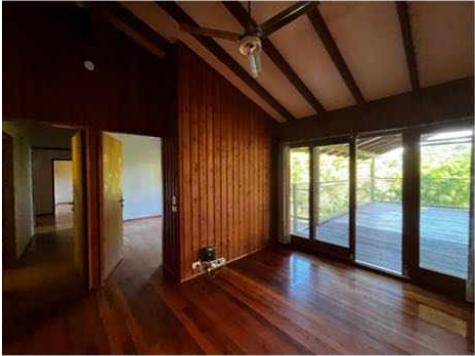
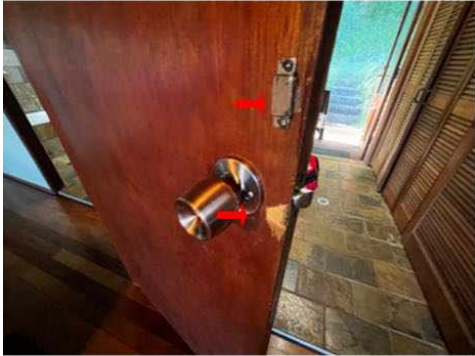
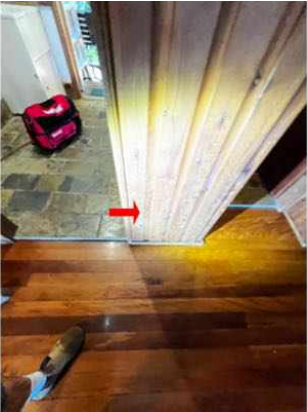
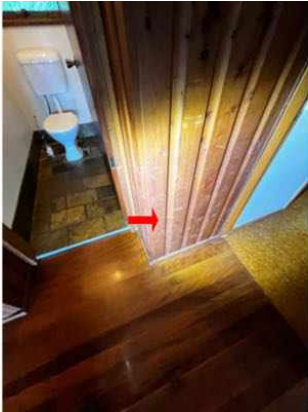
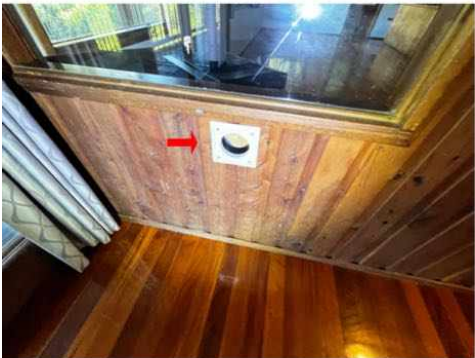
### Finding 3.08

Location: Breezeway  
Finding: Breezeway - defects  
Information: It was observed at the time of this inspection, it was observed that there was minor damage to the timber passage door and wall cladding, it is recommended that a painter should prepare all surfaces and repaint the entire room.

It was also observed that there was a hole in the timber cladding and appears to be missing a cover. A carpenter should fit a cover to this hole.

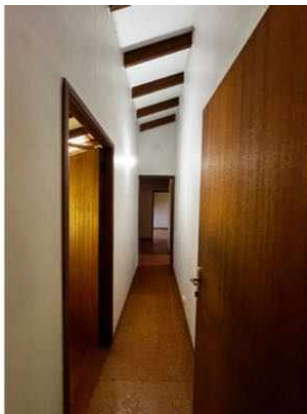
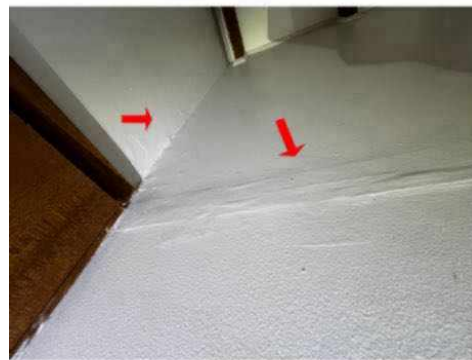
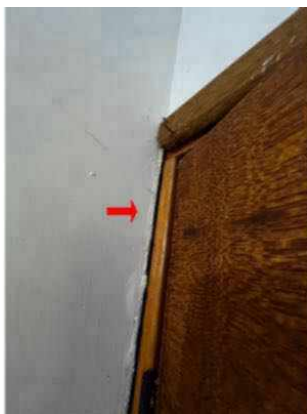
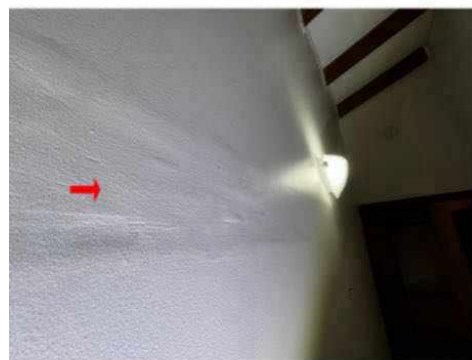
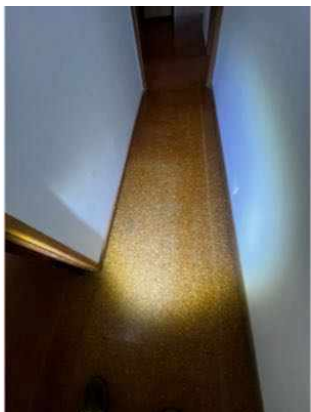
Information: At the time of this inspection several defects were observed in the hallway,

It was observed at the time of this inspection, that there were areas of rough finish to the wall sheets in the hallway, it is recommended that a plasterer re set the wall joins.

It was also observed that there was a timber trim missing from behind the passage door, this should be fitted by a carpenter.

It was also observed that there was minor damage to the floor coverings, it is recommended that new floor coverings be installed at your discretion.

It is recommended that all surfaces be prepared and a painter re paint the entire room.

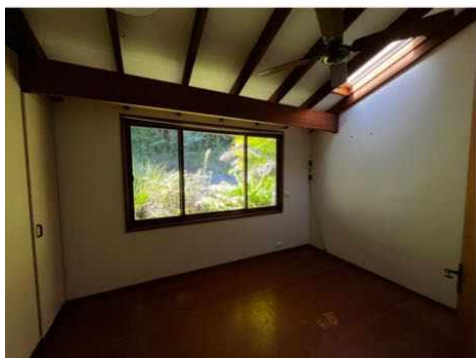
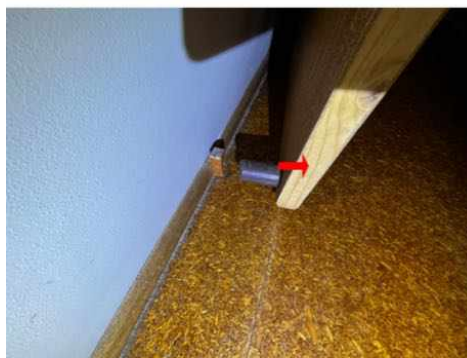
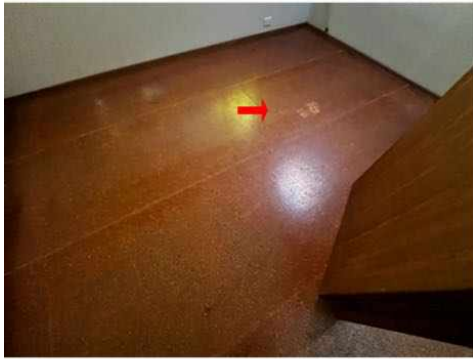
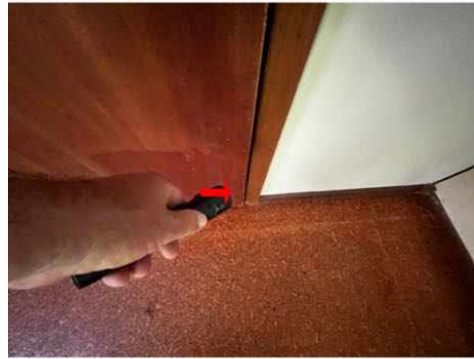
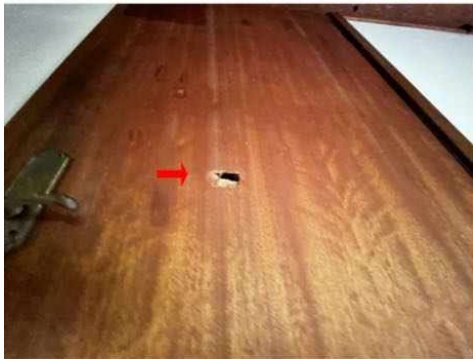
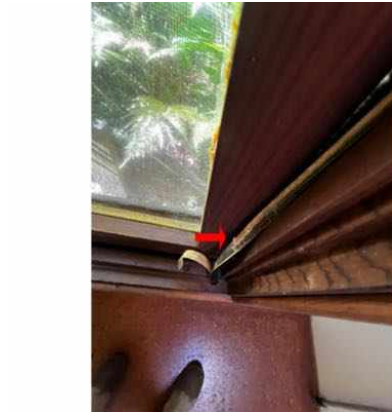
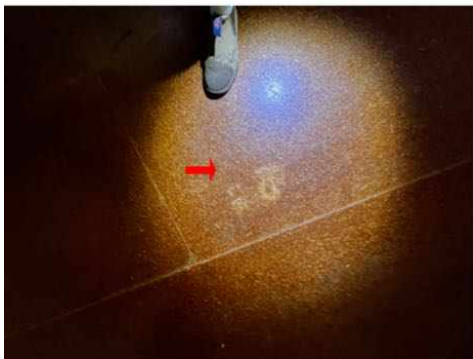
### Finding 3.10

Finding: Bedroom 3 - defects

Information: At the time of this inspection several defects were observed in bedroom 3,

It was observed that there were no floor coverings fitted to the bedroom it is recommended that floor coverings be installed at your discretion.

The passage door was damaged and was binding on the bottom lock side, it is recommended that the door be repaired or replaced by a carpenter.

It was observed that the seal was loose in the window, it is recommended that a glazier provide maintenance top all timber windows and doors.

It is recommended that all surfaces be prepared and a painter re paint the entire room.

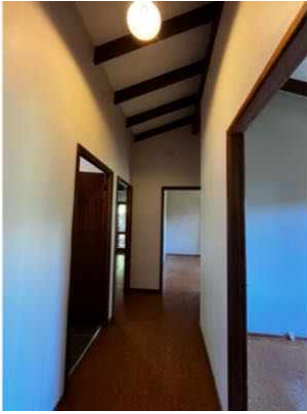
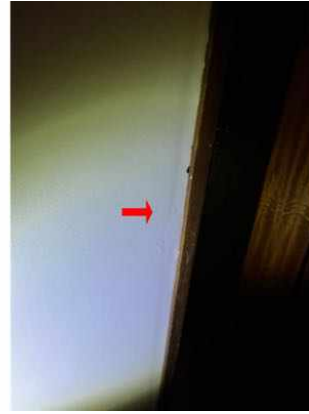
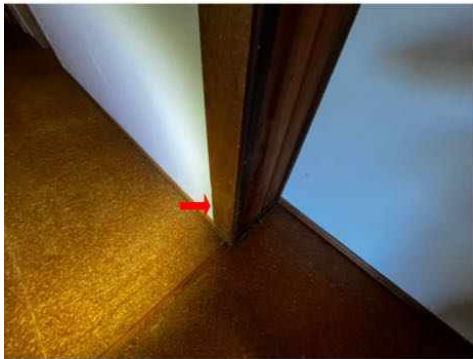
### Finding 3.11

Finding: Hallway 2 - defects

Information: At the time of this inspection it was observed that there was minor damage to the timber door jambs and wall area in hallway 2.

It is recommended that all surfaces be repaired by a painter and the entire room be repainted.

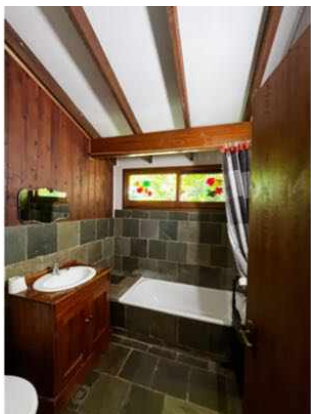
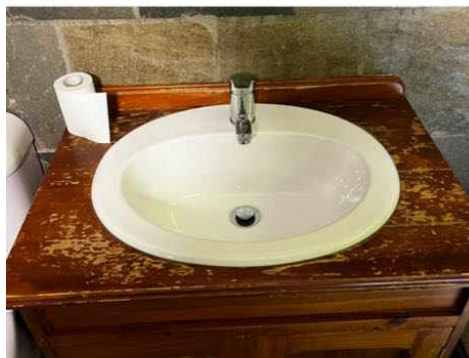
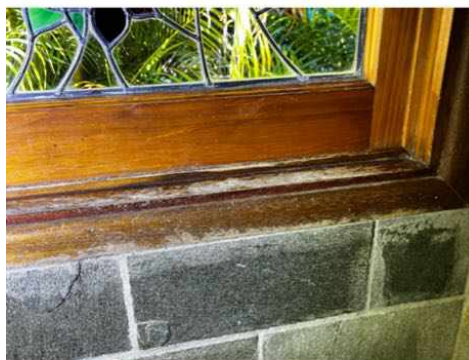
### Finding 3.12

Building: Main Building  
 Location: Bathroom  
 Finding: Bathroom - defects  
 Information: At the time of this inspection it was observed that there were a number of defects in the bathroom area,

1 - It was observed that the timber vanity bench was water affected, it is recommended that a painter sand and re coat the timber top.

2 - It was also observed that the timber window and frame was weathered and should be sanded and repainted.

3 - The bath tub had staining, this should be cleaned if possible.

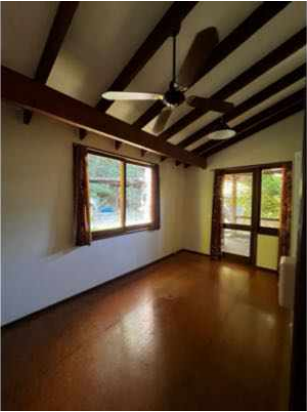
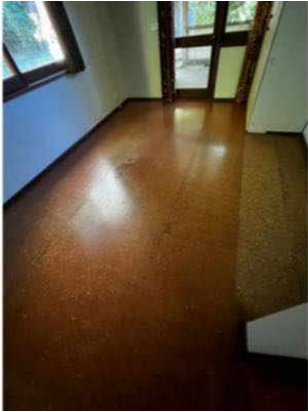
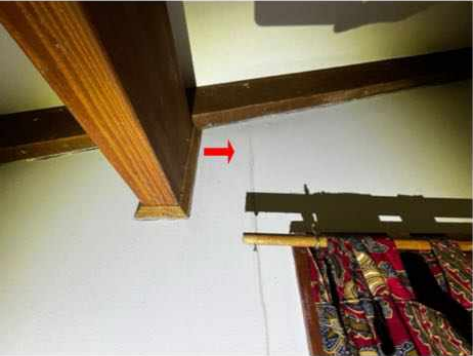
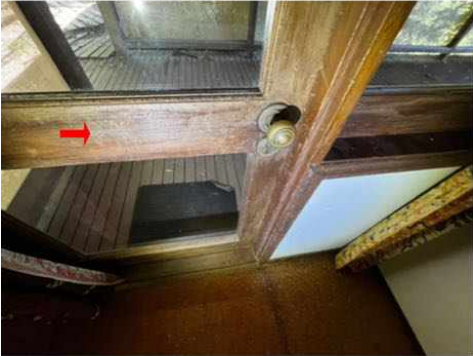
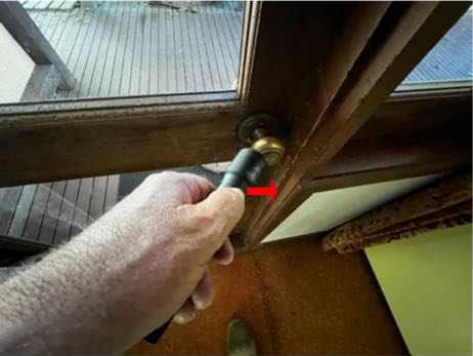
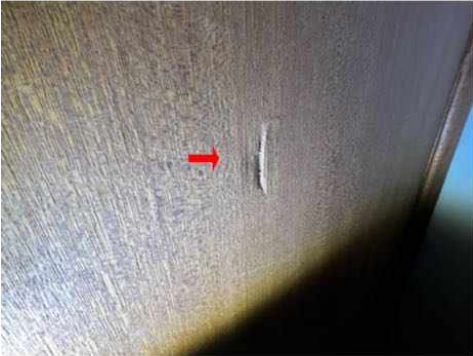
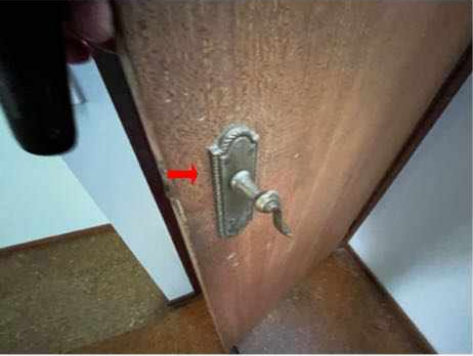
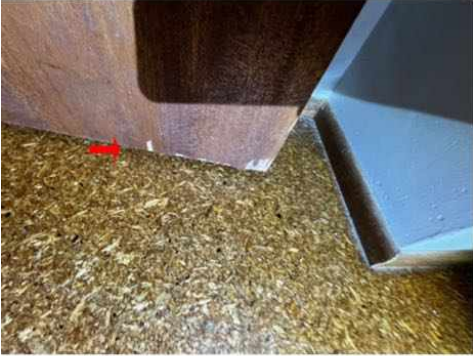
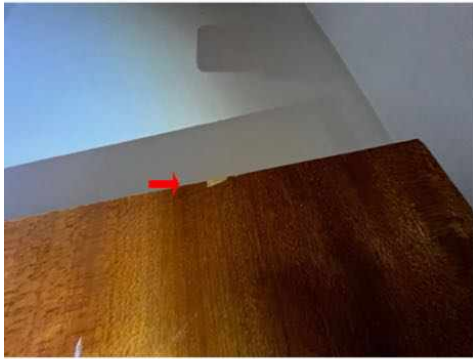
### Finding 3.13

Finding: Bedroom 2 - defects

Information: At the time of this inspection several defects were observed in bedroom 2,

It was observed that there were no floor coverings fitted to the bedroom it is recommended that floor coverings be installed at your discretion.

The passage door was damaged and the lock was damaged, it is recommended that the door be repaired or replaced by a carpenter.

The external door was not operational, it is recommended that a carpenter change the lock.

All timber windows and doors and frames were weathered with minor damage, it is recommended that all surfaces be prepared and a painter re paint the entire room.

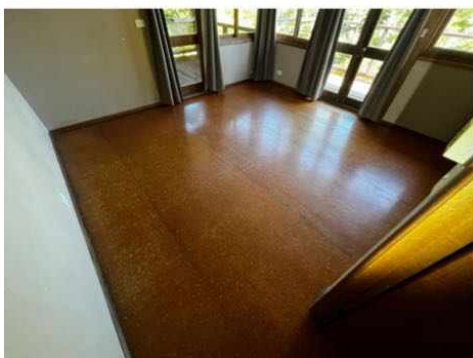
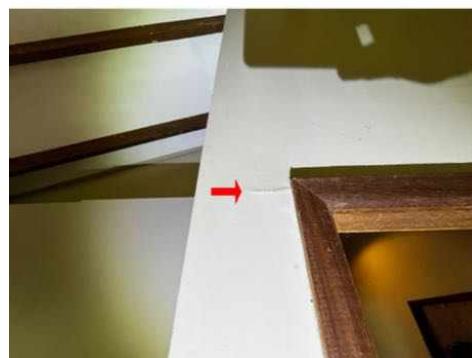
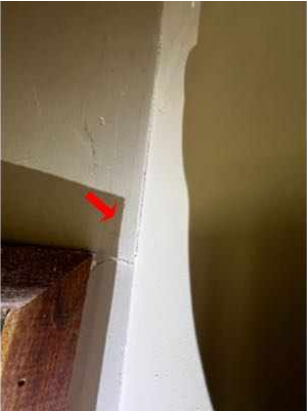
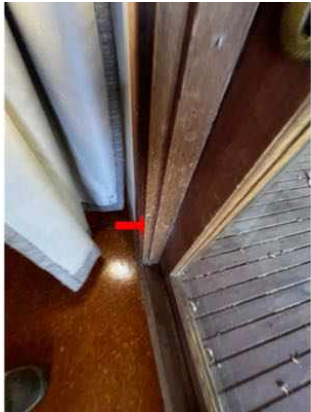
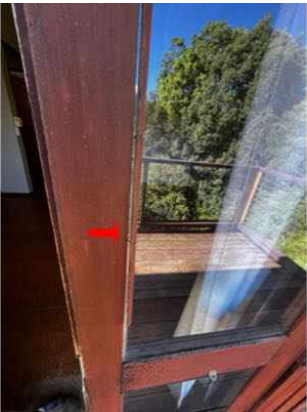
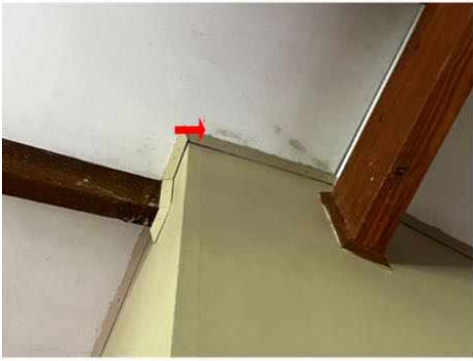
### Finding 3.14

Finding: Bedroom 1 - defects

Information: At the time of this inspection several defects were observed in bedroom 1,

1 - It was observed that there was minor cracking and damage to the wall sheeting, all areas should be patched and repainted.

2 - Minor marking was observed to the ceiling in one area, this area should be repainted at your discretion.

3 - It was observed that all timber windows and doors were weathered and should be prepared and repainted.

4 - It was observed that a trim was broken to the external door, a carpenter should repair the door and all surfaces be repainted.

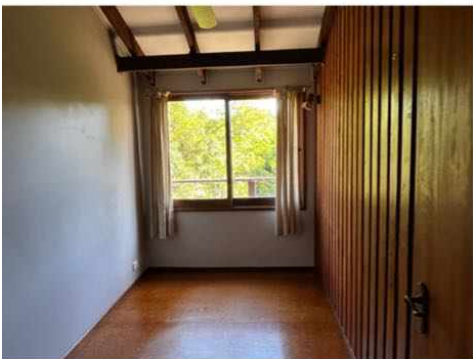
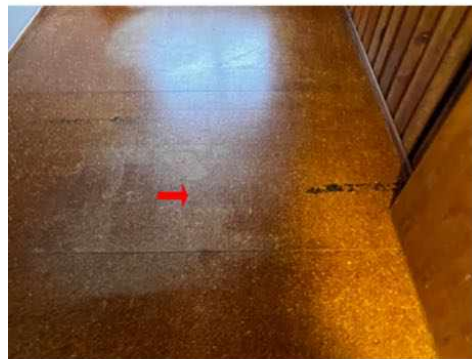
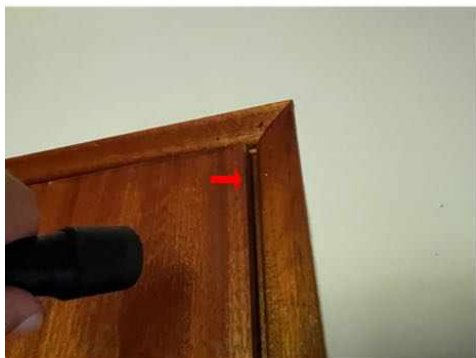
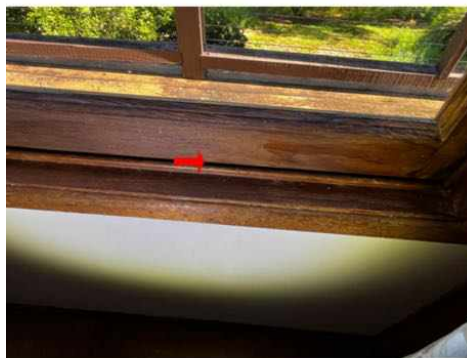
### Finding 3.15

Finding: Study - defects

Information: At the time of this inspection several defects were observed in the study,

It was observed that there were no floor coverings fitted to the bedroom it is recommended that floor coverings be installed at your discretion.

All timber windows and doors were weathered and should be prepared by a painter.

It is recommended that all surfaces be prepared and a painter re paint the entire room.

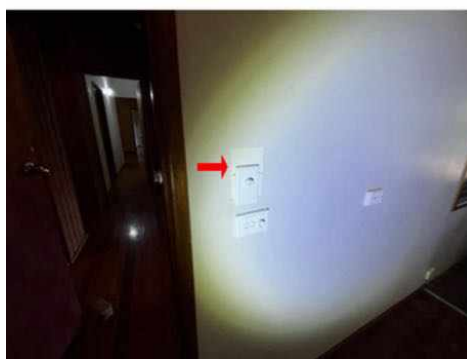
### Finding 3.16

Building: Main Building  
 Location: Lounge Room  
 Finding: Lounge room - defects  
 Information: At the time of this inspection it was observed that there were a number of defects in the lounge room,

1 - It was observed that there was minor damage to the wall sheeting and ceiling sheeting where replacement items have been fitted, these unpainted areas should be prepared and painted.

2 - It was observed that there was mould growth and marking evident to areas of the ceiling, the ceiling should be cleaned and repainted.

3 - All timber windows and doors were weathered and require preparing and re coating. Also observed were a number of minor areas of maintenance required and should be provided by a glazier.

4 - It was observed that there was minor damage and scratching to the timber flooring, a flooring expert should sand and re coat the floor at your discretion.
