# Building and Timber Pest Inspection Report

Inspection Date: Wed, 11 Mar 2026

Property Address: 140 Kalang Rd, Bellingen NSW 2454,  
Australia

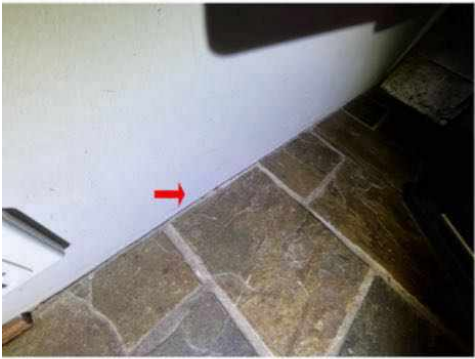
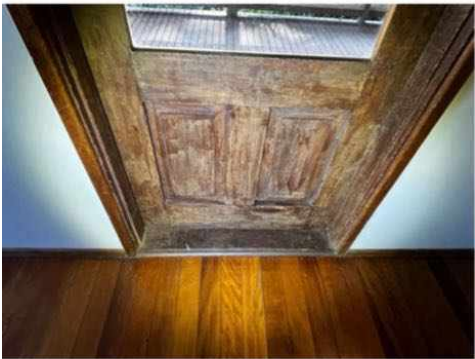
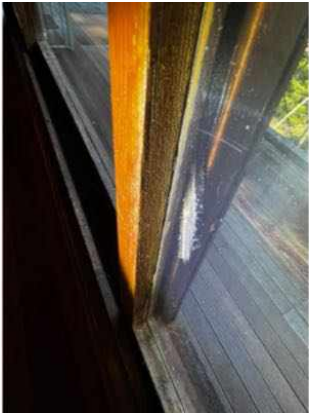
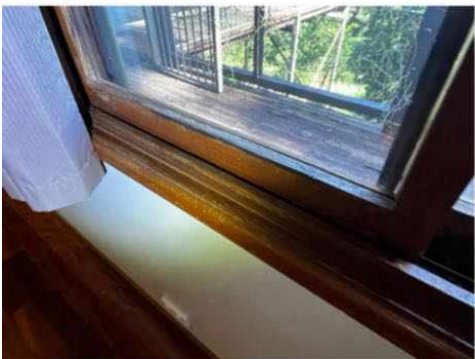
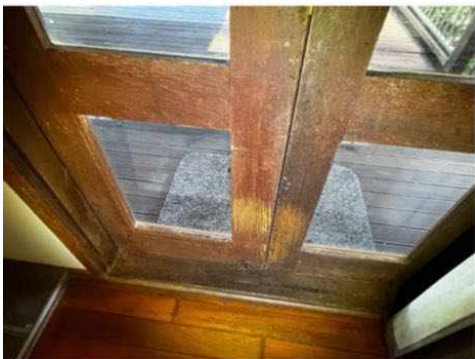
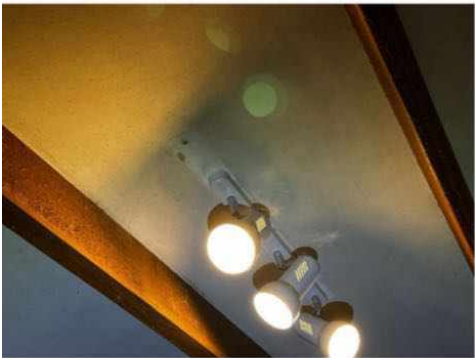
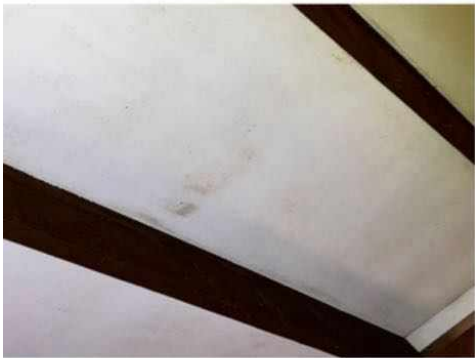
Building: Main Building  
 Location: Lounge Room  
 Finding: Lounge room - defects  
 Information: At the time of this inspection it was observed that there were a number of defects in the lounge room,

1 - It was observed that there was minor damage to the wall sheeting and ceiling sheeting where replacement items have been fitted, these unpainted areas should be prepared and painted.

2 - It was observed that there was mould growth and marking evident to areas of the ceiling, the ceiling should be cleaned and repainted.

3 - All timber windows and doors were weathered and require preparing and re coating. Also observed were a number of minor areas of maintenance required and should be provided by a glazier.

4 - It was observed that there was minor damage and scratching to the timber flooring, a flooring expert should sand and re coat the floor at your discretion.

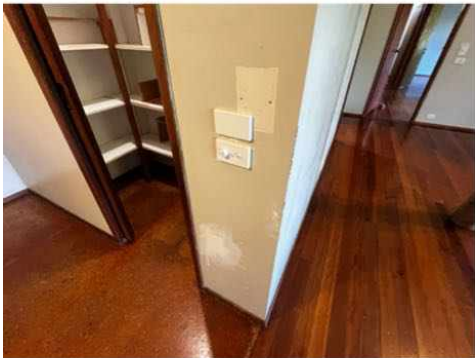
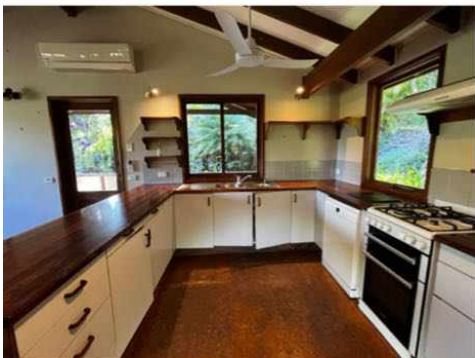
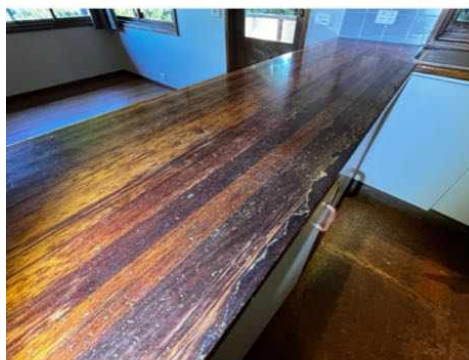
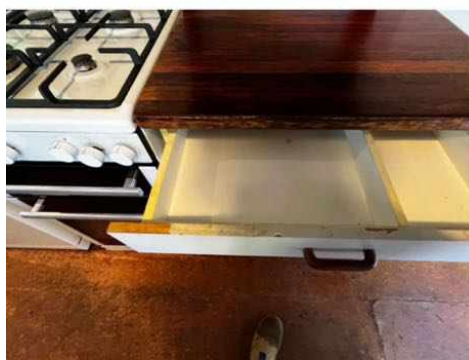
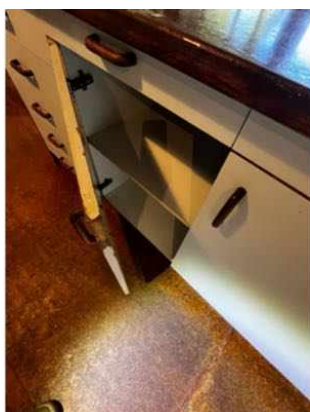
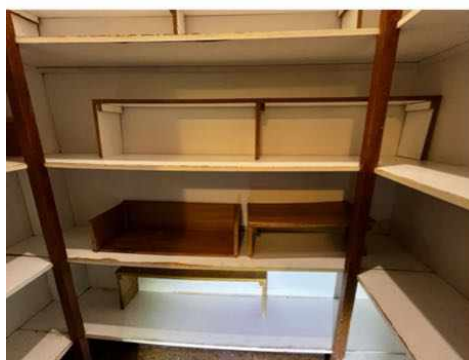
**Finding 3.17**

Building: Main Building  
Location: Kitchen  
Finding: Kitchen - minor defects  
Information: At the time of this inspection, it was observed that the kitchen and pantry were in poor condition, it is recommended that the areas be renovated as soon as possible.

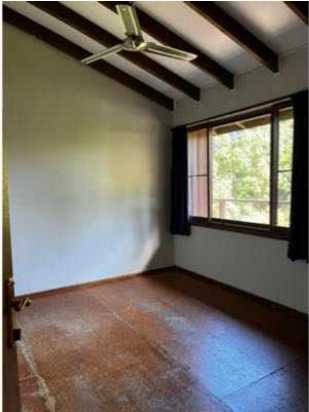
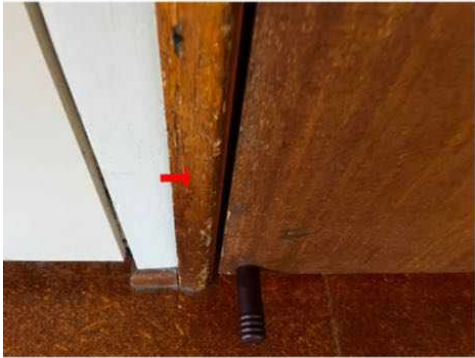
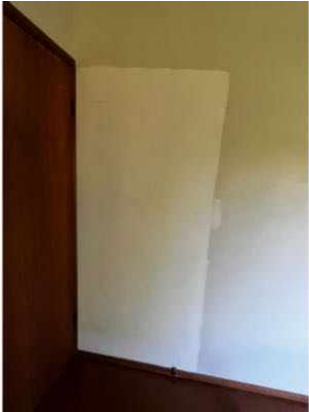
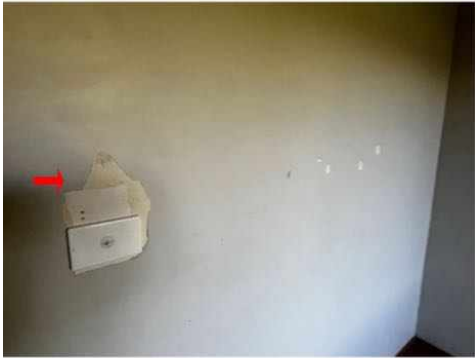
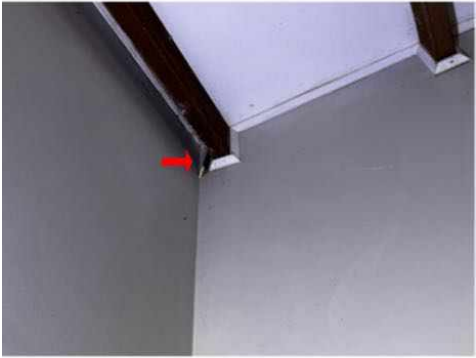
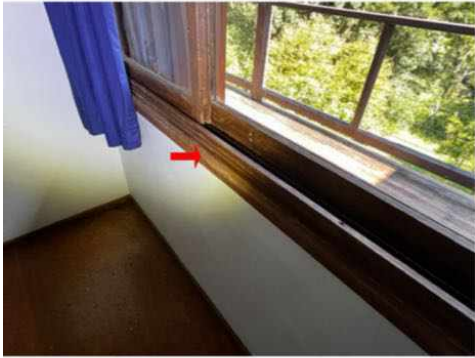
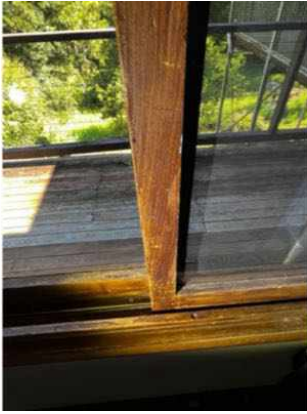
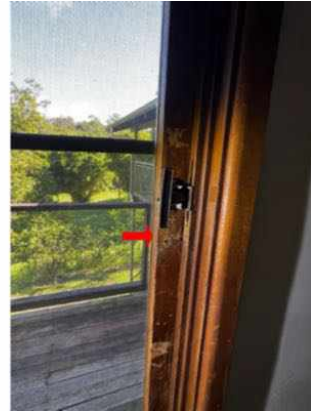
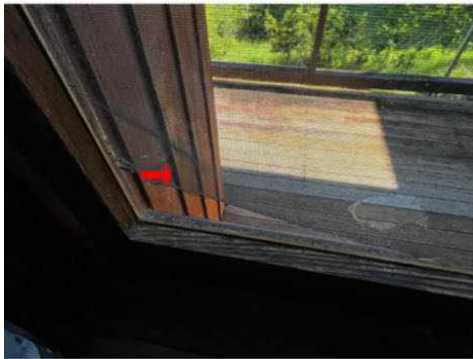
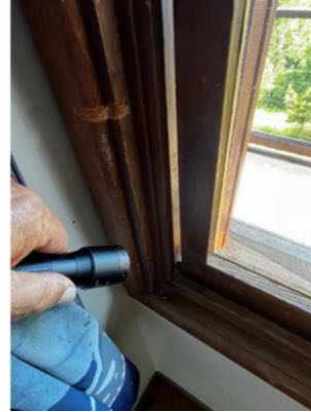
### Finding 3.18

Building:	Main Building
Location:	Bedroom 4
Finding:	Bedroom 4 - defects
Information:	<p>At the time of this inspection several defects were observed in bedroom 4,</p> <p>1 - It was observed that there was minor damage to the wall sheeting with areas unpainted, all areas should be patched and repainted.</p> <p>2 - A timber trim to the rafter was loose, a carpenter should re fix the trim.</p> <p>3 - It was observed that all timber windows and doors were weathered and should be</p>

4 - It was observed that the fly screen was damaged and the timber window would not close, it is recommended that a glazier provide maintenance to all timber windows and doors.

5 - No floor coverings were fitted to this room and there was damage to the floor sheets, it is recommended that floor coverings be fitted at your discretion.

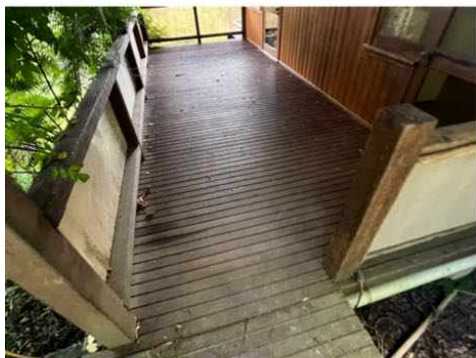
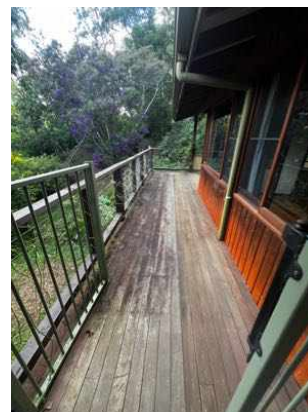
### Finding 3.19

Building:	Main Building
Location:	Decks
Finding:	External Timber Balcony or Deck - Structural Stability
Information:	The load capacity of the external balcony or deck could not be verified during the inspection.

External timber structures are also constantly exposed to weather elements and can deteriorate in an accelerated manner, ongoing assessments are required.

It is highly recommended that a Structural Engineer further assess the external timber balcony or deck to inform the client of its load capacity. Regular maintenance inspections by competent practitioners is needed.

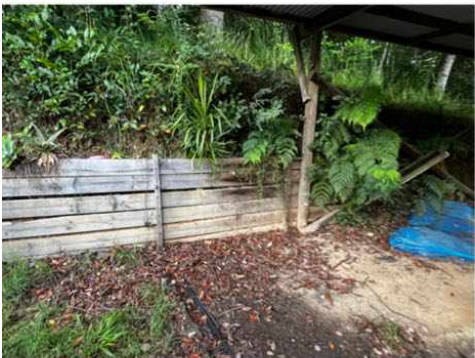
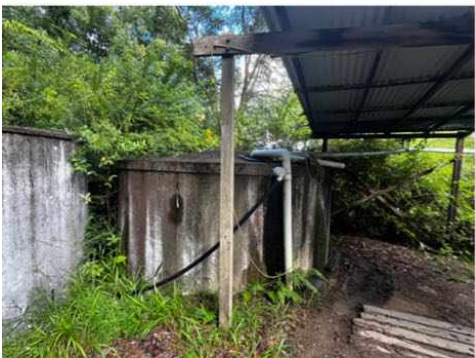
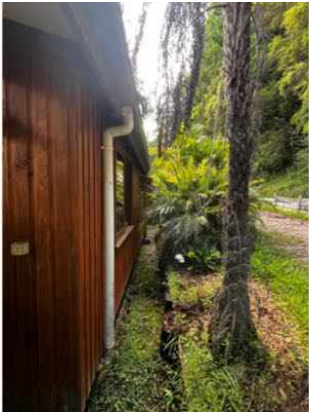
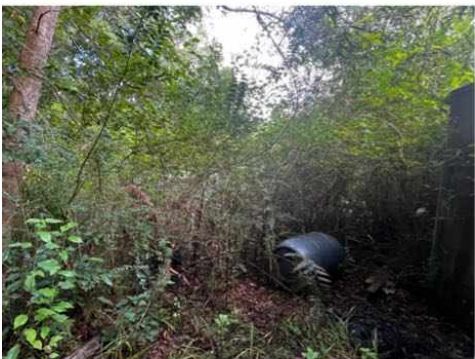
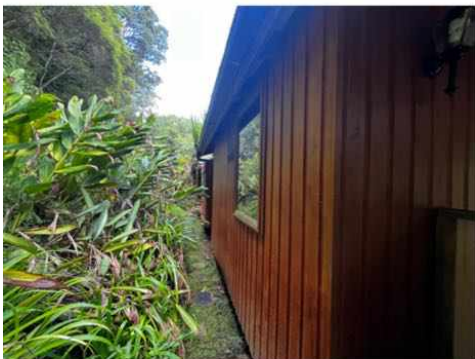
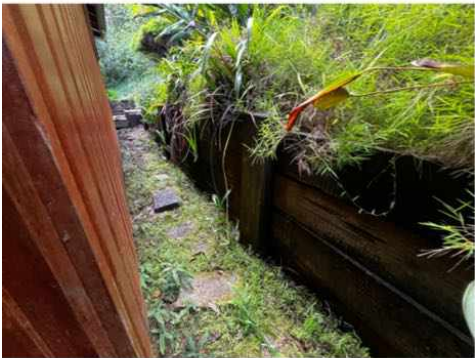
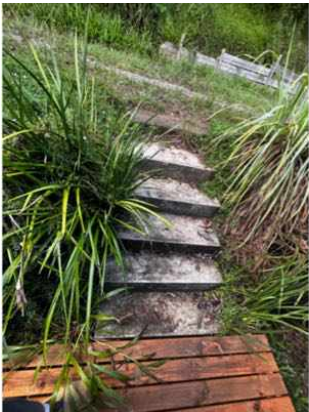
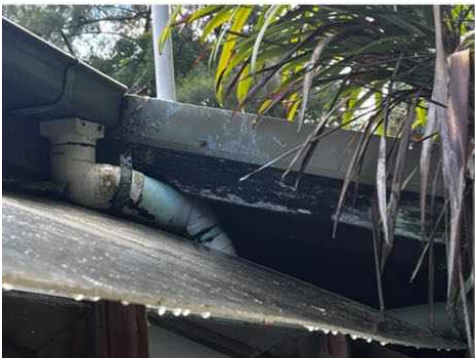
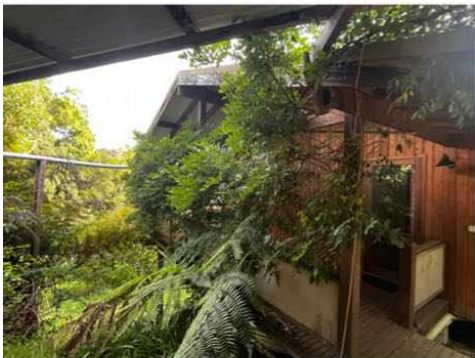
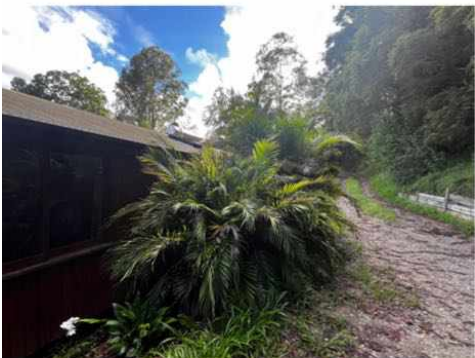
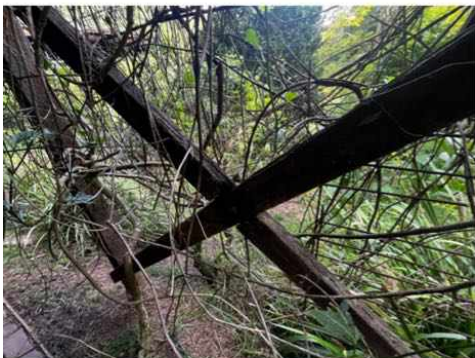
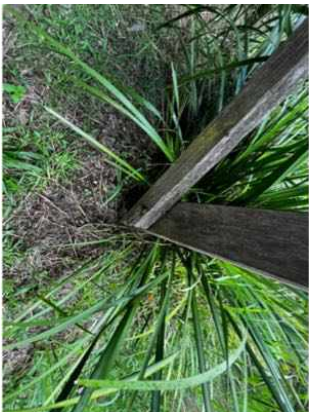
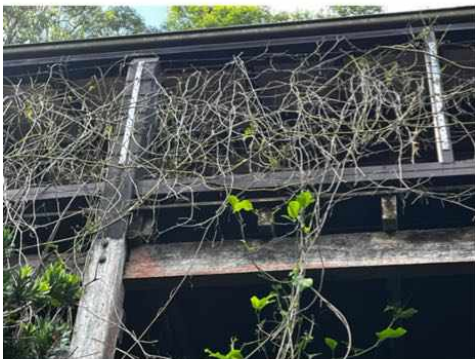
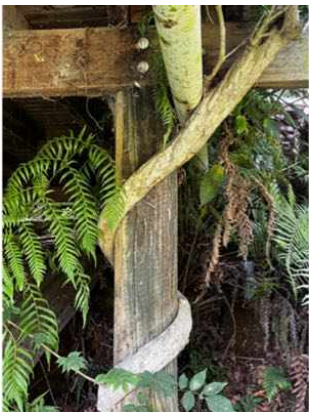
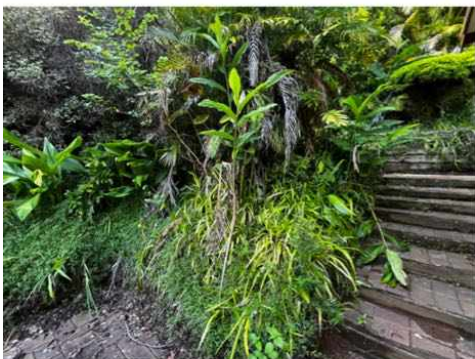
Building: Main Building  
Location: All External Areas  
Finding: Overgrown vegetation  
Information: Extensive and overgrown vegetation was observed to all areas of the house and yard, this vegetation should be thinned out or removed and all areas reinspected.

In areas the vegetation is causing damage to the building.

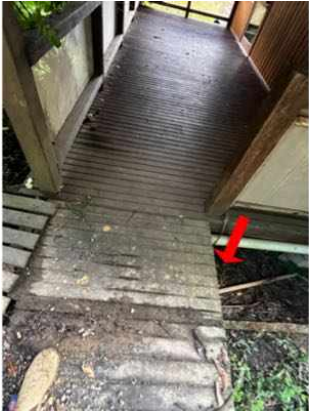
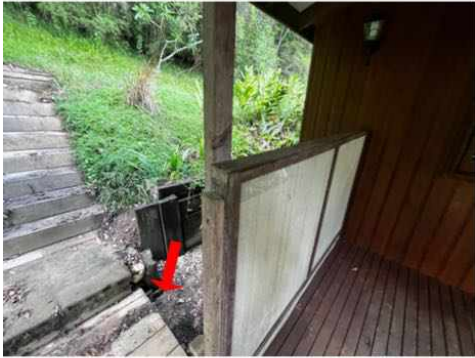
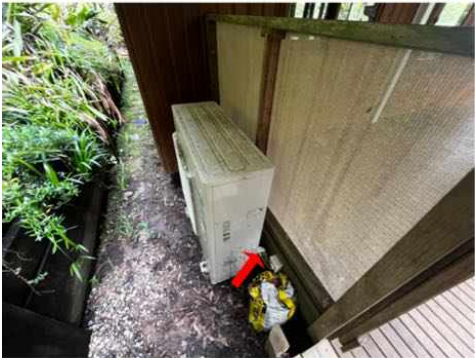
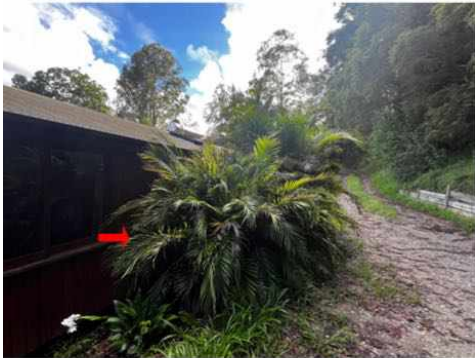
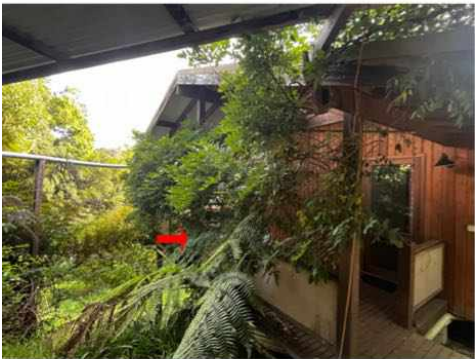
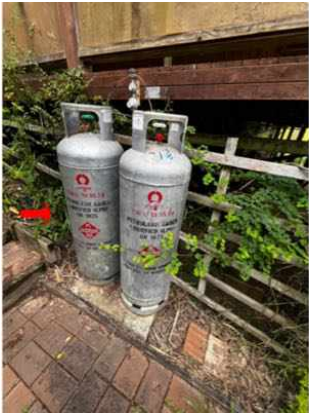
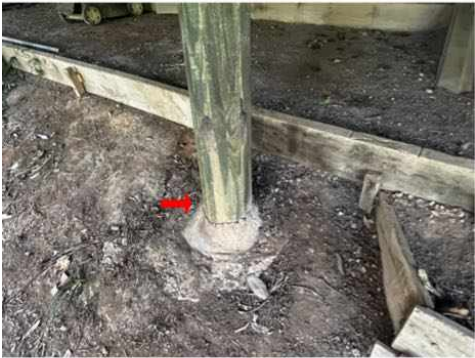
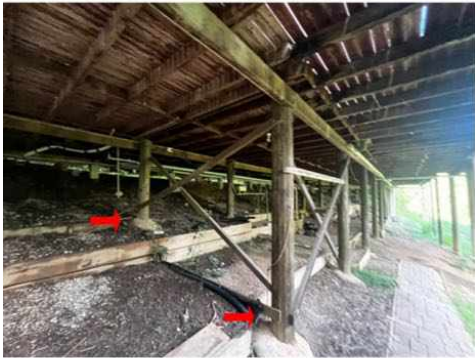
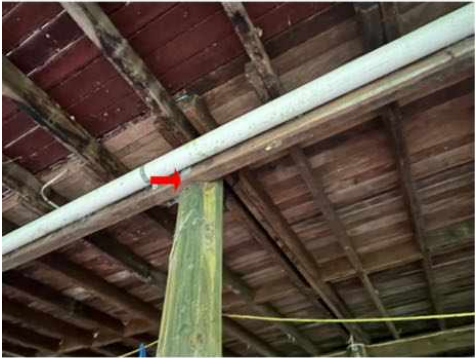
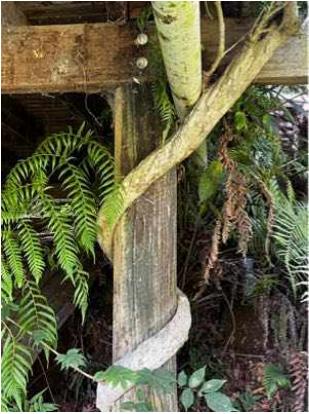
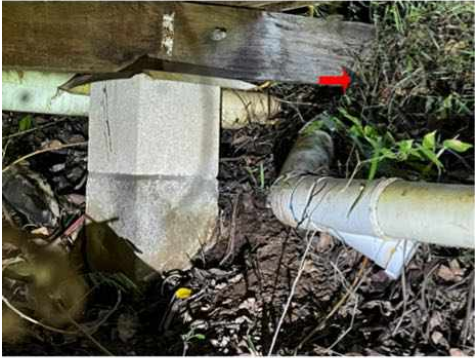
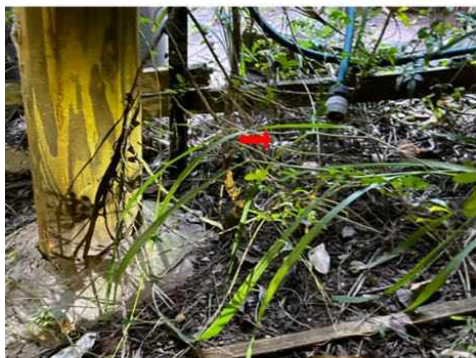
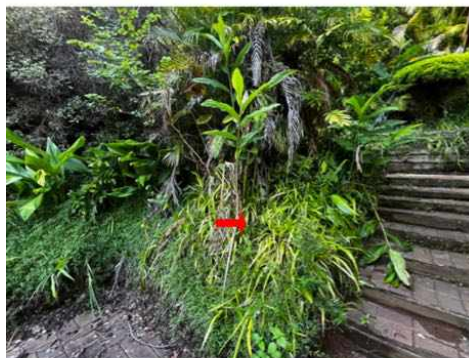
Building: Main Building  
Location: All External Areas  
Finding: Possible concealed termite entry areas - conducive to termite attack  
Information: At the time of this inspection, numerous areas of possible concealed termite entry points were observed around the exterior of the building.

These areas are points on the exterior of the building where it is not possible to view the external cladding or slab/foundation edge because of close proximity of external members/features.

It was also observed that numerous areas around the perimeter of the building and deck had Timbers in contact with the ground. This has the potential to attract termites to the building and should be removed as soon as possible.

These areas should be cleared if possible and monitored regularly for termite infestation by a timber pest expert.

It is recommended that a timber pest expert provide and implement a Timber Pest Management Plan as soon as possible.

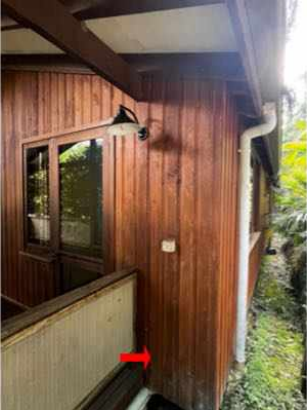
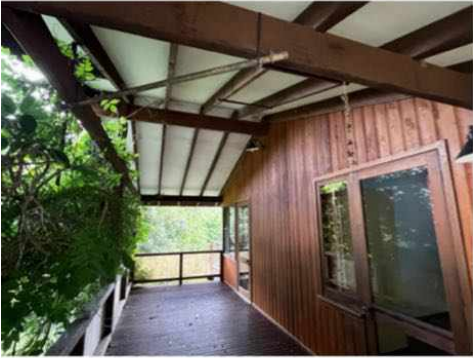
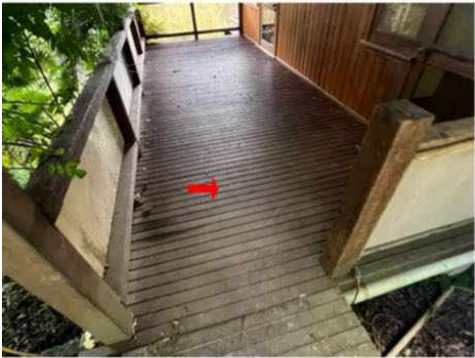
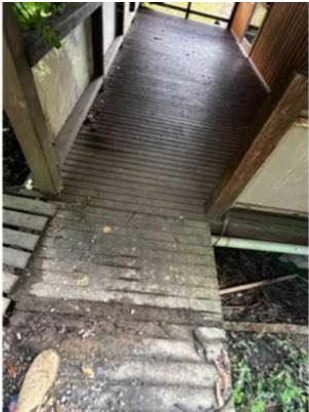
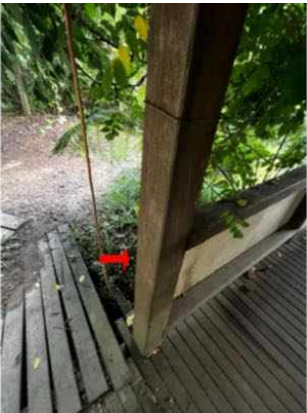
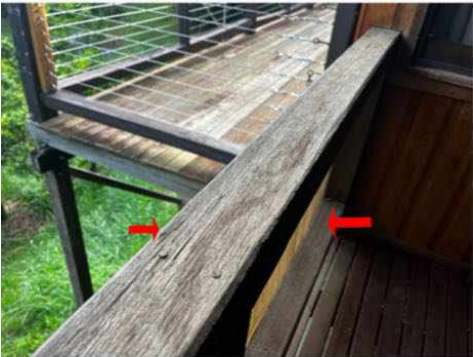
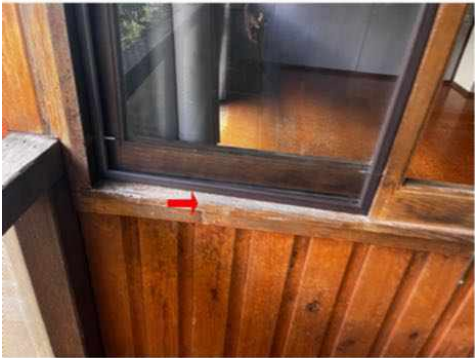
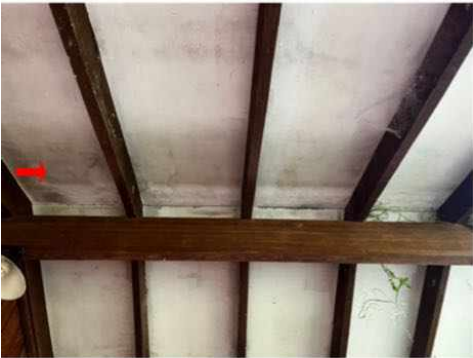
### Finding 7.01

Building:	Main Building
Location:	South deck
Finding:	Southern deck area - defects
Information:	It was observed at the time of this inspection that the southern deck area was in poor condition.

It was also observed that the deck ceiling was mouldy and should be pressure cleaned and repainted.

It was observed that the timber balustrade was non compliant under current regulations, however the balustrade may have been compliant when constructed. It is recommended that the balustrade be made compliant in the interests of safety.

Maintenance is required to a number of items in this area, decking, timber balustrade, timber wall cladding, timber fascias and timber roof support posts all require sanding repairing and re coating, it is recommended that a carpenter and painter complete these work as soon as possible.

All vegetation should be removed from this area as soon as possible.

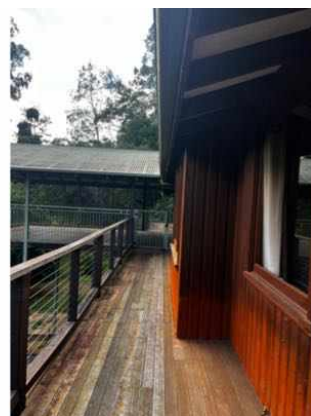
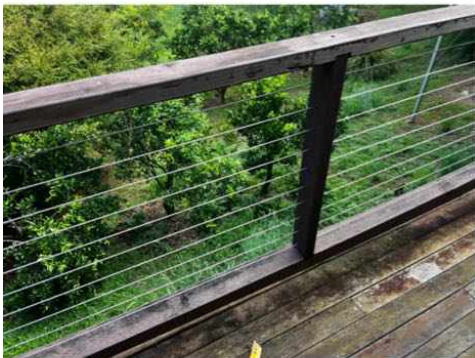
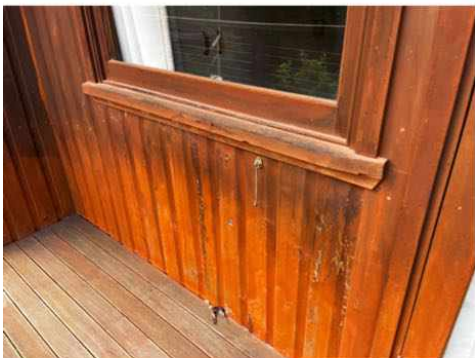
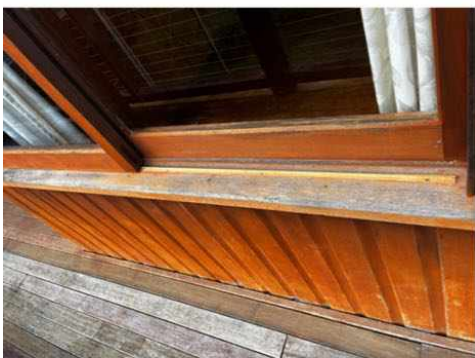
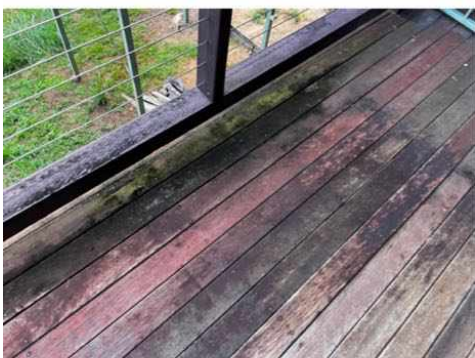
### Finding 7.02

Building:	Main Building
Location:	Rear uncovered deck
Finding:	Rear uncovered deck - defects
Information:	It was observed at the time of this inspection that the rear uncovered deck and rear wall area was in poor condition.

It was also observed that the rear eaves sheets were mouldy and should be pressure cleaned and repainted.

It was observed that the timber balustrade was non compliant under current regulations, however the balustrade may have been compliant when constructed. It is recommended that the balustrade be made compliant in the interests of safety.

Maintenance is required to a number of items in this area, decking, timber balustrade, timber wall cladding, timber fascias and timber window frames all require repairing, sanding and re coating, it is recommended that a carpenter and painter complete these work as soon as possible.

The guttering should be cleaned of leaf litter.

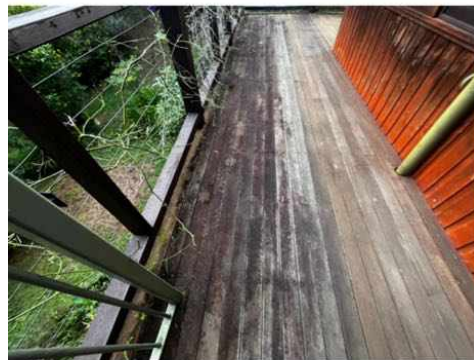
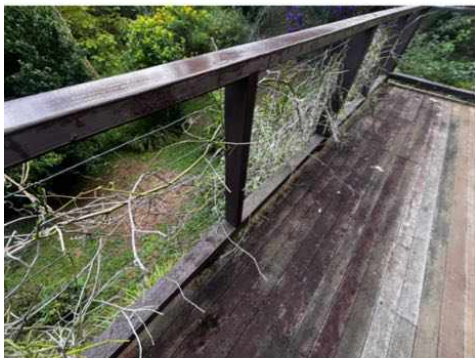
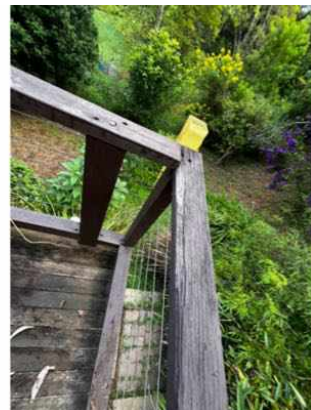
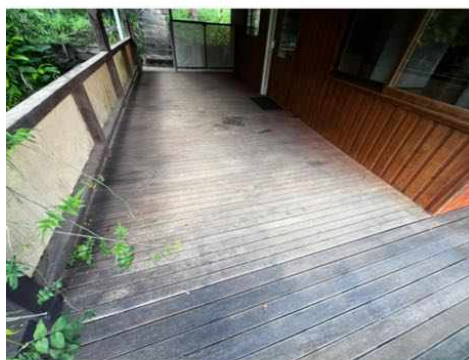
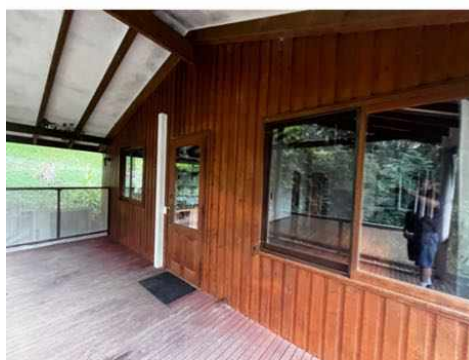
Finding 7.03

Building: Main Building  
Location: Rear covered deck  
Finding: East deck and wall area - defects  
Information: It was observed at the time of this inspection that the eastern wall and deck area was in poor condition.

It was also observed that the deck ceiling was mouldy and should be pressure cleaned and repainted.

It was observed that the timber balustrade was non compliant under current regulations, however the balustrade may have been compliant when constructed. It is recommended that the balustrade be made compliant in the interests of safety.

Maintenance is required to a number of items in this area, decking, timber balustrade, timber wall cladding and timber roof support posts all require sanding repairing and re coating, it is recommended that a carpenter and painter complete these work as soon as possible.

All vegetation should be removed from this area as soon as possible.

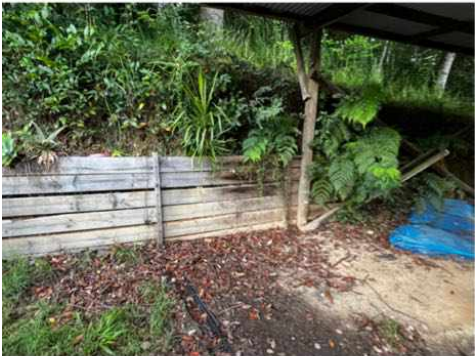
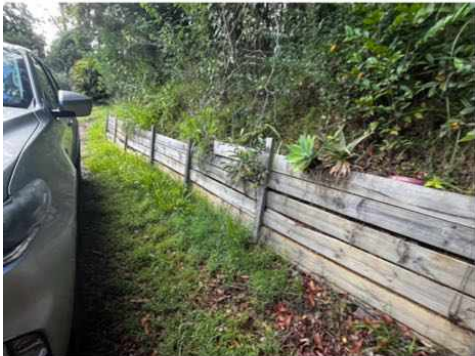
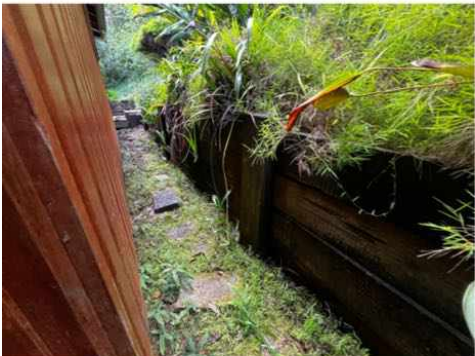
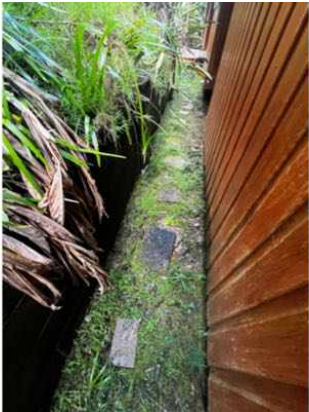
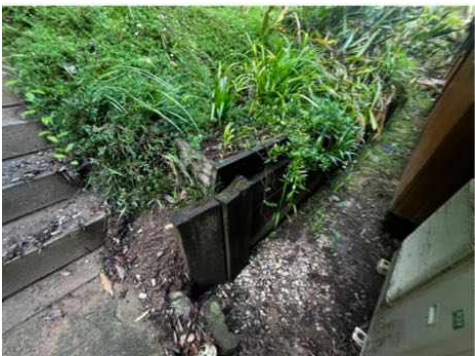
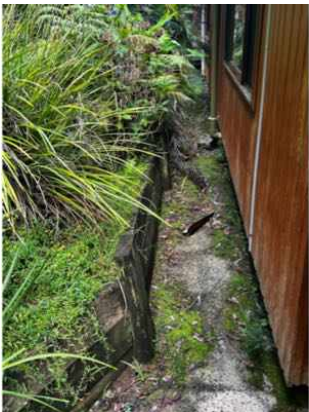
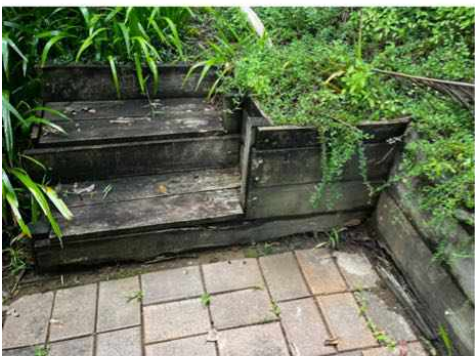
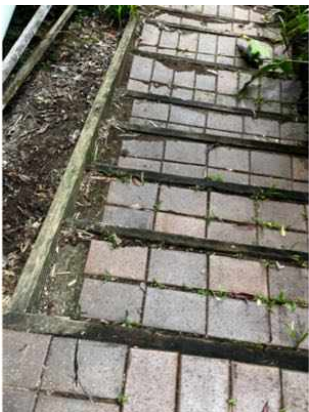
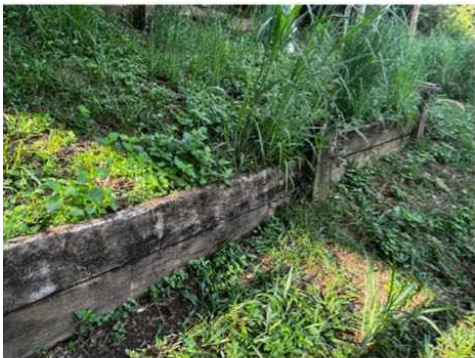
### Finding 7.04

Building:	Main Building
Location:	All External Areas
Finding:	Landscaping Timbers and retaining wall - defects
Information:	At the lke of this inspection it was observed that there was numerous timber elements used in the landscaping, these elements were garden edging, garden featured and retaining walls timbers.

Generally the timber elements were in fair condition with elements generally having fungal decay (wood rot) and mould evident. It was observed that the front retaining walls to the house were very wet. It is recommended that a plumber installs addition drainage to the front of the house to capture water prior to it entering the front gardens and going under the house.

It is recommended that all vegetation be thinned out or removed and a landscaper is engaged to provide maintenance (repair or replace damaged elements) to all retaining walls and landscaping Timbers as soon as possible.

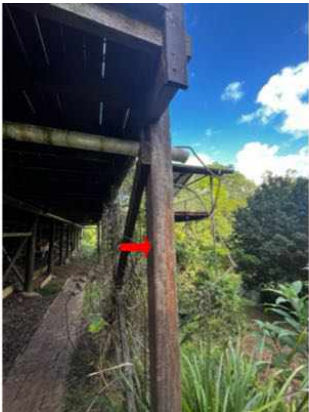
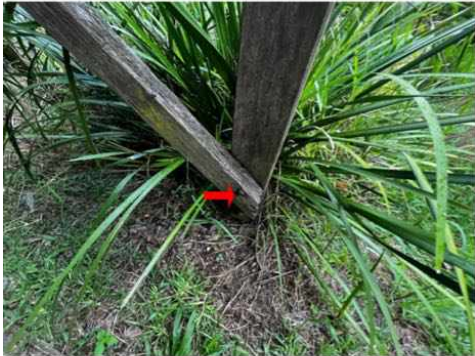
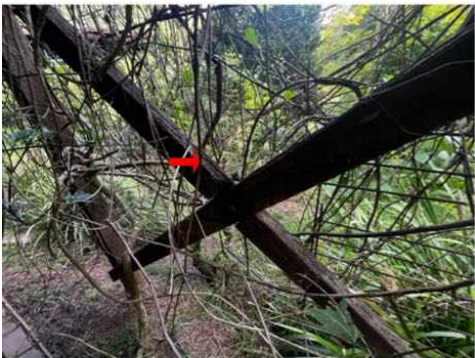
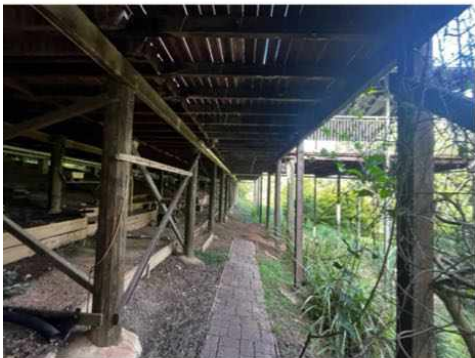
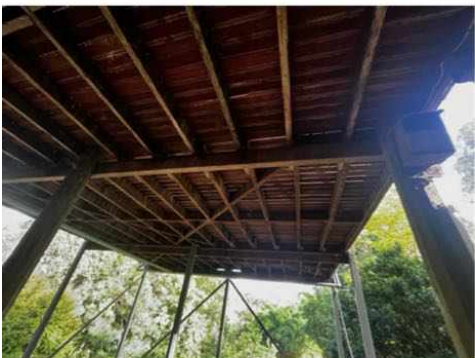
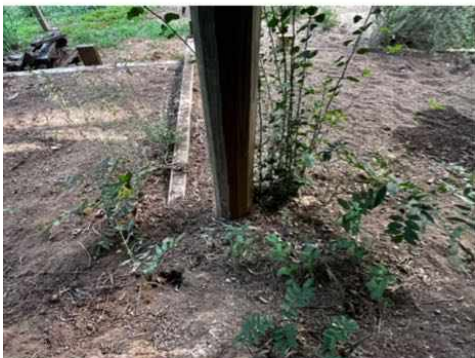
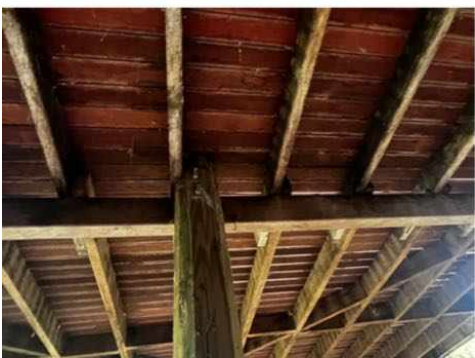
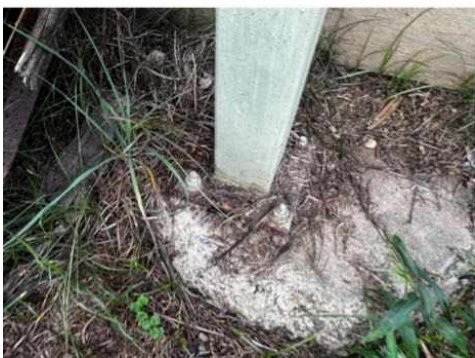
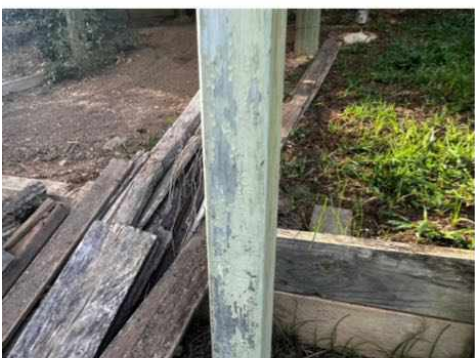
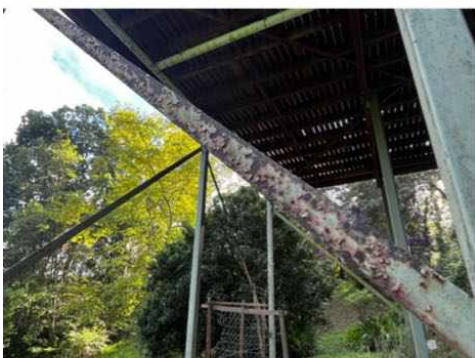
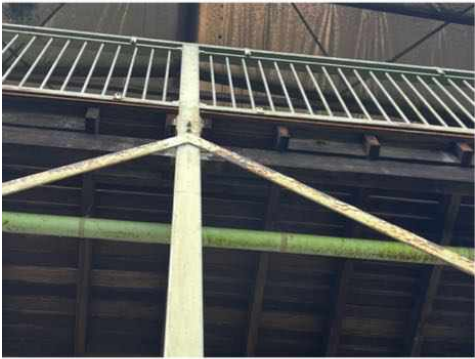
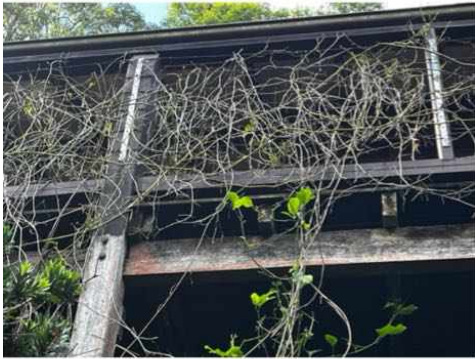
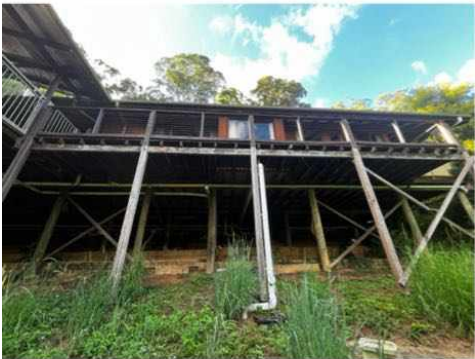
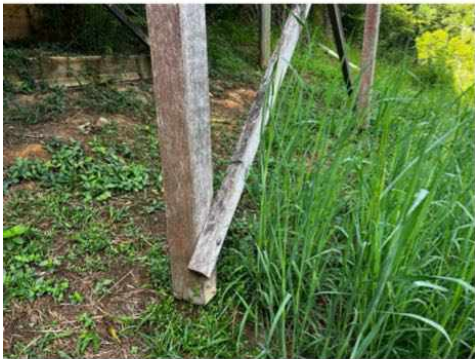
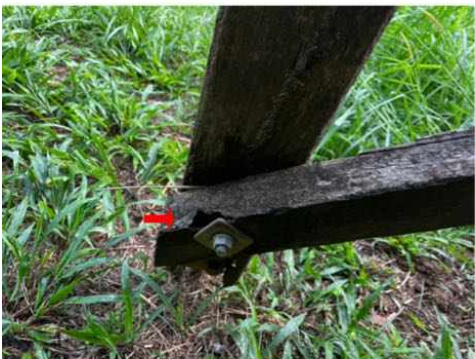
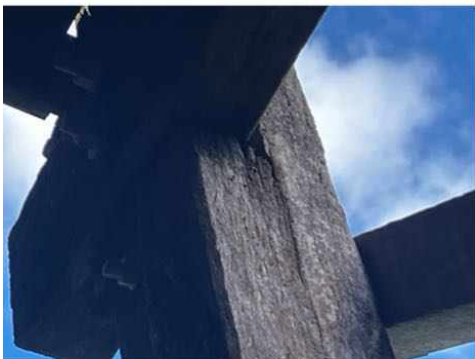
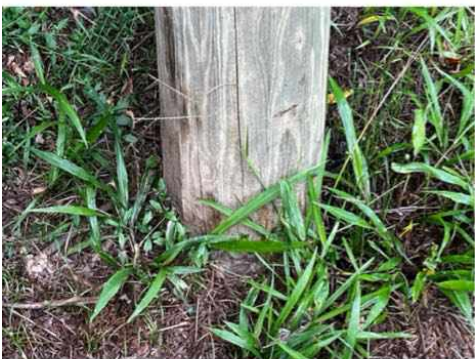
Building: Main Building  
Location: Deck structure  
Finding: Deck structure - defects  
Information: It was observed at the time of this inspection that there all deck structure and backing timber elements and steel elements were in poor to fair condition only.

It was observed that the steel posts, post feet and steel bracing all had rusting evident, it is recommended that a steel worker repair, grind, prime and repaint all steel elements as soon as possible to prevent further damage.

It was also observed that all external timber structural and bracing elements had extensive weathering and some fungal decay evident. It is recommended that a builder repair or replace any affected element and a painter sand, prepare and re coat all external timber elements, this will increase the service life of the timber.

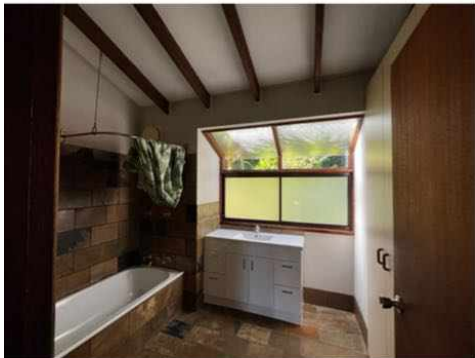
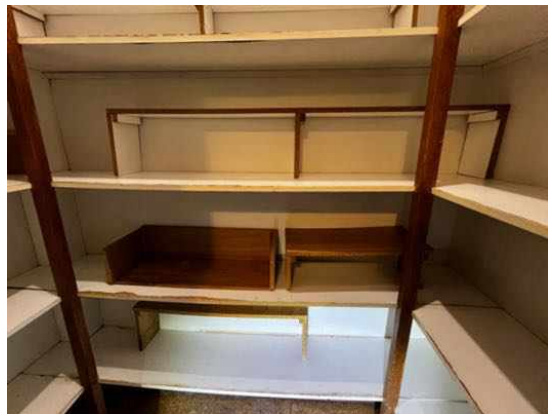
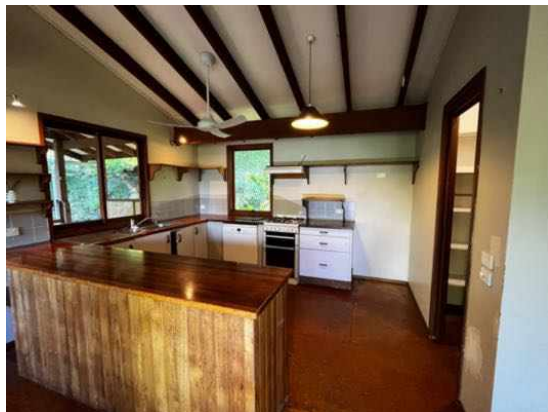
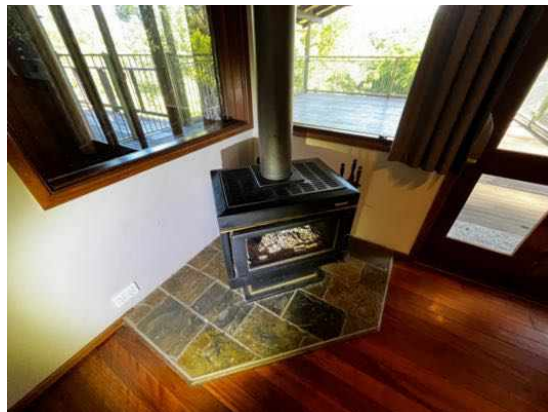
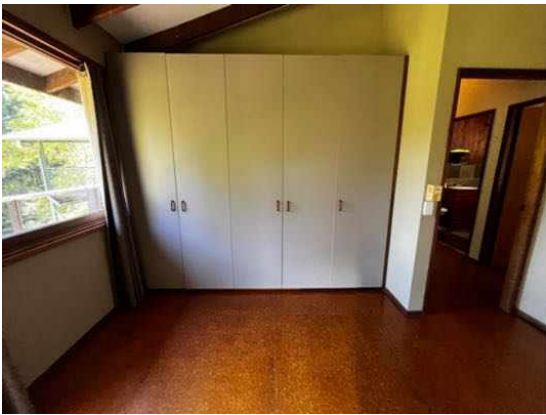
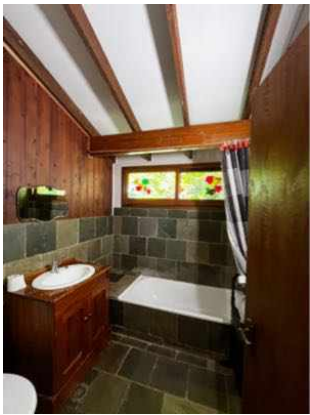
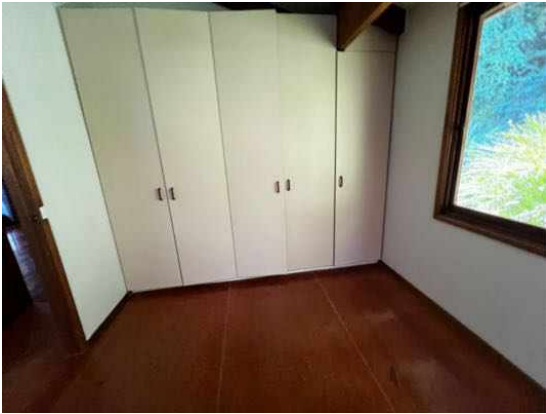
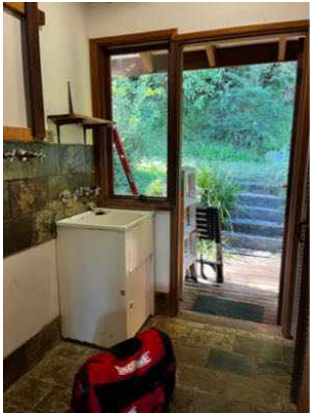
Building: Main Building  
Location: All Internal Areas  
Finding: Obstructions and Limitations Internal Areas  
Information: These photographs are an indication of the obstructions and limitations which impeded full inspection of internal areas of the property at the time of inspection. These obstructions can hide an array of defects and should be removed to allow full inspection to be carried out. A re-inspection is recommended once the areas are made accessible.

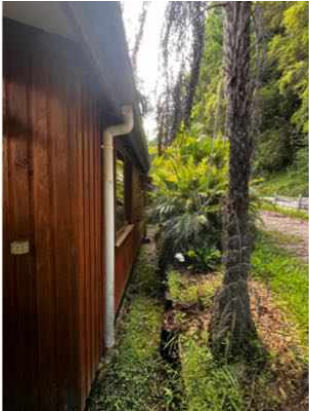
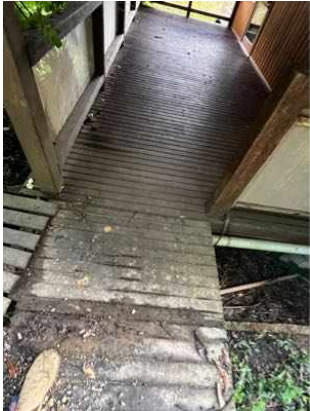
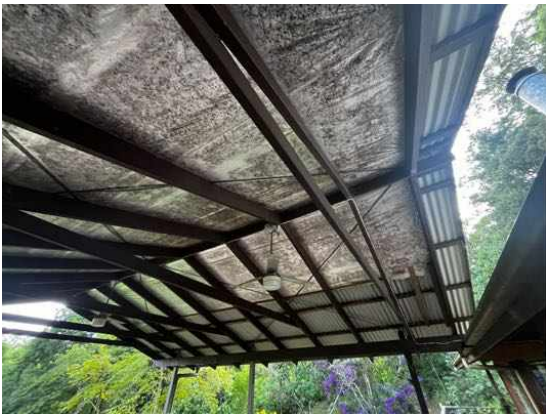
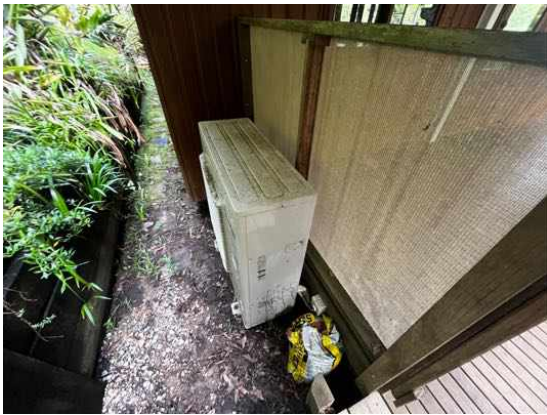
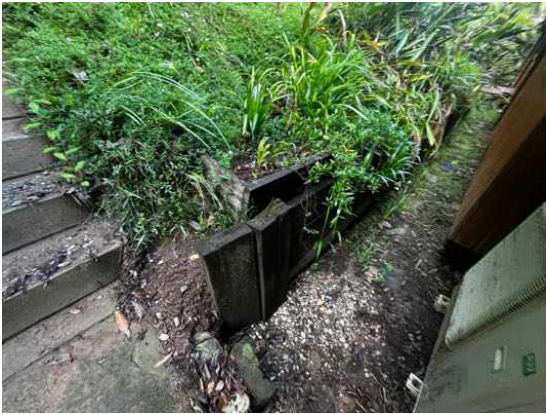
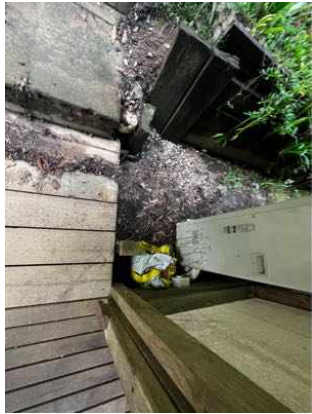
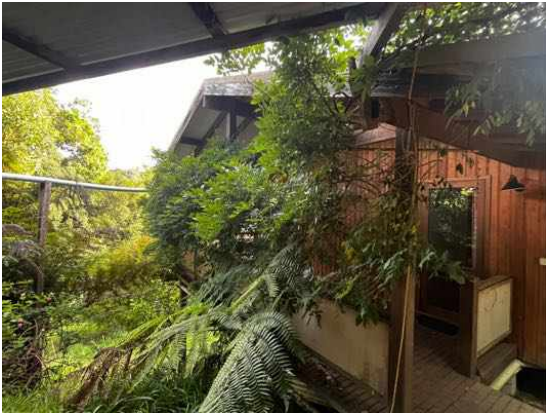
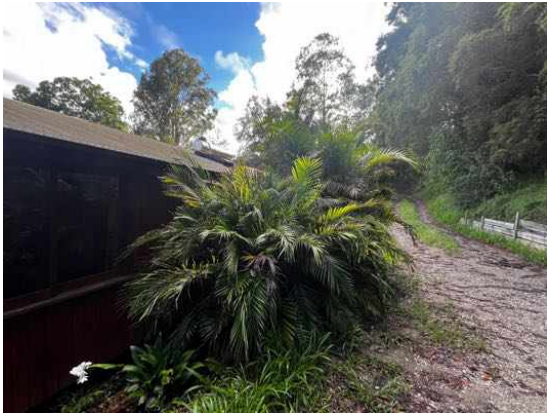
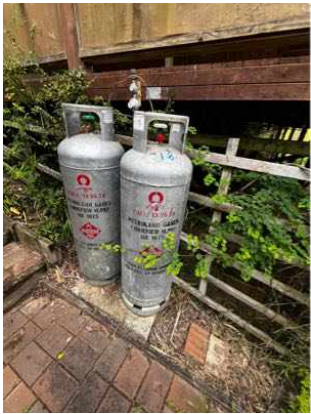
Building: Main Building  
Location: All External Areas  
Finding: Obstructions and Limitations External Areas  
Information: These photographs are an indication of the obstructions and limitations which impeded full inspection of external areas of the property at the time of inspection. These obstructions can hide an array of defects and should be removed to allow full inspection to be carried out. A re-inspection is recommended once the areas are made accessible.

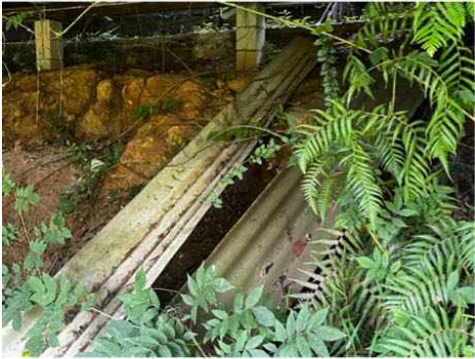
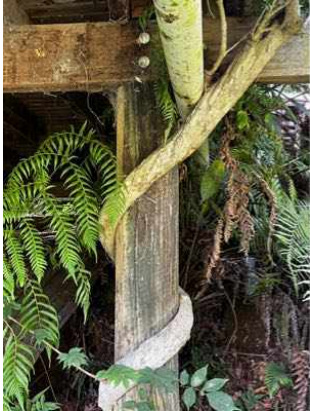
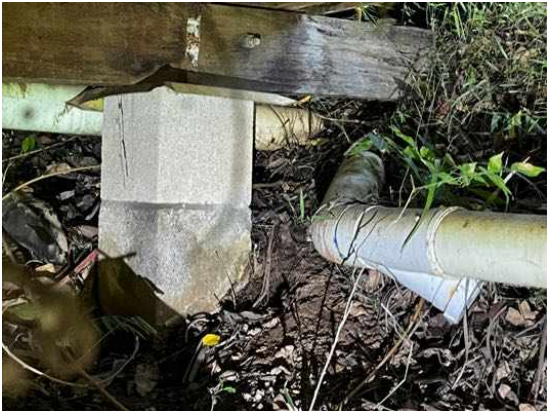
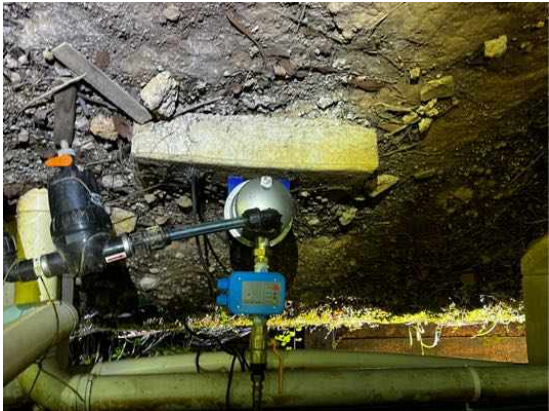
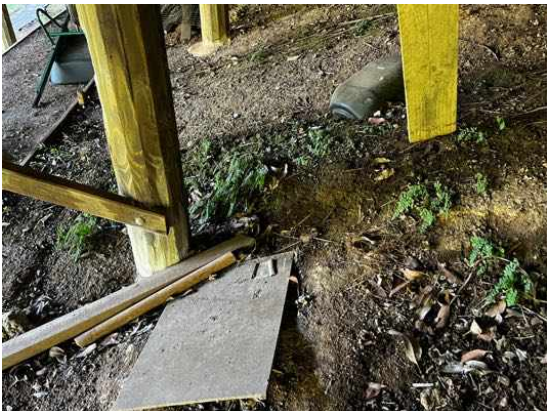
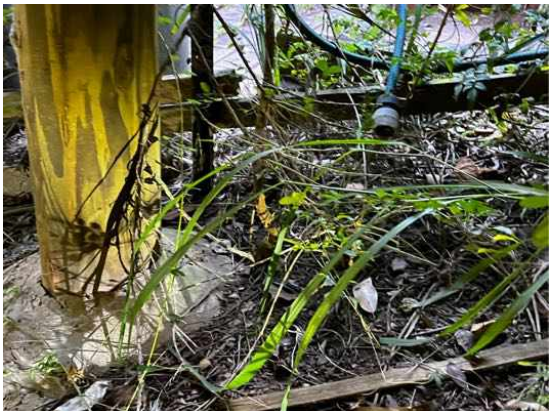
Building: Main Building  
Location: Subfloor  
Finding: Obstructions and Limitations Sub Floor Areas  
Information: These photographs are an indication of the obstructions and limitations which impeded full inspection of sub floor areas of the property at the time of inspection. These obstructions can hide an array of defects and should be removed to allow full inspection to be carried out. A re-inspection is recommended once the areas are made accessible.

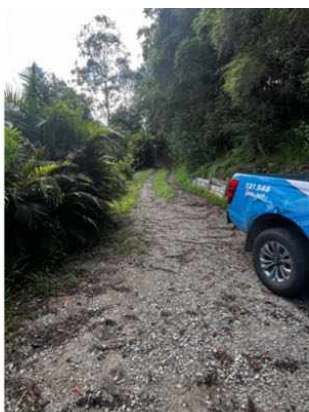
Building: Main Building

Location: Driveway  
 Finding: Driveway  
 Information: It was observed that the driveway was unformed gravel.
