# Building and Timber Pest Inspection Report

Inspection Date: Fri, 20 Mar 2026

Property Address: 426 Union Rd, Lavington NSW 2641,  
Australia

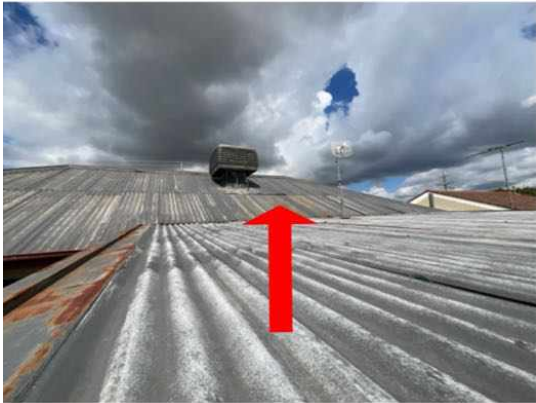
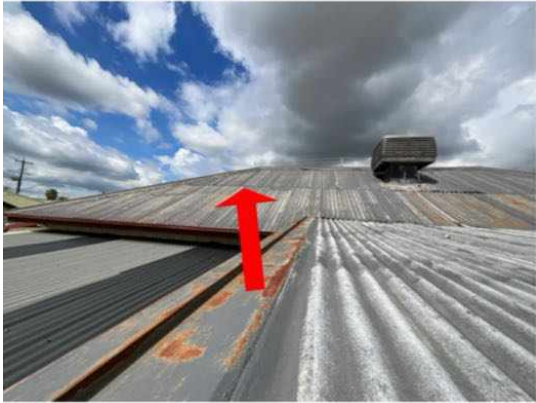
Finding: Roof sheets - Loose

Information: Upon inspection of the exterior roof covering, it was noted that numerous roof sheets have become loose from their original fixings. It is suspected that this defect has developed as a result of a lack of adequate maintenance, but may also have been caused by inappropriate fixings being used in the construction process.

Loose roof sheeting detracts from the weather tightness of the roof covering, making the internal roofing structure susceptible to water penetration and subsequent damage. If left unaddressed, it is likely that secondary damage to associated building elements will develop, potentially necessitating remedial works to these structures.

A roofing restoration contractor should be appointed to advise on rectification options and on the cost of repair. It is advised that remedial works be performed as soon as possible to prevent any further damage.

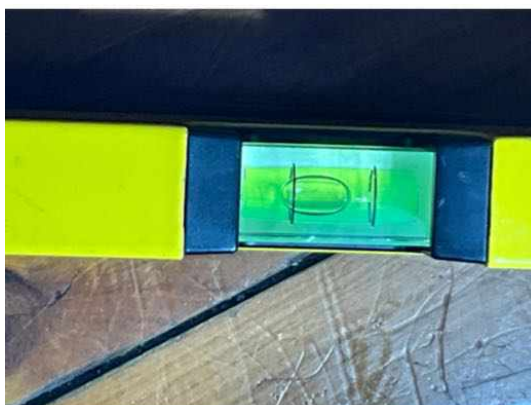
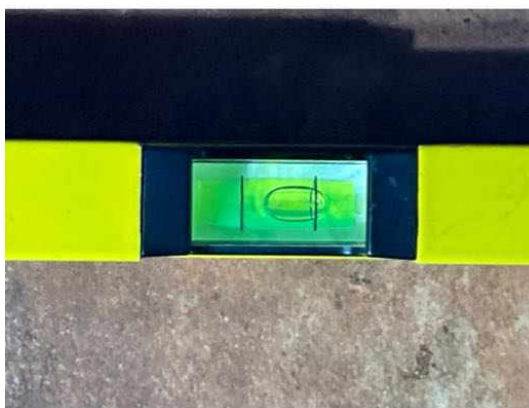
indicate minor defects such as expected movement of the foundations of the property, but may also indicate subsidence of the associated subfloor stumps.

It is advised that the flooring be closely monitored to identify any further movement. Where flooring remains relatively unchanged for an extended period of time (i.e. several months), it is likely that this defect has been caused by expected movement of the foundations of the property.

However, where flooring is uneven further, potentially invasive inspection of the subfloor structures and stumps in this area is required. In this case, works to repair are likely to be required, and would be carried out by a registered builder specialising in re-stumping.

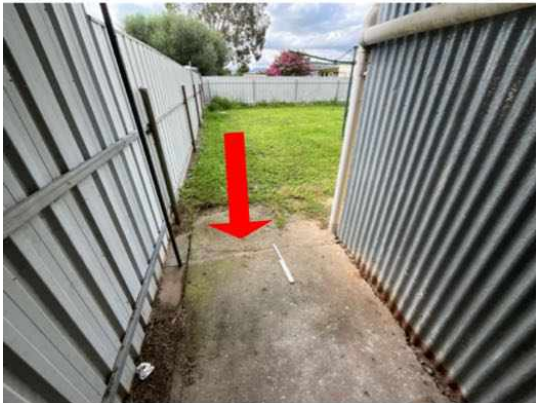
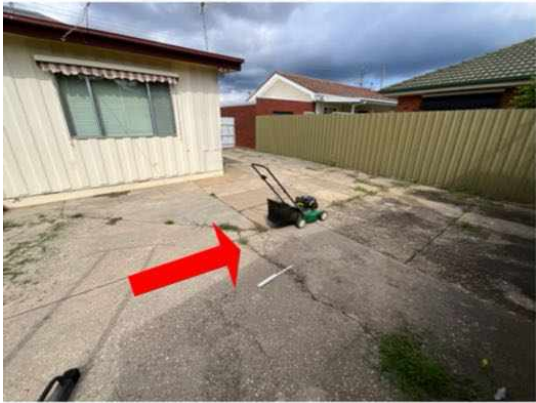
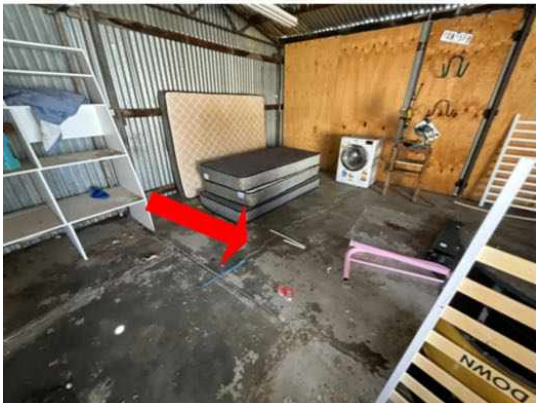
### Finding 3.09

Cracking to this degree may also be due to poor original installation of the concrete. Factors such as poor compaction of the sub surface and/or inadequate reinforcing of the slab may create cracking and other secondary defects. Wide cracks may also have a more significant structural cause, such as subsidence of soils.

Where the crack is located adjacent to structural elements of the building, the advice of a Structural Engineer is advisable before undertaking repairs. Significant repair and likely replacement of the concrete paving is probable.

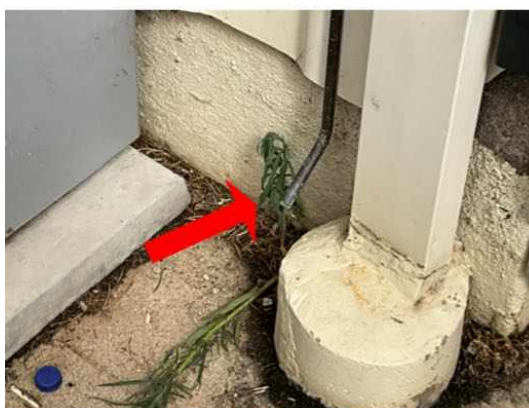
These damp conditions can lead to secondary defects such as rot, rust or corrosion of associated building elements, the formation of fungal decay, or even the creation of potential slip hazards. When coupled with poor site drainage, pooling of water may also attract termite activity to this area.

It is highly recommended that a licensed plumber be appointed to connect the HWS overflow in order to prevent such an environment from being created. These minor works should be carried out as soon as possible.

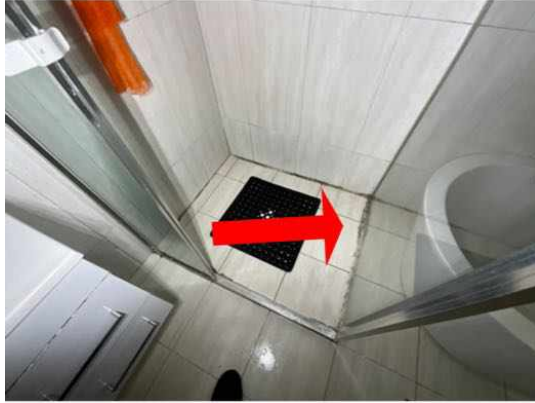
### Finding 6.05

Building: Building 1  
 Location: Bathroom  
 Finding: Inadequate sealant or Grout  
 Information: This area has a lack of effective Sealant or Grout. This is allowing the ingress of water

The presence of water encourages Termite attack, Mould and Fungal Decay.

A Tiler or General Handy person must be contacted as soon as possible to effect repairs and prevent further deterioration.

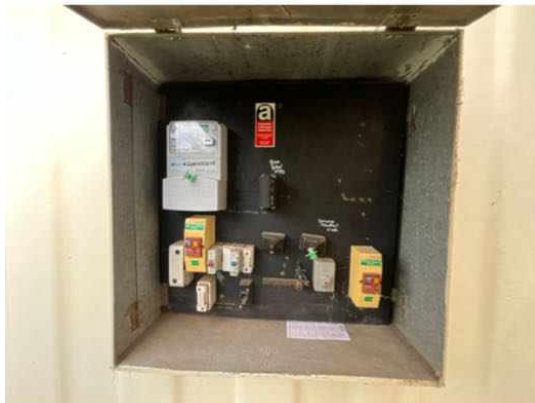
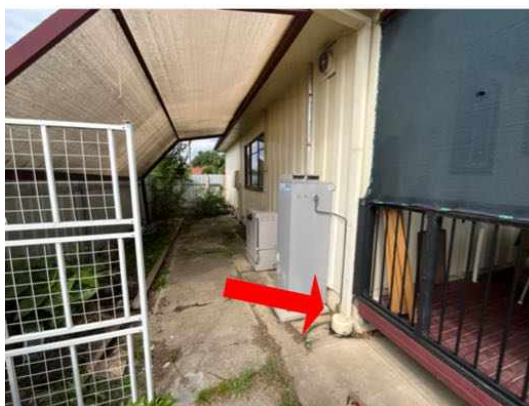
A durable notice should be placed in the switchboard unit to indicate current termite barriers. At the time of inspection, it appeared as though no termite management system has been installed, with no evidence to suggest preventative works taking place.

The client may consider gaining further advice from a pest controller as to the costs and procedures involved with this application. It is recommended that obtaining such advice be a short-term priority.

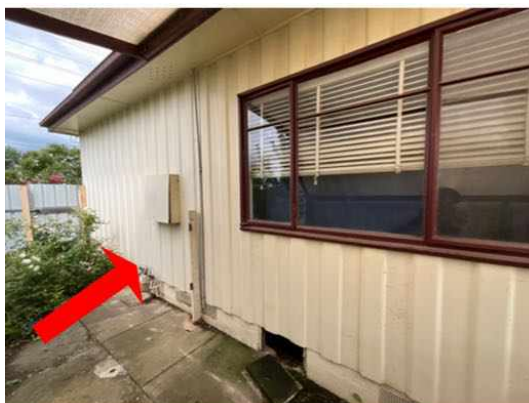
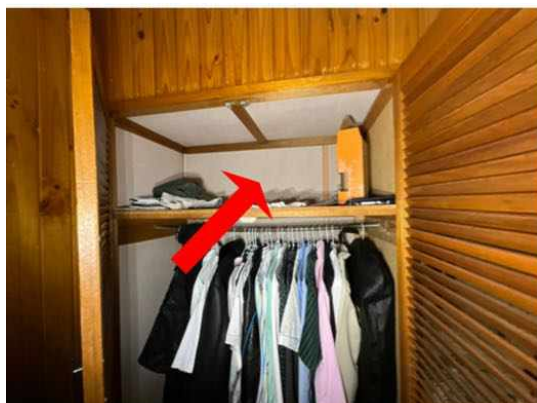
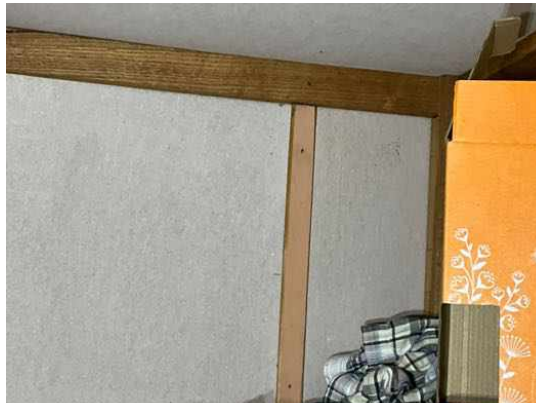
As Asbestos Reporting is outside the scope of this report, we advise that you consider a separate Asbestos Inspection and Condition Audit, which can include the taking of samples for definitive confirmation of the presence of Asbestos.

In the interim, the client is advised to act with caution, especially when considering any damage to building materials general wear and tear renovations extensions demolition and general maintenance activities due to the suspected presence of Asbestos.

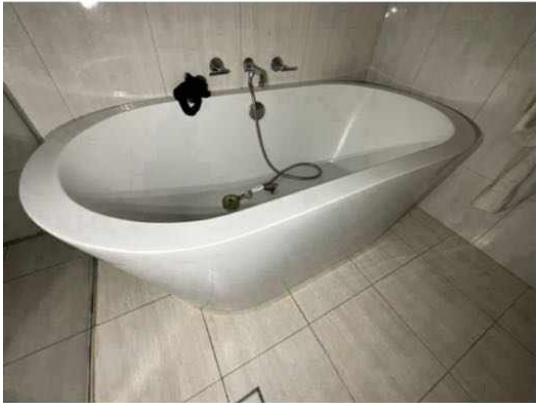
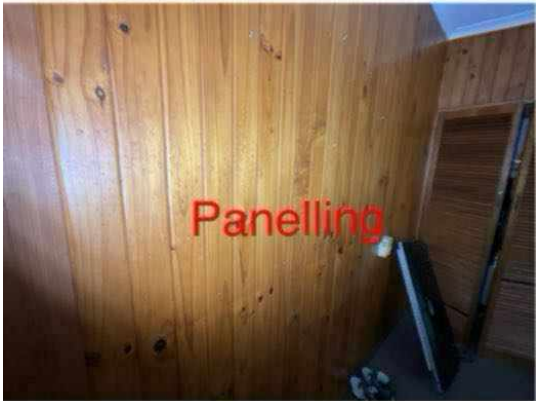
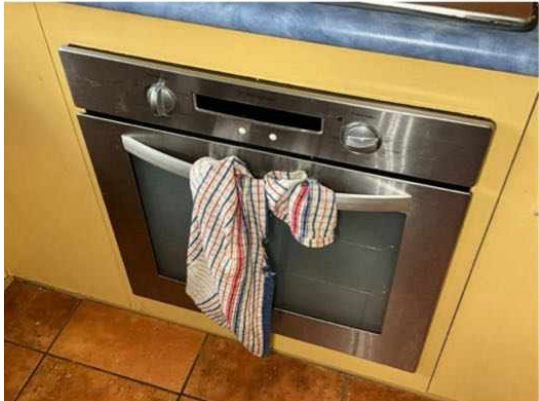
### Noted Item

Building: Building 1  
Location: All Areas  
Finding: Additional Photos - Obstructions and Limitations  
Information: These photographs are an indication of the obstructions and limitations which impeded full inspection of the property at the time of inspection. These obstructions can hide an array of defects and should be removed to allow full inspection to be carried out. A re-inspection is recommended once the areas are made accessible.
