## Building Inspection Report

Inspection Date: Fri, 27 Mar 2026

Property Address: 1/68 Heyington Ave, Thomastown VIC 3074,  
Australia

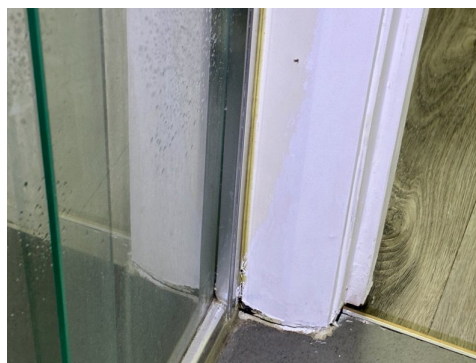
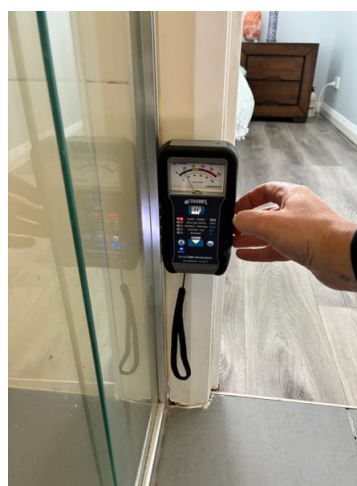
#### Defects 3.01

Finding: Shower external - Water damage

Information: At the time of inspection, water damage was apparent to the door architrave side of the shower. The shower did not appear to be currently leaking and damage could be pre-existing. It is suspected that the leaking could have occurred as a result of shower not being sealed correctly.

Water leaking from the shower, where left unattended, is likely to lead to water damage to adjoining flooring and walls. Such damage can lead to water damage and necessitate extensive remedial works being required. Active water leaks may also create an environment that is susceptible to the formation and development of mould.

Flexible and mould resistant materials should be applied to affected areas to prevent any subsequent water damage that is likely to occur. Regular maintenance and replacement of damage or missing or damaged sealant and grout is highly recommended to the wet areas, as this is a regular wear and tear defect.

Sealant and grouting in areas that come into regular contact with water should be maintained for the long term care of your property.

It is advised that these areas be monitored and if there is signs of water leaking, a sealant specialist or shower screen contractor should be appointed to complete these works immediately. It is also advisable that a qualified carpenter or general handyperson be engaged to repair damaged materials.

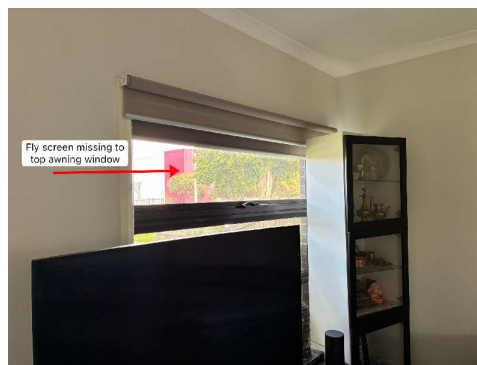
### Defects 3.02

Finding: Flyscreens - Missing

Information: At the time of inspection the flyscreen was found to be missing to the top Lounge room window. Whether the flyscreens has not been installed or have been removed post-installation, this missing building element detracts from the operational state of the window.

Where not replaced, missing flyscreens allow pest and insect ingress into the adjoining room/s.

It is advised that all missing building elements be replaced in order to ensure the full function of all building structures.

A general handyperson may be appointed to replace flyscreens at the discretion of the client.

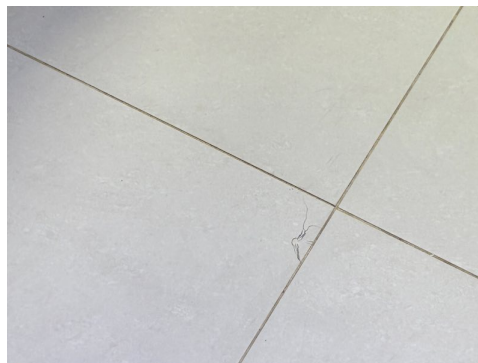
### Defects 3.03

Finding: Cracked floor tiles

Information: At the time of inspection cracking in the floor tiles was evident Lounge and Kitchen area. It is suspected that this cracking has occurred as a result of minor impact damage.

Cracked tiles throughout the household detract from the overall appearance of the affected areas however it is unlikely to create or lead to any secondary defects.

While not considered a matter of urgency, replacement of cracked floor tiles is recommended at the clients discretion.

A tiling contractor may be appointed to perform these works. Where cracks become more numerous, contact a licensed building inspector for further investigation.

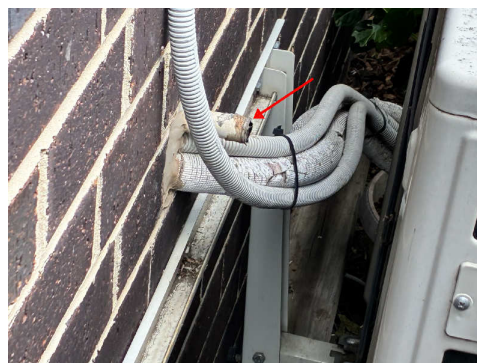
### Defects 3.04

Finding: Air conditioner - Disconnected overflow

Information: The Air Conditioner (A/C) overflow to the A/C unit in the rear yard was found that the overflow is not connected to a storm water drainage point and is creating excessive moisture in the surrounding area.

Such leaking creates an environment which is conducive to an array of defects, including water damage to associated building elements and the attraction of termite or timber pest infestation.

It is highly recommended that a licensed plumber be appointed to connect the A/C overflow in order to prevent such an environment from being created. These minor works should be carried out as soon as possible.

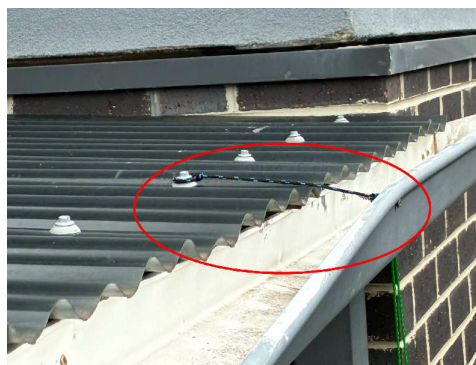
### Defects 3.05

In addition, the guttering servicing the pergola was observed to have inadequate fixing brackets securing it to the main structure.

The lack of sufficient fixings increases the likelihood of the guttering becoming loose or collapsing, particularly during heavy rainfall or high wind conditions, which may result in damage or pose a safety risk.

☒ It is recommended that a licensed roofing plumber be engaged as a matter of priority to assess and rectify the guttering installation.

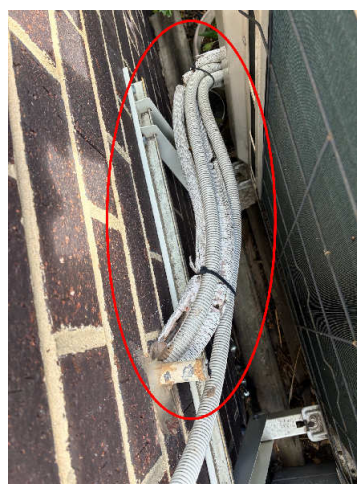
### Defects 3.06

Finding: Ground floor Condenser Electrical Conduit Deteriorated

Information: At the time of inspection, external cabling was observed to be enclosed within flexible corrugated conduit; however, sections of the conduit and protective sleeving appear to be deteriorated. The installation does not appear to provide consistent mechanical protection along the full length of the cabling.

Where conduit or sleeving is damaged, unsupported, or degraded, the underlying cables may be exposed to physical damage, UV degradation, and moisture ingress.

☒ It is recommended that a licensed electrician or air conditioner contractor inspect and where necessary, damaged or deteriorated conduit and sleeving should be replaced.

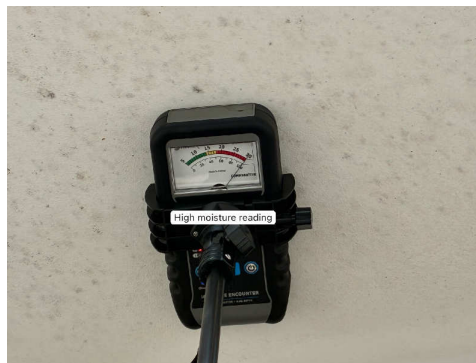
### Defects 3.07

Finding: Eave Linings - Water stained

Information: At the time of inspection water staining to eave linings to the left hand side of the dwelling was evident. Water staining indicates that surfaces have been exposed to excessive moisture over time. The minerals and other elements in the water lead to staining, which may graduate to corrosion and deterioration if left unmanaged.

It is suspected that the downpipe spreader above when raining may have caused water to get in under the roof tiles. While mostly an appearance defect, water staining can be indicative of more serious defects, which may be currently concealed by interior ceilings.

It is suspected that water staining is active and highly advise a licensed roof plumber consulted as soon as possible to identify the cause of the staining and to provide advice on any reparation works that may be required.

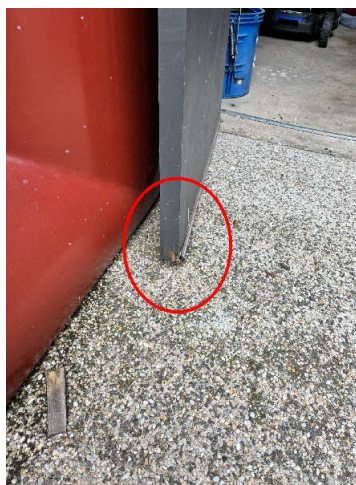
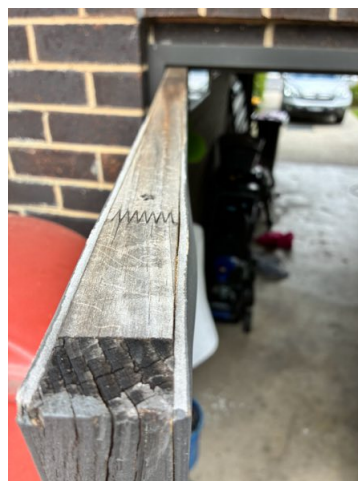
### Defects 3.08

Information: At the time of inspection the Rear Garage access door is Binding and jamming during standard operation. This defect inhibits the functionality of the affected door as well as creating potential for secondary defects to associated building elements, such as damage to the door frame.

It is suspected the door has been damaged due to weather and moisture has affected the door.

It is recommended that a qualified carpenter or general handyperson should be appointed to replace the door at client discretion.

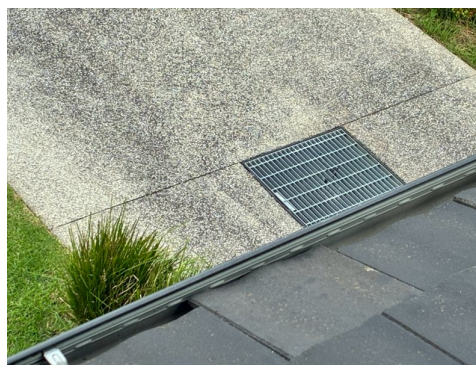
### Defects 3.09

Information: Upon inspection of the exterior roof covering, it was noted that a tile have slipped from their original fixing front of house below Bed room 2 . Tiles may slip over time due to a number of minor causes, including breakage of tiles, failings in the adjoining battens, or fixings that may have failed.

This creates an environment that is conducive to water damage and accelerated deterioration of all associated building elements.

Replacement of loose or missing roofing tiles is recommended immediately to prevent the development of any secondary defects. A roofing restoration specialist should be appointed to complete such works as necessary.

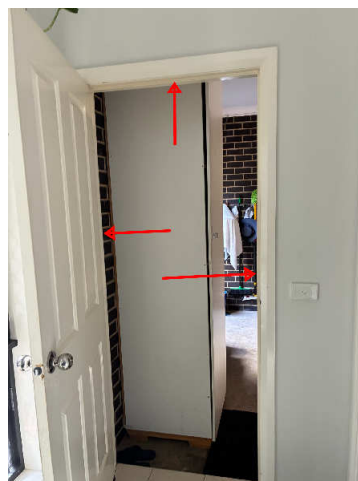
Building:	Main Building
Location:	House Garage access door
Finding:	External Door Seals - Missing
Information:	At the time of inspection the internal access door between house and garage did not have a door seal around the perimeter edges of the door frame.

Where external door seals are missing the area is no longer weather-tight. Insulation of the area against external weather conditions will also be compromised.

It is recommended that all missing weather seals be installed by a general handyperson or a licensed carpenter to prevent any damage and to restore the external door seals to a fully functional level.

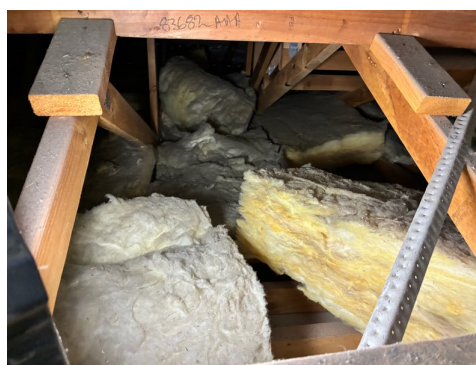
- Ceiling insulation batts have been moved in areas and not replaced.
- Limited access due to roof trusses

A re-inspection is recommended once the area are made accessible.

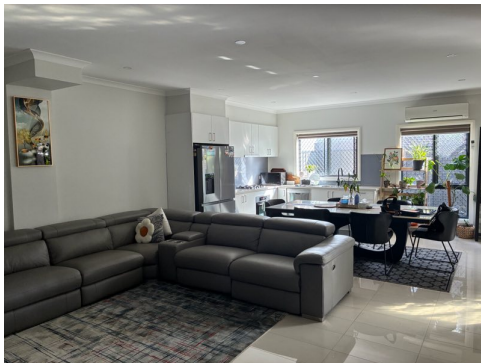
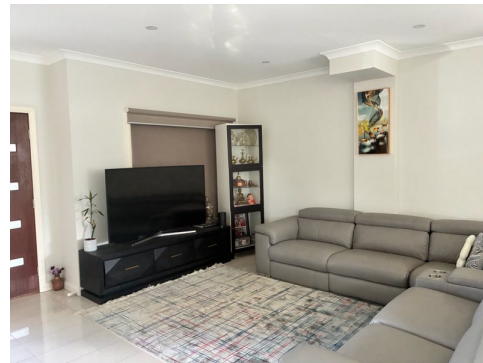
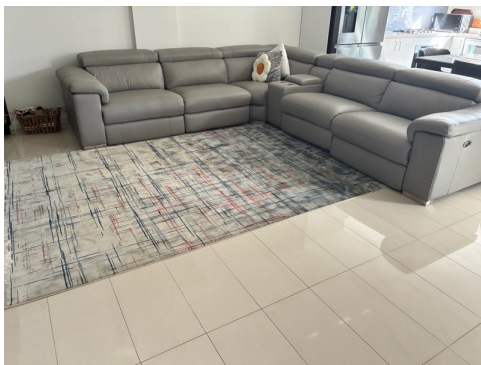
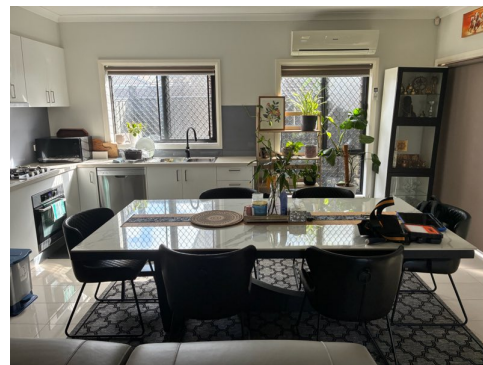
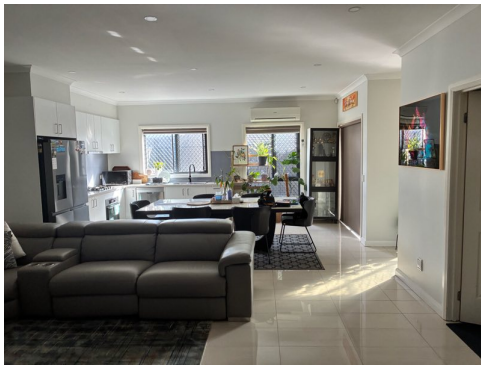
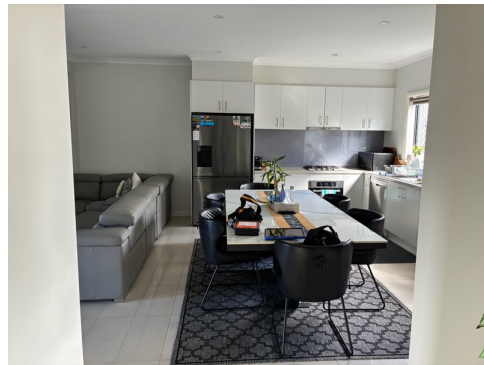
Finding: Additional Photos - Obstructions and Limitations

Information: These photographs are an indication of the obstructions and limitations which impeded full inspection of the property at the time of inspection. These obstructions can hide an array of defects and should be removed to allow full inspection to be carried out. A re-inspection is recommended once the areas are made accessible.

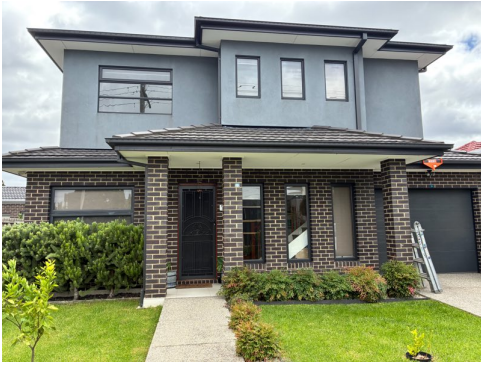
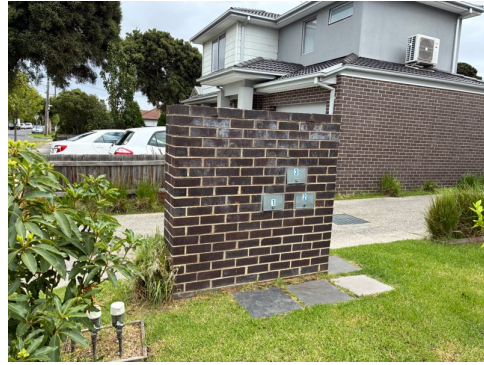
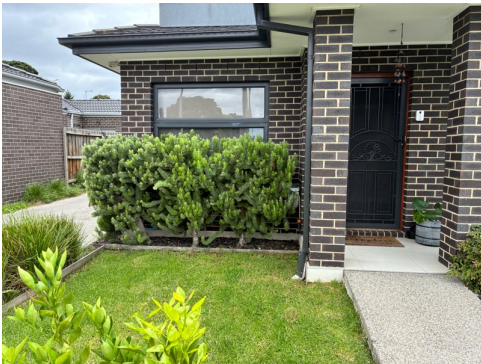
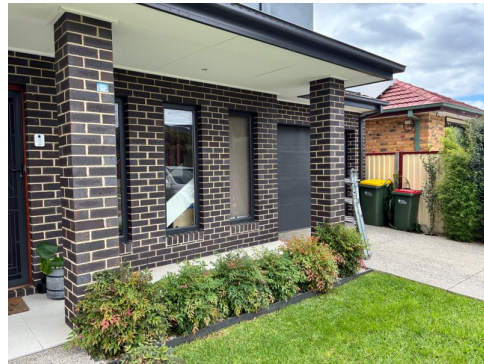
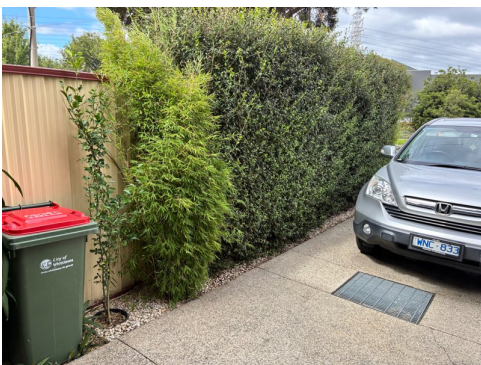
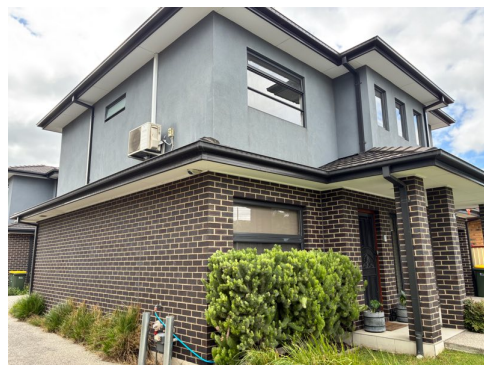
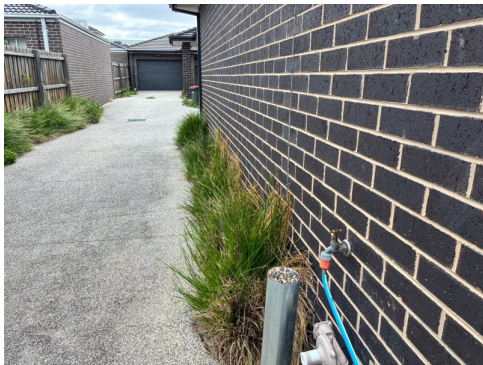
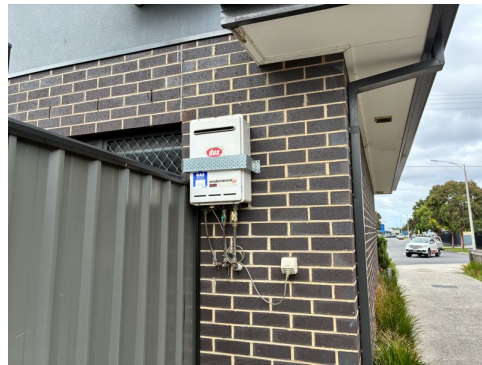
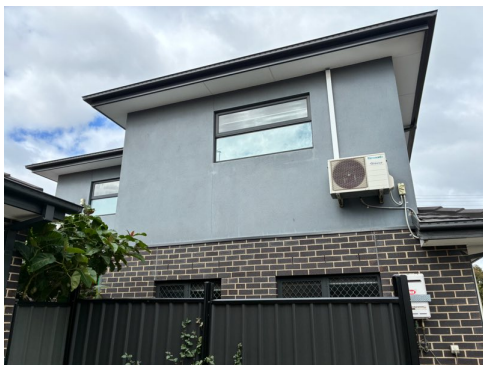
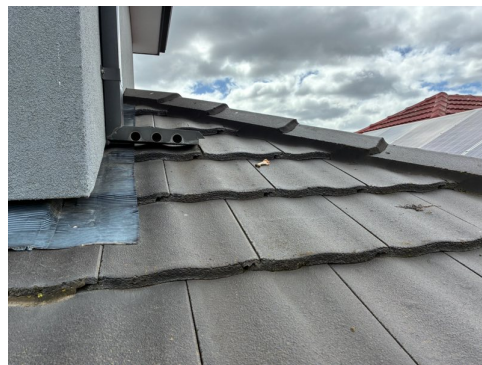
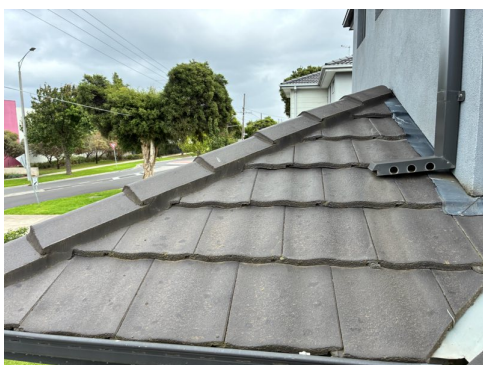
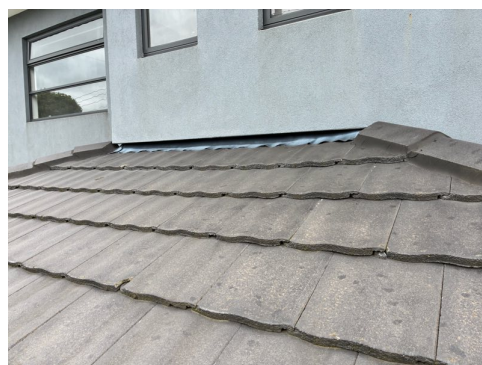
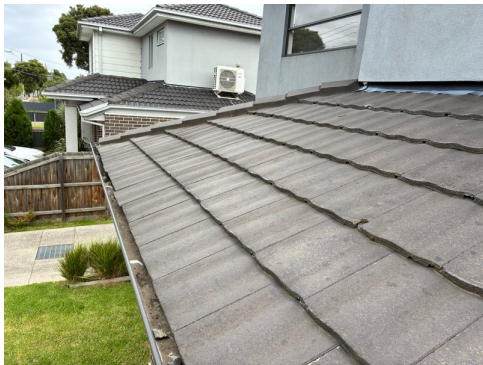
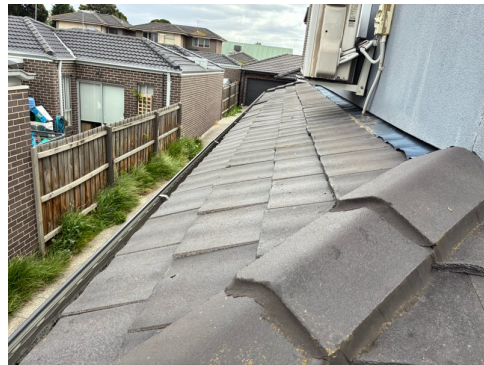
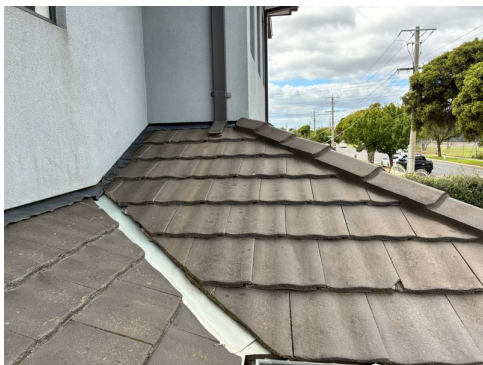
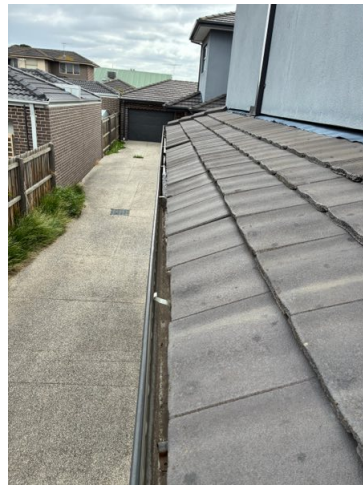
Building: Main Building  
Location: All External Areas  
Finding: Additional Photos  
Information: Additional photos are provided for your general reference
