Building Inspection Report

Inspection Date: Tue, 27 Jan 2026

Property Address: 5 Hazlewood St, New Norfolk TAS 7140,
Australia

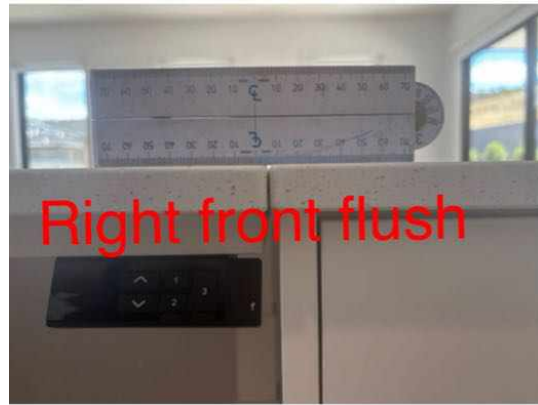
Right front flush

Recommend client request if the agent can liaise with the builder to identify the kitchen installers. They may have greater experience with this system as it is not common.

If kitchen installers decline, recommend client engage a Handy Person to rectify as soon as possible.

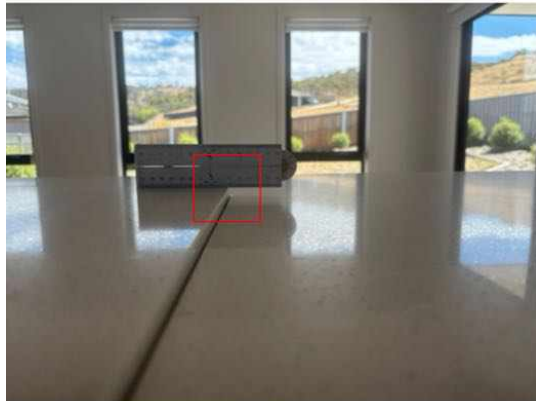
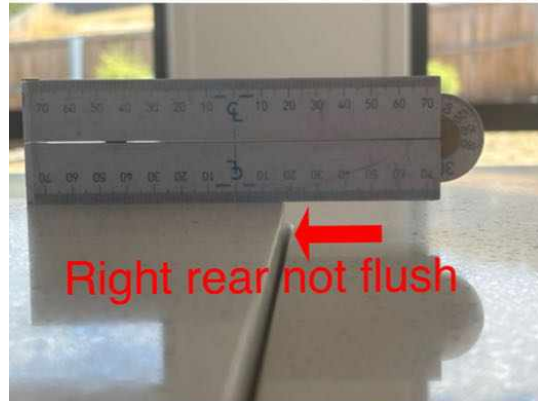
Right rear not flush

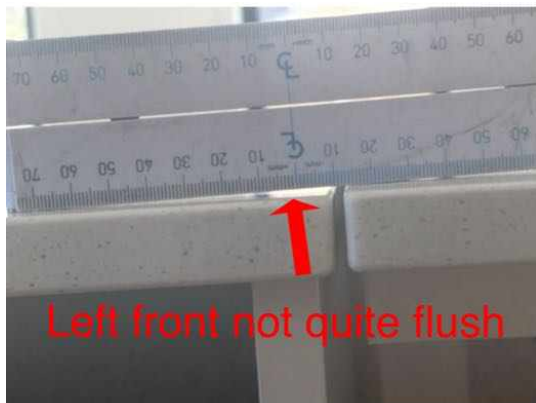
Left front not quite flush

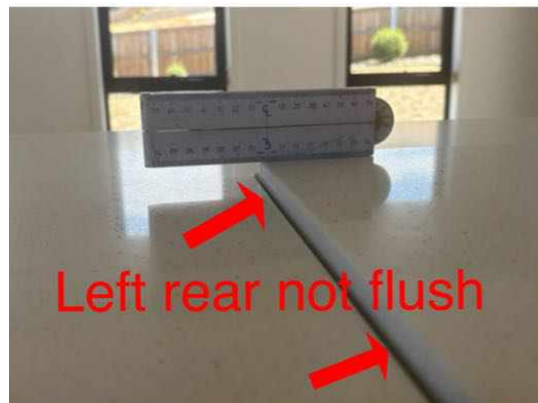
Left rear not flush

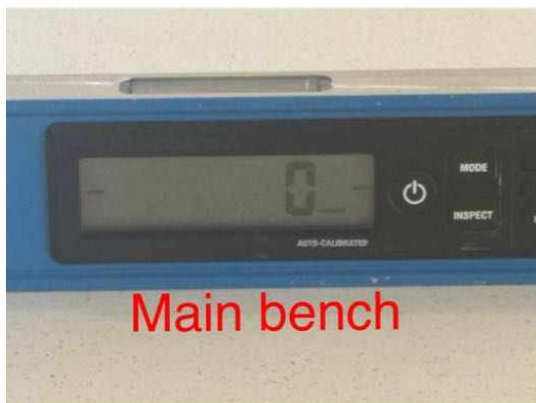
Main bench

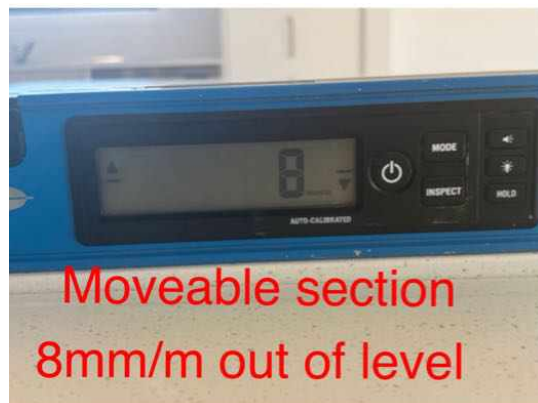
Failure to rectify could lead to damage to the adjustable bench and surrounding bench top.

Moveable section
8mm/m out of level

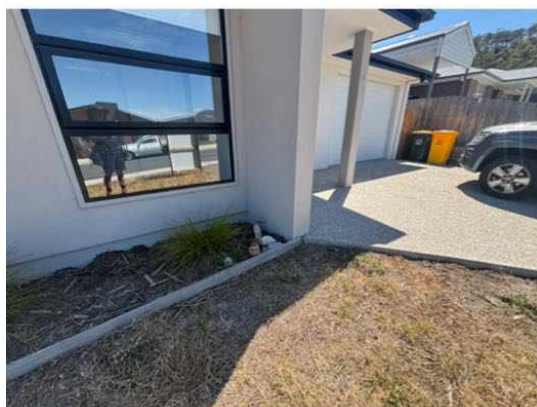
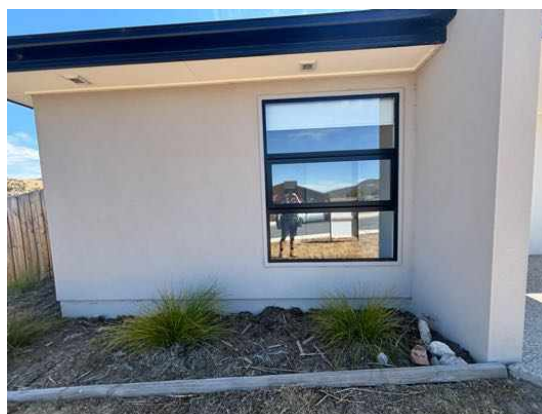
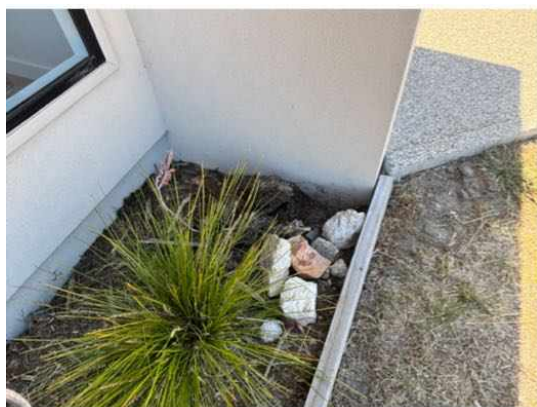
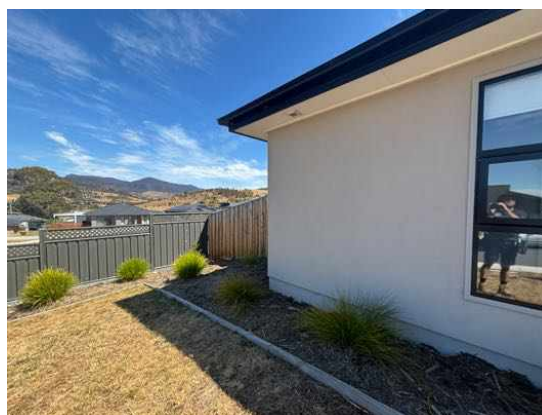
Noted Item

Building: Main Building
 Location:
 Finding: Additional Photos - Obstructions and Limitations
 Information: These photographs are an indication of the obstructions and limitations which impeded full inspection of the property at the time of inspection. These obstructions can hide an array of defects and should be removed to allow full inspection to be carried out. A re-inspection is recommended once the areas are made accessible.

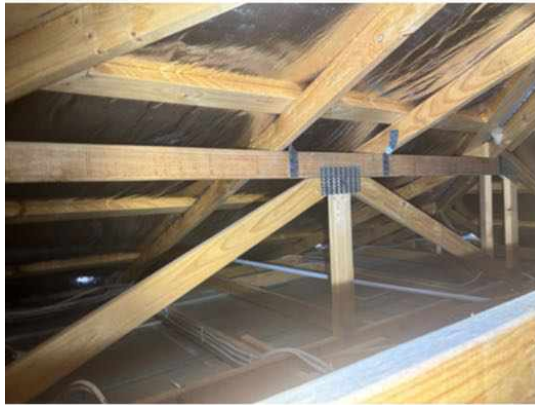
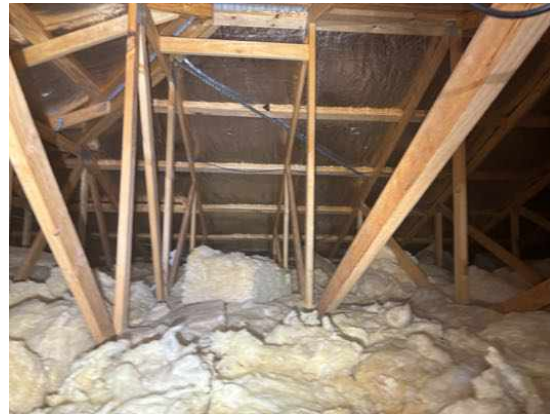
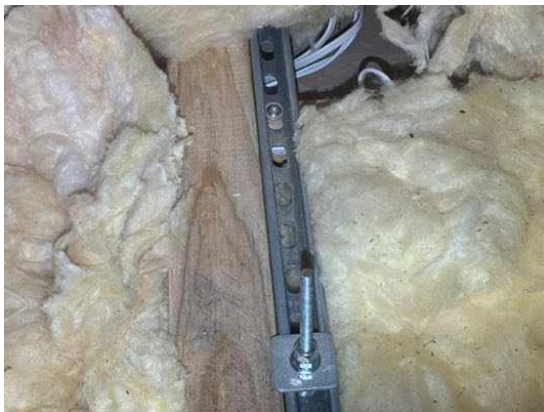
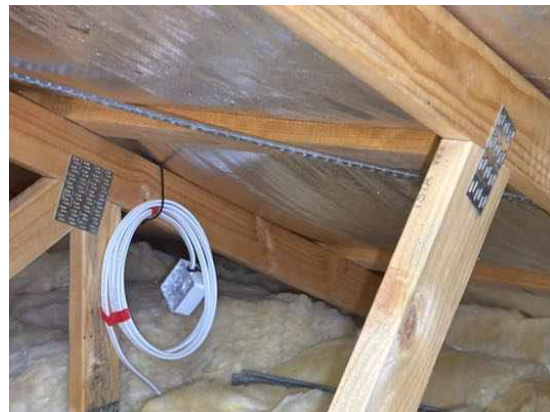
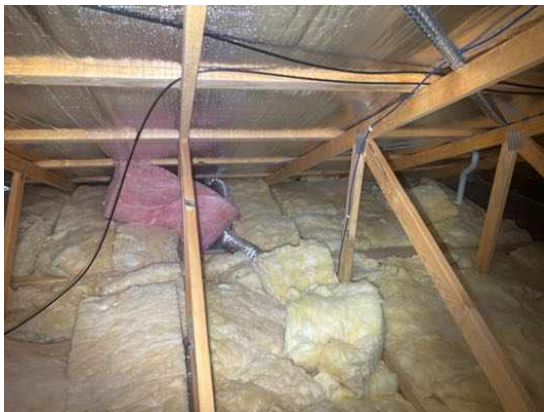
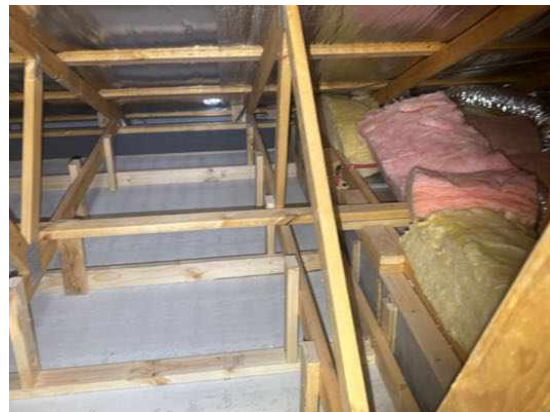
Noted Item

Building: Main Building
 Location:
 Finding: Additional Photos - Obstructions and Limitations
 Information: These photographs are an indication of the obstructions and limitations which impeded full inspection of the property at the time of inspection. These obstructions can hide an array of defects and should be removed to allow full inspection to be

carried out. A re-inspection is recommended once the areas are made accessible.

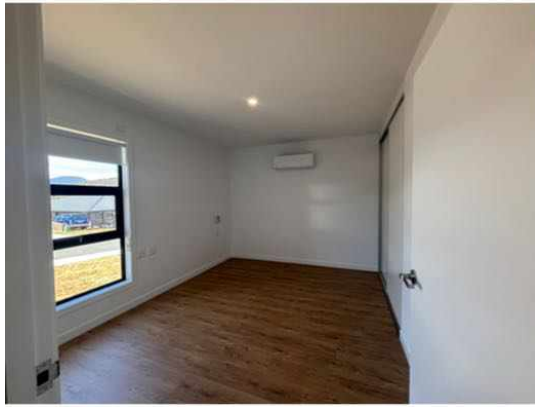
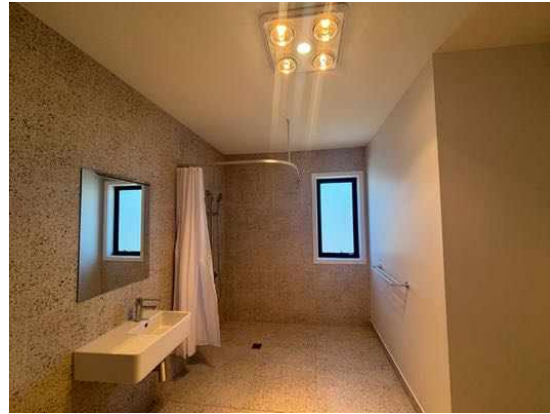
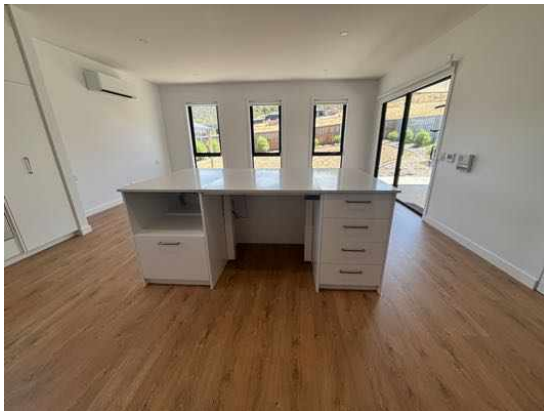
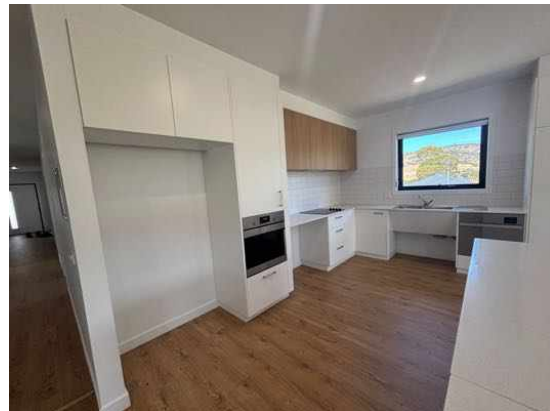
Noted Item

Building:	Main Building
Location:	
Finding:	Additional Photos - Obstructions and Limitations
Information:	These photographs are an indication of the obstructions and limitations which impeded full inspection of the property at the time of inspection. These obstructions can hide an array of defects and should be removed to allow full inspection to be carried out. A re-inspection is recommended once the areas are made accessible.

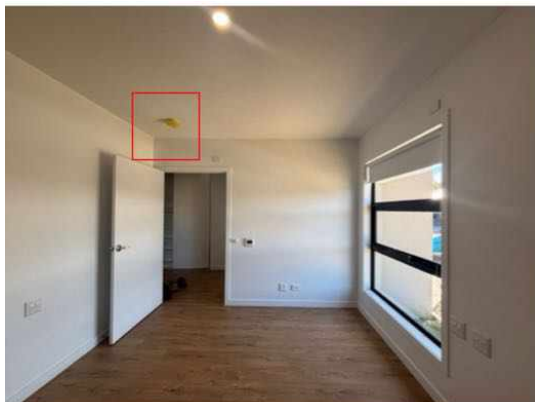
Noted Item

Building: Main Building
Location: Front bedroom
Finding: Smoke Alarm
Information: FYI In the front bedroom, the smoke alarm still has the cover fitted over it. Recommend client engage a Handy Person to rectify as soon as practicable.

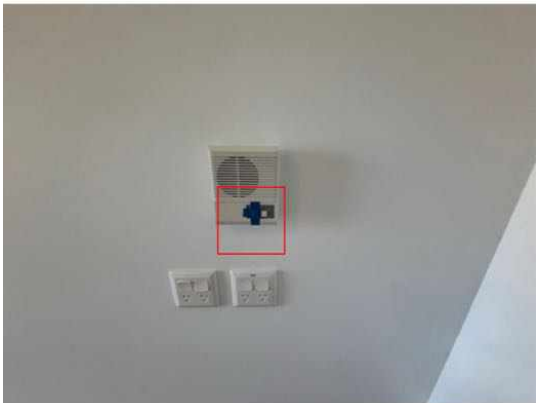
Noted Item

Building: Main Building
Location: Front bedroom

Finding: Intercom taped
Information: FYI there is tape on the intercom. Recommend engage a Handy Person to rectify as soon as practicable.

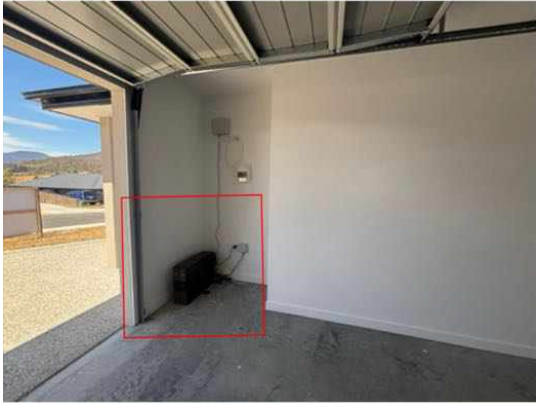
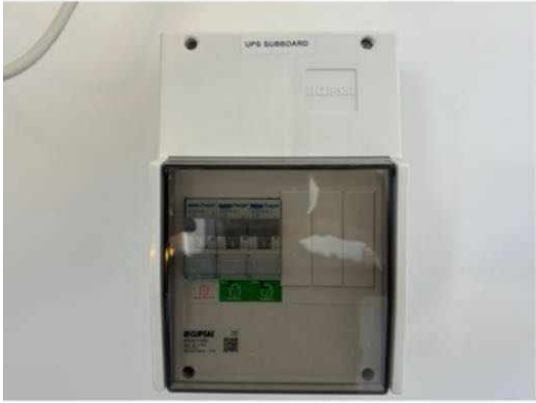
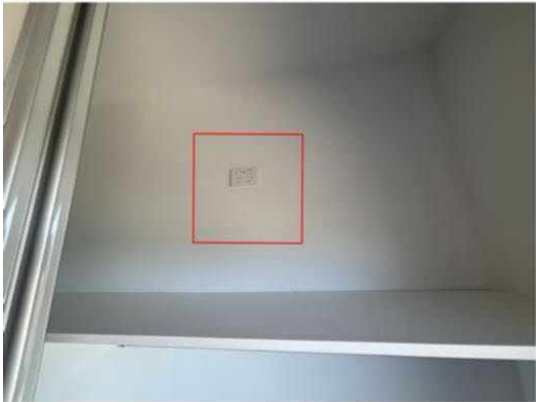
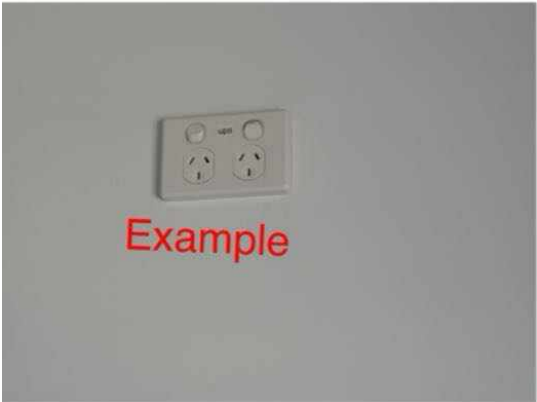
Noted Item

Building: Main Building
Location: Garage
Finding: Uninterruptible Power Supply
Information: FYI there is an Uninterruptible Power Supply (UPS) fitted in the garage. My understanding is that some power points are fed from this and are typically labelled.

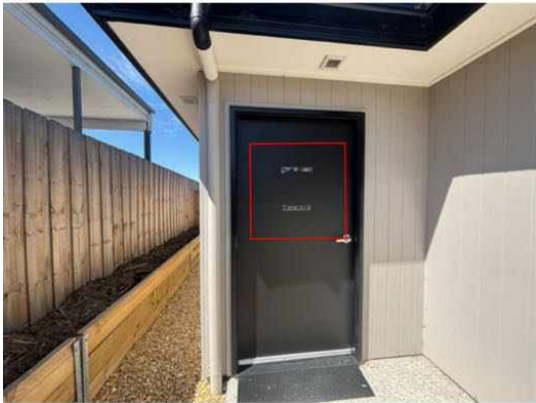
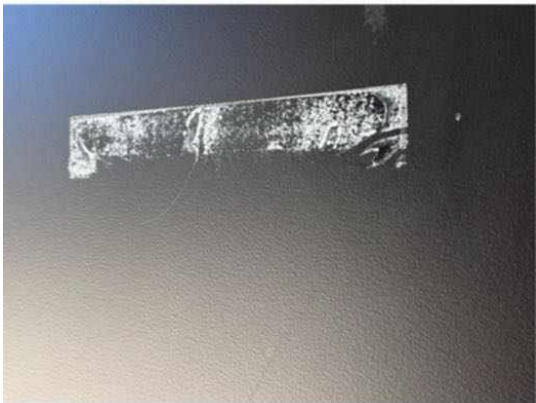
Noted Item

Building: Main Building
 Location: Garage
 Finding: Personal access door
 Information: FYI the exterior personal access door to the garage has some tape residue on it, most likely from having a notice taped to it. Recommend client engage a Handy Person to rectify as soon as practicable.

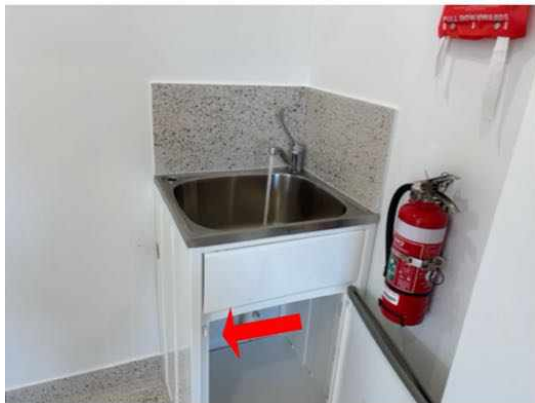
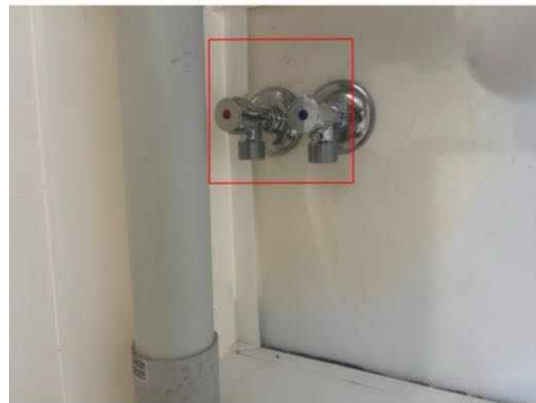
Noted Item

Failure to do so could lead to water damage to the surrounding building elements.

Recommend client engage a Lic Plumber to rectify as soon as possible.

Recommend client do not turn on the stop cocks unless they are connected to a washing machine or have been capped by a Lic Plumber.

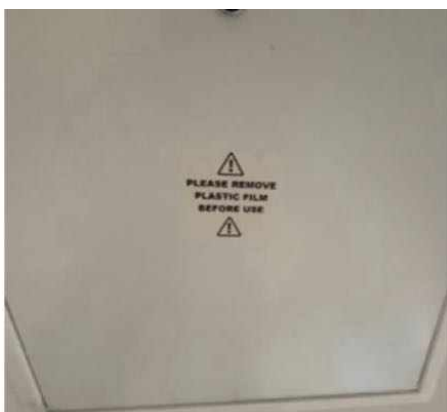
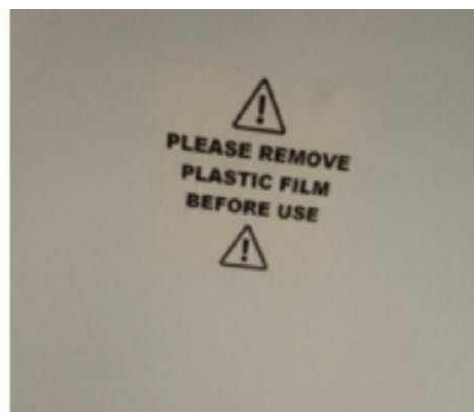
Noted Item

Building: Main Building
Location: Garage
Finding: Access cover
Information: FYI In the garage the access cover to the roof void, still has protective film on it.

Recommend client engage a Handy Person to rectify as soon as practicable.

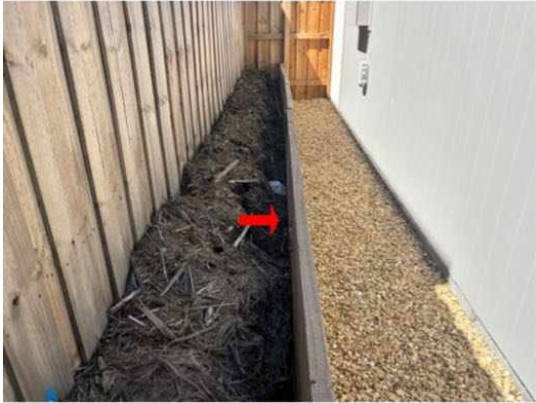
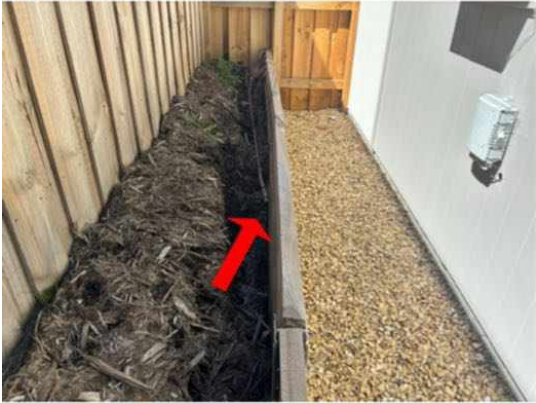
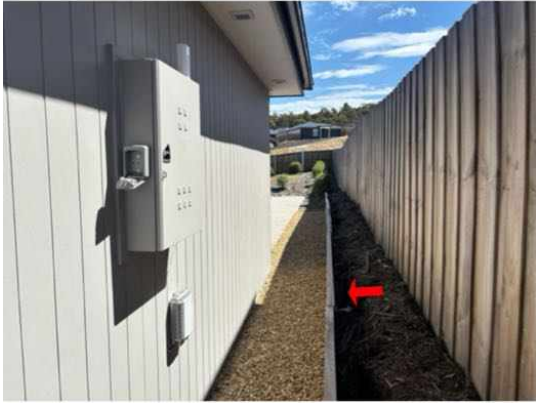
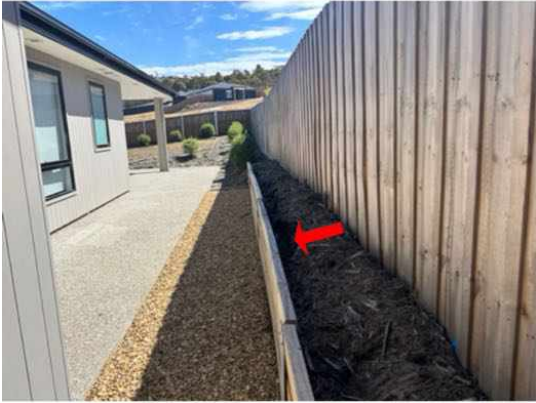
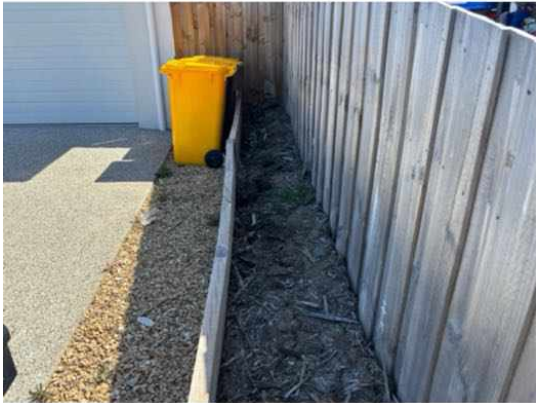
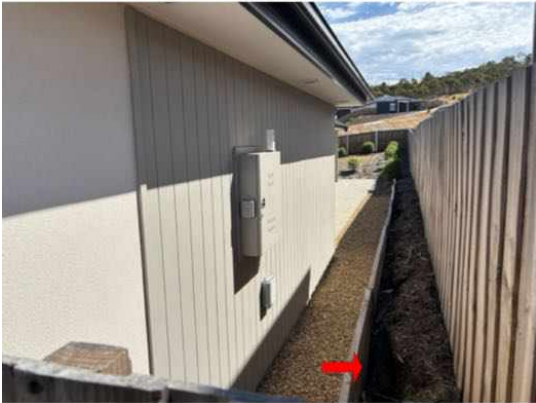
Noted Item

Location: Right hand side of house
Finding: Mulch
Information: FYI on the right hand side of the house, the mulch to the retaining wall has a large gap.

Recommend client engage a Handy Person to rectify at clients convenience.
