Building and Timber Pest Inspection Report

Inspection Date: Wed, 25 Feb 2026

Property Address: 79 Holden drive Oran park

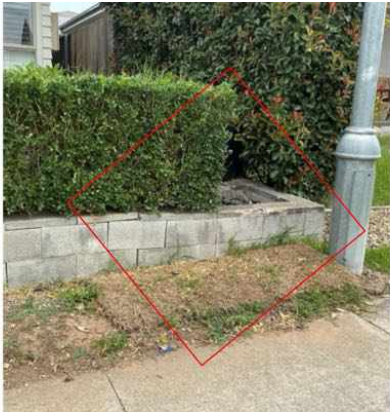
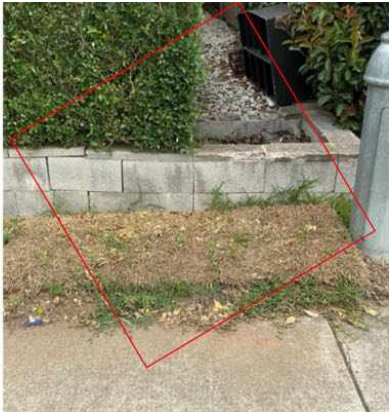
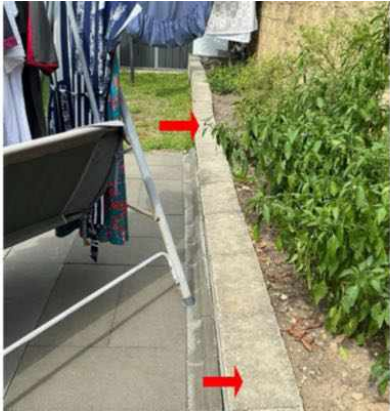
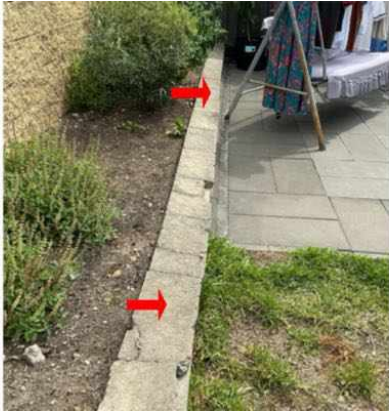
Finding 3.01

Building: Main Building
Location: All External Areas - Front, rear
Finding: Retaining wall - Defective - Misaligned and damaged capping ,
Information: Minor misalignment and uneven capping were noted. While the retained height is relatively low, ongoing movement or soil pressure may contribute to further displacement over time. Recommended a licensed landscaper to review and rectify.

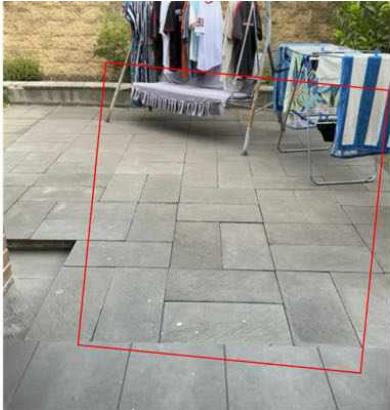
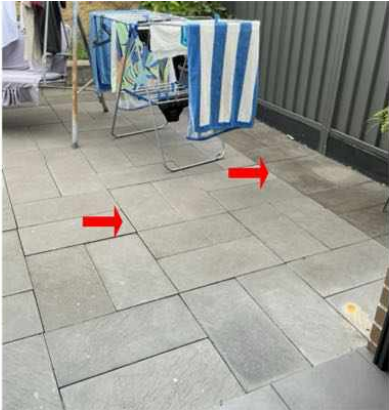
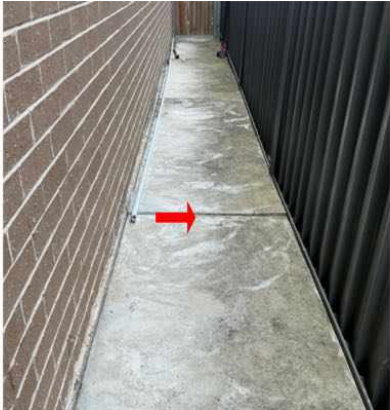
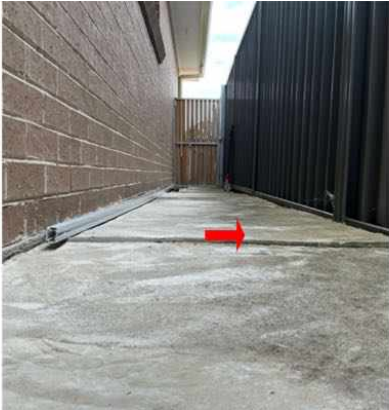
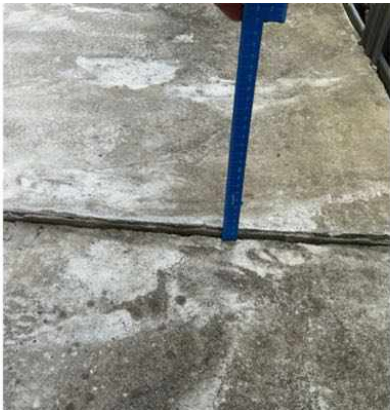
Finding 3.02

Building: Main Building
Location: All External Areas - Rear
Finding: Paving - Uneven
Information:

Sections of the external paved area are uneven, creating a potential trip hazard. It appears as though the area has been subject to rough installation, or that paving sections have lifted due to movements in the foundation of the property.

Where paving creates a trip hazard, personal injury may ensue if due caution is not taken by all persons within this area.

Re-paving of the area is required as soon as possible to remedy this situation. Further consultation with a specialist concreter is advised.

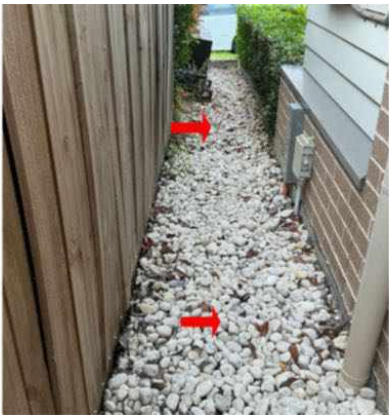
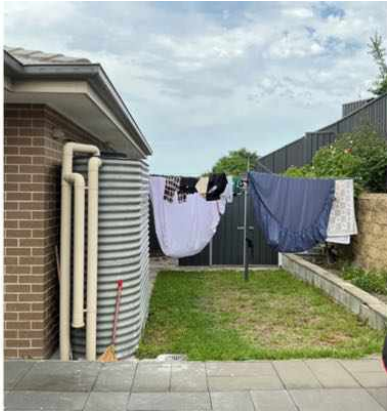
Finding 3.03

Building: Main Building
Location: All External Areas
Finding: Surface Drainage - Gravel and uneven pavement
Information: The setback is finished with loose aggregate. While gravel can assist with surface dispersion of water, it is not a controlled drainage system. The adequacy of falls and stormwater connection could not be confirmed at the time of inspection. Monitoring during rainfall is recommended to ensure no ponding or water discharge occurs toward the slab edge. recommended a licensed plumber to further access for grading to all exterior areas including uneven paved surfaces to ensure water is diverted away from the building in accordance with good building practice.

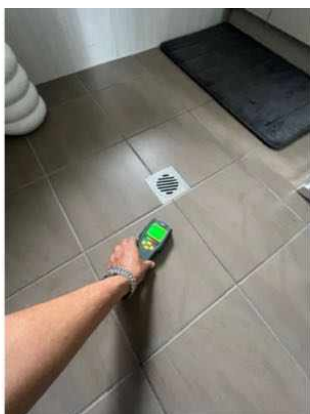
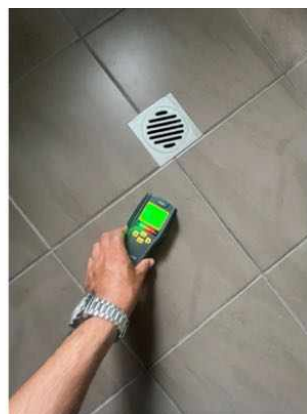
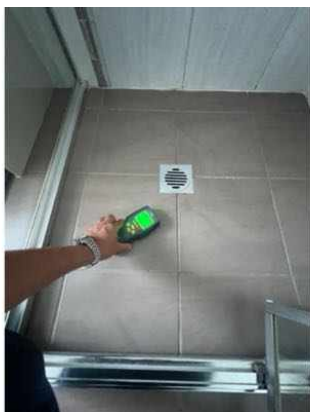
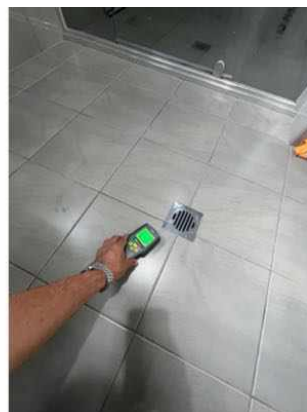
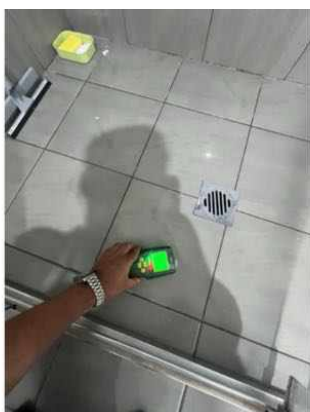
Building:	Main Building
Location:	Bathroom, Ensuite
Finding:	Elevated Moisture Bathroom (No visible deterioration noted)
Information:	Elevated moisture levels were detected to tiled surfaces in bathroom/shower areas. Persistent moisture ingress can lead to concealed damage, including timber rot and mould growth.

Elevated moisture readings in tiled wet areas can occur from normal shower use, age/deterioration of waterproofing membranes, plumbing leaks or moisture absorption through grout lines. While no damage was visible, elevated readings may indicate moisture retention behind tiles, which can be a conducive condition for future deterioration if not monitored.

No immediate action required. Monitor the area over time for signs of drumming, efflorescence, tile movement, or grout deterioration. If concerns arise, a licensed waterproofing specialist can perform further investigation (e.g., pressure testing, membrane assessment).

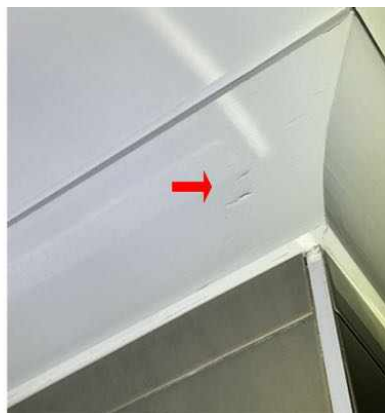
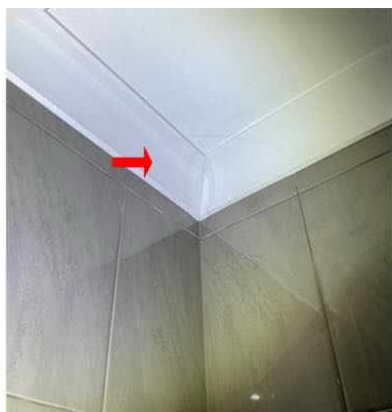
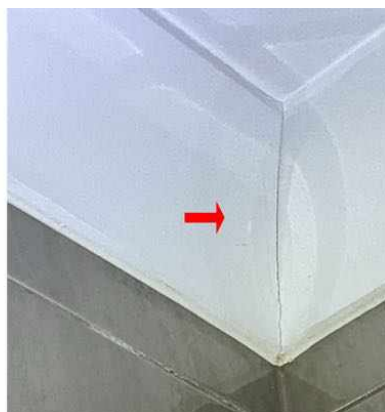
Finding 3.06

Finding: Painted surface - Bubbling - possible humidity

Information: Sections of paint in this area was found to have bubbled and deteriorated. Paint bubbling is generally an indication of excessive moisture in the area, that is currently hidden by the painted surface.

The presence of excessive moisture can have major implications on associated building elements if left unattended. While only seemingly minor at this stage, the damage cannot be determined due to the paint obstructing any further inspection of the damage.

It is highly advised that the affected paint be cleaned to allow a further, more invasive inspection by a licensed plumber. Failure to act on this defect may necessitate major works in the future.

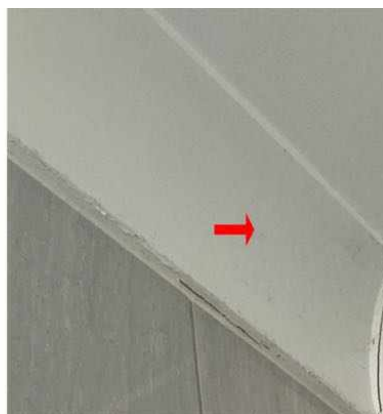
Finding 3.07

Building:	Main Building
Location:	Bathroom, ensuite
Finding:	Water Staining - Humidity or Ventilation
Information:	The ceiling surface shows faint darkened spotting or shadowing, commonly consistent with surface mould or humidity-related staining, often found in bathroom or wet area ceilings with insufficient ventilation. While there is no visible sagging or major water damage, the pattern suggests prolonged moisture exposure, possibly due to steam accumulation or minor condensation issues. According to AS 4349.1-2007 (Appendix C), this would be classified as a minor defect unless further deterioration or active leaks are found. Recommend improving mechanical or natural ventilation, cleaning the surface with mould treatment, and monitoring for recurrence.

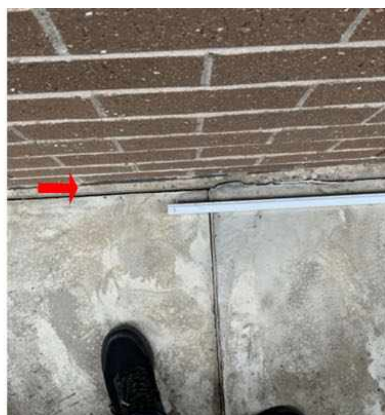
Finding 3.10

Building:	Main Building
Location:	All External Areas
Finding:	Gap Between Concrete and External Wall - to some areas
Information:	Visible gaps were observed between the external masonry wall and adjacent concrete slab at the pathway.

This separation may permit water ingress and contribute to concealed moisture-related damage, pest ingress, or slab movement if left unsealed.

The defect appears consistent with common differential settlement or poor sealant detailing at the slab-to-wall junction. Recommend a licensed contractor seal the gap with an appropriate flexible, UV-stable exterior-grade sealant to prevent moisture entry

and pest intrusion.

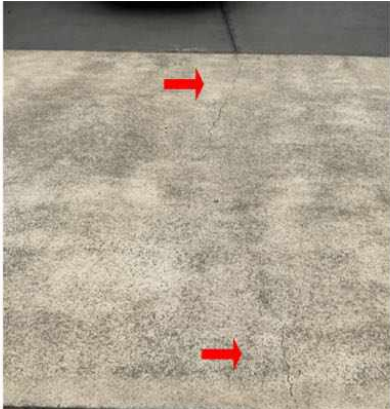
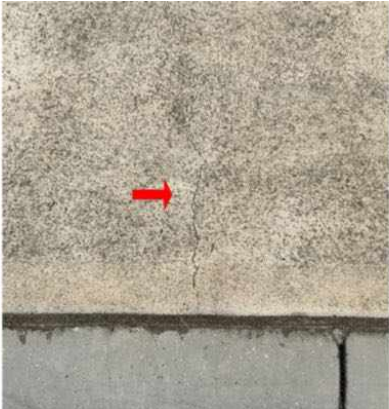
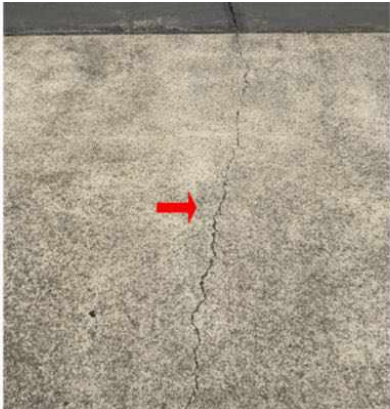
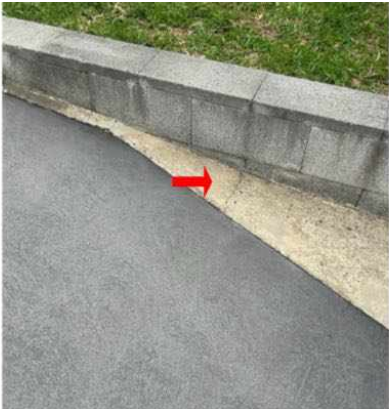
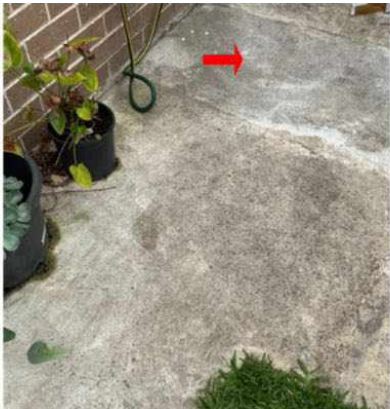
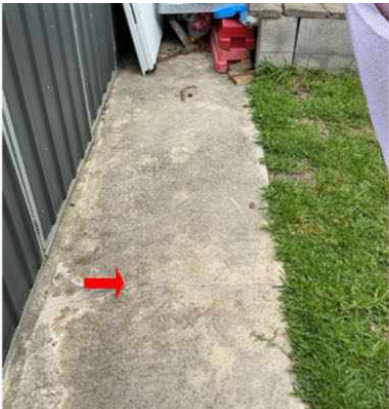
Finding 3.11

Building:	Main Building
Location:	All External Areas
Finding:	Cracking - External Concrete Paving Damage Category 2 - Distinct (less than 3mm) to some areas
Information:	Distinct cracks were identified in external concrete paving. Distinct cracks are generally found in older concrete paving, and may also present as a trip hazard as consequence of an uneven or curved surface.

General age and expected deterioration of the paved areas is a common cause of this type of cracking. However, expansion and contraction of the slab may also have occurred due to environmental factors. Such factors include variable moisture and weather conditions, the presence of trees and their roots having a settling or lifting affect on the soil, or the effect of load bearing, e.g. heavy vehicles over a sustained period of time.

Cracking to this degree may also be due to poor original installation of the concrete. Factors such as poor compaction of the sub surface and/or inadequate reinforcing of the slab may create cracking and other secondary defects.

Repairs are likely to be required to prevent further cracking and to reduce hazards

associated with cracking, such as tripping. Monitoring of all cracking should be conducted frequently. Always contact a building inspector should cracks widen, lengthen, or become more numerous.

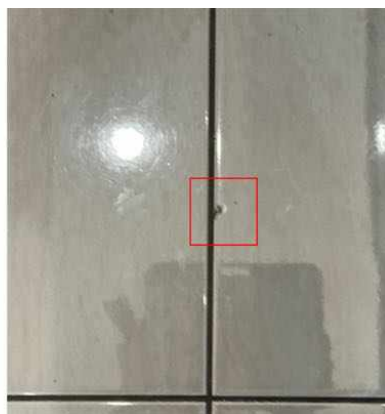
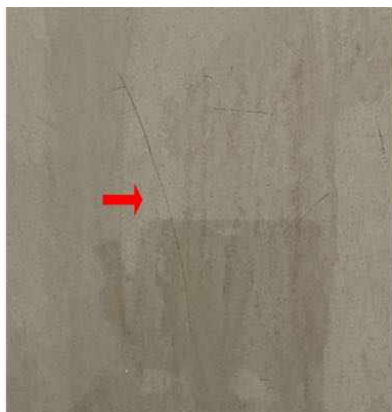
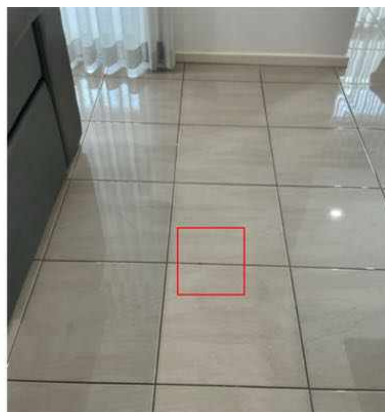
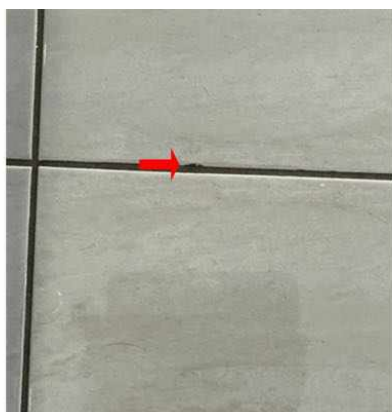
Finding 3.12

Building:	Main Building
Location:	Kitchen, hallway
Finding:	Tiles - Cracked or damaged (Minor chips or hairline)
Information:	Cracking was evident to the tiling in this area at the time of inspection. While the cracking appears to be minor, this area is frequently exposed to water, allowing potential for water penetration into adjoining sections of walls or flooring.

If left unmanaged, water penetration to these areas may lead to subsequent water damage, which is likely necessitate repair work to affected building elements.

A tiling contractor should be appointed to ensure that no further water damage occurs. The re-application of silicone and grouting throughout remaining tile work is also advised, to further protect the area against water penetration.

Where water penetration has led to water damage, appointment of a relevant tradesperson may be required to repair damaged building elements.

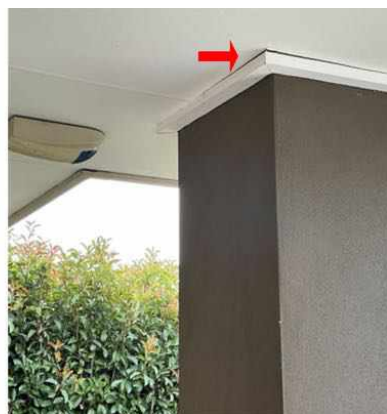
Finding 3.13

Building:	Main Building
Location:	All External Areas
Finding:	Eave Trim Separation - to some areas
Information:	The external timber trim at the eaves corner displays a visible separation crack, likely due to minor building movement or timber shrinkage over time. While not structurally significant on its own, the gap may allow moisture ingress and should be sealed with a flexible exterior-grade sealant to prevent further deterioration.

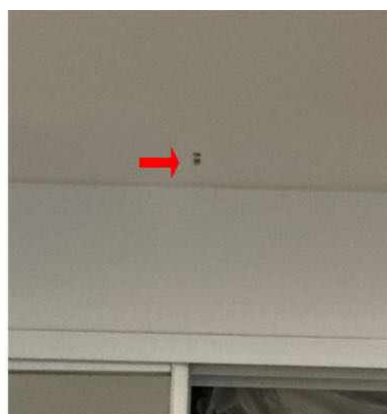
Finding 3.14

Building: Main Building
 Location: All Internal Areas - Garage , bathroom
 Finding: Ceiling nails - Popping To some areas
 Information: Numerous popped nails were identified in the internal ceiling at the time of inspection. Nails and screws hold simply by the friction between them and the surface they are applied to. Over time, the nails and screws can back out, which is often a result of general ageing and deterioration of the building structure.

If left unmanaged, the ceiling sheets may become loose and unstable, increasing the rate of deterioration of the internal ceiling and creating potential for the development of secondary defects.

Re-fastening of popped nails will help to maintain the stability of the internal ceiling and associated building elements. Such minor works will also help to improve the appearance of the affected area and secure the ceiling sheets, so as to prevent the onset of ceiling sagging. These works should be performed by a qualified carpenter or plasterer at client discretion.

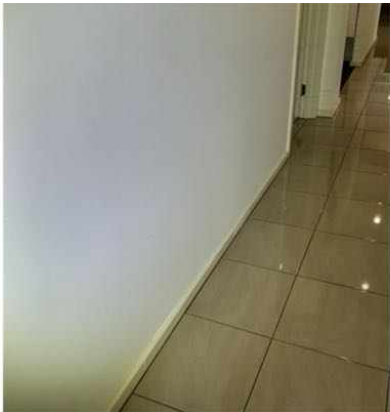
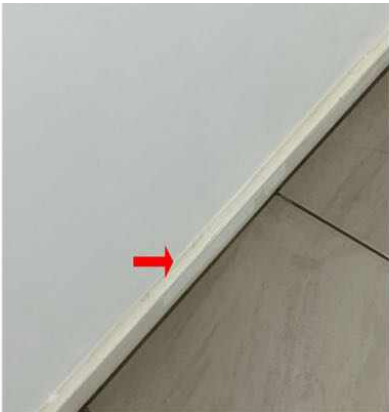
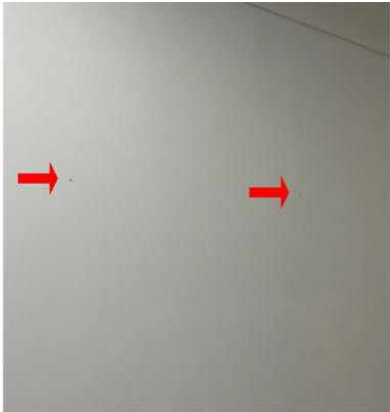
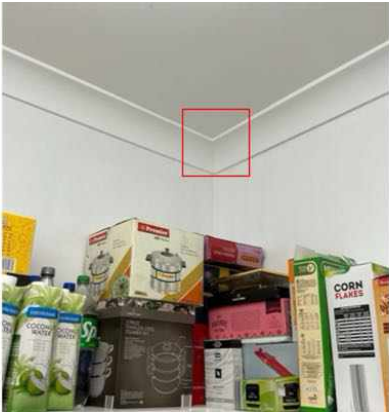
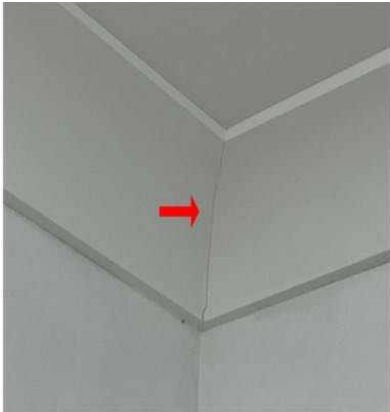
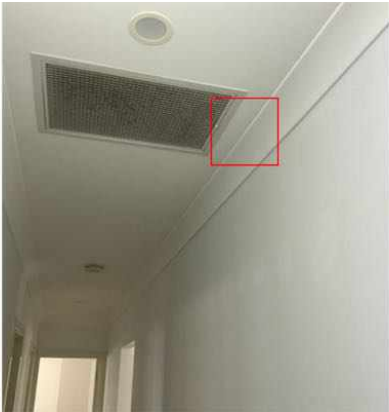
Finding 3.22

Building:	Main Building
Location:	All Internal Areas
Finding:	Sealant and grouting - Missing or degraded to some areas
Information:	It was noted on inspection that sealant or grout is degraded.

Different materials and floor areas move at different rates, generally causing cracking to grout or sealant at this point. A flexible sealant is required to allow for expected expansion and contraction, while keeping the joint water tight and protective of all associated building materials.

Excessive mould to the sealant and grout may require scraping out and replacement.

Flexible and mould resistant materials should be applied to affected areas to prevent any subsequent water damage that is likely to occur. Regular maintenance and replacement of damage or missing or damaged sealant and grout is highly recommended to the wet areas, as this is a regular wear and tear defect. Sealant and grouting in areas that come into regular contact with water should be maintained for the long term care of your property.

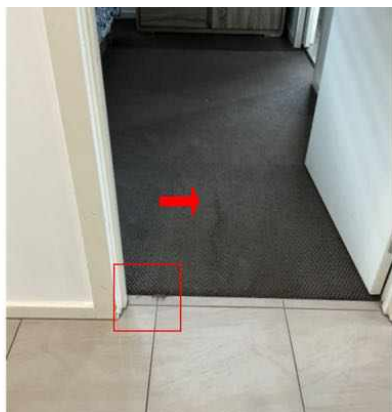
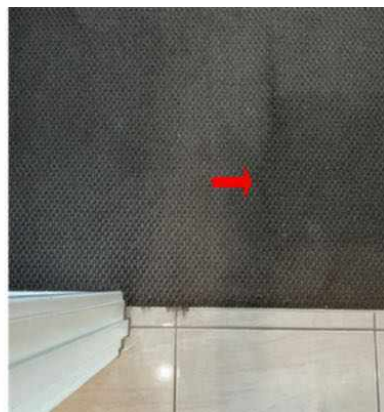
Finding 3.23

Building: Main Building
 Location: All Internal Areas- master bed
 Finding: Carpet Wear and Shading
 Information: Carpet shows pile flattening, shading/lifting and or staining .

Condition is consistent with normal wear and tear.

Recommend to rectify to prevent further deterioration or damage

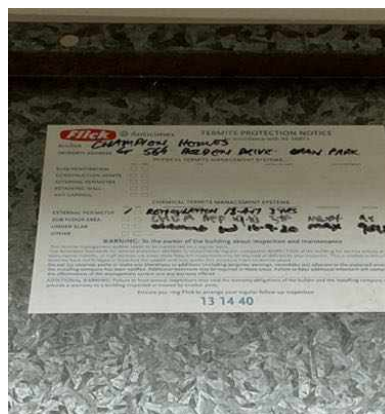
Building: Main Building
 Location: All External Areas
 Finding: Termite Management System - no evidence of a chemical installation
 Information: The application of a post-construction chemical termite barrier is highly recommended for all properties, particularly if live termite activity has been found on the site previously. Such barriers are highly effective in preventing termite attack on any timber building elements throughout the property.

A durable notice should be placed in the switchboard unit to indicate current termite barriers. At the time of inspection, it appeared as though no termite management system has been installed, with no evidence to suggest preventative works taking place.

The client may consider gaining further advice from a pest controller as to the costs and procedures involved with this application. It is recommended that obtaining such advice be a short-term priority.

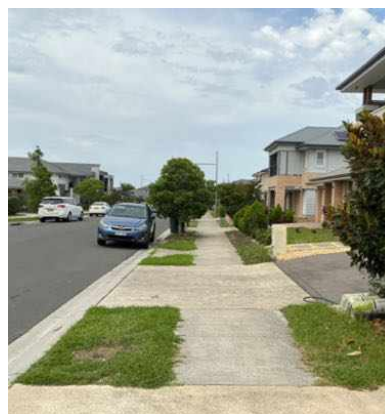
Finding 6.02

- Building: Main Building
- Location: All External Areas
- Finding: Trees within 50m
- Information: Trees within 50m of the property can be conducive to termite activity. It is recommended an invasive inspection of all trees with 50m to the property be carried out by a qualified pest control expert.

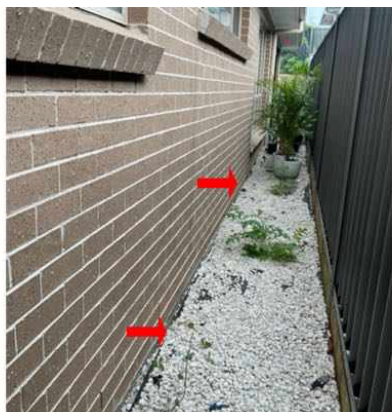
Finding 6.03

- Building: Main Building
- Location: All External Areas
- Finding: Slab Edge - Exposure
- Information: An inspection zone of at least 75mm in relation to the exposed slab edge, between the bottom brick and the perimeter pavement, is required. This inspection zone should be maintained in order to force termites into the open where they can be detected more readily during regular inspections. The slab edge should not be

If the slab edge is not properly exposed there is a high risk of termite attack. Sometimes, in order to determine the type of slab, a suitably qualified person such as an architect or builder may be required to consult the construction plans.

Where the slab edge cannot be properly inspected, it is highly recommended that termite or timber pest inspections be carried out every 6-12 months to aid protection of the property against infestation.

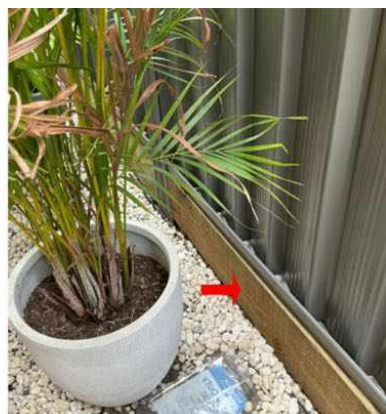
Finding 6.04

Building:	Main Building
Location:	All External Areas
Finding:	In ground contact - Timber
Information:	Any timbers in direct ground contact provide opportunity for concealed termite entry and are likely to be subject to premature rot and decay as the soil retains moisture or damp conditions against the timbers.

Remove untreated timber that is in direct contact with external grounds. Consider replacement with more durable materials i.e. treated timber or non timber elements. Frequent pest inspections are advised to readily identify any termite activity in these areas.

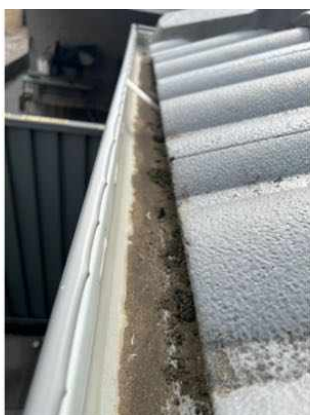
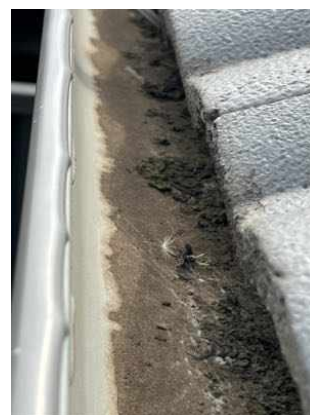
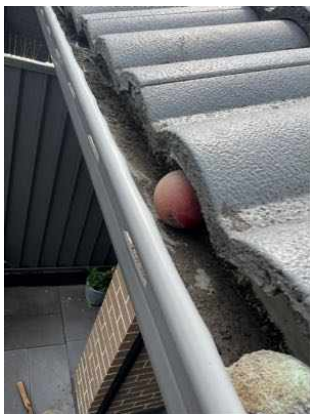
Finding 6.05

Building:	Main Building
Location:	All External Areas
Finding:	Gutters - Blocked
Information:	Roof plumbing structures, such as guttering and downpipes, should be free of all debris to prevent blockages. Blockages of the guttering and downpipes will lead to pooling and accumulated water overflows, which is likely to subsequently flood eaves and exterior walls.

Blocked gutters are likely to lead to high levels of moisture in the affected areas. Such moisture will not only cause rust and decay of the associated building materials, but can also provide conditions that are conducive to termite and timber pest activity. Blockages in gutters should therefore be removed immediately to ensure dry conditions are maintained.

Consult a Licensed Plumber for further specific advice on remedial works that may be required. In the interim, it is highly advised that blocked gutters be removed by the homeowner or a general handyperson as a matter of urgency.

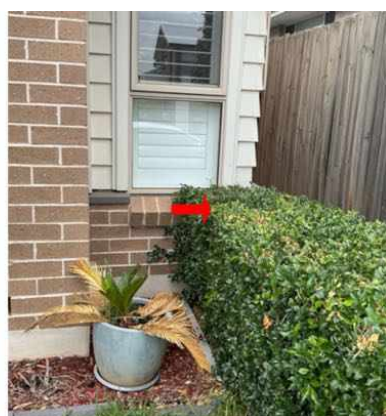
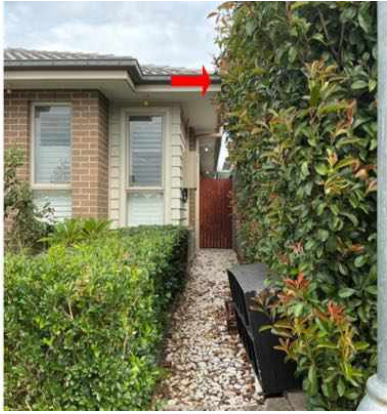
Finding 6.06

Building:	Main Building
Location:	All External Areas
Finding:	Bridging - Vegetation
Information:	Where vegetation obstructs inspection of building elements, also known as bridging as it provides a bridging point for the access of termites, full inspection can not be achieved. Consequently moisture or dampness may be present and the areas becomes conducive to termite activity. Plants against or very close to buildings provide cover, shade and can provide an environment that is attractive to termite infestation.

The removal and replanting of species that do not provide "cover" or cutting back of existing vegetation will assist greatly in preventing Bridging from occurring.

The removal of any such materials that may be conducive to termite activity should be carried out as soon as possible and arrange re inspection to minimize the risk of termite attack.

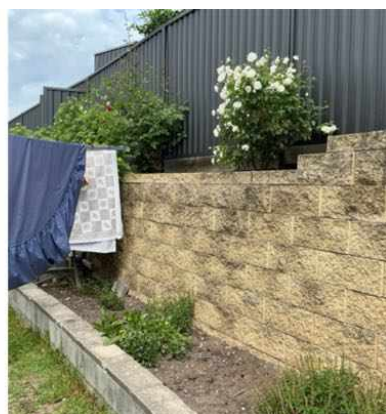
Building:	Main Building
Location:	All External Areas
Finding:	Retaining Wall Drainage
Information:	Drainage provisions could not be confirmed during visual inspection. Recommend inspection by a licensed landscaper to ensure adequate drainage provisions have been provided.

Retaining walls require ongoing maintenance to ensure stability and drainage performance. Regularly check for signs of cracking, movement, or leaning, and ensure that weep holes or subsoil drains remain unobstructed to prevent water pressure buildup. Vegetation should be kept clear from the wall face and upper edge to avoid root pressure or added moisture. Periodic inspection and maintenance will help extend the wall's service life and prevent structural deterioration.

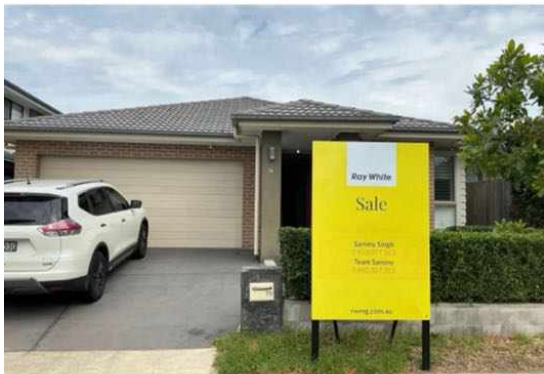
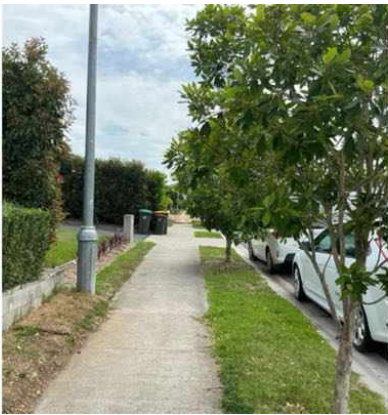
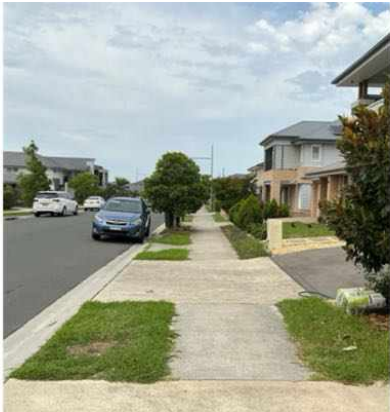
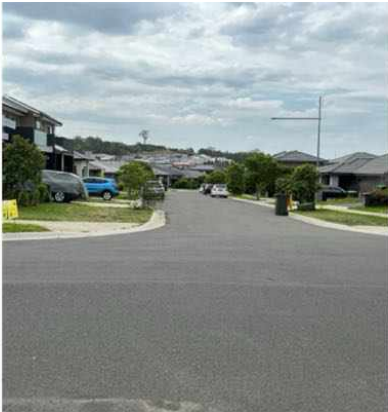
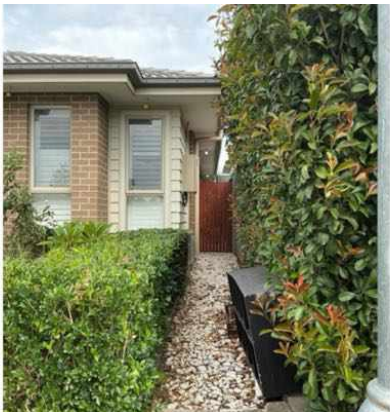
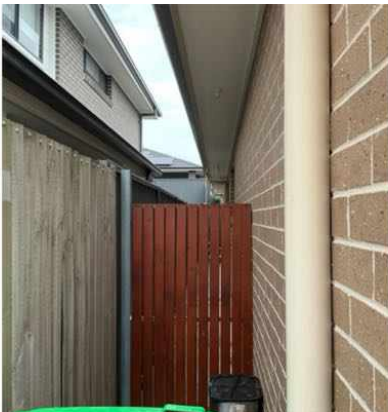
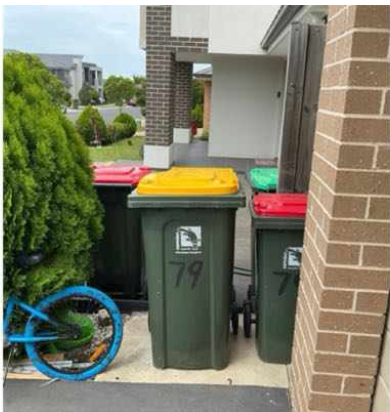
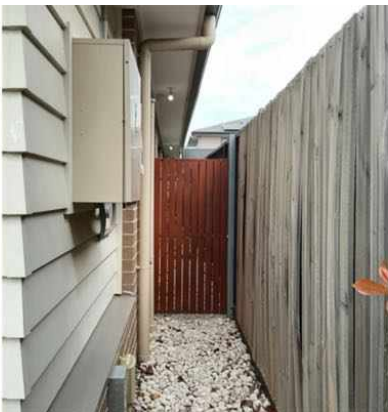
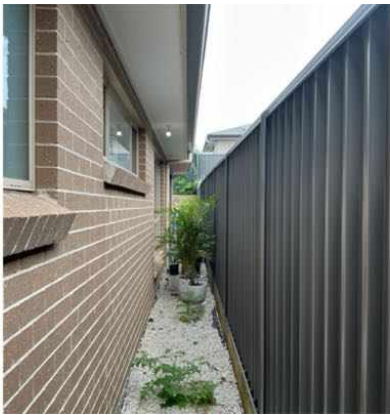
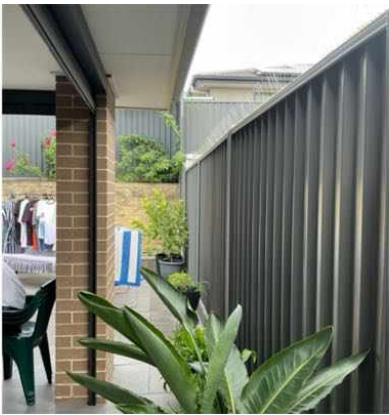
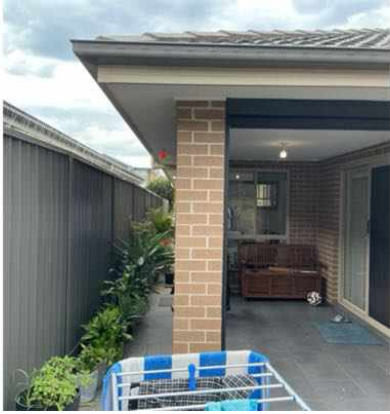
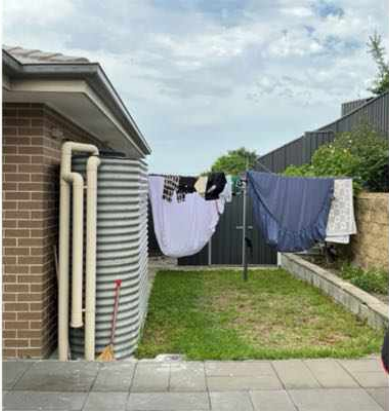
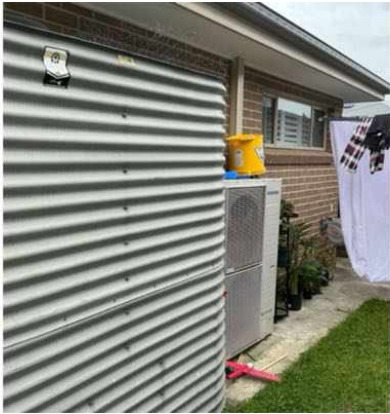
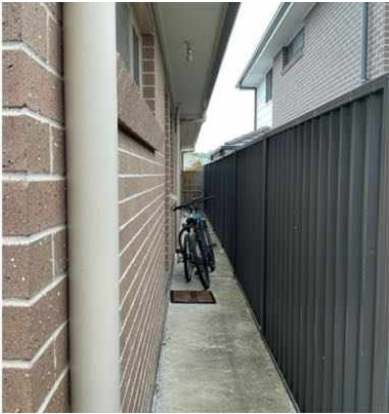
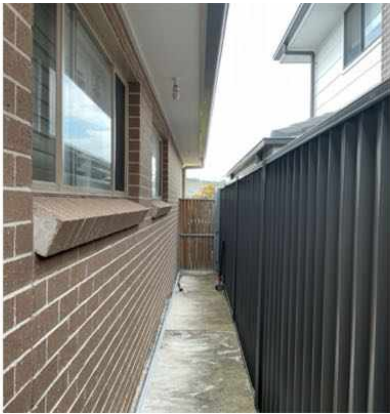
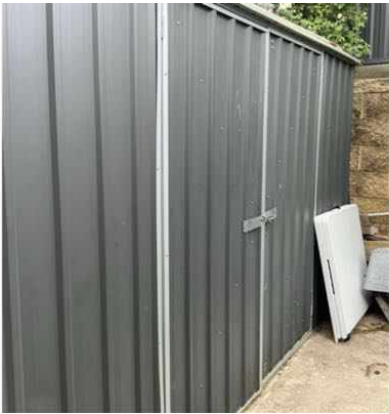
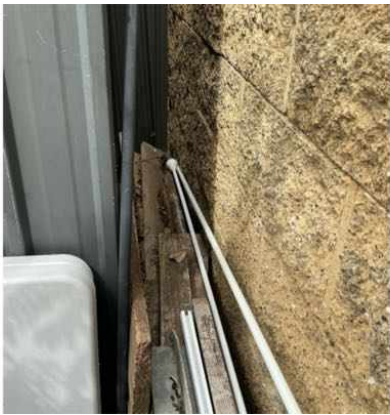
Building:	Main Building
Location:	All External Areas
Finding:	Additional Photos - Obstructions and Limitations
Information:	These photographs are an indication of the obstructions and limitations which impeded full inspection of the property at the time of inspection. These obstructions can hide an array of defects and should be removed to allow full inspection to be carried out. A re-inspection is recommended once the areas are made accessible.

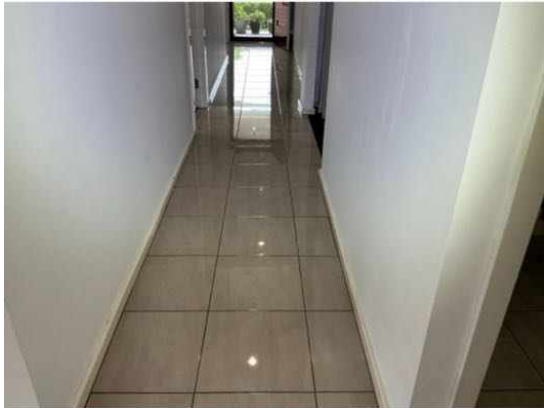
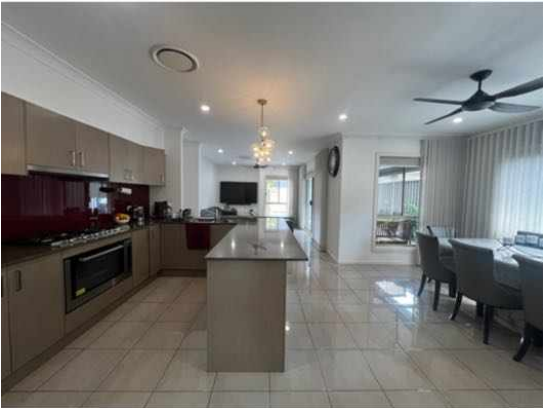
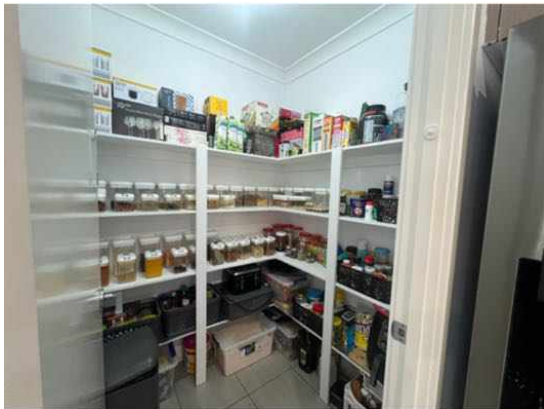
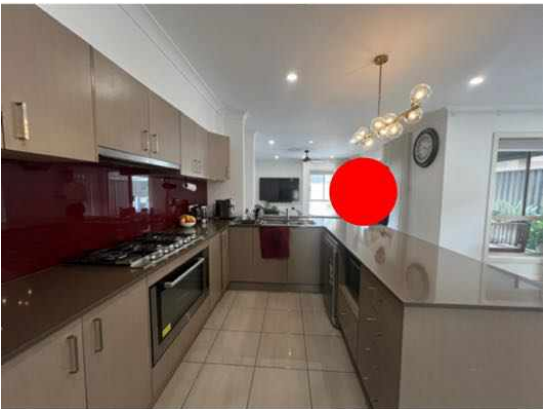
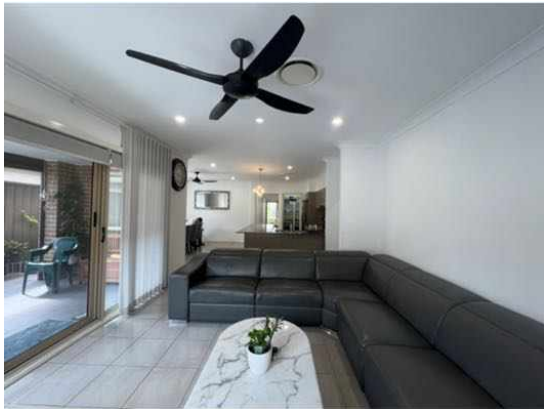
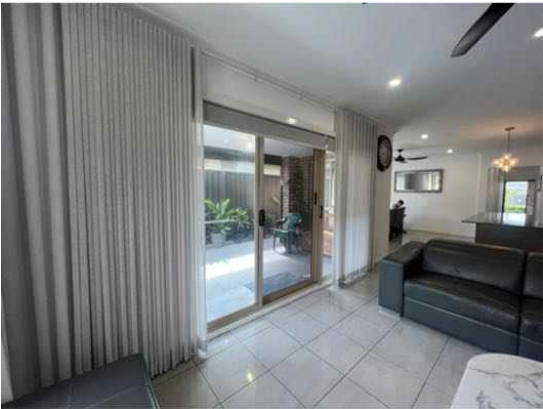
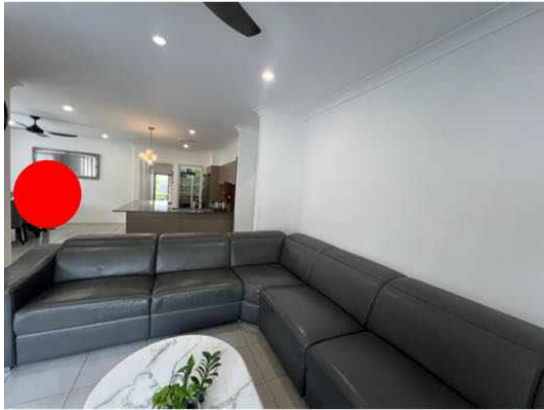
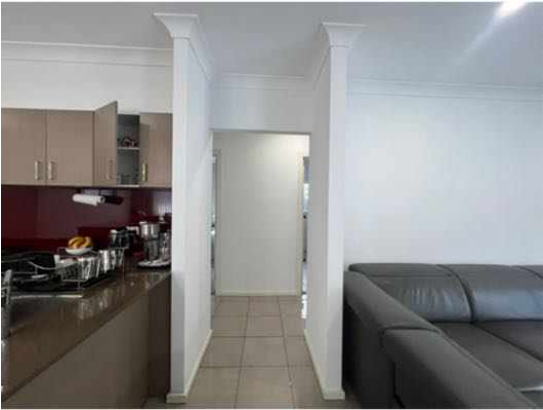
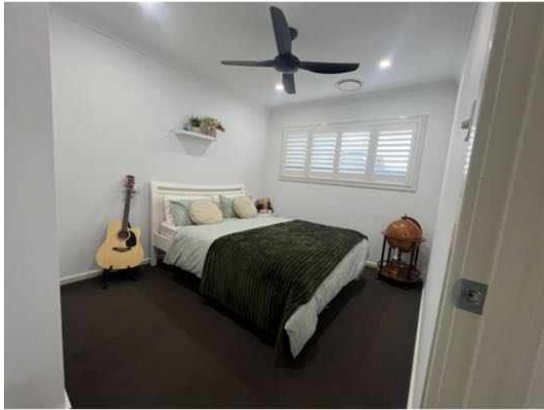
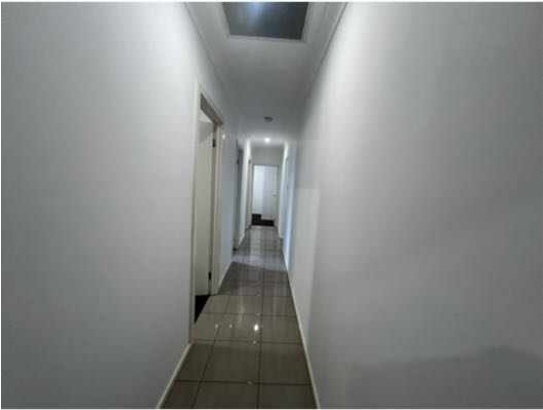
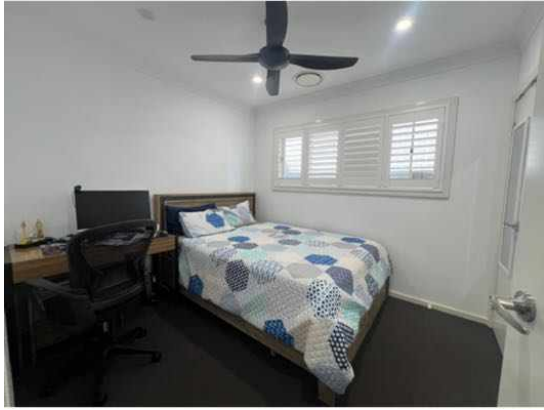
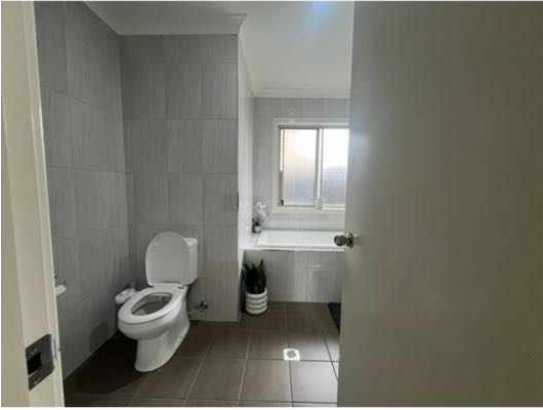
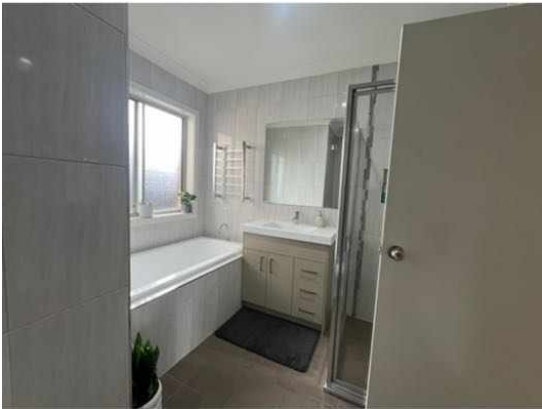
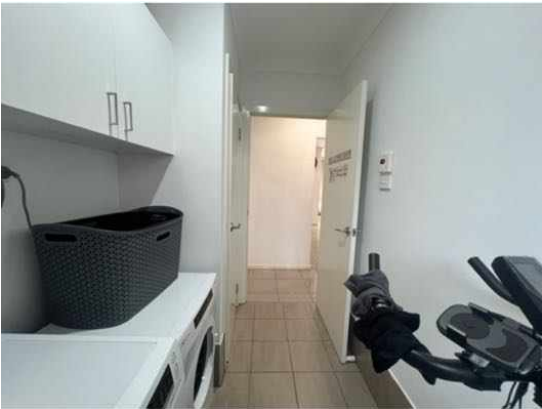
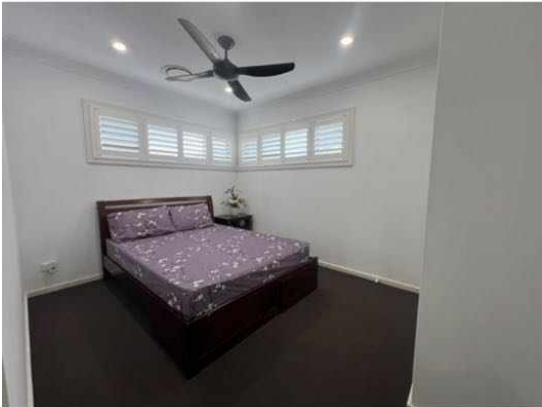
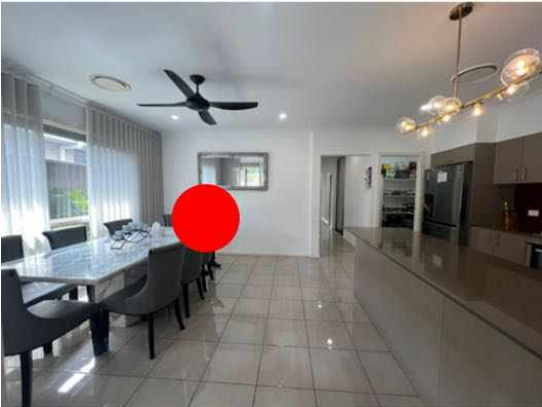
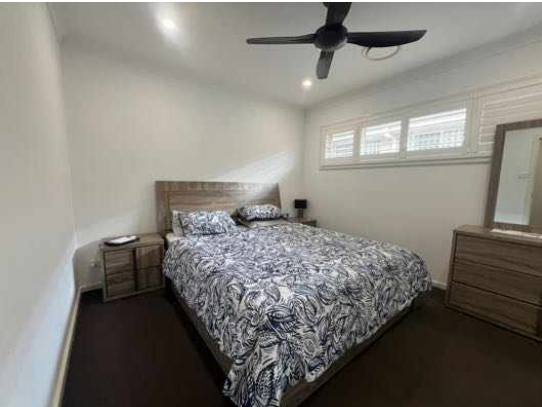
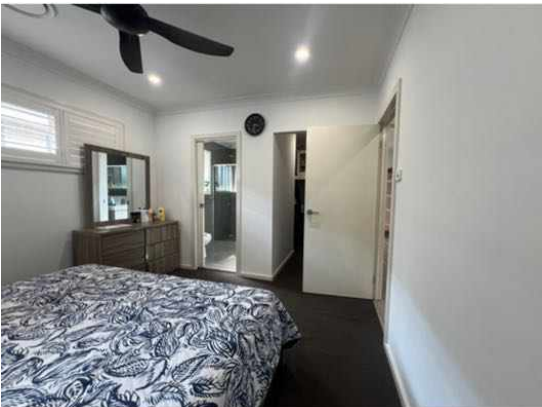
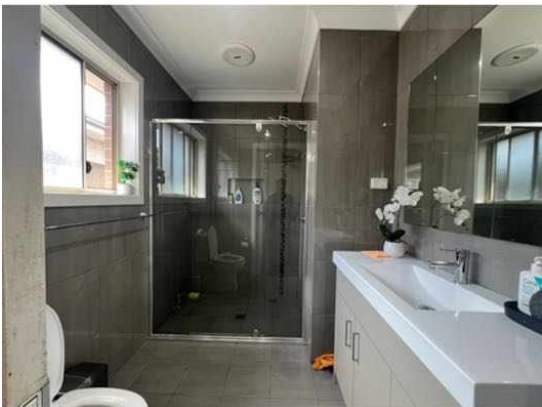
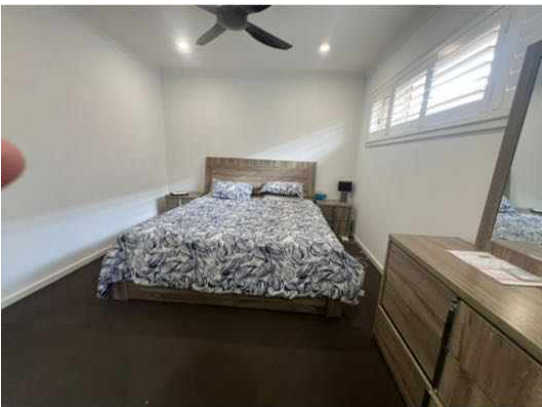
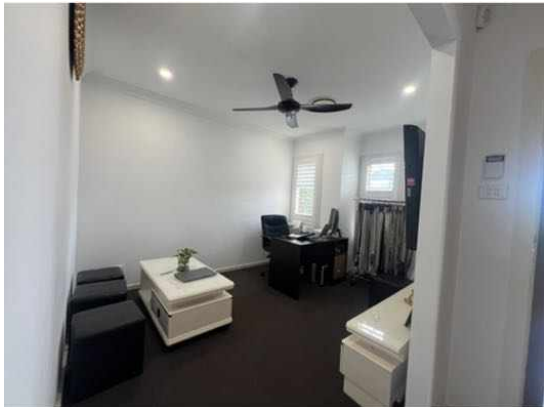
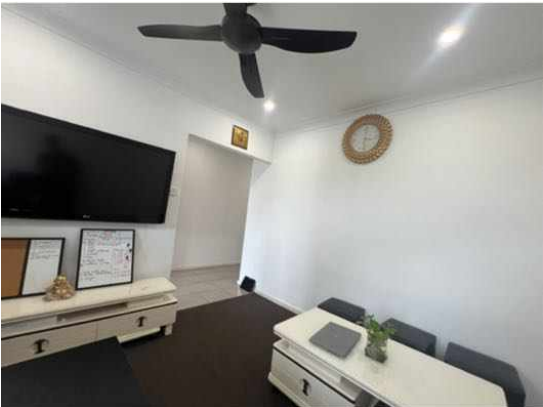
Building: Main Building
Location: All Internal Areas
Finding: Additional Photos - Obstructions and Limitations
Information: These photographs are an indication of the obstructions and limitations which impeded full inspection of the property at the time of inspection. These obstructions can hide an array of defects and should be removed to allow full inspection to be carried out. A re-inspection is recommended once the areas are made accessible.

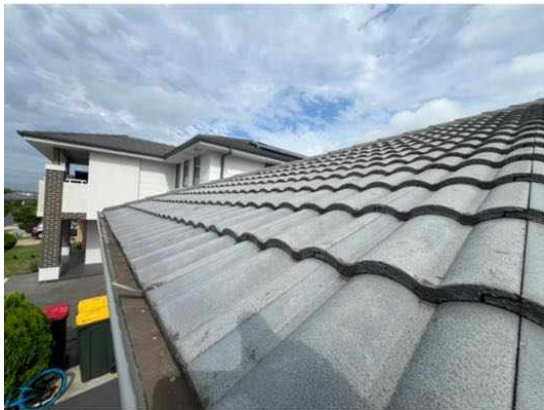
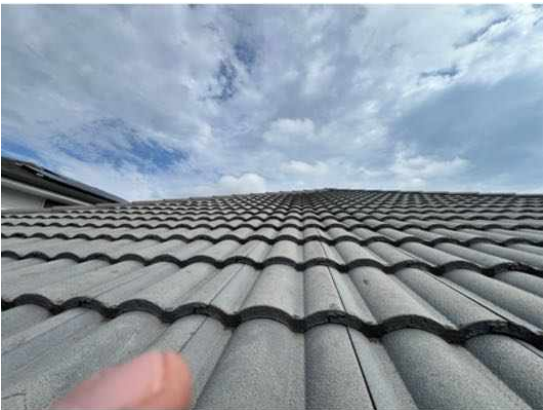
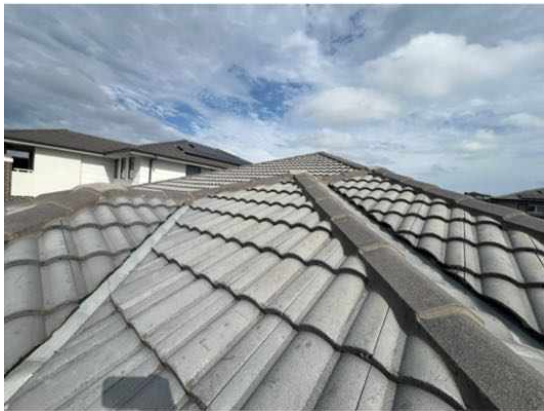
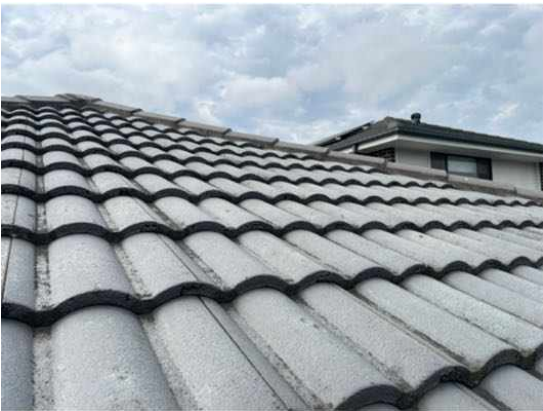
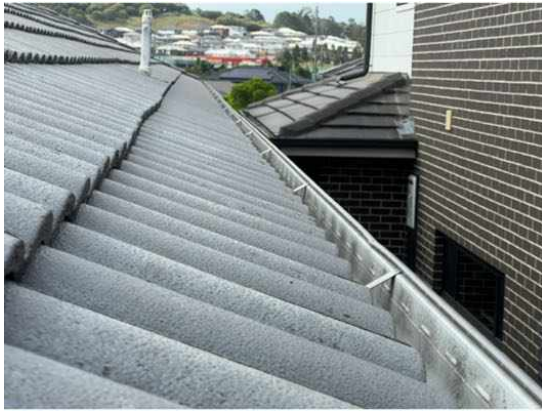
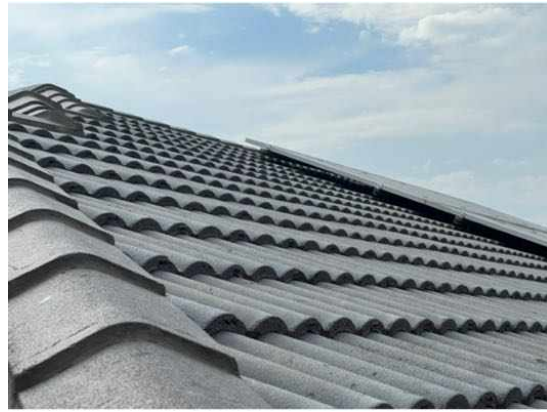
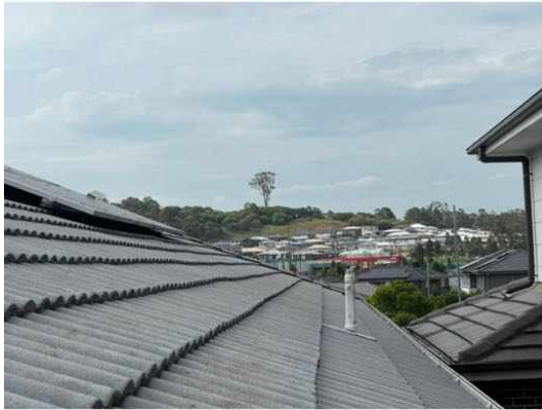
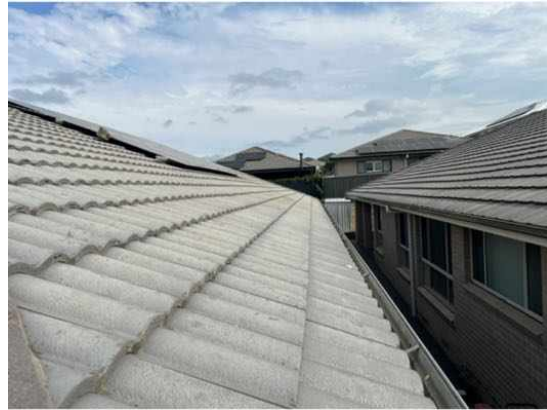
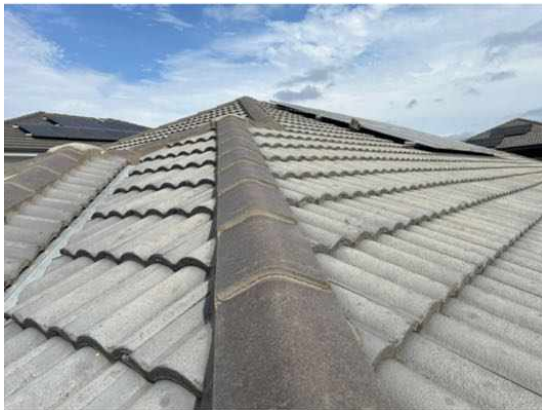
Building: Main Building
Location: Roof Exterior
Finding: Additional Photos - Obstructions and Limitations
Information: These photographs are an indication of the obstructions and limitations which impeded full inspection of the property at the time of inspection. These obstructions can hide an array of defects and should be removed to allow full inspection to be carried out. A re-inspection is recommended once the areas are made accessible.
