Building and Timber Pest Inspection Report

Inspection Date: Wed, 25 Feb 2026

Property Address: 79 Holden drive Oran park

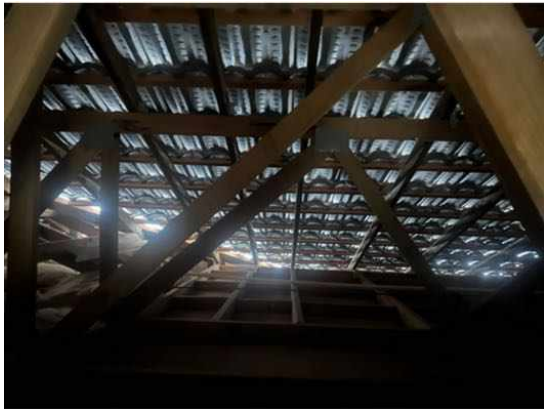
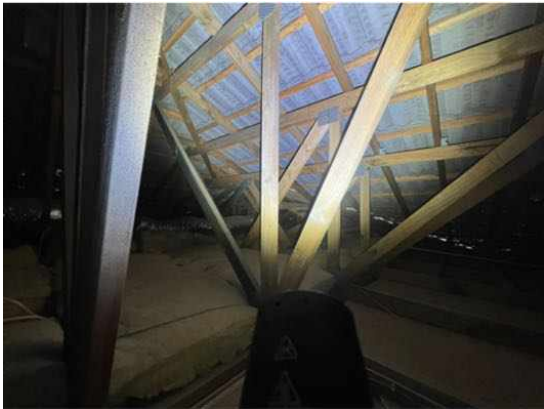
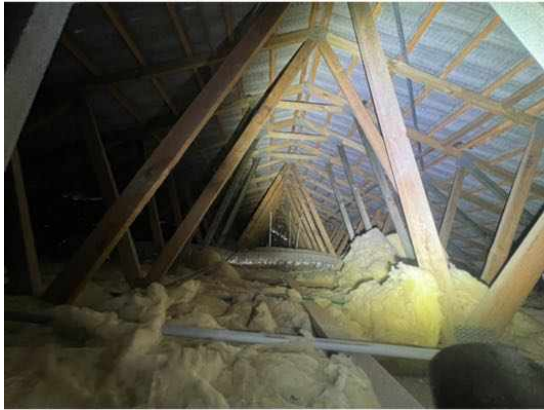
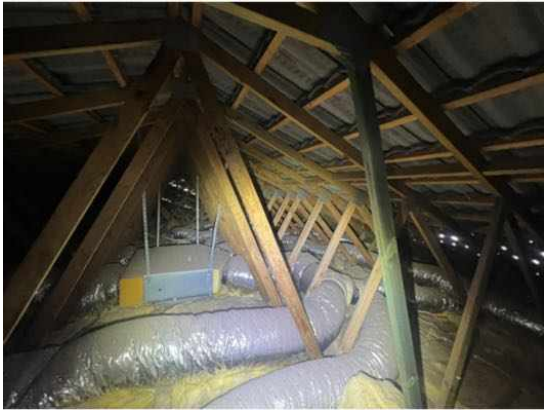
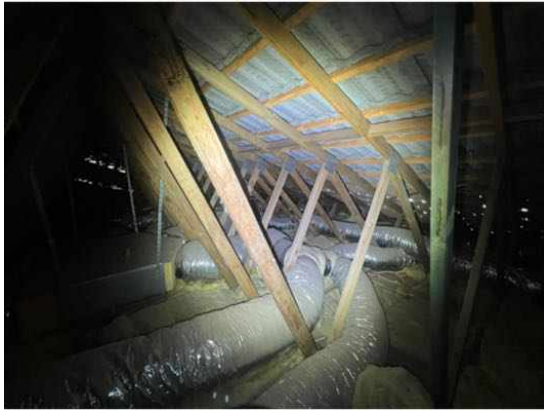
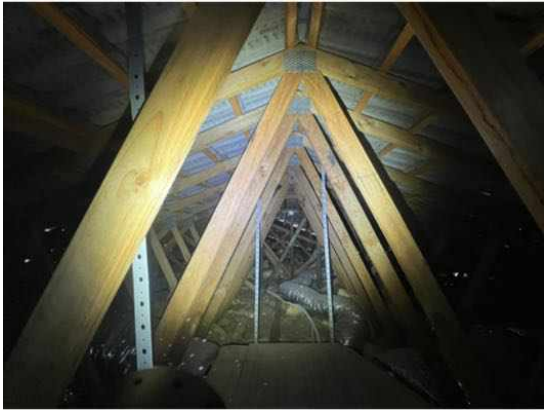
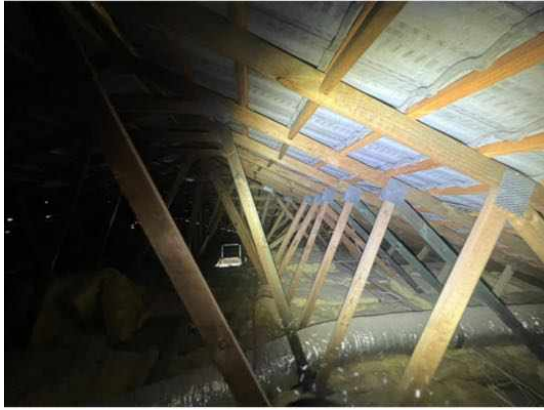
Building:	Main Building
Location:	Roof Void
Finding:	Additional Photos - Obstructions and Limitations
Information:	These photographs are an indication of the obstructions and limitations which impeded full inspection of the property at the time of inspection. These obstructions can hide an array of defects and should be removed to allow full inspection to be carried out. A re-inspection is recommended once the areas are made accessible.

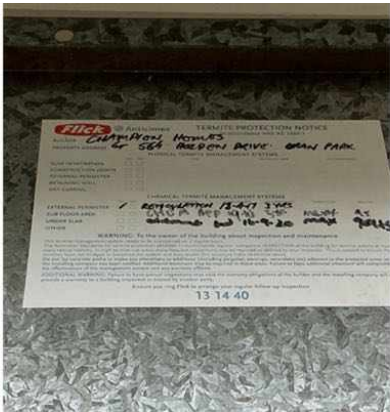
Where a Termite Management System has been identified you should refer to the type of barrier date of installation warranty conditions and any documentation provided by a builder or past owner. Consult the company who installed the barrier to confirm whether the system is still under warranty.

Most chemical termite management systems expire and require replenishment and all physical systems are primarily designed to prevent concealed entry.
