Building and Timber Pest Inspection Report

Inspection Date: Tue, 17 Feb 2026

Property Address: 1 Sherridon Cres, Quakers Hill NSW 2763,
Australia

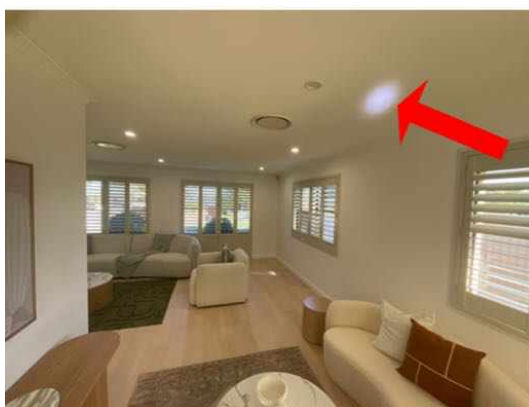
Building: Main Building
 Location: Living Room
 Finding: Ceiling - Water damaged
 Information: Water damage to the ceiling lining is generally an indication of excessive moisture being present in the roof void, usually via a leak to the roof covering.

Where water damage is evident to the ceiling, the primary requirement is to identify and rectify the source of the leak. A roofing plumber should be appointed as soon as possible to identify the leak and perform rectification works as necessary, ensuring the water damage is restricted.

Once the leak is repaired, consultation with relevant tradespeople, including plasterers and painters, is advised. Rectification works may include replacement of ceiling lining or minor repainting, depending on the extent of the damage.

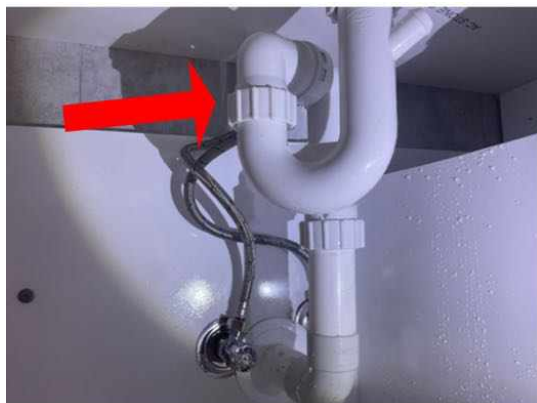
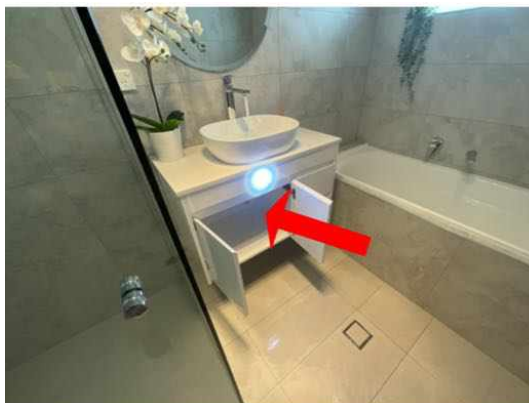
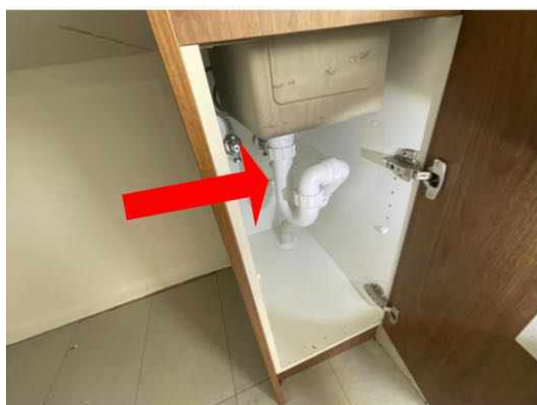
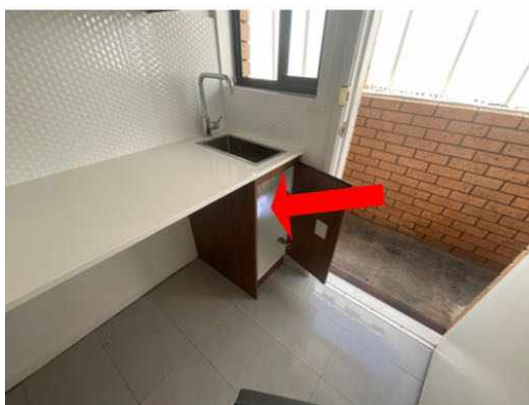
Finding 2.02

Building: Main Building
 Location: Bathroom / Laundry
 Finding: Active Plumbing Leak – bathroom
 Information: An active water leak was observed to plumbing pipework in the wet areas. Water discharge was evident at the time of inspection.

Ongoing leakage may lead to timber decay, structural deterioration, mould growth,

and further damage to structure components if not promptly rectified.

Immediate attention by a licensed plumber is required to identify the source and repair the defect. Following rectification, a thorough assessment of surrounding structural timbers should be undertaken to determine whether secondary damage has occurred.

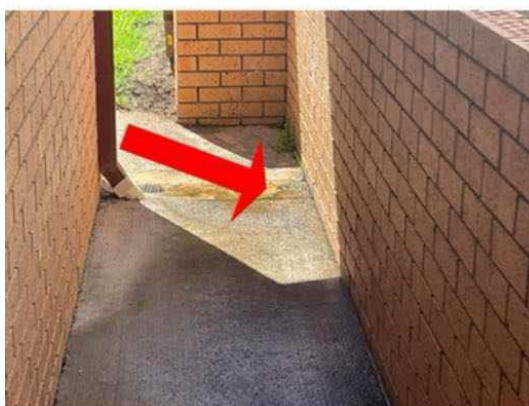
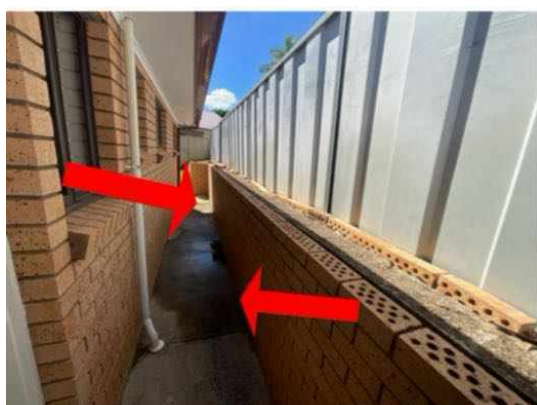
Finding 3.01

Building: Main Building
 Location: All External Areas
 Finding: Evidence of Water Ponding and Possible Moisture Ingress
 Information: Water ponding was observed on the concrete surface adjacent to the boundary retaining wall. The moisture appears to be accumulating along the base of the wall and does not appear to be draining adequately away from the structure.

The source of the water could not be confirmed at the time of inspection. Possible causes include:

- Inadequate surface drainage and fall toward a suitable stormwater outlet

- Failure or lack of subsoil drainage behind the retaining wall
- Water ingress from the neighbouring property
- Concealed plumbing leak within the vicinity

Prolonged moisture accumulation in this area may contribute to deterioration of masonry, mortar joints, footing movement, rising damp, or structural issues over time.

Recommendation:

An invasive inspection is strongly recommended to determine the source of the moisture. This may include:

- Pressure testing of nearby plumbing services by a licensed plumber
- Investigation of subsoil drainage behind the retaining wall
- Moisture testing of adjacent wall surfaces
- Lifting sections of concrete (if required) to inspect drainage conditions

A licensed plumber and/or drainage specialist should be engaged as soon as possible to identify the source and carry out rectification works as necessary.

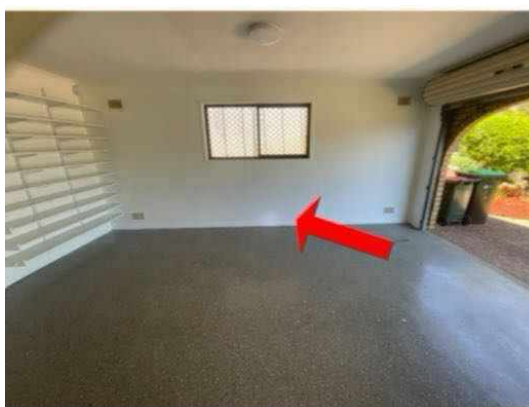
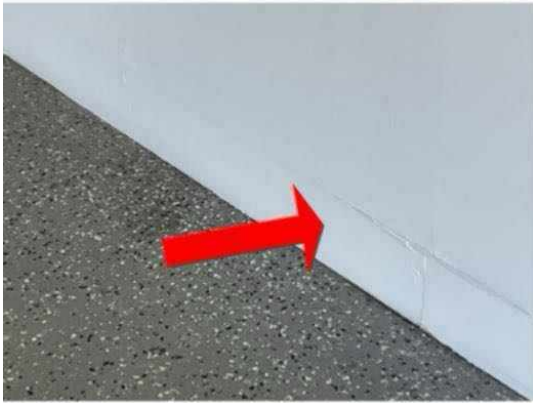
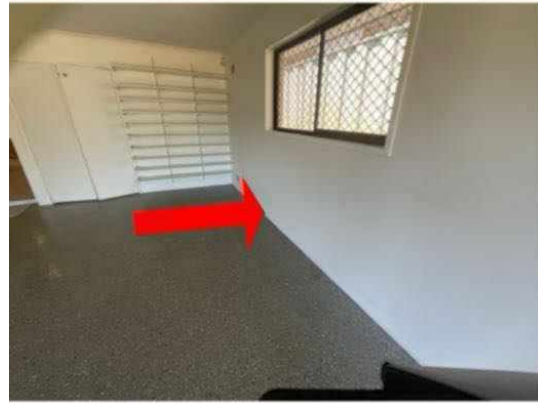
Finding 3.02

Building:	Main Building
Location:	Garage
Finding:	Garage – Wall Lining (Evidence of Possible Moisture Damage)
Information:	Evidence of previous plasterboard replacement was observed to the lower section of the garage walls. The wall lining has been cut approximately 200mm above slab level around the perimeter and patched with replacement sections.

This type of repair is commonly associated with previous moisture or damp-related damage at slab level. The presence of perimeter cutting suggests the lower wall lining may have been affected by moisture ingress or rising damp. The workmanship of the repair is uneven.

If the underlying moisture source has not been rectified, further deterioration of wall lining and potential corrosion to steel framing components may occur.

Recommendation:

An invasive inspection is recommended to:

- Remove sections of wall lining as required
- Inspect the slab edge, bottom track and wall cavity for moisture, corrosion or ongoing damp issues
- Identify the source of moisture (if present)

Moisture monitoring is also recommended to confirm whether the condition is active or historical.

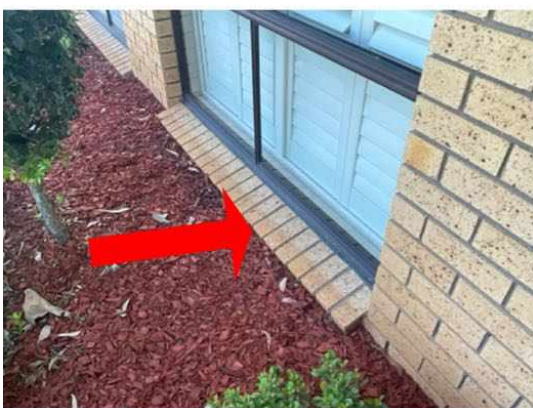
Finding 3.03

Building:	Main Building
Location:	All External Areas
Finding:	Site drainage - Inadequate
Information:	The site drainage in this area was found to be inadequate at the time of inspection, creating potential for subsequent water damage to associated building elements.

It is important that water does not lie against the base of walls; surrounding paths and ground levels should be sloped to drain water away from walls. Downpipes should not discharge stormwater onto lower walls or plinths. Stormwater should be carried away by large, regularly cleaned drains. Ground levels may need to be lowered to expose a buried DPC.

Where site drainage is inadequate, installation of an Agricultural (Aggie) Drain may be required. A qualified plumber should be appointed to further inspect the property and perform any remedial works as necessary. Water damage and secondary defects are likely to occur if left unmanaged.

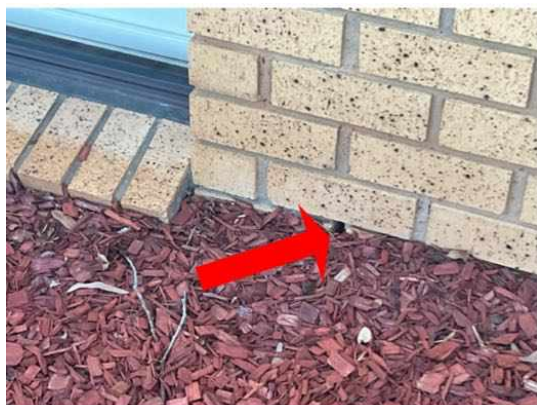
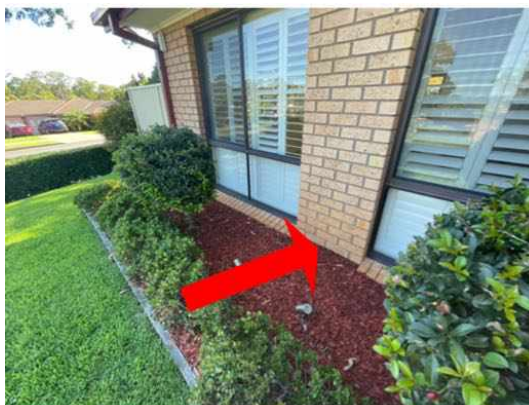
Finding 3.04

Building:	Main Building
Location:	Exterior walls

Information: It was noted during the time of inspection that some of the weep holes to the brickwork were blocked. Weep holes are designed to allow water from leaks or seepages in brickwork to be directed to the external environment, prior to entering the wall cavity or associated building materials. Weep holes should therefore be kept clean and free of debris or blockages.

Blocked weep holes are likely to result in the presence of excessive moisture within the brickwork and associated structures, creating potential for water damage and moisture problems.

Depending on the nature of the blockage, the homeowner may be able to undertake remedial works to remove blockages. Alternatively, appointment of a registered builder may be required to remove blockages. Preventative works are necessary in ensuring the structural integrity of the affected brickwork and should be performed as soon as possible.

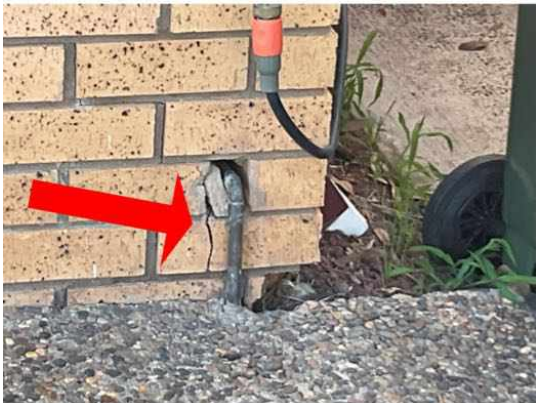
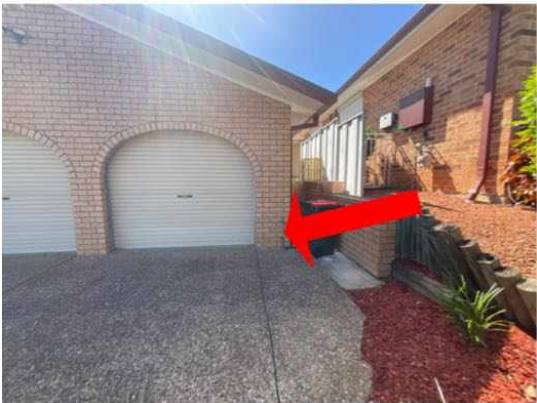
Finding 3.05

Finding: Brickwork - Cracking [Fine]

Information: Although fine cracks are quite noticeable, they are often only considered to be an appearance defect and usually do not indicate any structural damage. Generally, the cause of a fine crack is indicative of a separation between brickwork and mortar throughout the structure, but single bricks may also show cracks of this nature.

Cracking of this nature can generally be repaired with minor filling and should be conducted by a qualified bricklayer.

Always contact a building inspector should cracks widen lengthen or become more numerous.

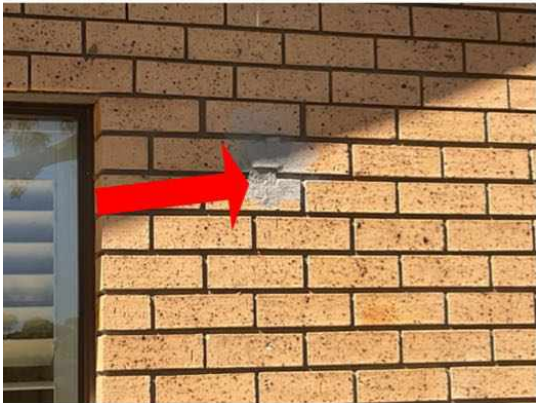
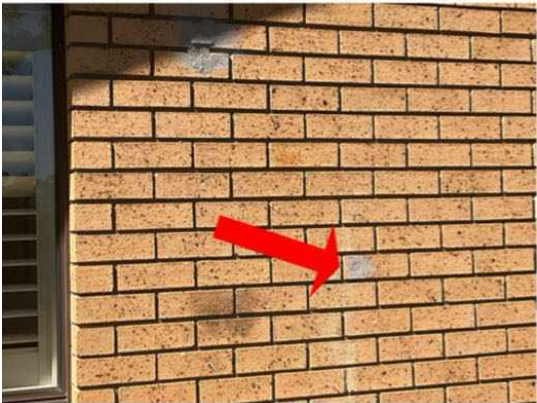
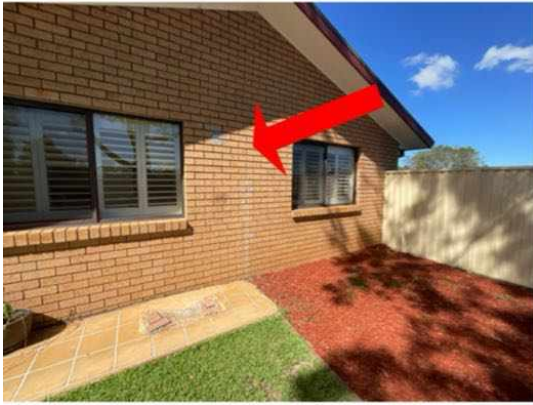
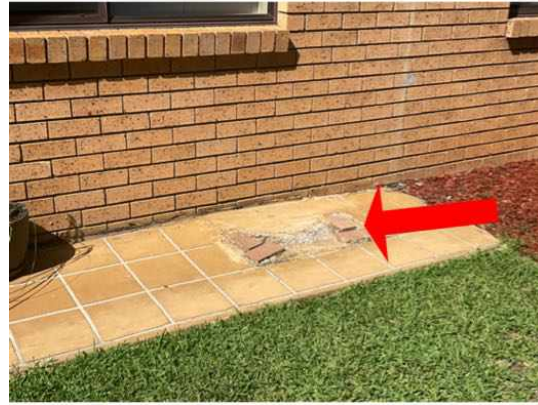
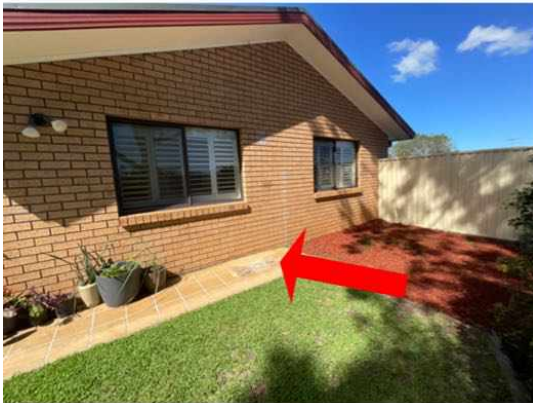
Finding 3.06

Building: Main Building
Location: Exterior walls
Finding: Brickwork / Concrete - damaged
Information: At the time of inspection, damaged bricks / concrete were identified. Significant deterioration is apparent in both the brick and concrete surfaces, with areas showing signs of erosion, crumbling, and loss of material, likely due to environmental exposure or aging or building structure moving.

Evidence of structural instability is present in both the brickwork and concrete, with sections showing signs of leaning, bulging, or displacement, posing safety hazards and requiring immediate attention

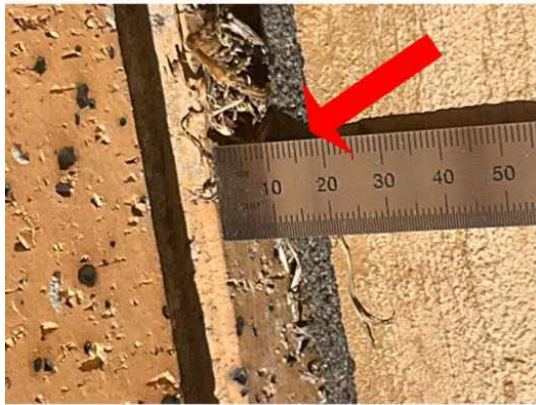
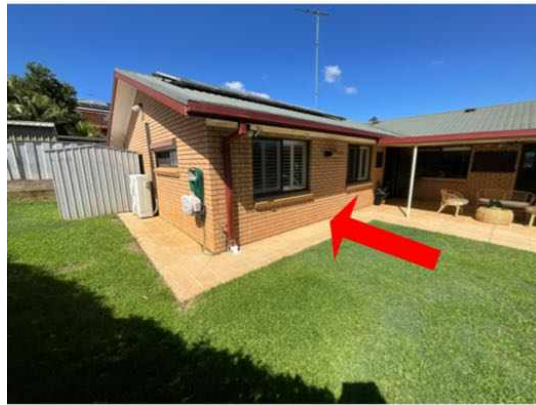
Finding 3.07

Building:	Main Building
Location:	All External Areas
Finding:	Cracking and Movement in External Concrete Paving
Information:	Cracking and movement observed in external concrete paving, with sections sliding away from the building.

Likely due to subgrade failure, potentially from damaged or leaking stormwater pipes causing soil erosion.

Recommend further investigation of stormwater system and subbase. Rectification may include drainage repair and concrete replacement.

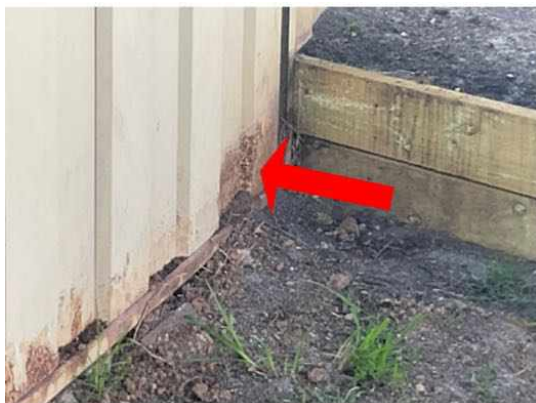
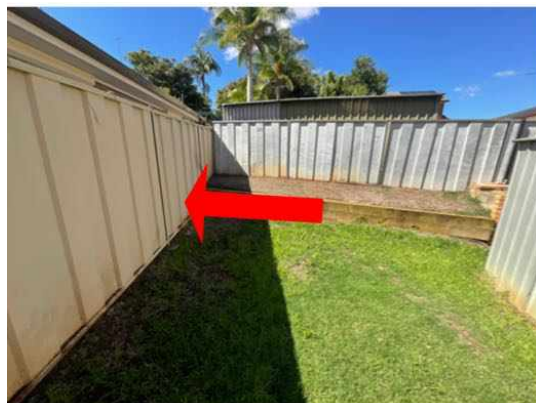
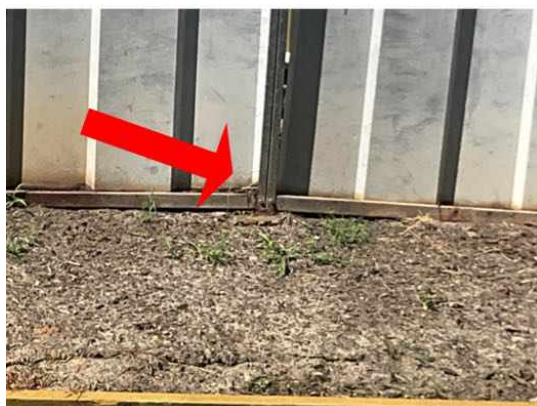
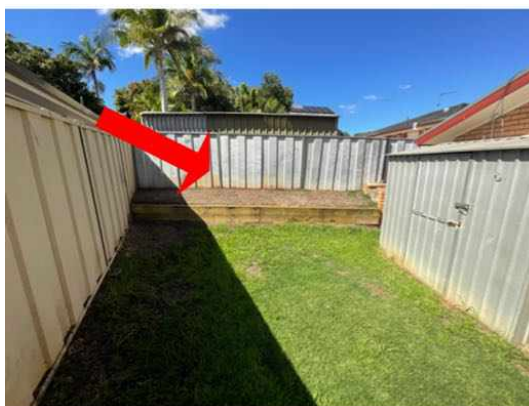
Finding 3.08

Building:	Main Building
Location:	All External Areas
Finding:	Fencing - Deteriorated
Information:	It was noted at the time of inspection that sections of the fencing throughout the property have deteriorated. Typically fencing deteriorates due to age and or wear and or rust which is generally expected for a structure of this age, due to prolonged exposure to weather conditions. Sometimes inadequate installation or maintenance can be to blame.

If left unattended, it is likely that further damage will occur. It is suspected that repair of several elements of the fencing may be required however replacement may be a consideration of the client also.

A licensed fencing contractor should be appointed to provide further advice and perform rectification works as necessary.

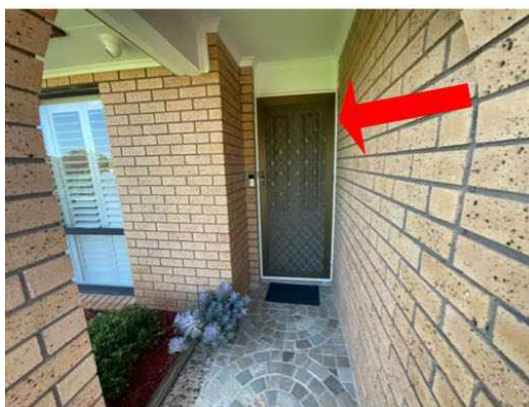
Finding 3.09

Building:	Main Building
Location:	Exterior walls - front
Finding:	Window / Door - Gap
Information:	A significant gap was identified between the brick and window / door frame in this area. Where large gaps to the head / side appear, it may indicate a variety of defects, ranging from uneven framework, sagging hinges or uneven flooring.

A gap to the head of the window may also indicate movement of the foundation of the property, which is a common occurrence and does not indicate structural damage.

A qualified tradesmen should be appointed to perform remedial works to restore the window to a fully operational level.

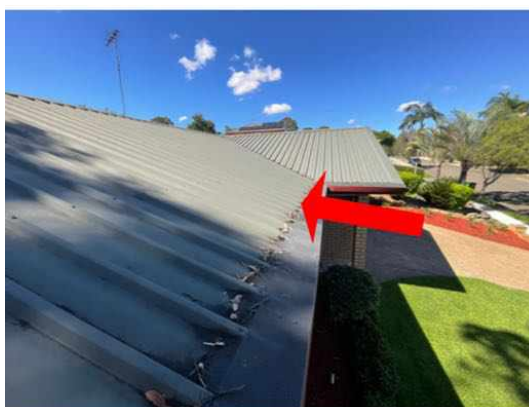
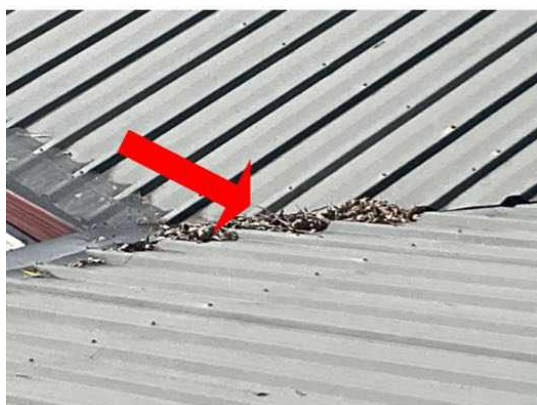
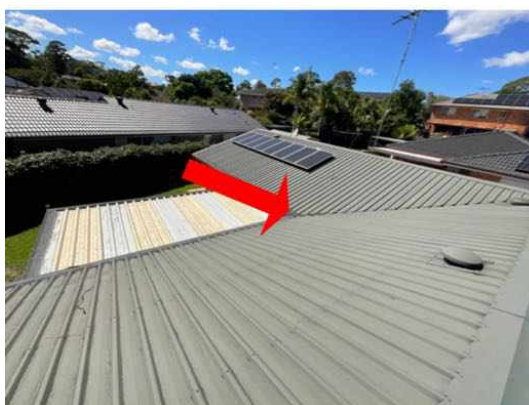
Finding 3.10

Building:	Main Building
Location:	Roof Exterior
Finding:	Gutters - Blocked
Information:	Roof plumbing structures, such as guttering and downpipes, should be free of all debris to prevent blockages. Blockages of the guttering and downpipes will lead to pooling and accumulated water overflows, which is likely to subsequently flood eaves

Blocked gutters are likely to lead to high levels of moisture in the affected areas. Such moisture will not only cause rust and decay of the associated building materials, but can also provide conditions that are conducive to termite and timber pest activity. Blockages in gutters should therefore be removed immediately to ensure dry conditions are maintained.

Consult a Licensed Plumber for further specific advice on remedial works that may be required. In the interim, it is highly advised that blocked gutters be removed by the homeowner or a general handyperson as a matter of urgency.

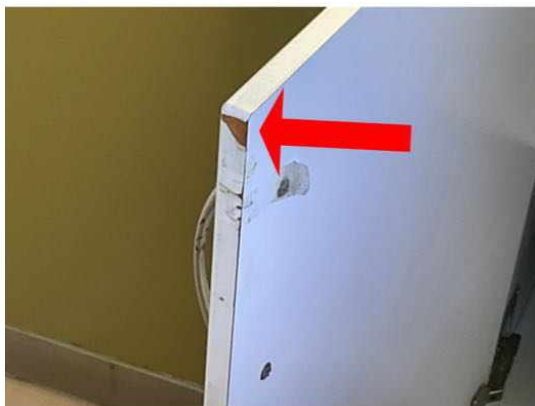
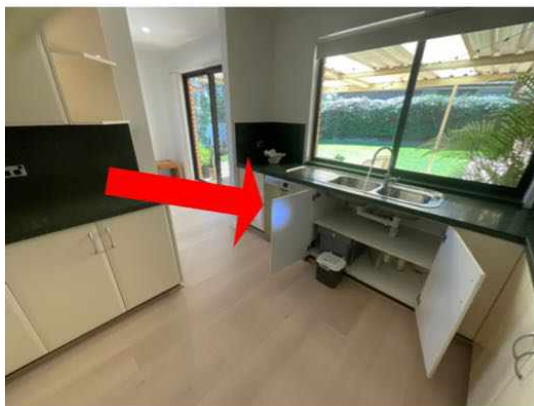
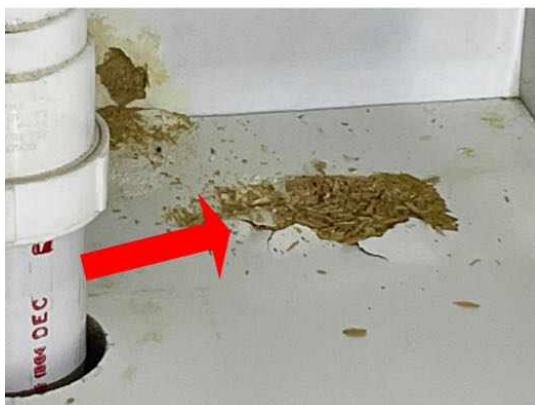
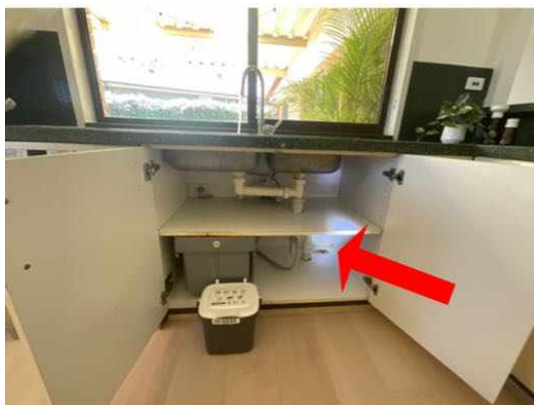
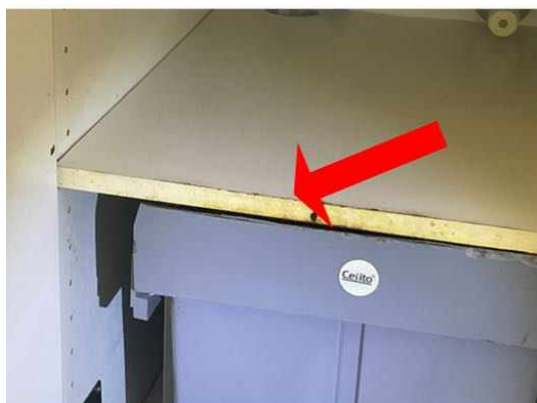
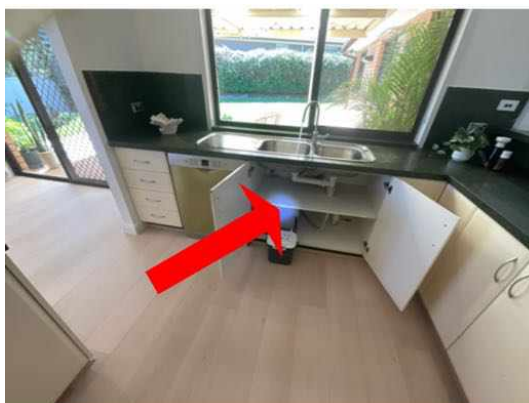
Finding 3.11

Building:	Main Building
Location:	Kitchen
Finding:	Delamination of timbers
Information:	Delamination is one means by which composite materials (e.g. layered timber composites) may fail over time. In laminated materials, repeated cyclic stresses may lead to the formation of mini-structures of separate layers, with significant loss of mechanical toughness. Water penetration or the presence of excessive moisture also

Where building materials have become delaminated, they lose their structural strength, and are likely to have a variety of appearance and serviceability defects as a result.

Delamination of timbers may be repaired where the area affected is minor and/or easily accessible, by gluing and screwing layers back together. However, this is an interim repair, and where delamination has occurred, the client should plan for the replacement of affected timbers sooner than would otherwise be expected.

All timber structures affected by delamination should be replaced as soon as possible to avoid any further damage. Repair and replacement estimates should be sought from a registered builder or qualified carpenter.

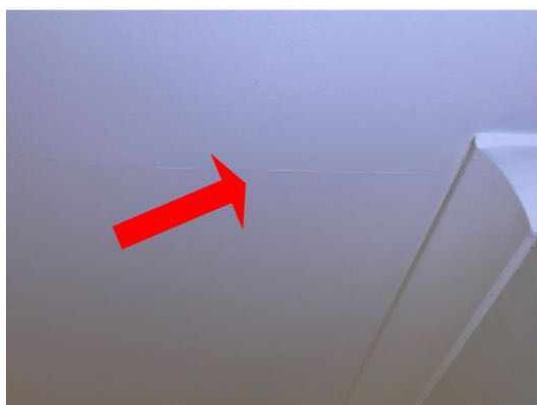
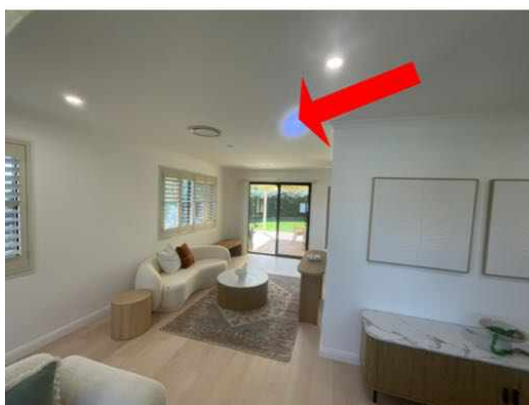
Finding 3.12

Building:	Main Building
Location:	All Internal Areas
Finding:	Cracking - Damage Category 1 - Fine (up to 1mm)
Information:	Although fine cracks are quite noticeable, they are often only considered to be an appearance defect, and usually do not indicate any structural damage. Generally, the cause of a fine crack is indicative of a separation between building materials and finishes (e.g. paint, plaster, etc.) along joins.

Cracking of this nature can generally be repaired with minor sanding, filling and/or repainting. Such works should be performed by a qualified painter or a general handyman.

Monitoring of all cracking should be conducted frequently. Always contact a building inspector should cracks widen, lengthen, or become more numerous.

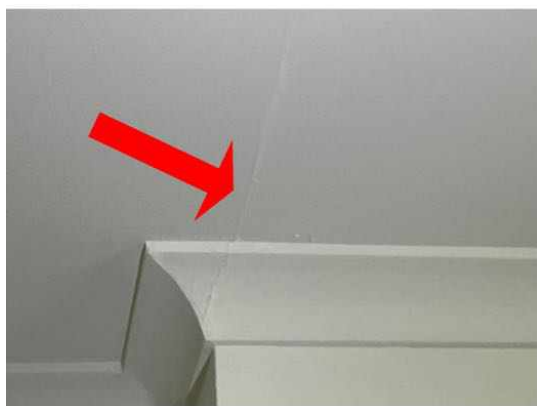
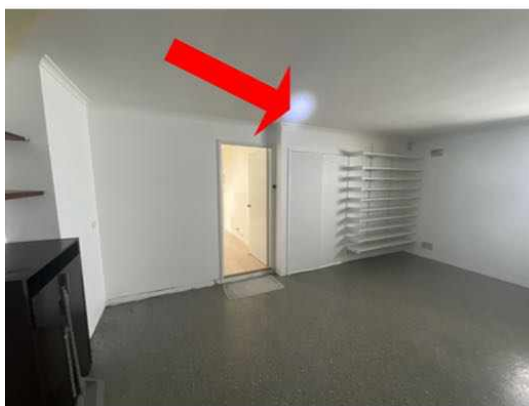
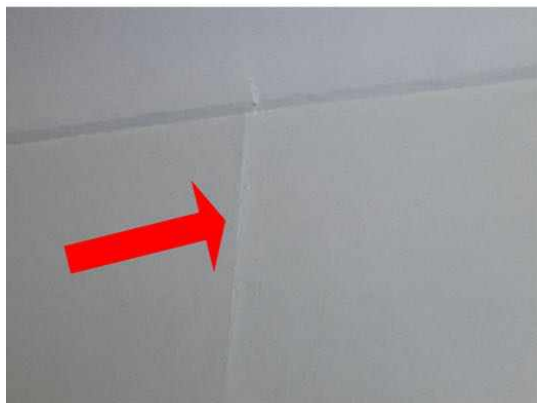
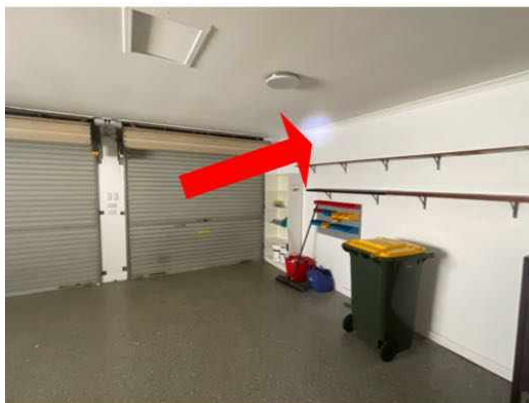
Finding 3.13

Information: Sections of the ceiling were found to be sagging at the time of inspection. Sagging to the fixed ceiling structure generally indicates that the building materials have swollen, due to contact with water, or that fixings (e.g. nails or glue) have become loose and require reattachment.

In some cases, sagging ceiling linings may also indicate that there are structural issues, causing surfaces to warp, twist or sag. Where sagging appears to be major, appointment of a structural engineer is advised to further inspect the property and identify the source and rectification works required.

Where minor sagging is evident, comparatively minor works, such as re-gluing of ceiling sheets, may be required. Such works may be performed by relevant tradespeople, such as plasterers and painters. Where excessive moisture has caused the roofing structure to swell and sag, the source of the water leak should primarily be identified prior to any remedial works being performed.

The appropriate action should be taken by the client as soon as possible to ensure that any potential further damage is limited.

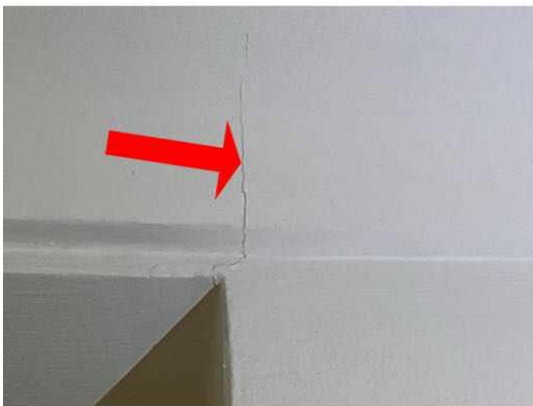
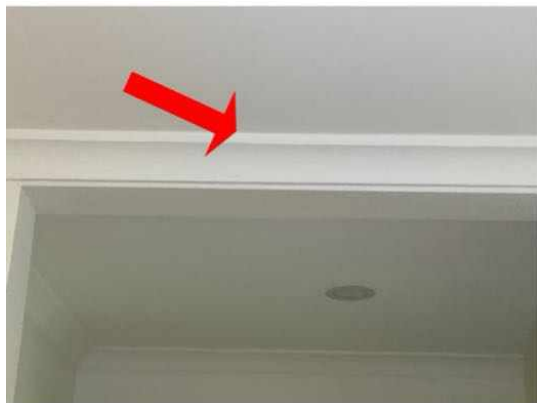
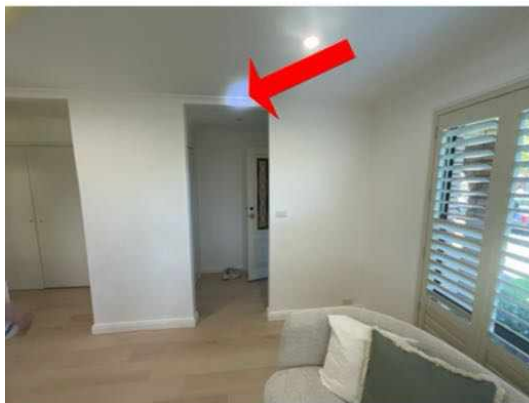
Finding 3.15

Building:	Main Building
Location:	All Internal Areas
Finding:	Paint finish - Incomplete
Information:	The paint finish in this area was identified as being incomplete at the time of inspection.

Whilst incomplete or missing paint finish is generally an appearance defect, it can also lead to the development of secondary building defects over time. Incomplete areas of paint finish expose the area to moisture, potentially accelerating the deterioration of underlying building materials.

Incomplete paint finishes should be sanded back, filled, leveled and painted, as applicable. Where inadequate or missing paint protection has led to the deterioration of the associated building element, repair and/or replacement of this building element may be required.

A painting contractor should be appointed as soon as possible to perform necessary works to aid the appearance of the affected area and to ensure the area is protected against further deterioration. Alternatively, the homeowner following manufacturer instructions may perform these works.

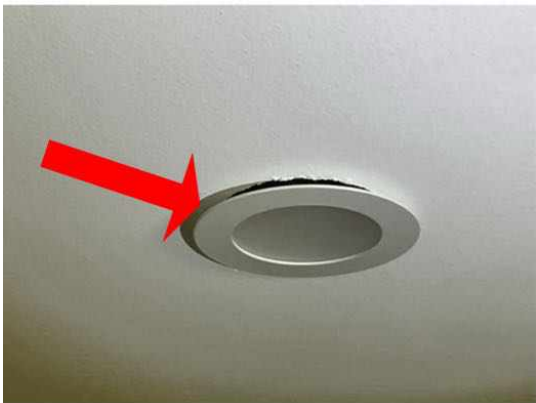
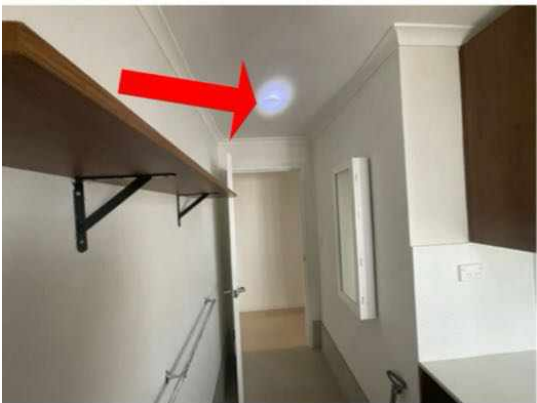
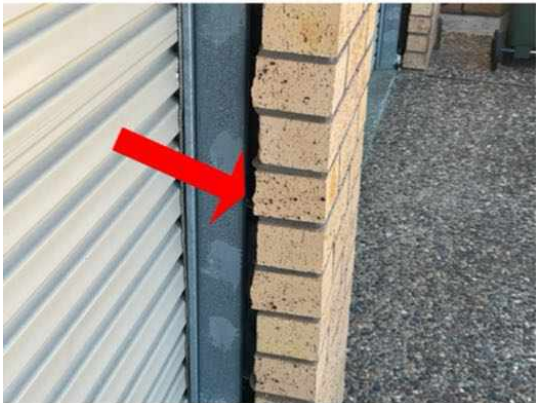
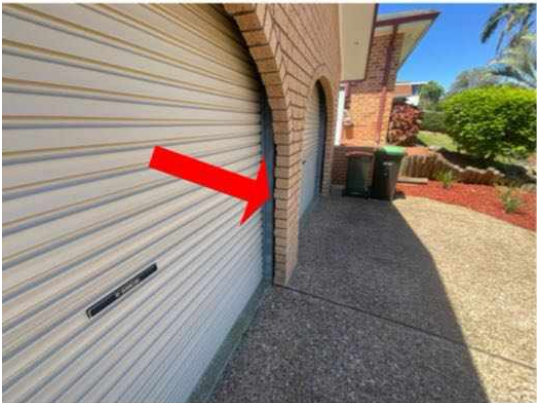
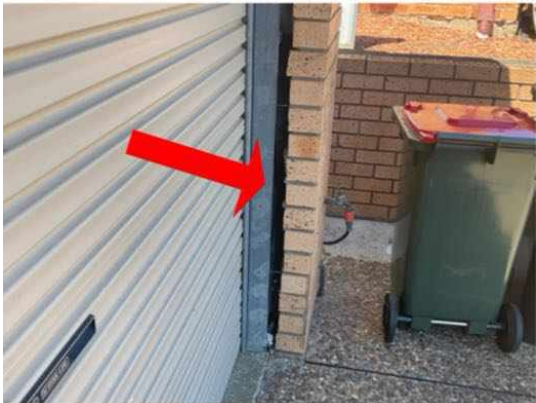
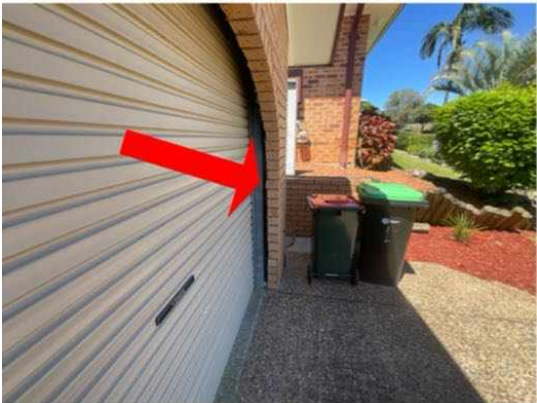
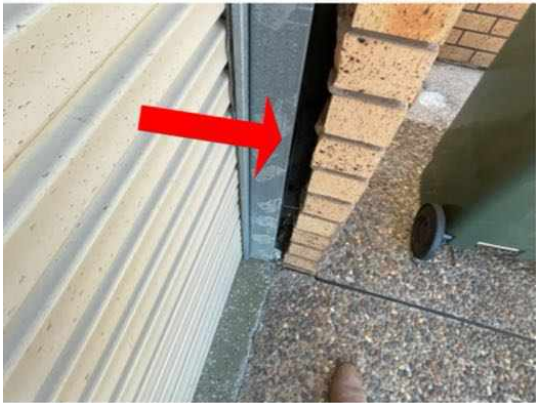
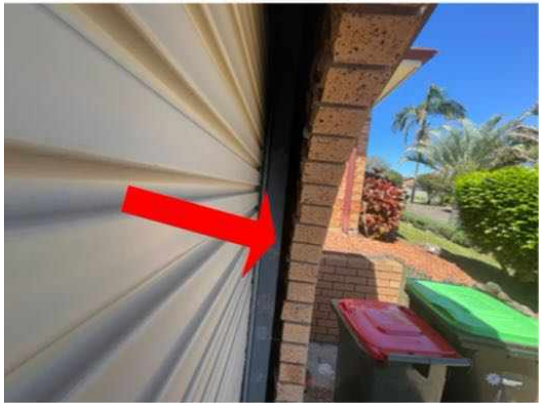
Building: Main Building
Location: Laundry / Exterior walls
Finding: Installation - substandard or incomplete
Information: The installation of this building element appears to have been completed to a substandard level of workmanship or is incomplete. Generally substandard repairs or installation are related to poor workmanship, the use of inappropriate materials, or a failure to complete installation to a suitable standard.

Where installation is substandard and/or incomplete, the client should contact the responsible trade to undertake rectification. Unfinished and substandard building works are likely to degrade more quickly and may create potential for secondary defects to associated building elements.

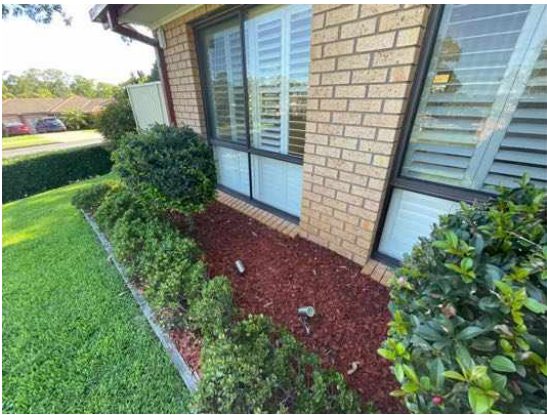
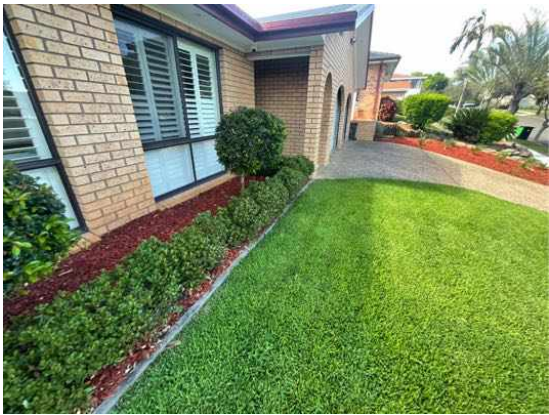
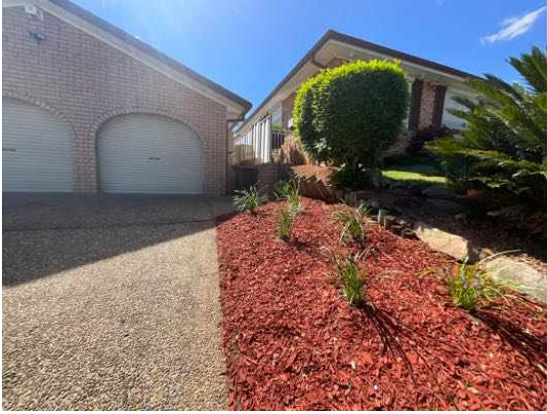
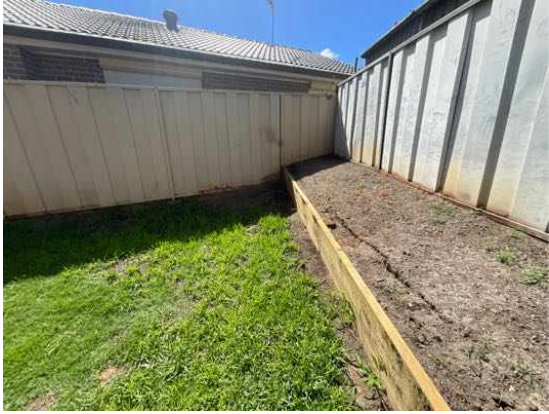
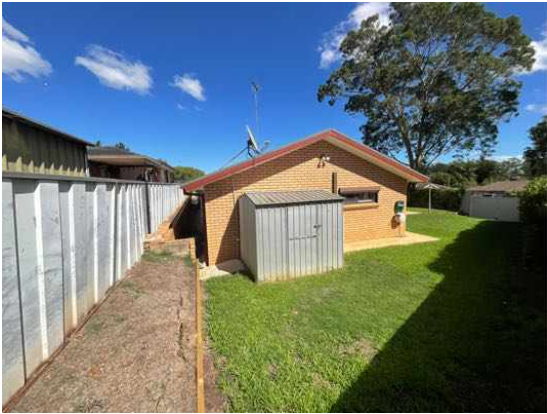
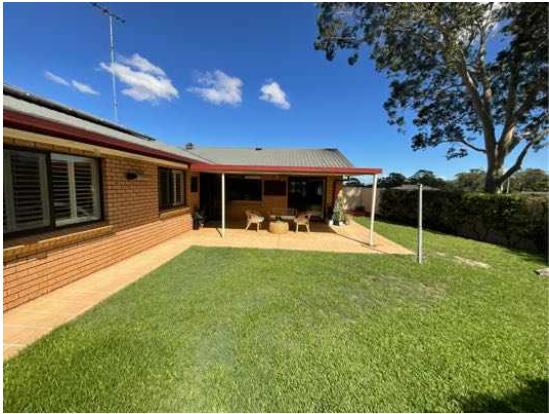
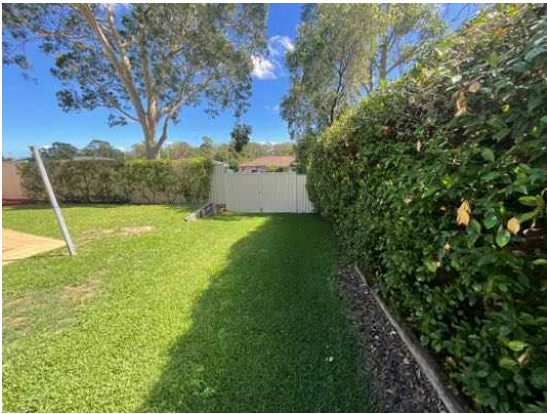
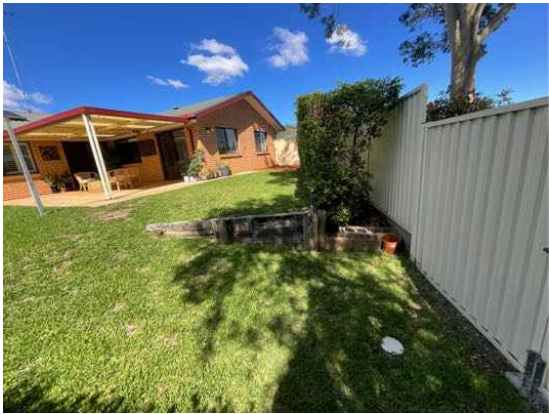
Building: Main Building
Location: All Areas
Finding: Garden Beds - Conditions Conducive to Termites
Information: Garden beds were found to be evident in the garden area. These garden beds can include untreated timber, and with a combination of moisture from watering hosing can make conditions conducive to termite activity and termite ingress.

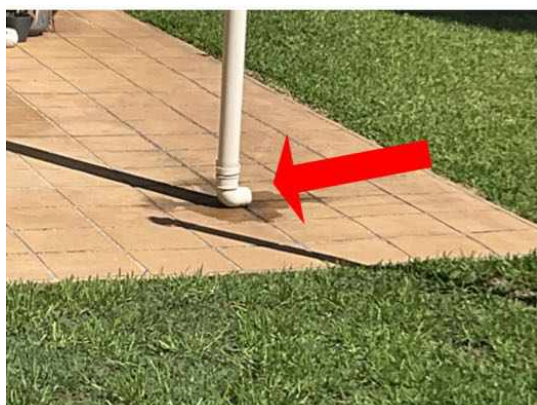
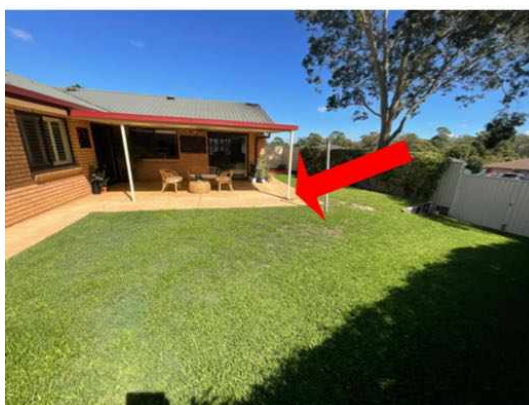
Finding 6.02

Building:	Main Building
Location:	All Areas
Finding:	Overflow - Not plumbed for drainage
Information:	The overflow is not plumbed or connected to suitable drainage, which has resulted in the surrounding area becoming excessively damp. These damp conditions can lead to secondary defects such as rot, rust or corrosion of associated building elements, the formation of fungal decay, or even the creation of potential slip hazards. When coupled with poor site drainage, pooling of water may also attract termite activity to this area. It is highly recommended that a qualified plumber be appointed to install adequate drainage to the overflow. These works will ensure that the area remains dry and free of any secondary defects.

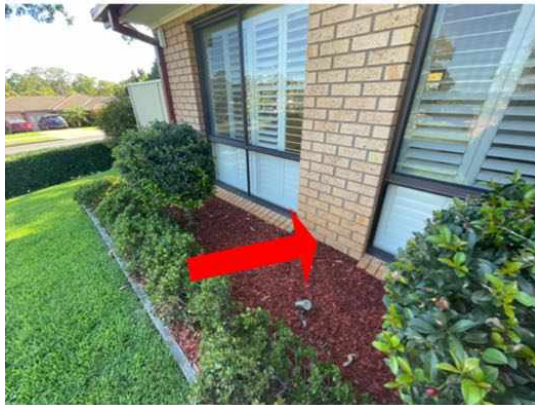
Finding 6.03

Building:	Main Building
Location:	All Areas
Finding:	Bridging or breaching of termite barriers - weep holes
Information:	Bridging is the spanning of a termite barrier or inspection zone so that subterranean termites are provided with passage over or around that barrier.

Weep holes in the exterior brickwork of the property are designed to allow condensation that may build up between the brickwork and subsequent timber framework to drain from within the wall hence preventing any deterioration of the timber building elements.

Additionally build-up of moisture is likely to occur if weep holes are covered further attracting termite activity to these areas.

It is highly recommended that weep holes are left exposed in all areas throughout the external property. Therefore if any termite activity leading into weep holes becomes easily detectable during frequent pest inspections.
