Building and Timber Pest Inspection Report

Inspection Date: Tue, 17 Feb 2026

Property Address: 1 Sherridon Cres, Quakers Hill NSW 2763,
Australia

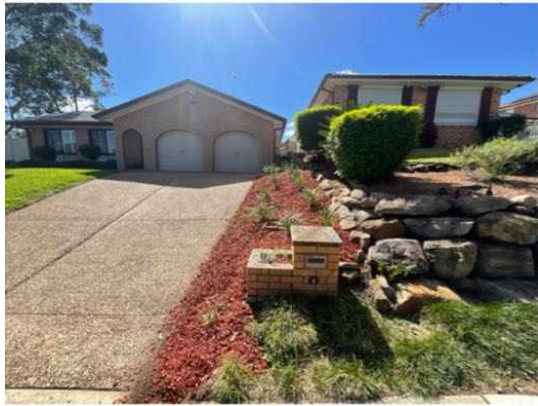
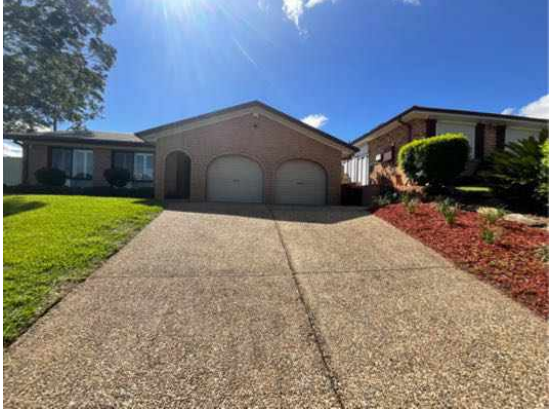
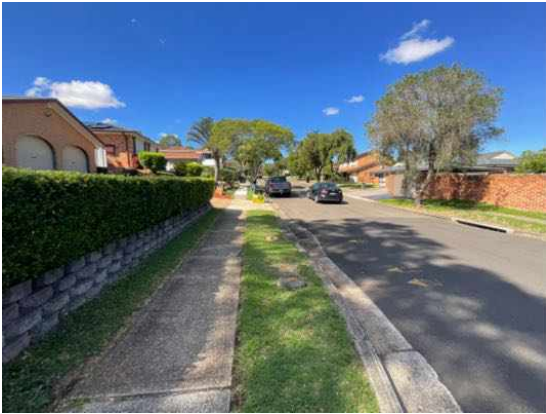
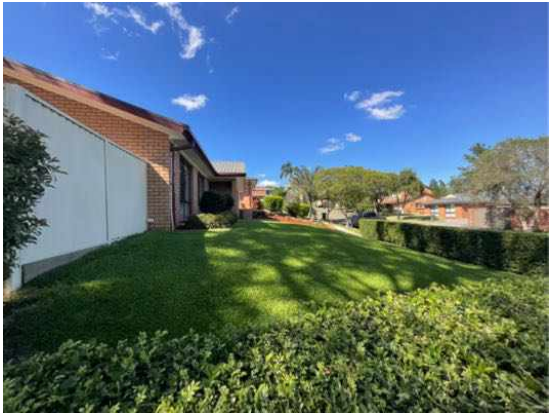
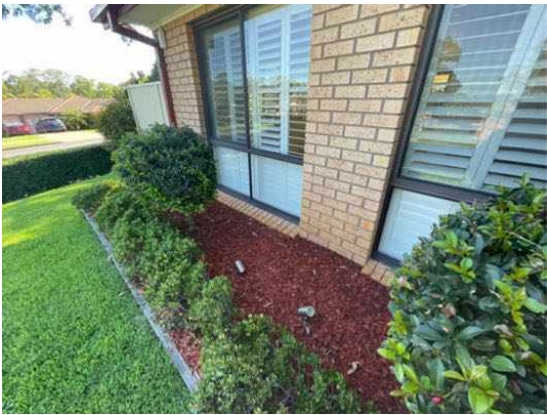
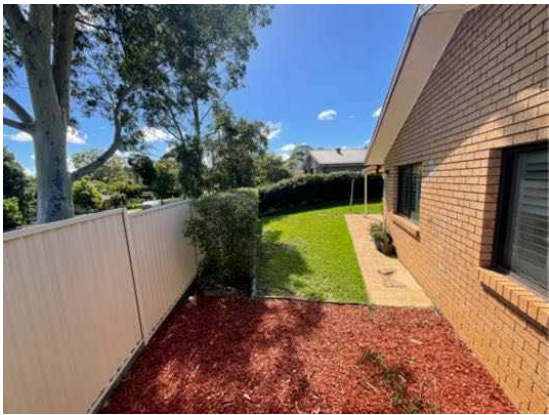
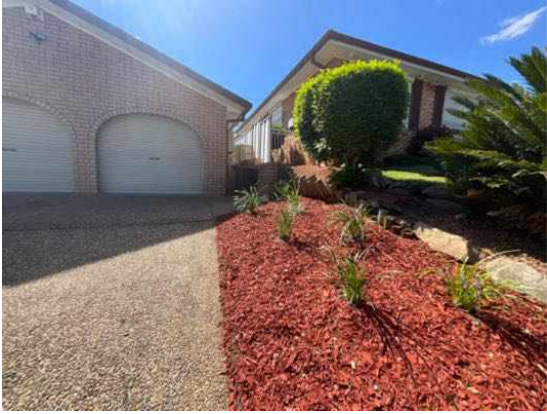
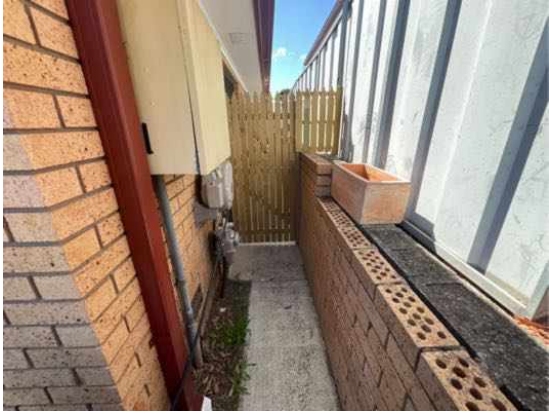
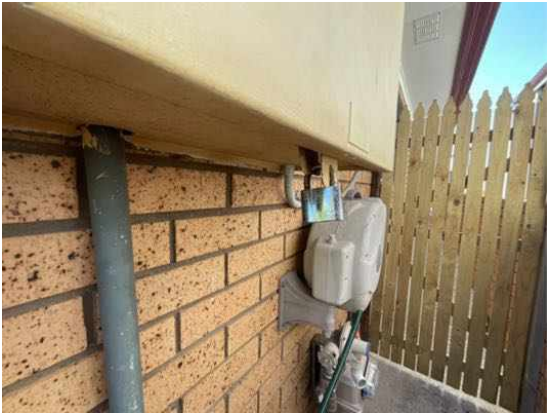
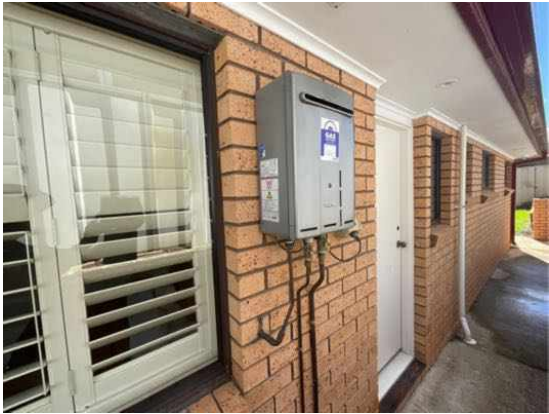
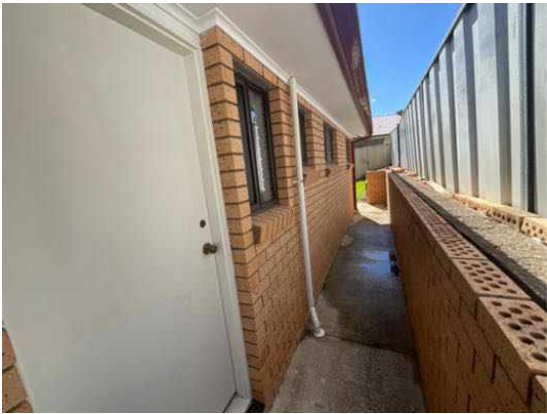
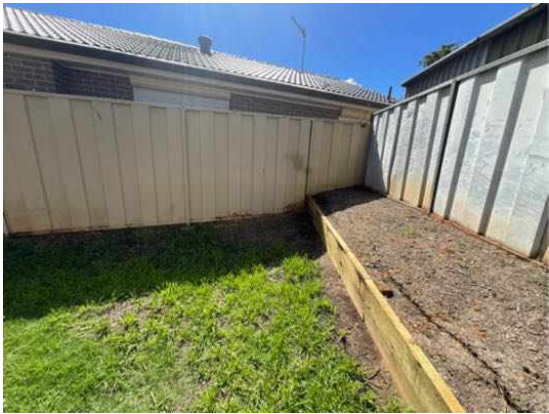
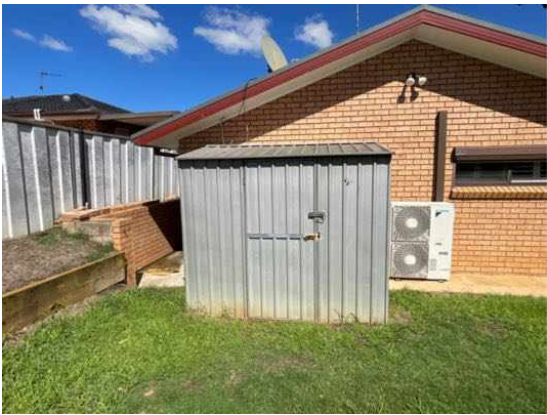
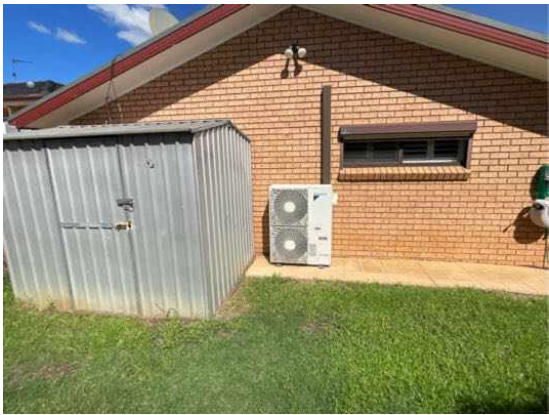
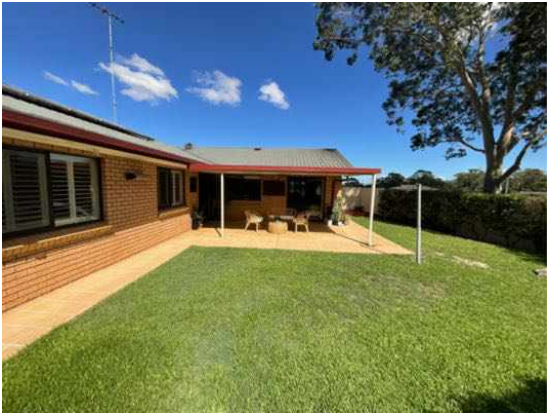
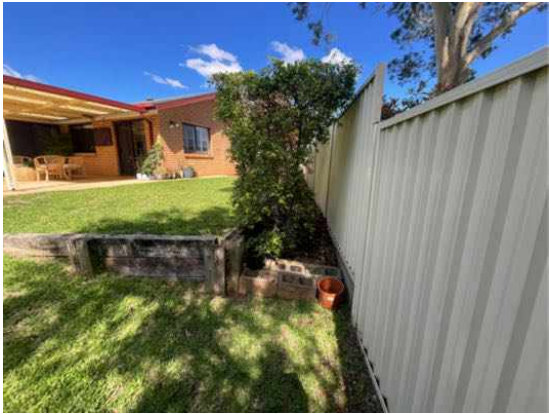
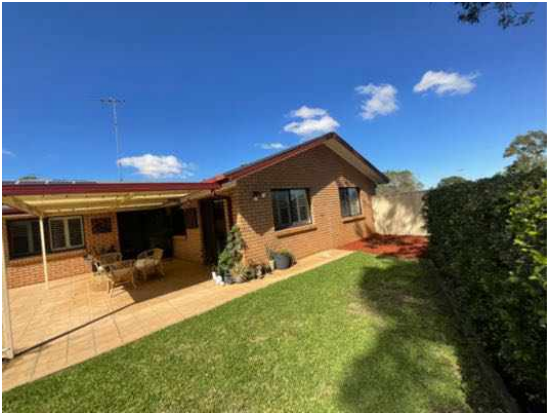
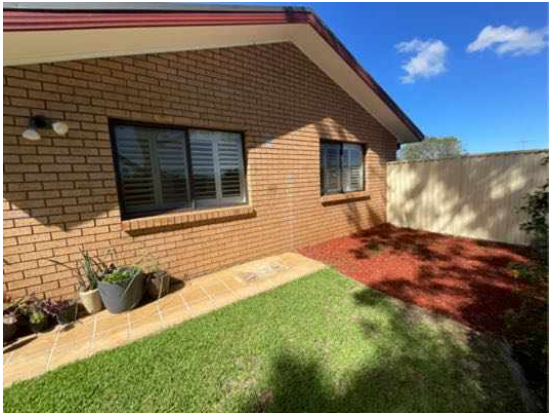
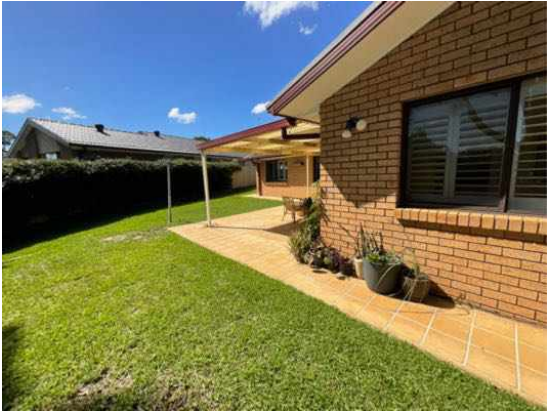
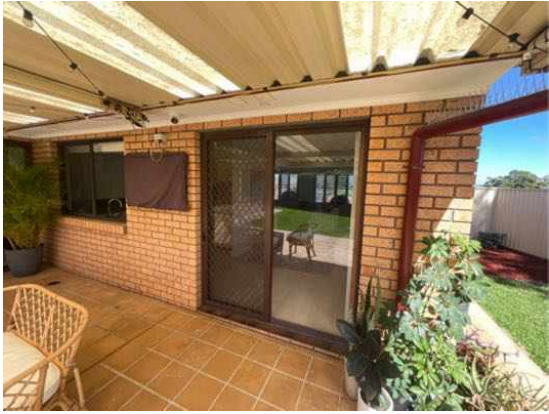
Noted Item

Building: Main Building
Location: All Areas
Finding: Additional Photos - Obstructions and Limitations
Information: These photographs are an indication of the obstructions and limitations which impeded full inspection of the property at the time of inspection. These obstructions can hide an array of defects and should be removed to allow full inspection to be carried out. A re-inspection is recommended once the areas are made accessible.

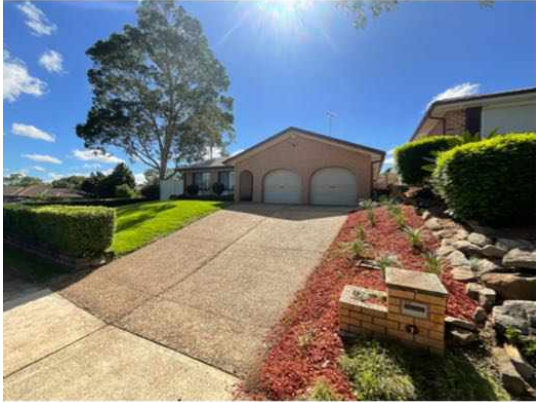
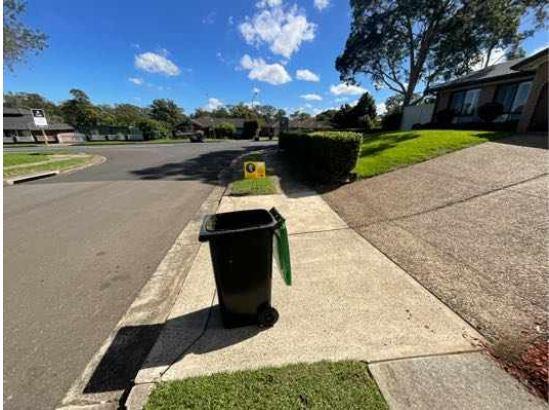
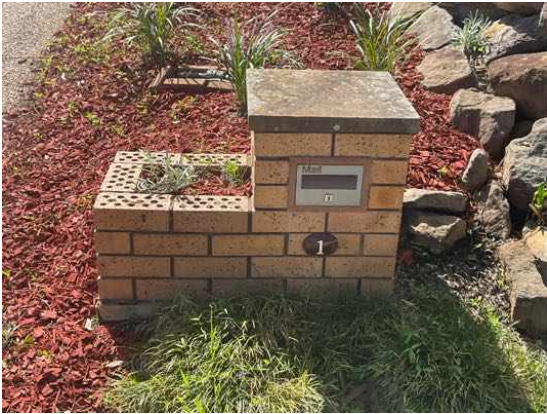
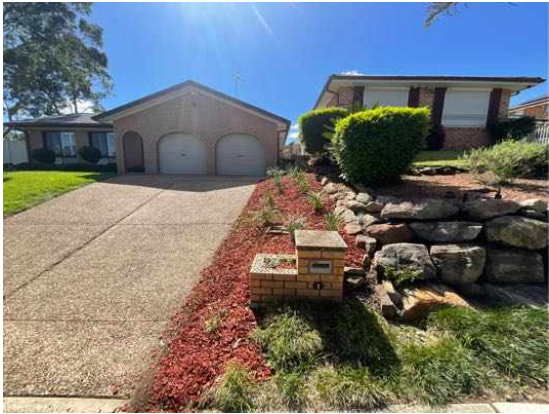
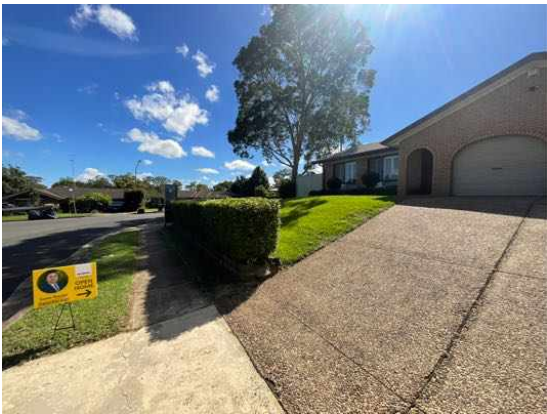
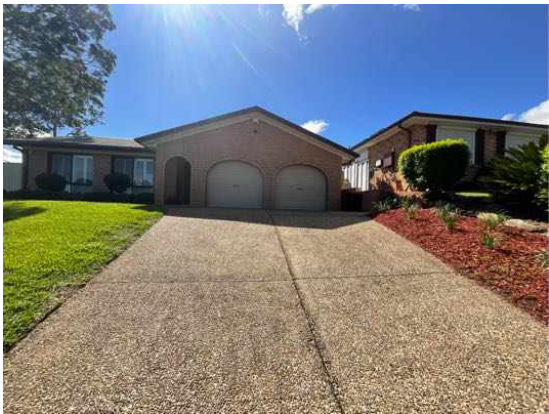
Building: Main Building
Location: All Areas
Finding: Additional Photos
Information: Additional photos are provided for your general reference
