Building and Timber Pest Inspection Report

Inspection Date: Wed, 25 Mar 2026

Property Address: 484 Beach Rd, Sunshine Bay NSW 2536,
Australia

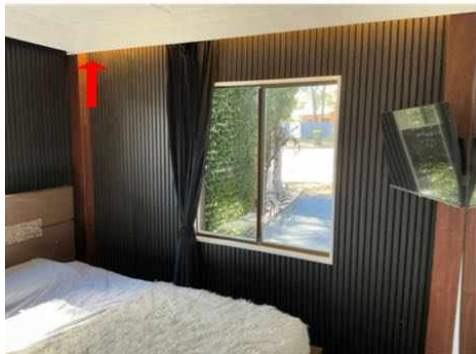
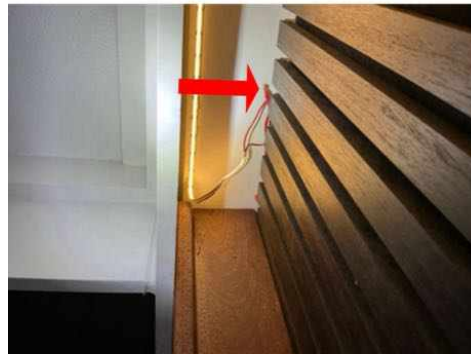
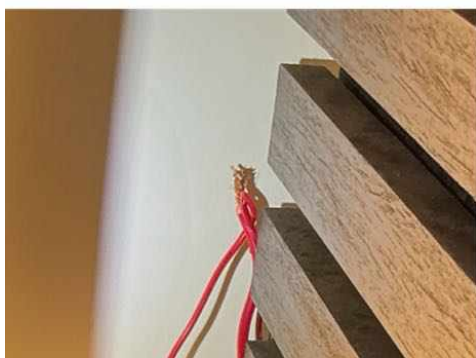
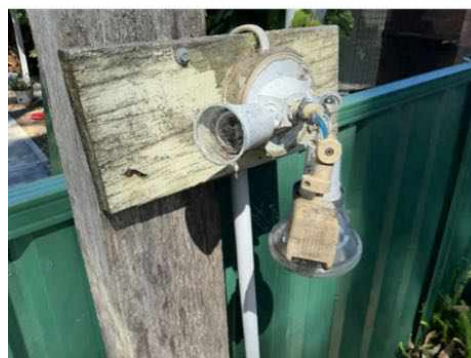
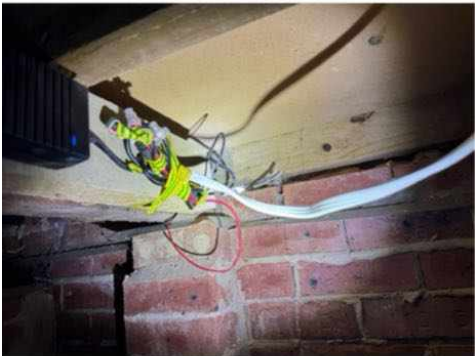
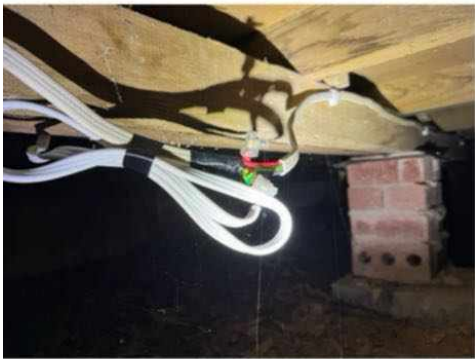
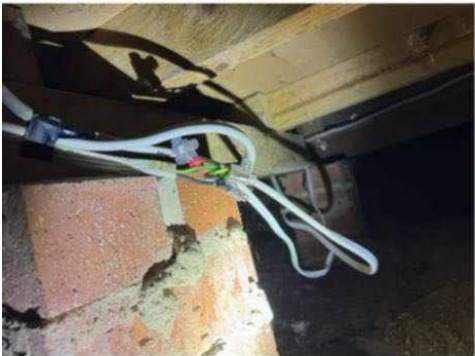
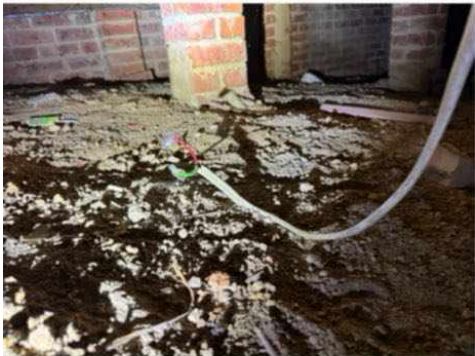
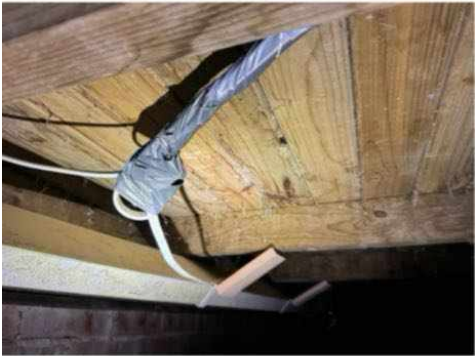
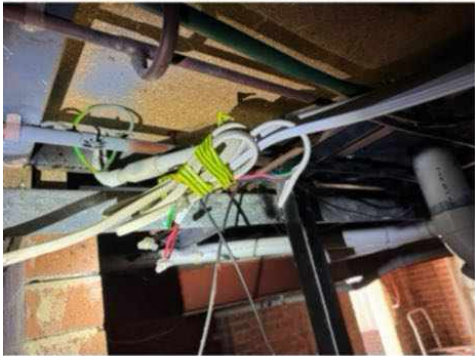
Building: Main Building
Location: All Areas
Finding: Electrical Defect Suspected
Information: At the time of inspection it appeared that there were suspected defects with the electricals. This includes;

- loose expose wiring was identified on the front power pole requiring urgent repairs.
- loose exposed electrical connections and terminations in the subfloor require immediate repairs.
- expose wiring connections in the house require urgent repairs.

Faulty wiring, switches and damaged outlets can cause shorting out of areas of the house, damage appliances and possibly cause electrocution or fires. It is advised all suspect issues be inspected by a licensed electrician before use.

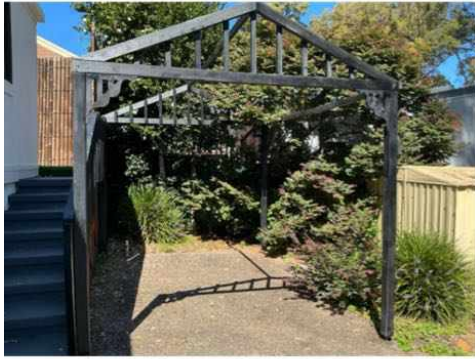
Finding 1.02

Building: Main Building
 Location: Exterior walls - rear
 Finding: Items - Non-compliant
 Information: This structure, whilst appearing to be adequate, does not comply with contemporary building practices and current Australian Standards. This includes:

All windows higher than 2000mm from the external ground/floor level must NOT be able to open wider than 125mm. It is highly recommended that permanent locks be fitted at 125mm open ASAP.

This area construction has excessive movement requiring additional supporting members and bracing to strengthen the structure. Failure to do so this area will further deteriorate to the point of collapse. It is strongly recommended that this area is avoided until the necessary repairs are made.

These items should be repaired by the relevant tradesman as soon as possible.

A licensed Builder should be consulted as soon as possible for the necessary repairs.

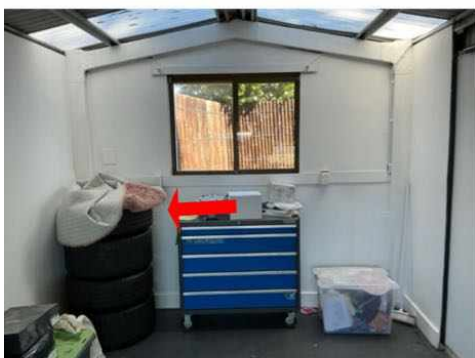
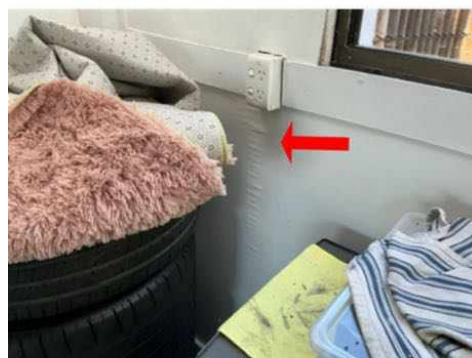
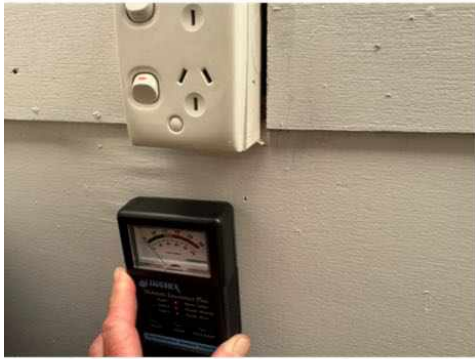
Finding 2.01

Finding: Water Damage.

Information: At the time of inspection apparent water damage was evident in this area;

- The back wall of the garage. The moisture meter reading in this area was normal.

Water damage can be in many forms from staining, peeling paint and mould to swollen materials, decay and structural damage. These kinds of defects can be the result of water penetration, either externally or internally. It is advised the cause of the water ingress be identified as soon as possible to prevent any further deterioration. A more invasive inspection may have to be conducted to determine the extent of the damage. Replacement of materials is likely.

A licensed Builder should be consulted for rectification works.

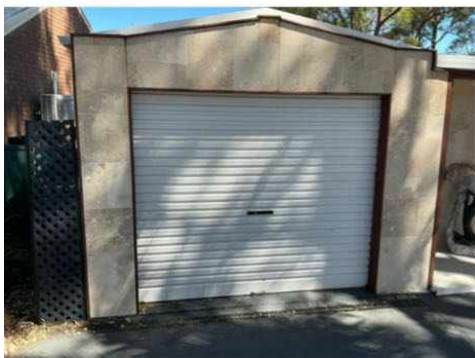
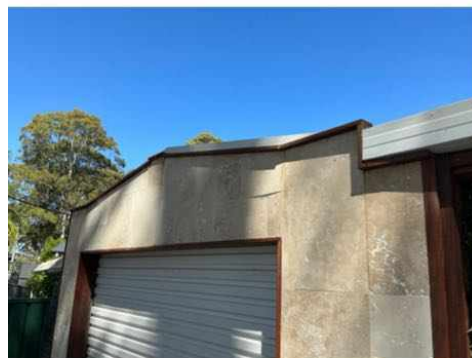
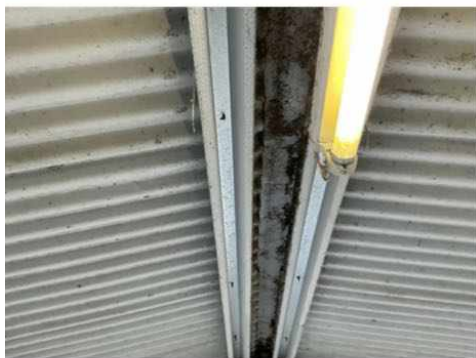
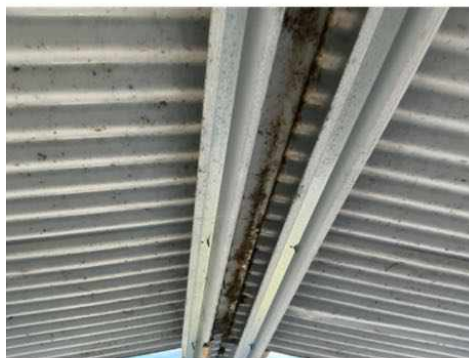
Finding 2.02

Building:	Main Building
Location:	All Areas
Finding:	Unconventional Works
Information:	This work appears to have been completed to a level that does not comply with regular building practices. This includes;

Where work is not completed satisfactorily, accelerated deterioration of the associated building elements is likely to occur and secondary defects to surrounding structures may develop. It is highly recommended that the substandard work be rectified by professional services. Works to improve this area are likely to increase the safety and the operation of the associated building elements.

The client should exercise care when coming into the immediate vicinity of these issues. Rectification works are advised by the appropriate trades.

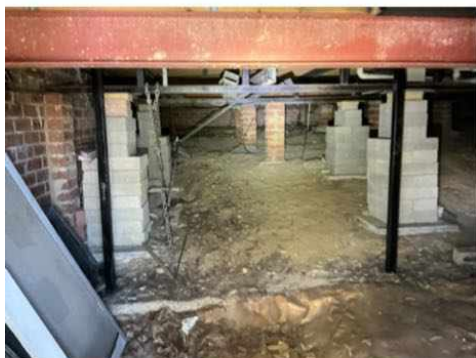
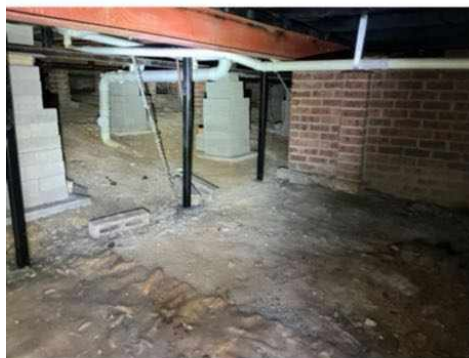
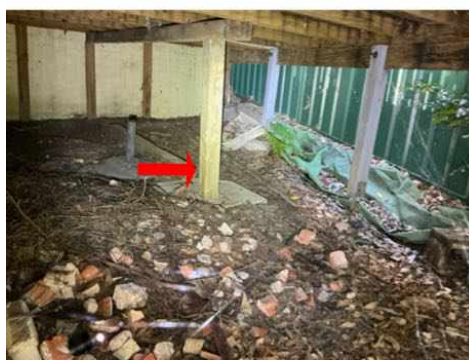
Finding 2.03

Building:	Main Building
Location:	Subfloor
Finding:	Support or Bearing - Inadequate
Information:	At the time of inspection it was evident that these subfloor structural building elements had insufficient support to take the surrounding building loads.

- these dry stacked masonry peers appear in adequate for their intended purpose. It is unknown if there are concrete footings underneath these peers. It is recommended an engineer be consulted for further instructions.

- The side decking centre pier post appears loose. It is unknown if this is sitting on a concrete footing.

Structural piers, bearers, braces and fittings are the strength of the building. If any of these components are compromised, damaged, deteriorated or missing this creates significant weakness in the buildings integrity. Repairs to any structural building members should be undertaken with urgency. Failure to do so will result in further damage possibly progressing to major safety hazards and even partial collapse.

It is advised you contact a licensed Builder as soon as possible to discuss repair works based on engineers instructions.

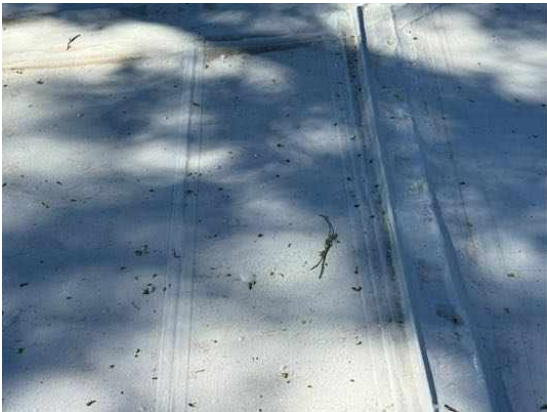
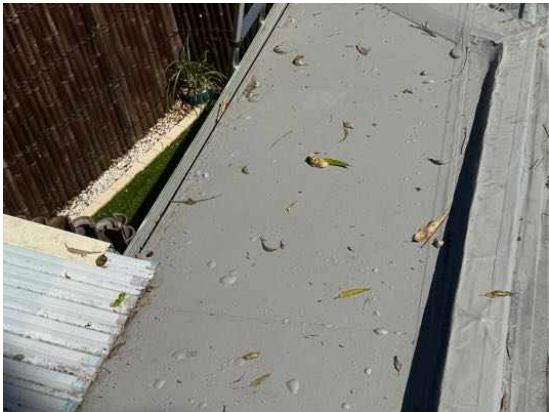
Finding 2.04

Building:	Main Building
Location:	Roof Exterior
Finding:	Unconventional Works
Information:	This work appears to have been completed to a level that does not comply with regular building practices. This includes;

Where work is not completed satisfactorily, accelerated deterioration of the associated building elements is likely to occur and secondary defects to surrounding structures may develop. It is highly recommended that the substandard work be rectified by professional services. Works to improve this area are likely to increase the safety and the operation of the associated building elements.

The client should exercise care when coming into the immediate vicinity of these issues. Rectification works are advised by the appropriate trades.

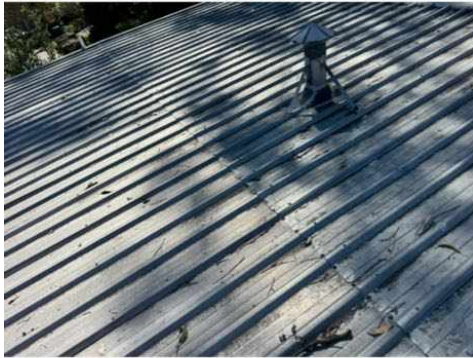
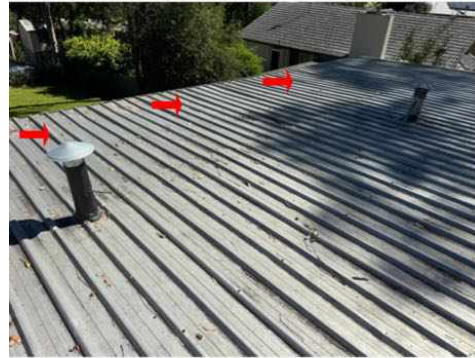
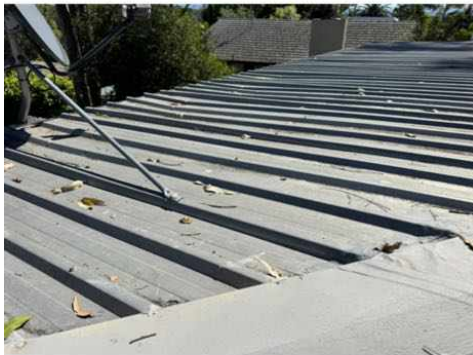
Finding 2.05

Building: Main Building
Location: Roof Exterior
Finding: Roof Sheets - Deteriorated
Information: Upon inspection of the exterior roofing, it was found that some roof sheets show signs of deterioration. This includes loose sheeting, dented and damaged roof sheets, and deterioration of associated building elements.

Loose, deteriorated and damaged roof sheets are susceptible to water penetration, exposing the surrounding associated area to internal roof leaks and water damage. Re-fixing and repairs of all loose roof sheets should be conducted as soon as possible to ensure that no further damage occurs. Depending on the extent of the damage, replacement of sections of roof sheets or associated materials may be required.

Engagement of a licensed Roof Plumber or Roofing Restoration contractor is highly advised to perform remedial works as necessary.

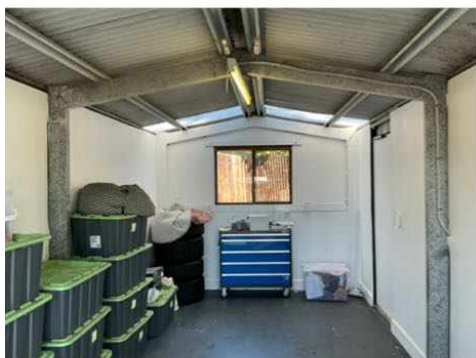
Finding 3.01

Location: All Areas
Finding: Building element - Rusted or corroded
Information: This building element shows evidence of rusting and corrosion, which is likely to have developed as a result of excessive exposure to moisture and or inadequate coatings. Rusted items include;

- The Apex end of garage roof sheets required treatment.
- some roofing screws require replacement before their rust begins to affect the roof sheets.
- What's the latest sections of the garden shed required treatment?

As surface rust provides no protection to the underlying iron, the deteriorating condition is likely to worsen if not addressed in the short-term future. Where possible, the use of galvanized (treated) metals or aluminium coated metals aid in rust prevention, as does regular general maintenance. Rust formation can be controlled with coatings, such as paint, that isolate the iron from the environment.

Rusting and corrosion should be managed by ideally removing or limiting the affected surface from exposure to moisture. A registered builder may be appointed to replace any building elements that have been severely affected by rust or water damage.

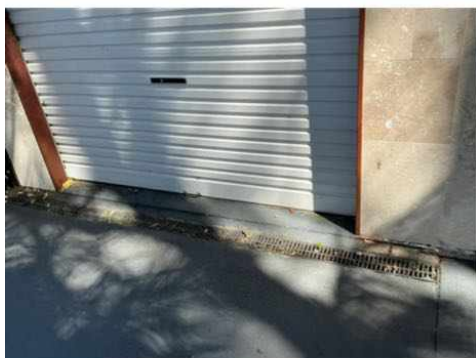
Finding 3.07

Building:	Main Building
Location:	Driveway
Finding:	Building element - Blocked
Information:	Blockages prevent building elements from operating as intended, detracting from the overall function of the affected building elements. Additionally, the lack of general maintenance may lead to the development of more significant defects, such as damage to surrounding building materials.

Blockages should be removed and addressed promptly, as they will lead to the development of secondary building defects. The blockage should be removed as the primary rectification works. Secondly, check for any secondary or concealed damage, and then attempt to address the cause of the blockage to prevent recurrence or any water damage to associated structures.

Depending on the location of the blockage and the building elements affected, a licensed plumber may be required to perform necessary remedial works.

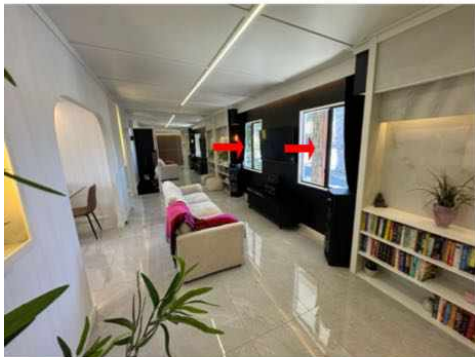
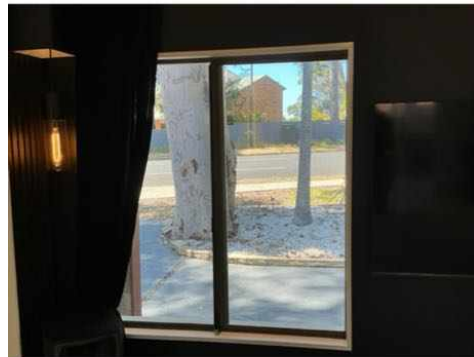
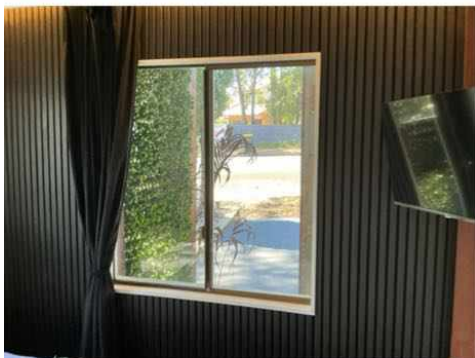
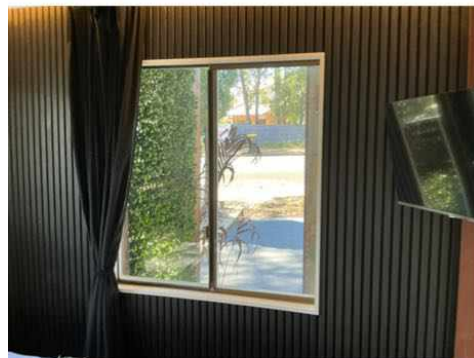
Building:	Main Building
Location:	Exterior walls - front
Finding:	Window handle - Not latching
Information:	It was noted that the window in this area was not latching during operation at the time of inspection.

Whilst detracting from the functionality of this building element, this minor defect may also be a security risk, and may therefore have serious implications if left unattended. Such damage is identified as general wear and tear, which is expected for building elements of this age.

A qualified carpenter or general handyperson may be appointed to perform rectification works as necessary. If left unattended, further functional impairment is likely to occur.

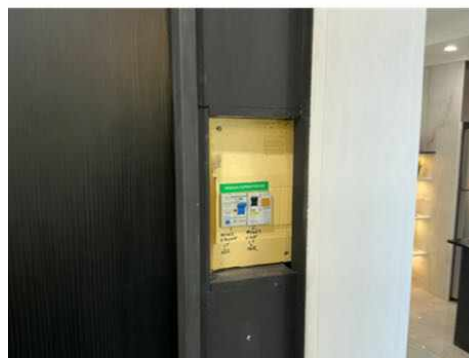
Finding 3.10

Building:	Main Building
Location:	All Areas
Finding:	Fitting or fixture - Loose
Information:	The fitting in this area is loose and requires adjustment to tighten.

If left unmanaged, the fitting may further deteriorate, causing potential for the development of other minor secondary defects.

A relevant tradesperson should be appointed to perform these rectification works at discretion of the client.

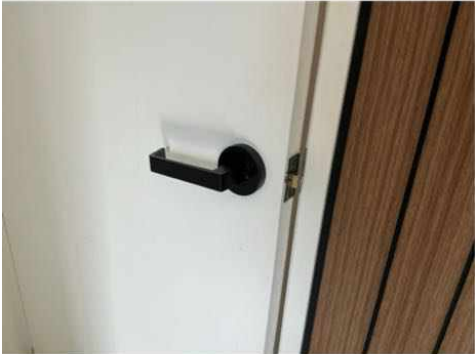
Finding 3.11

Building:	Main Building
Location:	All Areas
Finding:	Incomplete and Substandard Works
Information:	The works to this area appear to be incomplete and substandard. Including;

development of building defects and may impede on the safety and integrity of the overall structure.

It is highly recommended that the relevant trades be appointed to complete these works and ensure the safety of the area and the longevity of all associated building elements.

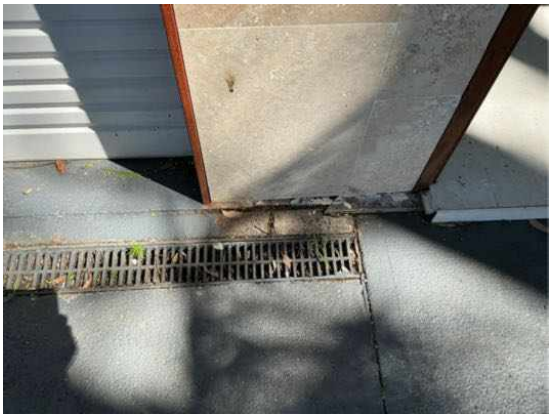
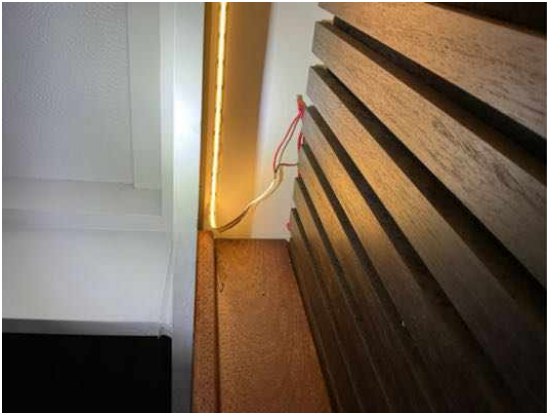
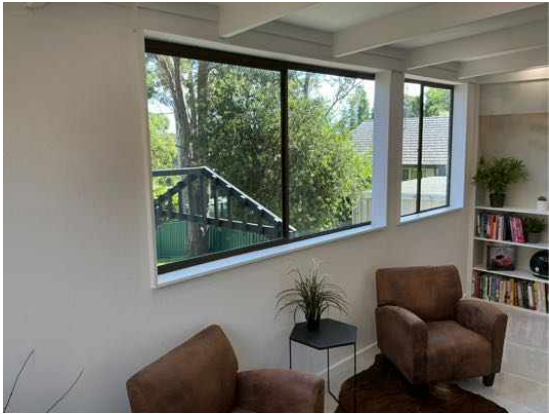
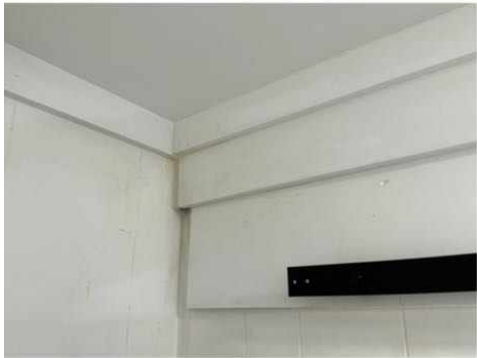
Information: Termite activity was found to have affected this area. Any affected building components should be replaced by the relevant tradesmen. It is advised that the area be visually inspected frequently to ensure that the condition of affected building materials does not reoccur.

Please note that although no evidence of live termite activity was found, because of obstructions and access restrictions the extent of any activity in the wall cavity and roof space areas is unknown. A building contractor may be appointed to provide a more invasive inspection.

It is strongly recommended that a licensed Timber Pest Controller is consulted for further information regarding a termite management system. Quotes for repairs and treatment should be sorted before purchase.

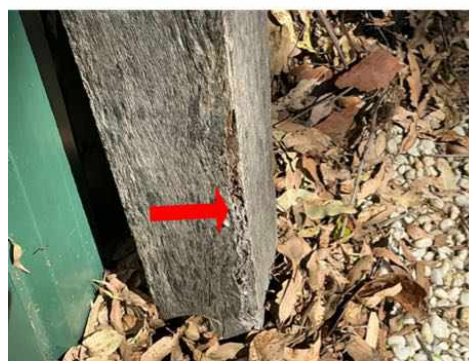
Generally this takes the form of finished ground levels external paving, concrete, fencing posts, gardens, vegetation, plumbing, stored items etc being retrospectively installed above the ant cap level or weep and ventilation holes.

Where bridging of the termite management system has occurred full inspection is prevented and termites may enter a property in a concealed or undetectable manner.

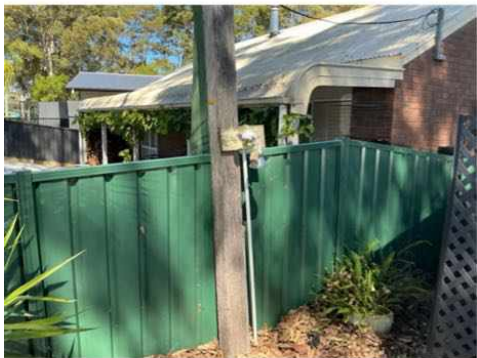
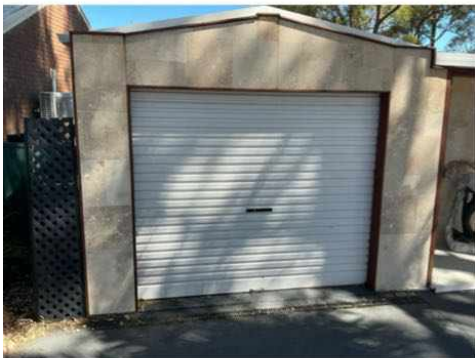
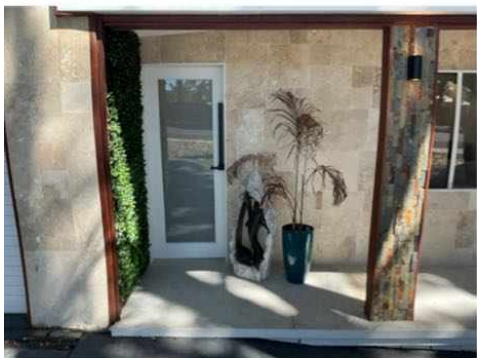
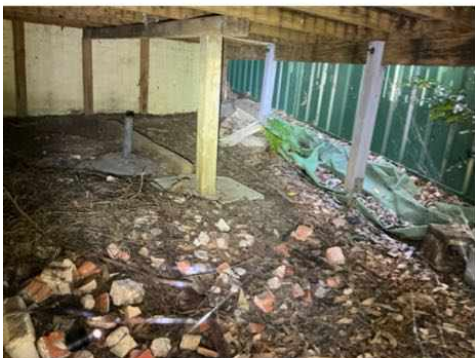
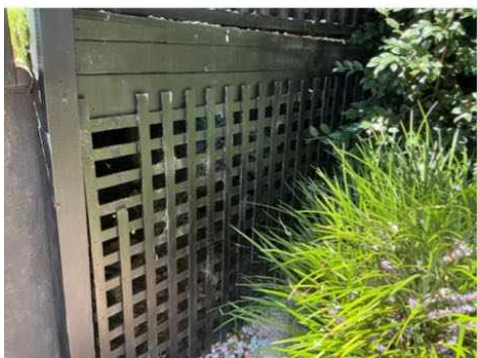
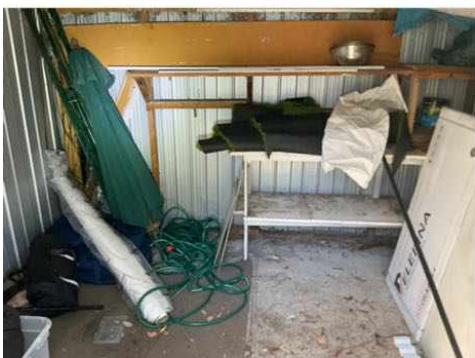
Finding 6.02

Building:	Main Building
Location:	All Areas
Finding:	In ground contact
Information:	Any timbers in direct ground contact provide opportunity for concealed termite entry and are likely to be subject to premature rot and decay as the soil retains moisture or damp conditions against the timbers.

Remove untreated timber that is in direct contact with external grounds. Consider replacement with more durable materials i.e. treated timber or non timber elements. Frequent pest inspections are advised to readily identify any termite activity in these areas.

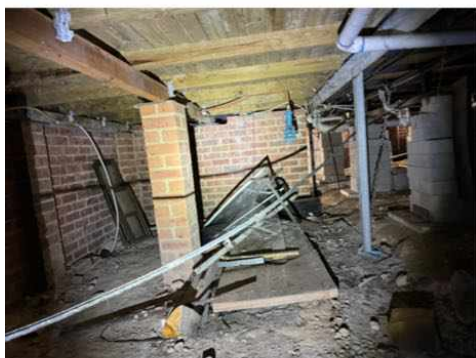
Finding 6.03

Building:	Main Building
Location:	Subfloor
Finding:	Subfloor - Debris
Information:	An array of debris was found in the subfloor area at the time of inspection. Debris in this area restricts subfloor ventilation and creates potential for concealed pest entry. Stored timbers and other materials may also make the area susceptible to termite activity and wood rot.

A clear and empty subfloor will be better ventilated and easier to maintain in a dry condition. The removal of any timber debris is vital in minimising the risk of termite or wood borer activity.

Debris in the subfloor should be removed as soon as possible. Depending on the location and amount of debris and stored items, the homeowner may elect to undertake this task. Alternatively there are a large number of rubbish removal subcontractors that could undertake these works.

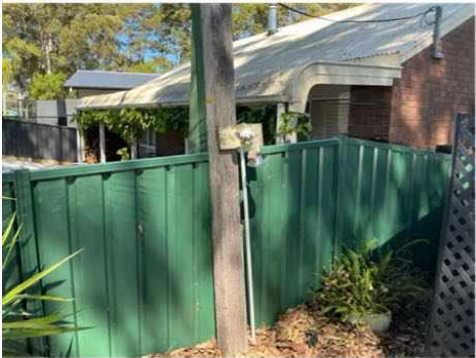
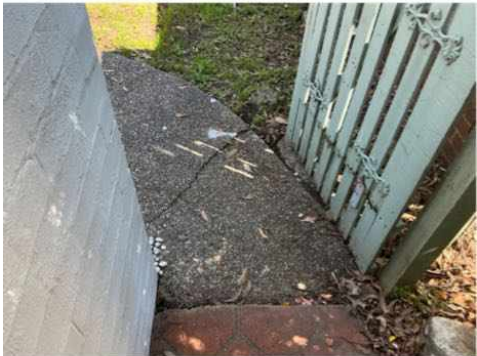
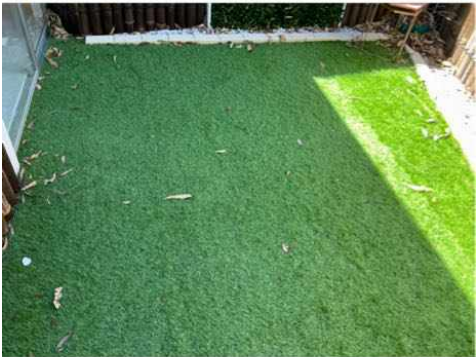
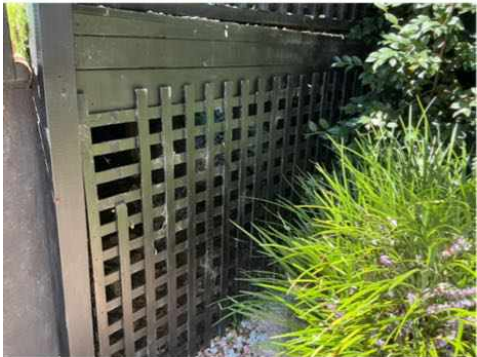
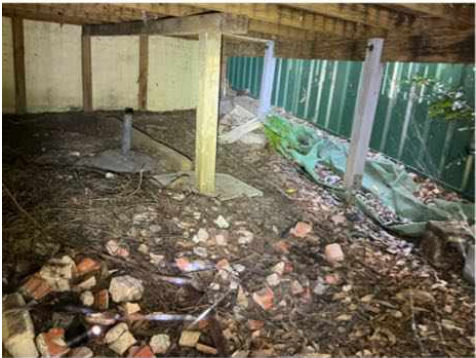
Finding 7.01

Building:	Main Building
Location:	All Areas
Finding:	Fungal decay - present (localised)
Information:	Fungal decay also known as wood decay generally refers to the deterioration of timber elements when in contact with excessive levels of moisture for a prolonged period of time. Generally fungal decay develops on timber elements that are in use in an external environment which are exposed to rain penetration.

In this case although the affected timber element is in a decaying state the extent of any visible damage appears to be localised to a specific area. The fungal decay is therefore likely to be of a relatively superficial nature with minimal impact on the structural integrity or tensile strength of the timber element.

- Treat, repair or replace any Fungal decay/wood decay.
- Remove or treat any materials bridging the termite management system (to prevent concealed termite entry).
- Remove any debris from the sub floor.
- Clear any debris, garden beds or soil covering ant caps, weep holes or vent holes (to prevent concealed termite entry).
- Remove, replace or treat any non-treated timbers in direct contact with the ground.
- Clean blocked guttering regularly.
- Trees over 100mm diameter on the property should be drilled and tested for termite activity.
- Regular inspections every 6-12 months.

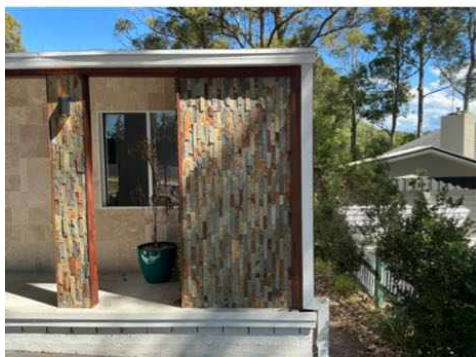
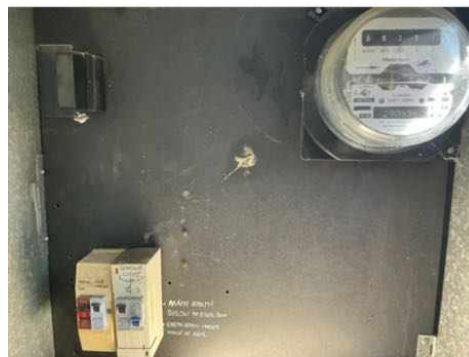
Building: Main Building
 Location: Meter Box
 Finding: Termite Management System - No Evidence
 Information: The application of a post-construction chemical termite barrier is highly recommended for all properties, particularly if live termite activity has been found on the site previously. Such barriers are highly effective in preventing termite attack on any timber building elements throughout the property.

A durable notice should be placed in the switchboard unit to indicate current termite barriers. At the time of inspection, it appeared as though no termite management system has been installed, with no evidence to suggest preventative works taking place.

The client may consider gaining further advice from a pest controller as to the costs and procedures involved with this application. It is recommended that obtaining such advice be a short-term priority.

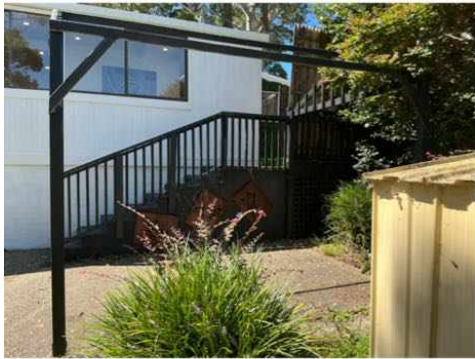
Building: Main Building
 Location: All Areas
 Finding: Balcony or Deck - Load Capacity
 Information: Because of obstructions the load capacity of the external balcony or deck could not be verified during the inspection.

External timber structures and fixings are also constantly exposed to weather elements and can deteriorate in an accelerated manner, ongoing assessments are required.

It is highly recommended that a Structural Engineer further assess the external timber balcony or deck to inform the client of its load capacity. Regular maintenance inspections by competent practitioners is needed.

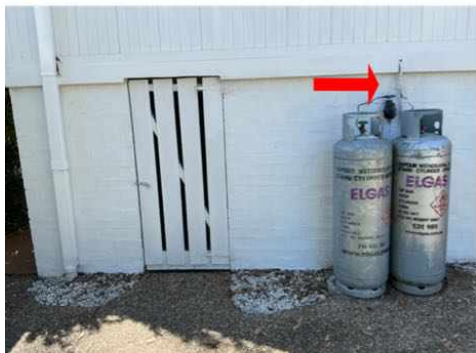
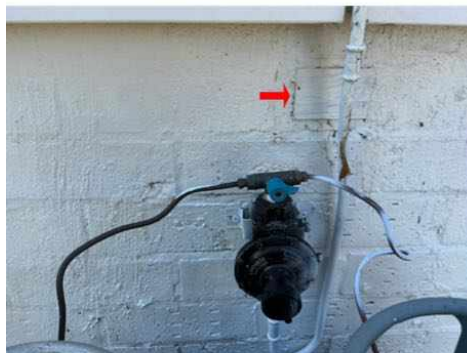
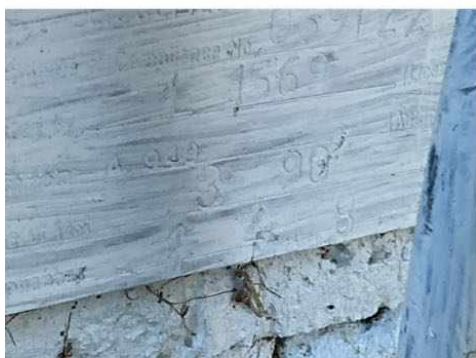
Building:	Main Building
Location:	Exterior walls - rear
Finding:	Gas Bottle Regulator - Non-compliant
Information:	In the opinion of the inspector, the gas bottle regulator is non compliant. However, in relation to gas and related gas plumbing, you should always consult a licensed plumber/gas fitter for further advice. This gas bottle regulator compliance plate

reads March 1990.

Where installation is out dated, the client should contact the responsible trade (gas plumber) to undertake further inspections.

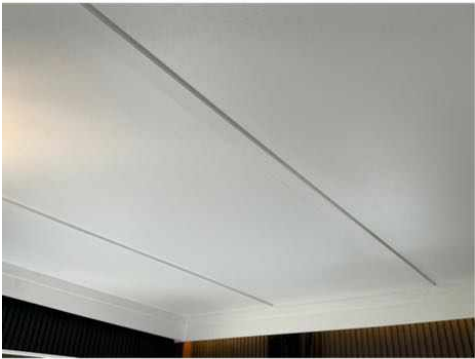
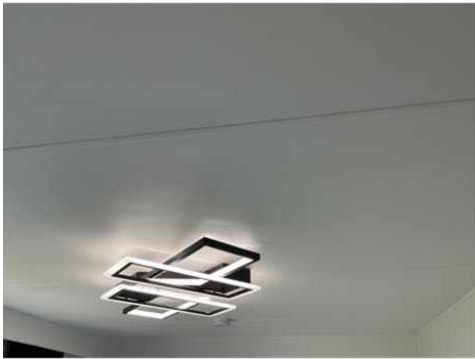
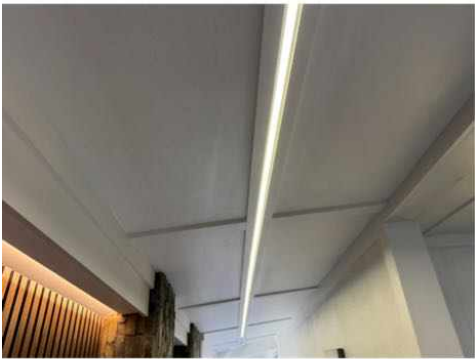
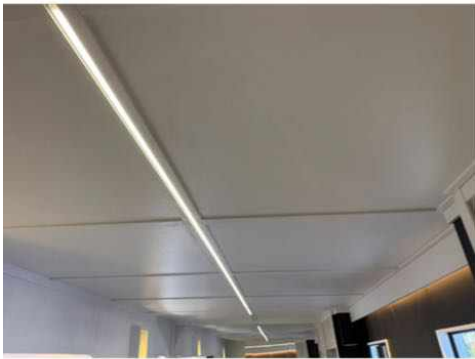
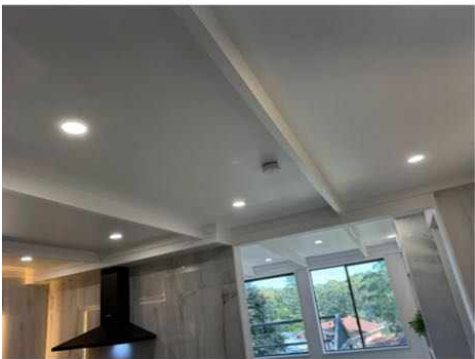
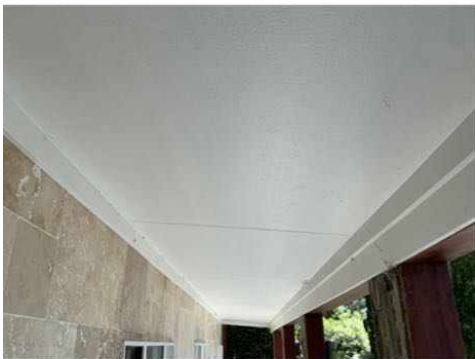
Building: Main Building
 Location: All Areas
 Finding: ACM Suspected - Lab Testing Recommended
 Information: These materials are suspected to be an Asbestos Containing Material (ACM). A sample should be taken from this location for lab analysis, by a NATA approved laboratory, to confirm the presence of asbestos. Removal of ACM is always recommended. Where the client chooses to keep suspected ACM, encapsulation of ACM is essential. This includes;

The client is advised to assume that the area contains ACM until a sample is tested and the lab analysis results are available. The area should be avoided and no works should be undertaken on the area until lab results are available.

No works should be carried out to these materials or associated building elements without further specialist advice. For Asbestos Condition Inspections please contact Nick Pepper on 0407 011 477.

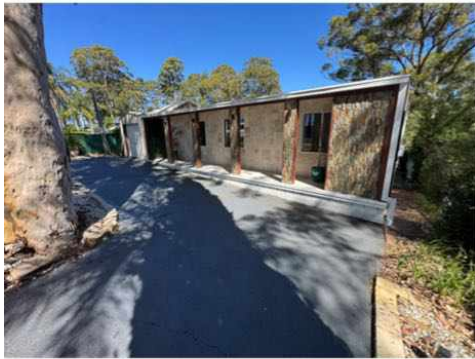
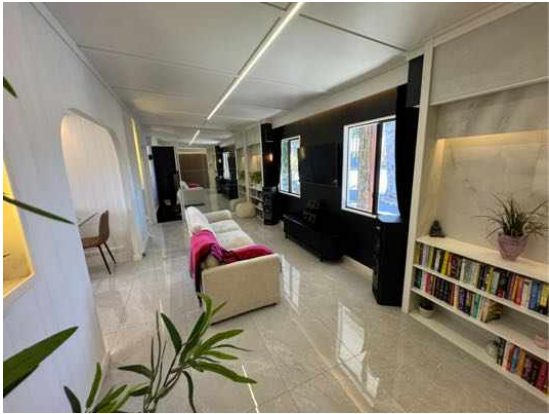
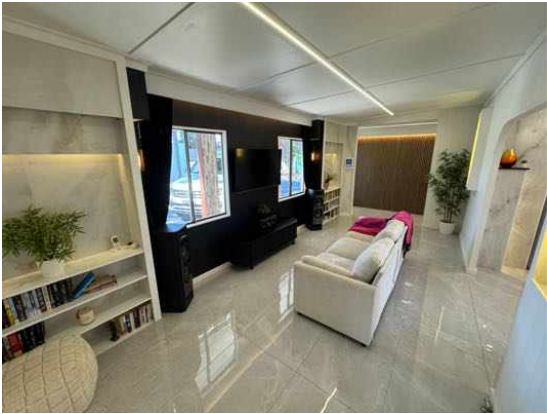
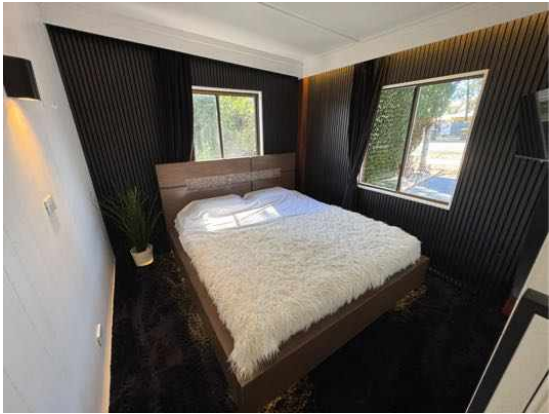
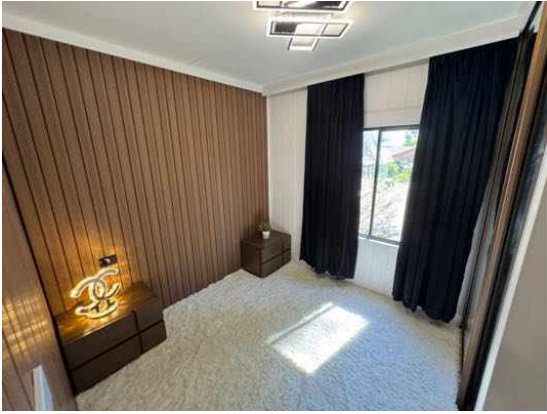
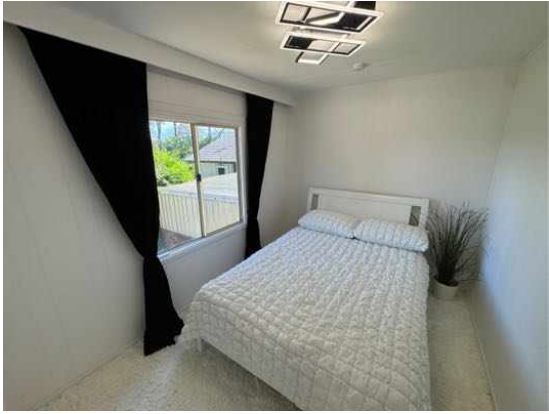
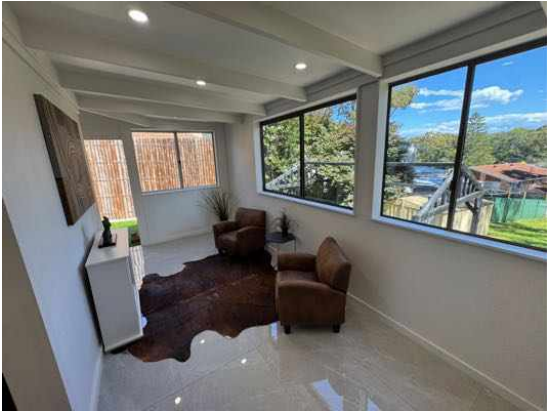
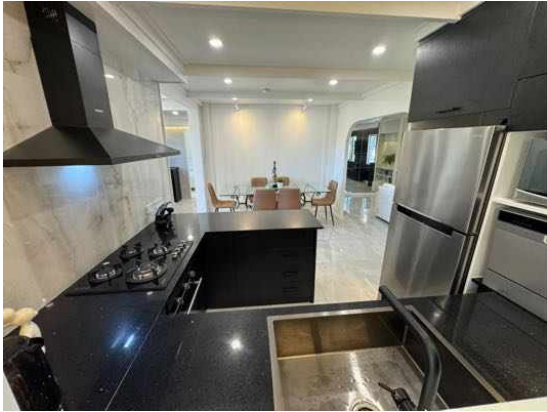
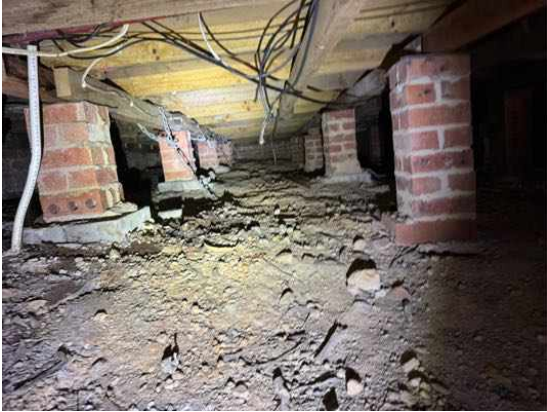
Building:	Main Building
Location:	All Areas
Finding:	Additional Photos - Obstructions and Limitations
Information:	These photographs are an indication of the obstructions and limitations which impeded full inspection of the property at the time of inspection. These obstructions can hide an array of defects and should be removed to allow full inspection to be carried out. A re-inspection is recommended once the areas are made accessible.

- decking.
- stored items.
- furniture.
- rubbish and debris.
- obstructions from other building materials.
- finished concrete and paving levels.
- finished ground levels.
- vegetation.

A further invasive inspection is recommended to these areas immediately.
