Building and Timber Pest Inspection Report

Inspection Date: Thu, 8 Jan 2026

Property Address: 15 Hazel Pl, Glenview QLD 4553, Australia

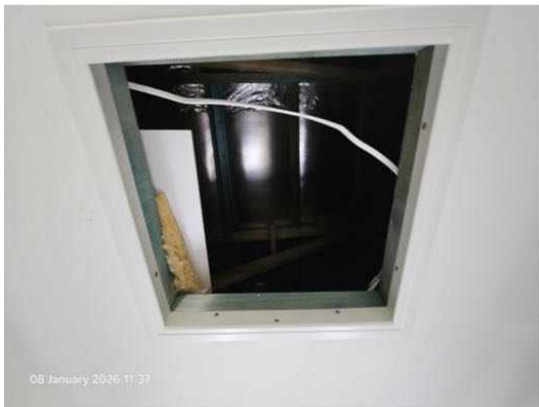
Finding 1.03

Building: Main Building
 Location: Bedroom - Master
 Finding: Cable in access hatch
 Information: On the day of inspection the ceiling space access hatch was partially blocked by the presence of an electrical cable across the opening.

This has the potential to become caught on items or persons entering the roof space. It should be clipped in a safe position away from the access hatch.

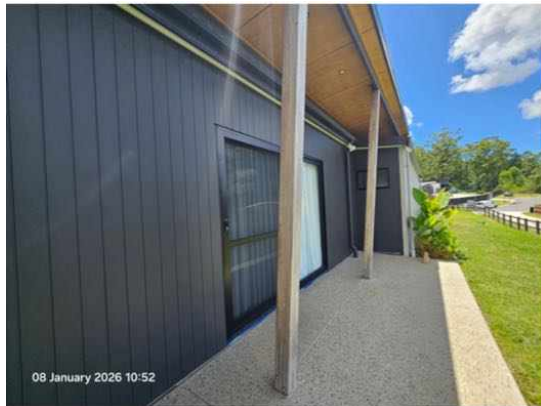
Location: Front patio
 Finding: Timber - exposed to weather
 Information: External timbers that are frequently exposed to harsh weather conditions require adequate protection in order to maintain their condition. Where timbers have not been painted or treated adequately, general deterioration is likely to occur at an accelerated rate.

Adequate treatment of these timbers is required as soon as possible by a painting contractor or general handyman.

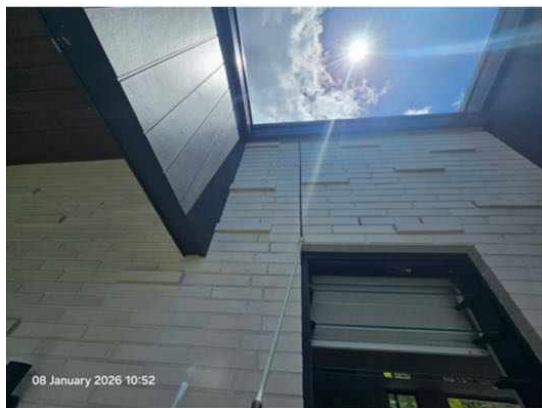
Finding 3.02

Building: Main Building
 Location: Front elevation
 Finding: Expansion / Control joints - unsealed.
 Information: At the front of the building, there is a control / expansion joint in the brick work. This joint is unsealed and requires filling with correct sealant to prevent moisture and vermin from entering the building via these joints.

This can be done at the clients discretion, by the client or a general handyman.

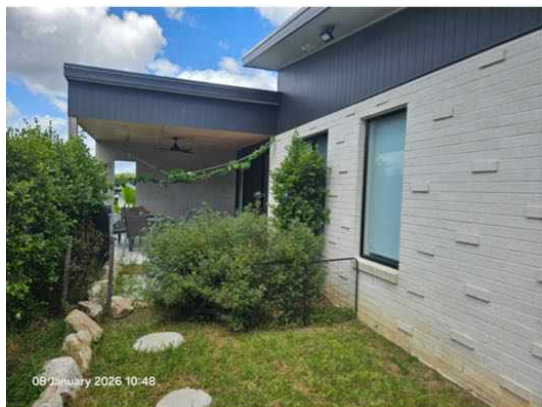
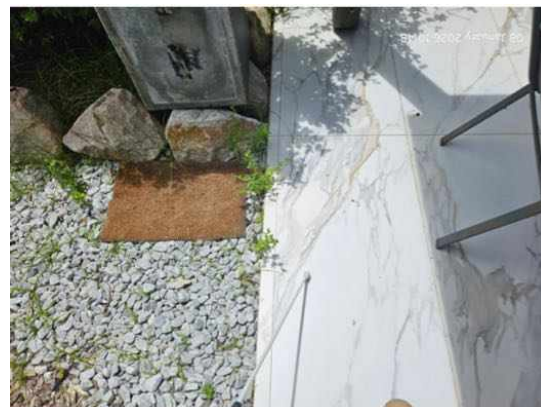
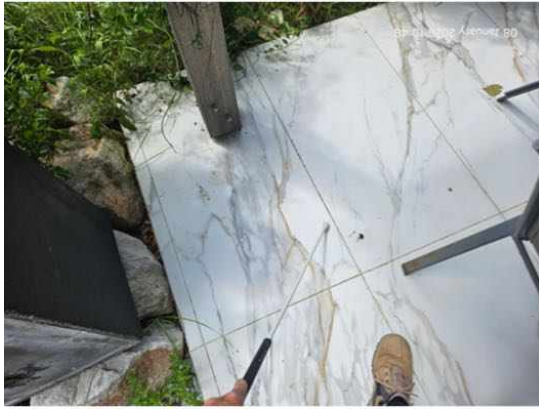
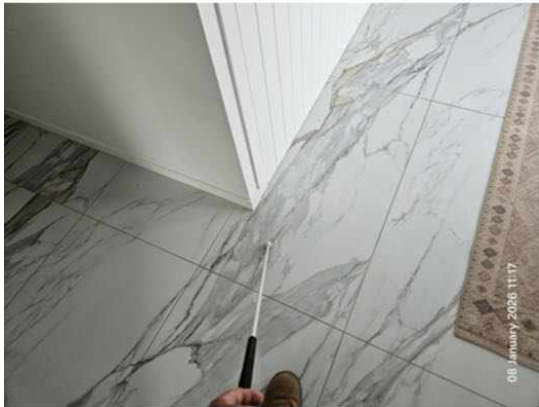
Finding 3.03

Building:	Main Building
Location:	As shown
Finding:	Tiles - Drummy
Information:	Drummy tiled areas were identified at the time of inspection. Please see the attached photos for locations.

The term 'drummy' refers to tiles that have become detached from their fixing, despite otherwise being in relatively good condition. Such defects are generally caused by physical or moisture damage to the area. Drummy tiled areas may also be a direct result of poor workmanship during the construction process.

Tiled areas may swell and shrink with changes in air humidity if the area has sustained moisture damage. Any exposure to moisture is capable of causing tiled areas to become drummy and/or cracked over a prolonged period of time. Drummy tiled areas generally require removal and replacement of affected tiles.

Specialist trades are available for these types of services. A licensed builder may be required to undertake works if damage is extensive or if secondary building defects have resulted. Otherwise, it is advised that a tiling contractor or a tile adhesive injection service may be appointed to perform works as necessary.

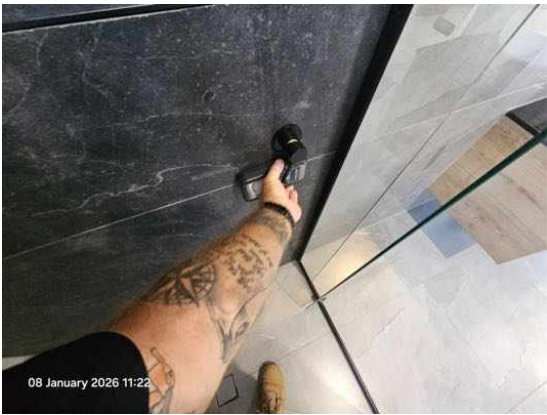
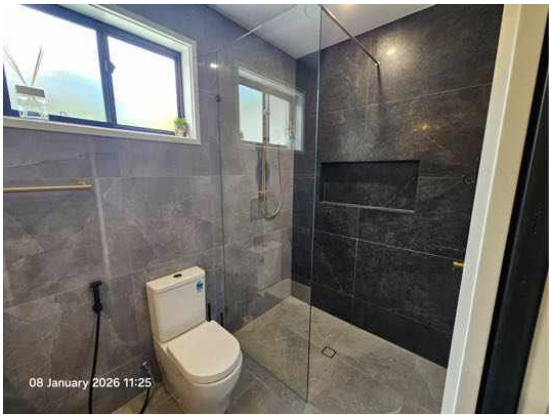
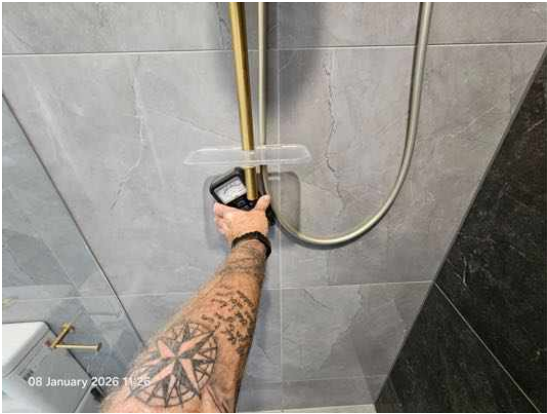
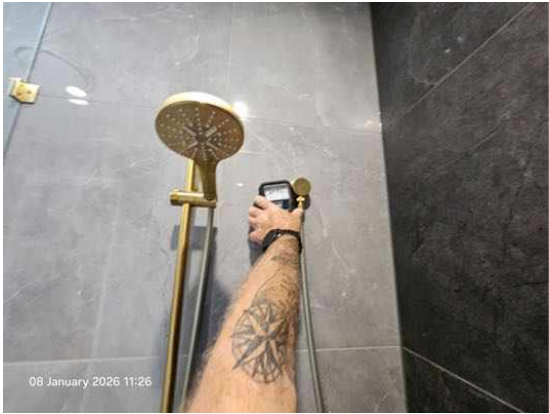
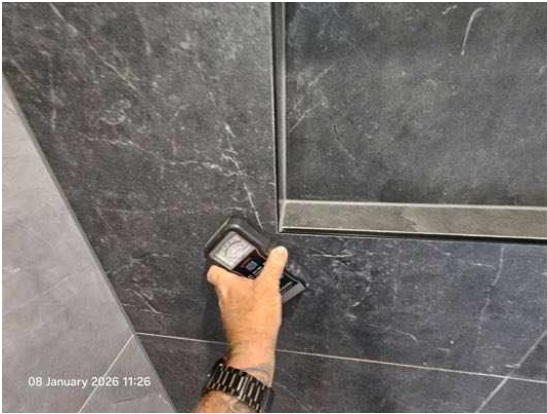
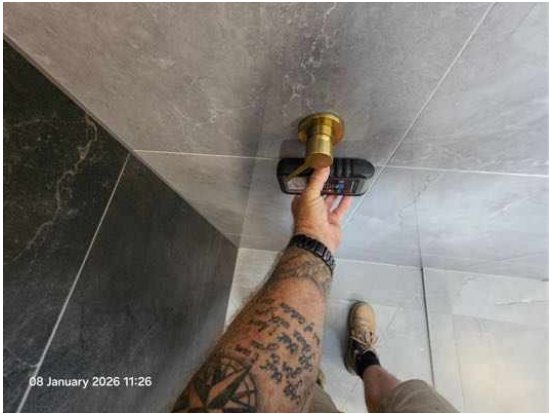
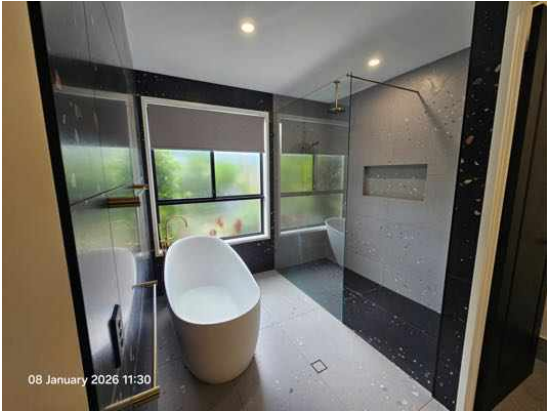
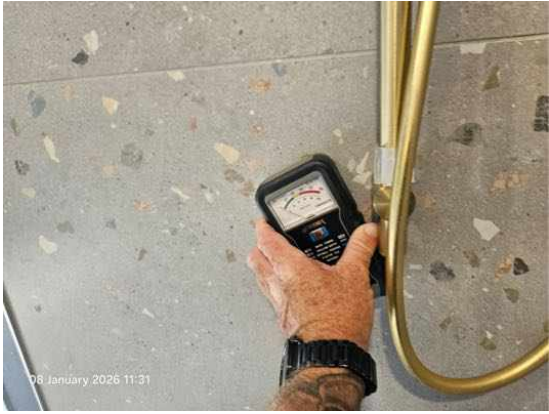
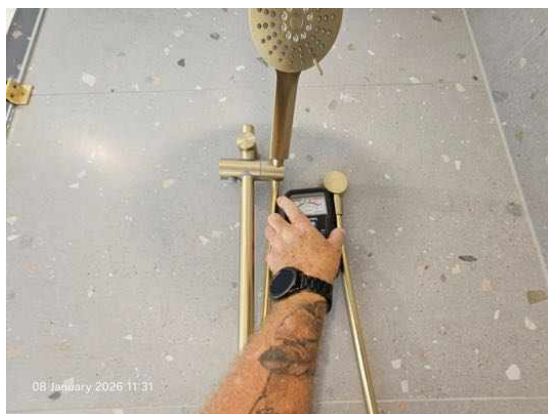
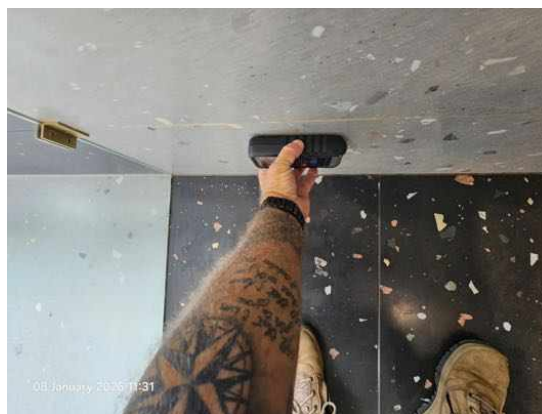
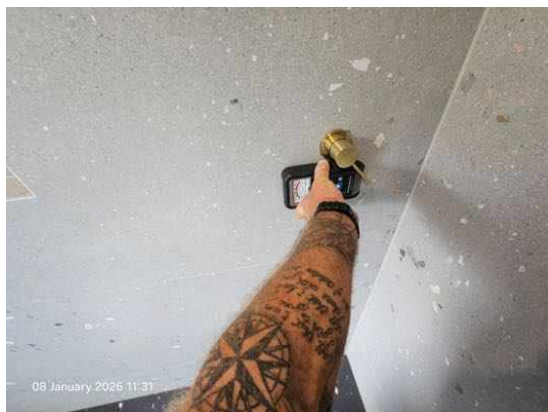
Building: Main Building
Location: Bathroom, ensuite
Finding: No moisture detected in bathroom / ensuite
Information: On the day of inspection the showers in the bathroom/s and ensuite are measure for moisture using a "Tramex" moisture meter. During this inspection no moisture was detected in these areas and the tiled / sheeted surfaces appear to be in good order.

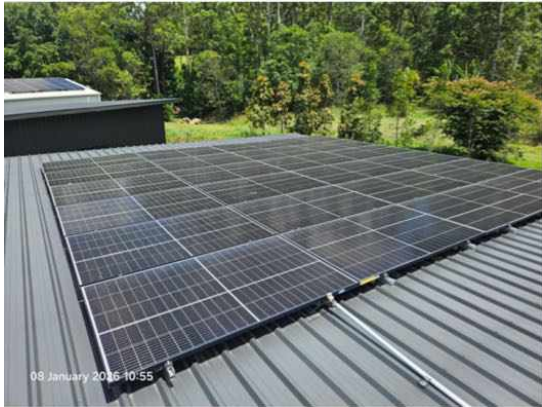
Noted Item

Building: Main Building
Location: All Areas
Finding: Additional Photos - Obstructions and Limitations
Information: These photographs are an indication of the obstructions and limitations which impeded full inspection of the property at the time of inspection. These obstructions can prevent full inspections of the areas shown.

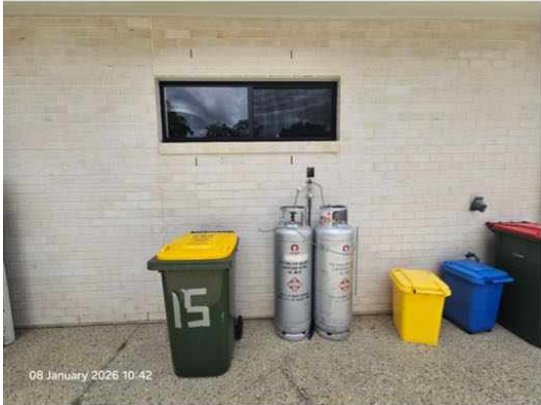
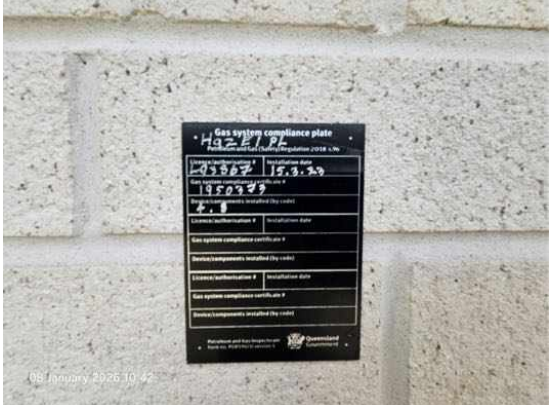
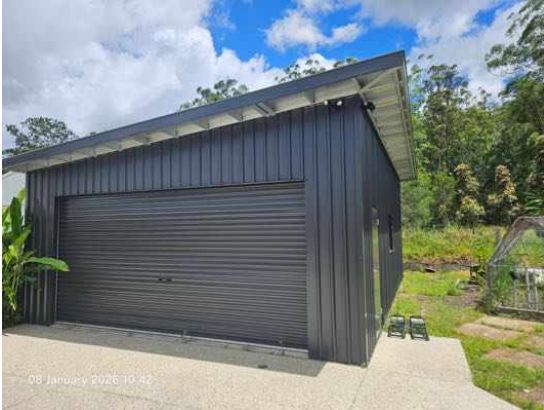
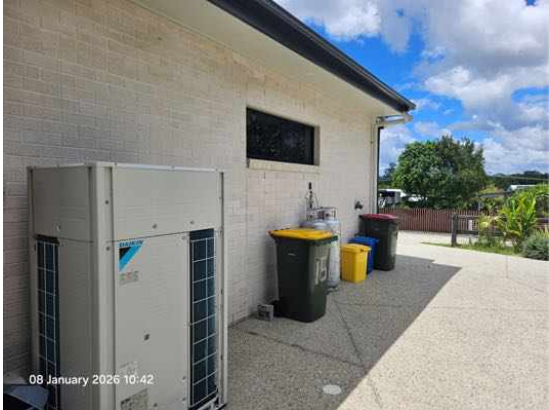
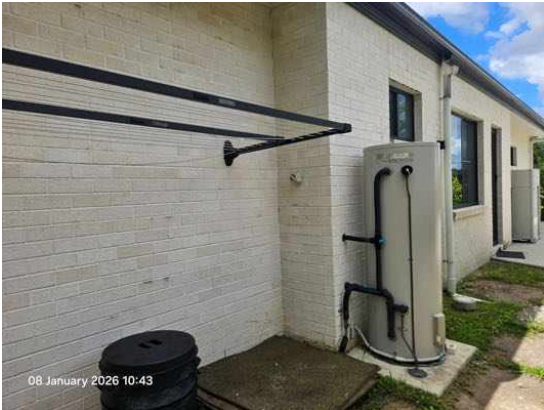
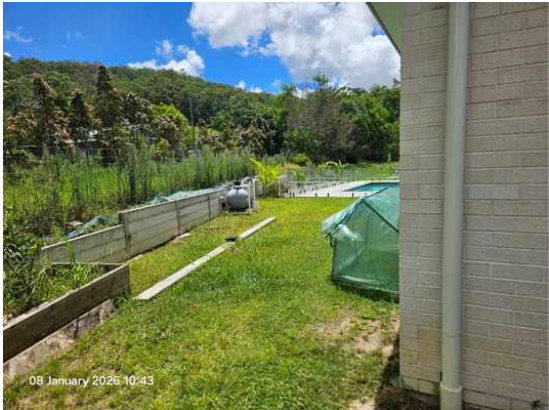
Noted Item

Building: Main Building
Location: All Areas
Finding: Additional Photos for client reference
Information: Additional photos are provided for your general reference.

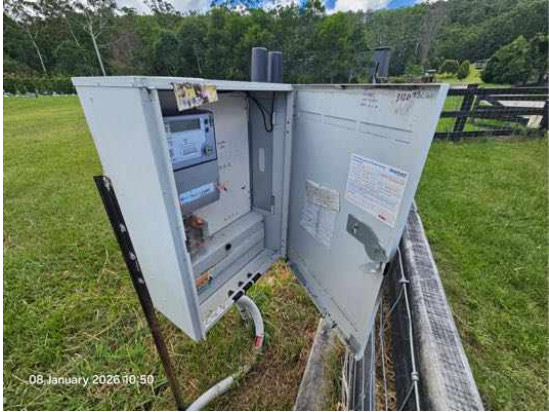
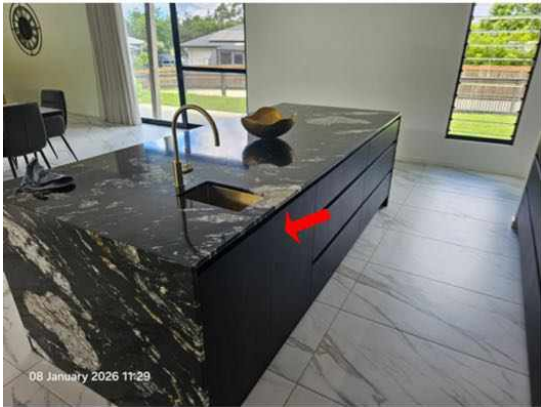
Building: Main Building
 Location: Meter box, kitchen cupboard
 Finding: Durable pest inspection notice - not assessable
 Information: On the day of inspection it was noted that the durable timber pest inspection / treatment notice was missing, not visible or out of date. These notices / stickers are to verify the timber pest inspection dates, the inspector, the currency and type of timber pest system / barrier in place or being used in and around the property.

Annual, or more regular, inspections are crucial in maintaining and managing the properties timber pest risk profile. By not having regular inspections of the property raises the properties risk of undetected defects and damage. Without regular inspection at intervals of not greater than annually the buildings risk profile will categorised as high. Properties with trees within 50m and with gardens close to the building are at greater risk and will have a high risk profile.

It is recommend that a licensed timber pest controller be contacted to assess the properties needs and provide costings for an annual inspection programme.

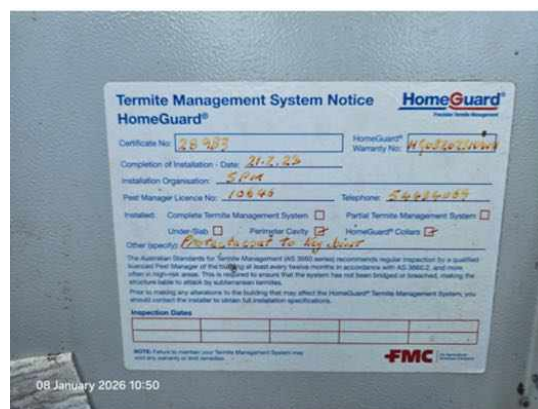
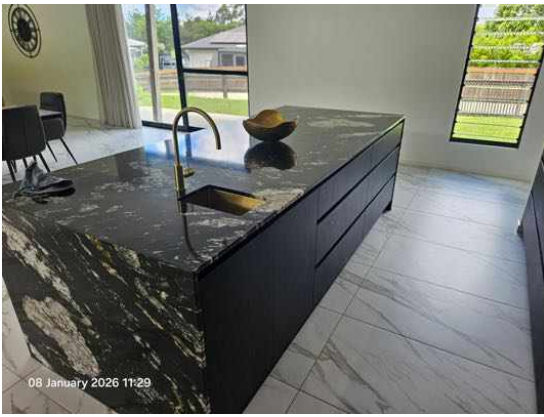
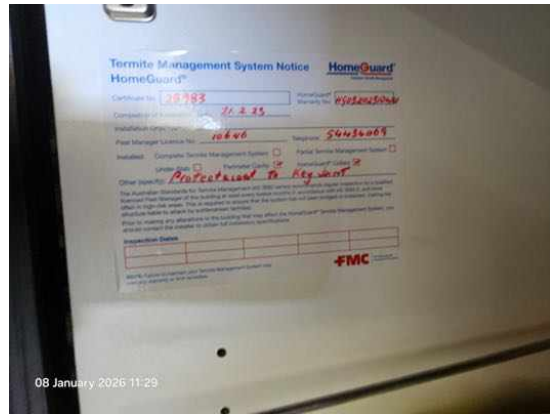
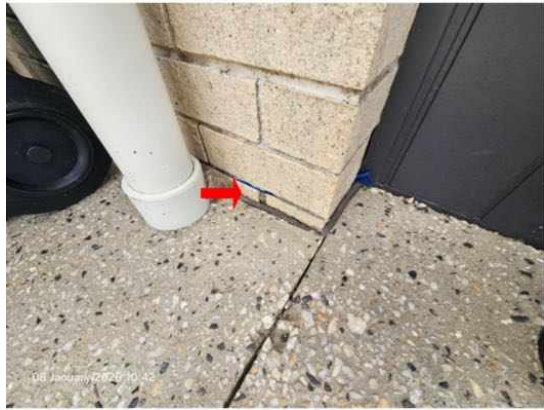
The following items were noted as - Evidence of a previous termite management program

The building employs a physical barrier system to the perimeter and slab penetrations. In order for a barrier system to be effective, the property must have regular inspections at intervals of not greater than 12 months. Depending on the risk profile attributed to the property, these inspections may be recommended at lesser time periods.

Where a Termite Management System has been identified you should refer to the type of barrier, date of installation, warranty conditions and any documentation provided by a builder or past owner. Consult the company who installed the barrier to confirm whether the system is still under warranty.

Most chemical termite management systems expire and require replenishment and all physical systems are primarily designed to prevent concealed entry. It is strongly advised to read and become familiar with the barrier systems requirements and maintenance. The implementation of a licensed timber pest controllers inspection programme is strongly advised.
