Building and Timber Pest Inspection Report

Inspection Date: Thu, 26 Mar 2026

Property Address: 39 Bartlett Ave, Nerang QLD 4211,
Australia

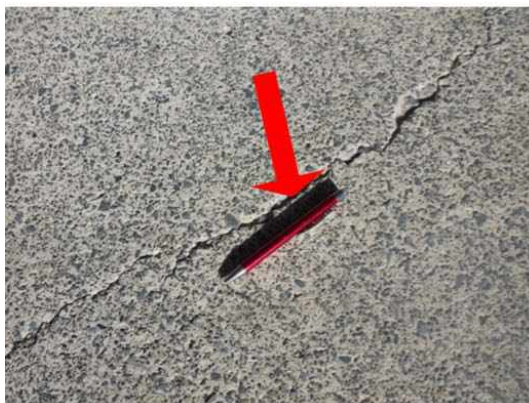
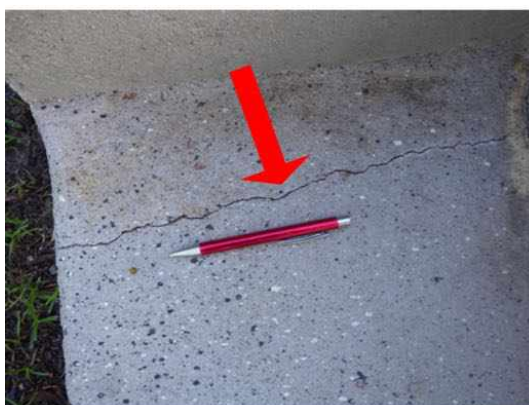
Building: Main Building
 Location: Driveway > Ground Level
 Finding: Cracking in concrete slab - Category 1
 Information: Cracking coded as Category 1 was identified in the driveway and/or footpaths concrete slabs. A Category 1 crack is described as a fine but noticeable crack, with the slab at an otherwise reasonable level.

To be considered Category 1, the approximate width of the crack is less than 1.0mm, or a less than 10mm change in offset when a 3m straight edge is placed over the defect.

Category 1 cracks should be monitored for a period of 12 months. At the end of the monitoring period, identified cracks that are rated greater than Category 2 are considered defects, and require rectification.

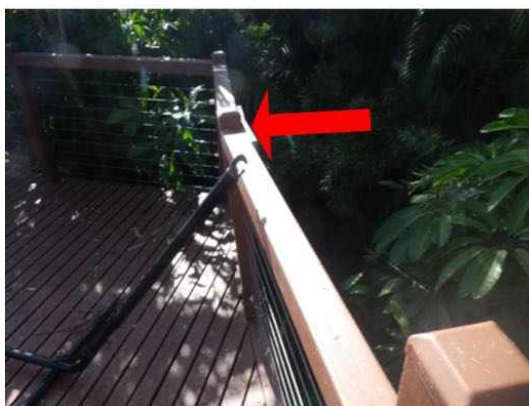
Finding 3.02

Building:	Main Building
Location:	Deck > Rear Left
Finding:	Deck
Information:	It was noted at the time of inspection that a section of the timber deck hand railing to the rear of the property showed signs of movement or deterioration. Typically timber decking or balustrade deteriorates due to age and or wear, rot and or rust which is generally expected for a structure of this age, due to prolonged exposure to weather conditions. Sometimes inadequate installation or maintenance can be to blame.

It is suspected that repair of several elements of the decking handrail may be required.

A licensed carpenter could be engaged to perform rectification works as necessary.

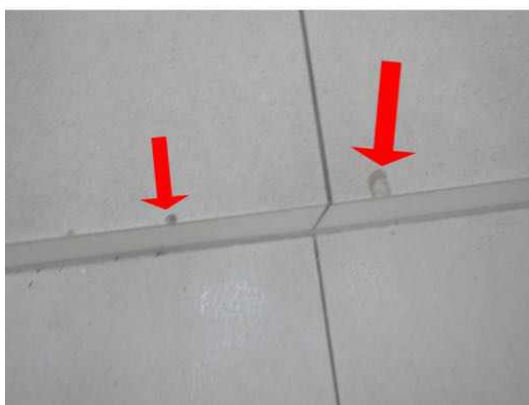
Finding 3.03

Building:	Main Building
Location:	Stairs - Internal > Front
Finding:	Tiles - Chipped
Information:	Chipped tiles to the internal stairs floor area were identified at the time of inspection. Chipped tiles are generally caused by impact.

A tiling contractor could be appointed to perform repair works at the clients discretion.

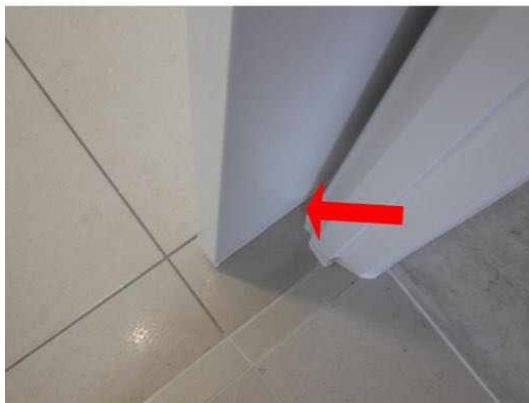
Finding 3.04

Building:	Main Building
Location:	Bathroom > Front
Finding:	Door Guide
Information:	It was noted that the door guide to the bathroom area sliding door was missing at the time of inspection.

This is noted as a minor defect that you need to be aware of.

A licensed carpenter or general handyman could be engaged to adjust or replace the door guide at the clients discretion.

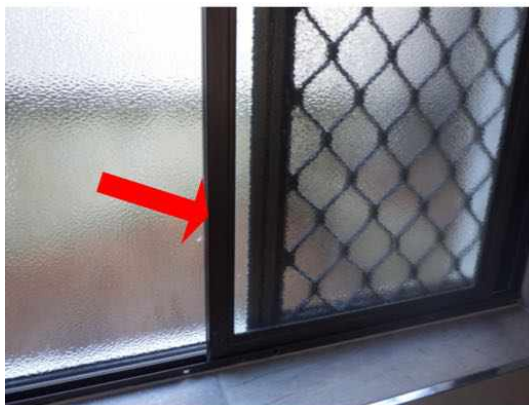
Finding 3.05

Building: Main Building
 Location: Bathroom > Rear Right
 Finding: Window Catch - missing
 Information: It was noted that the window handle/catch to the bathroom area aluminium sliding window was missing at the time of inspection. Whilst detracting from the functionality of the window, this minor defect may also be a security risk.

It is suspected that this defect has occurred due general wear and tear, which is expected for building elements of this age.

An aluminium sliding window service agent or general handyperson may be appointed to perform rectification works as necessary, at client discretion.

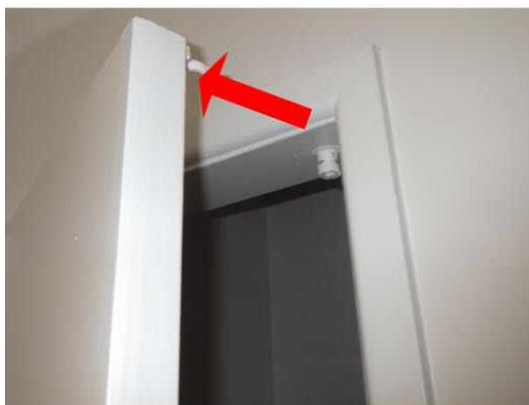
Finding 3.06

Building: Main Building
 Location: Storage Cupboard > Front
 Finding: Door - Broken latch
 Information: The door latch to the linen cupboard door was found to be broken at the time of inspection. Breakage occurs generally when the building materials have aged and decayed, but may be indicative of impact damage (accidental or deliberate).

A general handyman could be appointed to replace the door latch at the client's discretion.

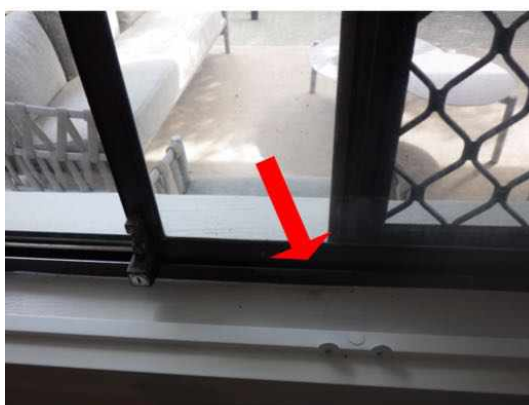
Finding 3.07

Building:	Main Building
Location:	Bedroom 2 > Rear
Finding:	Window - Stiff to Slide
Information:	The aluminium sliding window in bedroom 2 was stiff to operate at the time of the inspection. Windows provide ventilation to the adjoining area and should be at a fully operational level to ensure user comfort. Restricted function of the window may also pose as a potential safety hazard if required for emergency egress from the building.

Generally, factors such as general age of the building element and a lack of maintenance are the usual causes for this type of defect.

An aluminium window service agent will be required to repair the affected windows.

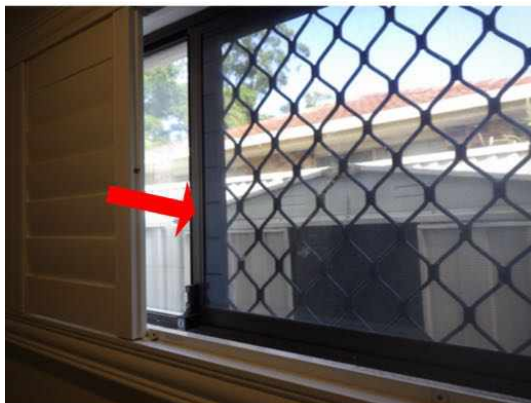
Finding 3.08

Building:	Main Building
Location:	Bedroom 2 > Centre Left
Finding:	Window Catch - missing

Information: It was noted that the window handle/catch to the bedroom 2 aluminium sliding window was missing at the time of inspection. Whilst detracting from the functionality of the window, this minor defect may also be a security risk.

It is suspected that this defect has occurred due general wear and tear, which is expected for building elements of this age.

An aluminium sliding window service agent or general handyperson may be appointed to perform rectification works as necessary, at client discretion.

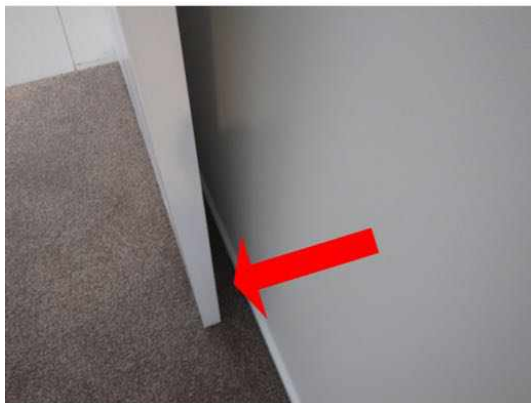
Finding 3.09

Building: Main Building
 Location: Bedroom 3 > Front
 Finding: Door stop - Missing
 Information: The bedroom 3 door stop is missing or is inadequate to stop the door handle from impacting the wall.

Re-installation or replacement of the door stop is advised to prevent any subsequent damage to the wall linings or associated structures.

A general handyman may be appointed to perform these works at client discretion.

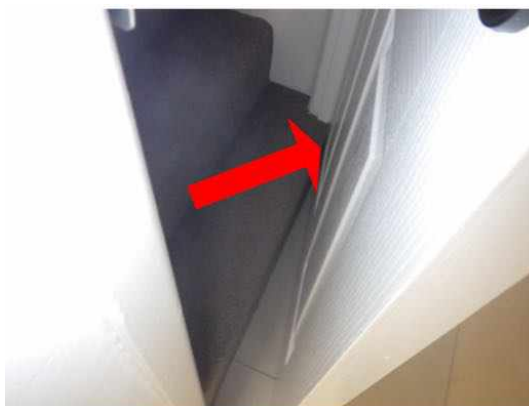
Finding 3.10

Building: Main Building
 Location: Bedroom 4 > Front
 Finding: Door - Binding/Jamming
 Information: Binding and/or jamming of the bedroom 4 door on the door frame or stair tread carpet was evident during standard operation. This defect inhibits the functionality of affected door as well as creating potential for secondary defects to associated building elements, such as damage to the door framing.

A door that binds on the door frame or adjoining stairs may have several causes, such as poor installation of the door or deteriorated hinges.

A qualified carpenter or general handyman could be appointed to perform minor rectification works at client discretion.

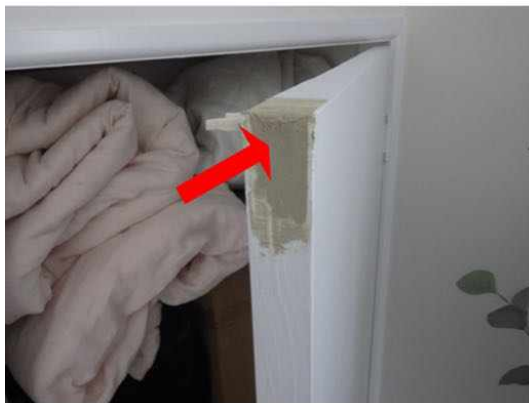
Finding 3.11

Building: Main Building
 Location: Bedroom 4 > Rear Right
 Finding: Door - Paint
 Information: At the time of inspection it was noted the bedroom 4 right side cupboard door had not been fully painted along the top edge. It is important that all door surfaces and edges are painted or sealed as per the manufactures specifications to preserve the life of the door.

A qualified painter or general handyman could be engaged to undertake minor painting works.

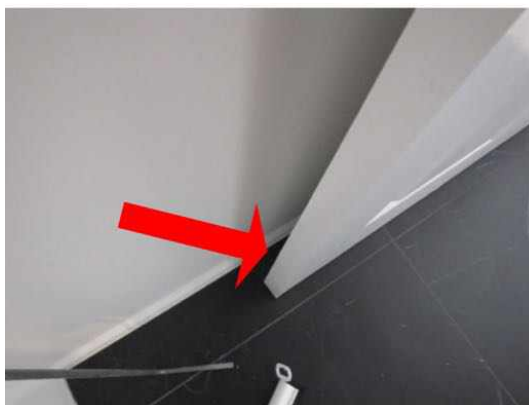
Finding 3.12

Building: Main Building
 Location: Garage > Front
 Finding: Door stop - Missing
 Information: The garage interior door stop is missing or is inadequate to stop the door handle from impacting the wall.

Re-installation or replacement of the door stop is advised to prevent any subsequent damage to the wall linings or associated structures.

A general handyman may be appointed to perform these works at client discretion.

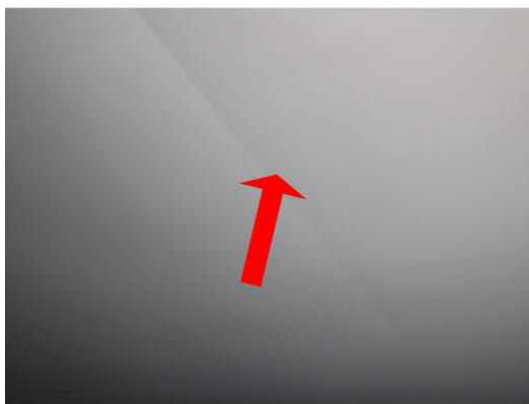
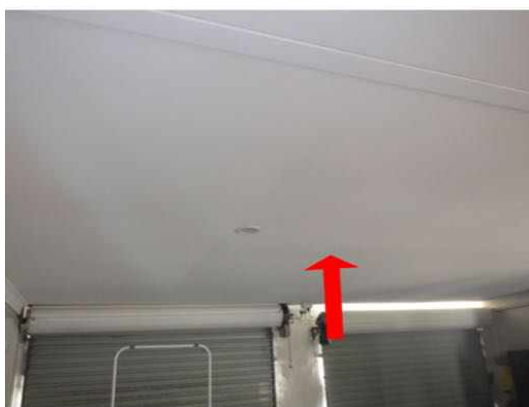
Finding 3.13

Building: Main Building
 Location: Garage > Centre
 Finding: Ceiling - Sagging
 Information: The ceiling linings in the garage showed signs of minor sagging at the time of inspection. Sagging to the fixed ceiling structure generally indicates that the building materials have swollen, due to exposure to moisture, or that fixings (e.g. nails or glue) have become loose and require reattachment.

screwing of ceiling sheets, may be required.

Such works may be performed by relevant tradespeople, such as plasterers and painters.

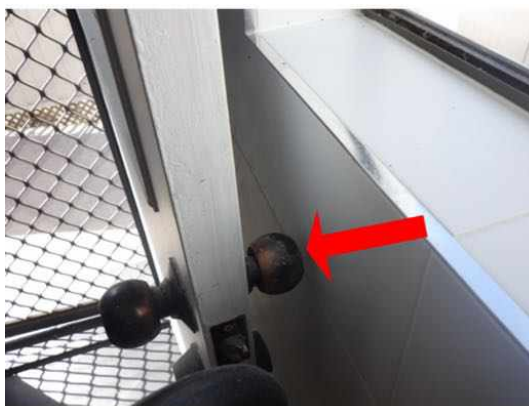
Finding 3.14

Building:	Main Building
Location:	Garage > Rear Left
Finding:	Door stop - Missing
Information:	The garage/laundry exterior door stop is missing or is inadequate to stop the door handle from impacting the wall.

Re-installation or replacement of the door stop is advised to prevent any subsequent damage to the wall linings or associated structures.

A general handyman may be appointed to perform these works at client discretion.

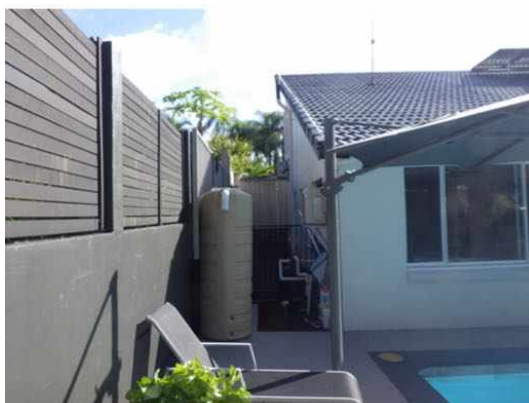
Finding 6.02

Building:	Main Building
Location:	Exterior walls - right side > Centre Right
Finding:	Overflow - Not plumbed for drainage
Information:	The air conditioning unit overflow is not plumbed or connected to suitable drainage, which can result in the surrounding area becoming excessively damp. These damp conditions can lead to secondary defects such as rot, rust or corrosion of associated building elements, the formation of fungal decay, or even the creation of potential slip hazards. When coupled with poor site drainage, pooling of water may also attract termite activity to this area. It is highly recommended that a qualified plumber be appointed to install adequate drainage to the overflow. These works will ensure that

the area remains dry and free of any secondary defects.

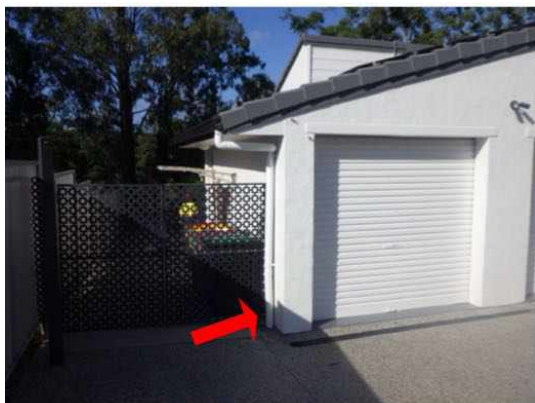
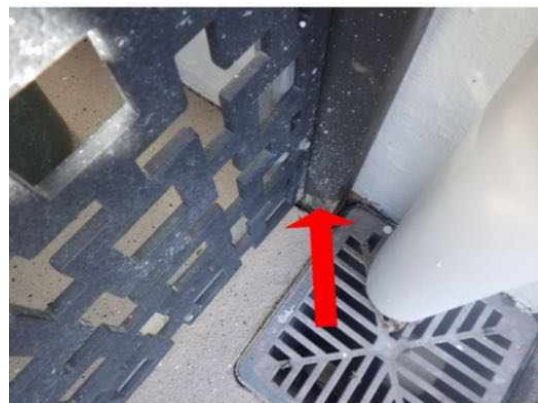
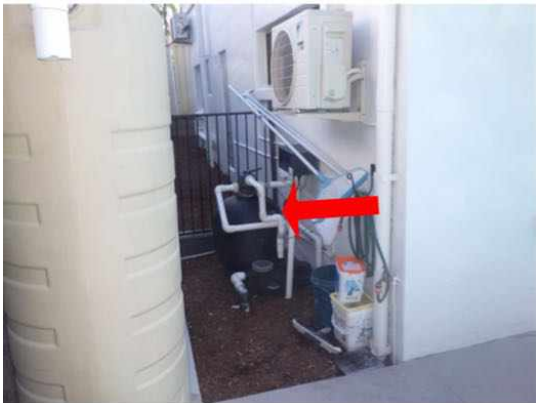
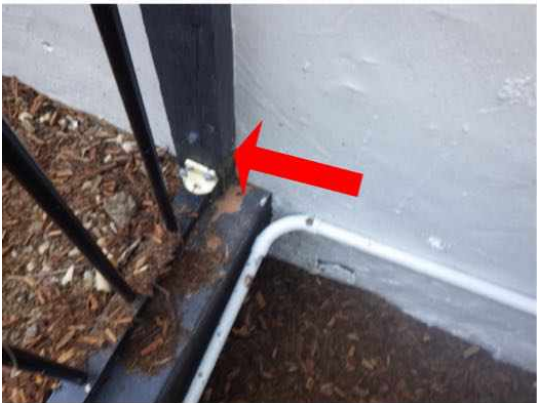
Building: Main Building
 Location: Exterior walls - sides > Existing
 Finding: In ground contact
 Information: It was noted at the time of inspection the timber gate/ fence posts fixed to the exterior wall brickwork are in direct contact with the concrete slabs or ground surfaces.

Any timbers in direct ground contact provide opportunity for concealed termite entry and are likely to be subject to premature rot and decay as the ground retains moisture or damp conditions against the timbers.

Ideally these types of timber members would be clear of the ground area by a minimum of 50mm to provide a clear inspection zone.

Frequent pest inspections are advised to readily identify any termite activity in these areas.

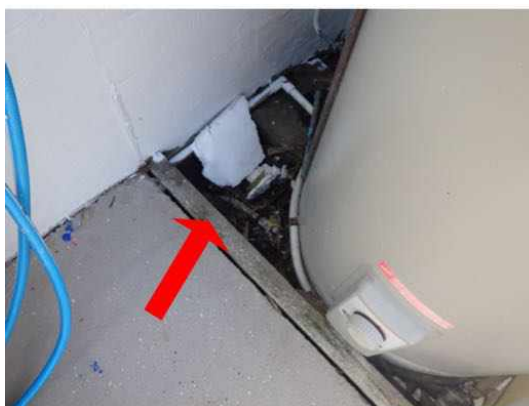
Finding 6.04

Building: Main Building
Location: External Areas > Ground Level
Finding: In ground - Timber
Information: At the time of inspection there was timber on/in ground areas to the right and left sides of the property.

Any timbers in direct ground contact provide opportunity for concealed termite activity and are likely to be subject to premature rot and decay as the soil retains moisture or damp conditions against the timbers.

Removal of any untreated timber or tree stumps which are in direct contact with external ground is recommended. Frequent pest inspections are advised to readily identify any termite activity in these areas.

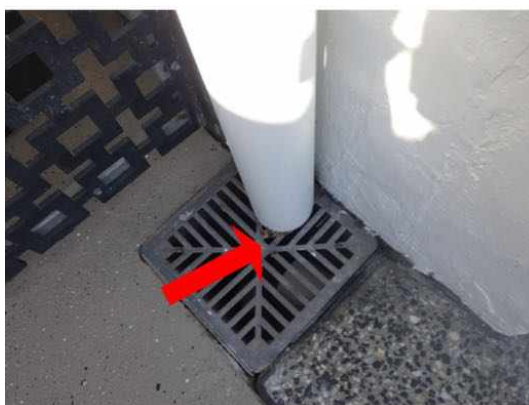
Finding 6.05

Building:	Main Building
Location:	Exterior walls - left side > Front Left
Finding:	Stormwater downpipes
Information:	The down pipe to the front right side of the property is not connected directly to the stormwater drainage on the site. This disconnection can negatively impact the functional capacity of the downpipe and the surrounding ground area.

Where roof plumbing doesn't drain as required, the area at the base perimeter can become excessively damp, potentially creating an environment that is susceptible to flooding and rust or corrosion of surrounding building elements, as well as attracting termites and other pests.

It is recommended that a licensed plumber be appointed to further inspect and to extend the down pipes to the properties stormwater line as necessary.

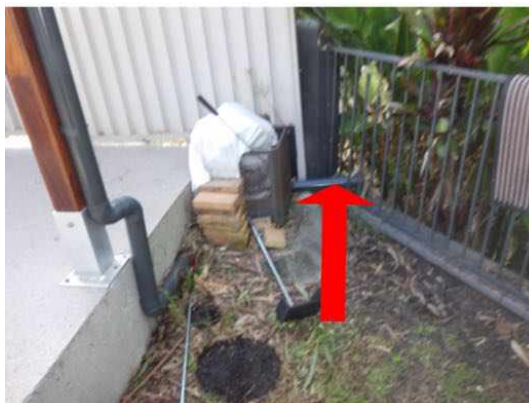
Finding 6.06

Building:	Main Building
Location:	Cabana > Rear Left
Finding:	Stormwater downpipes
Information:	The down pipe to the cabana roof area at the rear of the property is not connected to

Where roof plumbing doesn't drain as required, the area at the base perimeter can become excessively damp, potentially creating an environment that is susceptible to flooding and rust or corrosion of surrounding building elements, as well as attracting termites and other pests.

It is recommended that a licensed plumber be appointed to further inspect and to extend the down pipes to the properties stormwater line as necessary.

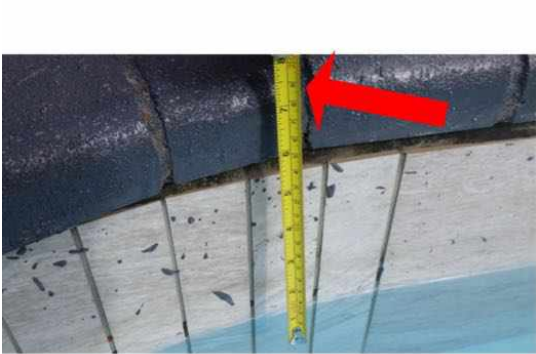
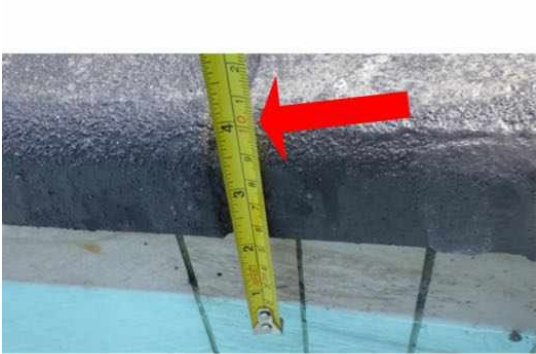
Building: Main Building
 Location: Swimming Pool - Below Ground > Existing
 Finding: Swimming Pool
 Information: At the time of inspection it was observed there is a noticeable difference in the water height - pool coping tile margins to each end of the pool.

Additionally as there is no obvious signs of ground erosion, cracking or damage to the pool shell, it is assumed the pool shell structure has been constructed approximately 100mm off level.

Monitoring the pool area is advised to identify any signs of movement or damage in the area.

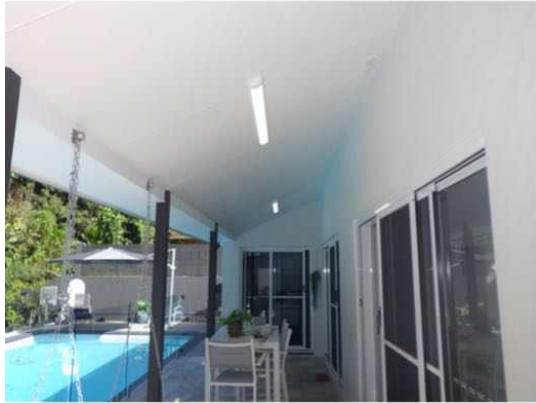
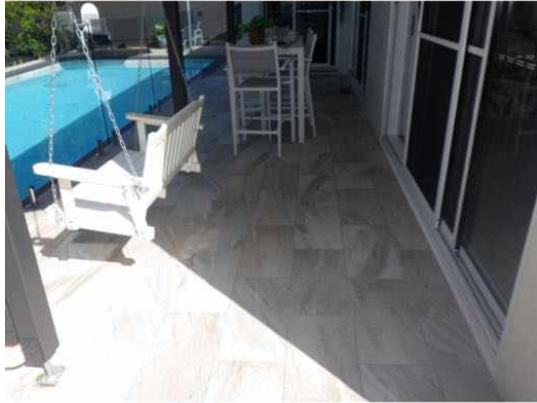
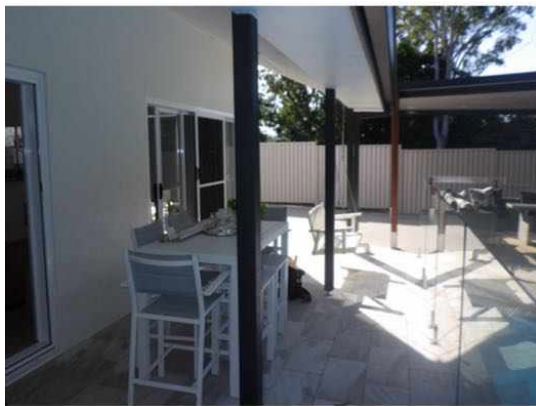
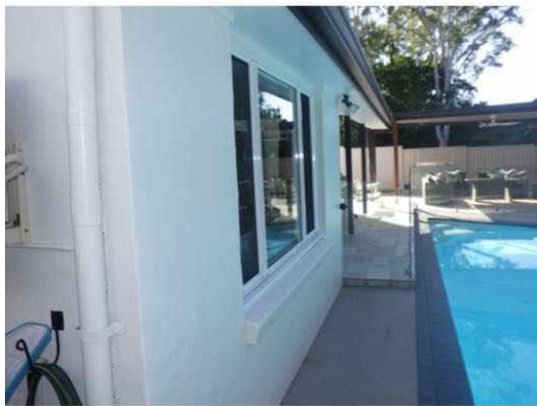
Building: Main Building
 Location: Alfresco > Existing
 Finding: No obvious defect

Information: No obvious defects found at the time of inspection.

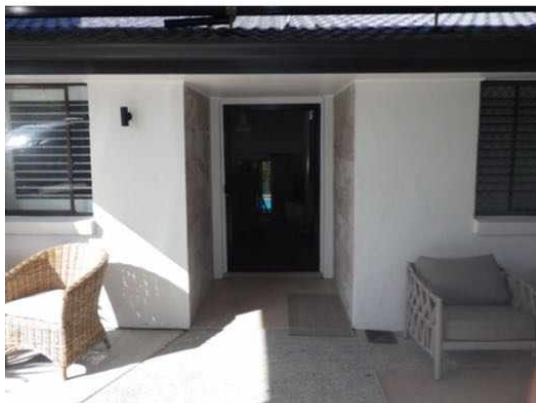
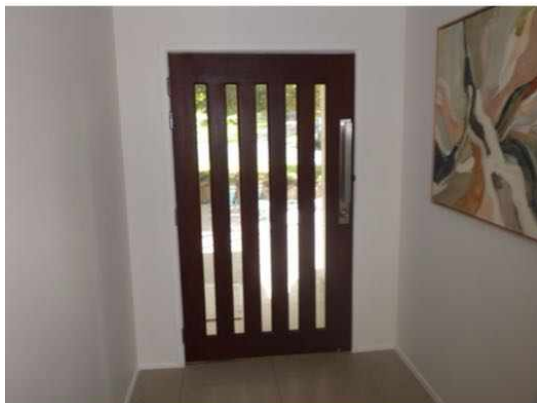
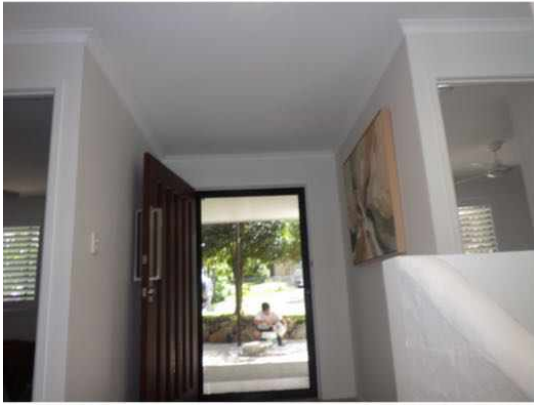
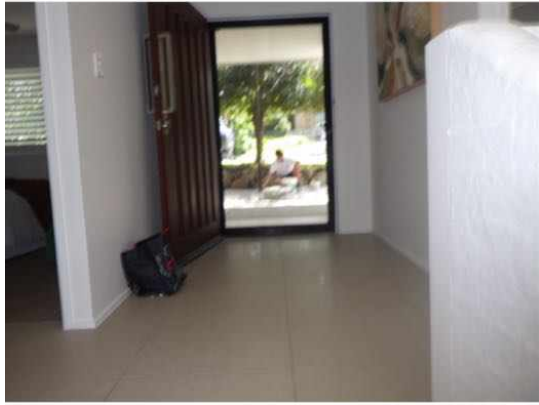
Building: Main Building
Location: Entry > Existing
Finding: No obvious defect
Information: No obvious defects found at the time of inspection.

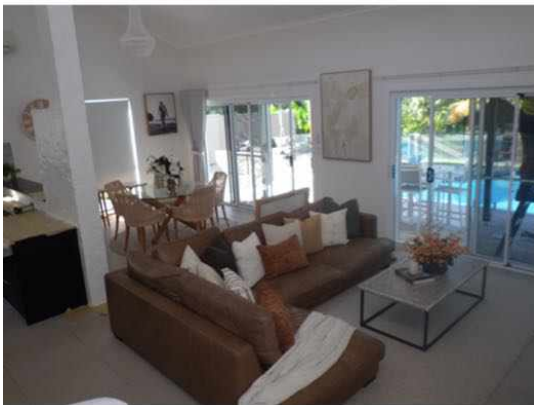
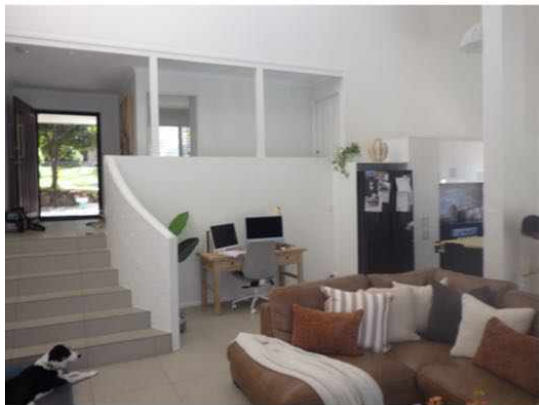
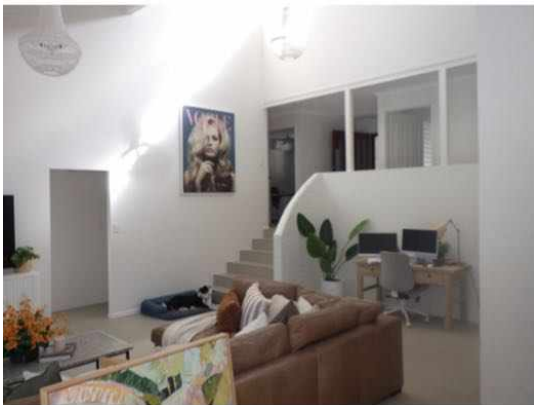
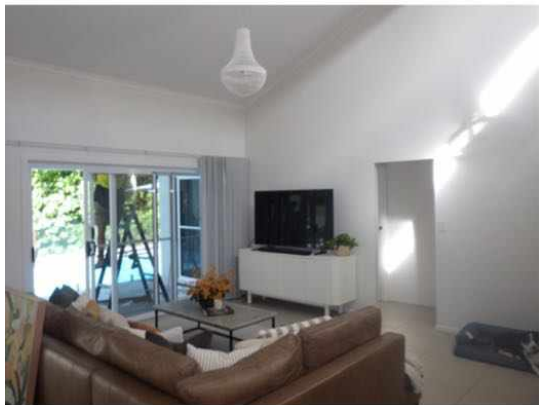
Building: Main Building
Location: Living Room > Existing
Finding: No obvious defect
Information: No obvious defects found at the time of inspection.

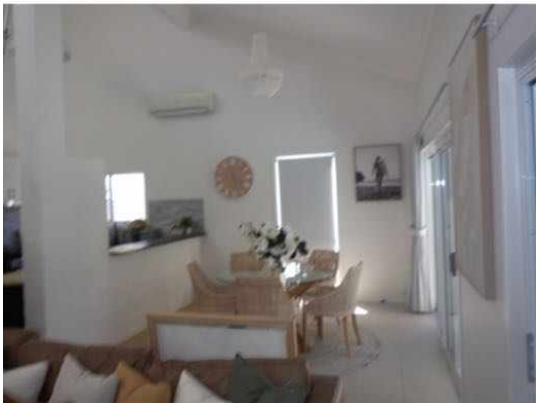
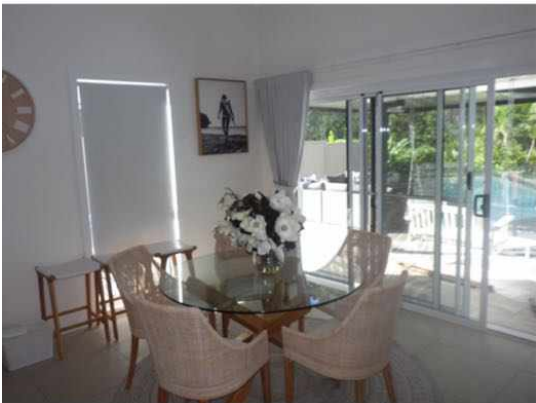
Building: Main Building
Location: Dining Room > Existing
Finding: No obvious defect

Information: No obvious defects found at the time of inspection.

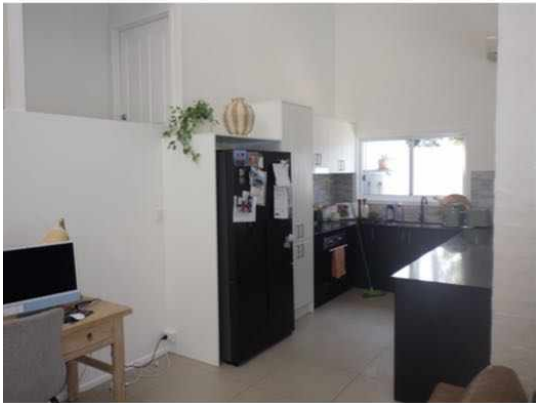
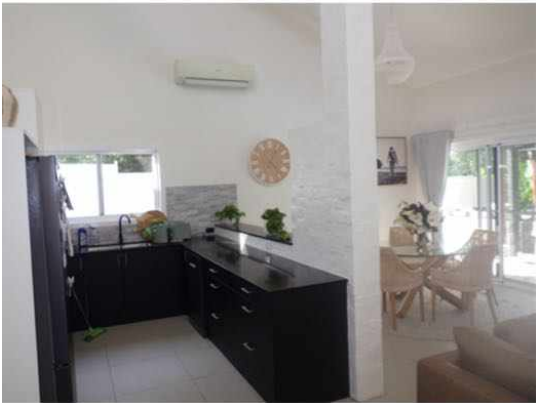
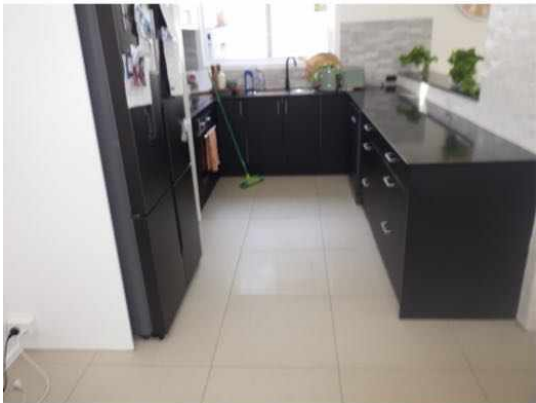
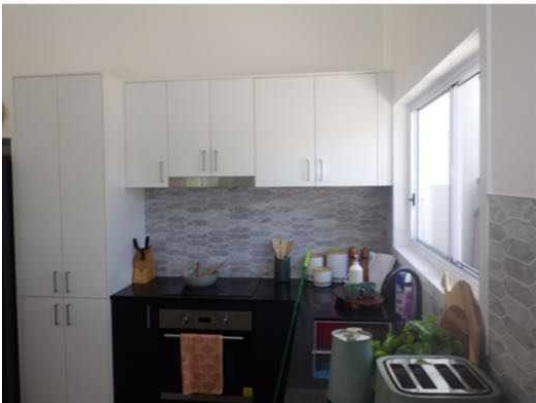
Building: Main Building
Location: Kitchen > Existing
Finding: No obvious defect
Information: No obvious defects found at the time of inspection.

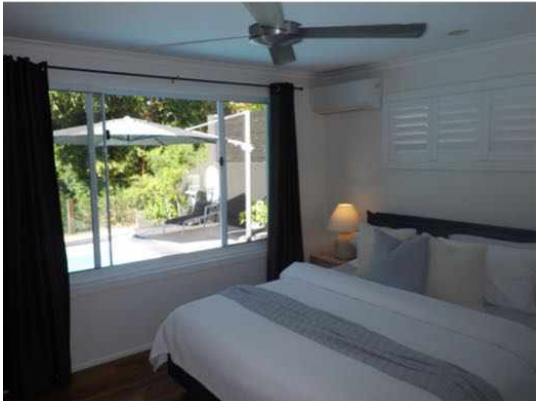
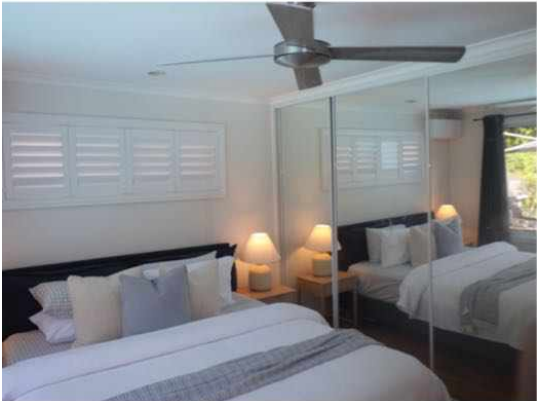
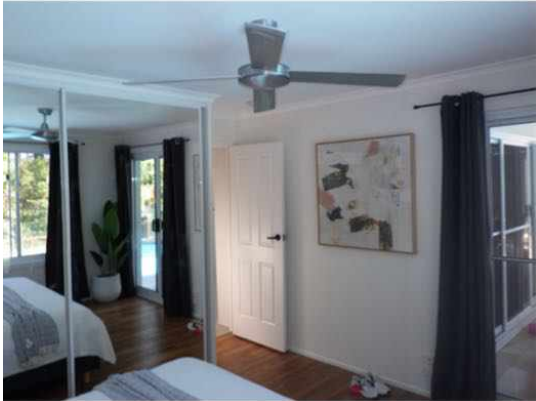
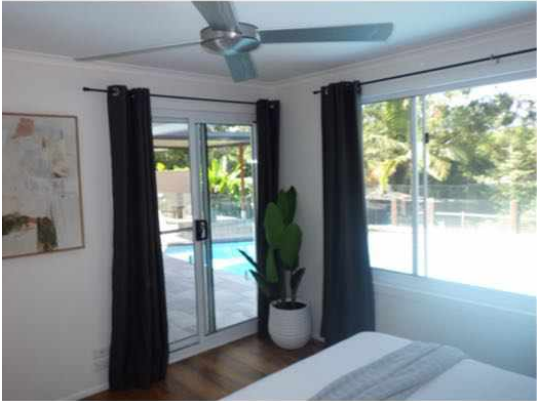
Location: Bedroom - Master > Existing
Finding: No obvious defect
Information: No obvious defects found at the time of inspection.

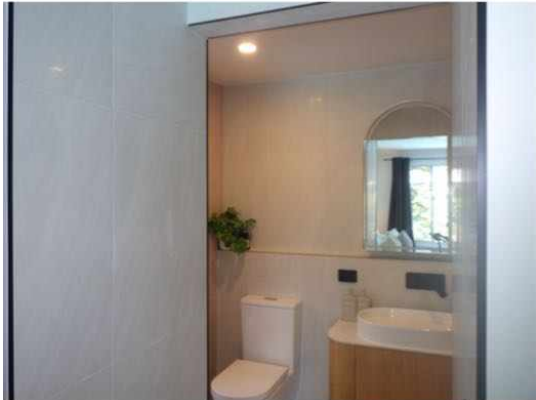
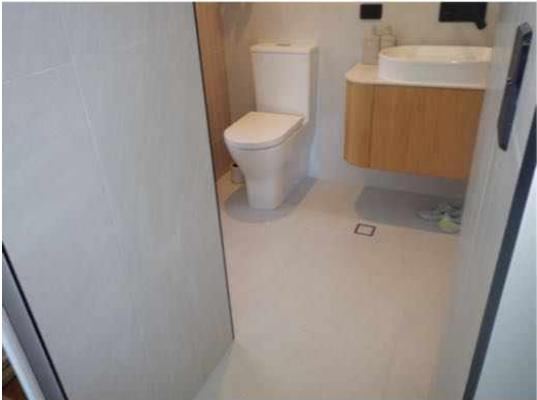
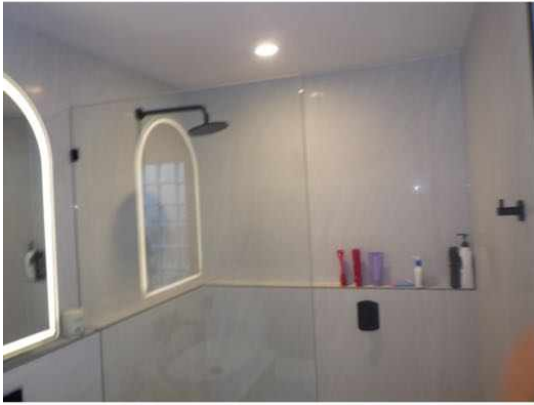
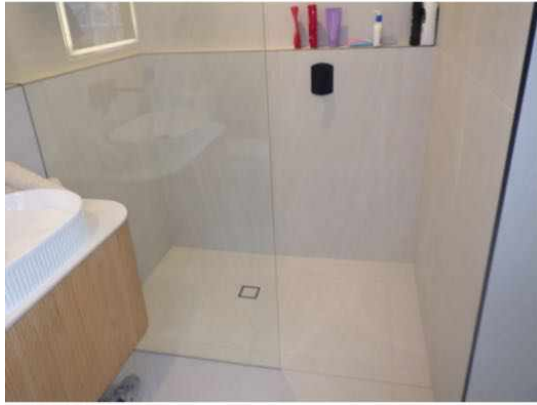
Building: Main Building
Location: Ensuite > Existing
Finding: No obvious defect
Information: No obvious defects found at the time of inspection.

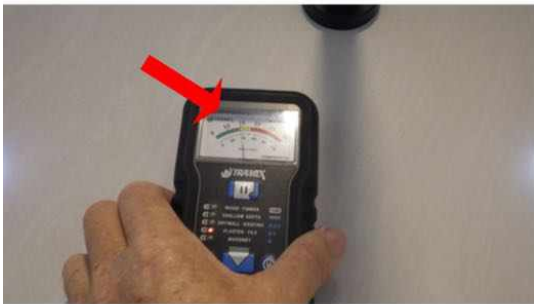
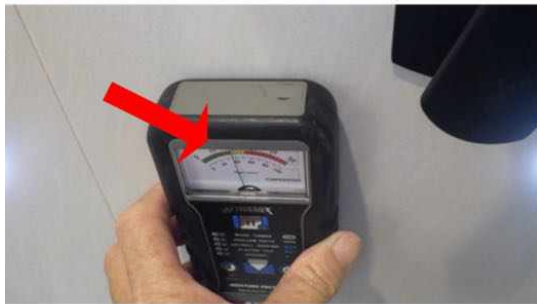
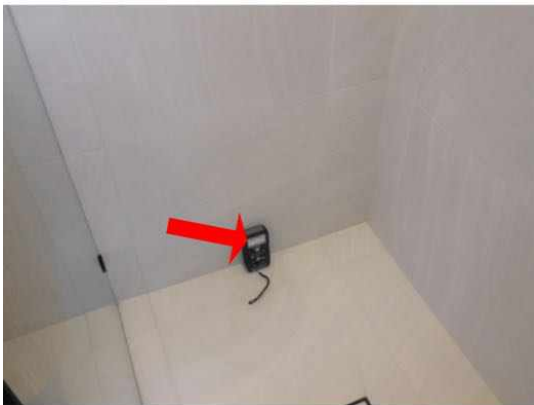
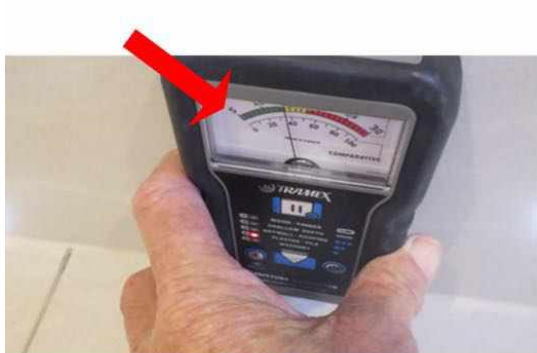
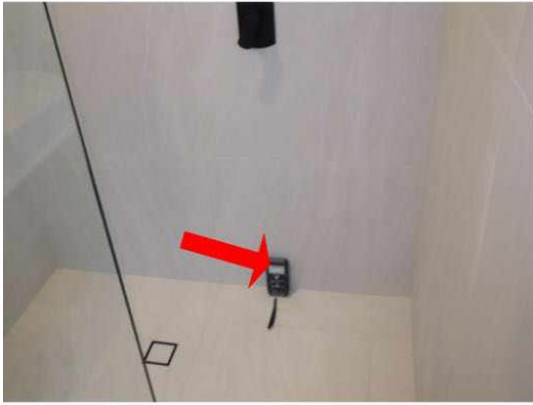
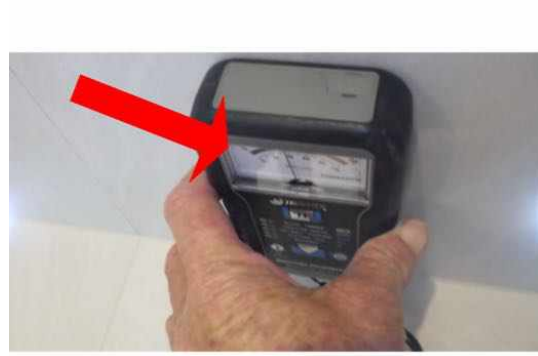
Building: Main Building
Location: Ensuite > Centre Right
Finding: Moisture Level Readings
Information: At the time of inspection the ensuite shower cubicle areas checked with the Tramex Moisture Meter returned low - normal moisture level readings.

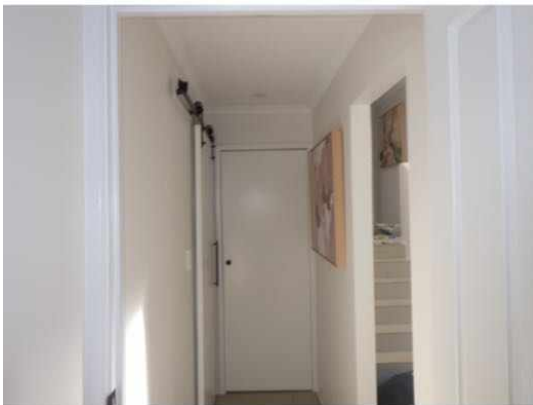
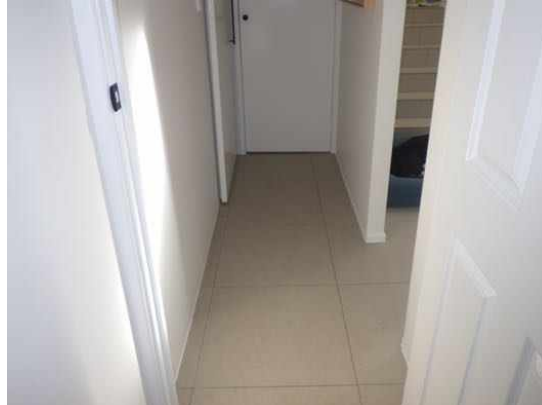
Building: Main Building
 Location: Hallway > Existing
 Finding: No obvious defect
 Information: No obvious defects found at the time of inspection.

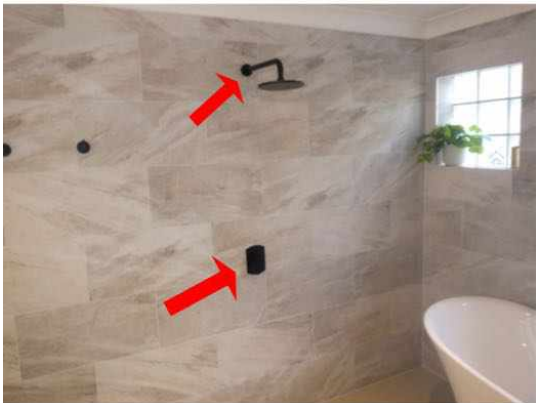
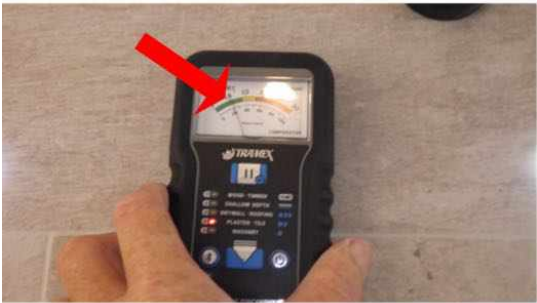
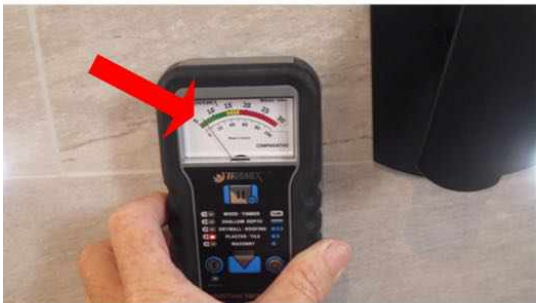
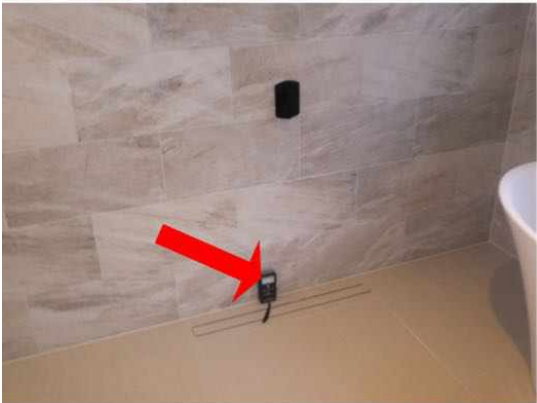
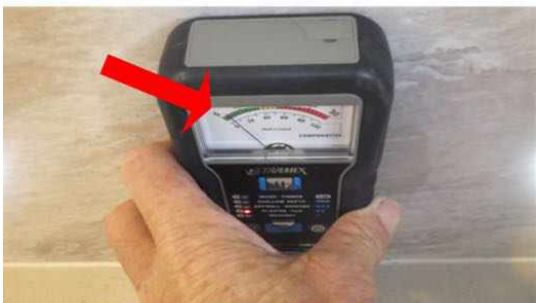
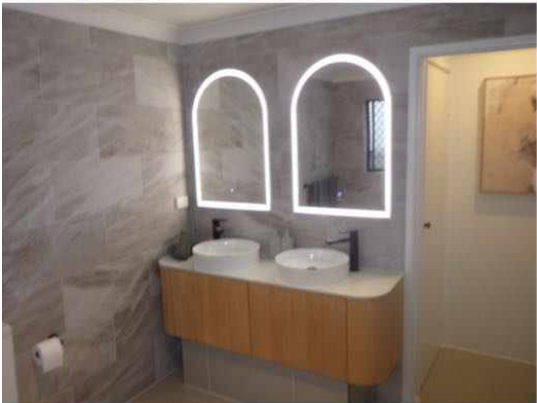
Building: Main Building
 Location: Bathroom > Centre Left
 Finding: Moisture Level Readings
 Information: At the time of inspection the bathroom shower areas checked with the Tramex Moisture Meter returned low - normal moisture level readings.

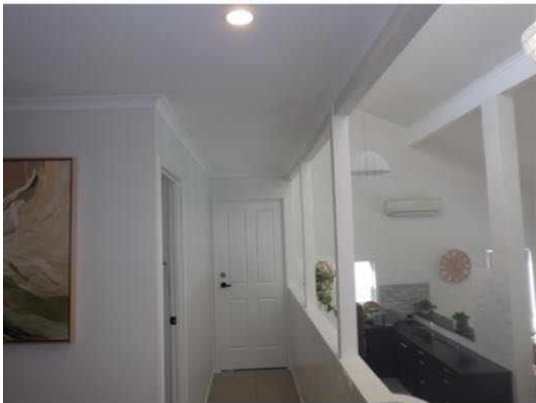
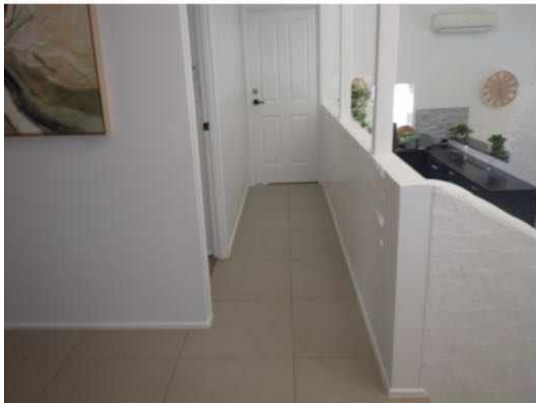
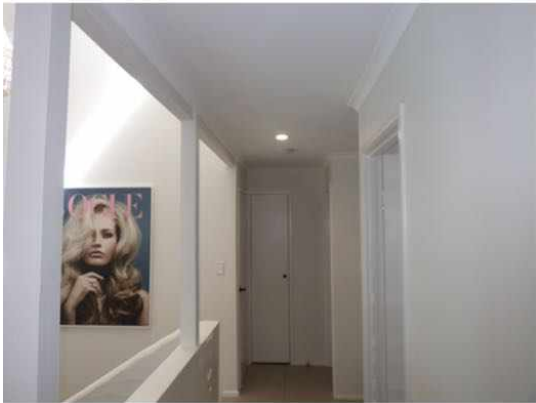
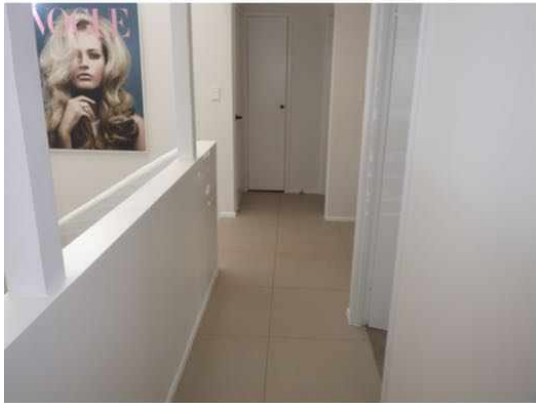
Building: Main Building
 Location: Hallway > Existing
 Finding: No obvious defect

Information: No obvious defects found at the time of inspection.

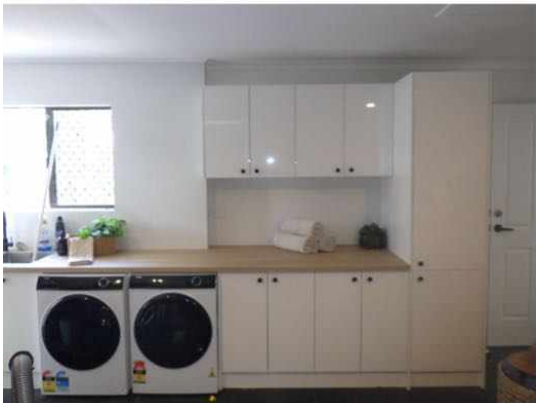
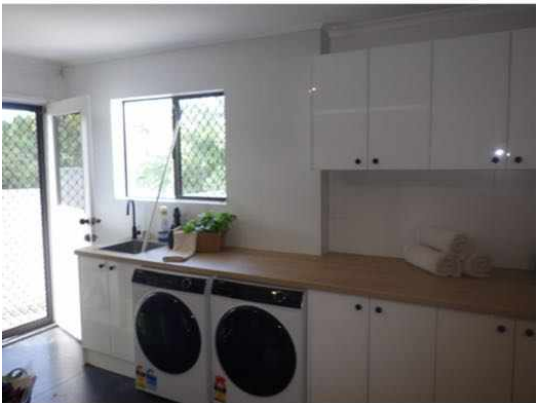
Building: Main Building
Location: Laundry > Existing
Finding: No obvious defect

Information: No obvious defects found at the time of inspection.

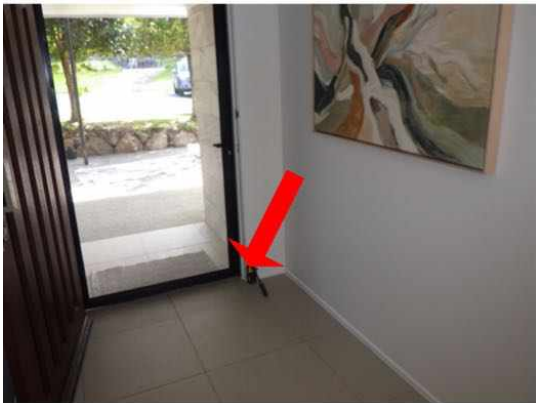
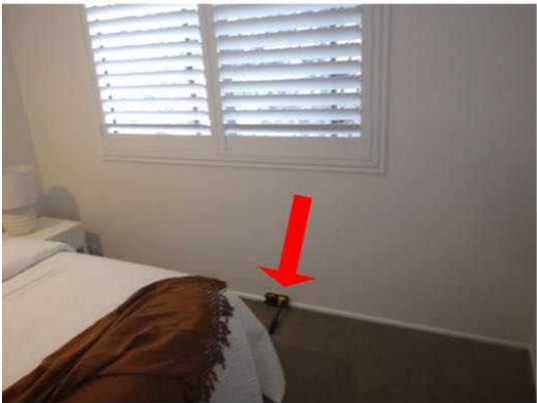
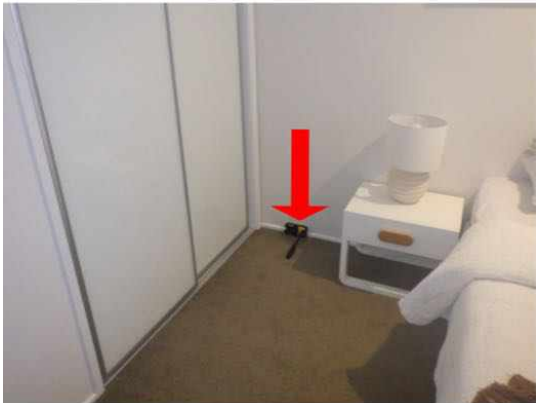
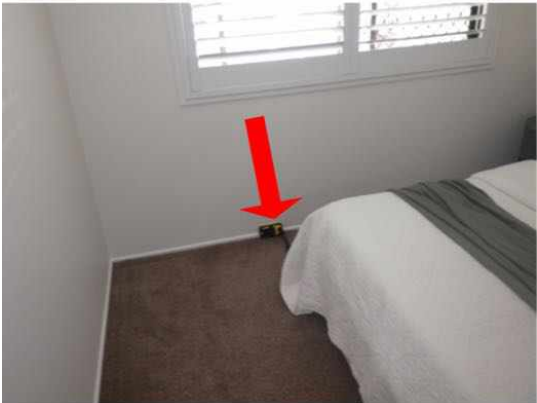
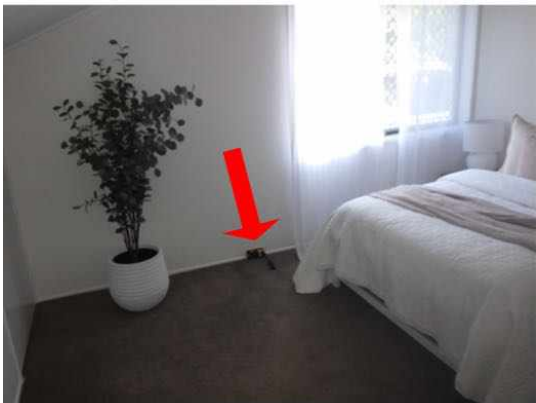
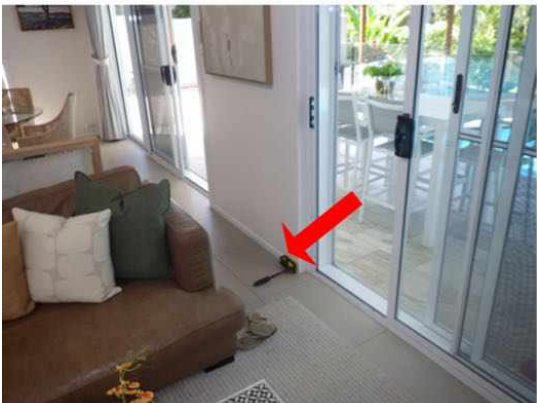
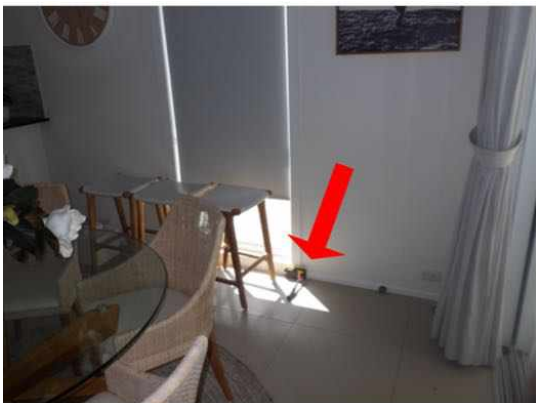
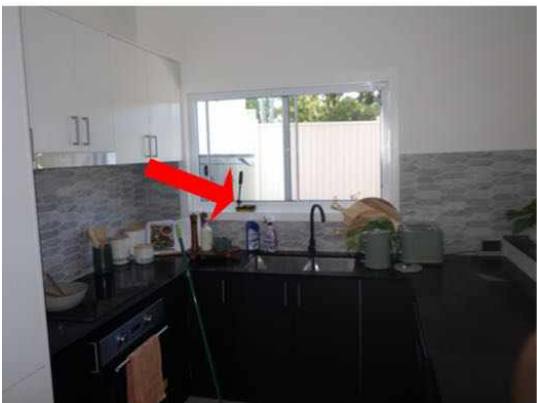
Building: Main Building
Location: Internal Areas > Existing
Finding: Termitracker
Information: The termitracker itracker was positioned randomly to internal wall, timber skirting and window frame areas checking for signs of termite activity.

No activity was recorded at the time of inspection.

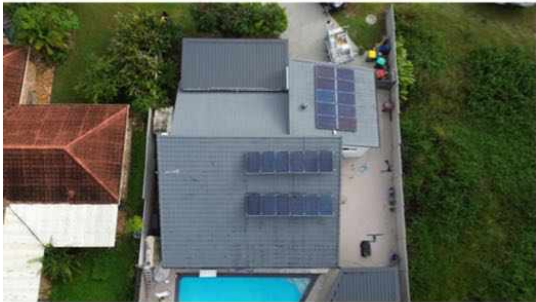
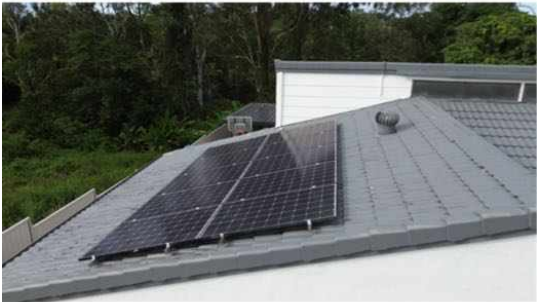
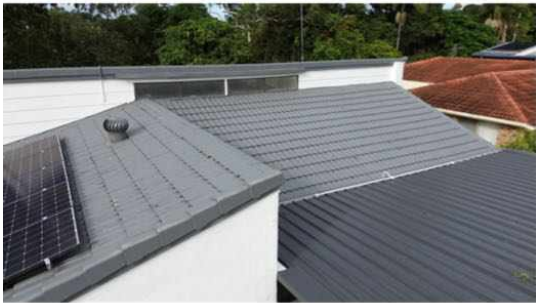
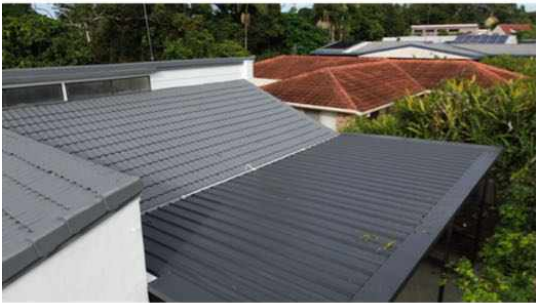
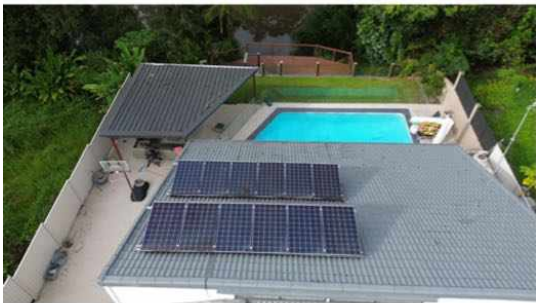
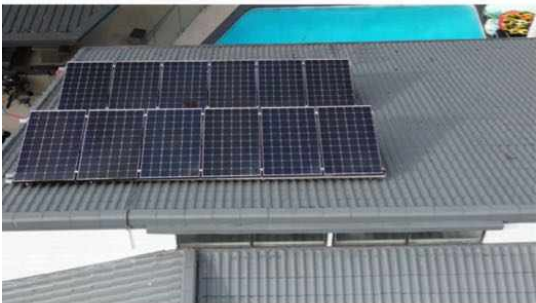
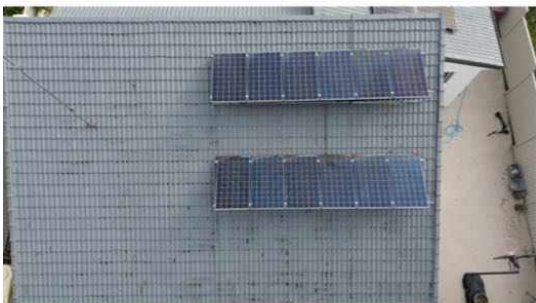
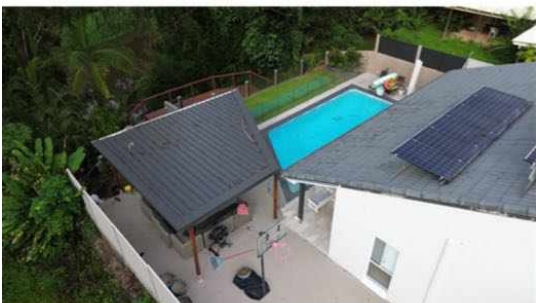
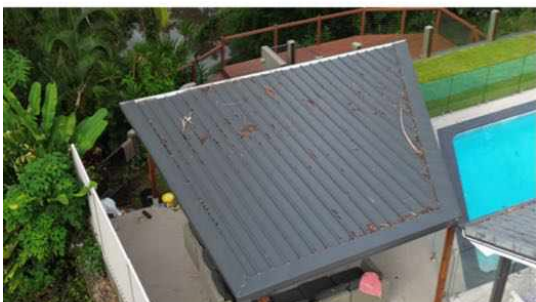
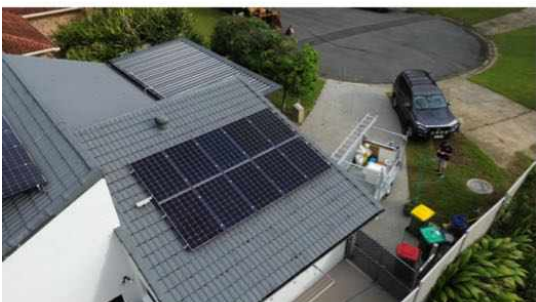
Building: Main Building
 Location: Roof Exterior > Existing
 Finding: Roof Photos
 Information: Roof area photos were taken with the DJI Mini 3 Drone flown over the roof at the time of inspection.
