Building and Timber Pest Inspection Report

Inspection Date: Mon, 23 Mar 2026

Property Address: 14 Cressy St, Goulburn NSW 2580,
Australia

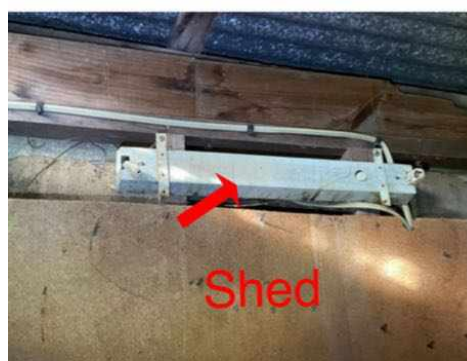
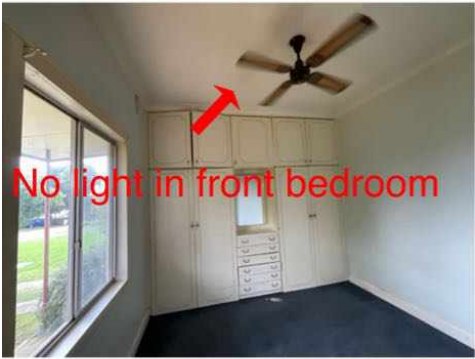
Building:	Building 1
Location:	Exterior walls - left side
Finding:	Light fittings - Damaged or missing
Information:	The light fitting in the driveway area were found to be damaged at the time of inspection creating a safety issue. The front left bedroom has no light and the garage light is missing a tube.

Left unmanaged, the driveway fitting is unlikely to cause further damage to surrounding building elements. However, the broken light fitting may expose electrical works, and may create a minor safety hazard if there is potential contact with persons in the area.

Repair and/or replacement of the damaged fitting is advised. A Licensed electrician should be appointed to repair/replace the light fitting at the client's discretion.

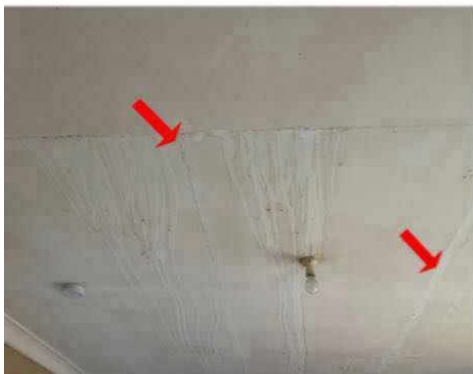
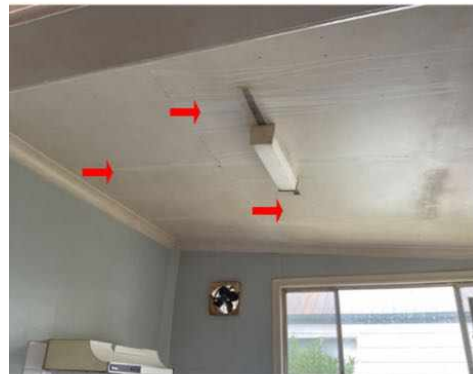
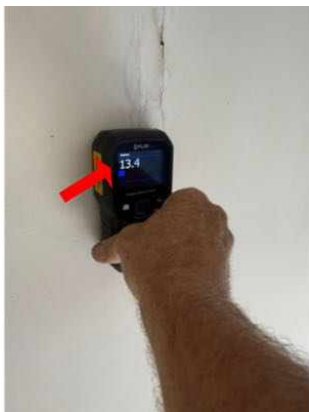
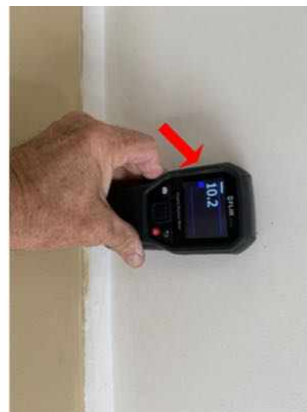
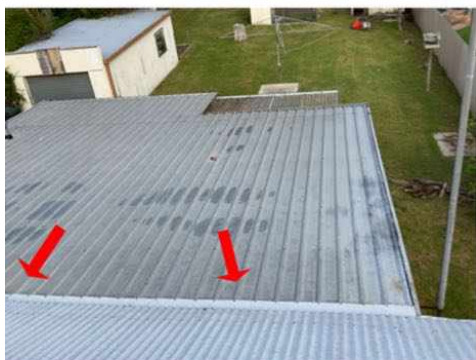
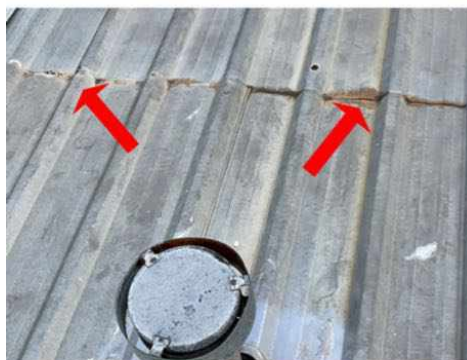
Building: Building 1
Location: Kitchen & lounge areas
Finding: Ceiling - Water stained
Information: Water staining to ceiling linings in these areas was evident at the time of inspection. Water staining indicates that surfaces have been exposed to excessive moisture over time. The minerals and other elements in the water lead to staining, which may graduate to corrosion and deterioration if left unmanaged.

While mostly an appearance defect, water staining can be indicative of more serious defects, which may be currently concealed by interior ceilings.

Minor moisture readings of up to 13.4 were recorded with rain falling in the previous 7 days.

Where water staining is active, a licensed plumber must be consulted to identify the cause of the staining and to provide advice on any reparation works that may be required. Replacement of any damaged structures is advised. It is suspected the join between the different sloping rooves requires sealing and 6 monthly inspection for further leaks.

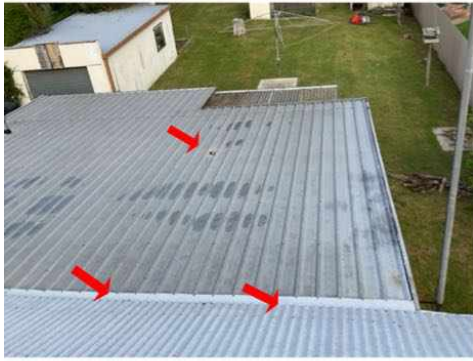
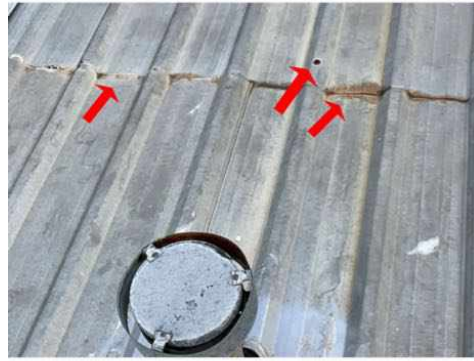
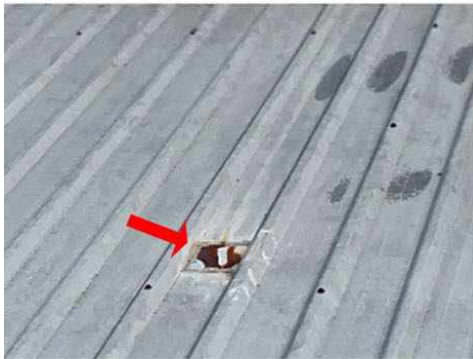
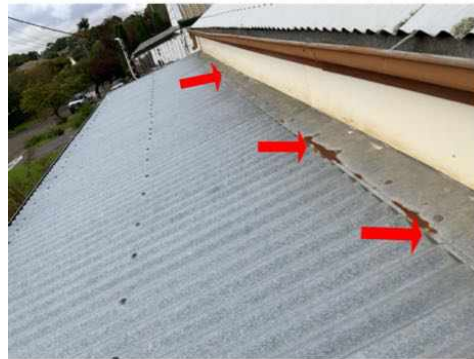
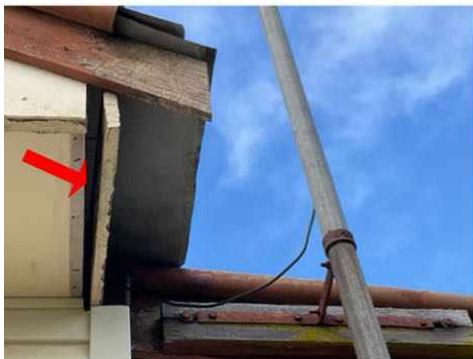
Finding 3.05

Building:	Building 1
Location:	Roof Exterior
Finding:	Roofing areas - Weathered
Information:	Upon inspection of the exterior roofing, the majority of the steep pitched front roof areas were considered to be in a good condition. While weathering of these rear pictured areas is consistent with the age of the property, maintenance works are required.

Re-sealing and replacing small areas of gaps, damage or rust the may be considered as an interim solution by the client to help preserve and extend the life span of these roofing areas, particularly where the steep roof and flat roof meet. Where left unmanaged, deteriorating roofing materials are likely to lead to a number of secondary defects, including minor water leaks and weather exposure to internal roofing structures.

Consultation with a roofing contractor is highly advised to gain advice on cost of remedial works, flashing and sarking in this rear area, that may be required in the short to medium term.

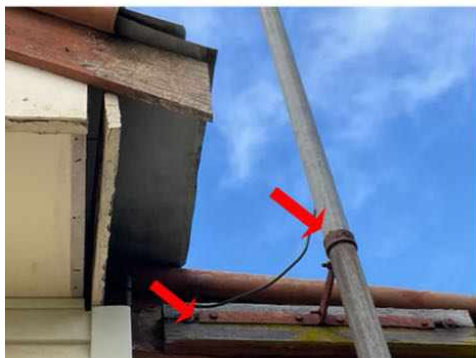
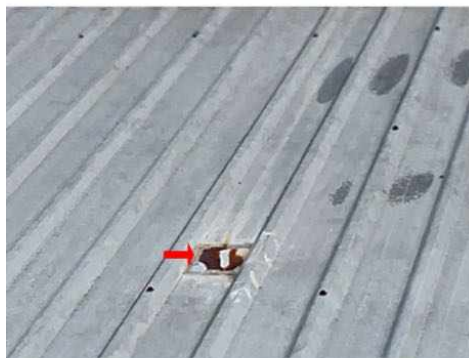
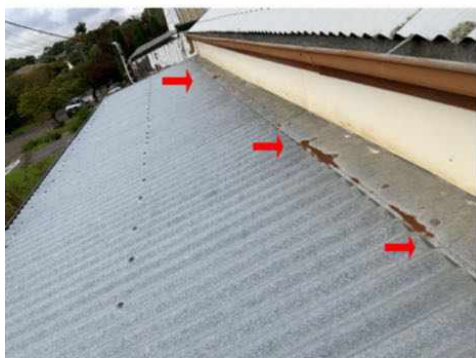
Finding 3.06

Building:	Building 1
Location:	Pictured Roof Areas
Finding:	Roof areas - Rusted or corroded
Information:	These roof areas shows evidence of rusting and corrosion, which is likely to have developed as a result of excessive exposure to moisture and or inadequate coatings.

As surface rust provides no protection to the underlying iron, the deteriorating condition is likely to worsen if not addressed in the short-term future.

Rusting and corrosion should be managed by ideally removing or limiting the affected surface from exposure to moisture. A registered builder may be appointed to replace any building elements that have been severely affected by rust or water damage.

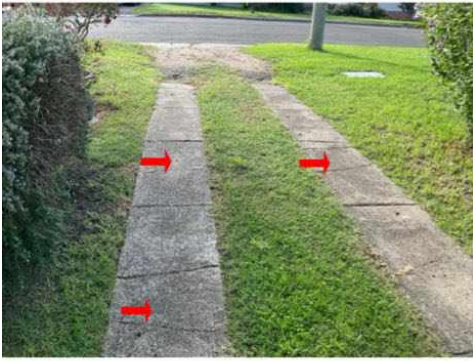
Finding 3.07

Building:	Building 1
Location:	Driveway
Finding:	Crack in concrete slabs - Category 1
Information:	Cracks coded as Category 1 was identified in these pictured slabs. A Category 1 crack is described as a fine but noticeable crack, with the slab at an otherwise reasonable level. To be considered Category 1, the approximate width of the crack is less than 1.0mm, or a less than 10mm change in offset when a 3m straight edge is placed over the defect.

Category 1 cracks should be monitored for a period of 12 months. At the end of the monitoring period, identified cracks that are rated greater than Category 2 are considered defects, and require rectification.

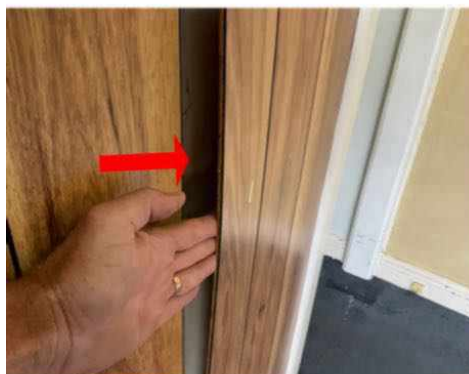
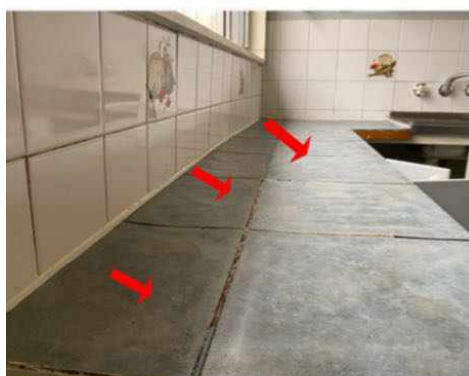
Finding 3.08

Building:	Building 1
Location:	Pictured external areas
Finding:	Building elements - Damaged
Information:	Evidence of minor missing or damaged areas was identified at the time of the inspection. These include -

1. The rear pergola roof is disintegrating and requires replacement.
2. The right rear eave shows minor sagging requiring refixing in place by a handyperson.
3. Some internal wall panelling is loose requiring a carpenter to refix this in place. It is suspected this is covering plaster cracking.
4. The kitchen bench is made of chipboard and is bowing, sagging and not level.

A carpenter would be the trade responsible for rectification of these areas when convenient.

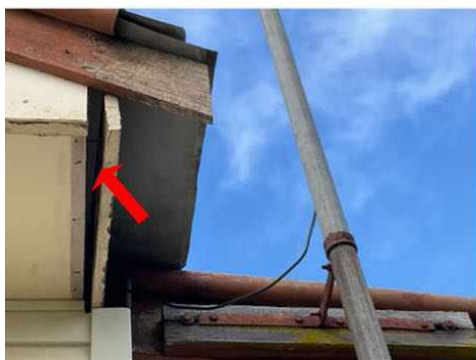
Finding 3.09

Building: Building 1
 Location: Pictured Right Area
 Finding: Sealant (external) - Missing.
 Information: It was noted on inspection that areas of external sealant was missing to one small areas of the external right middle wall.

Flexible sealants should be applied to these affected areas to prevent any subsequent water damage that is likely to occur.

A sealant specialist or skilled handy person should be appointed to complete these works as soon as possible

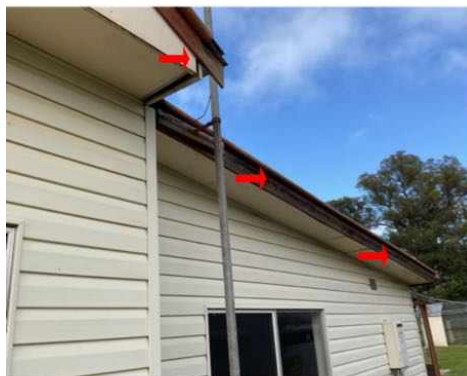
Building:	Building 1
Location:	Internal and external areas
Finding:	External painting deteriorated
Information:	Some of the external paintwork has been neglected and require attention to prepare and re-paint.

Whilst incomplete or missing paint finish is generally an appearance defect, it can also lead to the development of secondary building defects over time. Incomplete areas of paint finish expose the area to moisture, potentially accelerating the deterioration of underlying building materials.

A painting contractor should be appointed as soon as possible to perform necessary works to aid the appearance of the affected area and to ensure the area is protected

against further deterioration. Alternatively, the homeowner following manufacturer instructions may perform these works.

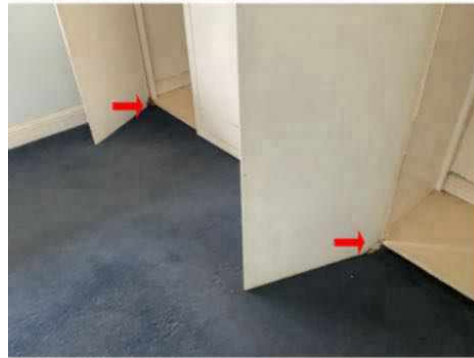
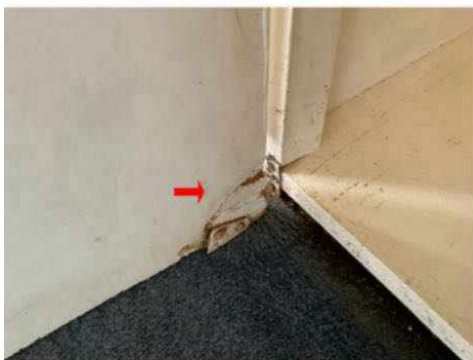
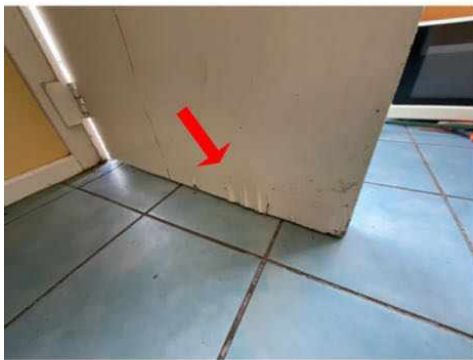
Finding 3.13

Building:	Building 1
Location:	Pictured Areas
Finding:	Doors - Binding and damaged
Information:	Binding and/or jamming of these doors is evident during standard operation. This defect inhibits the functionality of the affected doors as well as creating potential for secondary defects to associated building elements, such as damage to the floor covering or the adjoining door jamb. The rear door is delaminating and may need redo, a cement in a few years.

For minor causes, a qualified carpenter or general handyperson should be appointed

to perform minor rectification works at client discretion.

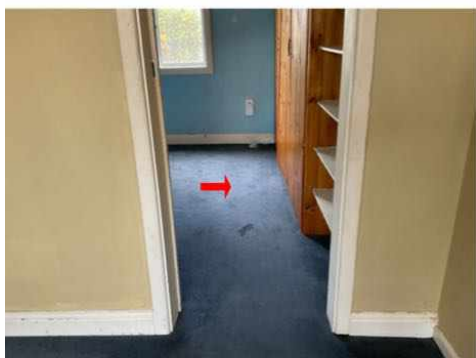
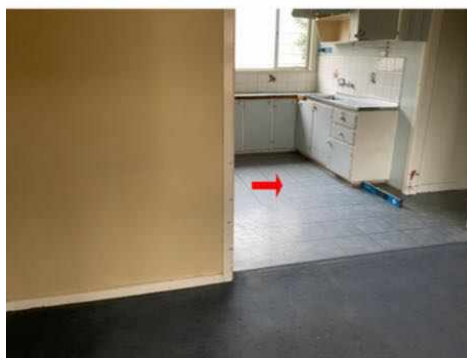
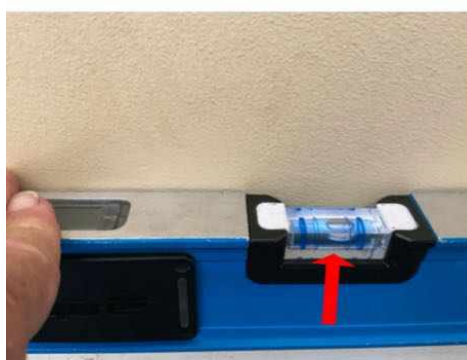
Finding 3.14

Building:	Building 1
Location:	Many Areas
Finding:	Flooring - Uneven
Information:	The internal flooring in some areas is out of level and uneven. Uneven flooring is likely to indicate minor defects such as expected movement of the foundations of the property, but may also indicate subsidence of the associated subfloor stumps.

However, where flooring is uneven further, potentially invasive inspection of the subfloor structures and stumps in this area is required. In this case, works to repair are likely to be required, and would be carried out by a registered builder specialising in re-stumping.

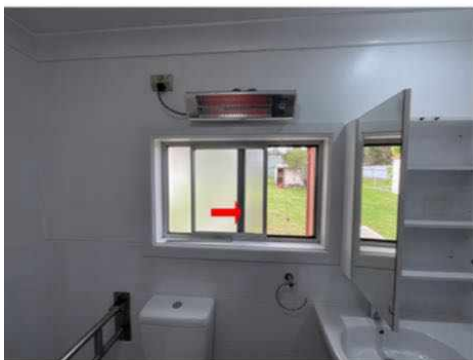
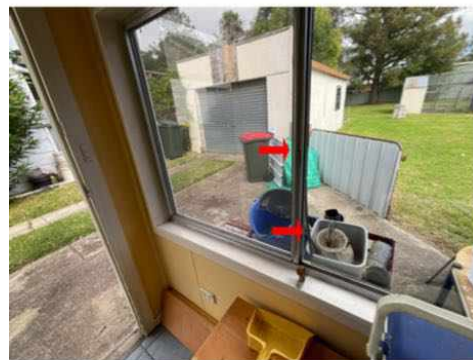
Finding 3.15

Building:	Building 1
Location:	Pictured Areas
Finding:	Windows - Stiff to slide and rear window areas damaged.
Information:	The windows in these areas were jammed and difficult to operate at the time of the inspection. Some sills are not level. Windows provide ventilation to the adjoining area and should be at a fully operational level to ensure comfort. The rear window has a damaged latch and window seal.

Replacement of window hardware or frame may be required, as well as minor repairs and cleaning. A registered builder or general handy person will be required to repair

the window.

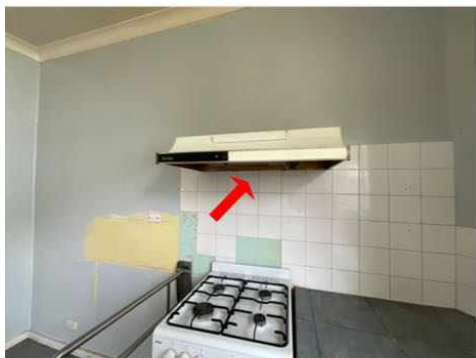
Finding 3.16

Building: Building 1
 Location: Kitchen
 Finding: Rangehood - Light not working
 Information: While the range hood appears to be working at a satisfactory level, the light to the appliance was not working at the time of inspection.

A licensed electrician should be appointed to replace the light on the range hood to restore it to a fully operational state.

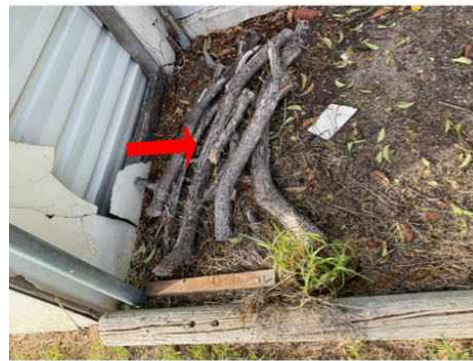
Finding 6.02

Removal of all waste timber that is in direct contact with ground is highly advised. This timber is promoting mould and wood rot and is very attractive to termites.

Frequent pest inspections are advised to readily identify any termite activity in these areas.

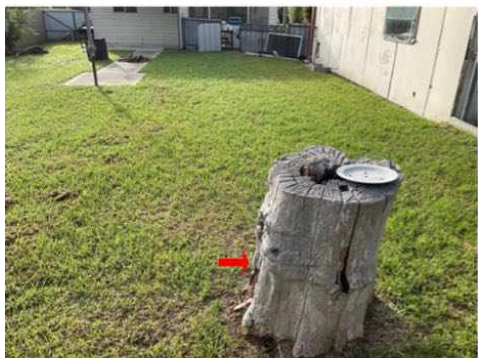
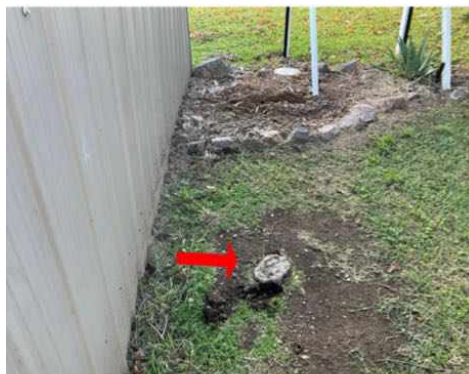
Finding 6.03

Building: Building 1
 Location: Many yard areas
 Finding: Tree stumps - left in ground
 Information: Tree stumps left in ground provide opportunity for termite attack as they are likely to be subject to rot and decay providing an attractive food source. Treatment and/or Removal of the stumps is highly recommended. A pest controller and tree removalist should be engaged to perform such works.

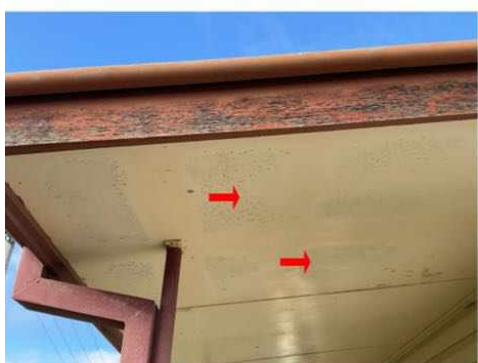
Finding 6.04

Building: Building 1
 Location: Verandah eaves
 Finding: Mould - Present
 Information: Where evidence of mould growth was noted, there may be environmental, biological or health issues associated with the report. A specialist inspection by a suitably qualified environmental health inspector is warranted, where mould is extensive or where any queries regarding air quality spores or other related issues apply.

Generally, the client is advised to ensure that the general environment is free of moisture and humidity to aid in the prevention of mould formation and development. Any mould found during the inspection should be cleaned immediately by a cleaning contractor or the homeowner as applicable.

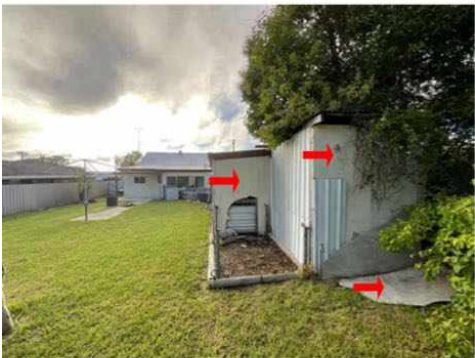
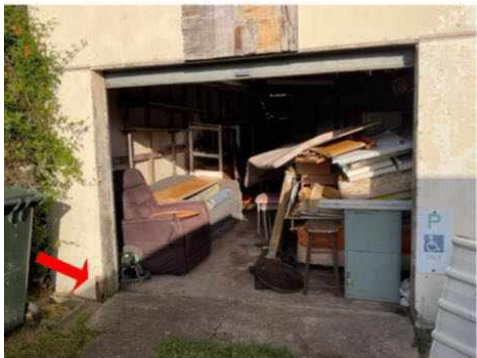
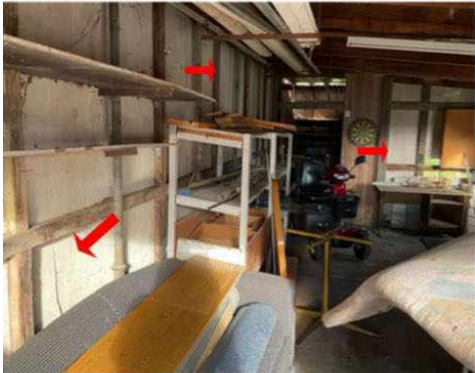
Building: Building 2
Location: Many shed areas
Finding: Asbestos - Suspected ACM Identified on Site and damaged cladding
Information: Reporting on Asbestos is outside the Scope of this Report. This suspected defect is highlighted as a caution only. We suspect, based on our experience in the building industry, that there is a higher risk of the shed walls containing asbestos.

As Asbestos Reporting is outside the scope of this report, we advise that you consider a separate Asbestos Inspection and Condition Audit, which can include the taking of samples for definitive confirmation of the presence of Asbestos.

In the interim, the client is advised to act with caution, especially when considering any damage to building materials general wear and tear renovations extensions demolition and general maintenance activities due to the suspected presence of Asbestos.

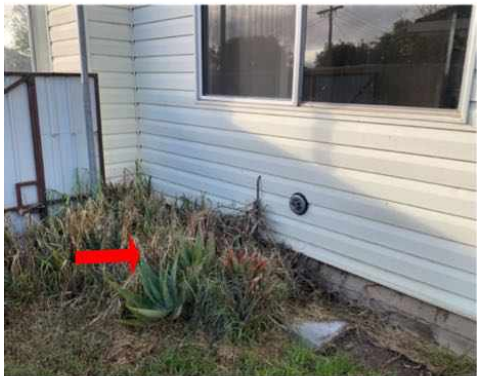
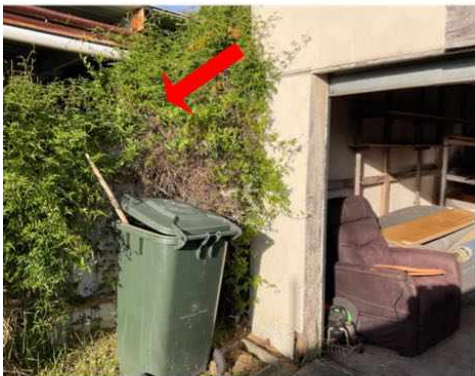
Building: Building 1
 Location: All External Areas
 Finding: Additional Photos - Obstructions and Limitations of EXTERNAL AREAS
 Information: These photographs are an indication of the obstructions and limitations which impeded full inspection of external areas at the time of inspection. These obstructions can hide an array of defects and should be removed to allow full inspection to be carried out. A re-inspection is recommended once the areas are made accessible.

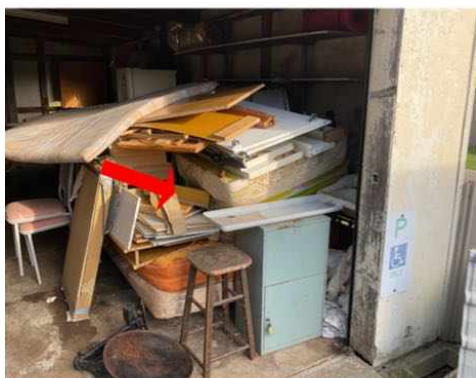
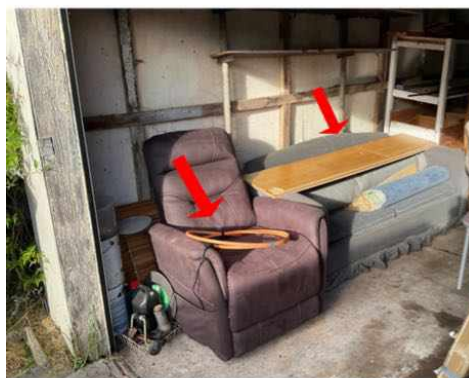
Building: Building 1
 Location: All Internal Areas
 Finding: Additional Photos - Obstructions and Limitations of INTERNAL AREAS
 Information: These photographs are an indication of the obstructions and limitations which impeded full inspection of Internal areas at the time of inspection. These obstructions can hide an array of defects and should be removed to allow full inspection to be carried out. A re-inspection is recommended once the areas are made accessible.

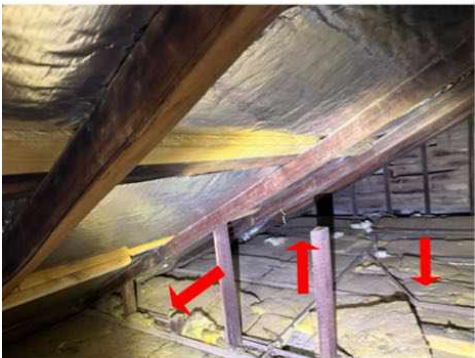
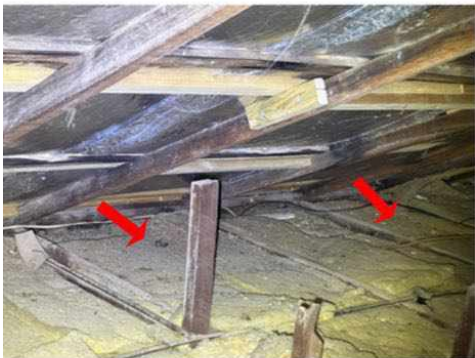
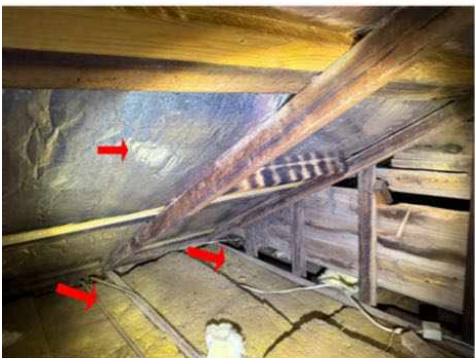
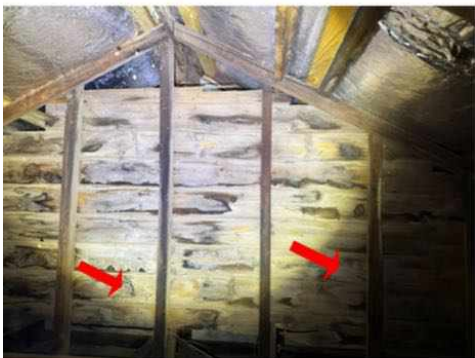
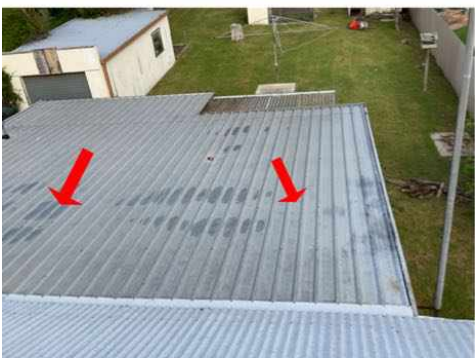
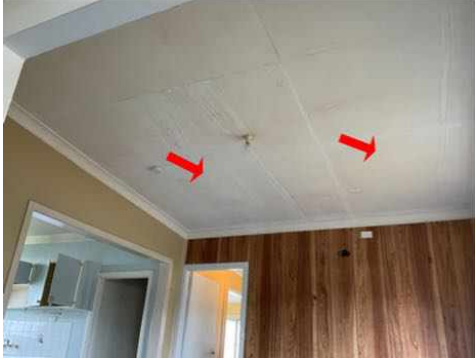
Building: Building 1
 Location: All Roof cavity areas
 Finding: Additional Photos - Obstructions and Limitations of the ROOF CAVITY / FLAT ROOF AREAS
 Information: These photographs are an indication of the obstructions and limitations which impeded full inspection of roof cavity areas at the time of inspection. These obstructions can hide an array of defects and should be removed to allow full inspection to be carried out if applicable. A re-inspection is recommended once the areas are made accessible.

The inspection was also limited to areas with an allowable crawl space of 600mm x 600mm, in particular towards the external walls where the roof line diminishes, these areas were not accessible.
