Building and Timber Pest Inspection Report

Inspection Date: Fri, 20 Mar 2026

Property Address: 64 Rangeview Dr, Skye VIC 3977, Australia

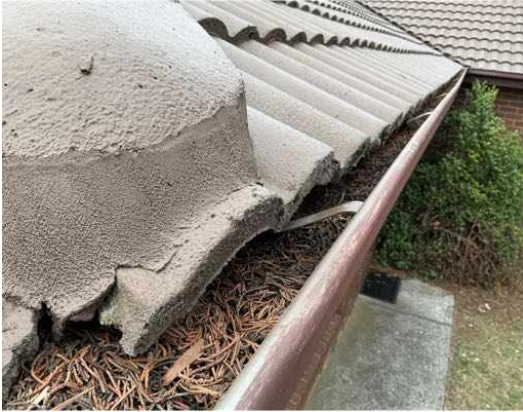
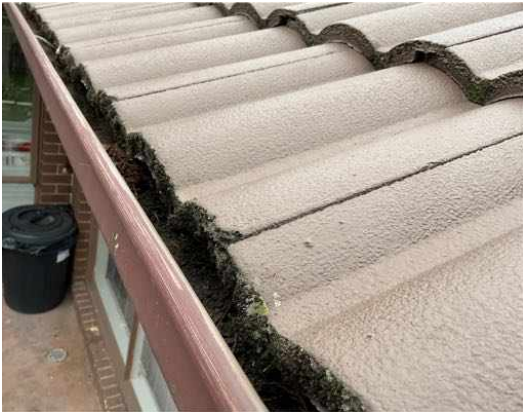
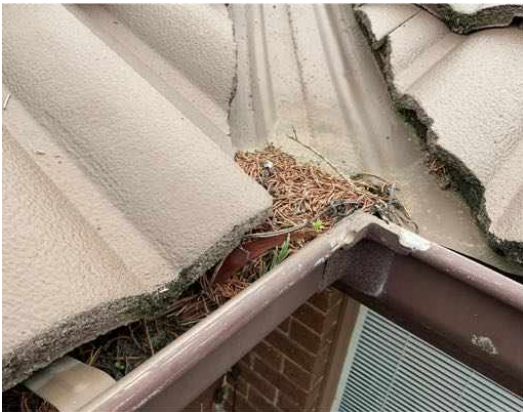
Finding 3.02

Building:	Main Building
Location:	Roof Exterior
Finding:	Roof tile - Broken
Information:	Upon inspection of the exterior roof covering, a broken roofing tile was identified. Broken tiles are generally the result of ageing and weathering of what is essentially a porous material.

If left to further deteriorate, broken and brittle roof tiles are likely to lead to water penetration via the roof into the ceiling space, causing excessive moisture and secondary damage to ceiling linings, insulation and roof structures. Broken roof tiles are also likely to detract from the effectiveness of the roof drainage system, creating potential for secondary damage to the exterior roof covering and roof plumbing. Excessive moisture could attract termites.

Replacement of broken tiles is required and should be performed by a roofing contractor as soon as possible.

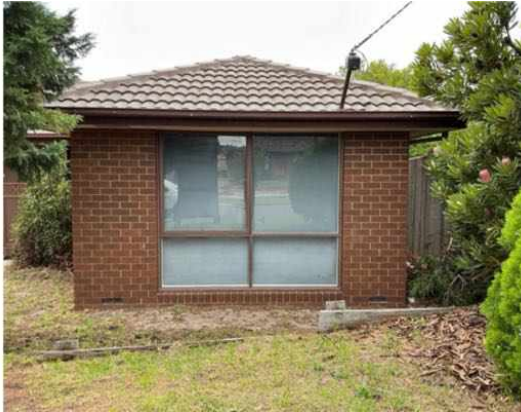
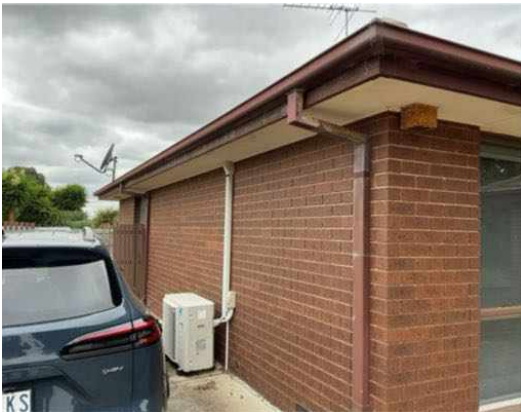
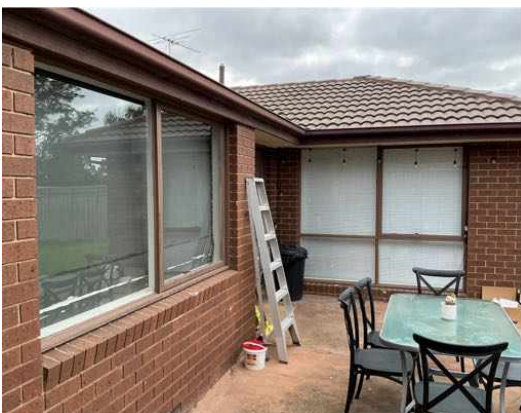
Finding 3.07

Building: Main Building
Location: Various parts of the building
Finding: A few gaps to the exterior walls/windows
Information: A few gaps were noticed to some of the exterior walls/windows to the building. These gaps can let in water, drafts, and pests. Overtime moisture ingress may cause damage to internal walls, mould growth, or structural issues. Gaps also reduce the energy efficiency of the property. Recommend engaging a caulker to seal gaps with an exterior grade flexible sealant that is UV and weather resistant to reduce the risk of pest/water penetration to the building as soon as possible.

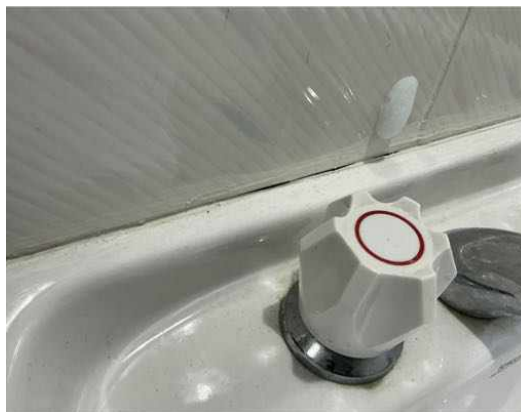
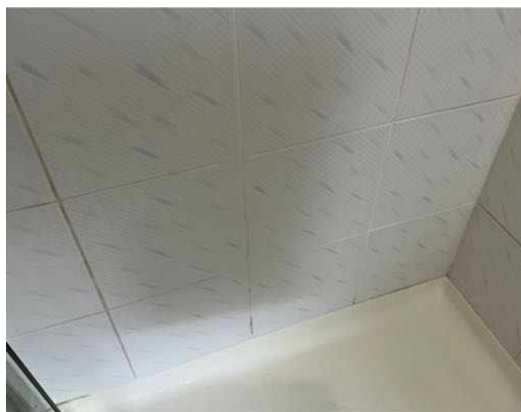
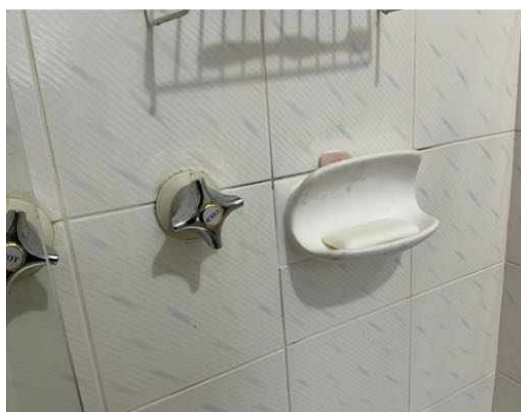
Finding 3.11

Building: Main Building
 Location: Bathroom
 Finding: Bathroom Sealant and grouting - Missing or damaged
 Information: It was noted on inspection that sealant or grout is degraded to the tiled shower alcove and or other areas of the bathroom.

Different materials and floor areas move at different rates, generally causing cracking to grout or sealant at this point. A flexible sealant is required to allow for expected expansion and contraction, while keeping the joint water tight and protective of all associated building materials.

Flexible and mould resistant materials should be applied to affected areas to prevent any subsequent water damage that is likely to occur. Regular maintenance and replacement of damage or missing or damaged sealant and grout is highly recommended to the wet areas, as this is a regular wear and tear defect. Sealant and grouting in areas that come into regular contact with water should be maintained for the long term care of your property.

A sealant specialist or tiling contractor should be appointed to complete these works as soon as possible

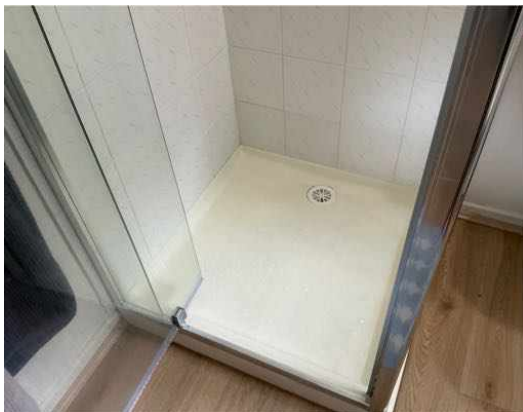
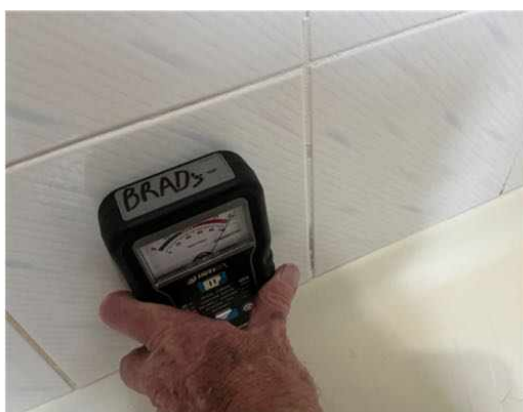
Finding 6.04

Building: Main Building
Location: Bathroom

Information: Damp is evident to parts of the bathroom shower alcove found using using a moisture meter. This defect is quite common, and is suspected to have been caused by moisture permeating through the grouting in this area, which shows evidence of deterioration creating moist conditions. Leaking pipes within the adjoining wall is also a possible cause. Excessive moisture can attract termites.

Damp (or structural damp) refers to the presence of unwanted moisture in the structure of a building, either as the result of intrusion from outside, or condensation from within the structure. In the shower area, internal water leaks or other sources of excessive moisture are generally the cause of damp.

Unmanaged damp in the shower recess is likely to facilitate the formation and development of mould and fungi growth, decaying associated building materials and compromising their structural integrity. It is important to address damp conditions, as the World Health Organisation notes that excess moisture leads - on almost all indoor materials - to growth of microbes such as moulds, fungi and bacteria, which subsequently emit spores and other matter into the indoor air. Exposure to these contaminants is associated with a wide range of respiratory and other health-related problems.

Consultation with a qualified plumber or bathroom specialist is advised immediately to identify the cause of damp and to perform remedial works as required. Where excessive mould growth is present, further inspection by a specialist environmental health inspector should also be considered.

Always ensure that sealant and grout is in good condition to prevent any moisture issues occurring in the future.

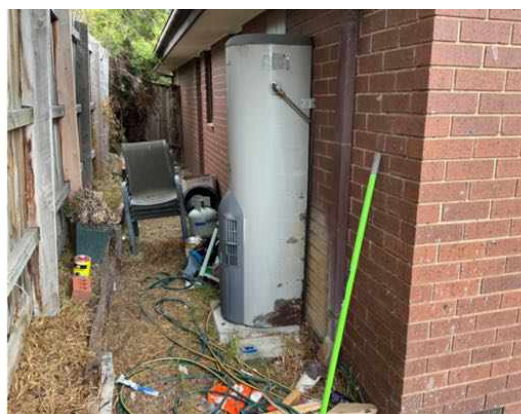
Finding 6.07

Building:	Main Building
Location:	Various parts of the building
Finding:	Bridging attachments to buildings
Information:	Bridging occurs when items against a building provide a concealed entry point for termites into the building or by passing around a termite management system.

Where any part of an attachment to a building is not isolated and is not provided with a clear gap of not less than 25mm from building, bridging occurs. Attachments to buildings such as hot water services, downpipes, verandahs, decks, steps, fences, service conduits and the like provide the opportunity for concealed entry.

Building attachments of this nature need to be frequently inspected for termite activity by a qualified inspector.

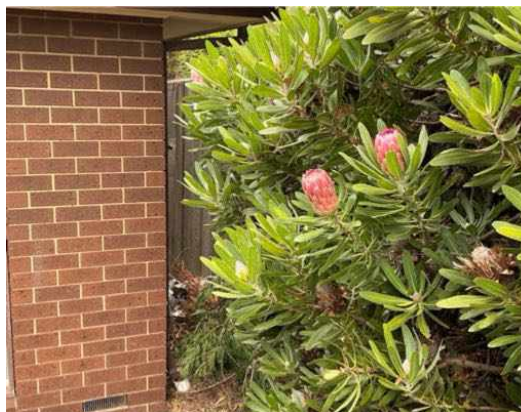
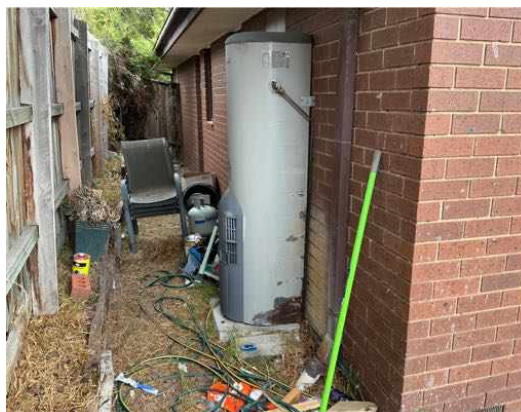
Finding 6.08

Building:	Main Building
Location:	Various parts of the building
Finding:	In ground contact
Information:	<p>Any timbers in direct ground contact provide opportunity for concealed termite entry and are likely to be subject to premature rot and decay as the soil retains moisture or damp conditions against the timbers.</p> <p>Remove untreated timber that is in direct contact with external grounds. Consider replacement with more durable materials i.e. treated timber or non timber elements. Frequent pest inspections are advised to readily identify any termite activity in these areas.</p>

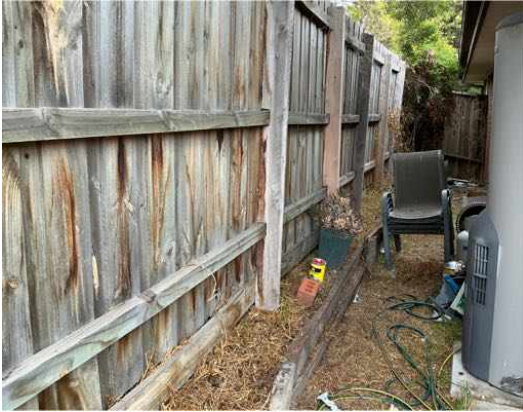
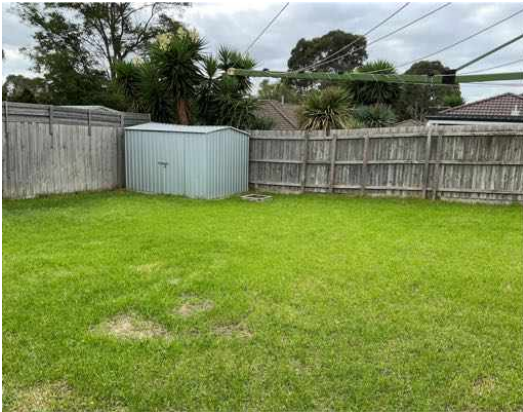
Finding 6.09

Building:	Main Building
Location:	Yard - Front
Finding:	Garden Beds Conditions Conducive to Termites
Information:	Garden beds were found to be evident in close proximity to the building. Garden beds immediately adjacent to the perimeter of the building block the visual inspection of these areas, providing a concealed termite entry point.

These garden beds can include untreated timber, and with a combination of moisture from watering hosing can make conditions conducive to termite activity and termite ingress.

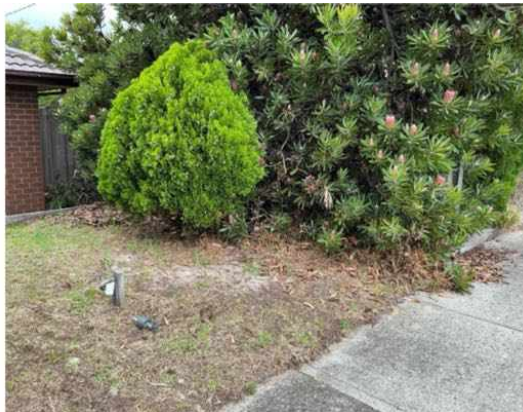
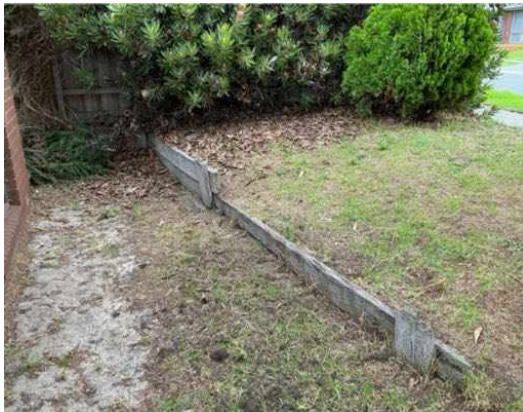
Finding: Fencing and retaining walls - wood rot-fungal decay

Information: It was noted at the time of inspection that sections of the fencing and retaining walls to the property have deteriorated and have fungal decay/wood rot present. Typically fencing deteriorates due to age and or wear, rot and or rust which is generally expected for a structure of this age, due to prolonged exposure to weather conditions. Sometimes inadequate installation or maintenance can be to blame.

If left unattended, it is likely that further damage will occur. It is suspected that repair of several elements of the fencing may be required however replacement may be a consideration of the client also.

A licensed fencing contractor should be appointed to provide further advice and perform rectification works as necessary.

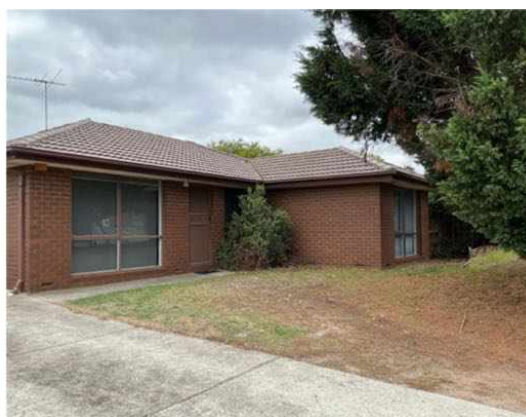
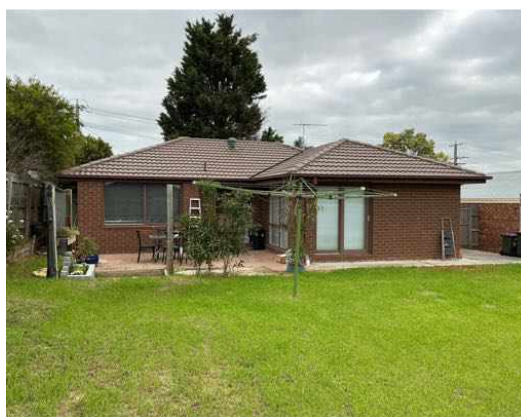
Building: Main Building
Location: All External Areas
Finding: Additional Photos - Obstructions and Limitations
Information: These photographs are an indication of the obstructions and limitations which impeded full inspection of the property at the time of inspection. These obstructions can hide an array of defects and should be removed to allow full inspection to be carried out. A re-inspection is recommended once the areas are made accessible.

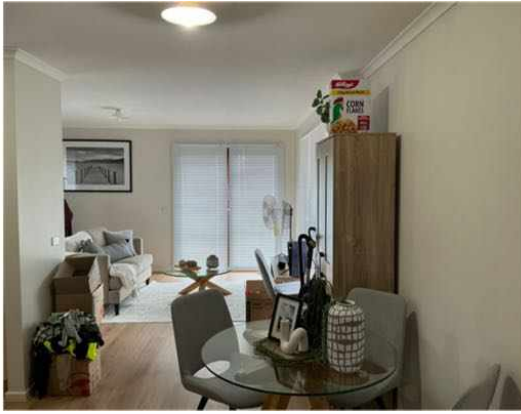
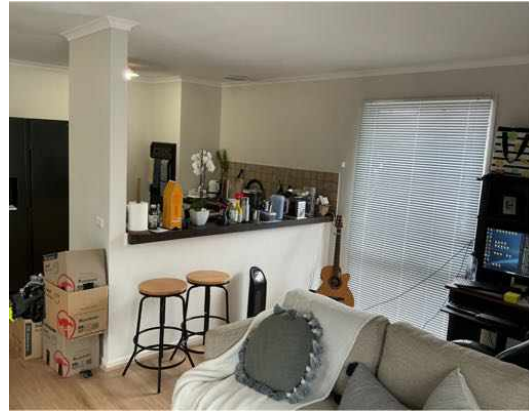
Building: Main Building
Location: All Internal Areas
Finding: Additional Photos - Obstructions and Limitations
Information: These photographs are an indication of the obstructions and limitations which impeded full inspection of the property at the time of inspection. These obstructions can hide an array of defects and should be removed to allow full inspection to be carried out. A re-inspection is recommended once the areas are made accessible.

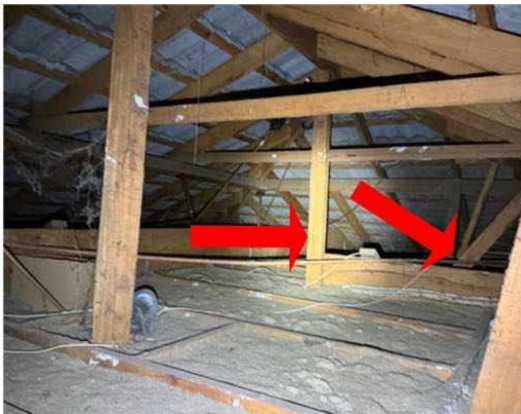
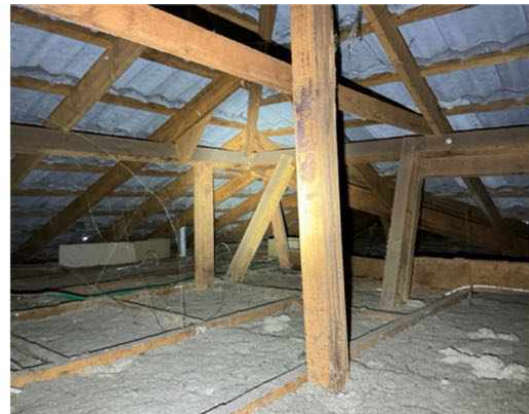
Finding: Obstructions and Limitations -roof cavity

Information: These photographs are an indication of the obstructions and limitations which impeded full inspection of the roof cavity at the time of inspection. These obstructions can hide an array of defects and should be removed to allow full inspection to be carried out. A re-inspection is recommended once the areas are made accessible.
