Building Inspection Report

Inspection Date: Fri, 20 Mar 2026

Property Address: 3/1 Merrilong St, Ringwood East VIC 3135,
Australia

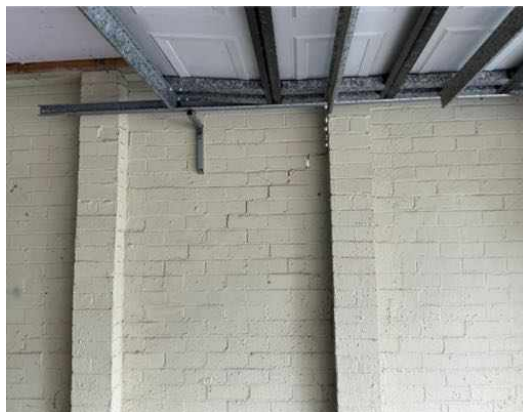
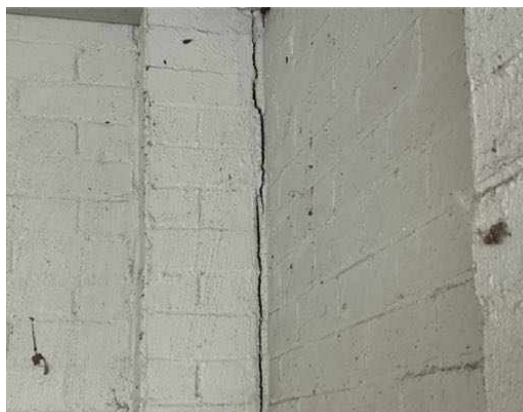
Defects 2.01

Building: Garage
Location: Garage
Finding: Brickwork - Step cracking
Information: Step cracking was identified to the brickwork in this area at the time of inspection. Step cracking, which is similar to other forms of cracking, has a variety of possible causes. However, the most common is the subsidence of adjacent footings.

Step cracking is a relatively common defect, and is most likely to occur adjacent to windows, doors and other openings. Mortar failure in the gaps between affected bricks indicates the stresses and tensions affecting the wall.

Where step cracking is extensive or severe, the client is advised to consult a structural engineer. Minor step cracking can be used as a warning sign to address factors causing stress to the wall, which can include the effect of surrounding trees, water leaks, soil erosion, or even the presence of reactive soils in the surrounding area.

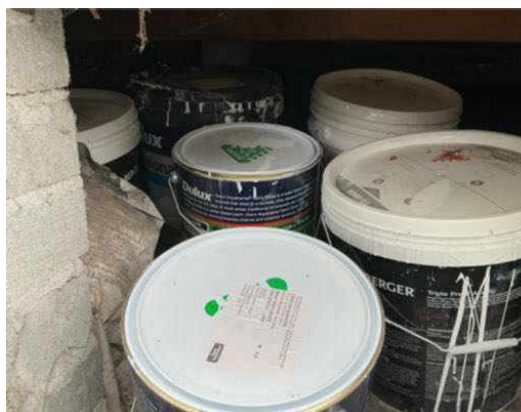
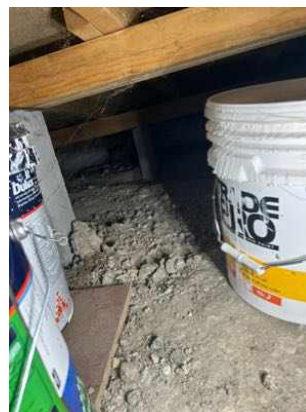
Defects 3.03

Building:	Main Building
Location:	Subfloor
Finding:	Subfloor - Debris
Information:	An array of debris was found in the subfloor area at the time of inspection. Debris in this area restricts subfloor ventilation and creates potential for concealed pest entry. Stored timbers and other materials may also make the area susceptible to termite activity and wood rot.

A clear and empty subfloor will be better ventilated and easier to maintain in a dry condition. The removal of any timber debris is vital in minimising the risk of termite or wood borer activity.

Debris in the subfloor should be removed as soon as possible. Depending on the location and amount of debris and stored items, the homeowner may elect to undertake this task. Alternatively there are a large number of rubbish removal subcontractors that could undertake these works.

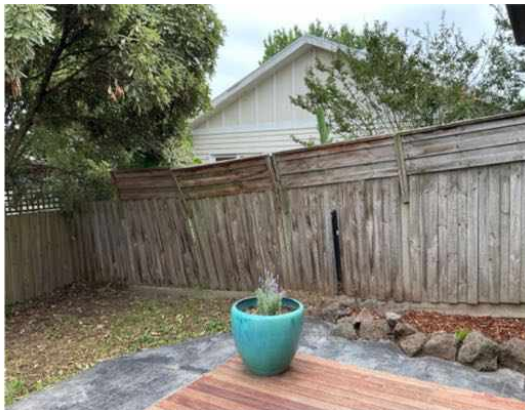
Defects 3.05

Finding: Fencing - Deteriorated

Information: It was noted at the time of inspection that sections of the fencing throughout the property have deteriorated. Typically fencing deteriorates due to age and or wear, rot and or rust which is generally expected for a structure of this age, due to prolonged exposure to weather conditions. Sometimes inadequate installation or maintenance can be to blame.

If left unattended, it is likely that further damage will occur. It is suspected that repair of several elements of the fencing may be required however replacement may be a consideration of the client also.

A licensed fencing contractor should be appointed to provide further advice and perform rectification works as necessary.

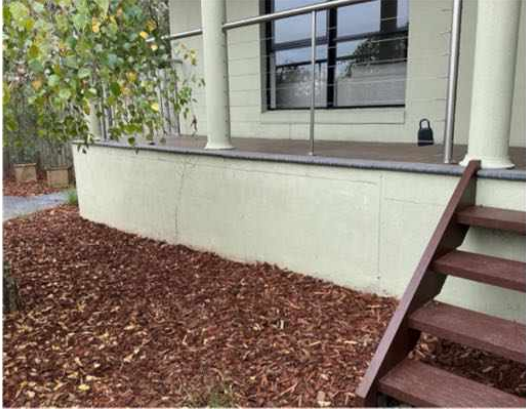
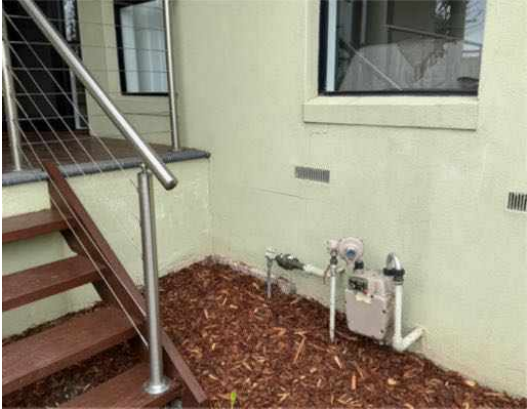
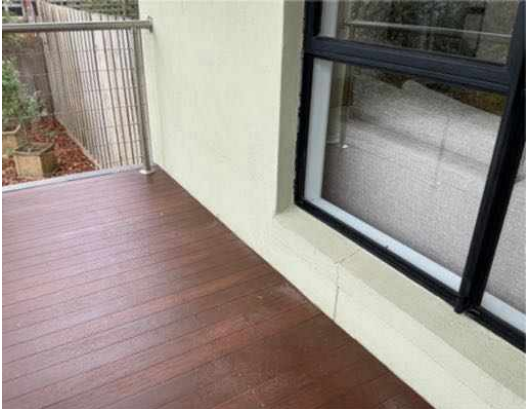
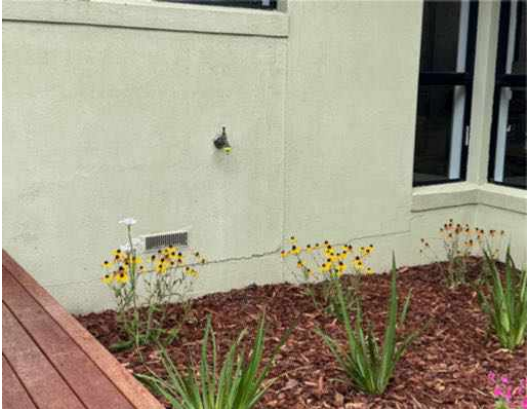
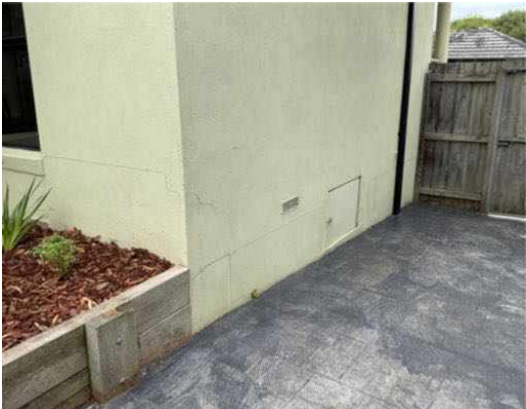
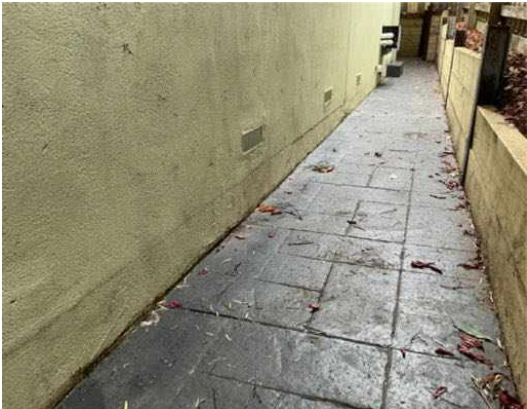
Defects 3.07

Building:	Main Building
Location:	All Areas
Finding:	Cracks to render - Category 2
Information:	It has been observed that cracking to rendered surfaces has occurred. The degree of damage falls within Category 2, described as noticeable cracks which are easily filled. Cracking of this size are generally less than 5mm in width.

Category 2 damage is required to be monitored for a period of 12 months. After the monitoring period, a crack rated at Category 2 or above is considered a defect requiring rectification.

Always contact your building inspector should cracks widen, lengthen, or become more numerous.

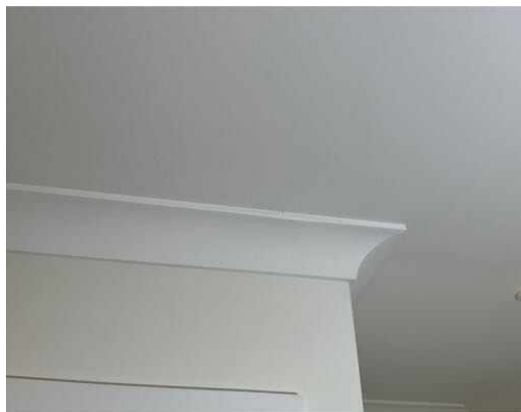
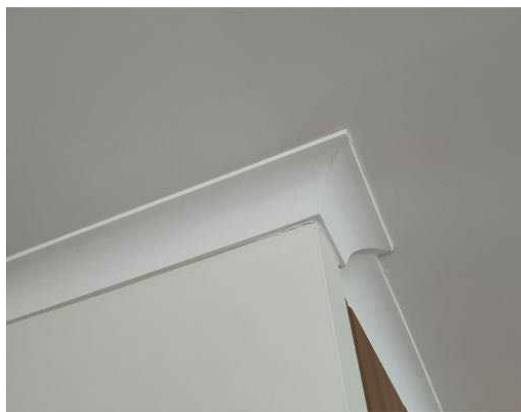
Building:	Main Building
Location:	All Areas
Finding:	Cornice - Cracking
Information:	The cornice has separated and cracking is apparent in this area.

This area should be carefully monitored to identify any further damage.

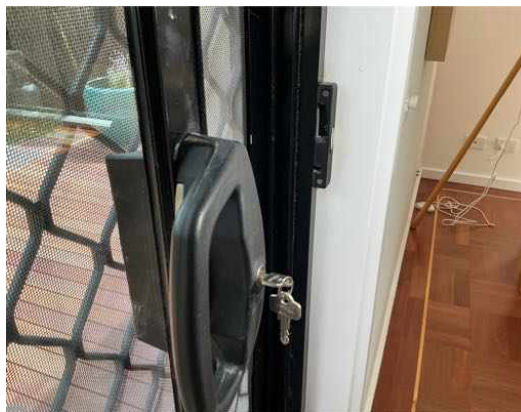
Building:	Main Building
Location:	Family Room
Finding:	Lock - Not working
Information:	The lock in this area was not operational at the time of inspection. Where locks have deteriorated to a point where they are no longer usable, the security of the property is immediately compromised.

Repair or replacement of the lock is highly recommended. Consultation with a locksmith or general handyman is required to gain further advice on any added security that may be available for the area.

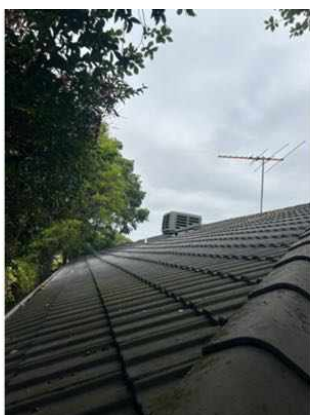
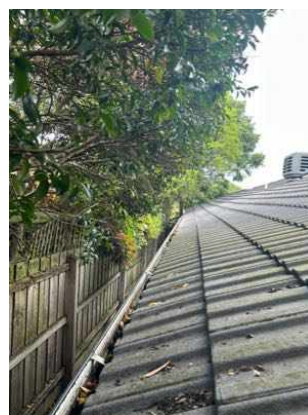
Defects 3.20

Building:	Main Building
Location:	Roof Exterior
Finding:	Trees - Overhanging and filling gutters
Information:	Overhanging trees often result in excessive amounts of leaf debris accumulating in gutters.

It is highly advised that all overhanging tree branches be removed as soon as possible to prevent any further damage. Repair and/or replacement of sections of damaged guttering may also be required where the extent of the damage necessitates.

Such works should be performed by the homeowner; however, appointment of a landscape contractor or an arborist may be required. Consultation with a licensed roof plumber is required where guttering has been damaged.

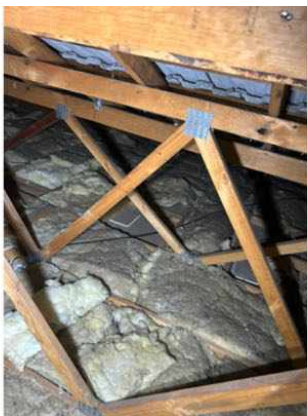
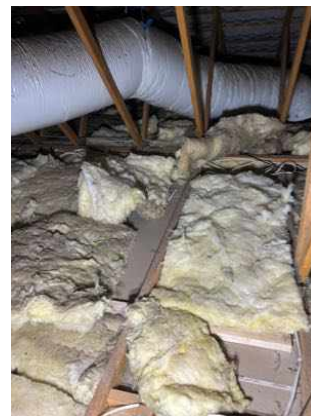
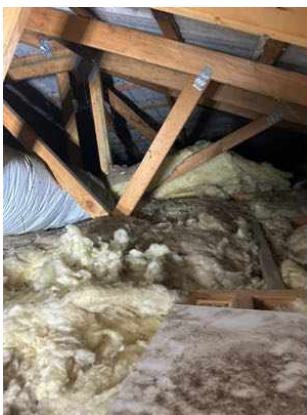
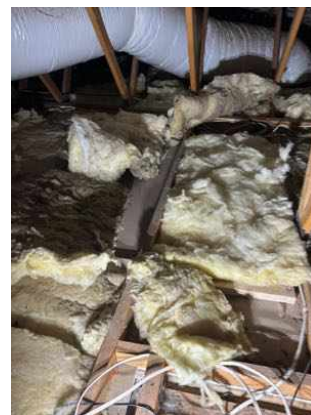
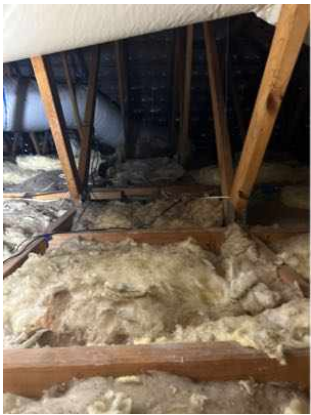
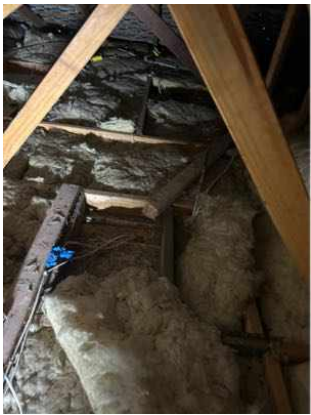
Defects 3.21

Building: Main Building
 Location: Roof Void
 Finding: Insulation - Inadequate
 Information: Upon inspection of the roof void it was noted that there is a lack of adequate insulation.

The level of insulation in the property does not meet current Australian Standards. Installation of adequate insulation is required and should be conducted as soon as possible.

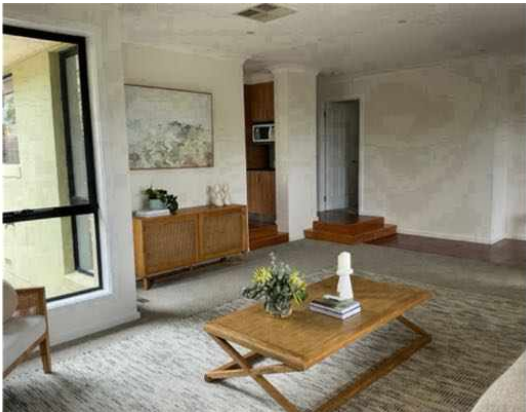
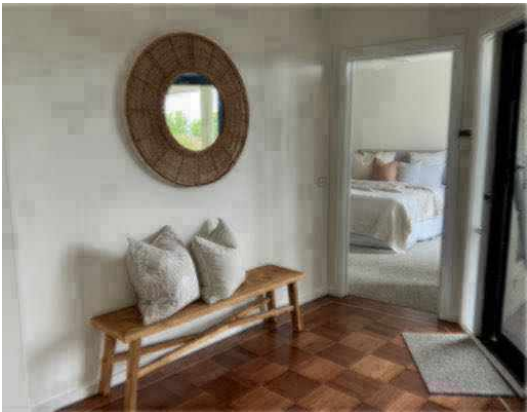
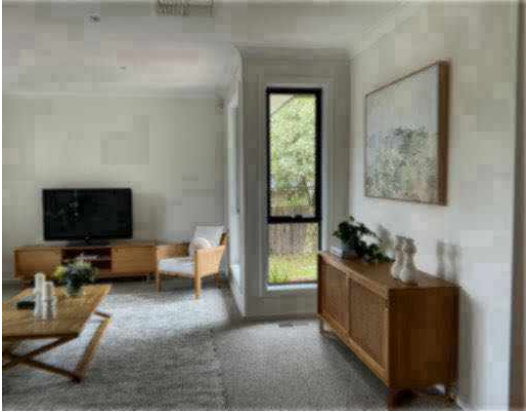
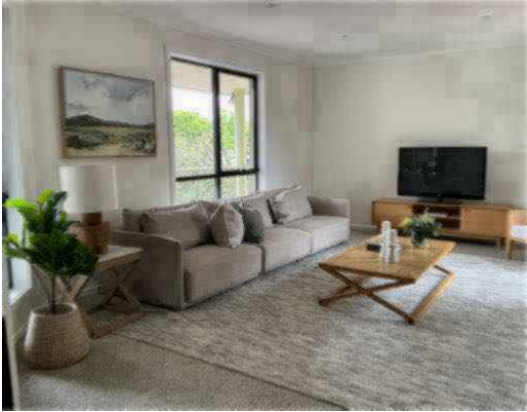
Noted Item

Building: Main Building
Location: All Areas
Finding: Additional Photos and Obstructions and Limitations
Information: These are additional photographs and photographs of the obstructions and limitations inside and outside (furniture, landscaping etc) which may impede full inspection of the property at the time of inspection. These obstructions can hide an array of defects and may be removed to allow full inspection to be carried out. A re-inspection may be made if clients require once the areas are made accessible.

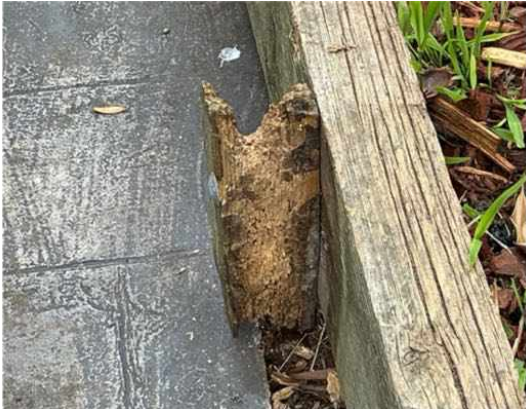
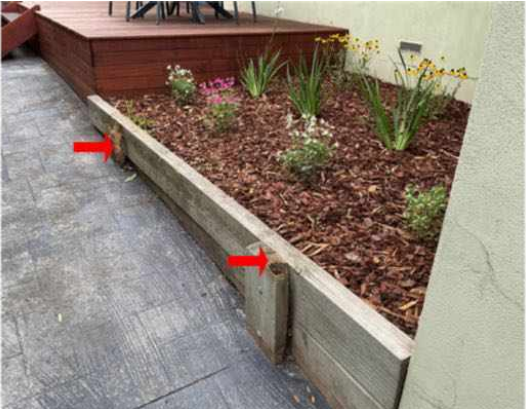
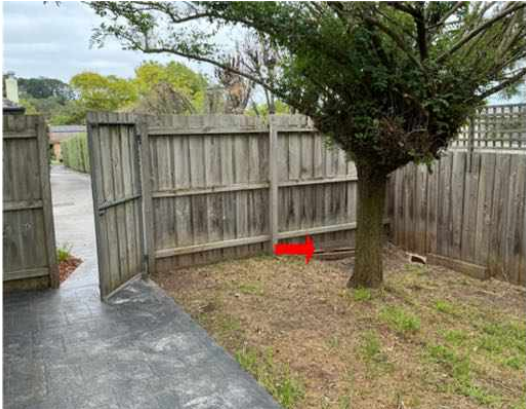
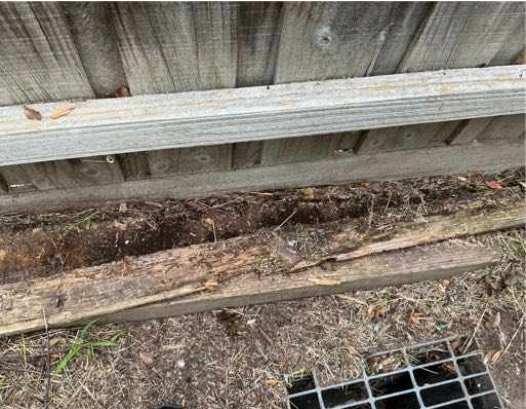
And especially as there was evidence of termite damage to the retaining wall putting this property at high risk of termite attack if not properly treated to protect this property.

Building: Main Building
 Location: Retaining Walls
 Finding: Suspected termite activity identified
 Information: Although no evidence of live termite activity was found at the time of inspection it is suspected that a termite colony is present on the property. Further inspection of external and internal areas is required in order to correctly identify the presence of termite activity and may include works of an intrusive nature.

There was no evidence of a previous termite treatment, we recommend a preventative timber pest treatment to all Properties of this construction method.

It is strongly recommended that further inspection be conducted as soon as possible by a qualified timber pest technician in order to prevent any further damage that may ensue and install a treatment

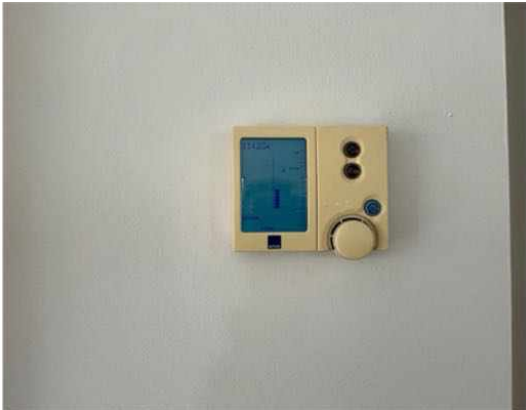
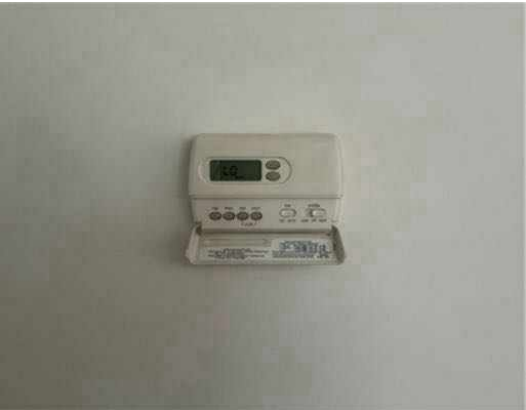
Building: Main Building
 Location: Appliances
 Finding: Warranty - Expired
 Information: Where appliances are beyond their warranty period, the owner should be prepared to meet the cost of replacement or repair of the item at any time. The operation of the appliance can not be guaranteed and further inspection by an appropriately qualified tradesperson may be required.

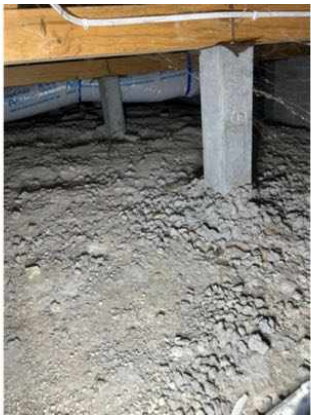
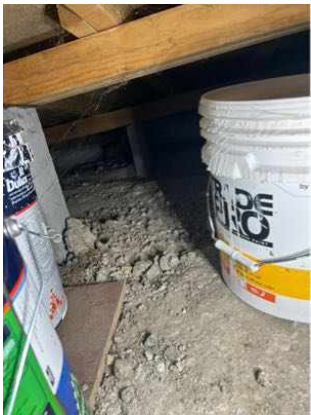
Noted Item

Building: Main Building
Location: Subfloor
Finding: Additional Photos - Obstructions and Limitations
Information: These photographs are an indication of the obstructions and limitations which impeded full inspection of the property at the time of inspection. These obstructions can hide an array of defects and should be removed to allow full inspection to be carried out. A re-inspection is recommended once the areas are made accessible.
