Building and Timber Pest Inspection Report

Inspection Date: Wed, 11 Mar 2026

Property Address: 2-8 Elwood St, Notting Hill VIC 3168,
Australia

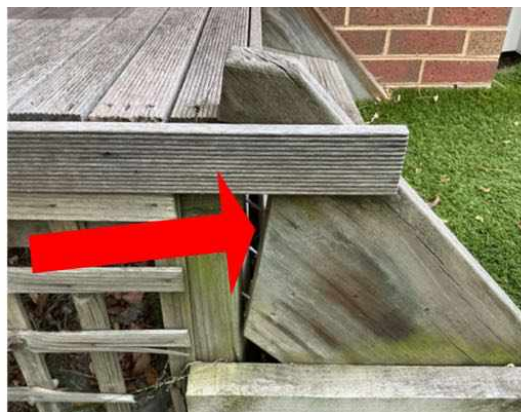
Building: Main Building
Location: Yard - Back
Finding: Rear steps coming loose
Information: On inspection of the rear steps/treads it was noticed that the steps/treads are starting to come loose. Loose steps/treads can create a risk of slips trips and falls for anyone using the stairs. Continued use without repair may result in further loosening or detachment of the treads increasing the likelihood of injury.

It is recommended to engage a carpenter as soon as possible to repair/replace the stairs to reduce the risk of safety hazards and further deterioration.

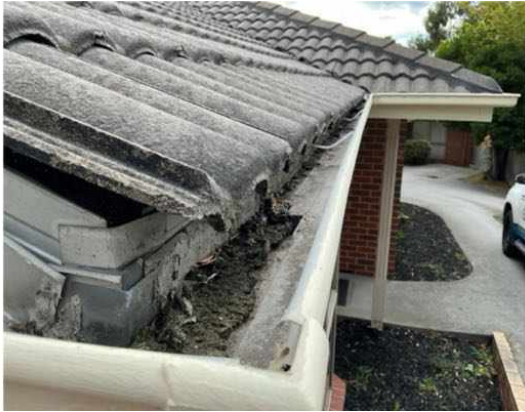
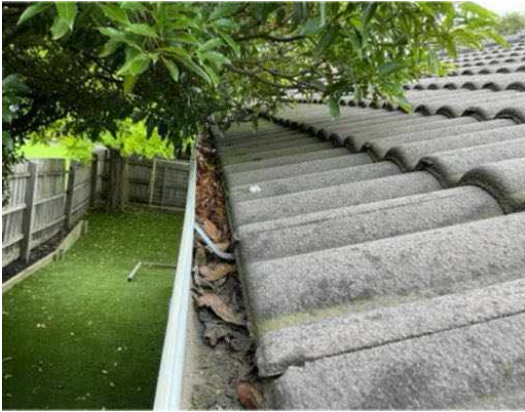
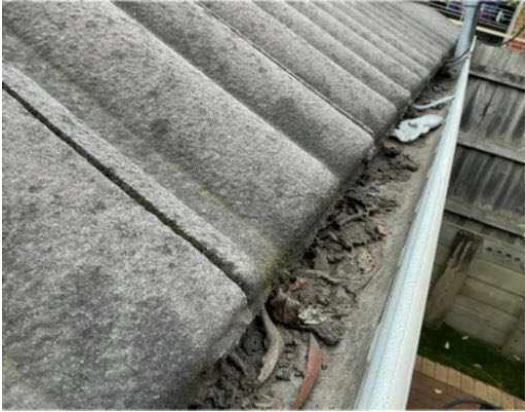
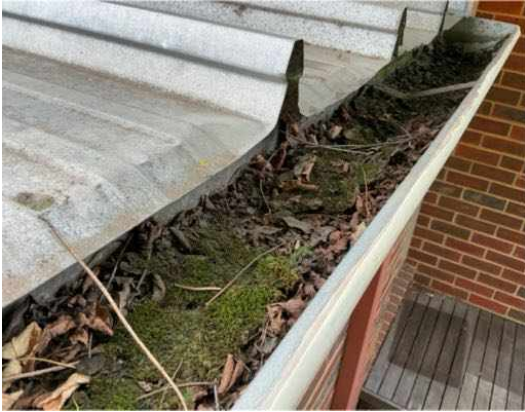
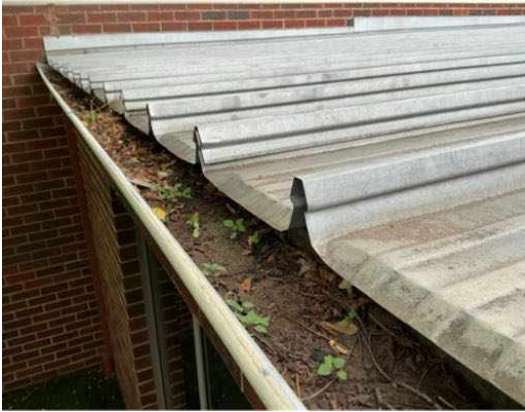
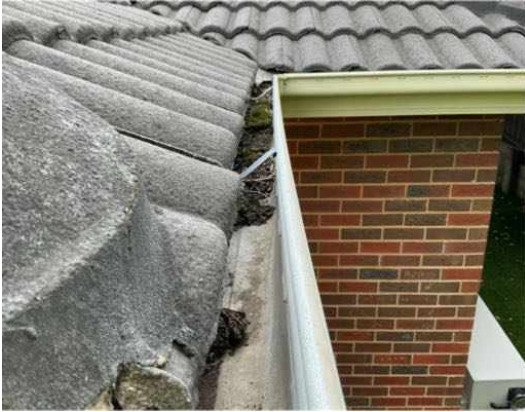
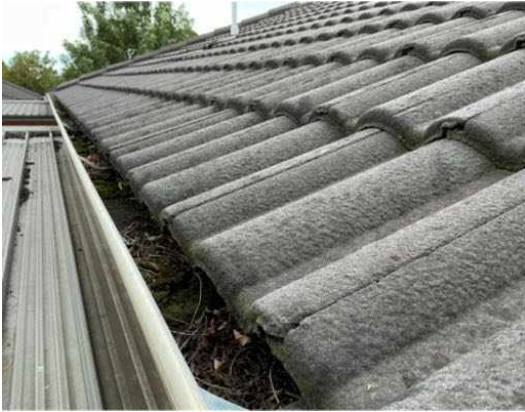
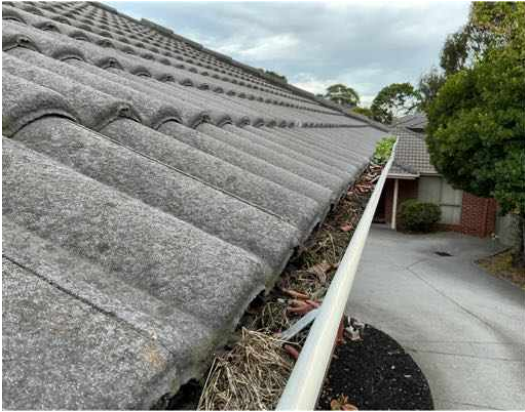
Blocked gutters are likely to lead to high levels of moisture in the affected areas. Such moisture will not only cause rust and decay of the associated building materials, but can also provide conditions that are conducive to termite and timber pest activity. Blockages in gutters should therefore be removed immediately to ensure dry conditions are maintained.

Consult a Licensed Plumber for further specific advice on remedial works that may be required. In the interim, it is highly advised that blocked gutters be removed by the homeowner or a general handyperson as a matter of urgency.

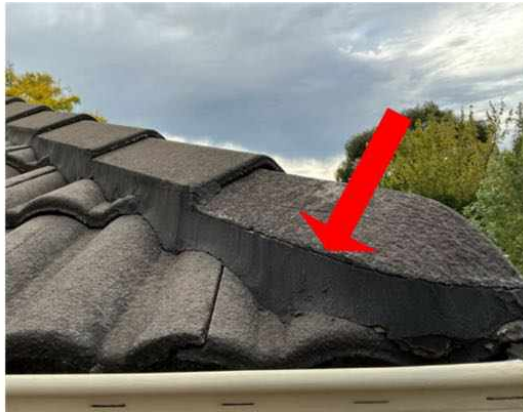
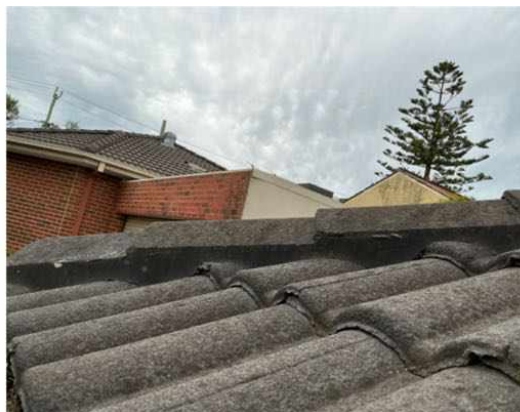
Finding 3.02

Building: Main Building
Location: Roof Exterior
Finding: Roof tile mortar deterioration and cracking
Information: Cracking and deterioration was observed in the parts of the ridge and hip tile mortar bedding. The mortar has separated in several areas, with visible gaps forming between ridge tiles and the underlying bedding. This condition indicates age-related degradation and exposure to the elements, which has caused the mortar to become brittle and lose its bonding integrity.

Compromised mortar may lead to further deterioration, potentially allowing water ingress and structural damage to the roof structure below.

Recommend engaging a qualified roofing contractor to carry out repointing or full re-bedding of affected ridge and hip tiles as necessary. All deteriorated mortar should be removed and replaced with new flexible roof bedding compound in accordance with current Australian Standards (AS 2050).

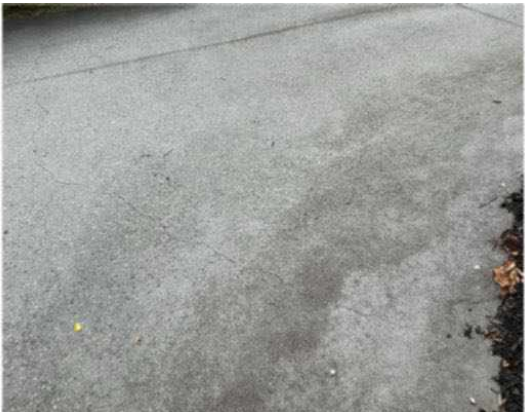
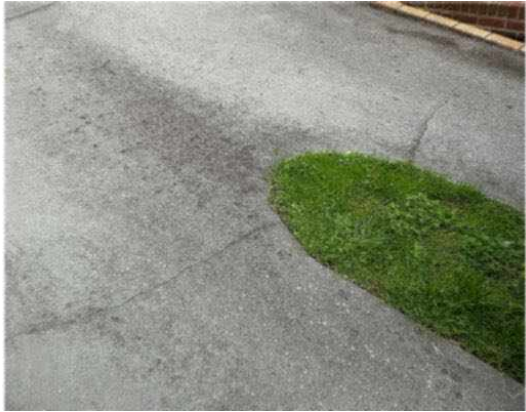
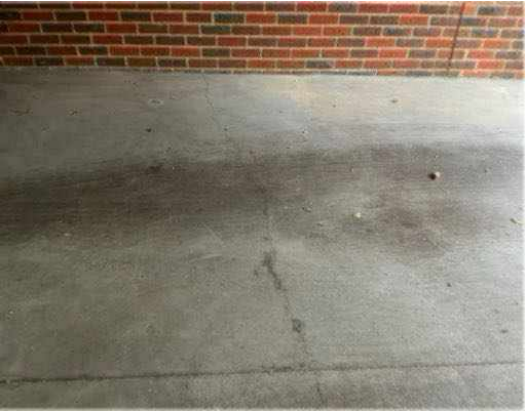
Building:	Main Building
Location:	Driveway/garage
Finding:	Driveway/garage Cracking
Information:	Cracks were identified in the driveway and garage concrete paving. Although cracks are quite noticeable, they are often only considered to be an appearance defect, and usually do not indicate any structural damage.

Generally the cause of the cracks in existing concrete paving such as driveways and pathways is indicative of the expansion and contraction of the concrete. Such causes are generally due to environmental factors, such as moisture levels, weather conditions, root systems of nearby trees or the soil types on which they are laid.

Cracks may also be due to poor original installation of the concrete. Factors such as poor compaction of the sub surface and/or inadequate reinforcing of the slab may create cracking and other secondary defects.

Monitoring of all cracking should be conducted frequently. Always contact a building inspector should cracks widen, lengthen, or become more numerous.

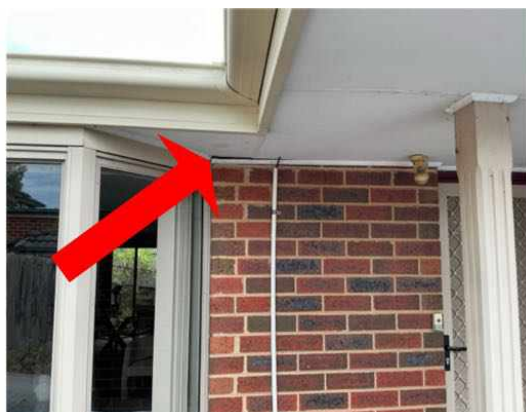
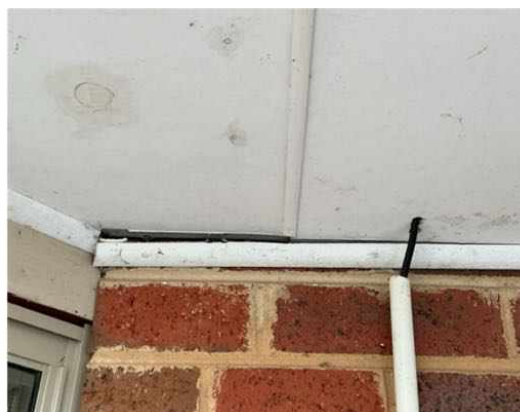
Finding 3.06

Building:	Main Building
Location:	Exterior walls - front
Finding:	Loose moulding/trim
Information:	One of the mouldings/trims is coming loose to the front of the building. This can happen overtime with deterioration or if installed incorrectly. Recommend engaging a carpenter to repair to reduce the risk of further deterioration at the owners discretion.

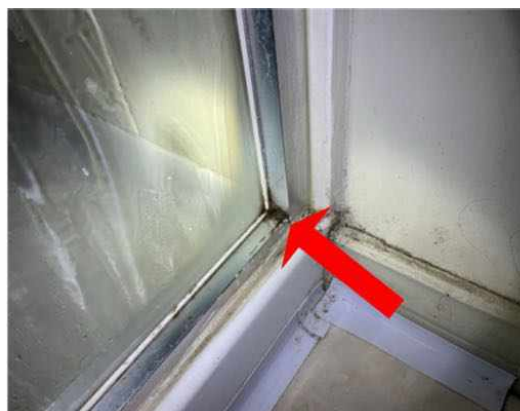
Finding 3.07

Building:	Main Building
Location:	Bathroom
Finding:	Shower screen - Leaking bathroom
Information:	Leaking was evident to the shower screen in the bathroom at the time of inspection. It is suspected that the leaking has occurred as a result of deteriorated or missing caulking to the shower or general ageing of the building elements.

Leaking from the shower where left unattended, is likely to lead to water damage to adjoining flooring and walls. Such damage can lead to water damage and necessitate extensive remedial works being required. Active water leaks may also create an environment that is susceptible to the formation and development of mould.

Appointment of a caulking contractor is required to repair or replace the caulking to the shower area. Such works should be performed as soon as possible to ensure that no further damage occurs.

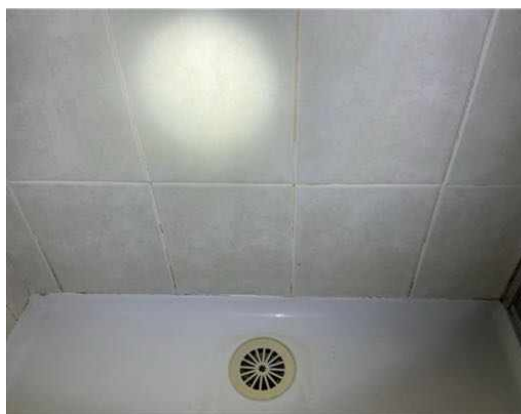
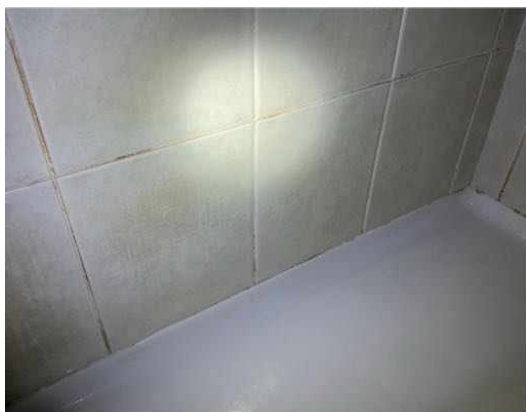
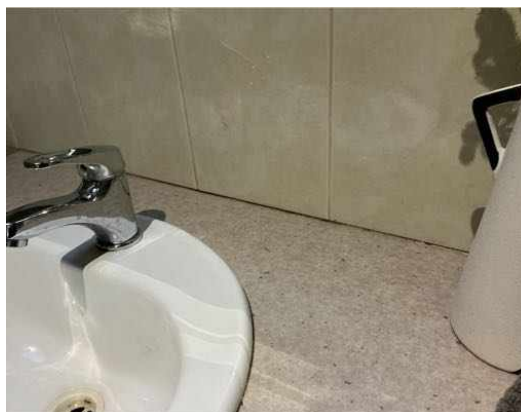
Finding 3.08

Building:	Main Building
Location:	Bathroom
Finding:	Bathroom Sealant and grouting - Missing or damaged
Information:	It was noted on inspection that sealant or grout is degraded to the tiled shower alcove and or other areas of the bathroom.

Different materials and floor areas move at different rates, generally causing cracking to grout or sealant at this point. A flexible sealant is required to allow for expected expansion and contraction, while keeping the joint water tight and protective of all associated building materials.

Flexible and mould resistant materials should be applied to affected areas to prevent any subsequent water damage that is likely to occur. Regular maintenance and replacement of damage or missing or damaged sealant and grout is highly recommended to the wet areas, as this is a regular wear and tear defect. Sealant and grouting in areas that come into regular contact with water should be maintained for the long term care of your property.

A sealant specialist or tiling contractor should be appointed to complete these works as soon as possible

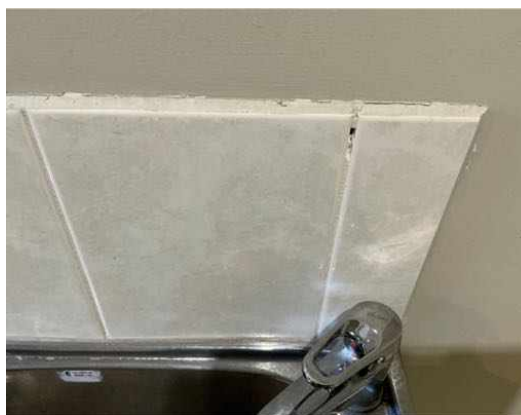
Finding 3.09

Building:	Main Building
Location:	Laundry
Finding:	Laundry- Sealant and grouting - Missing or damaged
Information:	It was noted on inspection that sealant or grout is degraded to the laundry splash back and or other areas of the laundry.

Different materials and floor areas move at different rates, generally causing cracking to grout or sealant at this point. A flexible sealant is required to allow for expected expansion and contraction, while keeping the joint water tight and protective of all associated building materials.

There appears to be excessive mould to the sealant and grout which will likely require scraping out and replacement.

Flexible and mould resistant materials should be applied to affected areas to prevent any subsequent water damage that is likely to occur. Regular maintenance and replacement of damage or missing or damaged sealant and grout is highly recommended to the wet areas, as this is a regular wear and tear defect. Sealant and grouting in areas that come into regular contact with water should be maintained for the long term care of your property.

A sealant specialist or tiling contractor should be appointed to complete these works

as soon as possible

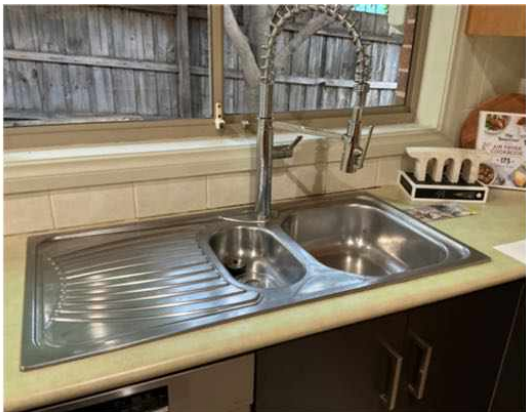
Finding 3.10

Building:	Main Building
Location:	Kitchen
Finding:	Kitchen Sealant and grouting - Missing or damaged
Information:	It was noted on inspection that sealant or grout is degraded to the kitchen splash back and or other areas of the kitchen.

Different materials and floor areas move at different rates, generally causing cracking to grout or sealant at this point. A flexible sealant is required to allow for expected expansion and contraction, while keeping the joint water tight and protective of all associated building materials.

There appears to be excessive mould to the sealant and grout which will likely require scraping out and replacement.

Flexible and mould resistant materials should be applied to affected areas to prevent any subsequent water damage that is likely to occur. Regular maintenance and replacement of damage or missing or damaged sealant and grout is highly recommended to the wet areas, as this is a regular wear and tear defect. Sealant and grouting in areas that come into regular contact with water should be maintained for the long term care of your property.

A sealant specialist or tiling contractor should be appointed to complete these works as soon as possible

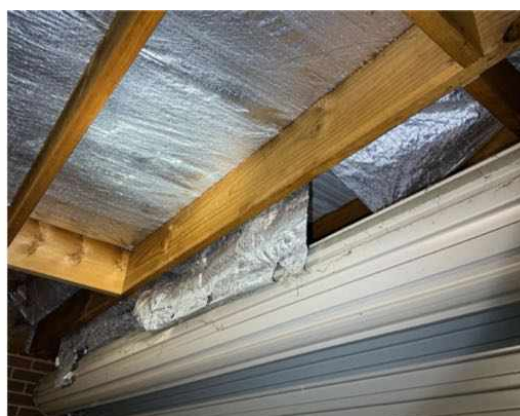
Building:	Main Building
Location:	Garage
Finding:	Sarking deteriorated
Information:	The garage roof sarking is showing signs of deterioration near the roller door. The material appears aged and weakened, with sections beginning to break down. This reduces its effectiveness as a secondary barrier against water ingress, dust, and wind-driven rain.

Reduced protection of the roof cavity from moisture, which may lead to water ingress during heavy rainfall.

Increased risk of condensation forming in the roof space, potentially contributing to timber decay and mould growth.

Engage a qualified roofing contractor to carry out a detailed assessment of the sarking.

Replace deteriorated sections where necessary to restore full functionality.

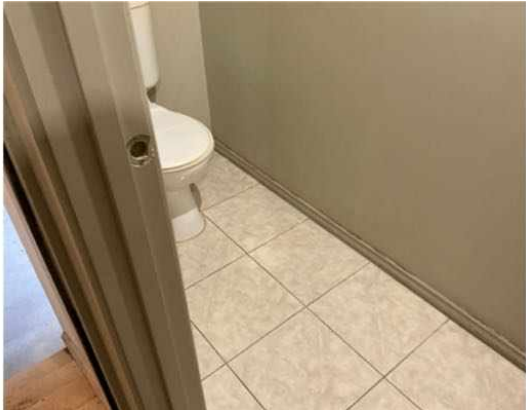
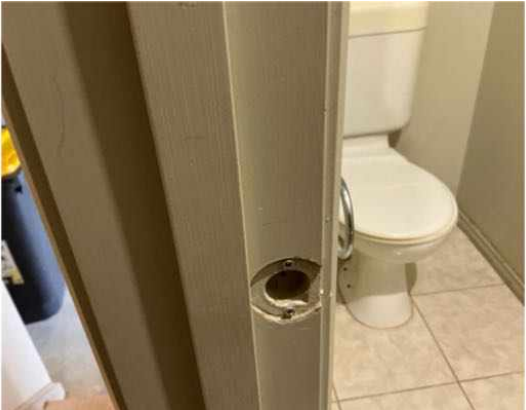
Finding 3.14

Building:	Main Building
Location:	Toilet (WC)
Finding:	Door striker plate missing
Information:	The door striker plate to the toilet was found to be missing and needs replacing at the time of inspection.

Repair is advised to improve the operational state of the associated door.

A qualified carpenter or general handyman should be appointed to repair at the client's discretion.

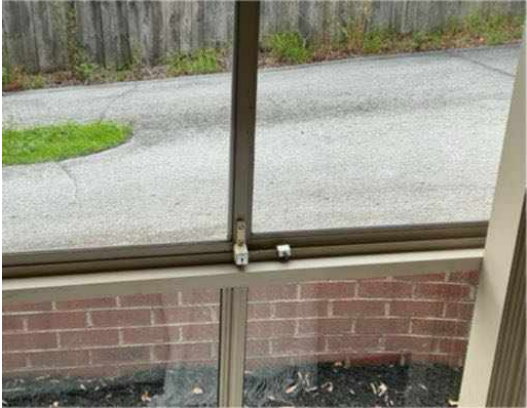
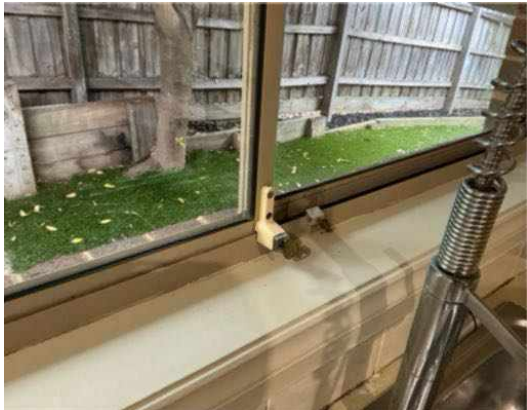
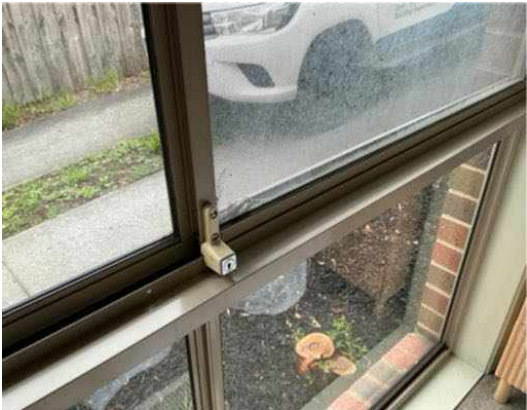
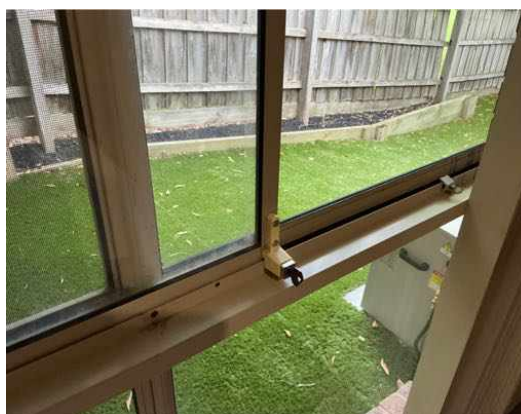
Finding 3.15

Building: Main Building
Location: Various parts of the building
Finding: Window locks stiff to operate
Information: The window locks to the building are stiff to operate. This can happen overtime in harsh weather conditions or through lack of maintenance. Recommend engaging a carpenter to repair/maintain to make more operational at the owners discretion.

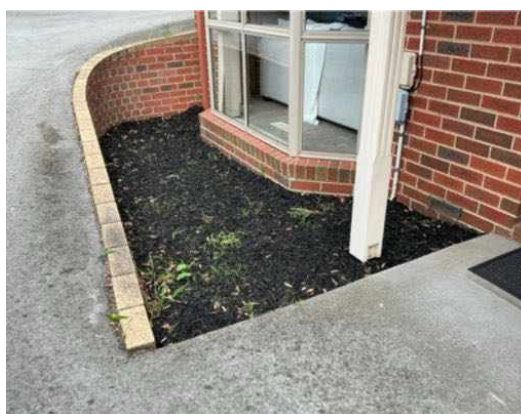
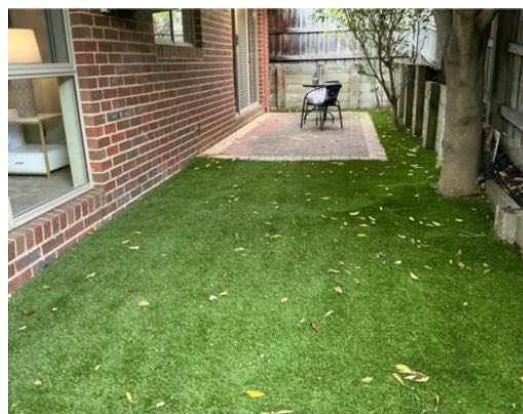
Building:	Main Building
Location:	Yards
Finding:	Site drainage - poor/inadequate
Information:	The site drainage to parts of the yards was found to be inadequate at the time of inspection, creating potential for subsequent water damage to associated building elements. Excessive moisture will attract termites.

It is important that water does not lie against the base of walls; surrounding paths and ground levels should be sloped to drain water away from walls. Downpipes should not discharge stormwater onto lower walls or plinths. Stormwater should be carried away by large, regularly cleaned drains. Ground levels may need to be lowered to expose a buried DPC.

Where site drainage is inadequate, installation of an Agricultural (Aggie) Drain may be required. A qualified plumber should be appointed to further inspect the property and perform any remedial works as necessary. Water damage and secondary defects are likely to occur if left unmanaged.

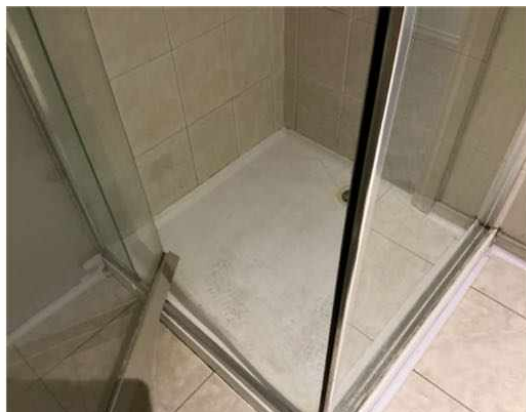
Finding 6.03

Building:	Main Building
Location:	Bathroom
Finding:	Shower - Damp
Information:	Damp is evident to parts of the bathroom shower alcove found using using a moisture meter. This defect is quite common, and is suspected to have been caused by moisture permeating through the grouting in this area, which shows evidence of deterioration creating moist conditions. Leaking pipes within the adjoining wall is also a possible cause. Excessive moisture can attract termites.

Damp (or structural damp) refers to the presence of unwanted moisture in the structure of a building, either as the result of intrusion from outside, or condensation from within the structure. In the shower area, internal water leaks or other sources of excessive moisture are generally the cause of damp.

Unmanaged damp in the shower recess is likely to facilitate the formation and development of mould and fungi growth, decaying associated building materials and compromising their structural integrity. It is important to address damp conditions, as the World Health Organisation notes that excess moisture leads - on almost all indoor materials - to growth of microbes such as moulds, fungi and bacteria, which subsequently emit spores and other matter into the indoor air. Exposure to these contaminants is associated with a wide range of respiratory and other health-related problems.

Consultation with a qualified plumber or bathroom specialist is advised immediately to identify the cause of damp and to perform remedial works as required. Where excessive mould growth is present, further inspection by a specialist environmental health inspector should also be considered.

Always ensure that sealant and grout is in good condition to prevent any moisture issues occurring in the future.

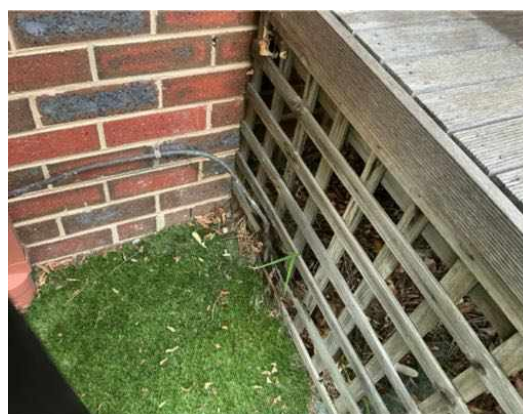
Finding 6.04

Building: Main Building
 Location: Yard - Back
 Finding: HWS Overflow - Not Connected
 Information: The Hot Water System (HWS) overflow was found to be disconnected from storm water drainage and is creating excessive moisture in the surrounding area.

These damp conditions can lead to secondary defects such as rot, rust or corrosion of associated building elements, the formation of fungal decay, or even the creation of potential slip hazards. When coupled with poor site drainage, pooling of water may also attract termite activity to this area.

It is highly recommended that a licensed plumber be appointed to connect the HWS overflow in order to prevent such an environment from being created. These minor works should be carried out as soon as possible.

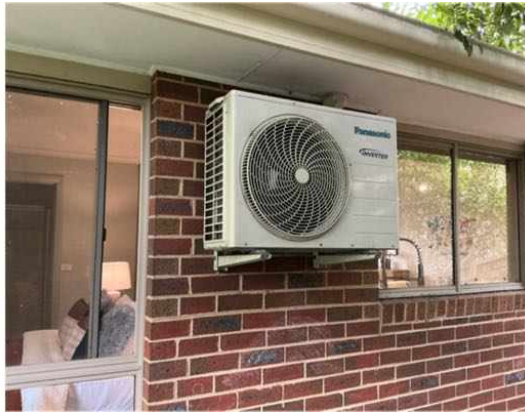
Finding 6.05

Building: Main Building
 Location: Yard - Back
 Finding: Air conditioning unit overflow -Not plumbed for drainage
 Information: The overflow to the air conditioning unit is not plumbed or connected to suitable

drainage, which has resulted in the surrounding area becoming excessively damp. These damp conditions can lead to secondary defects such as rot, rust or corrosion of associated building elements, the formation of fungal decay, or even the creation of potential slip hazards. When coupled with poor site drainage, pooling of water may also attract termite activity to this area. It is highly recommended that a qualified plumber be appointed to install adequate drainage to the overflow. These works will ensure that the area remains dry and free of any secondary defects.

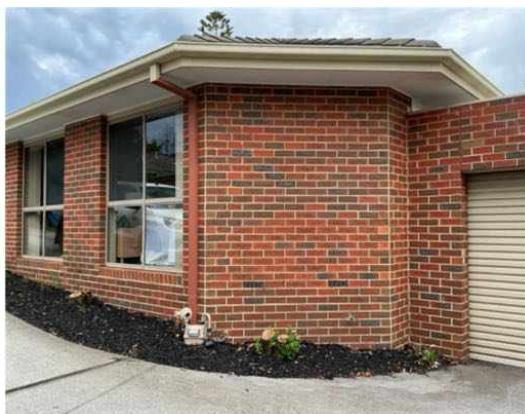
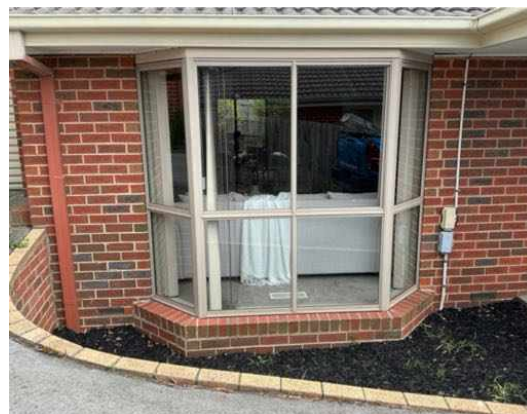
Finding 6.06

Building:	Main Building
Location:	Various parts of the building
Finding:	Bridging attachments to buildings
Information:	Bridging occurs when items against a building provide a concealed entry point for termites into the building or by passing around a termite management system.

Where any part of an attachment to a building is not isolated and is not provided with a clear gap of not less than 25mm from building, bridging occurs. Attachments to buildings such as hot water services, downpipes, verandahs, decks, steps, fences, service conduits and the like provide the opportunity for concealed entry.

Building attachments of this nature need to be frequently inspected for termite activity by a qualified inspector.

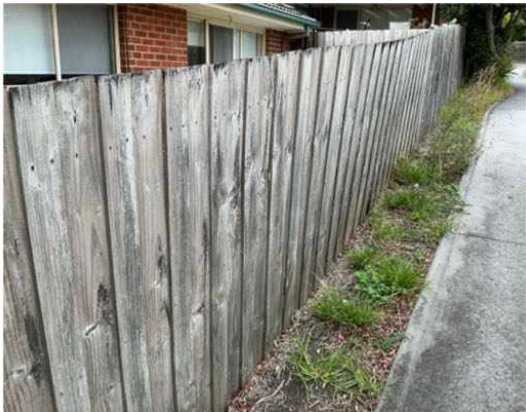
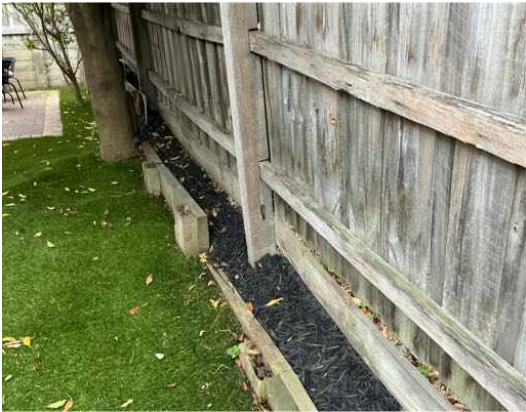
Building:	Main Building
Location:	Yards
Finding:	Fencing and retaining walls - wood rot-fungal decay
Information:	It was noted at the time of inspection that sections of the fencing and retaining walls to

the property have deteriorated and have fungal decay/wood rot present. Typically fencing deteriorates due to age and or wear, rot and or rust which is generally expected for a structure of this age, due to prolonged exposure to weather conditions. Sometimes inadequate installation or maintenance can be to blame.

If left unattended, it is likely that further damage will occur. It is suspected that repair of several elements of the fencing may be required however replacement may be a consideration of the client also.

A licensed fencing contractor should be appointed to provide further advice and perform rectification works as necessary.

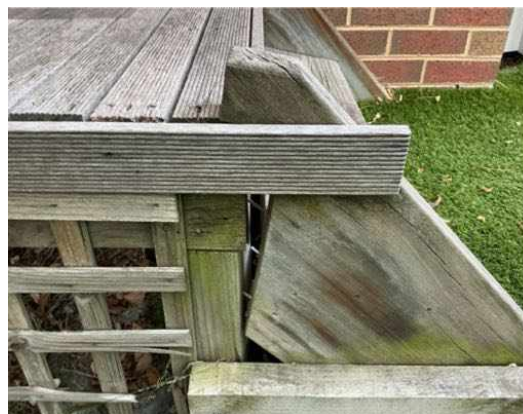
Finding 7.02

Building:	Main Building
Location:	Yard - Back
Finding:	Wood rot rear steps
Information:	The rear steps shows evidence of wood rot and deterioration with parts coming loose. Wood rot, also known as Fungal Decay, occurs when timbers and other cellulose building materials are exposed to damp conditions on an ongoing basis. This could be the result of exposure to weathering over a prolonged period of time, or the attraction of excessive moisture from other abutting building materials. Contributing factors also include poor air ventilation in the area.

Wood rot is often associated with general damp problems and is evidenced by a 'musty' smell or mould and mildew occurring on surfaces. If left unmanaged, damp conditions can lead to further health problems and the decay of timbers will continue.

On inspection of the rear steps/treads it was noticed that the steps/treads are starting to come loose. Loose steps/treads can create a risk of slips trips and falls for anyone using the stairs. Continued use without repair may result in further loosening or detachment of the treads increasing the likelihood of injury.

Early intervention and regular maintenance, particularly of exterior timbers, will prolong the useful life of these building elements. Prior to any works being performed, the cause of the moisture that has created the visible wood rot should be identified and addressed in a suitable manner. Replacement of affected timbers may then be a necessary step in protecting surrounding building elements from such deterioration.

A qualified plumber may be appointed to assess the cause of excessive moisture and to provide advice on any remedial works as required. A qualified carpenter or registered builder may also be required to replace affected building materials.

It is recommended to engage a carpenter as soon as possible to repair/replace the stairs to reduce the risk of safety hazards and further deterioration.

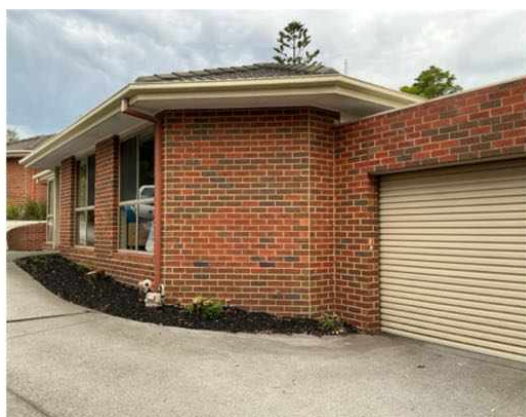
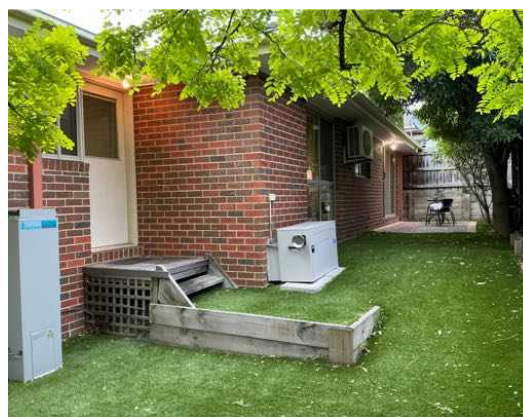
Building: Main Building
Location: All External Areas
Finding: Additional Photos - Obstructions and Limitations
Information: These photographs are an indication of the obstructions and limitations which impeded full inspection of the property at the time of inspection. These obstructions can hide an array of defects and should be removed to allow full inspection to be carried out. A re-inspection is recommended once the areas are made accessible.

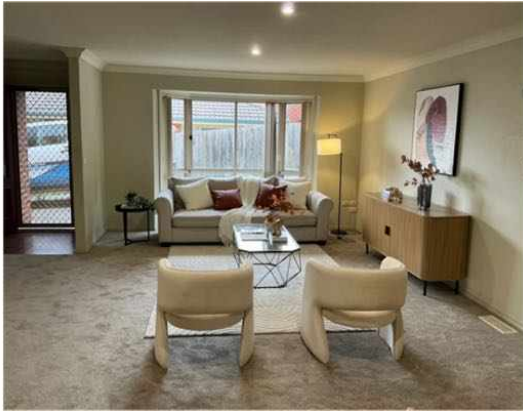
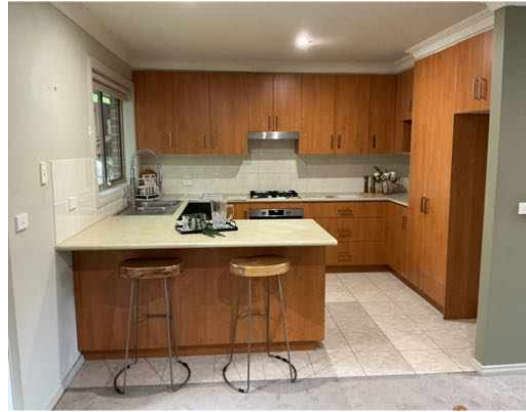
Building: Main Building
Location: All Internal Areas
Finding: Additional Photos - Obstructions and Limitations
Information: These photographs are an indication of the obstructions and limitations which impeded full inspection of the property at the time of inspection. These obstructions can hide an array of defects and should be removed to allow full inspection to be carried out. A re-inspection is recommended once the areas are made accessible.

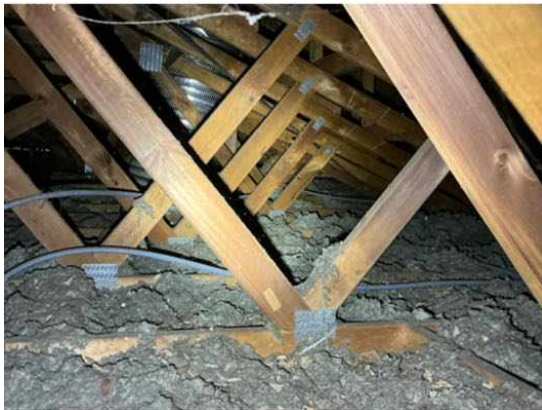
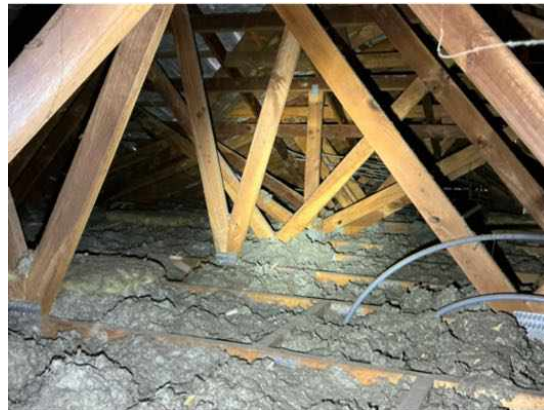
Building: Main Building
 Location: Roof Void
 Finding: Obstructions and Limitations -roof cavity
 Information: These photographs are an indication of the obstructions and limitations which impeded full inspection of the roof cavity at the time of inspection. These obstructions can hide an array of defects and should be removed to allow full inspection to be carried out. A re-inspection is recommended once the areas are made accessible.

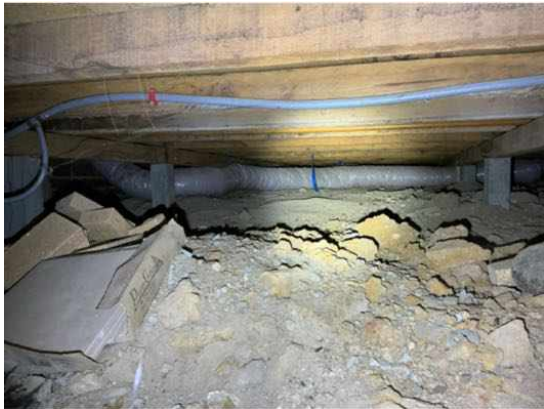
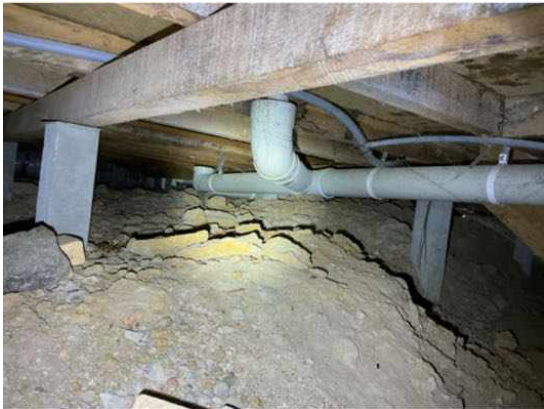
Building: Main Building
 Location: Subfloor
 Finding: Obstructions and Limitations -subfloor
 Information: These photographs are an indication of the obstructions and limitations which impeded full inspection of the subfloor at the time of inspection. These obstructions can hide an array of defects and should be removed to allow full inspection to be carried out. A re-inspection is recommended once the areas are made accessible.
