# Building and Timber Pest Inspection Report

Inspection Date: Fri, 9 Jan 2026

Property Address: 43 Ngungun Cr, Glass House Mountains  
QLD 4518, Australia

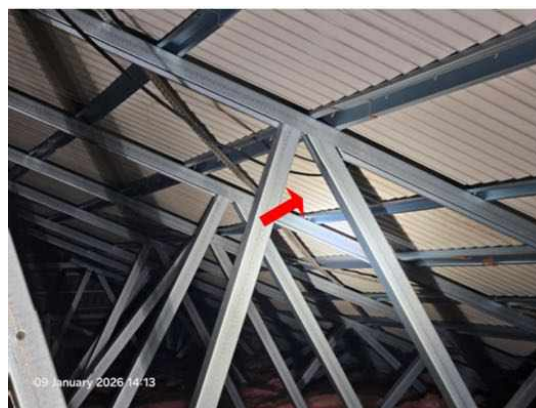
#### Finding 3.02

Building: Main Building  
 Location: As shown  
 Finding: TV antenna seal  
 Information: It was noted during the inspection of the roof space that the TV antenna coaxial cable access point through the roof sheet may require resealing to prevent water entry.

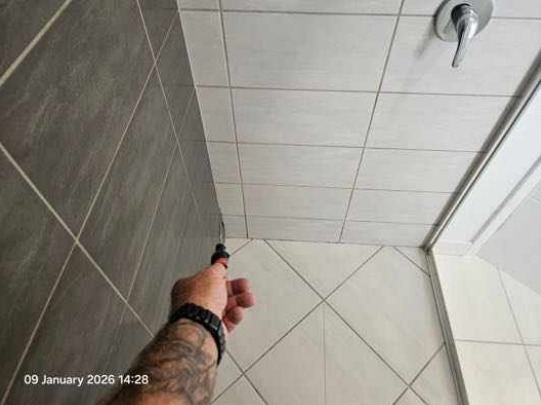
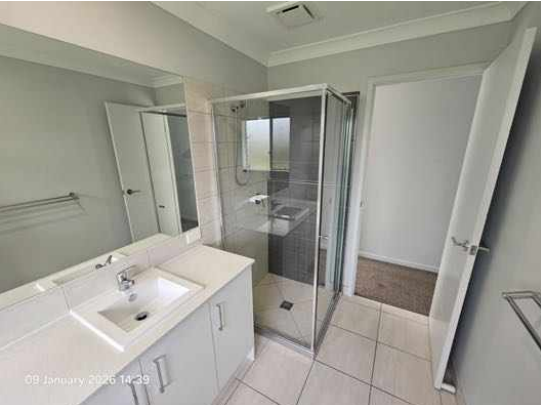
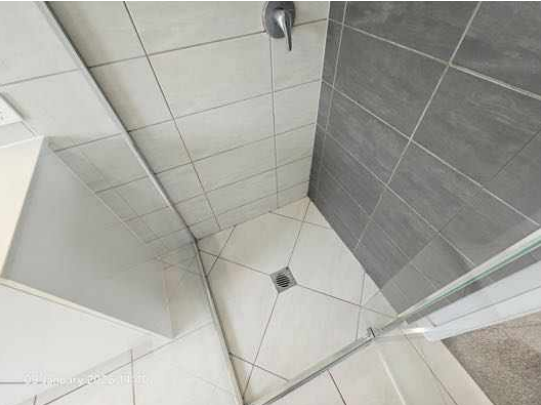
### Finding 3.04

Building:	Main Building
Location:	Bathroom, ensuite
Finding:	Sealant - requires renewal, showers
Information:	<p>The silicone sealant around the edges of the shower recesses require renewal as it has become deteriorated and some places delaminated from the floor / wall junction.</p> <p>It is recommended that the existing silicone sealant be removed and new sealant be applied.</p> <p>A licensed tiler or suitably qualified handy person could be engaged to carry out this work.</p>

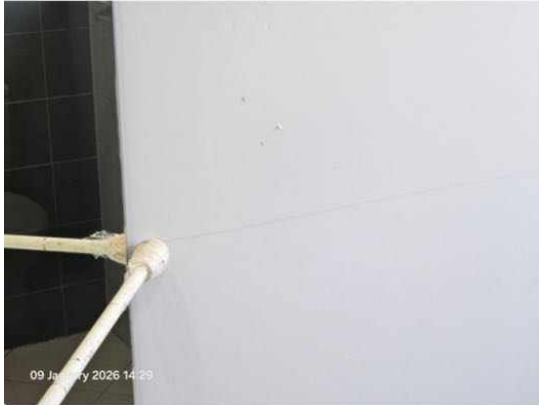
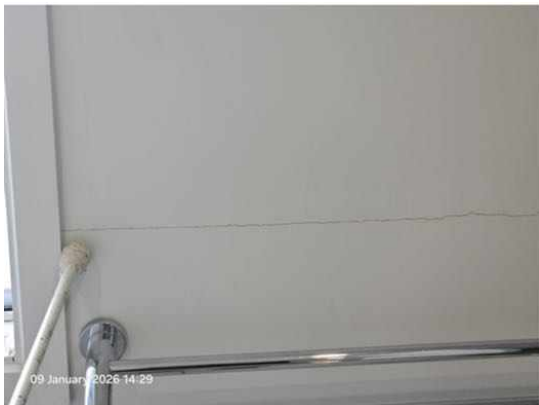
**Finding 3.05**

Building: Main Building  
Location: Ensuite - Master  
Finding: Cracking to internal wall sheets  
Information: On the day of inspection cracking was noted to the joints of the ensuite walls. These may possibly be attributed to settlement and movement of the building.

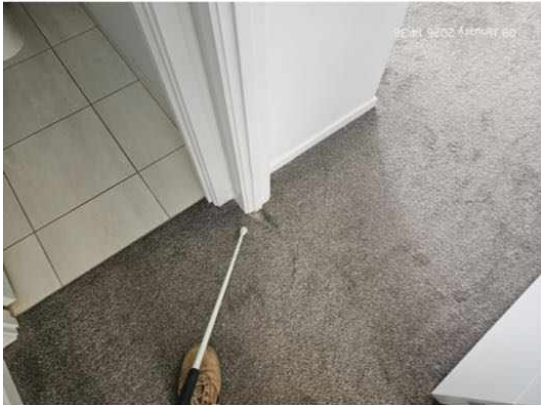
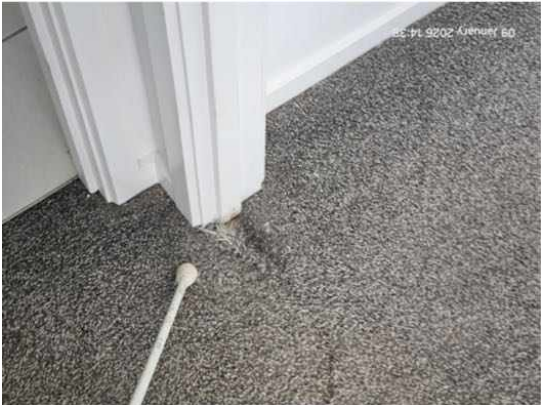
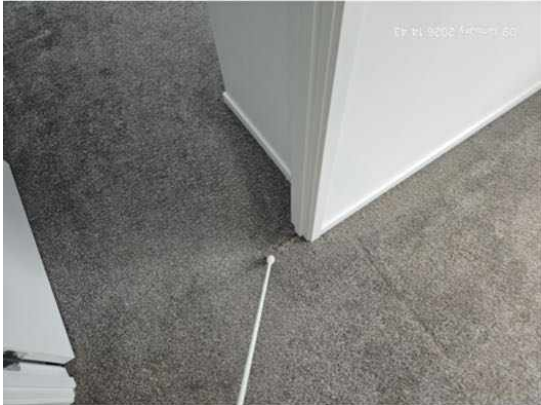
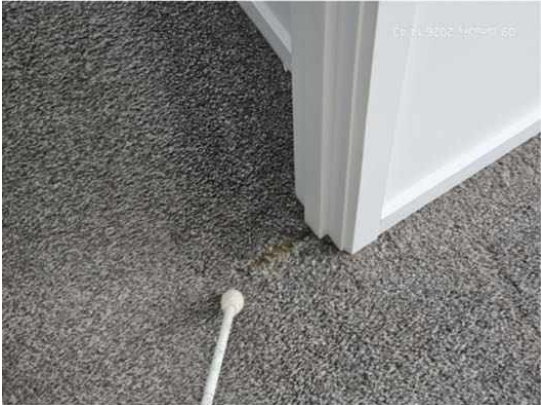
### Finding 3.06

Information: At the time of inspection the carpet in the bedroom doorways showed signs of wear. It appears to have tears and fraying at the join.

A carpet / flooring contractor could be engaged to make good the carpet surface.

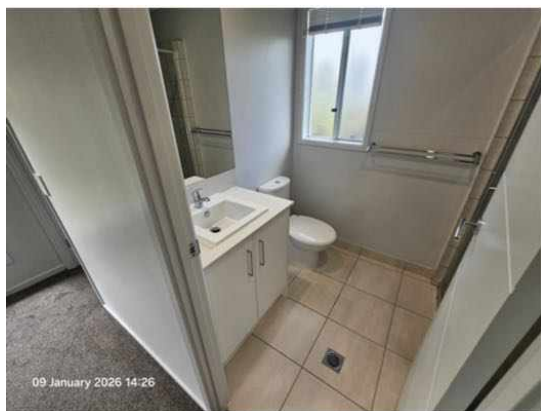
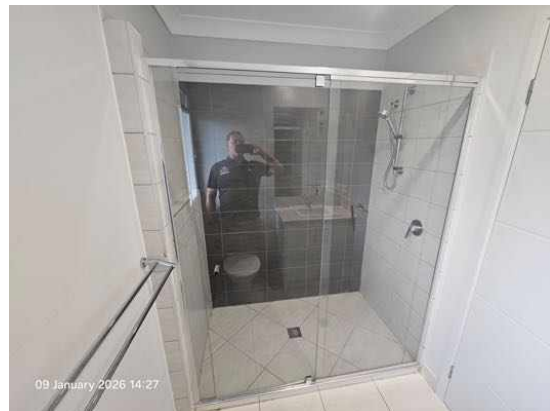
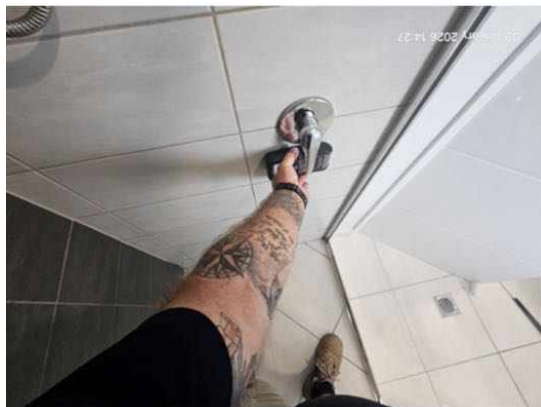
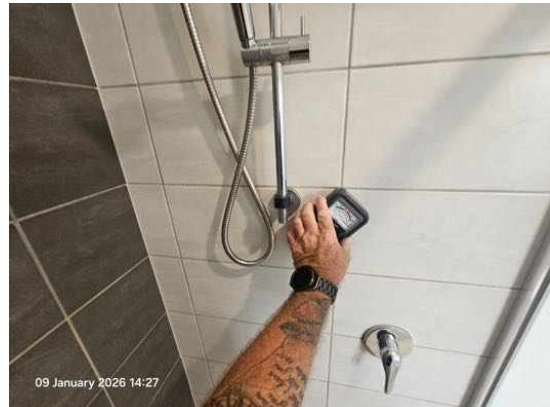
Building: Main Building  
Location: Bathroom, ensuite  
Finding: No moisture detected in bathroom / ensuite  
Information: On the day of inspection the showers in the bathroom/s and ensuite are measure for moisture using a "Tramex" moisture meter. During this inspection no moisture was detected in these areas and the tiled / sheeted surfaces appear to be in good order.
