Building and Timber Pest Inspection Report

Inspection Date: Mon, 12 Jan 2026

Property Address: 48 Church St, Beaumaris VIC 3193, Australia

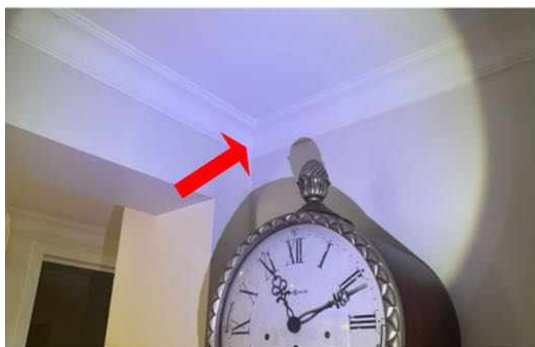
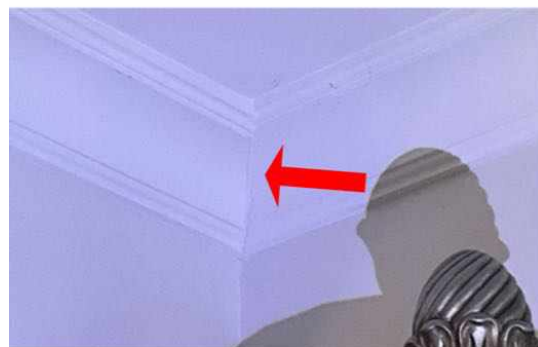
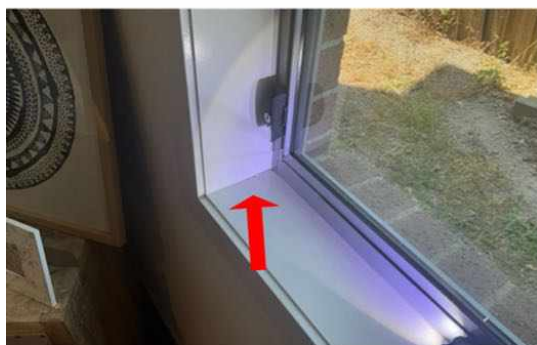
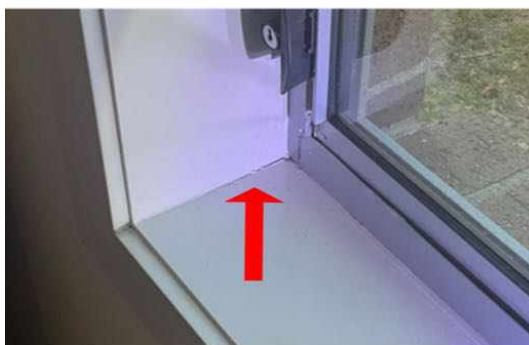
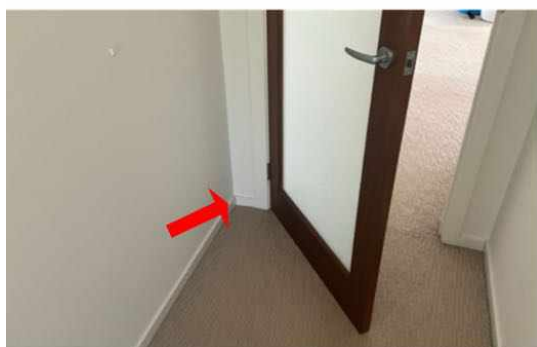
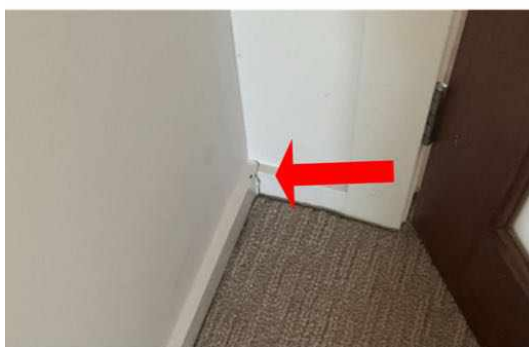
Finding: Cracking - fine

Information: Some fine cracking was noted throughout the property.

Although fine cracks are quite noticeable, they are often only considered to be an appearance defect, and usually do not indicate any structural damage. Generally, the cause of a fine crack is indicative of a separation between building materials and finishes (e.g. paint, plaster, etc.) along joins.

Cracking of this nature can generally be repaired with minor sanding, filling and/or repainting. Such works should be performed by a qualified painter or a general handyman.

Monitoring of all cracking should be conducted frequently. Always contact a building inspector should cracks widen, lengthen, or become more numerous.

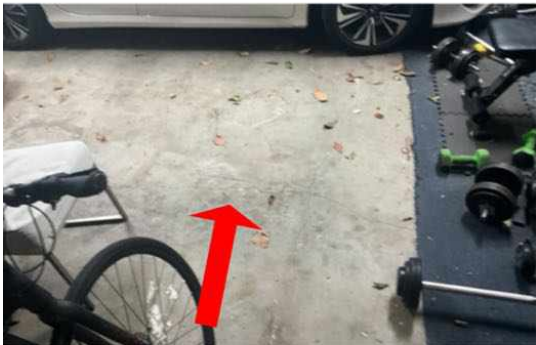
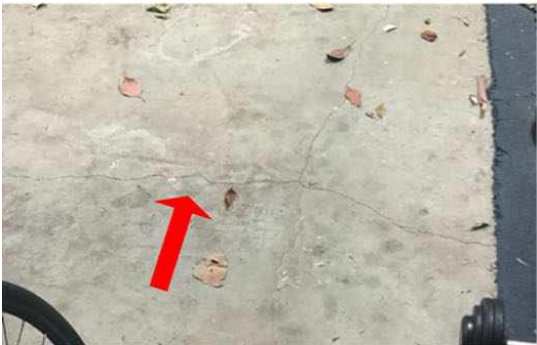
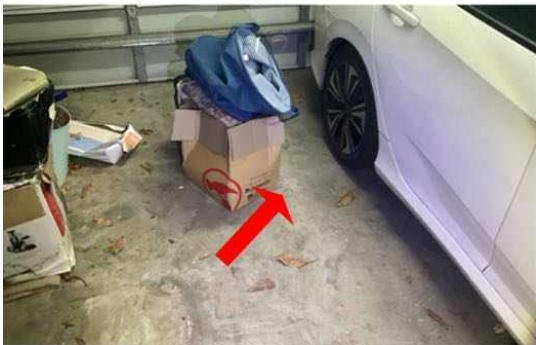
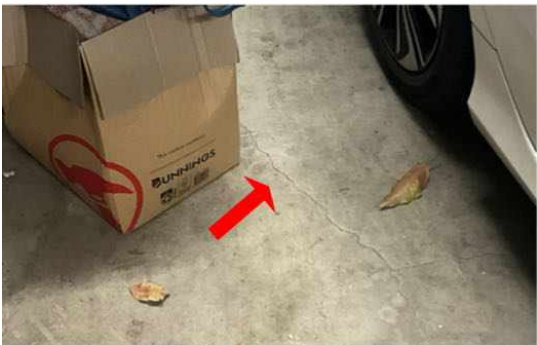
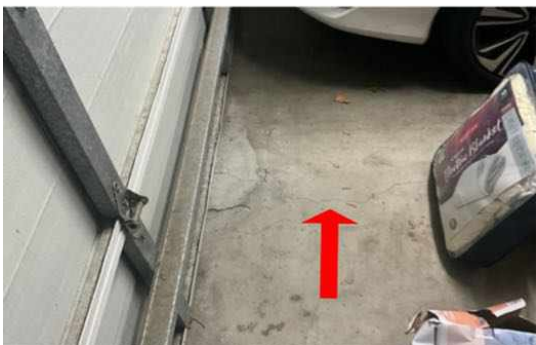
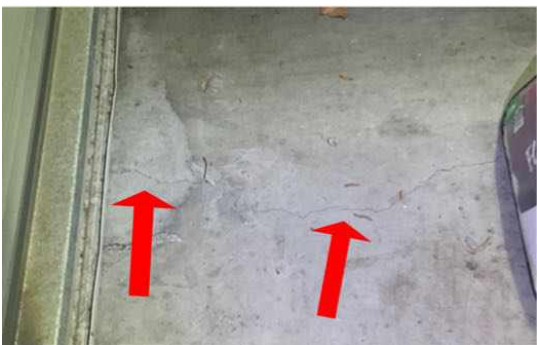
Finding 3.02

Finding: Cracking - Concrete flooring within garage - Fine

Information: Fine cracks were identified in the concrete flooring of the garage . Although fine cracks are quite noticeable, they are often only considered to be an appearance defect, and usually do not indicate any structural damage.

Generally the cause of a fine crack in existing concrete paving such as driveways and pathways is indicative of the expansion and contraction of the concrete. Such causes are generally due to environmental factors, such as moisture levels, weather conditions, root systems of nearby trees or the soil types on which they are laid.

Fine cracks may also be due to poor original installation of the concrete. Factors such as poor compaction of the sub surface and/or inadequate reinforcing of the slab may create cracking and other secondary defects.

Monitoring of all cracking should be conducted frequently. Always contact a building inspector should cracks widen, lengthen, or become more numerous.

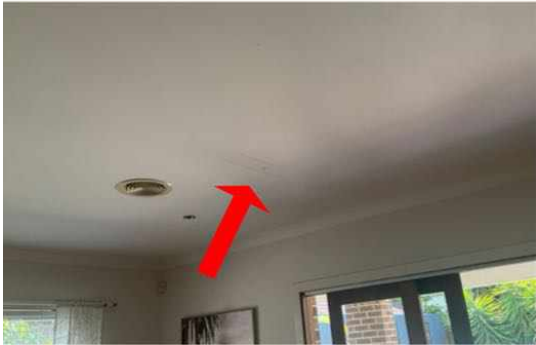
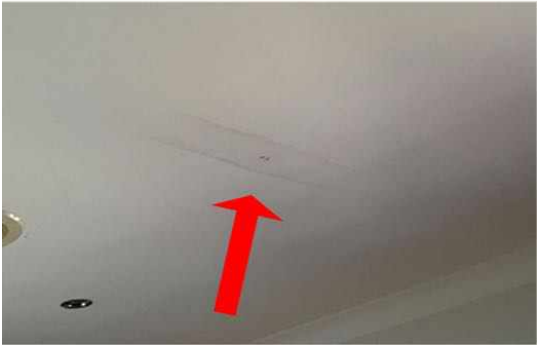
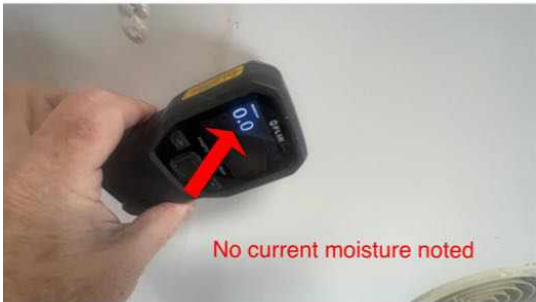
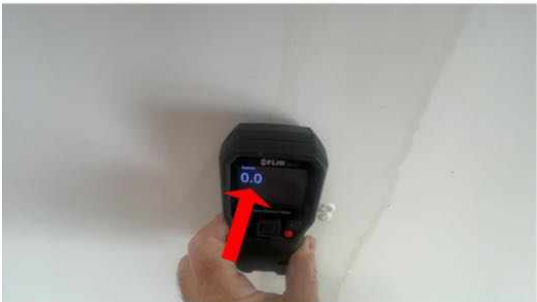
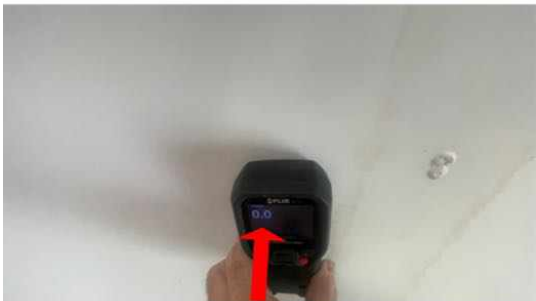
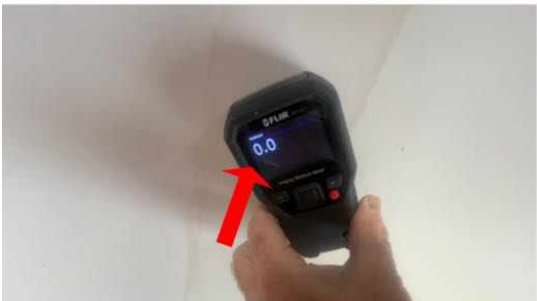
Finding 3.03

Building:
Location: Dining Room
Finding: Ceiling - Water stained
Information: Water staining to ceiling linings in this area was evident at the time of inspection. Water staining indicates that surfaces have been exposed to excessive moisture over time. It is suspected that the bathroom immediately above this area may have leaked previously, resulting in the ceiling becoming stained. No current moisture was noted within the area when tested with a moisture meter.

While mostly an appearance defect, water staining can be indicative of more serious defects, which may be currently concealed by interior ceilings.

Where water staining is active (not suspected in this instance), a licensed plumber must be consulted to identify the cause of the staining and to provide advice on any reparation works that may be required. Replacement of any damaged structures is advised.

Conversely, where water staining is old and inactive, affected building materials may be repaired or replaced at client discretion.

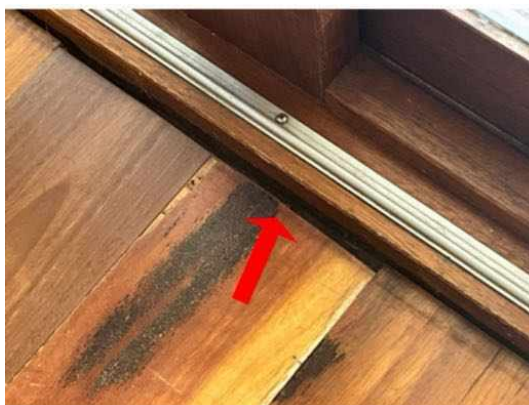
Finding 3.04

Location: Dining Room
 Finding: Flooring - slight gaps to ends of boards
 Information: At the time of inspection, it was noted there were slight gaps to the ends of some floor boards.

It is suspected that this may have been caused by either poor installation of the boards or the boards have shifted over time.

Monitoring of the flooring is recommended to look for any changes. Should no changes occur, a flooring specialist may be engaged to inspect the floor and advise of ways to repair the flooring.

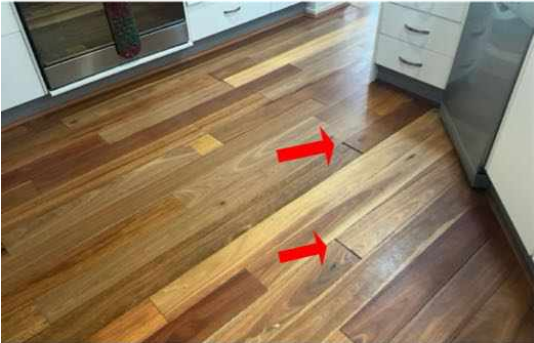
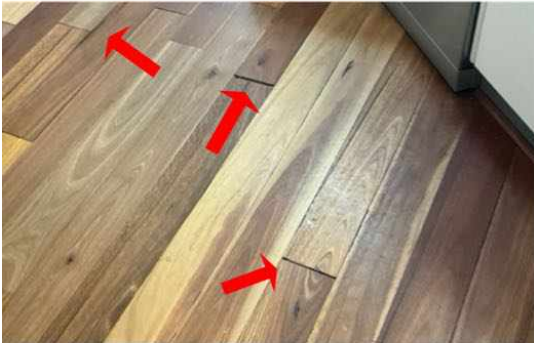
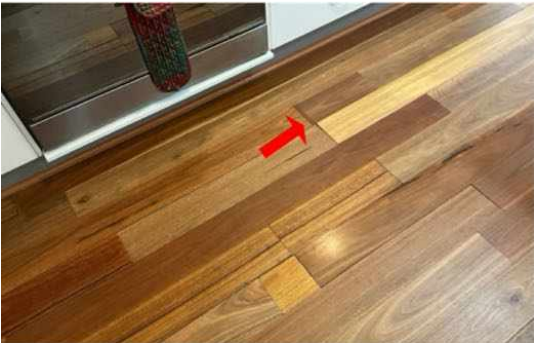
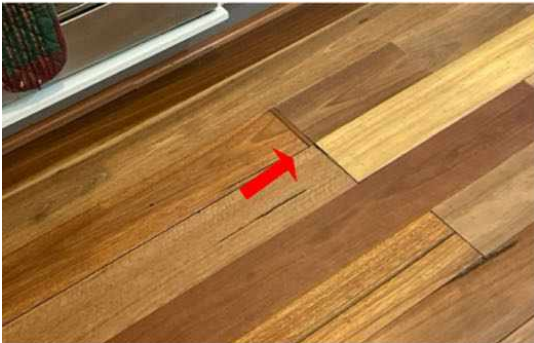
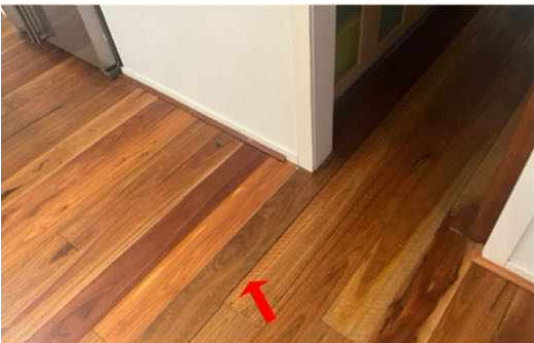
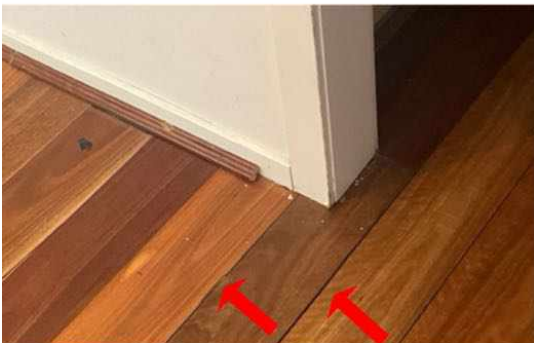
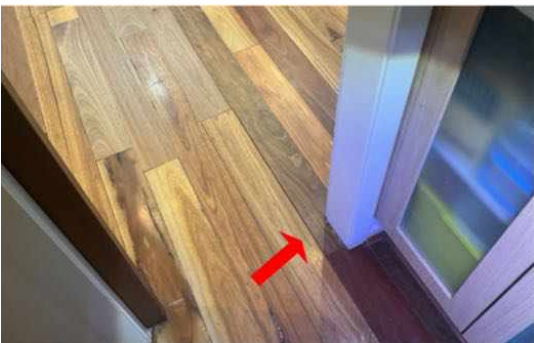
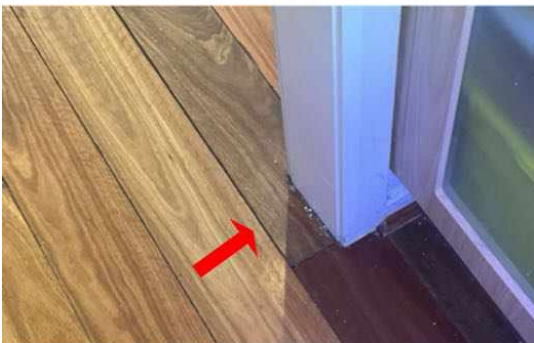
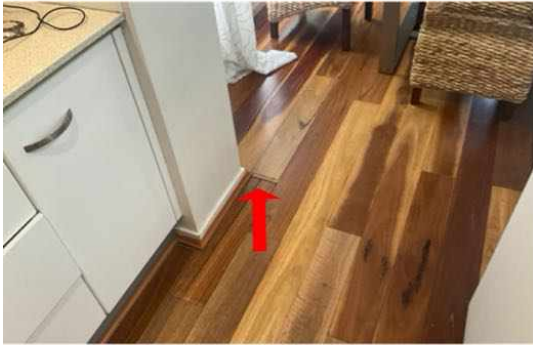
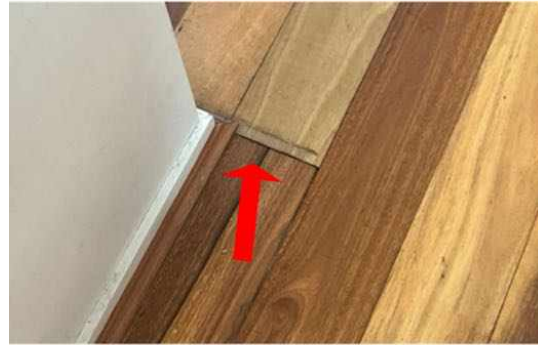
Finding 3.05

Building:
 Location: Kitchen
 Finding: Damage to flooring within the kitchen
 Information: Damage was noted to the floorboards of the kitchen area at the time of inspection. It is suspected that previous leaking from the dishwasher may have caused the damage. There was no signs of any current leaking.

An invasive inspection (ie lifting the floorboards) may be required to determine the extent of the damage. Depending on the extent of the damage, repairs may range from lifting , filling , sanding and relaying the existing floorboards, through to full replacement of the boards in this area.

A flooring specialist can be engaged to perform this task.

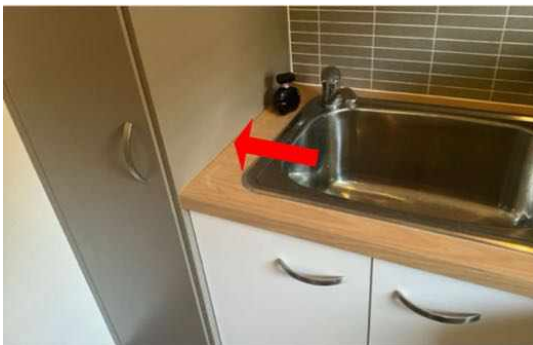
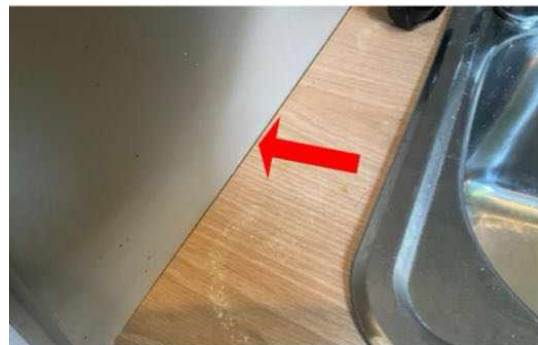
Finding 3.06

Finding: Sealant - Damaged or Missing

Information: Sealant is damaged or missing in this area. Sealant is used to protect gaps and crevices in building materials to ensure that they are water-tight and prevent water penetration to the associated structures.

Failure to do so may lead to water damage to the surrounding area.

Where sealant is missing or damaged , a general handyman may be appointed to re-apply any silicone where necessary.

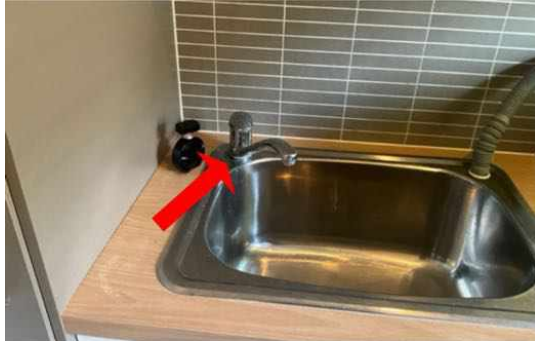
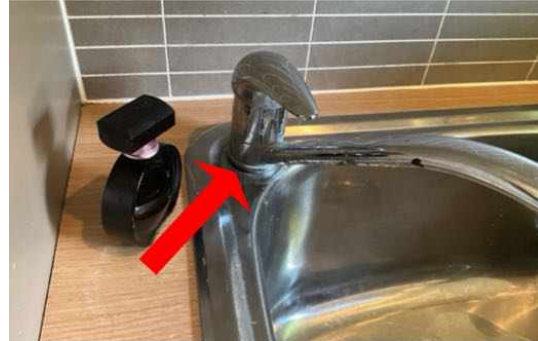
Finding 3.07

Finding: Tap - Loose

Information: The tap in this area has not been installed correctly, or has deteriorated with age, and is consequently loose. This tap being loose creates potential for water leaks and subsequent water damage to the surrounding area.

Where taps or spouts are loose, a qualified plumber should be appointed to re-fix the

plumbing fitting.

This defect should be addressed as soon as possible so as to prevent further deterioration and possible water leaks.

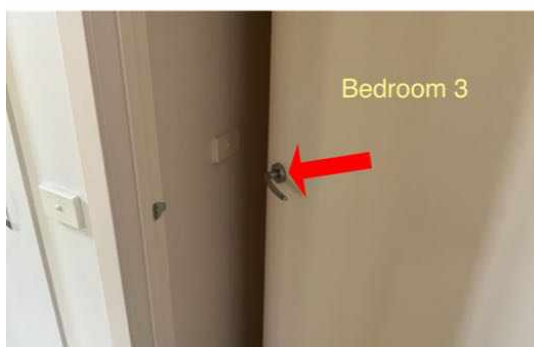
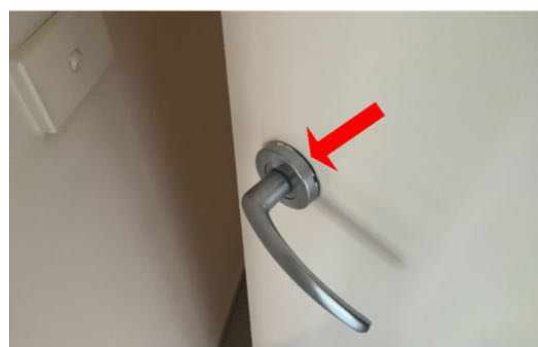
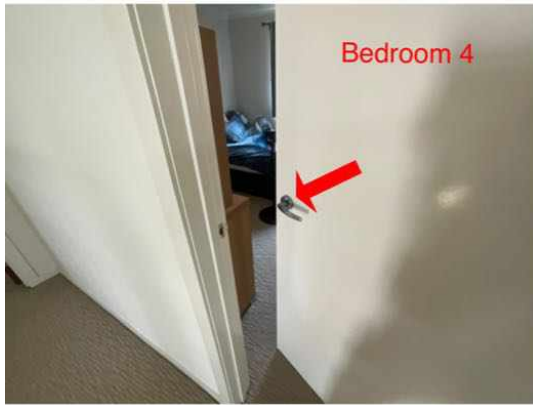
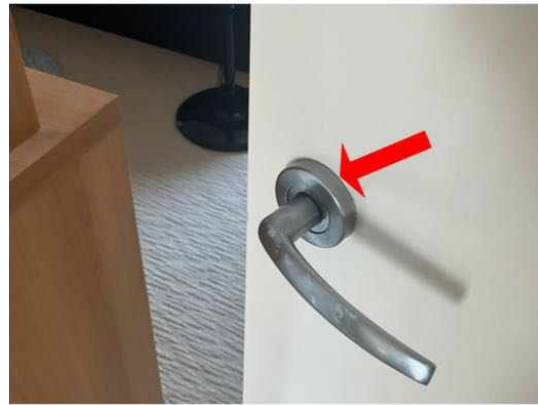
Finding 3.08

Finding: Door - loose handle

Information: The door handle in this area was found to be loose at the time of inspection. This can occur when the building materials have aged, but may be indicative of impact damage (accidental or deliberate).

Repair and/or replacement of the loose door handle is advised to improve the operational state of the associated door.

A qualified carpenter or general handyman should be appointed to perform this task at the client's discretion.

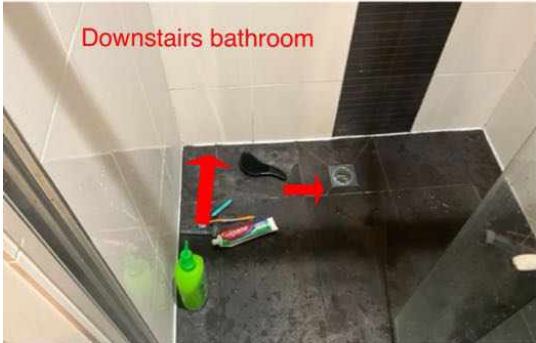
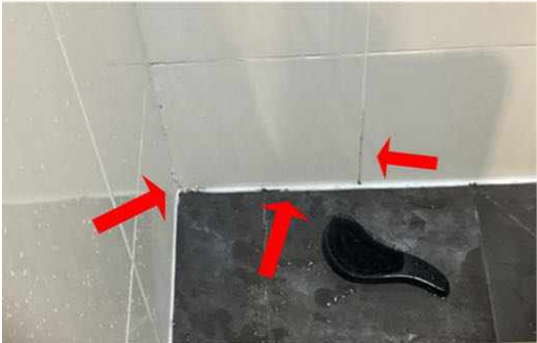
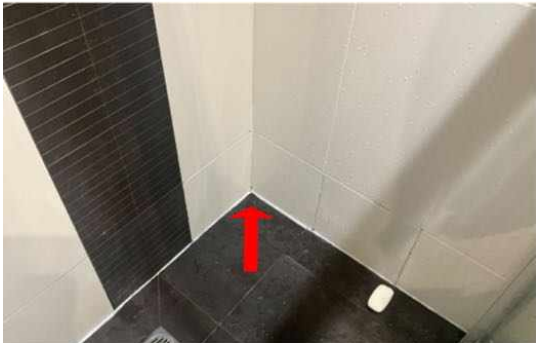
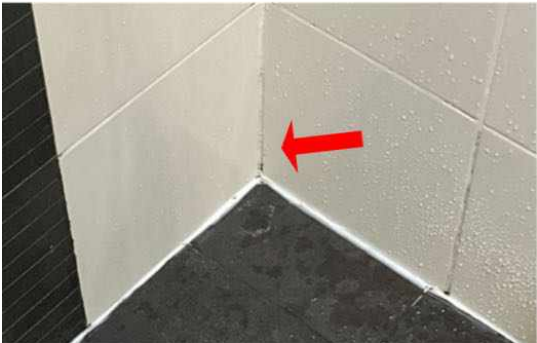
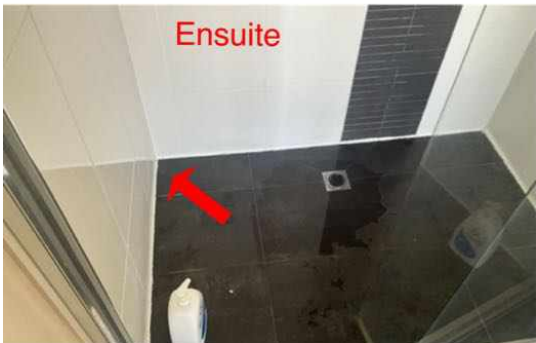
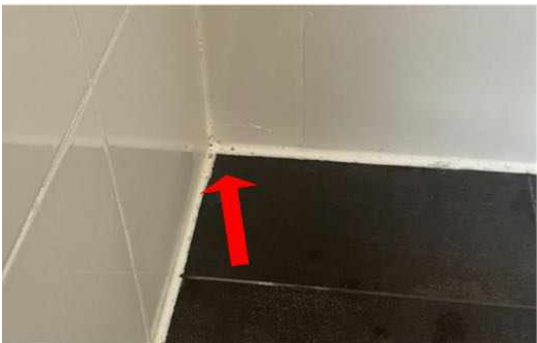
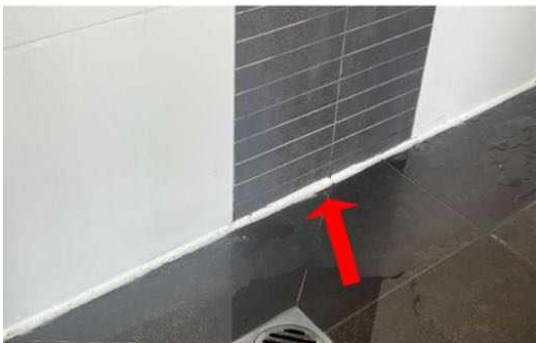
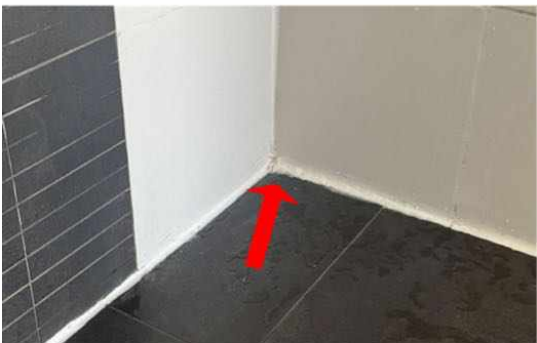
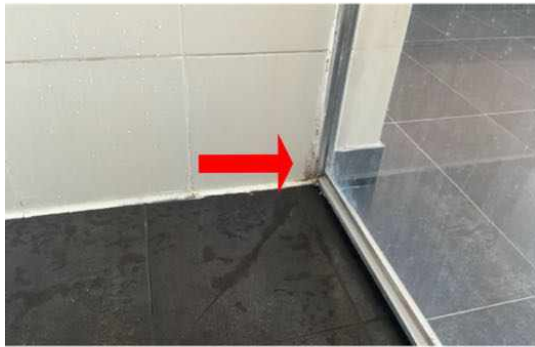
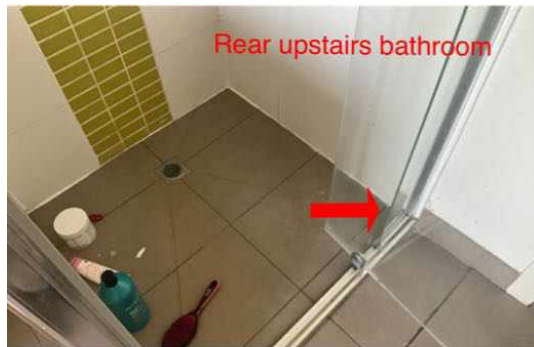
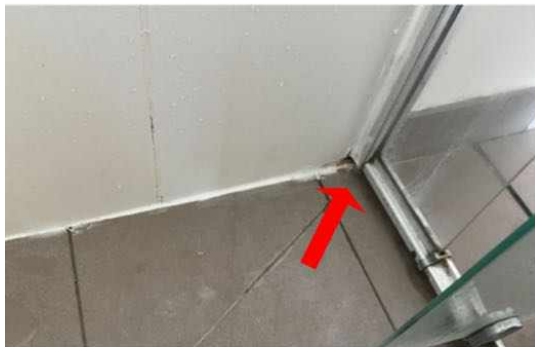
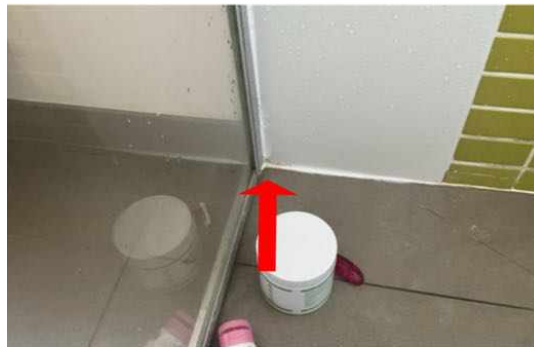
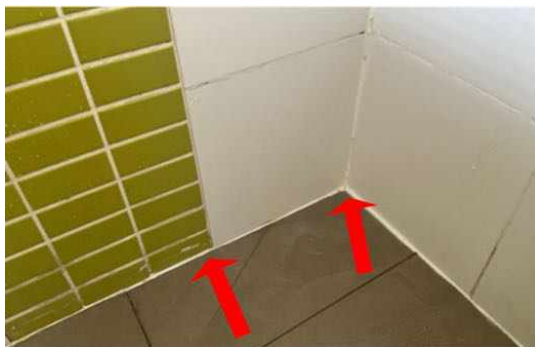
Finding 3.10

Building:	
Location:	Bathroom
Finding:	Sealant and grouting - degraded in bathroom
Information:	It was noted on inspection that sealant and/or grout is degraded to the tiled shower alcove area of the bathroom.

Different materials and floor areas move at different rates, generally causing cracking to grout or sealant at various points. A flexible sealant is required to allow for expected expansion and contraction, while keeping the joint water tight and protective of all associated building materials.

Flexible and mould resistant materials should be applied to affected areas to prevent any subsequent water damage that is likely to occur. Regular maintenance and replacement of damage or missing or damaged sealant and grout is highly recommended to the wet areas, as this is a regular wear and tear defect. Sealant and grouting in areas that come into regular contact with water should be maintained for the long term care of your property.

A sealant specialist or tiling contractor should be appointed to complete these works as soon as possible

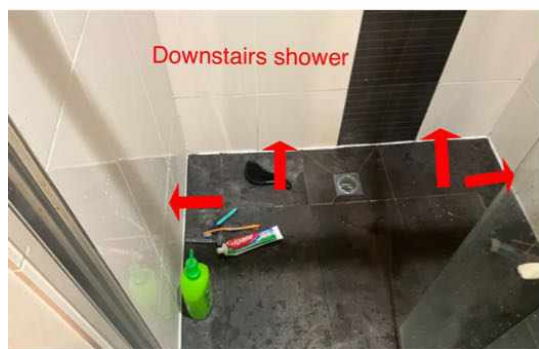
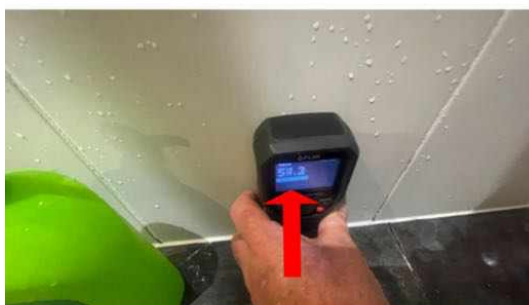
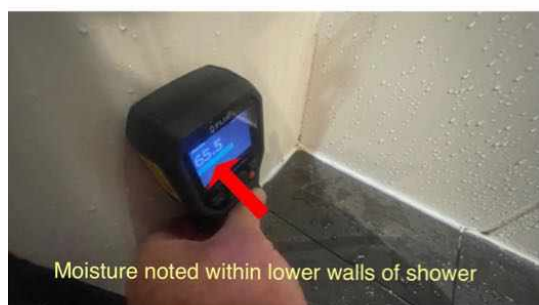
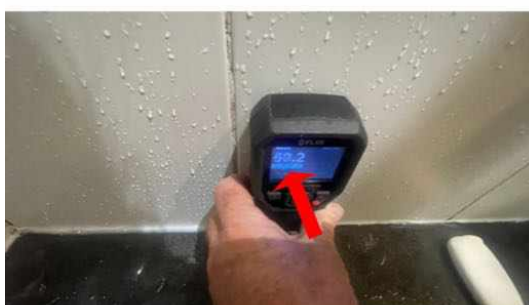
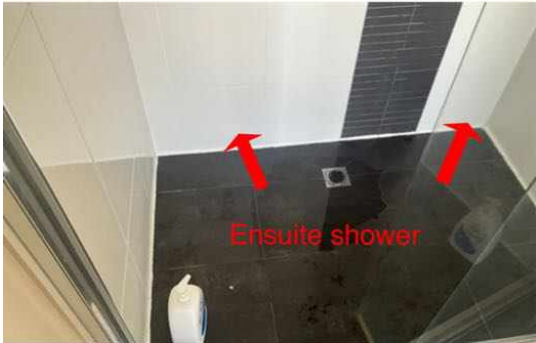
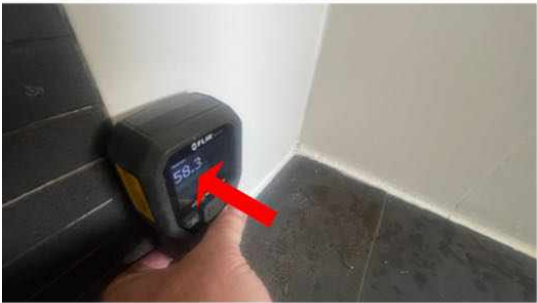
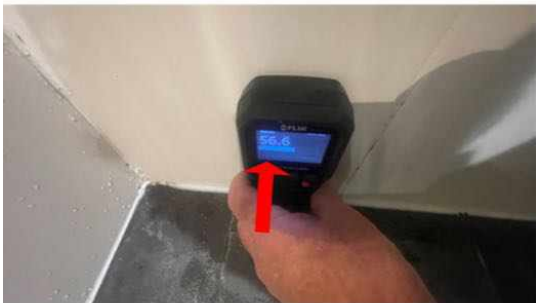
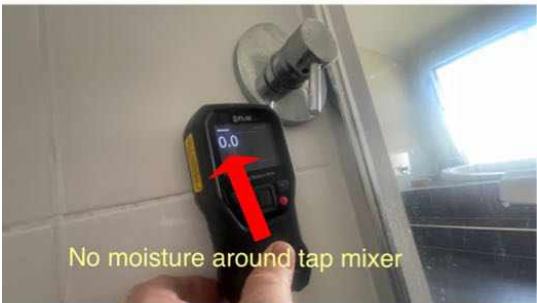
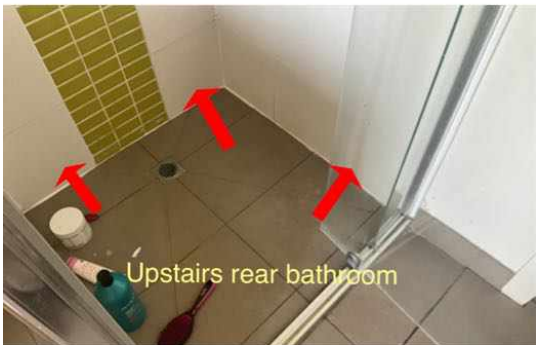
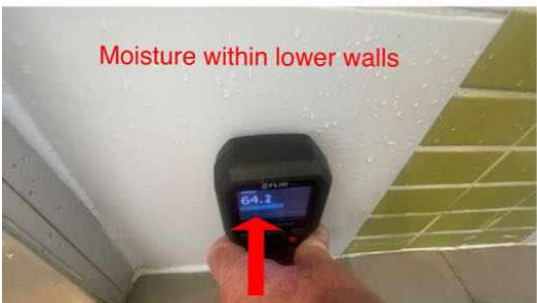
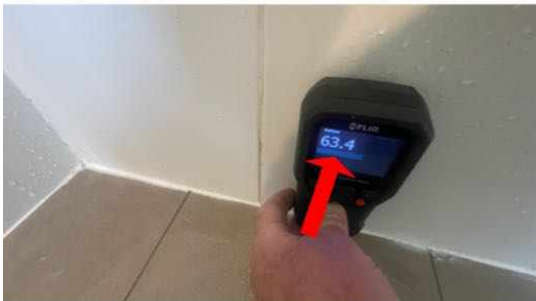
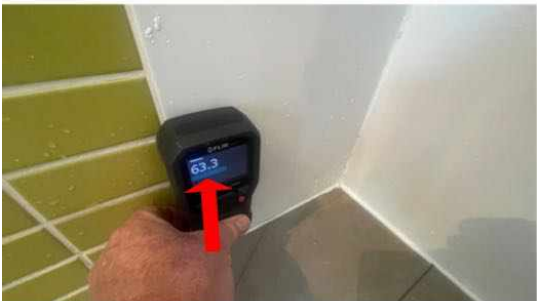
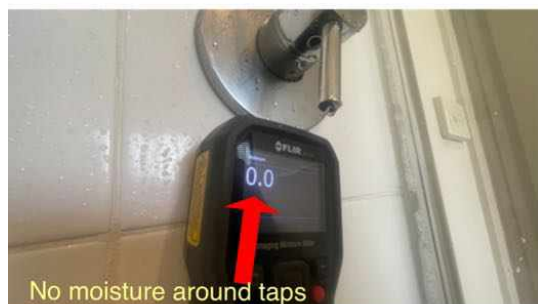
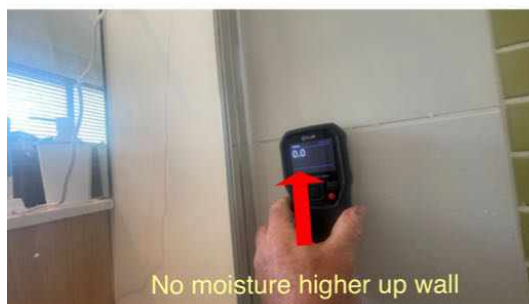
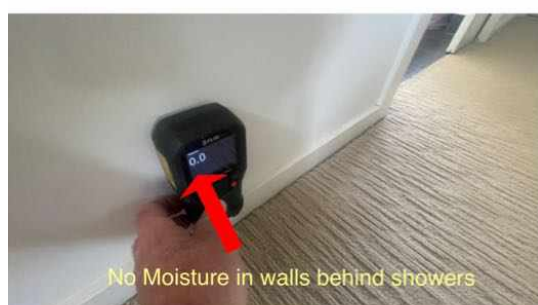
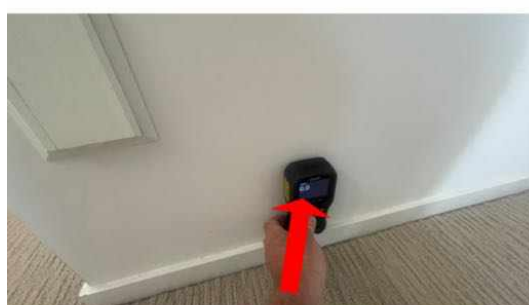
Finding 3.11

Information: Damp is evident to the lower 400mm of wall to the shower alcoves. This defect is quite common, and is suspected to have been caused by moisture permeating or leaching through the grouting and sealant in these areas, which show evidence of deterioration. Leaking pipes within the walls is also a possible cause however this seems unlikely in this instance as there is no moisture build up around the tap mixers nor transferring to the other side of the wall.

Damp (or structural damp) refers to the presence of unwanted moisture in the

structure of a building, either as the result of intrusion from outside, or condensation from within the structure. In the shower area, internal water leaks, degraded materials or other sources of excessive moisture are generally the cause of damp.

Unmanaged damp in the shower recess is likely to facilitate the formation and development of mould and fungi growth, decaying associated building materials and compromising their structural integrity of associated elements. It is important to address damp conditions, as the World Health Organisation notes that excess moisture leads - on almost all indoor materials - to growth of microbes such as moulds, fungi and bacteria, which subsequently emit spores and other matter into the indoor air. Exposure to these contaminants is associated with a wide range of respiratory and other health-related problems. Damp conditions also create a conducive environment for termite infestation.

Please note : the showers had recently been used which can affect moisture readings.

Consultation with a bathroom sealant specialist is advised immediately to identify the cause of damp and to perform remedial works as required. Always ensure that sealant and grout is in good condition to prevent any moisture issues occurring in the future.

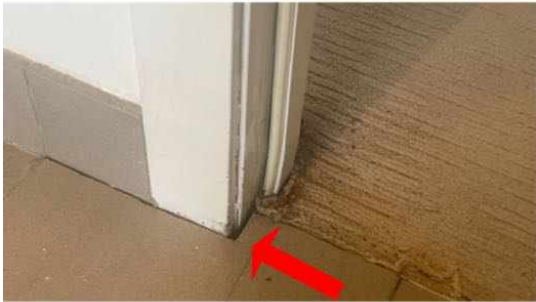
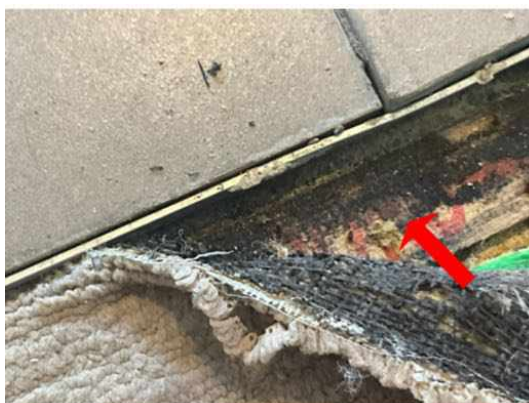
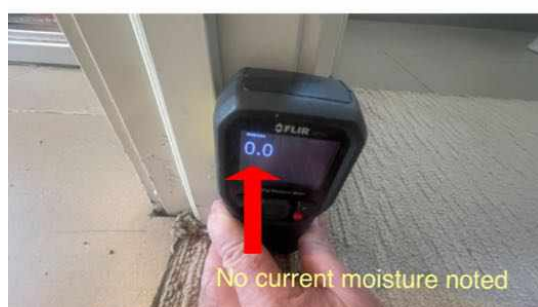
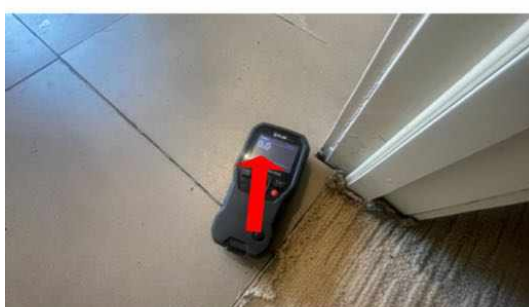
Finding 3.12

Building:	
Location:	Bathroom > Upstairs,Rear
Finding:	Moisture damage to door frame and possible lack of an effective water stop.
Information:	Evidence of moisture damage was identified to the door frame in the bathroom. It is suspected that this has occurred as a result of excess moisture from internal spills or from water seeping under the tiles.

A water stop is a barrier which prevents moisture that may have seeped under the floor tiles to move out of the wet area into the hallway. This barrier forms part of the waterproofing system in the bathroom. Having gaps at either end means the water stop is not complying with current standards. Standards have changed however over the years and bathrooms only needed to meet the standards that were applicable at the time of installation.

Please note: staining was noted to the ceiling of the dining area immediately

underneath this bathroom. It is suspected this staining was caused by leaking in the bathroom. No current moisture was noted in the ceiling at the time of inspection when tested with a moisture meter.

It is highly recommended that a Tiler be engaged to inspect the area to improve the water tightness of the bathroom and prevent moisture exiting. This could involve sealing the ends of the water stop, through to installing new stops. Regrouting and ref sealing of the bathroom is also required.

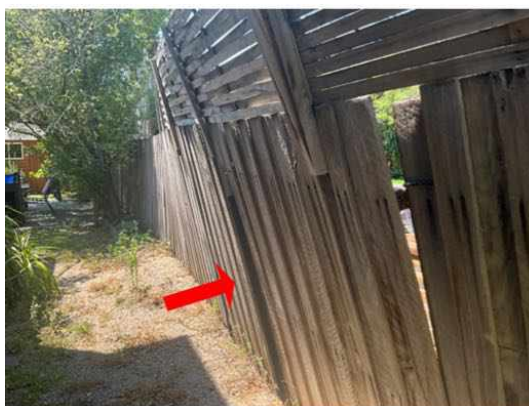
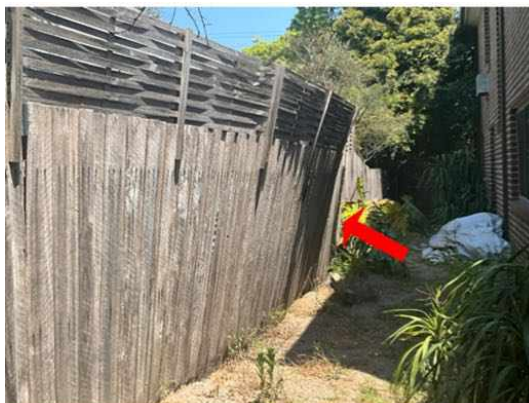
Finding: Fencing - leaning and deteriorated

Information: It was noted at the time of inspection that a section of the fencing at the side of the property was leaning quite substantially. Other sections of the fence were also deteriorated.

Typically fencing deteriorates due to age and or wear, rot and or rust which is generally expected for a structure of this age, due to prolonged exposure to weather conditions. Sometimes inadequate installation or maintenance can be to blame.

Repair of several elements of the fencing will be required. Replacement may also be a consideration.

A licensed fencing contractor should be appointed to provide further advice and perform rectification works as necessary.

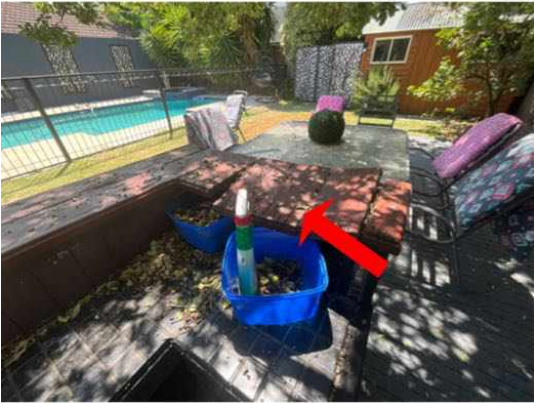
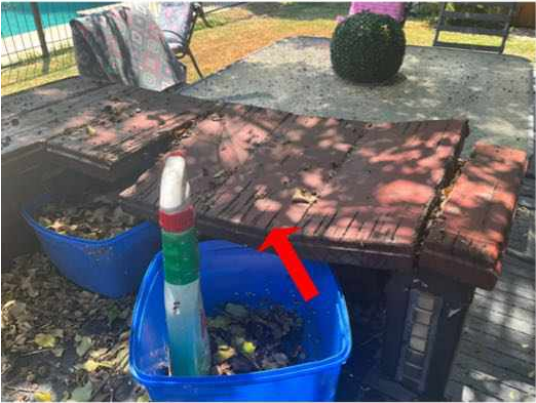
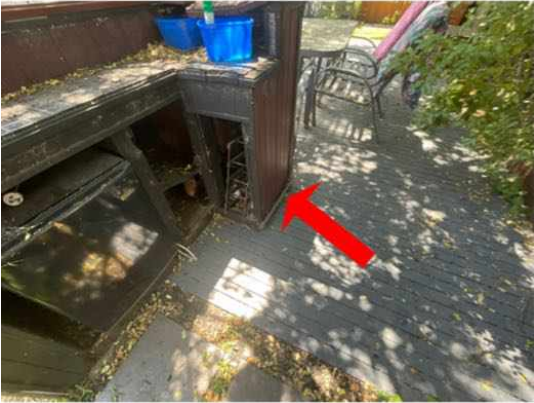
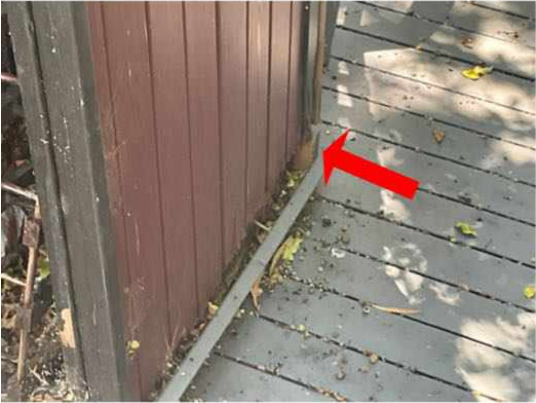
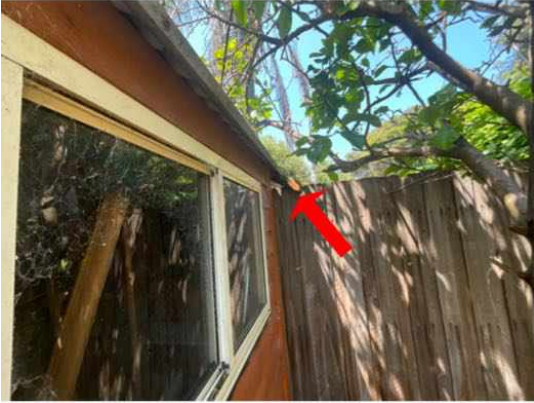
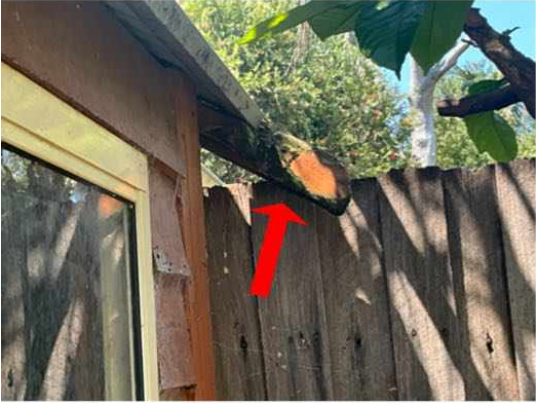
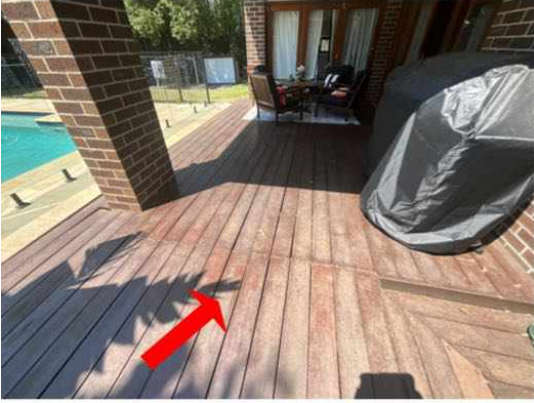
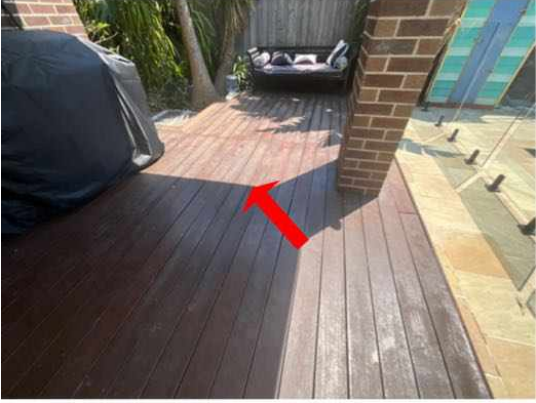
Building:
Location: All External Areas
Finding: Timber - exposed to weather
Information: External timbers that are frequently exposed to harsh weather conditions require adequate protection in order to maintain their condition. Where timbers have not been painted or treated adequately, general deterioration is likely to occur at an accelerated rate.

If left unattended, replacement of these timbers is likely to be necessary in the short-term future.

Adequate treatment of these timbers is required as soon as possible by a painting contractor or general handyman.

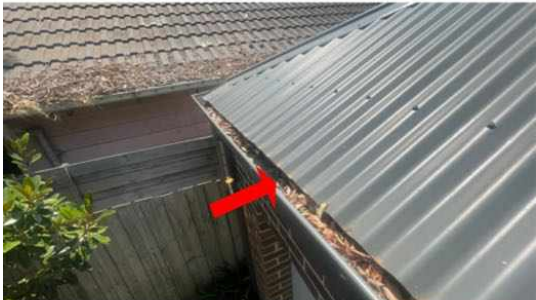
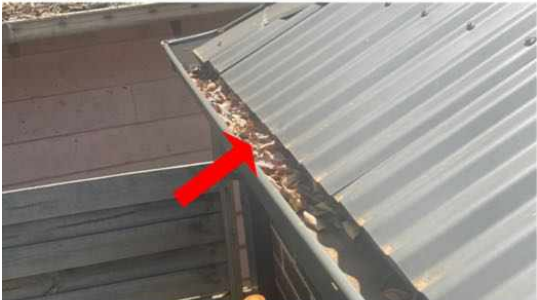
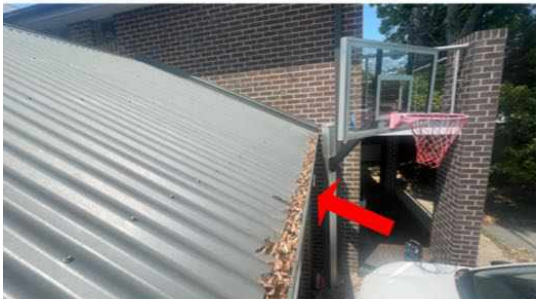
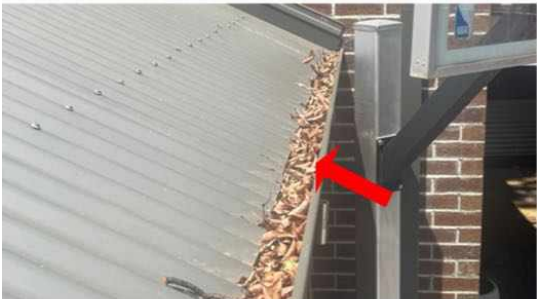
Finding 3.17

Blocked gutters are likely to lead to high levels of moisture in the affected areas. Such moisture will not only cause rust and decay of the associated building materials, but can also provide conditions that are conducive to termite and timber pest activity. Blockages in gutters should therefore be removed immediately to ensure dry conditions are maintained.

Consult a Licensed Plumber for further specific advice on remedial works that may be required. In the interim, it is highly advised that blocked gutters be removed by the homeowner or a general handyperson as a matter of urgency.

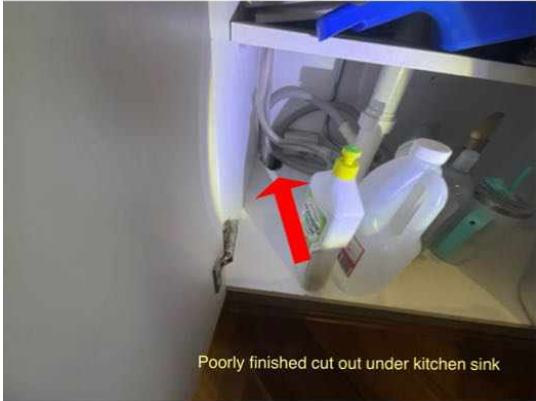
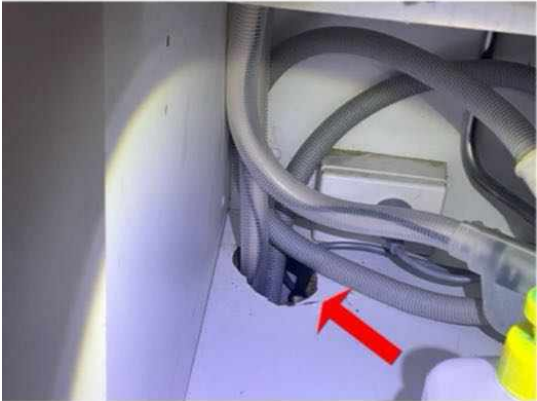
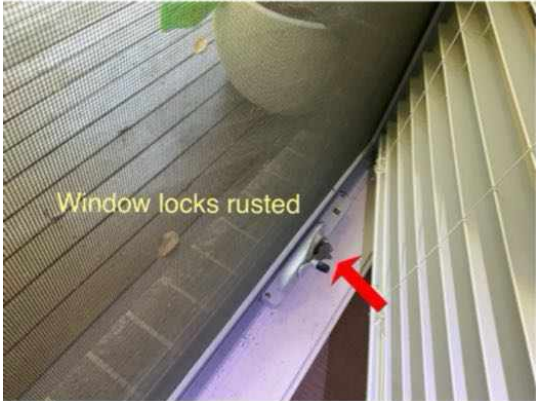
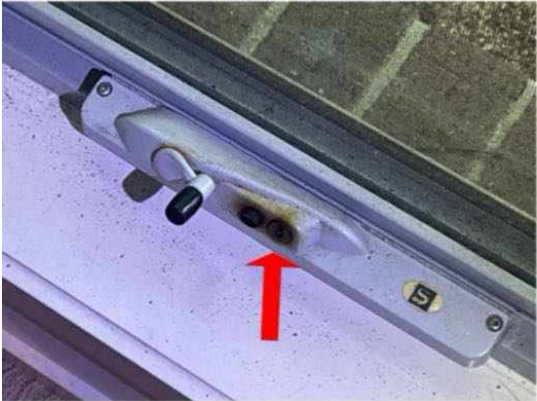
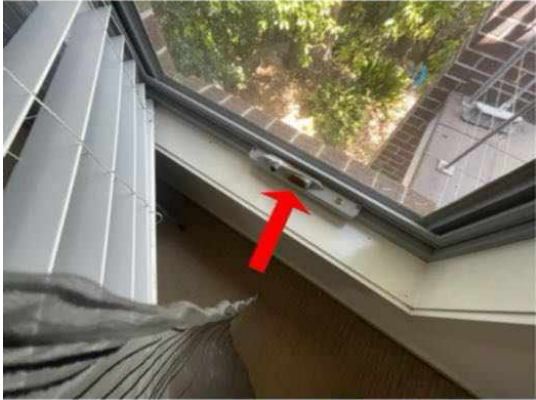
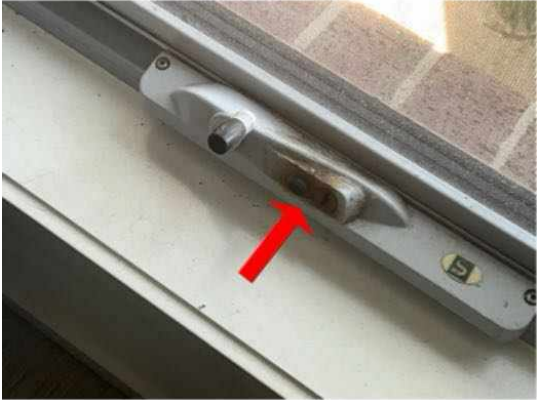
Building:
Location: All Areas
Finding: Additional Photos - minor defects
Information: Additional photos are provided for your general reference. Arrows have been included where necessary to highlight areas of importance.

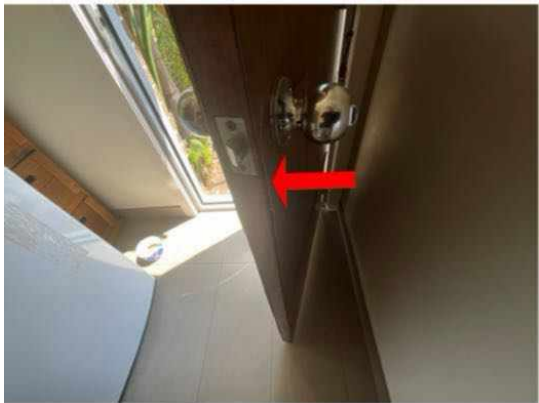
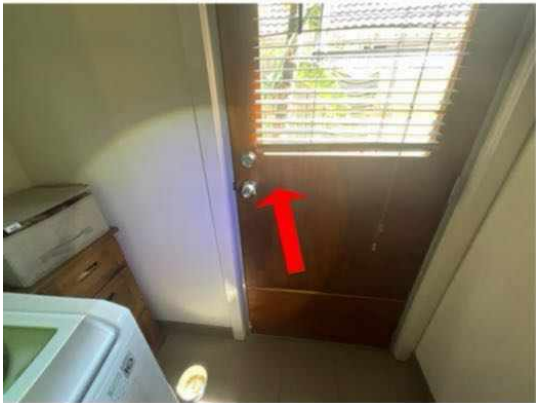
Laundry door damaged

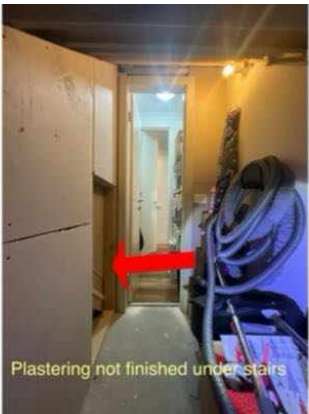
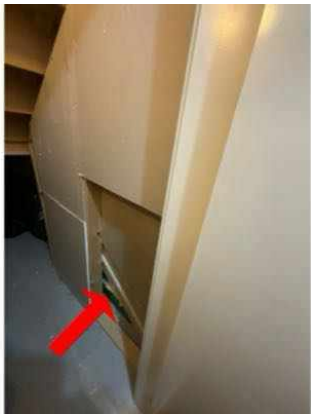
Plastering not finished under stairs

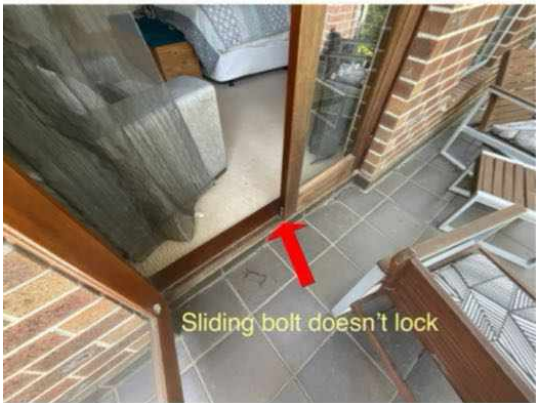
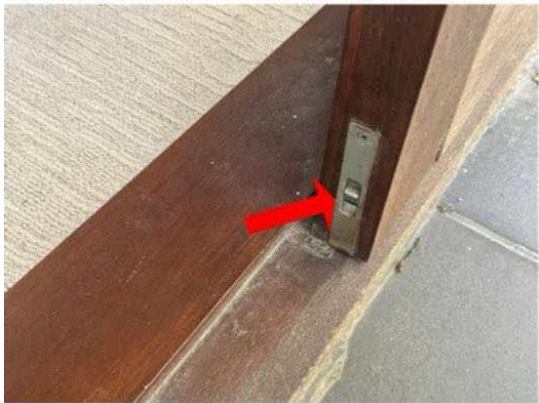
Sliding bolt doesn't lock

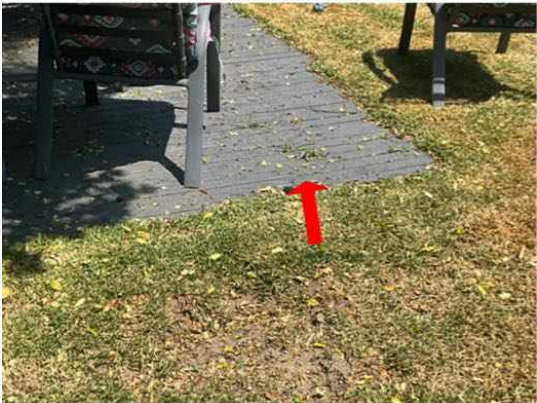
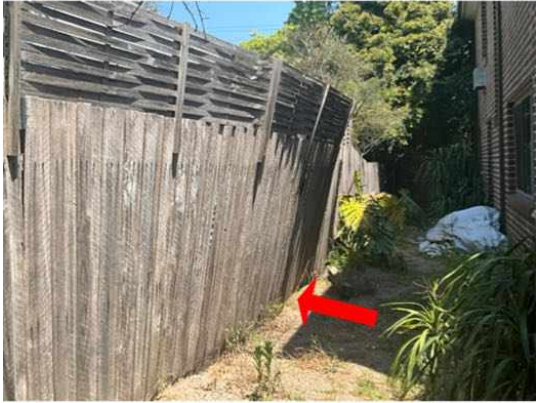
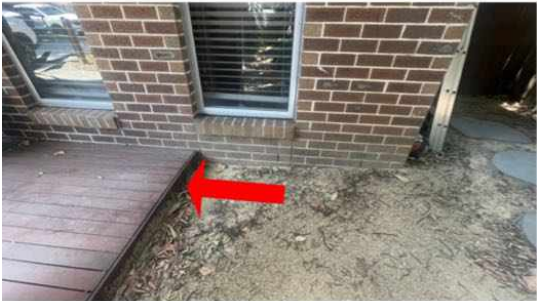
Information: Where timber elements are in direct contact with the ground and consequently moisture or dampness, they become conducive to termite activity. Whether timber is used as a building element, part of a fencing structure or stored as an unused item, they can provide an environment that is attractive to termite infestation.

When met with excessive moisture, timber begins to decay and develop wood rot. Any timbers that are in direct contact with external grounds especially if left untreated or non-durable also provide ingress for subterranean termites into that particular element.

Where possible, the removal of any such materials that may be conducive to termite activity should be carried out as soon as possible to minimise the risk of termite attack. Where not possible or practical, regular monitoring of timber elements is recommended. Replacement of any damaged materials should be carried out where necessary.
