Building and Timber Pest Inspection Report

Inspection Date: Mon, 12 Jan 2026

Property Address: 48 Church St, Beaumaris VIC 3193, Australia

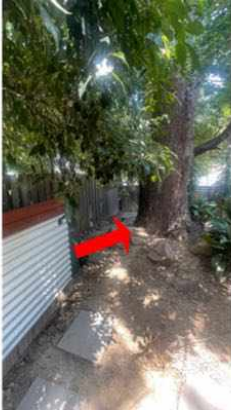
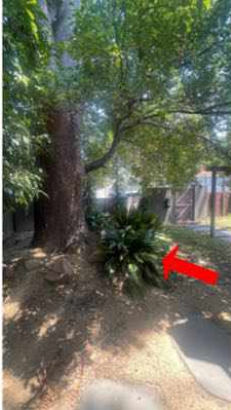
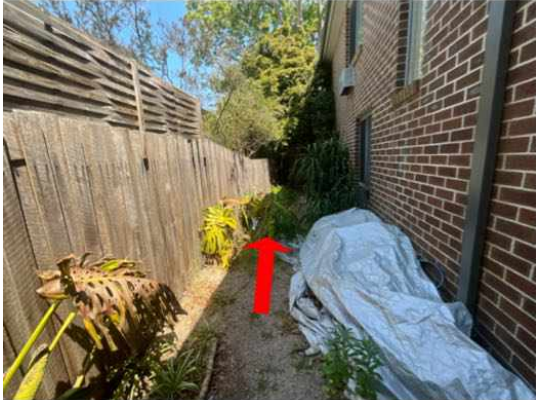
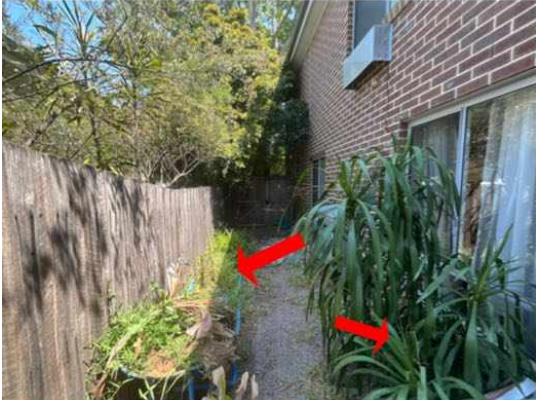
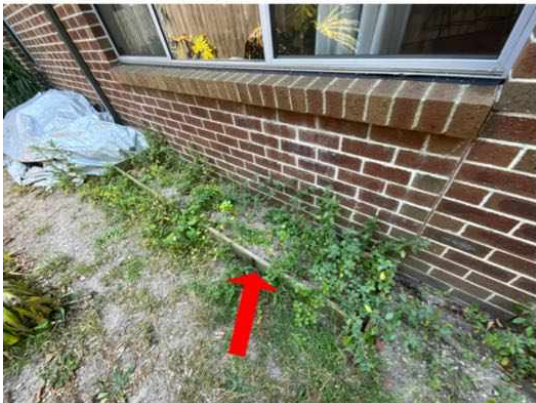
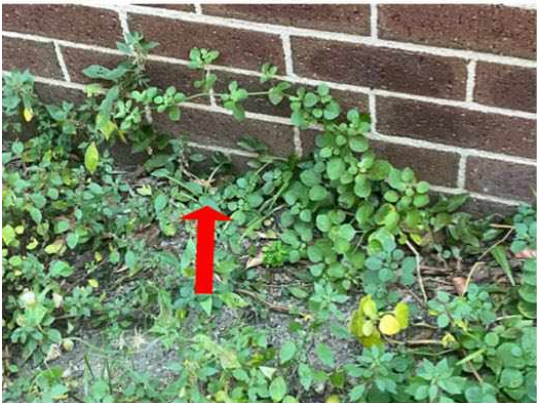
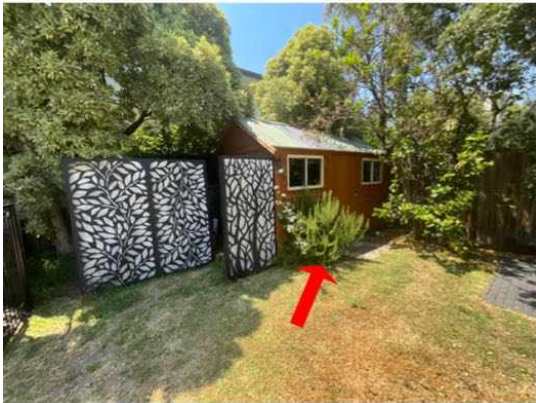
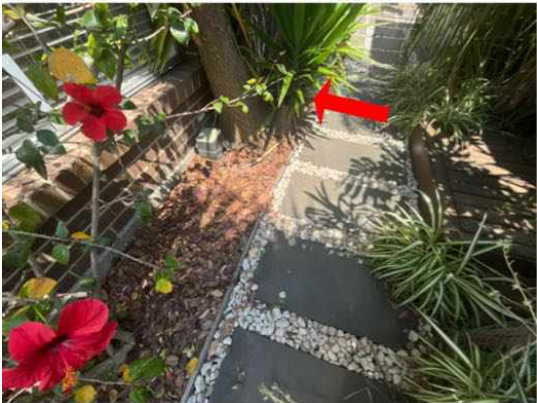
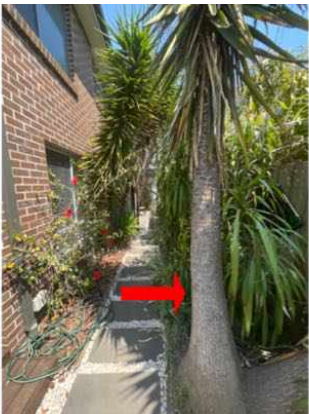
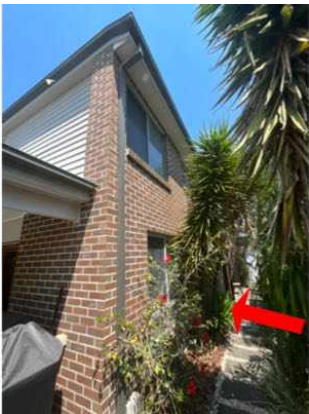
Finding 6.02

Building:
Location: All External Areas
Finding: Trees and Garden Beds - Conditions Conducive to Termites
Information: Trees and Garden beds were found to be evident around and against the property. These areas can include untreated timber, and with a combination of moisture from rainfall and hosing, can make conditions conducive to termite activity and termite ingress.

The removal and replanting of species that do not provide "cover" or cutting back of existing vegetation will assist greatly in preventing this from occurring.

The removal of any such materials that may be conducive to termite activity should be carried out as soon as possible to minimize the risk of potential termite attack.

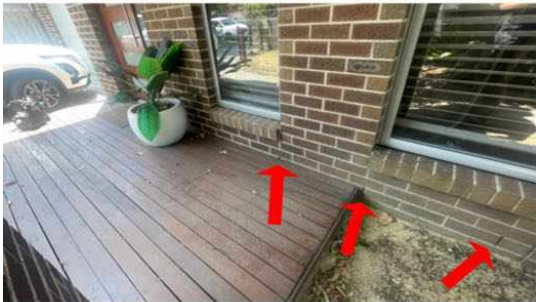
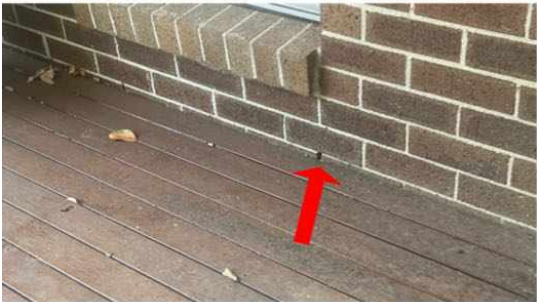
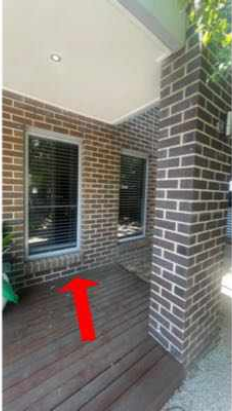
Finding 6.03

Information: It was noted during the time of inspection that some of the weep holes to the brickwork were blocked. Weep holes are designed to allow water from leaks or seepages in brickwork to be directed to the external environment, prior to entering the wall cavity or associated building materials. Weep holes should therefore be kept clean and free of debris or blockages.

Blocked weep holes are likely to result in the presence of excessive moisture within the brickwork and associated structures, creating potential for water damage and

moisture problems.

Depending on the nature of the blockage, the homeowner may be able to undertake remedial works to remove blockages. Alternatively, appointment of a registered builder may be required to remove blockages. Preventative works are necessary in ensuring the structural integrity of the affected brickwork and should be performed as soon as possible.

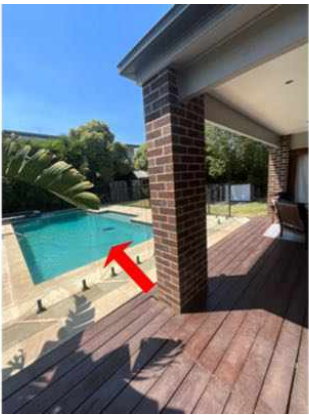
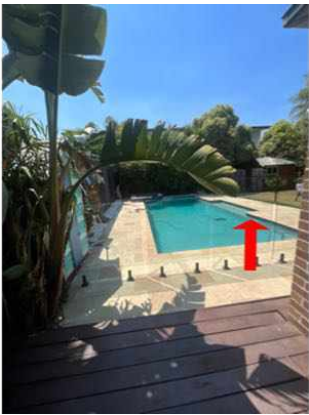
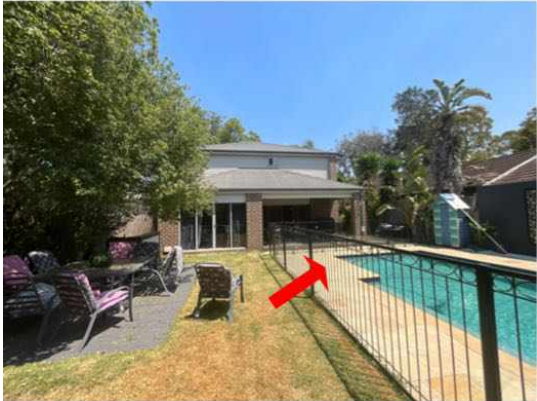
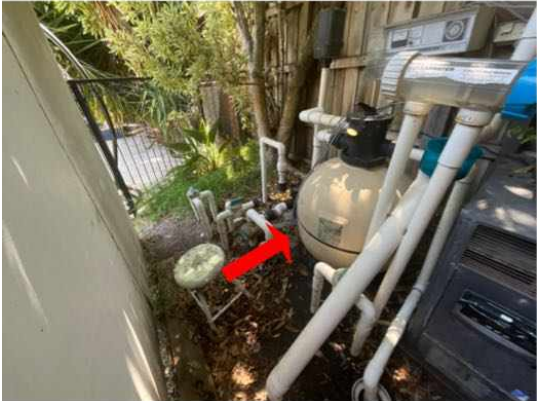
Building:
 Location: Pool Area
 Finding: Pool , equipment and fencing
 Information: Please note that this inspection does not cover pool, equipment or fencing.

It is highly advised that a pool specialist be appointed to inspect the pool and associated equipment and provide advice on compliance and any rectification works that may be required.

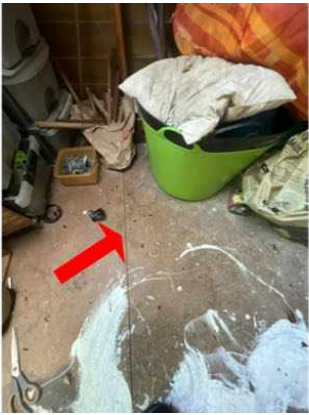
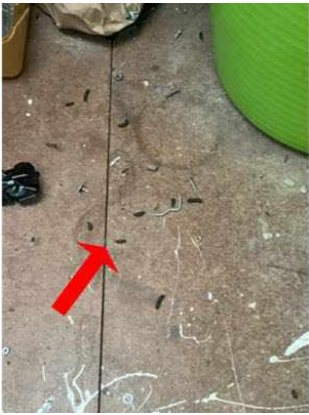
Building: Shed
 Location: Shed
 Finding: Evidence of Vermin (suspected rats)
 Information: Evidence of pests or rodents were present in the rear shed at time of inspection including animal droppings and odor.

Rodents can cause issues ranging from smells and stains through to physical damage.

A licensed pest controller should be appointed to free the area of any pests.

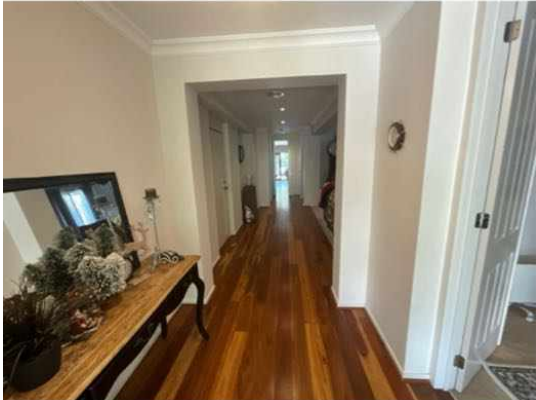
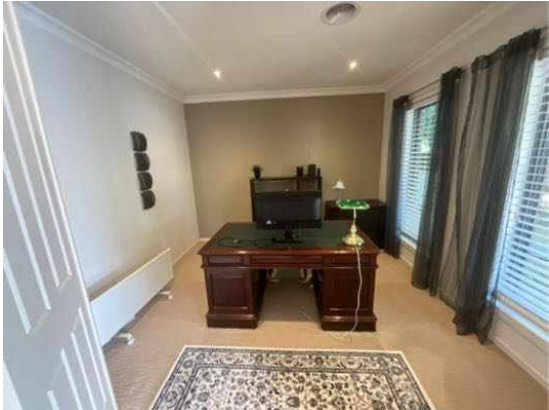
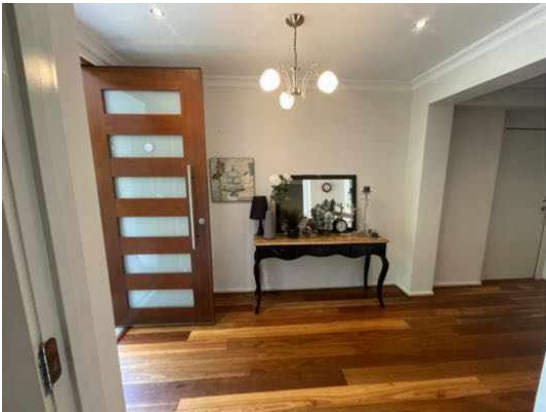
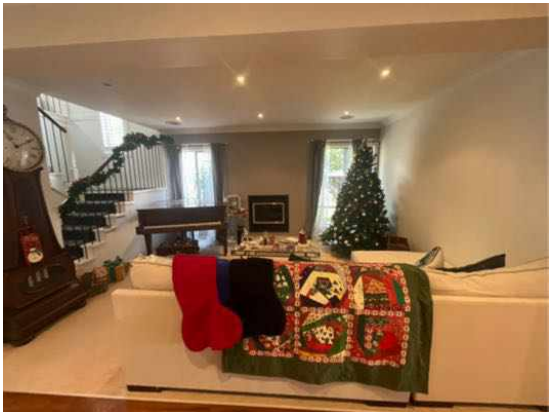
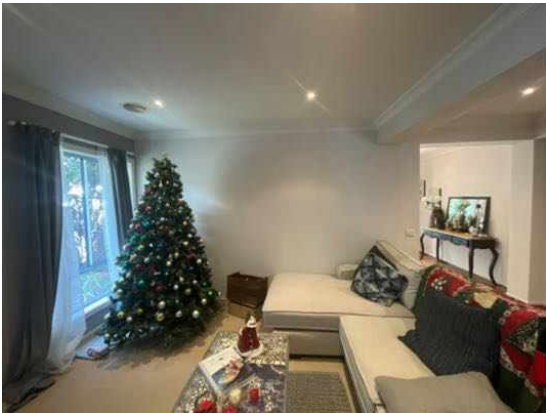
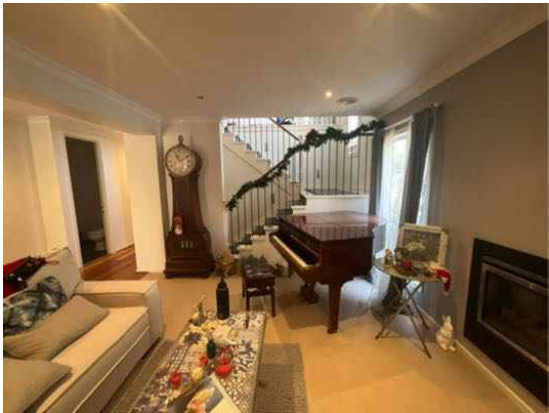
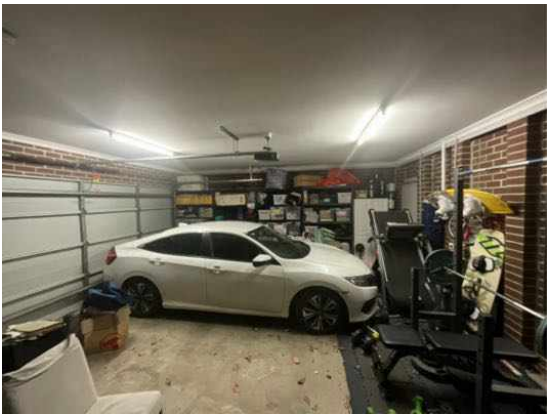
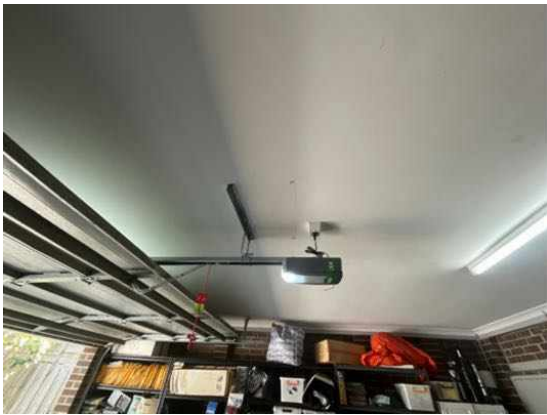
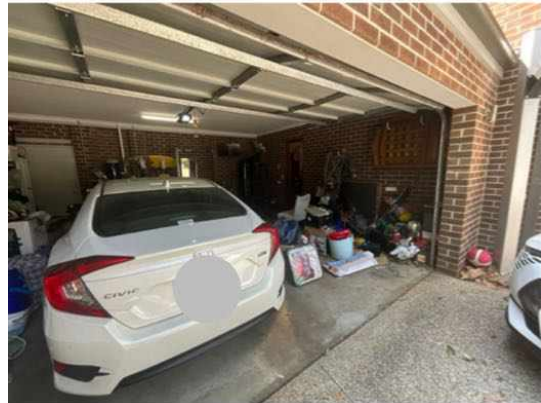
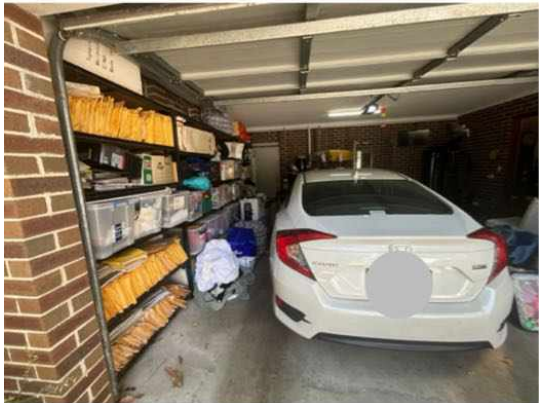
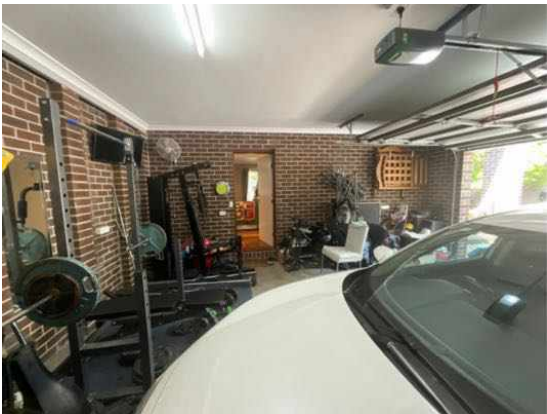
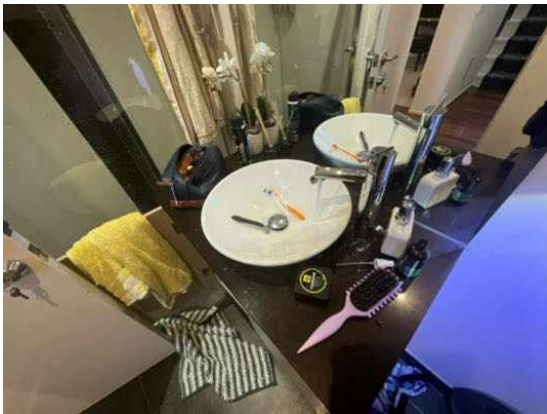
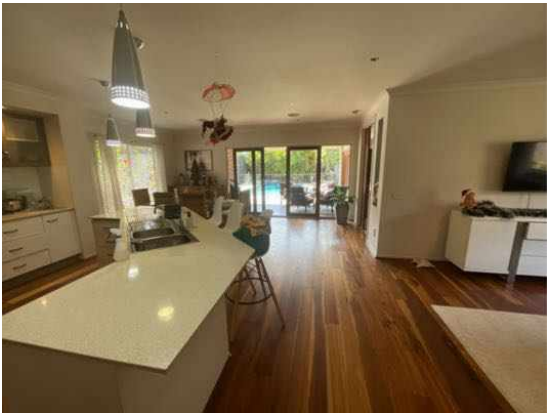
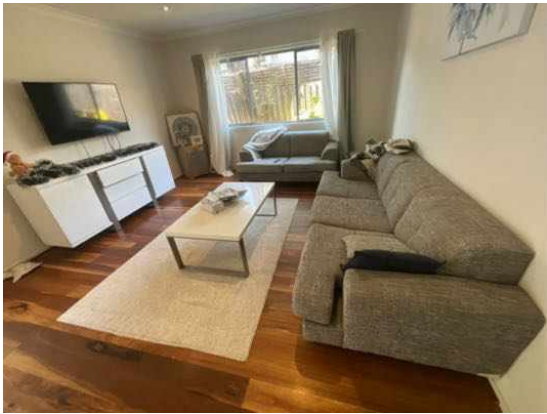
Building:
Location: All Areas
Finding: Additional Photos - Obstructions and Limitations
Information: These photographs are an indication of the obstructions and limitations which impeded full inspection of the property at the time of inspection. These obstructions can hide an array of defects and should be removed to allow full inspection to be carried out. A re-inspection is recommended once the areas are made accessible.

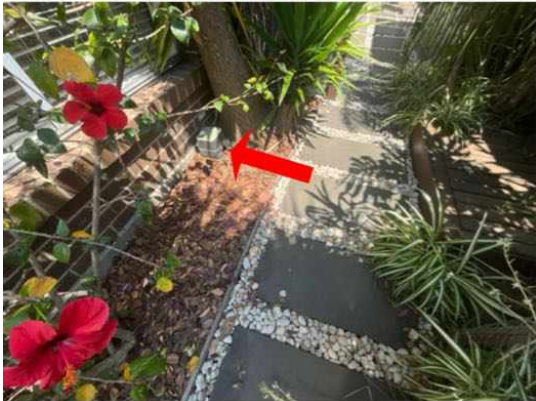
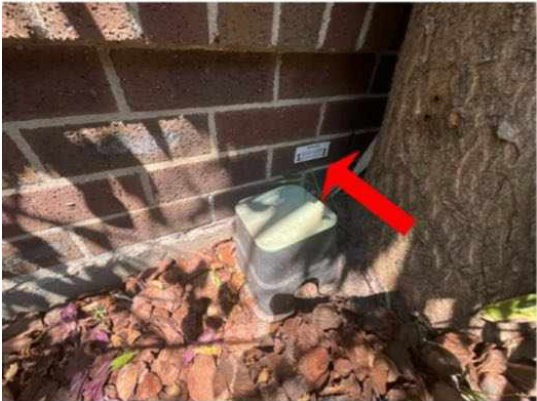
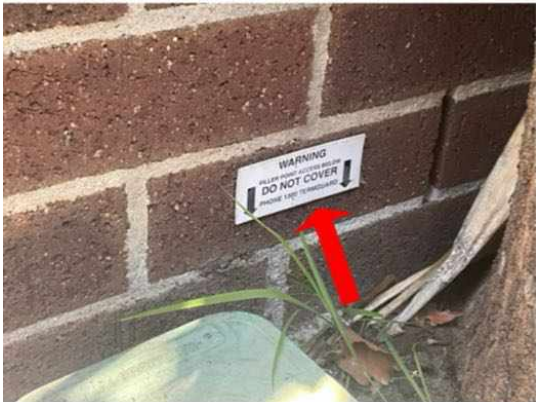
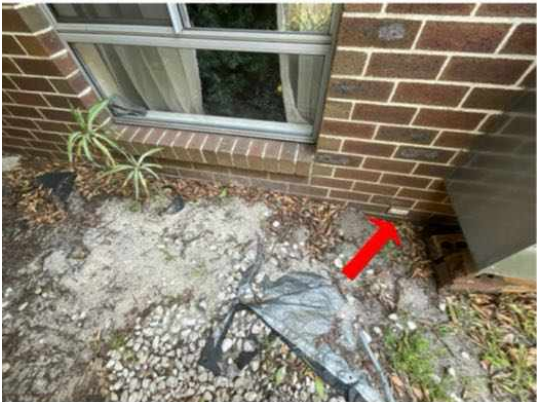
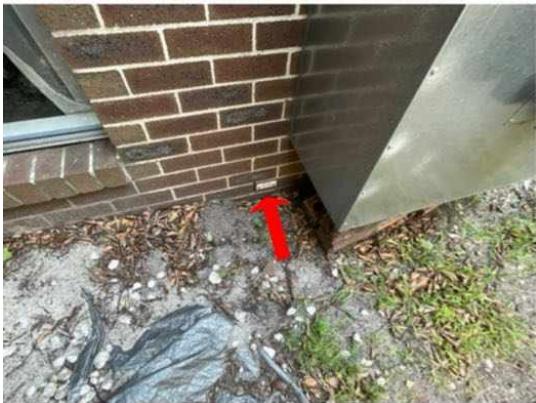
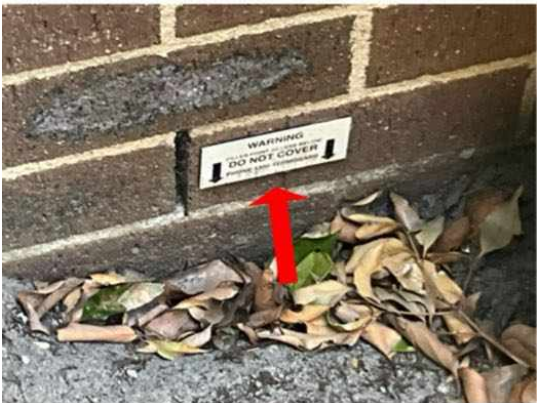
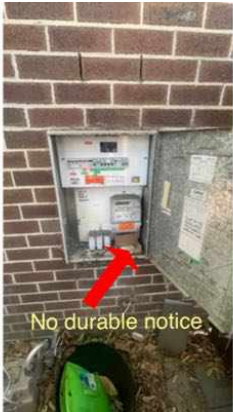
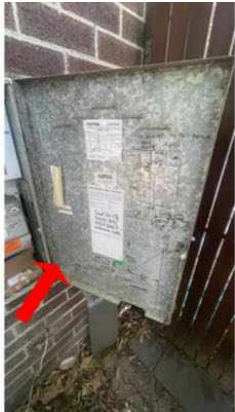
Building: All External Areas
Location: All External Areas
Finding: Evidence of a previous termite management system was identified
Information: There are a number of factors which indicate the presence of a previously installed or applied termite barrier. The most common are a durable notice (to the inside of your meter box) observable physical barriers installed to building perimeter and in ground reticulation systems (as noted here).

Where a Termite Management System has been identified you should refer to the type of barrier date of installation warranty conditions and any documentation provided by a builder or past owner. Consult the company who installed the barrier to confirm whether the system is still under warranty.

Most chemical termite management systems expire and require replenishment and all physical systems are primarily designed to prevent concealed entry.
