# Building and Timber Pest Inspection Report

Inspection Date: Sat, 14 Mar 2026

Property Address: 16 Airdsley Ln, Bradbury NSW 2560,  
Australia

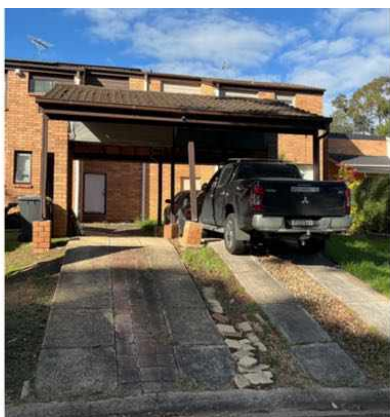
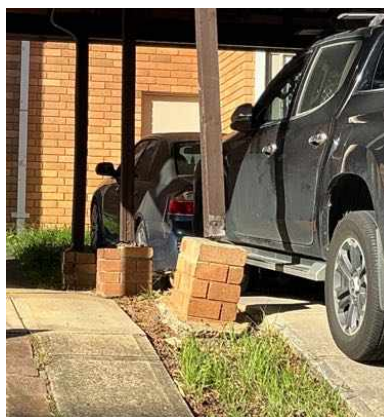
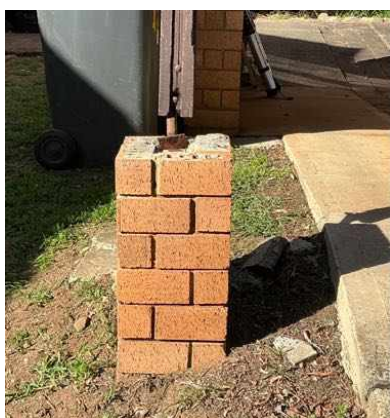
#### Finding 1.01

Building: Main Building  
Location: All External Areas - Carport  
Finding: Carport Structure safety - Refer to Defect 2.1  
Information:

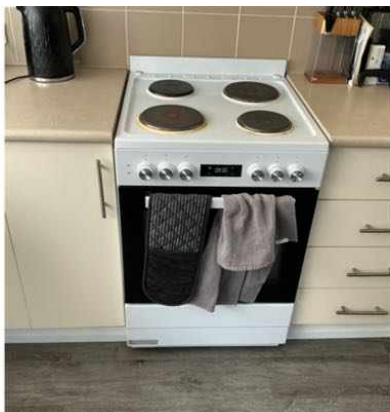
#### Finding 1.02

Building: Main Building  
Location: All Internal Areas  
Finding: Unsecured Oven Installation  
Information: The electric oven located beneath the gas cooktop in the kitchen island was found to be unsecured.

During a light pull, the oven moved forward freely, presenting a potential safety hazard, especially if weight is applied to the open door. According to AS 4349.1–2007 Appendix C (C2.2 and C2.3), appliances should be properly installed to prevent movement or dislodgement.

This defect is considered a major safety concern due to the risk of injury or damage. Immediate rectification is recommended by a licensed kitchen installer or qualified tradesperson to properly secure the appliance in accordance with manufacturer installation instructions. Rectification should occur within 24–48 hours to eliminate the risk.

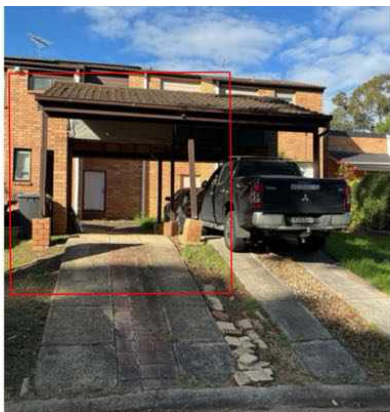
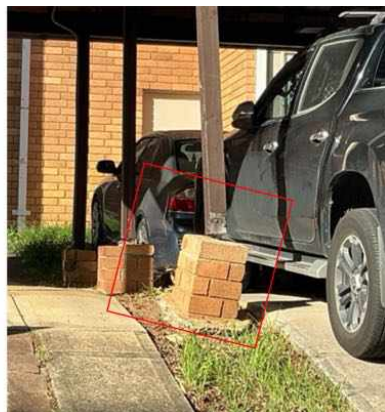
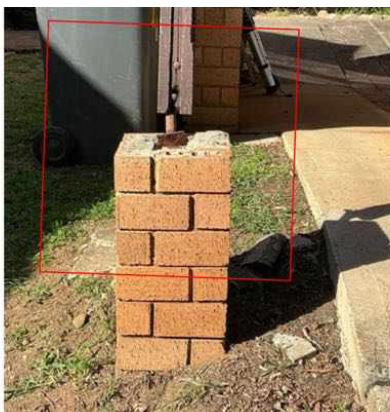
### Finding 2.01

Building:	Main Building
Location:	All External Areas - Carport
Finding:	Building element - Damaged - carport supports misaligned , displaced footing - Safety Hazard
Information:	Movement and misalignment of the carport support posts were observed, with one or more posts leaning and the supporting brick pier appearing displaced from its original position. Movement of supporting footings can occur due to settlement, soil movement, inadequate footing depth, or impact damage and may affect the structural stability of the carport roof structure. Where supporting posts are not adequately supported or aligned, loads may not be transferred correctly which may increase the risk of further movement or potential structural failure if left unaddressed.

Further Assessment and rectification by a suitably qualified builder or structural engineer is recommended. As this inspection is visual and non-invasive, the full extent of footing adequacy, structural movement and structural capacity could not be determined at the time of inspection.

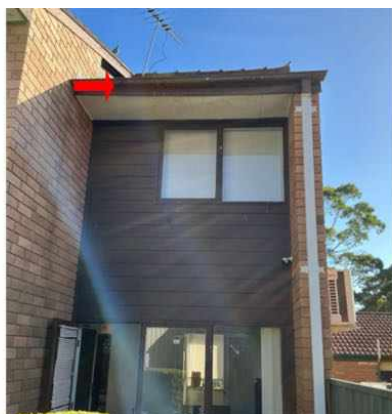
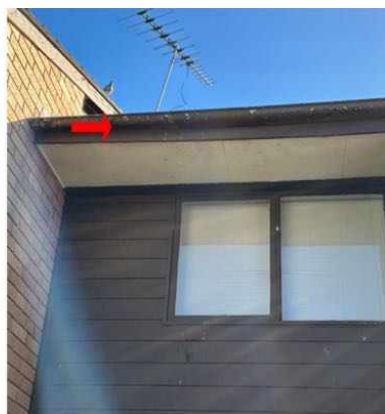
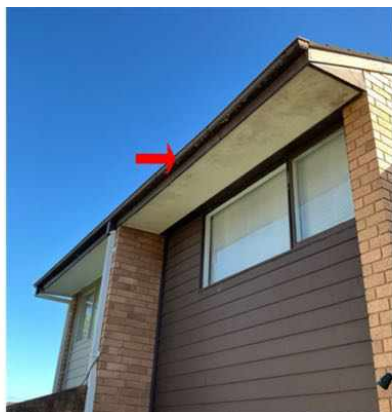
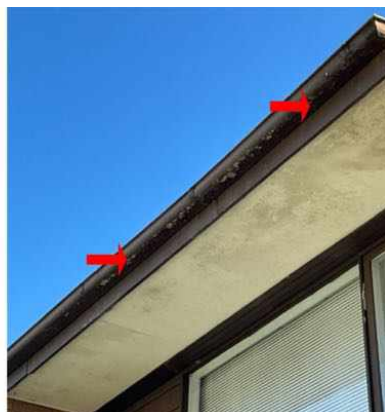
## Finding 2.02

Building:	Main Building
Location:	All External Areas
Finding:	Building element - Damaged - Rear gutter misaligned and rusted
Information:	Breakage occurs generally when the building materials have either aged and decayed, or as a result of damage (accidental or deliberate).

Repair and/or replacement of broken elements is advised to ensure that additional secondary defects do not arise as a consequence. Such works are necessary, as all building elements play a key role in the operation and function of the overall structure and its performance.

A relevant tradesperson should be appointed to repair or replace the affected building element prior to any subsequent damage being caused.

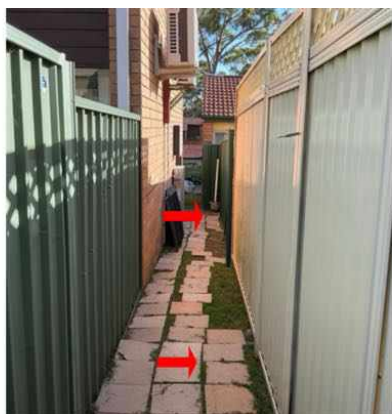
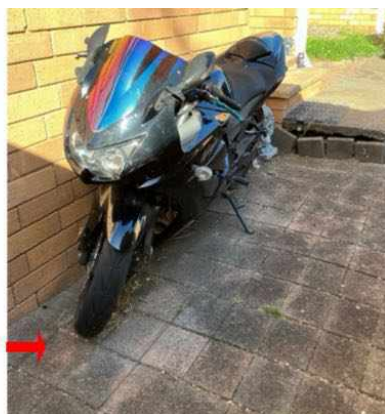
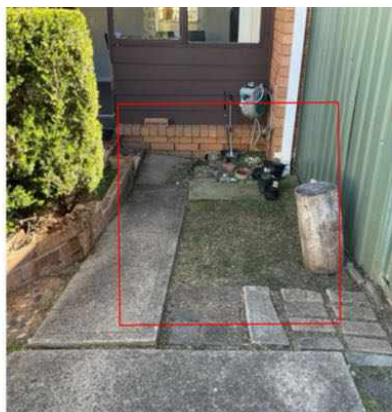
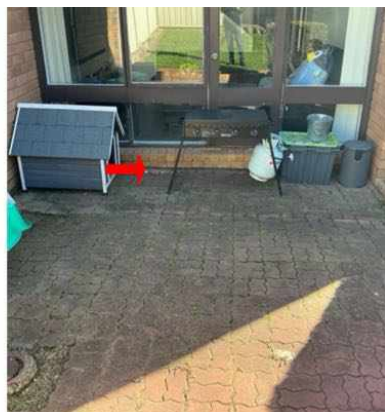
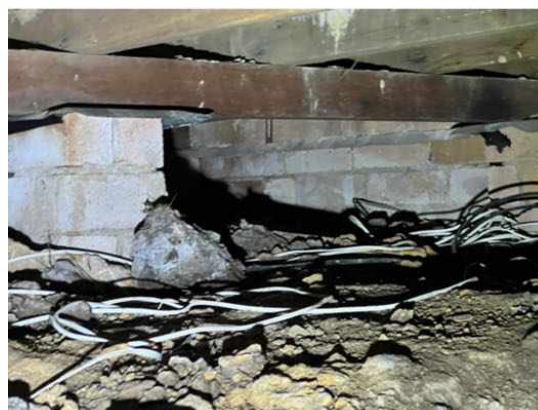
### Finding 3.01

Building:	Main Building
Location:	All External Areas
Finding:	Site drainage - Inadequate
Information:	The site drainage in this area was found to be inadequate at the time of inspection, creating potential for subsequent water damage to associated building elements.

It is important that water does not lie against the base of walls; surrounding paths and ground levels should be sloped to drain water away from walls. Downpipes should not discharge stormwater onto lower walls or plinths. Stormwater should be carried away by large, regularly cleaned drains. Ground levels may need to be lowered to expose a buried DPC.

Where site drainage is inadequate, installation of an Agricultural (Aggie) Drain may be required. A qualified plumber should be appointed to further inspect the property and perform any remedial works as necessary. Water damage and secondary defects are likely to occur if left unmanaged.

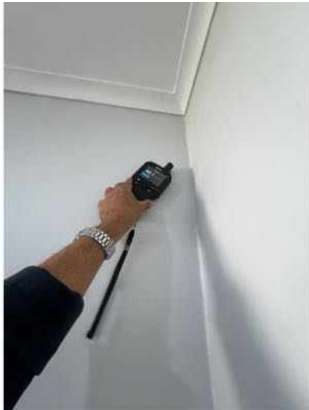
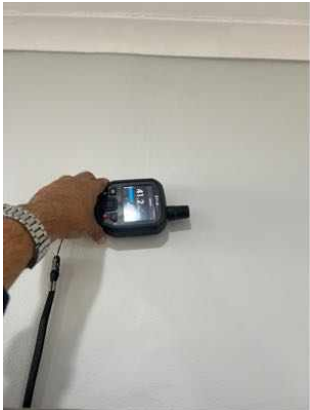
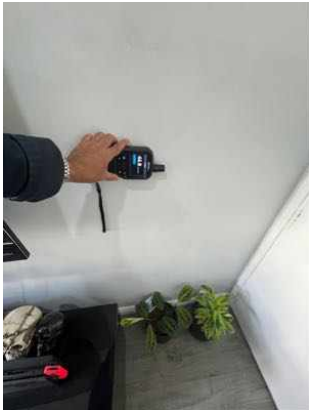
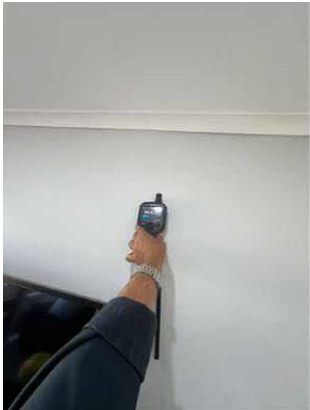
### Finding 3.02

Building:	Main Building
Location:	Lounge Room Right wall
Finding:	Elevated Moisture – Further Investigation Recommended
Information:	Elevated moisture readings were detected in several locations, with some areas also showing signs of dampness while others did not present visible surface issues, although no significant structural damage was evident at the time of inspection, dampness can contribute to deterioration if left unaddressed. Inspector was not able to inspect the external wall due to space constraints. A further investigation by a licensed plumber or waterproofing specialist is recommended to confirm the source and ensure no concealed issues are developing.

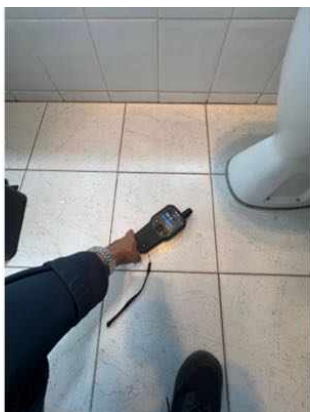
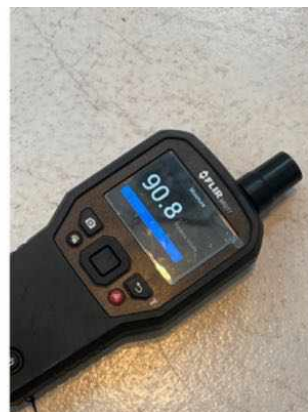
**Finding 3.03**

Building: Main Building  
Location: Bathroom  
Finding: Elevated Moisture Bathroom (No visible deterioration noted)  
Information: Elevated moisture levels were detected to tiled surfaces in bathroom/shower areas. Persistent moisture ingress can lead to concealed damage, including timber rot and mould growth.

Elevated moisture readings in tiled wet areas can occur from normal shower use, age/deterioration of waterproofing membranes, plumbing leaks or moisture absorption

through grout lines. While no damage was visible, elevated readings may indicate moisture retention behind tiles, which can be a conducive condition for future deterioration if not monitored.

Monitor the area over time for signs of drumming, efflorescence, tile movement, or grout deterioration. Recommend a licensed waterproofing specialist to perform further investigation (e.g., pressure testing, membrane assessment).

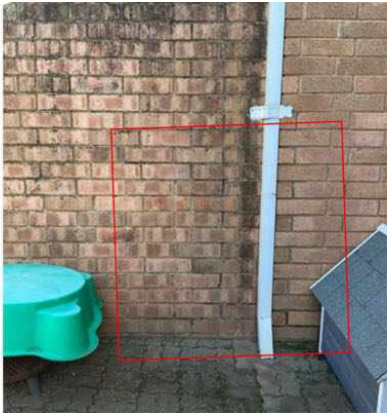
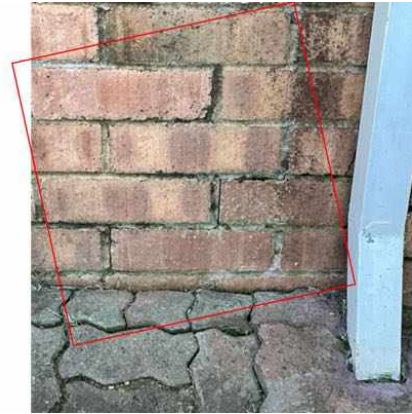
### Finding 3.04

Building:	Main Building
Location:	All External Areas - Boundary wall
Finding:	Brickwork - Step cracking
Information:	Step cracking was identified to the brickwork in this area at the time of inspection. Step cracking, which is similar to other forms of cracking, has a variety of possible causes. However, the most common is the subsidence of adjacent footings.

Step cracking is a relatively common defect, and is most likely to occur adjacent to windows, doors and other openings. Mortar failure in the gaps between affected bricks indicates the stresses and tensions affecting the wall.

Where step cracking is extensive or severe, the client is advised to consult a structural engineer. Minor step cracking can be used as a warning sign to address factors causing stress to the wall, which can include the effect of surrounding trees, water

leaks, soil erosion, or even the presence of reactive soils in the surrounding area.

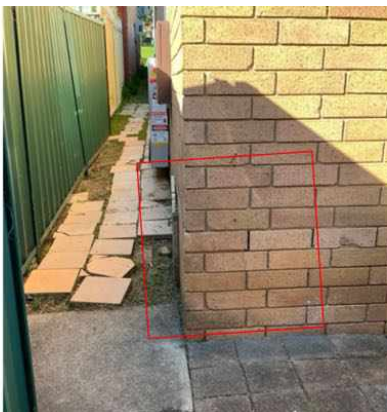
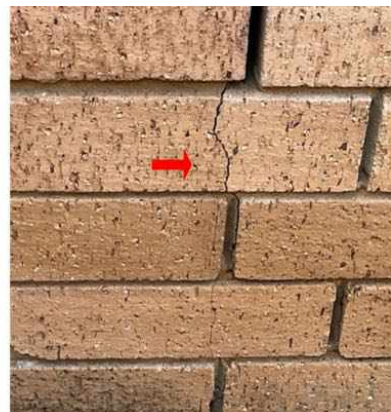
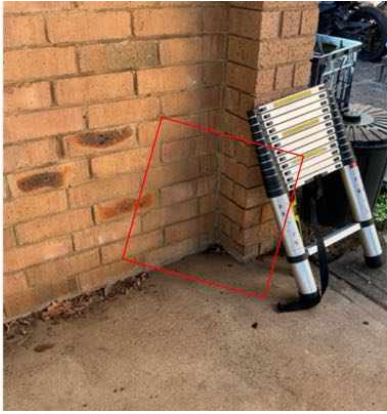
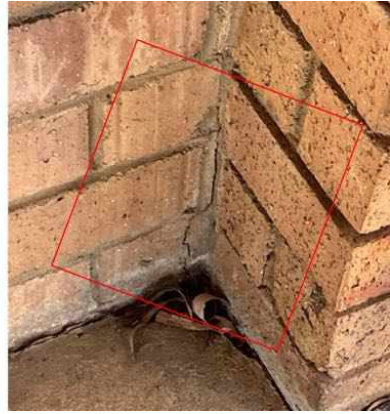
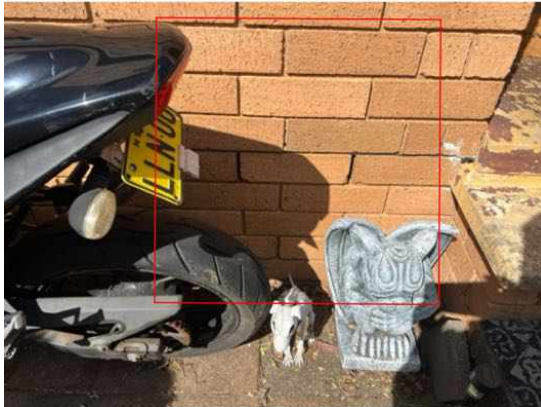
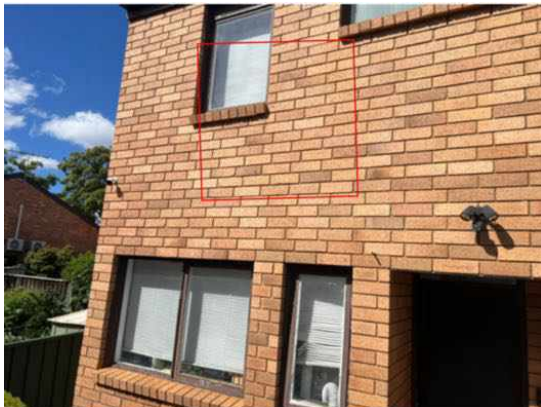
### Finding 3.05

Building:	Main Building
Location:	All External Areas , carport , main building
Finding:	Brickwork - Cracking noticeable to some areas
Information:	There were several cracks and or crack repairs evident to external brickwork.

Noticeable cracks are a common occurrence in external brickwork and are a likely result of age expected building movement, general expansion, and/or contraction of building materials in different weather conditions. Noticeable cracks in brickwork may develop if left unattended, with potential for necessitating major remedial works or replacement of the brickwork.

It is highly advised that a qualified bricklayer be appointed to provide necessary works to cracked brickwork to prevent any further damage. Such works should be conducted as soon as possible.

Always monitor these cracks and contact a building inspector should cracks widen, lengthen, or become more numerous.

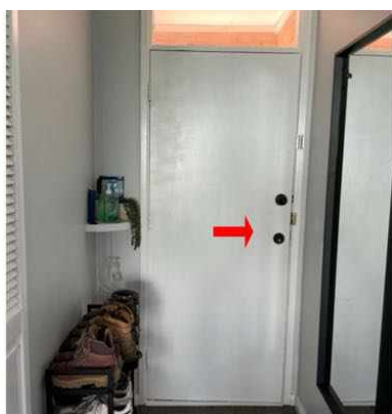
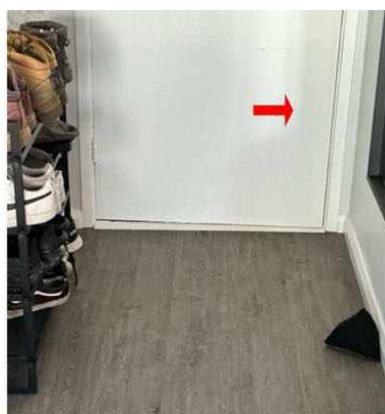
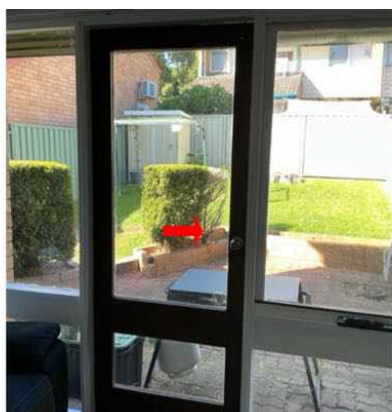
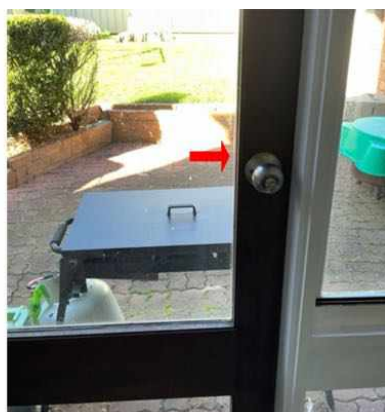
### Finding 3.06

Building:	Main Building
Location:	All Internal Areas - Front , rear window door
Finding:	Doors - Binding/Jamming
Information:	Binding and/or jamming of several doors throughout the property were evident during standard operation. This defect inhibits the functionality of affected doors as well as creating potential for secondary defects to associated building elements, such as damage to the floor covering.

A door that binds to flooring or to the associated door frame may have several causes, ranging from minor defects, such as poor installation of the door or deteriorated hinges, through to major structural issues, such as damage to subfloor

Where door binding/jamming appears to indicate major structural issues, a registered builder specialising in re-stumping should be appointed to provide an estimate on the cost of rectification.

For minor causes, a qualified carpenter or general handyperson should be appointed to perform minor rectification works at client discretion.

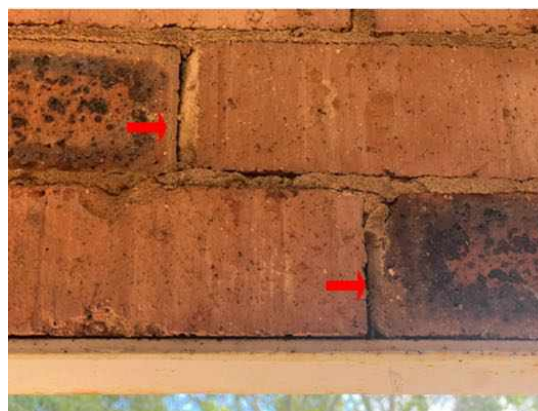
### Finding 3.07

Building:	Main Building
Location:	All External Areas
Finding:	Brickwork - Deteriorated mortar to some areas
Information:	Mortar, or 'bedding', is the material which fills joins and intersections between bricks in masonry walls and structures. Sections of mortar in this brickwork were identified as having deteriorated, which is generally expected for a property of this age and condition.

Mortar may deteriorate as a result of age of building materials, minor movement of bricks, or frequent exposure to weathering. Mortar should be replaced to ensure that bricks remain in their intended location and to prevent gaps, which would allow water or moisture ingress and secondary damage as a result.

Mortar deterioration can be addressed by a bricklayer where areas of deterioration are localised and easily accessible. Alternatively, appointment of a registered builder is advised, to repoint large areas of decaying mortar. Where secondary structural defects have become evident, consultation with a structural engineer may be required.

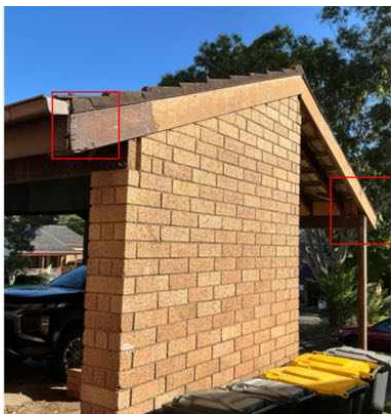
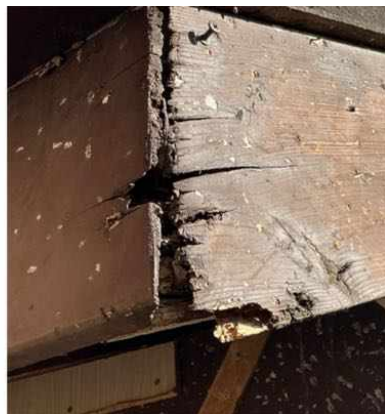
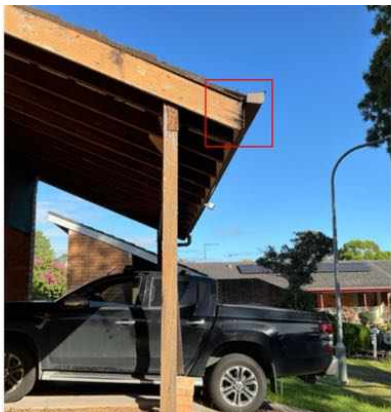
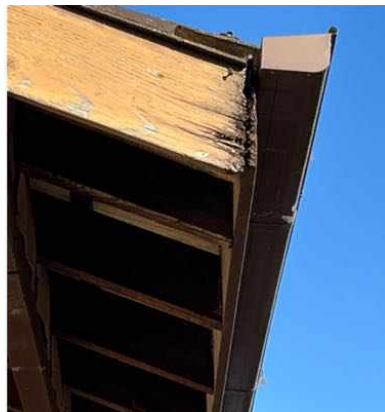
Building:	Main Building
Location:	All External Areas
Finding:	Fascias - Wood rot to some areas
Information:	Wood rot was found to be affecting fascias and barges in this area, evidenced by the presence of mould on the surface in some areas. Wood rot, also known as Fungal Decay, occurs when timbers and other cellulose building materials are exposed to damp conditions on an ongoing basis.

It is likely that this wood rot has developed as a result of faults in the roof plumbing, creating excessive moisture in this areas. Frequent exposure to rain and other weather conditions also make fascias and barges susceptible to accelerated deterioration.

Early intervention and regular maintenance will prolong the useful life of these building elements. Prior to any works being performed, the cause of the moisture that has created the visible wood rot should be identified and addressed in a suitable manner.

It is advised that a roof plumber be appointed to inspect all roof plumbing and subsequently identify the cause of the wood rot. Replacement of affected fascias and barges may then be a necessary step in protecting surrounding building elements from such deterioration.

A qualified plumber may be appointed to assess the cause of excessive moisture and to provide advice on any remedial works as required. A qualified carpenter or registered builder may also be required to replace affected building materials.

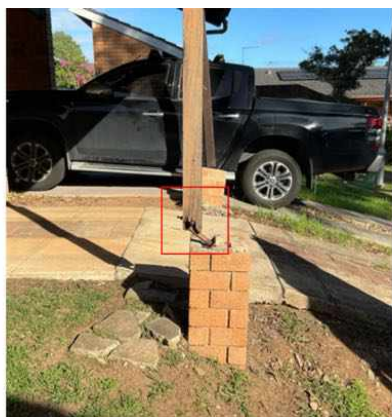
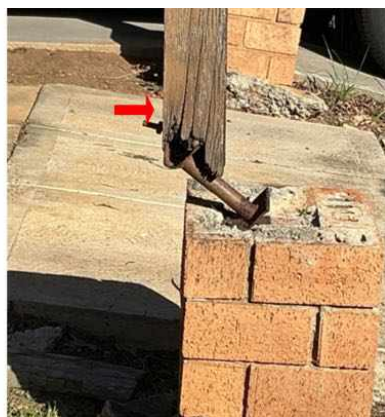
### Finding 3.09

Building:	Main Building
Location:	All External Areas
Finding:	Wood rot to some areas
Information:	This building element shows evidence of wood rot. Wood rot, also known as Fungal Decay, occurs when timbers and other cellulose building materials are exposed to damp conditions on an ongoing basis. This could be the result of exposure to weathering over a prolonged period of time, or the attraction of excessive moisture from other abutting building materials. Contributing factors also include poor air ventilation in the area.

Wood rot is often associated with general damp problems and is evidenced by a

'musty' smell or mould and mildew occurring on surfaces. If left unmanaged, damp conditions can lead to further health problems and the decay of timbers will continue.

Early intervention and regular maintenance, particularly of exterior timbers, will prolong the useful life of these building elements. Prior to any works being performed, the cause of the moisture that has created the visible wood rot should be identified and addressed in a suitable manner. Replacement of affected timbers may then be a necessary step in protecting surrounding building elements from such deterioration.

A qualified plumber may be appointed to assess the cause of excessive moisture and to provide advice on any remedial works as required. A qualified carpenter or registered builder may also be required to replace affected building materials.

Even though Liverpool termite activity was not visible. A further invasive inspection by a licensed termite technician its also highly recommended to eliminate possibility of potential termite activity.

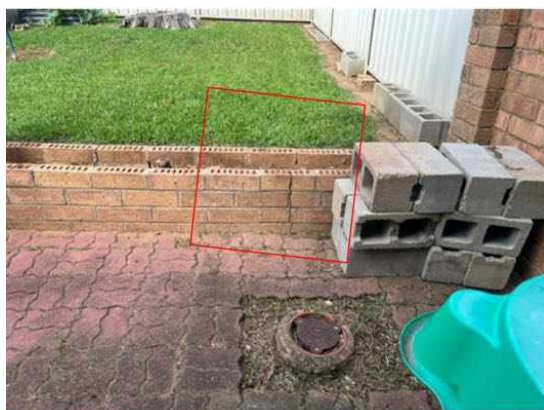
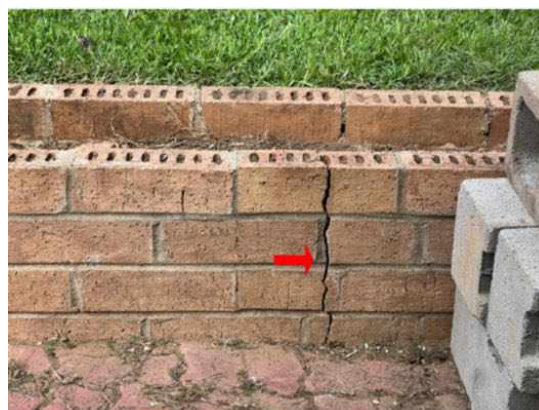
### Finding 3.10

Building:	Main Building
Location:	All External Areas
Finding:	Retaining wall - Defective - Cracking (Requires repair)
Information:	The retaining wall in this are was found to be defective at the time of inspection. Generally, defective retaining walls are caused by poor original design or material use. However, deteriorated retaining walls may also be a result of substandard construction, poor site drainage or unmanaged stormwater flows.

If left unmanaged, the retaining wall may become a safety hazard if it continues to destabilise. Where retaining walls further rot and decay, an environment is created that is conducive to termite and pest infestation.

Significant repair and replacement should be expected. Where retaining walls are considered structural walls, a structural engineer / surveyor should be consulted regarding required remedial works. Otherwise, a landscaper or retaining wall installer may be appointed to repair or replace the wall, at the discretion of the client.

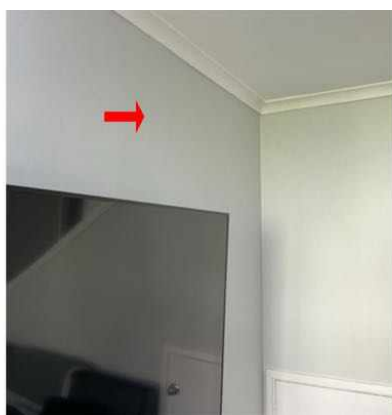
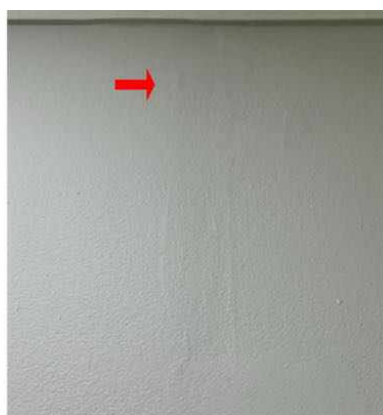
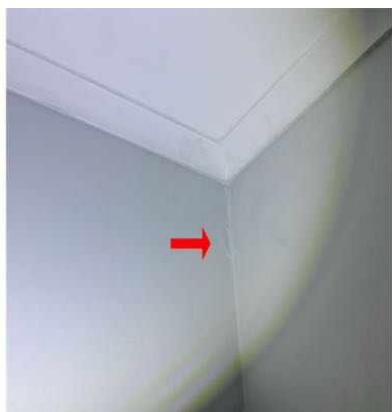
Building:	Main Building
Location:	All Internal Areas
Finding:	Painted surface - Bubbling
Information:	Sections of paint in this area was found to have bubbled and deteriorated. Paint bubbling is generally an indication of excessive moisture in the area, that is currently hidden by the painted surface.

The presence of excessive moisture can have major implications on associated building elements if left unattended. While only seemingly minor at this stage, the damage cannot be determined due to the paint obstructing any further inspection of the damage.

It is highly advised that the affected paint be cleaned to allow a further, more invasive inspection by a licensed plumber. Failure to act on this defect may necessitate major works in the future.

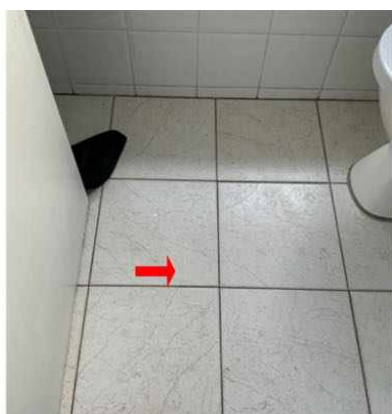
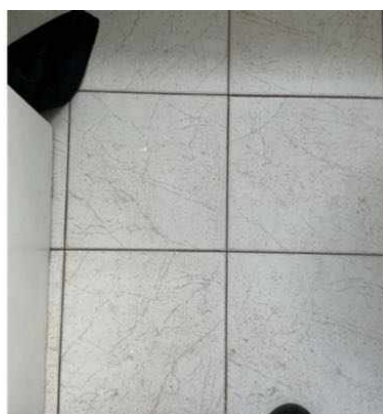
### Finding 3.13

Building:	Main Building
Location:	Bathroom
Finding:	Tiles - Drummy
Information:	Drummy tiled areas were identified at the time of inspection. The term 'drummy' refers to tiles that have become detached from their fixing, despite otherwise being in relatively good condition. Such defects are generally caused by physical or moisture damage to the area. Drummy tiled areas may also be a direct result of poor workmanship during the construction process.

Tiled areas may swell and shrink with changes in air humidity if the area has sustained moisture damage. Any exposure to moisture is capable of causing tiled areas to become drummy and/or cracked over a prolonged period of time. Drummy tiled areas

generally require removal and replacement of affected tiles, with adequate sealant and grouting.

Specialist trades are available for these types of services. A registered builder may be required to undertake works if damage is extensive or if secondary building defects have resulted. Otherwise, it is advised that a tiling contractor be appointed to perform works as necessary. Immediate action is recommended to ensure that no further damage is sustained in the affected area.

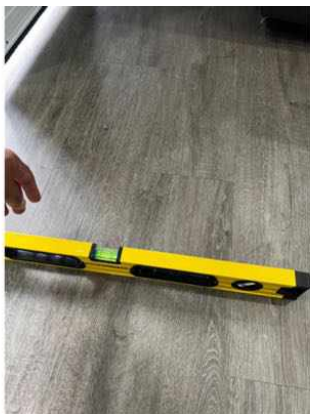
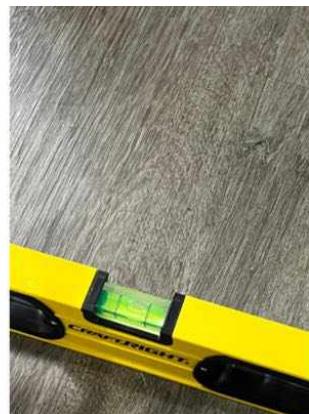
### Finding 3.14

Building:	Main Building
Location:	All Internal Areas
Finding:	Flooring - Uneven to some areas
Information:	The internal flooring in this area is out of level and uneven. Uneven flooring is likely to indicate minor defects such as expected movement of the foundations of the property, but may also indicate subsidence of the associated subfloor stumps.

It is advised that the flooring be closely monitored to identify any further movement. Where flooring remains relatively unchanged for an extended period of time (i.e. several months), it is likely that this defect has been caused by expected movement of the foundations of the property.

However, where flooring is uneven further, potentially invasive inspection of the subfloor structures and stumps in this area is required. In this case, works to repair are likely to be required, and would be carried out by a registered builder specialising in re-stumping.

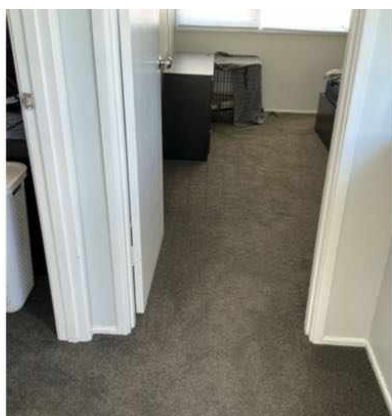
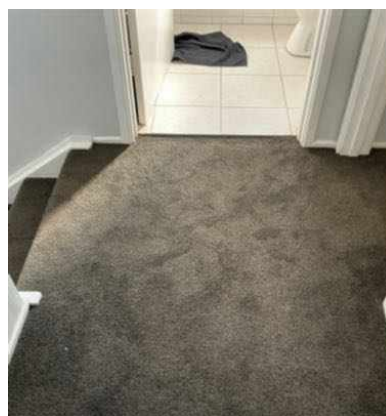
### Finding 3.15

Building: Main Building  
 Location: All Internal Areas  
 Finding: Floors - bouncy  
 Information:

Bouncy floors generally indicate that the floorboards or the subfloor structures are coming loose from the joists that they are installed on. Bouncy flooring may also be the result of gaps between flooring and stumps or joist structures, which require packing.

The client is advised to seek quotations for required repairs from a Registered Builder specialising in re-stumping. The potential resolution may range from packing gaps in subfloor structures through to replacement of subfloors stumps and refixing of flooring.

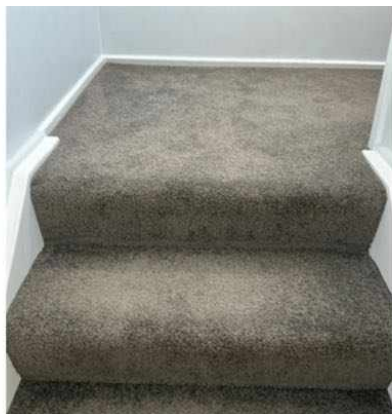
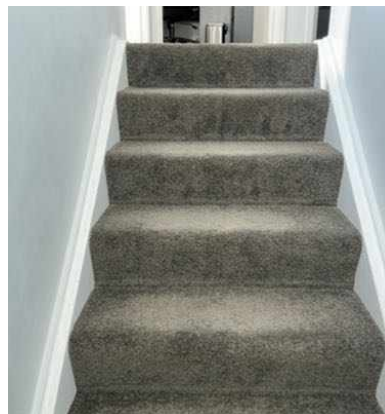
### Finding 3.16

Building: Main Building  
 Location: All Internal Areas

Finding: Staircase – Creaking and Bouncy When Walked On  
 Information: The stair treads produce creaking noises and a slight bouncy sensation when under load. The cause could not be confirmed during the visual inspection but may relate to normal material flex, loose fixings, or subframe movement. No visible structural damage was evident. Monitoring is recommended, and further assessment by a licensed builder or carpenter may be considered if movement increases or noise persists.

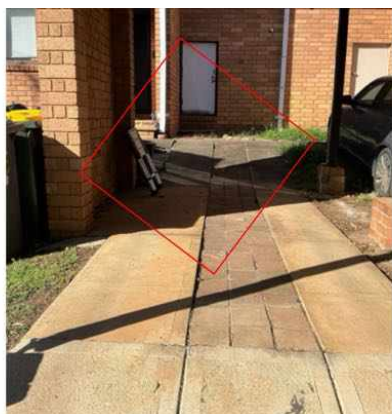
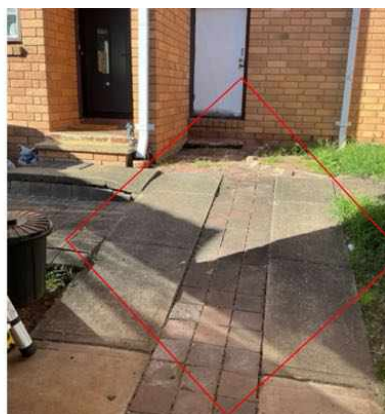
### Finding 3.17

Building: Main Building  
 Location: All External Areas  
 Finding: Paving - Uneven  
 Information: Sections of the external paved area are uneven, creating a potential trip hazard. It appears as though the area has been subject to rough installation, or that paving sections have lifted due to movements in the foundation of the property.

Where paving creates a trip hazard, personal injury may ensue if due caution is not taken by all persons within this area.

Re-paving of the area is required as soon as possible to remedy this situation. Further consultation with a specialist concreter is advised.

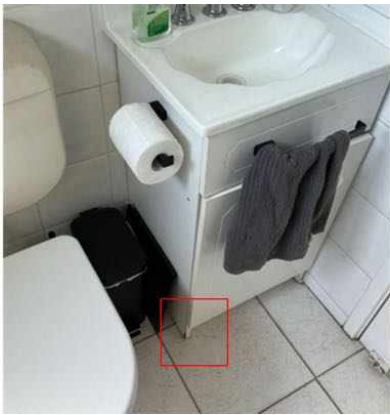
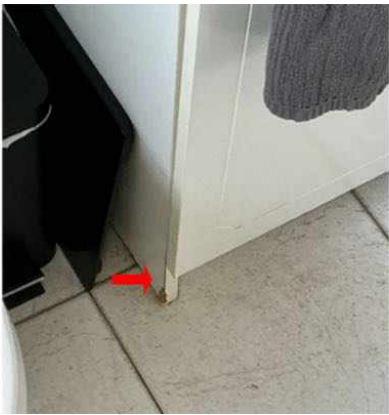
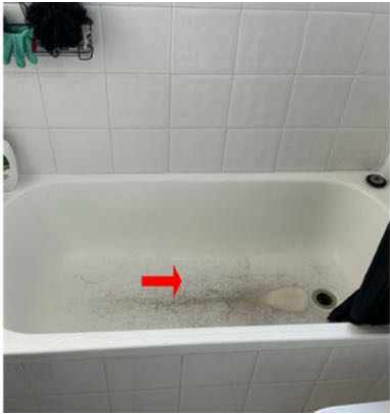
### Finding 3.24

Building:	Main Building
Location:	All Internal Areas
Finding:	Building element - Damaged - vanity water damaged , bathtub deteriorated coating
Information:	Breakage occurs generally when the building materials have either aged and decayed, or as a result of damage (accidental or deliberate).

Repair and/or replacement of broken elements is advised to ensure that additional secondary defects do not arise as a consequence. Such works are necessary, as all building elements play a key role in the operation and function of the overall structure and its performance.

A relevant tradesperson should be appointed to repair or replace the affected building element prior to any subsequent damage being caused.

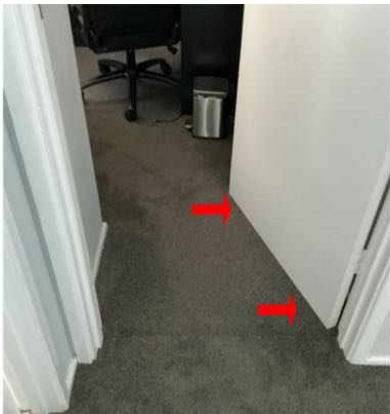
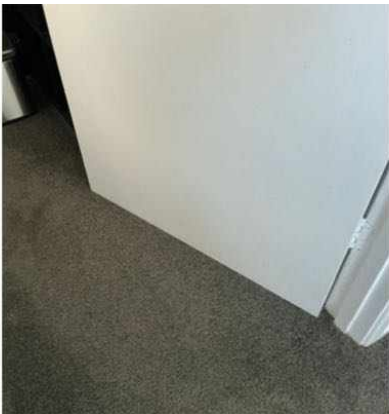
**Finding 3.25**

Building: Main Building  
Location: Bedroom  
Finding: Doors - Stiff to close possible due to carpet  
Information:

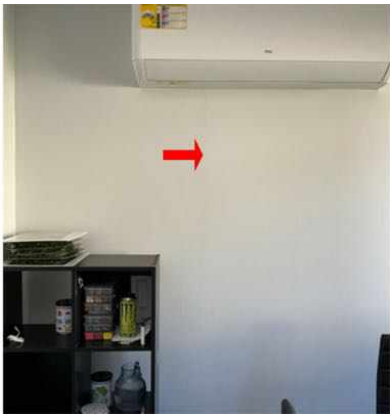
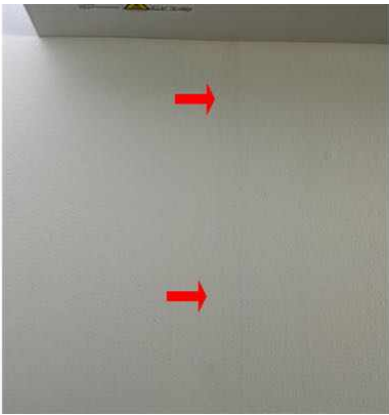
Finding: Water staining (Possible aircon condensation)

Information: Water staining was evident in this area at the time of inspection. Water staining indicates that surfaces have been exposed to excessive moisture over time. The minerals and other elements in the water lead to staining, which may graduate to corrosion and deterioration if left unmanaged.

While mostly an appearance defect, water staining can be indicative of more serious defects, which may be currently concealed by other building elements.

Where water staining is active, a licensed plumber must be consulted to identify the cause of the staining and to provide advice on any reparation works that may be required. Replacement of any broken or damaged structures is advised.

Conversely, where water staining is old and inactive, affected building materials may be repaired or replaced at client discretion. A qualified carpenter or registered builder may be appointed to perform these works.

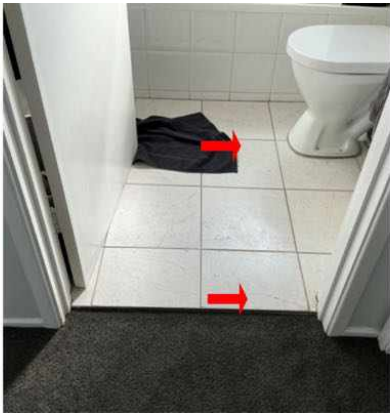
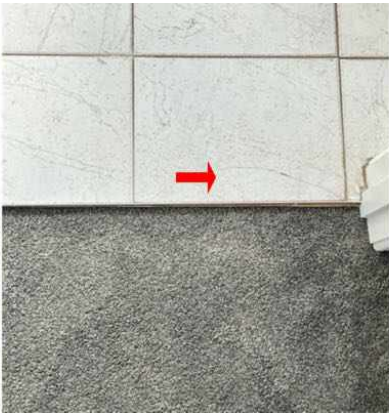
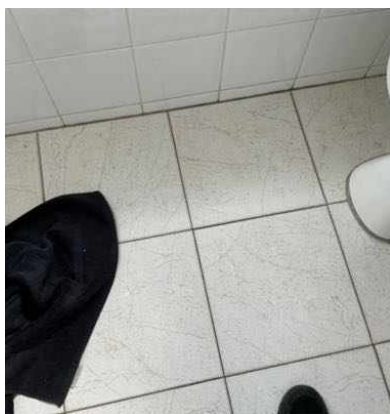
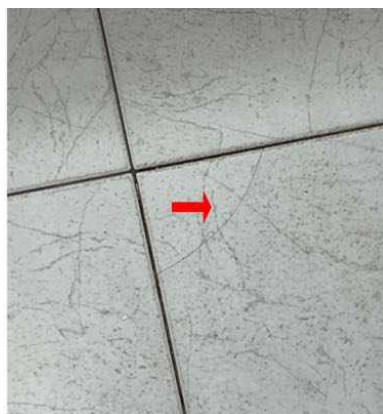
**Finding 3.28**

Finding: Tiles - Cracked or damaged

Information: Cracking was evident to the tiling in this area at the time of inspection. While the cracking appears to be minor, this area is frequently exposed to water, allowing potential for water penetration into adjoining sections of walls or flooring.

If left unmanaged, water penetration to these areas may lead to subsequent water damage, which is likely necessitate repair work to affected building elements.

A tiling contractor should be appointed to ensure that no further water damage occurs. The re-application of silicone and grouting throughout remaining tile work is also advised, to further protect the area against water penetration.

Where water penetration has led to water damage, appointment of a relevant tradesperson may be required to repair damaged building elements.

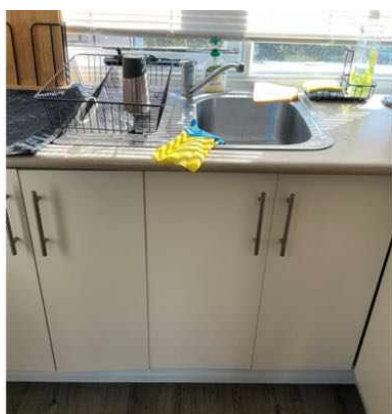
### Finding 3.29

Building:	Main Building
Location:	All Internal Areas
Finding:	Tap - Water hammer
Information:	This tap shows evidence of water hammer being present. Water hammer, a pressure surge resulting when a fluid is forced to suddenly change direction, is a common defect in plumbing fittings, particularly those that are aged and not frequently maintained. Water hammer is generally caused by factors that create high water pressure in the affected plumbing fixture, usually evidenced by a faint banging noise during operation of the affected tap.

Although water hammer is generally considered to be a minor defect, subsequent damage such as erosion of tap hardware and/or water damage to associated building elements is likely to occur if left unmanaged.

A licensed plumber should be appointed as soon as possible to replace any affected tap hardware and perform any remedial works as necessary. Please be advised that the appointment of a cabinet maker or qualified carpenter may be necessary if water damage to associated building elements has occurred.

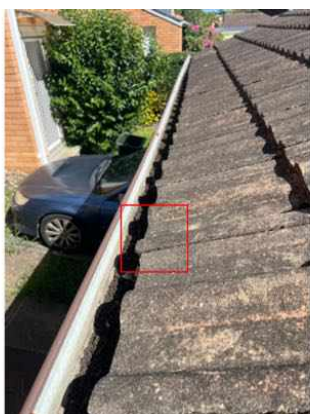
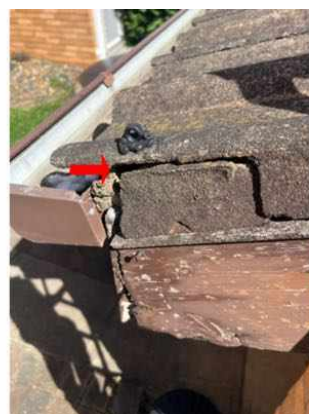
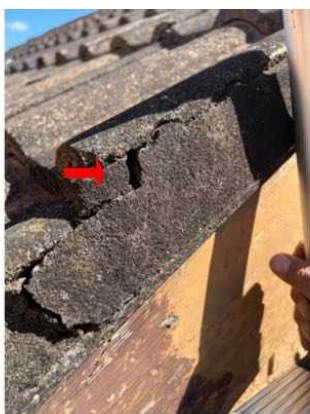
### Finding 3.30

Location: Roof Exterior - Carport  
Finding: Mortar - Deterioration  
Information: Mortar, or 'bedding', is the material which fills joints and intersections between tiles and other building elements on the exterior roof covering, such as gable ends, hip capping and valleys. Upon inspection of the exterior roof, it was noted that sections of the mortar show varying levels of deterioration.

Mortar generally deteriorates as a result of frequent exposure to weather conditions over a prolonged period of time. Mortar that is deteriorating may allow water ingress into the roof void, putting associated building elements and roofing structures at risk of water damage. Deteriorated mortar also detracts from the functionality of roof tiles and other roofing elements, potentially decreasing weather tightness and roof drainage.

Some tiles were also chipping and out of alignment at the time of inspection and should be replaced and aligned.

Mortar deterioration can be attended to by a handyman where areas of deterioration are localised and easily accessible. Otherwise, consultation with a roofing contractor is advised where greater works are required.

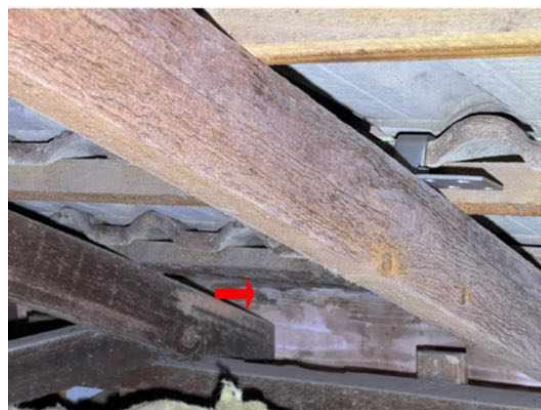
### Finding 3.31

Building:	Main Building
Location:	Roof Void
Finding:	Aged Timber and moisture staining – Roof Void
Information:	Visible decay was noted to some areas , consistent with age-related shrinkage and general weathering. The affected areas also exhibited localised surface darkening and moisture stains, which may indicate past moisture exposure. No evidence of structural compromise was observed at the time of inspection. These conditions appear typical for a dwelling of this age and construction, but ongoing monitoring is recommended. A licensed builder or licensed carpenter should be consulted if there is further deterioration or leaks. A further invasive inspection by a licensed timber pest technician is recommended for any concealed termite activity

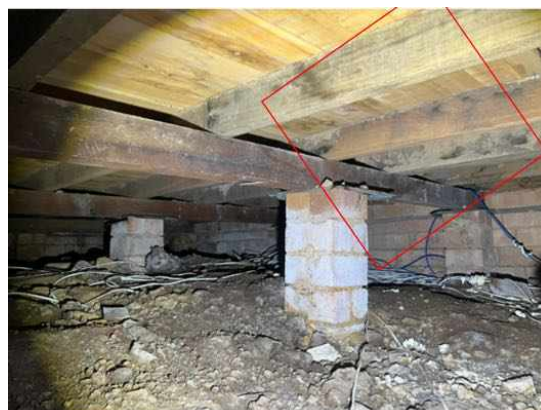
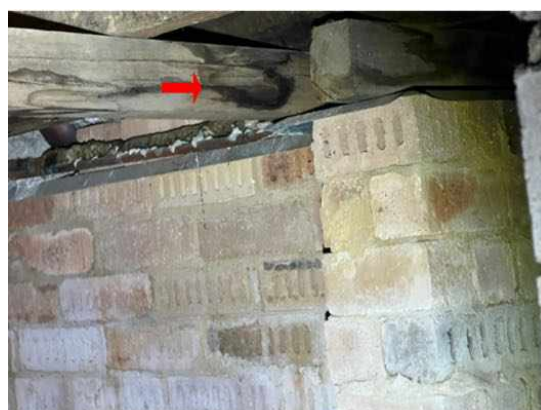
Building:	Main Building
Location:	Subfloor
Finding:	Subfloor Timber Staining – Moderate Condition
Information:	Discolouration and surface fungal growth were noted on several subfloor timbers likely due to historic moisture exposure. While the visual signs suggest past damp conditions, the timbers felt solid to touch during the inspection and showed no immediate evidence of structural failure or active decay. Ventilation appears limited in some areas, which may contribute to moisture retention. Although not classified as a major defect, ongoing monitoring is recommended, and a licensed plumber should be engaged to check for any slow leaks or past water ingress contributing to staining. Although no visible signs of termites was evident at the time of inspection however Due to presence of conducive conditions a further invasive inspection by a licensed termite specialist is recommended in the areas where access was limited due to obstructions and limited crawl space.

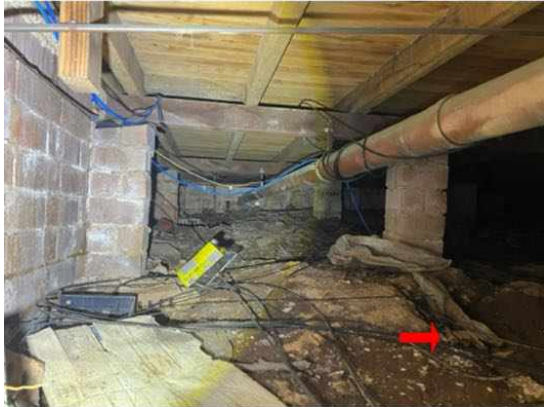
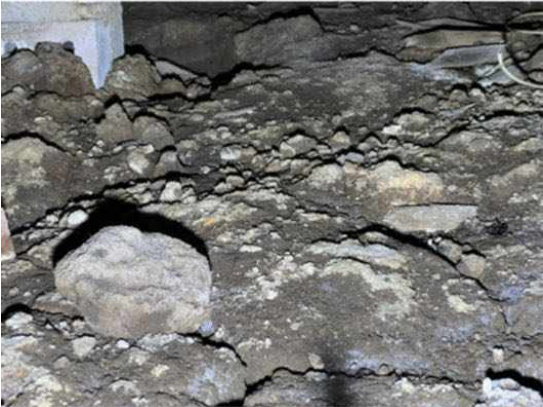
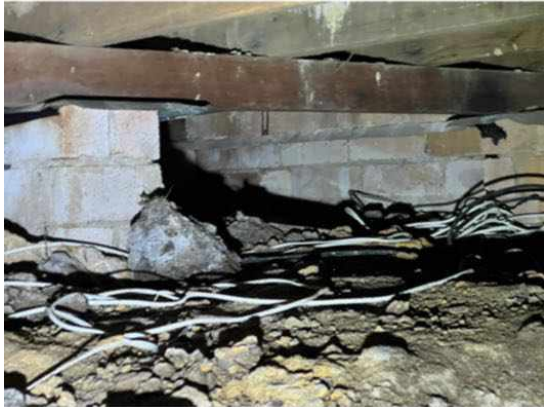
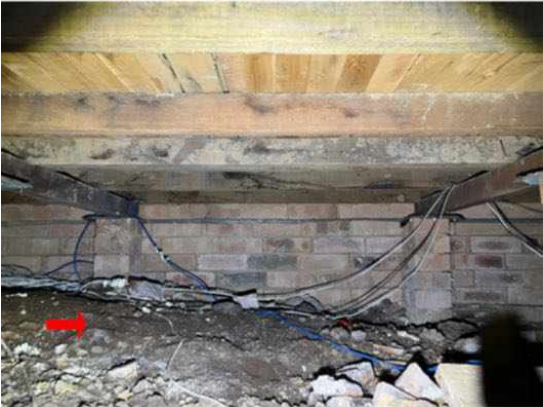
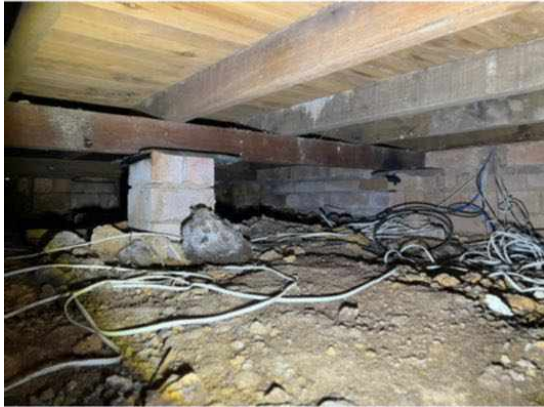
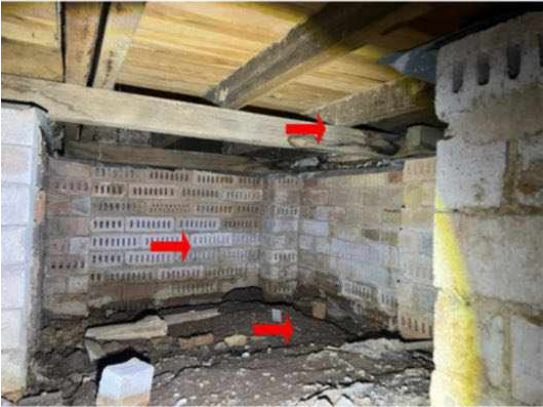
### Finding 3.36

Building:	Main Building
Location:	Subfloor
Finding:	Subfloor ventilation - Inadequate
Information:	Adequate subfloor ventilation aids in preventing excessive moisture wood rot and termite activity by ensuring a dry subfloor environment.

Where ventilation is substandard it is usually caused by factors such as failure to install adequate vents during construction subsequent building works or earth and vegetation covering over vents low subfloor clearance and items or debris in the subfloor restricting airflow.

Loose cables and debris was also present , debris should be cleared and cables should be secured for safety and access by a licensed electrician.

Subfloor ventilation can be improved in most cases by addressing the causes such as exposing subfloor vents installing additional new vents installing mechanical (forced airflow) ventilation and removing debris from the subfloor.

A registered builder should be appointed as soon as possible to perform these works as necessary.

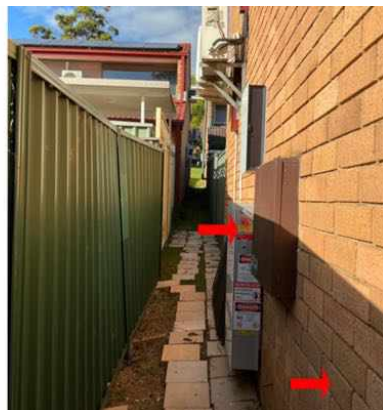
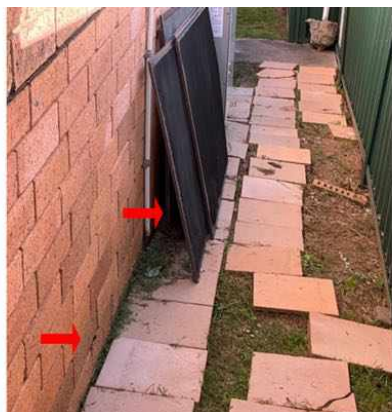
### Finding 3.37

Building:	Main Building
Location:	All External Areas - Rear
Finding:	Building element - Damaged- Rear windows damaged , rear hole not sealed , poor sealant application rear window , missing brick filled with foam rear x 2
Information:	Breakage occurs generally when the building materials have either aged and decayed, or as a result of damage (accidental or deliberate).

Repair and/or replacement of broken elements is advised to ensure that additional secondary defects do not arise as a consequence. Such works are necessary, as all building elements play a key role in the operation and function of the overall structure and its performance.

A relevant tradesperson should be appointed to repair or replace the affected building element prior to any subsequent damage being caused.

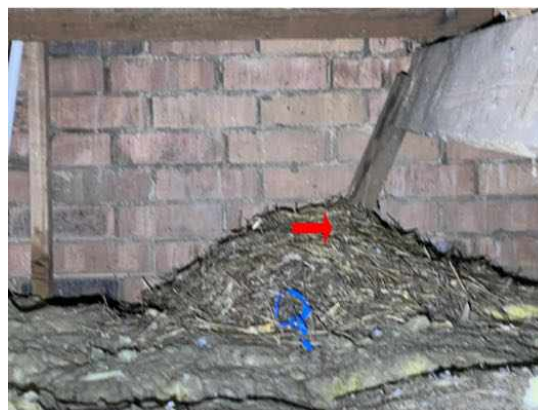
Finding 3.38

Building:	Main Building
Location:	Roof Void
Finding:	Bird Nesting & Debris – Roof Void
Information:	A substantial bird nest and associated organic debris were identified in the roof space near the wall. This presents a potential fire hazard, can attract pests or vermin, and may contribute to poor air quality or odour transfer into the living areas. The presence of nesting material also indicates a possible entry point or ventilation gap in the roof cladding or eaves. Recommend safe removal by a pest controller or roofer and sealing of any potential entry paths to prevent recurrence.

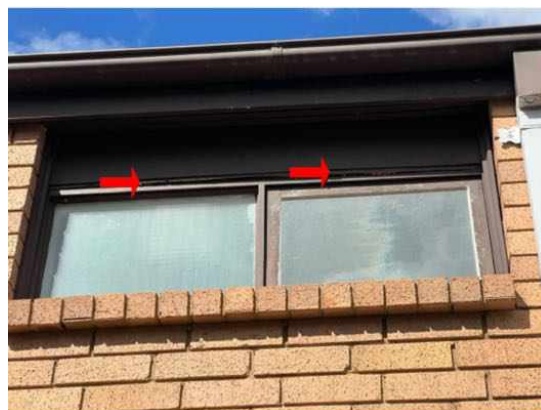
### Finding 3.39

Building:	Main Building
Location:	All External Areas
Finding:	Installation - substandard or incomplete - Unsealed gap
Information:	The installation of this building element appears to have been completed to a substandard level of workmanship or is incomplete. Generally substandard repairs or installation are related to poor workmanship, the use of inappropriate materials, or a failure to complete installation to a suitable standard.

Where installation is substandard and/or incomplete, the client should contact the responsible trade to undertake rectification. Unfinished and substandard building works are likely to degrade more quickly and may create potential for secondary defects to associated building elements.
