# Building and Timber Pest Inspection Report

Inspection Date: Sat, 14 Mar 2026

Property Address: 16 Airdsley Ln, Bradbury NSW 2560,  
Australia

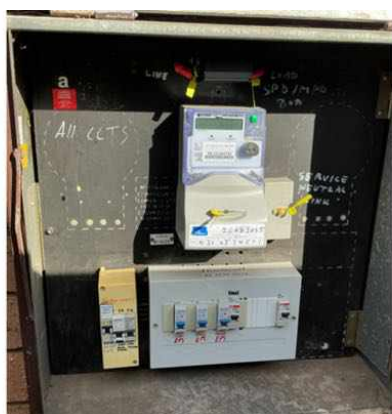
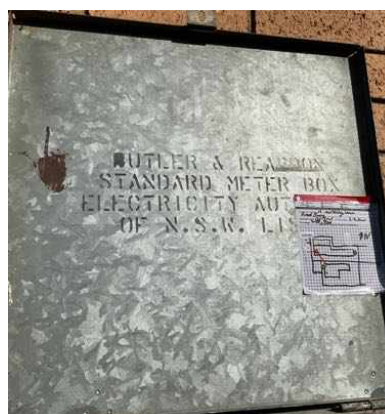
Building:	Main Building
Location:	All External Areas
Finding:	Termite Management System - no evidence of a chemical installation
Information:	The application of a post-construction chemical termite barrier is highly recommended for all properties, particularly if live termite activity has been found on the site previously. Such barriers are highly effective in preventing termite attack on any timber building elements throughout the property.

A durable notice should be placed in the switchboard unit to indicate current termite barriers. At the time of inspection, it appeared as though no termite management system has been installed, with no evidence to suggest preventative works taking place.

The client may consider gaining further advice from a pest controller as to the costs and procedures involved with this application. It is recommended that obtaining such advice be a short-term priority.

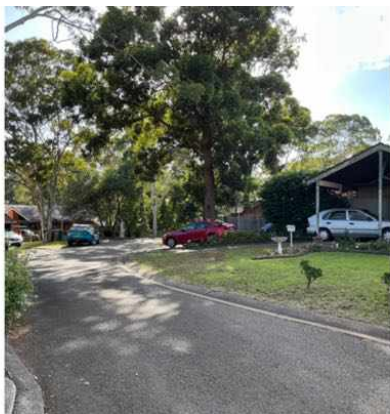
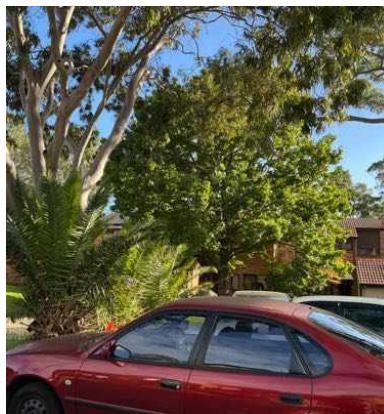
## Finding 6.02

Building:	Main Building
Location:	All External Areas
Finding:	Trees within 50m
Information:	Trees within 50m of the property can be conducive to termite activity. It is recommended an invasive inspection of all trees with 50m to the property be carried out by a qualified pest control expert.

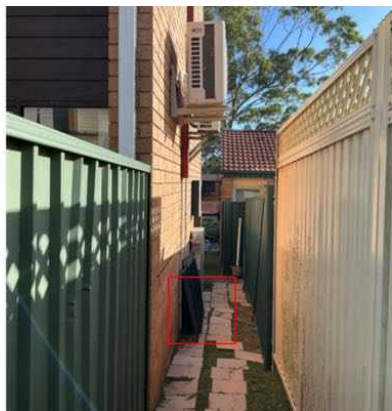
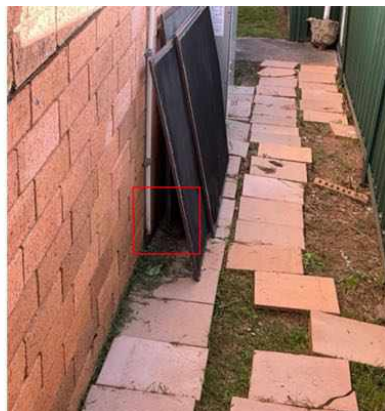
Building:	Main Building
Location:	All External Areas
Finding:	Air conditioner - Disconnected overflow
Information:	The Air Conditioner (A/C) overflow was found to be disconnected from storm water drainage and is creating excessive moisture in the surrounding area.

Such leaking creates an environment which is conducive to an array of defects,

including water damage to associated building elements and the attraction of termite or timber pest infestation.

It is highly recommended that a licensed plumber be appointed to connect the A/C overflow in order to prevent such an environment from being created. These minor works should be carried out as soon as possible.

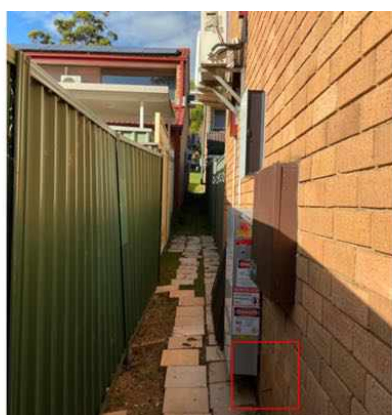
### Finding 6.05

Building:	Main Building
Location:	All External Areas
Finding:	HWS Overflow - Not Connected
Information:	The Hot Water System (HWS) overflow was found to be disconnected from storm water drainage and is creating excessive moisture in the surrounding area.

These damp conditions can lead to secondary defects such as rot, rust or corrosion of associated building elements, the formation of fungal decay, or even the creation of potential slip hazards. When coupled with poor site drainage, pooling of water may also attract termite activity to this area.

It is highly recommended that a licensed plumber be appointed to connect the HWS overflow in order to prevent such an environment from being created. These minor works should be carried out as soon as possible.

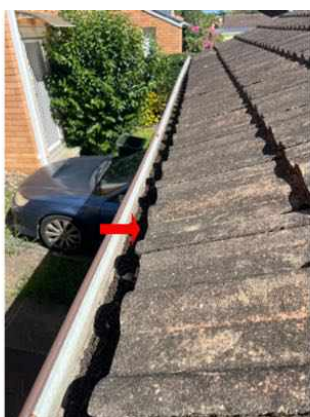
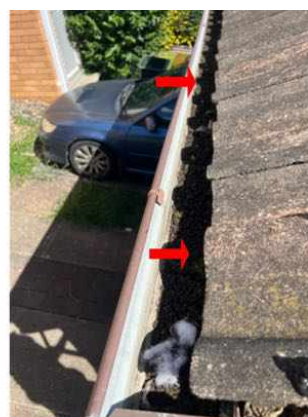
## Finding 6.06

Building:	Main Building
Location:	All External Areas
Finding:	Gutters - Blocked
Information:	Roof plumbing structures, such as guttering and downpipes, should be free of all debris to prevent blockages. Blockages of the guttering and downpipes will lead to pooling and accumulated water overflows, which is likely to subsequently flood eaves and exterior walls.

Blocked gutters are likely to lead to high levels of moisture in the affected areas. Such moisture will not only cause rust and decay of the associated building materials, but can also provide conditions that are conducive to termite and timber pest activity. Blockages in gutters should therefore be removed immediately to ensure dry conditions are maintained.

Consult a Licensed Plumber for further specific advice on remedial works that may be required. In the interim, it is highly advised that blocked gutters be removed by the homeowner or a general handyperson as a matter of urgency.

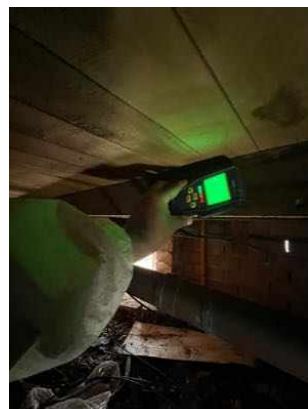
## Finding 6.07

Building:	Main Building
Location:	Subfloor
Finding:	Elevated moisture - identified
Information:	Elevated moisture can attract termites and produce conditions that promote fungal growth and wood decay.

Elevated moisture is generally caused by deteriorated, inadequate or missing roof drainage, leaking plumbing pipes or fixtures, poorly plumbed HWS overflows or condenser units and poor site drainage.

Prior to any remedial works being performed a qualified plumber should be appointed to further inspect the property and to identify the cause of the excessive moisture. Works to remove affected building elements may then be necessary and should be performed by an appropriate tradesperson.

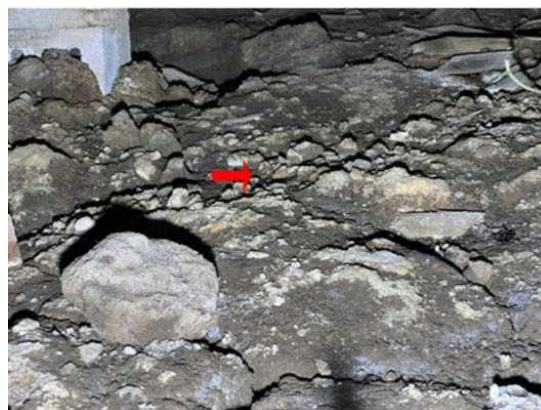
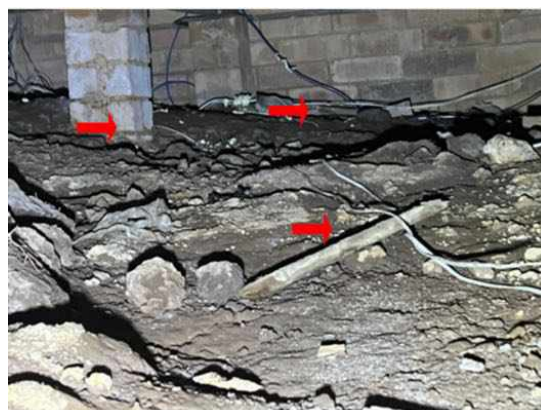
### Finding 6.08

Building:	Main Building
Location:	Subfloor
Finding:	Subfloor ventilation - Inadequate
Information:	Adequate subfloor ventilation aids in preventing excessive moisture wood rot and termite activity by ensuring a dry subfloor environment.

Where ventilation is substandard it is usually caused by factors such as failure to install adequate vents during construction subsequent building works or earth and vegetation covering over vents low subfloor clearance and items or debris in the subfloor restricting airflow.

Subfloor ventilation can be improved in most cases by addressing the causes such as exposing subfloor vents installing additional new vents installing mechanical (forced airflow) ventilation and removing debris from the subfloor.

A registered builder should be appointed as soon as possible to perform these works as necessary.

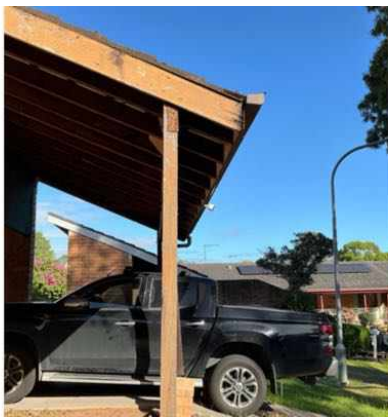
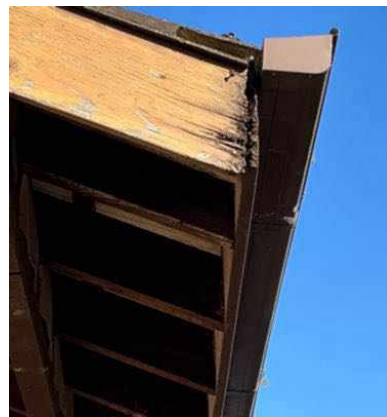
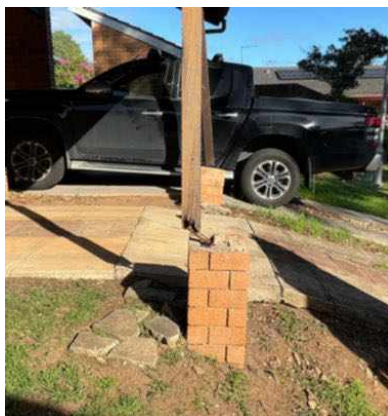
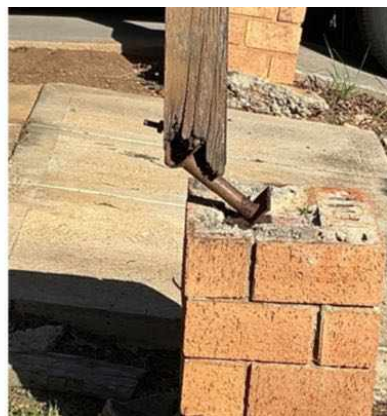
### Finding 7.01

Building:	Main Building
Location:	All External Areas
Finding:	Fungal decay - present to some areas
Information:	Fungal decay also known as wood decay or wood rot generally refers to the deterioration of timber elements when in contact with excessive levels of moisture for a prolonged period of time.

In this case although the affected timber element is in a decaying state the extent of any visible damage appears to be localised to a specific area and is yet to spread to other parts of the building element or affect adjoining structures. The fungal decay is therefore likely to be of a relatively superficial nature with minimal impact on the structural integrity or tensile strength of the timber element.

A further invasive inspection by a licensed timber pest technician is highly recommended to check for concealed activity.

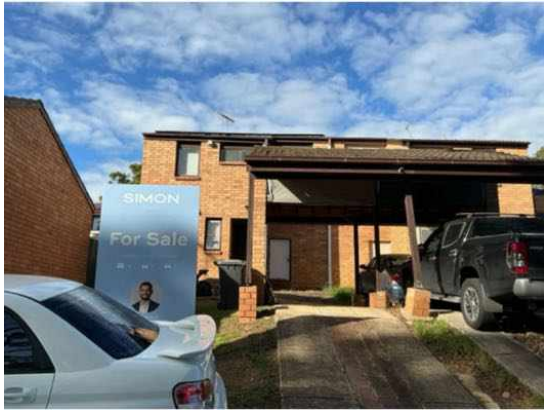
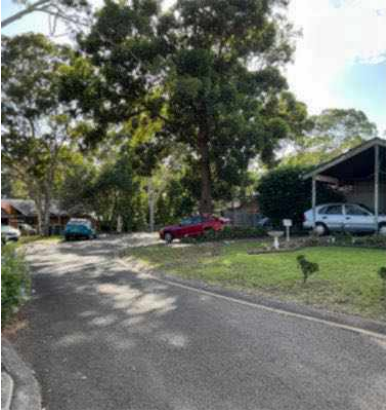
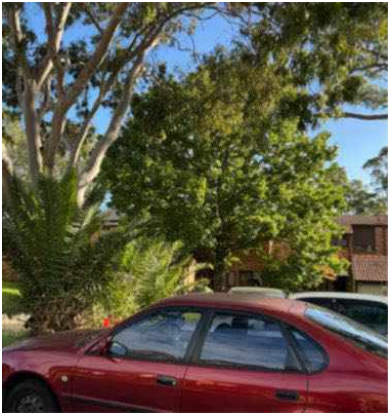
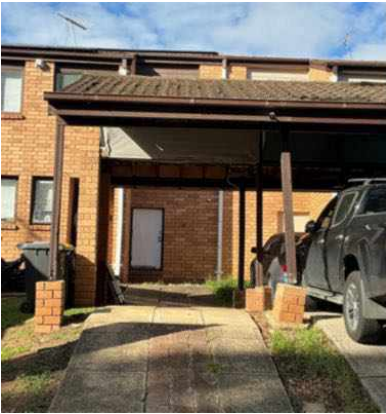
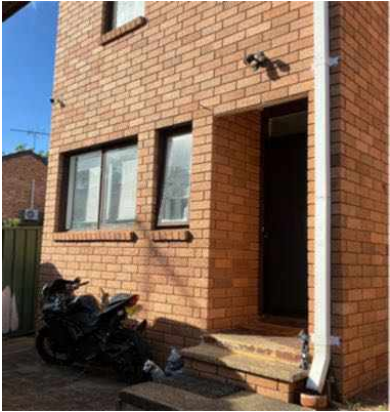
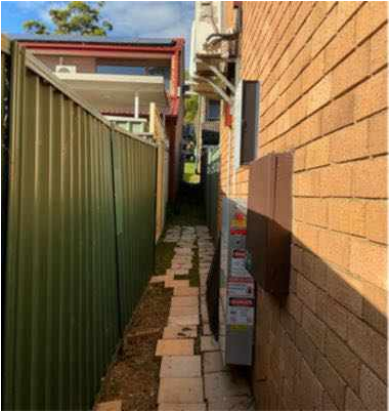
#### Noted Item

Building: Main Building  
Location: All External Areas  
Finding: Additional Photos - Obstructions and Limitations  
Information: These photographs are an indication of the obstructions and limitations which impeded full inspection of the property at the time of inspection. These obstructions can hide an array of defects and should be removed to allow full inspection to be carried out. A re-inspection is recommended once the areas are made accessible.

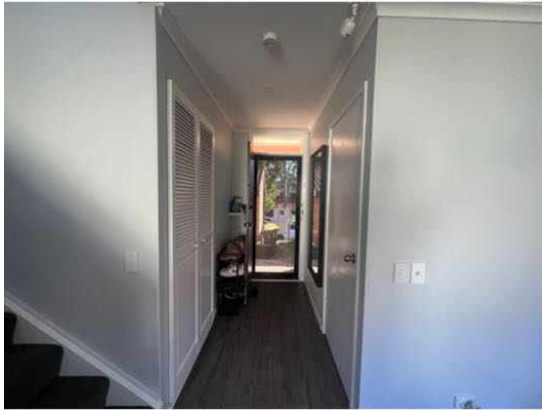
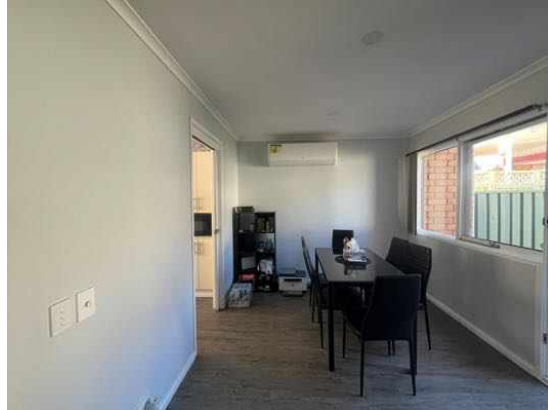
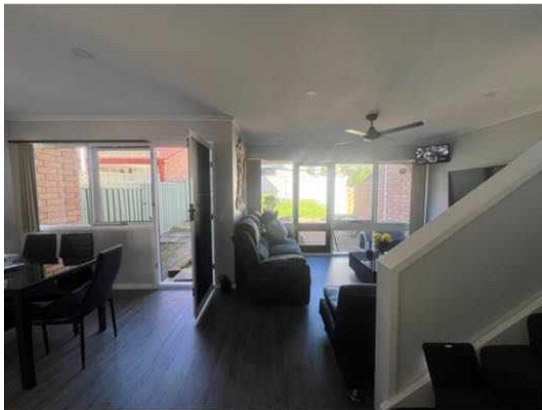
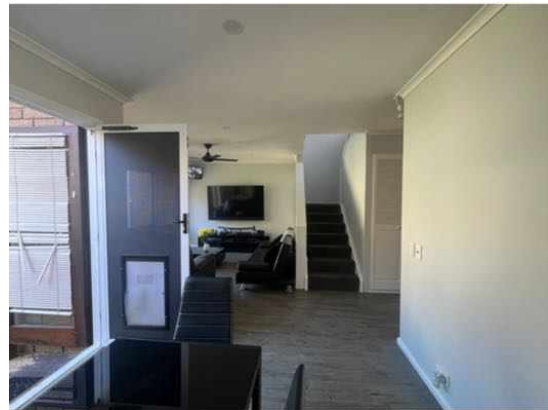
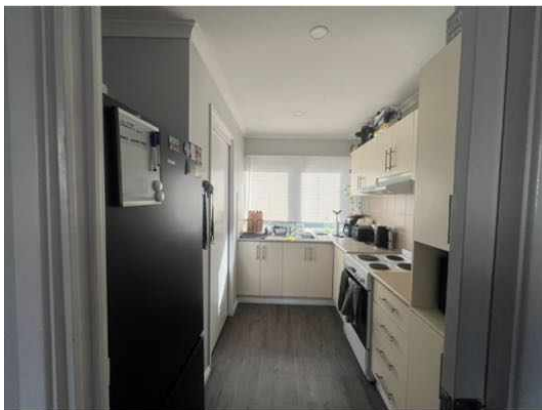
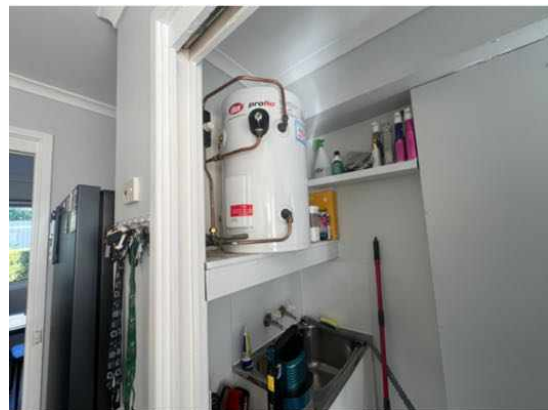
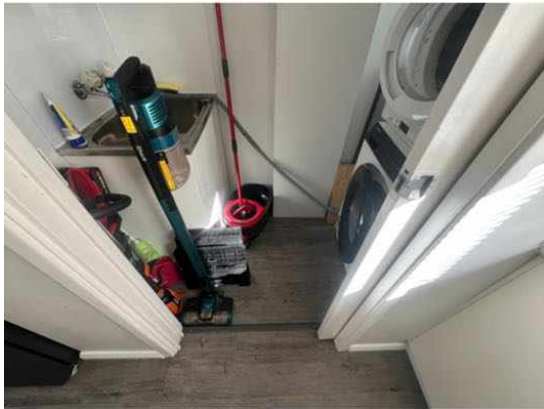
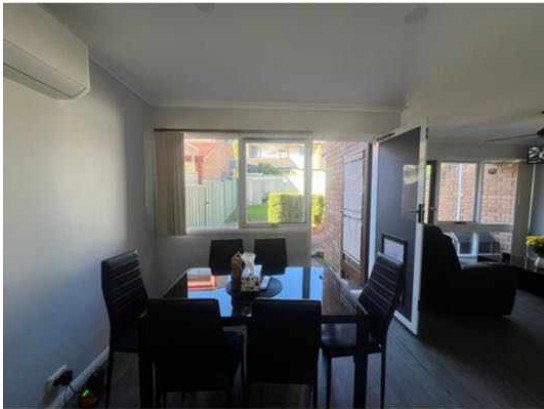
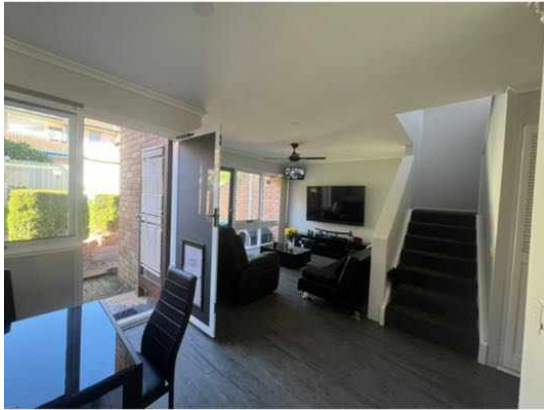
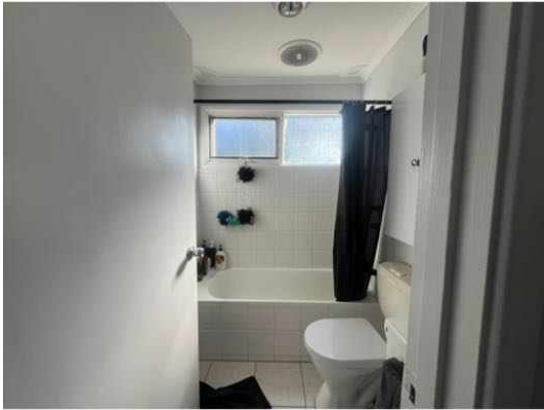
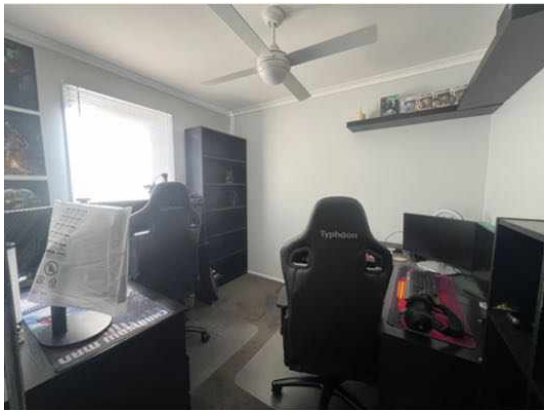
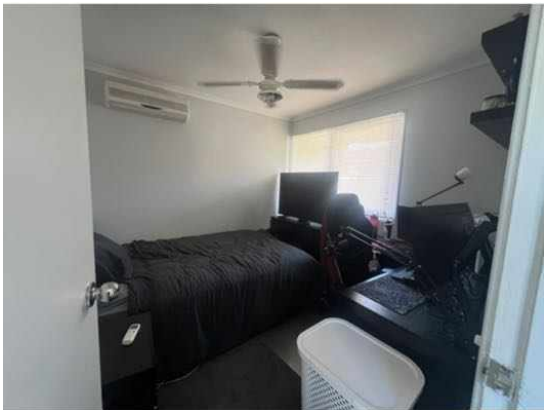
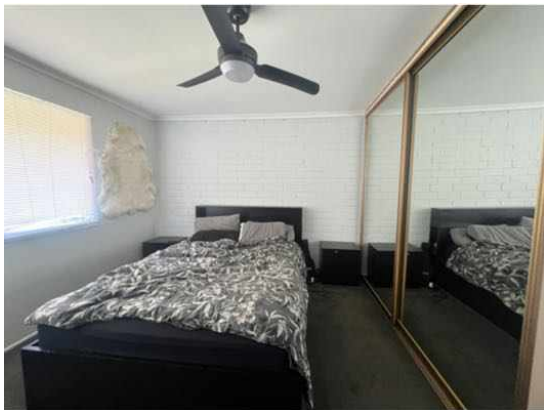
Building: Main Building  
Location: All Internal Areas  
Finding: Additional Photos - Obstructions and Limitations  
Information: These photographs are an indication of the obstructions and limitations which impeded full inspection of the property at the time of inspection. These obstructions can hide an array of defects and should be removed to allow full inspection to be carried out. A re-inspection is recommended once the areas are made accessible.

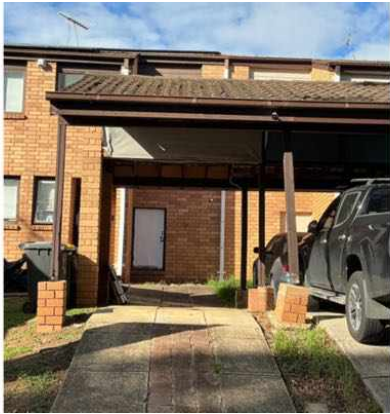
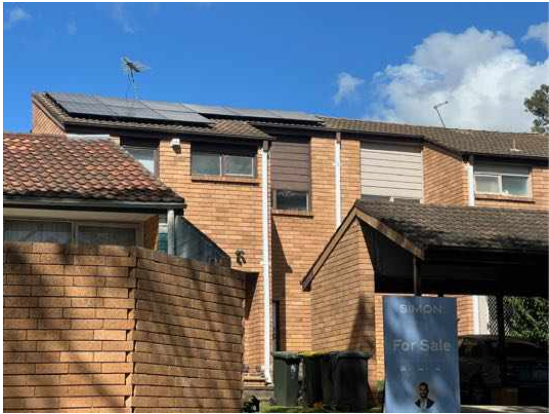
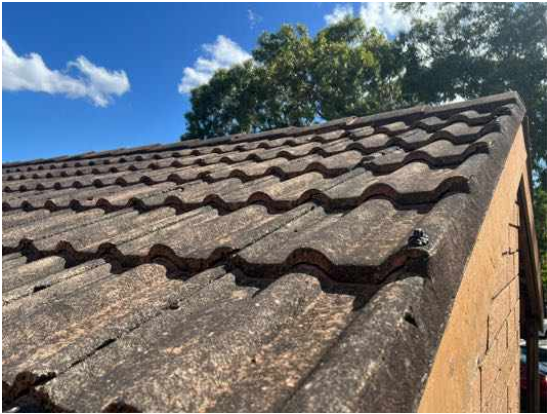
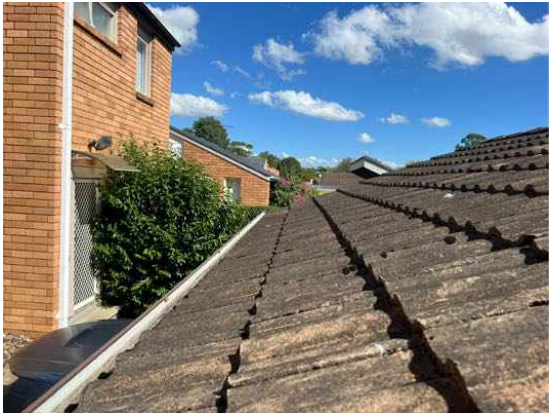
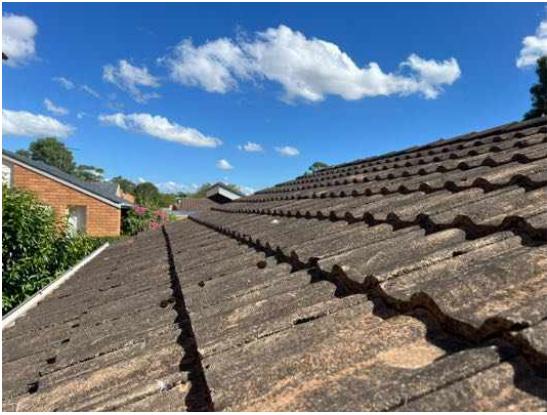
Building: Main Building  
Location: Roof Exterior  
Finding: Additional Photos - Obstructions and Limitations  
Information: These photographs are an indication of the obstructions and limitations which impeded full inspection of the property at the time of inspection. These obstructions can hide an array of defects and should be removed to allow full inspection to be carried out. A re-inspection is recommended once the areas are made accessible.

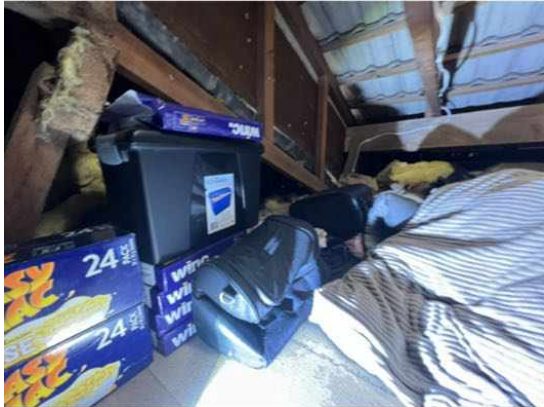
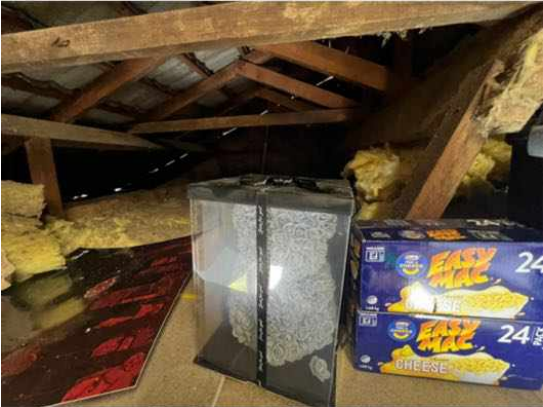
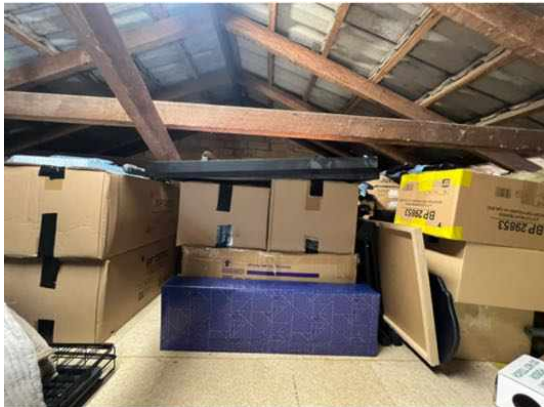
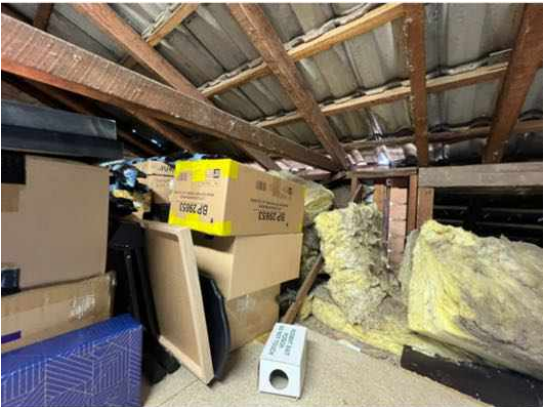
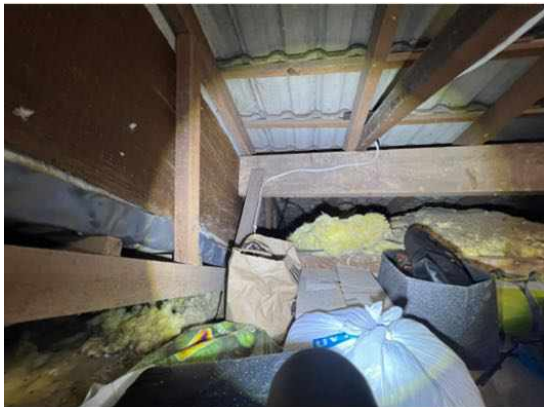
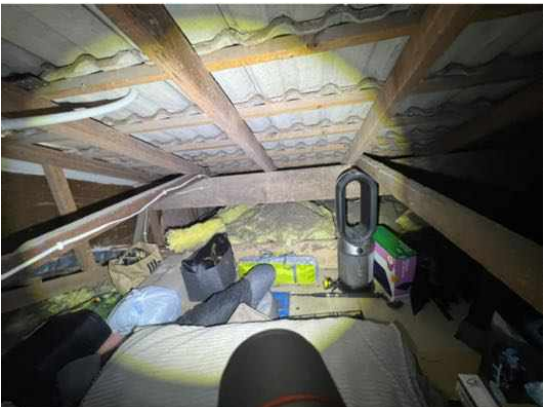
Building: Main Building  
Location: Roof Void

Finding: Additional Photos - Obstructions and Limitations  
 Information: These photographs are an indication of the obstructions and limitations which impeded full inspection of the property at the time of inspection. These obstructions can hide an array of defects and should be removed to allow full inspection to be carried out. A re-inspection is recommended once the areas are made accessible.

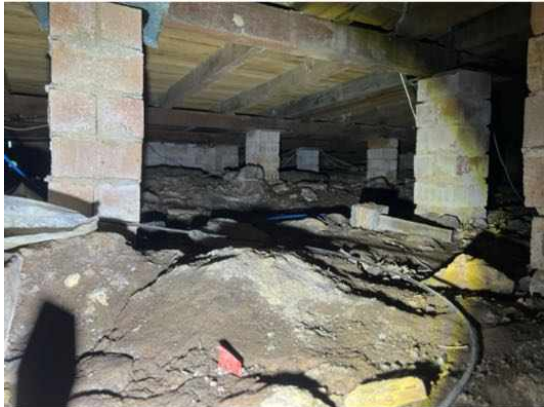
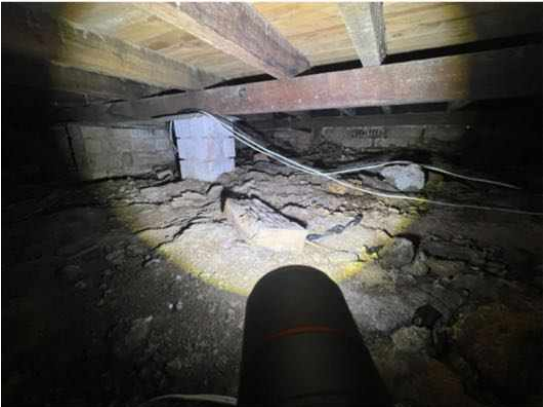
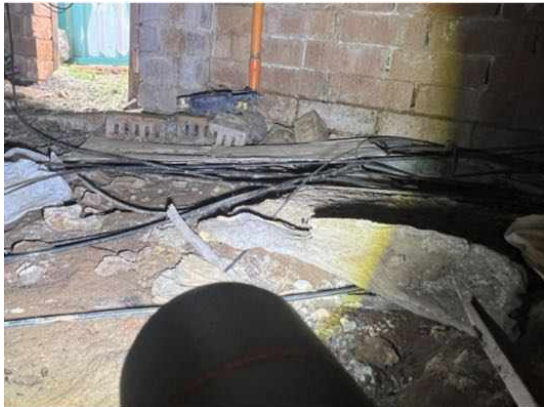
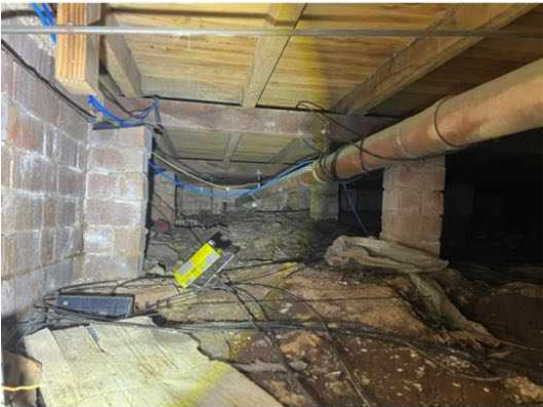
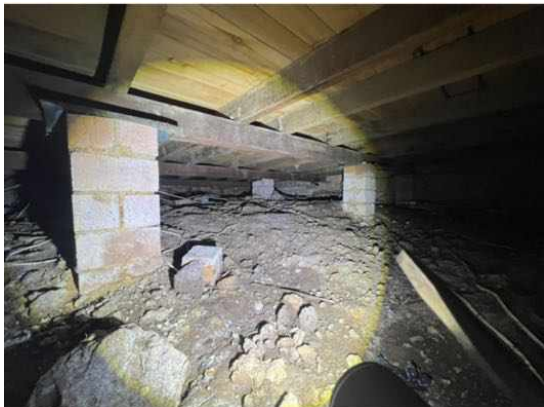
Building: Main Building  
 Location: Subfloor  
 Finding: Additional Photos - Obstructions and Limitations  
 Information: These photographs are an indication of the obstructions and limitations which

impeded full inspection of the property at the time of inspection. These obstructions can hide an array of defects and should be removed to allow full inspection to be carried out. A re-inspection is recommended once the areas are made accessible.
