# Building Inspection Report

Inspection Date: Fri, 27 Mar 2026

Property Address: 39 Dawn St, Highett VIC 3190, Australia

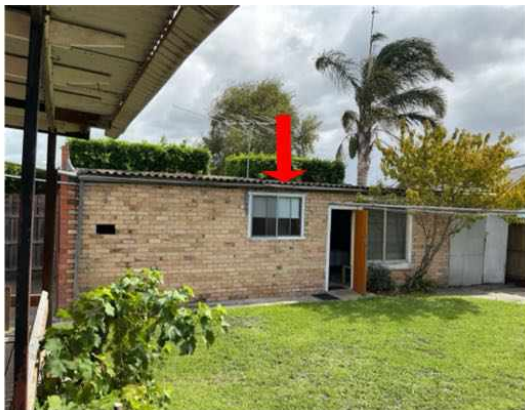
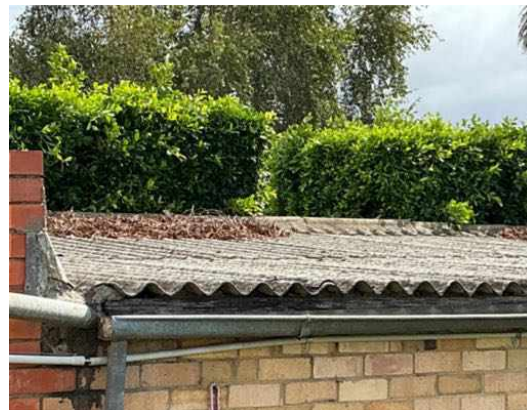
#### Defects 1.01

Building:	Main Building
Location:	Garage
Finding:	Asbestos - Suspected ACM Identified on Site
Information:	Reporting on Asbestos is outside the Scope of this Report. This suspected defect is highlighted as a caution only. We suspect, based on our experience in the building industry, that there is a higher risk of the identified building element containing asbestos.

As Asbestos Reporting is outside the scope of this report, we advise that you consider a separate Asbestos Inspection and Condition Audit, which can include the taking of samples for definitive confirmation of the presence of Asbestos.

In the interim, the client is advised to act with caution, especially when considering any damage to building materials general wear and tear renovations extensions demolition and general maintenance activities due to the suspected presence of Asbestos.

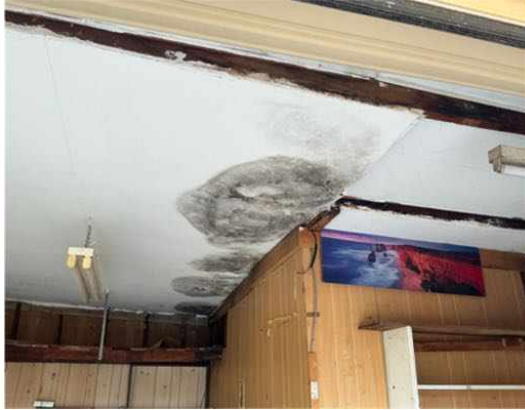
#### Defects 1.02

Building:	Main Building
Location:	Garage
Finding:	Mould - Present
Information:	Where evidence of mould growth was noted, there may be environmental, biological or health issues associated with the report. A specialist inspection by a suitably qualified environmental health inspector is warranted, where mould is extensive or where any queries regarding air quality spores or other related issues apply.

Generally, the client is advised to ensure that the general environment is free of moisture and humidity to aid in the prevention of mould formation and development.

Any mould found during the inspection should be cleaned immediately by a cleaning contractor or the homeowner as applicable.

Please note that severely affected building elements may require replacement by a registered builder or qualified carpenter.

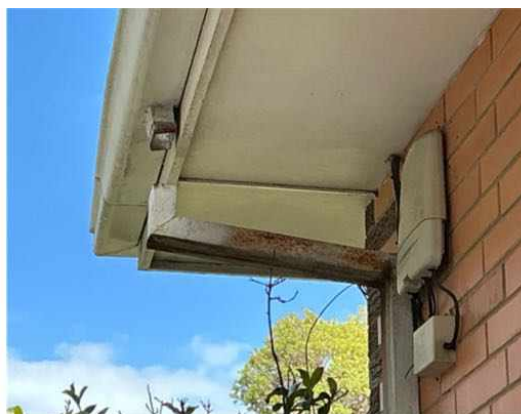
## Defects 2.02

Where roof plumbing doesn't drain adequately, the area at the base perimeter can become excessively damp, potentially creating an environment that is susceptible to rust and corrosion of surrounding building elements, as well as attracting termites and other pests.

It is highly recommended that a plumber be appointed to further inspect the area and to install adequate drainage equipment where necessary.

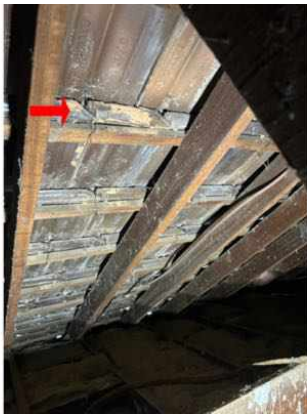
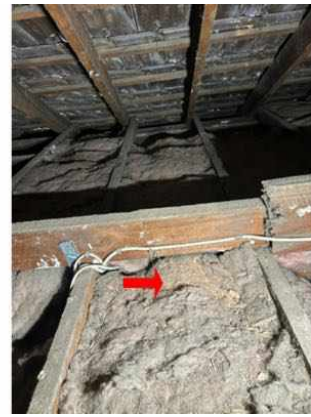
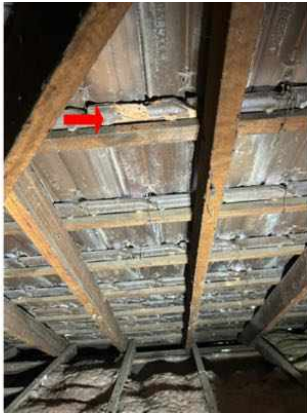
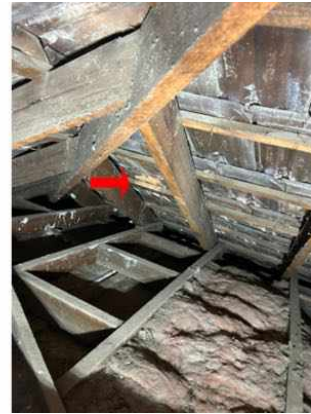
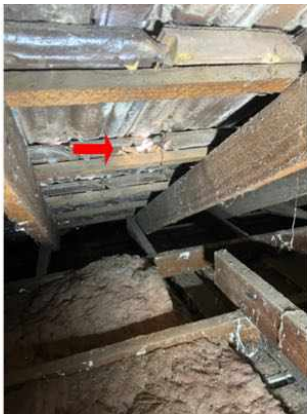
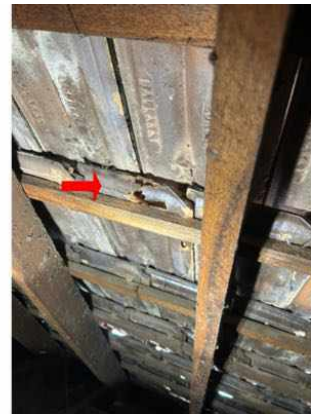
## Defects 2.03

Building:	Main Building
Location:	Roof Void
Finding:	Roof tiles - Fretting
Information:	Upon inspection of the exterior roofing, the roof tiles were found to be fretting

Fretting on a terracotta roof tile has various causes and salt is one common cause. It is hard to pin point the exact cause of the fretting.

Where left unmanaged, deteriorating roof tiles are likely to lead to a number of secondary defects, including minor water leaks and weather exposure to internal roofing structures.

A short term solution is to replace the tiles that are badly fretting. But fretting is a bit like cancer. It can be quite wide spread and you should consider a new roof if there is substantial fretting of your terracotta roof tiles.

Consultation with a roofing contractor is highly advised to gain advice on cost of remedial works that may be required in the short to medium term. Remedial works are likely to increase the longevity of the exterior roofing

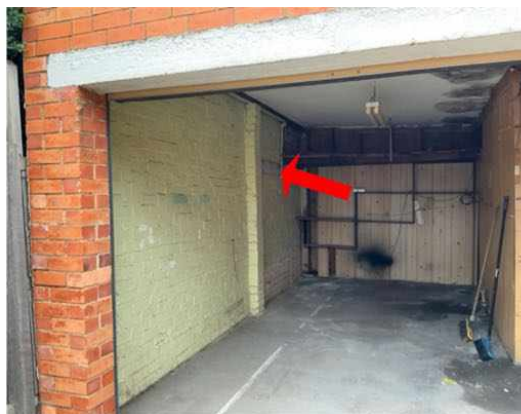
### Defects 3.02

Building:	Main Building
Location:	Garage and bungalow
Finding:	Brickwork - Step cracking
Information:	Step cracking was identified to the brickwork in this area at the time of inspection. Step cracking, which is similar to other forms of cracking, has a variety of possible causes. However, the most common is the subsidence of adjacent footings.

Step cracking is a relatively common defect, and is most likely to occur adjacent to windows, doors and other openings. Mortar failure in the gaps between affected bricks indicates the stresses and tensions affecting the wall.

Where step cracking is extensive or severe, the client is advised to consult a structural engineer. Minor step cracking can be used as a warning sign to address factors causing stress to the wall, which can include the effect of surrounding trees, water leaks, soil erosion, or even the presence of reactive soils in the surrounding area.

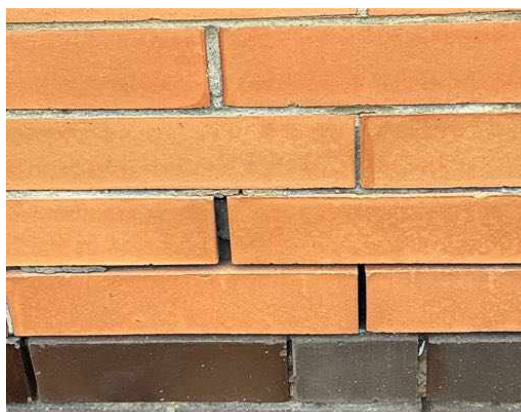
### Defects 3.03

Building:	Main Building
Location:	All areas
Finding:	Brickwork - Deteriorated mortar
Information:	Mortar, or 'bedding', is the material which fills joins and intersections between bricks in masonry walls and structures. Sections of mortar in this brickwork were identified as having deteriorated, which is generally expected for a property of this age and condition.

Mortar may deteriorate as a result of age of building materials, minor movement of bricks, or frequent exposure to weathering. Mortar should be replaced to ensure that bricks remain in their intended location and to prevent gaps, which would allow water or moisture ingress and secondary damage as a result.

Mortar deterioration can be addressed by a bricklayer where areas of deterioration are localised and easily accessible. Alternatively, appointment of a registered builder is advised, to repoint large areas of decaying mortar. Where secondary structural defects have become evident, consultation with a structural engineer may be required.

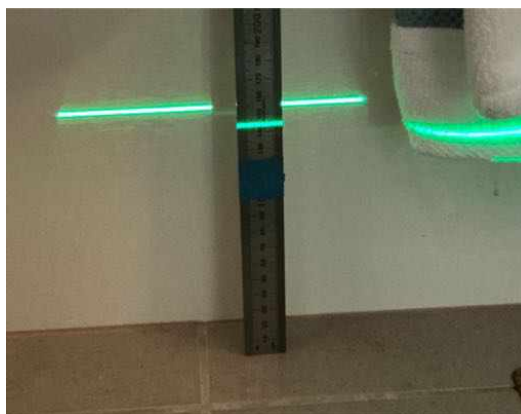
### Defects 3.07

Building:	Main Building
Location:	Bedroom - Master
Finding:	Floors - bouncy
Information:	The internal flooring in this area was identified as being bouncy at the time of inspection. A bouncy floor surface generally presents as a discernible change in level as they are walked across, in noisy or creaking flooring, or in consequent movement of surrounding furniture and fixtures.

Flooring in other areas was found to be within tolerance although not perfectly level in all areas

However, where flooring is uneven further, potentially invasive inspection of the subfloor structures and stumps in this area is required. In this case, works to repair are likely to be required, and would be carried out by a registered builder specialising in re-stumping.

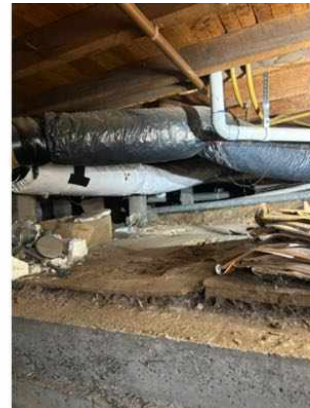
### Defects 3.13

The damage sustained by the ducts detracts from the energy efficiency of the property. The airflow within the property is likely to be restricted, particularly in areas where ducting shows signs of major damage.

A heating/cooling specialist should be appointed to provide further advice on remedial work options and to perform any works deemed necessary.

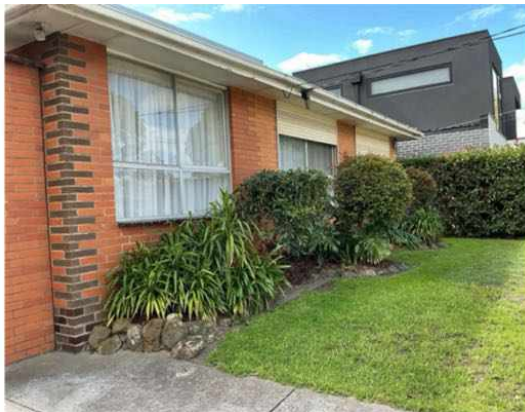
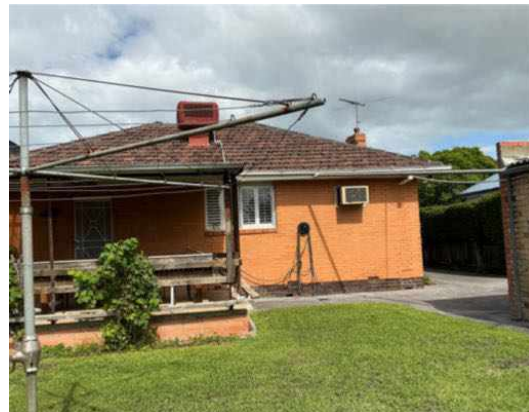
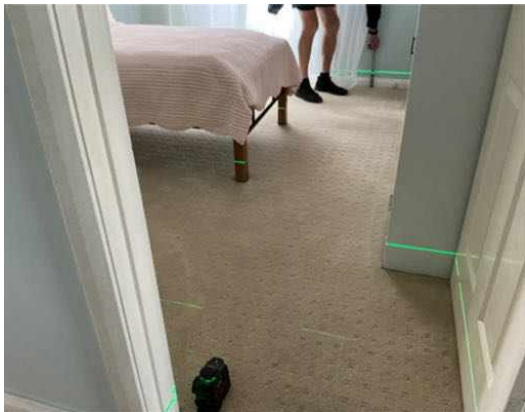
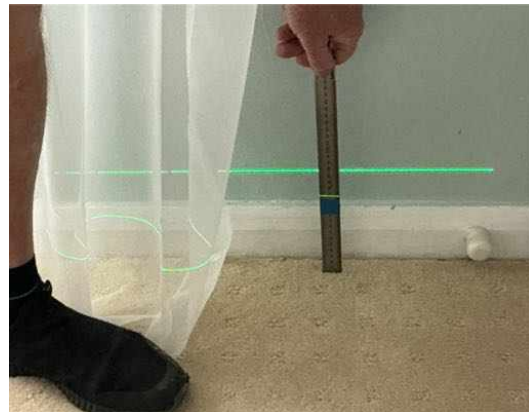
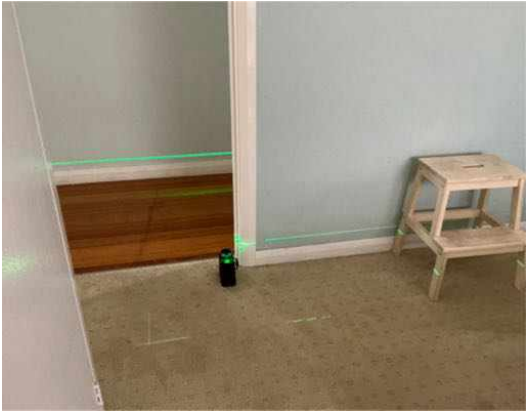
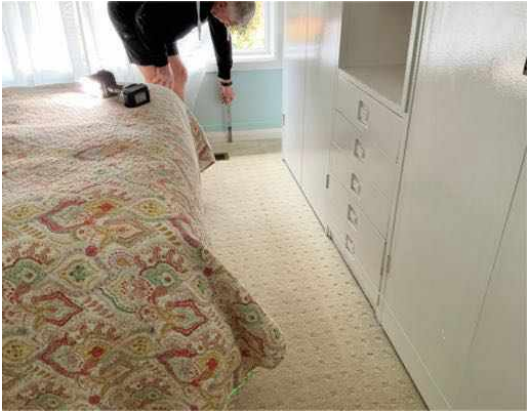
Finding: Additional Photos - Obstructions and Limitations

Information: These photographs are an indication of the obstructions and limitations which impeded full inspection of the property at the time of inspection. These obstructions can hide an array of defects and should be removed to allow full inspection to be carried out. A re-inspection is recommended once the areas are made accessible.

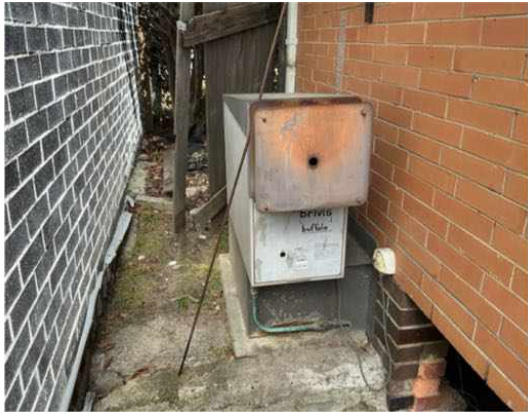
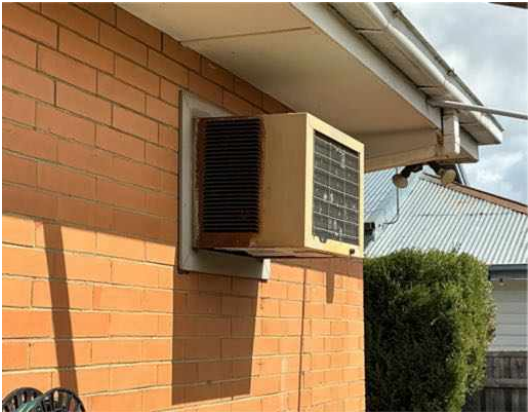
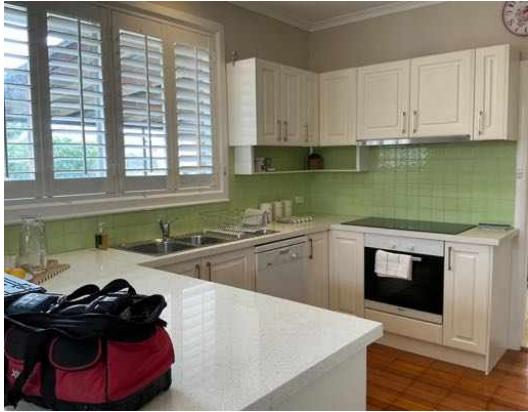
Building: Main Building  
 Location: All appliances  
 Finding: Warranty - Expired  
 Information: Where appliances are beyond their warranty period, the owner should be prepared to

meet the cost of replacement or repair of the item at any time. The operation of the appliance can not be guaranteed and further inspection by an appropriately qualified tradesperson may be required.

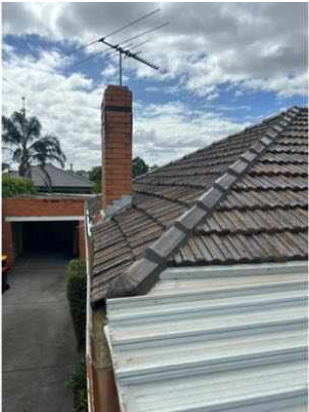
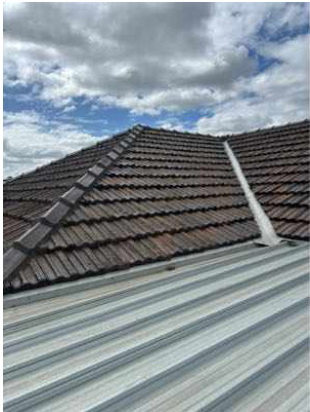
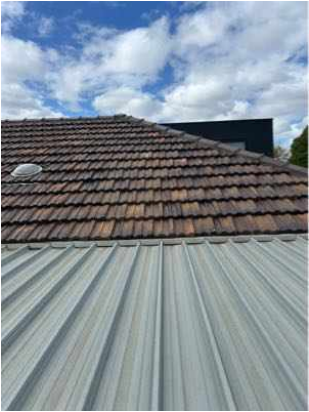
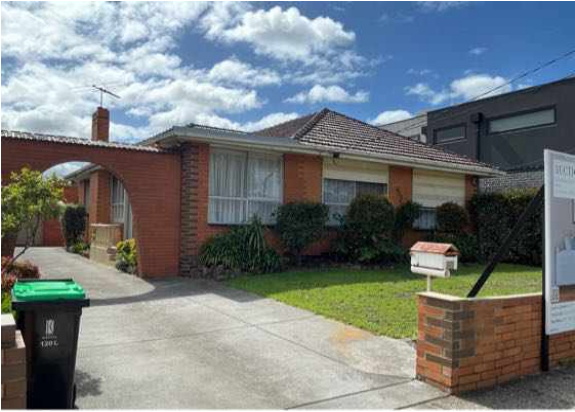
- Building: Main Building
- Location: All Areas
- Finding: Additional Photos
- Information: Additional photos are provided for your general reference
