Building and Timber Pest Inspection Report

Inspection Date: Thu, 19 Mar 2026

Property Address: 3B Kungar Rd, Caringbah South NSW 2229,
Australia

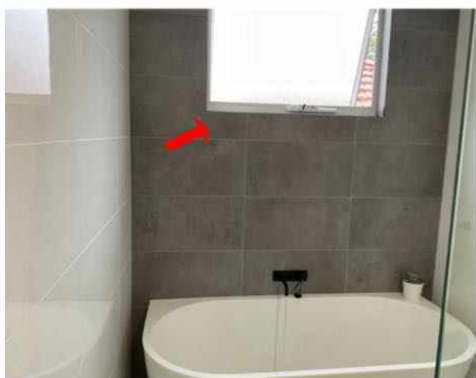
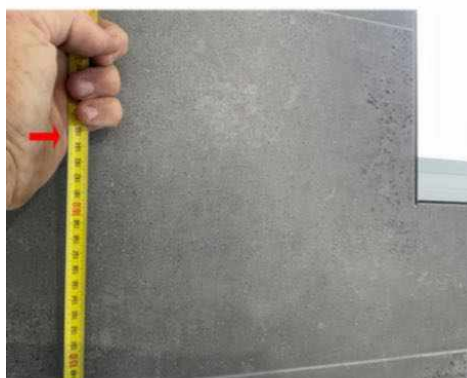
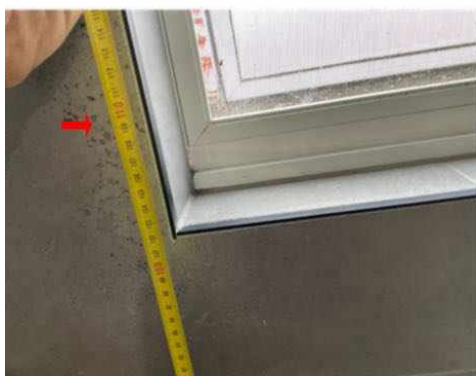
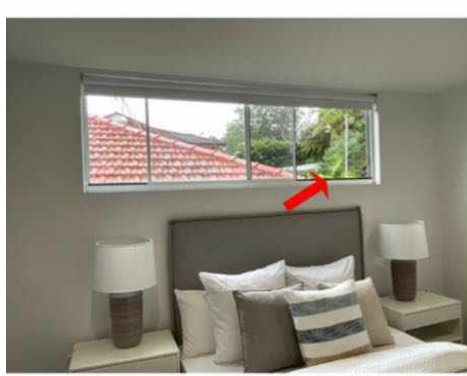
Building: Building 1
 Location: Bathrooms, master bedroom,
 Finding: Window opening restrictors missing.
 Information: These pictured windows are missing window restrictors. The Building Code of Australia rules require all openable windows (where the internal floor is more than 2m above the ground outside) in residential rooms to be fitted with a suitable screen or restrictor. Windows located 1.7m above the floor level do not require protection. These windows are approx 1.65 metres from the floor and 1.07 metres from the top of the bath.

Window restrictors are required where people who are vulnerable to the risk of falling have access to windows. This means all windows above ground level which do not have another fall prevention safety measure in place, such as a balcony or balustrade should have a restrictor.

These need to be added urgently for the safety of all persons.

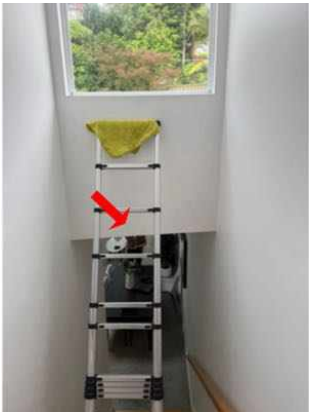
Location: Most windows, some doors and skylights
 Finding: Evidence of excessive moisture was present at the time of inspection
 Information: Excessive moisture was found around most of the house windows, some doors and all rear skylights.

Moisture readings of up to 52.2 were found in front window areas, 70.8 in rear window areas and 34.4 in skylight areas.

Minor mould and rust was found in the front bedroom window which will develop if not addressed.

Excessive moisture in these areas is suspected to be caused by incorrectly installed or missing flashings or damaged sealant.

The exact cause of the moisture ingress could not be determined at the time of the inspection.

Further investigation is required by a sealant expert.

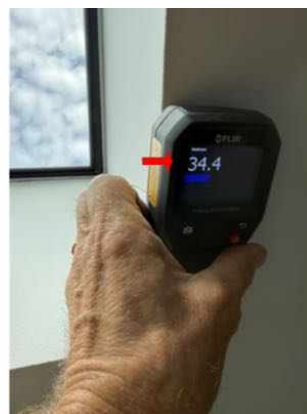
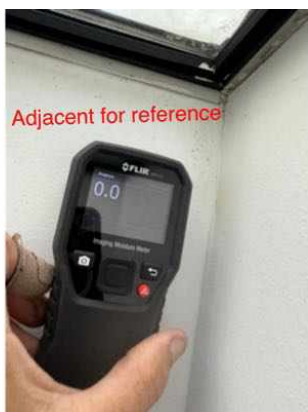
Finding 3.02

Building: Building 1
Location: Skylights
Finding: Evidence of excessive moisture around skylights
Information:

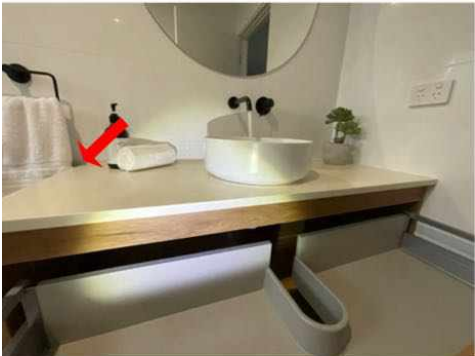
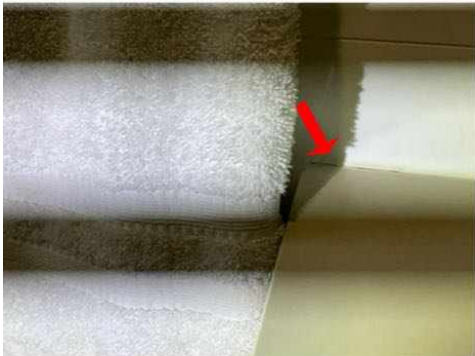
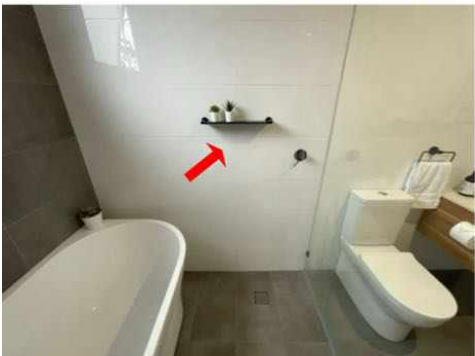
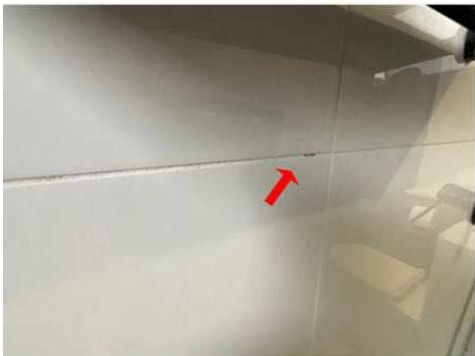
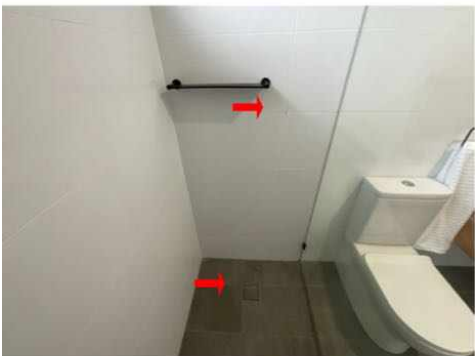
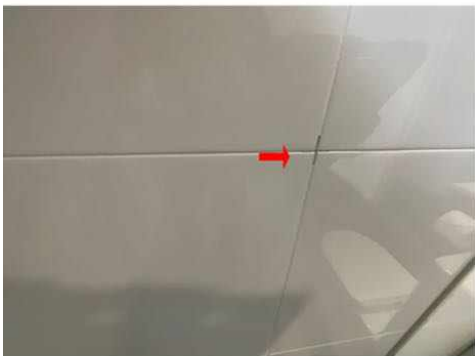
Finding 3.03

Building:	Building 1
Location:	Pictured areas
Finding:	Building elements - Damaged or missing
Information:	Evidence of minor missing or damaged areas was identified at the time of the inspection. These include -

A sealant specialist or tiling contractor should be appointed to complete these works

as soon as possible

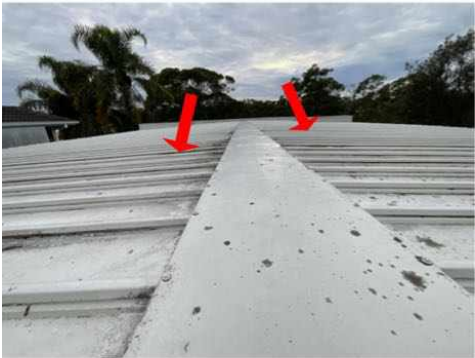
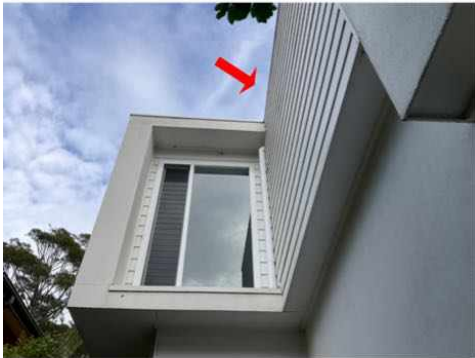
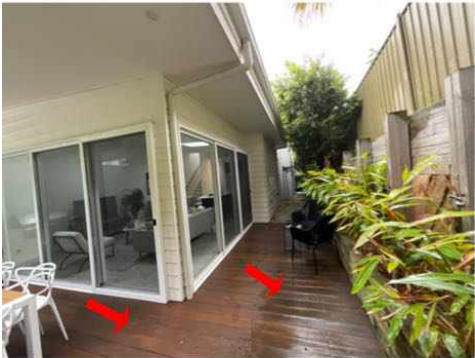
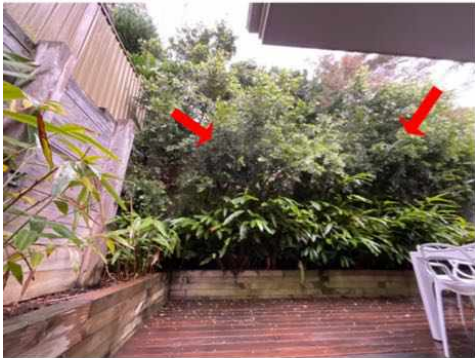
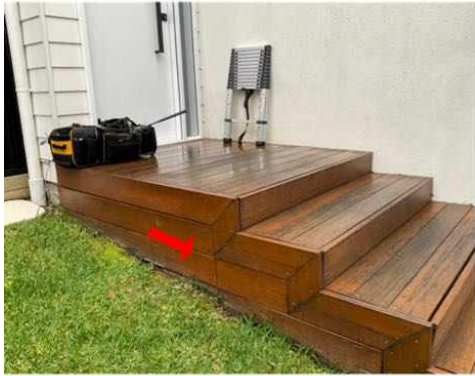
Building: Building 1
Location: All External Areas
Finding: Additional Photos - Obstructions and Limitations of EXTERNAL AREAS
Information: These photographs are an indication of the obstructions and limitations which impeded full inspection of external areas at the time of inspection. These obstructions can hide an array of defects and should be removed to allow full inspection to be carried out. A re-inspection is recommended once the areas are made accessible.

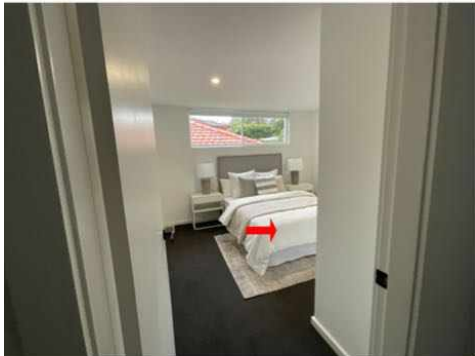
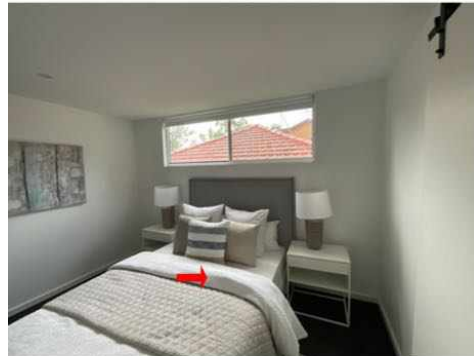
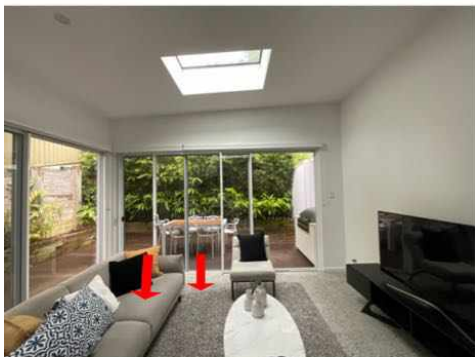
Building: Building 1
Location: All Internal Areas
Finding: Additional Photos - Obstructions and Limitations of INTERNAL AREAS
Information: These photographs are an indication of the obstructions and limitations which impeded full inspection of Internal areas at the time of inspection. These obstructions can hide an array of defects and should be removed to allow full inspection to be carried out. A re-inspection is recommended once the areas are made accessible.

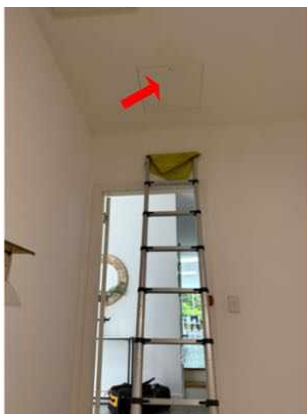
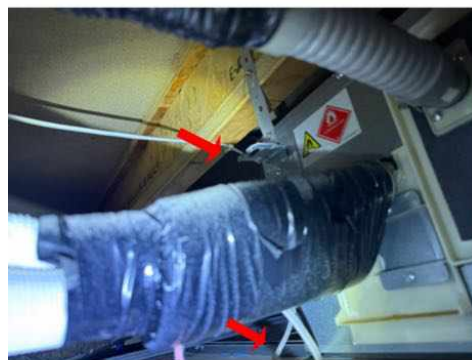
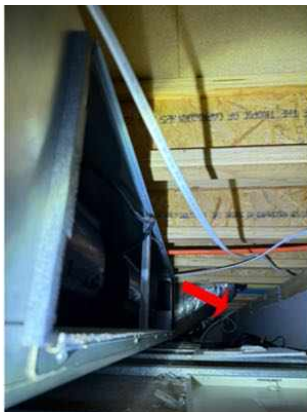
Building: Building 1
 Location: All Roof cavity areas
 Finding: Additional Photos - Obstructions and Limitations of the ROOF CAVITY
 Information: These photographs are an indication of the obstructions and limitations which impeded full inspection of roof cavity areas at the time of inspection. These obstructions can hide an array of defects and should be removed to allow full inspection to be carried out if applicable. A re-inspection is recommended once the areas are made accessible.

The inspection was also limited to areas with an allowable crawl space of 600mm x 600mm, in particular towards the external walls where the roof line diminishes, these areas were not accessible.

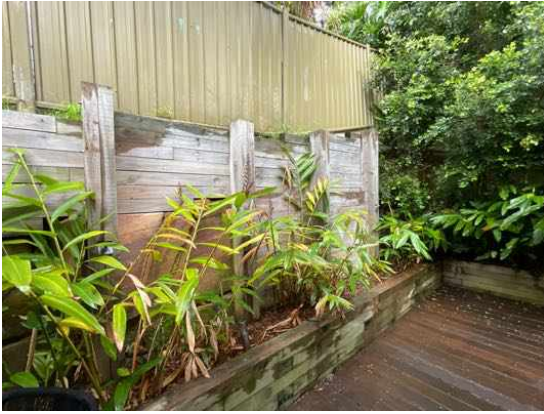
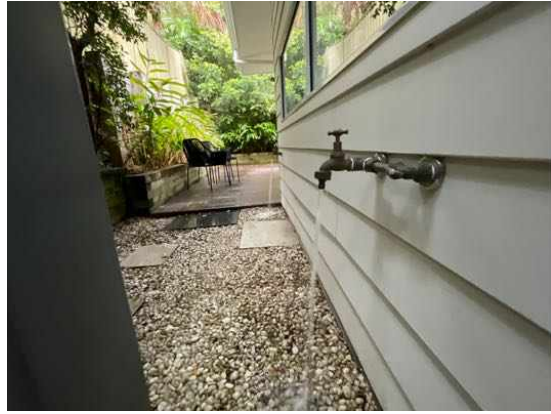
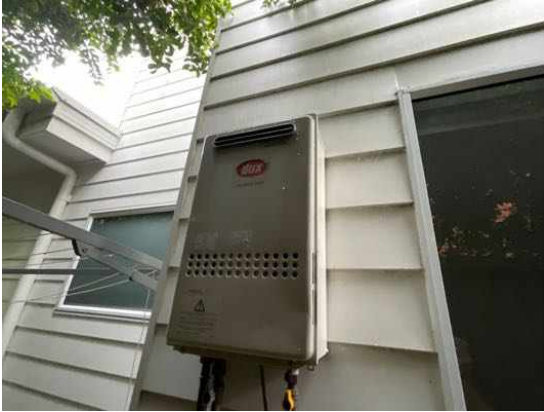
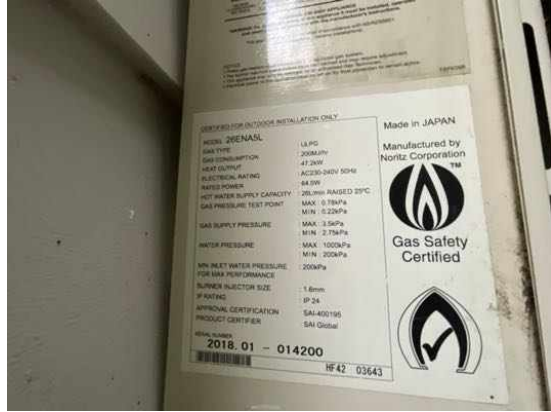
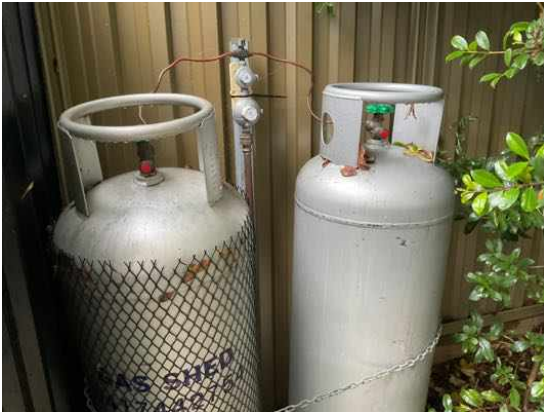
Building: Building 1
 Location: All External Areas
 Finding: Additional Photos
 Information: Additional photos are provided for your general reference

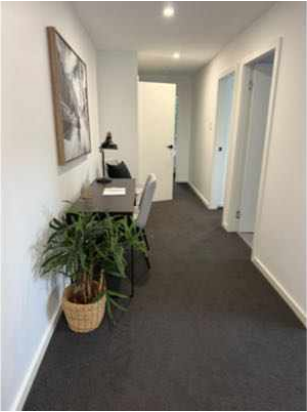
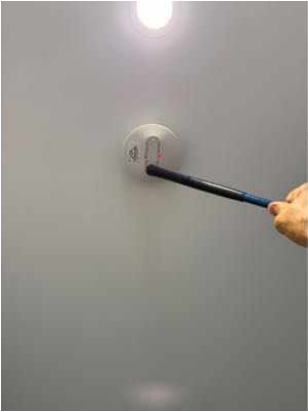
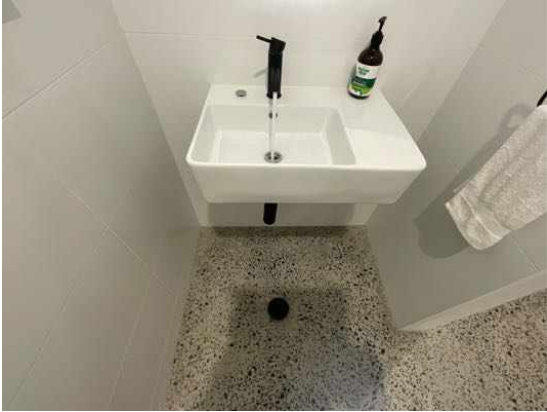
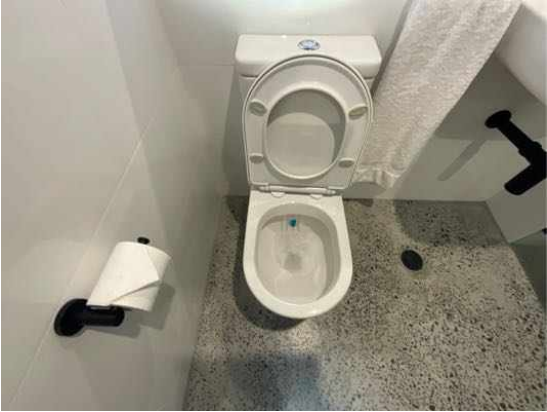
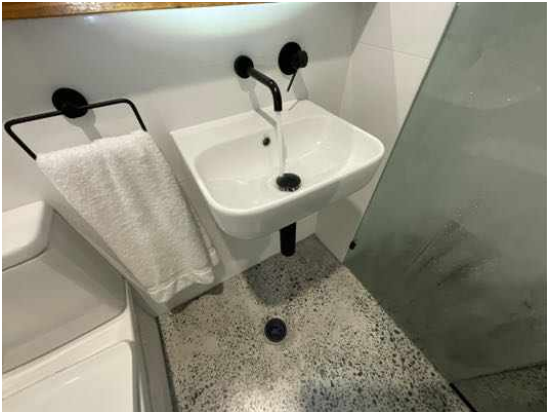
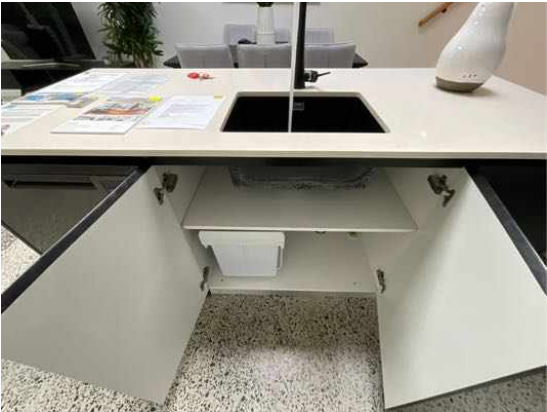
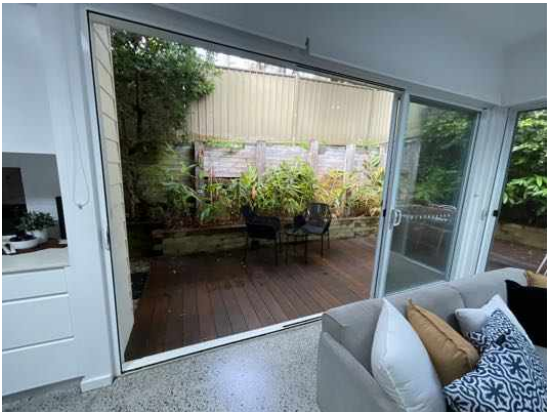
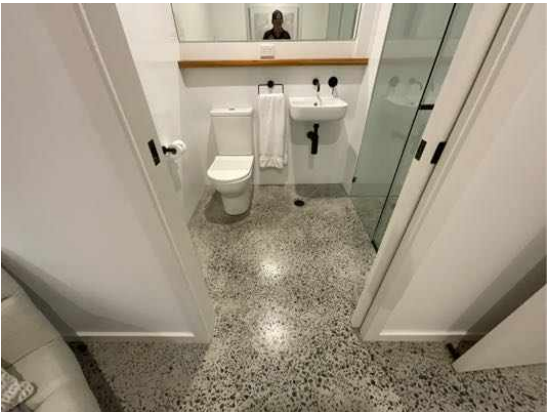
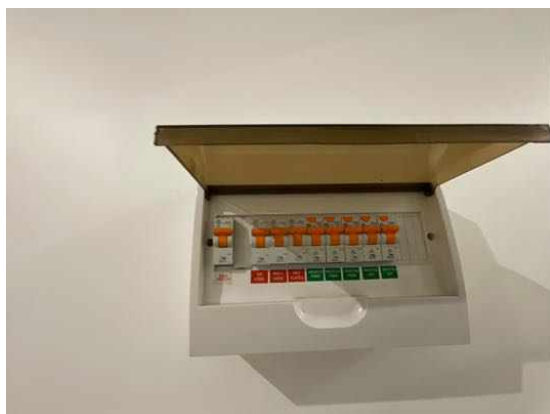
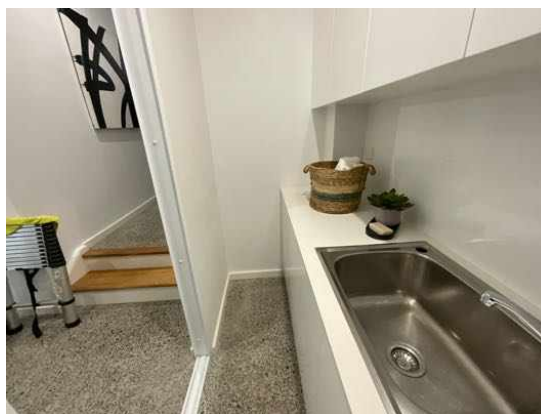
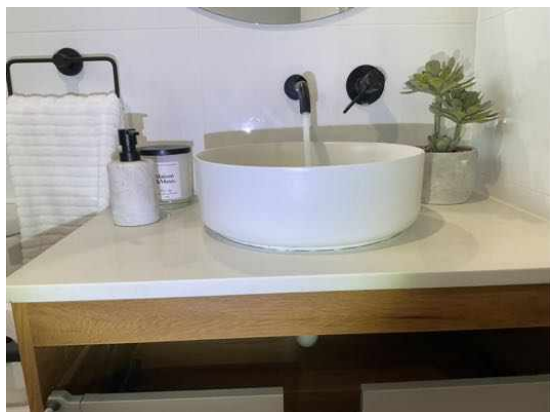
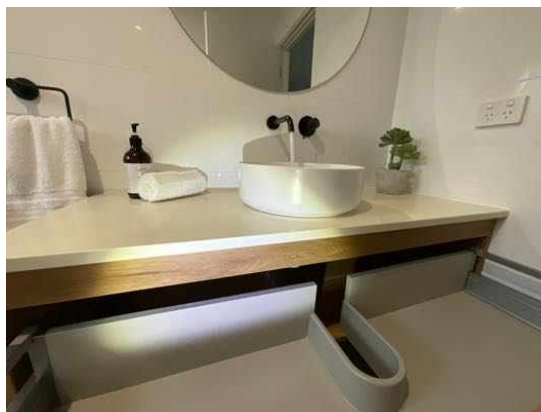
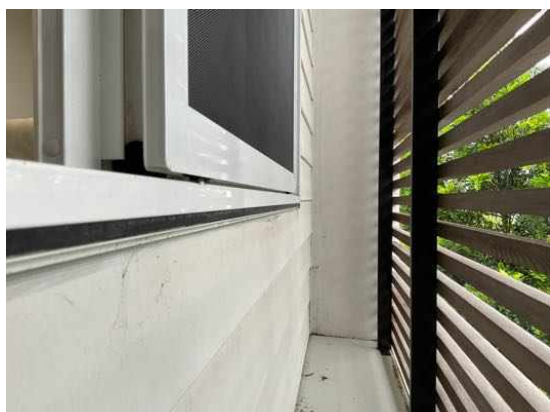
Building: Building 1
Location: All Internal Areas
Finding: Additional Photos
Information: Additional photos are provided for your general reference

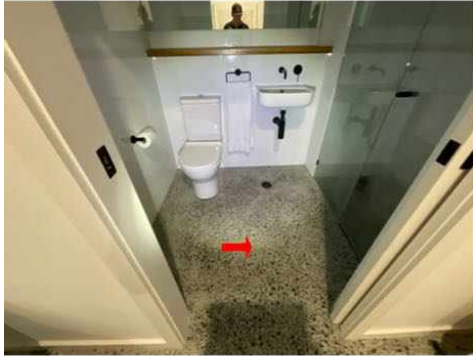
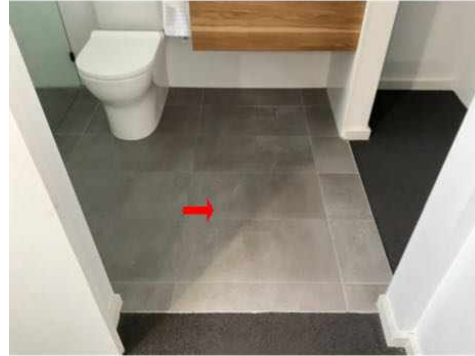
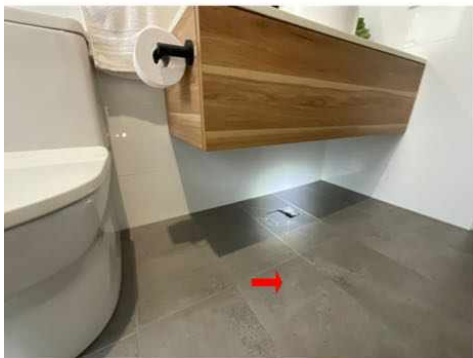
Building: Building 1
 Location: Bathrooms and laundry
 Finding: Waterproofing membranes - Information Only
 Information: Internal Water Proofing Membranes, are crucial in preventing water ingress into the property is important to know that the Membrane System used is to Australian Standards and has been installed correctly.

With older property's where this information is unavailable all wet areas should be monitored. If any leaks, water staining, peeling or bubbling of the paint become evident to any adjacent walls or ceilings below a licensed builder or waterproofing specialist is recommended to investigate further.
