Building and Timber Pest Inspection Report

Inspection Date: Wed, 18 Feb 2026

Property Address: 12 Steenson St, Edmondson Park NSW
2174, Australia

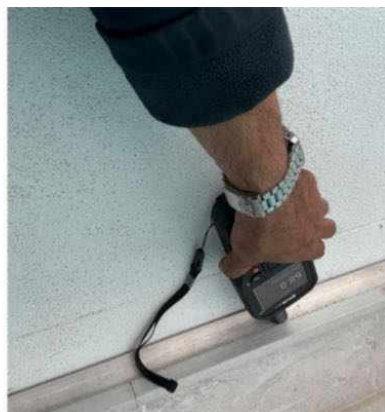
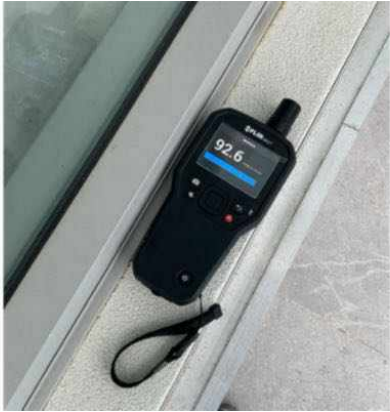
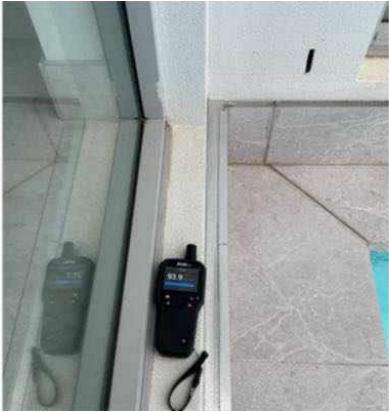
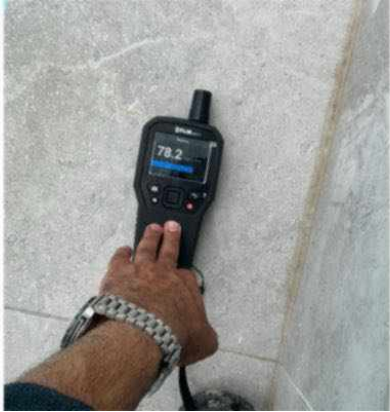
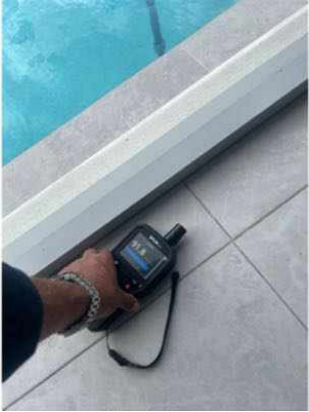
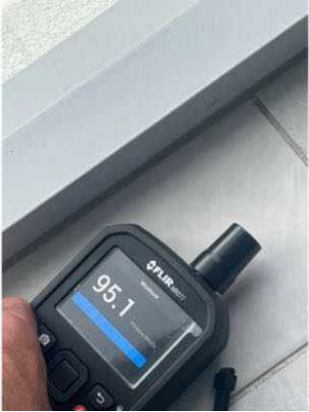
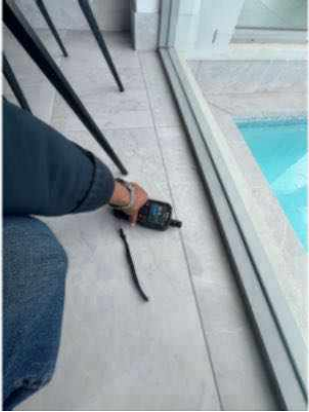
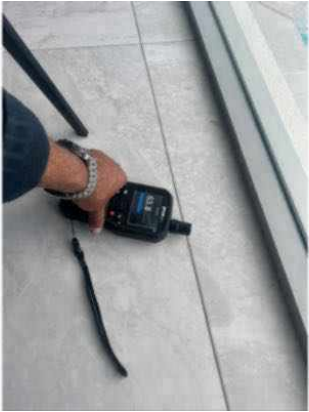
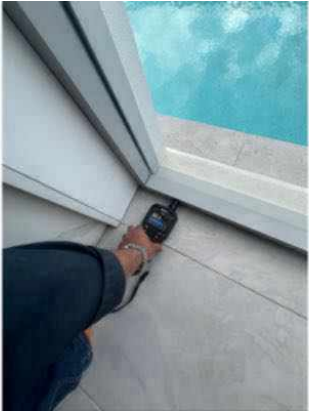
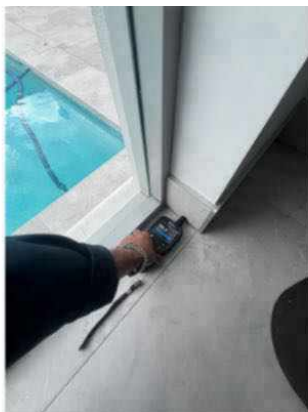
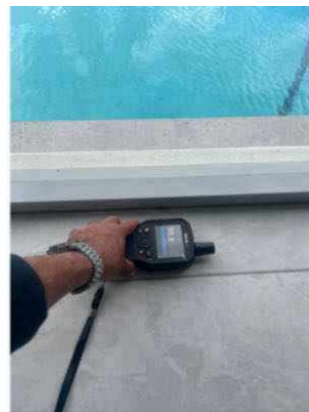
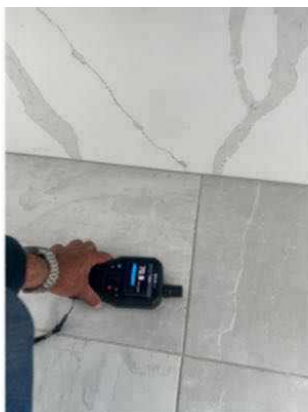
Finding 3.01

Building:	Main Building
Location:	All Internal Areas
Finding:	Elevated Moisture – Further Investigation Recommended
Information:	Elevated moisture readings were detected in several locations externally and tiles in the lounge area adjacent to pool, although no significant structural damage was evident at the time of inspection, dampness can contribute to deterioration if left unaddressed. Elevated moisture ingress these locations may indicate drainage , waterproofing or plumbing related issues. A further investigation by a licensed plumber or waterproofing specialist is recommended to confirm the source and ensure no concealed issues are developing. Failure to investigate this defect can be constitute significant costs in the future.

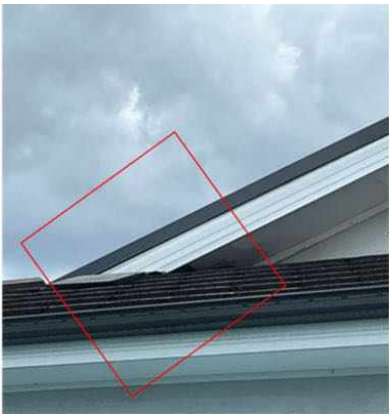
Finding 3.02

Building:	Main Building
Location:	Roof Exterior
Finding:	Installation - substandard or incomplete - Gap not sealed (Possible moisture ingress)/flashing to some areas
Information:	Visible gaps are present between the flashing and roof sheeting, and the end of the wall cladding/fascia trim does not appear fully sealed. The flashing edge appears loosely fitted in sections, with no evident continuous sealant bead or foam infill closure at the corrugation profiles. These gaps create a potential pathway for wind-driven rain to enter beneath the flashing and into the roof space or wall cavity. The detailing appears incomplete and may not provide adequate weatherproofing.

Further full roof inspection and rectification by a licensed roofer is recommended to properly secure, seal, and weatherproof the junction to prevent moisture ingress and possible concealed damage. Failure to perform these works can cause significant moisture related damage to the ceilings.

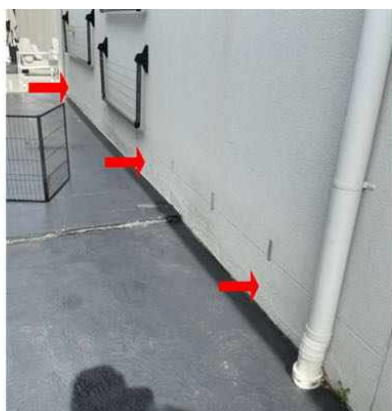
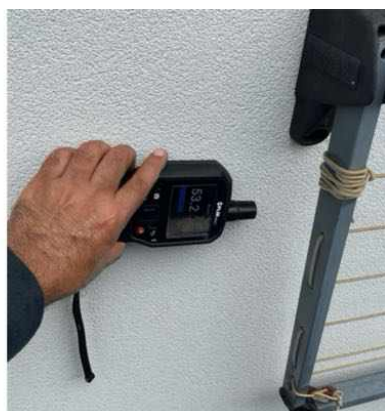
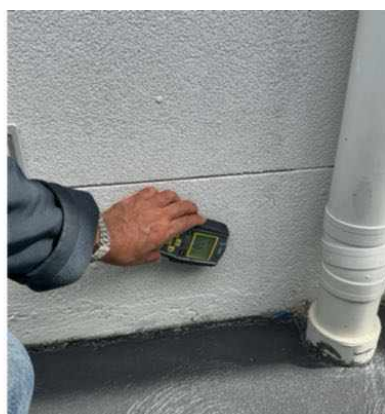
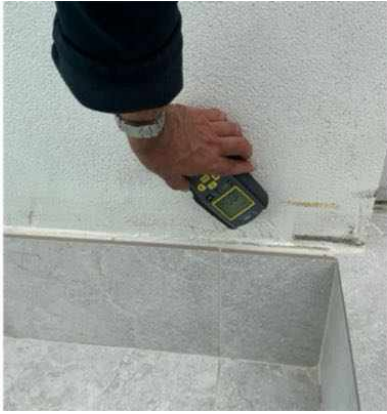
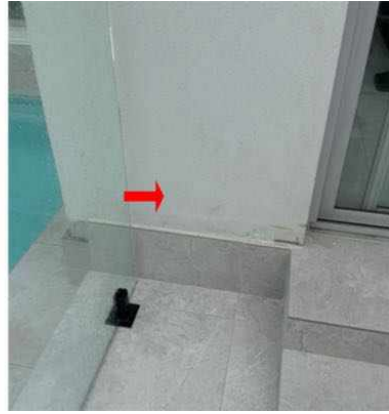
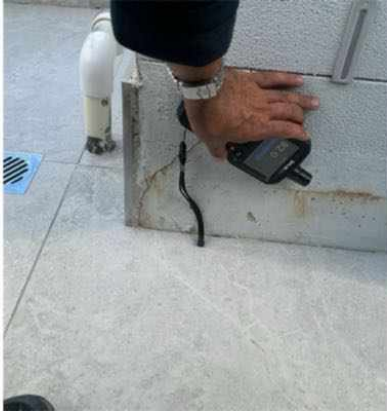
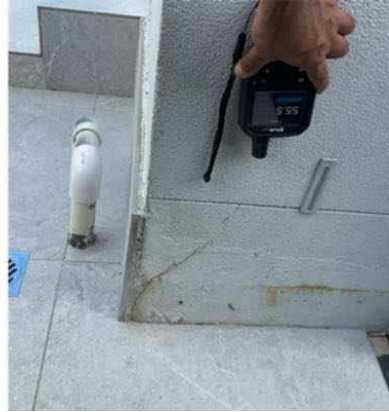
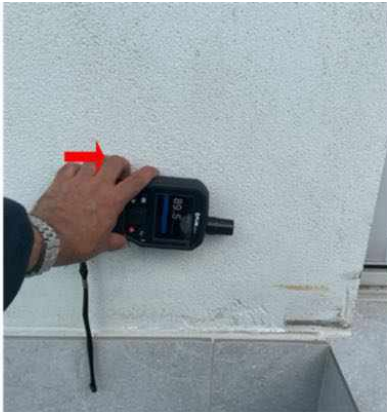
Finding 3.03

Building: Main Building
Location: All External Areas - Left , Rear
Finding: Damp (Elevated Moisture) and minor cracking
Information: The moisture profile and staining pattern are consistent with rising damp, capillary action, moisture bridging, or water accumulation at the wall-slab interface. The adjacent tiled surface and drainage configuration may be allowing water to pond or track toward the wall base. The cracking observed at the lower corner may be associated with shrinkage or minor movement, however, sustained moisture exposure can accelerate render deterioration and potentially impact internal linings if moisture ingress persists. Elevated readings of this magnitude warrant further investigation to determine whether the damp-proof course (DPC) has been bridged or compromised.

Further assessment is recommended to determine the source of moisture, including inspection of drainage falls, slab levels relative to the DPC, and waterproofing detailing at the wall-floor junction. Rectification may involve improving surface drainage, sealing cracks, and ensuring the DPC is not bridged by finishes. Monitoring of moisture levels and internal wall surfaces is advised to confirm whether the condition is active and ongoing.

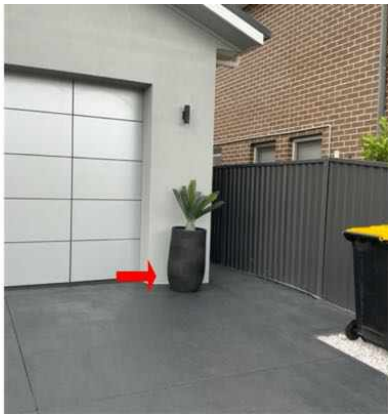
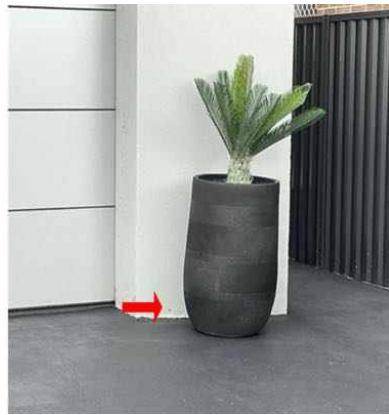
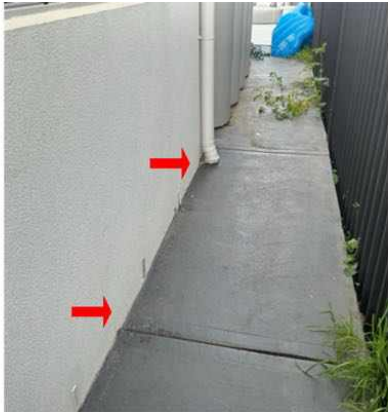
Finding 3.04

Building:	Main Building
Location:	All External Areas
Finding:	Render Finish Covering Damp Membrane
Information:	During the inspection, it was noted that the applied render finish is covering the damp-proof membrane. This is affecting the membrane's ability to prevent moisture movement above it, leading to moisture-related issues over time. It is recommended to consult a qualified builder to ensure the damp-proof membrane is properly exposed, maintaining its effectiveness in preventing moisture ingress.

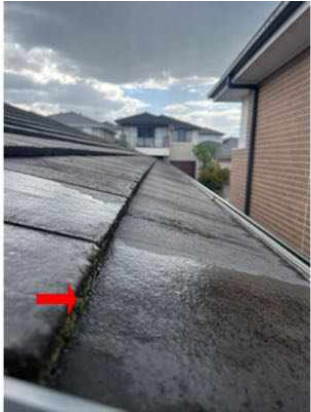
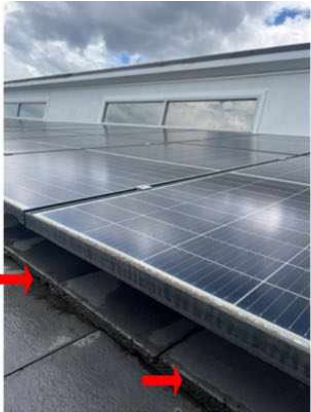
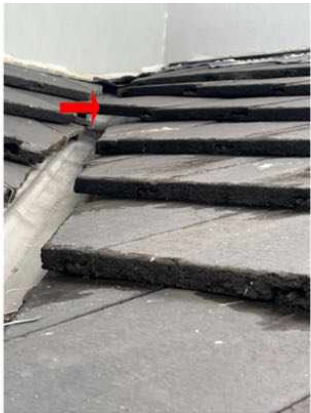
Finding 3.05

Building:	Main Building
Location:	Roof Exterior
Finding:	Roof tiles condition - Observation
Information:	The concrete roof tiles display general surface weathering, minor edge erosion and biological growth (moss/algae) along laps and lower edges, consistent with age and environmental exposure. Some tiles appear slightly uneven, likely due to minor settlement or past foot traffic, though no obvious broken tiles are evident. Routine maintenance including cleaning of biological growth, replacing damaged tiles and checking that tiles are properly seated is recommended to maintain effective drainage and long-term weatherproof performance.

A further thorough inspection of roof is highly recommended by a licensed roofing contractor to confirm there are no further concealed issues are present.

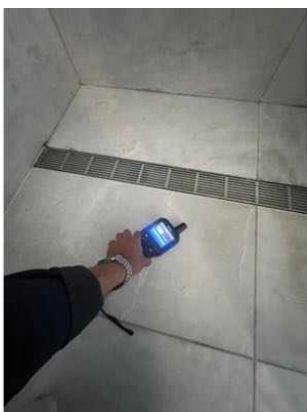
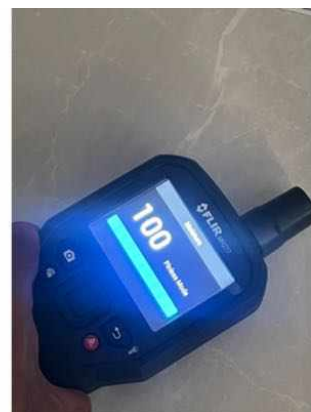
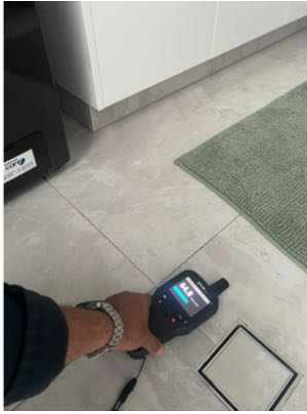
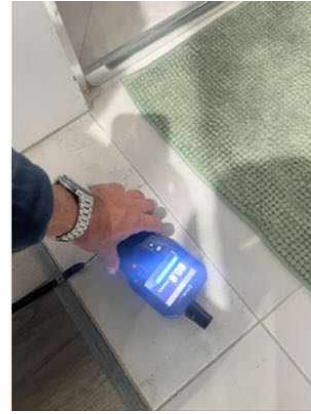
Finding 3.06

Building:	Main Building
Location:	Bathrooms
Finding:	Elevated Moisture Bathroom (No visible deterioration noted)
Information:	Elevated moisture levels were detected to tiled surfaces in bathroom/shower areas. Persistent moisture ingress can lead to concealed damage, including timber rot and mould growth.

Elevated moisture readings in tiled wet areas can occur from normal shower use, age/deterioration of waterproofing membranes, plumbing leaks or moisture absorption through grout lines. While no damage was visible, elevated readings may indicate moisture retention behind tiles, which can be a conducive condition for future deterioration if not monitored.

No immediate action required. Monitor the area over time for signs of drumming, efflorescence, tile movement, or grout deterioration. If concerns arise, a licensed waterproofing specialist can perform further investigation (e.g., pressure testing, membrane assessment).

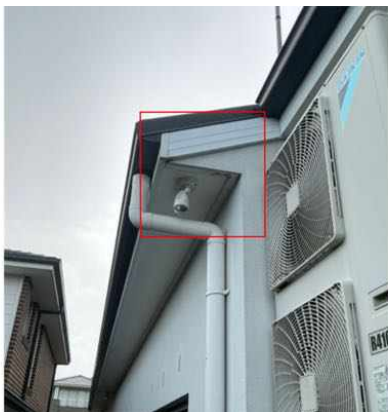
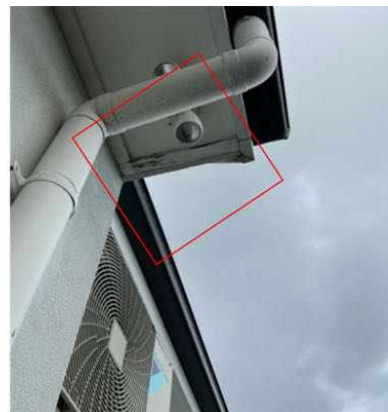
Finding 3.07

Finding: Water staining to some areas - Eaves

Information: Water staining was evident in this area at the time of inspection. Water staining indicates that surfaces have been exposed to excessive moisture over time. The minerals and other elements in the water lead to staining, which may graduate to corrosion and deterioration if left unmanaged.

While mostly an appearance defect, water staining can be indicative of more serious defects, which may be currently concealed by other building elements.

Where water staining is active, a licensed plumber must be consulted to identify the cause of the staining and to provide advice on any reparation works that may be required. Replacement of any broken or damaged structures is advised.

Conversely, where water staining is old and inactive, affected building materials may be repaired or replaced at client discretion. A qualified carpenter or registered builder may be appointed to perform these works.

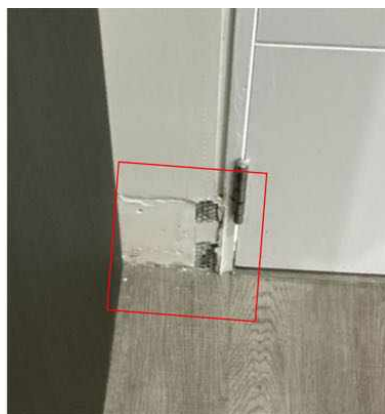
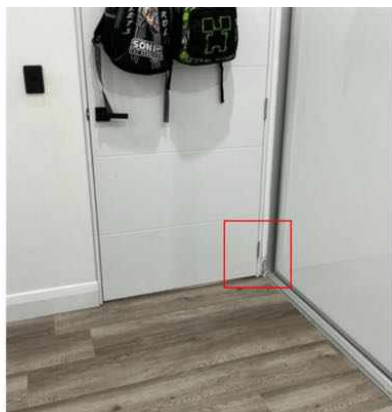
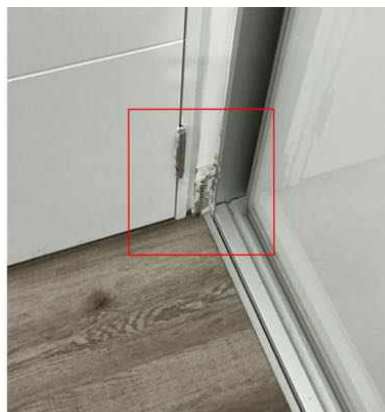
Finding 3.20

Building:	Main Building
Location:	All Internal Areas
Finding:	Building element - Damaged - Plaster damaged master bedroom , kids room
Information:	Breakage occurs generally when the building materials have either aged and decayed, or as a result of damage (accidental or deliberate).

Repair and/or replacement of broken elements is advised to ensure that additional secondary defects do not arise as a consequence. Such works are necessary, as all building elements play a key role in the operation and function of the overall structure and its performance.

A relevant tradesperson should be appointed to repair or replace the affected building element prior to any subsequent damage being caused.

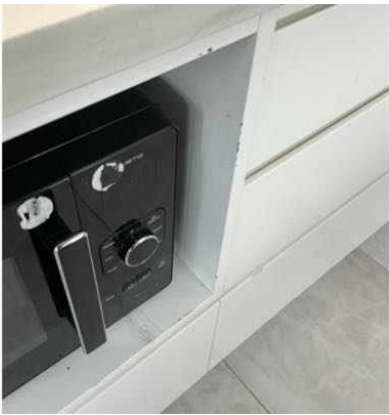
Finding 3.21

Building:	Main Building
Location:	All Internal Areas
Finding:	Building element - Damaged , kitchen cupboard minor scratches
Information:	Breakage occurs generally when the building materials have either aged and decayed, or as a result of damage (accidental or deliberate).

Repair and/or replacement of broken elements is advised to ensure that additional secondary defects do not arise as a consequence. Such works are necessary, as all building elements play a key role in the operation and function of the overall structure and its performance.

A relevant tradesperson should be appointed to repair or replace the affected building element prior to any subsequent damage being caused.

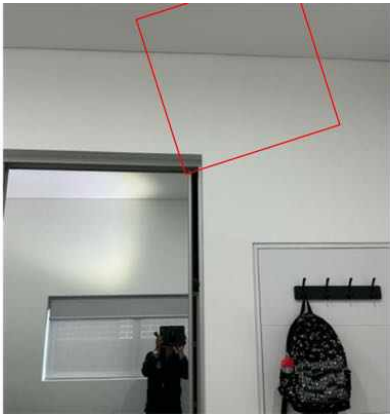
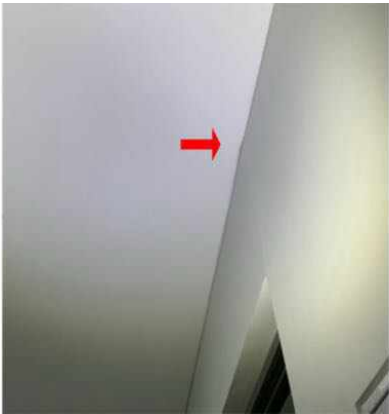
Finding 3.22

Building: Main Building
Location: Bedroom Kids right
Finding: Installation - substandard or incomplete - Uneven ceiling and wall junction
Information: The installation of this building element appears to have been completed to a substandard level of workmanship or is incomplete. Generally substandard repairs or installation are related to poor workmanship, the use of inappropriate materials, or a failure to complete installation to a suitable standard.

Where installation is substandard and/or incomplete, the client should contact the responsible trade to undertake rectification. Unfinished and substandard building works are likely to degrade more quickly and may create potential for secondary defects to associated building elements.

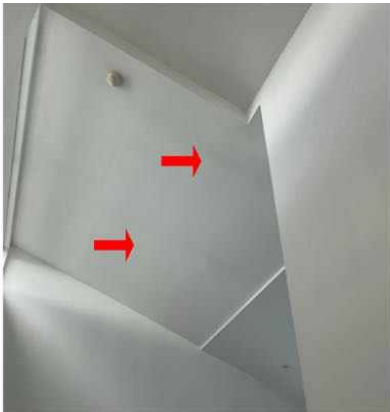
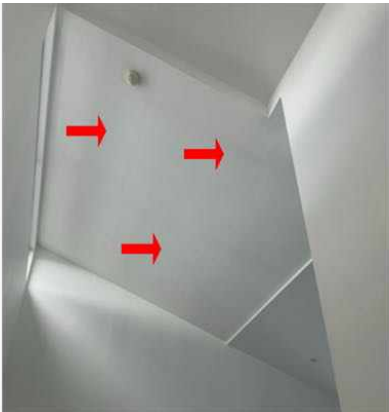
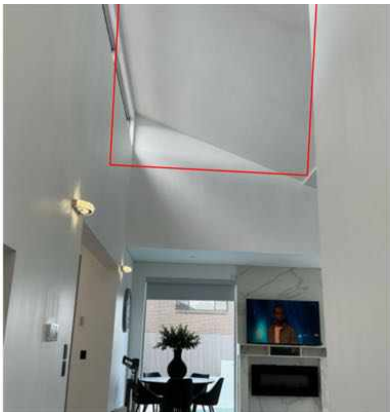
Finding 3.23

Building: Main Building
Location: All Internal Areas
Finding: Paint Defect - Shadowing
Information: Minor cosmetic shadowing is visible on the alfresco ceiling, presenting as faint straight lines along the plasterboard joints, this is a common effect caused by raking light, normal thermal movement, and variations in paint or compound finish, with no signs of moisture ingress this is considered a minor defect under AS 4349.1, with improvement achievable through skim-coating and repainting if desired.

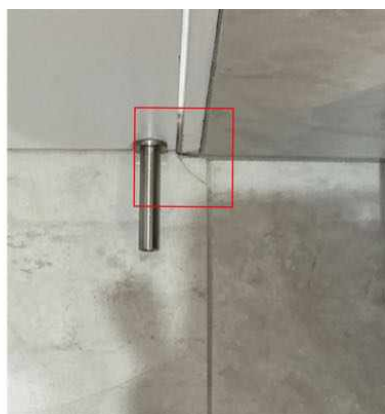
Finding 3.24

Building: Main Building
 Location: Bathroom
 Finding: Tiles - Cracked or damaged
 Information: Cracking was evident to the tiling in this area at the time of inspection. While the cracking appears to be minor, this area is frequently exposed to water, allowing potential for water penetration into adjoining sections of walls or flooring.

If left unmanaged, water penetration to these areas may lead to subsequent water damage, which is likely necessitate repair work to affected building elements.

A tiling contractor should be appointed to ensure that no further water damage occurs. The re-application of silicone and grouting throughout remaining tile work is also advised, to further protect the area against water penetration.

Where water penetration has led to water damage, appointment of a relevant tradesperson may be required to repair damaged building elements.

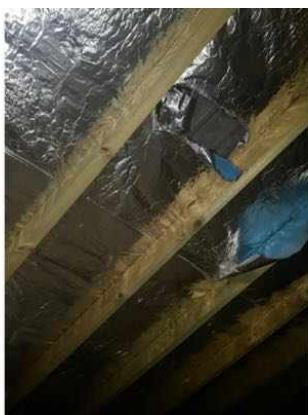
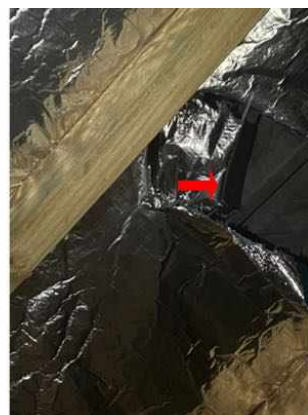
Finding 3.25

Building: Main Building
 Location: Roof Void
 Finding: Sarking - Damaged
 Information: Sarking, a laminated aluminium foil applied to the interior of the roof covering, assists in insulating the property and acting as a vapour-barrier to the roof void and, subsequently, to the household.

Where sarking is damaged, both insulation and moisture protection of the property are inhibited. This creates a loss of energy and thus negatively impacts the energy efficiency of the property, allowing potential for moisture ingress from condensation or leaking roof tiles.

It is important to repair any holes or damaged sections of sarking to ensure that the building material is fully functional. A registered builder or qualified carpenter should be consulted to provide further advice on this defect and to perform rectification works at

client discretion.

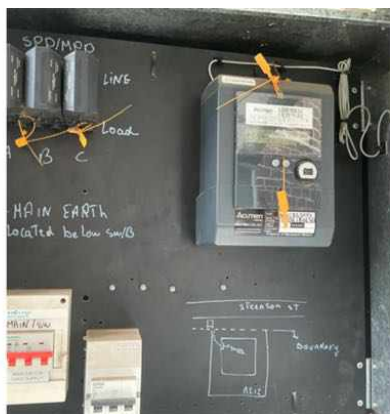
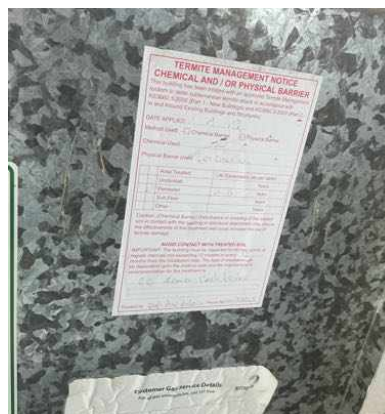
Building:	Main Building
Location:	All External Areas
Finding:	Termite Management System - no evidence of a chemical installation
Information:	The application of a post-construction chemical termite barrier is highly recommended for all properties, particularly if live termite activity has been found on the site previously. Such barriers are highly effective in preventing termite attack on any timber building elements throughout the property.

A durable notice should be placed in the switchboard unit to indicate current termite barriers. At the time of inspection, it appeared as though no termite management system has been installed, with no evidence to suggest preventative works taking place.

The client may consider gaining further advice from a pest controller as to the costs and procedures involved with this application. It is recommended that obtaining such advice be a short-term priority.

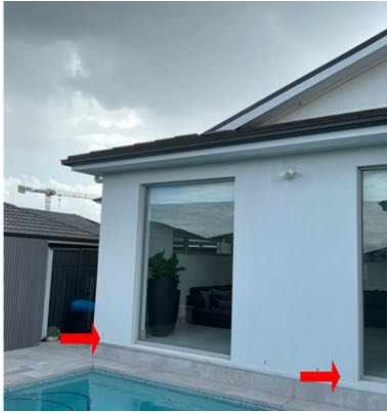
Finding 6.02

Building:	Main Building
Location:	All External Areas
Finding:	Slab Edge - Exposure
Information:	An inspection zone of at least 75mm in relation to the exposed slab edge, between the bottom brick and the perimeter pavement, is required. This inspection zone should be maintained in order to force termites into the open where they can be detected more readily during regular inspections. The slab edge should not be concealed by anything that may prevent inspection of the area, including render, landscaping, soil, turf, paving, concrete cladding or other structures.

Where the slab edge cannot be properly inspected, it is highly recommended that termite or timber pest inspections be carried out every 6-12 months to aid protection of the property against infestation.

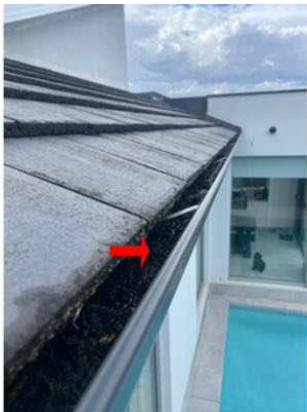
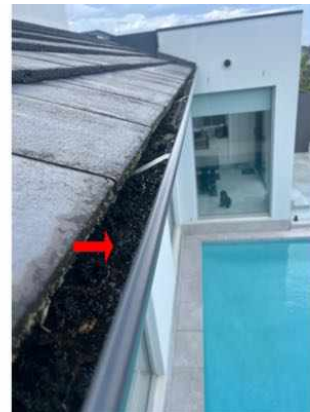
Finding 6.03

Building:	Main Building
Location:	All External Areas - Rear
Finding:	Gutters - Blocked
Information:	Roof plumbing structures, such as guttering and downpipes, should be free of all debris to prevent blockages. Blockages of the guttering and downpipes will lead to pooling and accumulated water overflows, which is likely to subsequently flood eaves and exterior walls.

Blocked gutters are likely to lead to high levels of moisture in the affected areas. Such moisture will not only cause rust and decay of the associated building materials, but can also provide conditions that are conducive to termite and timber pest activity. Blockages in gutters should therefore be removed immediately to ensure dry conditions are maintained.

Consult a Licensed Plumber for further specific advice on remedial works that may be required. In the interim, it is highly advised that blocked gutters be removed by the homeowner or a general handyperson as a matter of urgency.

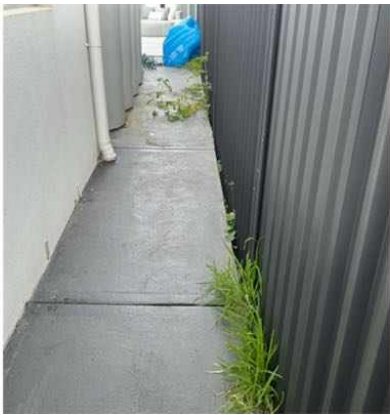
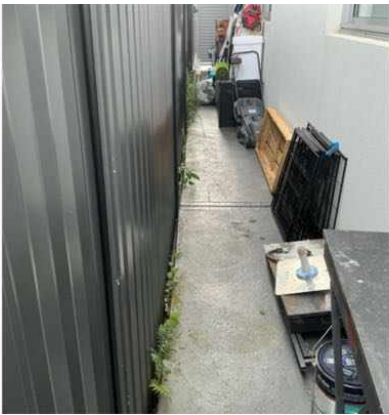
Noted Item

Building: Main Building
Location: All External Areas
Finding: Additional Photos - Obstructions and Limitations
Information: These photographs are an indication of the obstructions and limitations which impeded full inspection of the property at the time of inspection. These obstructions can hide an array of defects and should be removed to allow full inspection to be carried out. A re-inspection is recommended once the areas are made accessible.

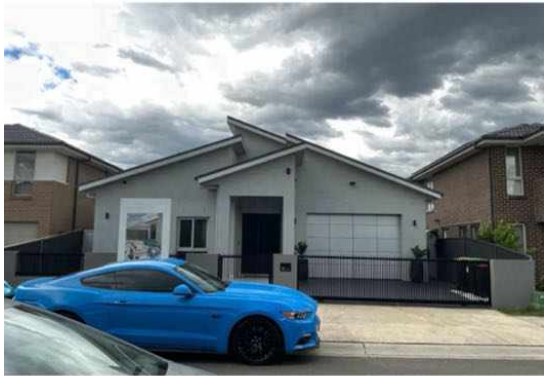
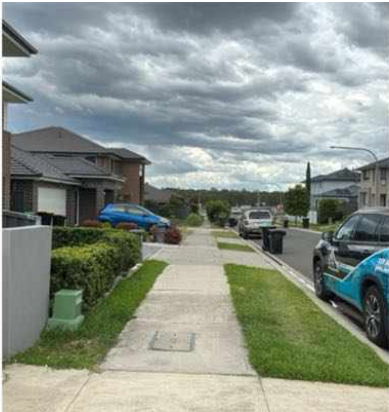
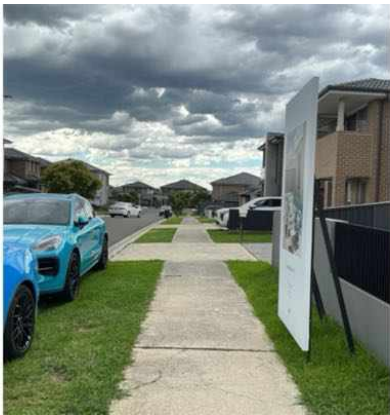
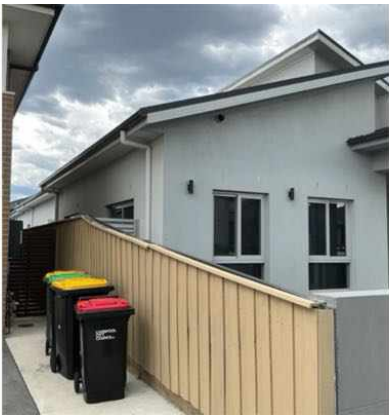
Noted Item

Building: Main Building
Location: All External Areas
Finding: Additional Photos - Obstructions and Limitations
Information: These photographs are an indication of the obstructions and limitations which impeded full inspection of the property at the time of inspection. These obstructions can hide an array of defects and should be removed to allow full inspection to be carried out. A re-inspection is recommended once the areas are made accessible.

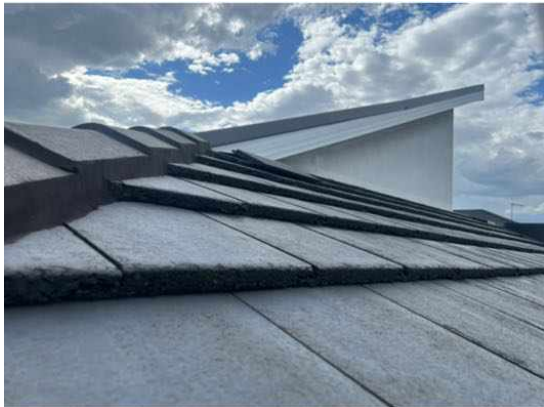
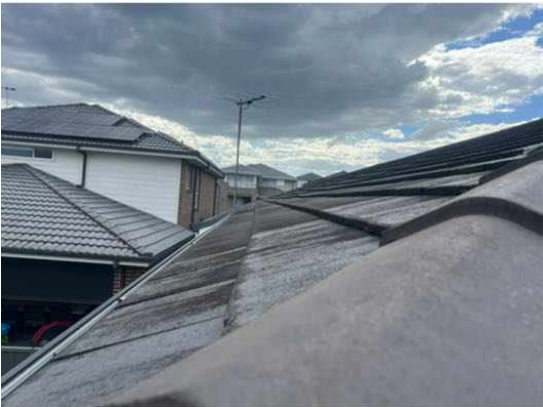
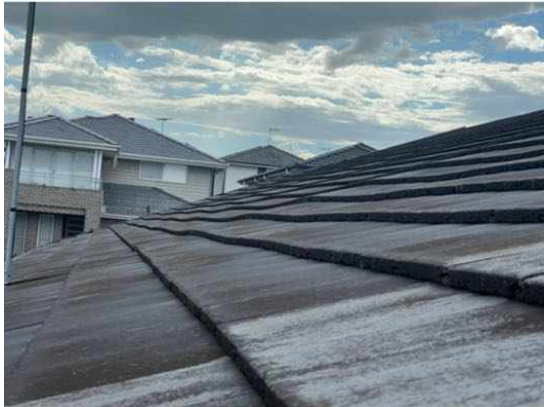
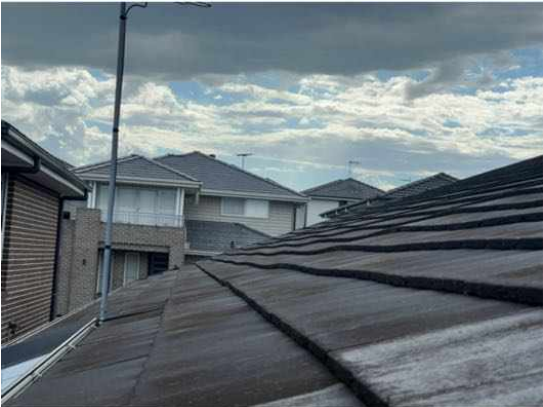
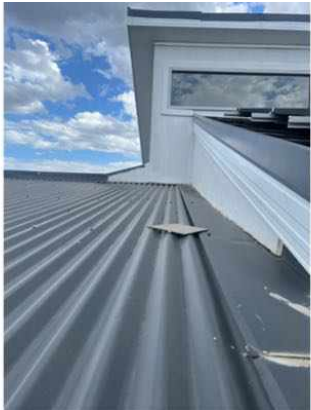
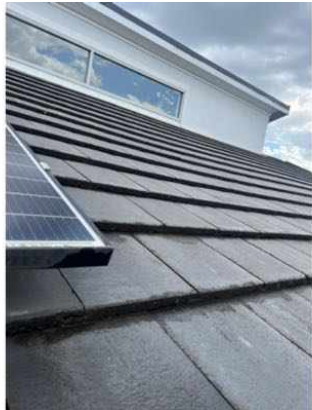
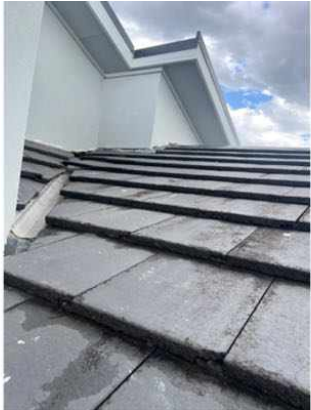
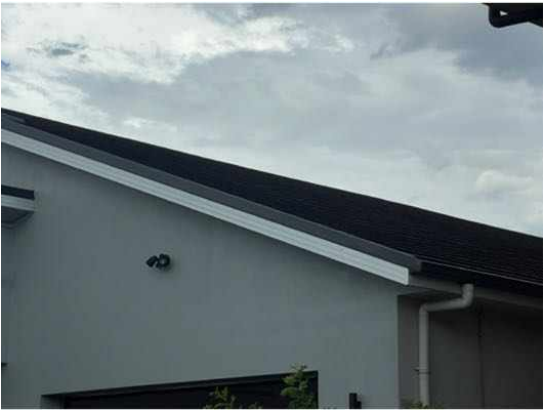
Finding: Additional Photos - Obstructions and Limitations

Information: These photographs are an indication of the obstructions and limitations which impeded full inspection of the property at the time of inspection. These obstructions can hide an array of defects and should be removed to allow full inspection to be carried out. A re-inspection is recommended once the areas are made accessible.

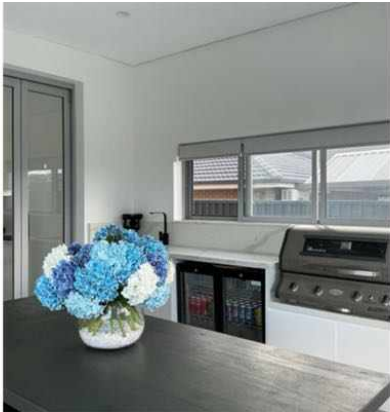
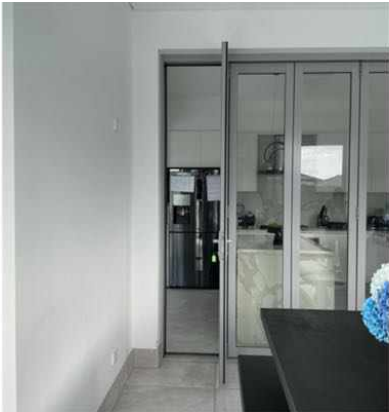
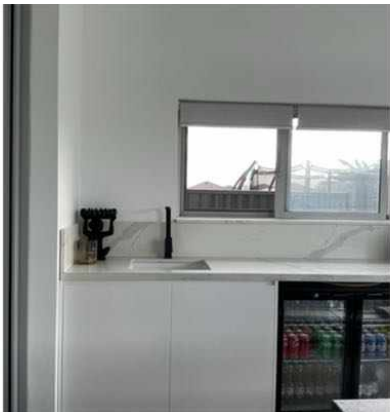
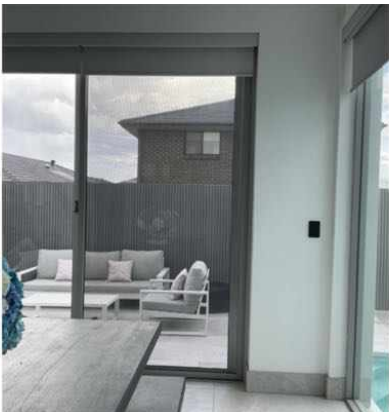
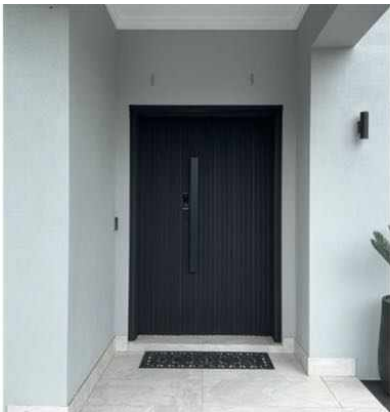
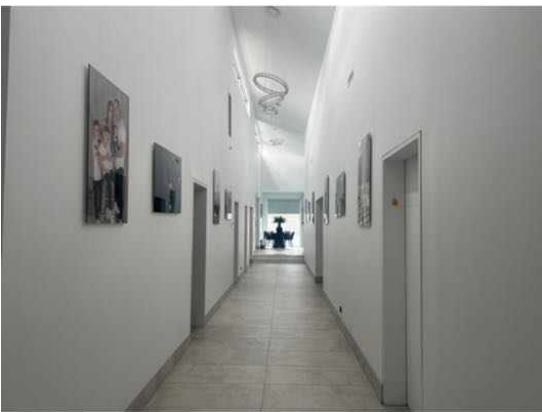
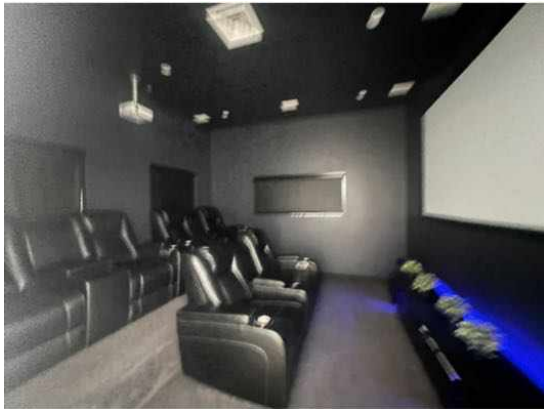
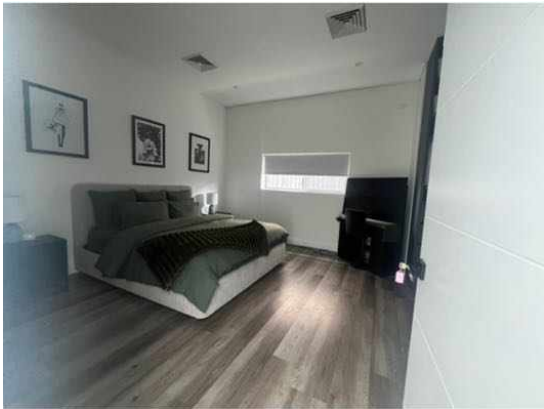
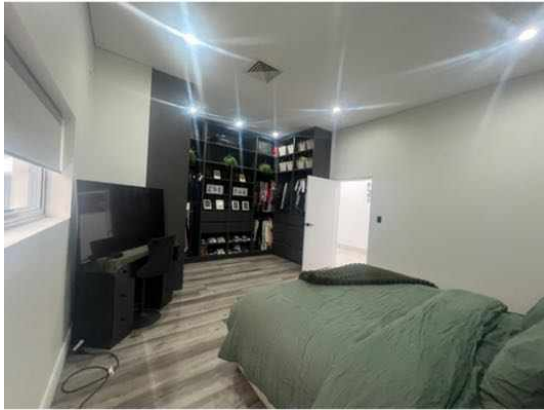
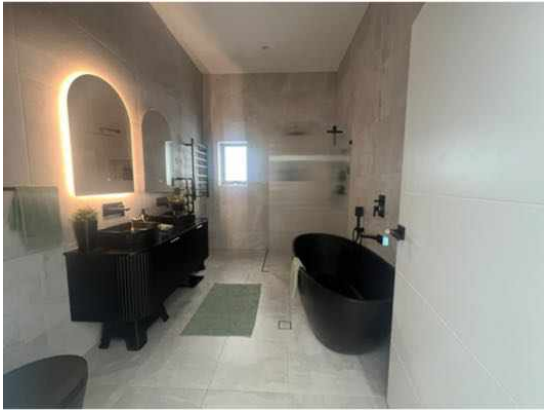
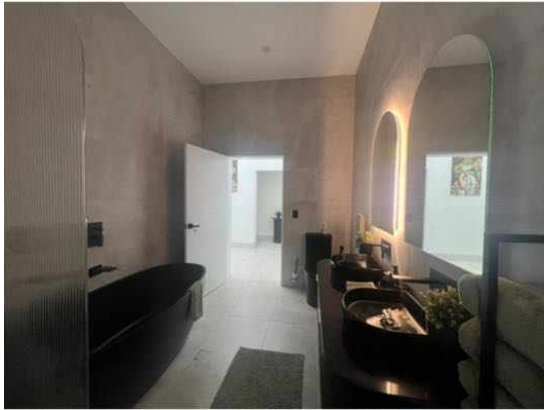
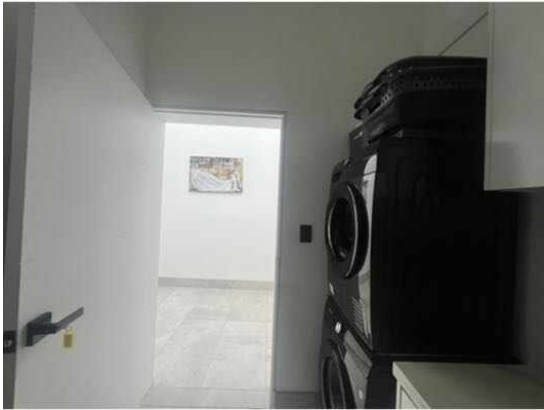
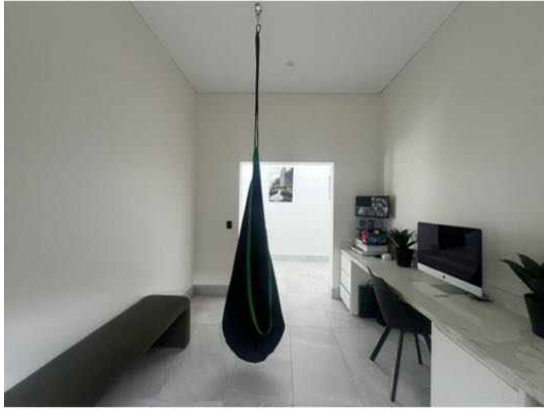
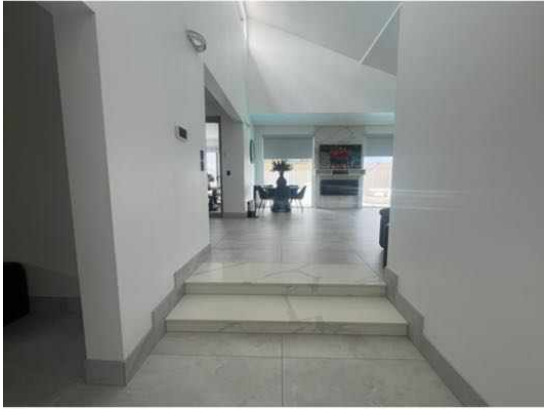
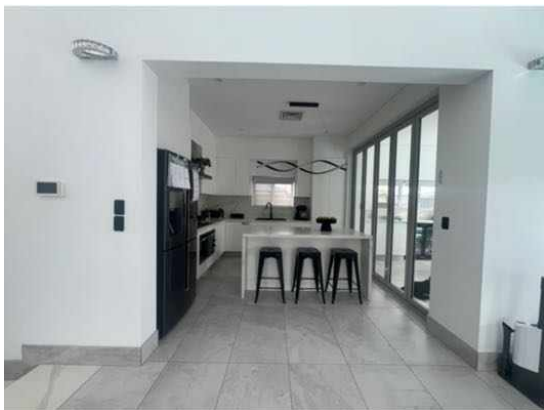
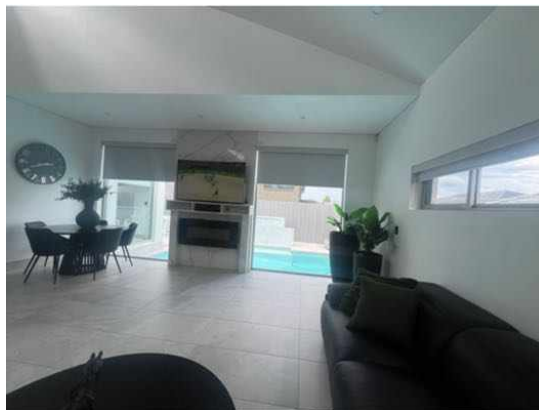
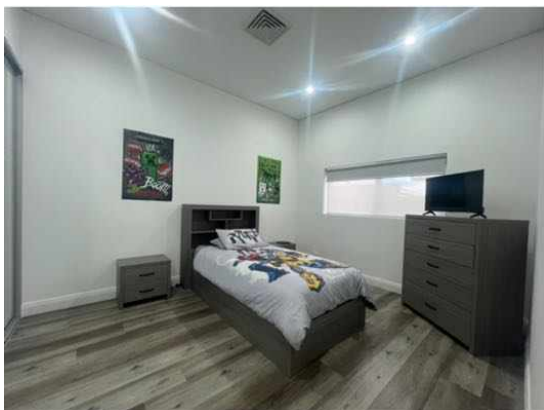
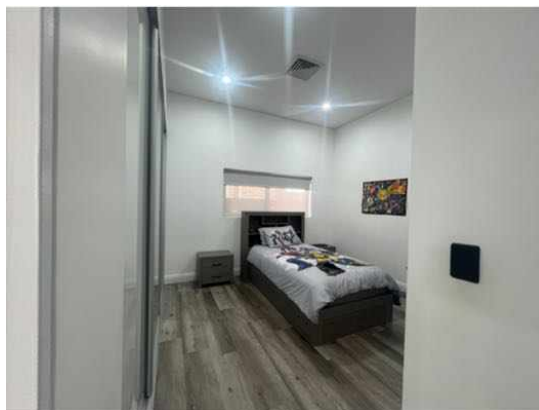
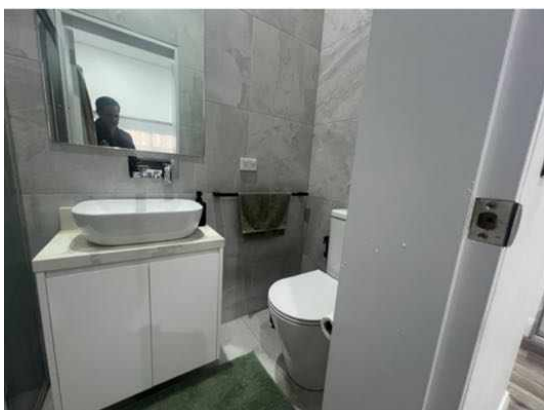
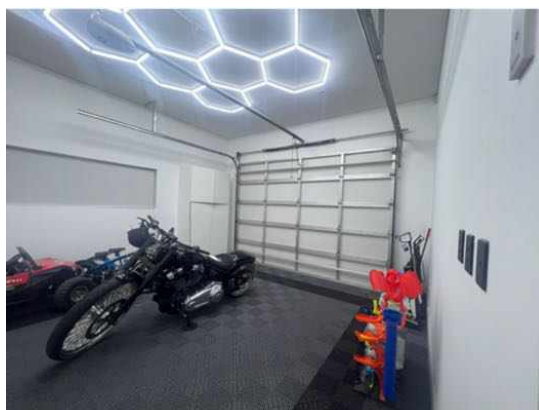
Building: Main Building
Location: All Internal Areas
Finding: Additional Photos - Obstructions and Limitations
Information: These photographs are an indication of the obstructions and limitations which impeded full inspection of the property at the time of inspection. These obstructions can hide an array of defects and should be removed to allow full inspection to be carried out. A re-inspection is recommended once the areas are made accessible.

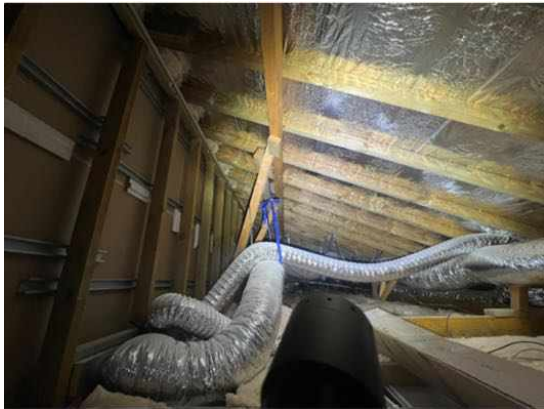
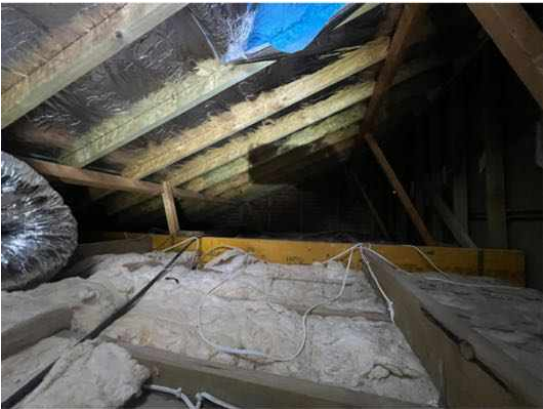
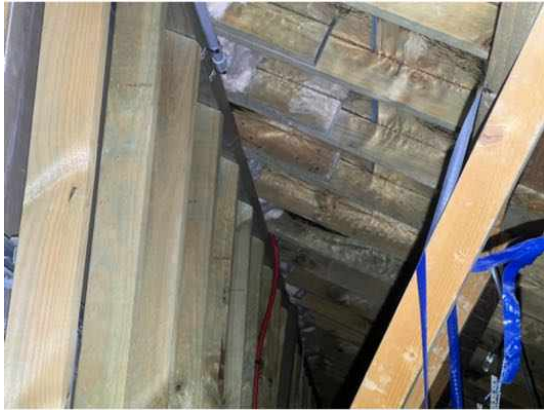
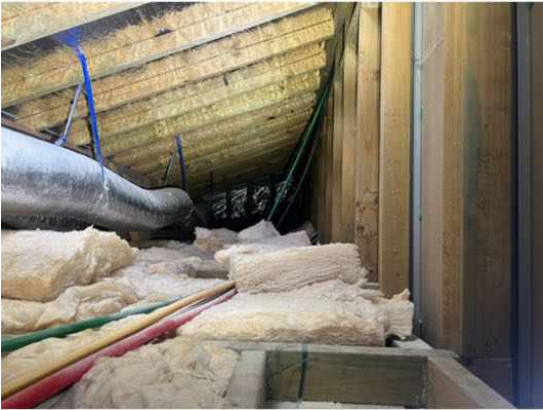
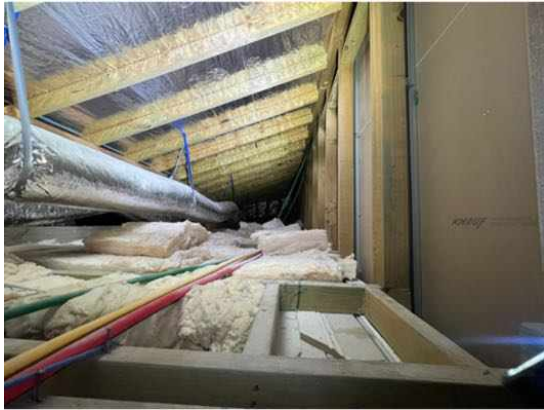
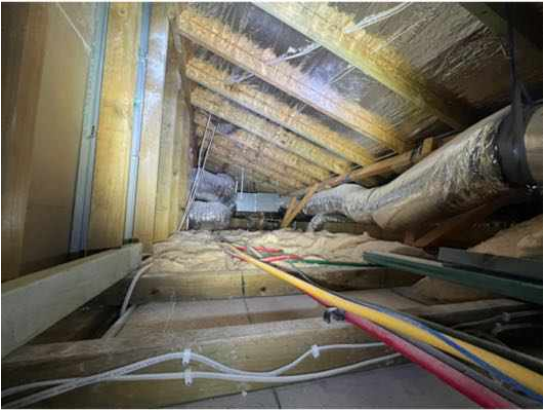
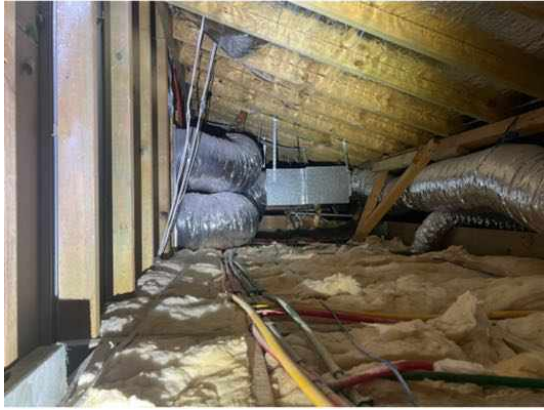
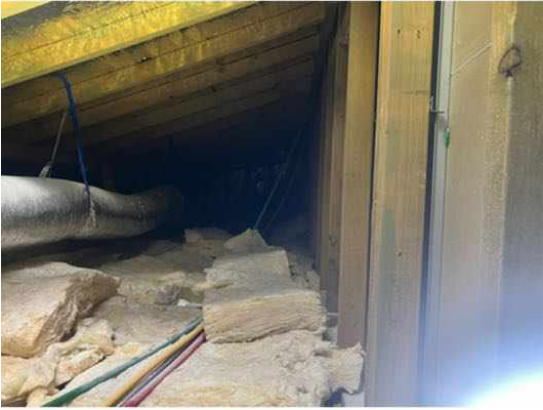
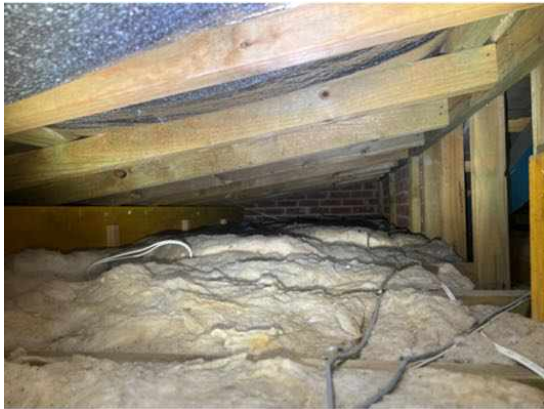
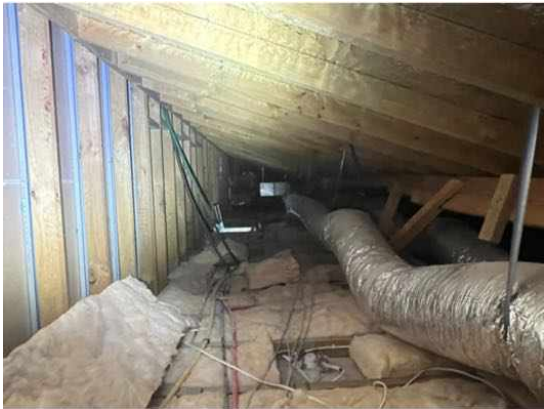
Building: Main Building
 Location: Roof Void
 Finding: Additional Photos - Obstructions and Limitations
 Information: These photographs are an indication of the obstructions and limitations which impeded full inspection of the property at the time of inspection. These obstructions can hide an array of defects and should be removed to allow full inspection to be carried out. A re-inspection is recommended once the areas are made accessible.

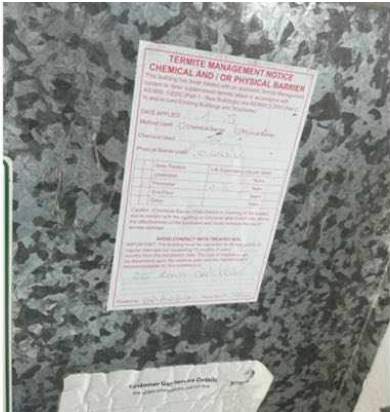
The following items were noted as - Evidence of a previous termite management program

Where a Termite Management System has been identified you should refer to the type of barrier date of installation warranty conditions and any documentation provided by a builder or past owner. Consult the company who installed the barrier to confirm whether the system is still under warranty.

Most chemical termite management systems expire and require replenishment and all physical systems are primarily designed to prevent concealed entry.
