Building and Timber Pest Inspection Report

Inspection Date: Tue, 27 Jan 2026

Property Address: 12 Bean Ct, Whittington VIC 3219,
Australia

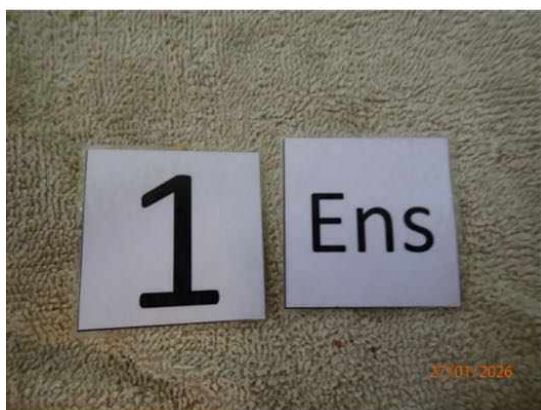
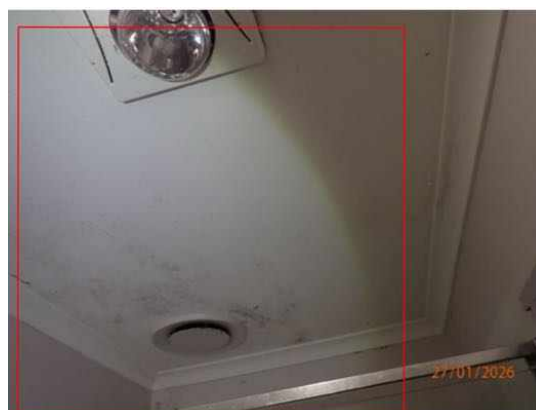
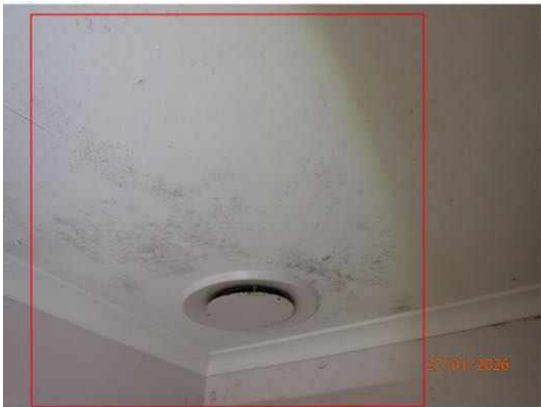
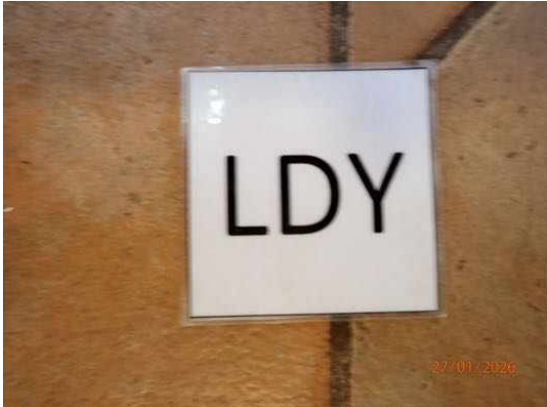
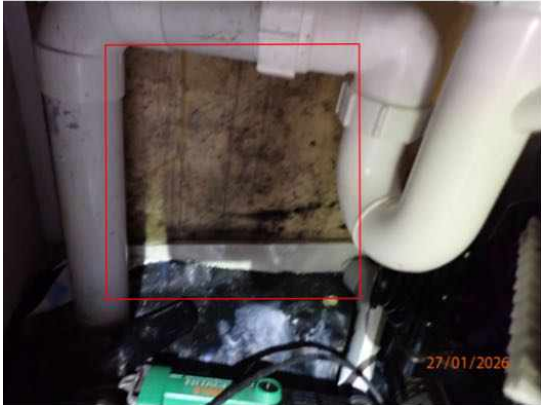
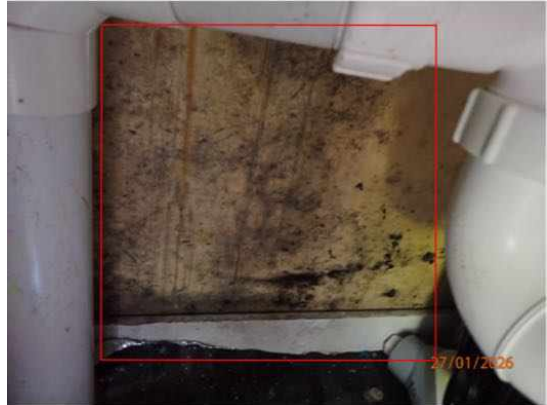
Building: Main Building
Location: Bedroom 1 Ensuite & Laundry
Finding: Mould - Present
Information: Where evidence of mould growth was noted, there may be environmental, biological or health issues associated with the report. A specialist inspection by a suitably qualified environmental health inspector is warranted, where mould is extensive or where any queries regarding air quality spores or other related issues apply.

Generally, the client is advised to ensure that the general environment is free of moisture and humidity to aid in the prevention of mould formation and development. Any mould found during the inspection should be cleaned immediately by a cleaning contractor or the homeowner as applicable. It is highly likely the material where the mould is located will need to be replaced rather than treated.

Please note that severely affected building elements may require replacement by a registered builder or qualified carpenter and review of the extraction fans will need to be channelled to the outside air immediately.

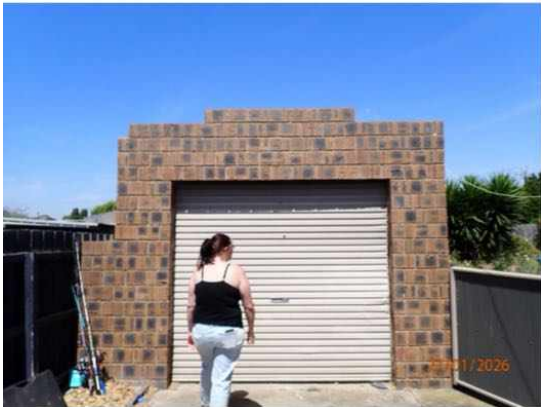
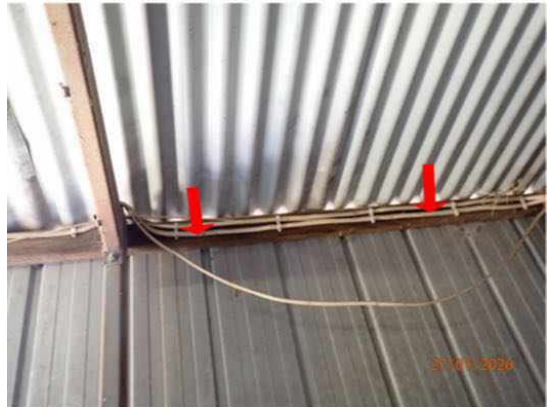
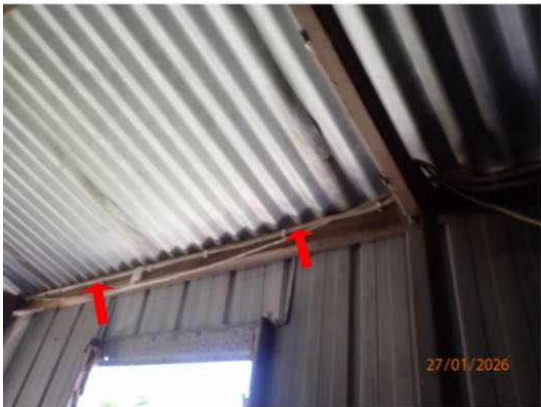
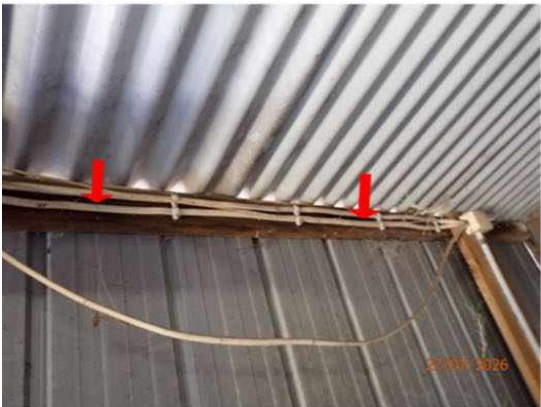
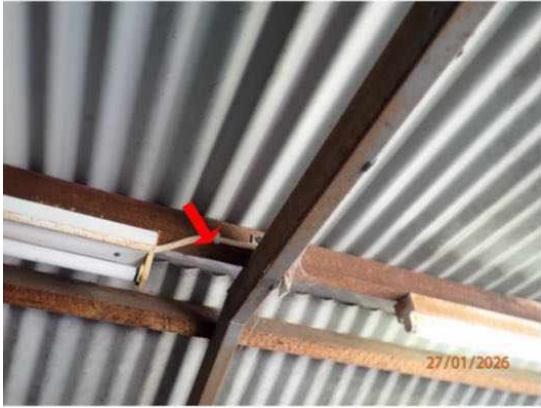
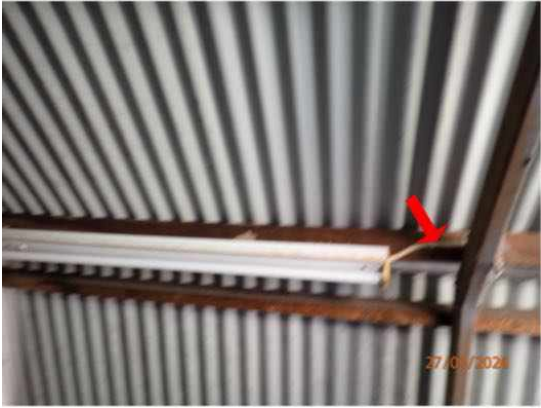
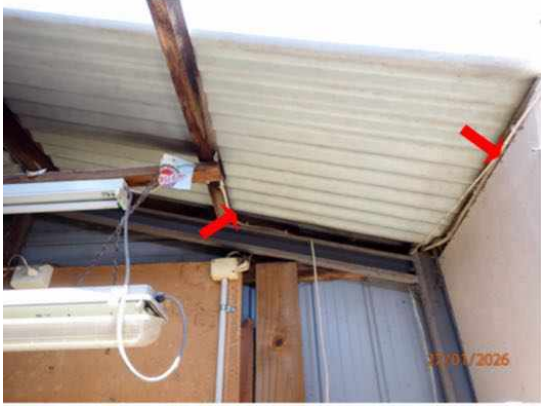
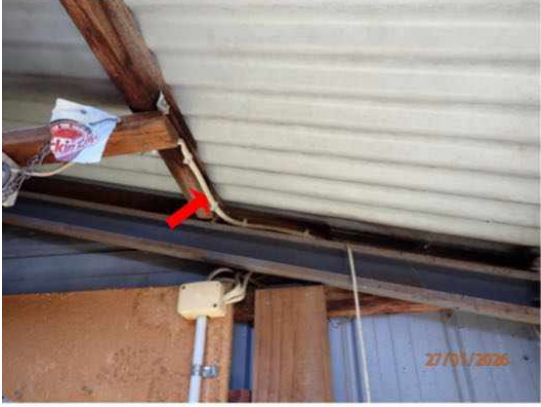
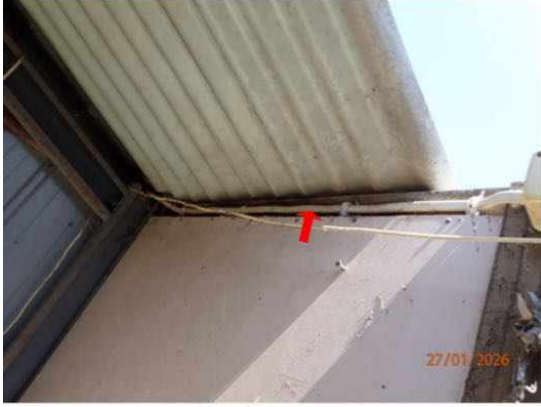
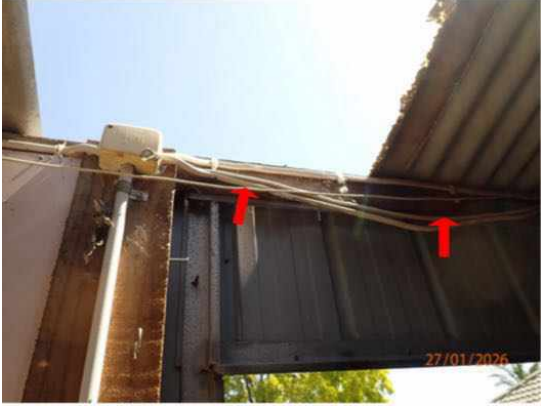
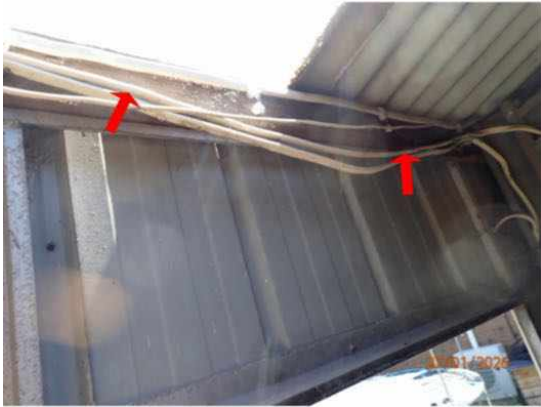
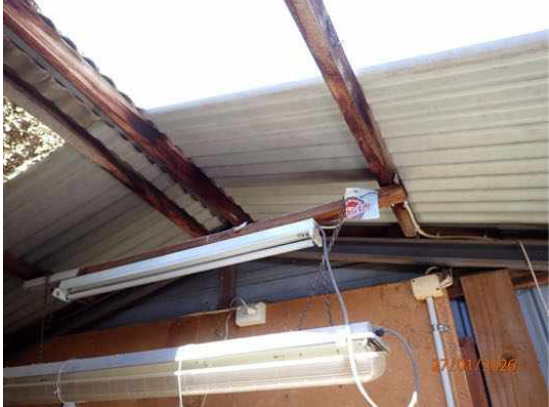
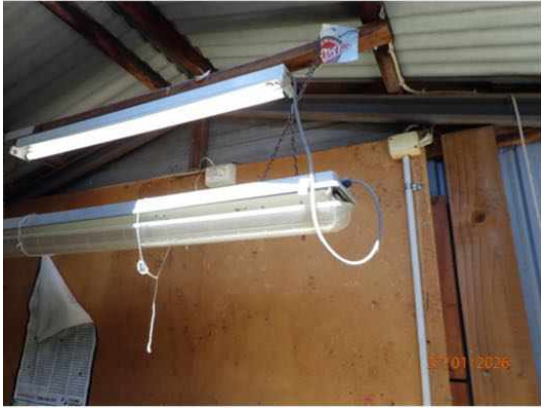
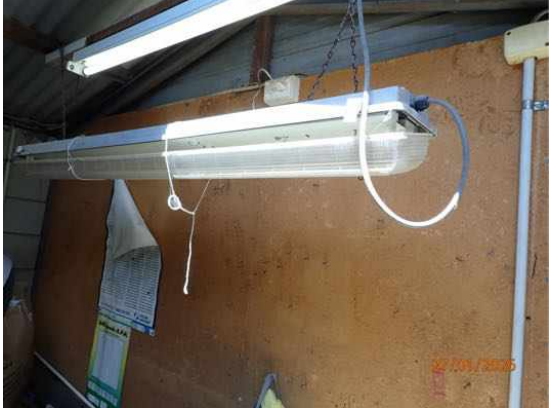
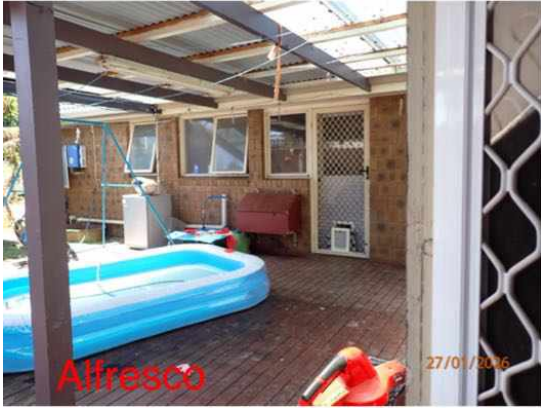
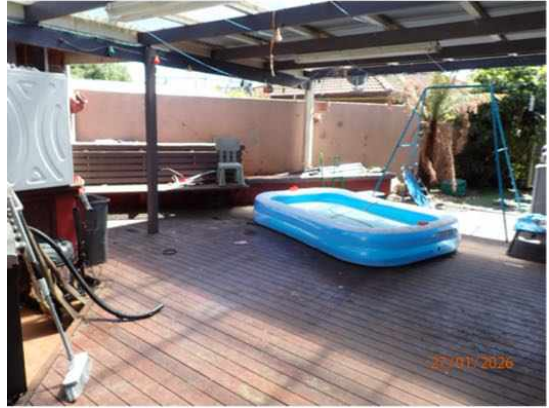
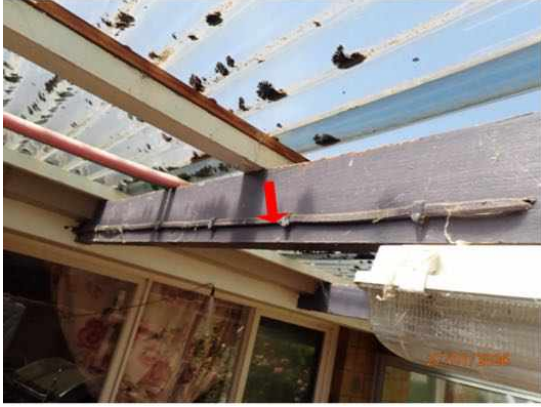
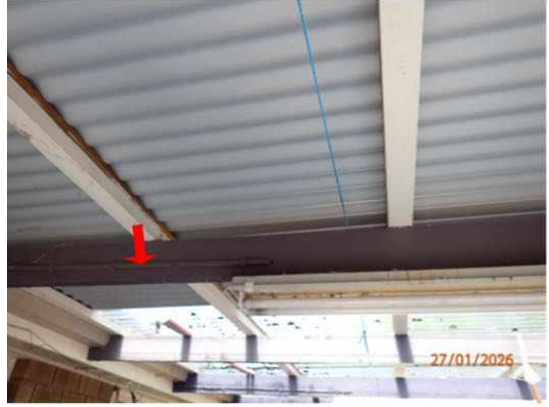
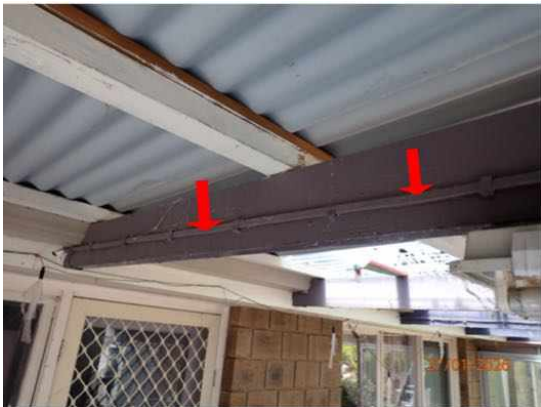
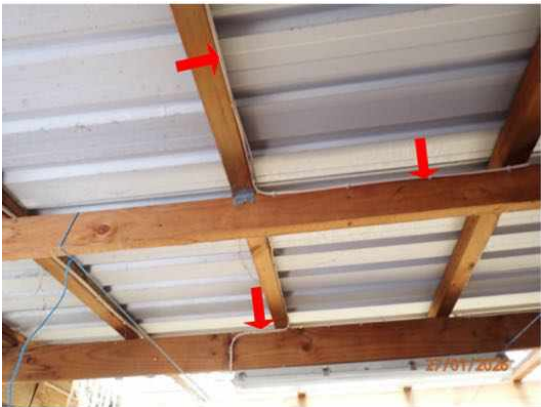
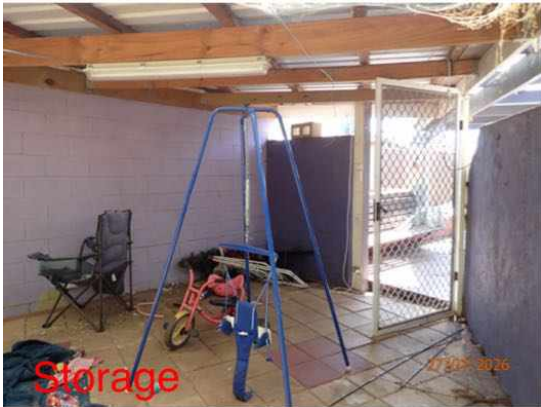
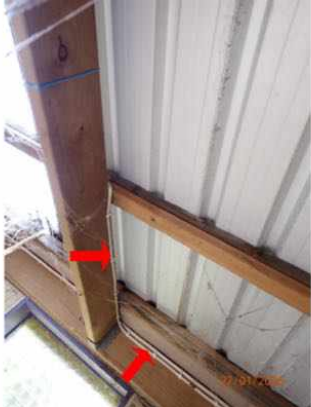
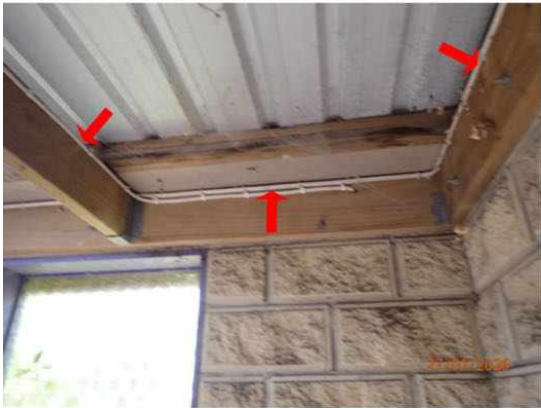
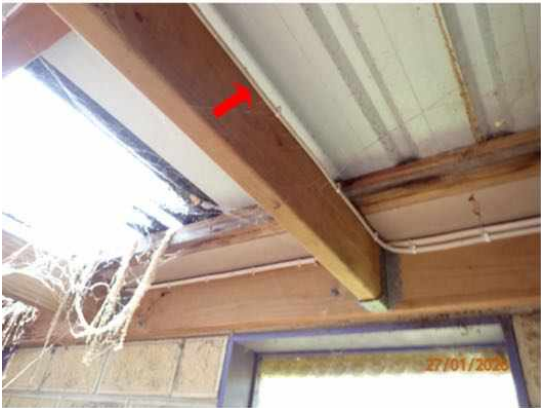
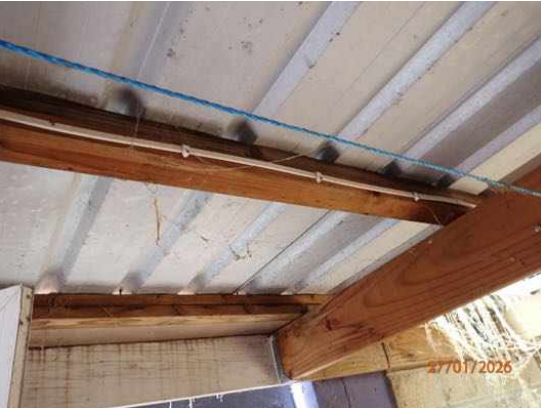
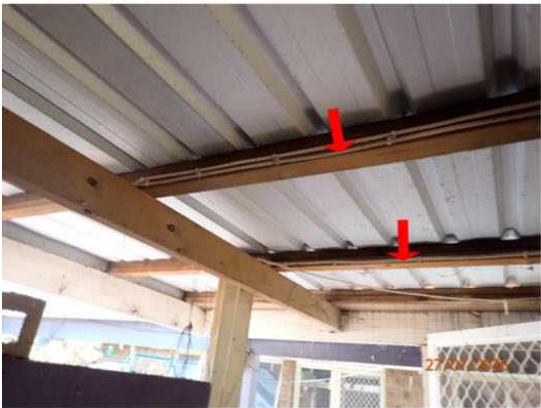
Finding 1.02

Building: Main Building
Location: All External Areas
Finding: Electrical Wires Exposed
Information: Exposed electrical wiring was identified. Exposed electrical wiring represents a potential safety hazard including for fire and personal contact.

Contact a licensed electrician urgently for further inspection investigation and rectification.

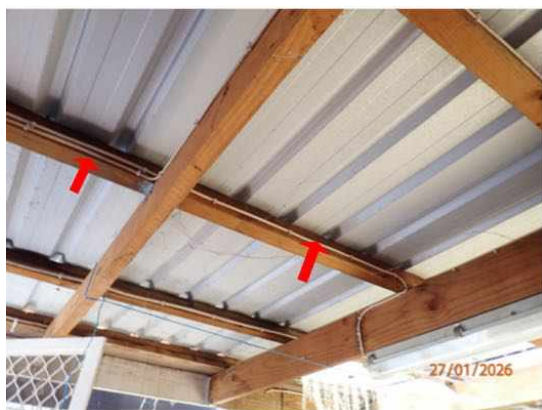
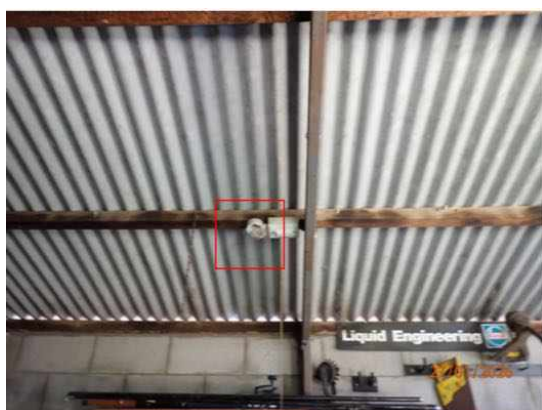
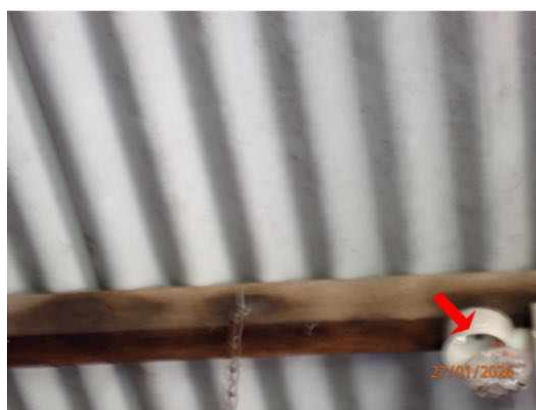
Finding 1.03

Building: Main Building
Location: Garage
Finding: Electrical Junction Box - Missing
Information: Several wiring joins in the roof space/subfloor are not adequately protected by a junction box. Junction boxes provide a second insulation barrier to adequately seal off and protect the wires, increasing the safety of the immediate environment and ensuring that the wiring is not damaged.

The absence of junction boxes in the roof space/subfloor poses as an electrical safety hazard, providing risk of electrocution. It appears as though wiring in this area has been completed to a substandard level of workmanship, evidenced by the lack of adequate wiring protection.

Appointment of a licensed electrician is highly advised to provide additional information on the risks of unprotected wiring and to install junction boxes and any other elements as required. Such works should be carried out as a matter of urgency; until this time, any persons within the roof space should exercise a high level of caution.

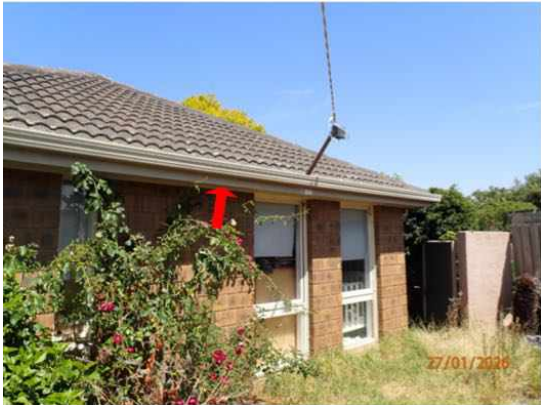
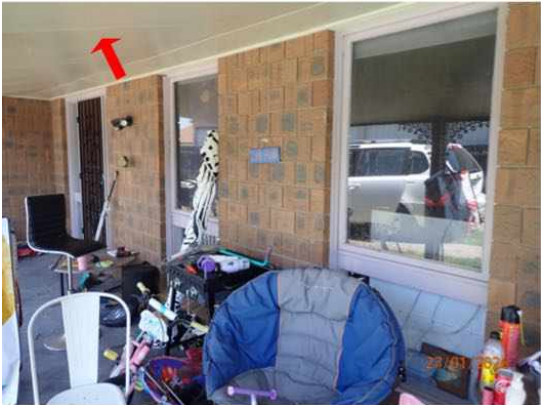
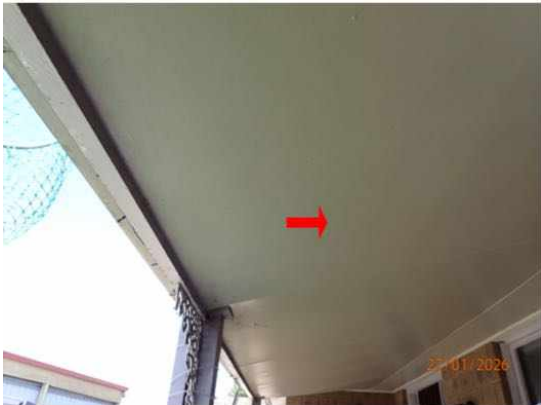
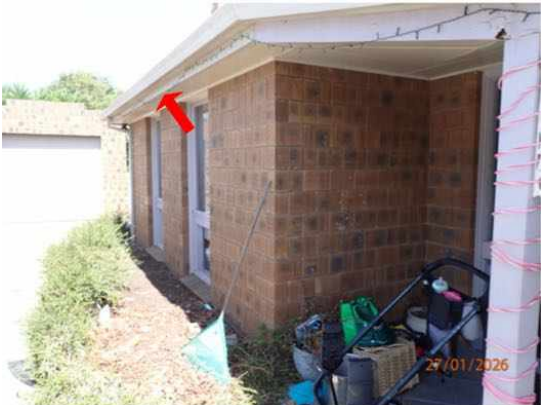
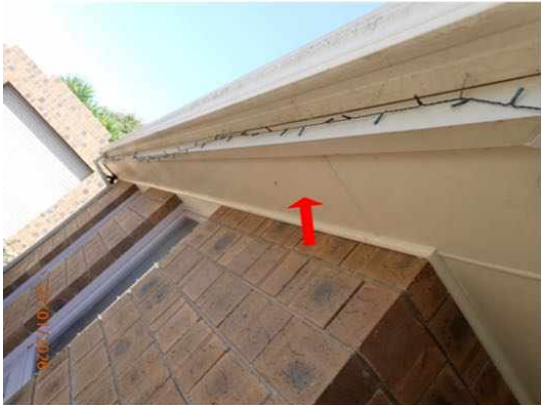
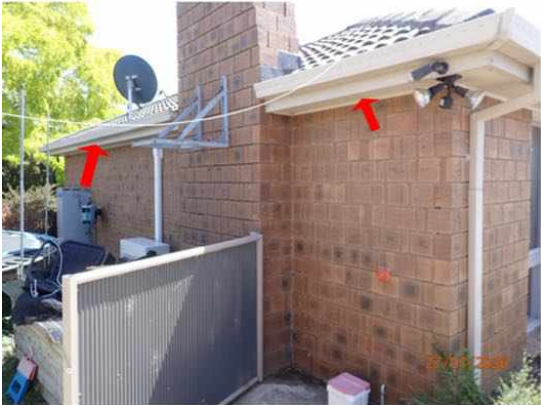
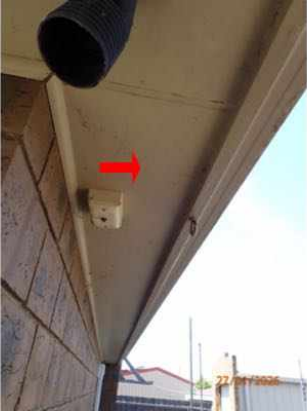
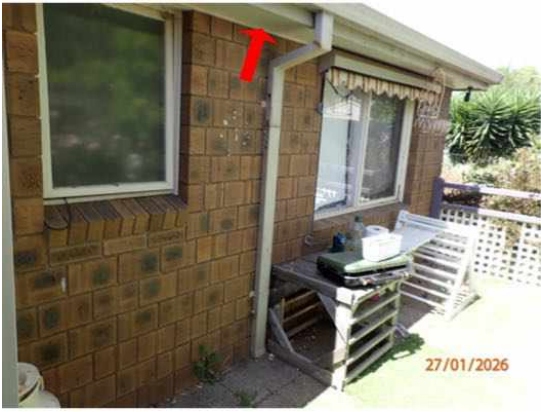
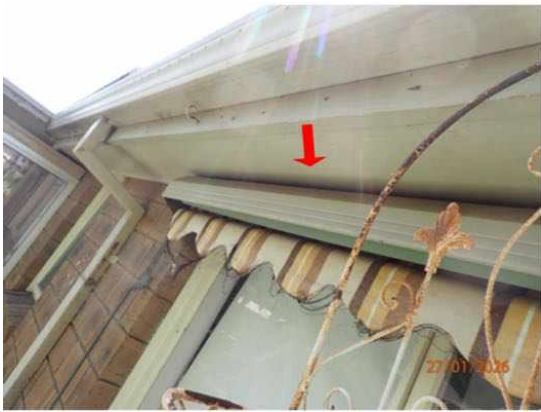
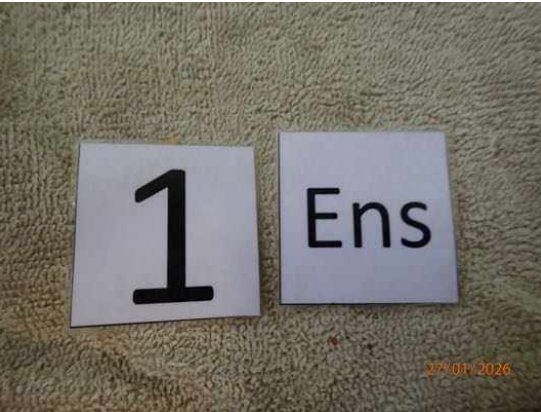
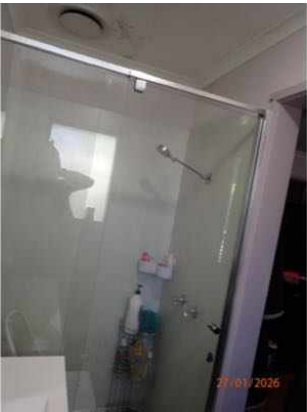
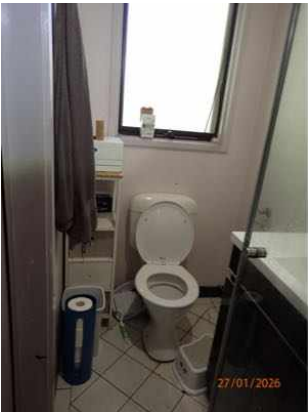
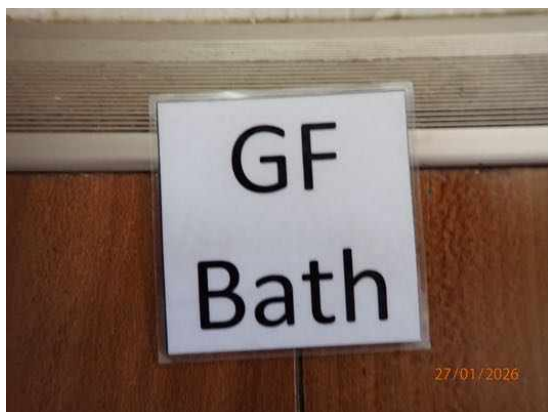
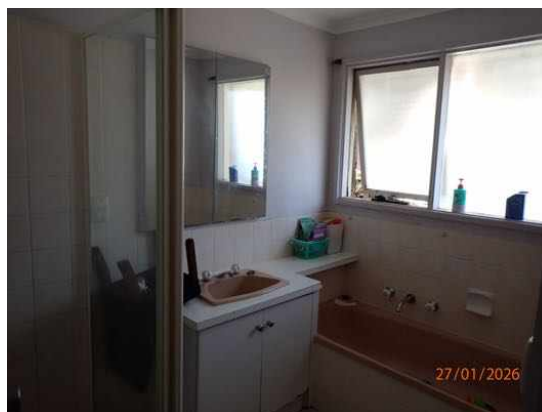
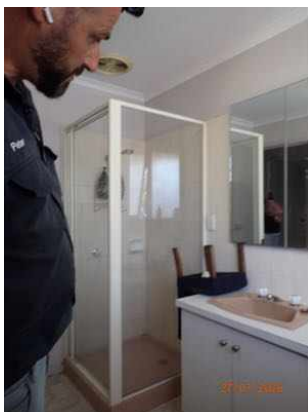
Information: Reporting on Asbestos is outside the Scope of this Report. This suspected defect is highlighted as a caution only. We suspect, based on our experience in the building industry, that there is a higher risk of the identified building element containing asbestos to areas inside and outside the property.

As Asbestos Reporting is outside the scope of this report, we STRONGLY advise that you consider a separate Asbestos Inspection and Condition Audit, which can include the taking of samples for definitive confirmation of the presence of Asbestos.

In the interim, the client is advised to act with caution not only to the areas within the report but all areas within the property, especially when considering any damage to building materials general wear and tear renovations extensions demolition and general maintenance activities due to the suspected presence of Asbestos.

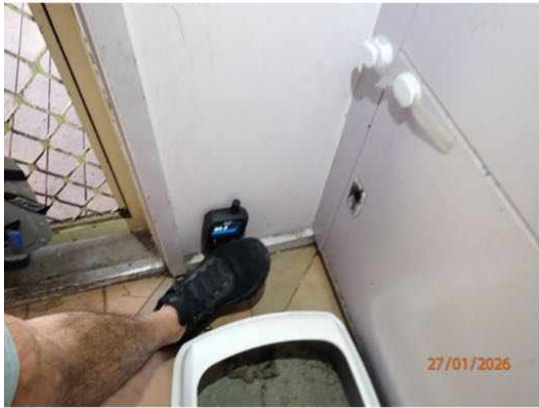
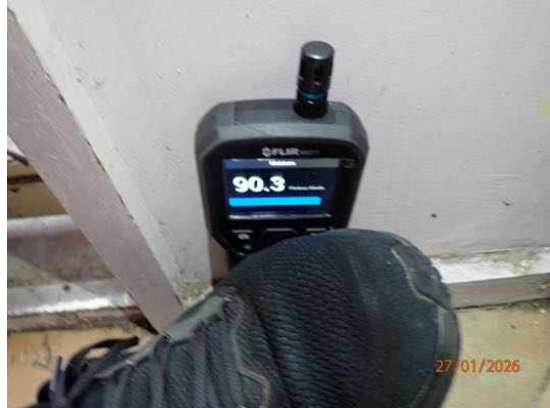
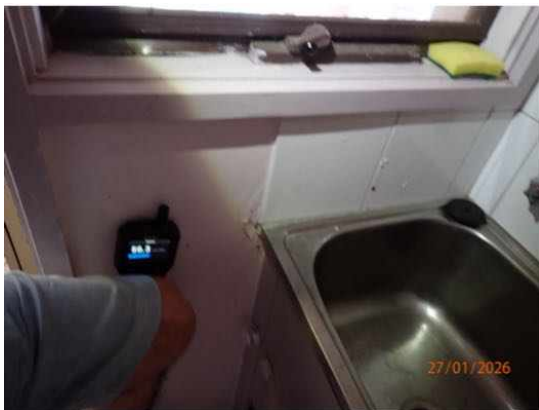
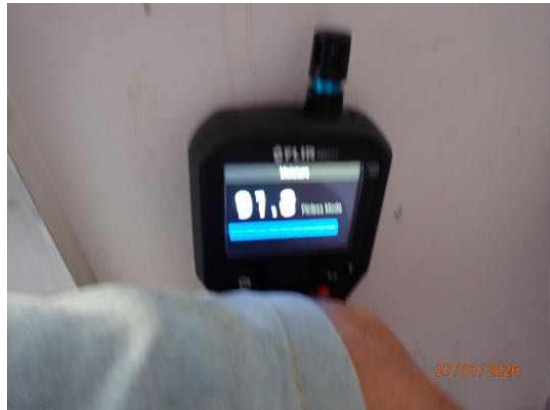
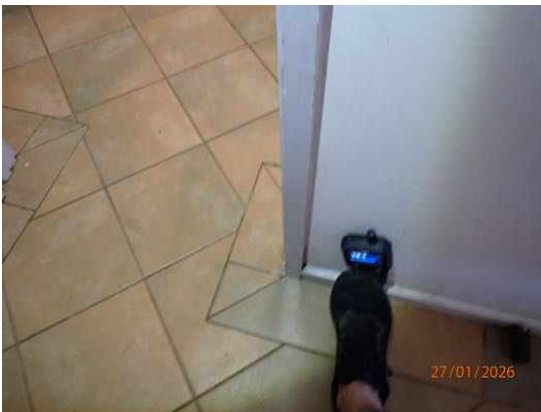
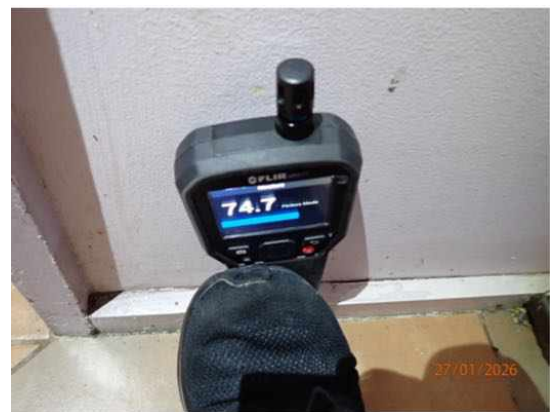
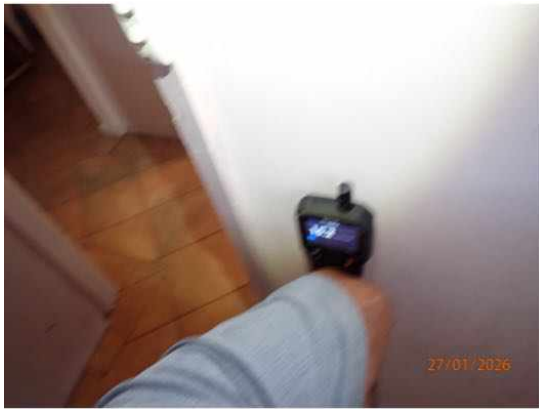
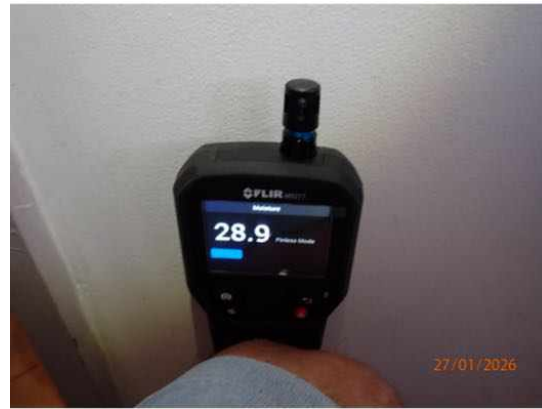
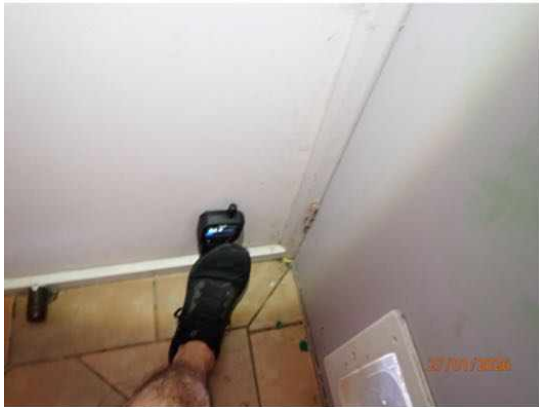
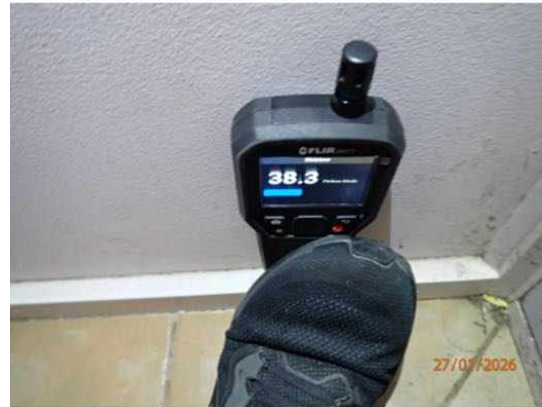
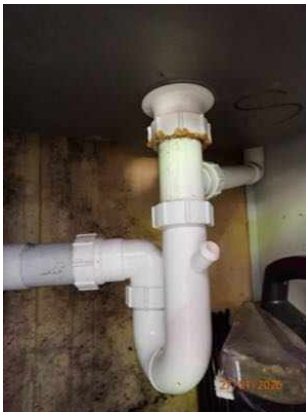
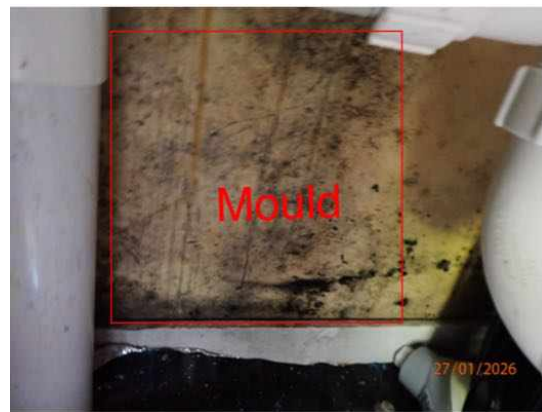
Finding 2.01

Building:	Main Building
Location:	Laundry
Finding:	Damp
Information:	Damp (or structural damp) refers to the presence of unwanted moisture in the structure of a building, either as the result of intrusion from outside, or condensation from within the structure. Generally, structural damp is caused by rain penetration, rising damp, and leaks from plumbing pipes.

Unmanaged damp facilitates the formation and development of mould, fungi growth and wood rot, decaying associated building materials and compromising their structural integrity. Damage to finishes is also likely to occur, including lifting, bubbling, peeling and staining of paint, plaster and wallpaper.

The first step in addressing damp is to diagnose the cause. The identified cause should be addressed first prior to repairing the appearance and other defects which have resulted from the rising damp. If the original cause is not resolved, further cases

of damp are likely to ensue, resulting in secondary defects.

Consultation with a qualified plumber and remedial builder is advised immediately to identify the cause of damp and perform remedial works as required. Where excessive mould growth is present, further inspection by a specialist environmental health inspector should also be considered.

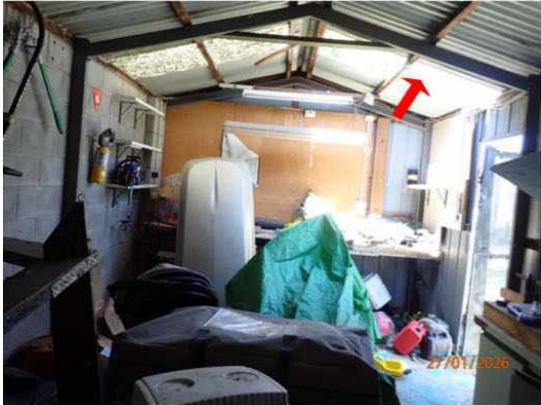
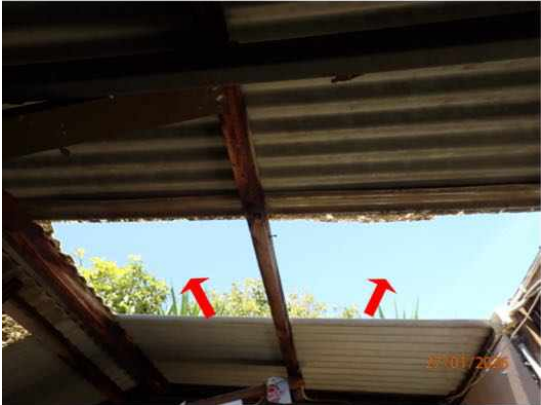
Finding 2.02

Building: Main Building
 Location: Garage Roof Exterior > Rear Left
 Finding: Polycarbonate sheeting - Damaged
 Information: The polycarbonate sheeting has deteriorated as a result of exposure to weather conditions over a prolonged period of time. Exposure to elements, such as heavy rain and hailstorms, is likely to damage polycarbonate sheeting, which is not as strong as other roof coverings.

Further deterioration of the remaining polycarbonate sheeting is likely to occur if left unchanged. Such deterioration has created the ability for water penetration and secondary damage to the structure, accelerating deterioration of all associated

building elements.

Repair and replacement of several sections of the sheeting is immediately required. Appointment of a roofing restorer is required to perform these works immediately to prevent any further damage being sustained.

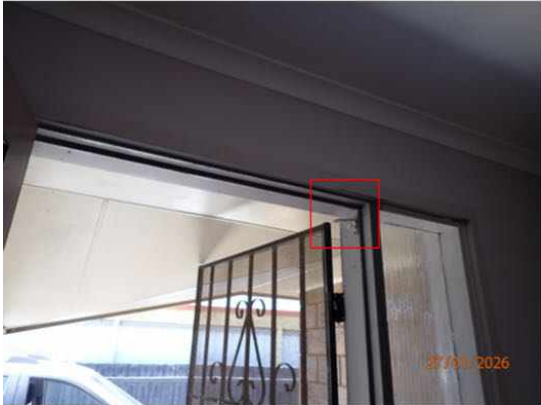
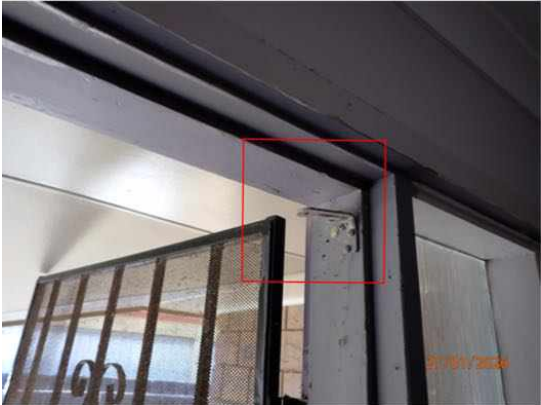
Finding 3.01

Building: Main Building
 Location: Entry
 Finding: Door Closer Missing/Damaged
 Information: The door closer was missing at the time of the inspection. Absence of the door closer limits the operation and security of the door and may pose as a safety risk.

Replacement of the door closer should be conducted as soon as possible. A general handy person or qualified carpenter should be appointed to perform these works to improve the operational state of the affected door and improve the safety of the internal area.

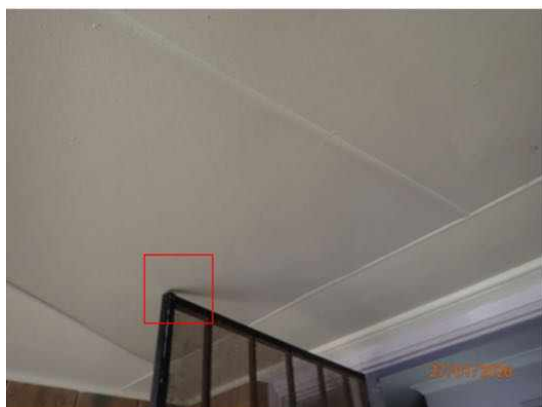
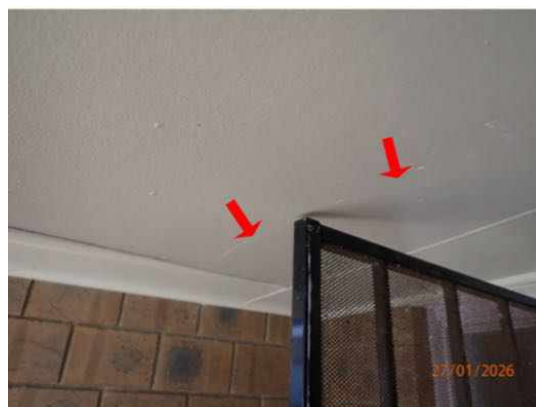
Finding 3.02

Building: Main Building
 Location: Entry
 Finding: Doors - Binding/Jamming
 Information: Binding and/or jamming of doors throughout the property were evident during standard operation. This defect inhibits the functionality of affected doors as well as creating potential for secondary defects to associated building elements, such as damage to the floor covering, doors and door jams.

A door that binds to flooring or to the associated door frame may have several causes, ranging from minor defects, such as poor installation of the door or deteriorated hinges, through to major structural issues, such as damage to subfloor structures.

Where door binding/jamming appears to indicate major structural issues, a registered builder specialising in sub floor foundations may be appointed to provide an estimate on the cost of rectification.

For minor causes, a qualified carpenter or general handyperson should be appointed to perform minor rectification works at client discretion.

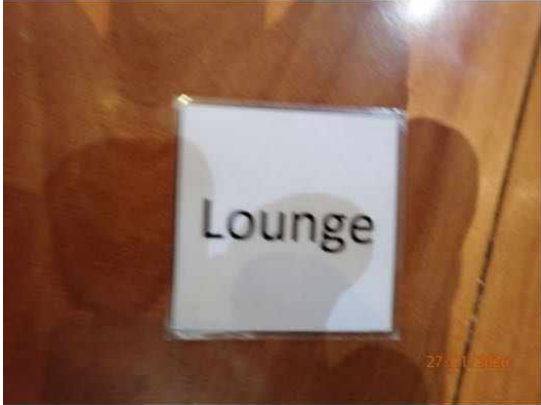
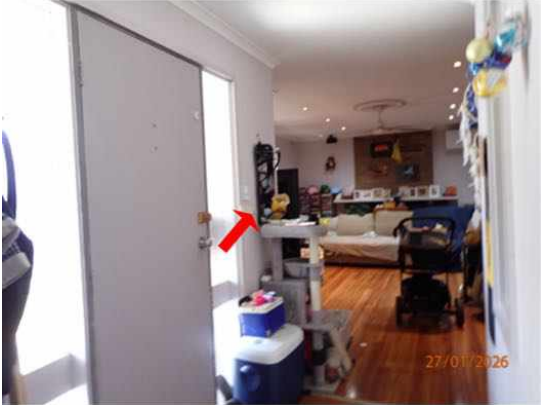
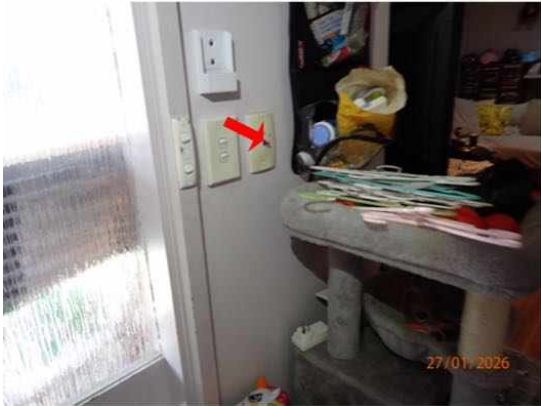
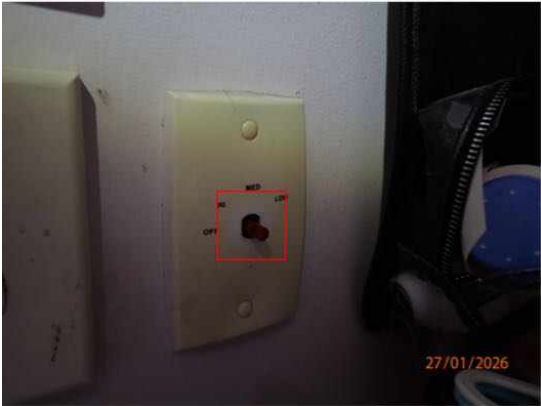
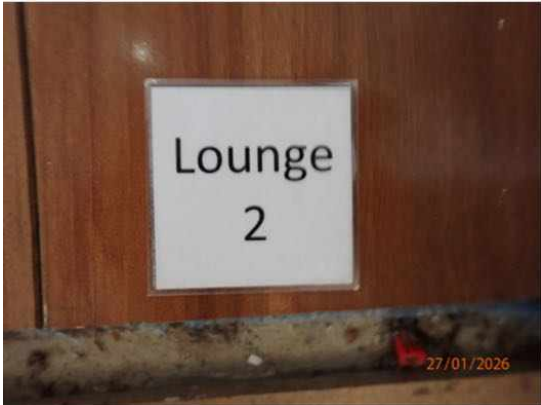
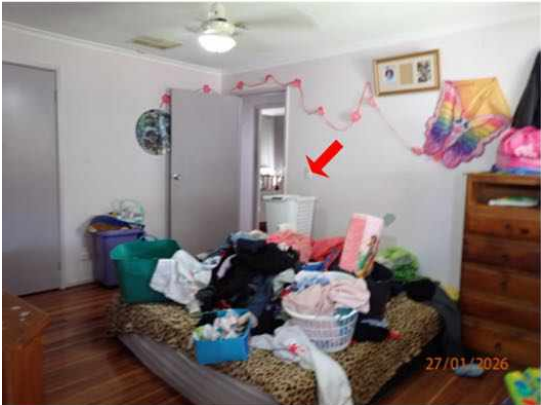
Finding 3.03

Building: Main Building
 Location: Lounge Room & Lounge Room 2 > Front Left, Front Right
 Finding: Switches - Damaged
 Information: The switches in this area was found to be damaged their cover plates at the time of inspection. This occurs generally when the building materials have either aged and decayed or as a result of impact damage (accidental or deliberate).

Repair and/or replacement of the power point or is advised to ensure the fixture and it's associated structures are safe and fully operational. A licensed electrician should be appointed to repair/replace the light switch as soon as possible.

Please note that commenting on electrical works are outside the scope of this

inspection. Please engage a licensed electrician to further inspect the property, at client discretion.

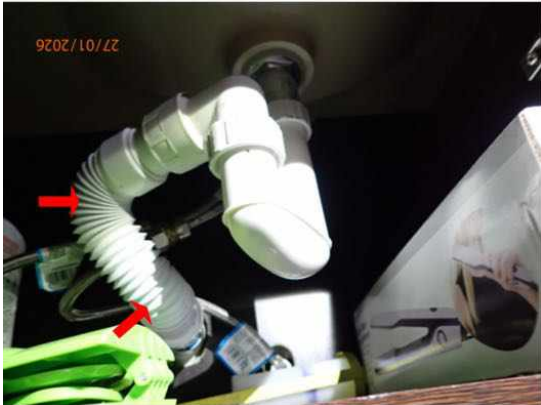
Finding 3.15

Building:	Main Building
Location:	Bedroom 1 Ensuite
Finding:	Substandard works - Basin Trap
Information:	The basin trap to this area appears to have been completed to a substandard level where the trap should be a smooth continuous PVC NOT a flexi hose as installed.

Works that have not been completed to a satisfactory level create potential for the development of building defects and may impede on the safety and integrity of the overall structure.

It is recommended that qualified plumber be appointed to complete these works and ensure the safety of the area and the longevity of all associated building elements.

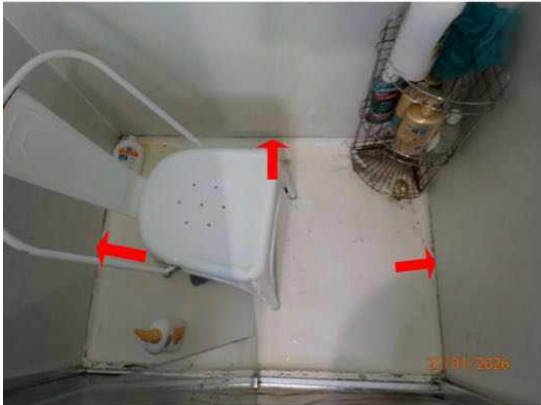
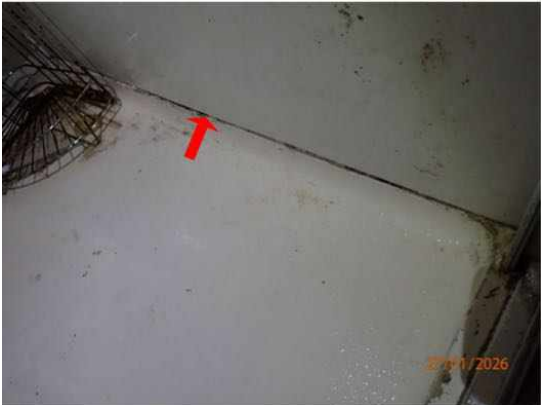
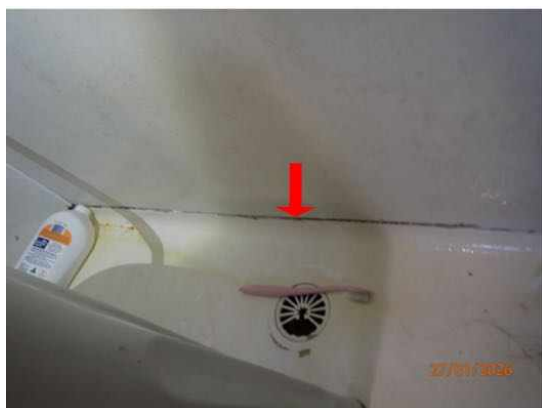
Finding 3.16

Building: Main Building
Location: Bedroom 1 Ensuite
Finding: Incomplete Sealants
Information: Sealant application. The works to this area appear to be incomplete.

Different materials and floor areas move at different rates, generally causing cracking to grout or sealant at this point. A flexible sealant is required to allow for expected expansion and contraction, while keeping the joint water tight and protective of all associated building materials.

It is recommended this be completed prior to secondary defects accruing.

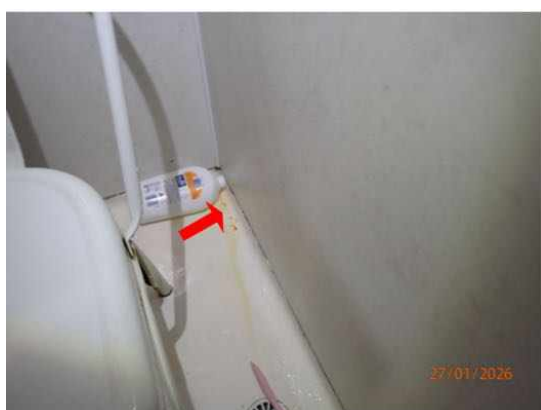
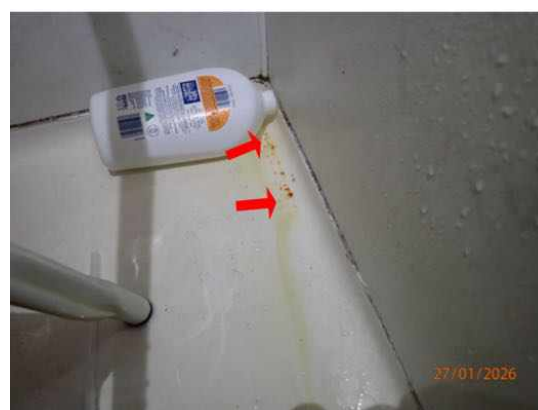
Finding 3.17

Building:	Main Building
Location:	Bedroom 1 Ensuite
Finding:	Shower Tray - Rusted
Information:	Rust in the base of the shower tray was evident in this area at the time of inspection.

Rust to the shower trays create potential for water penetration to adjoining building elements. If left unmanaged, the area will continue to rust where water damage may occur as a result of constant water penetration over a prolonged period of time.

Treatment to the eroded area or the replacement of rusted shower tray is advised prior to continuous use. A qualified builder, plumber or bathroom specialist may be appointed to perform these works at prior to continuing to use the shower recess.

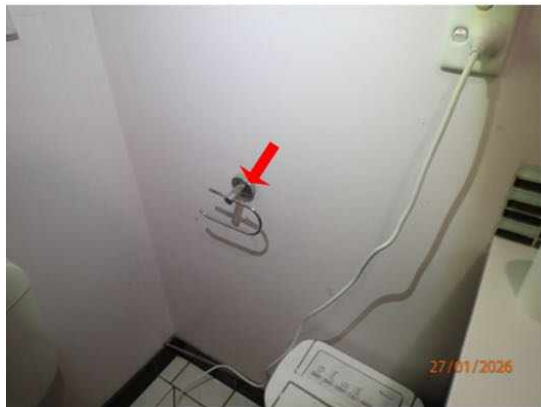
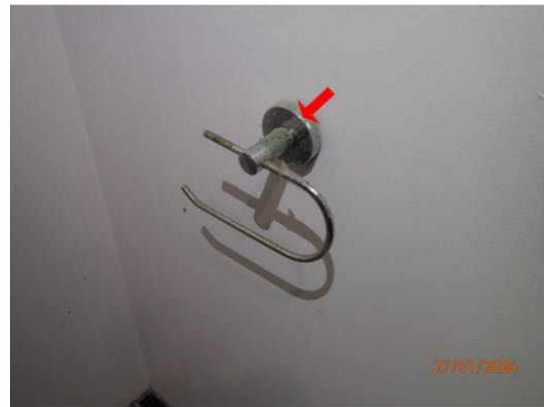
Finding 3.18

Building:	Main Building
Location:	Bedroom 1 Ensuite
Finding:	Fitting or Fixture - Loose
Information:	The fitting in this area is loose and requires adjustment to tighten.

If left unmanaged, the fitting may further deteriorate, causing potential for the development of other minor secondary defects.

A relevant tradesperson should be appointed to perform these rectification works at discretion of the client.
