Building and Timber Pest Inspection Report

Inspection Date: Tue, 27 Jan 2026

Property Address: 12 Bean Ct, Whittington VIC 3219,
Australia

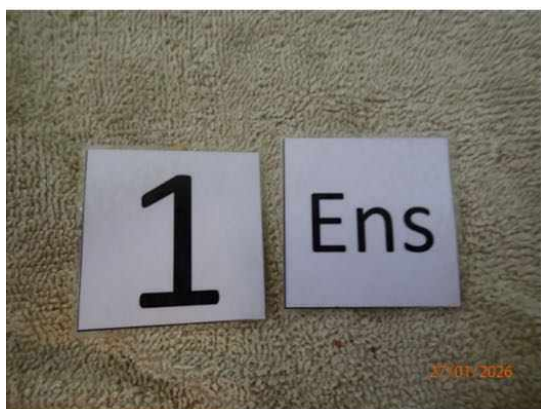
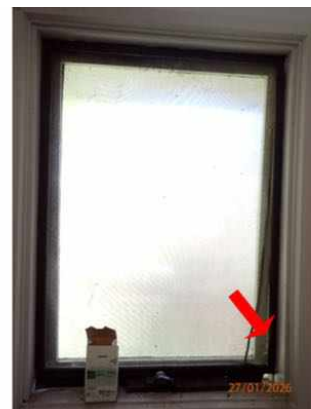
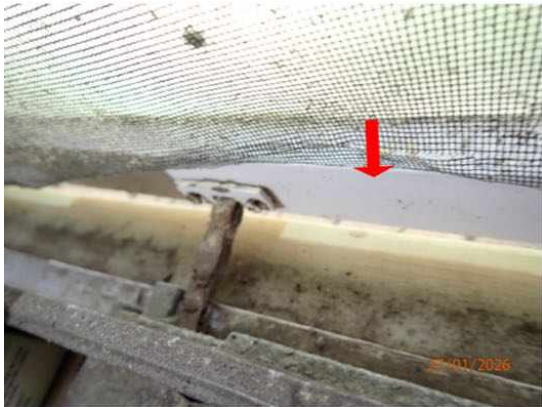
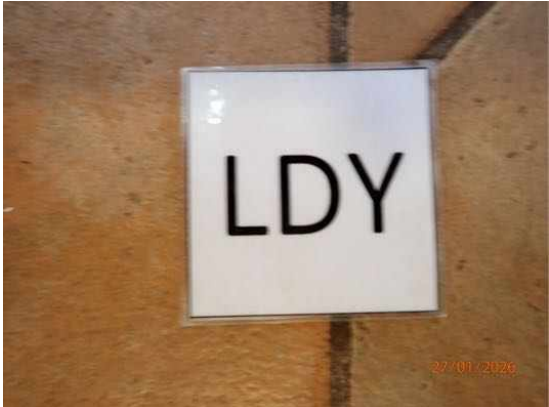
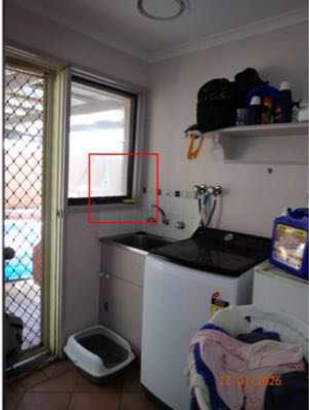
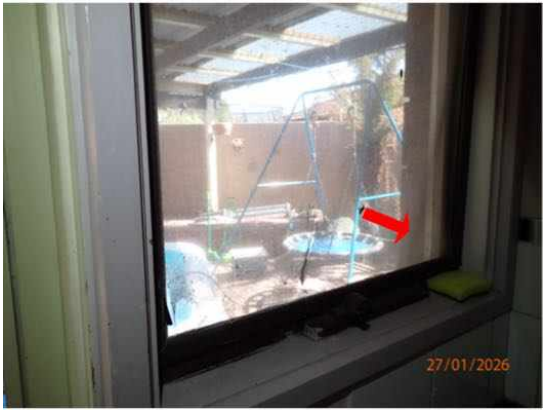
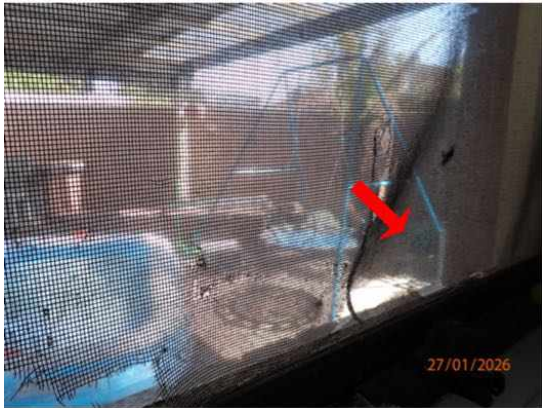
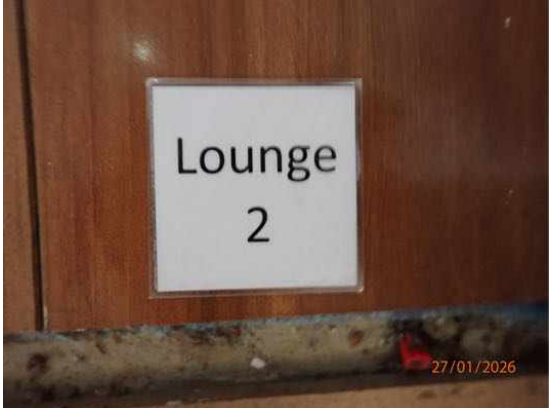
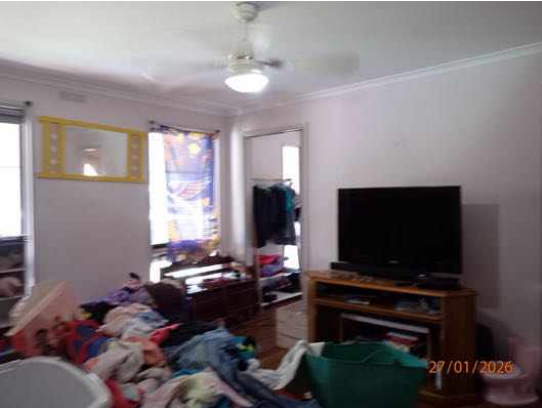
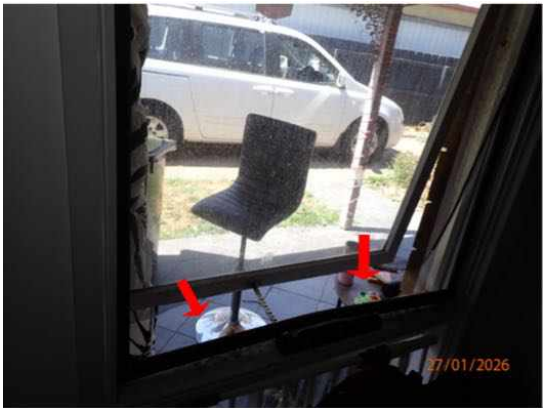
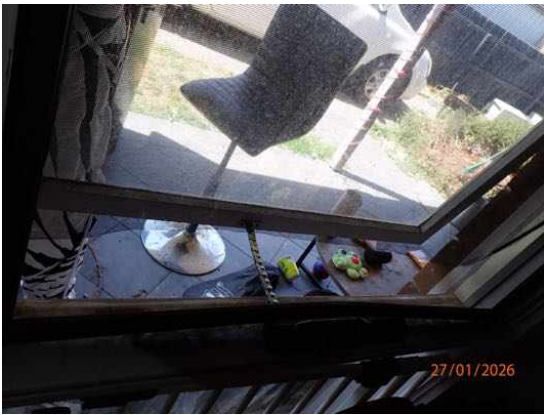
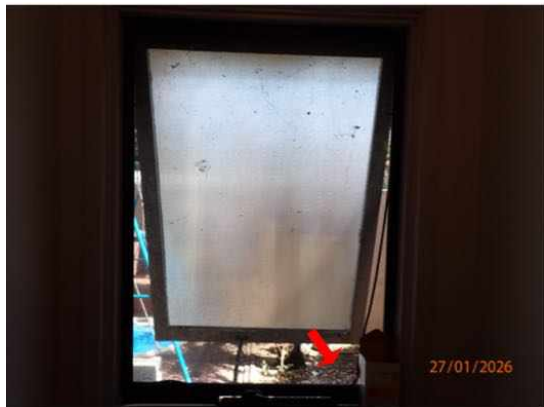
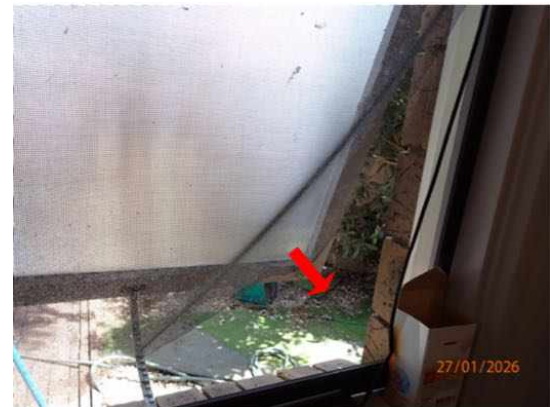
Finding 3.19

Building: Main Building
 Location: All Areas
 Finding: Flyscreens - Damaged
 Information: Flyscreens was found to be damaged to the windows in this area at the time of inspection. Whether the flyscreens have not been installed or damaged through wear and tear, this missing building element detracts from the operational state of the window.

Where not replaced, damaged flyscreens allow pest and insect ingress into the adjoining room. It is advised that all damaged flyscreen be replaced in order to ensure the full function of all building structures.

A general handyman may be appointed to replace flyscreens at the discretion of the client.

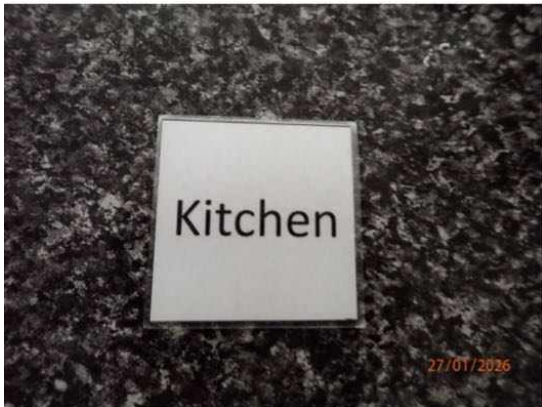
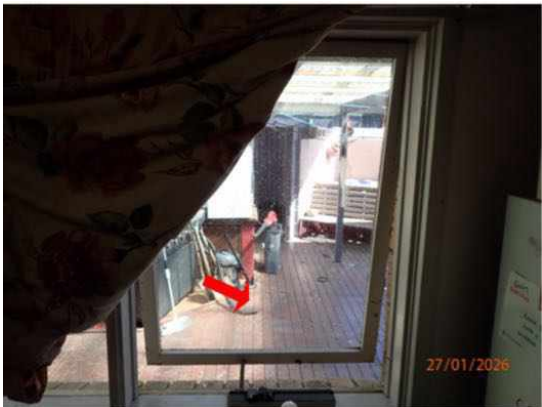
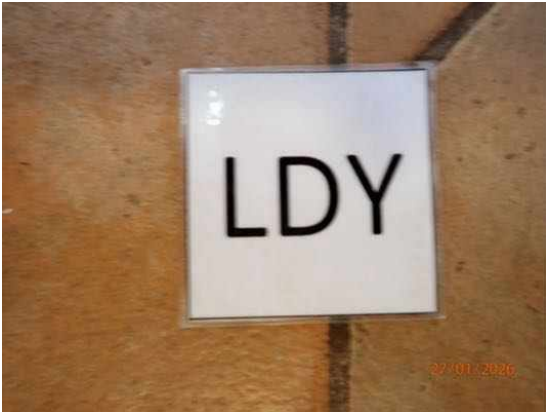
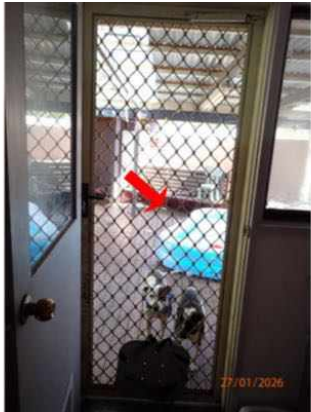
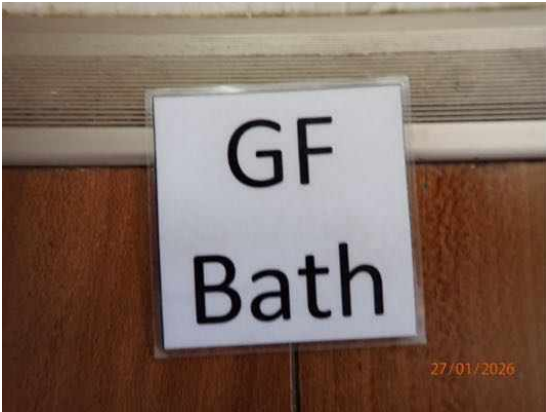
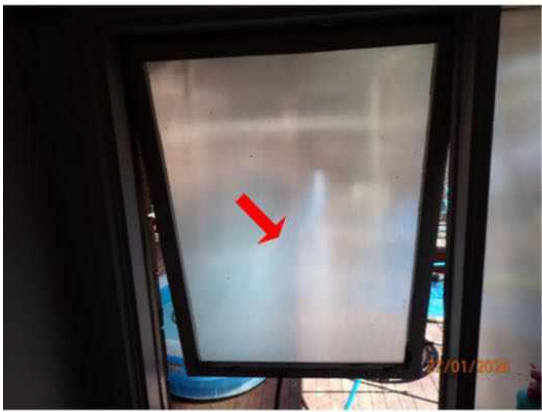
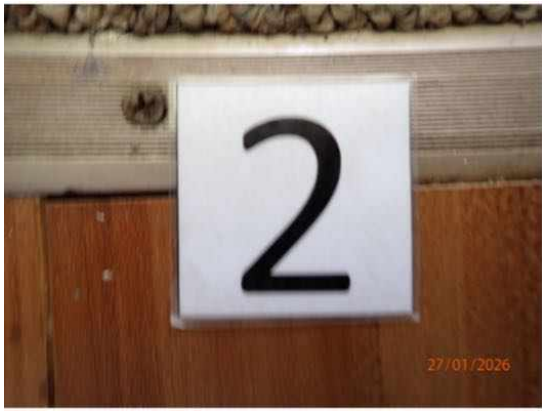
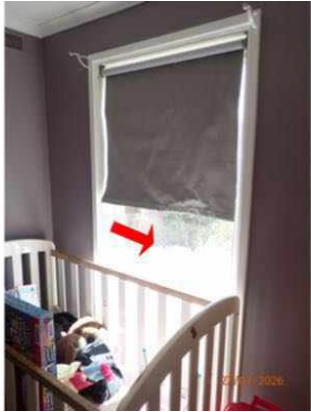
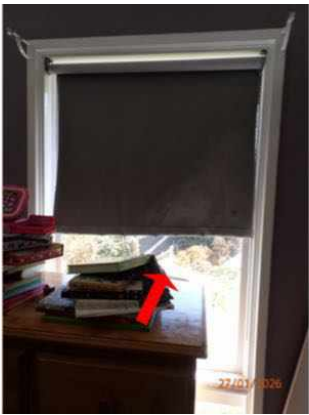
Finding 3.20

Building:	Main Building
Location:	All Areas
Finding:	Flyscreens - Missing
Information:	Flyscreens were found to be missing to the windows in this area at the time of inspection. Whether the flyscreens have not been installed or have been removed post-installation, this missing building element detracts from the operational state of the window.

Where not replaced, missing flyscreens allow pest and insect ingress into the adjoining room/s. It is advised that all missing flyscreens be replaced in order to ensure the full function of all building structures.

A general handyperson may be appointed to install flyscreens at the discretion of the client.

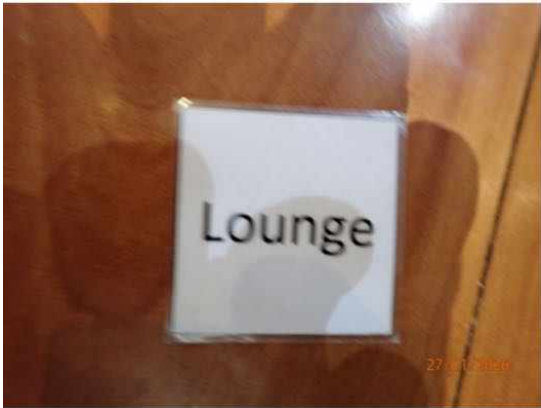
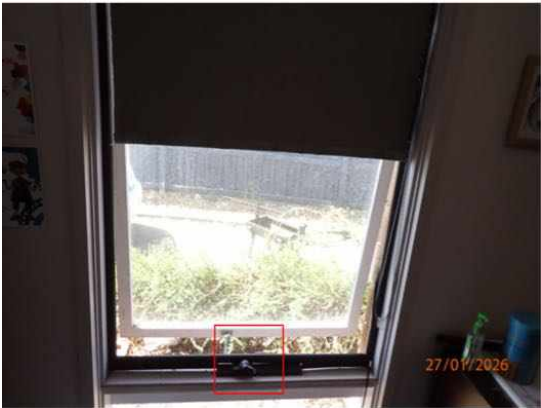
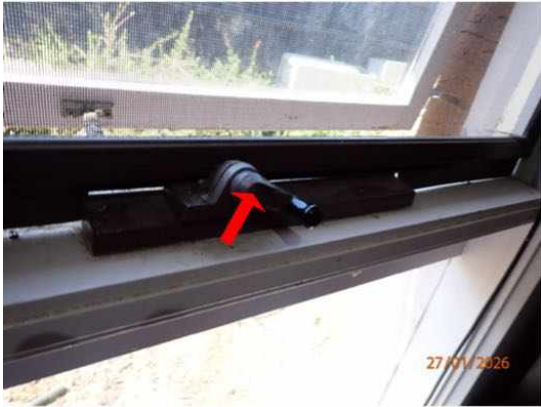
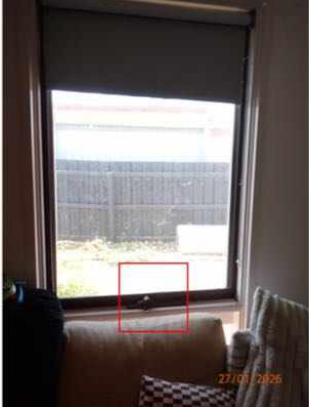
Finding 3.21

Building: Main Building
Location: All Areas
Finding: Window Missing Lock
Information: The window lock/handle was missing at the time of the inspection. Absence of the lock limits the operation and security of the window and may pose as a safety risk.

Replacement of the lock/handle should be conducted immediately. A general handy person or qualified carpenter should be appointed to perform these works to improve the operational state of the affected window and improve the safety of the internal area.

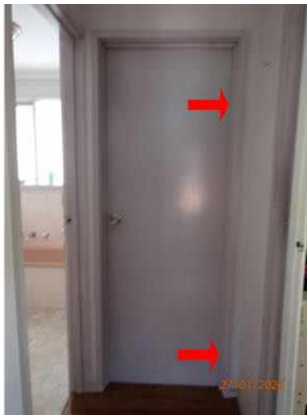
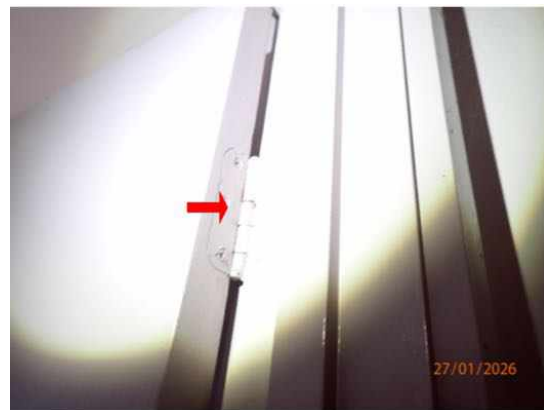
Finding 3.22

Building: Main Building
 Location: Toilet (WC)
 Finding: Lift Off Hinges
 Information: The Bathroom door has regular butt hinges which is suspected that the hinges required are lift off hinges.

This can pose a safety issue and should be rectified as soon as possible. A carpenter or handyman can be engaged to carry out the works.

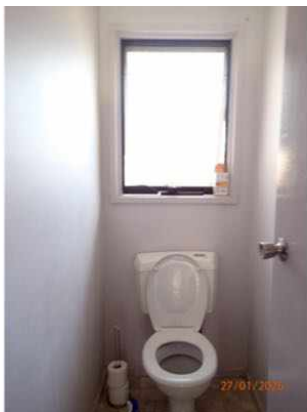
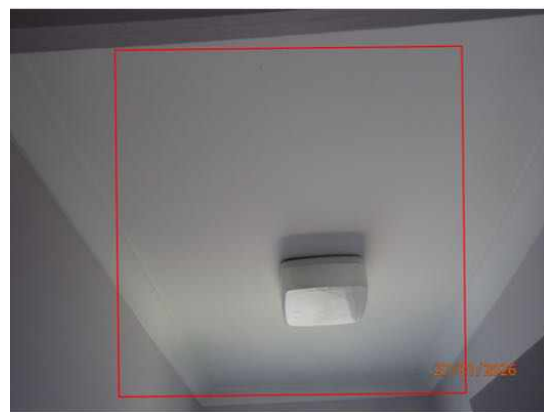
Finding 3.23

Building: Main Building
 Location: Toilet (WC)
 Finding: Exhaust fan - Missing
 Information: An exhaust fan has not been installed in this area. Missing exhaust fans may lead to the development of more significant defects such as moisture damage to surrounding building materials from inadequate ventilation. Inadequate ventilation in internal areas creates an environment that is conducive to the formation and development of mould and other respiratory hazards. It is highly advised that a licensed electrician be appointed to retrospectively install an exhaust fan. Failure to perform works to aid the ventilation of the area may lead to the development of these secondary defects.

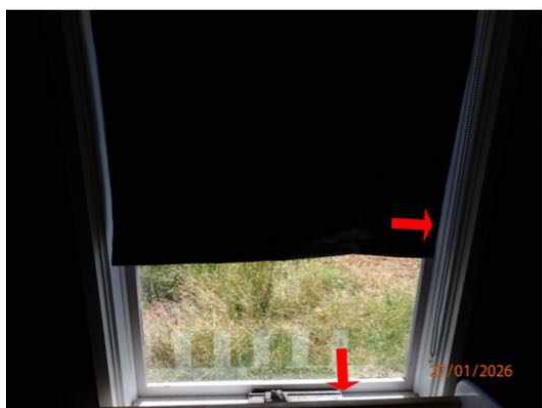
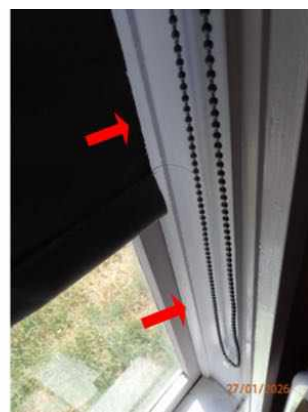
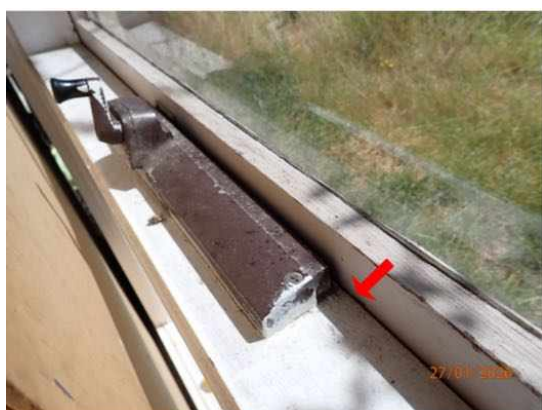
Finding 3.24

Building: Main Building
 Location: Bedroom 2 > Rear Right
 Finding: Window - Binding/jamming
 Information: Binding and/or jamming of this window is evident during standard operation. This defect inhibits the functionality of the affected window as well as creating potential for secondary defects to associated building elements, such as damage to the window reveal or sash.

A window that binds to the associated frame may have several causes, ranging from minor defects, such as poor installation of the door or deteriorated hinges or areas effected by weather.

For minor causes, a qualified carpenter or general handyman should be appointed to perform minor rectification works at client discretion.

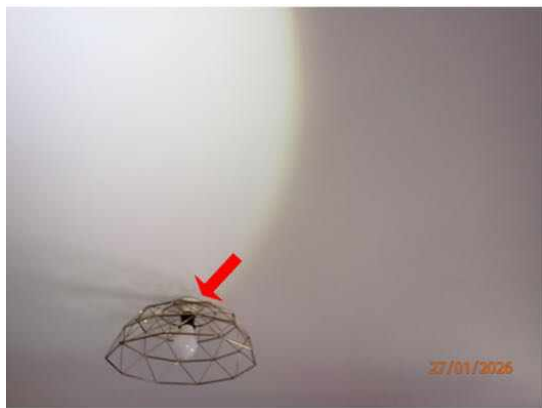
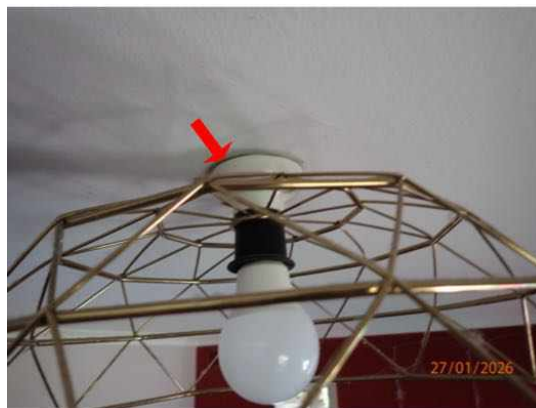
Finding 3.25

Building: Main Building
 Location: Bedroom 3 > Front Right
 Finding: Fitting or fixture - Loose Light
 Information: The light in this area is loose and requires adjustment to tighten.

If left unmanaged, the fitting may further deteriorate, causing potential for the development of other secondary defects or personal injury which poses a safety concern.

A qualified electrician should be appointed to perform these rectification works immediately.

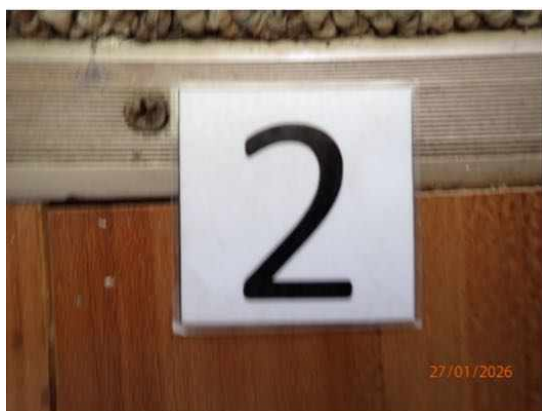
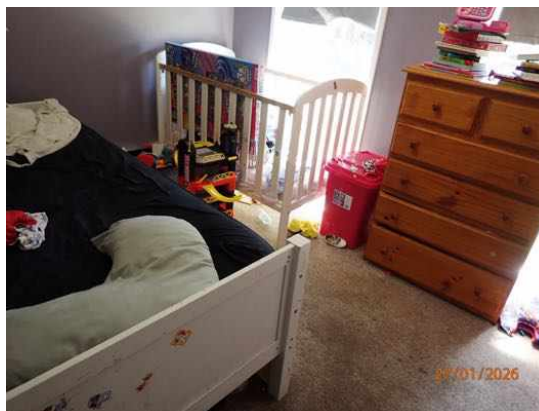
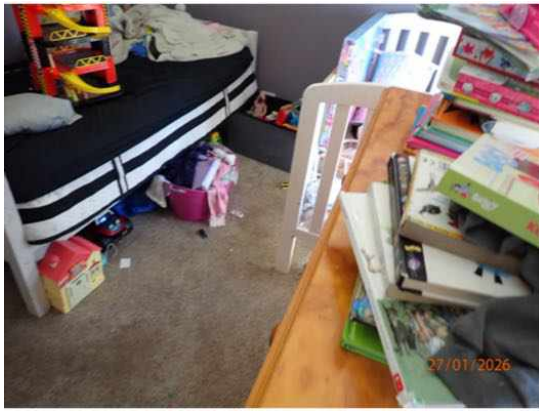
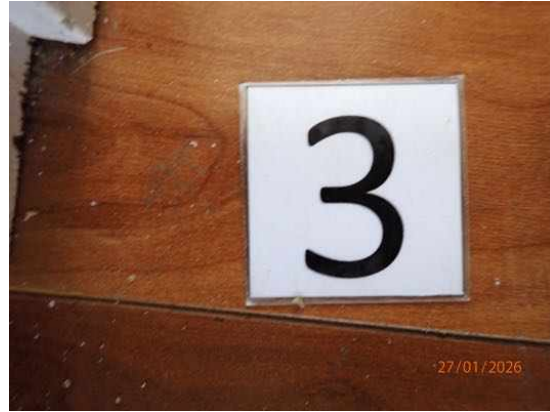
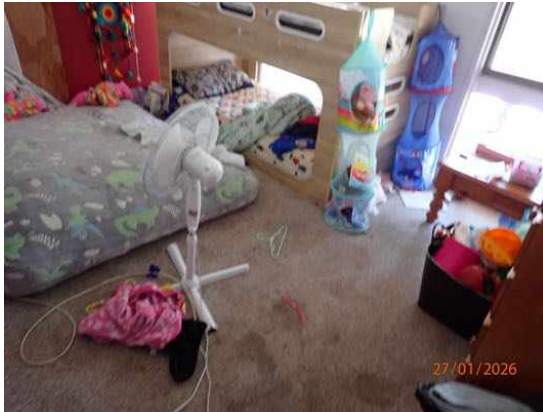
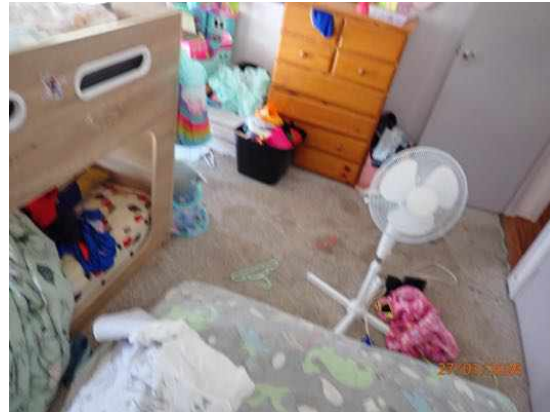
Building:	Main Building
Location:	Bedroom 2 & 3
Finding:	Carpet - Deteriorated
Information:	Sections of the carpet floor covering in this area appeared to be tired with considerable wear and tear. This can be from the age of the carpet or, possibly due to an internal water leak.

The first step is to diagnose the cause of the dampness. If the original cause is not resolved, further cases of damp are likely to ensue, resulting in secondary defects.

Replacement of the affected carpet is recommended at the clients discretion.

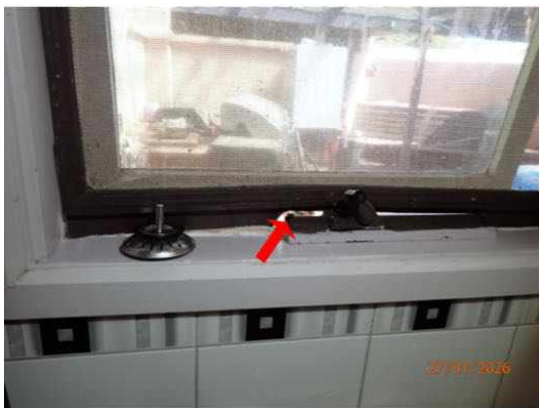
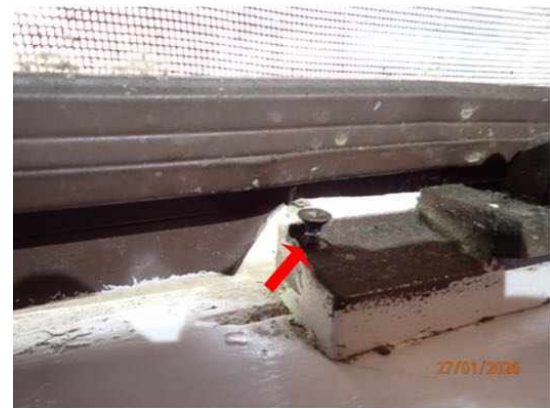
Finding 3.27

Building: Main Building
 Location: Kitchen
 Finding: Window Lock/Handle - Loose
 Information: The window lock/handle was loose at the time of the inspection. Loose lock/handle limits the operation and security of the window and may pose as a safety risk.

Replacement/Repair of the handle should be conducted as soon as possible. A general handy person or qualified carpenter should be appointed to perform these works to improve the operational state of the affected window and improve the safety of the internal area.

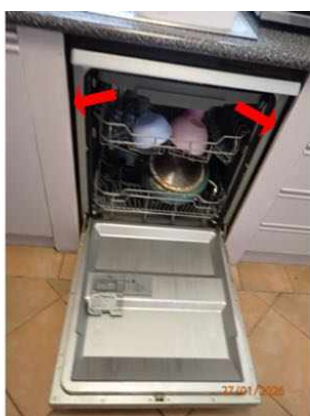
Finding 3.28

Building: Main Building
Location: Kitchen
Finding: Dishwasher Installation
Information: The dishwasher in this area is loose and requires to be securely installed.

If left unmanaged, the fitting may further deteriorate, causing potential for the development of other minor secondary defects.

A relevant tradesperson should be appointed to perform these rectification works at discretion of the client.

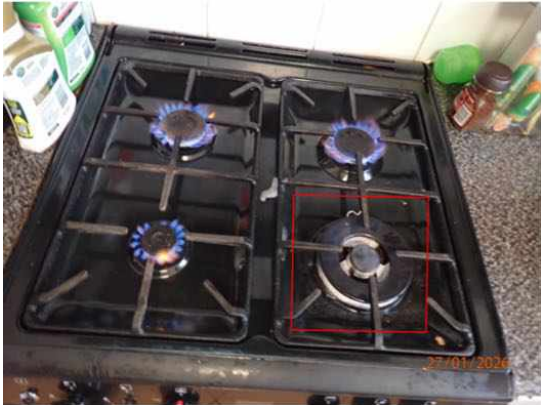
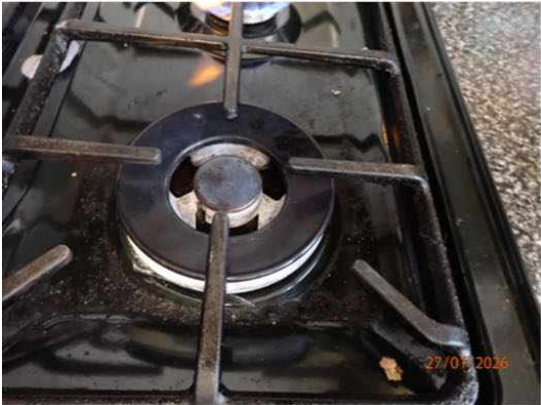
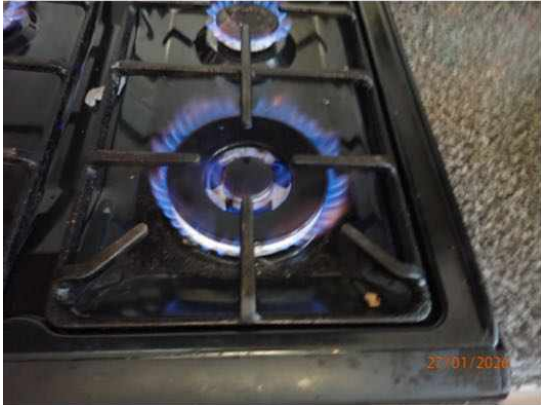
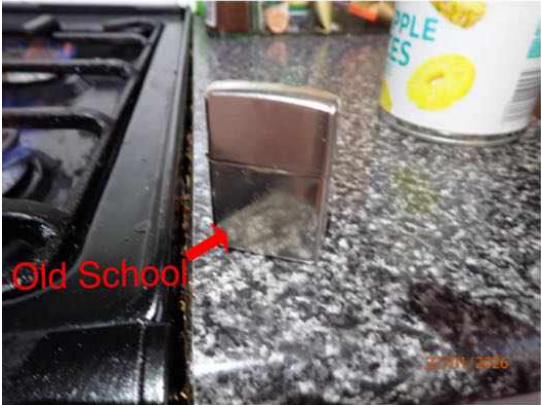
Finding 3.29

Building: Main Building
Location: Kitchen
Finding: Gas Installation - Cook Top - Igniter
Information: It was noted at the time of inspection that one or more of the gas cook top burners was not operational by the igniter not functioning at the time of the inspection.

It is advised to engage a qualified gas fitter to inspect repair or replace the appliance as needed. This is to be carried out asap.

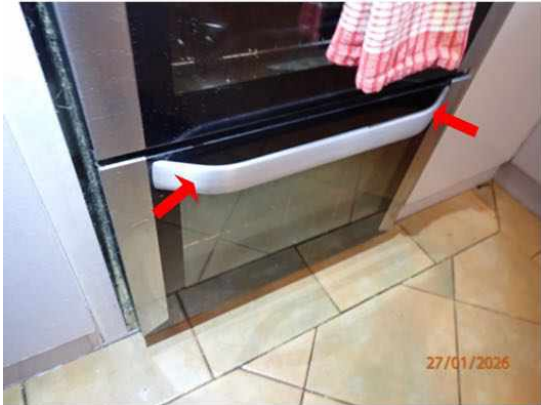
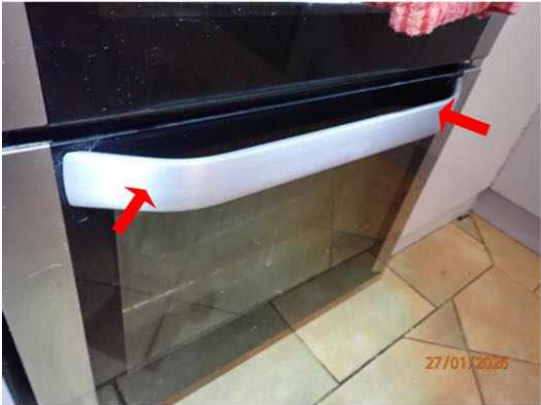
Finding 3.30

Building: Main Building
 Location: Kitchen
 Finding: Oven Door Handle - Loose
 Information: The oven door handle was loose at the time of the inspection. Loose handle limits the operation of the door and may pose as a safety risk.

Replacement/Repair of the handle should be conducted as soon as possible. A general handy person or qualified carpenter should be appointed to perform these works to improve the operational state of the affected window and improve the safety of the internal area.

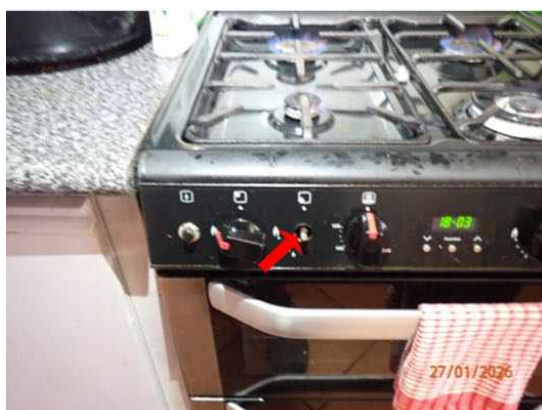
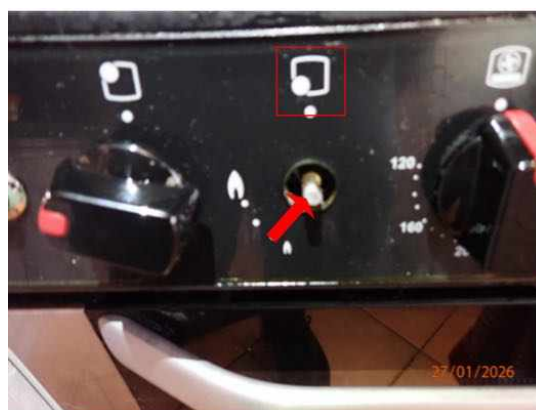
Finding 3.31

Building:	Main Building
Location:	Kitchen
Finding:	Building Element - Damaged - Cook Top Dial
Information:	Damaged occurs generally when the building materials have either aged and decayed, or as a result of damage (accidental or deliberate).

Repair and/or replacement of broken dial is advised to ensure that additional secondary defects do not arise as a consequence. Such works are necessary, as all building elements play a key role in the operation and function of the overall structure and its performance.

A qualified gas fitter should be appointed to repair or replace the affected building element prior to any subsequent damage being caused.

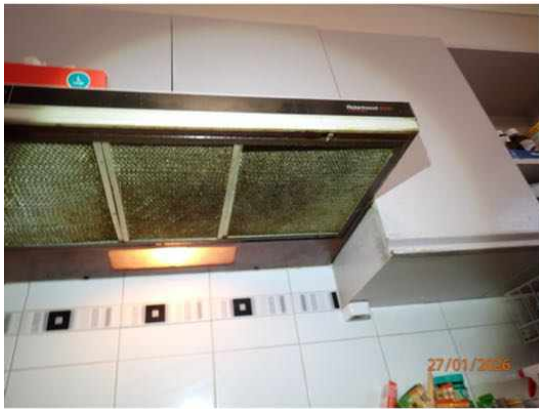
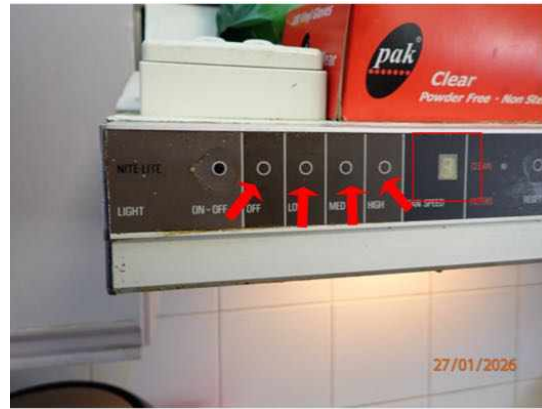
Finding 3.32

Building:	Main Building
Location:	Kitchen
Finding:	Building Element - Damaged - No Fan Speed
Information:	Damaged occurs generally when the building materials have either aged and decayed where there is only one speed to the range hood fan with a retro fitted switch to the range hood.

Repair and/or replacement of range hood is advised to ensure that the grill function of the range hood is achieved. Such works are necessary, as all building elements play a key role in the operation and function of the overall structure and its performance.

A electrician should be appointed to repair or replace the affected building element prior to any subsequent damage being caused.

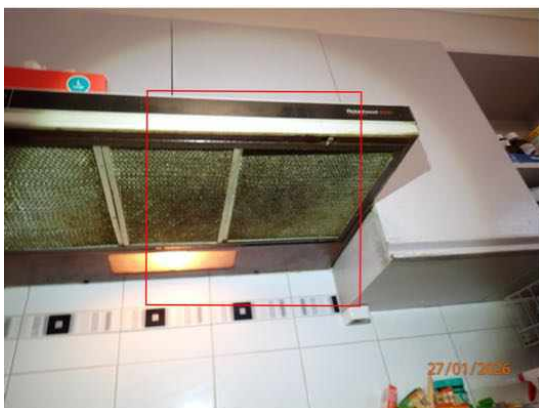
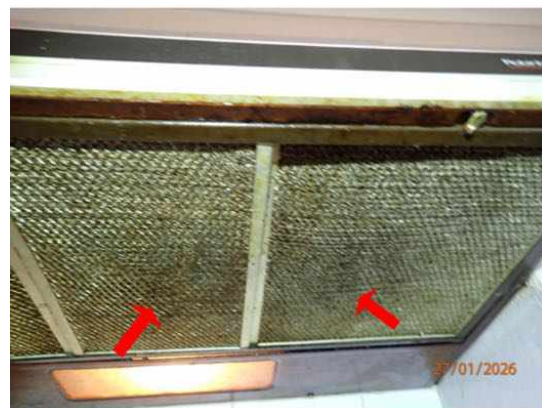
Finding 3.33

Building:	Main Building
Location:	Kitchen
Finding:	Range Hood - Filter Blocked
Information:	The range hood was found to the filter was blocked and required cleaning at the time of the inspection.

Without the filter the Rangehood is not considered fully operational and is deemed a minor defect. It is therefore preferable that the be installed or the range hood replaced.

A licensed electrician/mechanical ventilation contractor should be appointed as soon as possible to provide further consultation on the scope of these works and to provide quotations for any necessary works.

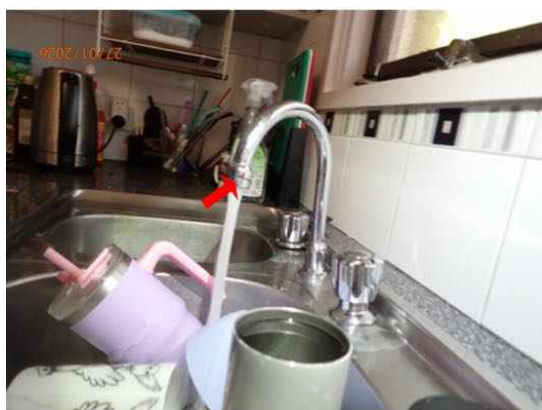
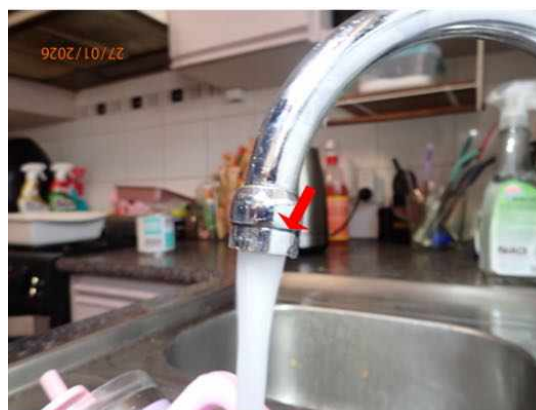
Finding 3.34

Building:	Main Building
Location:	Kitchen
Finding:	Tap - Leaking
Information:	The tap in this area was found to be leaking at the time of inspection. This is a

common defect that is consistent with general ageing of the building element. However, it may be indicative of substandard plumbing workmanship if the tap is relatively new.

While this defect only seems minor, if left unmanaged, it is likely to result in the development of rust, water damage and/or extensive water usage.

It is advised that a qualified handyman or licensed plumber be appointed to perform remedial works on the affected tap. Such works should be performed prior to the development of secondary defects to ensure adequate functionality of all associated building elements.

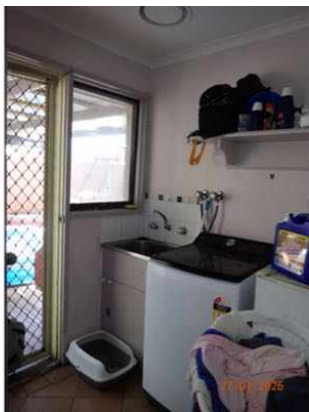
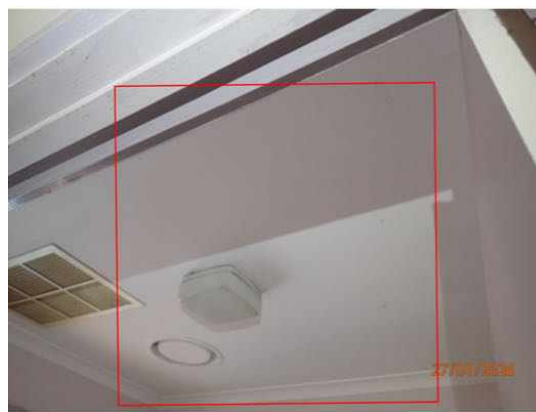
Finding 3.35

Building:	Main Building
Location:	Laundry
Finding:	Exhaust fan - Missing
Information:	An exhaust fan has not been installed in this area. Missing exhaust fans may lead to the development of more significant defects such as moisture damage to surrounding building materials from inadequate ventilation. Inadequate ventilation in internal areas creates an environment that is conducive to the formation and development of mould and other respiratory hazards. It is highly advised that a licensed electrician be appointed to retrospectively install an exhaust fan. Failure to perform works to aid the ventilation of the area may lead to the development of these secondary defects.

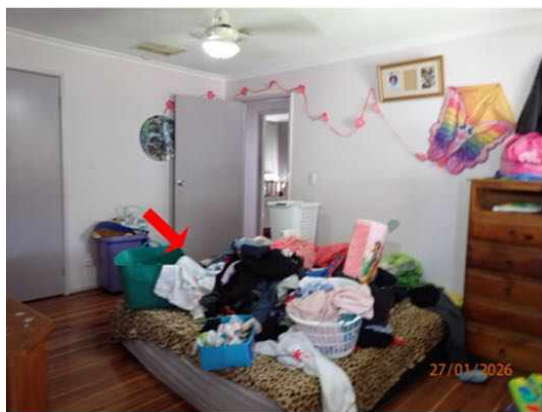
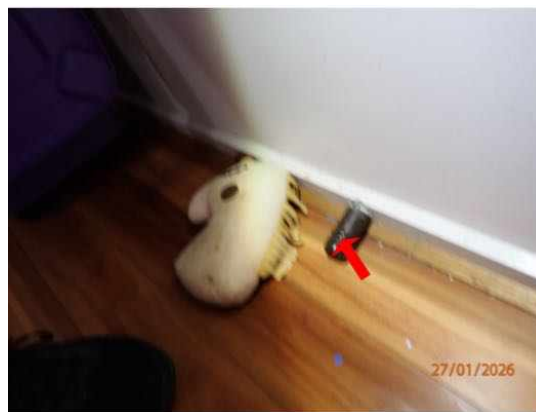
Finding 3.36

Building: Main Building
 Location: Lounge Room 2 > Front Right
 Finding: Fitting or Fixture - Loose - Door Stop
 Information: The door stop in this area is loose and requires adjustment to tighten.

If left unmanaged, the fitting may further deteriorate, causing potential for the development of other minor secondary defects.

A qualified handyman should be appointed to perform these rectification works at discretion of the client.

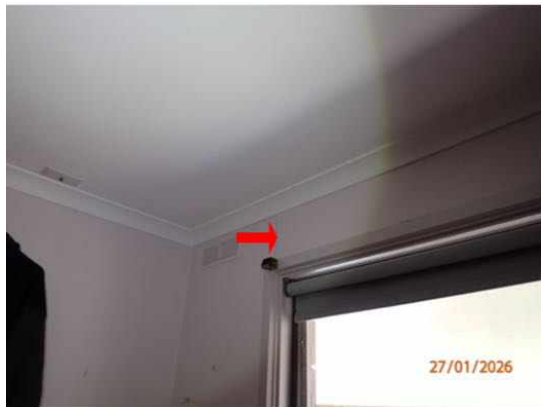
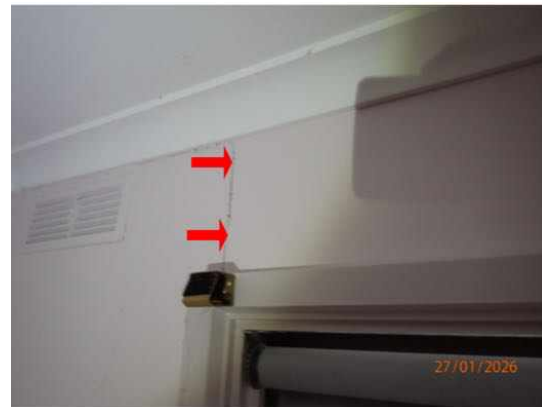
Finding 3.37

Building: Main Building
 Location: Lounge Room 2 > Front Right
 Finding: Cracking - Damage Category 2 - Noticeable (up to 5mm)
 Information: Noticeable cracks are a common occurrence as a result of many primary defects. Such causes may include age, general wear and tear, expected building movement, general expansion/contraction of building materials in different weather conditions, and/or minor failings in the installation or application of building materials.

Noticeable cracks may result in minor sticking or jamming of associated doors and

windows, which require easement. However, noticeable cracks are easily filled and repaired. A plasterer can be consulted to install an expansion joint at this point to allow for this movement during different weather conditions.

Monitoring of all cracking should be conducted frequently. Always contact a building inspector should cracks widen, lengthen, or become more numerous. Additionally, your building inspector should also be contacted if associated building elements such as doors and windows become more difficult to operate over time.

Relevant tradespeople, such as carpenters, painters and plasterers, should be appointed to perform remedial works, as deemed necessary.

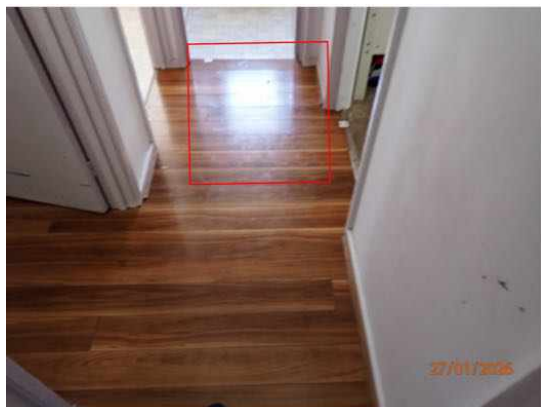
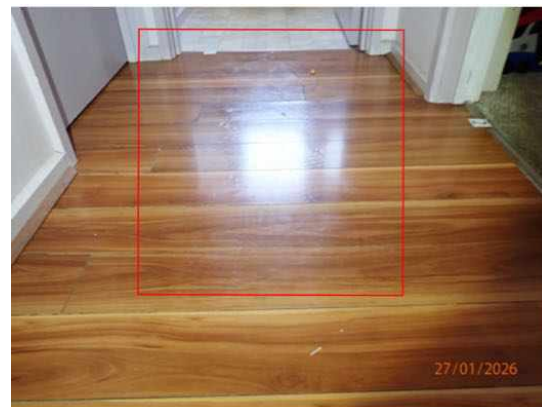
Finding 3.38

Building:	Main Building
Location:	Hallway > Rear Right
Finding:	Timber Floor - Popping
Information:	The timber floating floor was identified to be popping at the time of the inspection. If left unattended the underlying issue could effect the floor system or surrounding building elements and structure. This issue generally arises from excessive heat to the subfloor or a high moisture content which can subsiquesnty force the floors to move further than the manufacturers allowances. It is advised to engage a licenced builder to investigate the cause of this issue as soon as possible

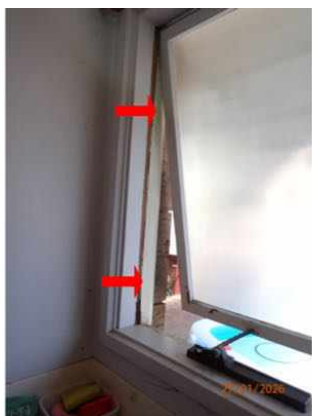
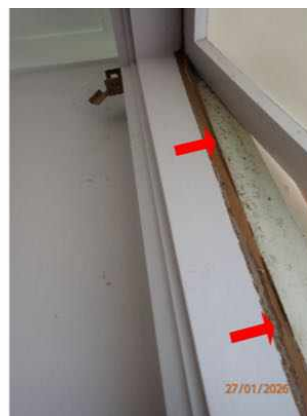
Finding 3.39

Building: Main Building
 Location: Bathroom > Rear Right
 Finding: Building Element - Damaged - Window Storm Mold
 Information: Damaged occurs generally when the building materials have either aged and decayed, or as a result of damage (accidental or deliberate).

Replacement of broken storm mold is advised to ensure that additional secondary defects do not arise as a consequence. Such works are necessary, as all building elements play a key role in the operation and function of the overall structure and its performance.

A qualified handyman d]or carpenter should be appointed to repair or replace the affected building element prior to any subsequent damage being caused.

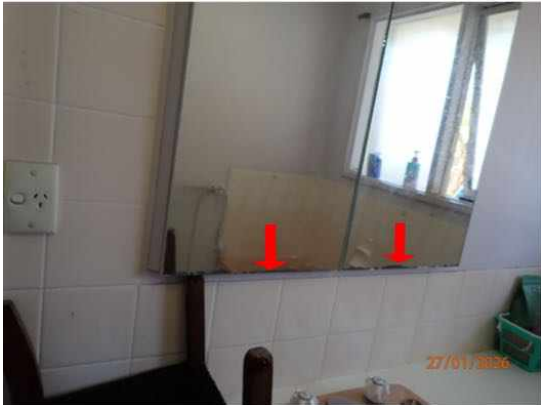
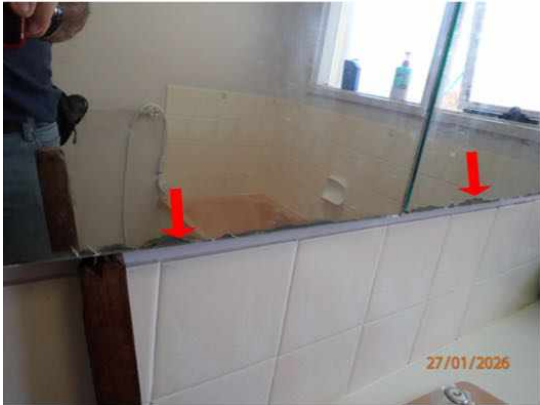
Finding 3.40

Building: Main Building
 Location: Bathroom > Rear Right
 Finding: Mirror - Delaminating
 Information: Delaminating was identified in the mirror in this area.

Delaminating affects the use and quality of the mirror and will restrict the visibility within the mirror over time.

A qualified mirror or glass repair service may be required to replace the mirror at the owners discretion

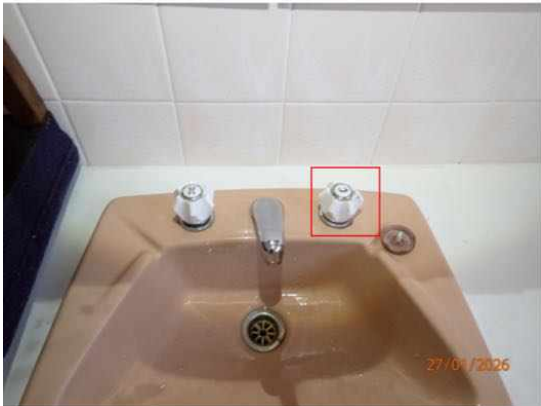
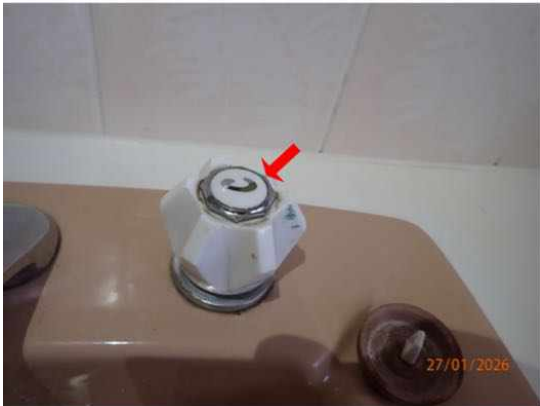
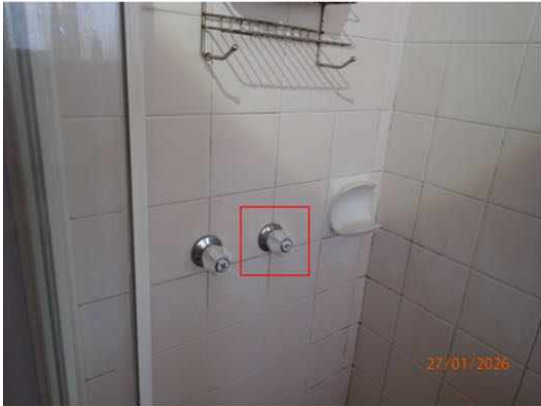
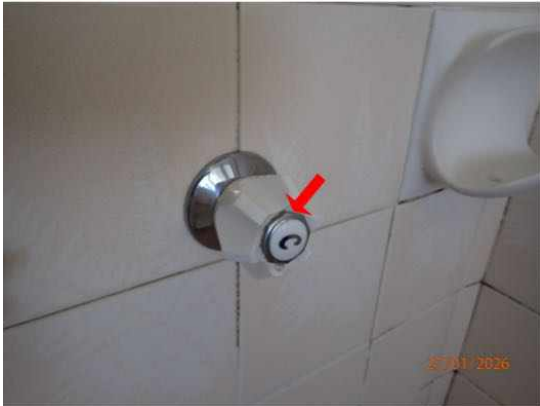
Finding 3.41

Building: Main Building
Location: Bathroom > Rear Right
Finding: Mild Water Hammer
Information:

It was observed during inspection that mild water hammer is present. Unless it is caused by the use of a solenoid or ceramic valve in an appliance supplied by the owner it is considered to be a defect with reference to Standards and Tolerances.

This defect is to be reviewed and addressed by a licensed plumber at the owners discretion.

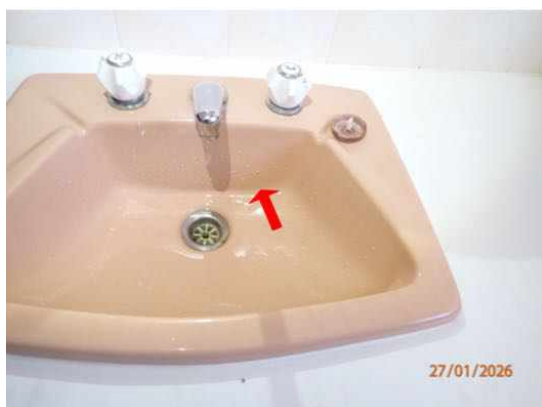
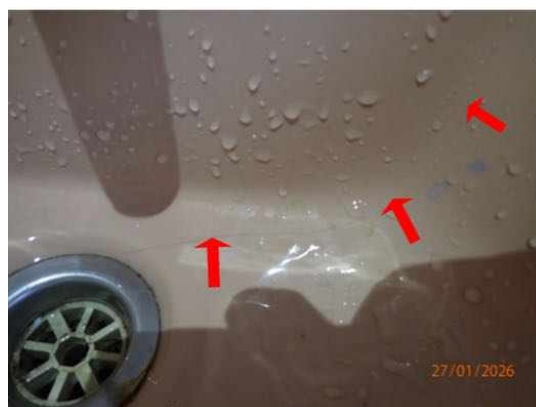
Building: Main Building
 Location: Bathroom > Rear Right
 Finding: Basin - Cracked
 Information: Cracking was evident to the basin at the time of inspection, which is suspected to have been by minor impact damage. While the cracking appears to be minor, any further impact damage sustained by the basin may lead to additional cracking.

As the cracking provides potential ingress for water, secondary water damage may occur to associated cabinetry, walls or flooring, if the cracking is left unmanaged.

Consultation with a plumber regarding basin repair or replacement is required. Remedial works may be required to protect against any further damage.

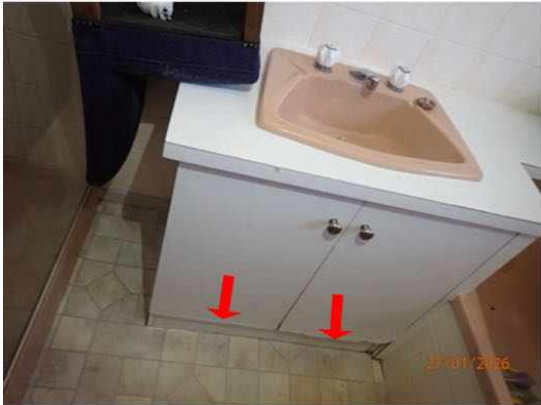
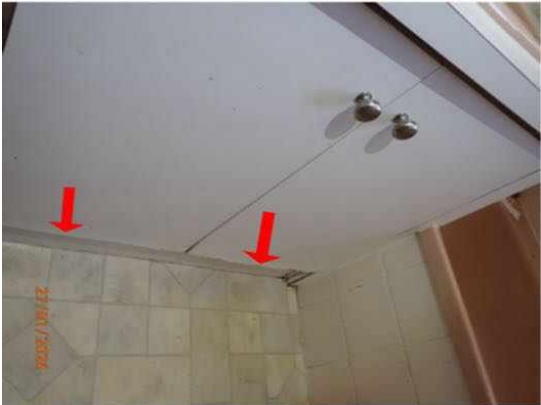
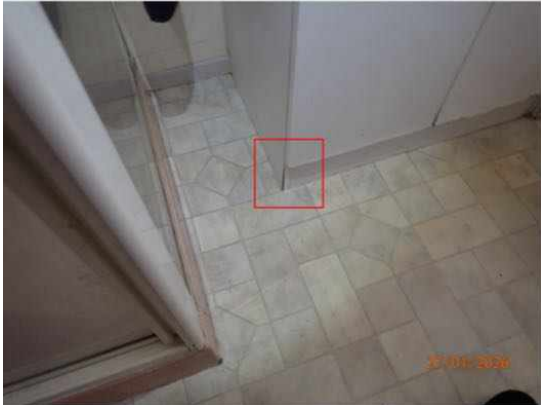
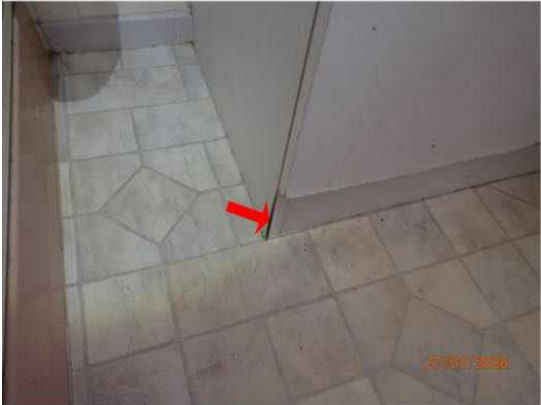
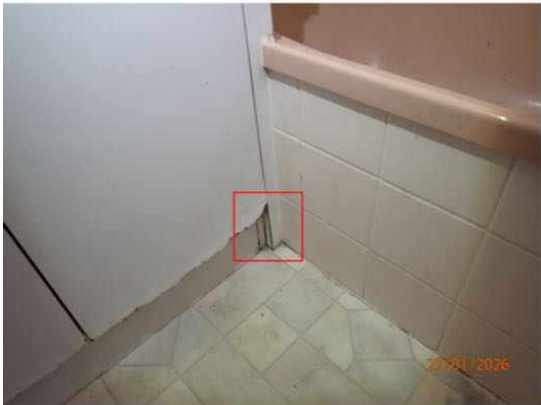
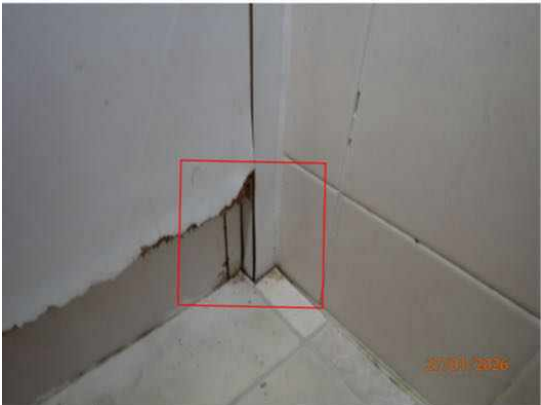
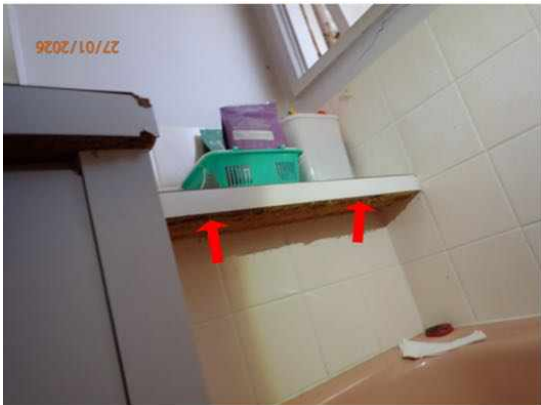
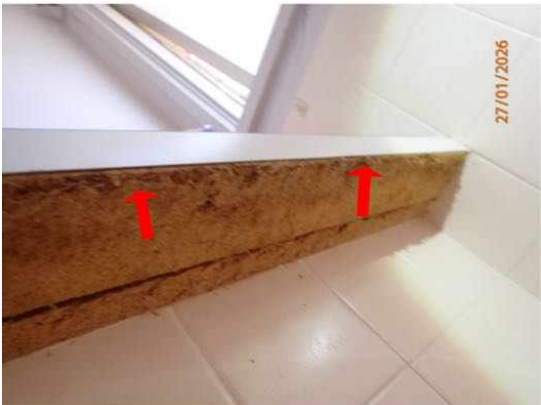
Finding 3.43

Building: Main Building
 Location: Bathroom > Rear Right
 Finding: Cabinetry - Water Damage
 Information: Swollen building elements generally indicate that the building materials have been affected by water / moisture and they have swollen in appearance.

No moisture or water leaks were evident at the time of inspection. Although not urgent replacement or repairs of affected building elements may be done by a cabinet maker at the clients discretion.
