Building and Timber Pest Inspection Report

Inspection Date: Tue, 27 Jan 2026

Property Address: 12 Bean Ct, Whittington VIC 3219,
Australia

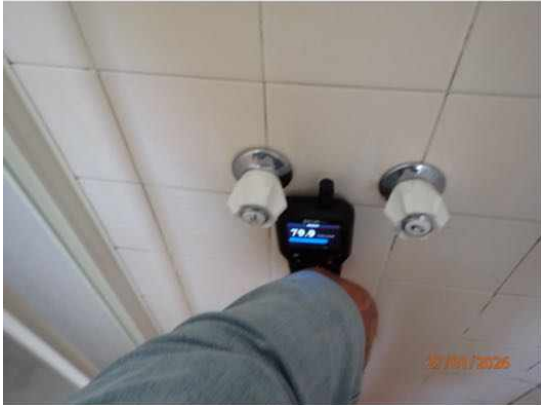
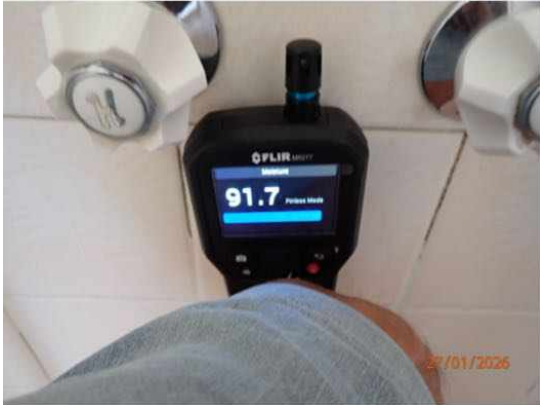
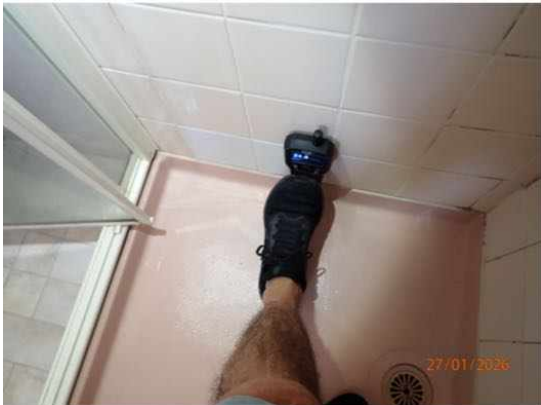
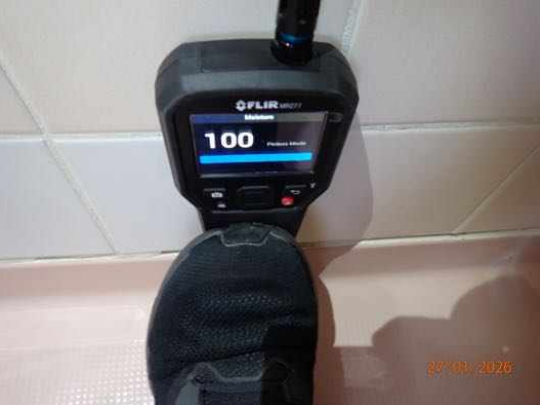
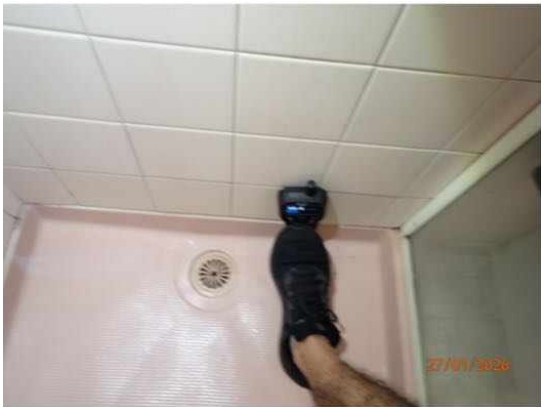
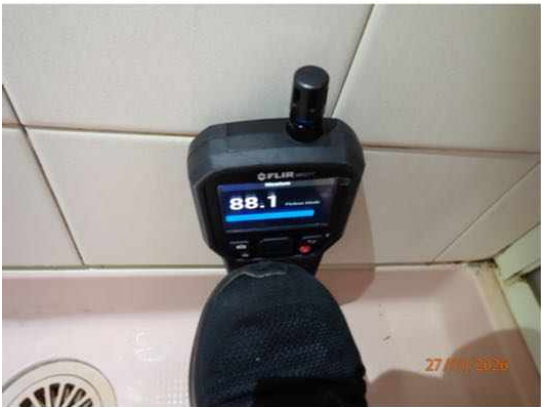
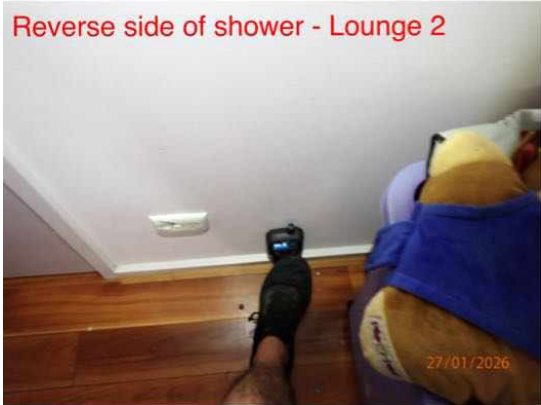
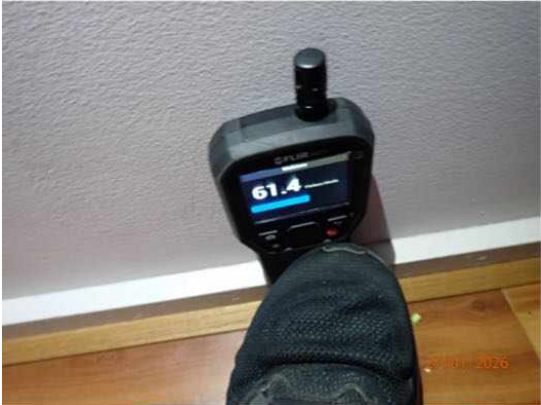
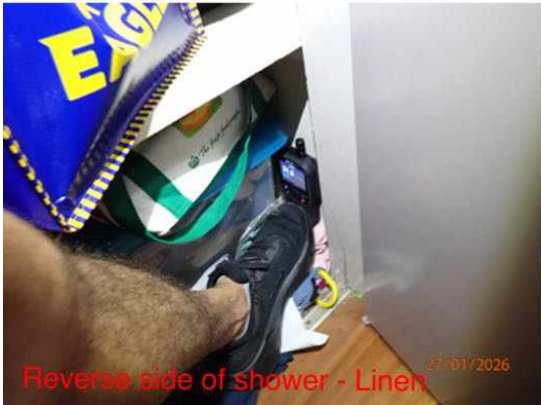
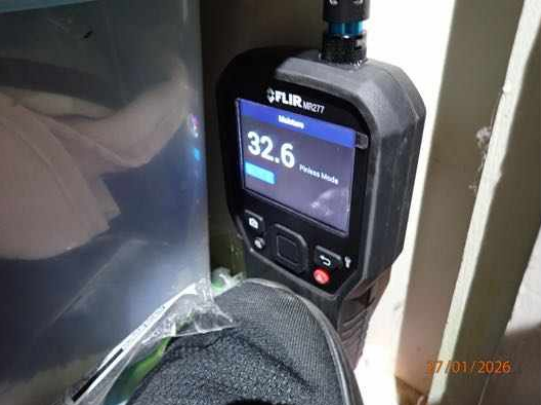
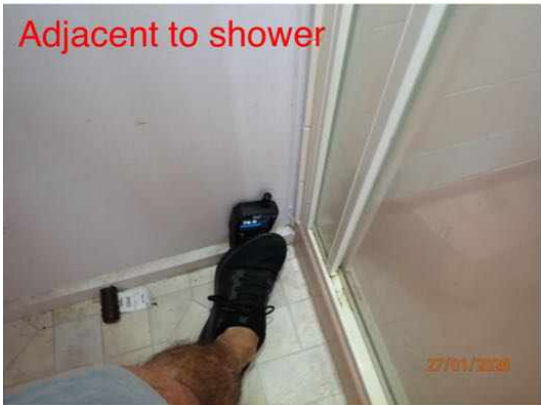
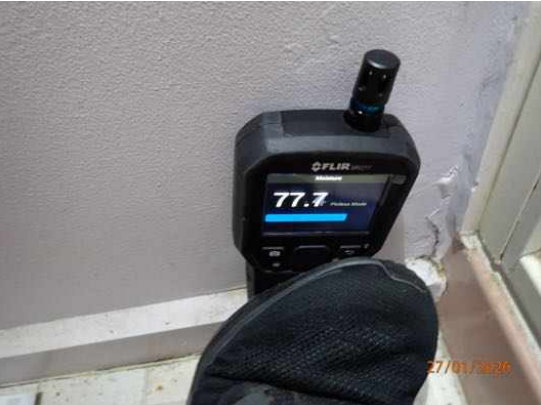
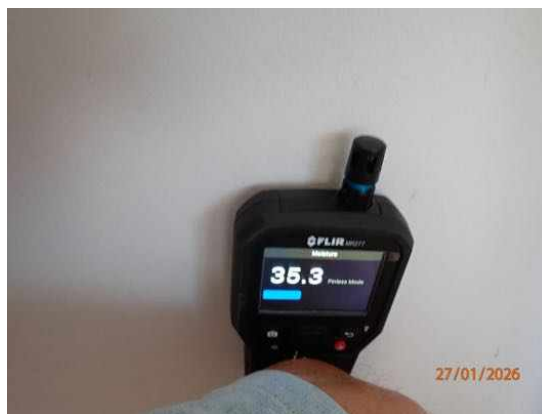
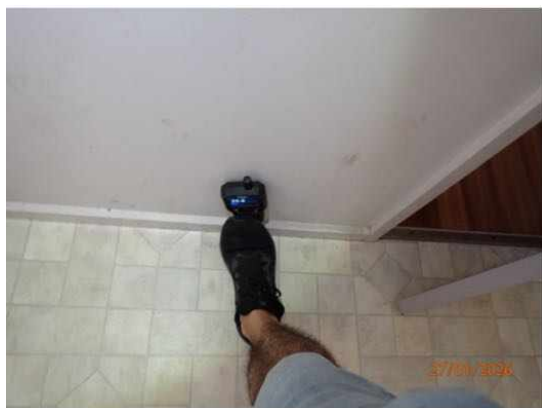
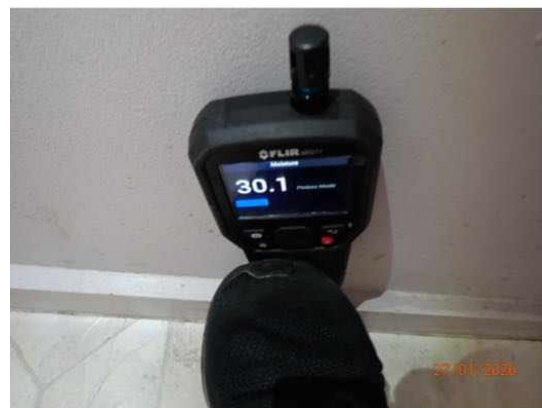
Finding 3.44

Building: Main Building
Location: Bathroom > Rear Right
Finding: Shower damp - To Be Monitored & Epoxy Grout
Information: Damp is evident to the lower wall to the shower alcove and acceptable level moisture reading were found to the reverse side of the shower. Elevated moisture readings were found to the wall adjacent to the shower.

Damp (or structural damp) refers to the presence of unwanted moisture in the structure of a building, either as the result of intrusion from outside, or condensation from within the structure. In the shower area, internal water leaks or other sources of excessive moisture are generally the cause of damp.

It is advised to engage a epoxy grout specialist to remove and replace the grout with epoxy grout and install epoxy to all floor wall corner joints.

Always ensure that sealant and grout is in good condition to prevent any moisture issues occurring in the future.

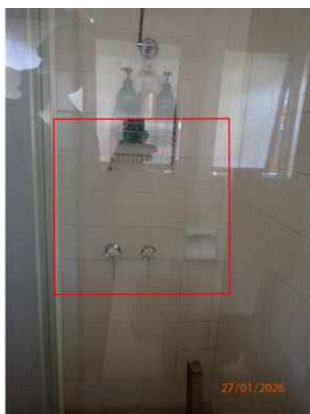
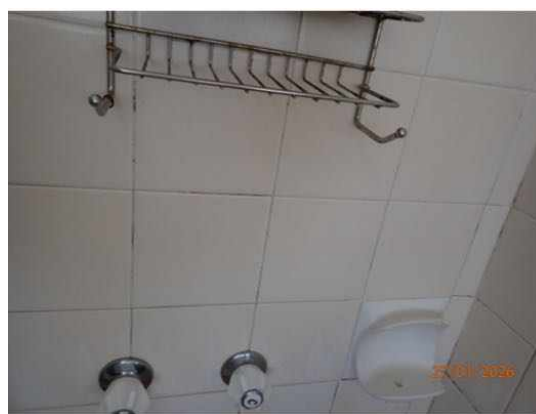
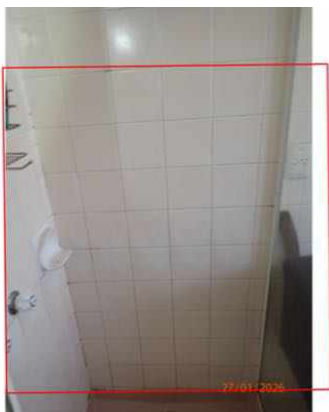
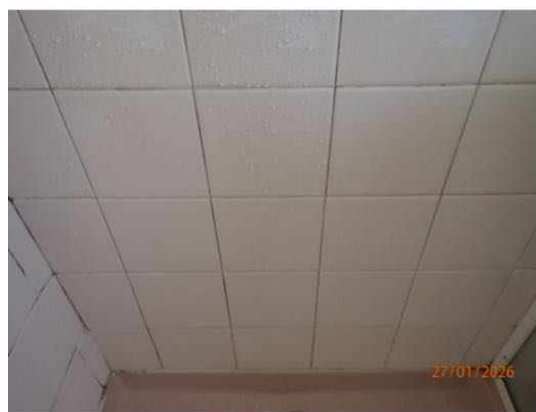
Finding 3.45

Building:	Main Building
Location:	Bathroom > Rear Right
Finding:	Grout - Missing with Epoxy
Information:	Grout is missing in this area. Grout is used to protect gaps and crevices in building materials to ensure that they are water-tight and prevent water penetration to the associated structures.

Where grout is missing, a tiling contractor should be appointed immediately to apply grout and re-apply any silicone where necessary. Failure to do so is likely to lead to water damage to the surrounding area.

It is advised that the showers are reviewed by a qualified specialist bathroom grout and sealant specialist to remove and replace all rout with EPOXY grout and re seal all wall for junctions asap.

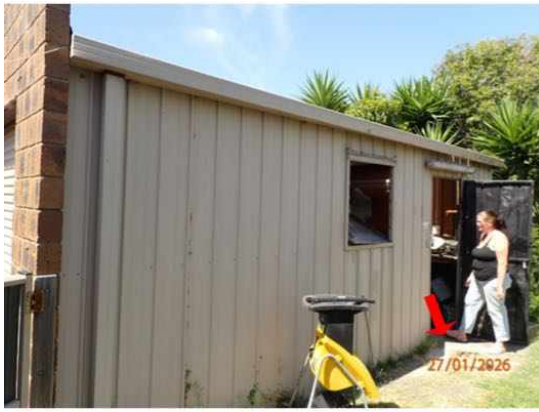
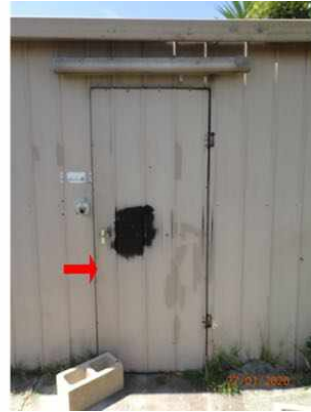
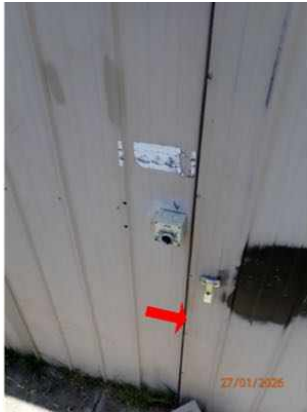
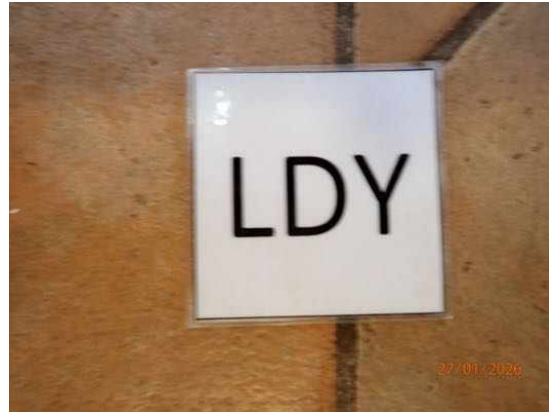
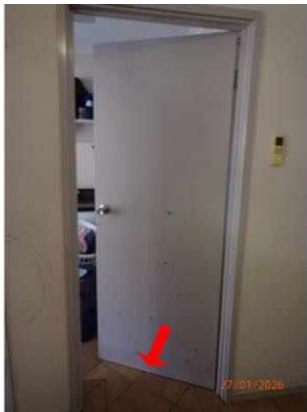
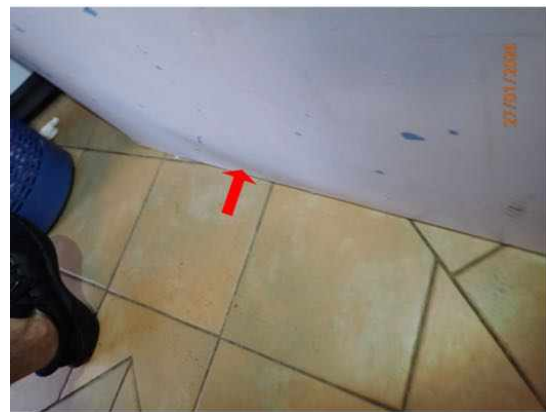
Finding 3.46

Building:	Main Building
Location:	Garage & Laundry
Finding:	Doors - Binding/Jamming
Information:	Binding and/or jamming of doors throughout the property were evident during standard operation. This defect inhibits the functionality of affected doors as well as creating potential for secondary defects to associated building elements, such as damage to the floor covering, doors and door jams.

A door that binds to flooring or to the associated door frame may have several causes, ranging from minor defects, such as poor installation of the door or deteriorated hinges, through to major structural issues, such as damage to subfloor structures.

Where door binding/jamming appears to indicate major structural issues, a registered builder specialising in sub floor foundations may be appointed to provide an estimate on the cost of rectification.

For minor causes, a qualified carpenter or general handyperson should be appointed to perform minor rectification works at client discretion.

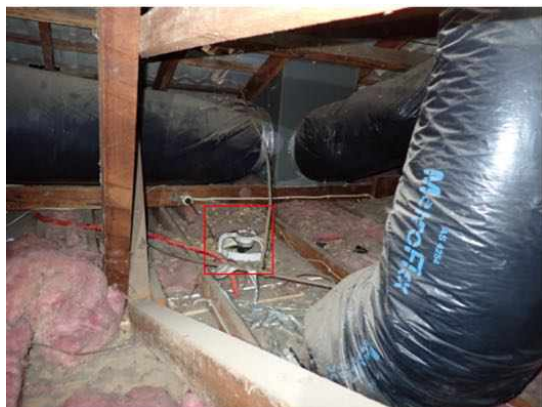
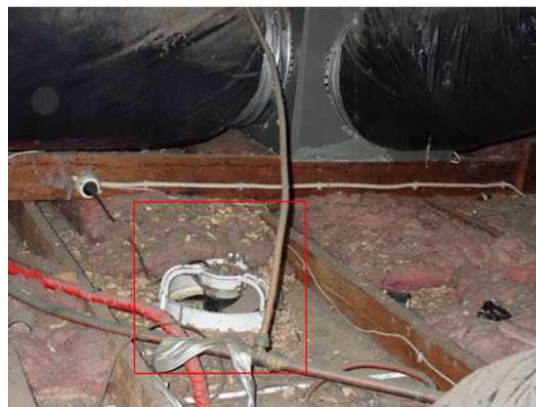
Finding 3.47

Building: Main Building
 Location: Roof Void
 Finding: Vent - Extracted into roof space
 Information: The bathroom ventilation was discharging within the roof space was dislodged at the time of the inspection and was found to lead directly into the roof space, rather than venting to the exterior of the building.

operational and is deemed a minor defect. It is therefore preferable that the flue be re-directed to vent into the external environment.

A licensed mechanical ventilation contractor/electrician should be appointed as soon as possible to provide further consultation on the scope of these works and to provide quotations for any necessary works.

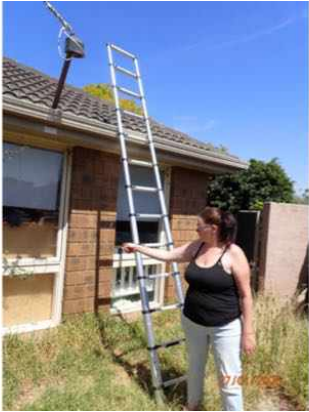
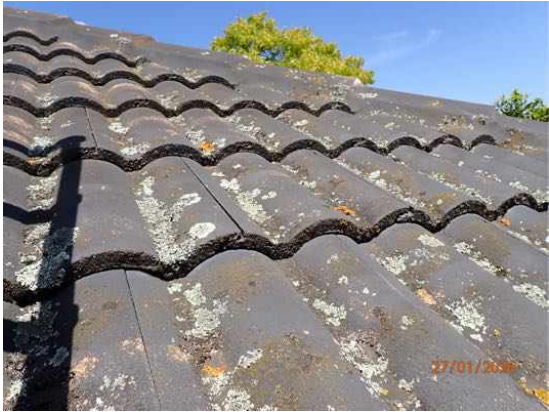
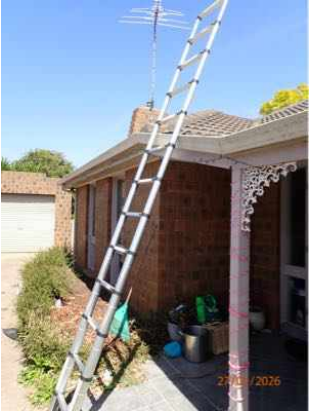
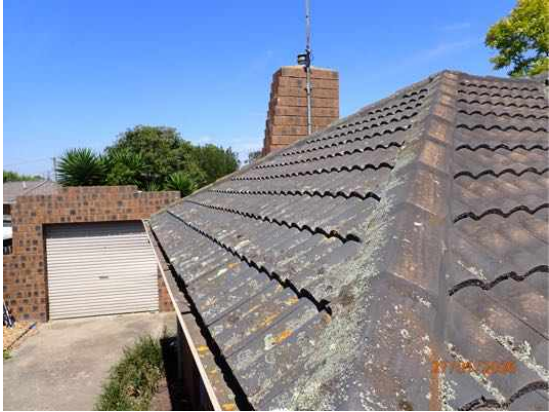
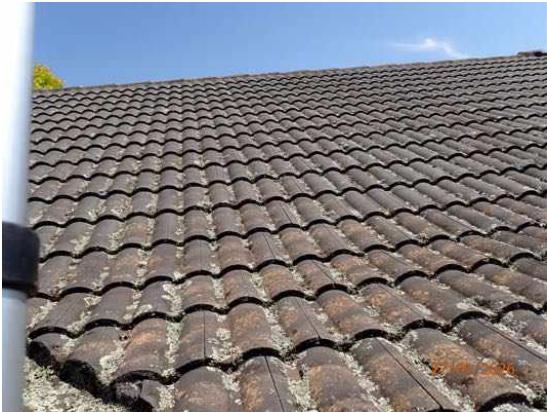
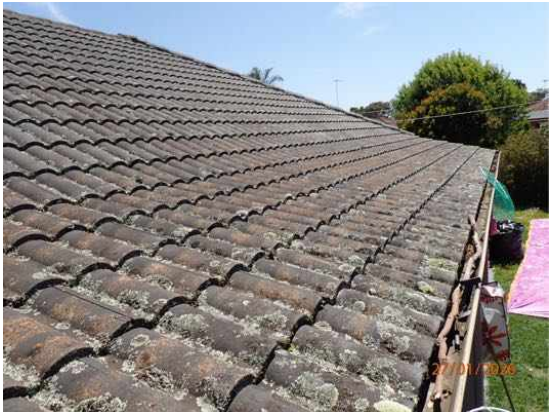
Building:	Main Building
Location:	Roof Exterior
Finding:	Roof - Weathered
Information:	Upon inspection of the exterior roofing, the majority of roof were considered to be in a fair condition. While weathering and ageing of the roof tiles and sheets over the alfresco and flashings are fairly consistent with the age of the property, maintenance works are required.

Where left unmanaged, deteriorating roof are likely to lead to a number of secondary defects, including minor water leaks and weather exposure to internal roofing structures. The ceilings to the inside were freshly painted and difficult to see any current active leaks.

Consultation with a roofing contractor is advised to review the roof and provide the costs to pressure clean the roof surfaces. Re inspection of the roof will be required to review any areas requiring rectification once the the roof is cleaned.. This is to be carried out asap.

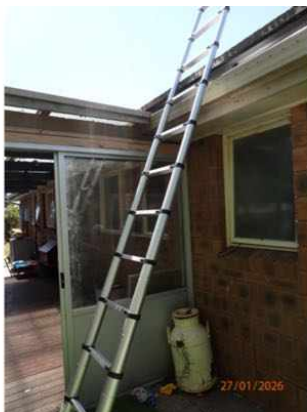
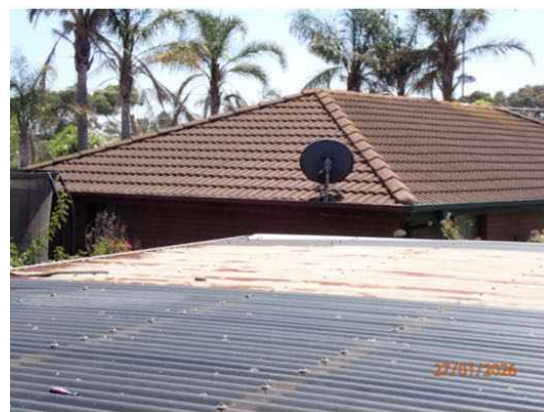
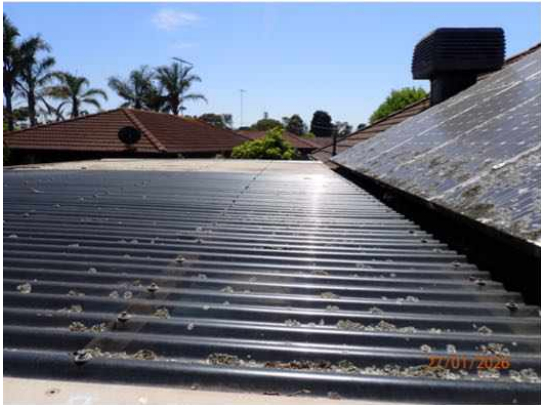
Finding 3.49

Building:	Main Building
Location:	Roof Exterior Alfresco
Finding:	Exterior roof - Insufficient fall
Information:	It was identified that there is insufficient fall or angle in the roofing structure, which is leading to pooling of water and an array of secondary related building defects. Such defects are likely to include material deterioration, leaks and/or corrosion of associated building materials.

The angle of the roof is insufficient to facilitate the effective drainage of rain water to the roof plumbing systems. Over time, if this defect is not addressed (potentially including structural changes to the roof), further building defects will develop.

Consultation with a roofing plumber or roofing restoration contractor is required for quotations regarding these works. Where water pooling is quite significant, structural alterations to the roof may potentially be expensive and time-consuming.

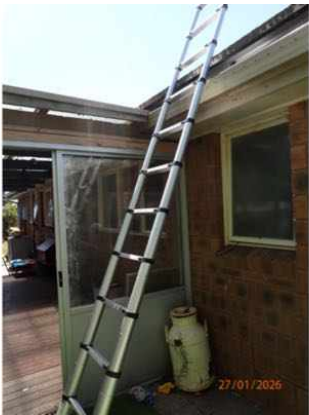
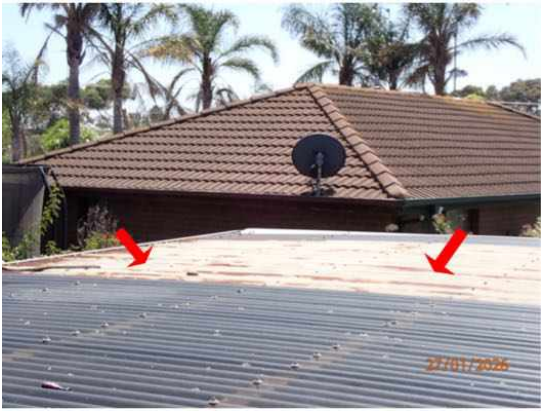
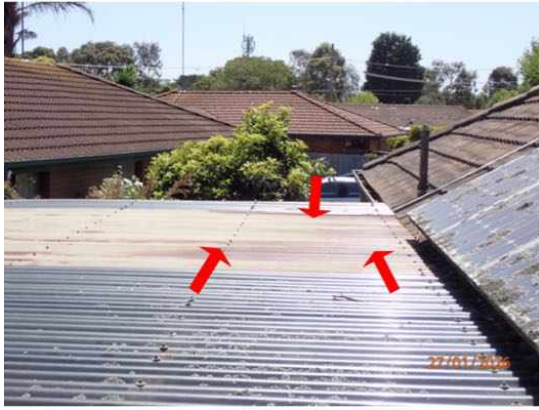
Finding 3.50

Building: Main Building
 Location: Roof Exterior
 Finding: Roof Plumbing - Rusted or Corroded
 Information: The roof plumbing has areas of rust and corrosion. It is suspected that this has been caused by blockages, resulting in pooling or standing water, that have prematurely rusted elements of the roof plumbing.

Rusted roof plumbing will generally develop holes and leaks that can affect other building elements with poor drainage of storm water. Poorly drained roof areas will also lead to damp conditions surrounding the base perimeter of the building which, if left unmanaged, can lead to a range of secondary building defects.

Repair and/or replacement of rusted roof plumbing is required in order to reinstate the roof drainage system to a fully operational level. To further maintain these areas, gutters should be cleaned frequently, allowing the avoidance of any partial blockages.

A licensed roof plumber or specialist roof restoration company should be appointed to undertake these works. It is advised that such works be completed as soon as possible to prevent any further damage and deterioration.

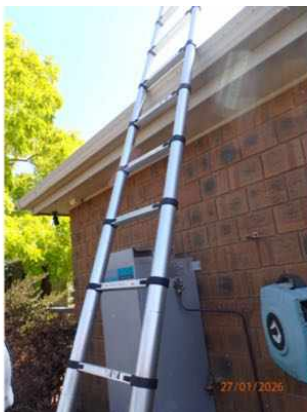
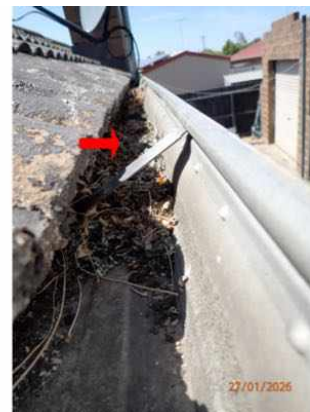
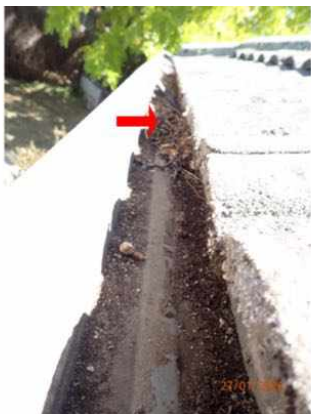
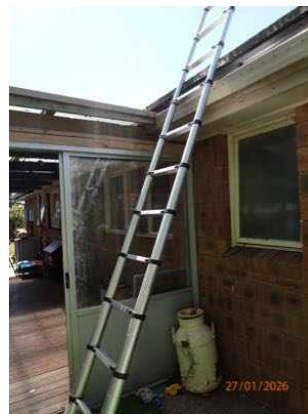
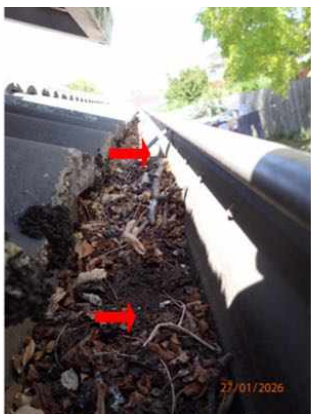
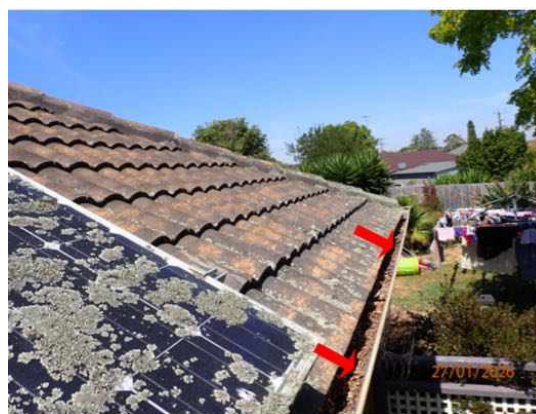
Finding 3.51

Blocked gutters are likely to lead to high levels of moisture in the affected areas. Such moisture will not only cause rust and decay of the associated building materials, but can also provide conditions that are conducive to termite and timber pest activity. Blockages in gutters should therefore be removed immediately to ensure dry conditions are maintained.

Consult a Licensed Plumber for further specific advice on remedial works that may be required. In the interim, it is highly advised that blocked gutters be removed by the homeowner or a general handyperson as a matter of urgency.

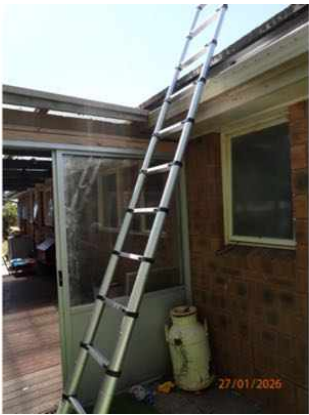
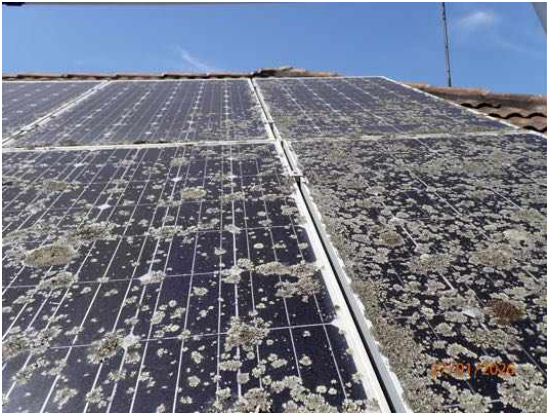
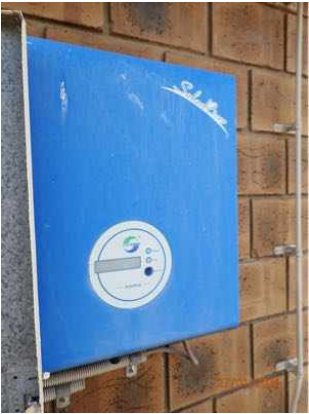
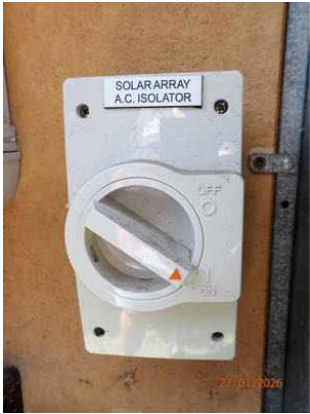
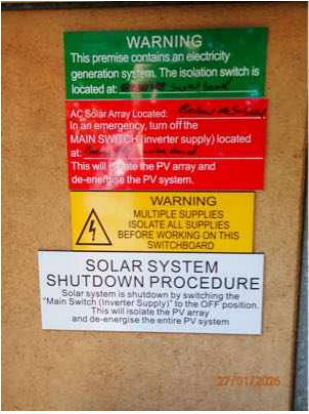
Finding 3.52

Information: Upon inspection of the exterior roofing, the majority of the solar panels were considered to be in a fair condition. While weathering and ageing of the solar panels maintenance works are required to review the condition of the panels and confirm they are actually functioning.

Where left unmanaged, deteriorating panels are likely to lead to a number of secondary defects, including the likelihood of decreasing the efficiency of the solar panels.

Consultation with a solar specialist is advised to review the panels and solar system and provide the costs to pressure clean the panels surfaces. This is to be carried out prior to the use of the panels.

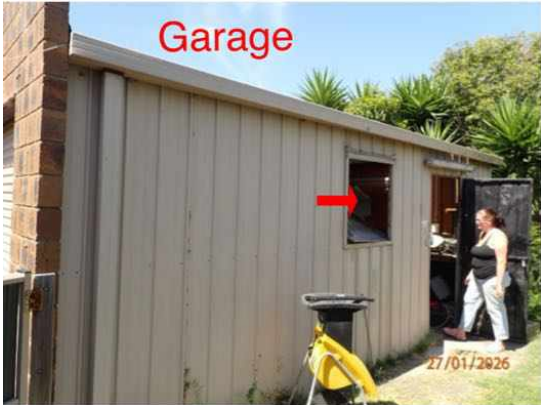
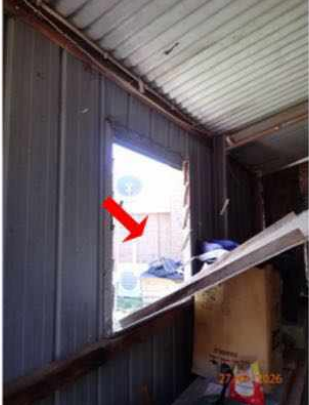
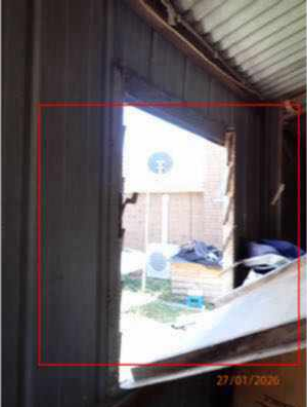
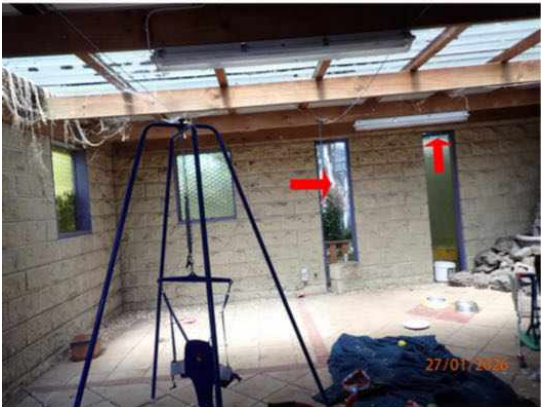
Finding 3.53

Building: Main Building
Location: Garage & External Storage Room
Finding: Window - Missing/Damaged
Information: Missing/damaged glass identified in the window in these areas. Missing window panes windows is generally the result of impact damage, and is likely to develop further when left unmanaged.

The likelihood of this windowpane further cracking and shattering is highly un;Kiel's given there is no glass left:). The cracked window also impairs the weather tightness of the building, creating potential for minor water leaks.

A qualified glazier is required to replace the window as soon as possible. Depending on the extent of the cracking, replacement of the window may be required. Please be advised that any persons coming into contact with the cracked window should do so with due caution to avoid any personal injury that may ensue.

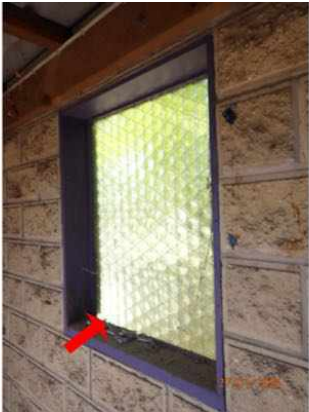
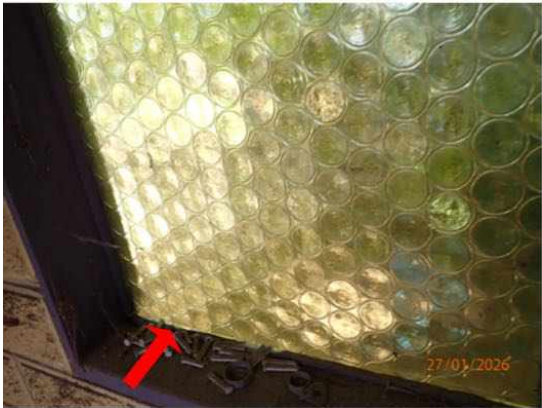
Finding 3.54

Building:	Main Building
Location:	Store Room
Finding:	Windows - Wood rot
Information:	Wood rot was found to be affecting external windows. Wood rot, also known as Fungal Decay, occurs when timbers and other cellulose building materials are exposed to damp conditions on an ongoing basis.

It is likely that this wood rot has developed as a result of frequent exposure to rain and other weather conditions. It is suspected that failure to maintain the window frames over a prolonged period has resulted in them deteriorating at an accelerated rate, increasing their susceptibility to the development of wood rot. Leaks in roof plumbing or associated pipework may have also contributed to the formation of the wood rot in this area.

Early intervention and regular maintenance will prolong the useful life of these building elements. Prior to any works being performed, any associated pipework or roof plumbing should be inspected by a licensed plumber for faults or leaks.

Repair and/or replacement of affected window frames may be a necessary step in protecting surrounding building elements from such deterioration. Remedial works should be performed by a qualified carpenter or registered builder as soon as possible to prevent any further damage.

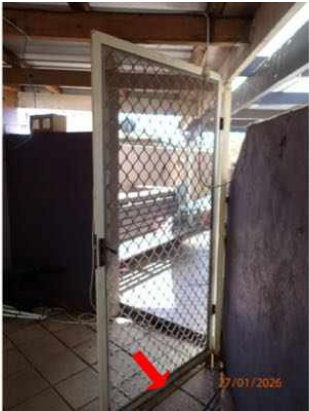
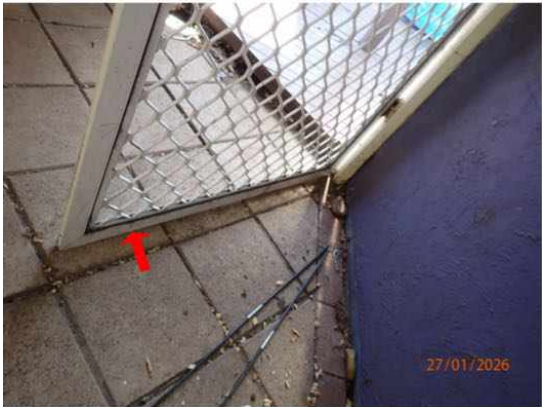
Finding 3.55

Building: Main Building
 Location: Store Room
 Finding: Door - Binding/Jamming
 Information: Binding and/or jamming of the door to to the storage room within the property was evident during standard operation. This defect inhibits the functionality of affected door as well as creating potential for secondary defects to associated building elements, such as damage to the floor covering, doors and door jams.

A door that binds to flooring or to the associated door frame may have several causes, ranging from minor defects, such as poor installation of the door or deteriorated hinges, through to major structural issues, such as damage to slab/base structures.

For minor causes, a qualified carpenter or general handyperson should be appointed to perform minor rectification works at client discretion.

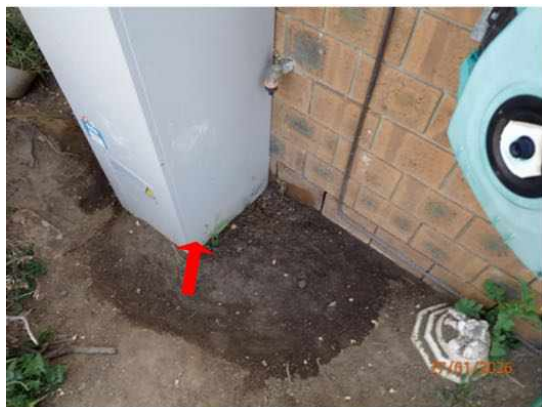
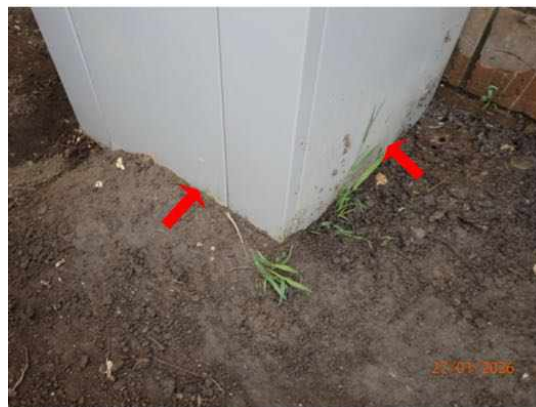
Finding 3.56

Building: Main Building
 Location: Yard - Back

Finding: Hot Water Unit Installation
 Information: It was noted at the time of inspection that the base of the hot water was sitting on the ground. Hot water units sitting on the ground could rust and erode causing a potential water leak as a secondary defect and can be conducive conditions timber and pest

It is advised to engage a qualified plumber to inspect repair, replace or adjust the unit as required prior to. Secondary defects occurring.

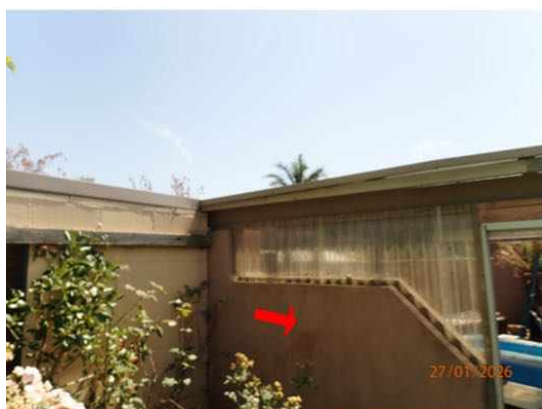
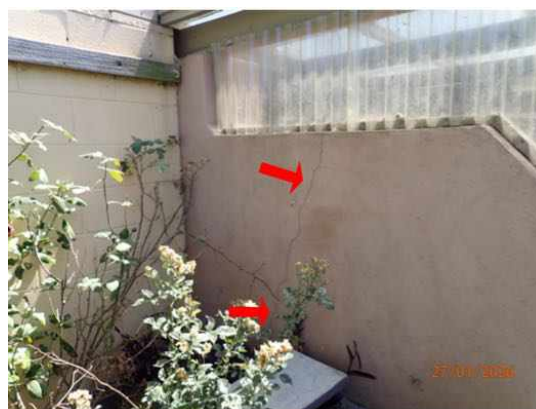
Finding 3.57

Building: Main Building
 Location: Alfresco >
 Finding: Cracks to Exterior Render - Category 1
 Information: It has been observed that cracking to external rendered surfaces has occurred. The degree of damage falls within Category 1, described as fine cracks that do not need repair and which are less than 1.0mm in width limit.

Damage of this category is not considered a defect for rectification. Always contact your building inspector should cracks widen, lengthen, or become more numerous.

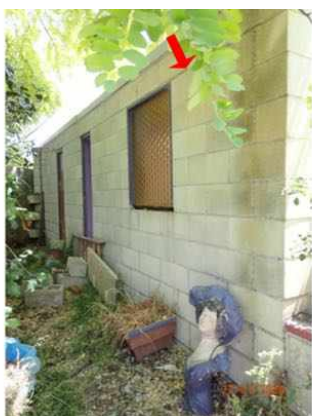
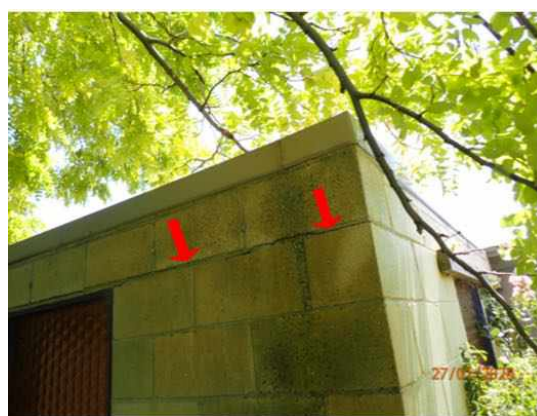
Finding 3.58

Building: Main Building

Location: Store Room
 Finding: Brickwork - Cracking noticeable
 Information: There were cracks evident to external blockwork.

Noticeable cracks are a common occurrence in external blockwork and could be as a result of age expected building movement, general expansion, and/or contraction of building materials in different weather conditions but more than likely as a result of the window lintel rusting and eroding causing the mortar to crack. Noticeable cracks in brickwork may develop if left unattended, with potential for necessitating major remedial works or replacement of the brickwork and lintels.

It is highly advised that a qualified bricklayer be appointed to provide necessary works to cracked brickwork to prevent any further damage. Such works should be conducted as soon as possible to be reviewed and replace any rusted or eroded steel lintels.

Always monitor these cracks and contact a building inspector should cracks widen, lengthen, or become more numerous.

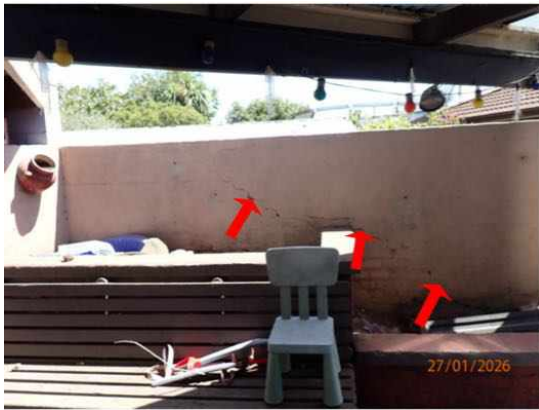
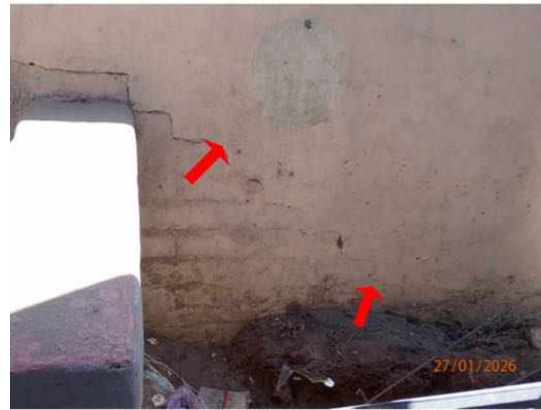
Finding 3.59

Building: Main Building
 Location: Store Room
 Finding: Brickwork - Step cracking
 Information: Step cracking was identified to the brickwork in this area at the time of inspection. Step cracking, which is similar to other forms of cracking, has a variety of possible causes. However, the most common is the subsidence of adjacent footings.

Step cracking is a relatively common defect, and is most likely to occur adjacent to windows, doors and other openings. Mortar failure in the gaps between affected bricks indicates the stresses and tensions affecting the wall.

Where step cracking is extensive or severe, the client is advised to consult a structural engineer. Minor step cracking can be used as a warning sign to address factors causing stress to the wall, which can include the effect of surrounding trees, water

leaks, soil erosion, or even the presence of reactive soils in the surrounding area.

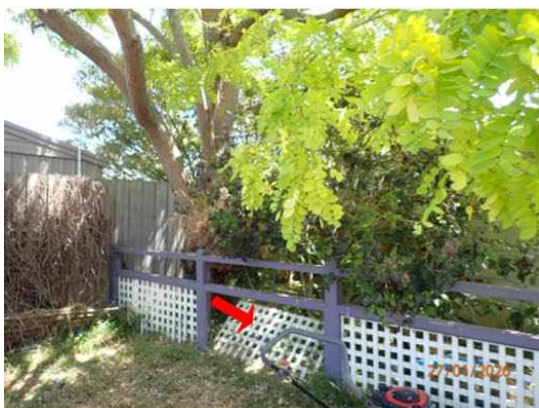
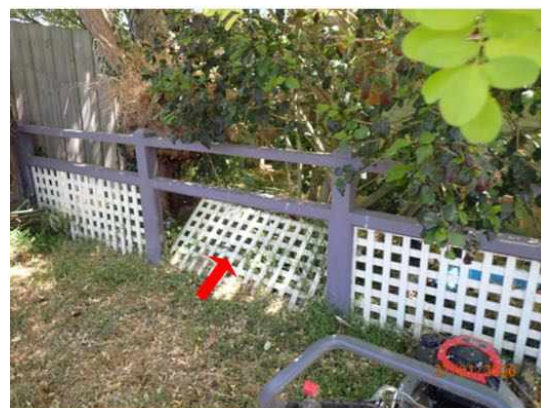
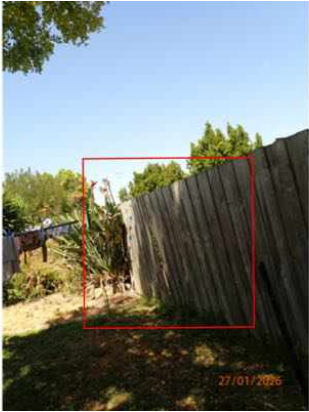
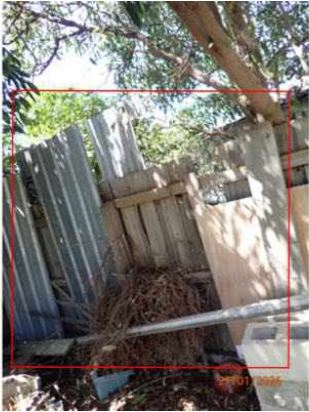
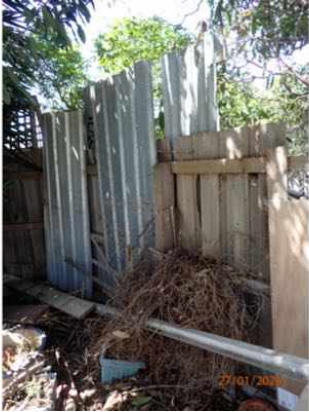
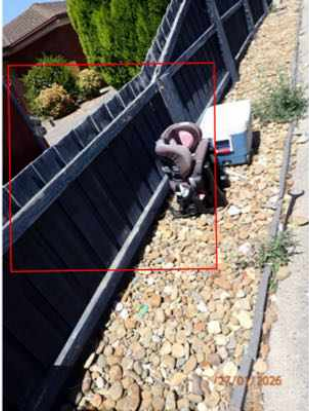
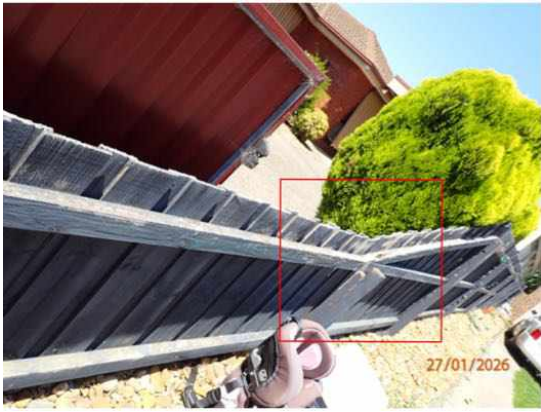
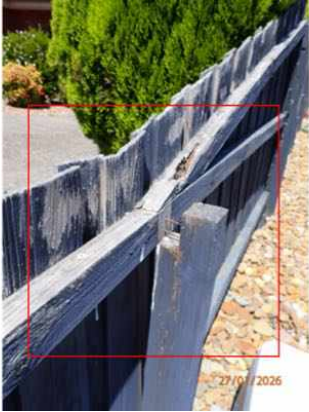
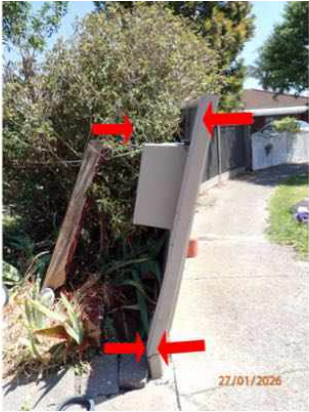
Finding 3.60

Finding: Fencing - Deteriorated

Information: It was noted at the time of inspection that sections of the fencing throughout the property have deteriorated. Typically fencing deteriorates due to age and or wear, rot and or rust which is generally expected for a structure of this age, due to prolonged exposure to weather conditions. Sometimes inadequate installation or maintenance can be to blame.

If left unattended, it is likely that further damage will occur. It is suspected that repair of several elements of the fencing may be required however replacement may be a consideration of the client also.

A licensed fencing contractor should be appointed to provide further advice and perform rectification works as necessary.

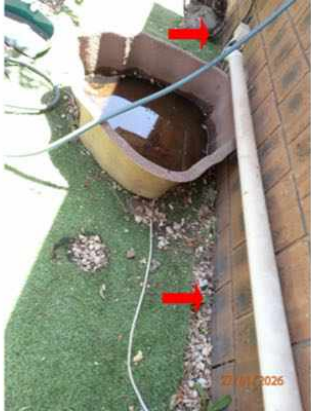
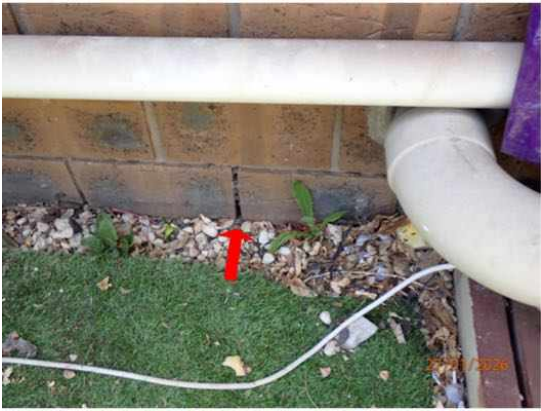
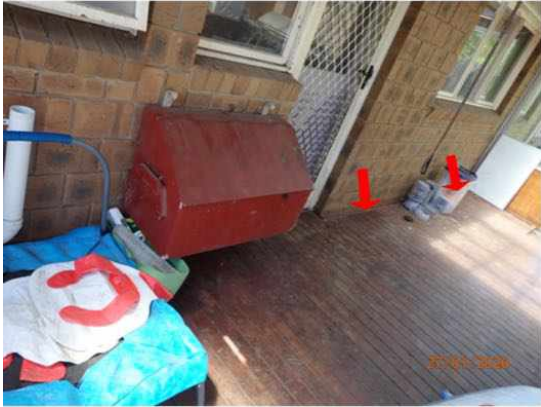
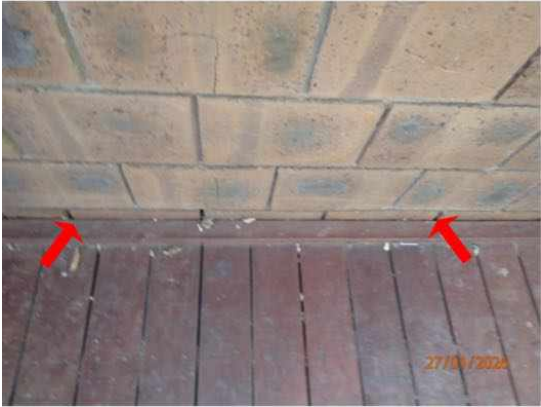
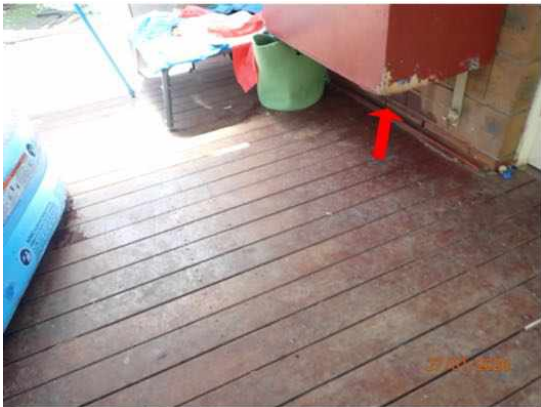
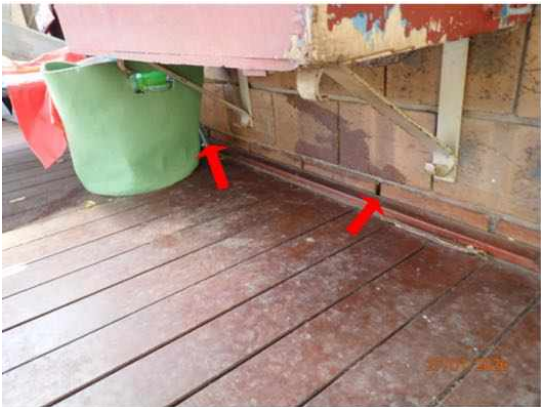
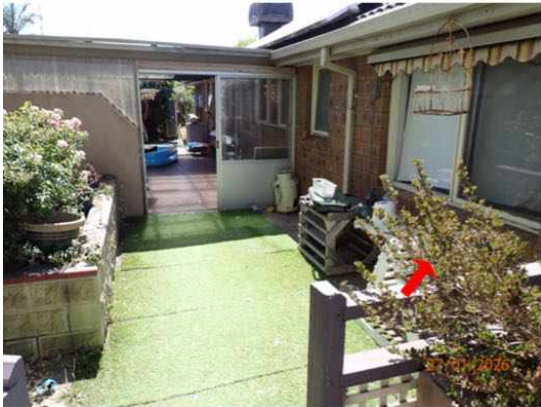
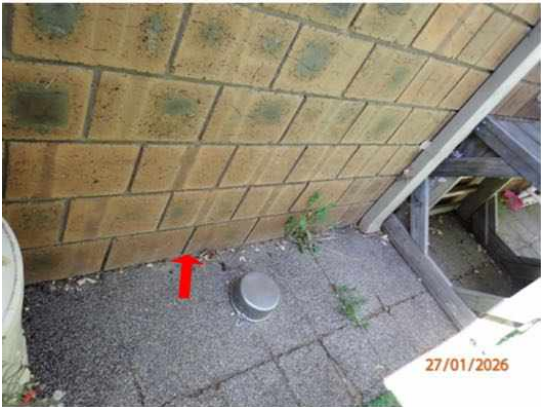
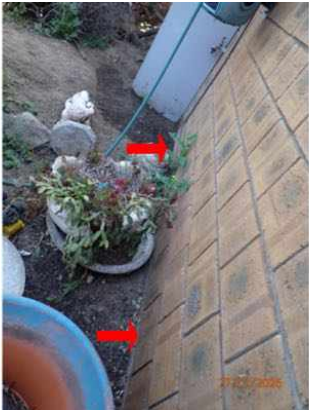
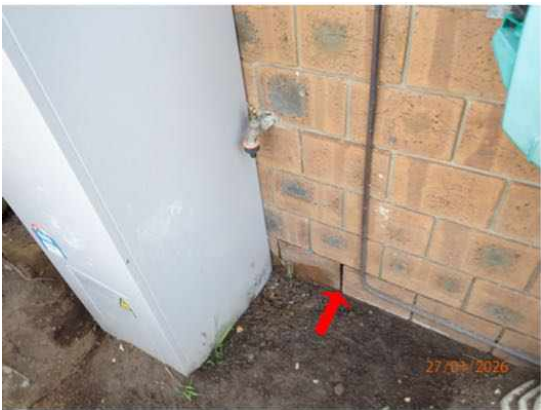
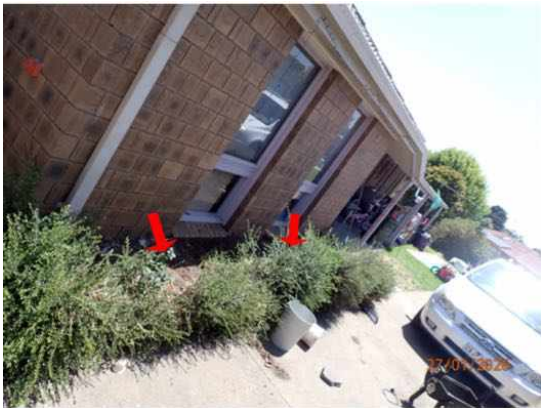
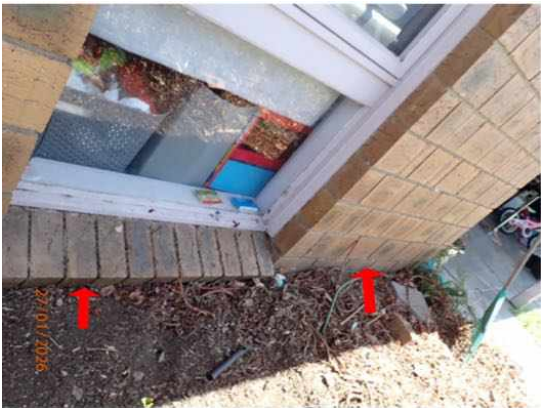
Finding 3.61

Building: Main Building
Location: All External Areas
Finding: Weep holes - Blocked
Information:

It was noted during the time of inspection that some of the weep holes to the brickwork were blocked. Weep holes are designed to allow water from leaks or seepages in brickwork to be directed to the external environment, prior to entering the wall cavity or associated building materials. Weep holes should therefore be kept clean and free of debris or blockages.

Blocked weep holes are likely to result in the presence of excessive moisture within the brickwork and associated structures, creating potential for water damage and moisture problems.

Depending on the nature of the blockage, the homeowner may be able to undertake remedial works to remove blockages. Alternatively, appointment of a registered builder may be required to remove blockages. Preventative works are necessary in ensuring the structural integrity of the affected brickwork and should be performed as soon as possible.
