Building and Timber Pest Inspection Report

Inspection Date: Tue, 27 Jan 2026

Property Address: 12 Bean Ct, Whittington VIC 3219,
Australia

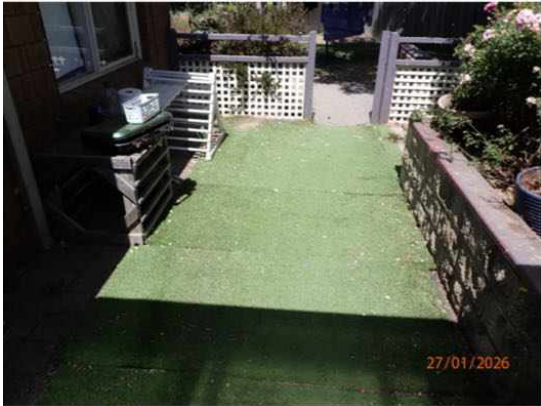
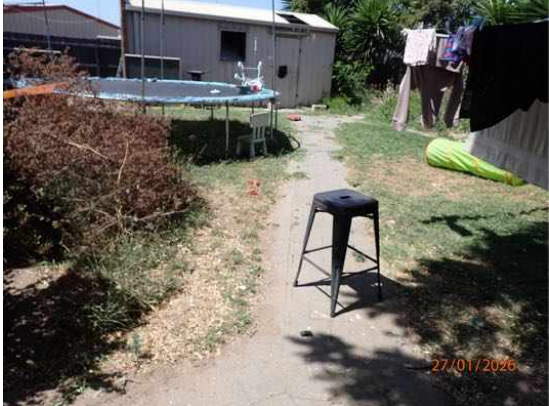
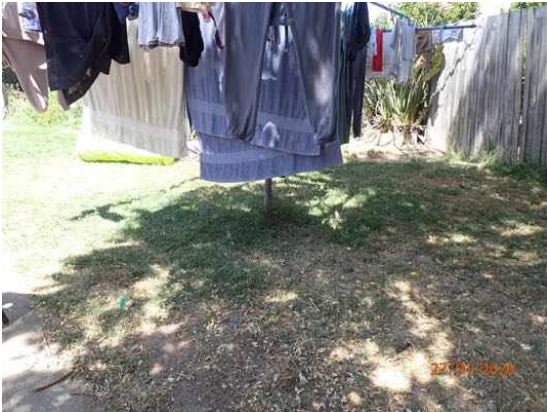
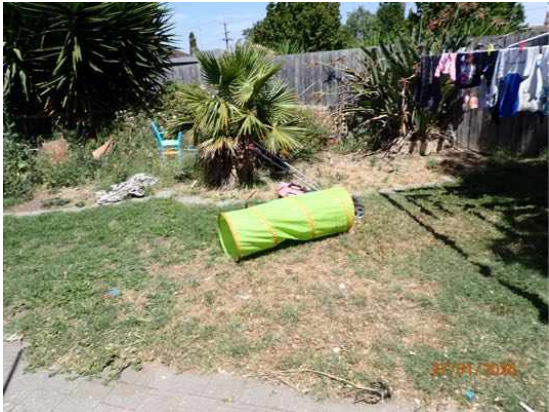
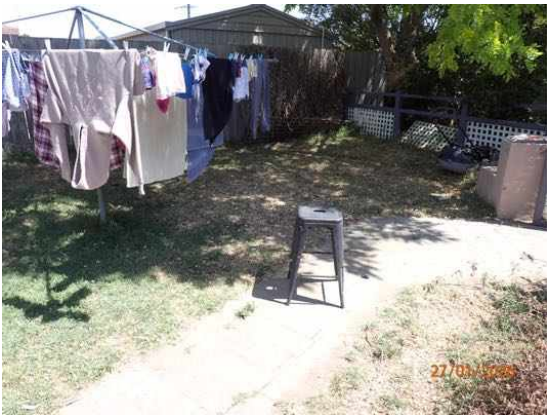
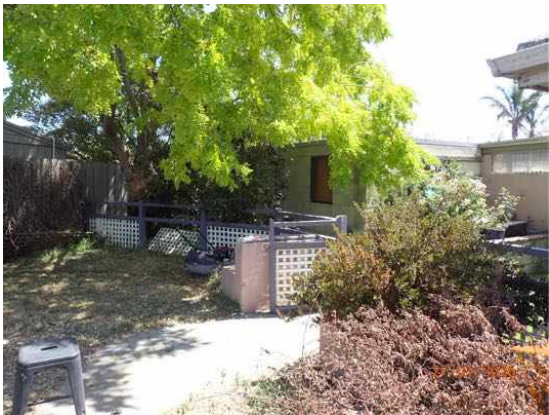
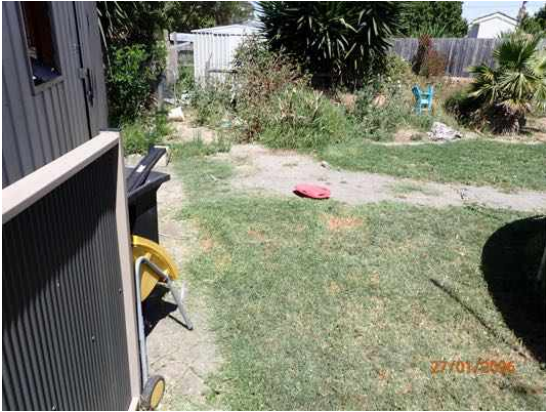
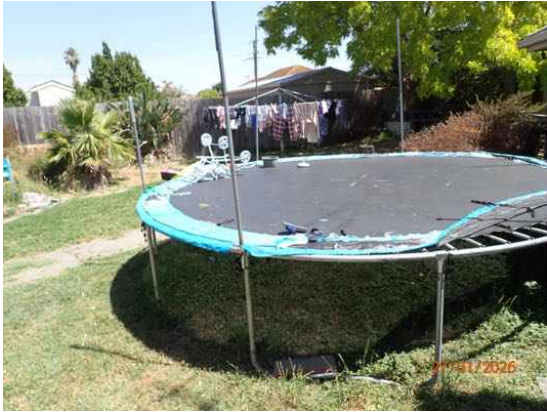
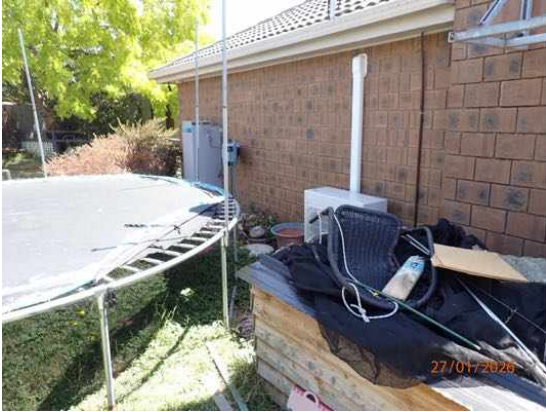
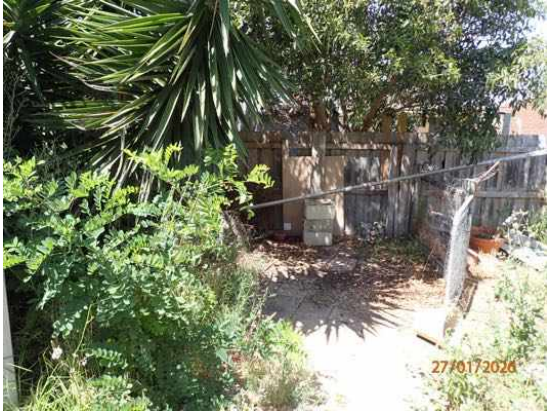
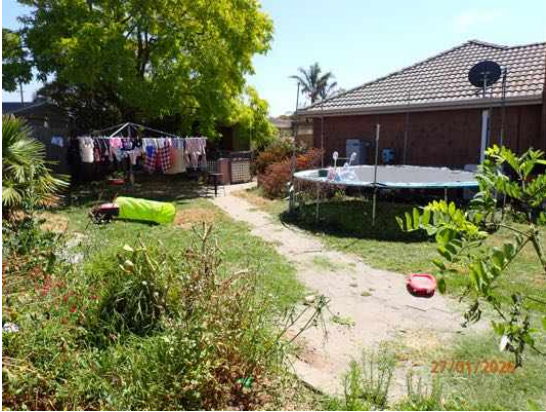
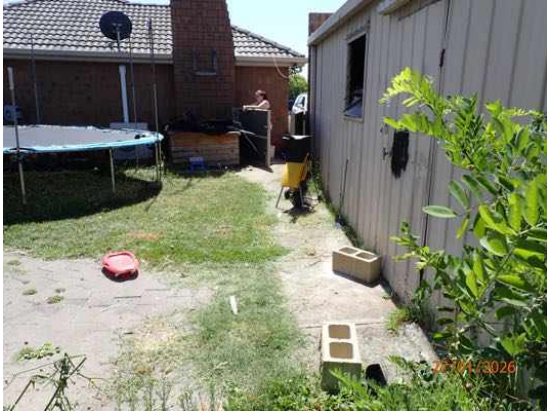
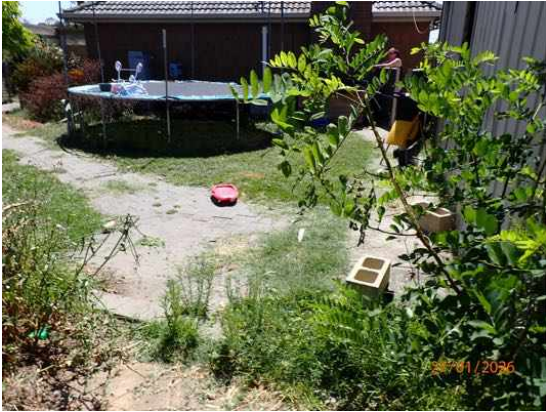
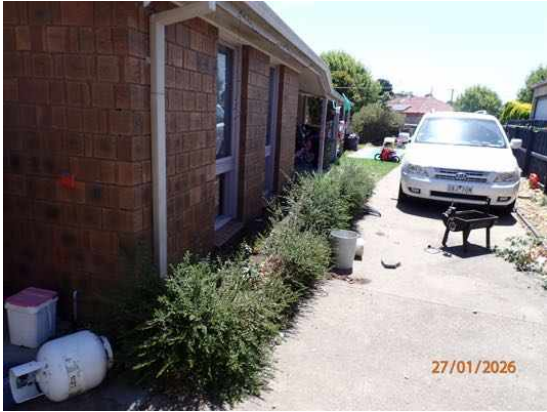
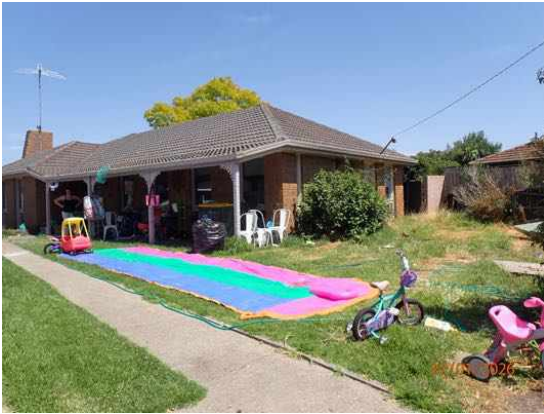
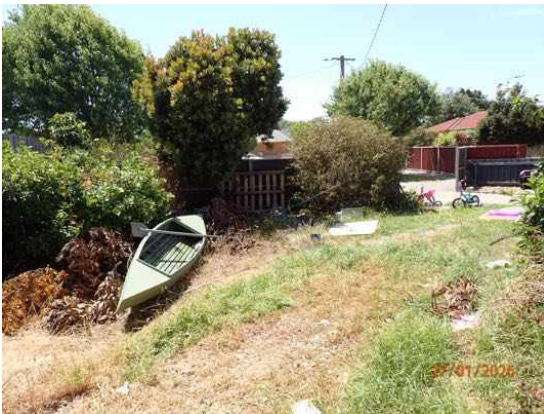
Building: Main Building
Location: All External Areas
Finding: Site Drainage - Building Inadequate
Information: The site drainage in this area was found to be inadequate at the time of inspection.

If left unattended excessive moisture and water can pool/pond and lie against building structures and possibly cause secondary defects.

It is strongly advised to engage a licensed builder/plumber to review and advise asap.

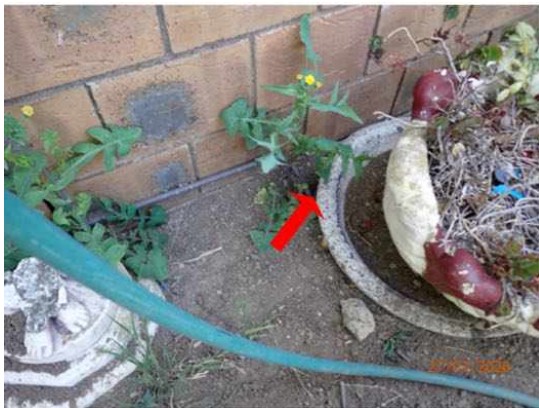
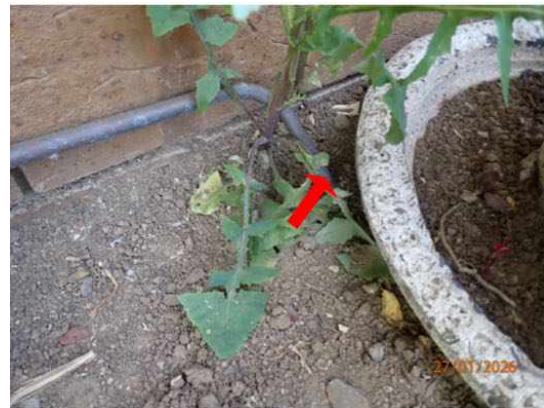
Finding 3.63

Building:	Main Building
Location:	Exterior walls - rear
Finding:	Overflow - Not Plumbed for Drainage
Information:	The overflow is not plumbed or connected to suitable drainage, which has resulted in the surrounding area becoming excessively damp. These damp conditions can lead to secondary defects such as rot, rust or corrosion of associated building elements, the formation of fungal decay, or even the creation of potential slip hazards.

When coupled with poor site drainage, pooling of water may also attract termite activity to this area. It is highly recommended that a qualified plumber be appointed to install adequate drainage to the overflow.

These works will ensure that the area remains dry and free of any secondary defects.

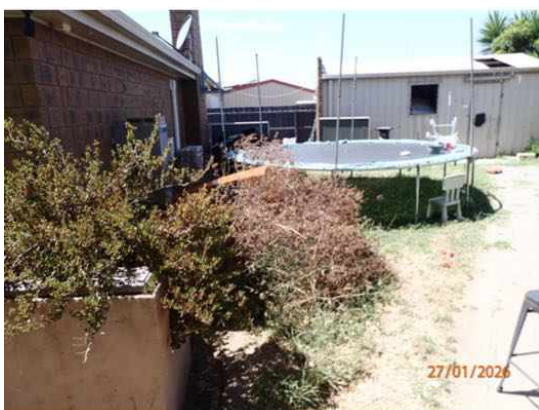
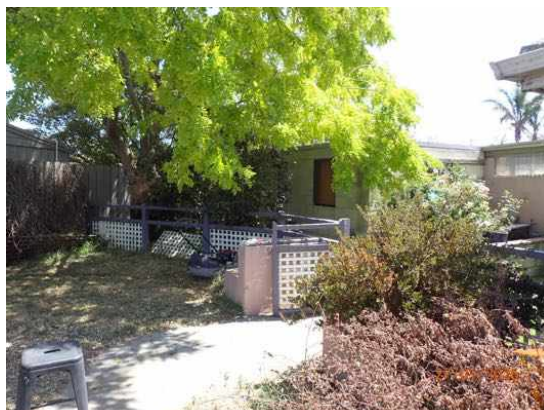
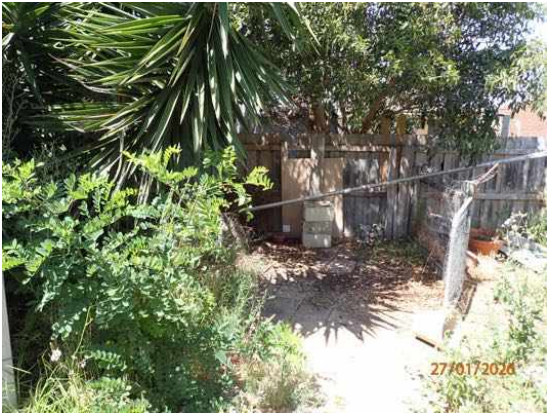
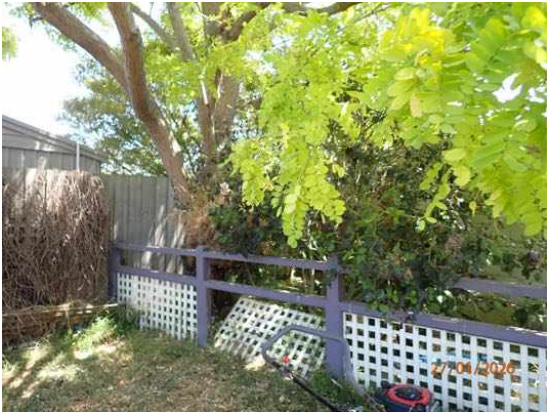
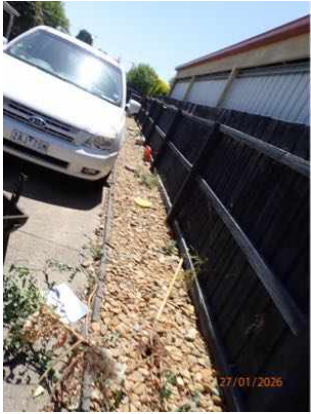
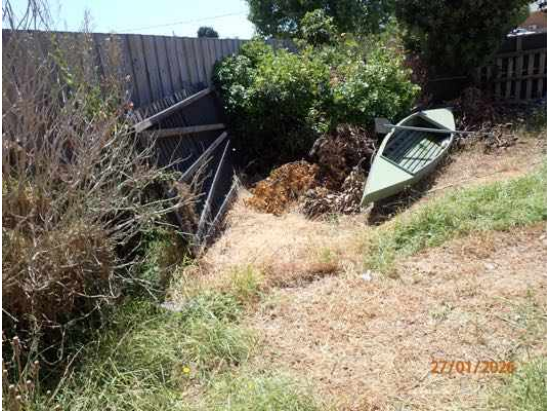
Finding 6.01

Building: Main Building
Location: All External Areas
Finding: Garden Beds - Conditions Conducive to Termites
Information: Garden beds were found to be evident in the garden area. These garden beds can include untreated timber, and with a combination of moisture from watering hosing can make conditions conducive to termite activity and termite ingress.

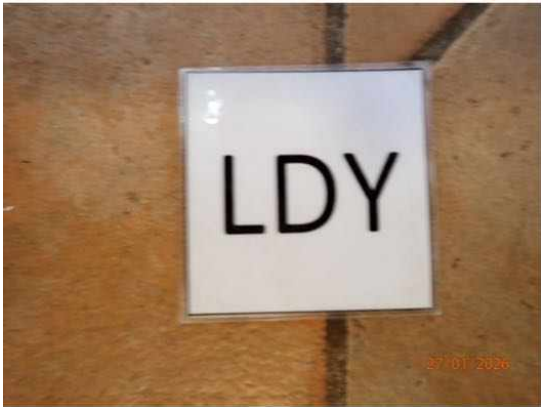
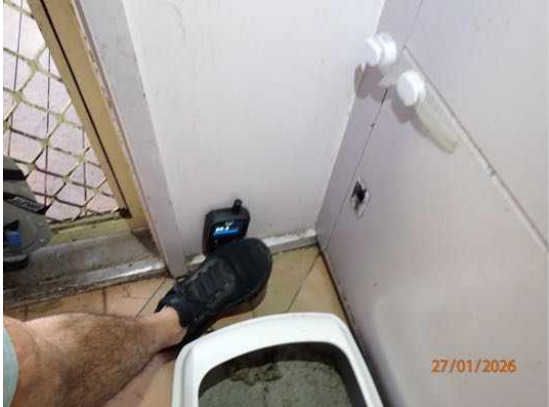
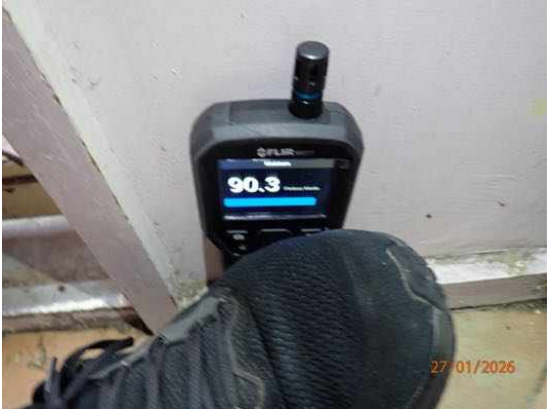
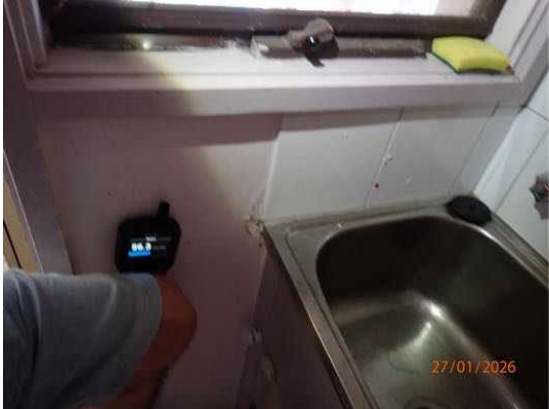
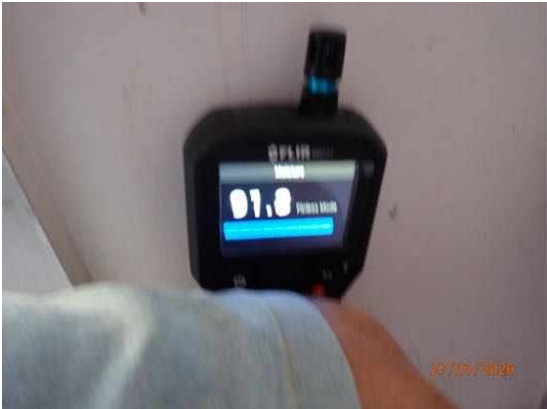
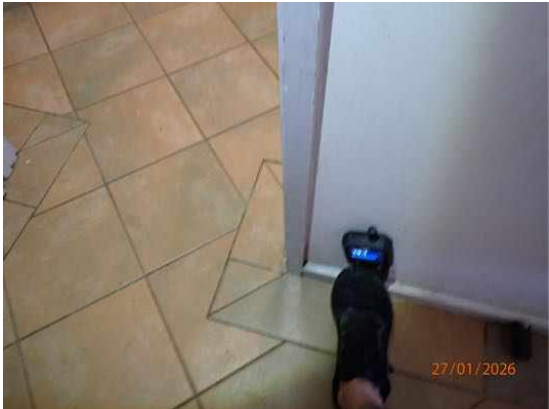
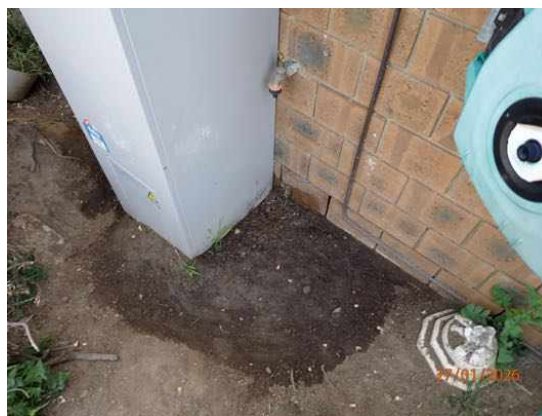
Finding 6.02

Building: Main Building
Location: All External Areas
Finding: Excessive Moisture - Identified
Information: Excessive moisture can attract termites and produce conditions that promote fungal growth and wood decay.

Excessive moisture is generally caused by deteriorated or leaking plumbing pipes or excessive subfloor moisture to the subfloor where a qualified plumber or a mechanical ventilation specialist should be engaged to further inspect the property to identify the cause of the excessive moisture and carry out any necessary repairs.

This is advised to be carried out as soon as possible.

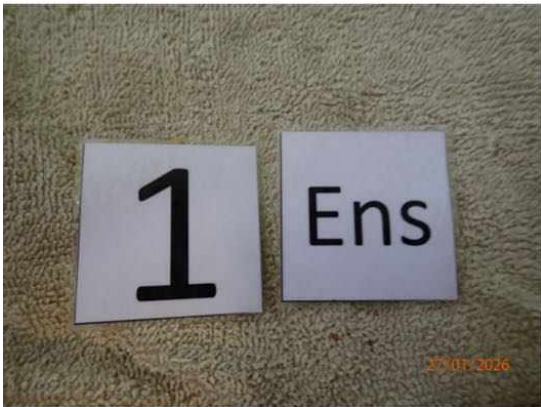
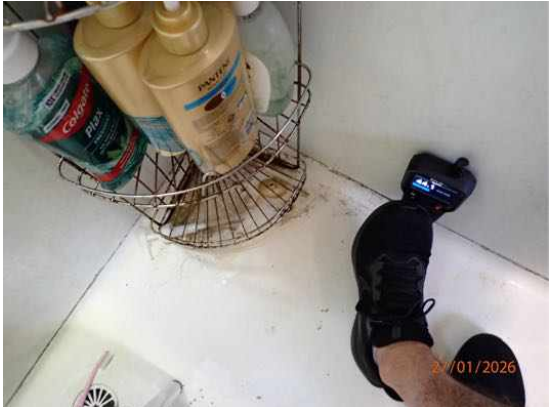
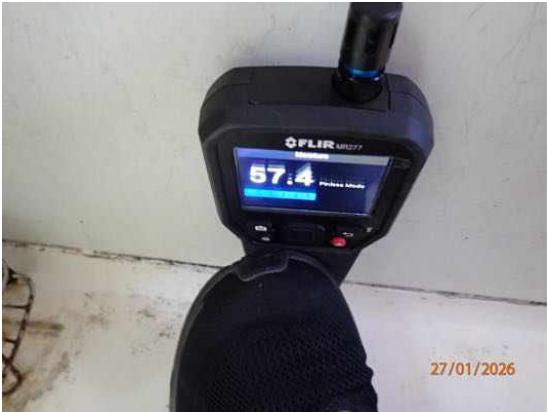
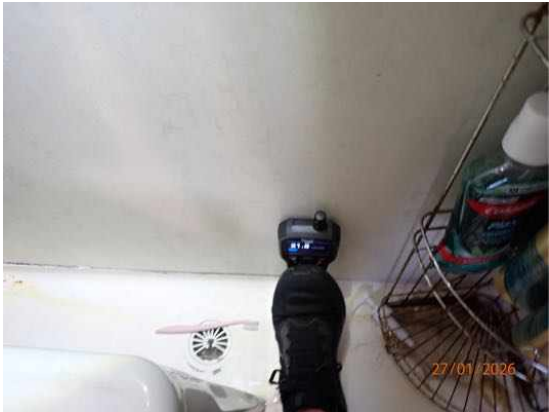
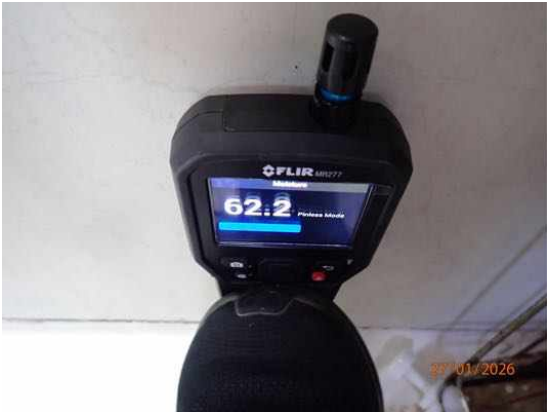
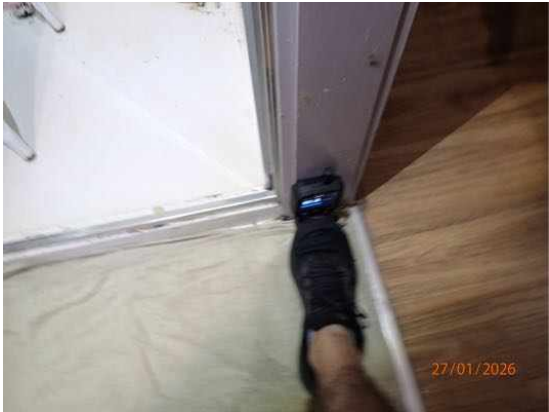
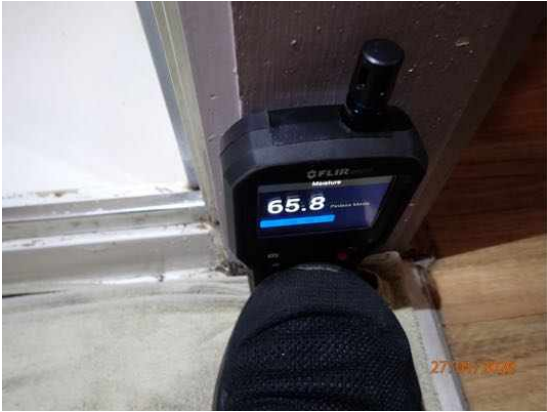
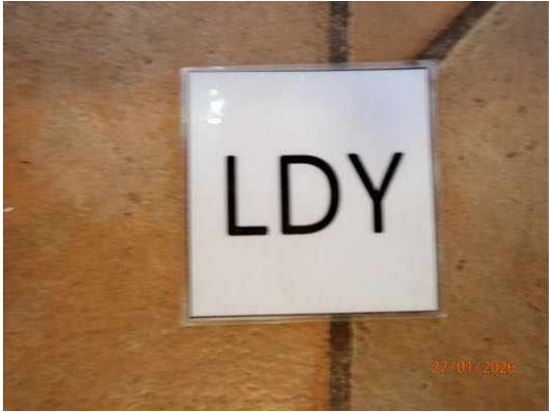
Finding 6.03

Building:	Main Building
Location:	All Internal Areas
Finding:	Wet Areas - Termite Techniques - Moisture Detected
Information:	Moisture readings was found in the walls of the wet areas which warrants further invasive investigation.

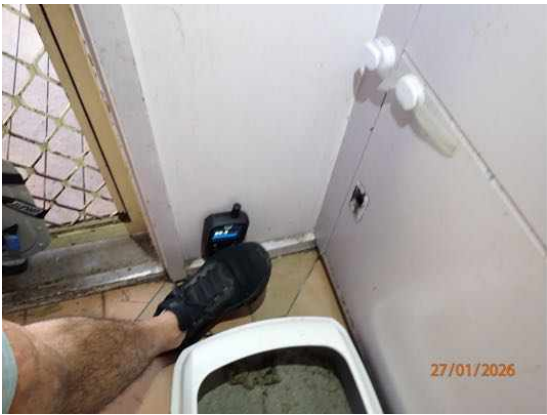
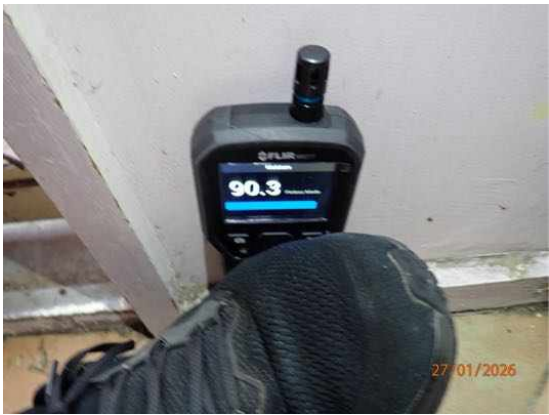
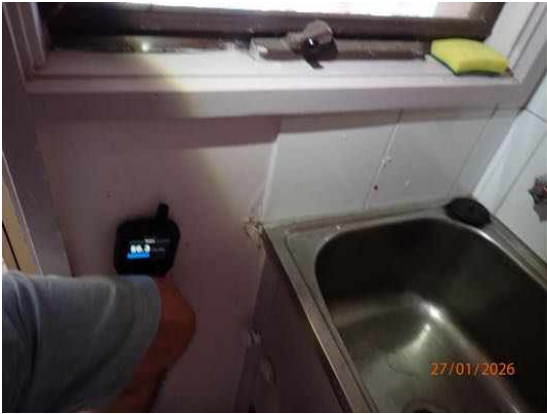
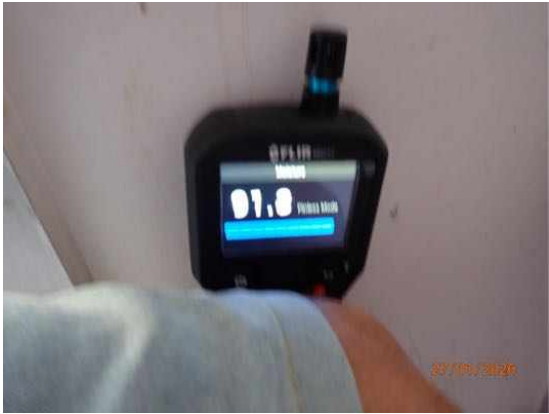
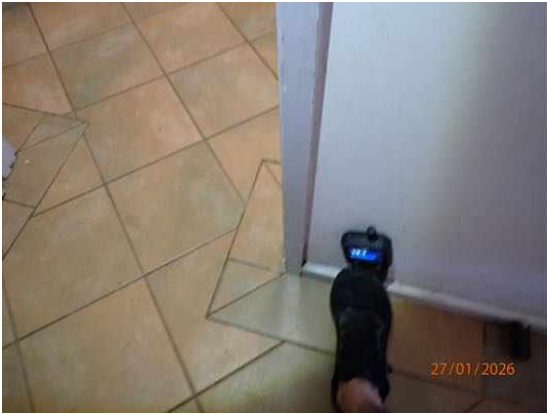
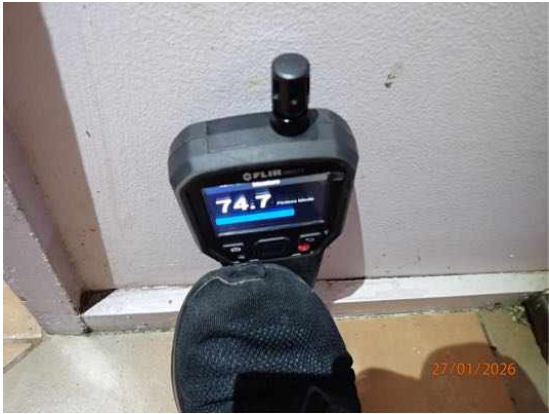
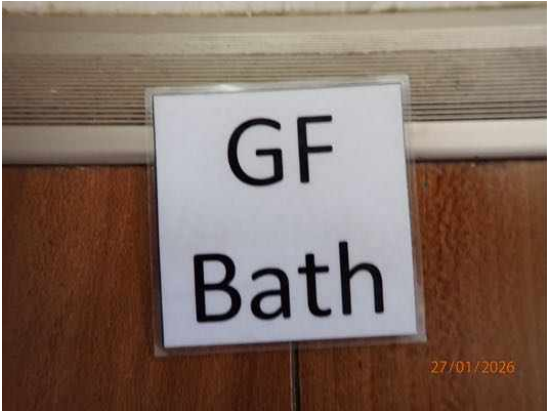
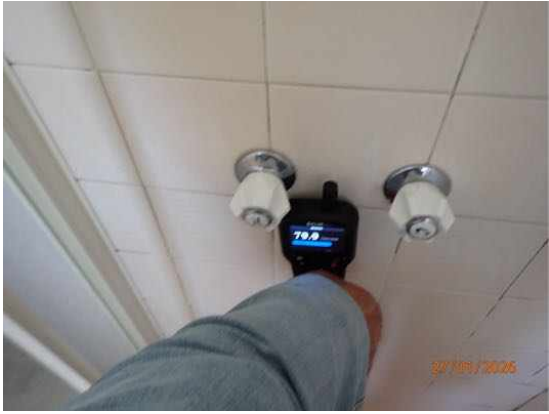
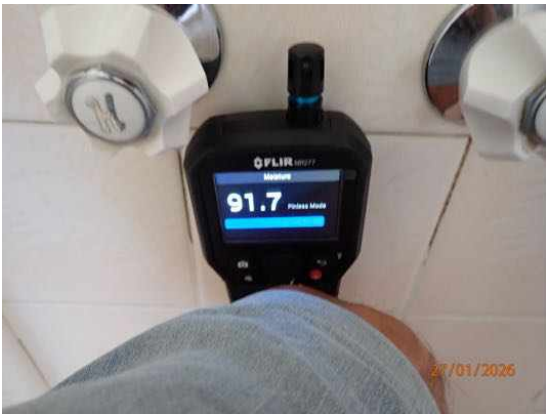
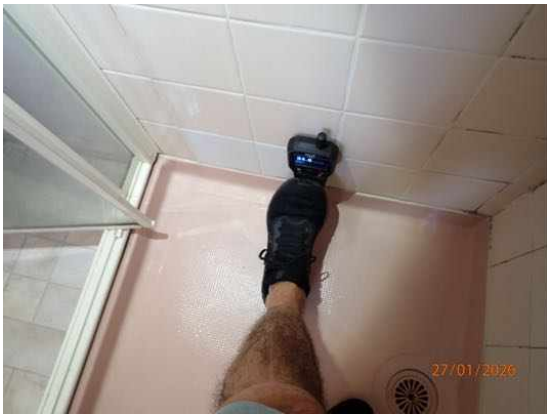
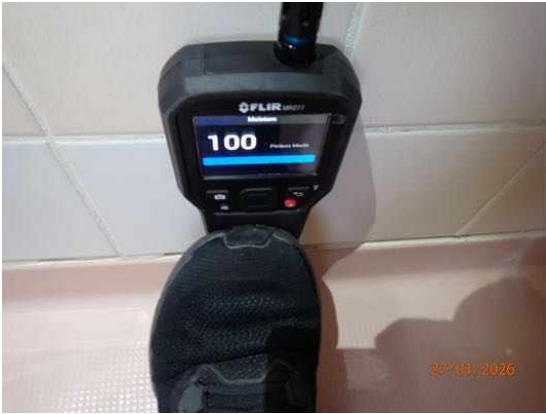
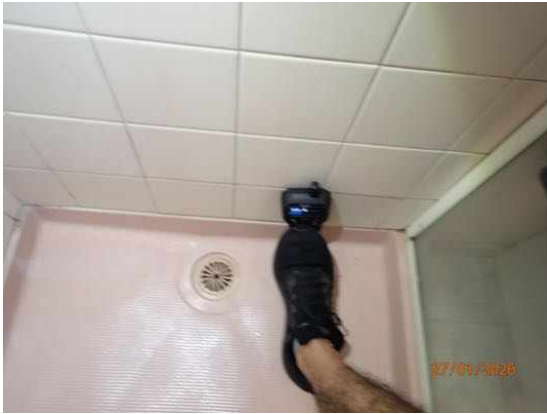
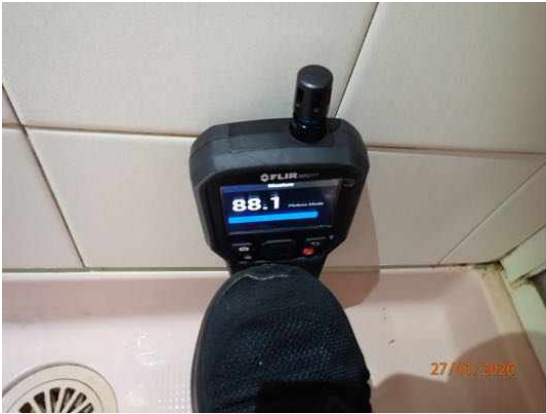
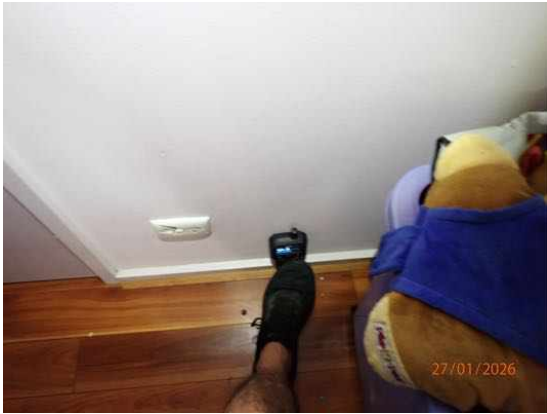
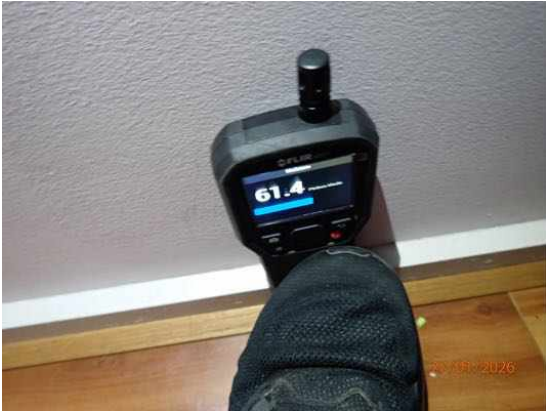
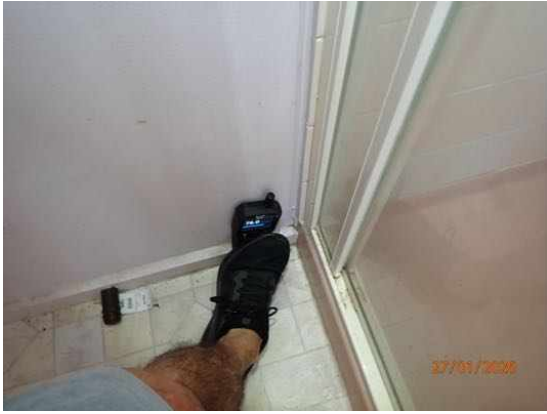
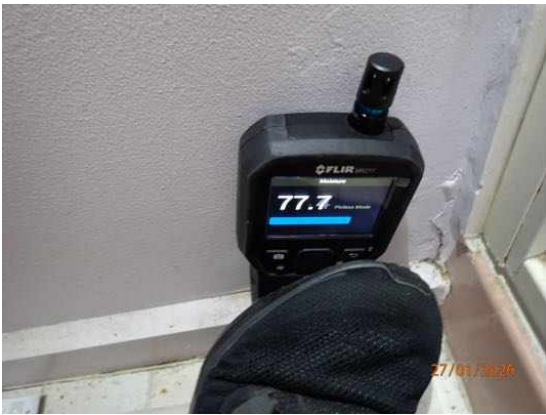
All areas of the dwelling are checked with particular attention paid to wet areas which were closely assessed to check for excessive levels of moisture.

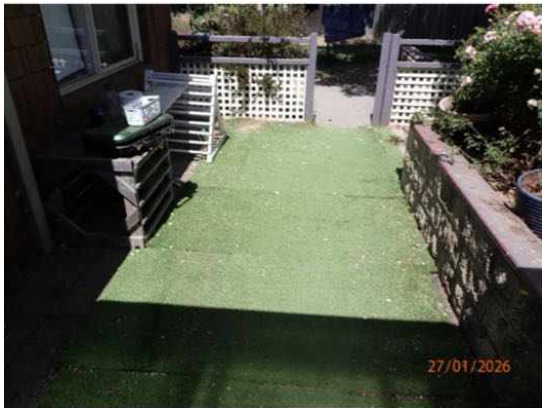
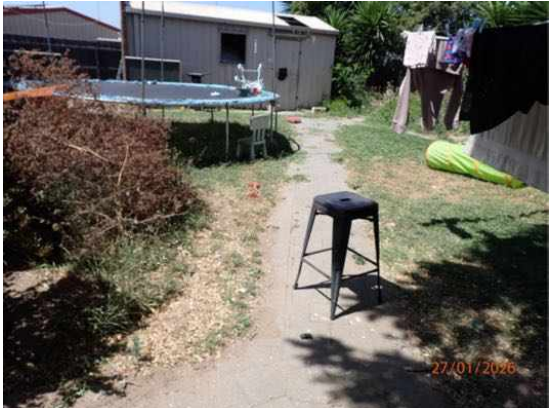
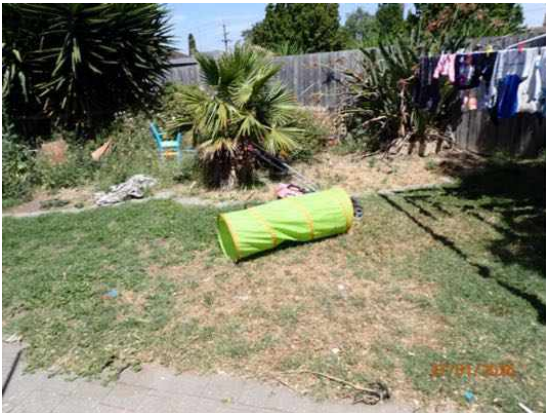
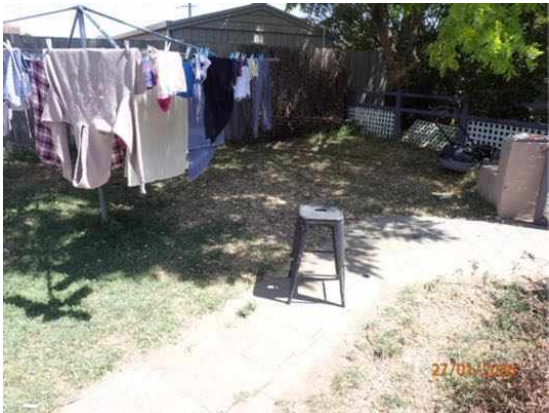
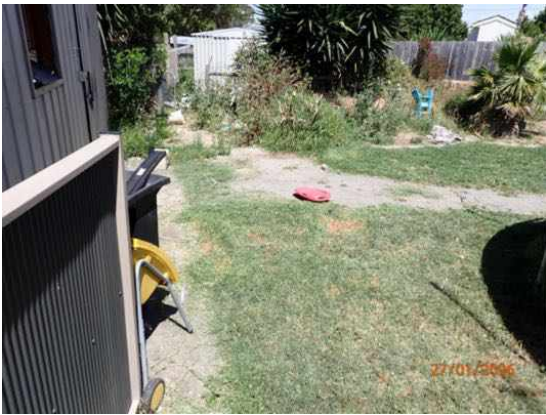
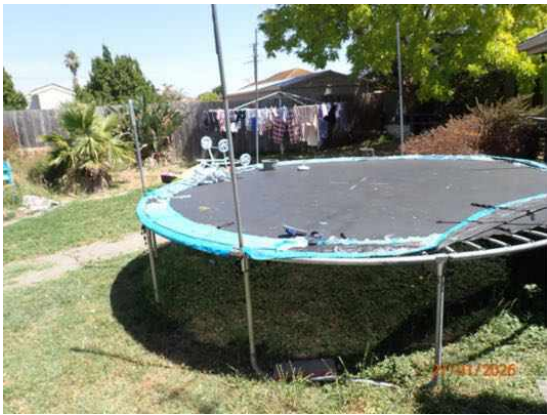
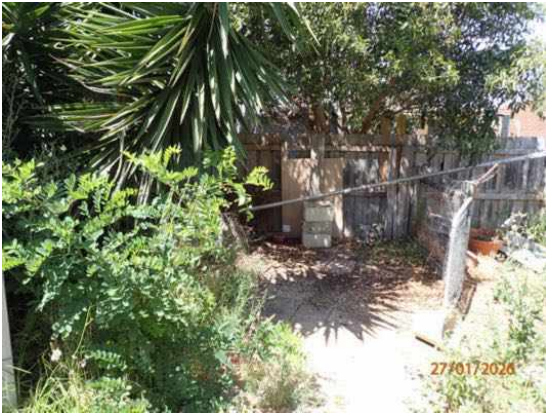
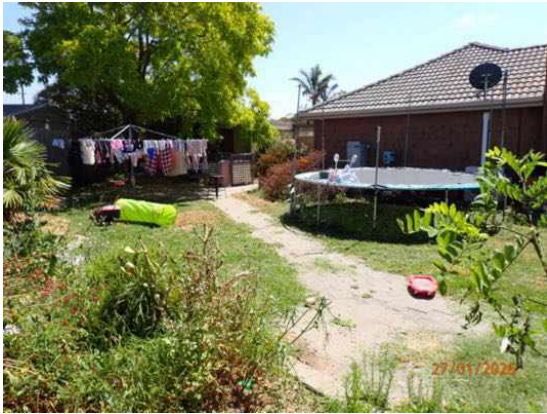
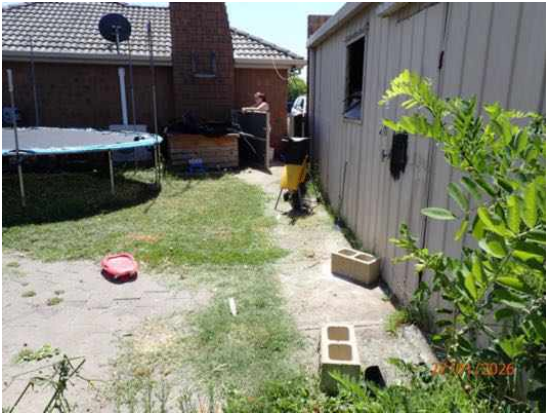
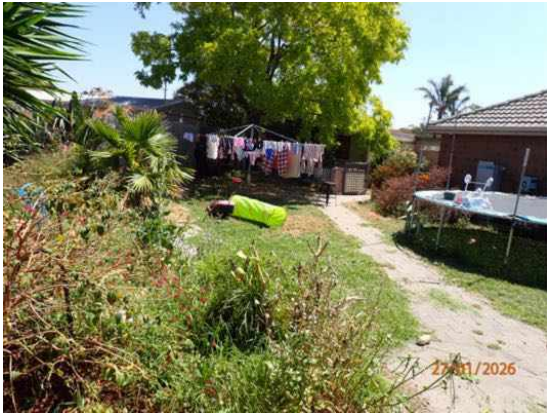
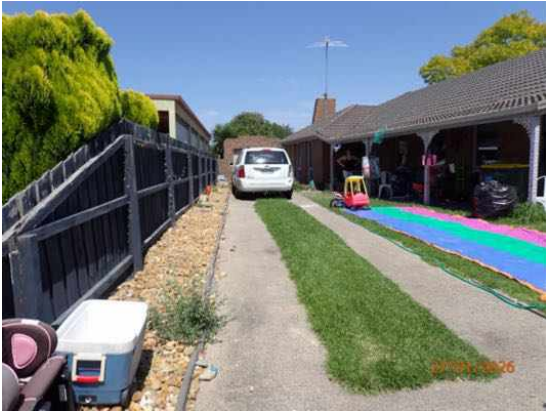
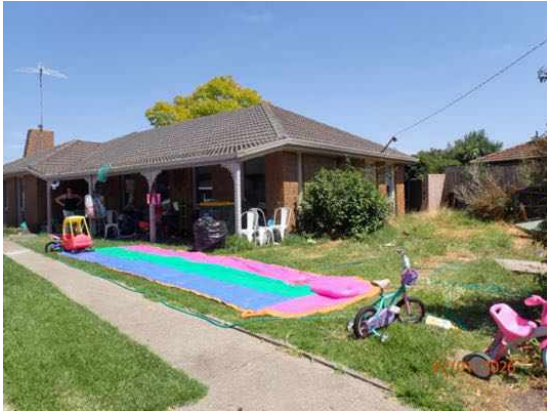
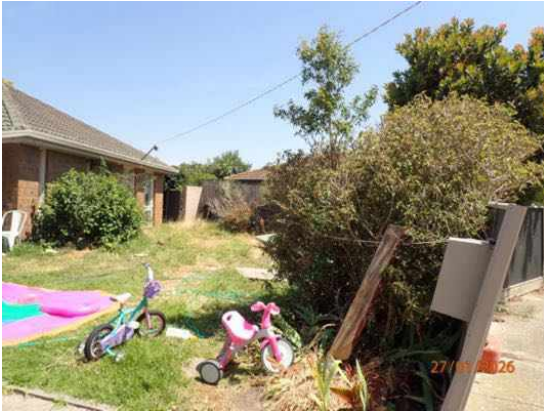
Finding 6.04

Building: Main Building
 Location: All External Areas
 Finding: Site Drainage - Inadequate Providing Conducive Condition
 Information: The site drainage in this area was found to be inadequate at the time of inspection.

If left unattended excessive moisture can attract termites and produce conditions that promote termite attack fungal growth, wood decay.

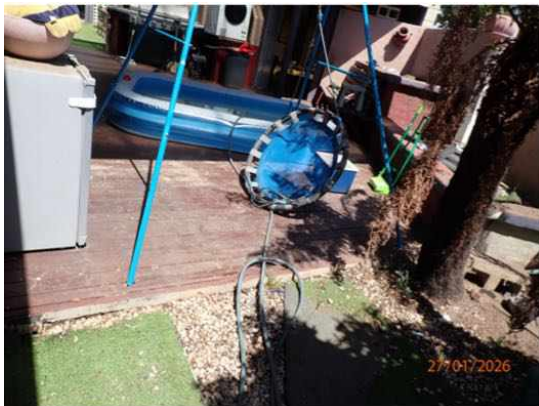
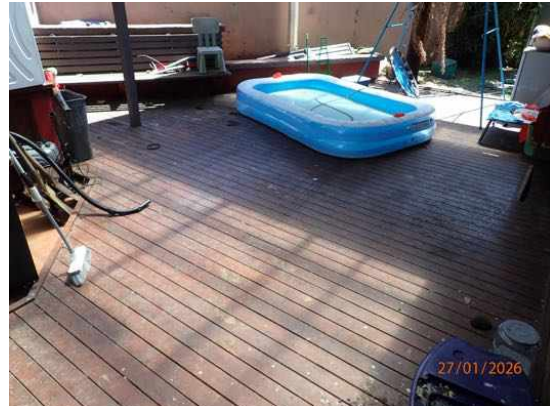
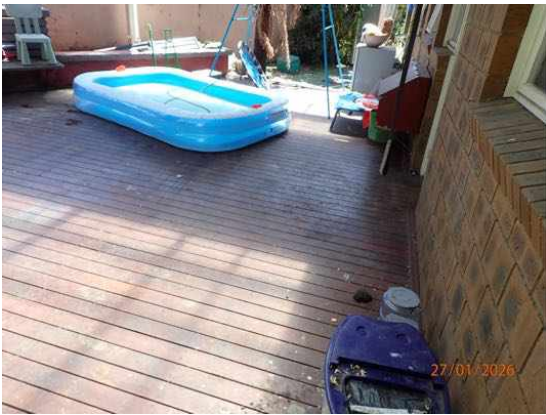
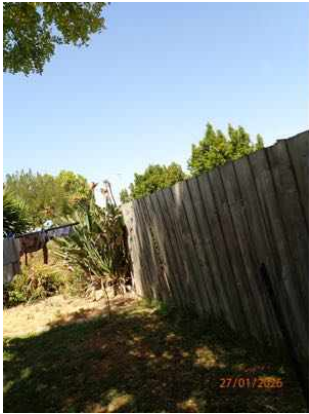
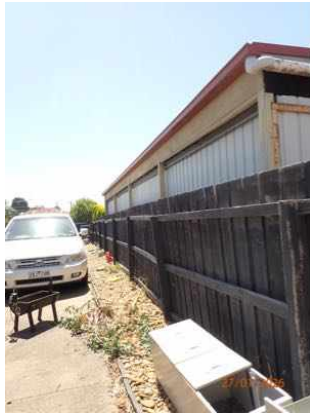
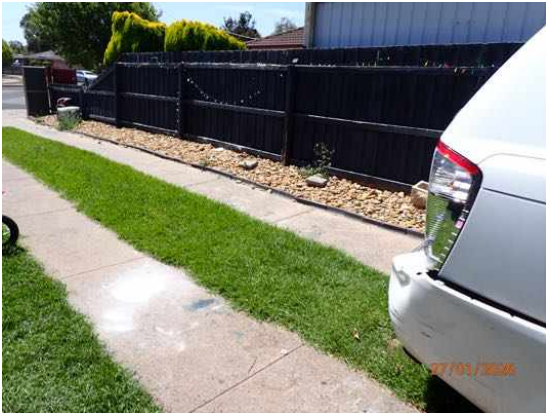
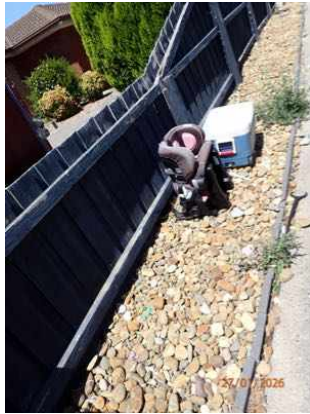
Finding 6.05

Building:	Main Building
Location:	All External Areas
Finding:	Building Materials in Direct Ground Contact - Conducive to Termites
Information:	Where timber elements are in direct contact with the ground and consequently moisture or dampness they become conducive to termite activity. Whether timber is used as a building element part of a fencing structure or stored as an unused item they can provide an environment that is attractive to termite infestation.

When met with excessive moisture timber begins to decay and develop wood rot. Any timbers that are in direct contact with external grounds especially if left untreated or non-durable also provide ingress for subterranean termites into that particular element.

The removal of any such materials that may be conducive to termite activity should be removed as soon as possible to minimise the risk of termite attack. All susceptible timbers should be removed and replaced with non susceptible timber.

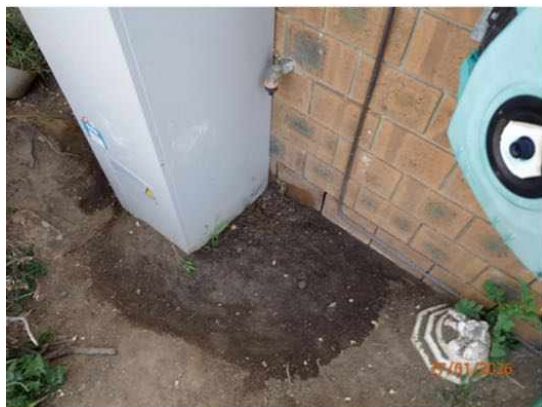
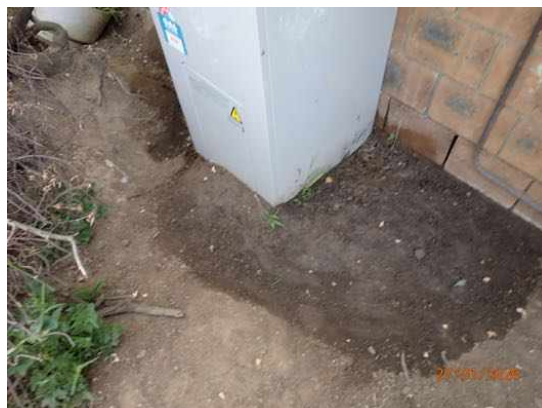
Finding 6.06

Building: Main Building
 Location: All External Areas
 Finding: Water Leak - External
 Information: Water leaks were found to be present to exterior plumbing work. Leaks are generally caused by deterioration of the plumbing elements over time, due to exposure to weather conditions, but may have also been caused by minor impact damage.

Such leaking creates damp conditions in the affected area, causing potential for water pooling and subsequent water damage if left unattended. These conditions may also attract termite attack, particularly if the area is subject to minimal levels of sun throughout daylight hours.

It is highly advised that a licensed plumber be appointed to rectify any water leaks that may be present.

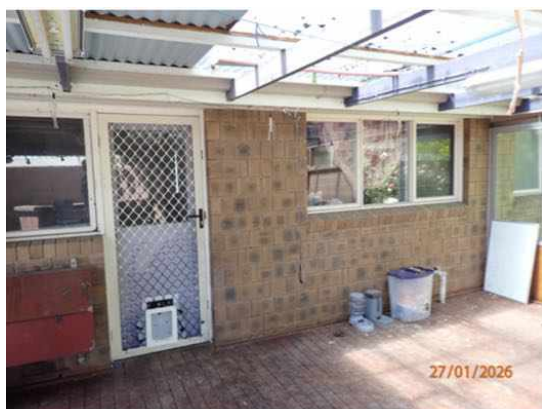
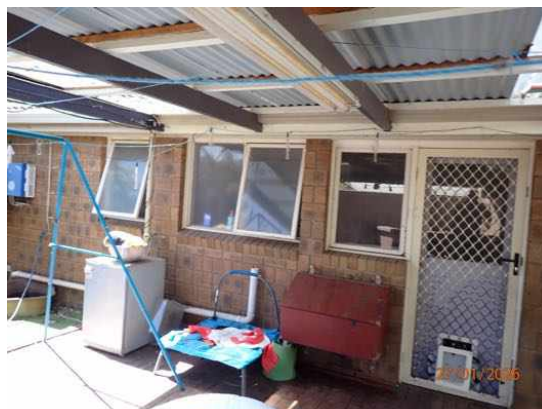
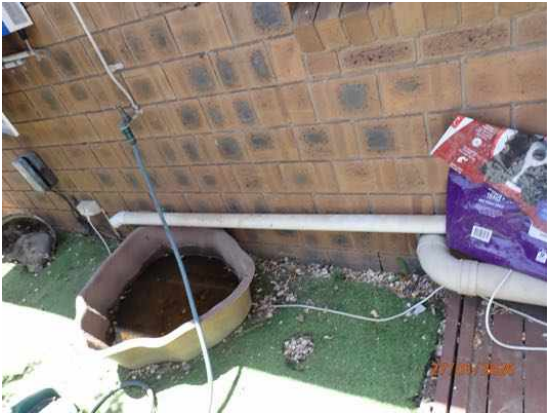
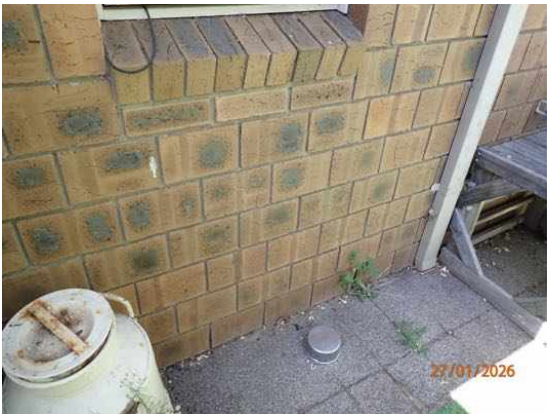
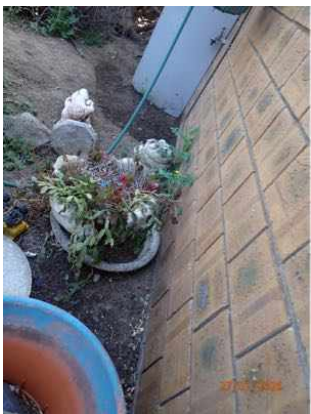
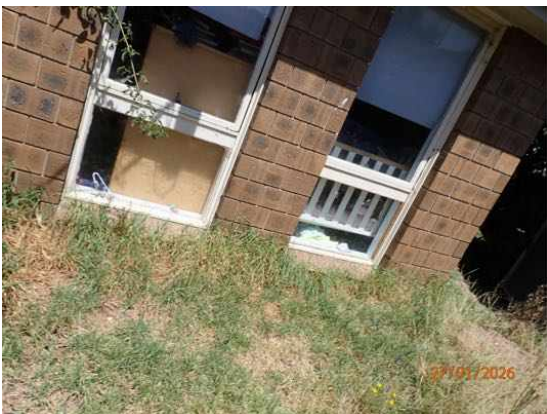
If the slab edge is not properly exposed there is a high risk of termite attack. Sometimes, in order to determine the type of slab, a suitably qualified person such as an architect or builder may be required to consult the construction plans.

Where the slab edge cannot be properly inspected, it is highly recommended that termite or timber pest inspections be carried out every 6-12 months to aid protection of the property against infestation.

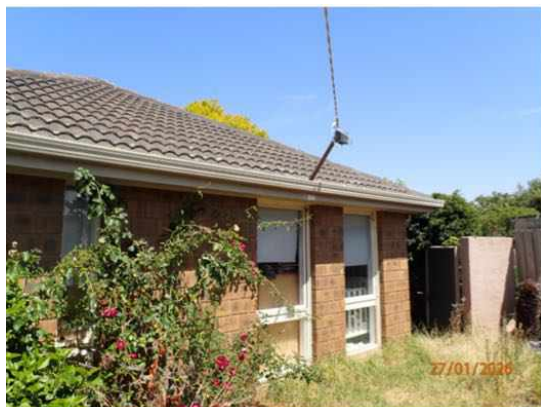
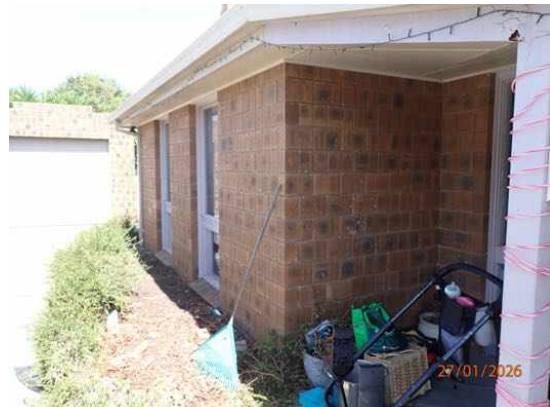
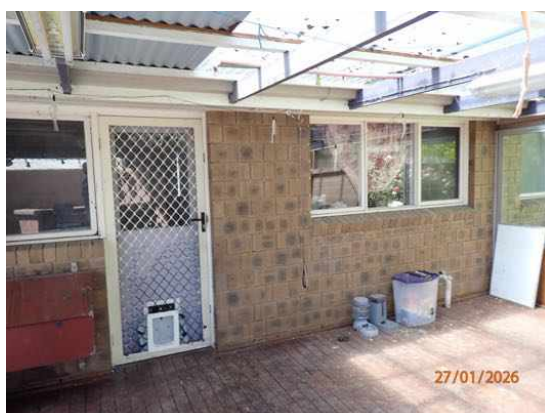
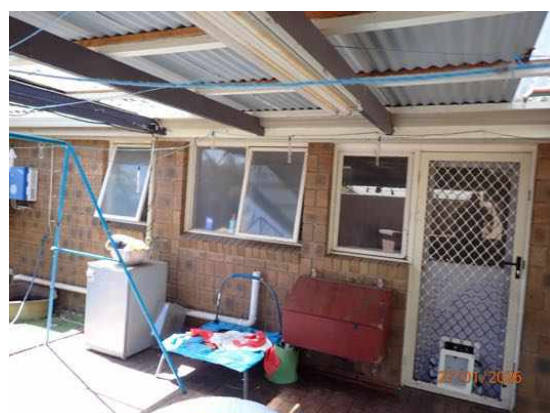
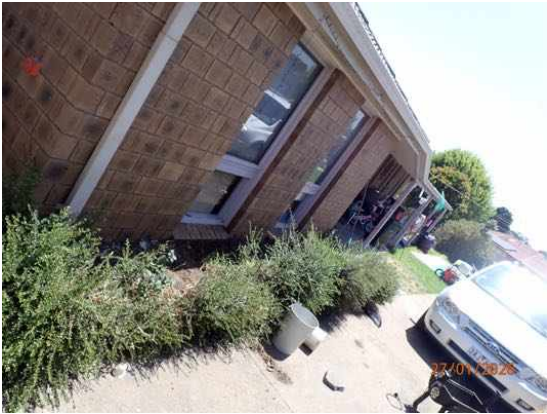
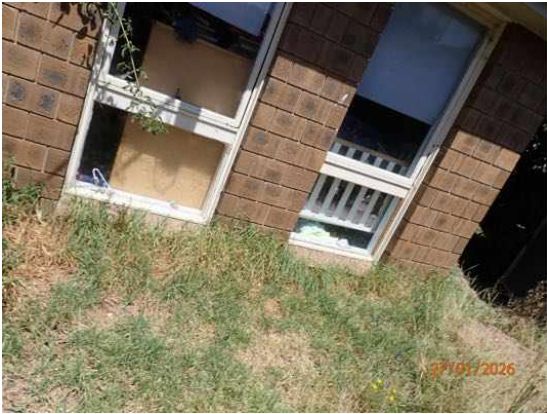
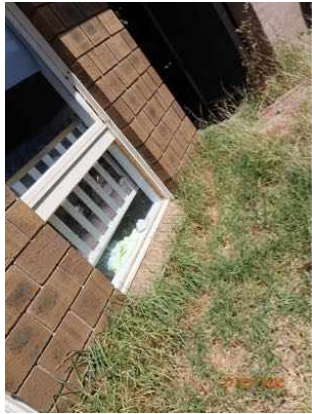
Finding 6.08

Building:	Main Building
Location:	All External Areas
Finding:	Bridging of Termite Barriers - Weep Holes
Information:	Bridging is the spanning of a termite barrier or inspection zone so that subterranean termites are provided with undetected passage over or around that barrier.

Weep holes in the exterior brickwork of the property are designed to allow condensation that may build up between the brickwork and subsequent timber framework to drain from within the wall hence preventing any deterioration of the timber building elements.

Additionally build-up of moisture is likely to occur if weep holes are covered further attracting termite activity to these areas.

It is highly recommended that weep holes are left exposed in all areas throughout the external property. Therefore if any termite activity leading into weep holes becomes easily detectable during frequent pest inspections.
