Building and Timber Pest Inspection Report

Inspection Date: Tue, 27 Jan 2026

Property Address: 12 Bean Ct, Whittington VIC 3219,
Australia

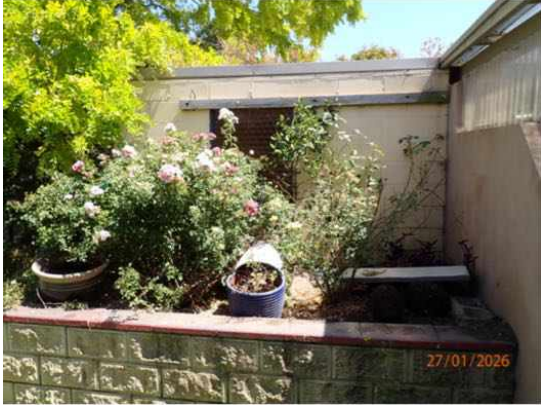
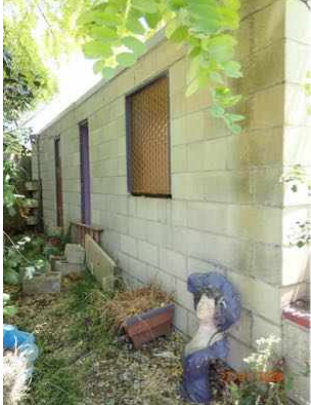
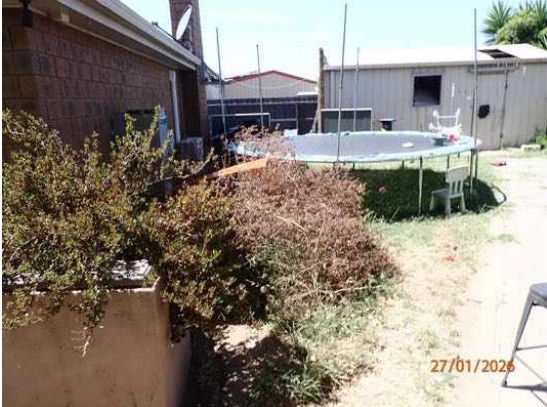
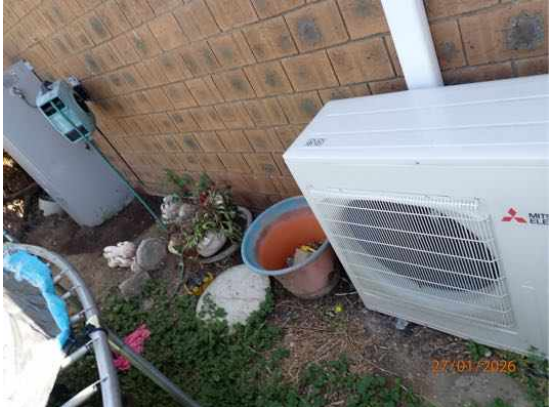
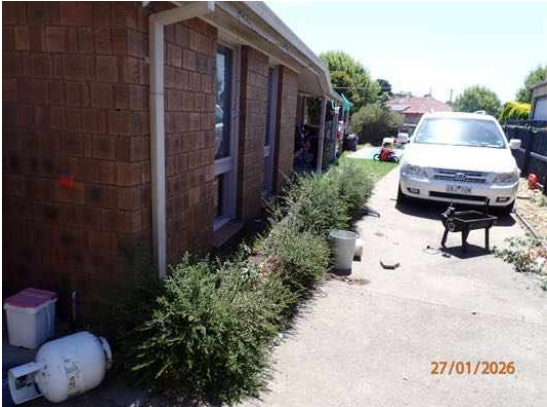
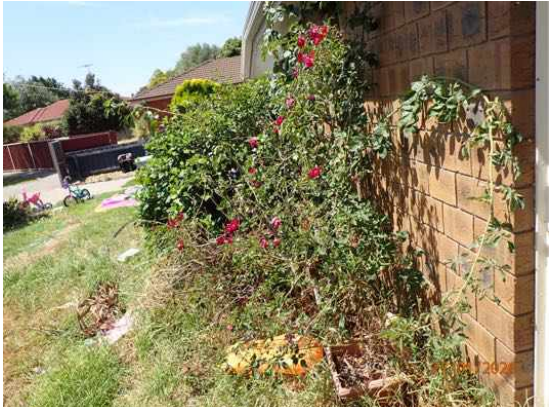
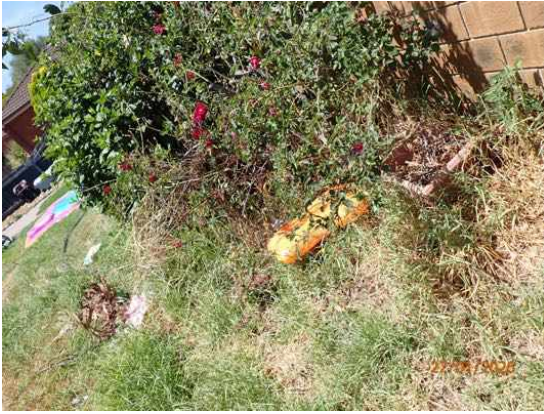
Finding 6.09

Building: Main Building
 Location: All External Areas
 Finding: Bridging - Vegetation
 Information: Where vegetation obstructs inspection of building elements, also known as bridging as it provides a bridging point for the access of termites, full inspection can not be achieved. Consequently moisture or dampness may be present and the areas becomes conducive to termite activity. Plants against or very close to buildings provide cover, shade and can provide an environment that is attractive to termite infestation.

existing vegetation will assist greatly in preventing Bridging from occurring.

The removal of any such materials that may be conducive to termite activity should be carried out as soon as possible and arrange re inspection to minimize the risk of termite attack.

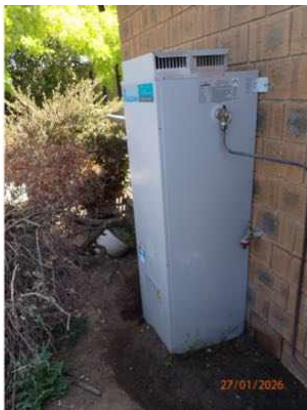
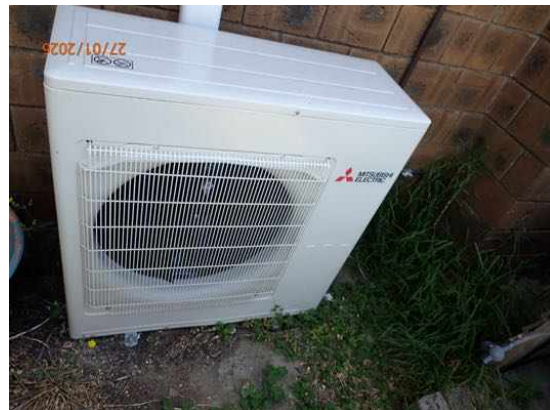
Finding 6.10

Building:	Main Building
Location:	All External Areas
Finding:	Bridging or Obstruction - Air Conditioner, Hot Water & Storage
Information:	Bridging of termite barriers occurs when termites bridge (usually by building a mud tunnel) a termite barrier or inspection zone or where termites have a passage allowing them to bridge the barrier. Either the A/C Unit, Hot Water unit, storage shed or stored goods obstructed a clear visual inspection to the wall(s) and weep holes in this area.

Where bridging has occurred full inspection is prevented and termites may enter a property in a concealed or undetectable manner.

Recommend moving obstructions away from the external walls for further and future inspections.

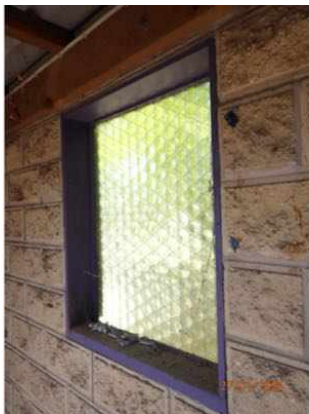
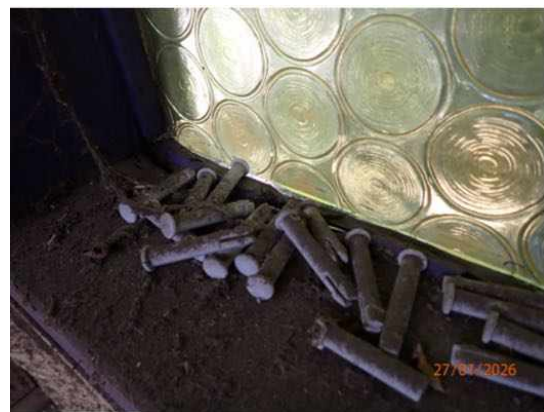
Finding 7.01

Finding: Wood Rot - Timber Pest Damage

Information: Wood rot or fungal decay was found in the shed at the time of inspection.

Wood rot which is technically known as Fungal Decay occurs when timbers and other cellulose building materials are exposed to damp conditions on an ongoing basis. This could be the result of exposure to weathering in the long term or the pooling of water or absorbed moisture from other abutting building materials.

Wood rot provides conditions that are conducive to termite and timber pest activity. Highly recommend to remove all susceptible timbers and replace with non susceptible timbers.

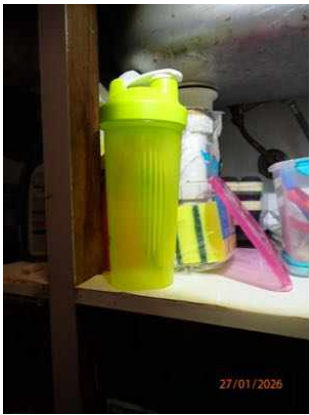
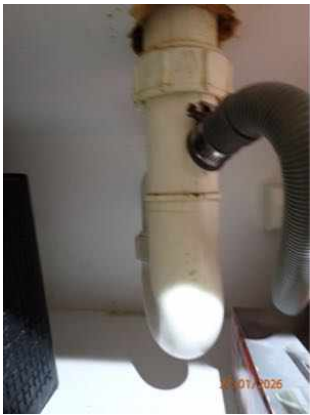
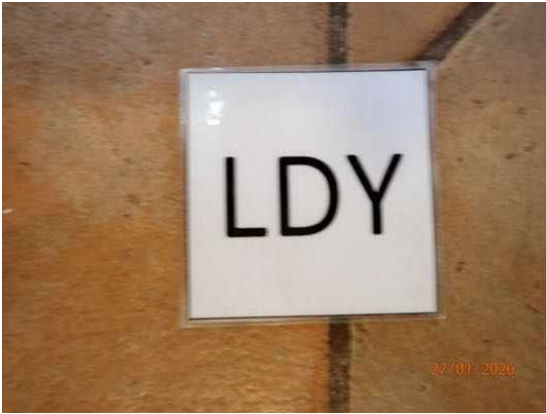
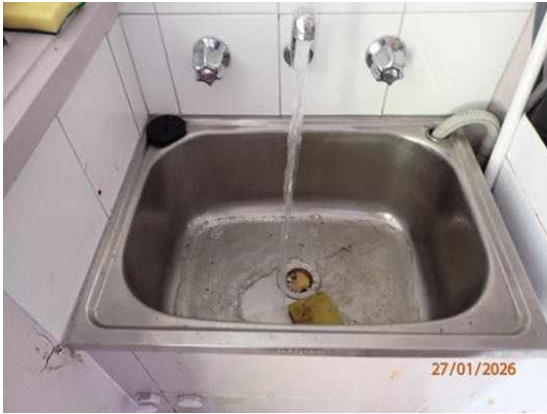
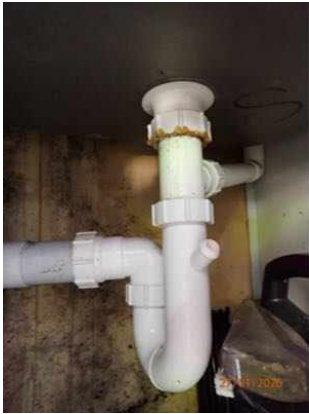
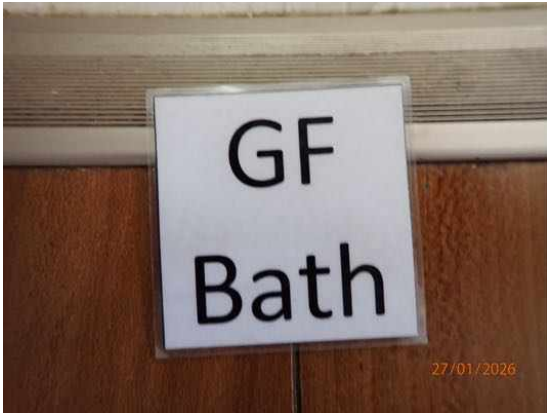
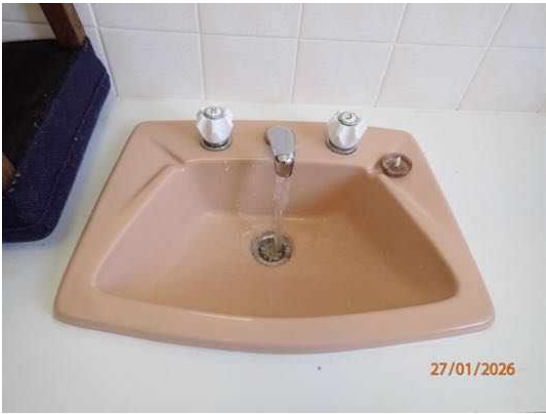
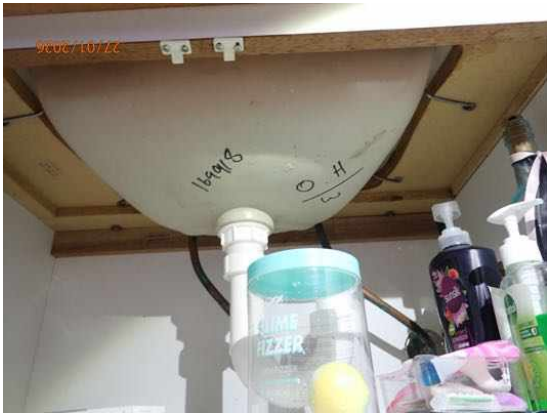
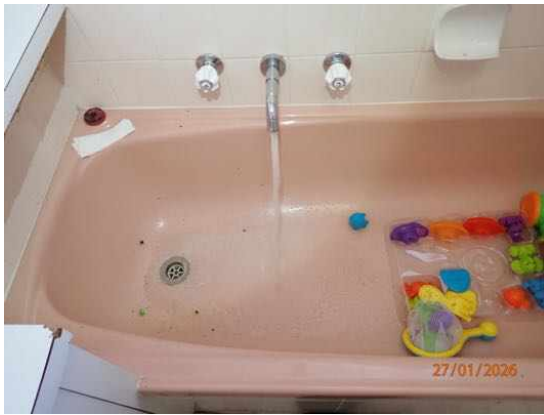
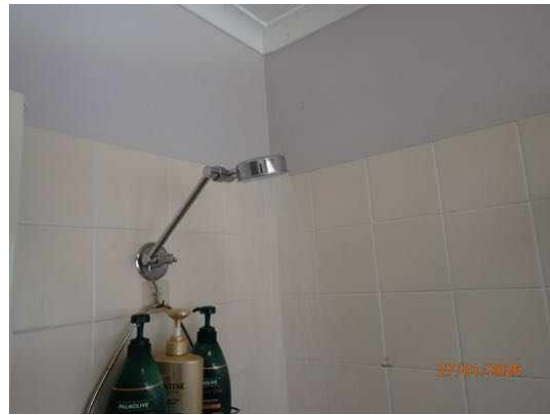
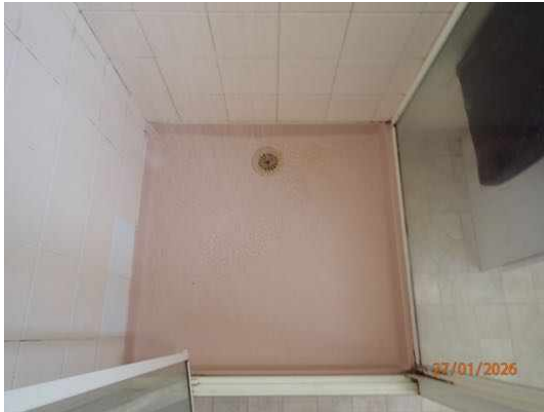
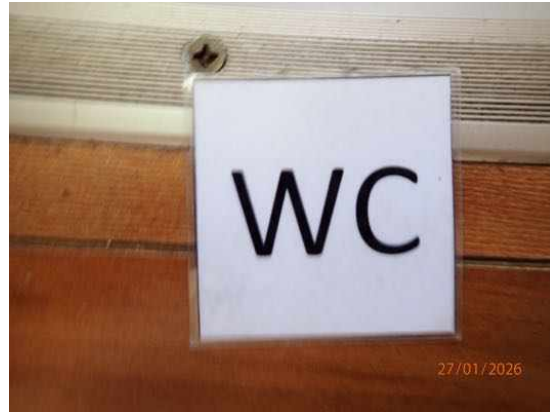
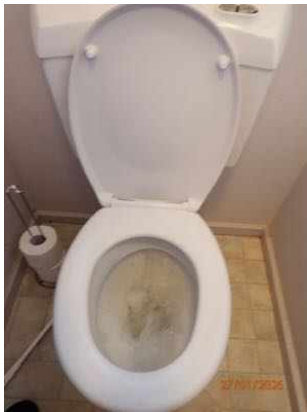
Building: Main Building
 Location: All Internal Areas
 Finding: Shower, Bath, Toilet & Basin Condition
 Information: The shower recess was tested and there was no visible water penetration to surrounding areas unless otherwise stated in a separate defect of the report. The water appeared to flow freely towards the floor waste at the time of inspection. Moisture was detected to the shower walls and the severity is documented within the report. The shower floor waste appeared to be clear at the time of inspection. No leaks were visible during flushing the toilet and appeared to operate as normal unless otherwise stated in a separate defect within the report. No water damage was noted to the vanity unit at the time of inspection unless otherwise stated in a separate defect within the report. Basins, laundry tubs, vanity's and sinks were water tested and inspected and no evidence of leaks or blockages in the plumbing/drainage was present at the time of inspection unless otherwise stated in a separate defect within the report. All internal taps and shower heads were tested with no leaks unless otherwise stated in a separate defect within the report.

IMPORTANT NOTE: This test may not reveal water leaks until the shower or toilet are put into constant use and surrounding areas monitored over a period of time.

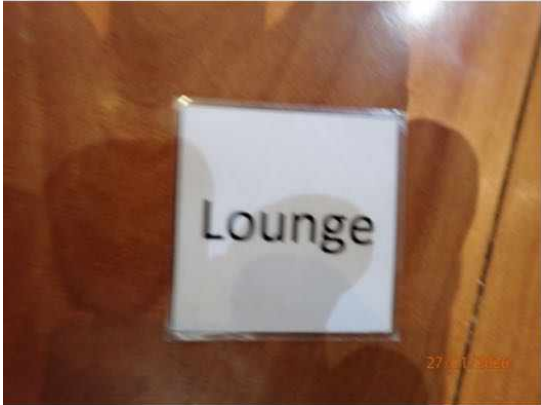
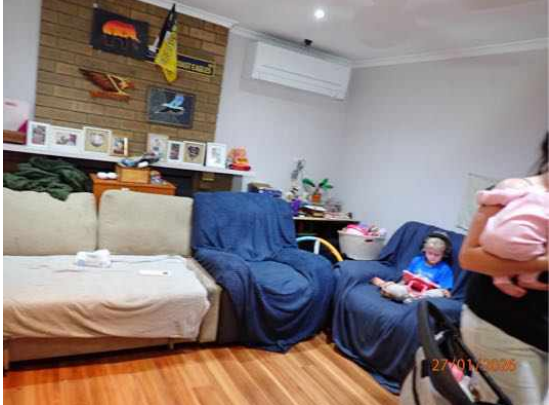
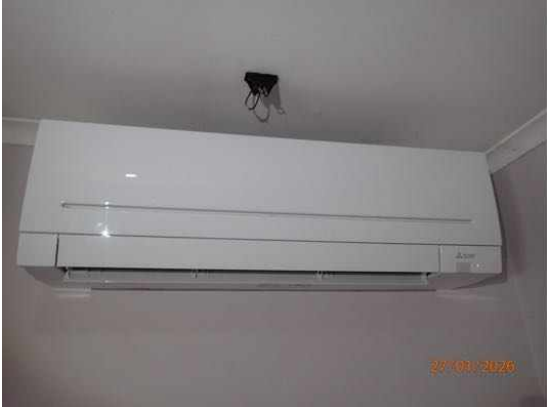
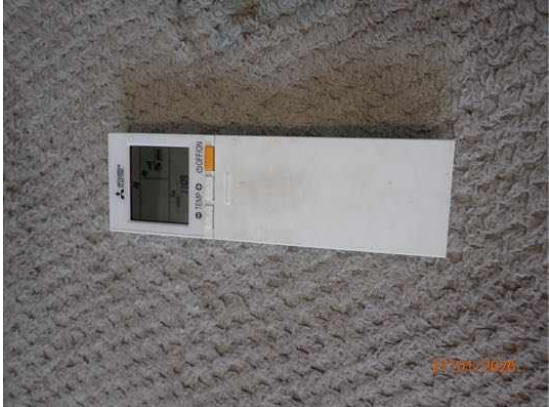
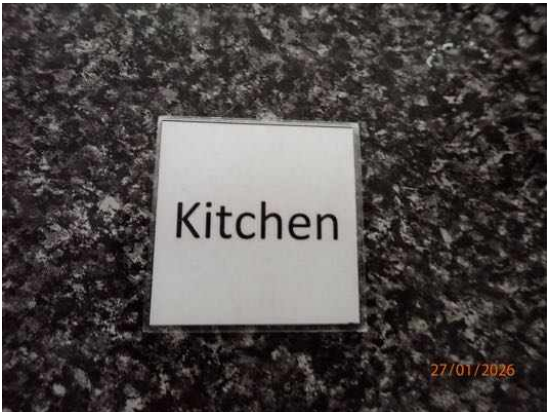
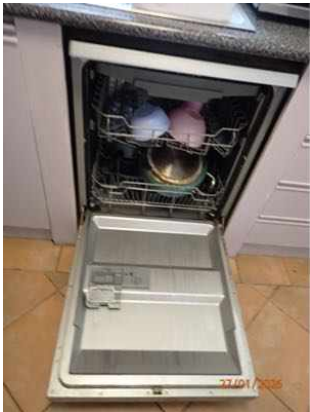
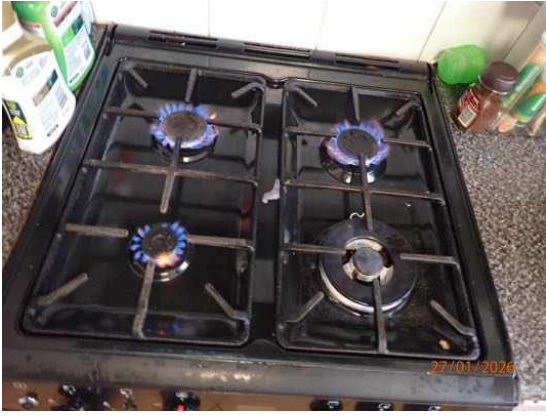
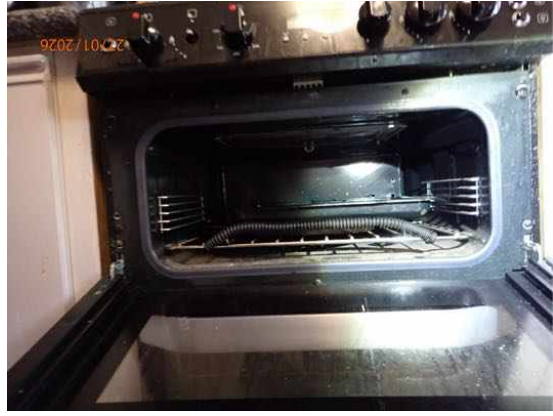
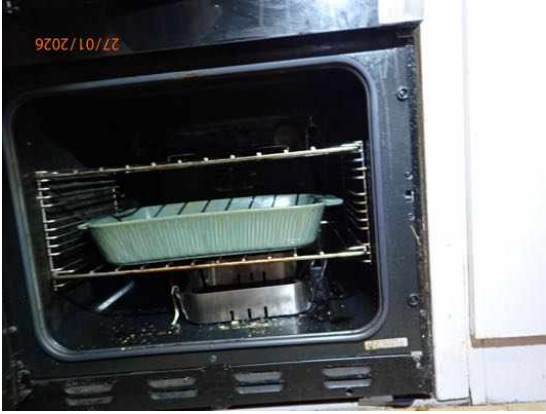
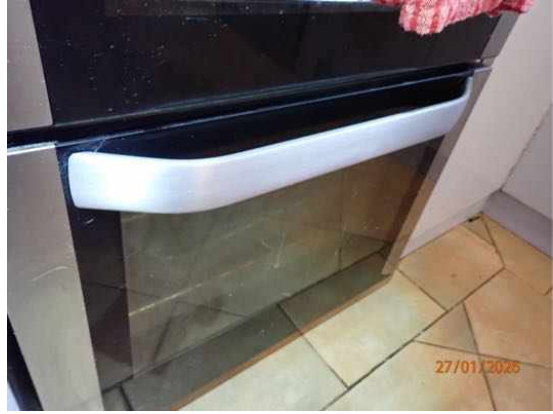
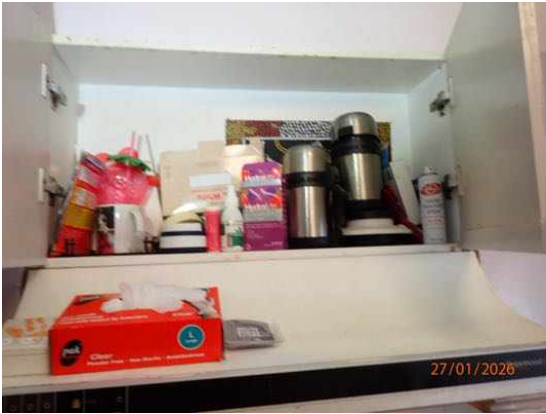
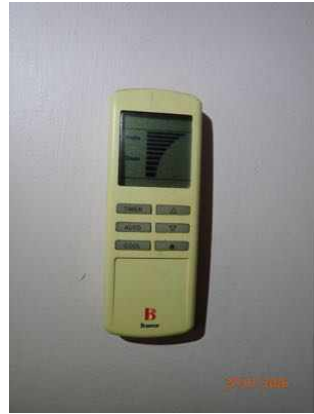
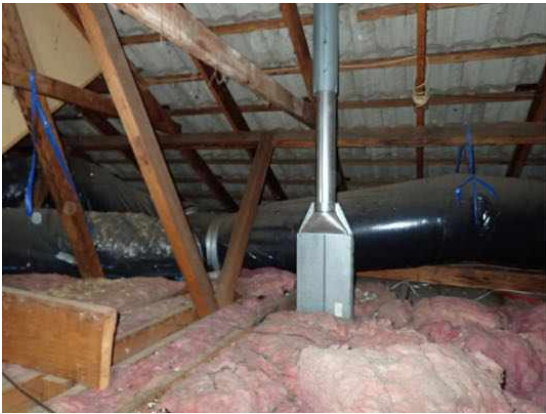
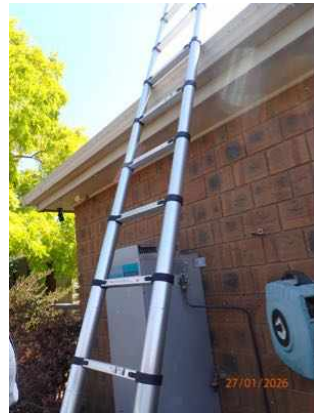
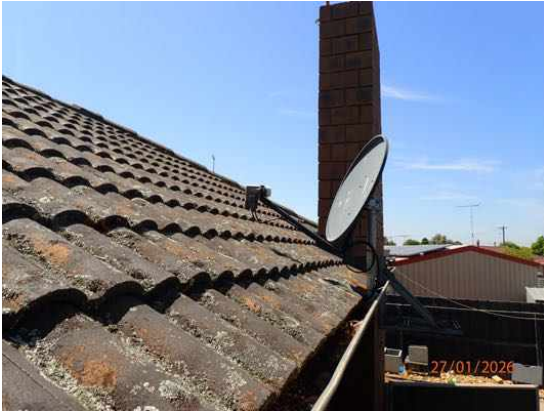
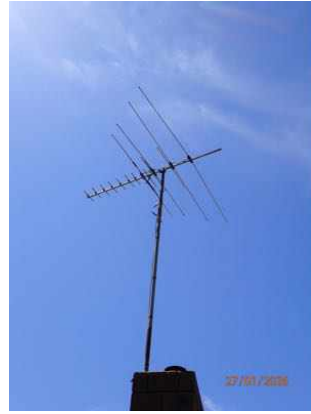
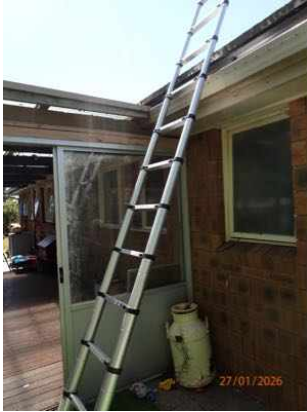
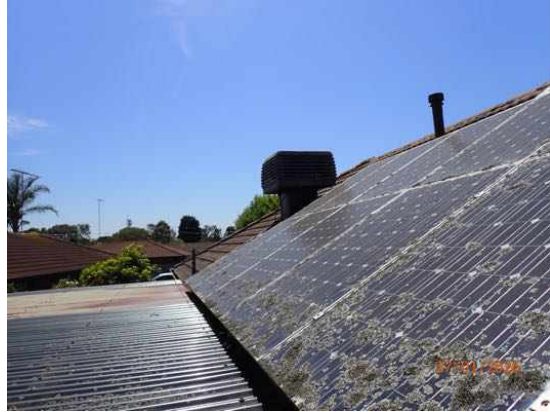
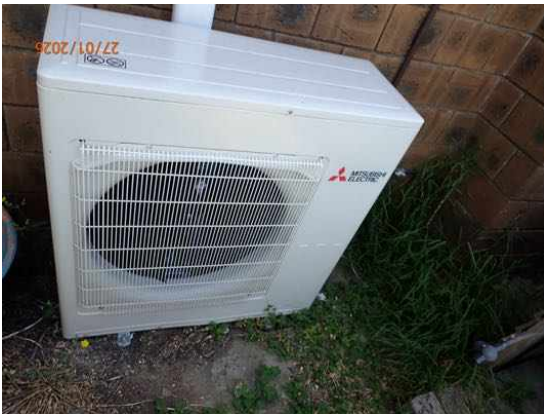
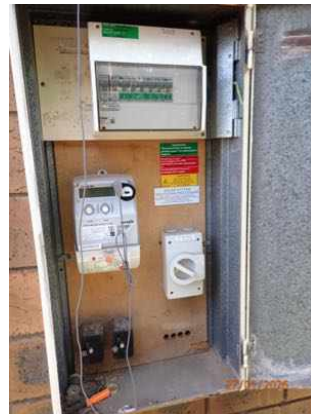
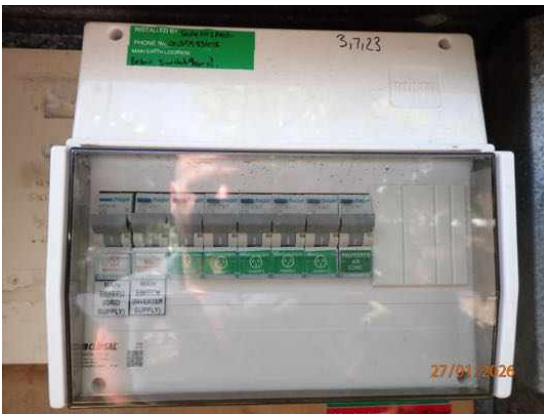
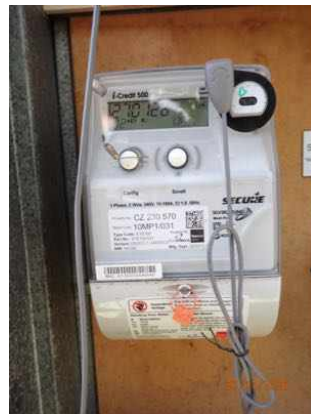
Building: Main Building
 Location: All Areas
 Finding: Plumbing & Electrical
 Information: All appliances need to be serviced and maintained in good order. Plumbing and electrical inspections are outside the scope of the building inspection and must be conducted by a Licensed and registered Trades person.

It is highly recommended that the client makes immediate arrangements to have all appliances checked by a licensed relevant contractor to ensure that the appliances are working safely and efficiently. We recommend all other installations be checked and a maintenance schedule be created for all appliances and equipment moving forward.

Whilst we note and comment of visually apparent defects that present during the building inspection, legislation requires the checking and documenting of compliance for plumbing and electrical requirements be done by licensed electrician and plumbers respectively to ensure they are functioning correctly.

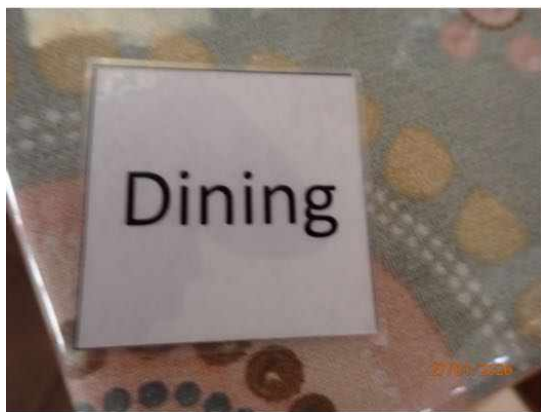
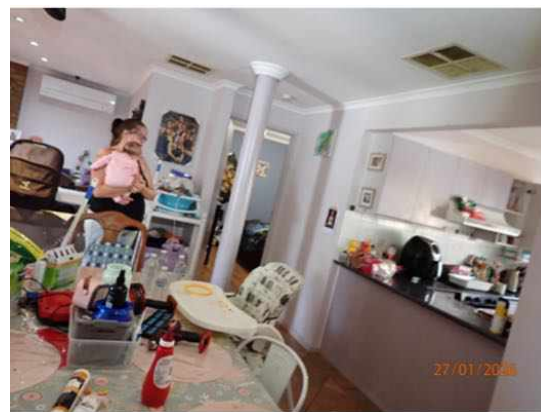
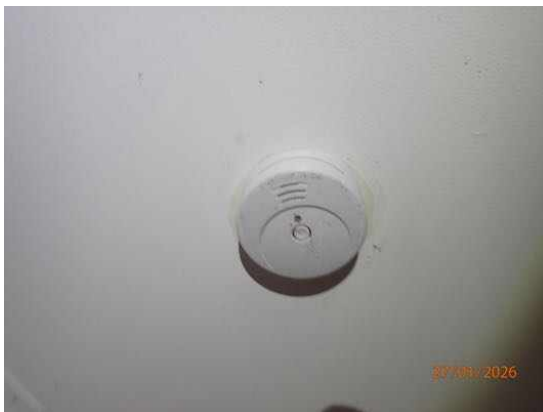
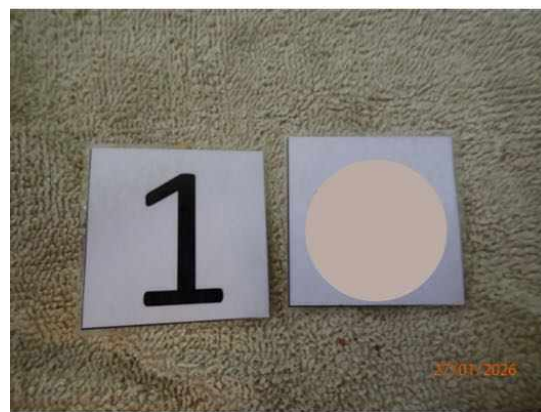
Building: Main Building
Location: All Internal Areas
Finding: Smoke Detectors & Alarms
Information: Reporting on Smoke Detectors or Alarms, including hard wired smoke detection systems and their legislative requirements, is outside the Scope of this Report. Please note that this is highlighted as a caution only. Further Inspection and/or advisory services is necessary to provide advice on the sufficiency, type and location of smoke detectors, and to test the functionality of all devices. Always ensure sufficient working and suitable smoke detectors are installed prior to occupying any building. Additionally, it is advised that all smoke detectors be tested by the homeowner on a monthly basis. Please refer to AS3786 and state based legislation, which may also apply.

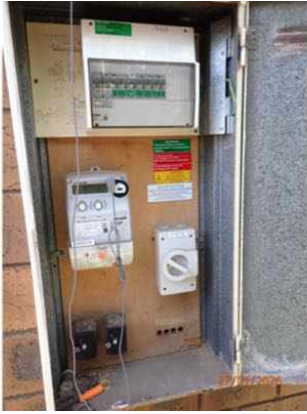
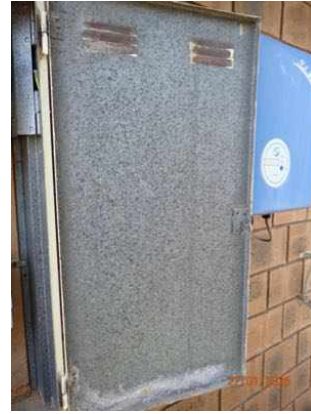
Building:	Main Building
Location:	All External Areas
Finding:	Termite Management System - No evidence of installation
Information:	The application of a post-construction chemical termite barrier is highly recommended for all properties, particularly if live termite activity has been found on the site previously. Such barriers are highly effective in preventing termite attack on any timber building elements throughout the property.

A durable notice should be placed in the switchboard unit to indicate current termite barriers. At the time of inspection, it appeared as though no termite management system has been installed, with no evidence to suggest preventative works taking place.

The client may consider gaining further advice from a pest controller as to the costs and procedures involved with this application. It is recommended that obtaining such advice be a short-term priority.

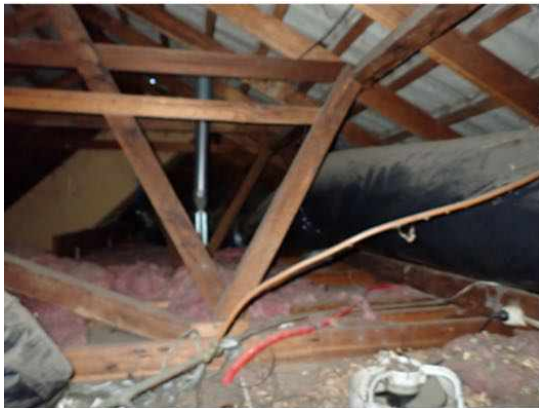
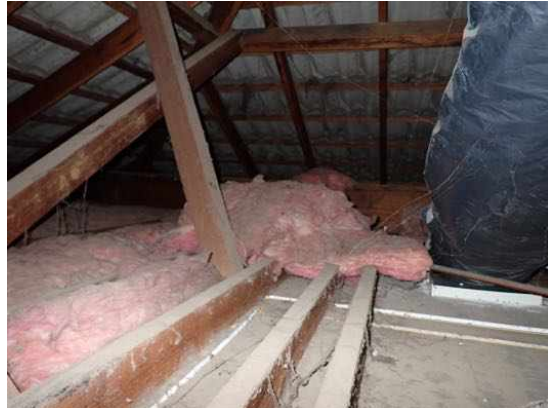
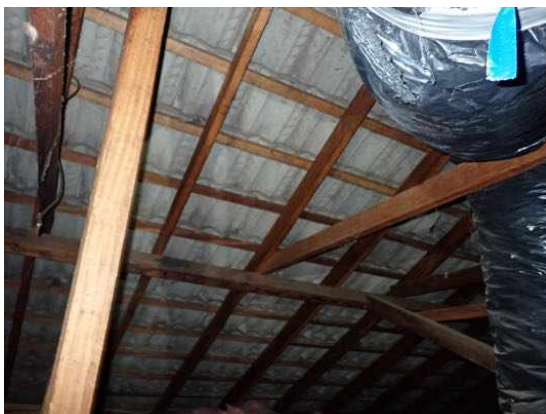
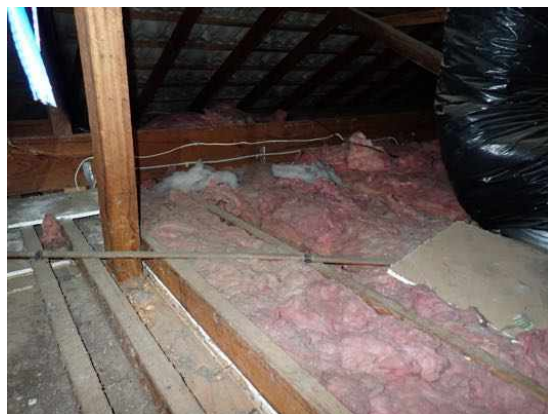
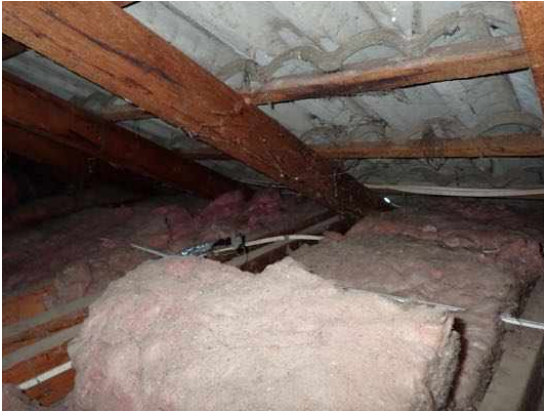
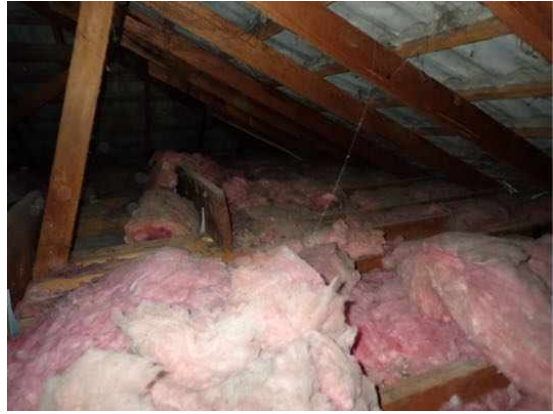
Building: Main Building
Location: Roof Void
Finding: Roof Void - Limited Access
Information: Limited access to the roof void was present due to facts including but not limited to, limited access, insulation, Air condition Unit & ducting, obstructions or placement of insulation and or sarking, for this reason complete access to the roof void was not possible.

NOTE: Unless all insulation is removed from the roof space a full inspection is never possible, timber pest or termite activity and/or damage may not be visible.

A visual inspection was carried out from accessible areas only, recommend installing another access hatch in a more accessible area for a re-inspection.

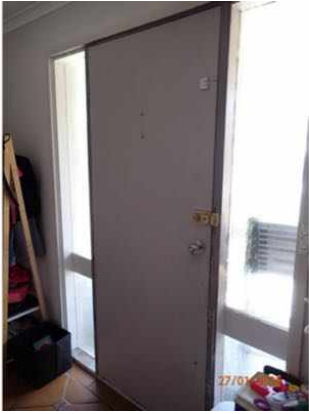
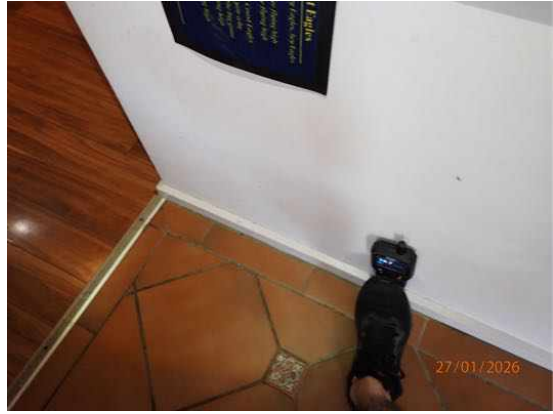
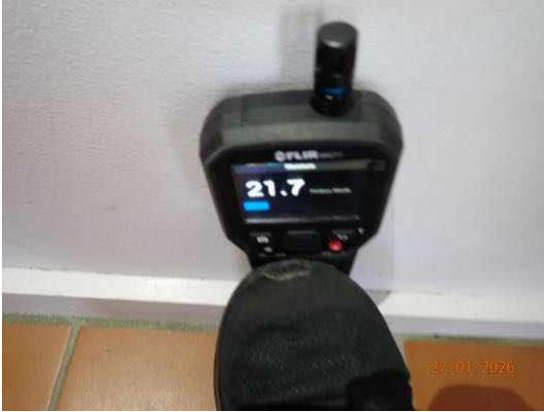
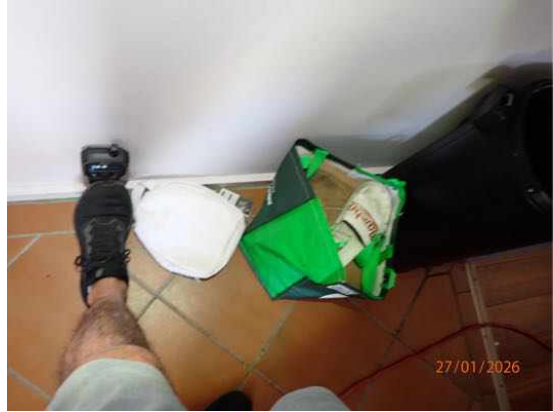
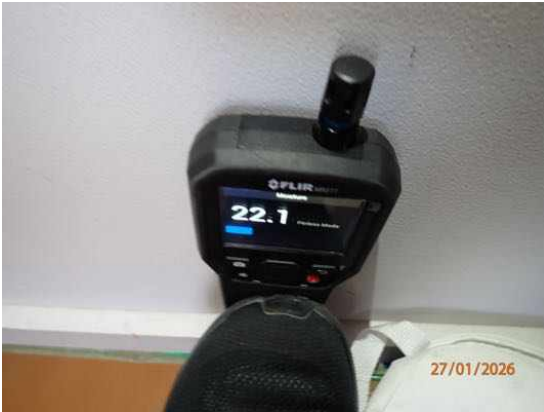
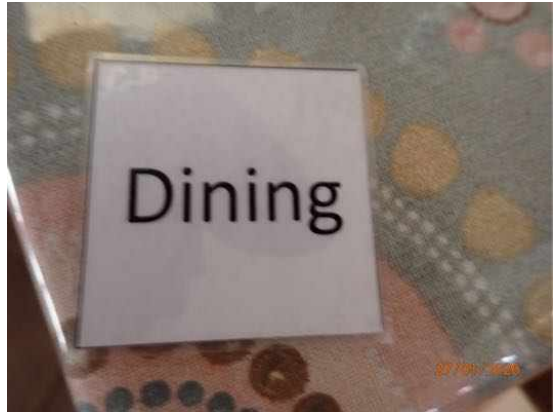
Building: Main Building
Location: All Internal Areas
Finding: Additional Photos Added - Moisture Readings
Information: Additional photos are added for your reference. Where additional moisture readings were made and clear of any elevated moisture present.
