Building and Timber Pest Inspection Report

Inspection Date: Tue, 27 Jan 2026

Property Address: 12 Bean Ct, Whittington VIC 3219,
Australia

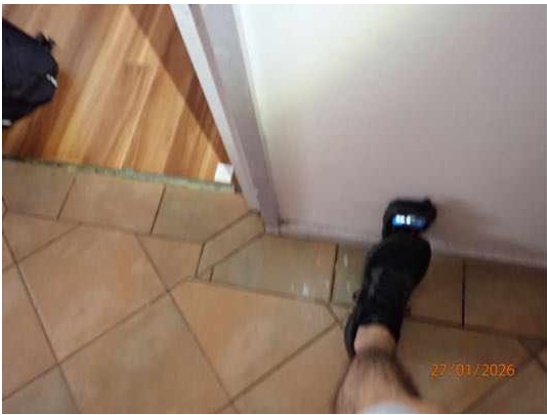
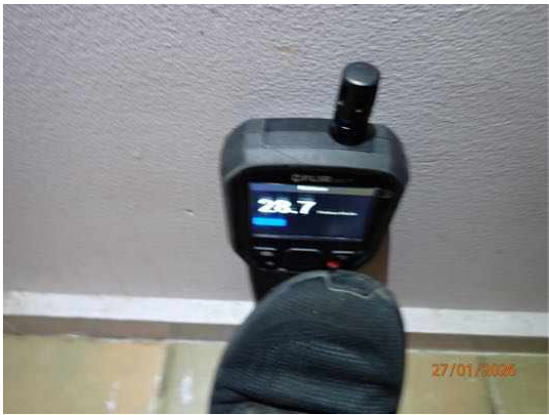
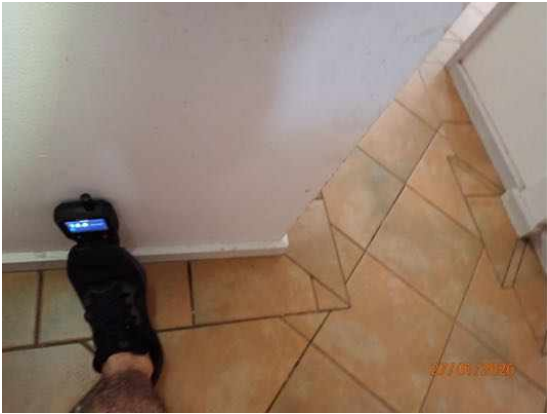
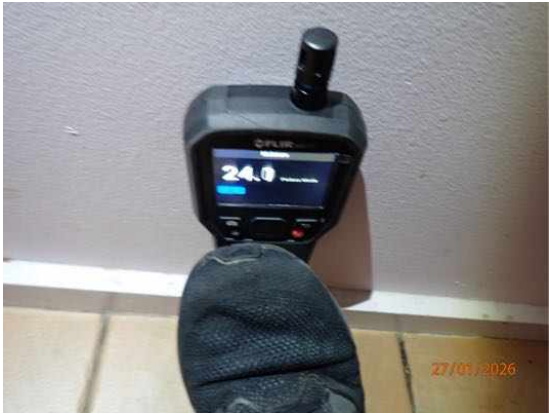
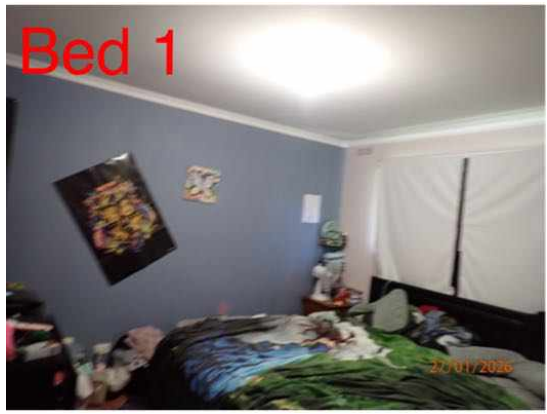
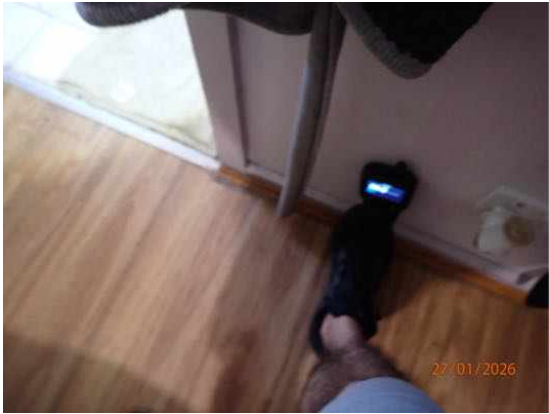
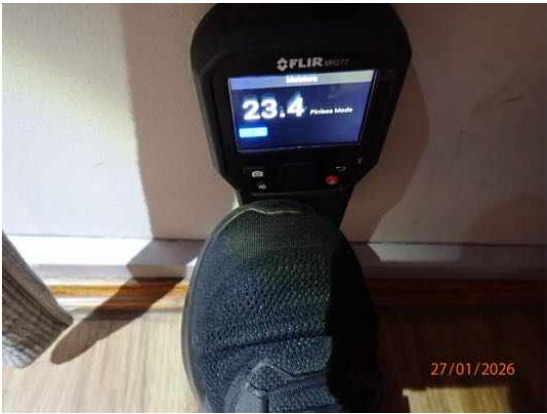
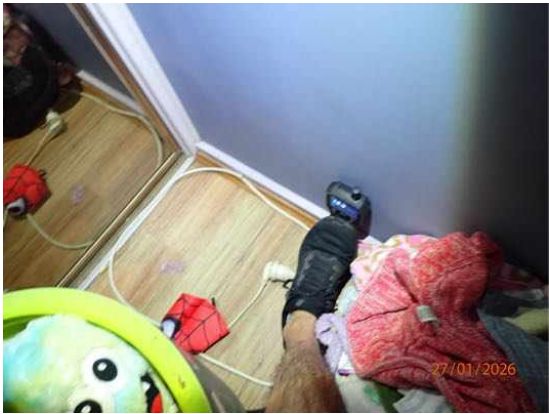
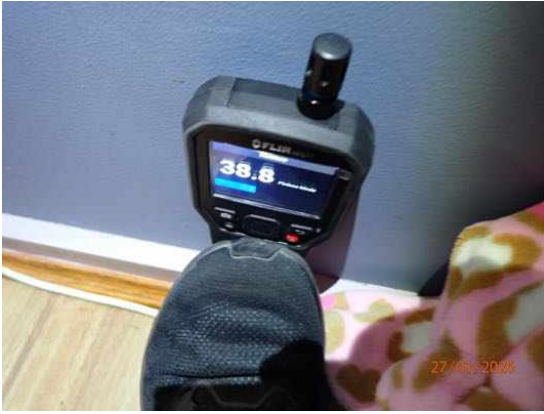
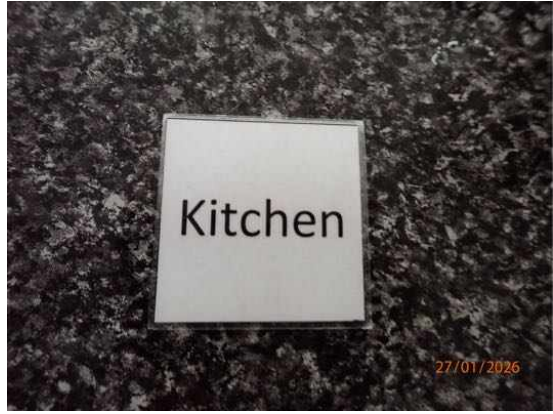
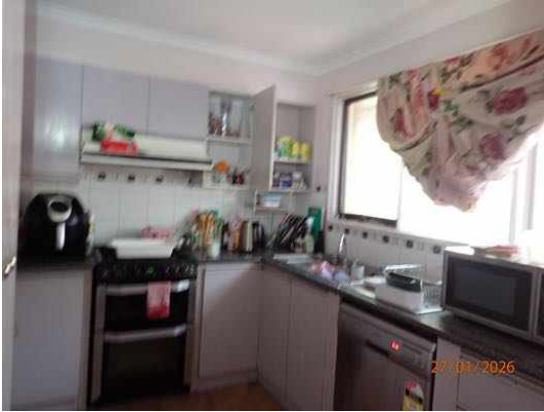
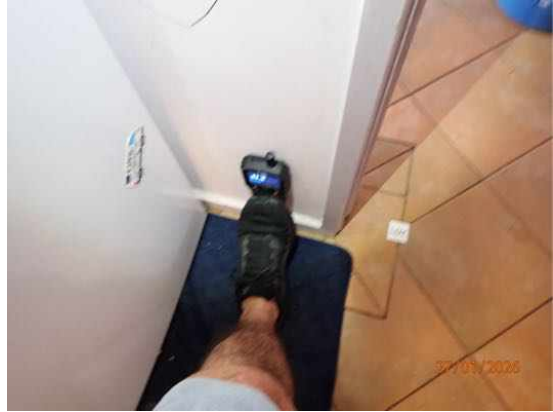
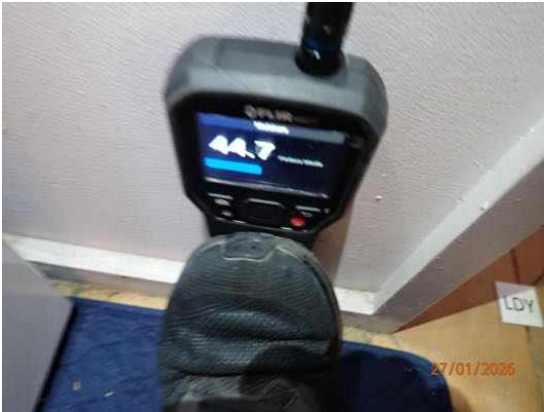
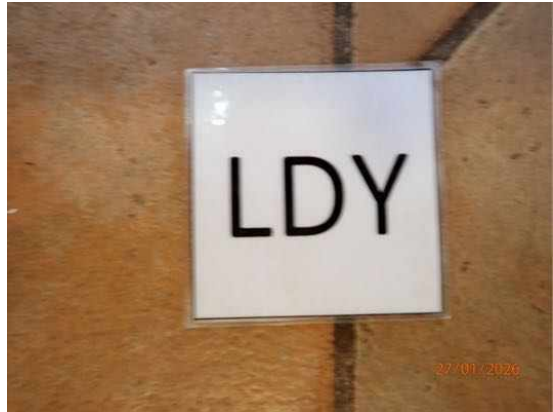
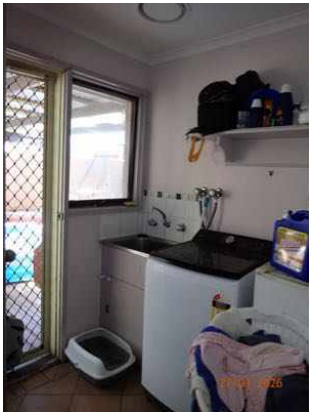
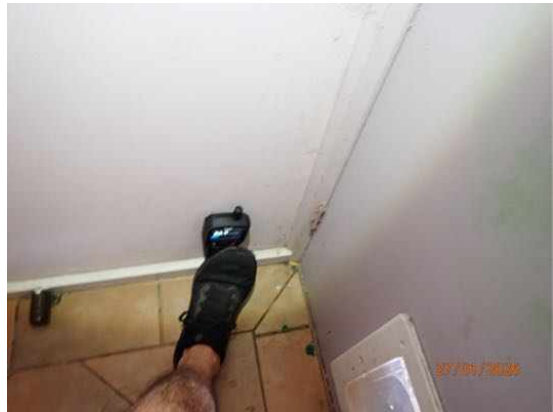
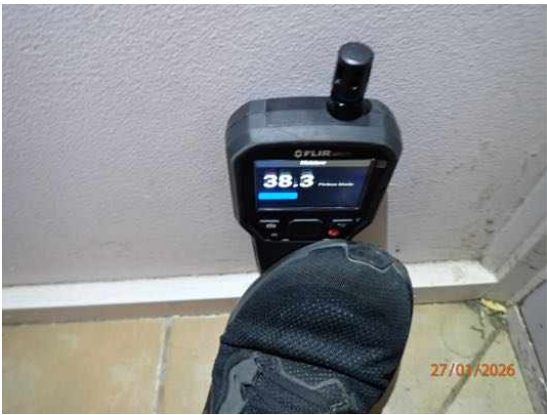
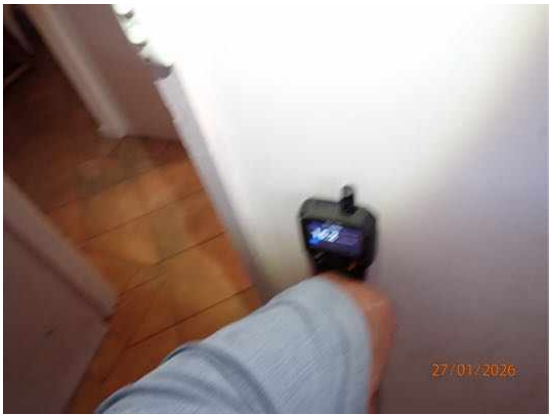
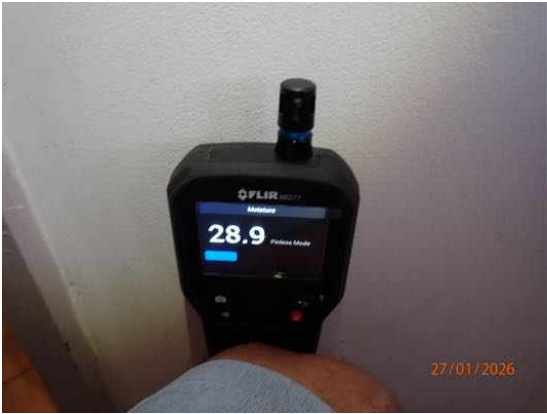
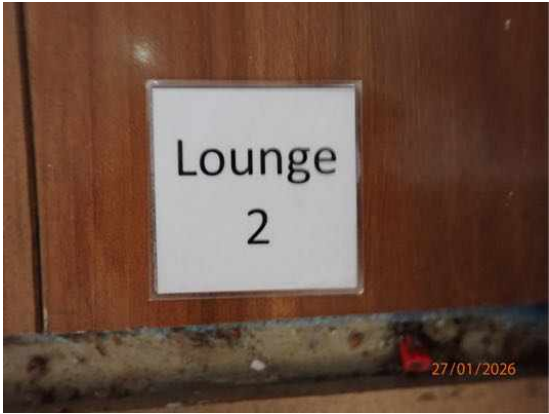
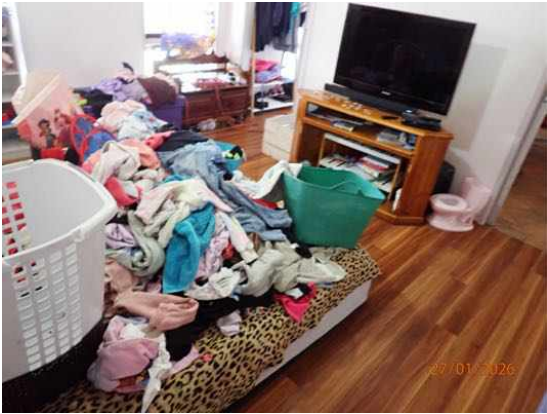
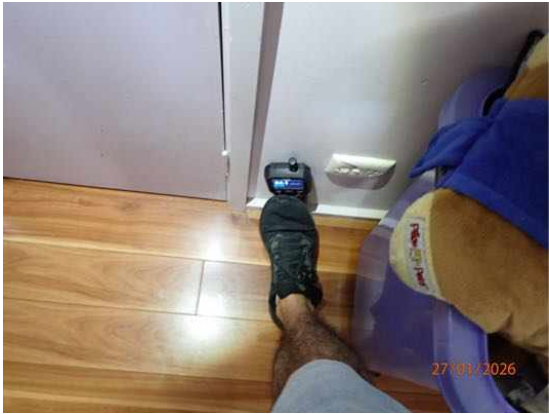
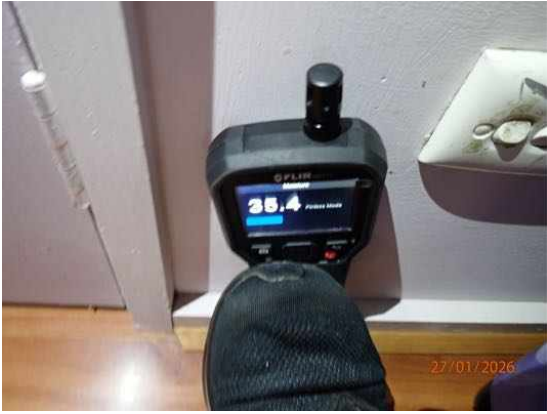
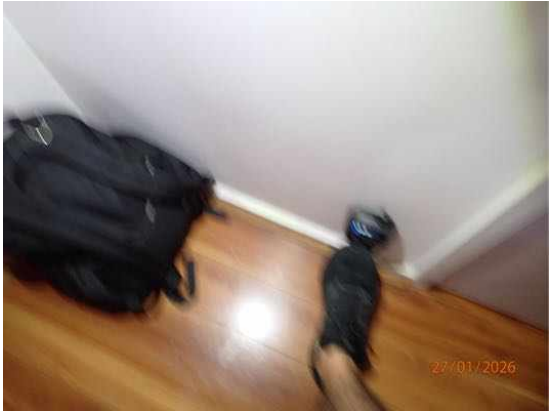
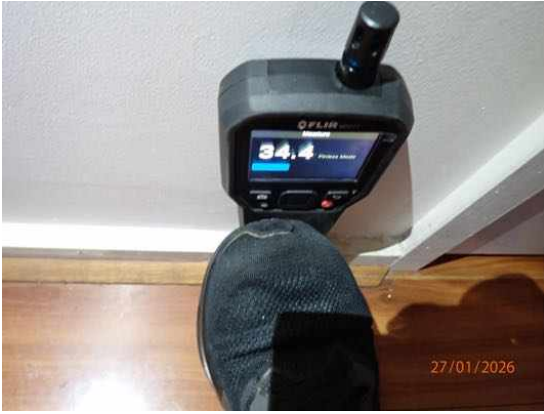
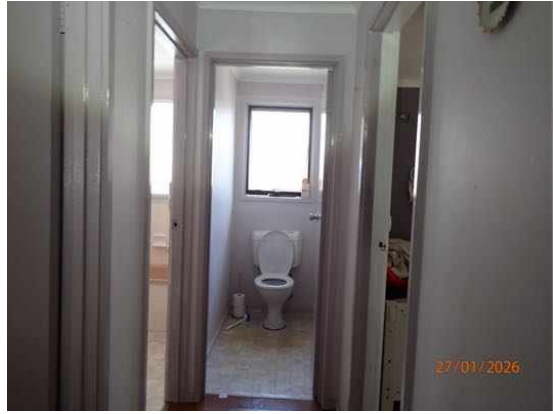
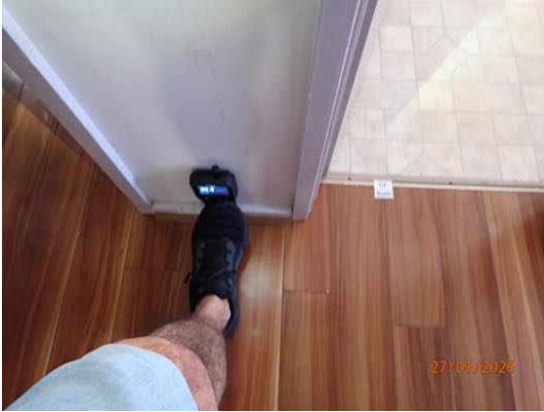
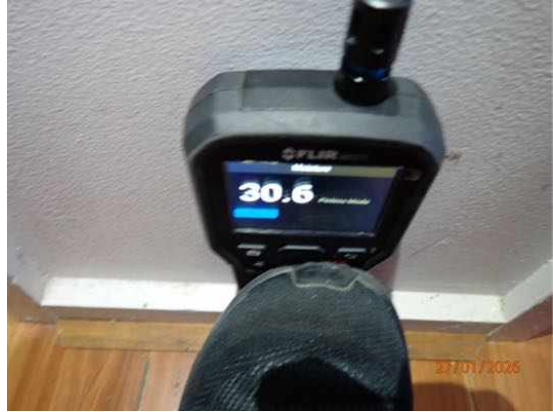
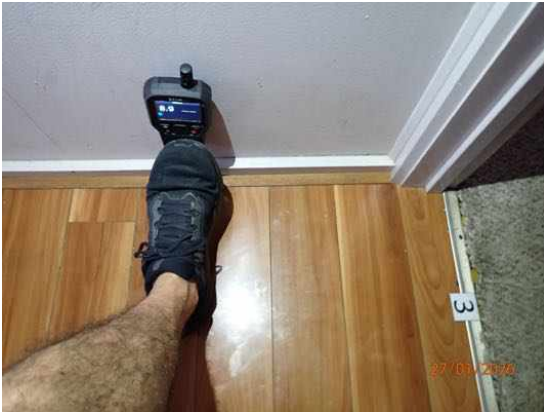
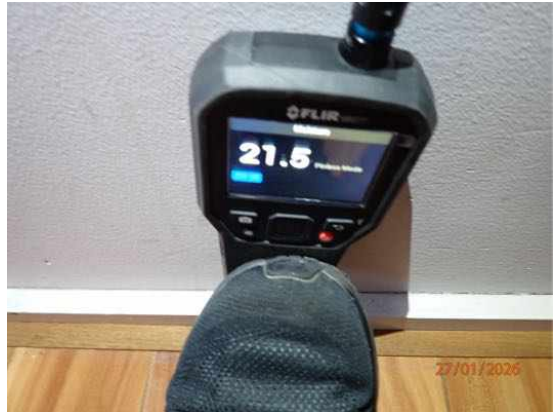
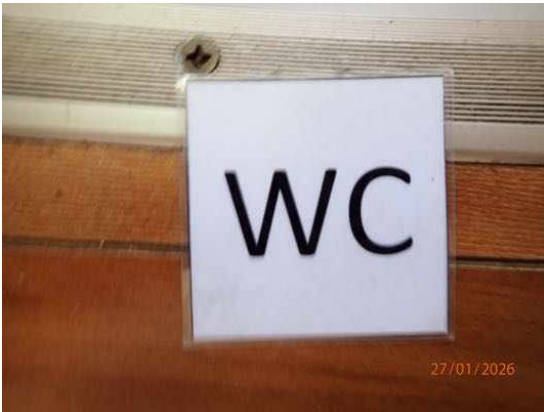
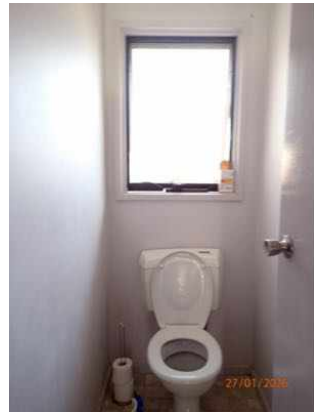
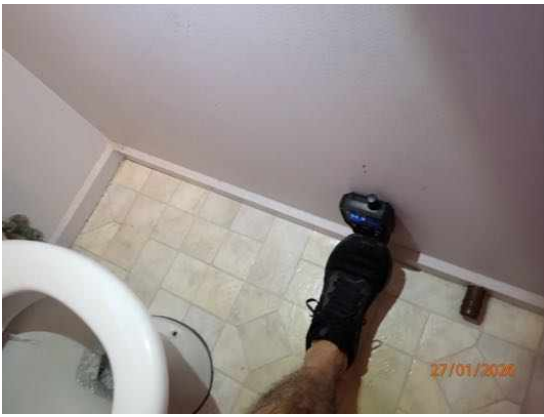
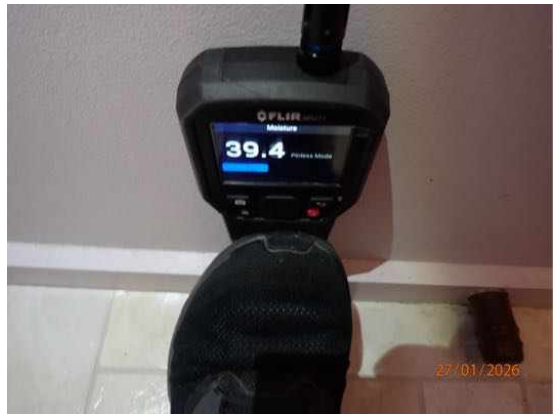
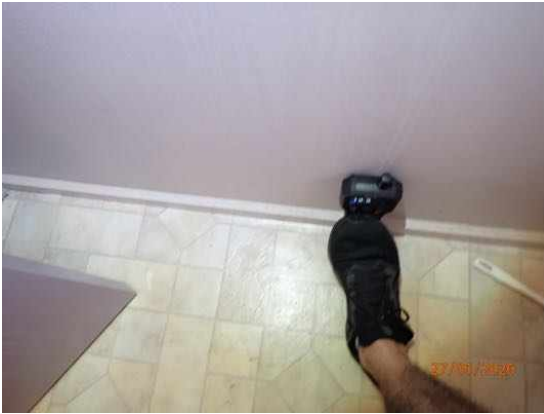
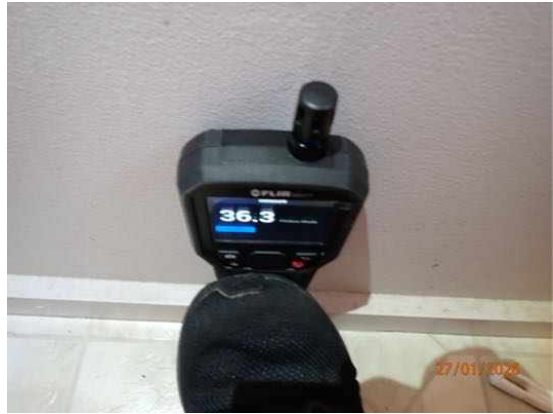
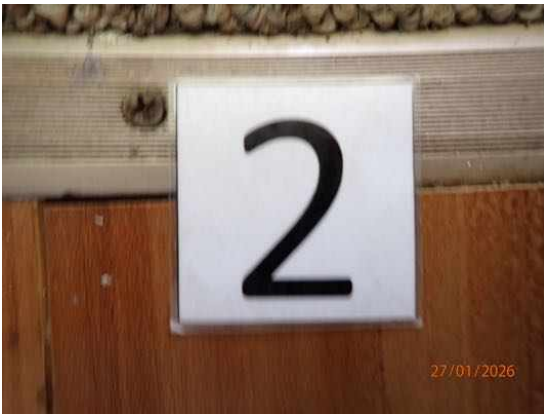
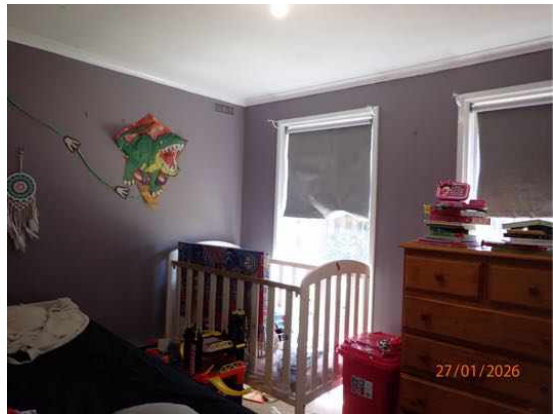
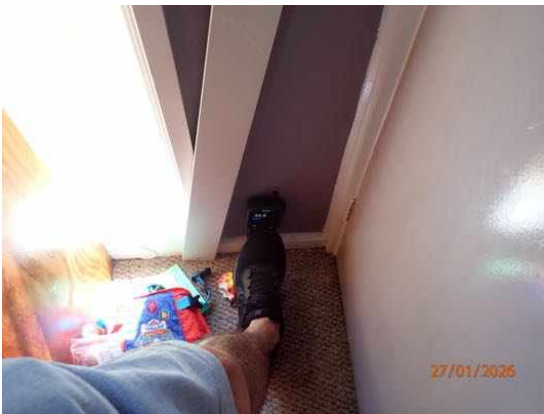
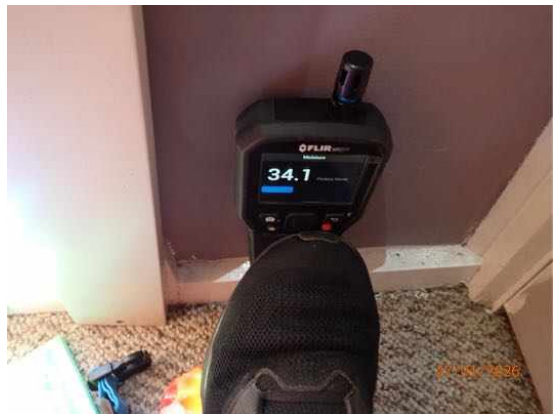
Building: Main Building
Location: All Internal Areas
Finding: Additional Photos Added - Moisture Readings
Information: Additional photos are added for your reference. Where additional moisture readings were made and clear of any elevated moisture present.

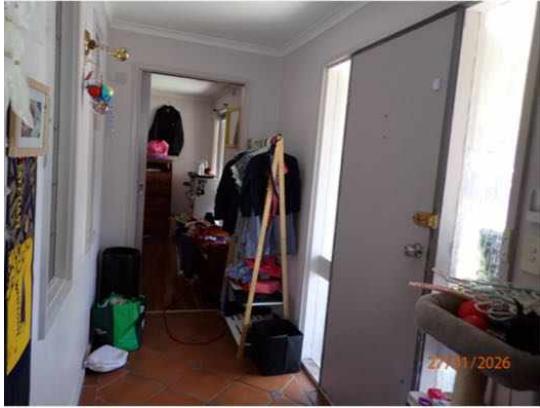
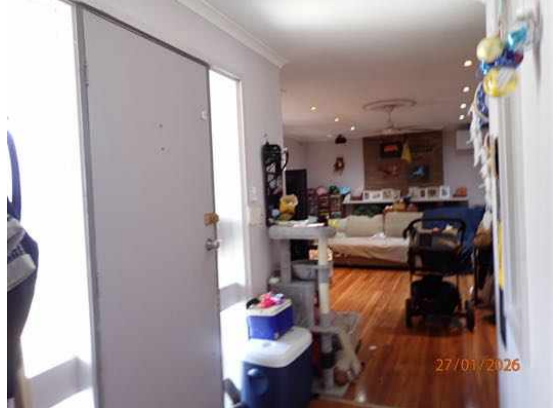
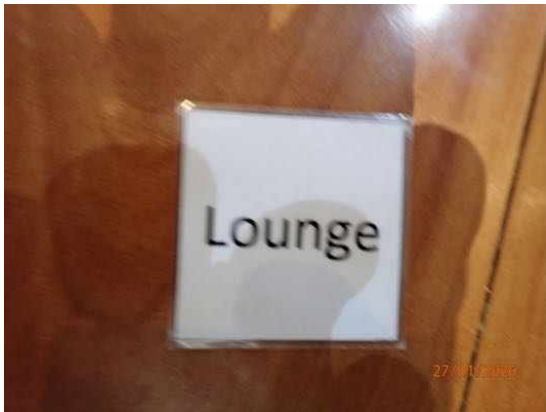
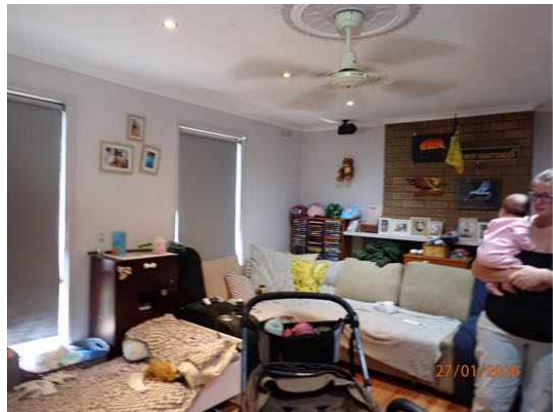
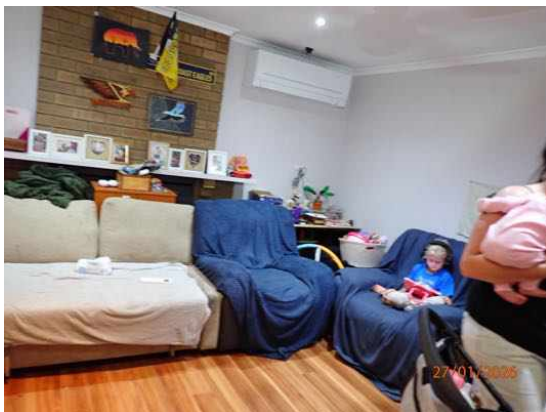
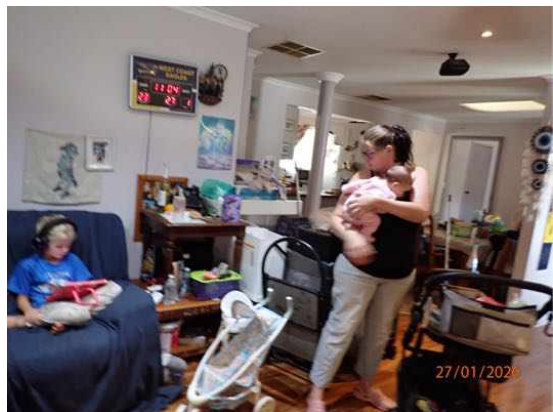
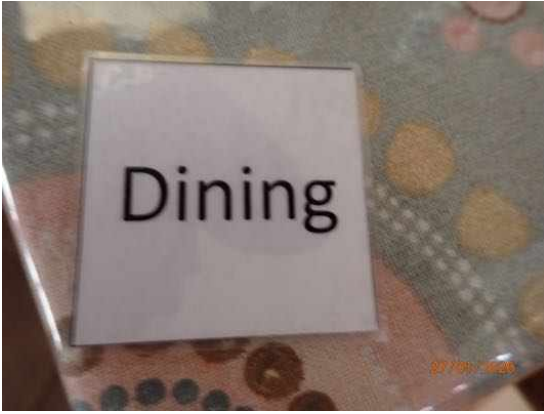
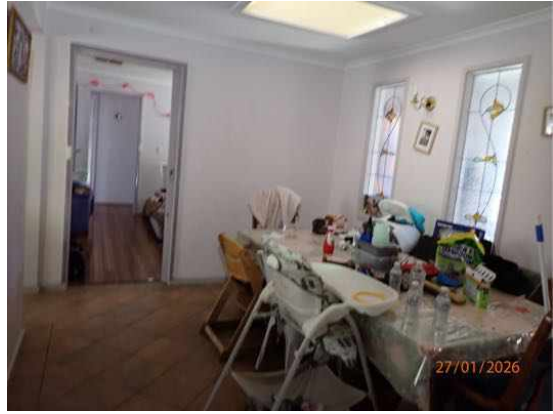
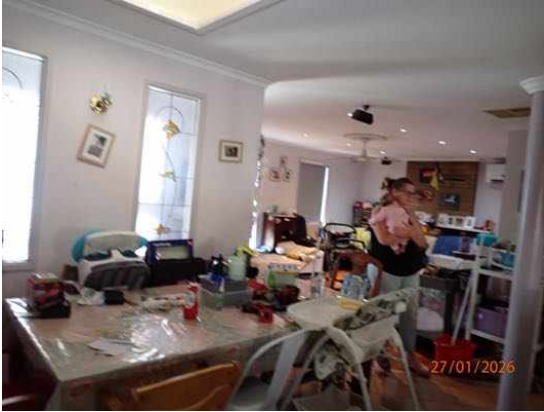
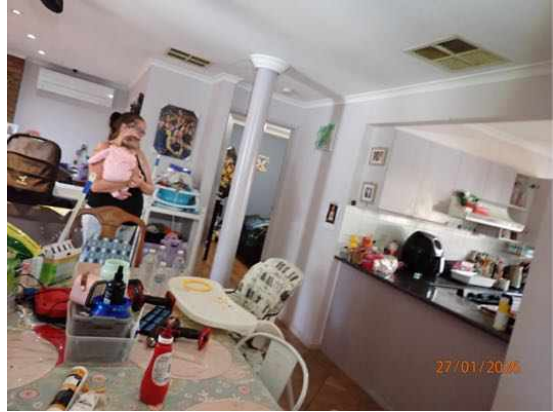
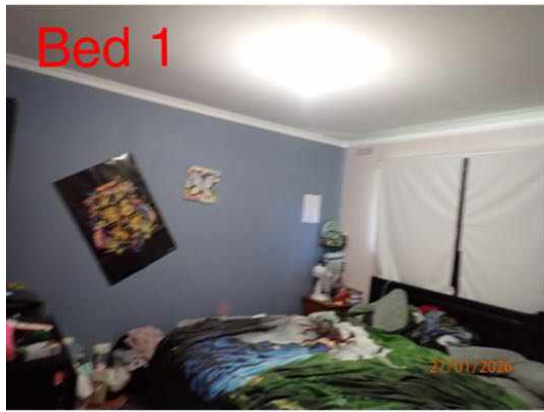
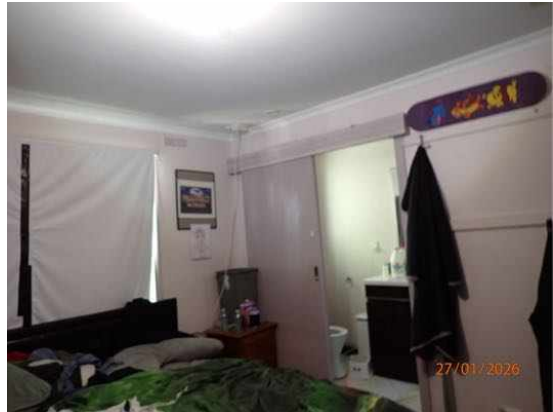
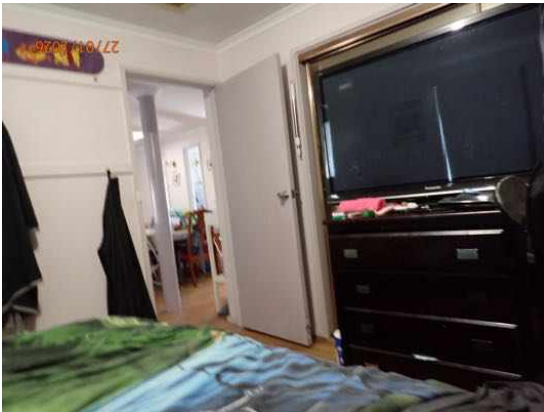
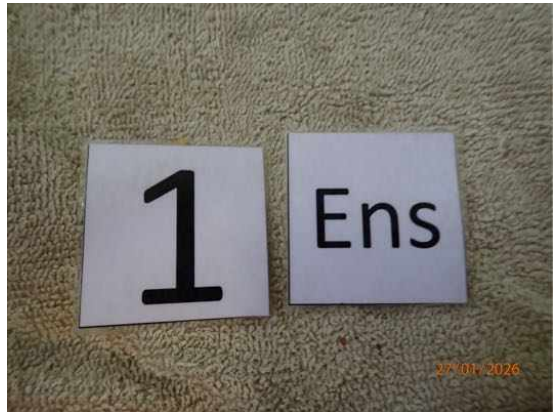
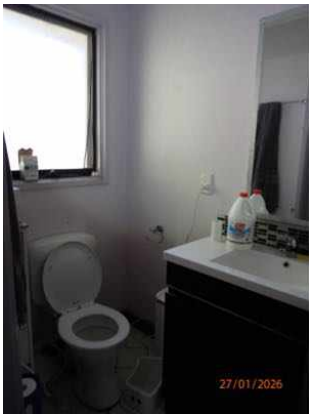
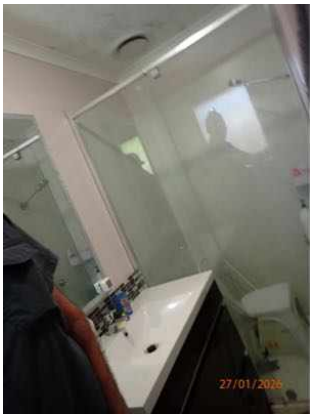
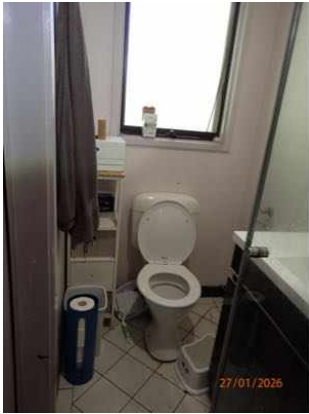
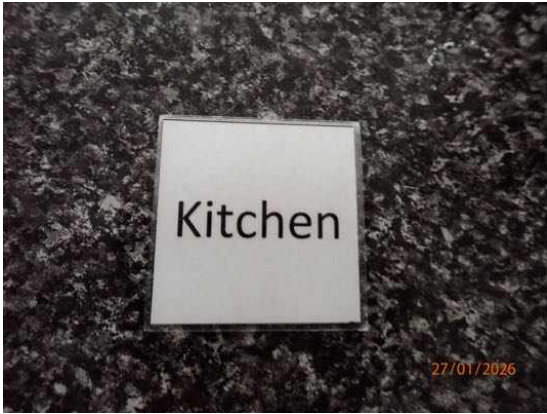
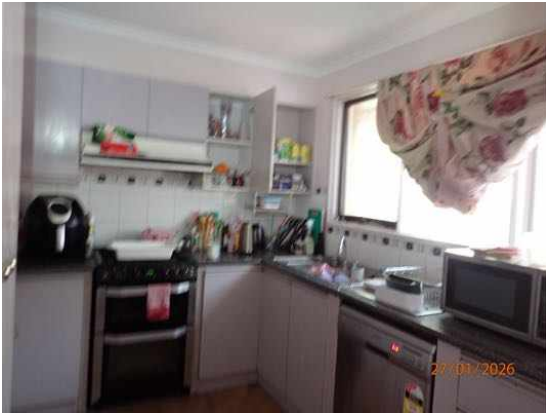
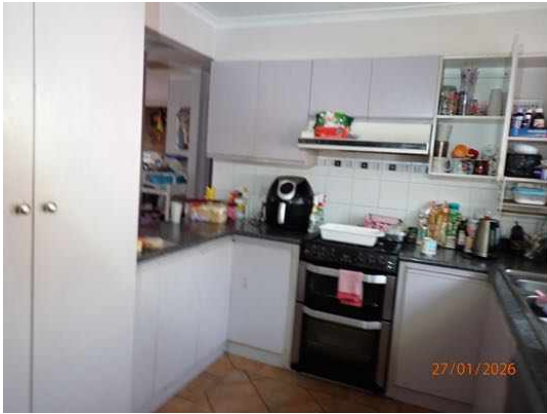
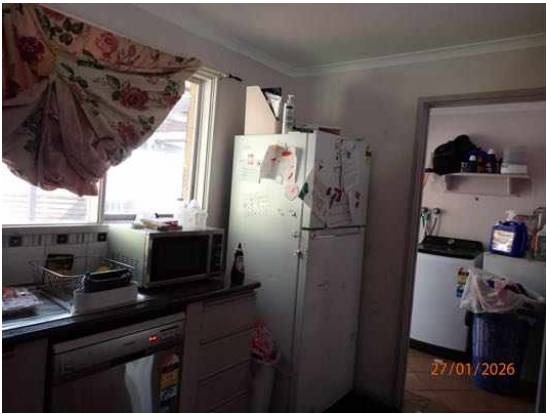
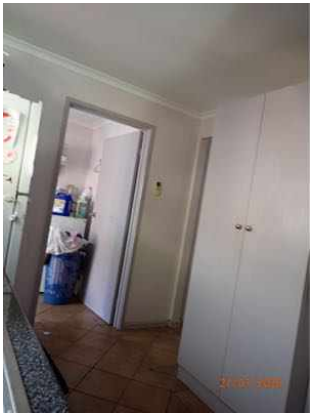
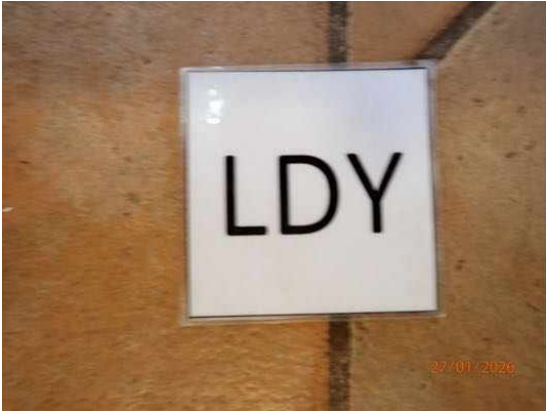
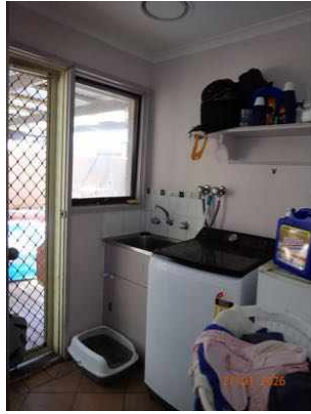
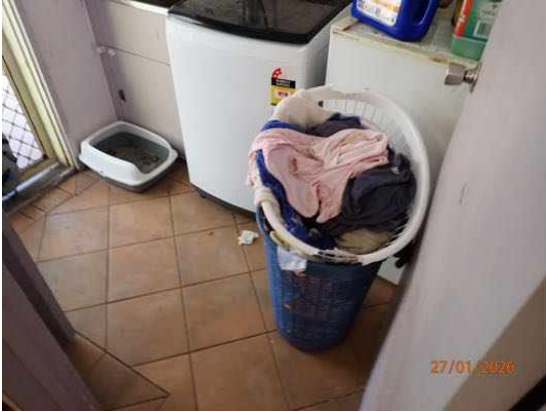
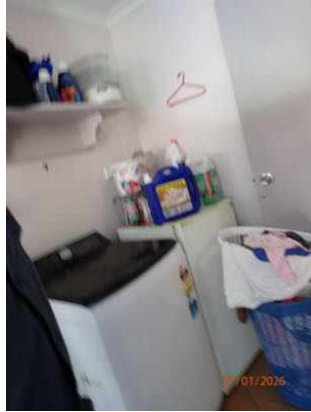
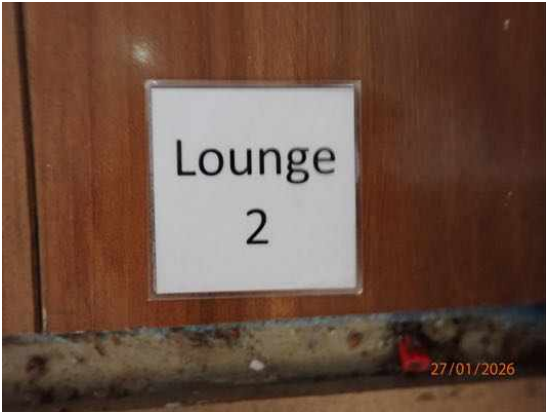
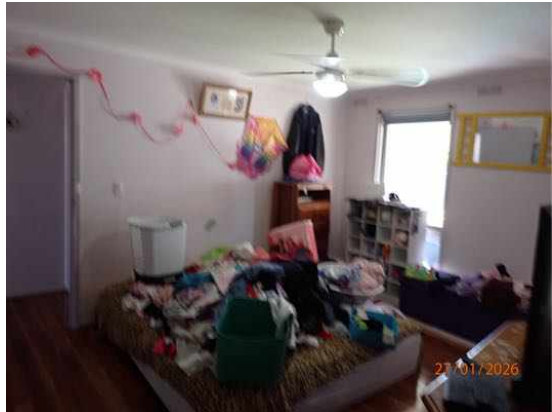
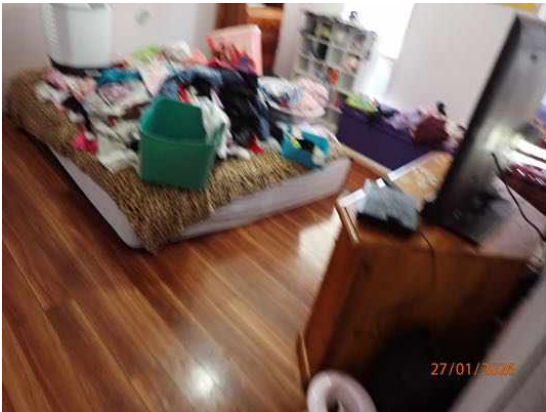
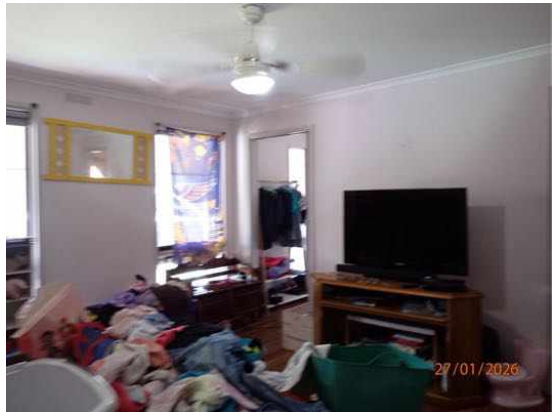
Noted Item

Building: Main Building
Location: All Areas
Finding: Additional Photos - Obstructions and Limitations
Information: These photographs are an indication of the obstructions and limitations which impeded full inspection of the property at the time of inspection. These obstructions can hide an array of defects and should be removed to allow full inspection to be carried out. A re-inspection is recommended once the areas are made accessible.
