Building and Timber Pest Inspection Report

Inspection Date: Tue, 27 Jan 2026

Property Address: 12 Bean Ct, Whittington VIC 3219,
Australia

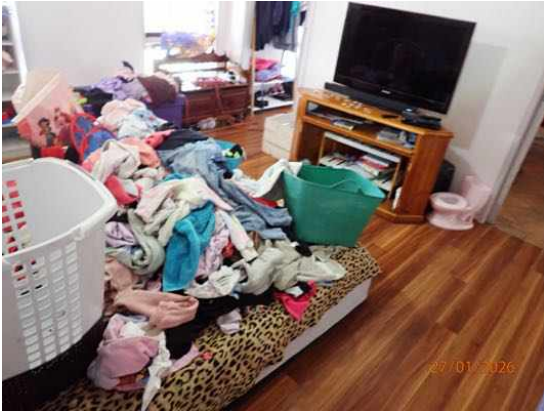
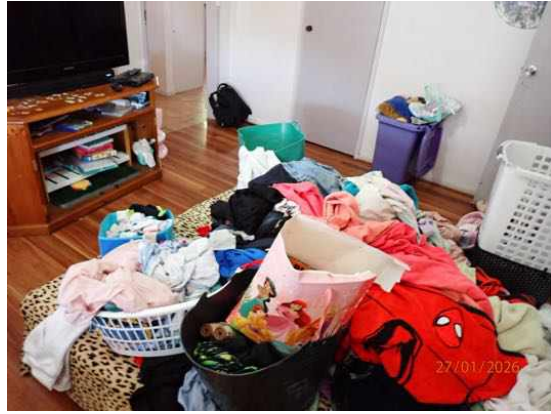
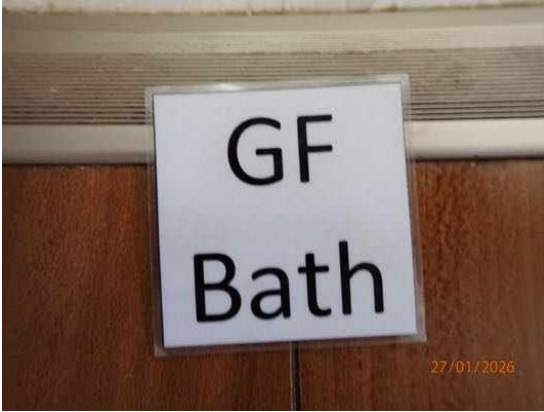
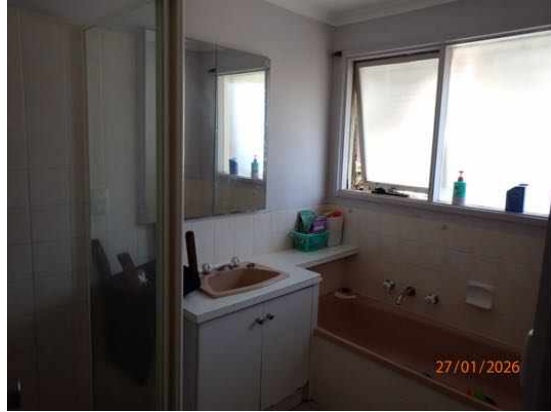
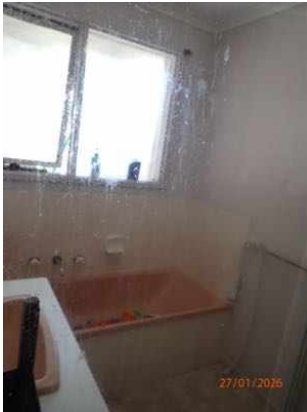
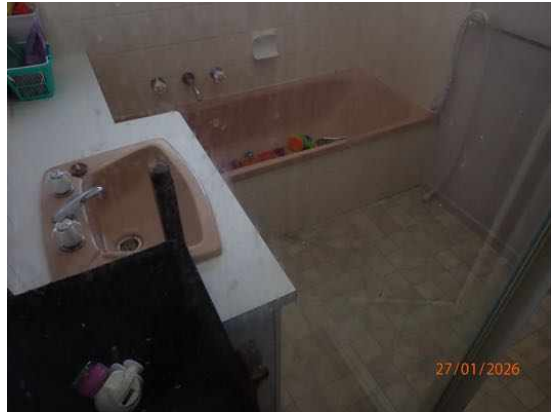
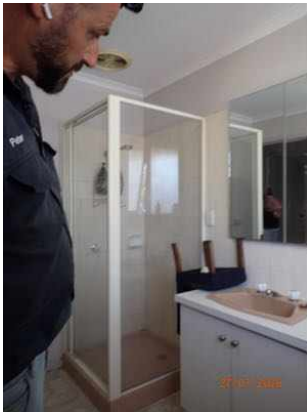
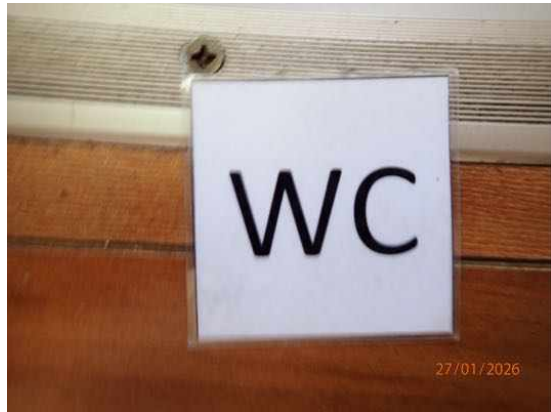
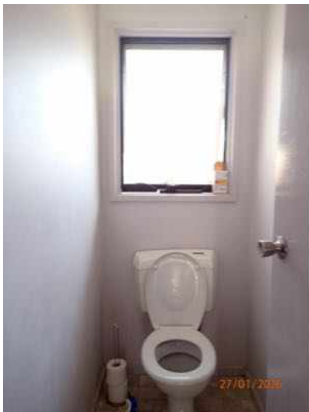
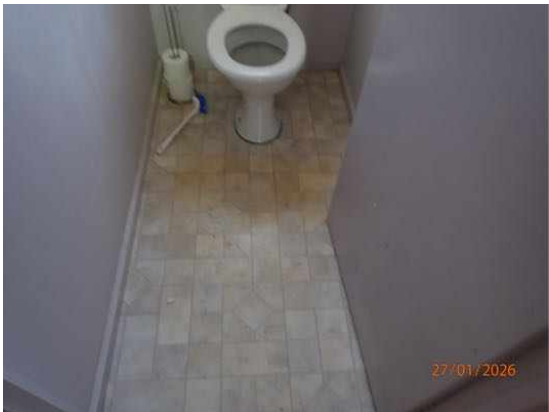
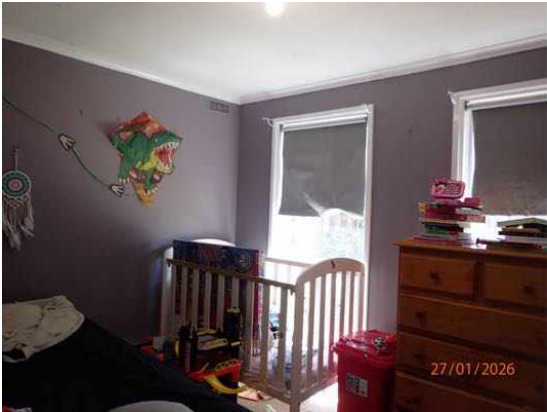
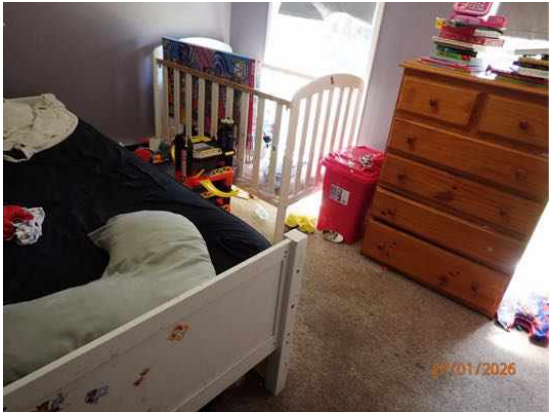
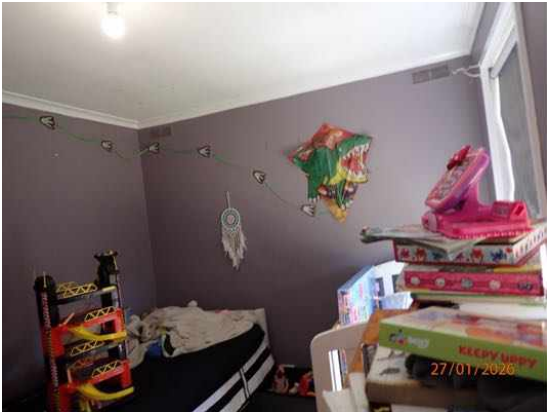
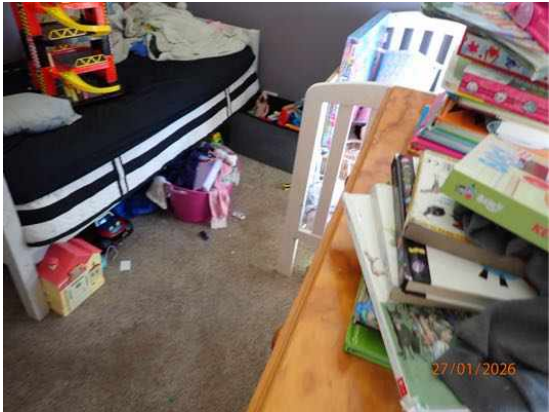
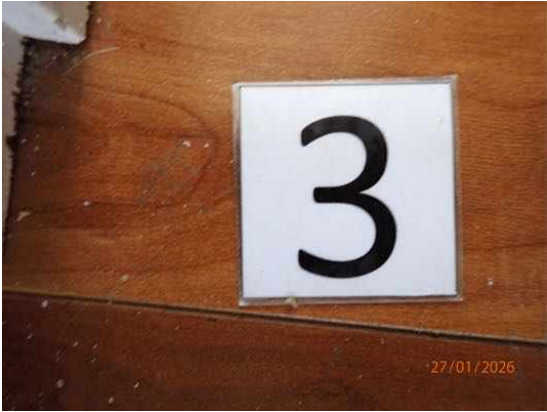
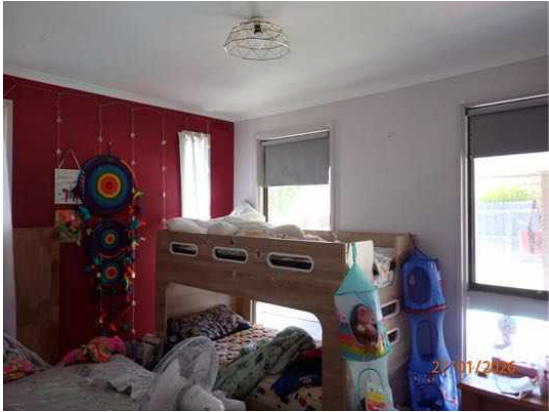
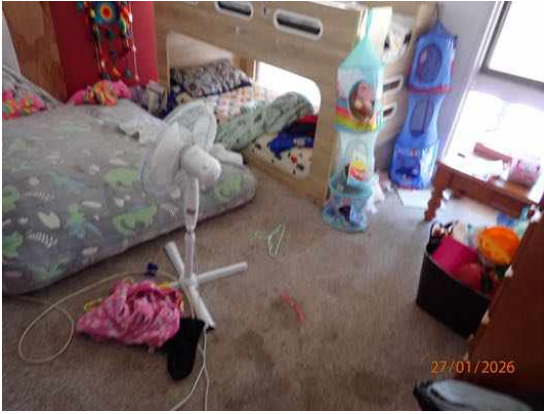
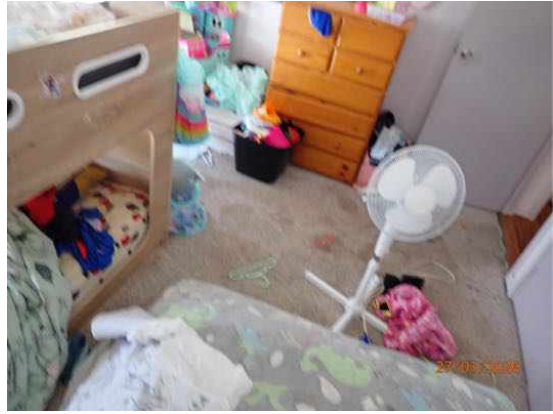
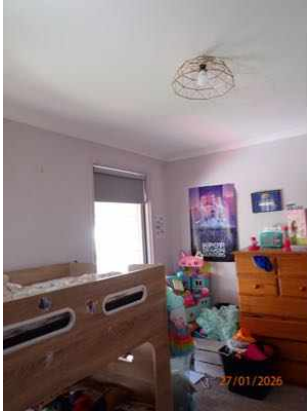
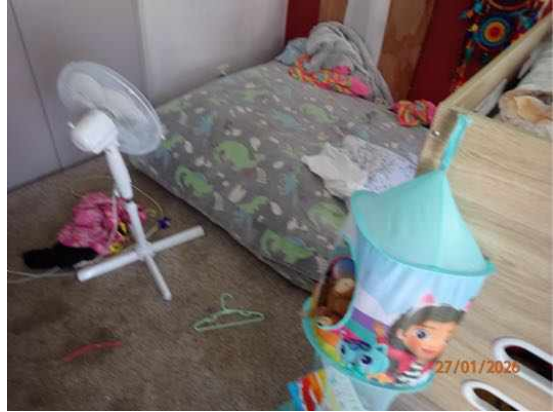
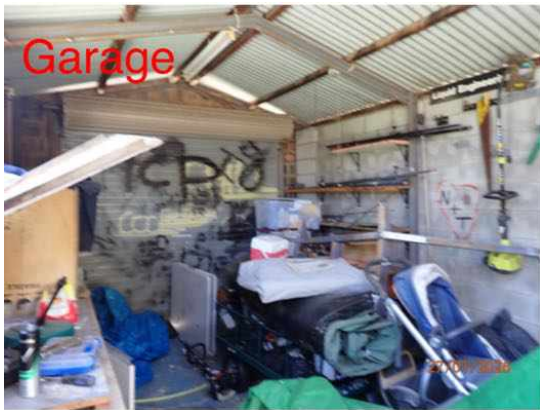
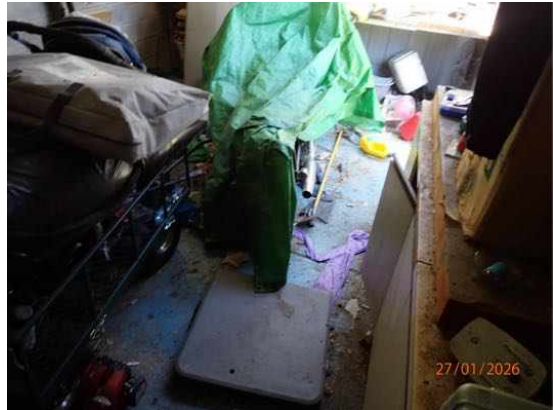
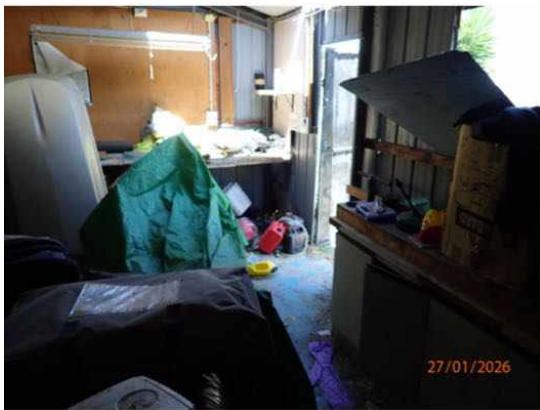
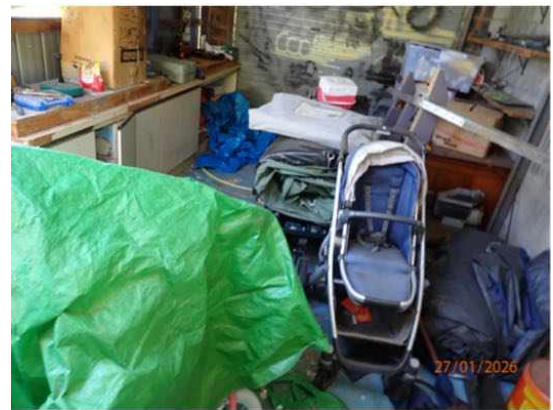
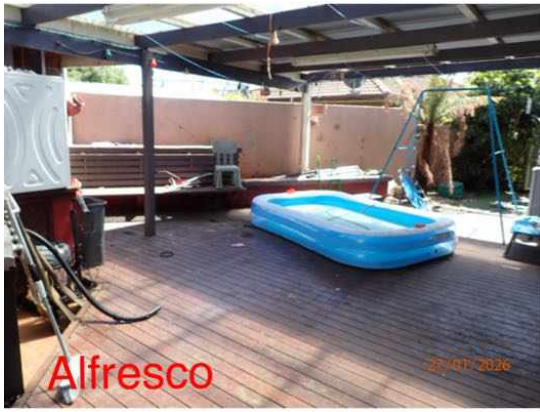
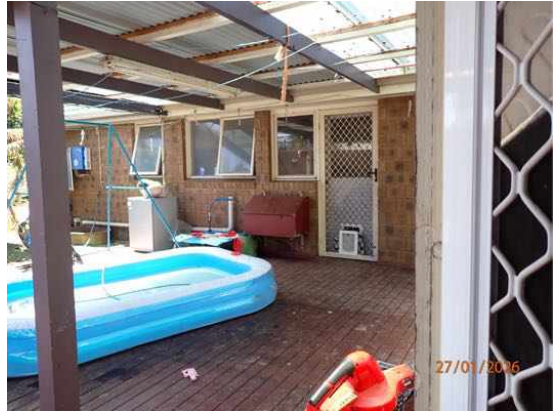
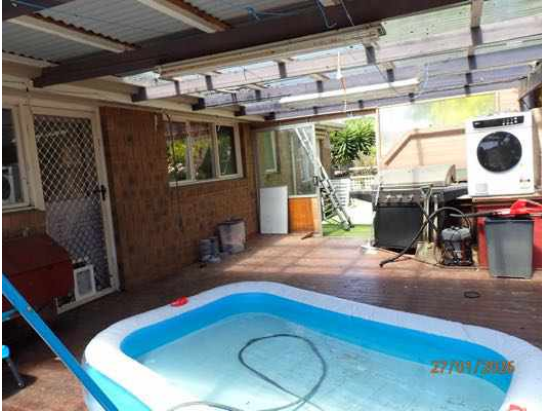
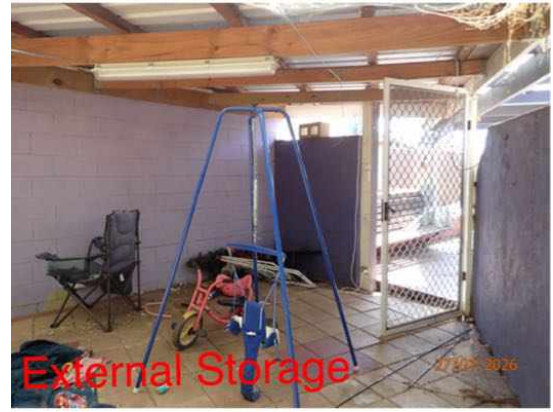
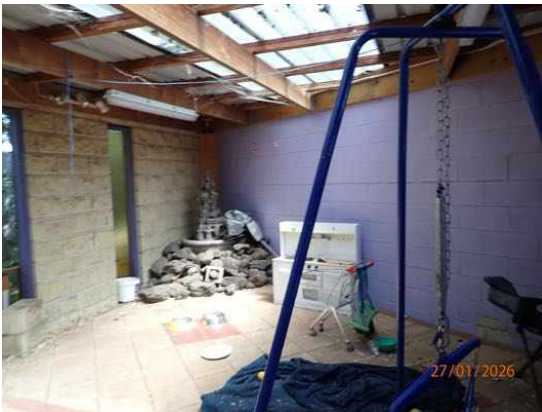
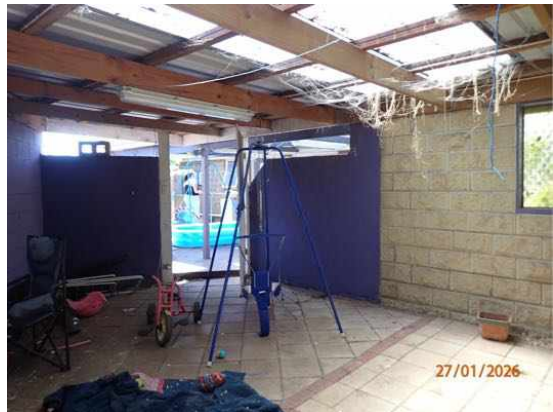
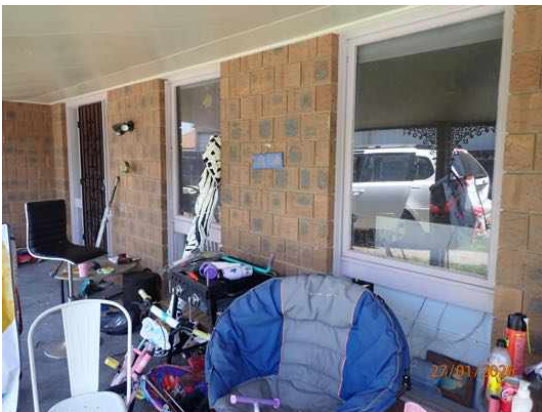
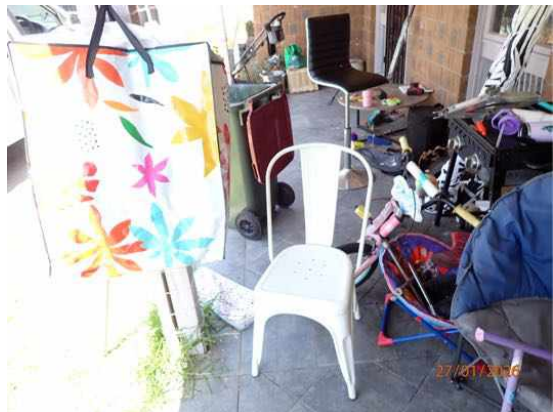
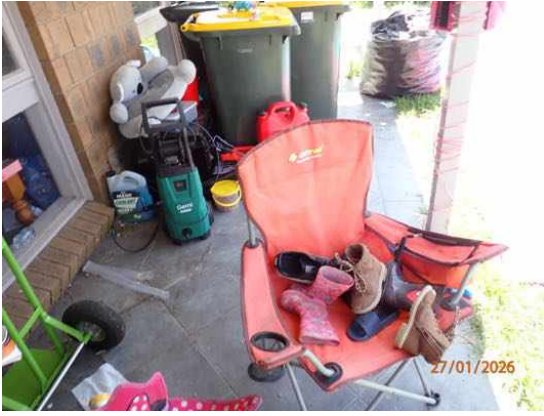
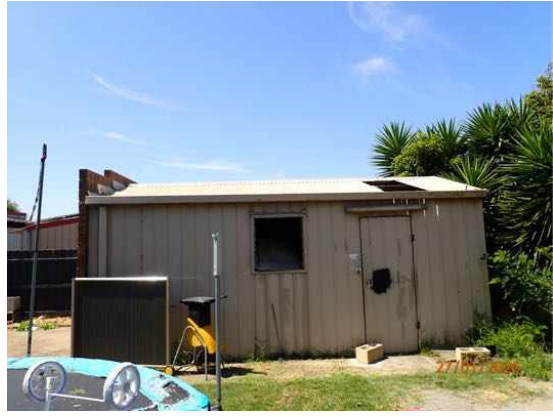
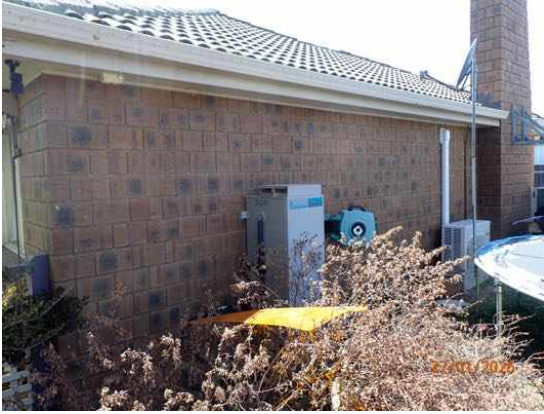
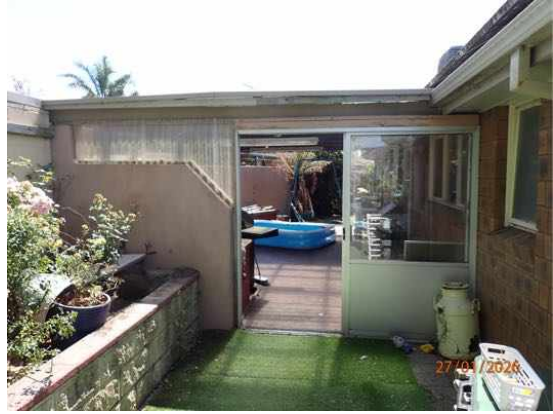
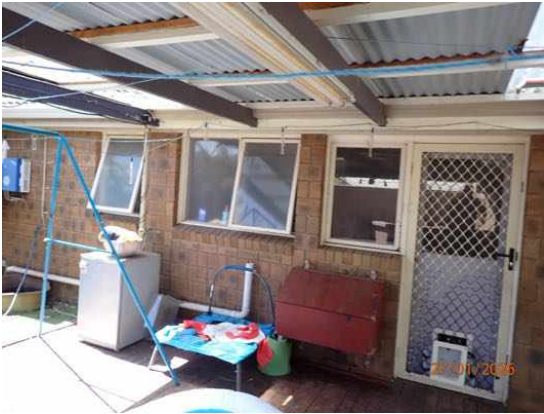
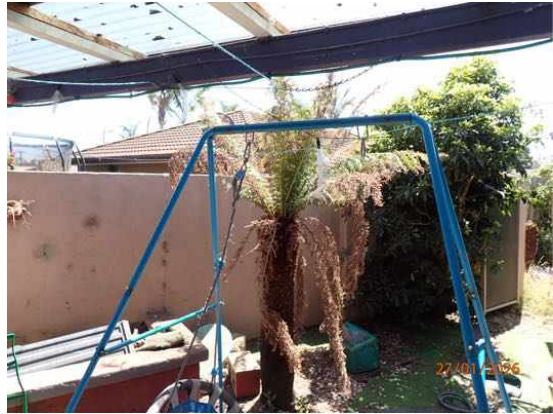
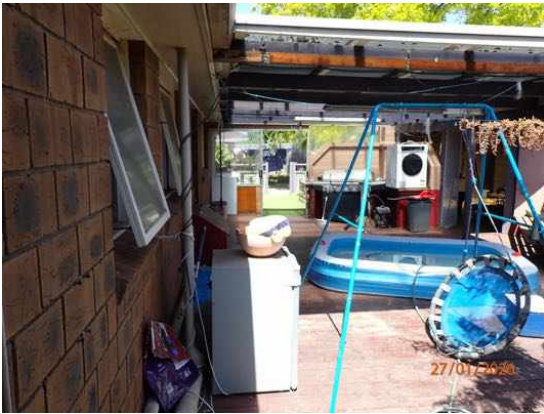
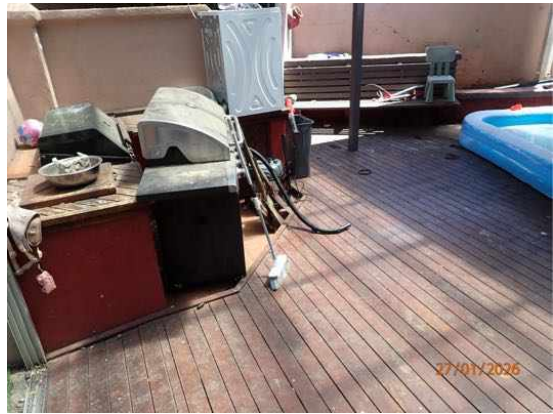
Building: Main Building
Location: All Areas
Finding: Additional Photos - Obstructions and Limitations
Information: These photographs are an indication of the obstructions and limitations which impeded full inspection of the property at the time of inspection. These obstructions can hide an array of defects and should be removed to allow full inspection to be carried out. A re-inspection is recommended once the areas are made accessible.
