Building and Timber Pest Inspection Report

Inspection Date: Tue, 10 Feb 2026

Property Address: 30 Murrumba Dr, Ashmore QLD 4214,
Australia

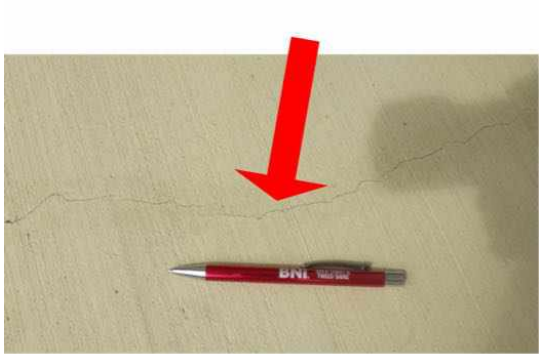
Building: Main Building
Location: Driveway > Ground Level
Finding: Cracking in concrete slab - Category 1
Information: Minor cracking coded as Category 1 was identified in the driveway and footpaths concrete slabs (as per example photos). A Category 1 crack is described as a fine but noticeable crack, with the slab at an otherwise reasonable level.

To be considered Category 1, the approximate width of the crack is less than 1.0mm, or a less than 10mm change in offset when a 3m straight edge is placed over the defect.

Category 1 cracks should be monitored for a period of 12 months. At the end of the monitoring period, identified cracks that are rated greater than Category 2 are considered defects, and require rectification.

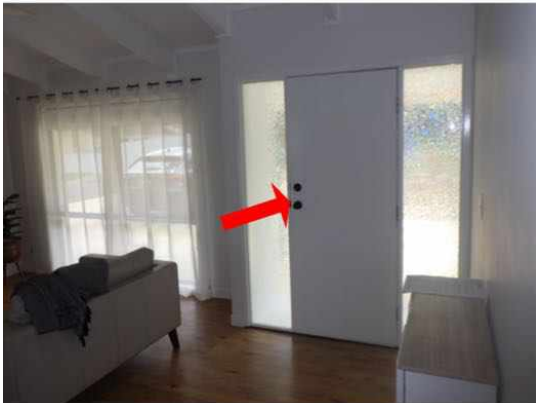
Finding 3.02

Building: Main Building
Location: Entry > Front
Finding: Door - Not latching
Information: The entry door was found to be difficult to latch at the time of inspection. Breakage occurs generally when the building materials have aged and decayed.

A qualified carpenter or general handyman could be appointed to adjust the door handle striker plate at the client's discretion.

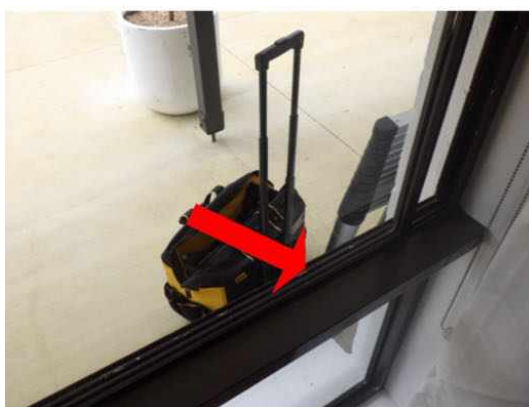
Finding 3.03

Building: Main Building
 Location: Living Room > Front Right
 Finding: Window - Stiff to Slide
 Information: The aluminium sliding window in the living room area was stiff to operate at the time of the inspection. Windows provide ventilation to the adjoining area and should be at a fully operational level to ensure user comfort. Restricted function of the window may also pose as a potential safety hazard if required for emergency egress from the building.

Generally, factors such as general age of the building element and a lack of maintenance are the usual causes for this type of defect.

An aluminium window service agent will be required to repair the affected windows.

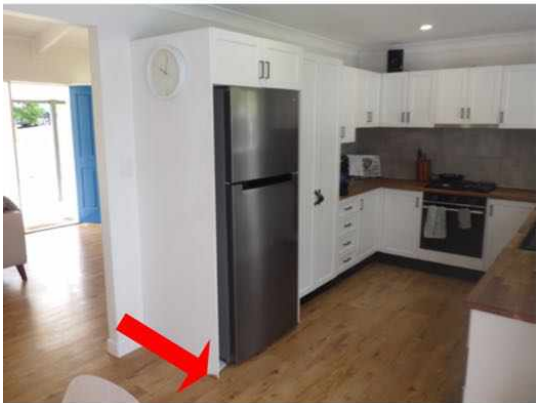
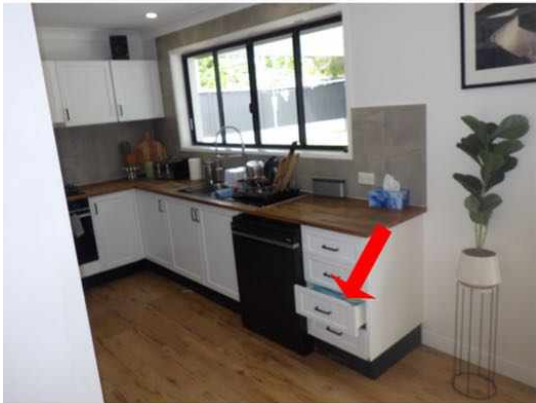
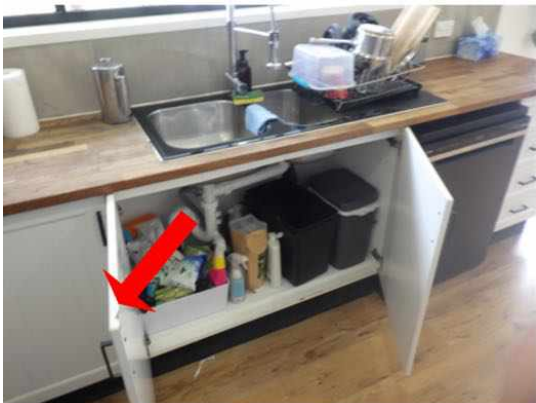
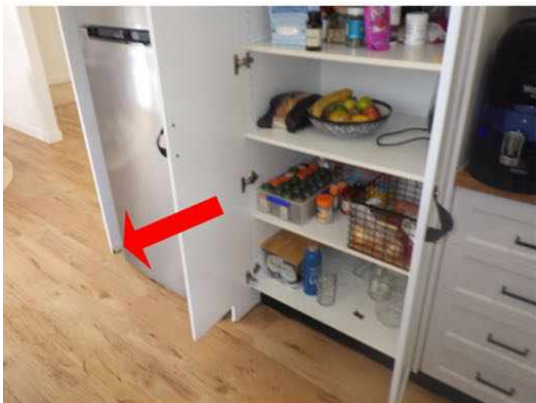
Finding 3.04

Building: Main Building
 Location: Kitchen > Existing
 Finding: Cabinetry - Deterioration
 Information: At the time of inspection the kitchen cabinetry showed signs of minor deterioration (as per example photos). The level of damage appears consistent with exposure to moisture or general wear and tear.

A qualified cabinet maker or general handyman could be engaged to undertake repair works at the clients discretion.

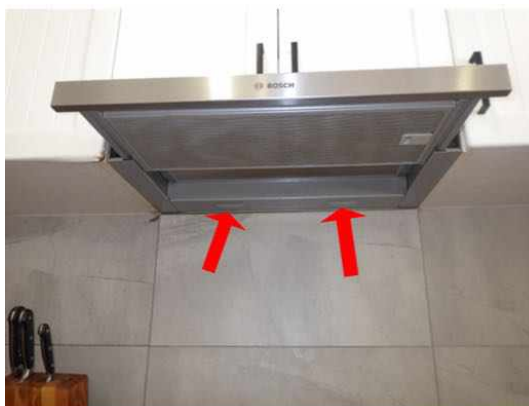
Finding 3.05

Building:	Main Building
Location:	Kitchen > Centre,Rear
Finding:	Rangehood - Light
Information:	The range hood light was not working at the time of inspection. It is advised to replace the bulb first - if still not functioning, a licensed electrician could be appointed to repair or replace the range hood to restore it to a fully operational state.

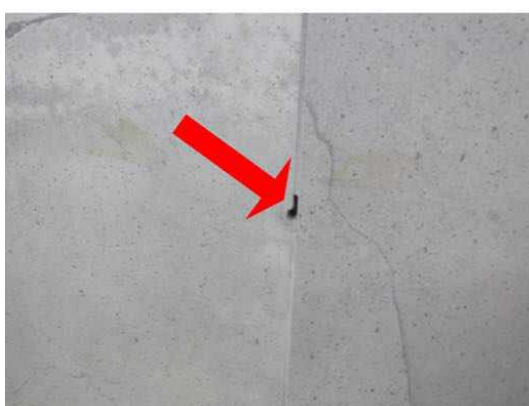
Finding 3.06

Building:	Main Building
Location:	Kitchen > Front Right
Finding:	Grout - Missing
Information:	A small section of grout is missing from the wall splash back tiles in the kitchen. Grout is used to protect gaps and crevices in building materials to ensure that they are water-tight and prevent water penetration to the associated structures.

Where grout is missing, a tiling contractor or general handyman could be appointed to undertake repair works.

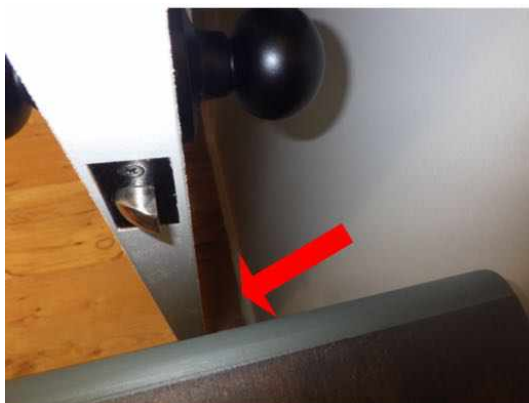
Finding 3.07

Building:	Main Building
Location:	Bedroom - Master > Front

Finding: Door stop - Missing
 Information: The main bedroom door stop is missing or is inadequate to stop the door handle from damaging the wall.

Re-installation or replacement of the door stop is advised to prevent any subsequent damage to the wall linings or associated structures.

A general handyman may be appointed to perform these works at client discretion.

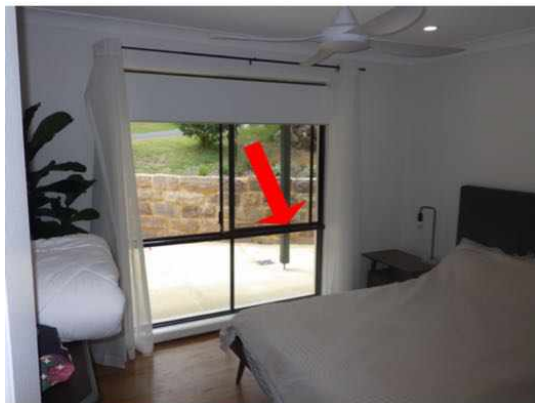
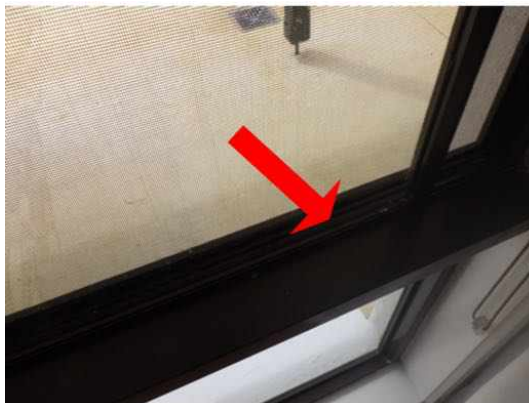
Finding 3.08

Building: Main Building
 Location: Bedroom - Master > Centre,Rear
 Finding: Window - Stiff to Slide
 Information: The aluminium sliding window in the main bedroom area was stiff to operate at the time of the inspection. Windows provide ventilation to the adjoining area and should be at a fully operational level to ensure user comfort. Restricted function of the window may also pose as a potential safety hazard if required for emergency egress from the building.

Generally, factors such as general age of the building element and a lack of maintenance are the usual causes for this type of defect.

An aluminium window service agent will be required to repair the affected windows.

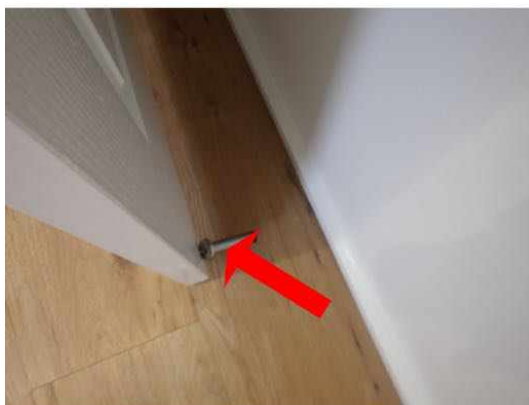
Finding 3.09

Building: Main Building
 Location: Bedroom 3 > Front Left
 Finding: Door stop -
 Information: The bedroom 3 door stop is loose or is inadequate to stop the door handle from damaging the wall.

Re-installation or replacement of the door stop is advised to prevent any subsequent damage to the wall linings or associated structures.

A general handyman may be appointed to perform these works at client discretion.

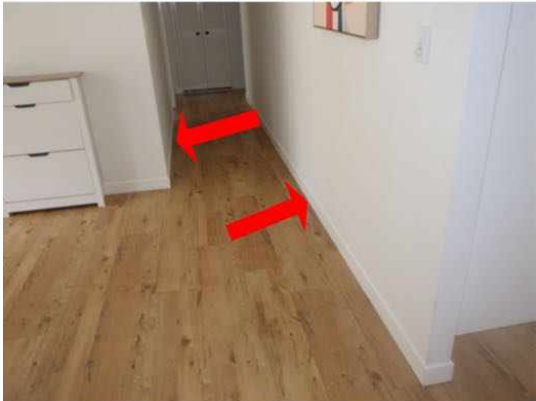
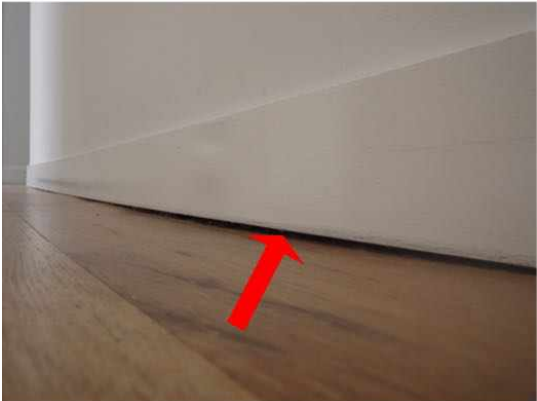
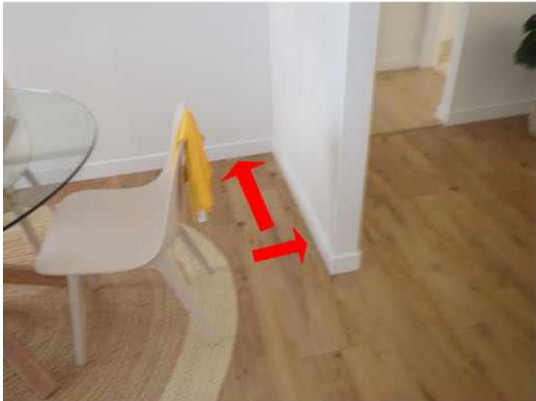
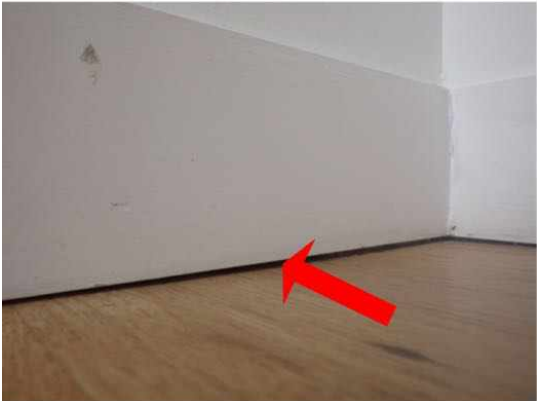
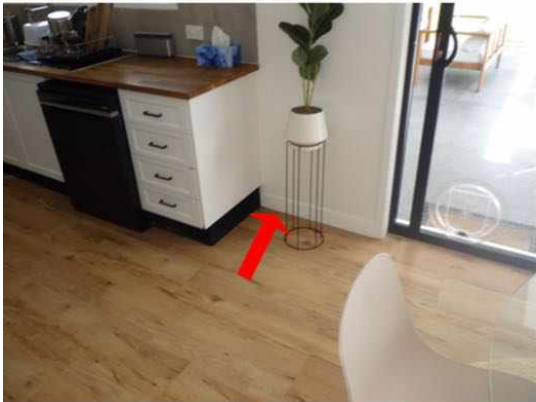
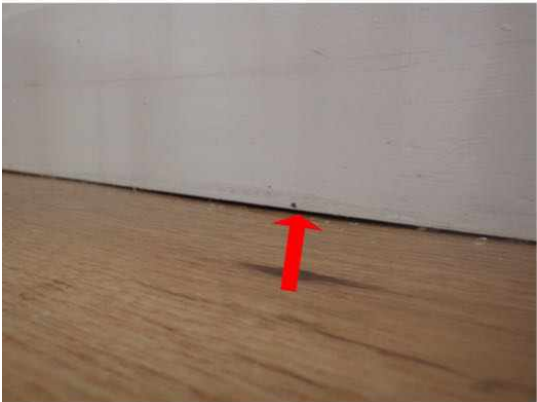
Finding 3.10

Building: Main Building
 Location: Internal Areas > Existing
 Finding: Skirting - Sealant
 Information: The skirting board/ floating floor intersection to the perimeter of the rooms in a number of areas throughout the property have not been sealed (as per example photos). The presence of these types of gaps can create areas for potential pest activity or nesting.

A qualified painter or general handyman could be engaged to fill the gaps with a suitable flexible sealant at the clients discretion.

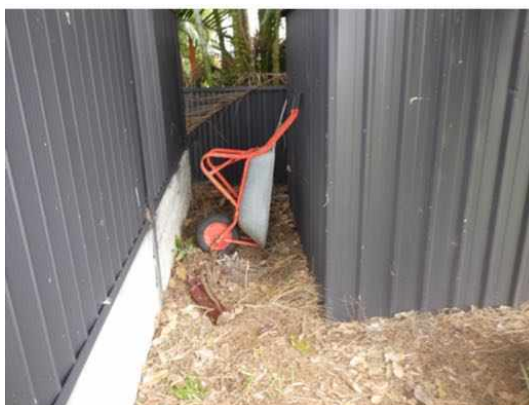
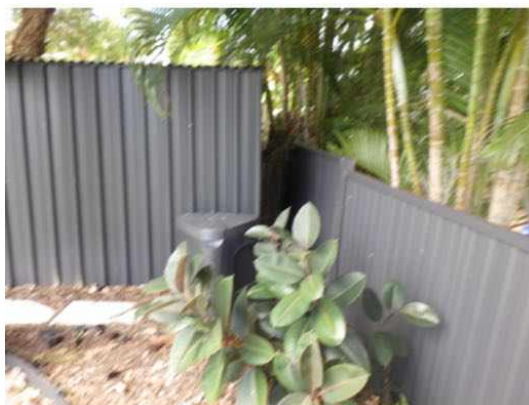
Finding 6.01

Building:	Main Building
Location:	Yard - Back > Ground Level
Finding:	Garden Beds - Conditions Conducive to Termites
Information:	Garden beds and external landscape areas were found to contain debris and garden waste at the time of inspection (as per example photos). These garden beds can include untreated timber, and with a combination of moisture from watering hosing can make conditions conducive to termite activity and termite ingress. Removal of any garden debris is highly advised. Frequent pest inspections are advised to readily identify any termite activity in these areas.

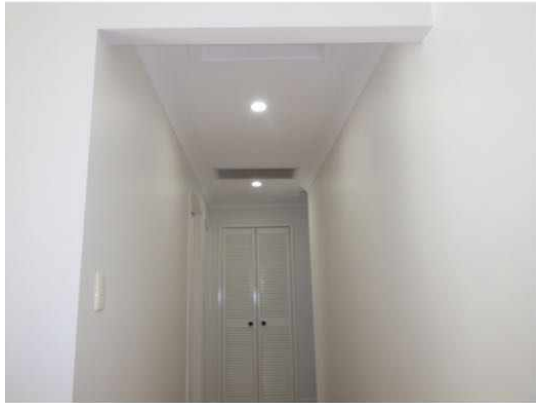
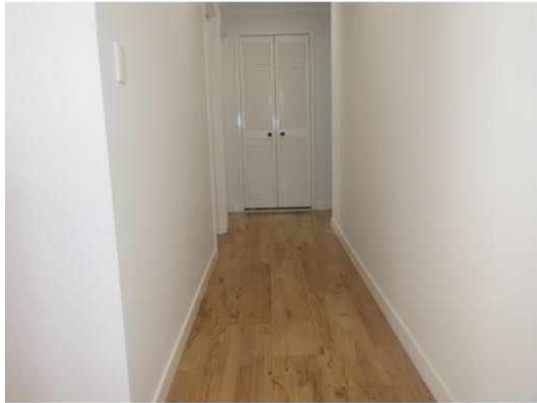
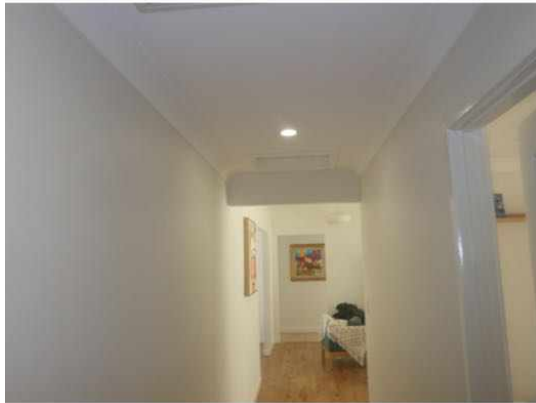
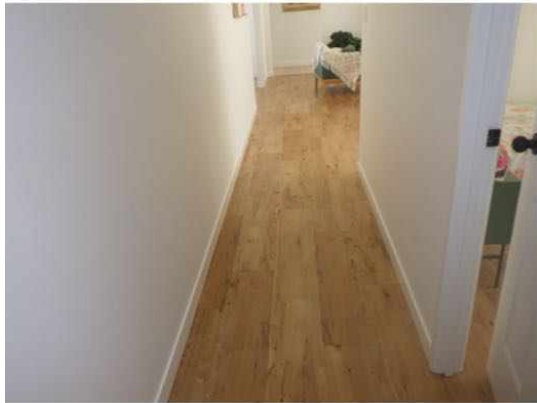
Location: Hallway > Existing
Finding: No obvious defect
Information: No obvious defects found at the time of inspection.

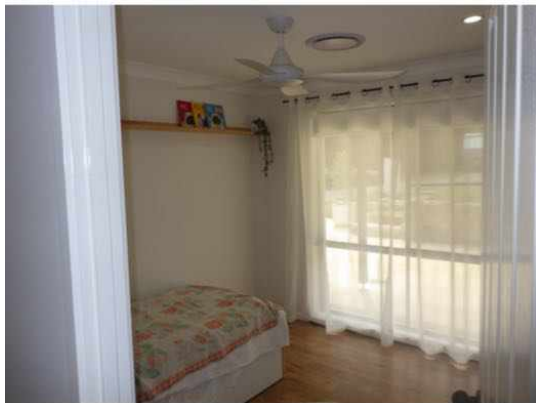
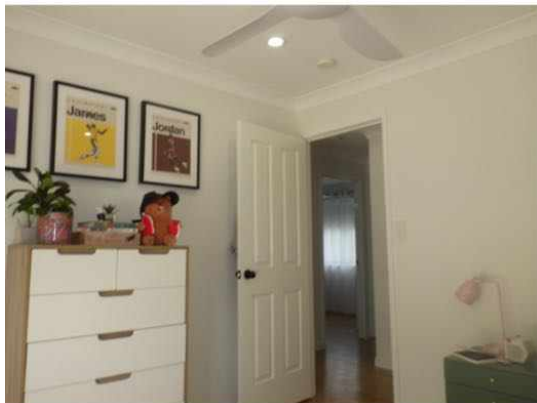
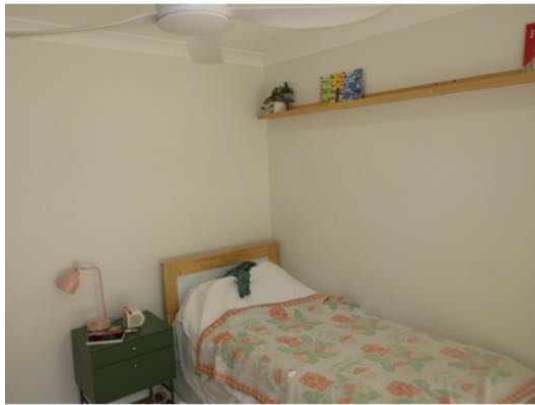
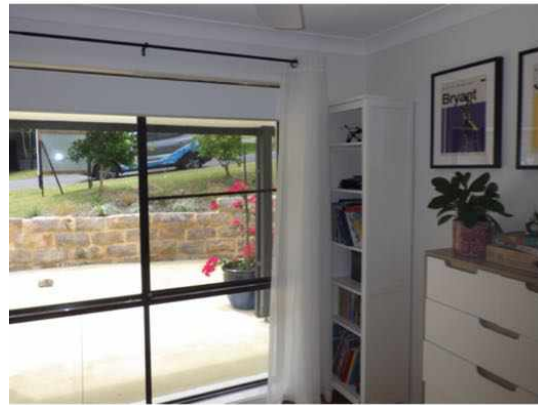
Building: Main Building
Location: Bedroom 2 > Existing
Finding: No obvious defect
Information: No obvious defects found at the time of inspection.

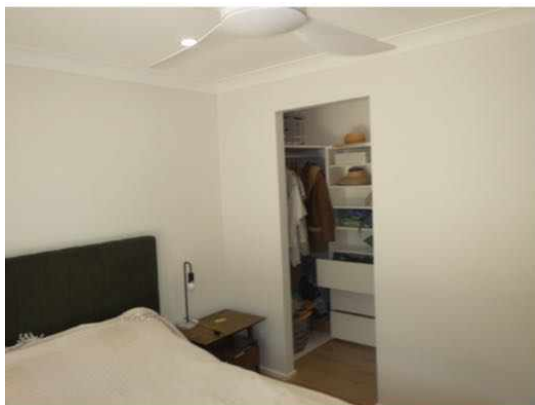
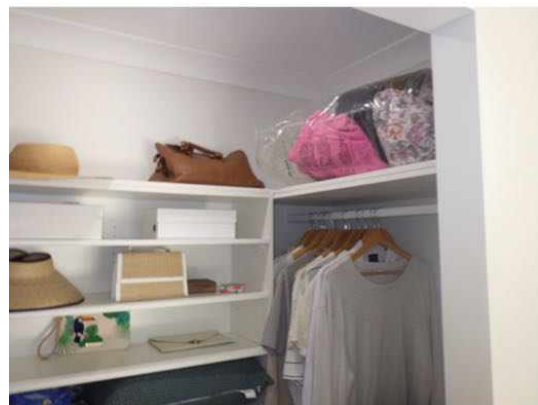
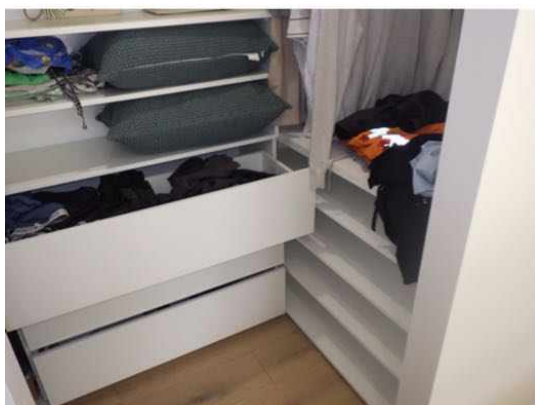
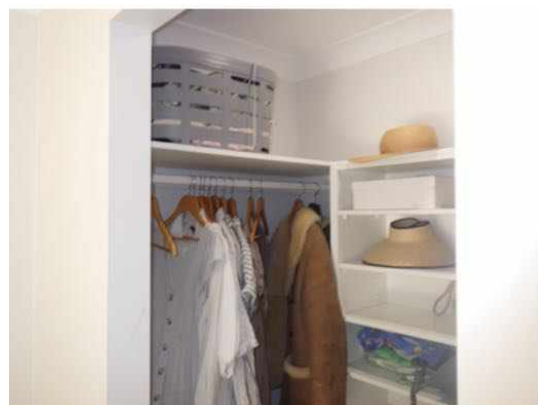
Building: Main Building
Location: Walk In Robe > Existing
Finding: No obvious defect
Information: No obvious defects found at the time of inspection.

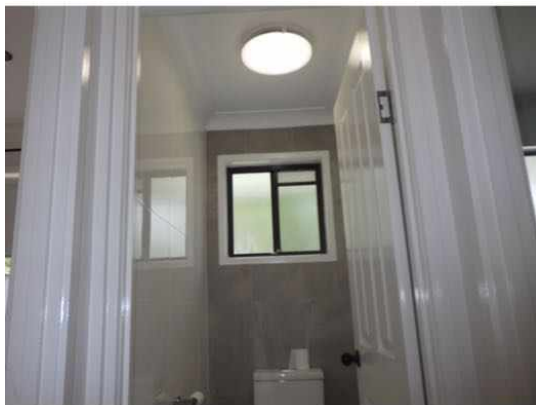
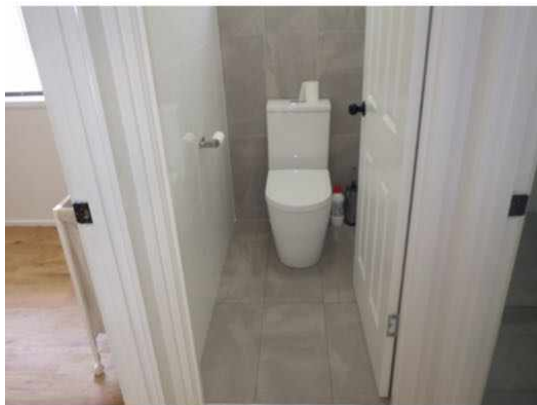
Building: Main Building
Location: Toilet (WC) > Existing
Finding: No obvious defect
Information: No obvious defects found at the time of inspection.

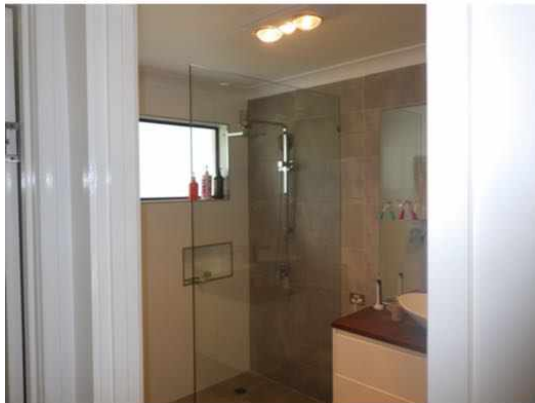
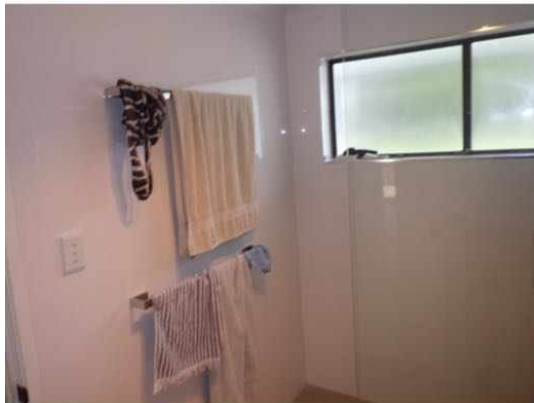
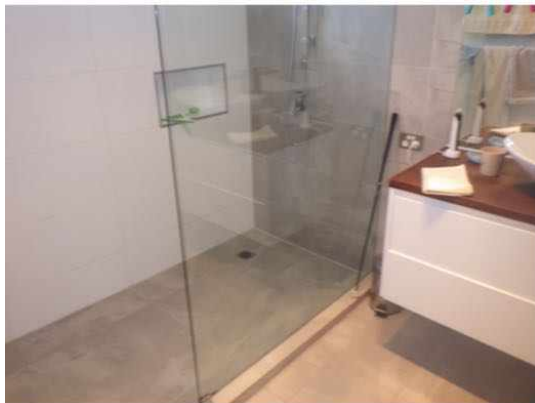
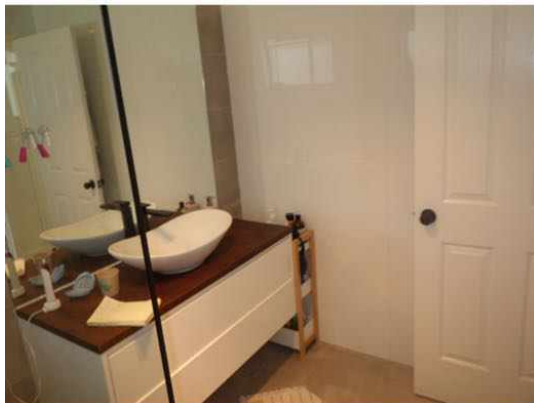
Location: Bathroom > Existing
 Finding: No obvious defect
 Information: No obvious defects found at the time of inspection.

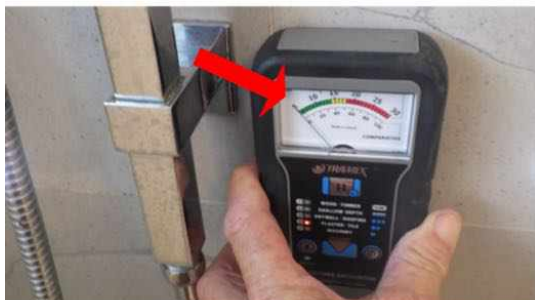
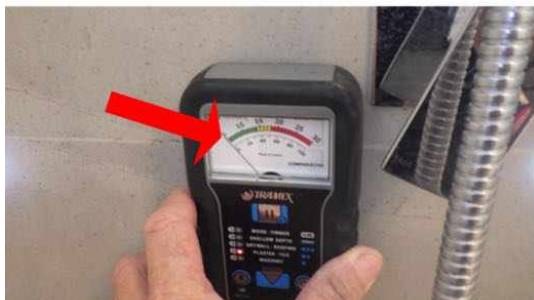
Building: Main Building
 Location: Bathroom > Rear Left
 Finding: Moisture Level Readings
 Information: At the time of inspection the bathroom shower cubicle areas checked with the Tramex Moisture Meter returned low - normal moisture level readings.

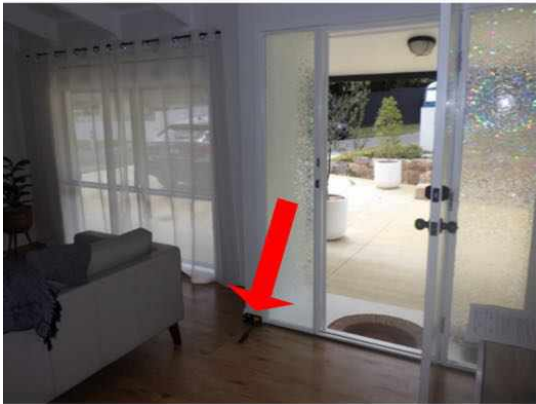
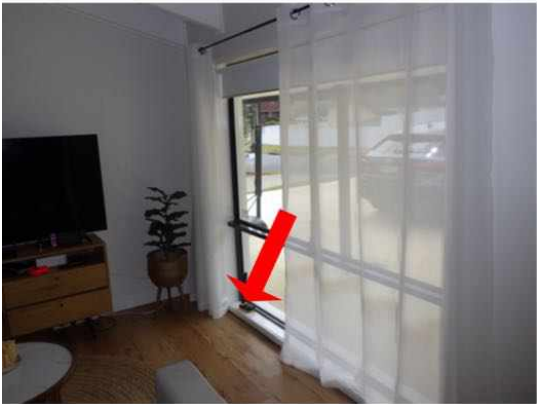
Building: Main Building
Location: Internal Areas > Existing
Finding: Termitracker
Information: The termitracker itracker was positioned randomly to internal wall, timber skirting and window frame areas checking for signs of termite activity.

No activity was recorded at the time of inspection.

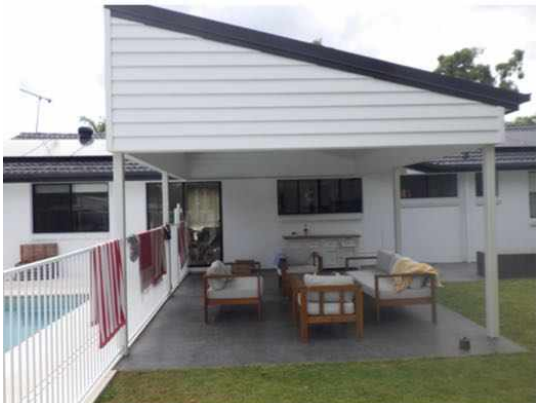
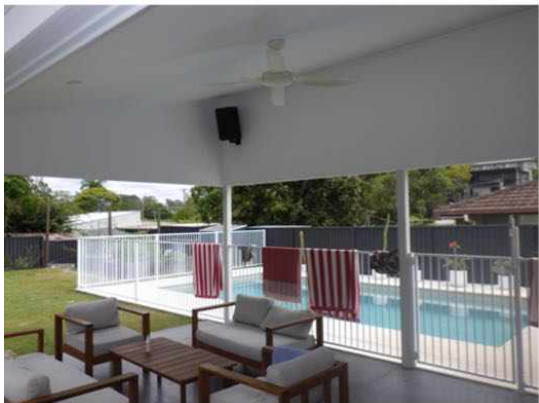
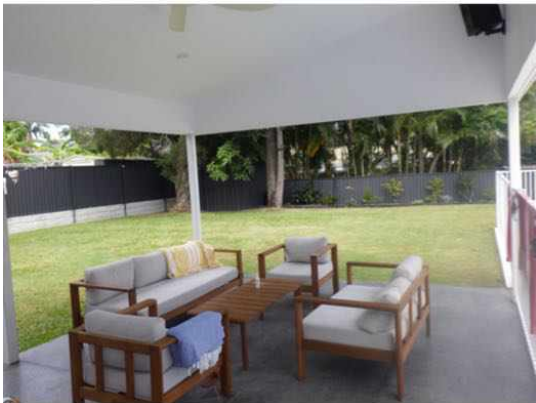
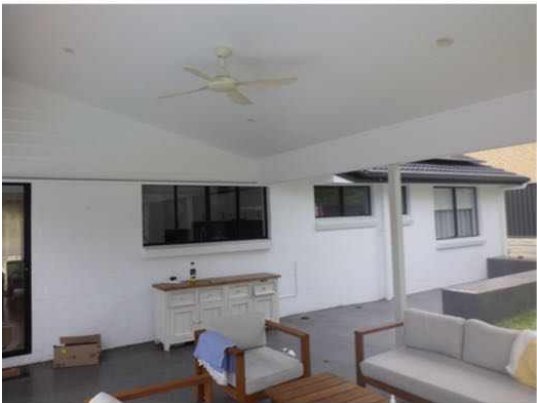
Building: Main Building
Location: Alfresco > Existing
Finding: No obvious defect
Information: No obvious defects found at the time of inspection.

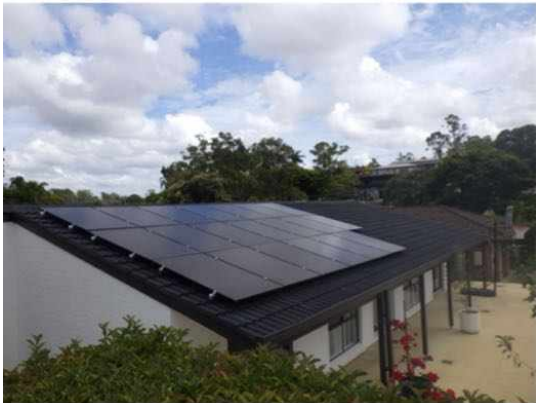
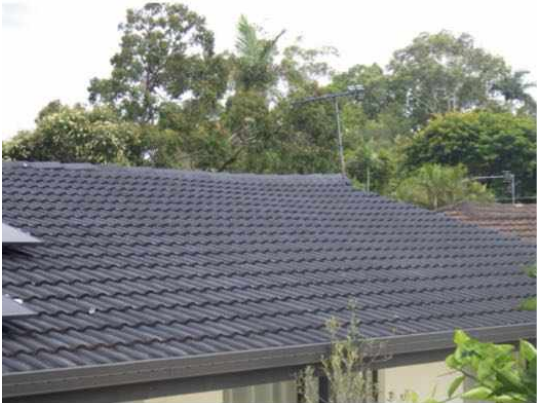
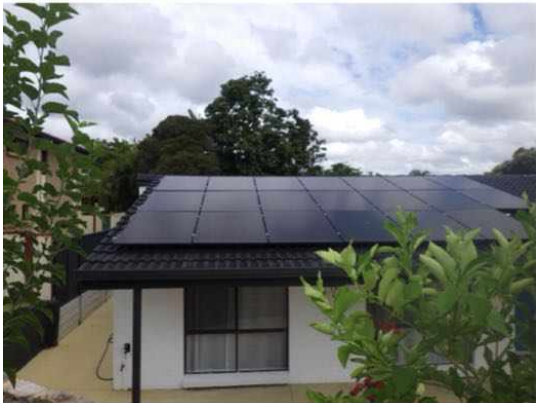
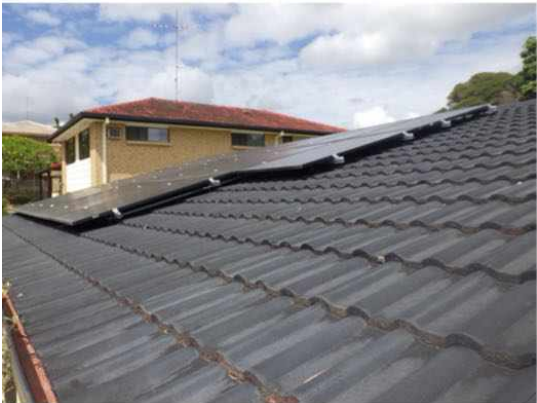
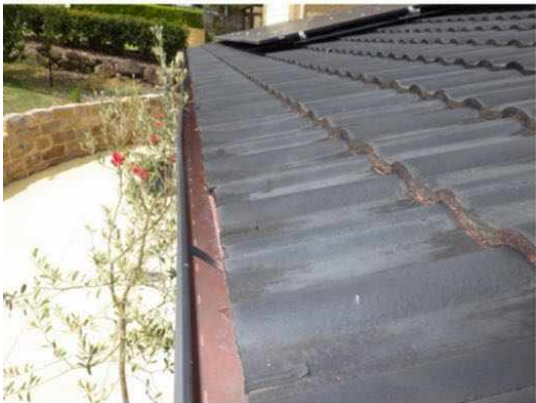
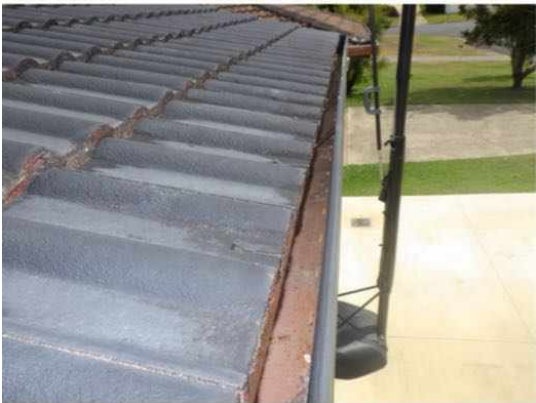
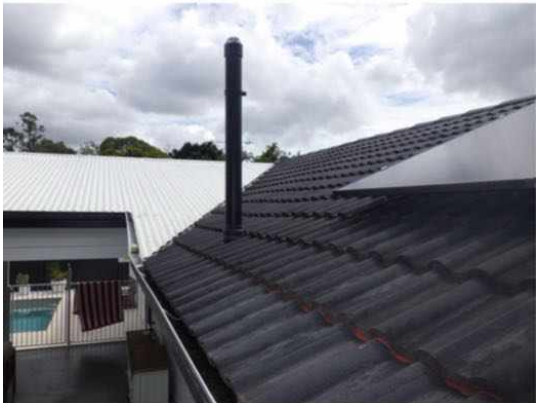
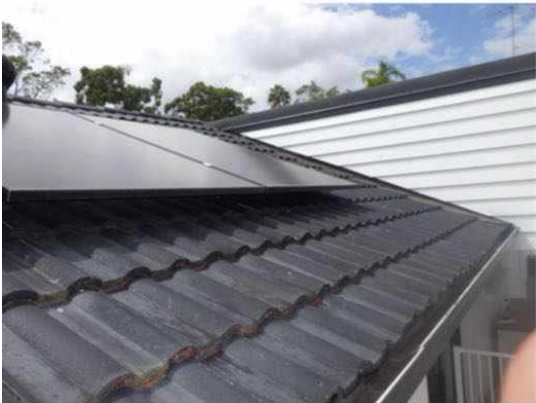
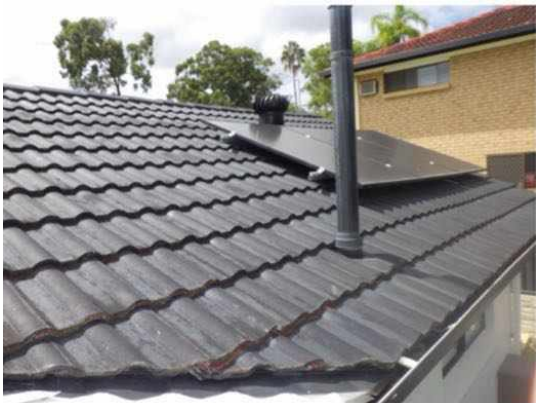
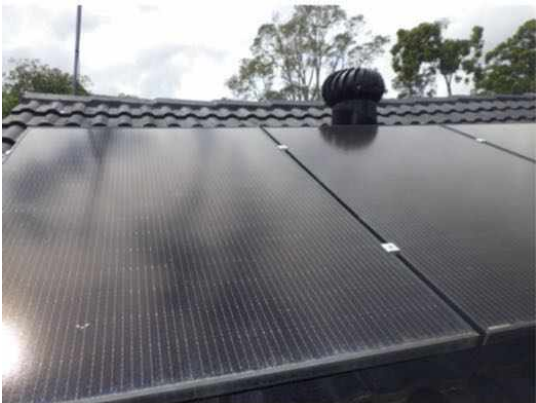
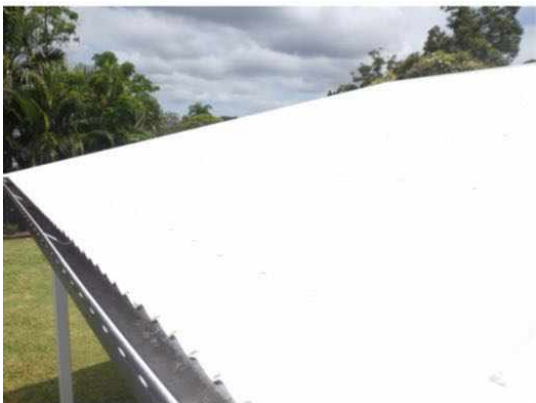
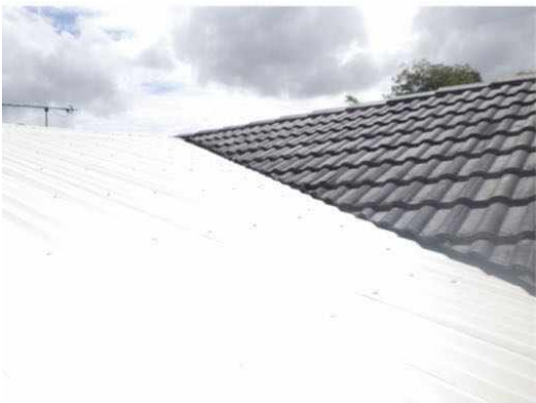
Building: Main Building
Location: Roof Exterior > Existing
Finding: No obvious defect
Information: No obvious defects found at the time of inspection.

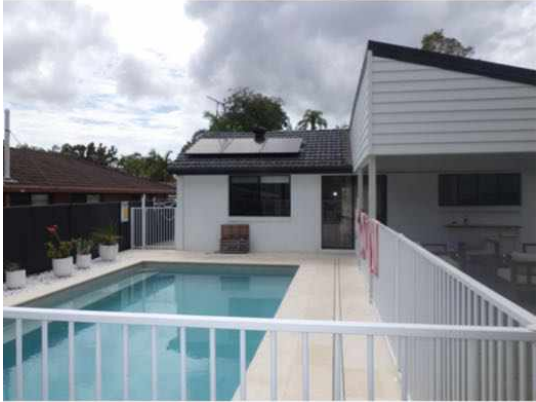
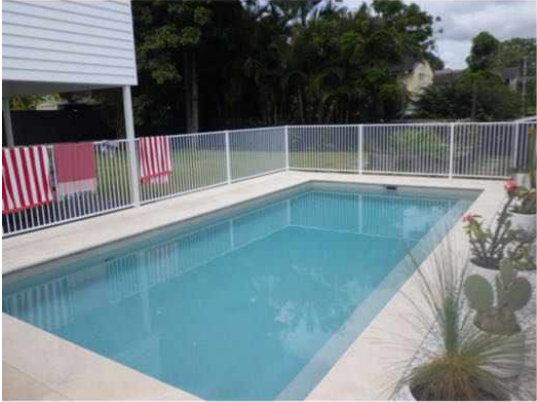
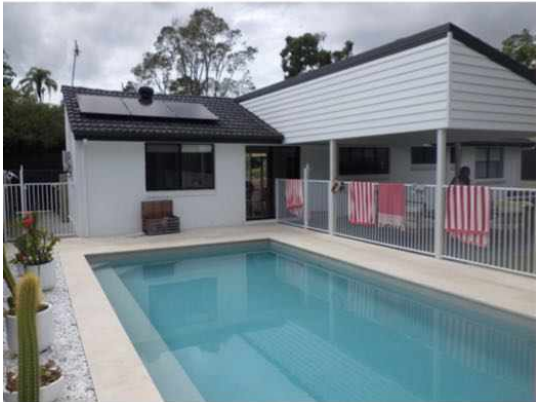
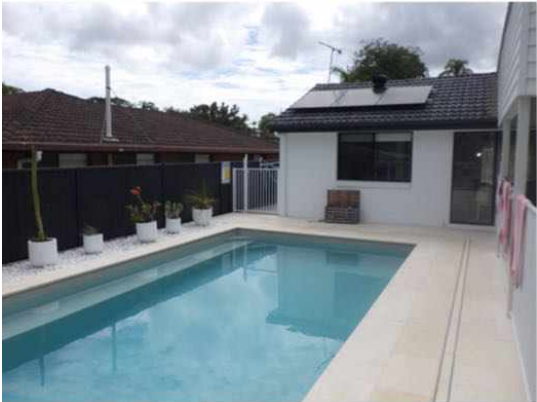
Building: Main Building
Location: Pool Area > Existing
Finding: No obvious defect
Information: No obvious defects found at the time of inspection.

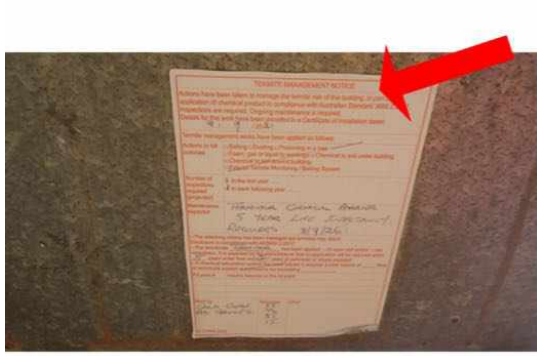
In this instance evidence of a previously installed chemical barrier was observed, with a durable notice (expiry 8/9/2026) observed inside the electrical meter box. This system requires regular annual inspections.

NOTE - No evidence of plugged holes to the building perimeter ground area concrete slabs, generally associated with post construction chemical treatments, or regular annual inspections was found.
