Building Inspection Report

Inspection Date: Tue, 27 Jan 2026

Property Address: 22 Coral Cl, Rosebud VIC 3939, Australia

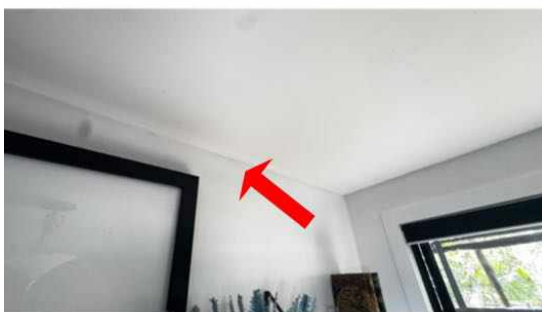
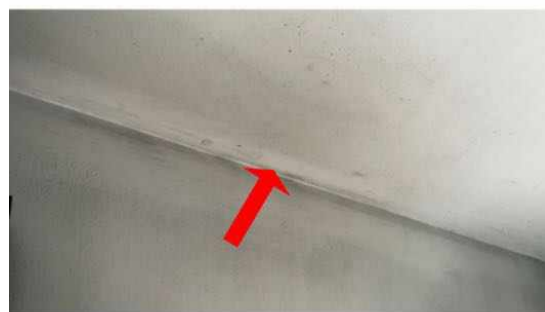
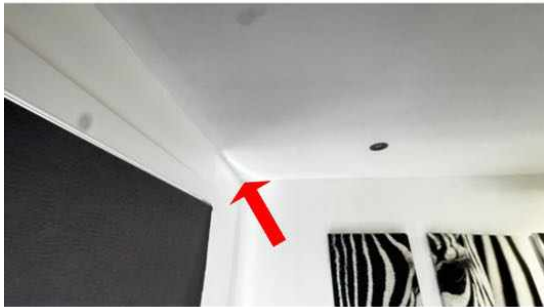
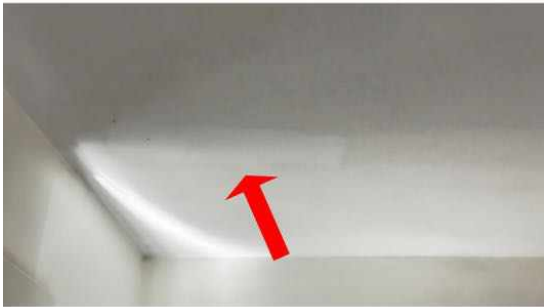
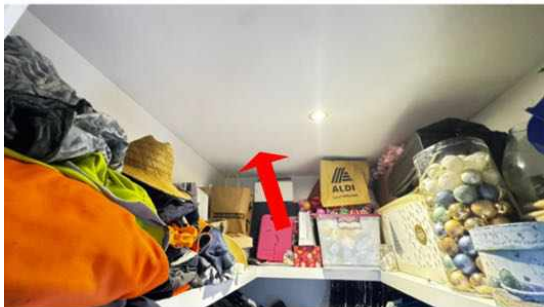
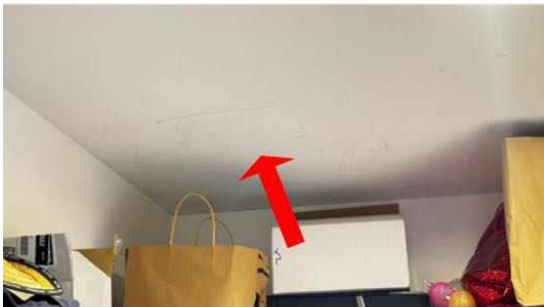
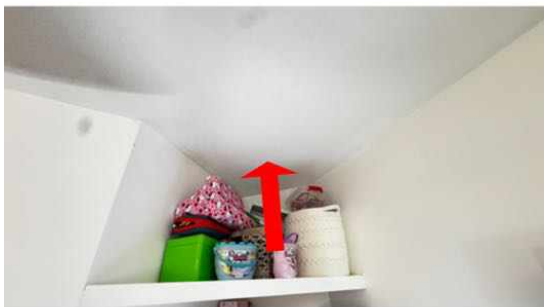
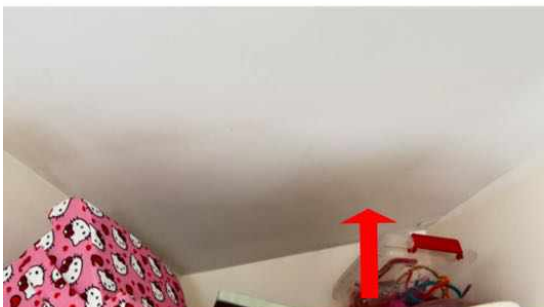
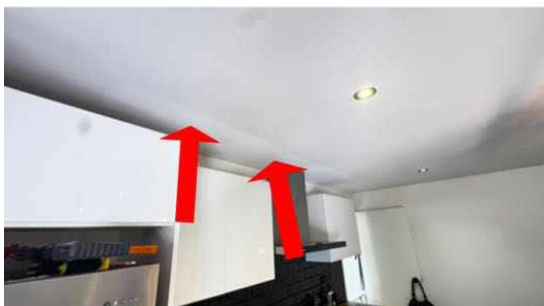
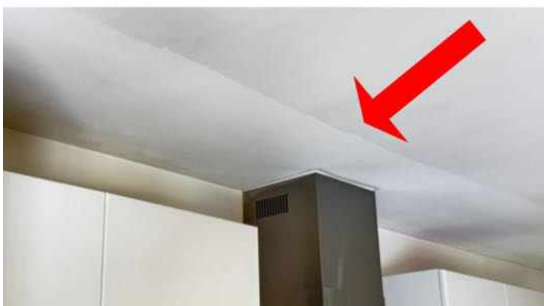
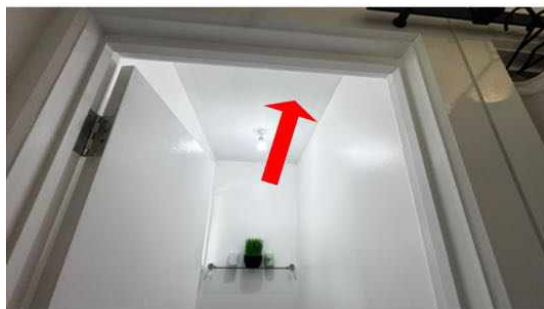
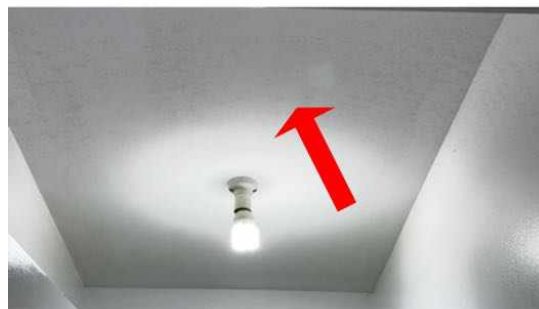
Defects 3.01

Building: Main Building
Location: All Areas
Finding: Ceilings - Paint Finishes Discolouration
Information: The ceilings were inspected for paint condition, and discolouration and uneven finishes were observed in this area. While primarily a cosmetic issue, the affected paint may indicate age-related wear, poor surface preparation, or previous repairs.

This may be due to age-related degradation of paint layers, poor application or surface preparation, or previous patching with incompatible paint.

When practical, a qualified painter should be engaged to prepare and repaint the affected areas. Addressing paint deterioration will improve the appearance of the ceilings and help protect the surfaces from further wear.

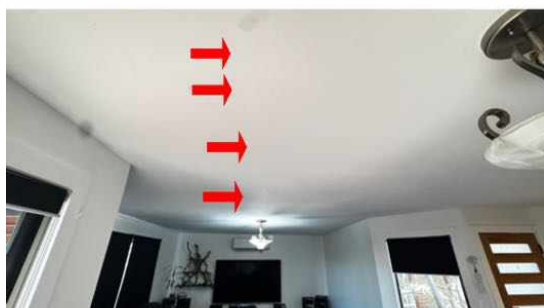
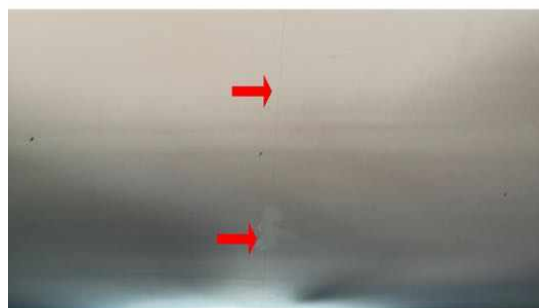
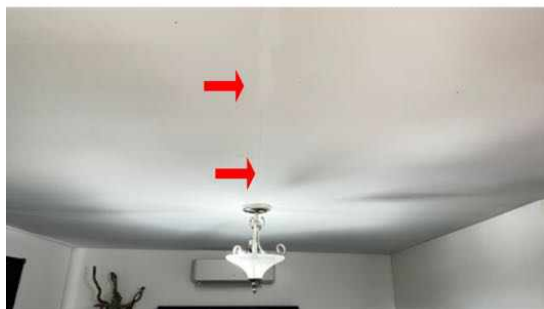
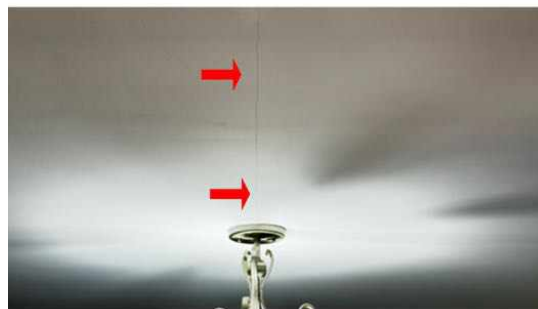
Defects 3.02

Building:	Main Building
Location:	Lounge Room >
Finding:	Ceilings - Plaster Cracking
Information:	The ceilings were inspected and cracking in the plaster was observed in this area. Cracks can affect the appearance of the ceilings and may worsen over time if left unaddressed.

When practical, a qualified plastering contractor should be engaged to assess and repair the cracked plaster. Prompt action will improve the appearance of the ceilings and help prevent further deterioration.

Cracking should be monitored over time to determine whether movement is ongoing. Where cracks are purely cosmetic, patching and repainting by a qualified plasterer may be undertaken as part of routine maintenance. If cracks widen, reappear after repairs, or are accompanied by other structural signs, further investigation by a registered builder or structural engineer is recommended immediately.

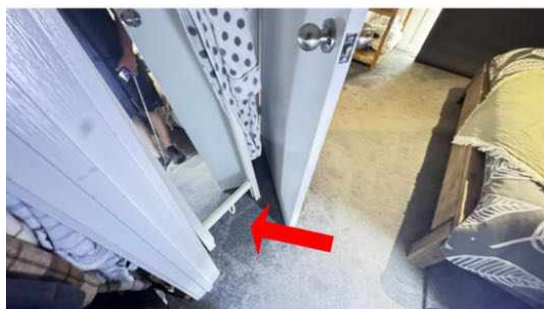
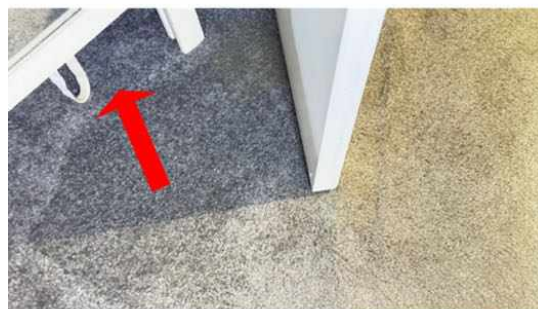
Defects 3.03

Finding: Doors - Missing Door Stops

Information: The inspection identified missing door stops in this area. Missing door stops can lead to damage to walls or doors and may impair the proper operation of the doors.

The absence of door stops may be due to them not being installed during construction or having been removed after installation.

It is recommended that a qualified carpenter or competent handyman be engaged promptly to install the missing door stops. Correct installation will protect doors and walls and ensure proper door functionality.

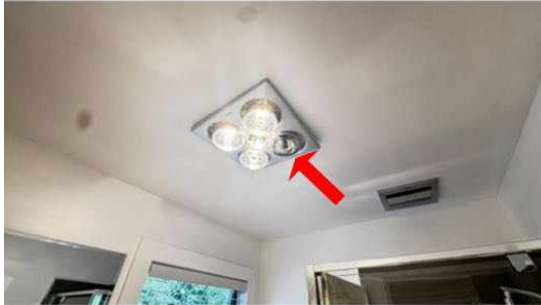
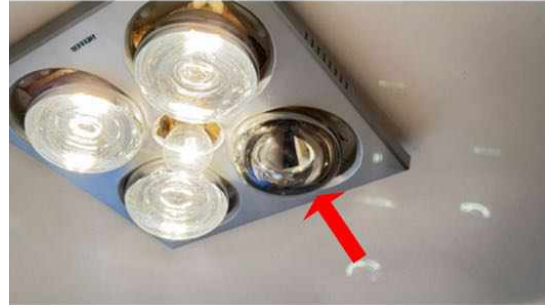
Defects 3.04

Finding: Electrical - Light Fitting Broken

Information: A light fitting was found to be broken in this area. Broken fittings can reduce functionality, limit lighting effectiveness, and, in some circumstances, increase the risk of electrical faults or minor hazards.

The damage may result from accidental impact, age-related deterioration, or wear and tear of components over time.

A licensed electrician should be engaged immediately to repair or replace the light fitting. Prompt rectification will restore lighting functionality, maintain electrical safety, and prevent further damage.

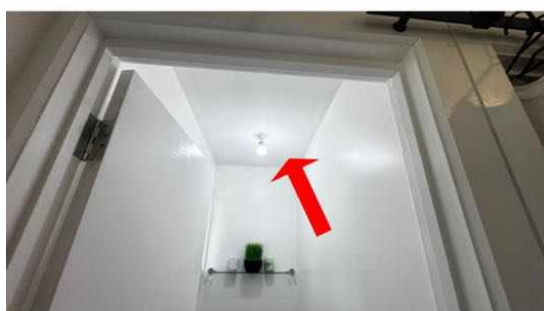
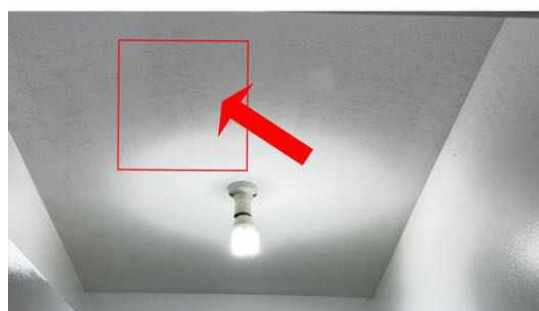
Defects 3.06

Building: Main Building
 Location: Toilet (WC)
 Finding: Bathroom Ventilation - Missing
 Information: Ventilation systems in the bathroom were observed to be missing. Missing ventilation can reduce air circulation, increase humidity, promote condensation and mould growth, and affect indoor air quality and occupant comfort.

This may be due to the systems being removed or not installed during construction.

When practical, a licensed HVAC technician or licenced electrician should be engaged to inspect and install adequate ventilation. This may include installing new compliant ventilation systems. Prompt action will help improve air quality, reduce condensation and mould risk, and ensure compliance with building standards.

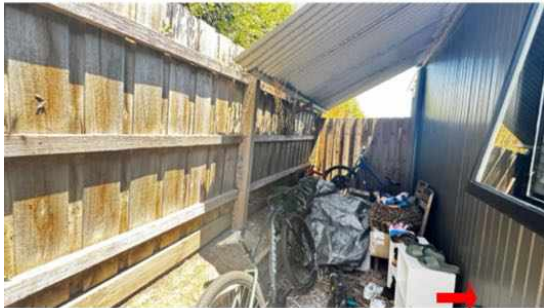
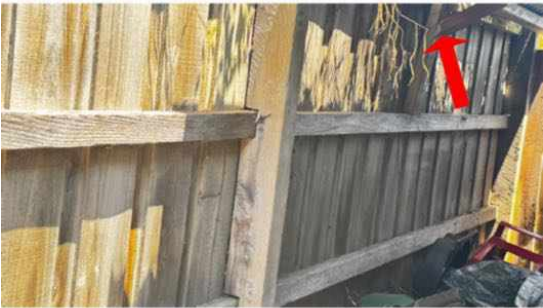
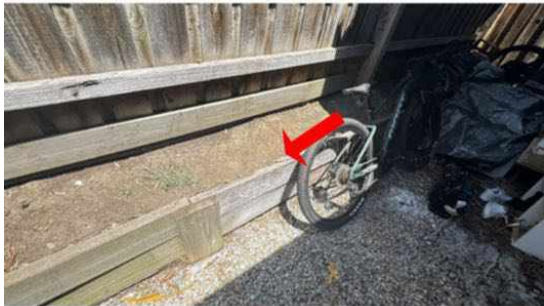
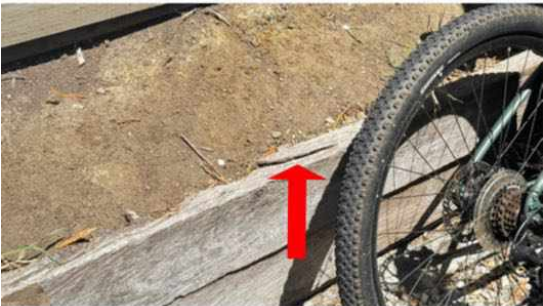
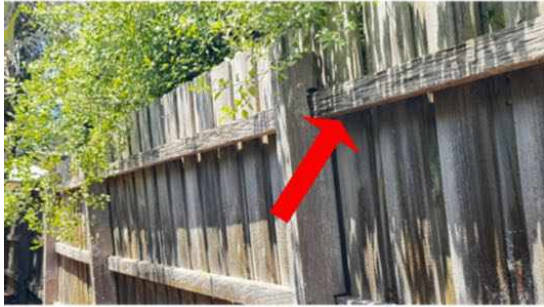
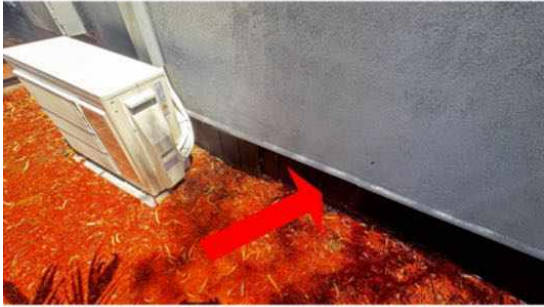
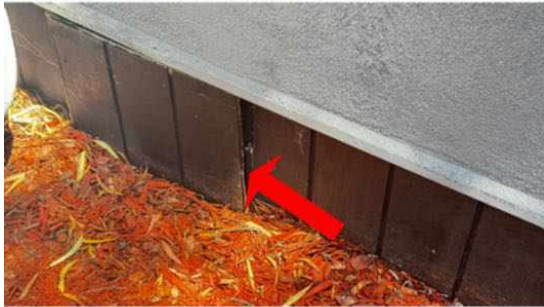
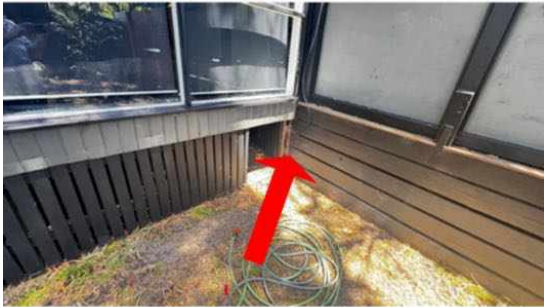
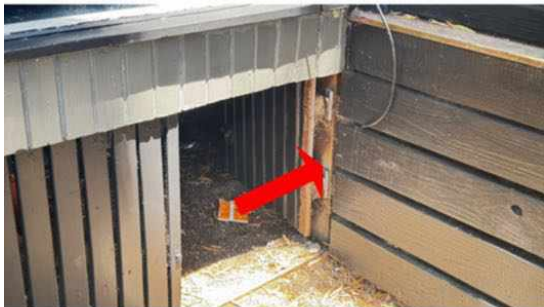
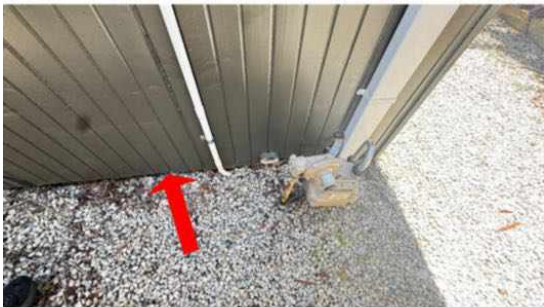
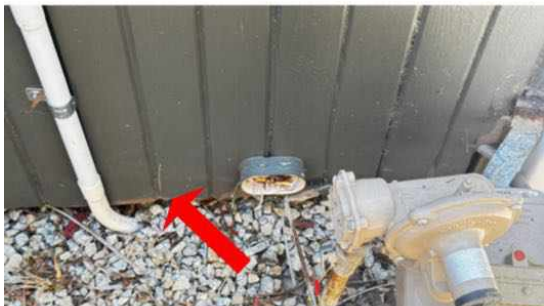
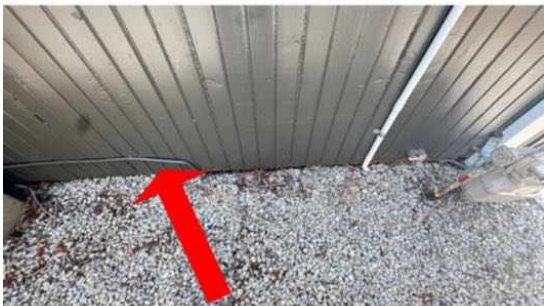
Defects 3.07

Building: Main Building
 Location: All External Areas
 Finding: External Timber - Timber Rot
 Information: Timber elements including wall claddings, timber rails & posts, landscaping timbers, and other external timber surfaces were inspected and show signs of rot, decay and

fungal attack in these areas. Softening, discoloration, splitting, and moisture penetration indicate ongoing timber degradation.

This is likely caused by prolonged moisture exposure, inadequate protective coatings or maintenance, direct contact with soil or water, or poor detailing that traps water or limits ventilation.

If left unaddressed, the affected timber may lose structural integrity, leading to progressive decay, potential collapse of walls, decks, or landscaping features, mould growth, and reduced durability and appearance of the building exterior.

A registered builder or timber specialist should inspect the affected areas immediately to determine the extent of damage. Damaged timbers should be repaired or replaced, protective treatments applied, and drainage or detailing corrected to prevent recurrence. Ongoing monitoring and urgent remedial action are required to prevent further deterioration.

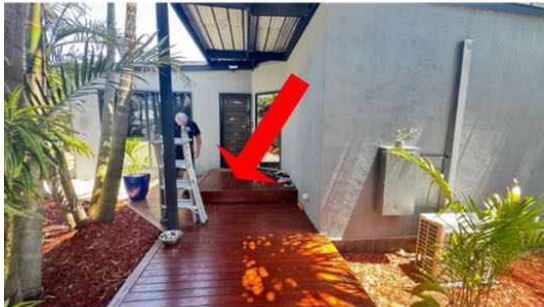
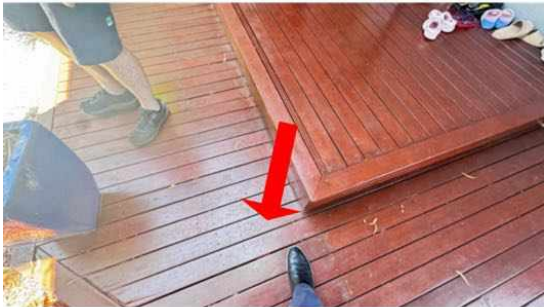
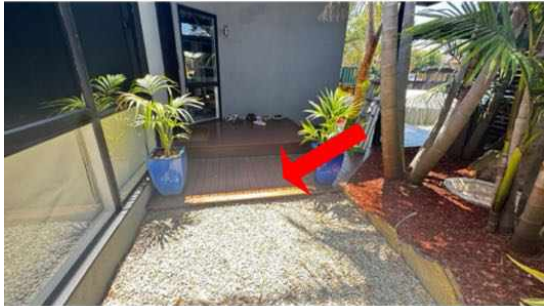
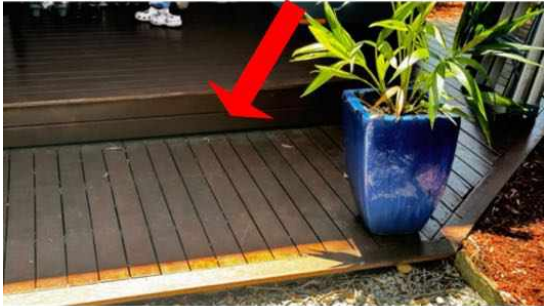
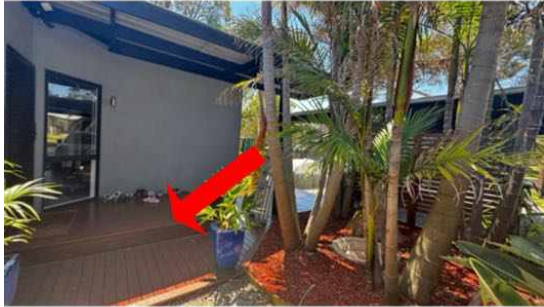
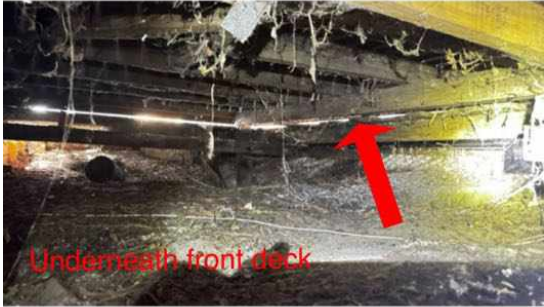
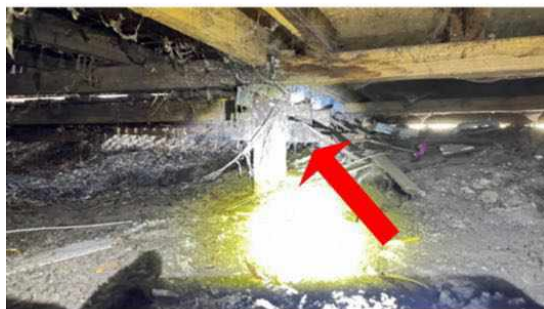
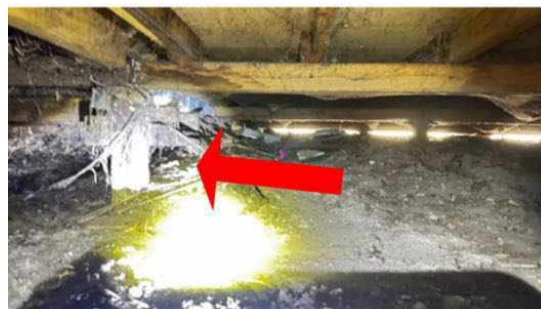
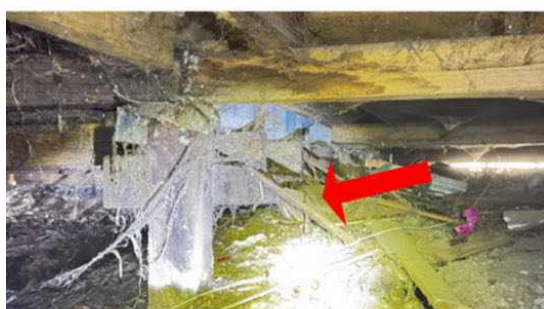
Defects 3.08

Building: Main Building
 Location: Entry Decking >
 Finding: Decking - Poor Condition
 Information: The external decking was inspected, and evidence of timber deterioration, loose and corroded fixings, warping, cracking, and uneven boards was observed.

The deterioration appears to be caused by age-related timber decay, weathering from sun, rain, and moisture and inadequate maintenance.

When practical, a registered builder or qualified carpenter should be engaged to inspect, repair, or replace affected decking components. Remedial works may include

reinforcing or replacing damaged timber, securing loose fixings, and applying protective coatings to maintain safety and prolong the lifespan of the decking.

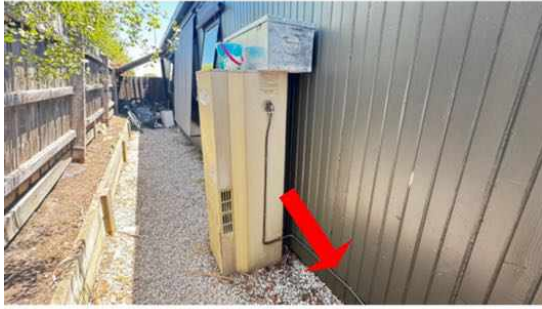
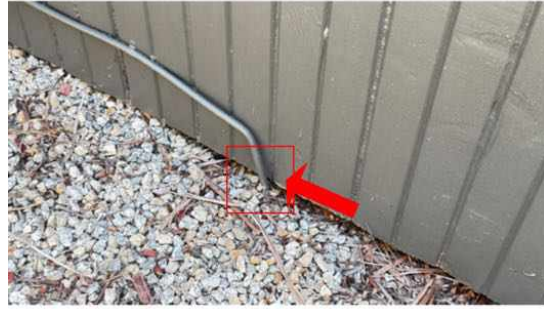
Defects 3.10

Building:	Main Building
Location:	External Walls
Finding:	AC Condensate Drain - Not Connected To Storm Water
Information:	The air conditioning condensate drain in this area was observed to be disconnected from stormwater drainage.

When condensate is not properly directed to a stormwater outlet, water can accumulate around the building or air conditioning unit, creating damp conditions that may lead to secondary defects such as timber rot, corrosion of nearby metal components, mould growth, or slippery surfaces. Prolonged pooling of water may also attract termites and contribute to long-term deterioration of surrounding building elements.

A qualified HVAC technician or licensed plumber should be engaged immediately to connect the condensate drain to a suitable stormwater outlet. Prompt rectification will ensure proper drainage, protect the building fabric, and reduce potential health and safety risks.

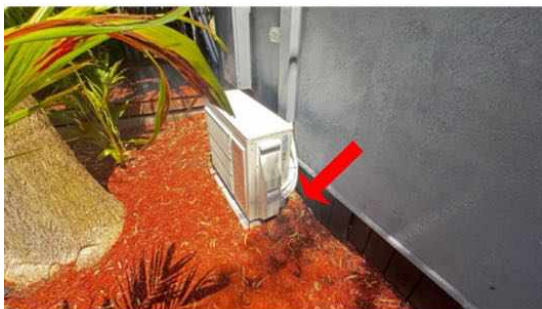
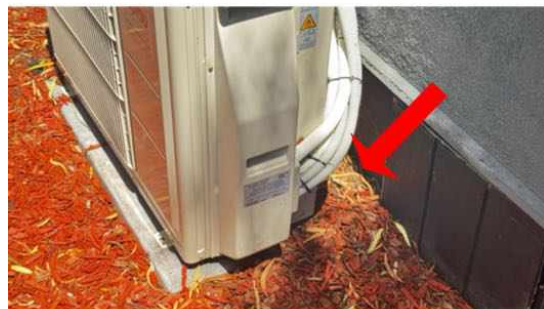
Defects 3.11

Building:	Main Building
Location:	External Walls

Finding: Building Element Hardware - Rust & Corrosion
 Information: This building element shows evidence of rusting and corrosion, which is likely to have developed as a result of excessive exposure to moisture and or inadequate coatings. As surface rust provides no protection to the underlying iron, the deteriorating condition is likely to worsen if not addressed in the short-term future.

These items can sometimes be treated but more than likely will require replacement. Where possible, the use of galvanized (treated) metals or aluminium coated metals aid in rust prevention, as does regular general maintenance. Rust formation can be controlled with coatings, such as paint, that isolate the iron from the environment.

Rusting and corrosion should be managed by ideally removing or limiting the affected surface from exposure to moisture. A qualified handyman or carpenter may be appointed to replace any building elements that have been affected by rust or water damage.

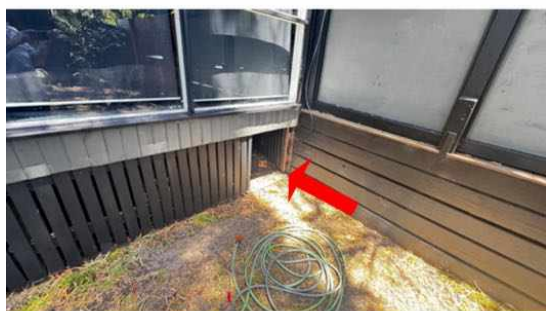
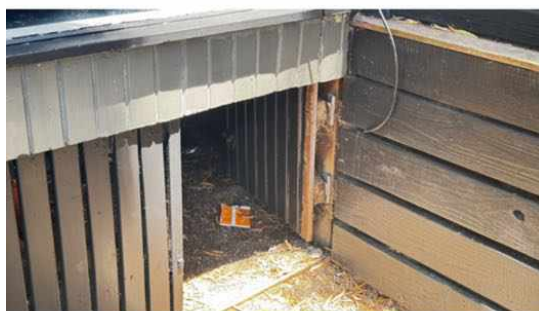
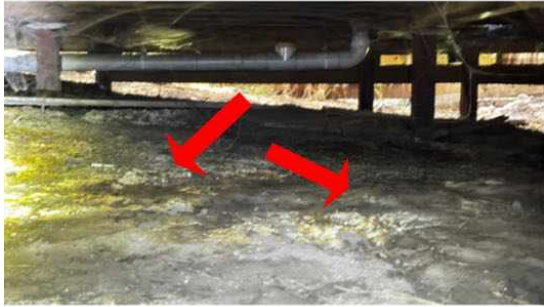
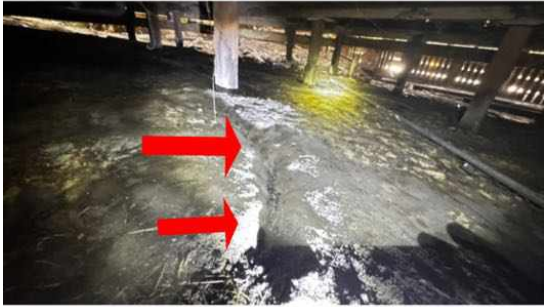
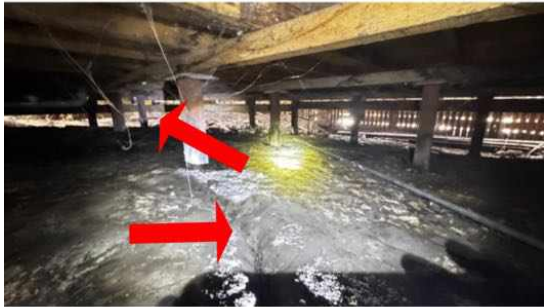
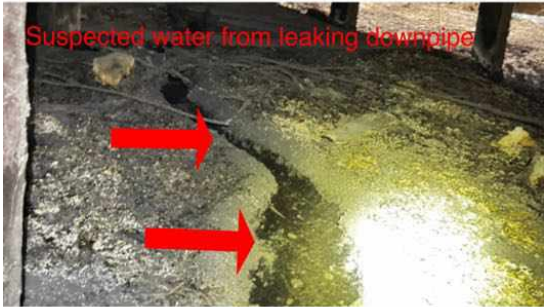
Defects 3.16

Building: Main Building
Location: Subfloor
Finding: Sub - Floor - Stored Items, Rubbish & Debris
Information: The subfloor was observed to contain stored items, rubbish, and debris. The issue is present where clutter restricts access and covers surfaces beneath the building.

This has likely occurred due to accumulation of materials over time or inadequate cleaning. Excess items can conceal defects, restrict inspections and maintenance, increase pest activity, and create fire or safety hazards.

This observation is provided for information only. When practical, a competent handyman should be engaged to remove all rubbish and clear access to ensure safe inspection, maintenance, and ongoing monitoring of the subfloor.

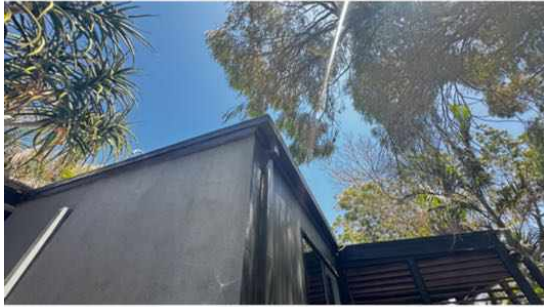
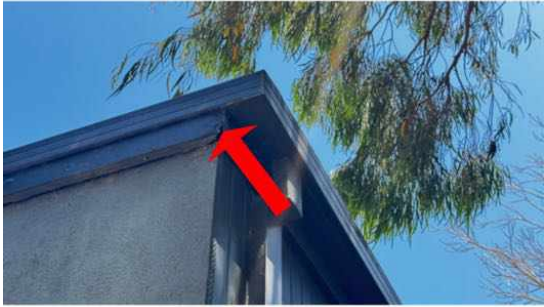
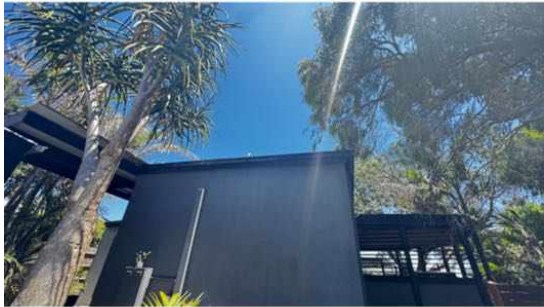
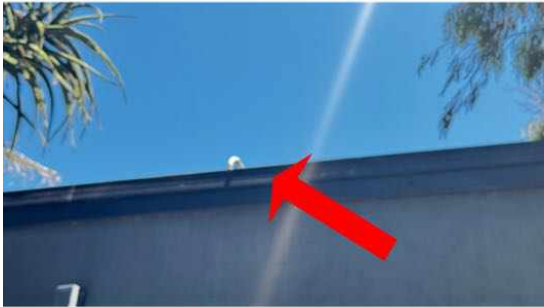
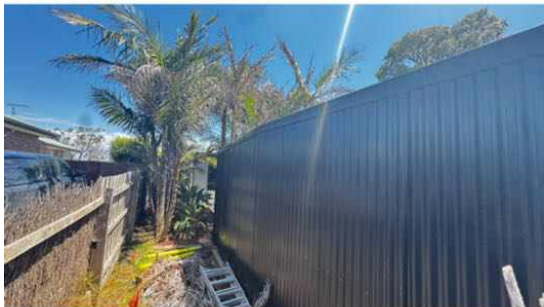
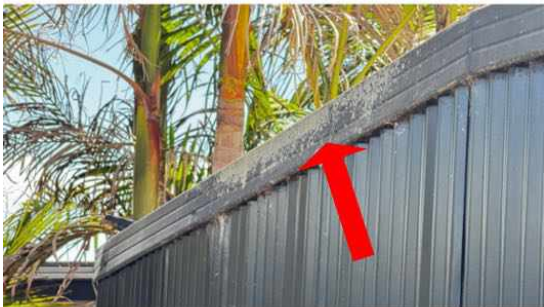
Defects 3.18

Building: Main Building
Location: Roof Exterior
Finding: Roof Plumbing - Gutters Blocked
Information: Gutters in this area are blocked and not allowing water to flow freely. The issue is observed along the gutter runs where leaves, debris, or other obstructions have accumulated.

This has likely occurred due to lack of maintenance or build-up of debris over time. Blocked gutters may cause water to overflow, damage the roof, walls, or foundations, and increase the risk of erosion or water ingress.

A licensed roof plumber or competent handy man is required to inspect and clear the blocked gutters in this area. This should be rectified immediately to ensure water drains correctly and to prevent potential damage to the building.

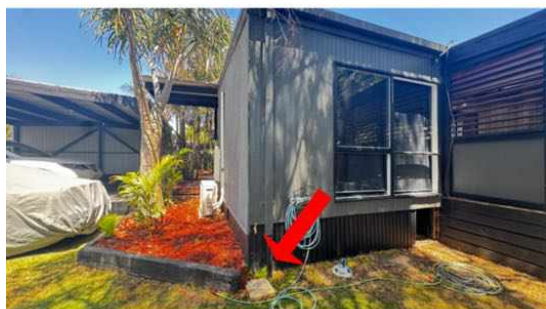
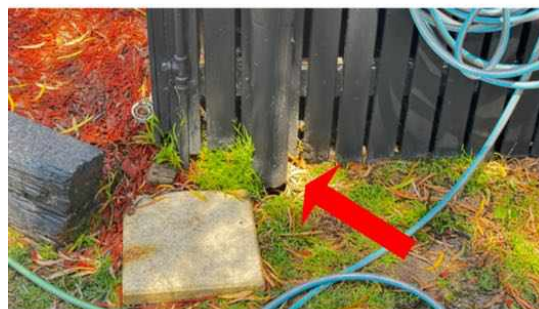
Defects 3.19

Building: Main Building
Location: Roof Exterior >
Finding: Roof Plumbing - Downpipes Not Connected To Storm Water
Information: Downpipes in this area are not connected to the stormwater drainage system, allowing water to discharge directly onto surrounding ground.

This has likely occurred due to missing connections, poor installation, or design oversight. Uncontrolled water discharge may cause erosion, pooling, water ingress near the building, and potential damage to landscaping, paving, or foundations.

A licensed roof plumber is required to inspect and connect the downpipes to the stormwater system in this area. This should be rectified immediately to ensure proper drainage and prevent potential water damage.

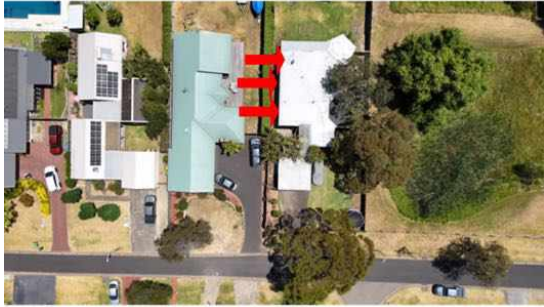
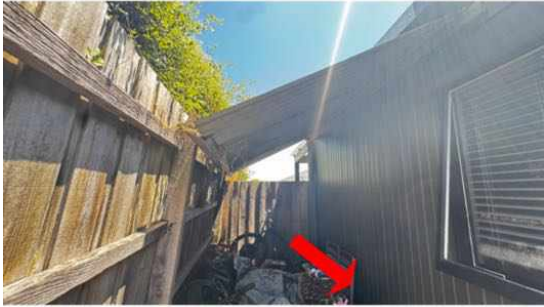
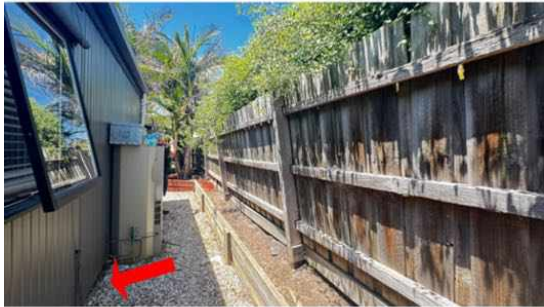
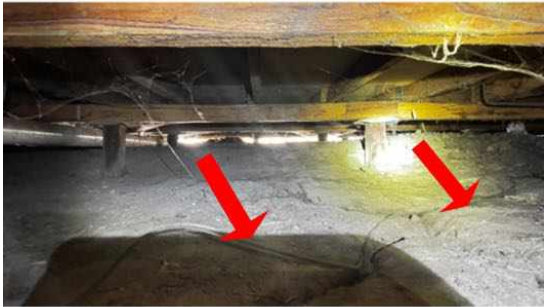
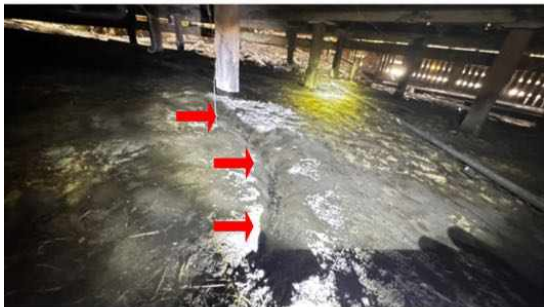
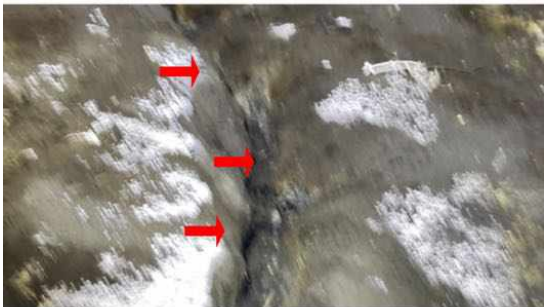
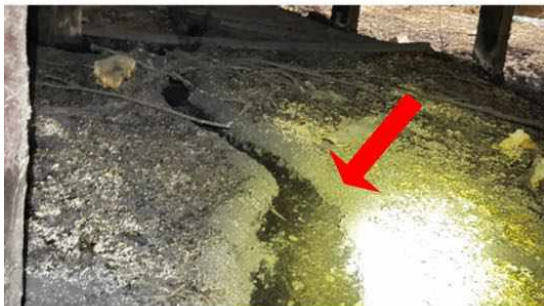
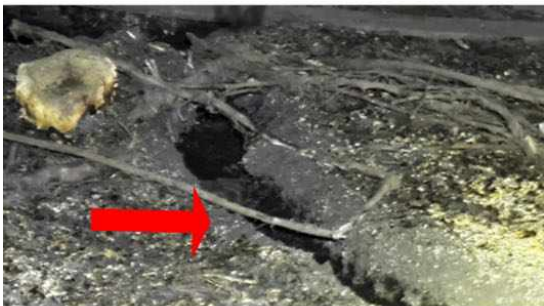
Defects 3.20

Finding: Site Drainage - Inadequate

Information: The overall site drainage was observed to be inadequate at the time of inspection. Poor drainage can cause water to pond near external walls, increasing the risk of rising damp, foundation movement, timber decay, and deterioration of associated building elements.

Ground levels should slope away from the dwelling to direct water from walls and footings. Downpipes must be properly connected to the stormwater system and should not discharge directly onto walls, paving, or plinths. Stormwater should be directed away from the property through adequately sized and maintained drains. Where ground levels are too high and cover the damp-proof course (DPC), lowering the levels may be necessary to expose the DPC and allow effective drainage.

A licensed plumber should be engaged promptly to investigate and recommend suitable remedial works, which may include the installation of an agricultural (aggie) drain or other site drainage improvements. Immediate action is strongly recommended, as inadequate drainage can lead to progressive water damage and secondary building defects over time.

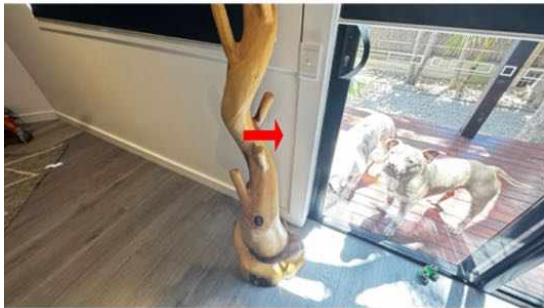
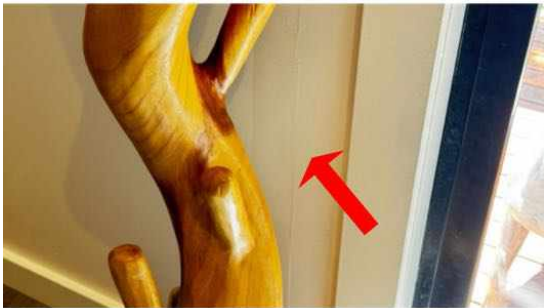
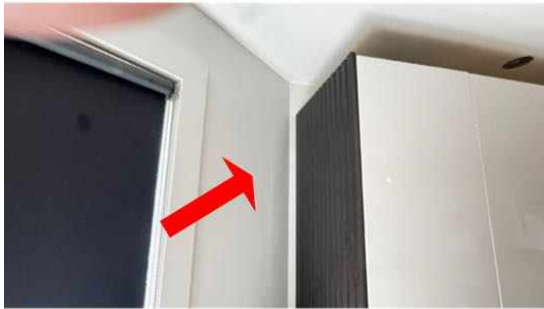
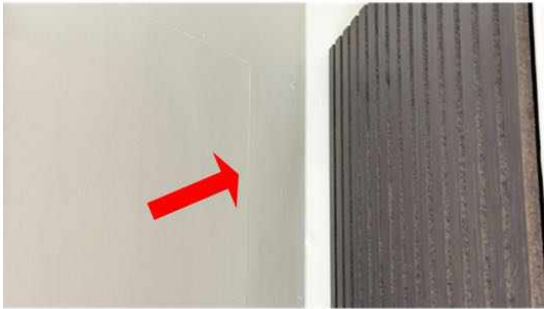
Building: Main Building
Location: Kitchen, Bed 3
Finding: Walls - Paint Finishes Discolouration
Information: The walls were inspected for paint condition, and discolouration was observed in this area.

While primarily a cosmetic issue, the affected paint may indicate age-related wear, poor surface preparation, or previous repairs.

When practical, a qualified painter should be engaged to prepare and repaint the affected areas. Addressing paint deterioration will improve the appearance of the ceilings and help protect the surfaces from further wear.

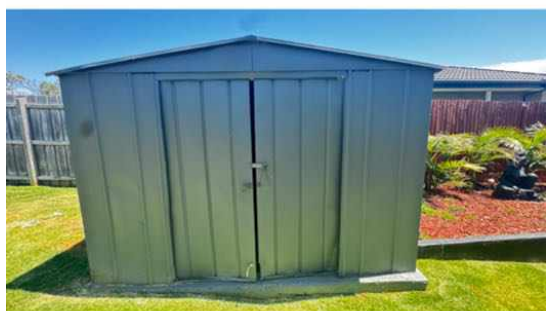
Building: Main Building
Location: All External Areas

Finding: Garden Shed - General Condition
 Information: The garden shed was inspected visually. The shed structure shows signs of age-related deterioration, including corrosion of roofing and walls and weathered components.

The shed does not appear to compromise the primary dwelling structure but may reduce usability, weatherproofing, and amenity. This deterioration is likely due to age, exposure to weather, and a lack of regular maintenance.

When practical, a competent hand man should be engaged to repair or replace damaged, missing, or weathered components. Rectification will restore functionality, durability, and weatherproofing of the shed.

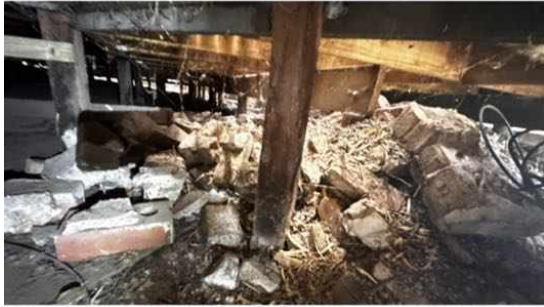
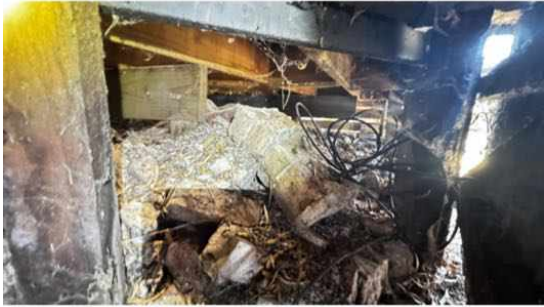
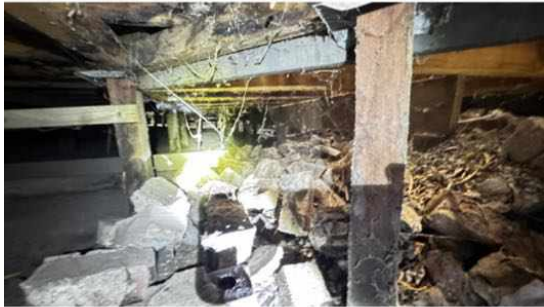
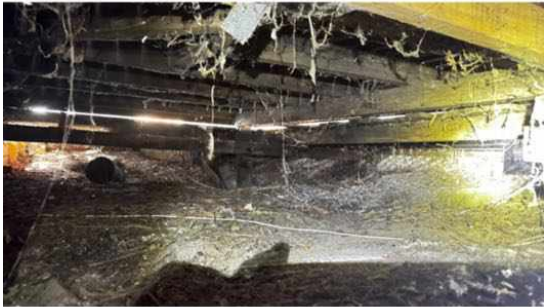
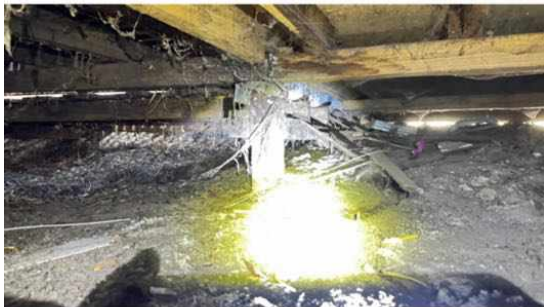
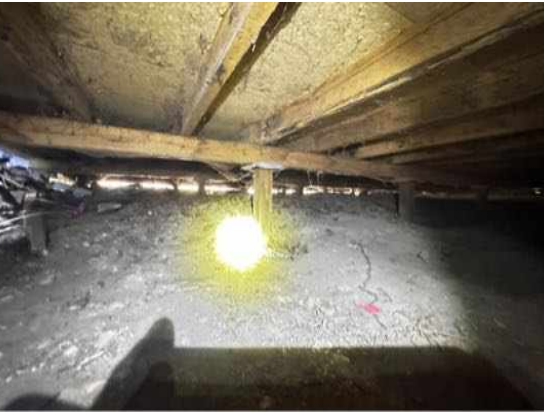
Building: Main Building
 Location: Subfloor
 Finding: Sub Floor - Limited Access
 Information: The subfloor area was observed to have restricted, limited and difficult access. The issue is present where limited space and obstacles prevent safe entry and movement beneath the building.

This has likely occurred due to inadequate access points. Poor access can impede inspections, maintenance, and timely identification of structural, pest, or service issues, increasing long-term repair costs and safety risks.

A registered builder is required to assess and improve subfloor access. This should be addressed as soon as possible to ensure safe entry, proper inspection, and maintenance of the subfloor.

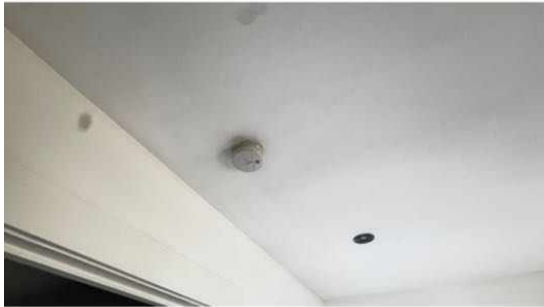
Building: Main Building
Location: All Internal Areas
Finding: Smoke Detectors - Advisory

Information: During the inspection, smoke detectors were noted for advisory purposes only. The operation, age, type, and compliance of smoke detectors could not be fully verified as part of this inspection.

Smoke detectors are critical life-safety devices, and non-compliant, outdated, or non-operational units may not provide adequate warning in the event of a fire.

It is recommended that a licensed electrician be engaged immediately to test, service, and upgrade smoke detectors as required to ensure correct operation and compliance with current safety requirements.

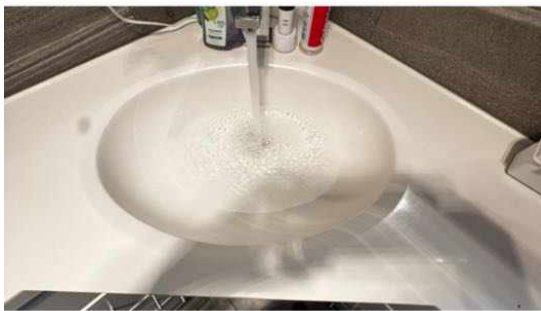
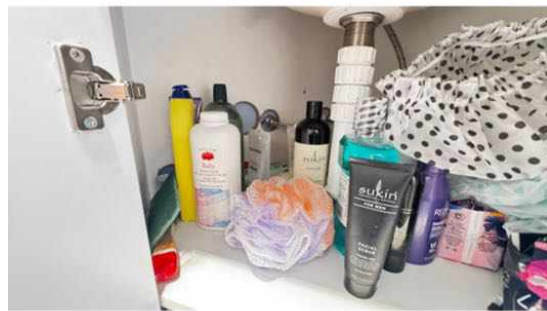
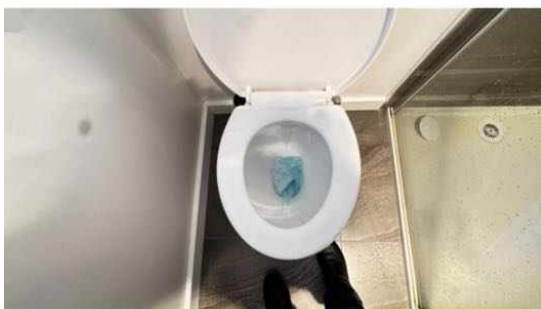
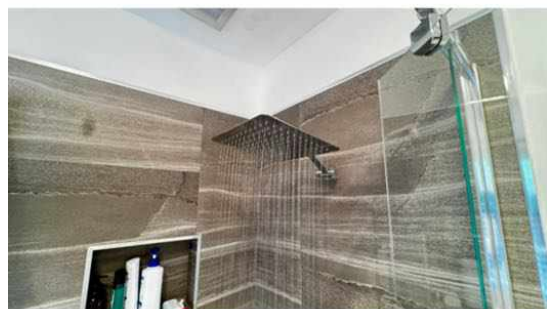
Building: Main Building
Location: All Internal Areas
Finding: Water Supply & Drainage - Shower, Basins, Toilets, & Plumbing Fixtures

Information: The shower recess was tested, and no visible water penetration to surrounding areas was observed at the time of inspection, except where noted as a separate defect

elsewhere in this report. Water appeared to flow freely toward the floor waste. Moisture detected to the shower walls is documented separately in the report. The shower floor waste appeared clear during inspection.

Flushing the toilet revealed no visible leaks, and the fixture appeared to operate normally unless otherwise noted as a separate defect. No water damage was observed to the vanity unit unless specifically stated elsewhere in the report. Basins, bathtubs, laundry tubs, vanities, and sinks were tested and inspected with no evidence of leaks, blockages, or drainage issues at the time of inspection unless otherwise noted. All internal taps and shower heads were tested with no leaks observed, unless documented as a separate defect.

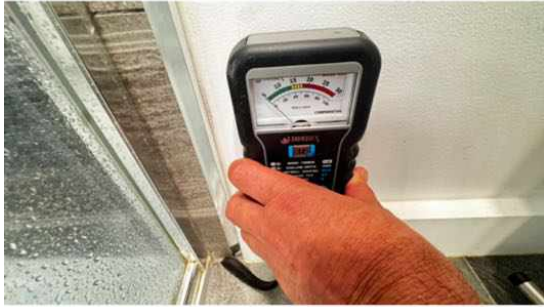
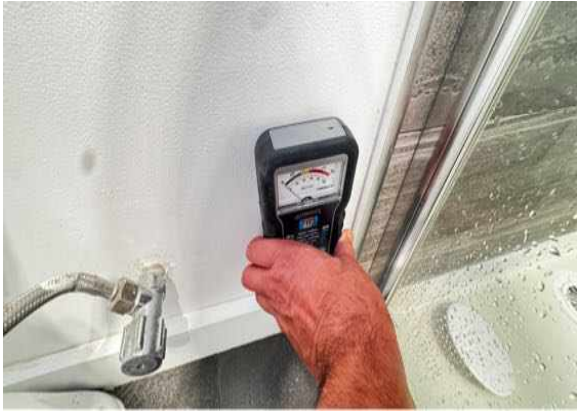
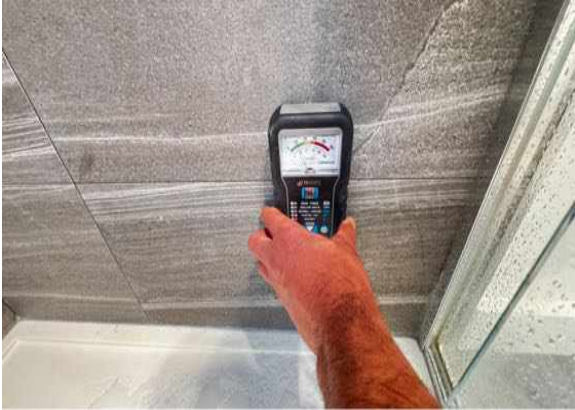
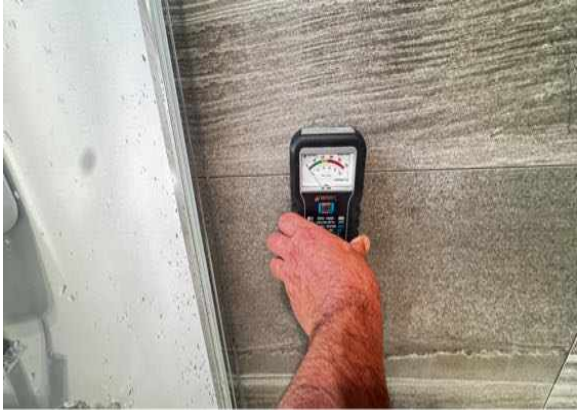
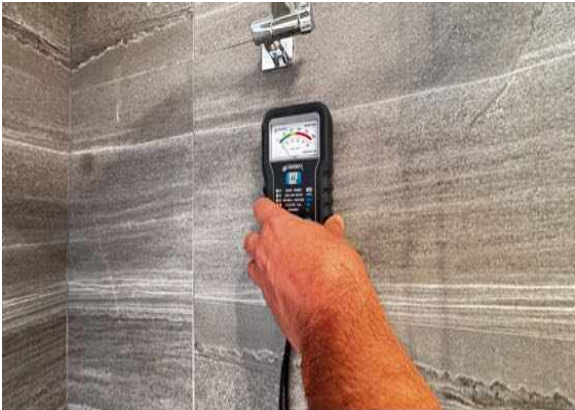
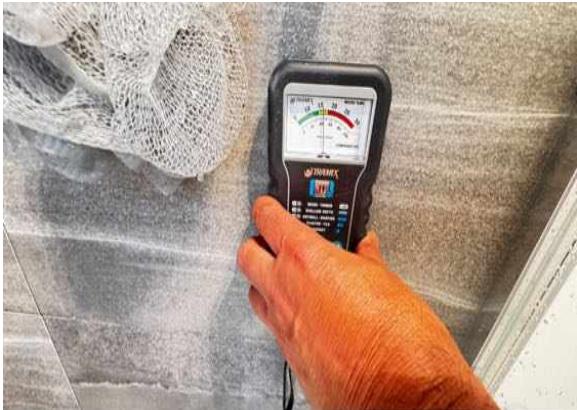
Building: Main Building
 Location: All Areas Interior & Exterior
 Finding: Moisture Levels - Advisory - No Elevated Moisture Levels Present
 Information: At the time of inspection, no elevated moisture levels were detected in these areas. Moisture readings were taken (using a Tramex Moisture Meter) and non-invasive testing methods and reflect conditions present at the time of inspection only. This item is noted for advisory purposes and should not be relied upon as a guarantee that moisture issues are not present elsewhere or may not occur in the future.

It is important to note that moisture levels can fluctuate due to weather conditions, plumbing usage, seasonal changes, or intermittent leaks. Concealed moisture within wall cavities, subfloor areas, or other inaccessible locations may not be detected during a visual or limited moisture assessment.

Ongoing monitoring of the property is recommended, and further investigation by a qualified tradesperson should be considered if signs of water ingress, dampness, staining, mould growth, or material deterioration become apparent.

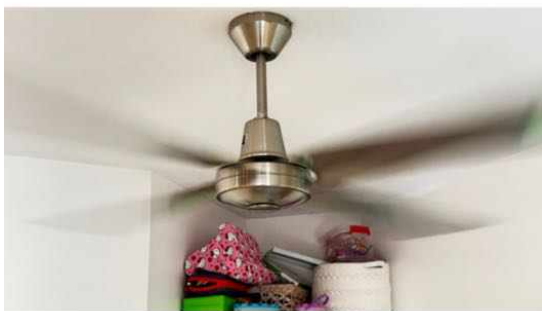
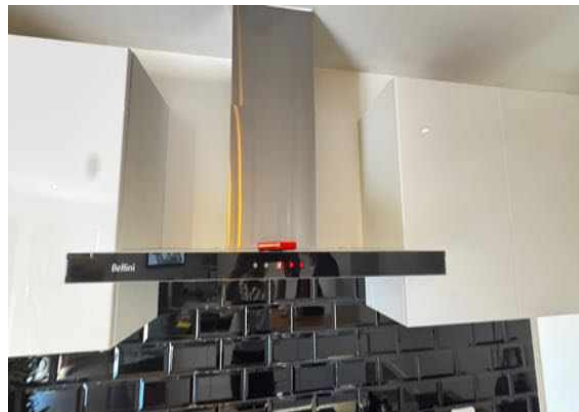
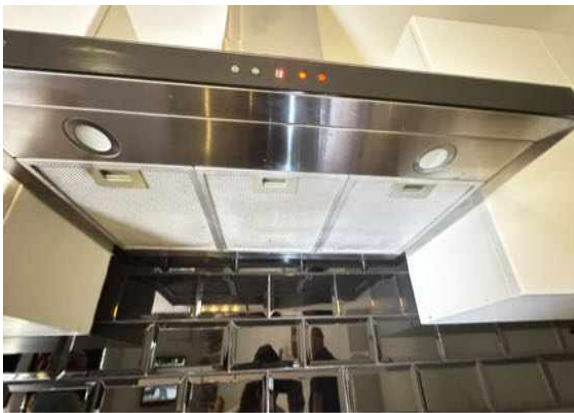
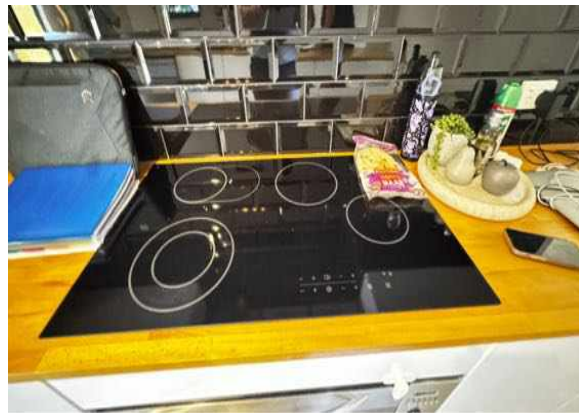
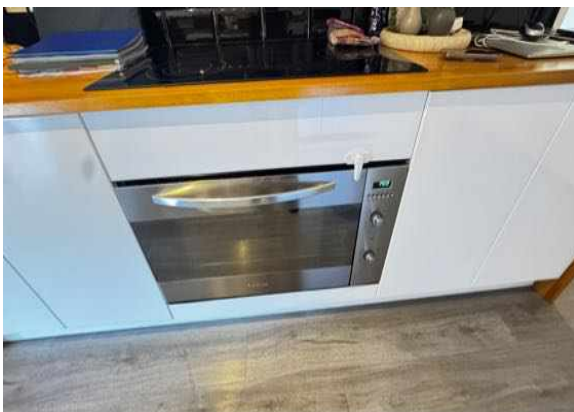
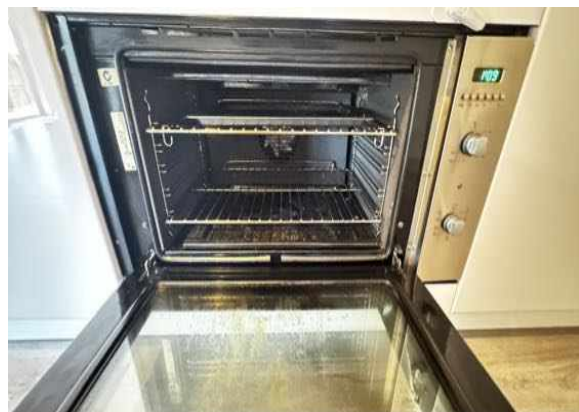
Building:	Main Building
Location:	All Areas, Interior & Exterior
Finding:	Appliances, Heating & Cooling Systems, Mechanical Systems, Plumbing, Electrical, Fireplaces - Advisory
Information:	The inspection did not include testing, operation, safety, or assessment of any installed or portable appliances or mechanical systems. This includes, but is not limited to, ovens, cooktops, microwaves, rangehoods, dishwashers, ducted vacuum systems, air-conditioning units, heating systems, hot water services, ceiling fans, exhaust fans, intercoms, security systems, fireplaces, and solid fuel heaters.

Appliances may be worn, damaged, or malfunctioning. Electrical or gas appliances can pose serious safety hazards if incorrectly installed or maintained.

Service, repair, or replace equipment as necessary, particularly where service history or warranty coverage is unknown.

Inspect any water, gas, or electrical connections associated with appliances to ensure safety and compliance.

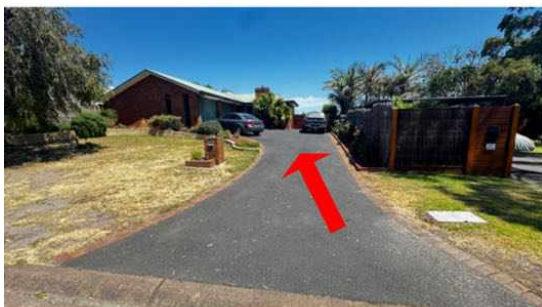
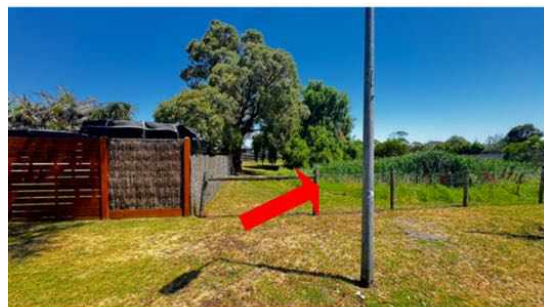
During the inspection, minor cracking, surface wear, or uneven sections were observed on footpaths or crossovers. Some accessible metal components, such as street signage or grates, showed signs of rust or deterioration. Debris accumulation and vegetation encroachment were also noted around council infrastructure. Access or visibility was limited to certain council-owned assets.

These areas should be monitored, and for detailed assessment, maintenance, or compliance verification, the relevant local council authority should be contacted immediately. Regular monitoring of adjacent council assets is recommended to ensure ongoing safety and proper maintenance.
