Building Inspection Report

Inspection Date: Tue, 27 Jan 2026

Property Address: 22 Coral Cl, Rosebud VIC 3939, Australia

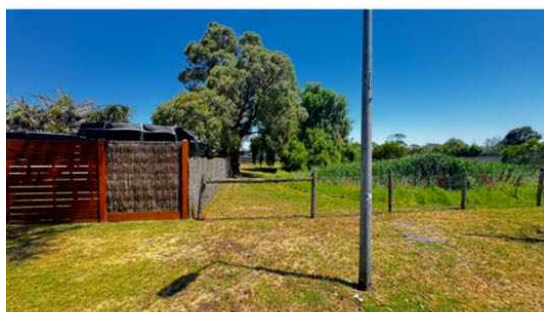
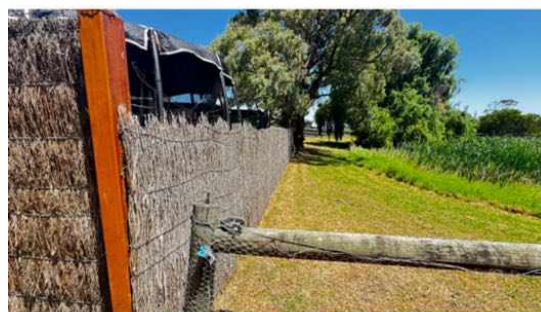
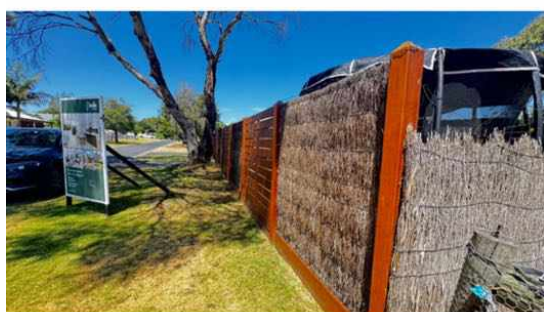
Building:
Location: All Areas
Finding: Additional Photos - Obstructions & Limitations
Information: These photographs provide evidence of obstructions and restrictions that prevented

It is important to note that these restrictions can conceal a wide range of building defects, including but not limited to:

Because these areas could not be visually assessed, no comment can be made on their condition within this report.

It is strongly recommended that obstructions be removed and concealed areas made fully accessible immediately. A re-inspection should then be carried out to allow a complete assessment of the property's condition. This is particularly important prior to purchase, as defects in concealed areas can carry significant rectification costs.

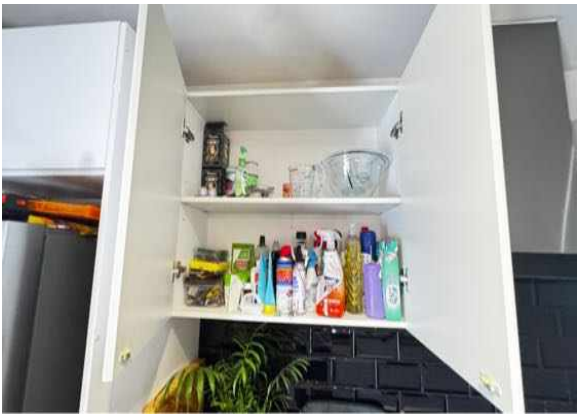
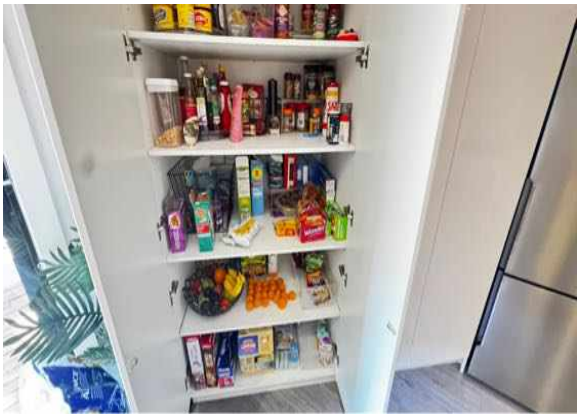
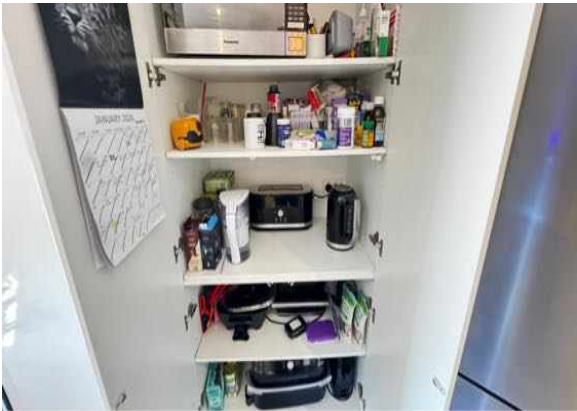
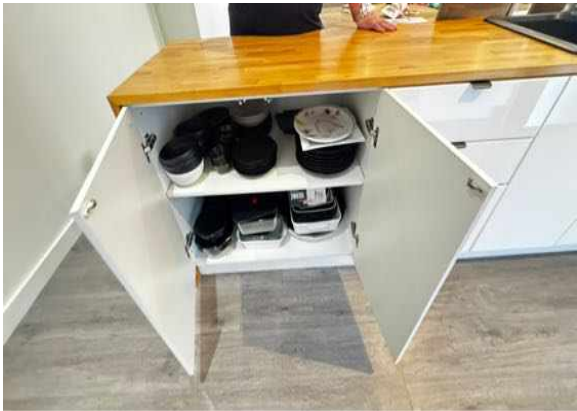
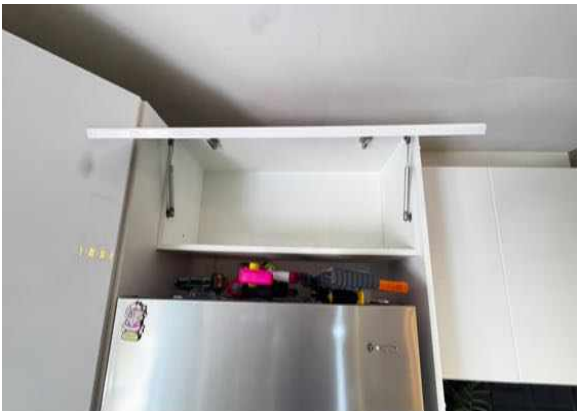
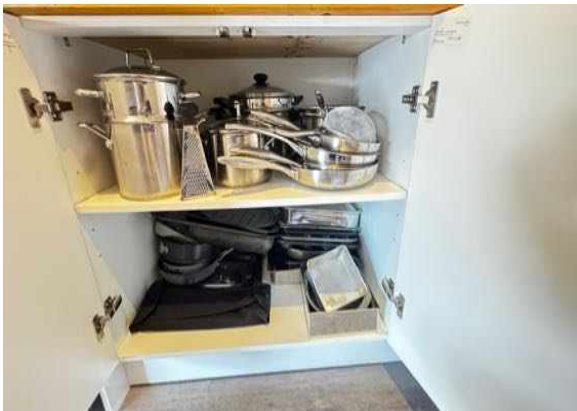
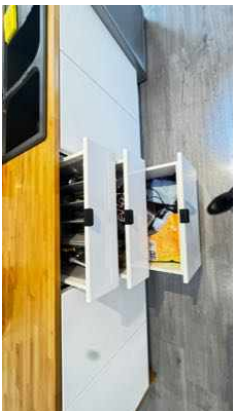
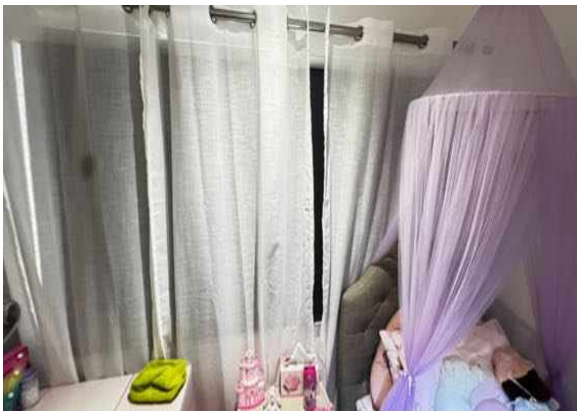
Structural damage such as cracking or movement in walls, floors, or ceilings.

Pest activity such as termites or timber decay.

Electrical, plumbing, or safety hazards.
