Building and Timber Pest Inspection Report

Inspection Date: Mon, 9 Mar 2026

Property Address: 16 Glen Lorne Cct, Gilead NSW 2560,
Australia

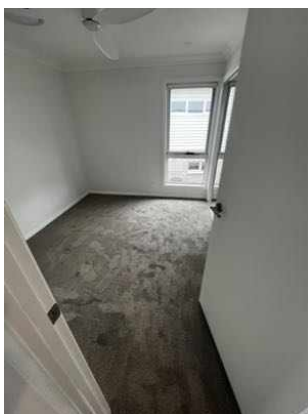
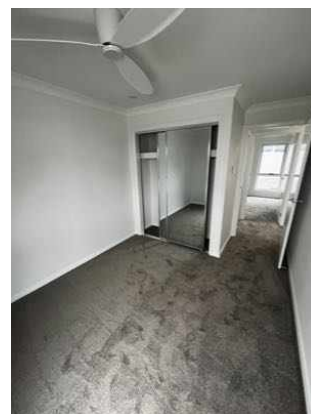
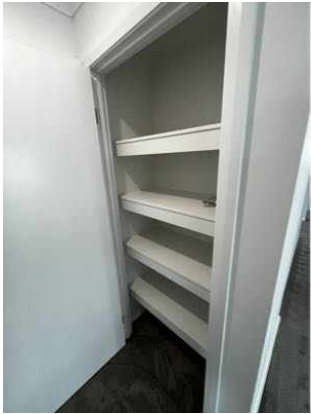
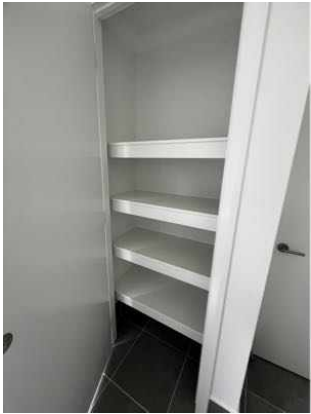
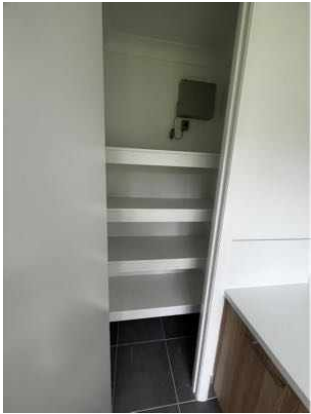
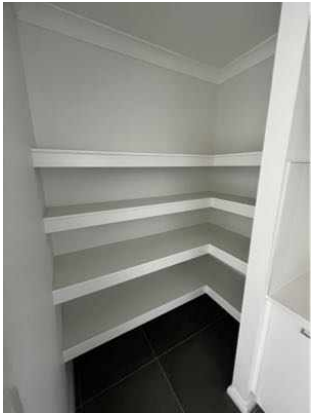
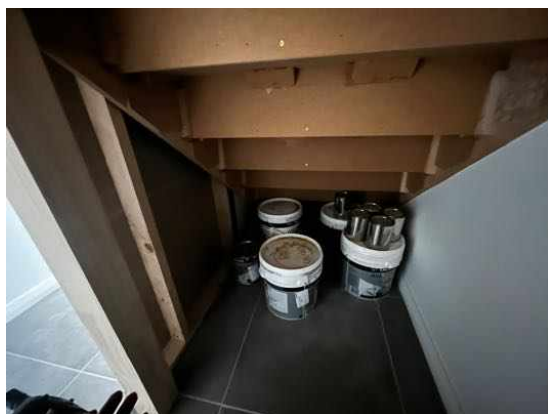
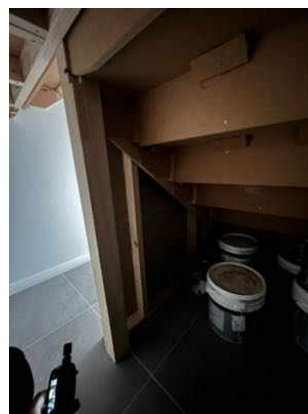
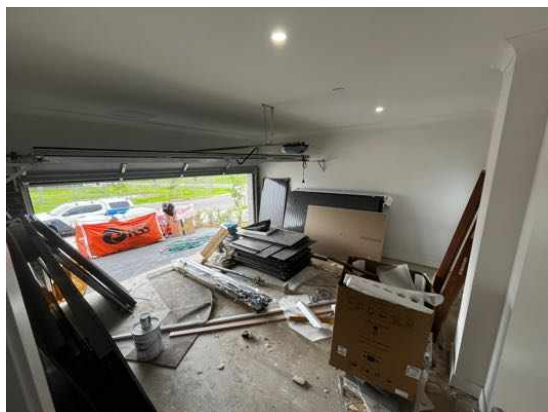
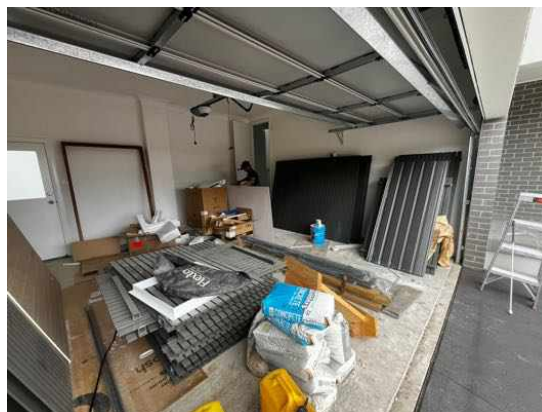
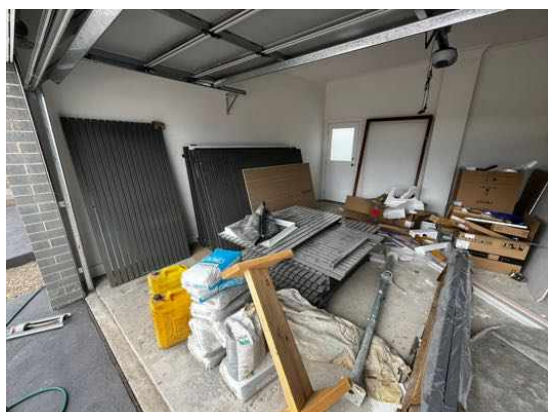
Finding: Additional Photos - Obstructions and Limitations

Information: These photographs are an indication of the obstructions and limitations which impeded full inspection of the property at the time of inspection. These obstructions can hide an array of defects and should be removed to allow full inspection to be carried out. A re-inspection is recommended once the areas are made accessible.

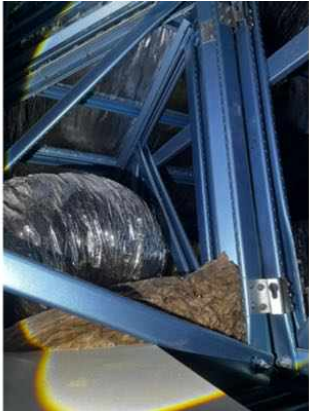
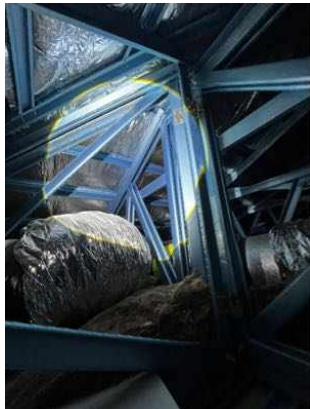
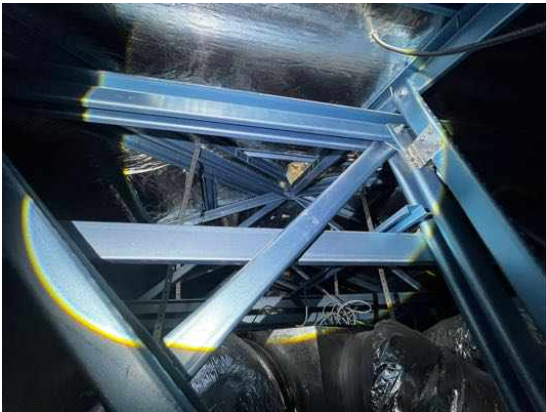
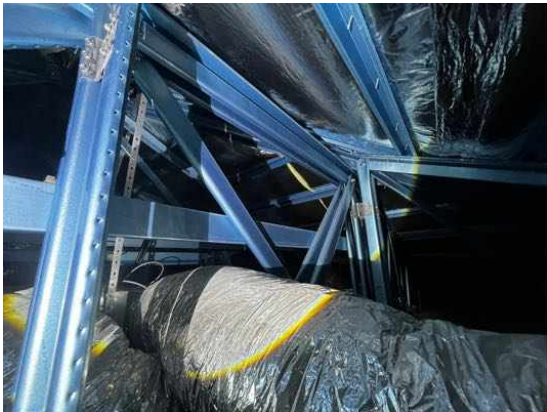
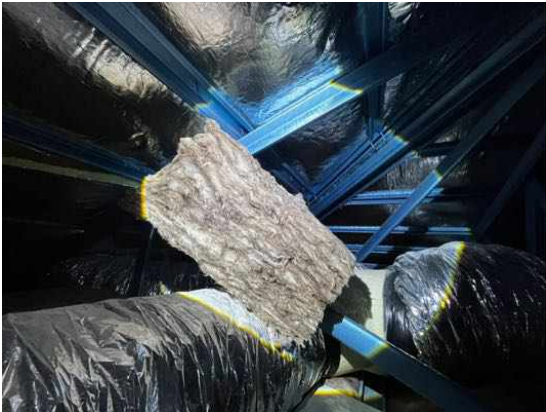
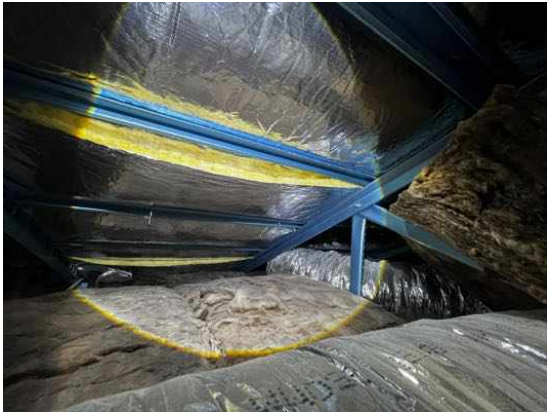
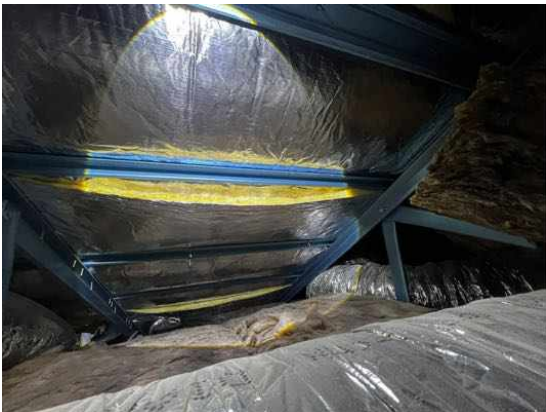
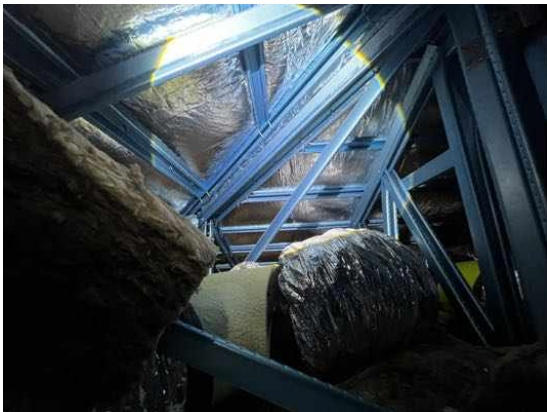
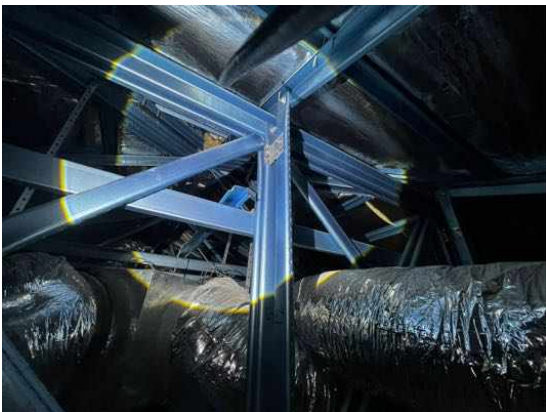
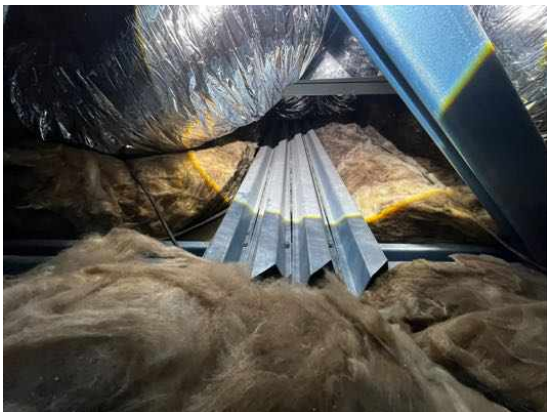
Finding 6.02

Building: Main Building
 Location: Roof Void
 Finding: Obstructions and Limitations - Roof space
 Information: Upon Inspection of the Roof void below mentioned photos have been attached as to the point been reachable to inspect the roof upon safe condition.

These photographs are an indication of the obstructions and limitations which impeded inspection of the Roof Space/Void at the time of inspection such as Stored items, Ducting, Aircon ducting, Skylight tubes, Electrical wires , insulation and cross beams, rafters, low clearance as of the pitch in the roof. These obstructions can hide an array of defects and should be removed to allow full inspection to be carried out.

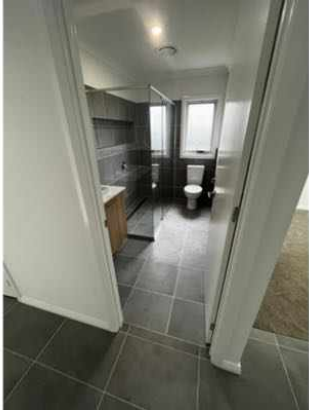
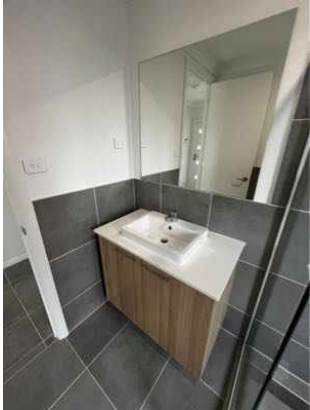
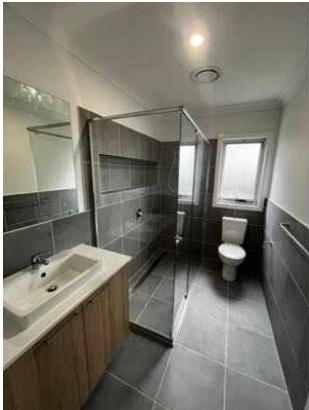
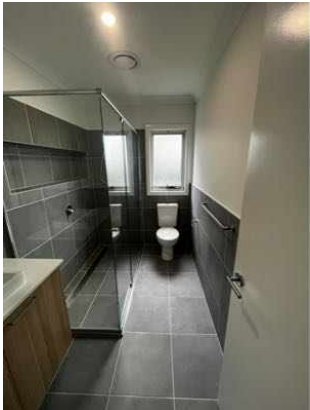
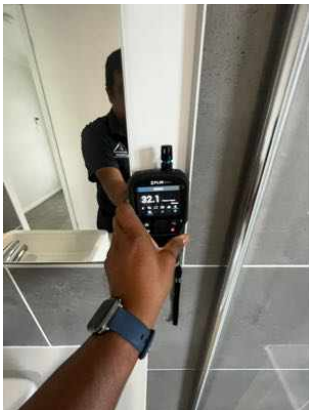
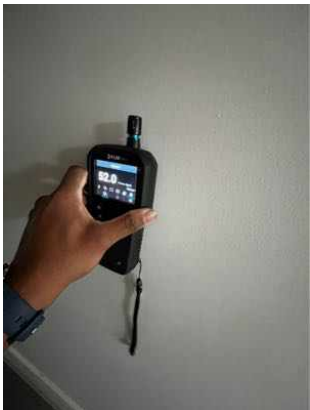
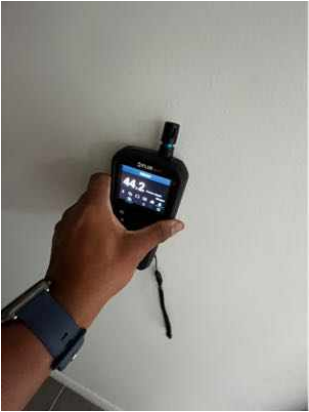
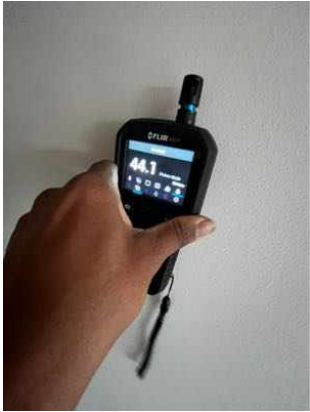
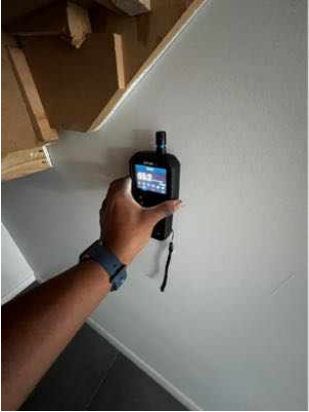
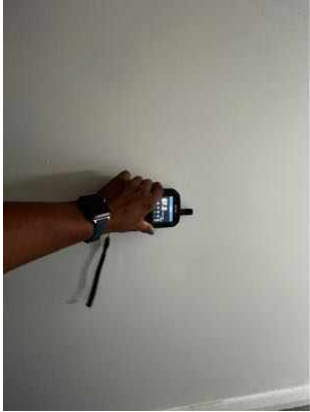
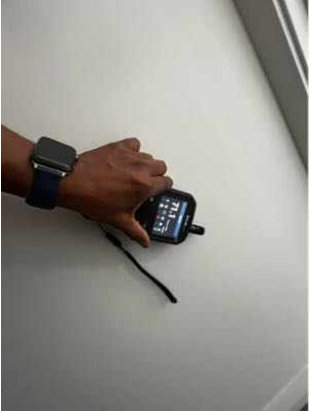
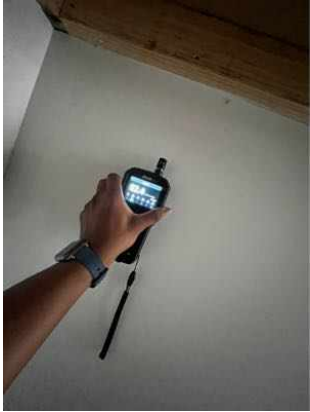
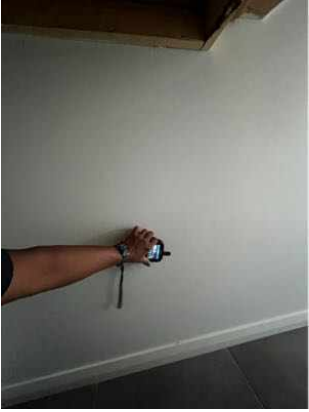
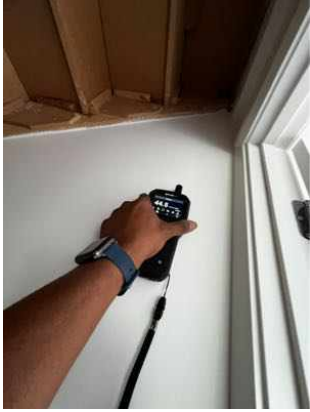
Noted Item

Building: Main Building
Location: Ground Floor Bathroom >
Finding: For information only
Information: No remedial works are required at the current time.

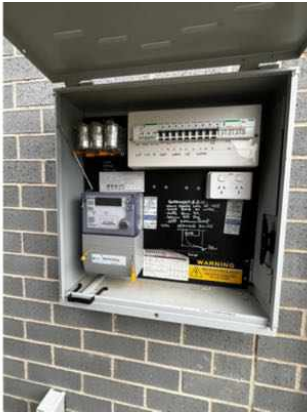
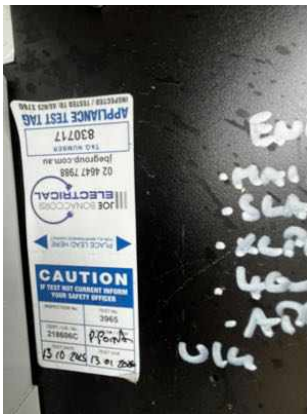
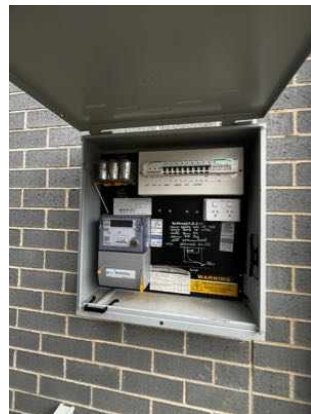
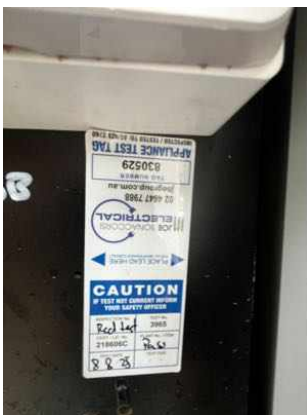
Building: Main Building
 Location: Electrical Meter Box
 Finding: Evidence of a previous termite management system was identified
 Information: Upon Inspection There was a Durable Notice of Termite treatment identified but the date and the information in the notice was not readable/ identifiable - So It is highly recommended to have a termite treatment organised and to follow a termite treatment proposal and keep note of the system every 12 months in duration.

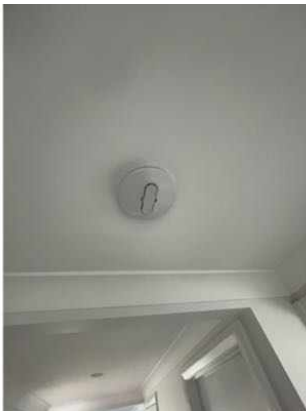
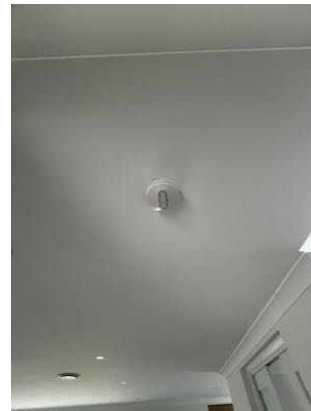
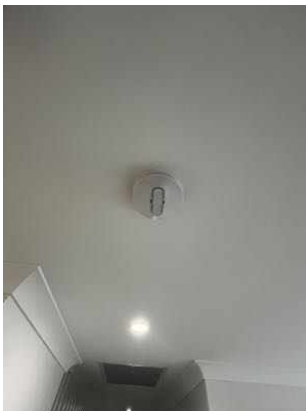
Building: Main Building
 Location: All Internal Areas
 Finding: Smoke Detector and Alarms
 Information: Reporting on Smoke Detectors or Alarms, including hard wired smoke detection systems and their legislative requirements, is outside the Scope of this Report.

Additionally, it is advised that all smoke detectors be tested by the homeowner on a monthly basis.

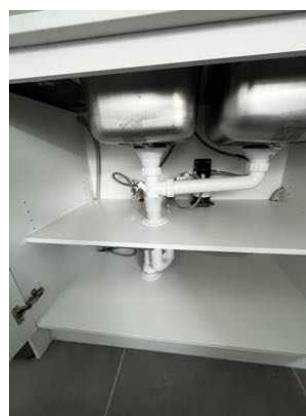
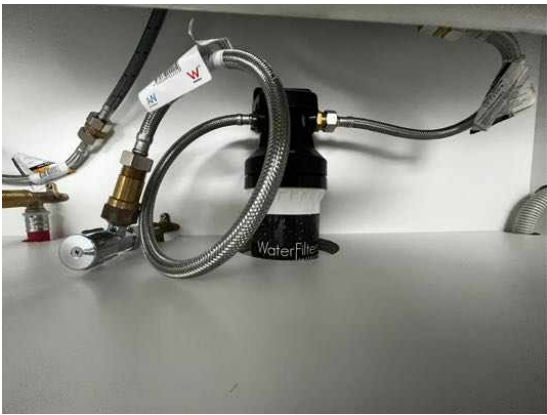
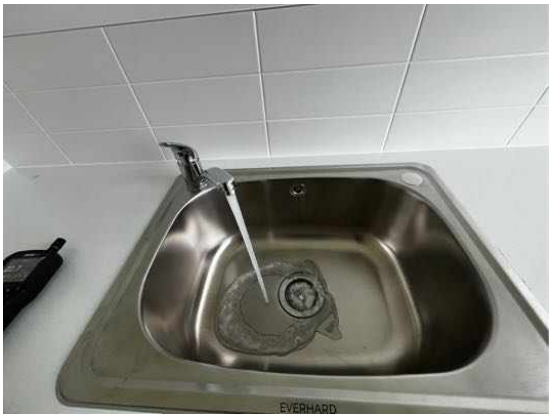
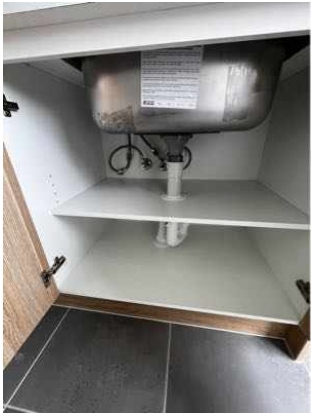
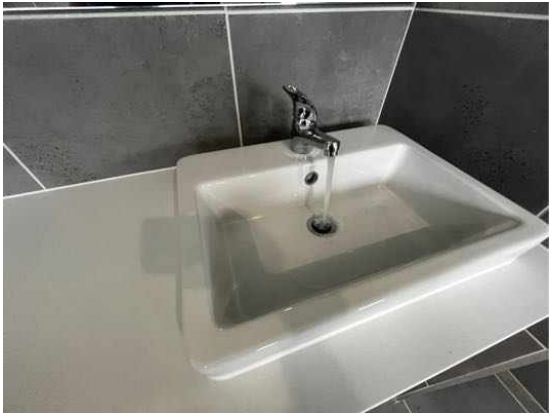
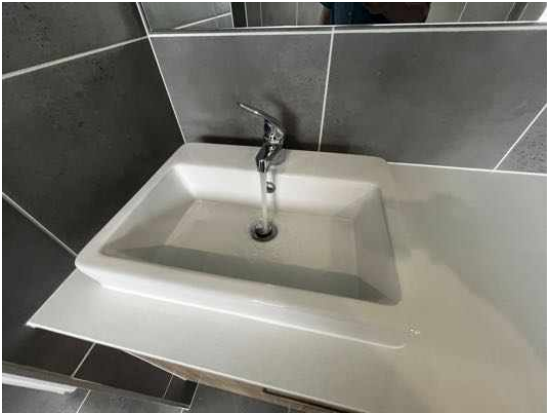
All cupboards where sinks and basins with drainage plumbing were inspected and no evidence of leaks were present at the time of inspection.

For your information only no remedial works are required at the time of inspection.

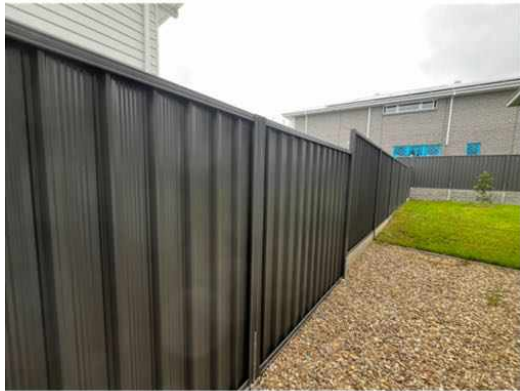
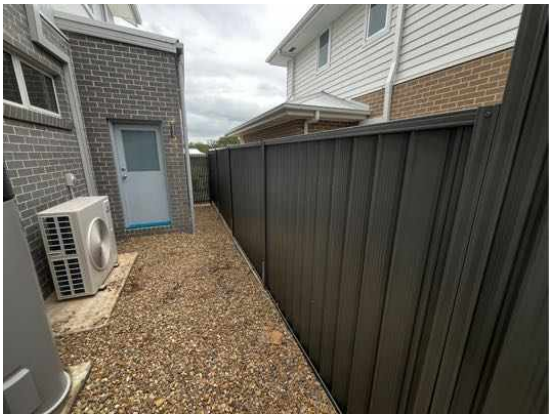
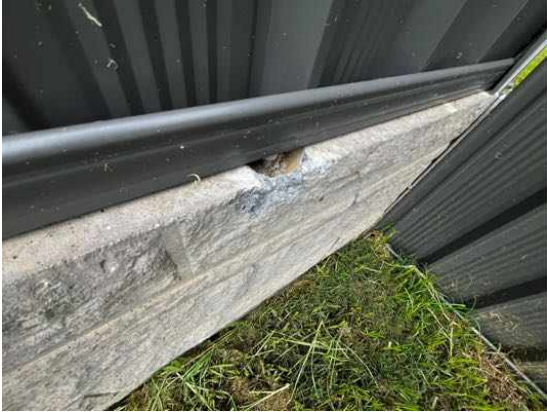
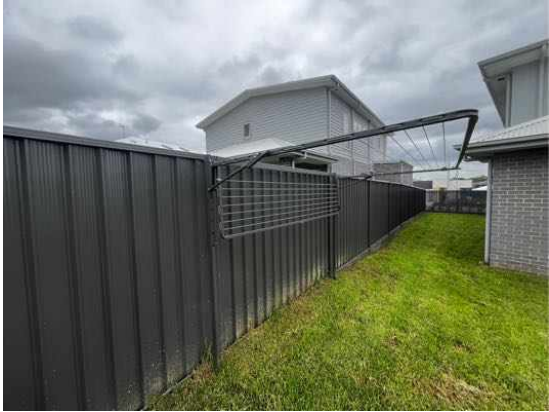
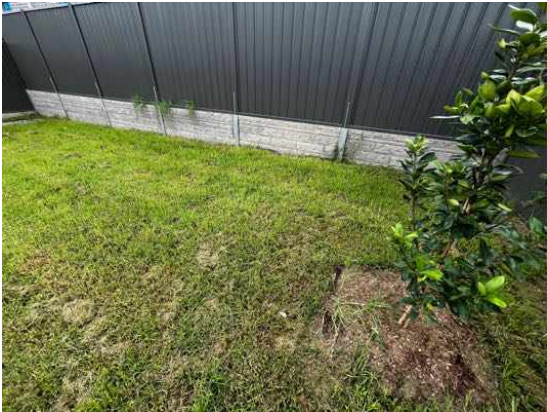
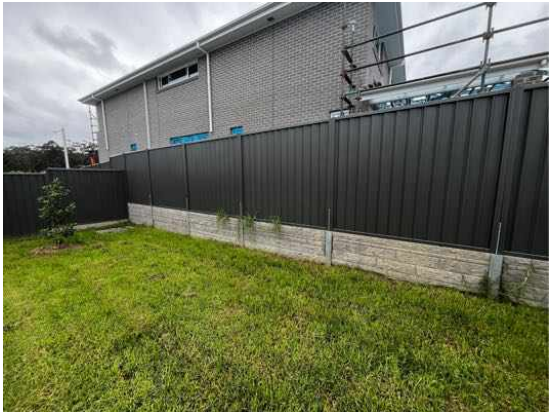
Building: Main Building
Location: Yard
Finding: Perimeter Fencing -
Information: For your information photos taken at the time of inspection.

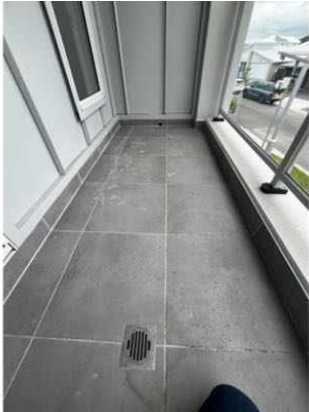
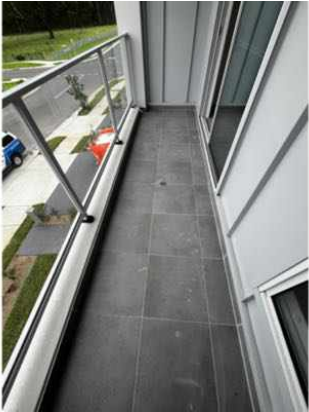
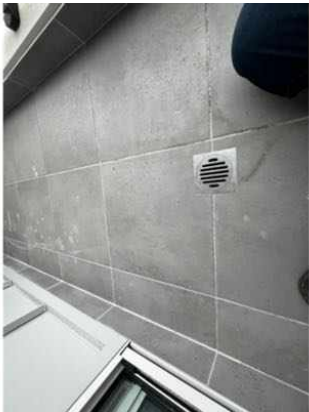
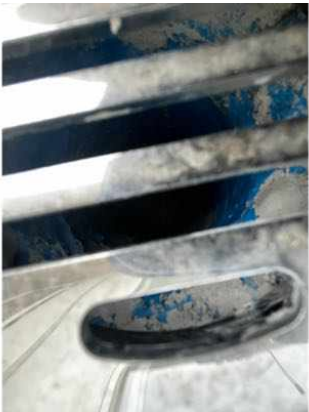
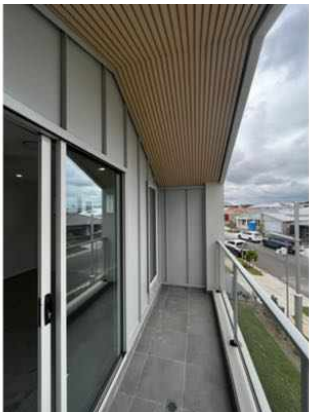
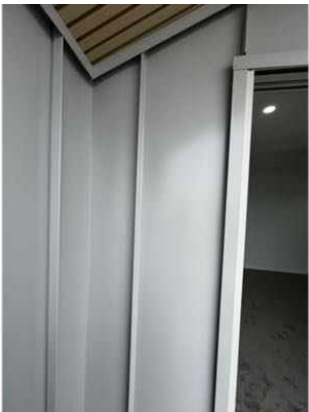
Building: Main Building
Location: Front Balcony
Finding: Balcony - Floor
Information: Upon Inspection The gradients of the Balcony floor levels are checked and found to be ok.

Suggest to always keep the area clear of rubbish and leaves, for the free flow of water/ rainwater to go through the downpipes.

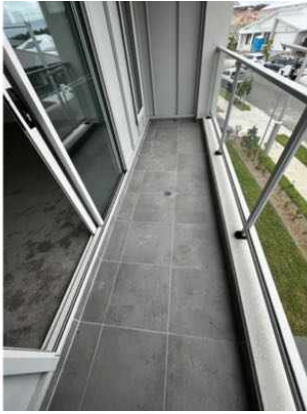
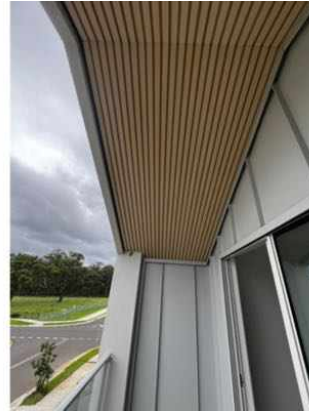
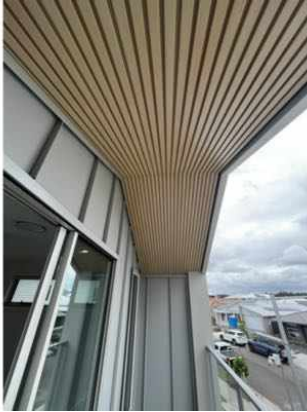
Building:	Main Building
Location:	All External Areas
Finding:	Site drainage - For your Information
Information:	Upon Inspection The site drainage was inspected, however, the site/ Yard should be monitored during heavy rain to determine whether the existing drains cope. If it appears that they cannot cope, then additional drains may be required.

Any comments made in the section are relevant only in light of the conditions present at the time of inspection. It is recommended that a smoke test be obtained to determine any illegal connections, blocked or broken drains.

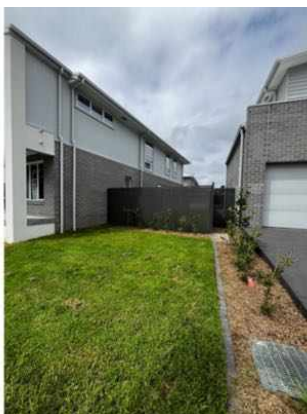
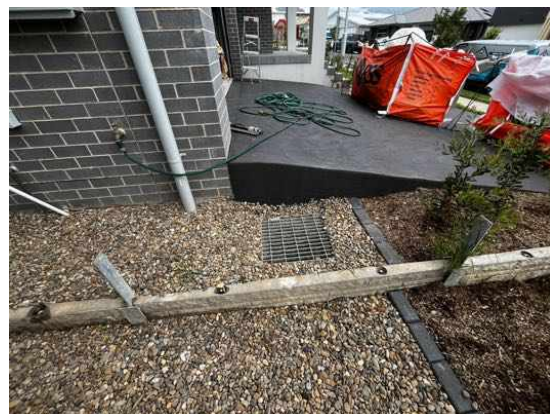
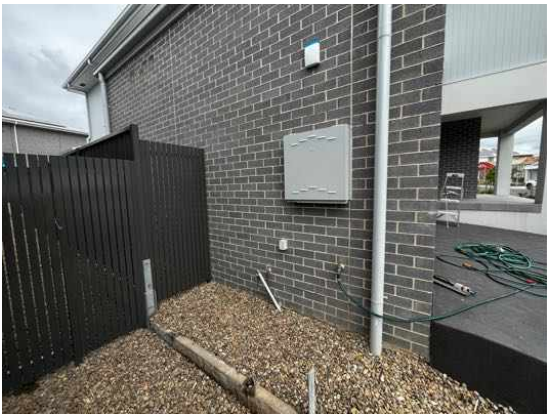
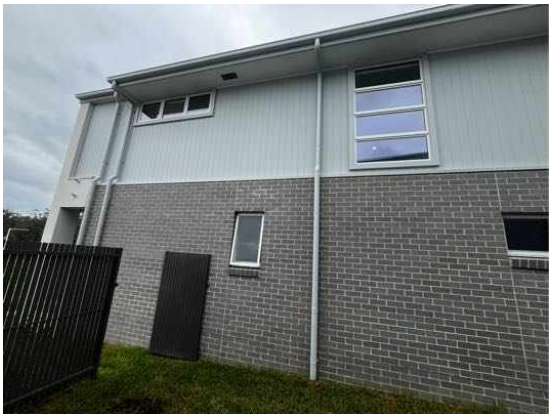
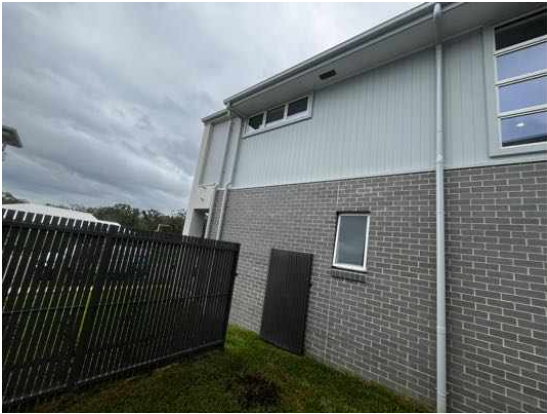
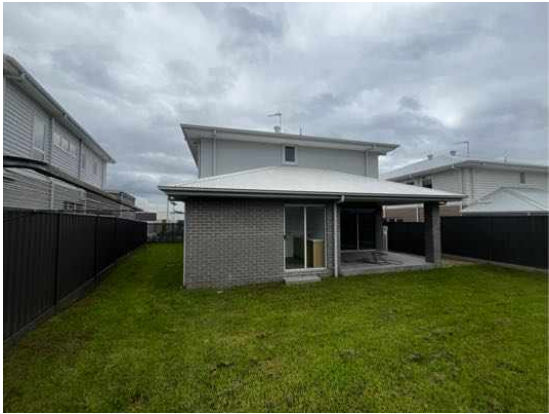
Building: Main Building
Location: All External Areas
Finding: For information only
Information: A Cluster of Photos taken at the time of inspection.

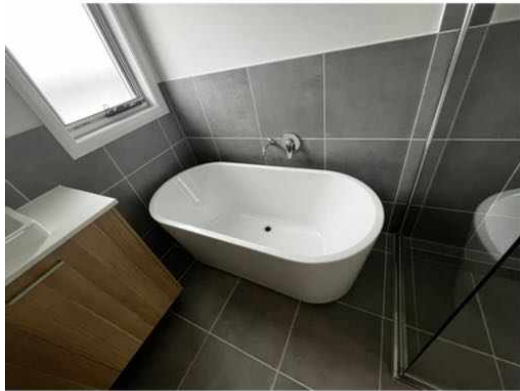
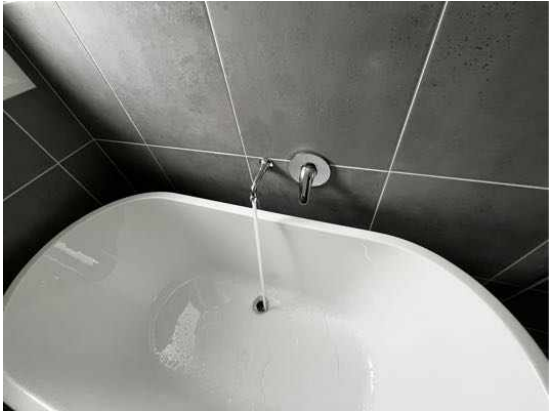
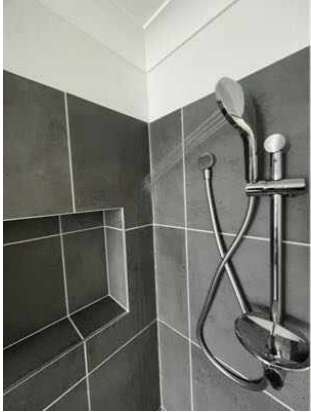
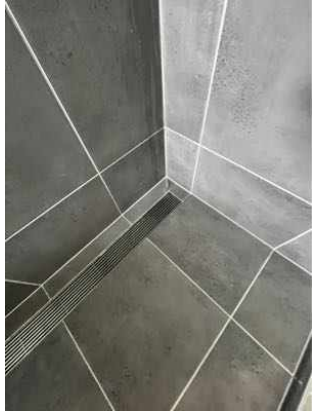
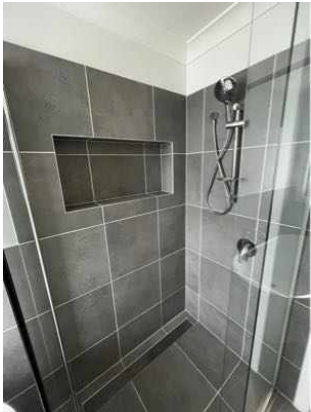
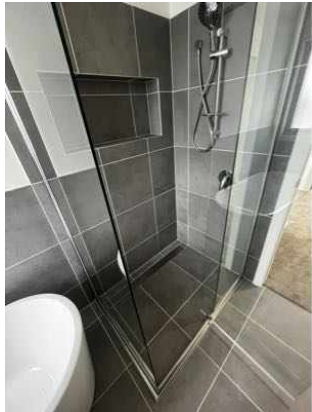
Building: Main Building
Location: Main Bathroom/ Toilet
Finding: For information only
Information: A Cluster of Photos taken at the time of inspection.

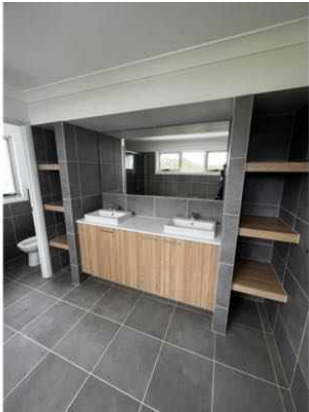
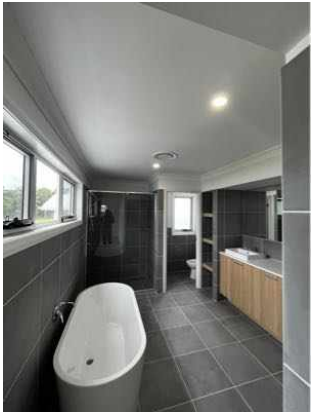
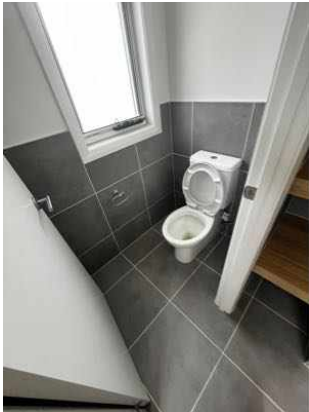
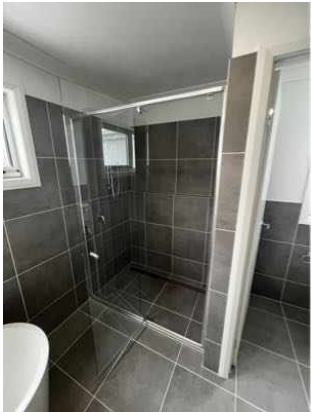
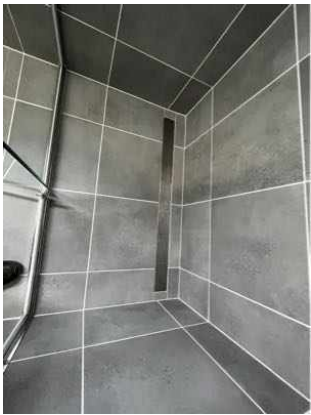
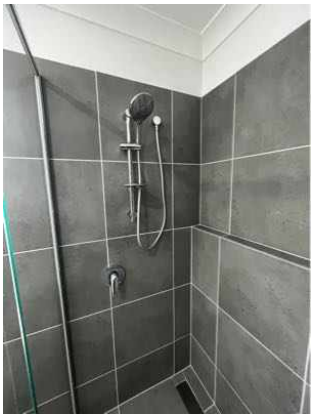
Building: Main Building
Location: Ensuite
Finding: For information only
Information: No remedial works are required at the current time.
