## Building Inspection Report

Inspection Date: Tue, 17 Mar 2026

Property Address: 35/728-730 Pacific Hwy, Gosford NSW  
2250, Australia

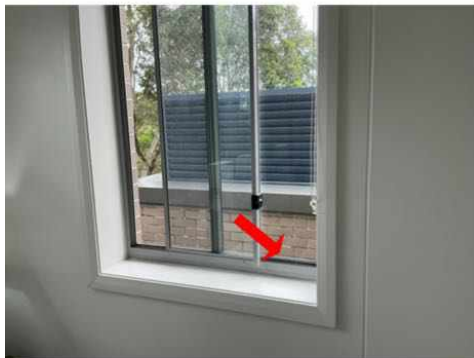
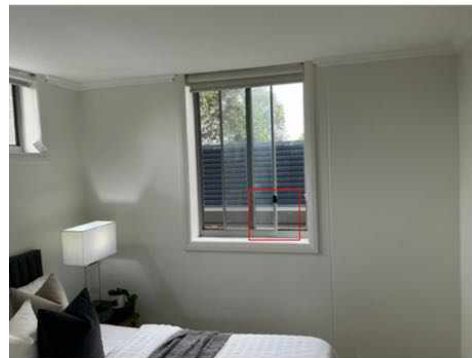
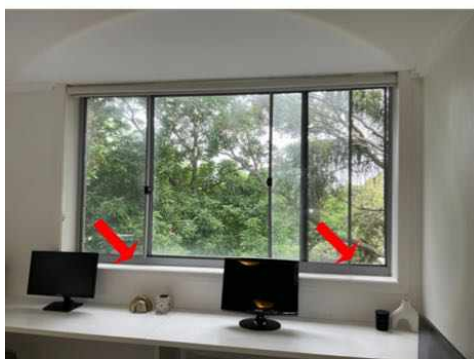
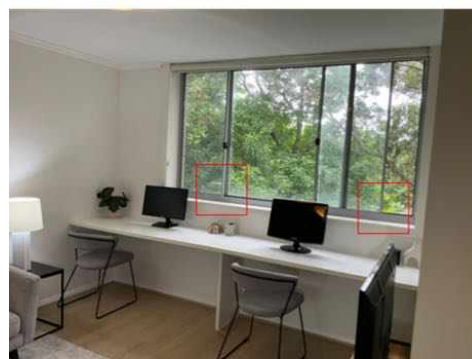
#### Defects 1.01

Building:	Main Building
Location:	All Areas
Finding:	Window Restrictors - Recommended
Information:	Upstairs windows did not have window restrictors installed. Although not a requirement at the time of construction, it is advisable to install window opening restrictors on all second storey windows with sill heights below 1.7 meter and potential fall of 2 meters or more.

If you live in a strata scheme, window safety devices must be installed on all applicable windows by 13 March 2018. Residents with safety devices installed can still fully open their windows but it's recommended that devices be engaged whenever children are present, to prevent falls.

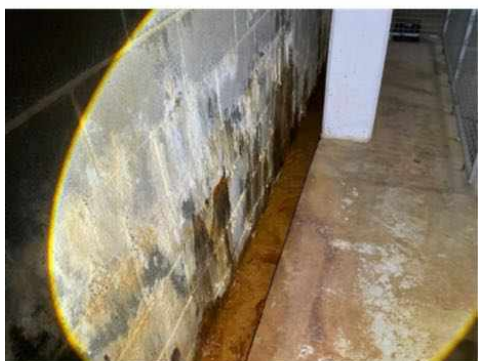
#### Defects 2.01

Building: Main Building  
Location: Garage  
Finding: Major Defect – Water Ingress and Moisture Penetration to Basement Walls  
Information: At the time of inspection, significant water ingress and moisture penetration were observed to the basement walls and slab areas. Evidence included widespread damp staining, efflorescence, mineral deposits, and active water seepage along the base of the masonry walls. Rust staining and prolonged moisture exposure were also noted, indicating that this is an ongoing and long-term issue rather than a recent occurrence.

The observed conditions are consistent with inadequate or overwhelmed stormwater drainage systems, resulting in water accumulation and migration through the retaining/basement walls. Prolonged exposure to moisture can contribute to deterioration of building materials, corrosion of embedded elements, potential mould growth, and may impact the durability and serviceability of the structure over time.

It is noted that the Owners Corporation has already engaged contractors to undertake major stormwater remediation works to address these issues, including upgrades to the drainage system, installation of new stormwater pumps, and improvements to overall water management within the basement area. These works are intended to reduce water ponding and improve stormwater discharge capacity. The remediation project is substantial in nature (noted to be in excess of \$400,000) and is scheduled over several weeks.

- Ongoing dampness or water ingress
  - New staining or efflorescence
  - Surface deterioration or mould growth
- If moisture ingress persists after completion of the remedial works, further investigation by a hydraulic engineer or waterproofing specialist may be required.

- It is also recommended that the client confirm whether there are any ongoing special levies, defects liabilities, or future capital works associated with this issue through the strata records.

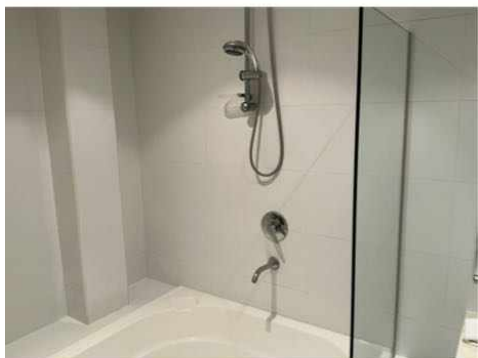
### Defects 3.01

Building:	Main Building
Location:	Bathroom
Finding:	Excessive Moisture - Shower Damp
Information:	At the time of inspection, excessive moisture was noted within the shower area, which is a common issue in wet areas due to the continual exposure to water. This condition is typically caused by moisture seeping through grout lines and settling behind tiles, resulting in localised high-moisture zones. Provided there is no evidence of water staining or elevated moisture readings on the opposite side of the wall, this is considered a minor defect.

However, persistently damp conditions may act as conducive conditions for termite activity, as termites are strongly attracted to moisture-rich environments. It is recommended that the client ensures regular use of the exhaust fan and maintains adequate ventilation after shower use to promote drying and reduce long-term moisture build-up, thereby also reducing the risk of attracting termites.

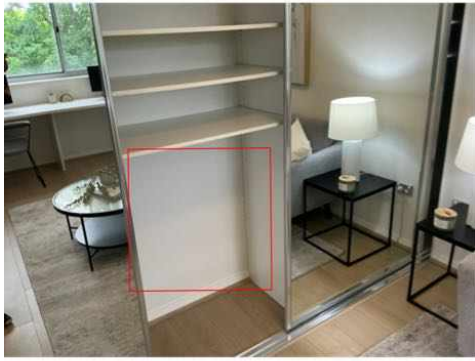
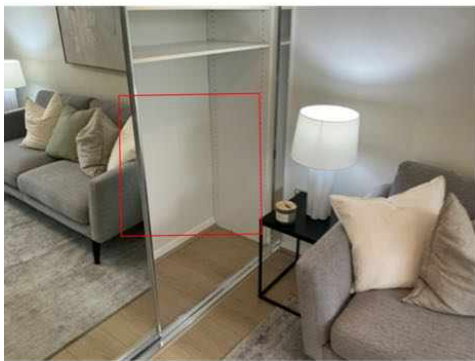
### Defects 3.02

Building:	Main Building
Location:	Living Room
Finding:	Shower Damp - Adjacent Bathroom (Monitoring)
Information:	At the time of inspection, elevated moisture levels were detected on the wall adjacent to the shower area. While no visible water damage or deterioration was noted, the presence of moisture suggests possible seepage or condensation associated with regular shower use.

At this stage, no immediate action is required. However, the area should be monitored over the next 12 months for any signs of deterioration such as staining, bubbling paint, or mould growth. It should be noted that moisture ingress of this nature does not generally resolve without intervention, and at some point remedial works are likely to be required. Should conditions worsen, the client is advised to engage services of a licensed plumber or waterproofing specialist to rectify the issue of moisture before this minor defect turns into major defect.

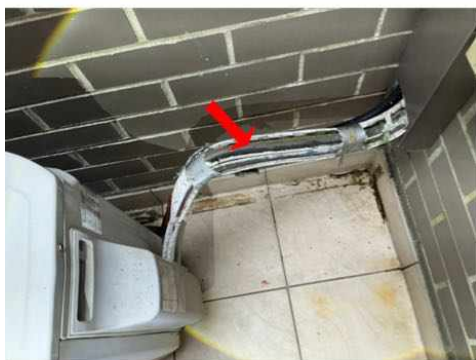
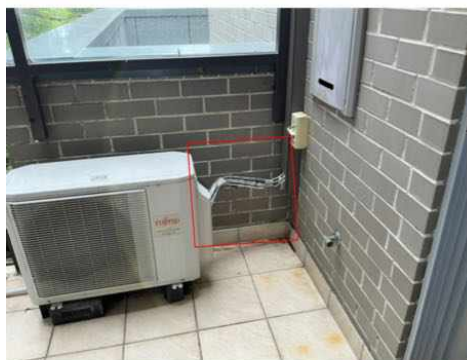
Defects 3.03

Building:	Main Building
Location:	Balcony
Finding:	Exposed Air Conditioning Services (Wiring/Insulation)
Information:	At the time of inspection, exposed and deteriorated air conditioning services (including insulated piping and associated cabling) were noted adjacent to the external condenser unit. The protective covering appears to be damaged and incomplete, leaving internal components exposed to environmental elements.

This condition may lead to accelerated deterioration of the insulation, potential damage to electrical components, reduced system efficiency, and increased risk of moisture ingress or failure over time. Exposed services may also present a minor safety risk if further deterioration occurs.

It is recommended that the client engage a licensed air conditioning specialist to properly enclose, repair, and protect the exposed services. This may include replacing damaged insulation, securing the pipework, and installing appropriate conduit or trunking to ensure the installation is safe, durable, and compliant with standard practices.

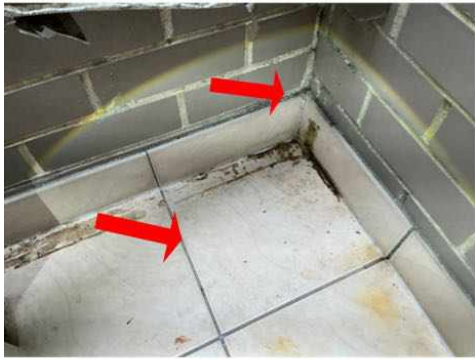
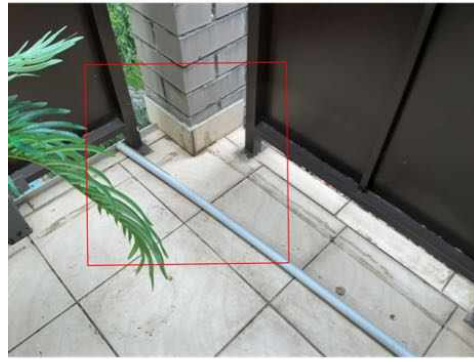
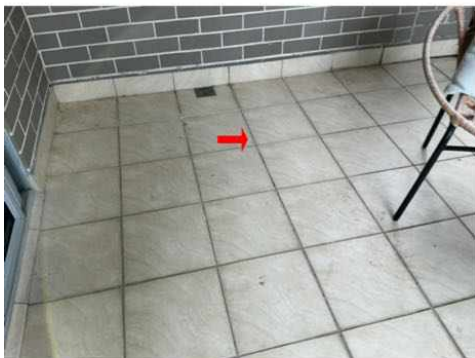
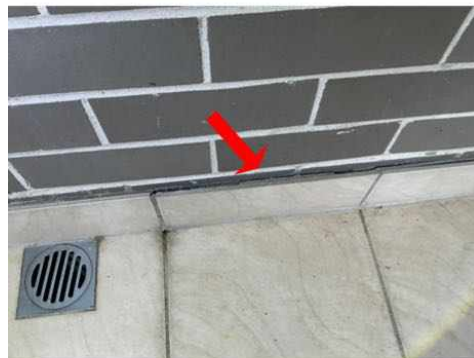
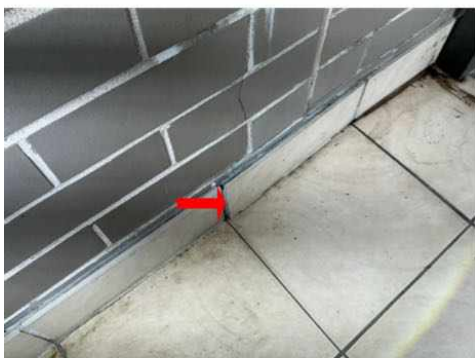
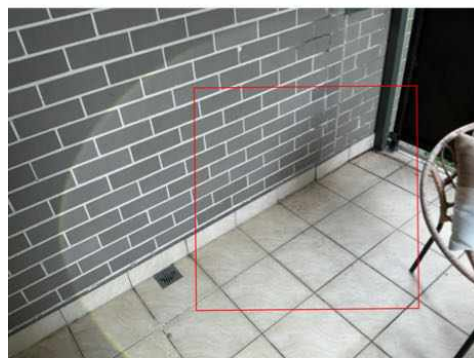
### Defects 3.04

Building:	Main Building
Location:	Balcony
Finding:	Tiles Coming off & Deteriorating Sealant/Grout
Information:	At the time of inspection, sections of tile were noted to be coming loose, with missing or deteriorated grout and sealant in the affected area. This condition may allow water to penetrate beneath the tiles, leading to potential moisture damage, mould growth, or further tile displacement. Rectification by a qualified tiler is recommended to resecure the loose tiles and reapply grout and waterproof sealant to restore the integrity of the surface.

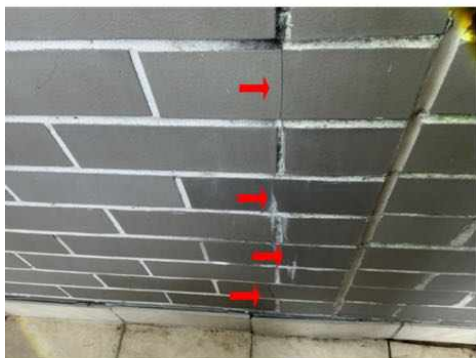
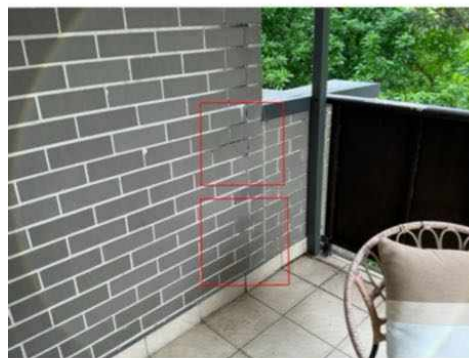
### Defects 3.05

Finding: Minor Cracks - Walls (Category 2)

Information: The minor cracks observed on the walls at the time of inspection, which are not a structural concern, could be caused by natural building movement, thermal expansion and contraction, drying shrinkage, or vibrations from nearby construction or traffic. These factors can cause the wall materials to crack over time. While these cracks are cosmetic, it is recommended to have them repaired by a painter to restore the appearance of the walls.

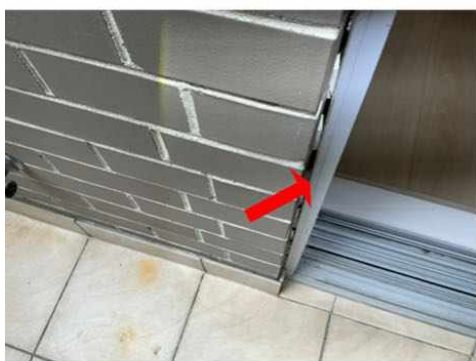
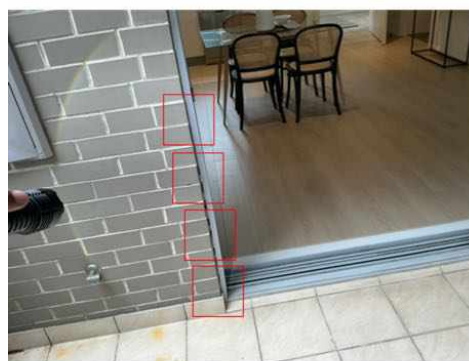
### Defects 3.06

Information: At the time of inspection, gaps were observed along the sides of the door frame. If left unaddressed, these gaps could lead to several issues impacting the functionality and condition of the property.

Unsealed gaps around the frame may compromise weatherproofing and thermal efficiency, allowing drafts and moisture ingress. This can result in higher energy costs due to heat loss, reduced comfort, and potential deterioration of interior finishes. Additionally, moisture intrusion through these gaps can encourage mould growth, damage adjacent building materials, and weaken the overall structural integrity of the installation.

A qualified tradesperson should be engaged to assess and carry out repairs.

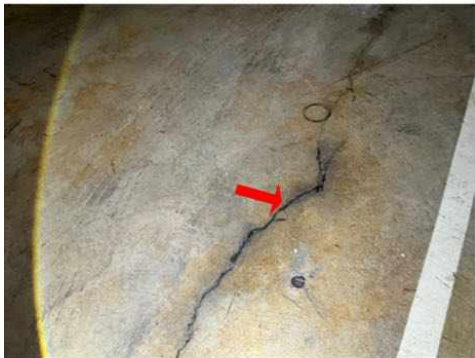
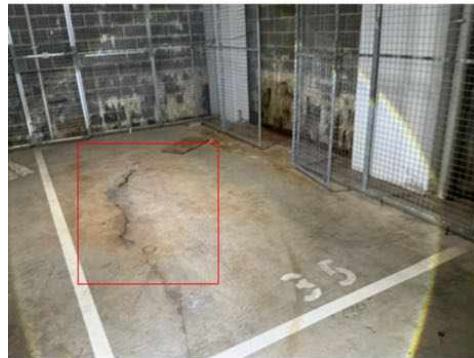
### Defects 3.07

Finding: Crack in concrete slab - Category 2

Information: A crack coded as Category 2 was identified in the slab. A Category 2 crack is described as a distinct crack, with the slab being noticeably curved or changed in level.

To be considered Category 2, the approximate width of the crack is less than 2.0mm, or a change in offset of less than 15mm when a 3m straight edge is placed over the defect.

Category 2 cracks to slabs should be monitored for a period of 12 months. At the end of the monitoring period, cracks rated greater than Category 2 are considered defects that require rectification.

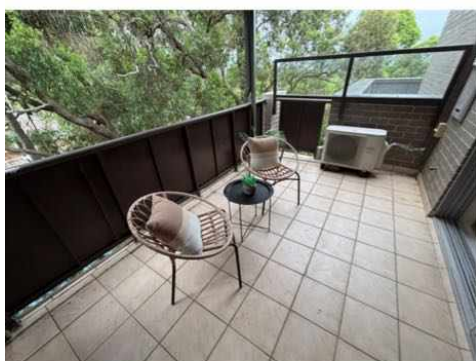
Building: Main Building  
 Location: All External Areas  
 Finding: Obstructions and Limitations - External Areas  
 Information: The attached photographs provide a visual representation of the obstructions and limitations that impeded a full inspection of the external areas of the property at the time of assessment. These obstructions, which may include vegetation, stored items, debris, or other physical barriers, can obscure potential defects and prevent a thorough evaluation of the property's condition. Obstructions of this nature can conceal a wide range of issues, such as structural damage, water ingress, pest infestations, or deteriorating building materials, which may not be visible during the initial inspection.

It is essential that these obstructions be cleared to allow for a comprehensive inspection of the external areas. Removing these barriers will enable a more accurate assessment of the property's condition and allow any hidden defects to be identified and addressed promptly. Failure to do so could result in undetected issues worsening over time, potentially leading to more costly repairs in the future.

Therefore, it is strongly recommended that the obstructions be removed and a re-inspection be scheduled once the affected areas are made fully accessible. This will ensure a complete evaluation of the property's exterior and provide the client with a clear understanding of any potential issues that may have been concealed during the initial inspection.

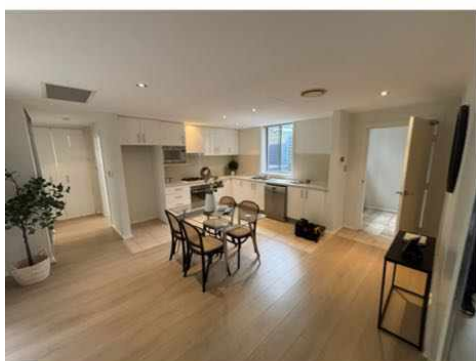
Building: Main Building  
 Location: All Internal Areas

Information: The accompanying photographs provide clear evidence of the obstructions and limitations that restricted a comprehensive inspection of the internal areas of the property at the time of assessment. These obstructions, which may include furniture, personal belongings, stored items, or structural elements such as wall coverings and built-ins, significantly hindered the ability to thoroughly evaluate these areas. It is important to note that such obstructions can potentially conceal a wide array of defects, ranging from hidden structural damage, water leaks, pest infestations, or electrical issues, to deteriorating materials that may not be visible during the initial inspection.

The presence of these impediments means that critical areas of the property were not accessible, and therefore, any underlying defects that may affect the integrity and safety of the property could remain undetected. These hidden defects, if left unaddressed, could worsen over time and may result in costly repairs or pose potential safety hazards to the occupants.

It is highly recommended that all obstructions be cleared to facilitate a complete and thorough inspection of the internal areas. Once the obstructions have been removed and full access is available, a re-inspection should be carried out to ensure that any previously concealed issues can be properly identified and rectified. This follow-up inspection will provide a more accurate assessment of the property's internal condition and help the client make informed decisions about any necessary repairs or maintenance.

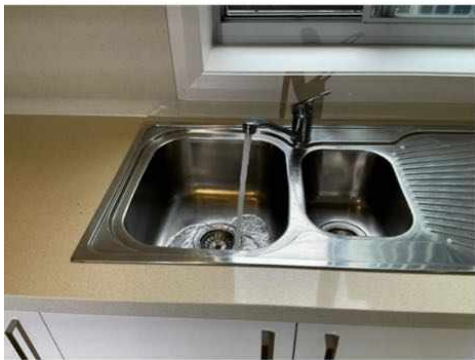
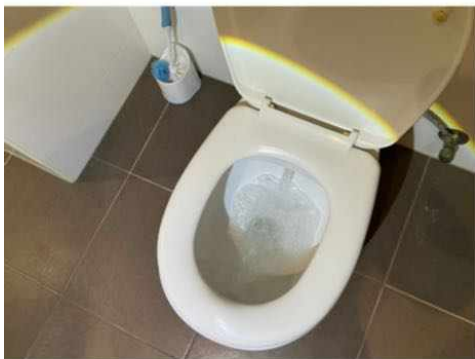
beneath sinks and vanities was undertaken, stored personal items and fixtures presented obstructions that limited full visibility of the internal areas. As per standard inspection practices, inspectors are not permitted to move or disturb personal belongings during the inspection process. Therefore, only visible and accessible sections were inspected, and concealed water damage or plumbing defects may not have been detected.

Given this, a re-inspection is recommended after all obstructions have been cleared to allow for a comprehensive assessment of these areas. Regular maintenance and monitoring of plumbing and drainage systems is also advised to ensure ongoing functionality and early detection of potential issues.

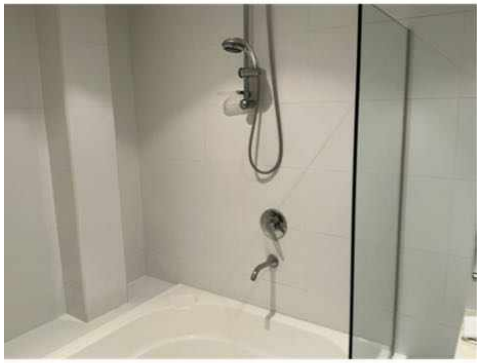
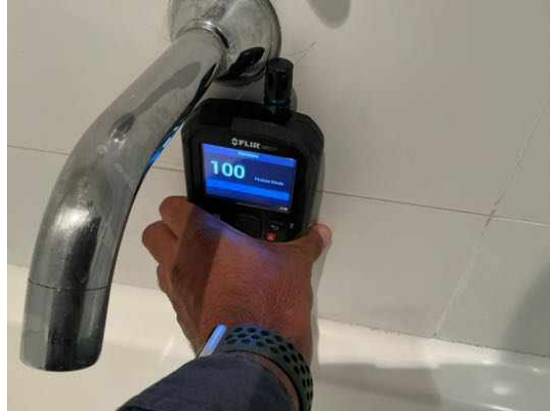
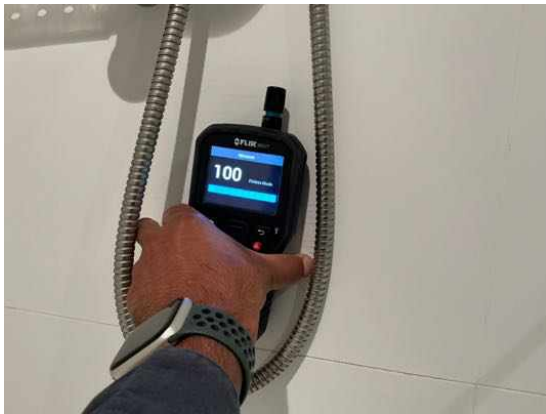
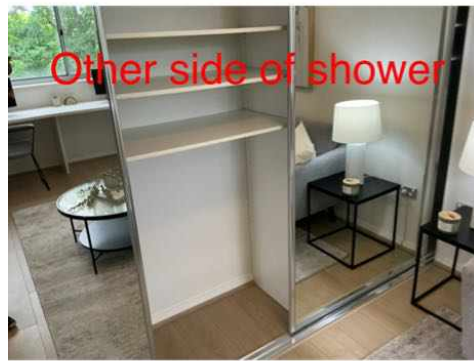
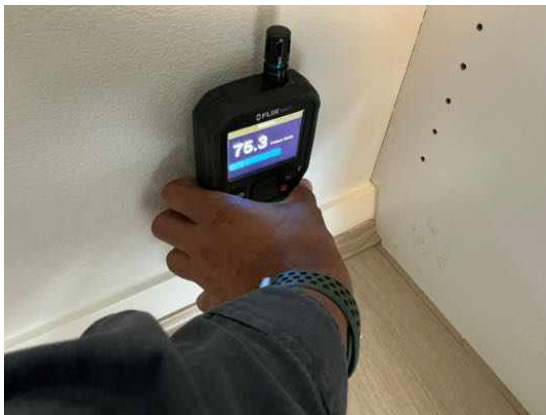
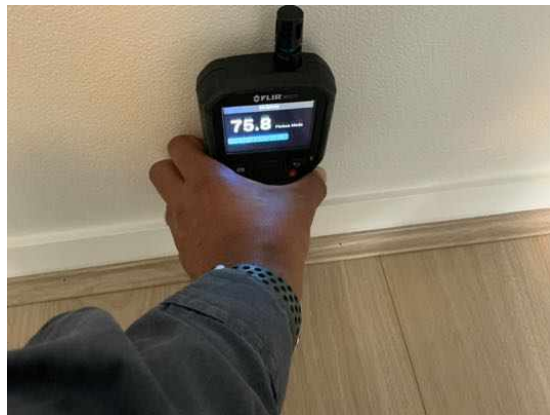
It is important for the client to understand that moisture levels can fluctuate over time due to various factors, including changes in weather, humidity, and environmental conditions. While the readings reflect the property's moisture levels during the inspection, they may not represent future conditions, and increased moisture could lead to issues such as dampness, mould growth, or deterioration of building materials if left unmonitored.

For further clarification or additional information regarding the moisture readings, the client is encouraged to contact the building inspector directly. Regular monitoring of moisture-prone areas is recommended to ensure any emerging concerns are addressed promptly, particularly during wetter seasons or in high-humidity conditions.

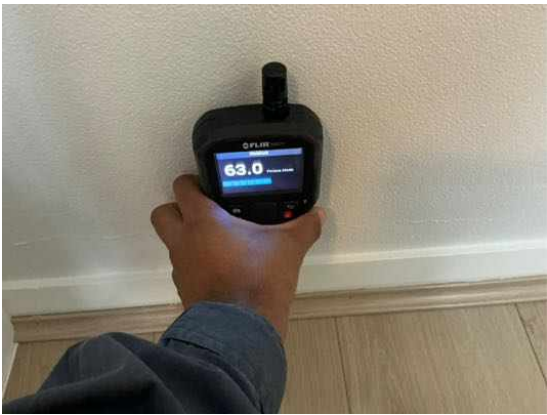
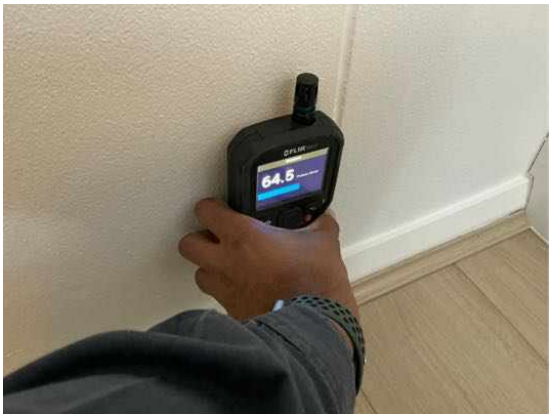
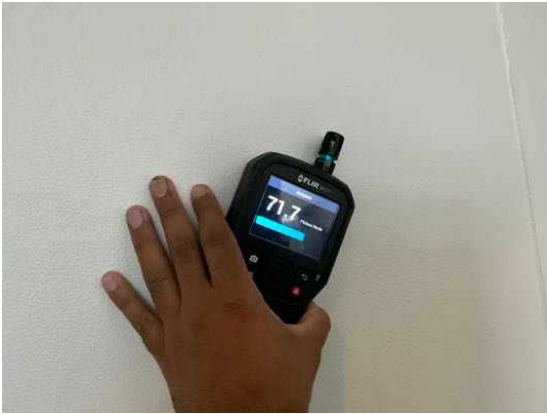
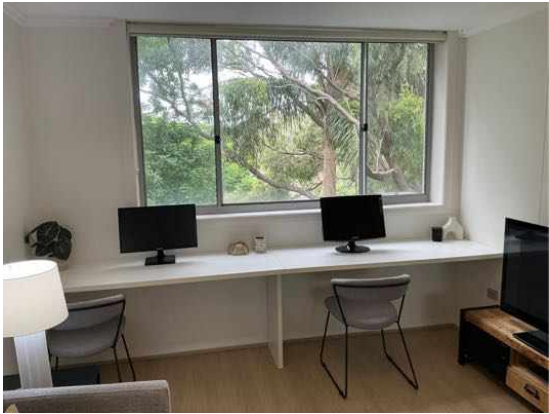
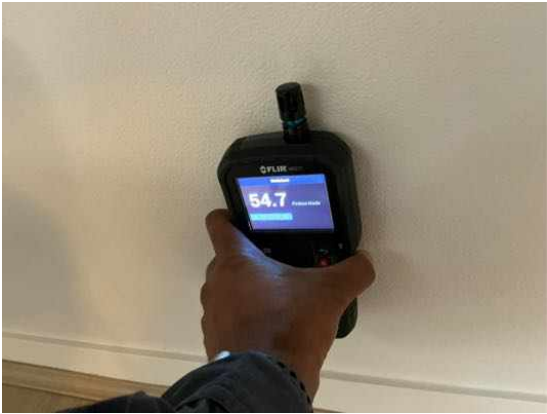
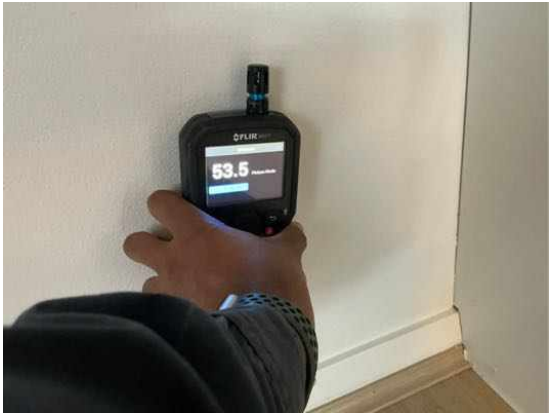
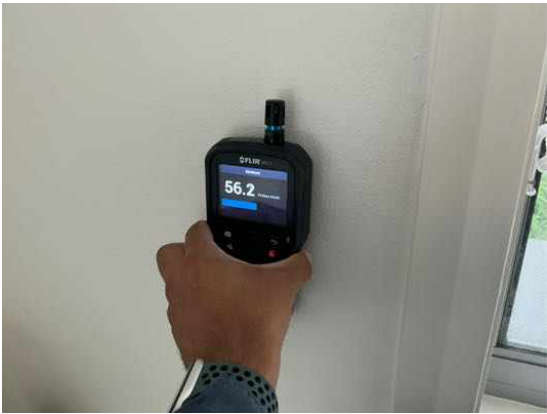
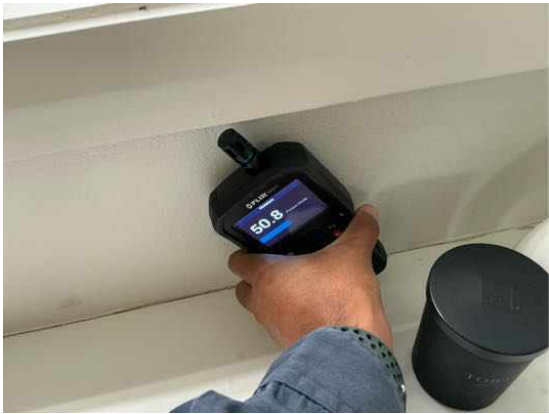
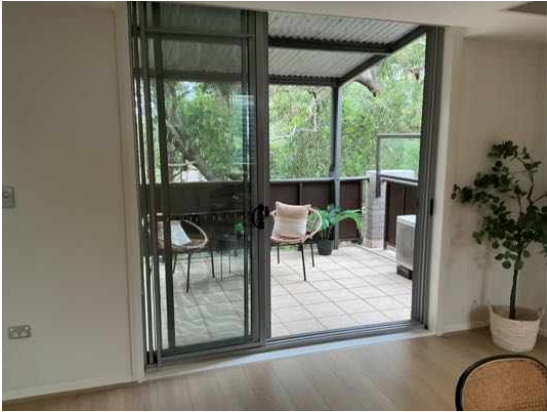
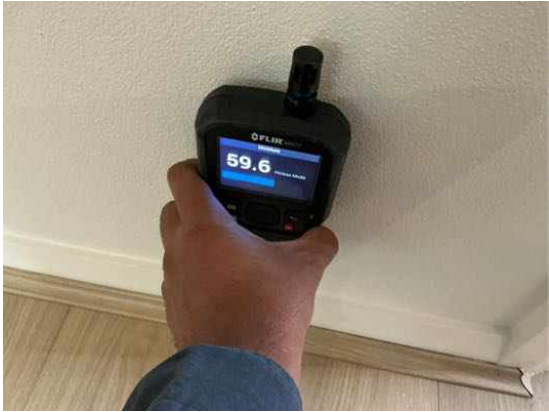
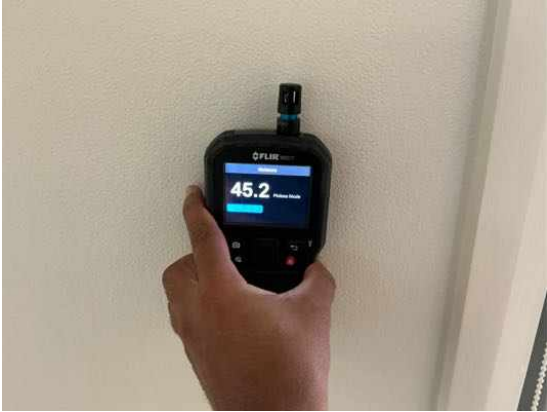
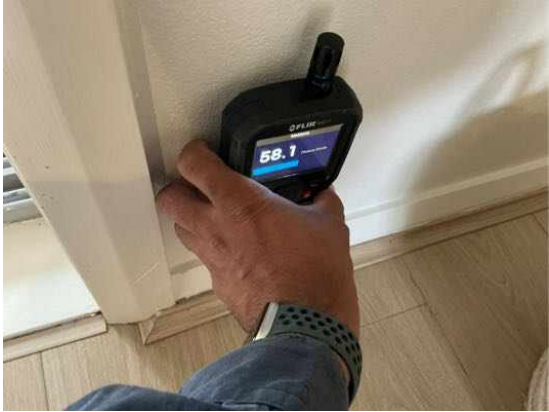
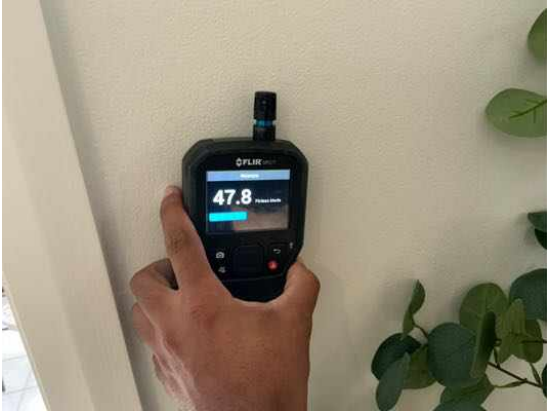
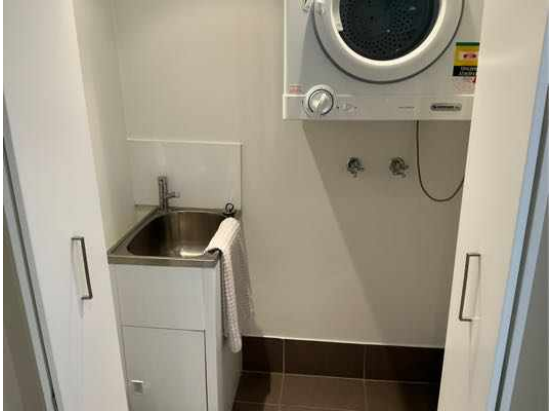
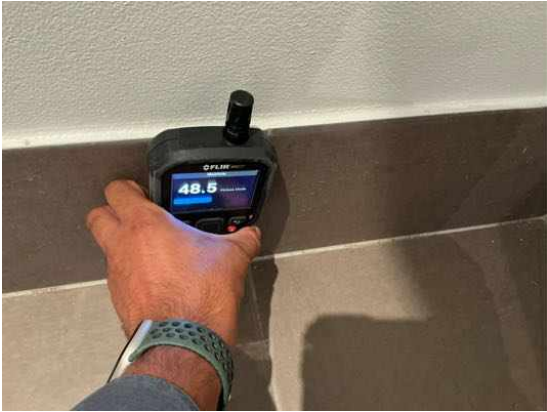
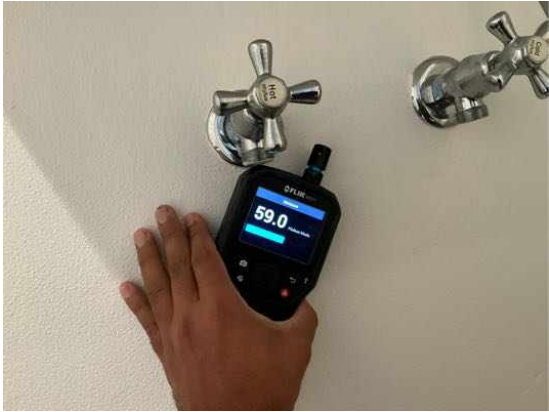
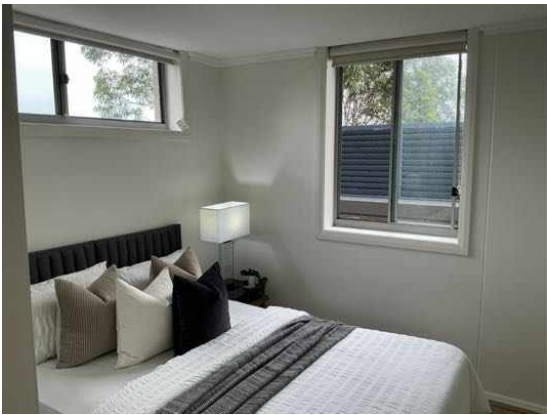
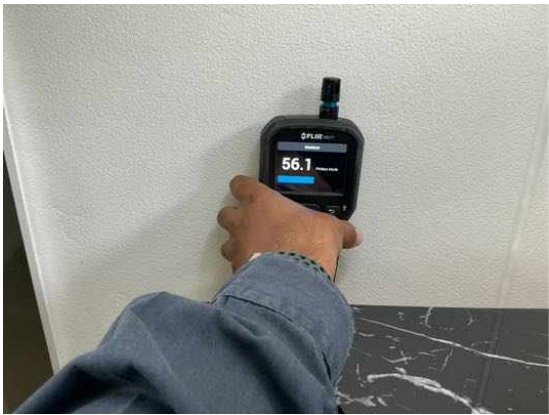
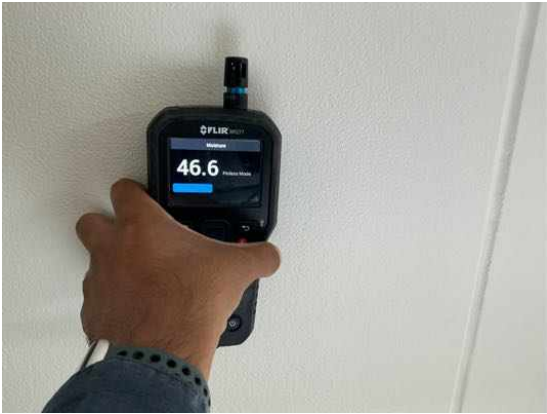
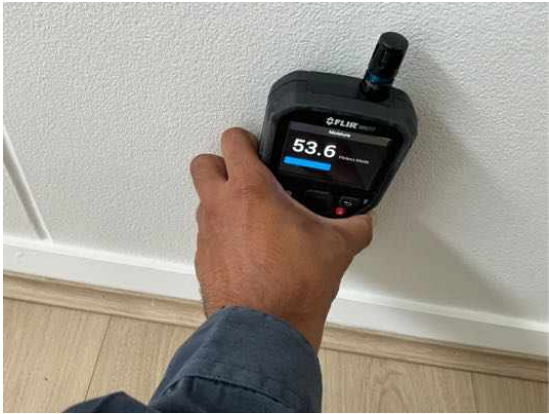
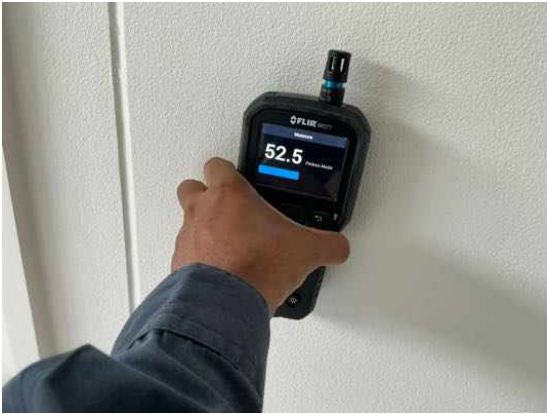
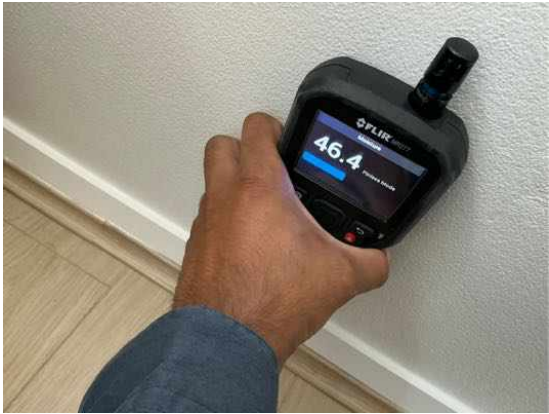
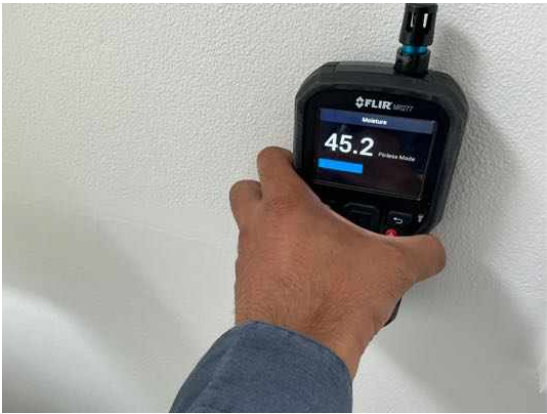
Building:	Main Building
Location:	All Areas
Finding:	Additional Photos - Moisture Meter Readings
Information:	Additional moisture meter reading photos have been provided for the property to offer further clarity on areas tested during the inspection. These photos are intended to give a visual reference for the specific locations where moisture levels were measured. These readings were taken at the time of the inspection to assess any potential moisture-related issues within the property. Any defects related to moisture that were identified during the inspection have been separately mentioned in the defect statements within the report.

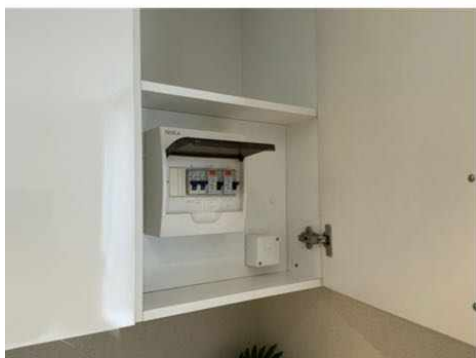
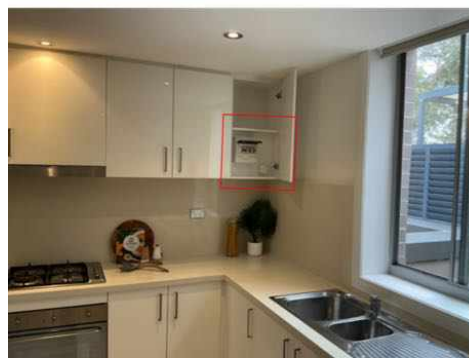
Building:	Main Building
Location:	Kitchen
Finding:	Electrical Meter Box
Information:	Electrical meter box is located in kitchen cabinets

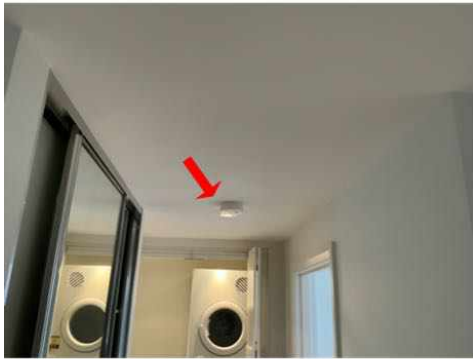
Building:	Main Building
Location:	Hallway
Finding:	Smoke Detectors and Alarms
Information:	The reporting on smoke detectors or alarms, including hard-wired smoke detection systems and their compliance with legislative requirements, falls outside the scope of this inspection report. However, based on our experience in the building industry, we feel it is important to highlight the absence or poor condition of smoke detectors as a significant safety concern. While this observation is included as a cautionary note, addressing the presence and condition of smoke detectors should be considered an urgent priority to enhance the safety of the building's occupants.

It is strongly recommended that a further inspection and advisory service be undertaken to assess the sufficiency, type, and location of smoke detectors throughout the property. This should also include testing the functionality of all devices to ensure they are operational and compliant with relevant safety standards. Greater fire safety and detection requirements, including specific placement and type of smoke detectors, apply to commercial buildings, which should be reviewed based on building use and local regulations.

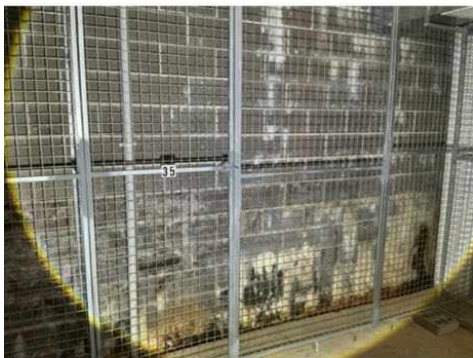
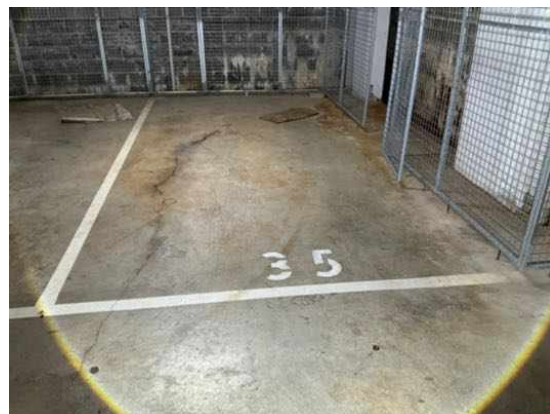
Finding: Allocated Car Spaces & Storage Room

Information: The accompanying photos are provided for your general reference, showcasing the current condition of the car parking spots and storage rooms as observed at the time of inspection. It is important to note that these images are meant to serve as a visual snapshot of the property's features at the time of the assessment. However, the client is strongly advised to confirm all allocations, such as car parking spots, storage rooms, and any associated rights or access, within the terms of the contract. Verifying these allocations through the contract ensures clarity and avoids potential disputes regarding ownership or usage. The photos included are intended to give an overview of the designated areas, but the final details should always be cross-referenced with the contractual agreements for accuracy and completeness.

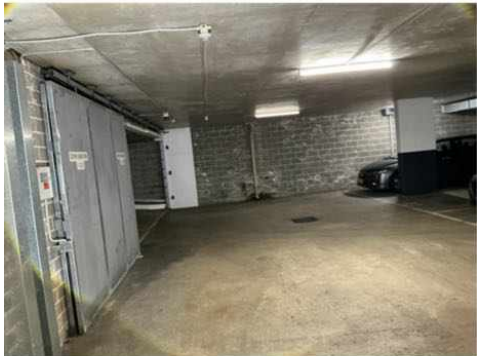
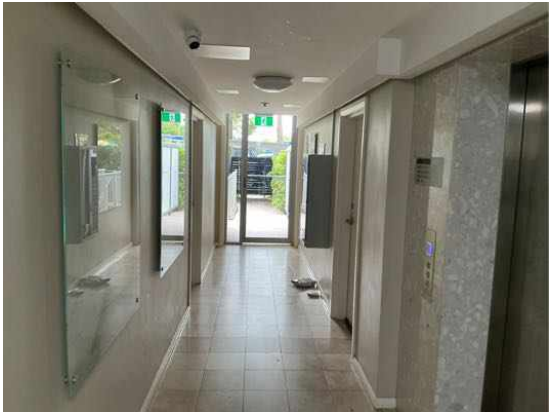
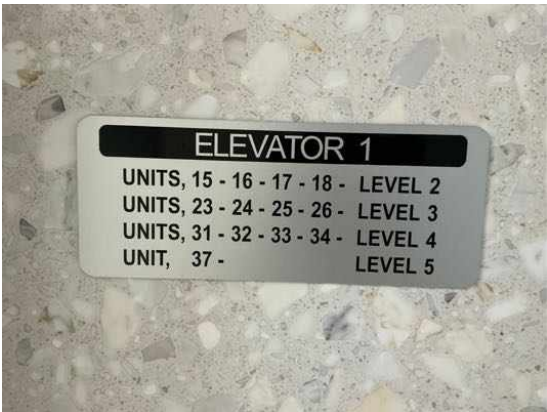
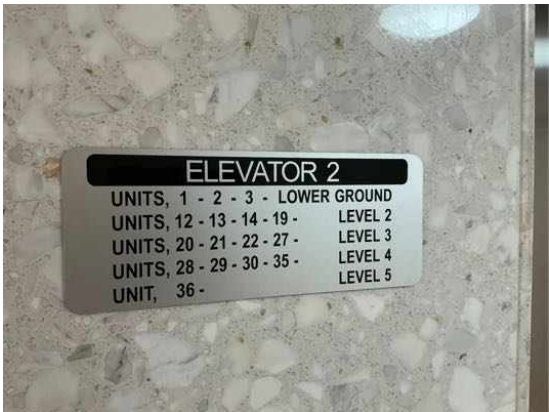
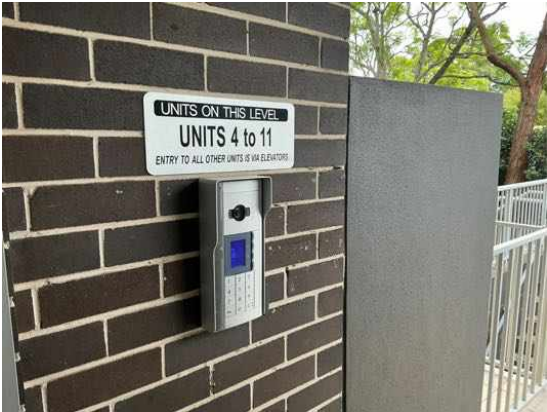
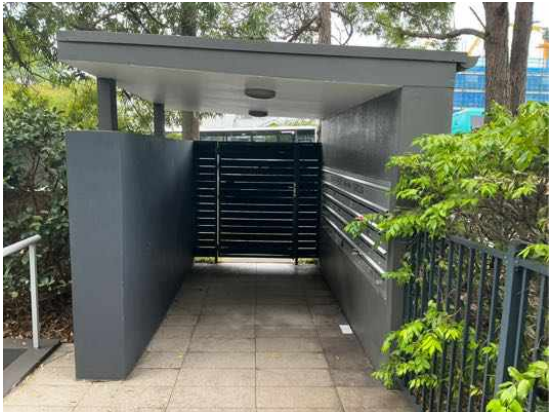
Finding: Additional Photos of Common Areas

Information: Additional photos have been provided for your general reference. These images serve as visual documentation of the current condition of the common areas within the building complex at the time of inspection. It is recommended that the client consult with strata management regarding any necessary repairs or maintenance required throughout the complex. These photographs are intended to illustrate the present state of the common areas and should be used as a basis for discussing and prioritizing any needed remedial works with the relevant parties.
